Structural Condition Analysis and Assessment of Dormitory Facilities

December 17, 2019

Site Located at 820 Ka'ahumanu Avenue, Kahului, Maui 96732 TMK: (2)3-8-07:117

Summary of Structural Field Condition Survey for the Existing University of Hawaii Community College Dorm Campus Buildings and Appurtenances

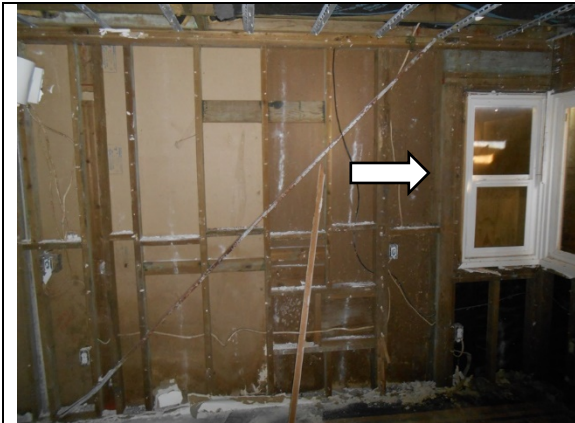
PA1CD.6: At various locations, openings missing king jamb post(s).

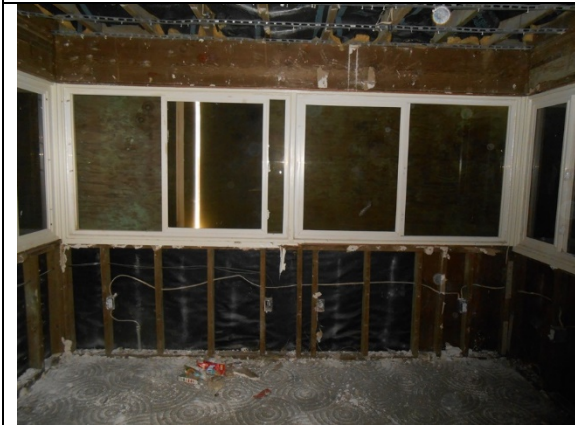
PA1CD.7: At various locations, wide wall opening with single sill plate.

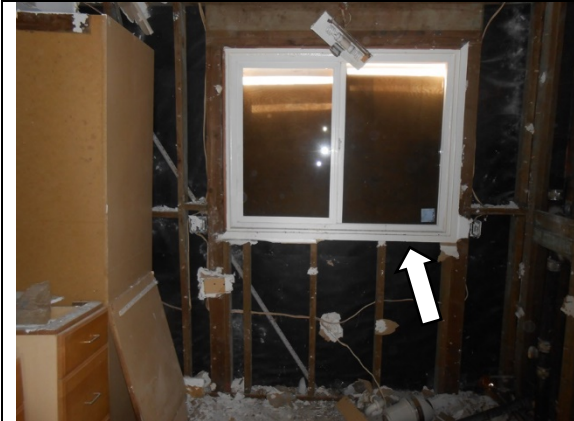
PA1CD.9: At various locations, openings missing sill plate.

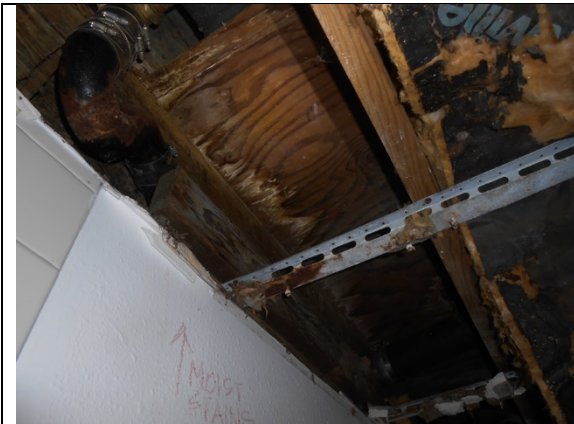
PA2D.1: Moisture stains present on plywood sheathing adjacent to rusty pipe.

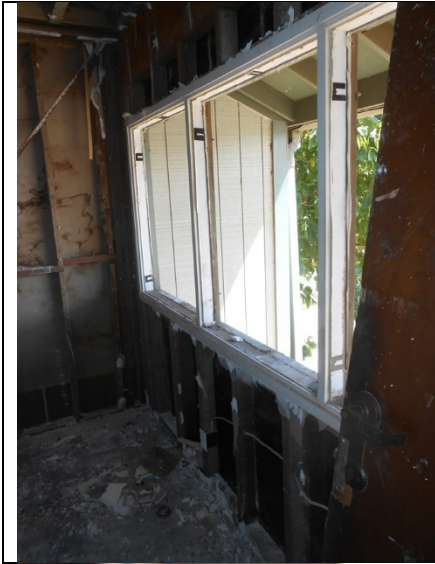
PA2CD.1: Wide opening single sill plate.

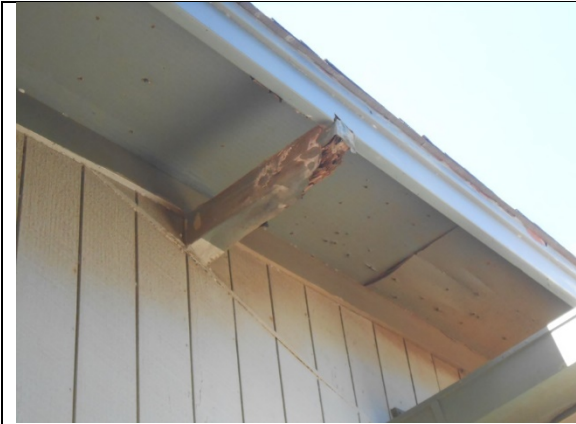
PARD.1: Beam overhang dry rot.

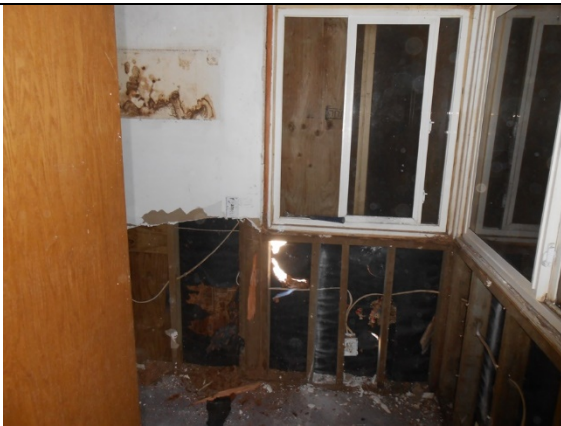
PB1D.2: Siding dry rot.

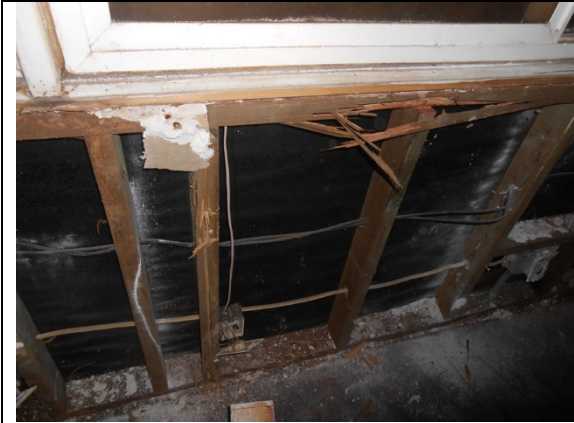
PB1D.4: Stud termite damage. Sill plate termite damage.

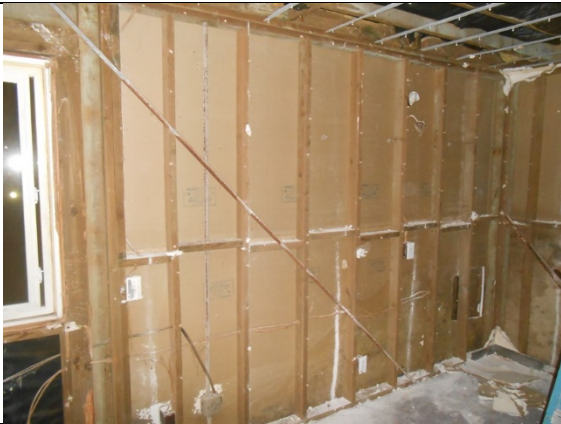
PB1D.6: Rusting steel wall braces.

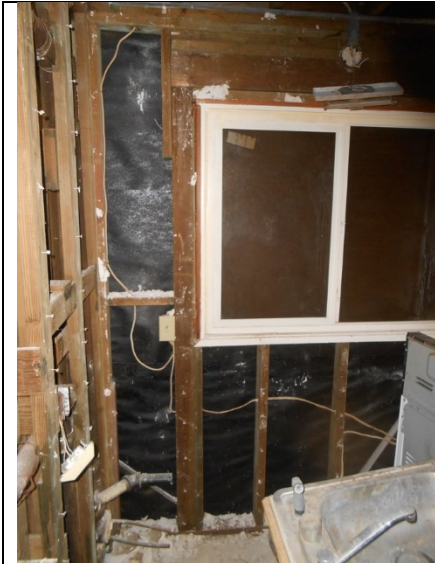
PB1CD.1: Missing opening king post.

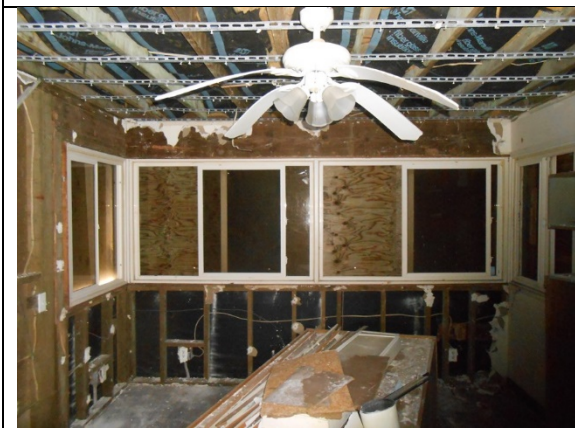
PB1CD.2: Wide opening with single sill plate.

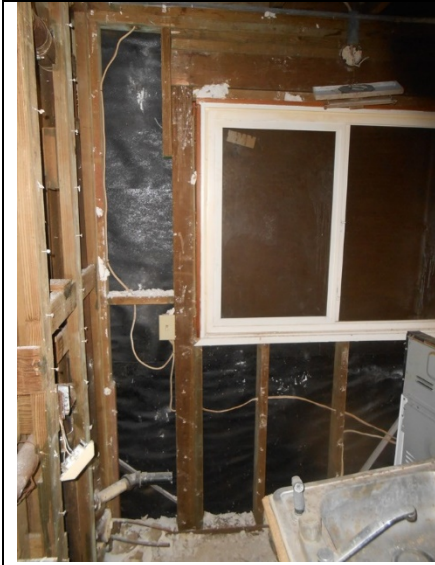
PB1CD.3: Missing opening sill plate.

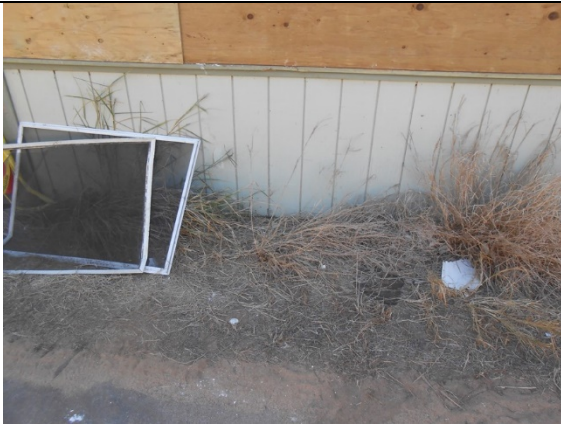
PB1CD.4: Vegetation against building façade.

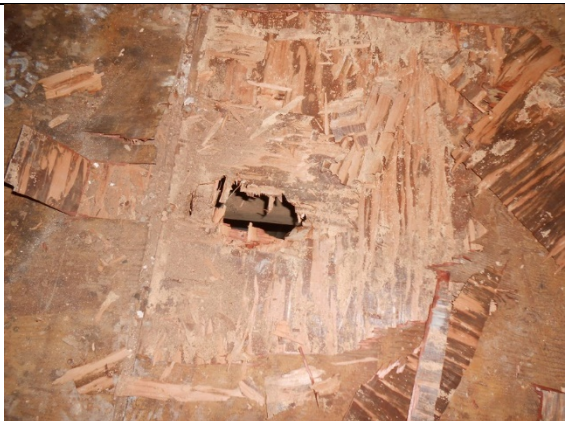
<p>PB2D.1: Floor sheathing dry rot.</p>

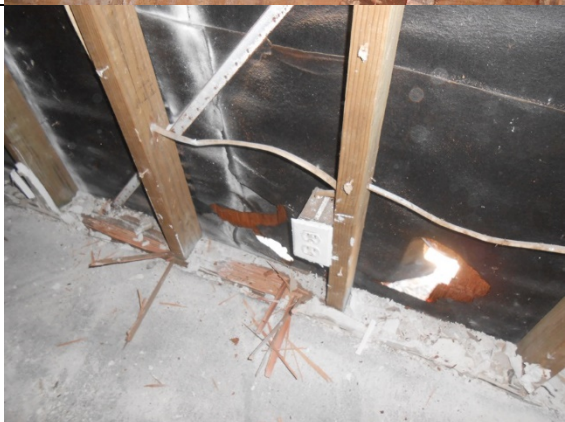
<p>PB2D.2: Sole plate dry rot.</p>

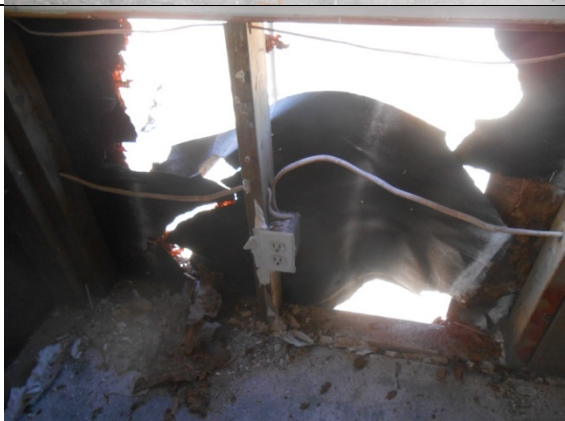
<p>PB2D.3: Sheathing dry rot.</p>

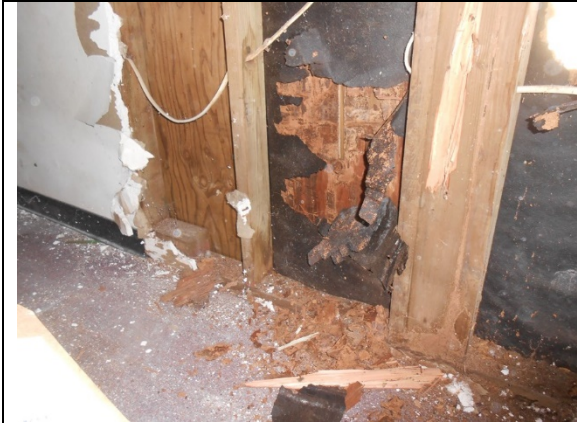
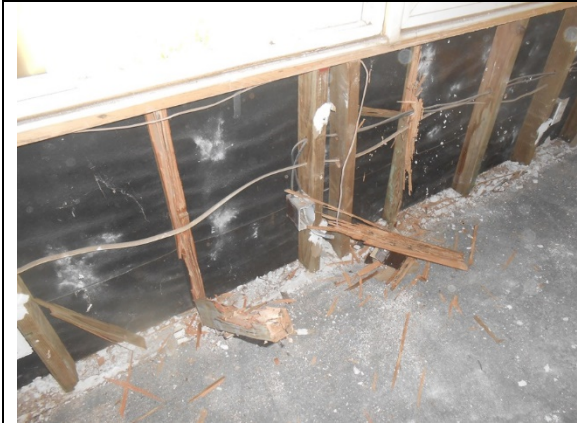
PB2D.4: Stud termite damage.

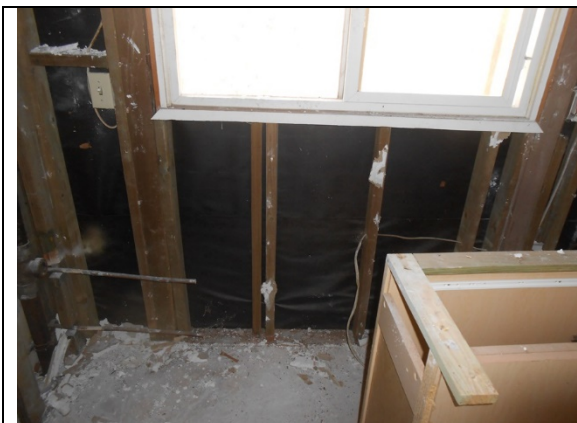
PB2CD.1: Missing wall blocking.

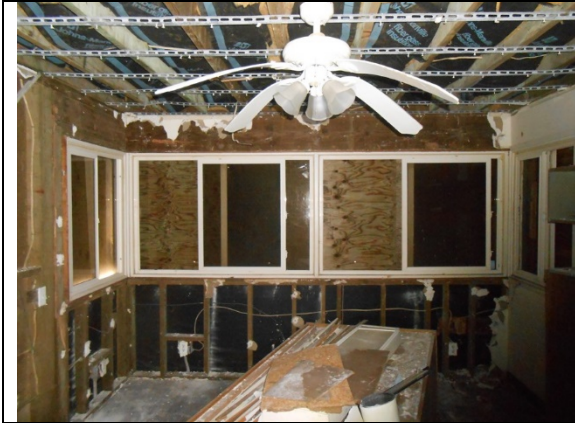
PB2CD.2: Missing blocking

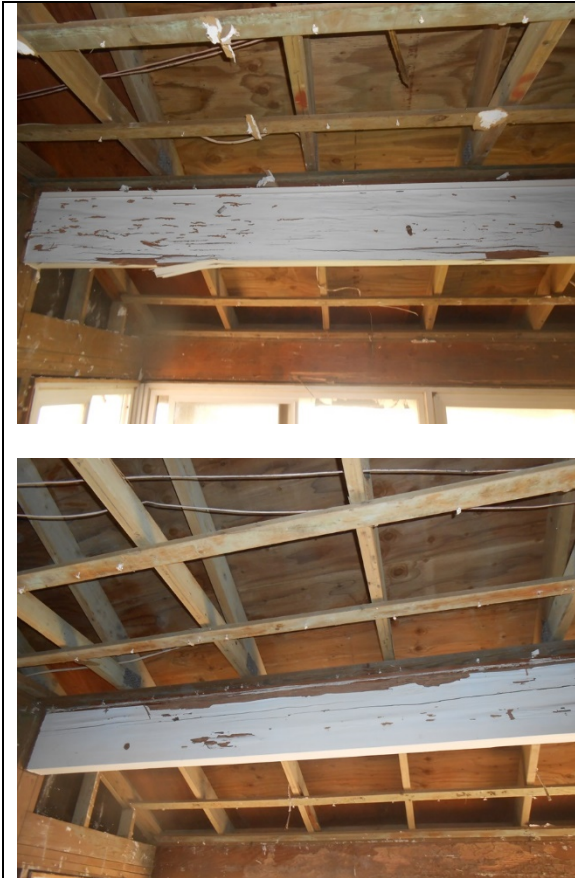
PBRD.1: Beam termite damage.

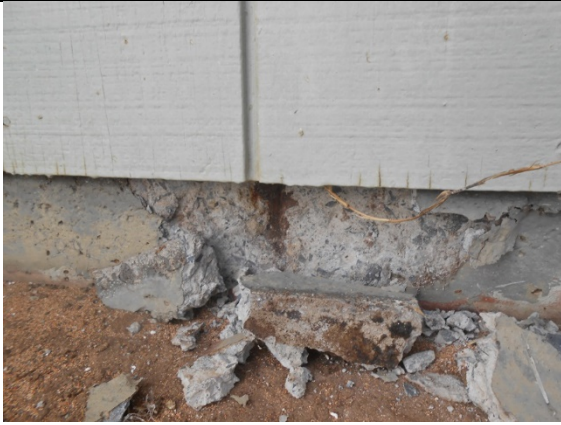
PC1D.1: Concrete spall with exposed corroded reinforcing steel.

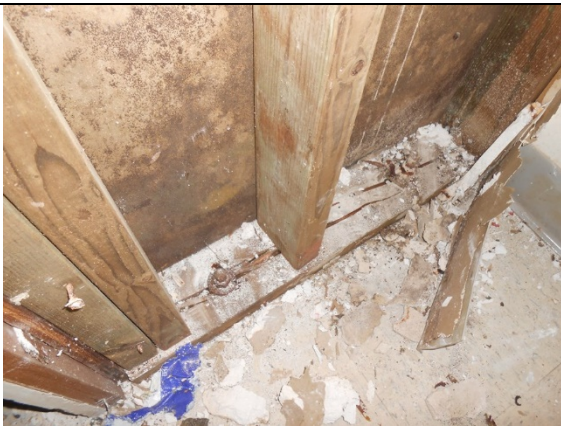
PC1D.2: Split sole plate.

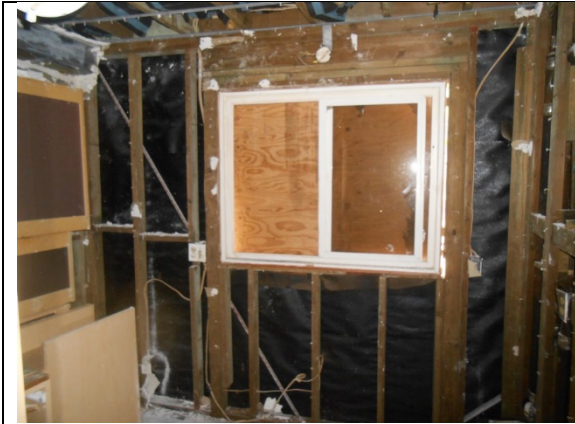
PC1CD.1: Missing opening king post.

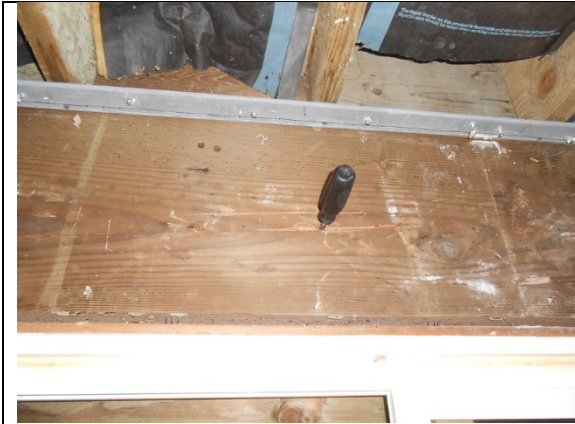
PC2D.1: Beam termite damage.

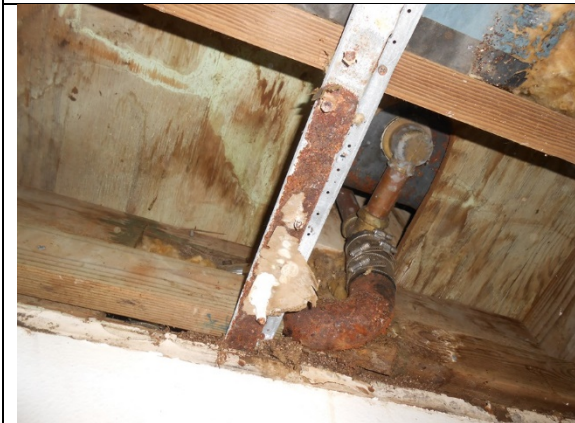
PC2D.2: Moisture damage to floor sheathing adjacent to rusting pipe.

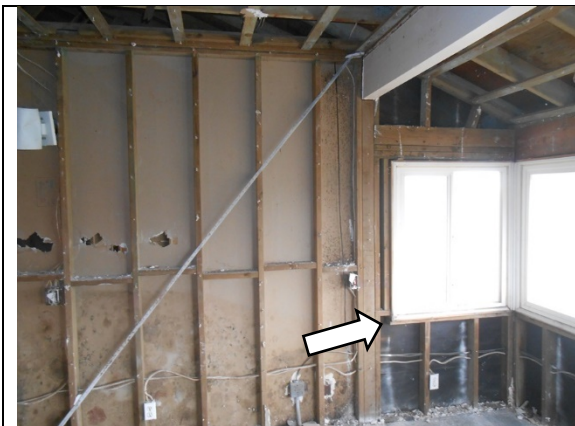
PC2CD. 1: Missing opening king post.

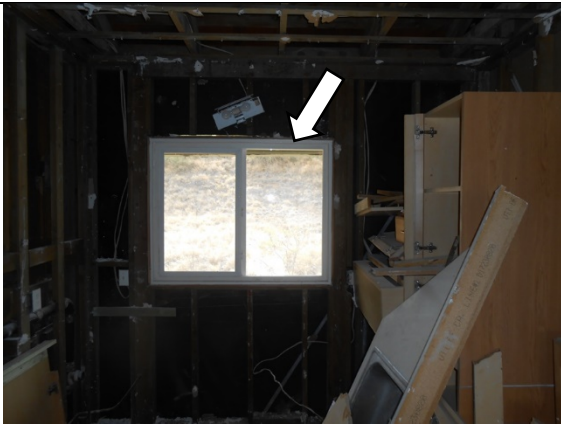
PC2CD.4: Missing opening header.

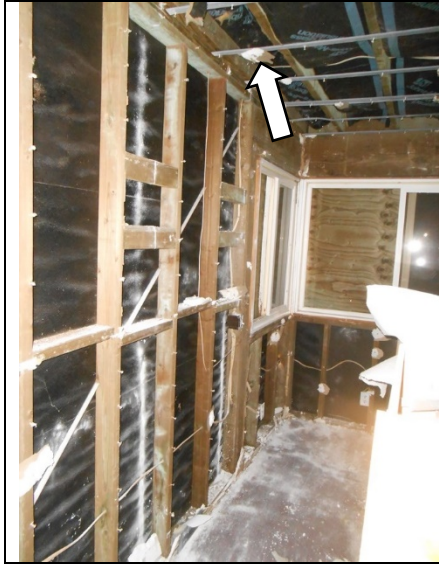
PC2CD.5: Missing wall blocking.

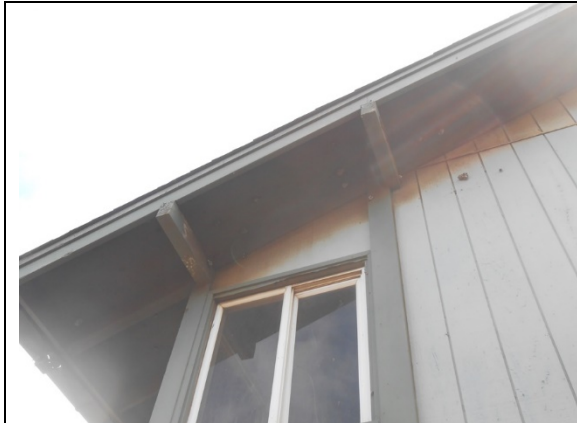
PCRD.1: Beam overhang dry rot.

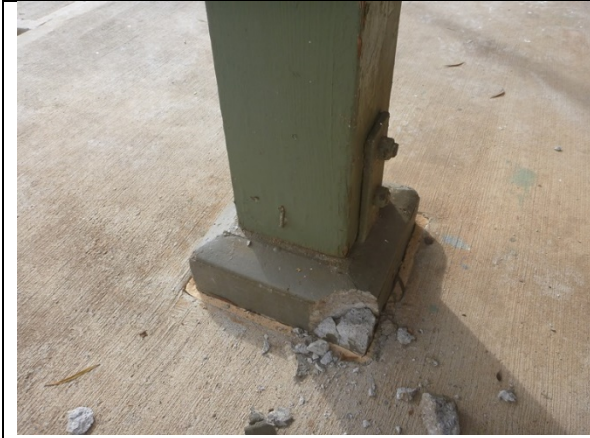
1. The top northwest corner of the concrete pier at Gridline '5-D' is broken off, spalled.
2. At Gridline '5-D', the top of the wood post is damaged by termites. The end of the beam, along Gridline '5', at this location is also damaged by termites.
3. At various locations, exterior sheathing is damaged or missing.
4. Minor dry rot is present at the base of the wood post at Gridline '1-D'.
5. A small region of roof sheathing is moderately damaged adjacent to Gridline's 'B-4'. A depression can be seen from the exterior.

RC1D.1: Minor concrete spall at the northwest corner of the concrete pier at Gridlines '5-D'.

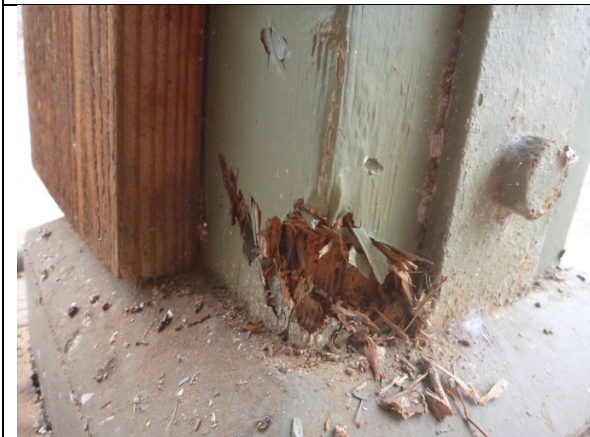
RC1D.2: Post at Gridlines 'D-1'; minor dry rot present at southeast corner of post base

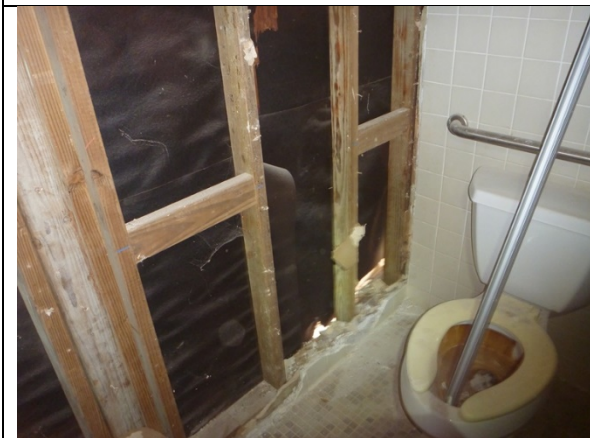
RC1D.3: Damaged siding at southwest corner of women's restroom.

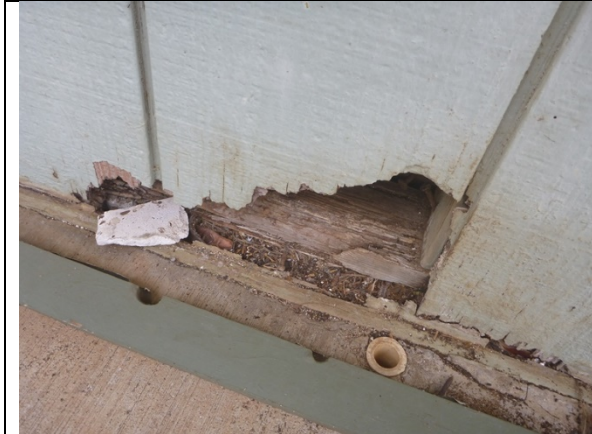
RC1D.4: Sole plate dry rot at heater room.

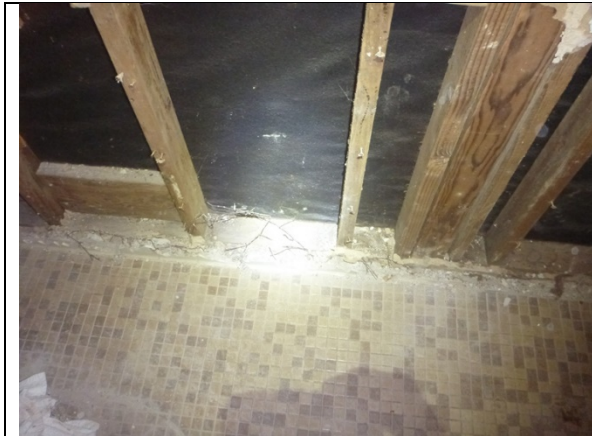
RC1CD.1: At various locations, sole plate anchor rods are installed at more than 32 inches on-center or missing.

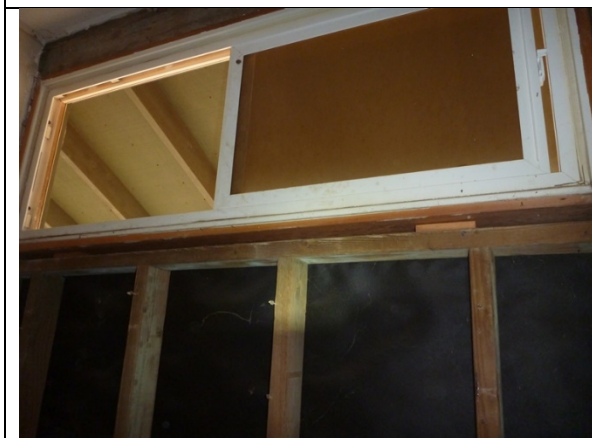
RC1CD.2: At various locations, windows are supported on spaced blocks.

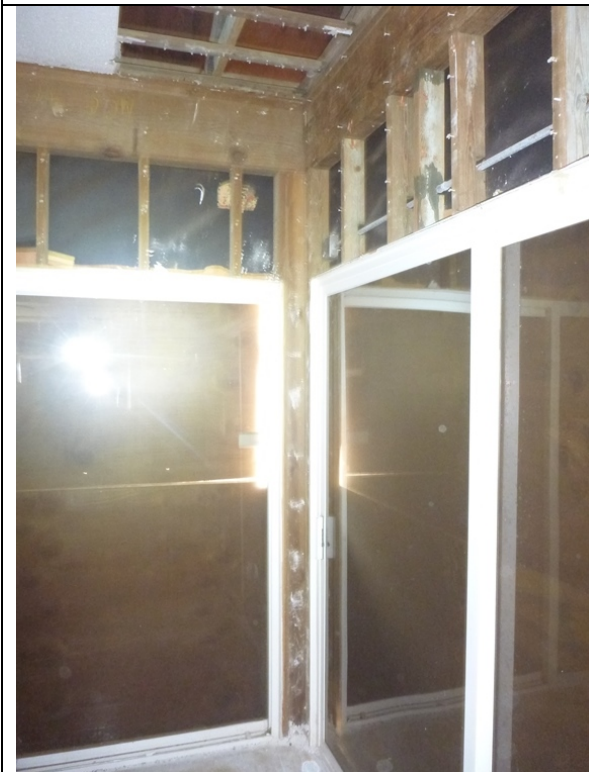
RC1CD.7: Typically, recreational room north, east, and west openings are missing double wood plate above the opening.

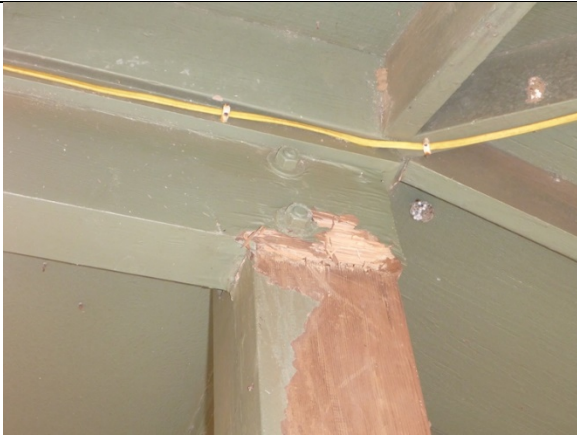
RCRD.1: Moderate termite damage present at beam to column connection at Gridlines '5-D'.

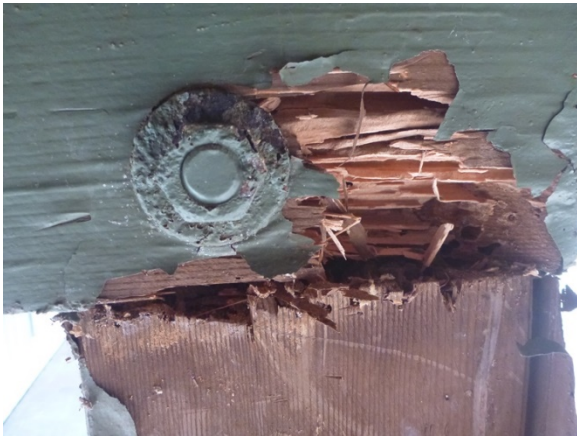
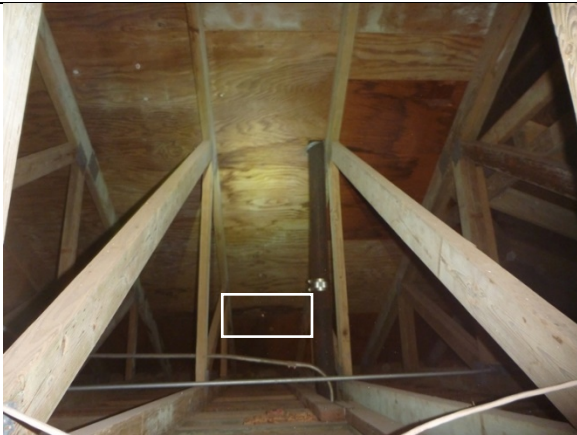
RCRD.2: Region of damaged plywood sheathing.

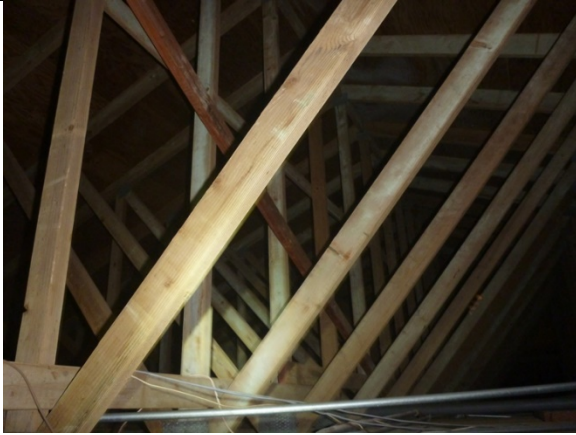
RCRCD.1: Web bracing missing.

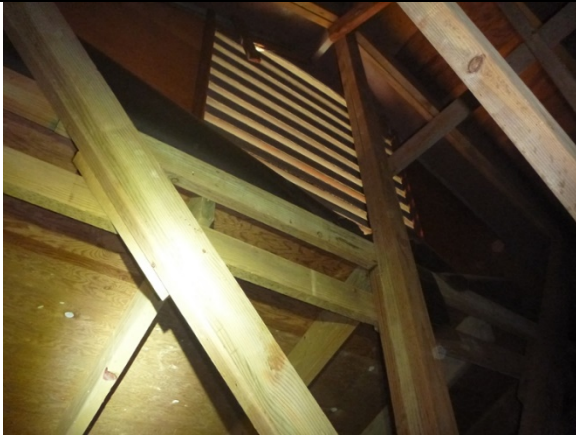
RCRCD.2: Gable end wall missing stud wall framing.

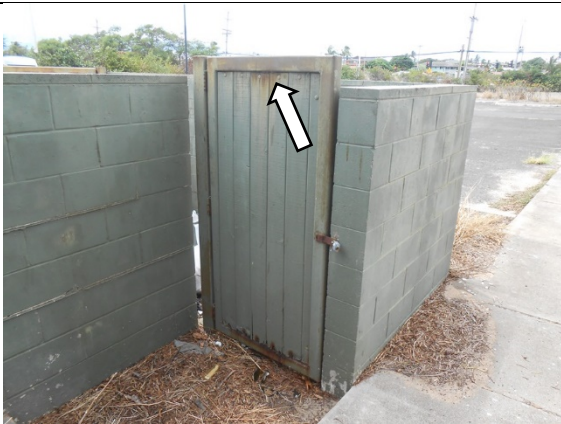
PTESB3: Rusting trash enclosure door.

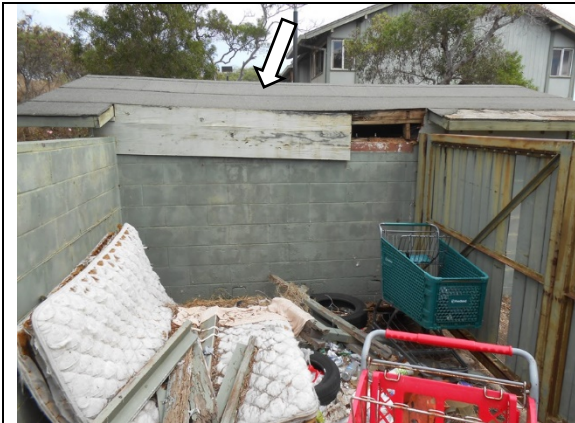
PTESB4: Damaged storage building roof.

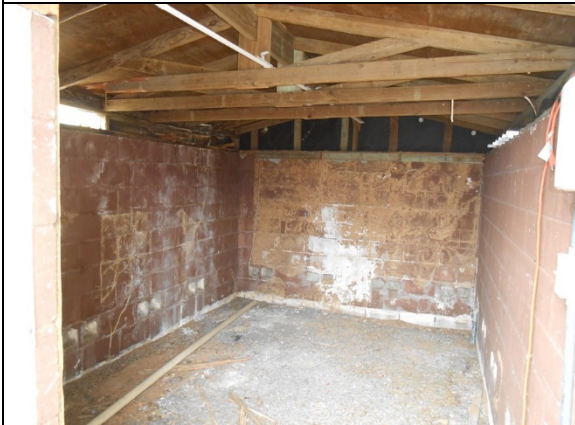
PTESB5: Interior view of storage building.

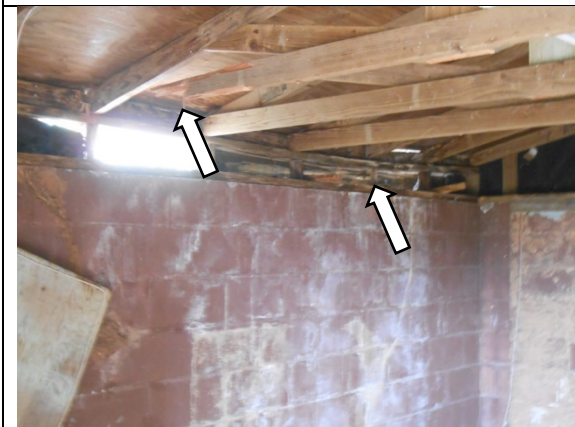
PTESB6: Collapsed storage building south wood framed stem wall. Damaged truss bottom chord.

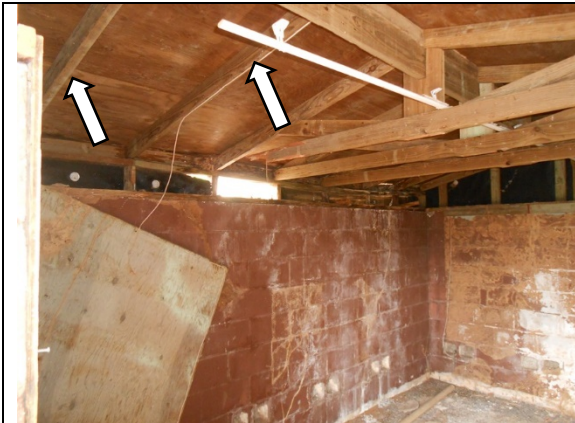
PTESB7: Damaged trusses. Missing truss framing.

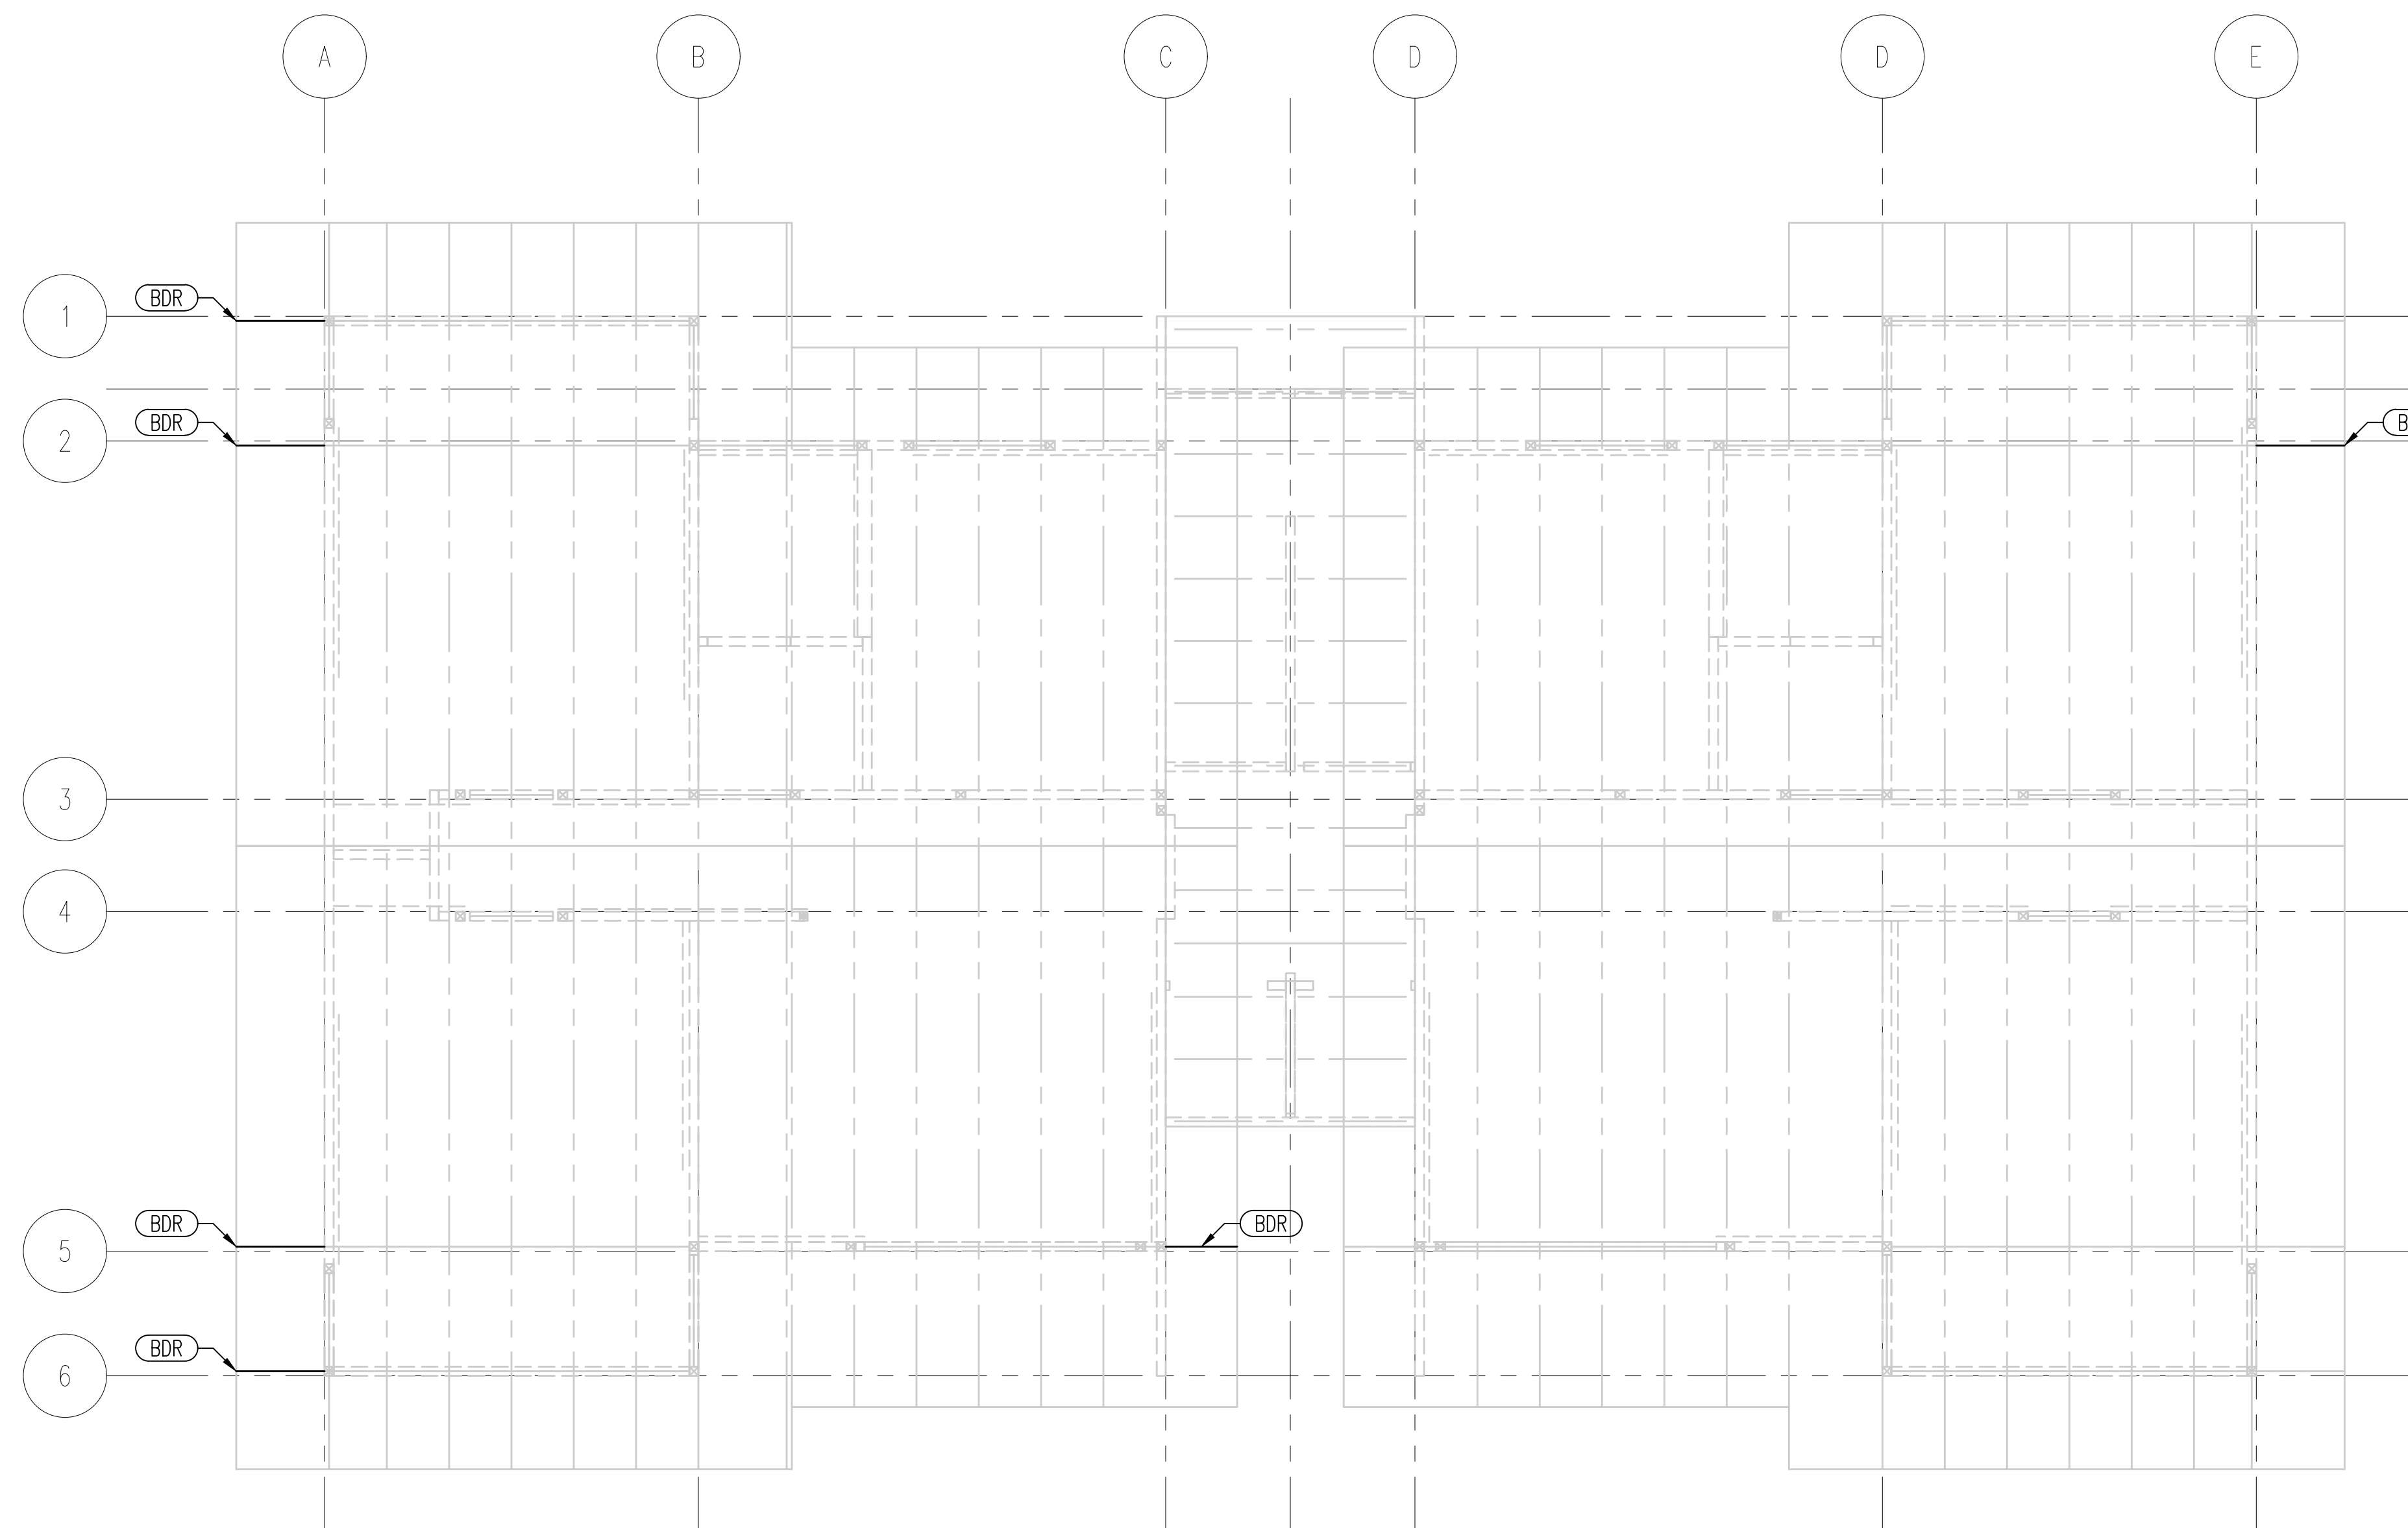
1 EXIST BUILDING A ROOF FRAMING PLAN
S-3 1/4" = 1'-0"

1. TYPICALLY, TRUSS WEB ARE UN-BRACED.
2. AT VARIOUS LOCATIONS, DAYLIGHT IS OBSERVED AT RIDGE.
3. GABLE END WALL IS UN-BRACED.

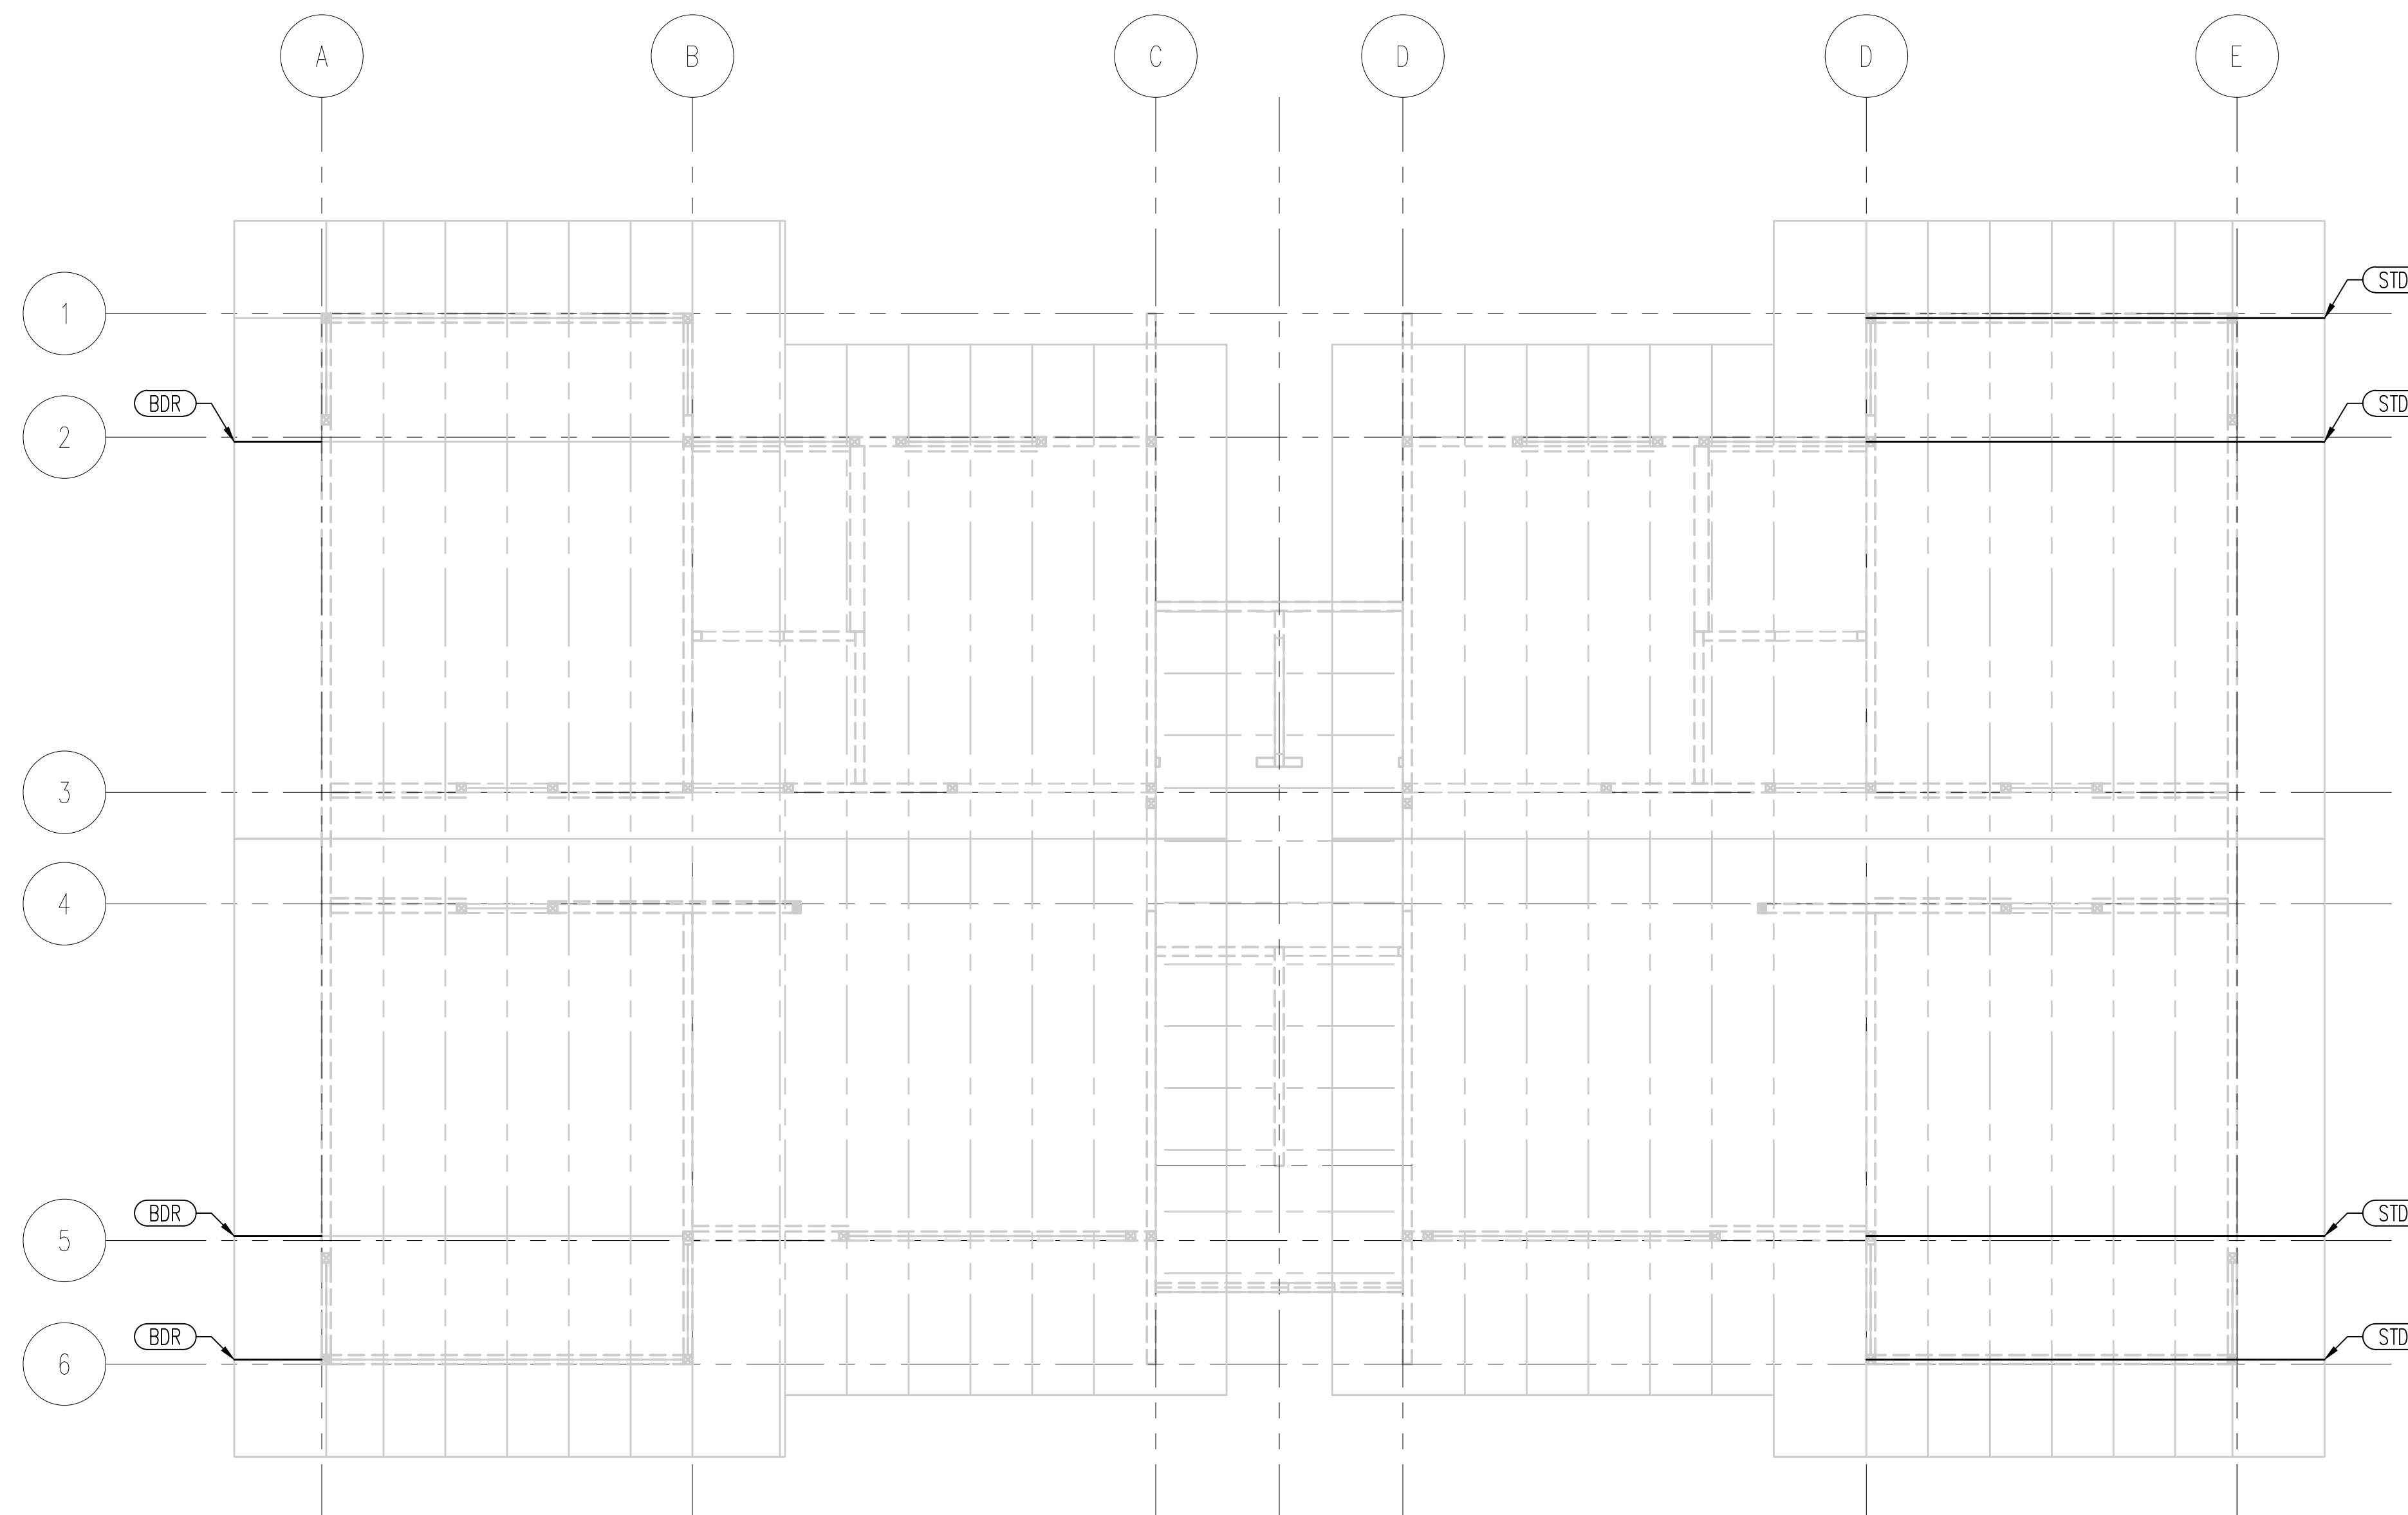
1 EXIST BUILDING B ROOF FRAMING PLAN
S-6 1/4" = 1'-0"

- CONSTRUCTION DEFECTS GENERAL NOTES:
1. TYPICALLY, TRUSS WEB ARE UN-BRACED.
 2. AT VARIOUS LOCATIONS, DAYLIGHT IS OBSERVED AT RIDGE.
 3. GABLE END WALL IS UN-BRACED.
