Structural Condition Analysis and Assessment of Dormitory Facilities

December 17, 2019

Site Located at 820 Ka'ahumanu Avenue, Kahului, Maui 96732 TMK: (2)3-8-07:117

Summary of Structural Field Condition Survey for the Existing University of Hawaii Community College Dorm Campus Buildings and Appurtenances

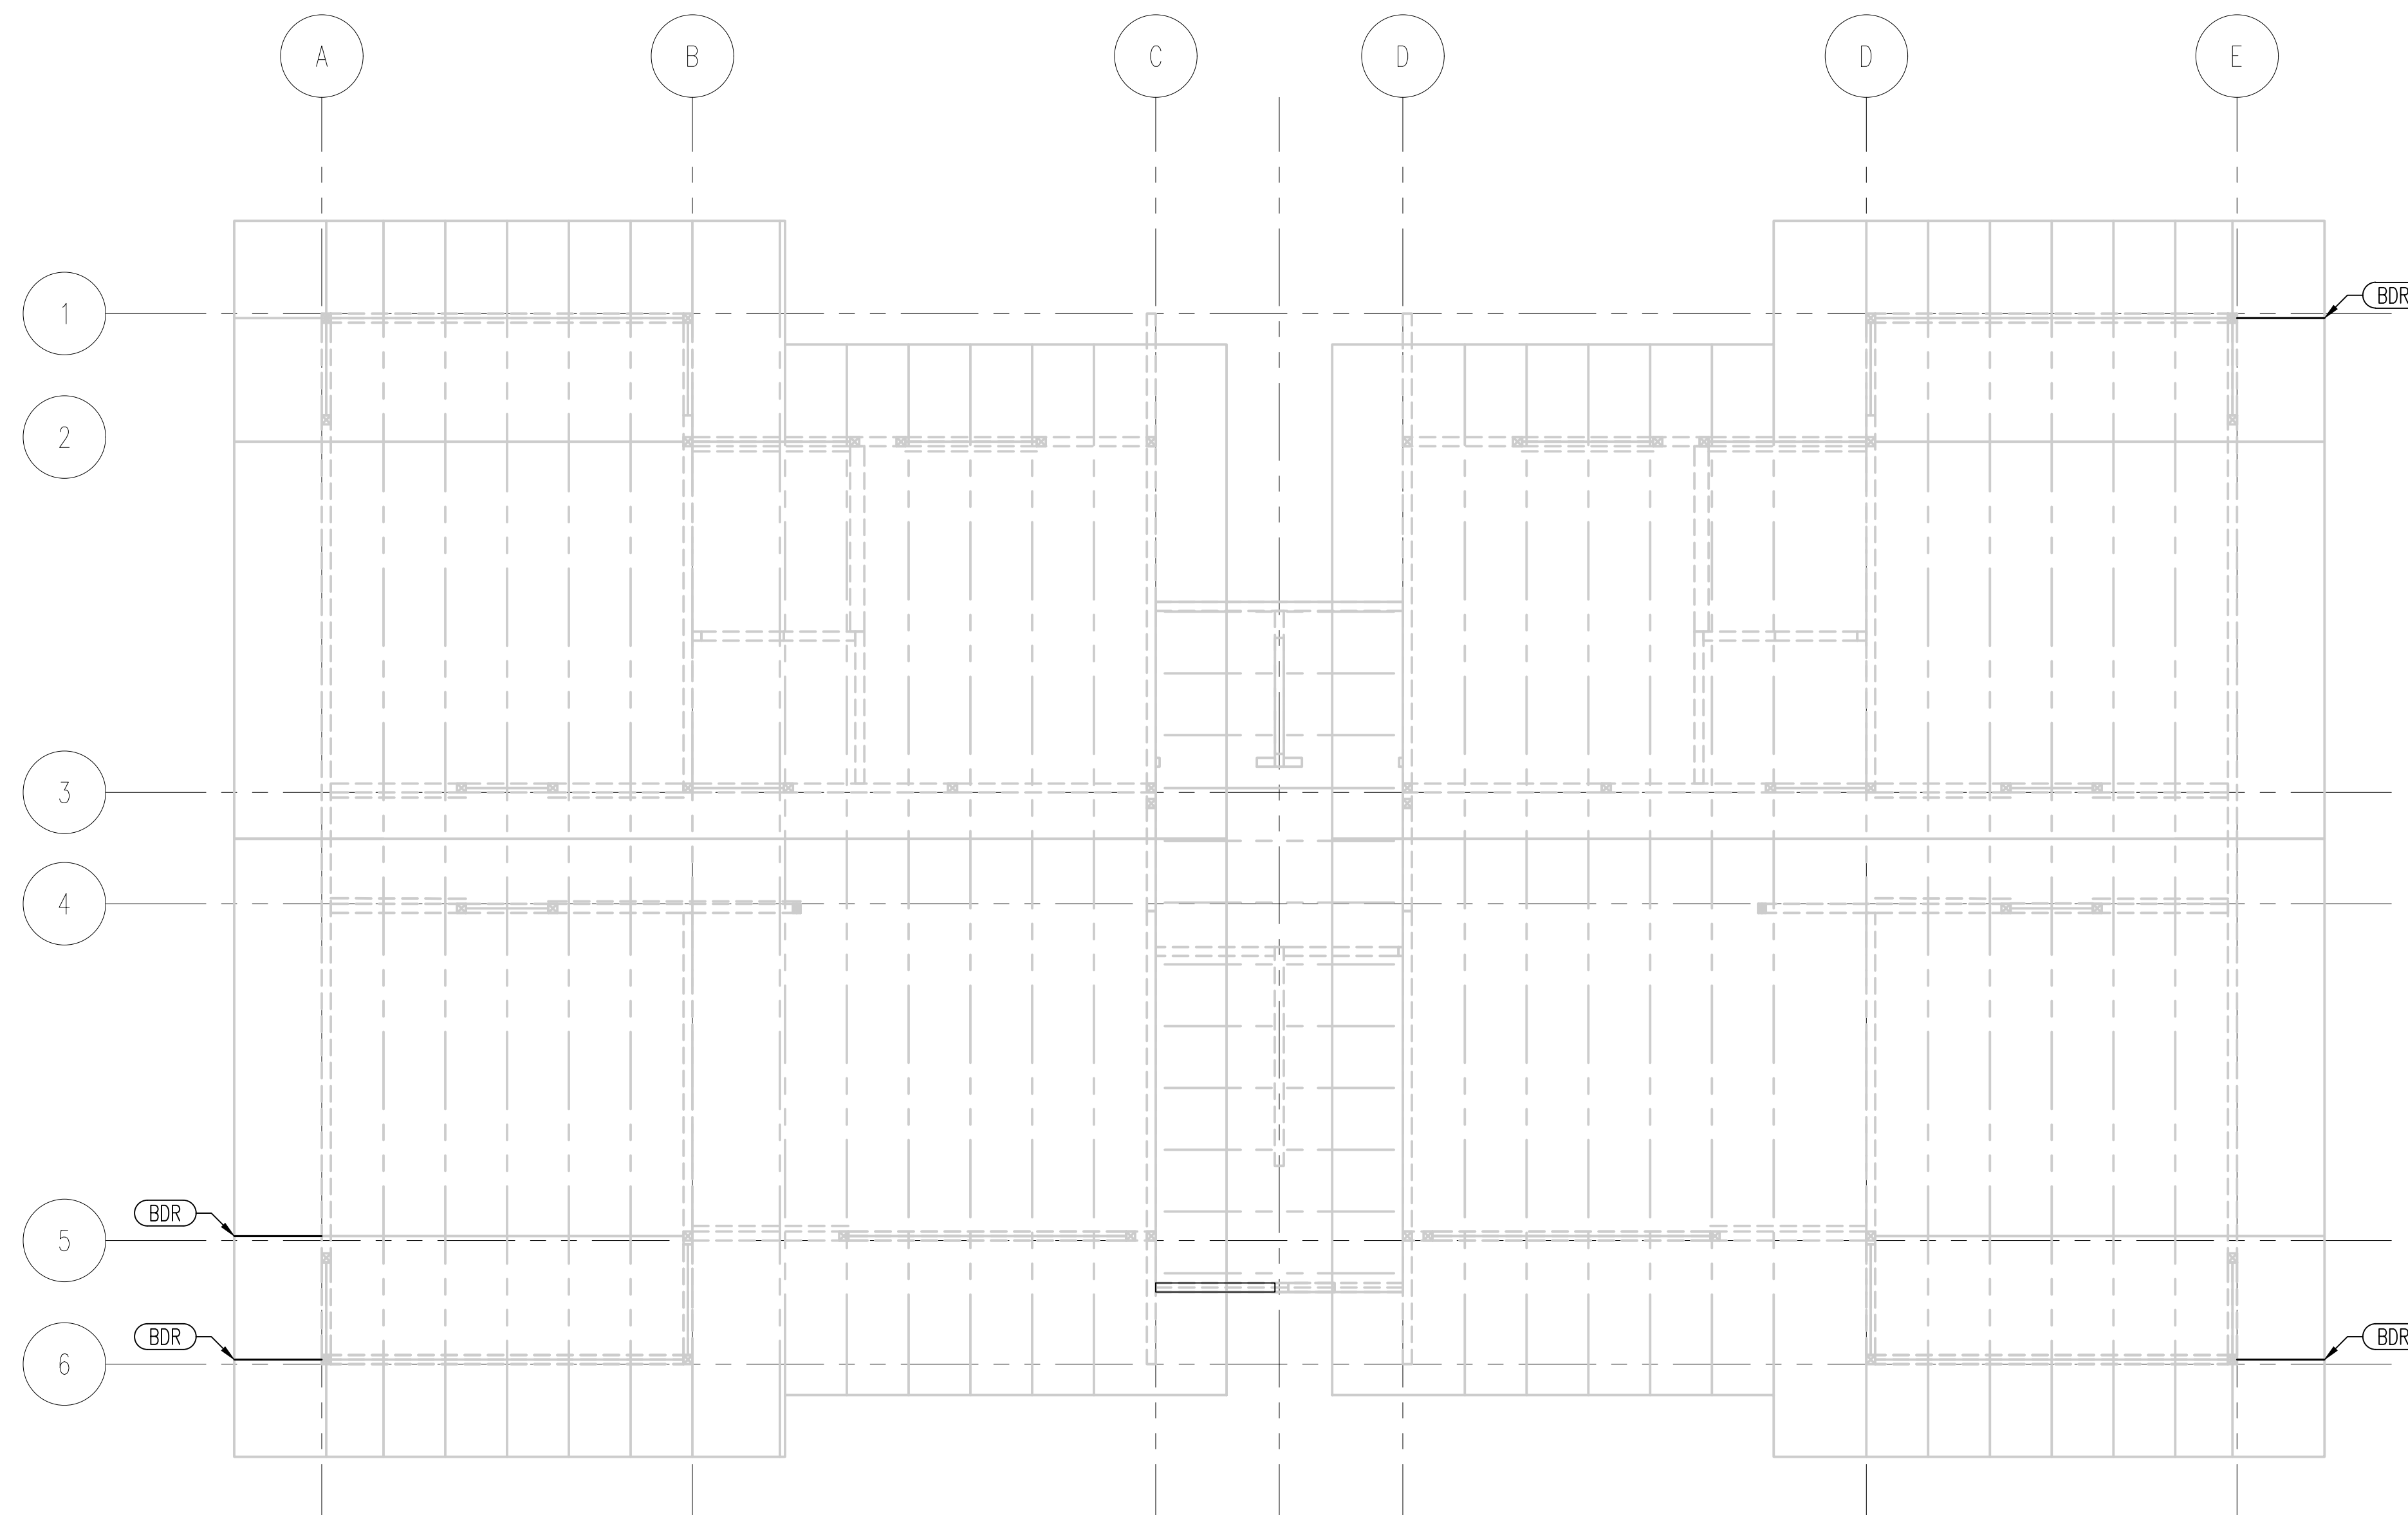
1 EXIST BUILDING C ROOF FRAMING PLAN
S-6 1/4" = 1'-0"

1. TYPICALLY, TRUSS WEB ARE UN-BRACED.
2. AT VARIOUS LOCATIONS, DAYLIGHT IS OBSERVED AT RIDGE.
3. GABLE END WALL IS UN-BRACED.

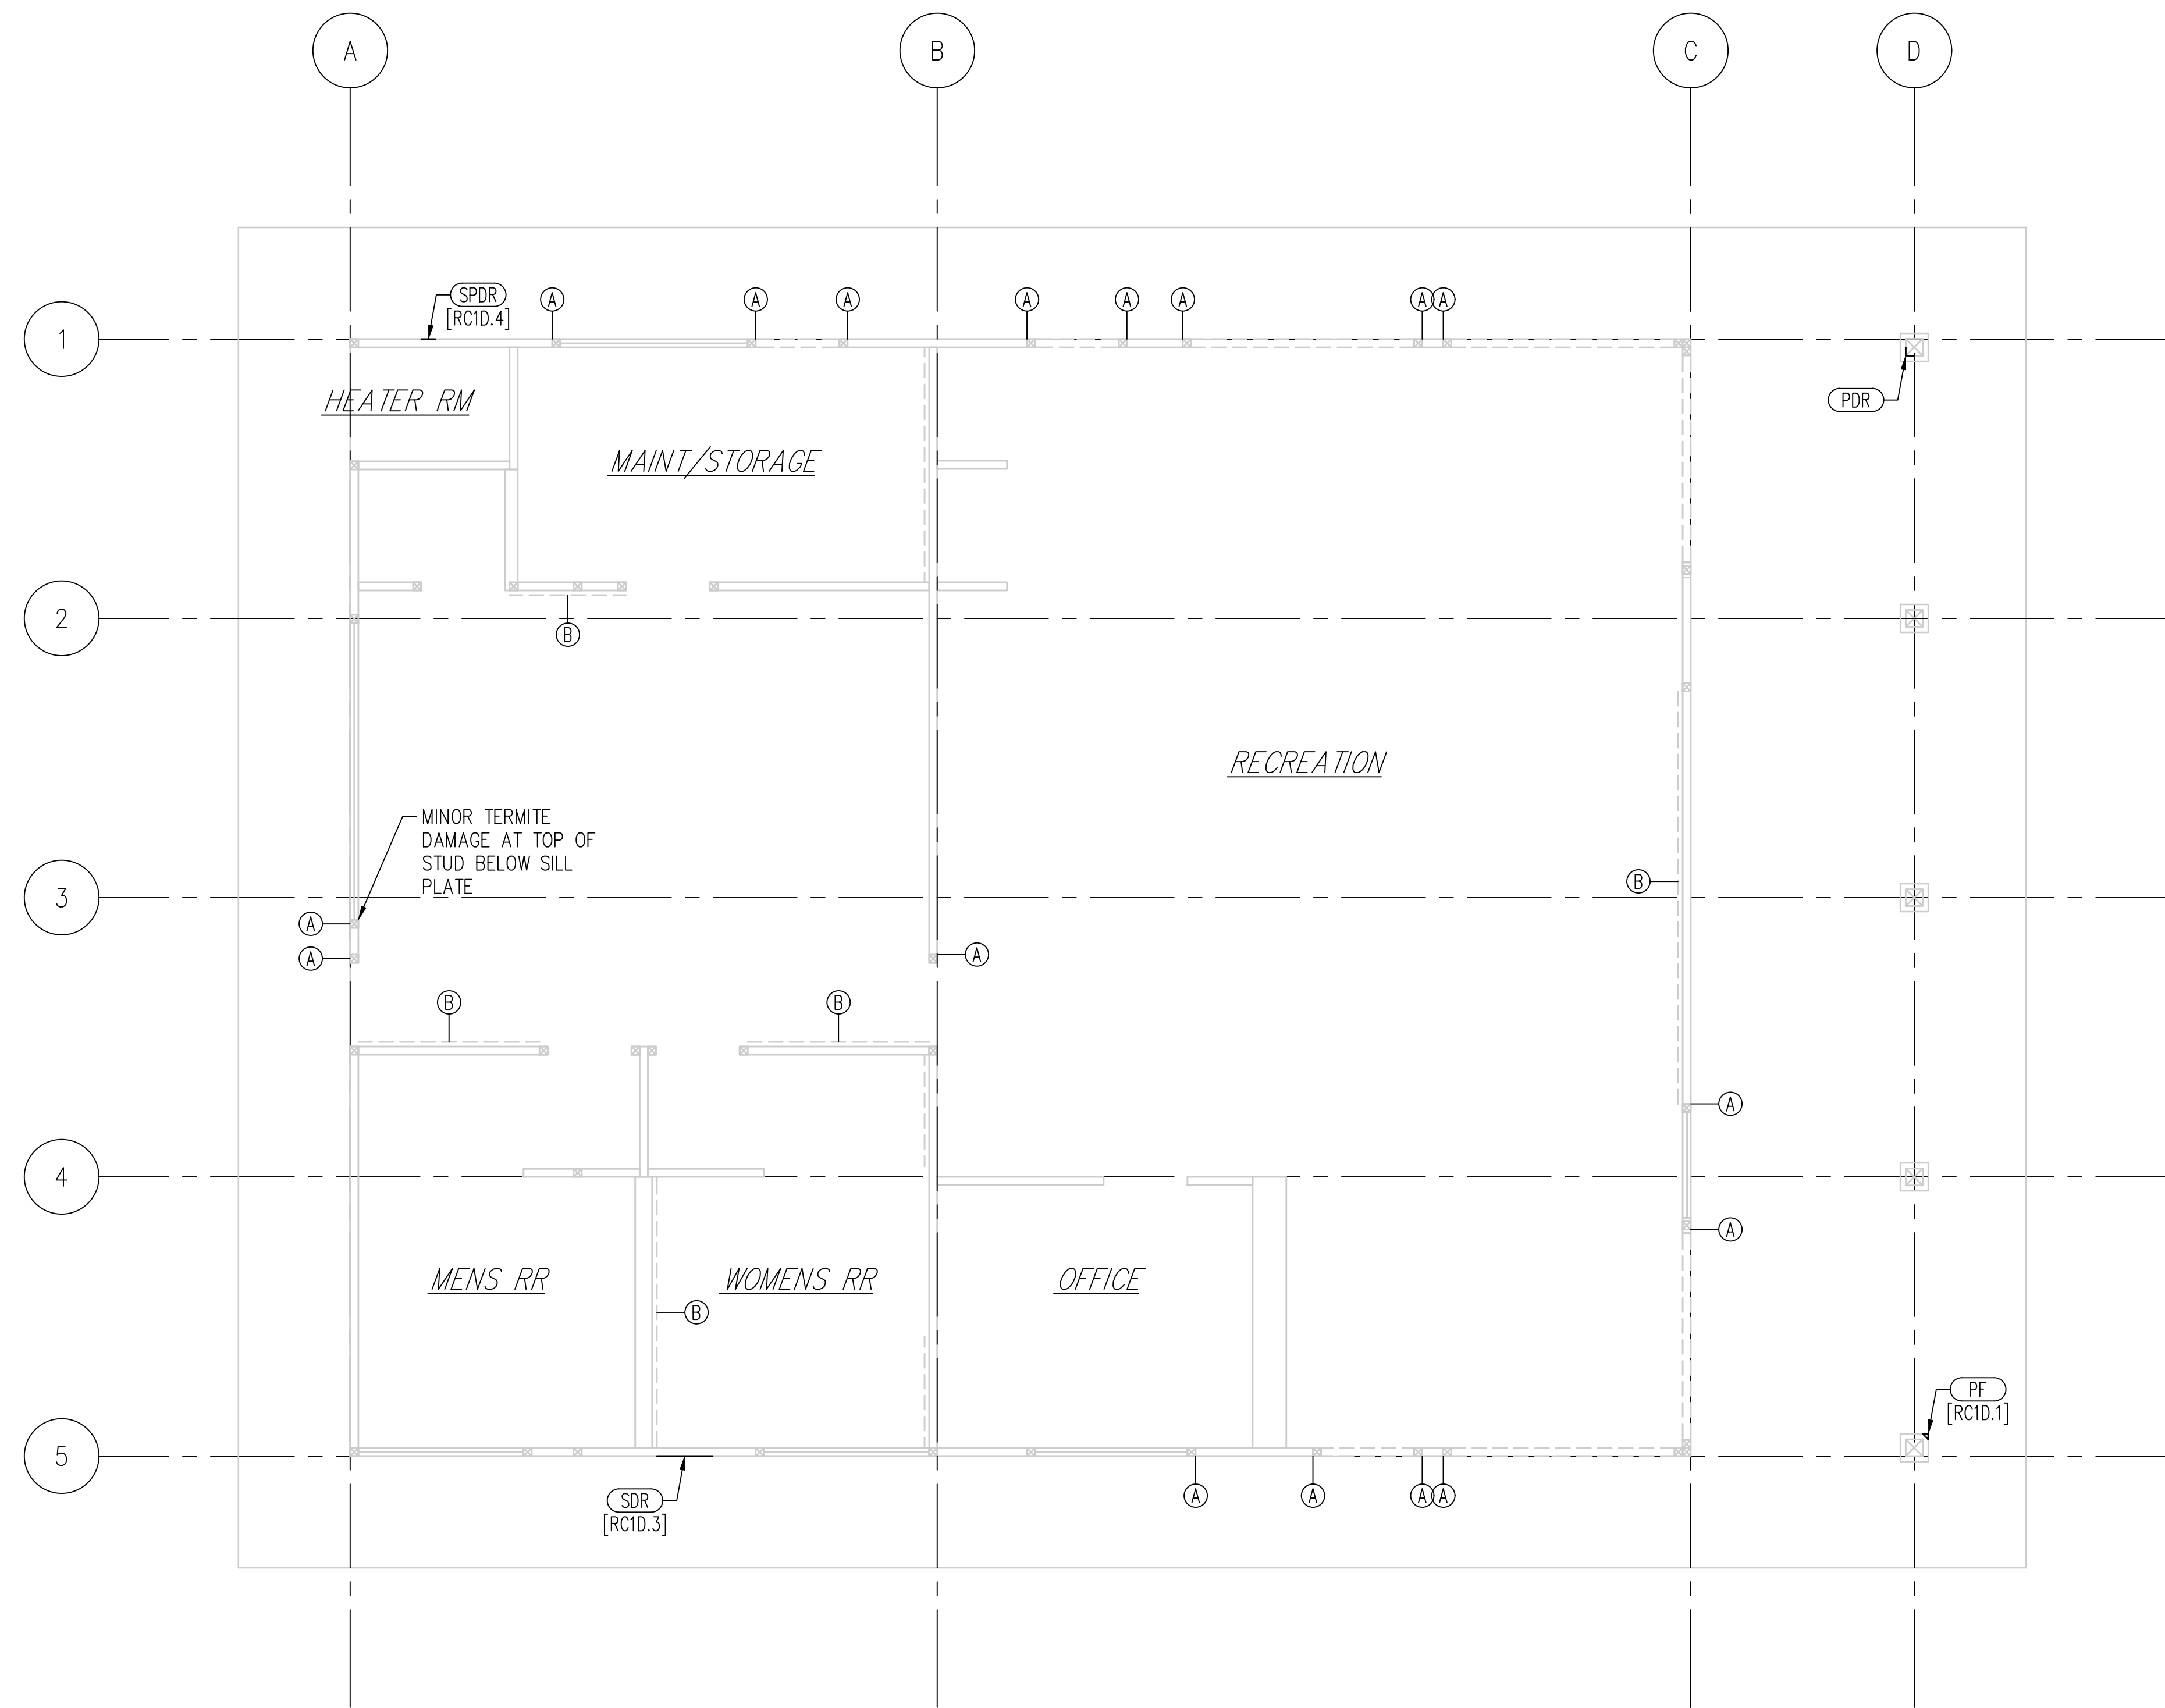
1 EXIST LAUNDRY/RECREATIONAL CENTER BUILDING FOUNDATION PLAN
 S-10 1/4" = 1'-0"

GENERAL CONSTRUCTION DEFECTS NOTES:
 1. TYPICALLY, INTERIOR PARTITION WALL SOLE PLATE ANCHOR RODS ARE MISSING OR INSTALLED @ GREATER THAN 32" OC. [RC1D.1]
