**SUBJECT: COUNTY-OWNED PARCEL ON NORTH PAPA AVENUE (KAHULUI)  
(HHT-14)**

## Property Condition Report

310 W Kaahumanu Ave, Kahului, HI 96732  
Inspection prepared for: Maui County c/o Buddy Almeida  
Real Estate Agent: -

This is a commercial property condition assessment to determine if three (3) former UH dormitories are suitable for housing. This inspection includes invasive and non-invasive inspection methods as well as sampling for asbestos and lead based paint.

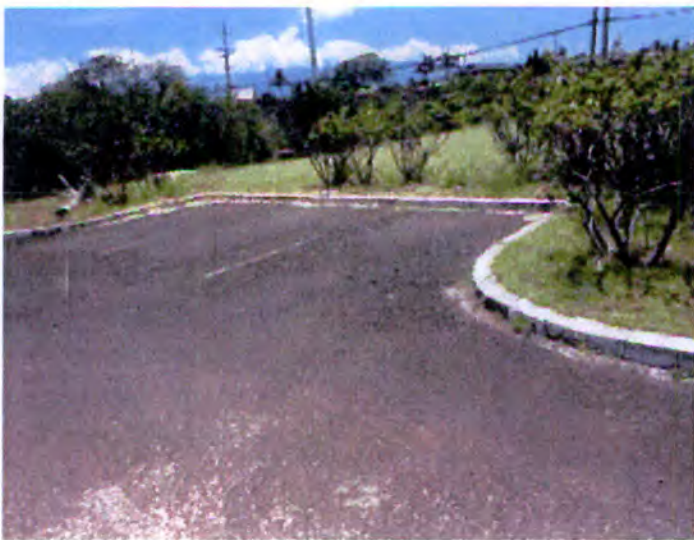
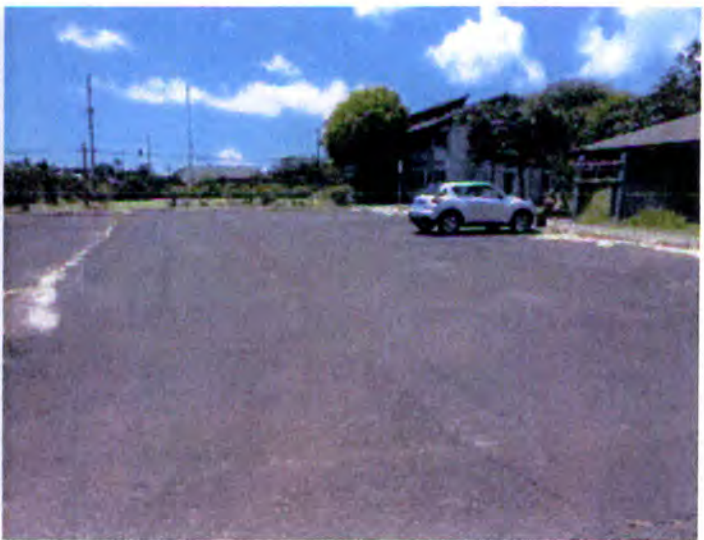
The parking area surface was deteriorated with lines weathered to the point of not providing clear lanes for parking use. Recommend having the parking area resurfaced and striped to ensure proper identification of parking stalls.

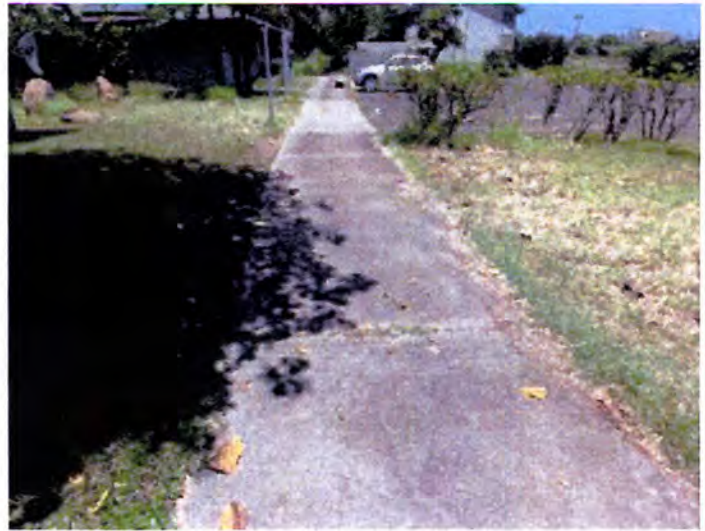
Bldg A hand rail was missing.  
Recommend installation as required.

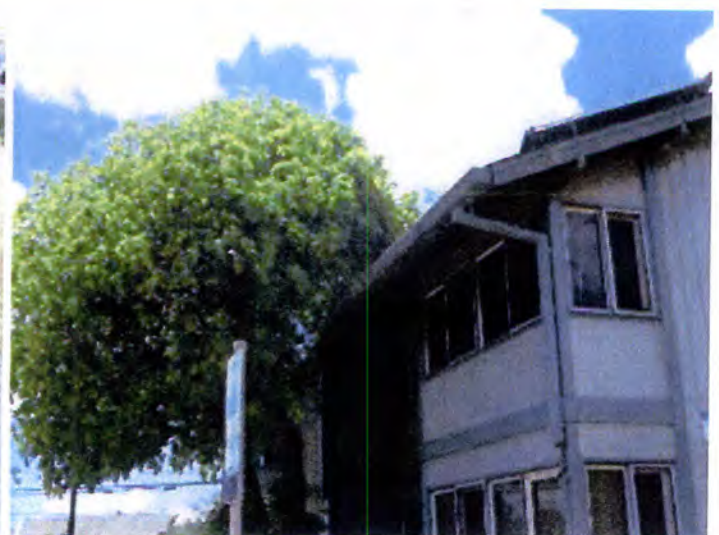
The vegetation was overgrown and causing deterioration/damage to the exterior curtain wall and fixtures.

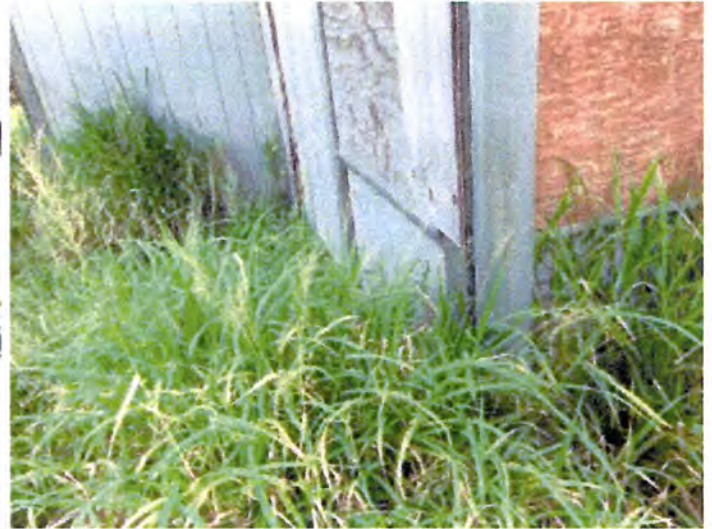
There were numerous trees contacting the building curtain walls and roof areas. Vegetation was overgrown and in need of removal in many areas.

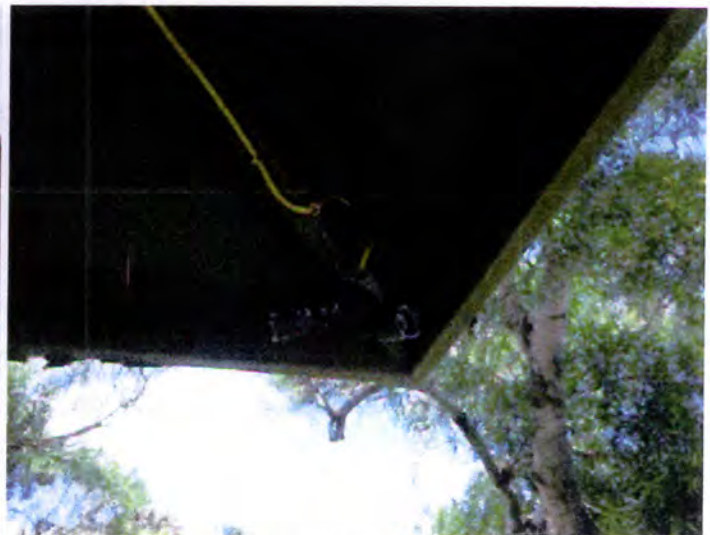
Some of the exterior lighting fixtures were damaged and need to be replaced.

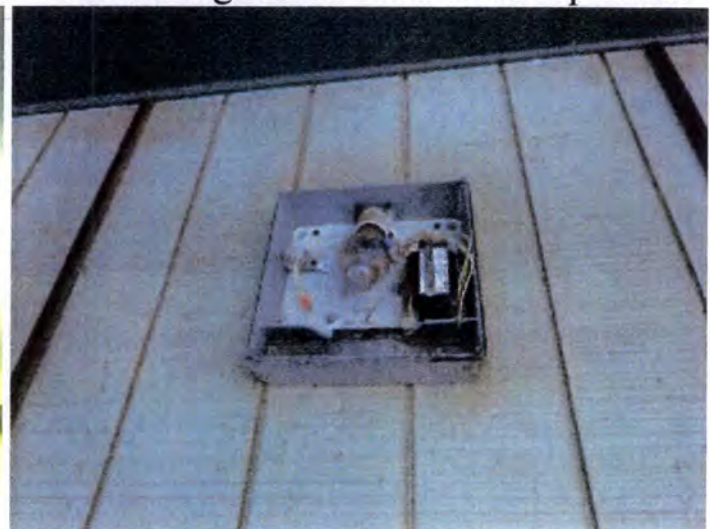
Some of the exterior lighting fixtures were damaged and need to be replaced.

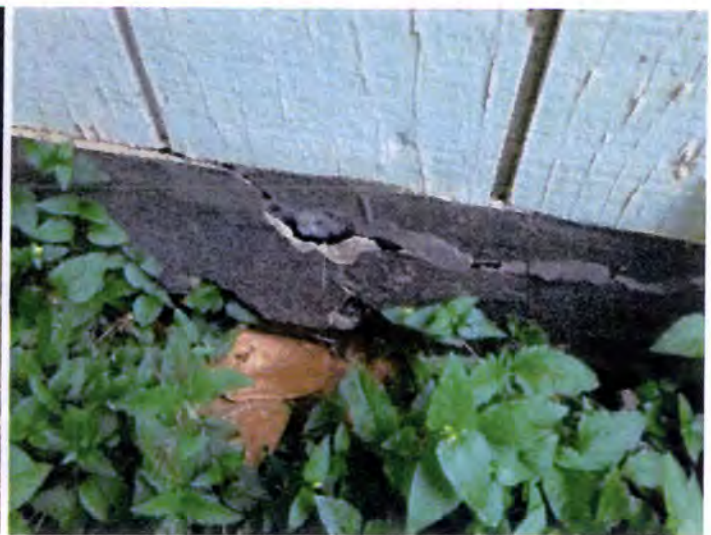
Building A and B: Visible cracks observed at the foundational areas of the buildings. There were separations observed along the defect areas which represent movement between the faults.

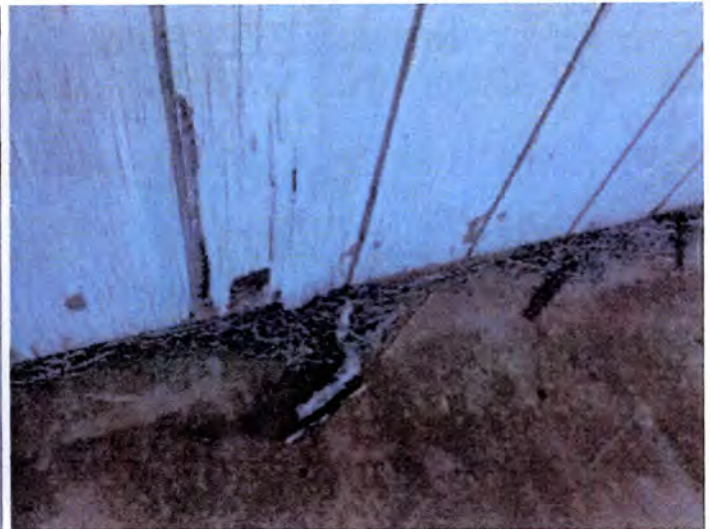
Moisture damage observed at exterior wall areas. Recommend select demolition and replacement of affected ground level exterior siding and finishes.

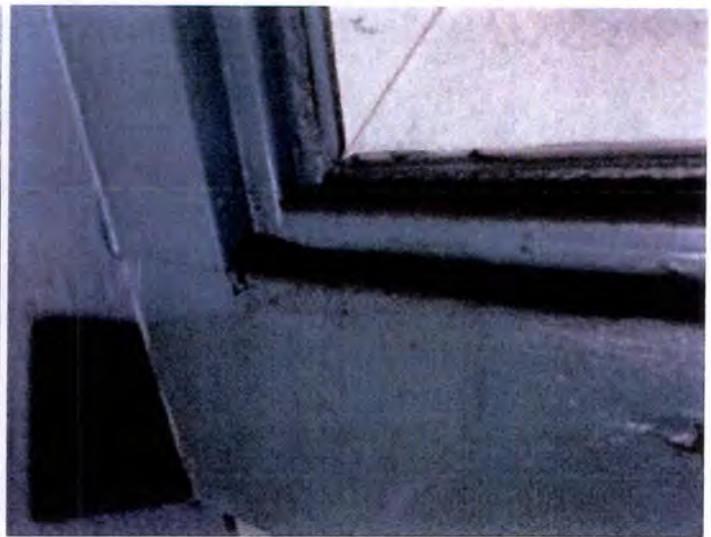
Visible indications of WDO (termite) damage noted. Recommend having a licensed pest contractor evaluate and treat as necessary. Also, recommend having a licensed contractor evaluate and repair/replace damaged material as necessary.

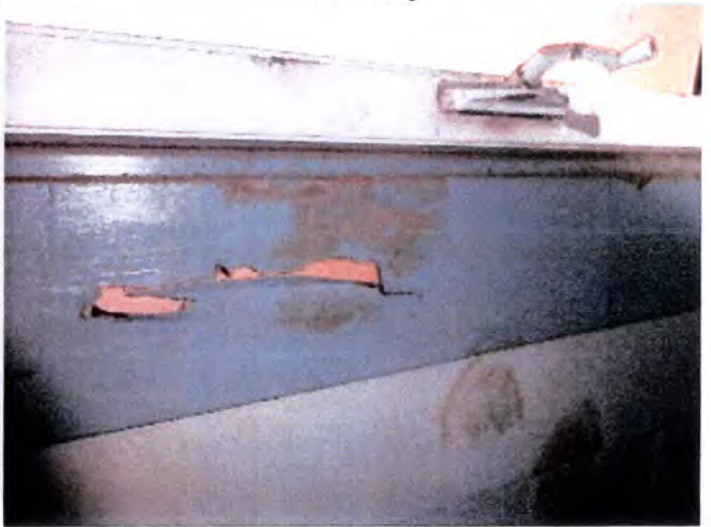
Visible indications of WDO (termite) damage noted. Recommend having a licensed pest contractor evaluate and treat as necessary. Also, recommend having a licensed contractor evaluate and repair/replace damaged material as necessary.

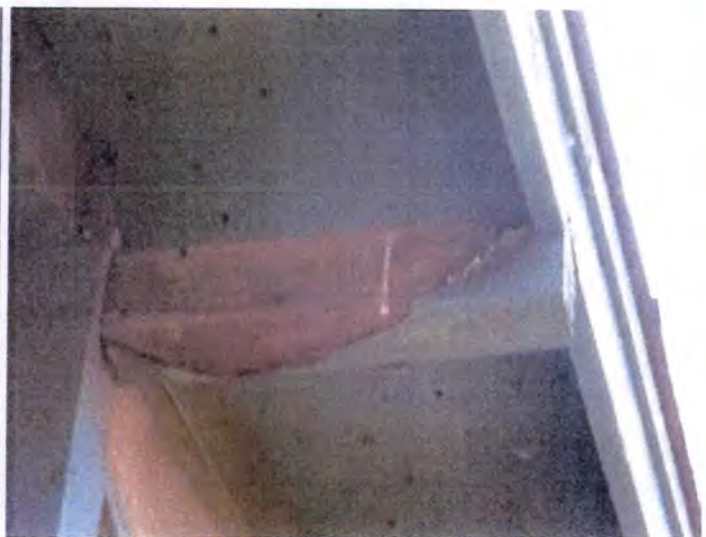
Blistering/peeling/missing paint observed at many exterior trim, fascia and soffit areas. Recommend properly preparing and refinishing exterior finishes.

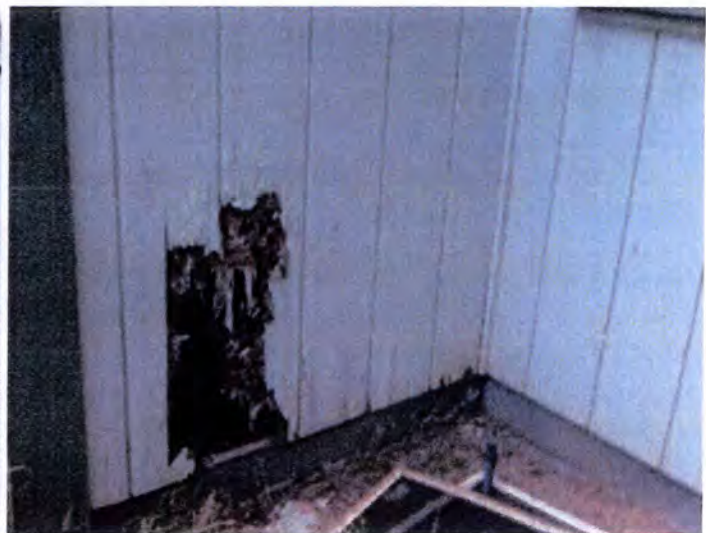
Visible indications of WDO (termite) damage noted. Recommend having a licensed pest contractor evaluate and treat as necessary. Also, recommend having a licensed contractor evaluate and repair/replace damaged material as necessary.

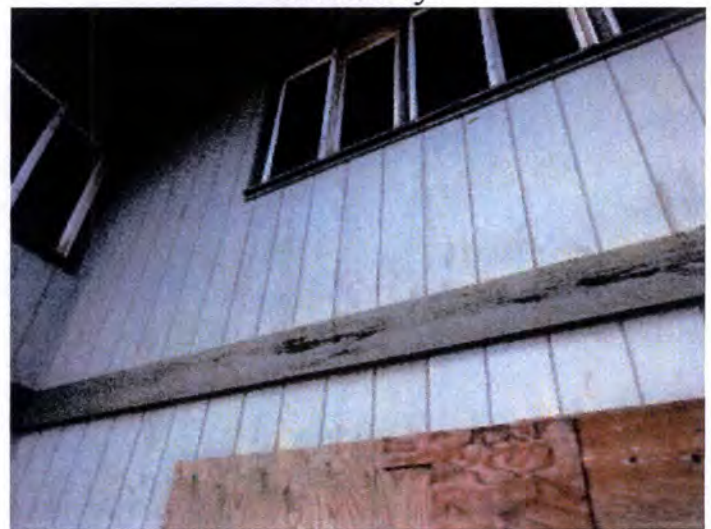
Visible indications of WDO (termite) damage noted. Recommend having a licensed pest contractor evaluate and treat as necessary. Also, recommend having a licensed contractor evaluate and repair/replace damaged material as necessary.

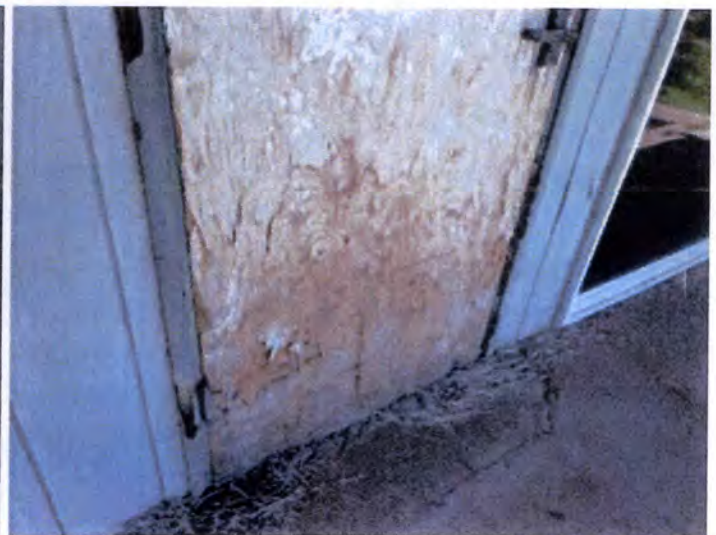
The exterior doors were termite damaged or deteriorated to the point of being inoperable. We recommend replacement of all exterior doors, framing and trim for all buildings.

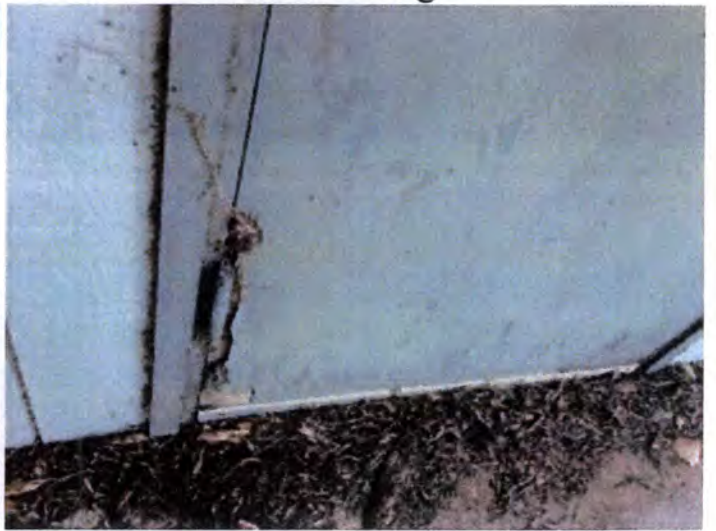
The exterior doors were termite damaged or deteriorated to the point of being inoperable. We recommend replacement of all exterior doors, framing and trim for all buildings.

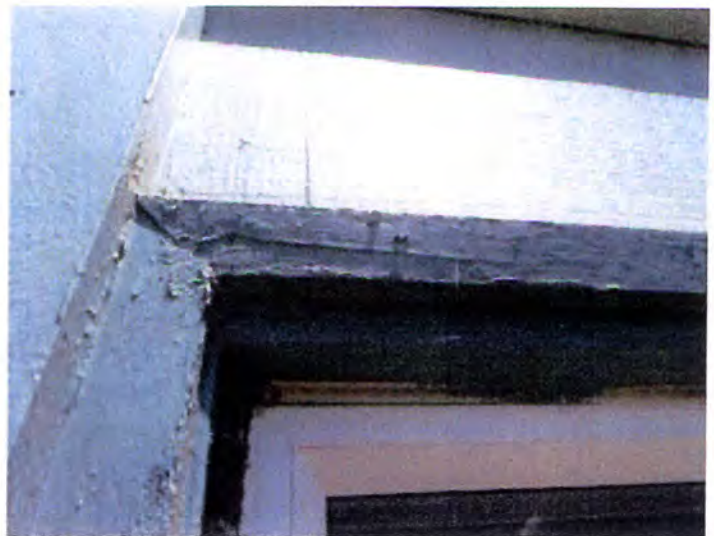
Due to the vegetative contact with exterior siding and finishes, the window trim is moisture/termite damaged at numerous locations. We recommend the removal and replacement of exterior window trim finishes.

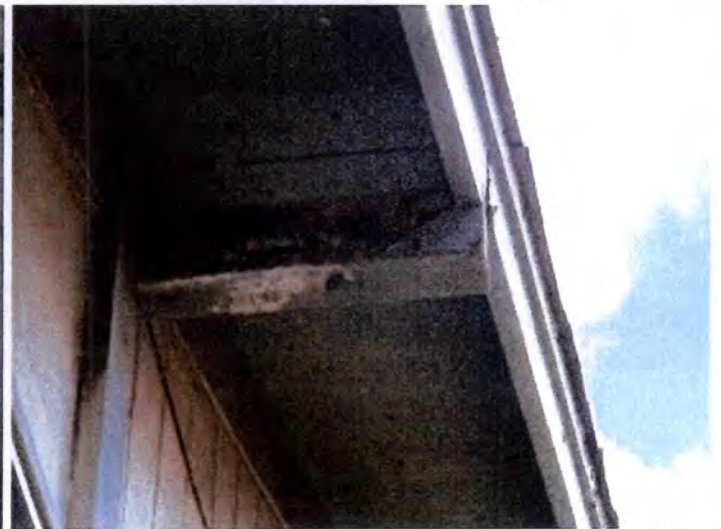
The fascia/soffit areas appeared to be rotted/water damaged/deteriorated at the time of inspection. Recommend having a licensed contractor evaluate and repair/replace as necessary.

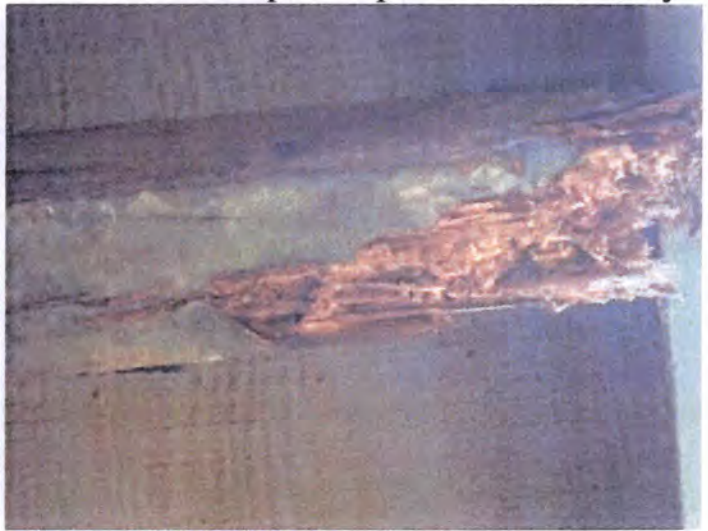
There were visible indications of WDO (Wood Destroying Organism) damage noted at the fascia and soffit areas. Recommend having a licensed contractor evaluate and repair/replace as necessary.

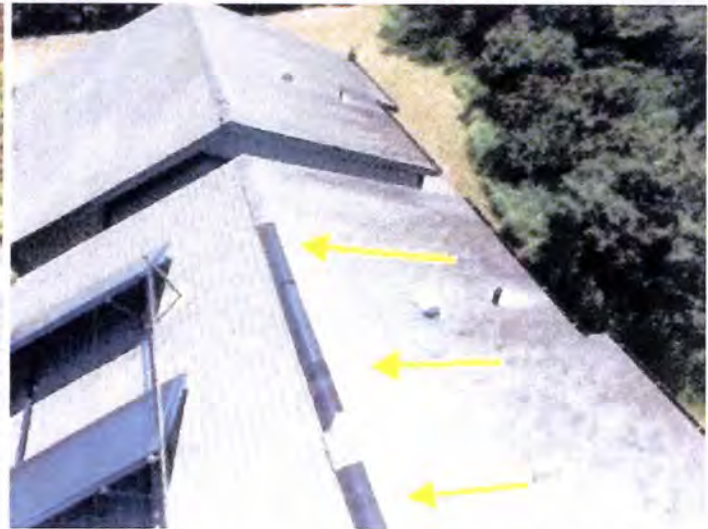
There were numerous areas of missing shingles observed at the roof ridge areas. Recommend repair in conjunction with roof replacement.

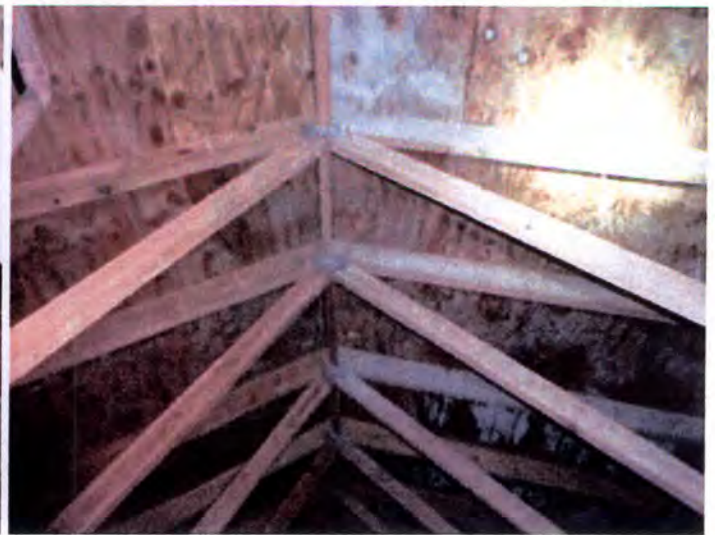
There were visible areas of moisture intrusion observed at the roof sheathing (within the attic spaces) at the time of inspection. This indicated a failed/failing roofing system. Recommend replacement of the installed sheathing and roofing finish.

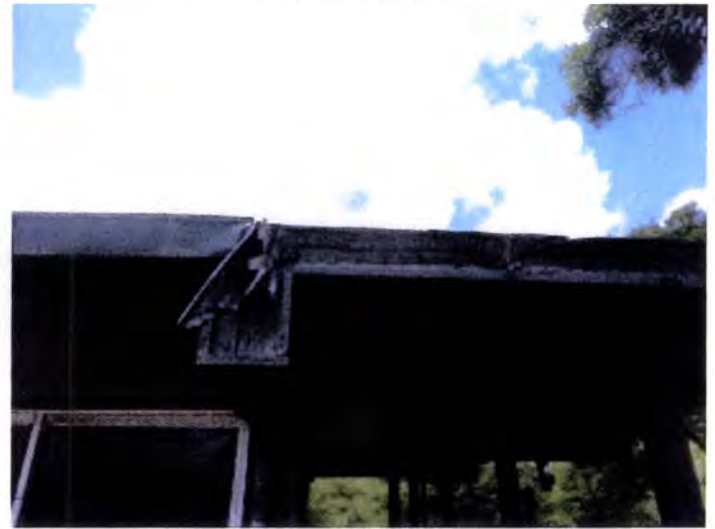
Damaged/broken/missing gutters noted. Recommend having a licensed contractor evaluate and repair/replace as necessary.

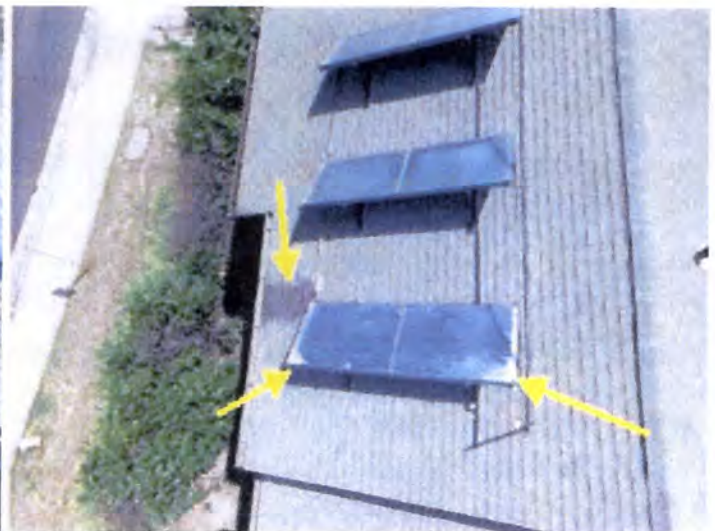
There were solar water heating panels located on the roofing areas of the buildings. There were visible indications of leaks and interior hazing at the panels which is an indication of damage to the environmental seals or panels. These panels did not appear to be in service and should be evaluated by a licensed plumbing contractor prior to use.

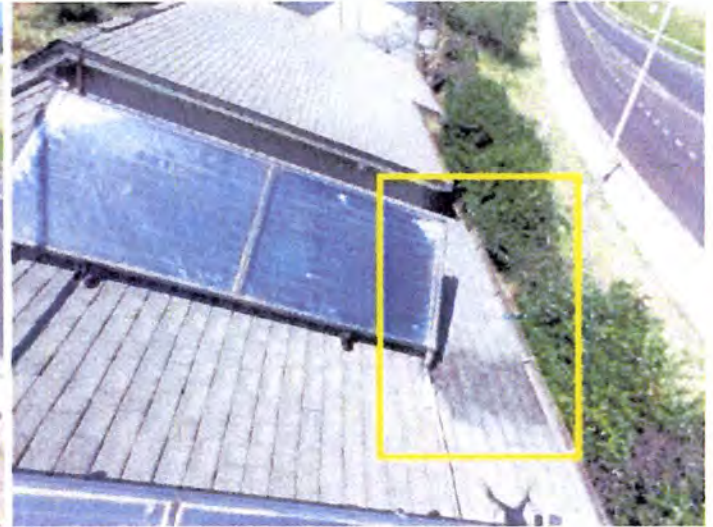
There were solar water heating panels located on the roofing areas of the buildings. There were visible indications of leaks and interior hazing at the panels which is an indication of damage to the environmental seals or panels. These panels did not appear to be in service and should be evaluated by a licensed plumbing contractor prior to use.

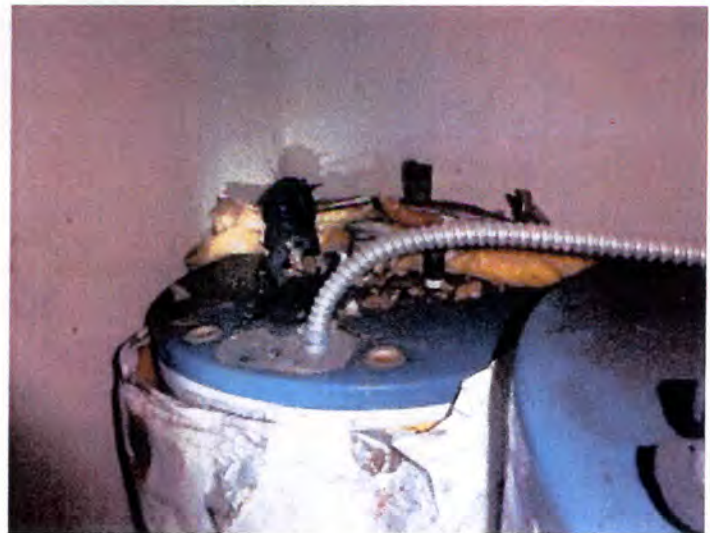
All water heating appliances were terminated with supply and service plumbing cut and electrical connections removed. Recommend having a licensed plumber evaluate and install commercial grade gas on demand hot water heating systems for each floor of each building.

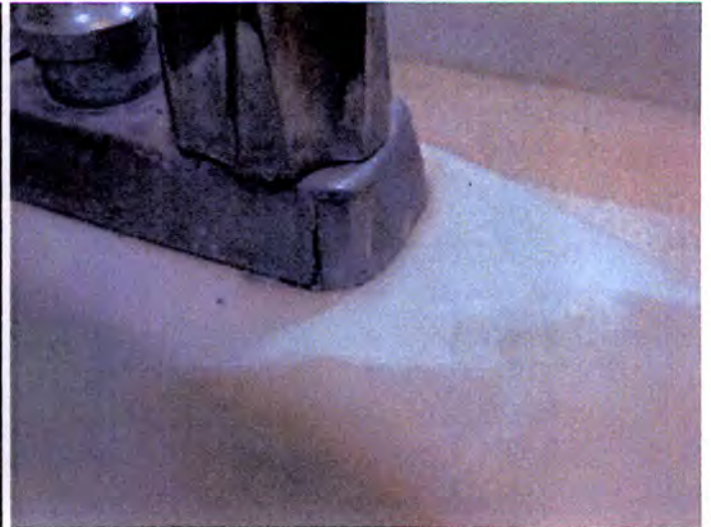
Based on the observed physical conditions of the installed fixtures, we recommend the replacement of all plumbing fixtures and shut off valves in all buildings to ensure proper future operation.

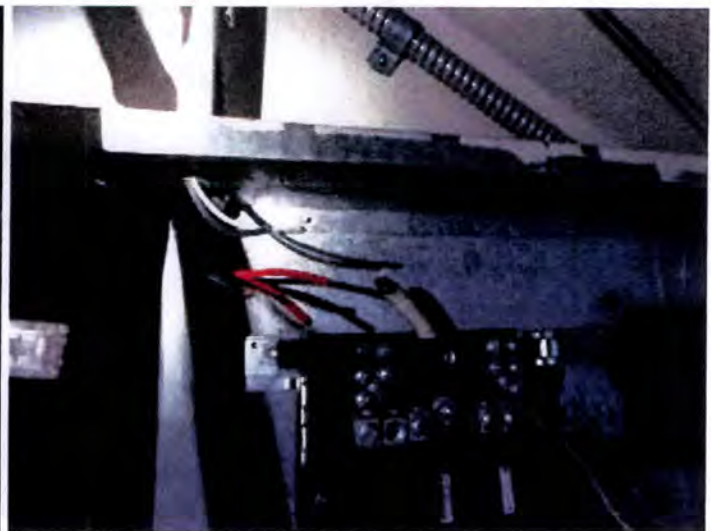
Building B and C: The main service conductors and all electrical branch wiring was cut at the main service panel entrances (located in the respective electrical rooms) when inspected. Recommend having a licensed electrical contractor evaluate and repair electrical service to each building. The installed cabinets, panels and service disconnects appeared serviceable.

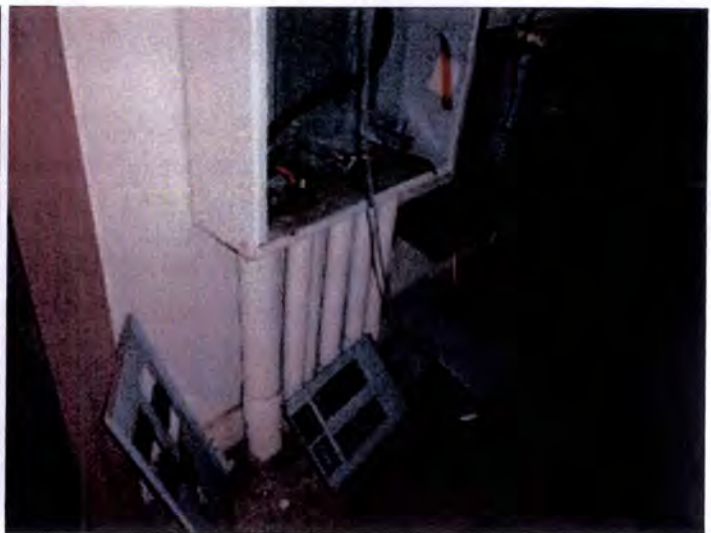
Building B and C: The main service conductors and all electrical branch wiring was cut at the main service panel entrances (located in the respective electrical rooms) when inspected. Recommend having a licensed electrical contractor evaluate and repair electrical service to each building. The installed cabinets, panels and service disconnects appeared serviceable.

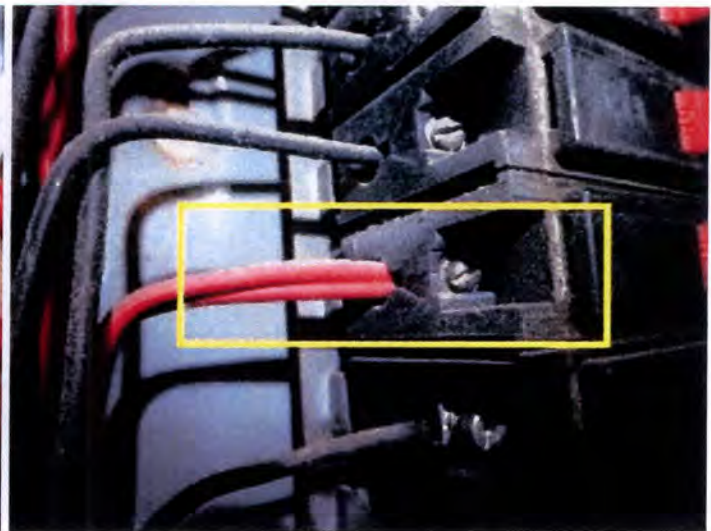
There were double tapped 1-pole circuit breakers noted at the time of inspection.

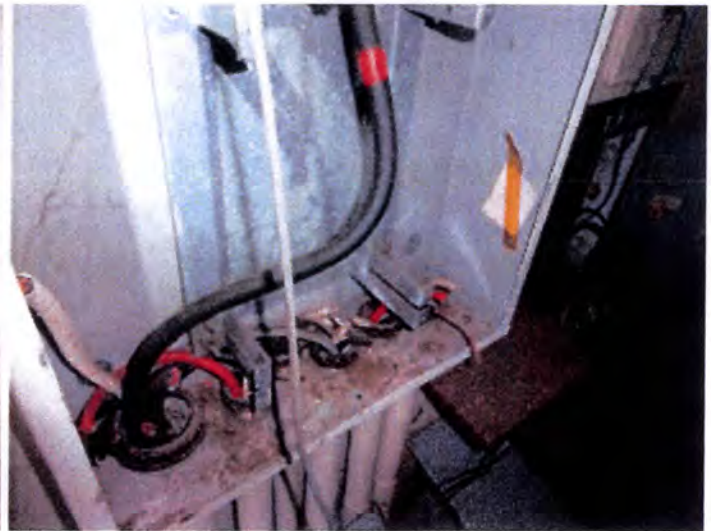
All of the branch wiring to buildings B and C was cut with circuit breakers removed. Recommend having a licensed electrical contractor repair.

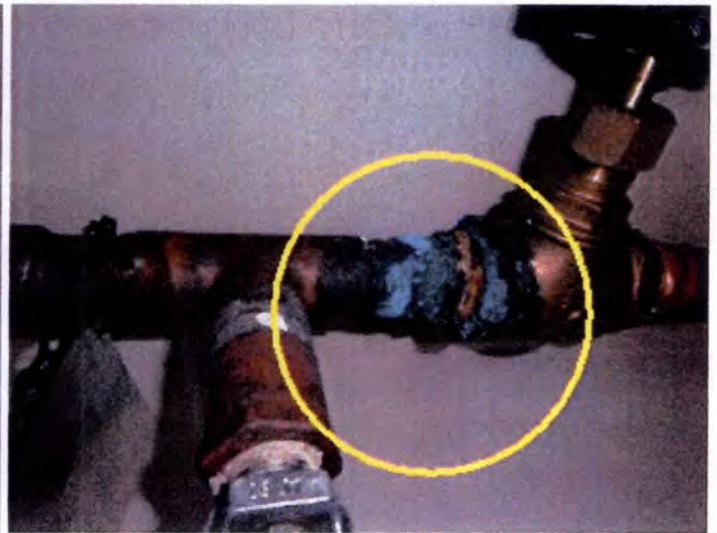
B-101: Fire sprinkler branch pipe and valve located in the hall closet was leaking when inspected.

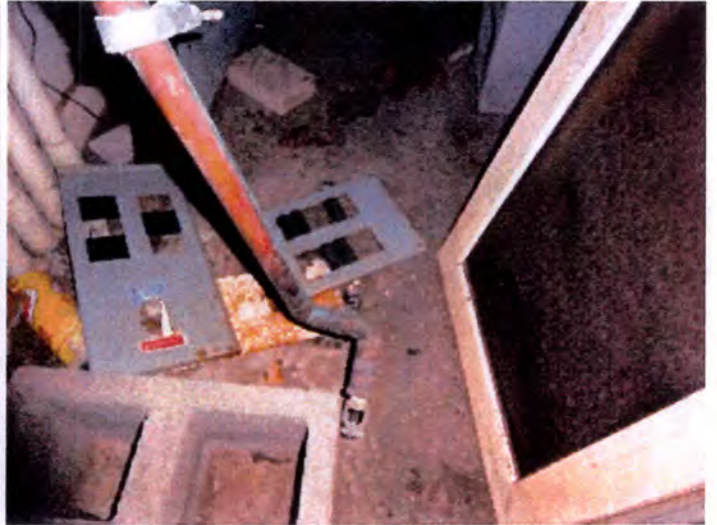
Building B: Sprinkler branch pipe was broken/bent down in the electrical room.  
Recommend repair.

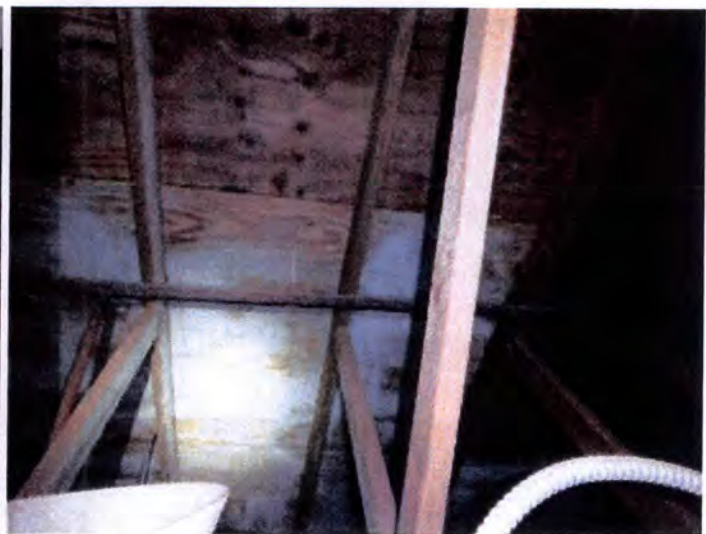
Visible indications of moisture intrusion and mold growth at building B and C interior, bedroom, bathroom and closet wall areas. Recommend removal and replacement of all interior wall finishes of B and C, after removal of all exterior vegetation.

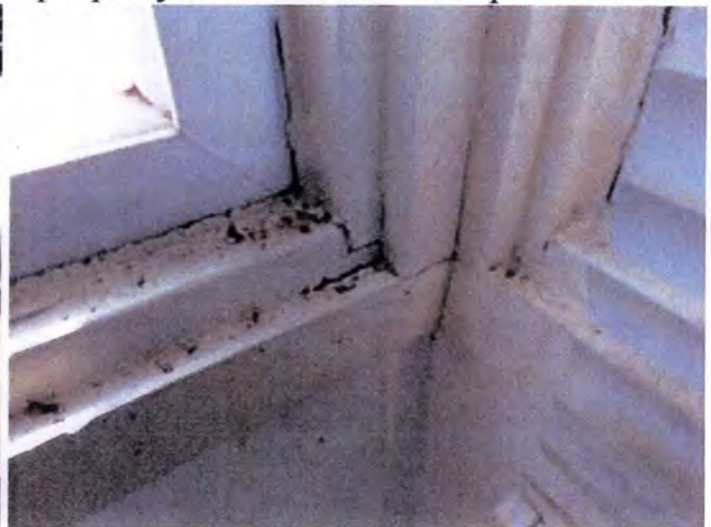
There were visible indications of moisture and termite damage observed at the interior window trim areas. Recommend replacement of all interior window trim and finishes.

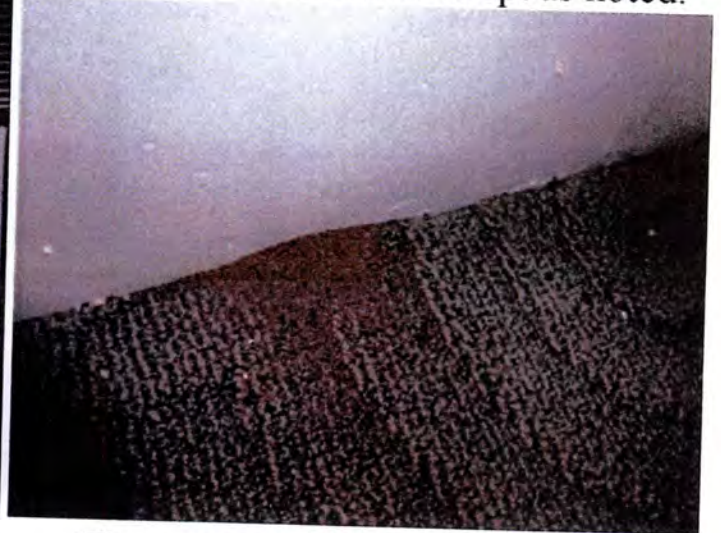
There were visible indications of moisture and termite damage observed at the interior window trim areas. Recommend replacement of all interior window trim and finishes.

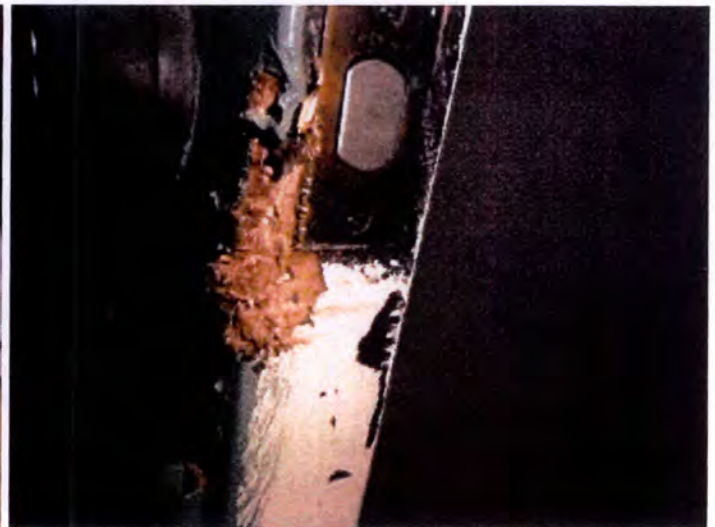
Most of the doors had varying degrees of damage observed when inspected. Based on the observed conditions, we recommend the replacement of all interior doors and trim within the dwelling units.

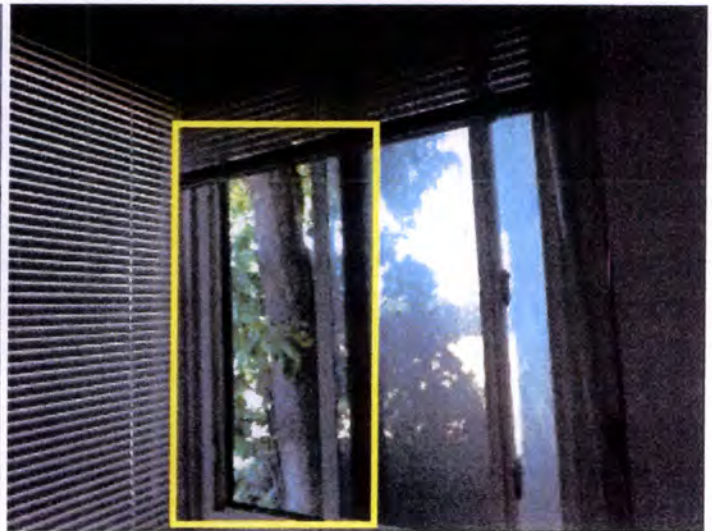
Many of the ground floor windows were broken at the time of inspection. Recommend replacement.

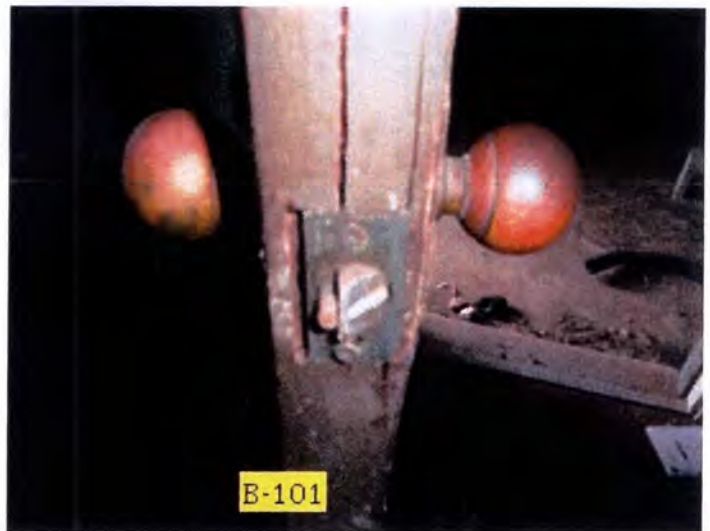
Most of the doors had varying degrees of damage observed when inspected. Based on the observed conditions, we recommend the replacement of all interior doors and trim within the dwelling units.

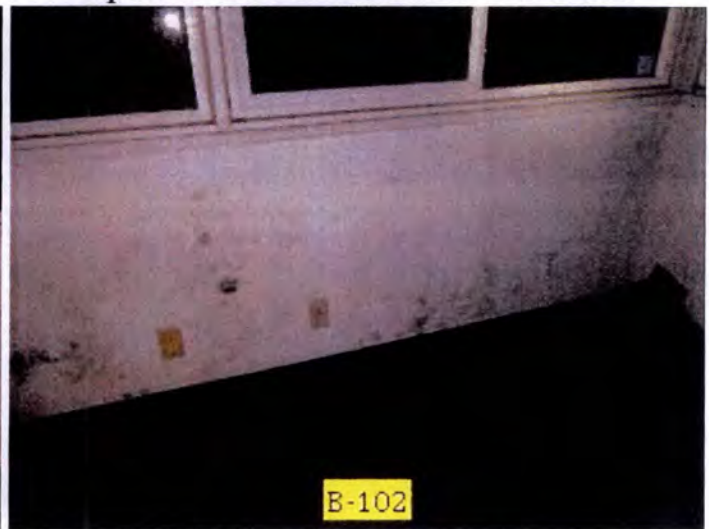
Visible indications of moisture intrusion and mold growth at building B and C interior, bedroom, bathroom and closet wall areas. Recommend removal and replacement of all interior wall finishes of B and C, after removal of all exterior vegetation.

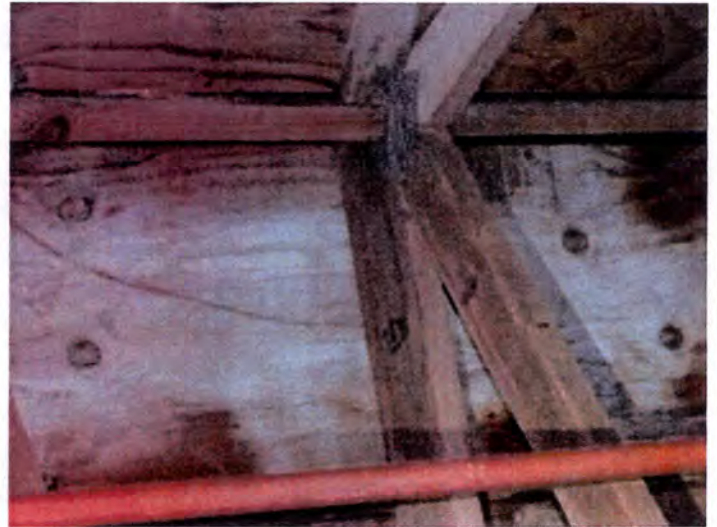
There were visible indications of mold present at all attic areas.

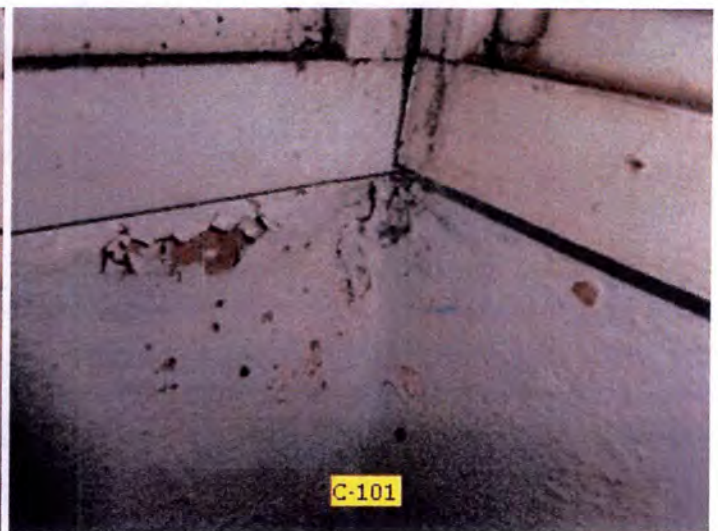
Visible indications of moisture intrusion and mold growth at building B and C interior, bedroom, bathroom and closet wall areas. Recommend removal and replacement of all interior wall finishes of B and C, after removal of all exterior vegetation.

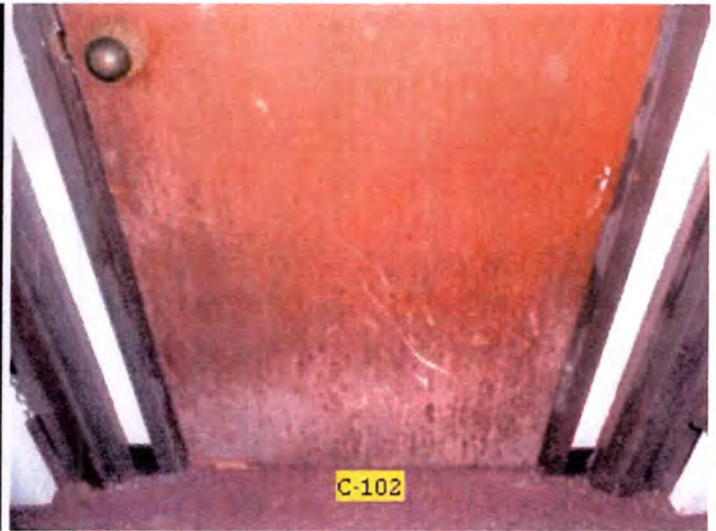
Visible mold observed at interior doors.

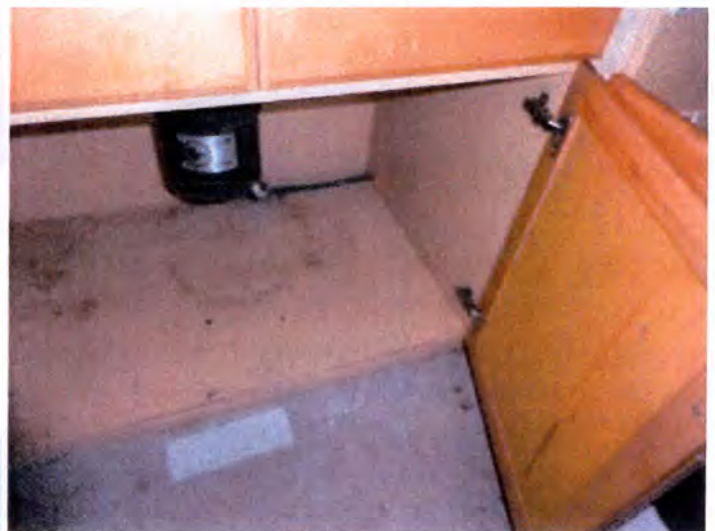
The kitchens of buildings B and C were deteriorated with moisture damage, termite damage and general damage observed at the cabinets, counters and finishes. Recommend the replacement of all dwelling unit kitchens, fixtures and appliances.

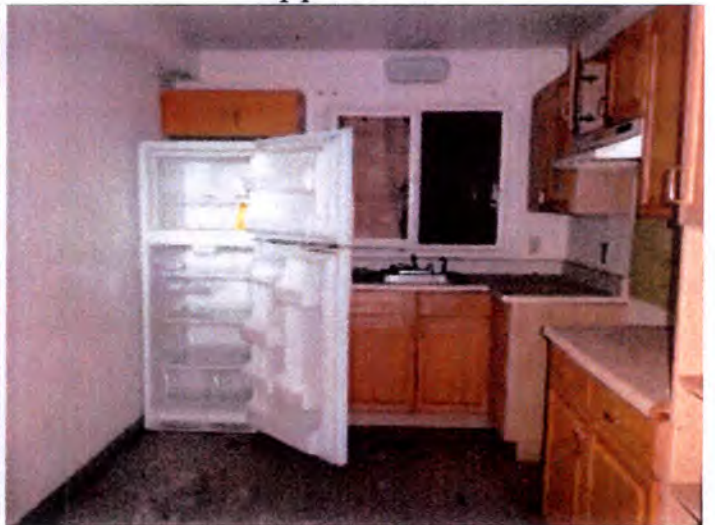
The kitchens of buildings B and C were deteriorated with moisture damage, termite damage and general damage observed at the cabinets, counters and finishes. Recommend the replacement of all dwelling unit kitchens, fixtures and appliances.

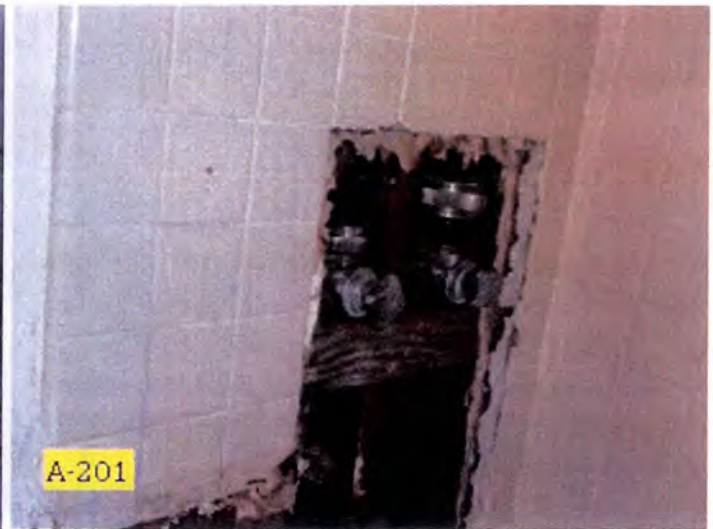
There were visible indications of moisture damage, mold growth, damaged flooring, damaged cabinets and counters, damaged mirrors, damaged toilets and damaged shower compartments observed at the time of inspection. Based on the observed conditions on site, we recommend the replacement of all dwelling unit bathrooms.

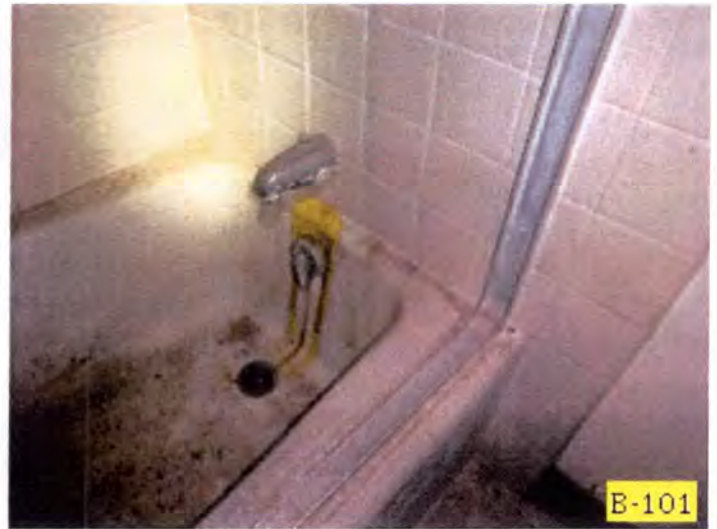
There were visible indications of moisture damage, mold growth, damaged flooring, damaged cabinets and counters, damaged mirrors, damaged toilets and damaged shower compartments observed at the time of inspection. Based on the observed conditions on site, we recommend the replacement of all dwelling unit bathrooms.

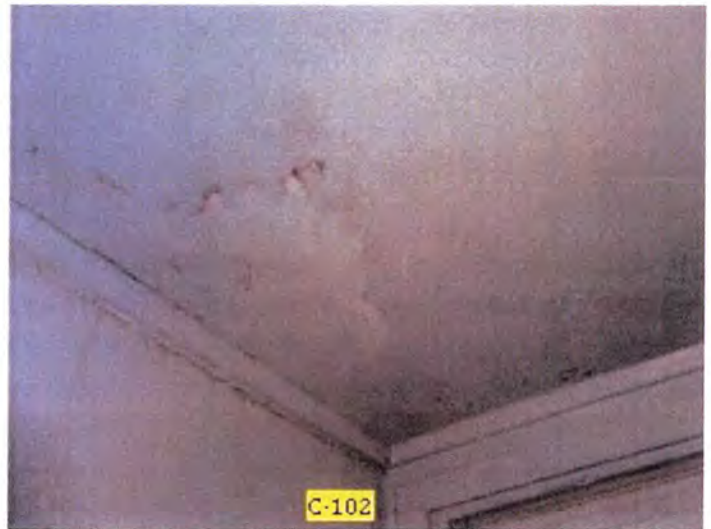
There were visible indications of moisture damage, mold growth, damaged flooring, damaged cabinets and counters, damaged mirrors, damaged toilets and damaged shower compartments observed at the time of inspection. Based on the observed conditions on site, we recommend the replacement of all dwelling unit bathrooms.

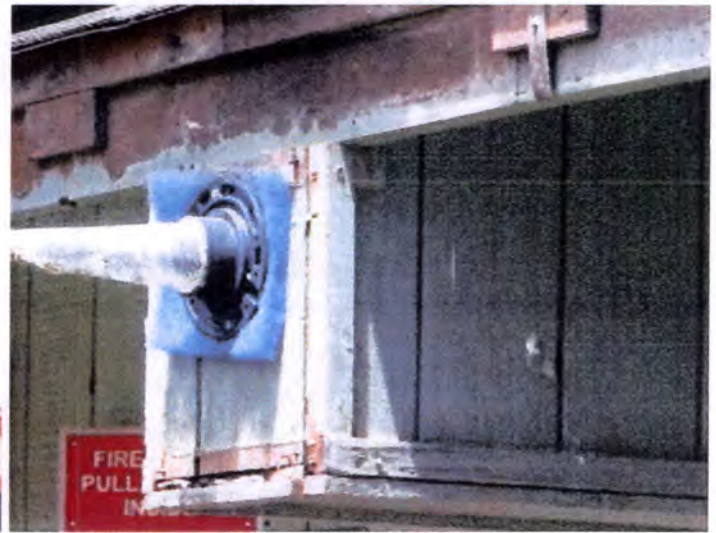
There was extensive pest (ie: cockroach) infestation observed at the interior and/or exterior areas of the building.

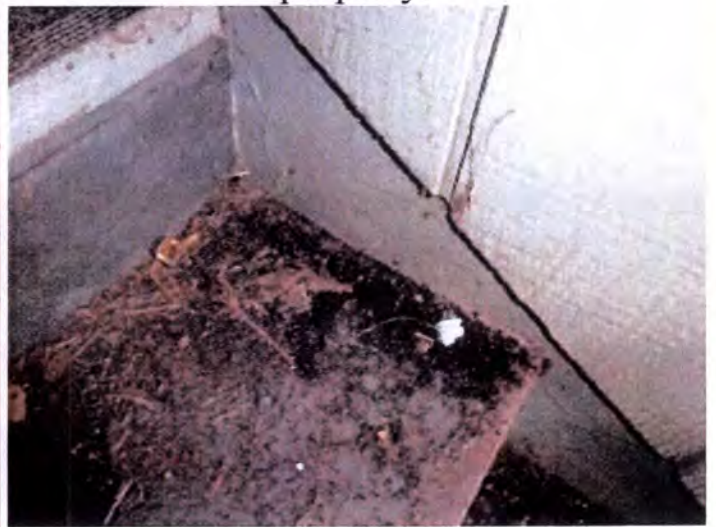
There was moderate/extensive termite/moisture damage observed at the interior and/or exterior areas of the building.

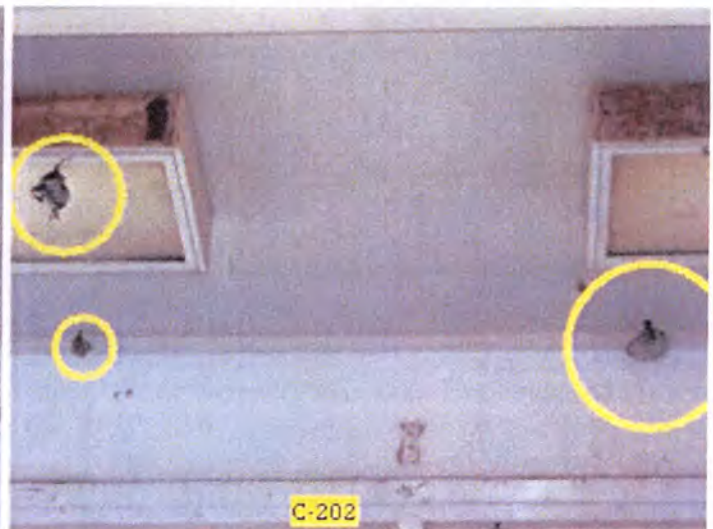
There was a hazardous bee population observed on site at the time of inspection. The single story storage building had sections of front wall removed for past been removal. The left side of the building had extensive and constant activity observed. There were been nests also observed at other exterior and interior locations through out the property.
