**SUBJECT: LOWER NAHIKU BRIDGE HEALTH AND SAFETY
CONCERNS (NAHIKU) (IEM-10)**

NAGAMINE OKAWA ENGINEERS INC.

Subject: Nahiku Bridge Condition Assessment No. 2
Lower Nahiku Road near Hana Highway, Route 360 M.P. 25
Maui, Hawaii

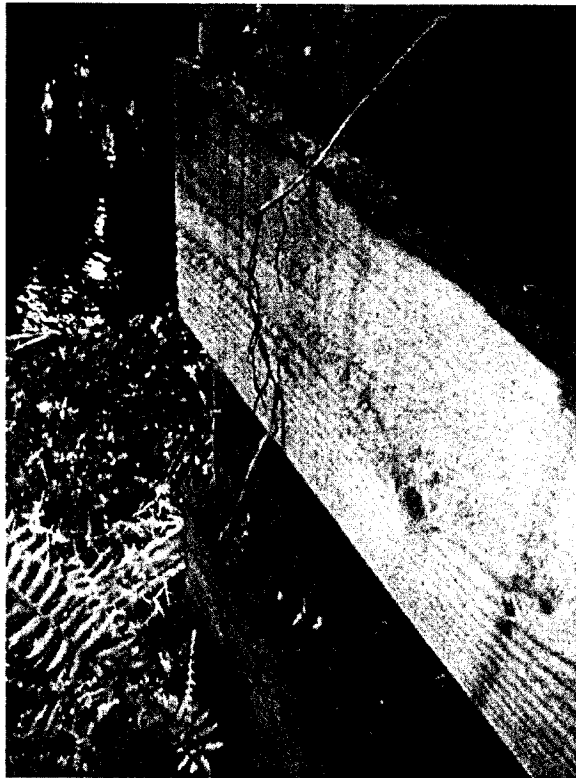
3. The built-up pier cap 6 x 12 timber beams generally appear to be in fair condition.
4. The built-up 6 x 12 timber pier columns generally appear to be in poor condition. One of two 6 x 12 members at both the upstream and center columns is rotted at the base (see Photo 6). The upstream pier column does exhibit a slight curvature in the plane of the pier. Both members of the downstream column is severely rotted at the base (see Photo 7). However, no signs of crushing, settlement, or other obvious vertical movement in the downstream column, cap beam or superstructure were observed.

PHOTO 7 Severe wood rot in downstream pier column

3. Recommend load posting (or vehicle weight limit) warning signs be installed at both ends of the bridge.
4. Short-term temporary shoring and repair:
 - a. Immediately shore and brace the timber pier structure until the severely damaged elements such as the timber columns, diagonal bracing and timber connection plates are properly repaired or replaced. The temporary shoring and bracing should be installed if the bridge is currently being used.

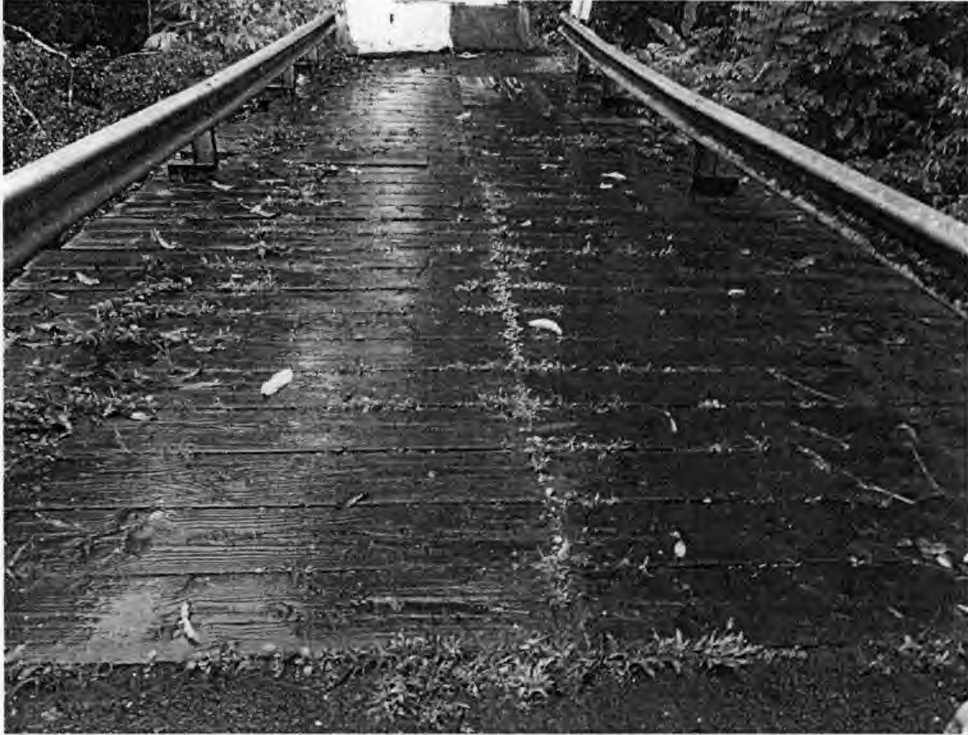
2. 4 x 12 Deck Planks: The timber planks are in poor to fair condition. A few planks have section loss due to decay and a majority of the planks are weathered and decayed to some degree. Three areas of the deck are covered with plywood sheathing (Photos 1 & 8).

PHOTO 1 4x12 DECK PLANKS AND METAL GUARDRAILS ON BRIDGE

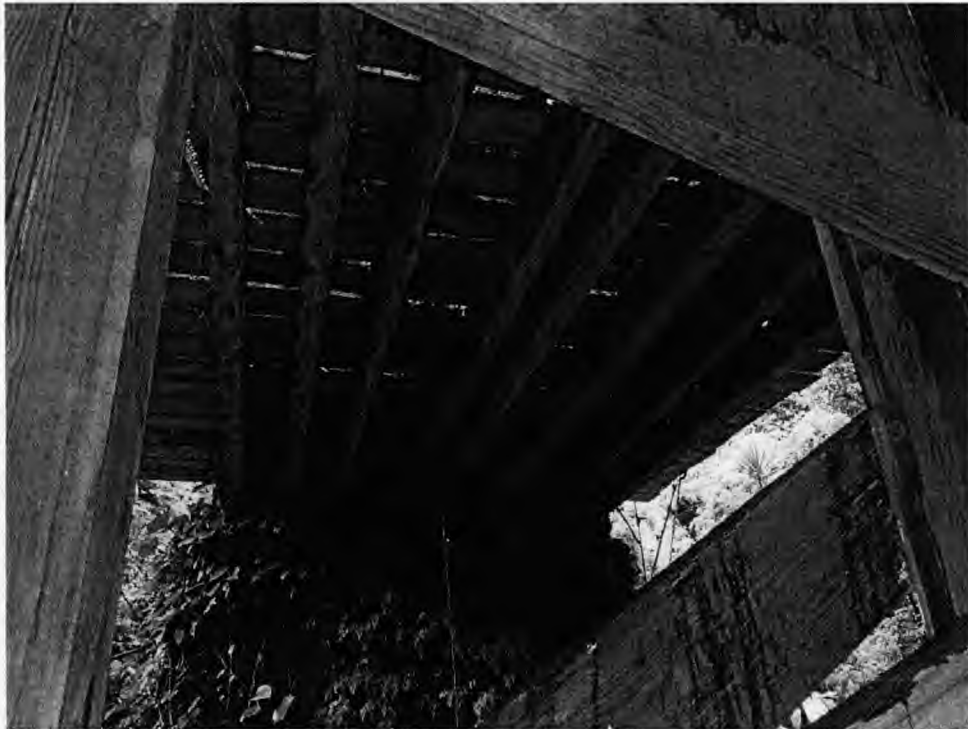
PHOTO 2 MAKAI SPAN

The eight 6 x 12 timber girders in the makai span are in fair condition (Photos 2). Some degree of decay is occurring typically at the bottoms of the timber girders where they bear on the pier and makai abutment and the tops of the girders where the deck planks bear on them. Probes with a metal rod were able to penetrate up to 1 inch into some of the timber girders.

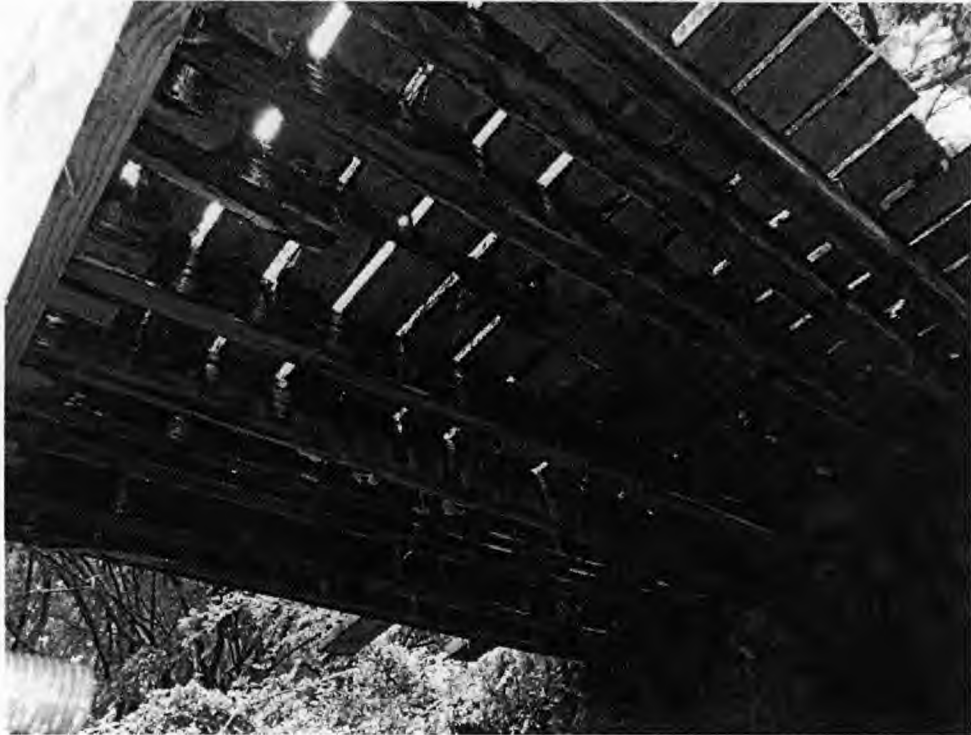
PHOTO 3 MAUKA SPAN

3. 6 x 12 Girders: The ten 6 x 12 timber girders in the mauka span are in poor to critical condition. The fourth girder from the upstream side of the bridge has failed and is no longer there (Photos 3). The bottoms of the timber girders bearing on the pier and mauka abutment and the tops of the girders where the deck planks bear on them are severely decayed. Probes with a metal rod were able to penetrate up to 6 inches into the timber girders.

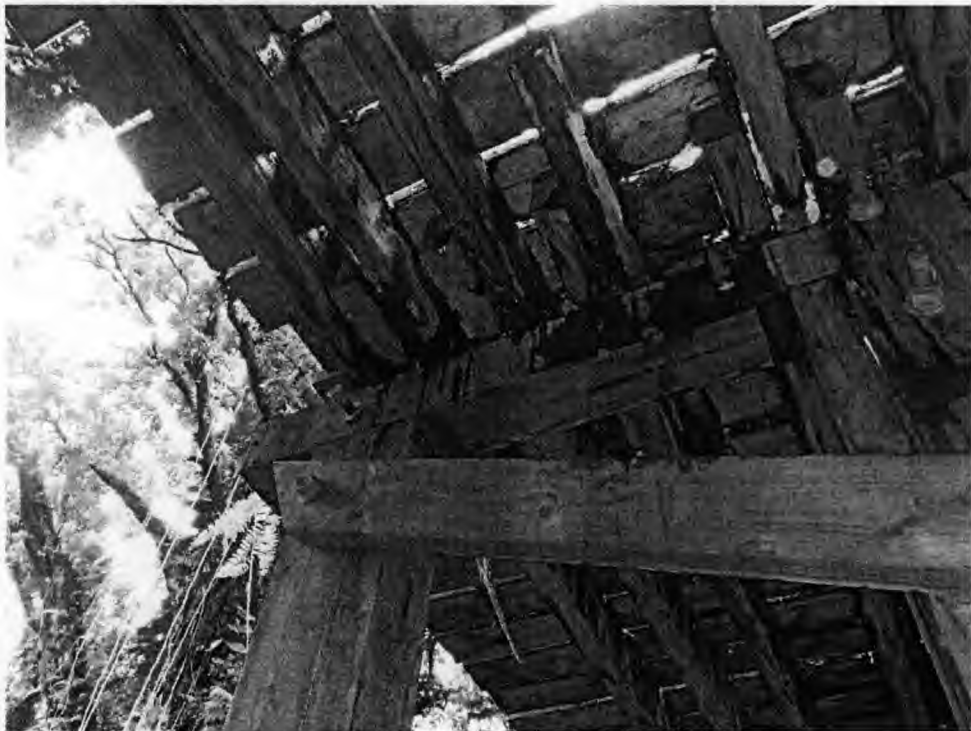
PHOTO 4 6x12 TIMBER GIRDERS LAPPED OVER INTERMEDIATE PIER

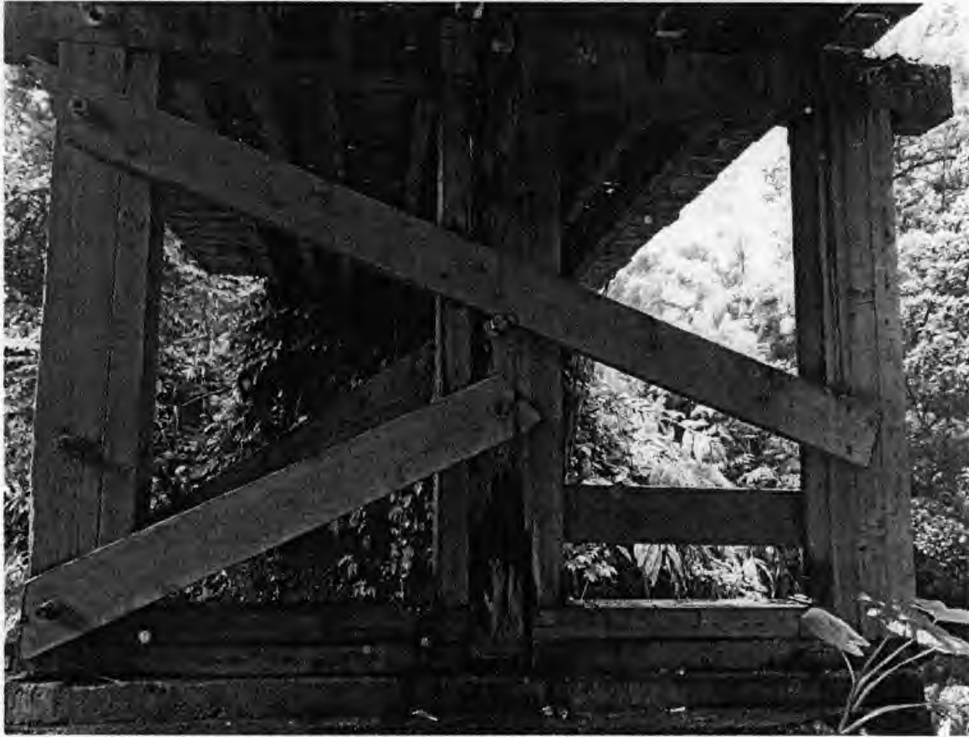
- b. Pier Columns: The timber pier columns are in fair to poor condition (Photos 5, 6, 10 & 11). The decayed 6 x 12 members reported in the previous September 12, 2011 assessment has been augmented with additional 6 x 12 timber members at all three pier columns. The timber plates, upon which the columns bear, are severely decayed (Photos 11 & 12).
- c. Pier Braces: The severely decayed 4 x 12 diagonal timber brace members reported in the previous September 12, 2011 assessment has been replaced with a 4 x 12 timber members (Photos 5). The braces are in satisfactory condition.

PHOTO 5 TIMBER PIER BETWEEN THE MAUKA AND MAKAI SPANS

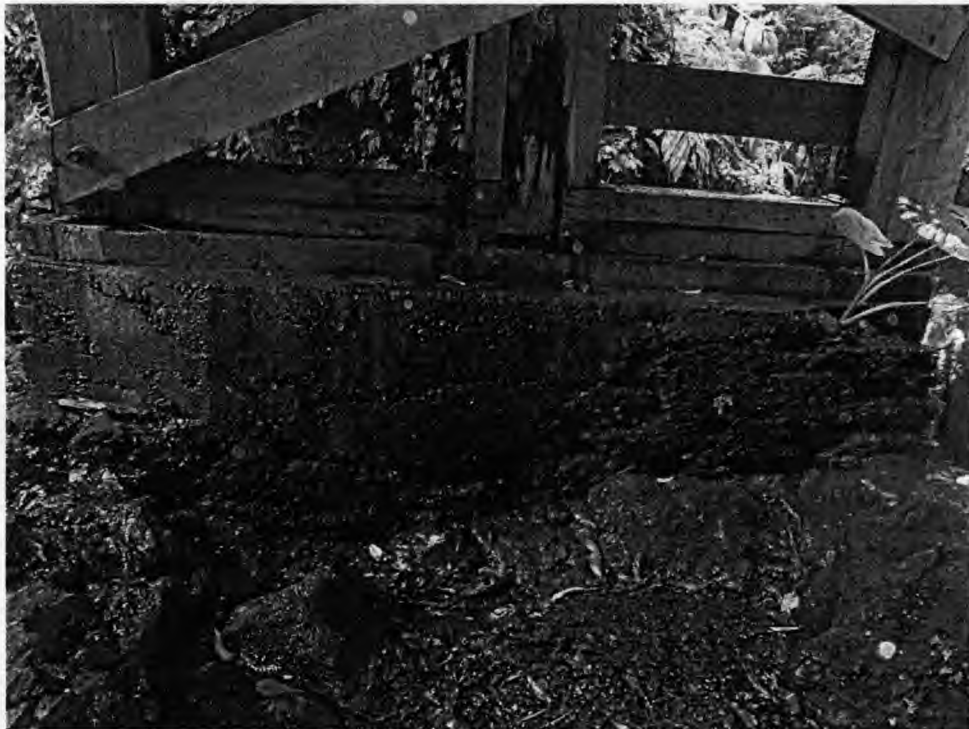
- d. Pier Wall: The concrete pier wall is in fair to poor condition. Honeycombing and heavy scaling has resulted in section loss (Photos 6). We suspect the concrete pier base wall is unreinforced concrete.

PHOTO 6 CONCRETE PIER WALL

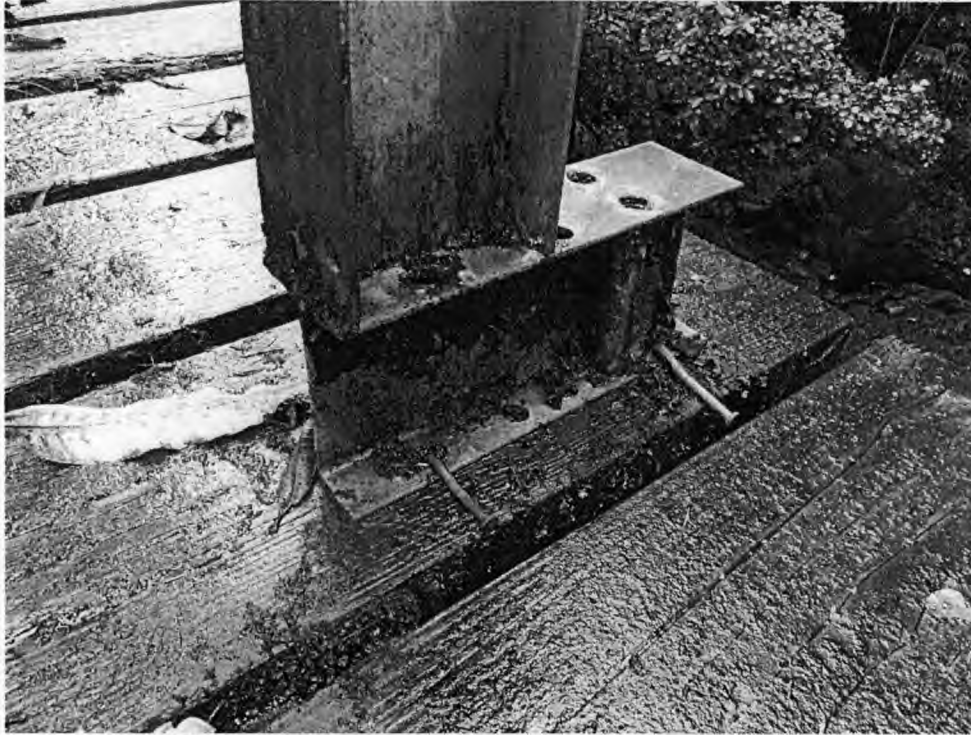
PHOTO 7 **BASE OF GUARDRAIL POST NAILED TO 4x12 DECK PLANK**

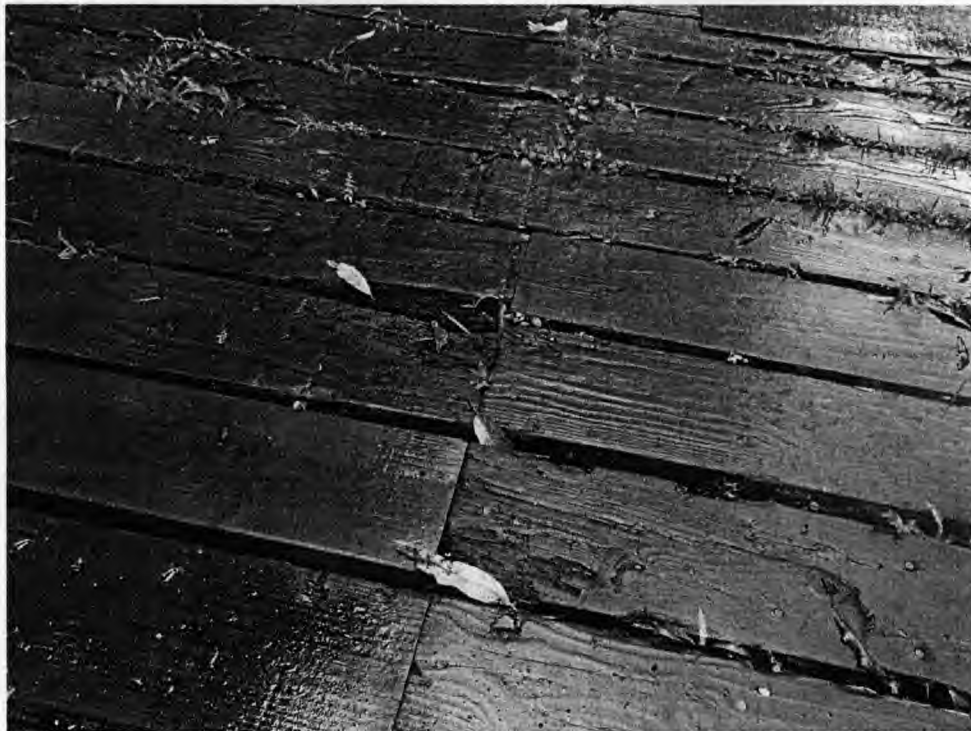
PHOTO 8 **CLOSE-UP VIEW OF 4x12 TIMBER DECK PLANKS**

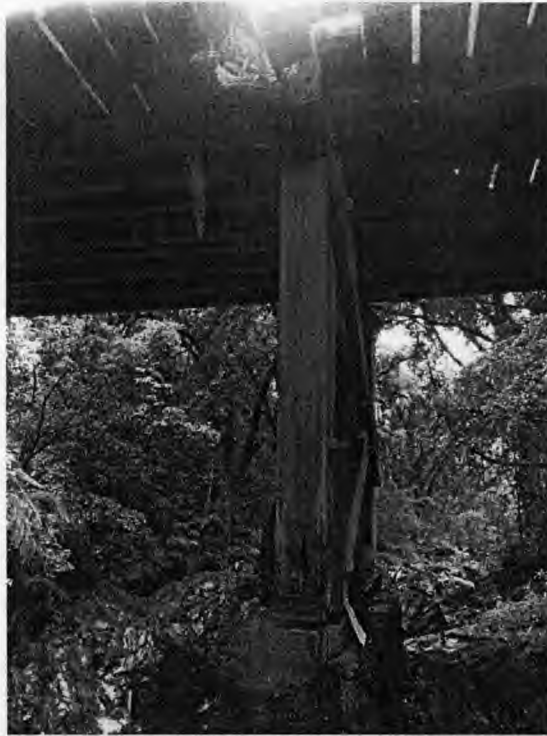
4. Timber Framed Pier:
 - a. Pier Cap Beam: The double 6 X 12 pier cap beams is in fair condition. The upstream end however is the severely decayed and we suspect it is

PHOTO 9 SEVERE DECAY AT UPSTREAM END OF TIMBER PIER CAP BEAM

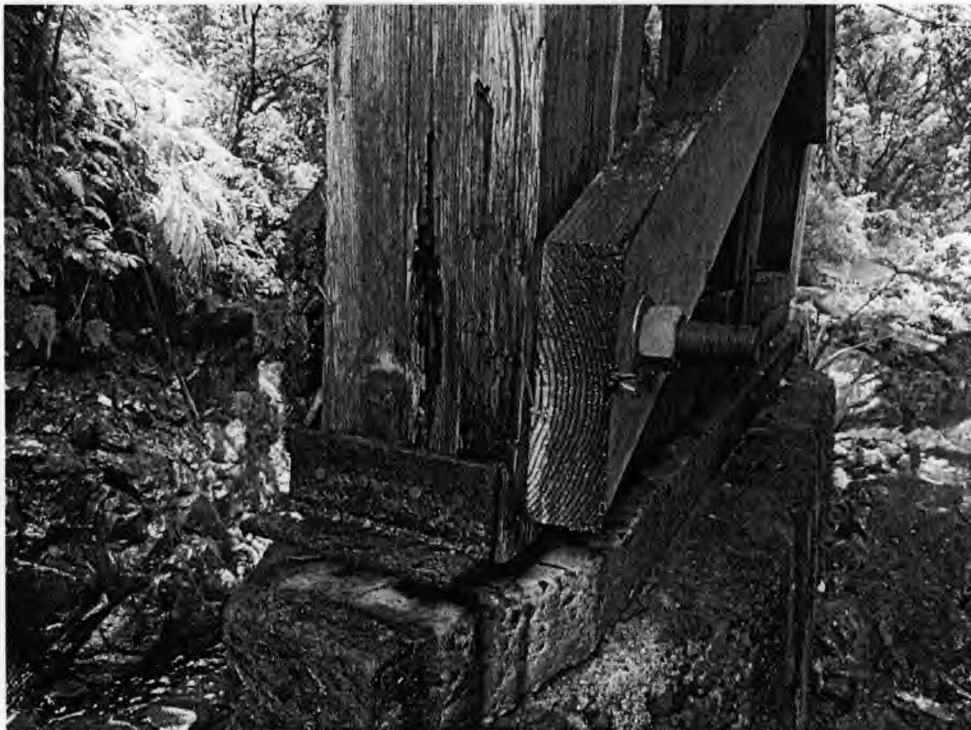
PHOTO 10 DECAYED UPSTREAM TIMBER PIER COLUMN

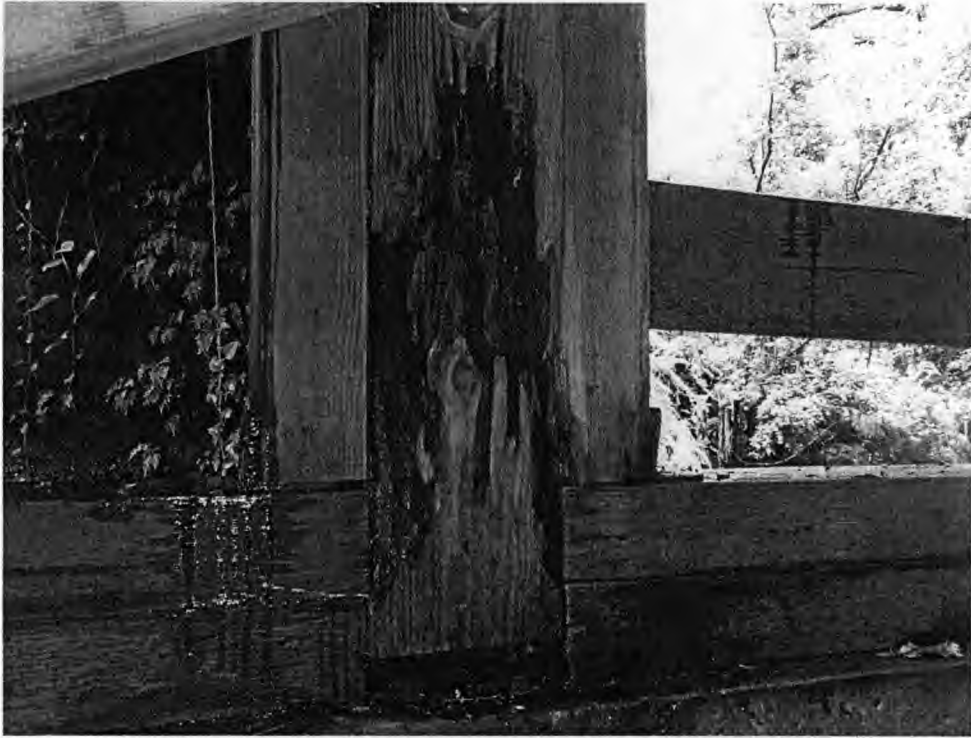
PHOTO 11 **DECAYED TIMBER COLUMN AND BEARING PLATE AT BASE OF CENTER
TIMBER PIER COLUMN**

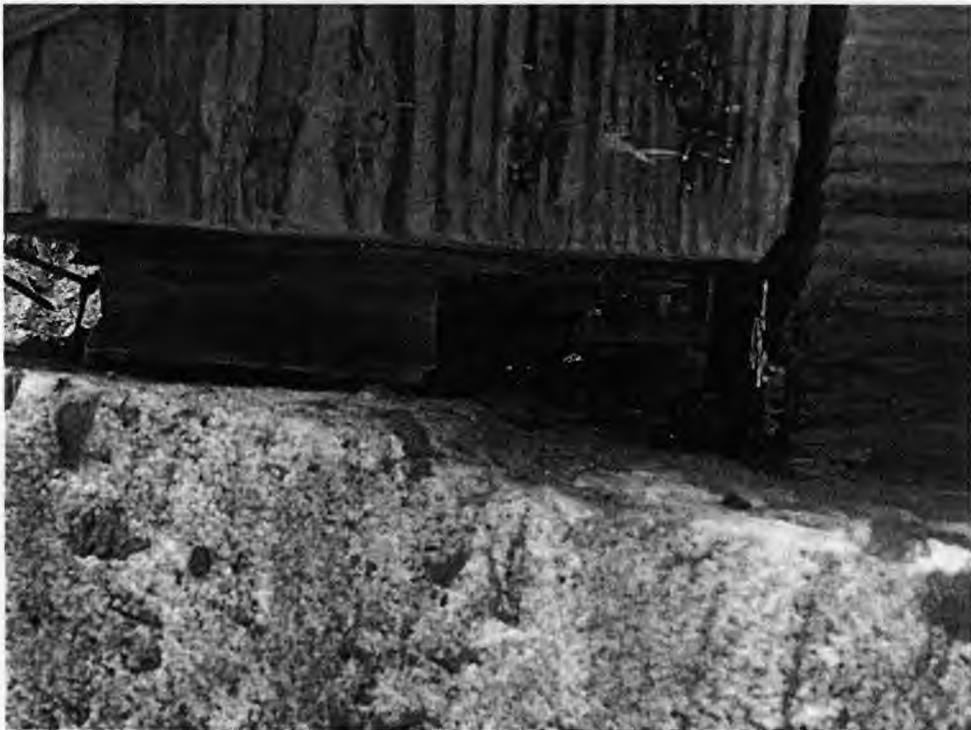
PHOTO 12 **DECAYED TIMBER BEARING PLATE AT BASE OF UPSTREAM TIMBER PIER
COLUMN**

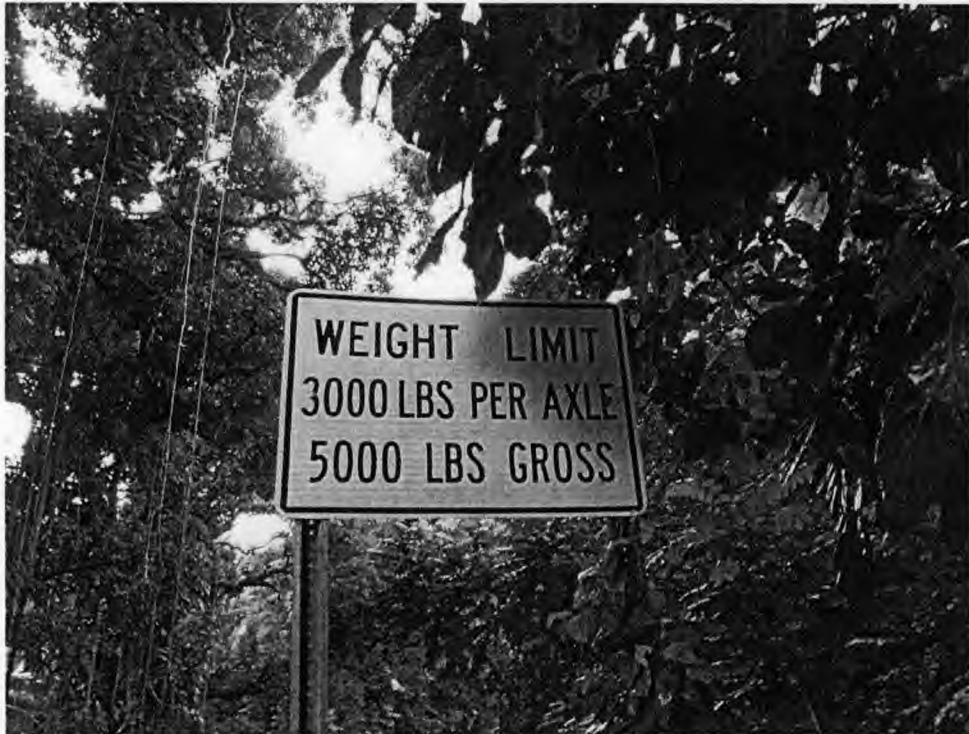
- 5. Abutments: The CRM abutments are in fair condition.
- 6. Signage: There is a weight limit sign stating a 3000 pound per axle/5000 pound gross vehicle weight limit at the mauka approach to the bridge (Photos 13). However, a temporary concrete barricade across the road just pass the weight limit sign has been installed along with a sign stating road closed (Photos 1 & 14). Further up the road from the bridge near the Nahiku Church a sign across the road states that the road is closed, local traffic only and that the bridge is closed indefinitely due to hazardous conditions (Photos 15).

PHOTO 13 WEIGHT LIMIT SIGN AT APPROACH TO BRIDGE

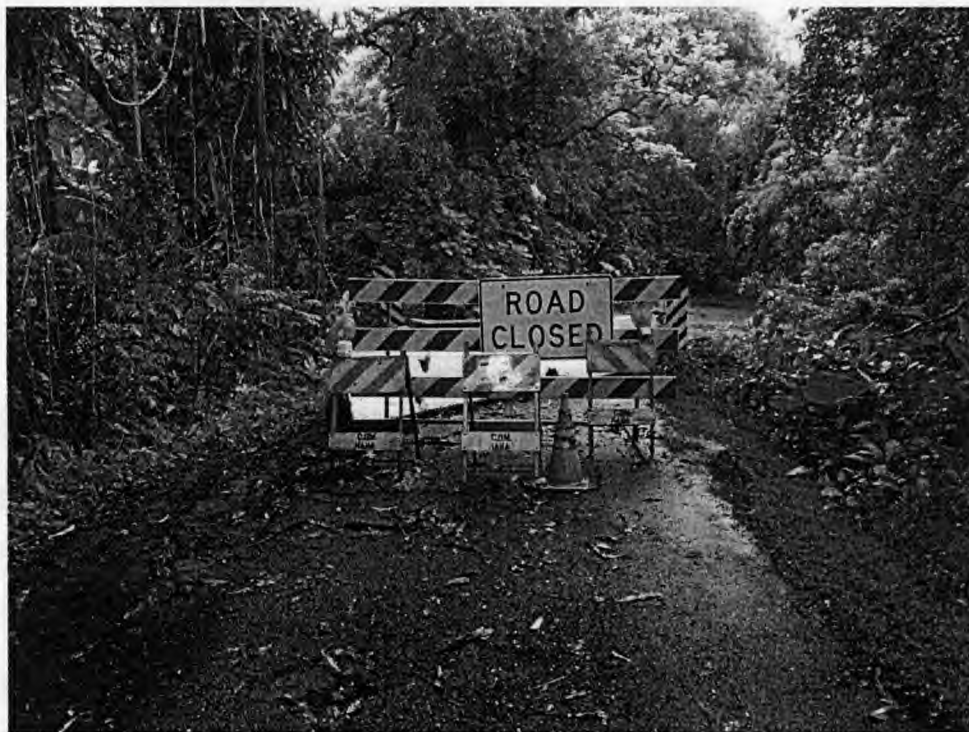
PHOTO 14 BARRICADE AT MAUKA END OF BRIDGE LOOKING MAKAI

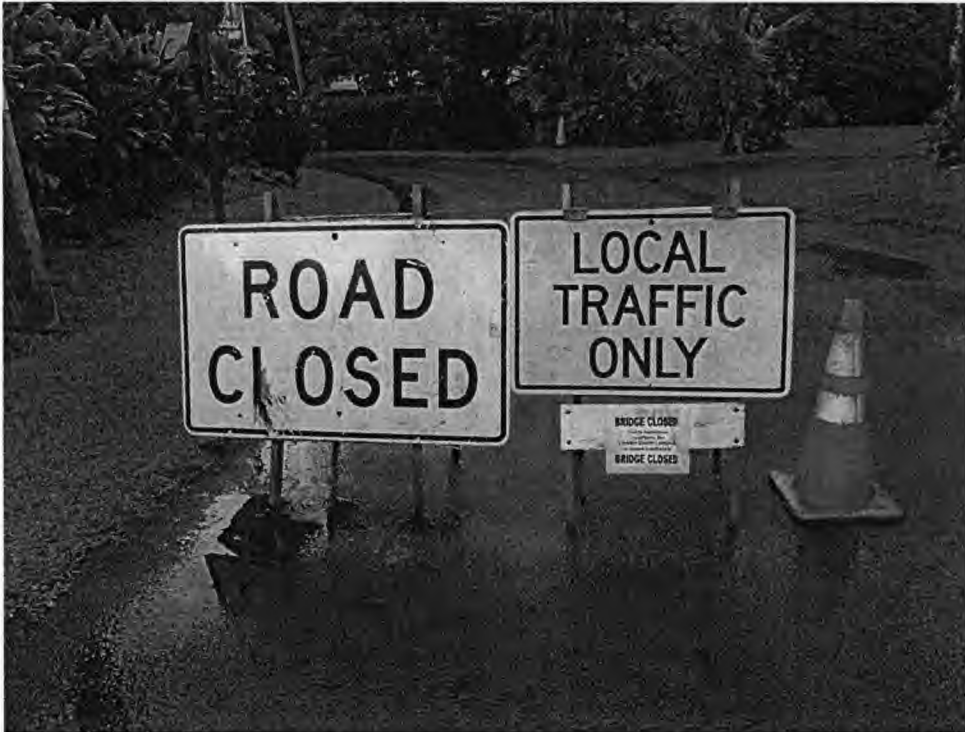
PHOTO 15 ROAD CLOSED SIGN ON LOWER NAHIKU ROAD NEAR NAHIKU CHURCH
