Property Condition Report

310 W Kaahumanu Ave, Kahului, HI 96732
Inspection prepared for: Maui County c/o Buddy Almeida
Real Estate Agent: -

Date of Inspection: 3/28/2018 Time: 8:00 AM
Age of Home: 1980 Size: 15000

This is a commercial property condition assessment to determine if three (3) former UH dormitories are suitable for housing. This inspection includes invasive and non-invasive inspection methods as well as sampling for asbestos and lead based paint.

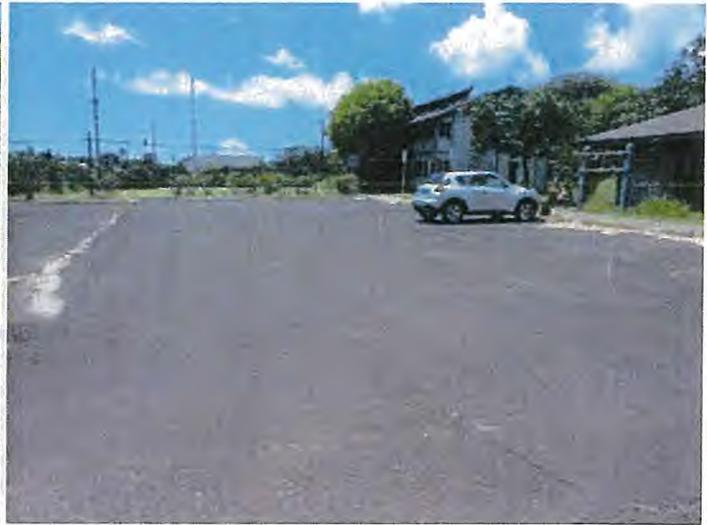
The parking area surface was deteriorated with lines weathered to the point of not providing clear lanes for parking use. Recommend having the parking area resurfaced and striped to ensure proper identification of parking stalls.

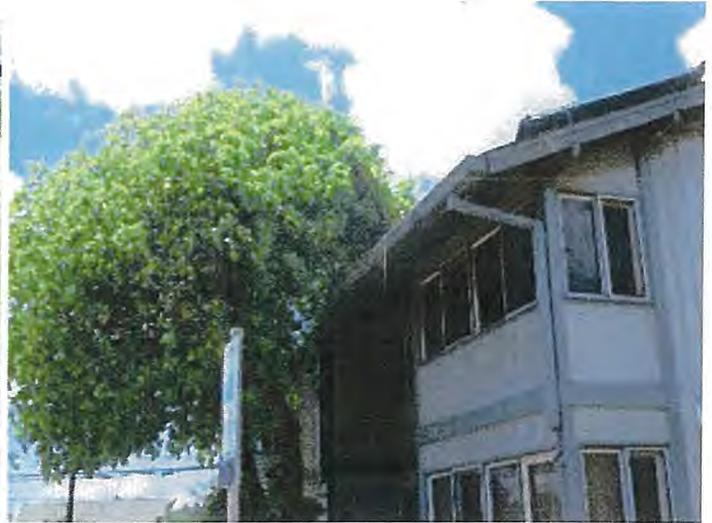
The vegetation was overgrown and causing deterioration/damage to the exterior curtain wall and fixtures.

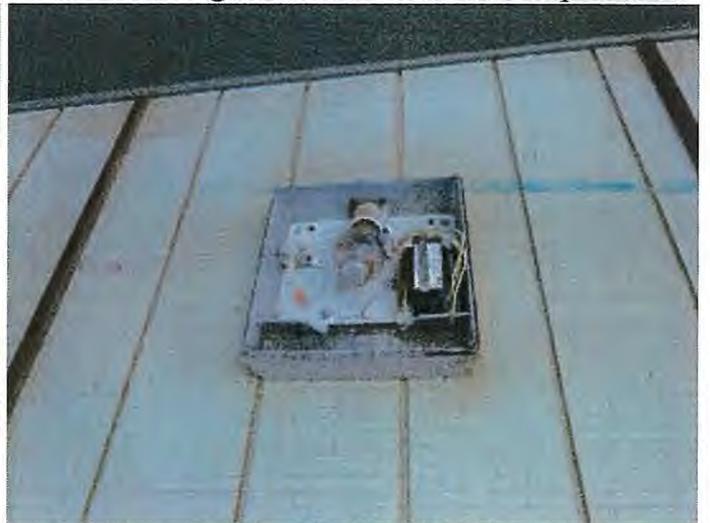
Some of the exterior lighting fixtures were damaged and need to be replaced.

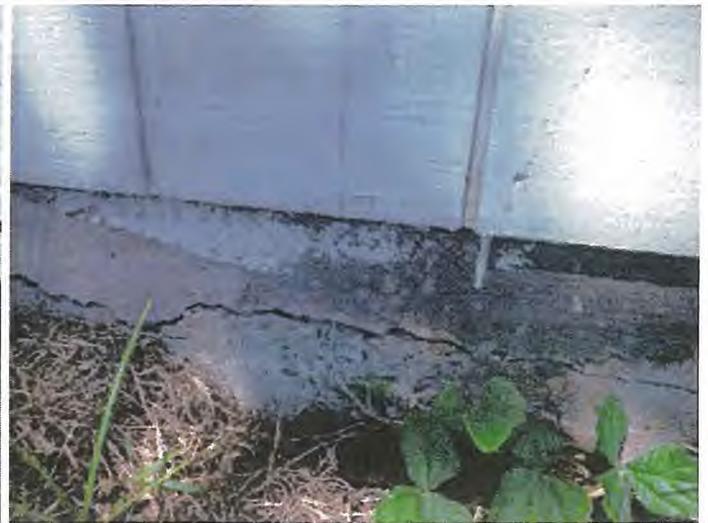
Building A and B: Visible cracks observed at the foundational areas of the buildings. There were separations observed along the defect areas which represent movement between the faults.

We recommend having a licensed foundation/masonry contractor evaluate and repair the affected areas as necessary to prevent further damage.

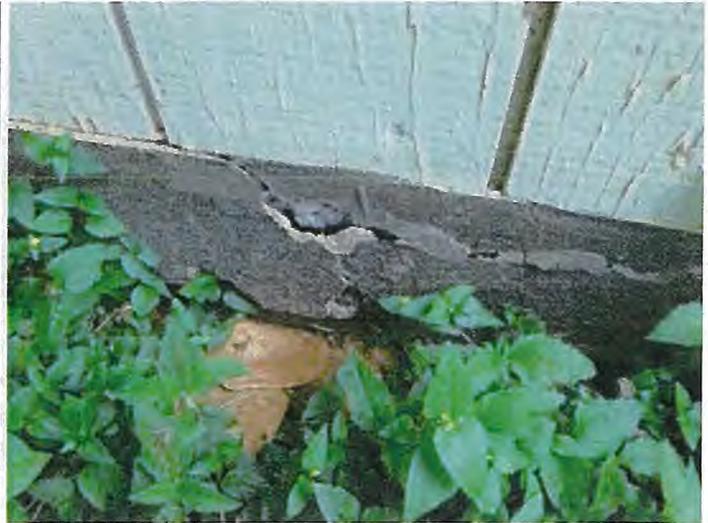
Building A and B: Visible cracks observed at the foundational areas of the buildings. There were separations observed along the defect areas which represent movement between the faults.

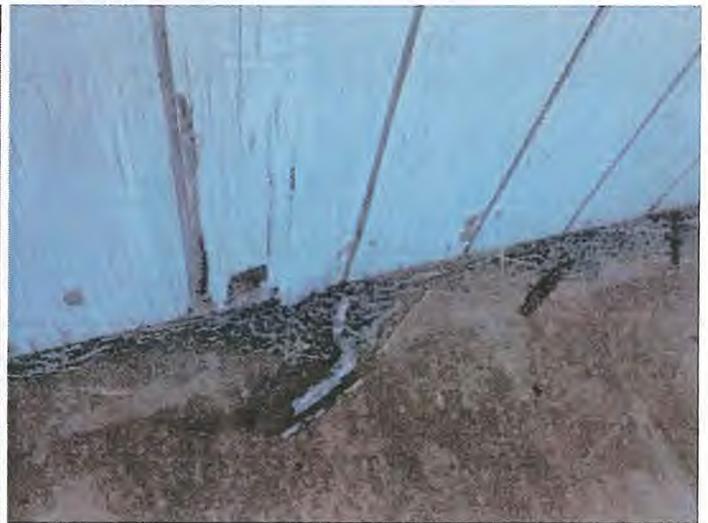
Moisture damage observed at exterior wall areas. Recommend select demolition and replacement of affected ground level exterior siding and finishes.

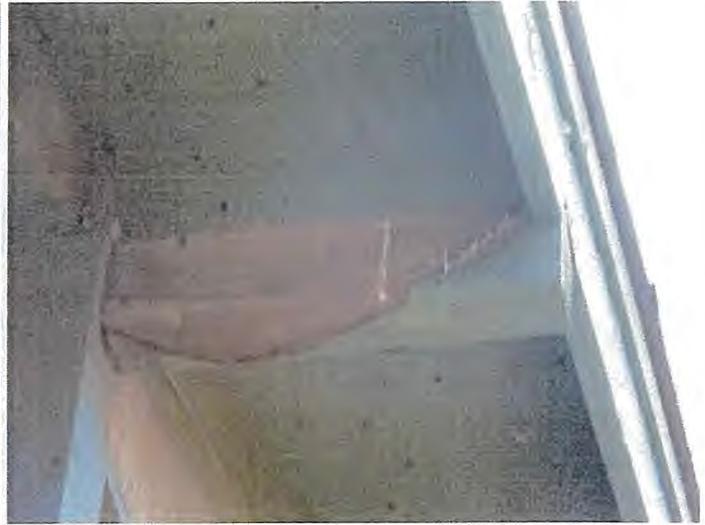
Blistering/peeling/missing paint observed at many exterior trim, fascia and soffit areas. Recommend properly preparing and refinishing exterior finishes.

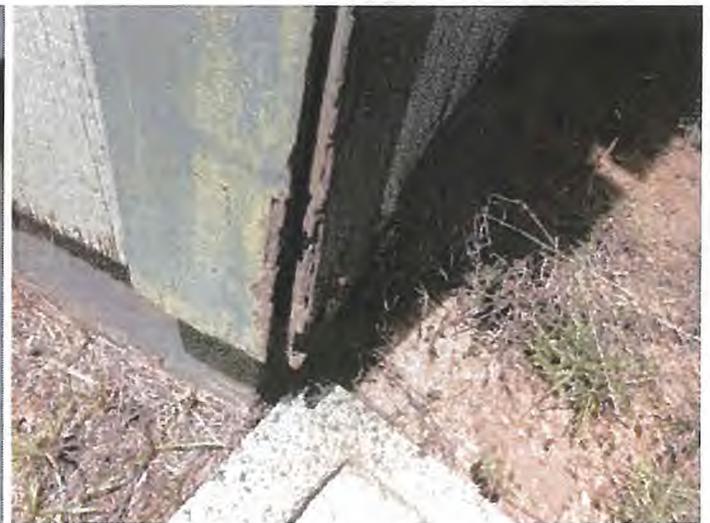
Visible indications of WDO (termite) damage noted. Recommend having a licensed pest contractor evaluate and treat as necessary. Also, recommend having a licensed contractor evaluate and repair/replace damaged material as necessary.

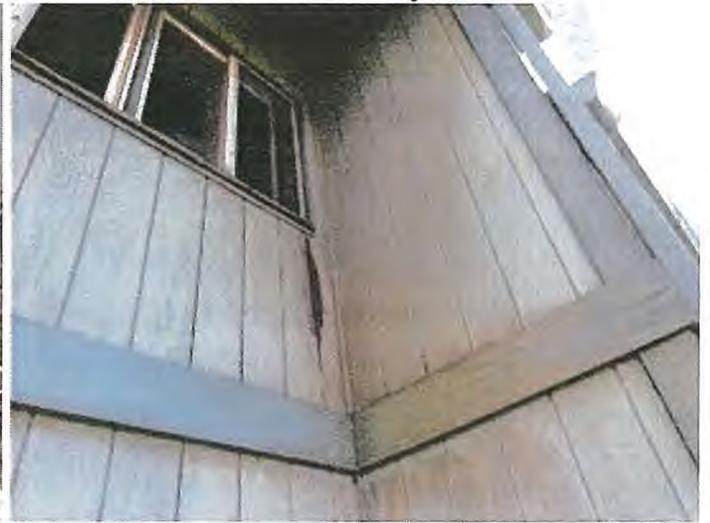
Moisture damage observed at exterior wall areas. Recommend select demolition and replacement of affected ground level exterior siding and finishes.

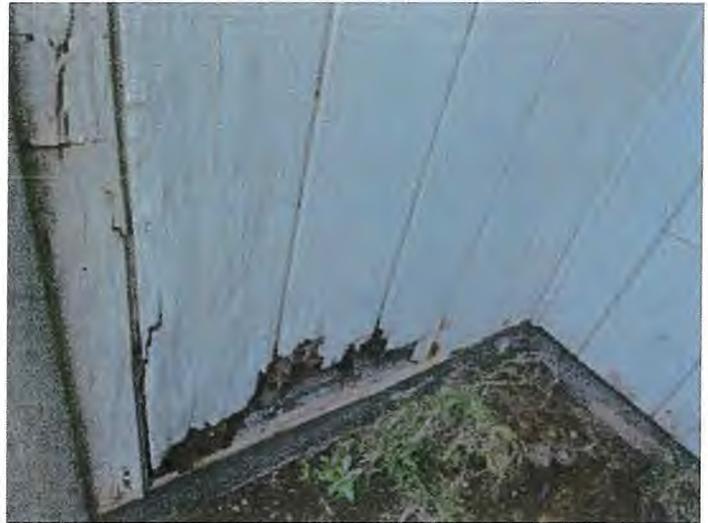
Visible indications of WDO (termite) damage noted. Recommend having a licensed pest contractor evaluate and treat as necessary. Also, recommend having a licensed contractor evaluate and repair/replace damaged material as necessary.

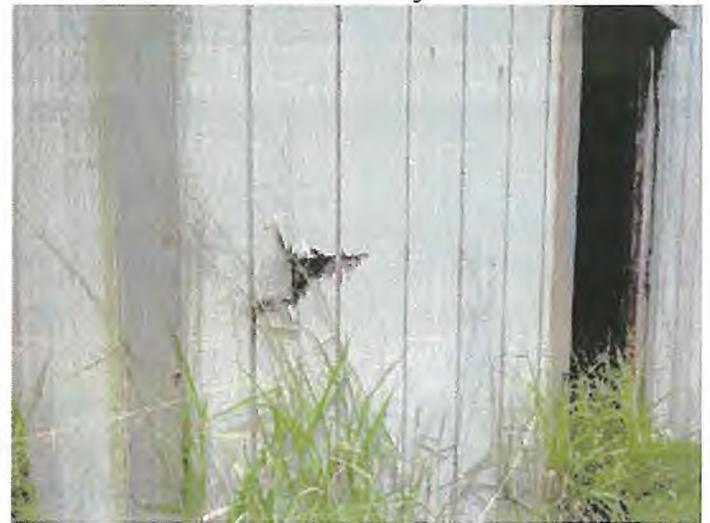
Visible indications of WDO (termite) damage noted. Recommend having a licensed pest contractor evaluate and treat as necessary. Also, recommend having a licensed contractor evaluate and repair/replace damaged material as necessary.

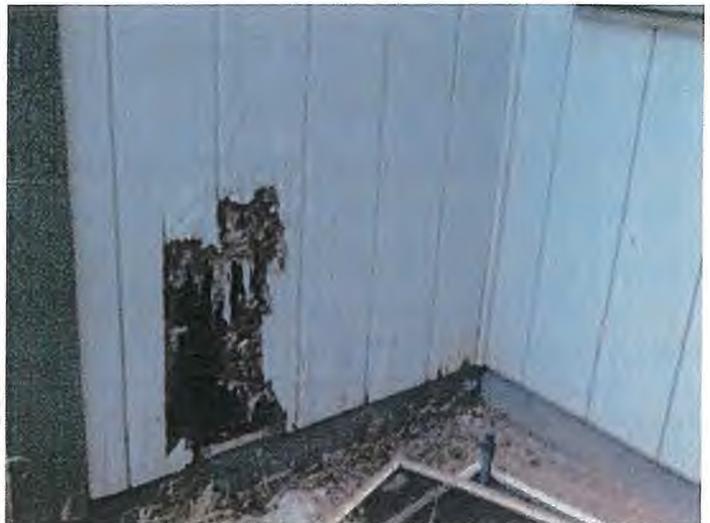
Visible indications of WDO (termite) damage noted. Recommend having a licensed pest contractor evaluate and treat as necessary. Also, recommend having a licensed contractor evaluate and repair/replace damaged material as necessary.

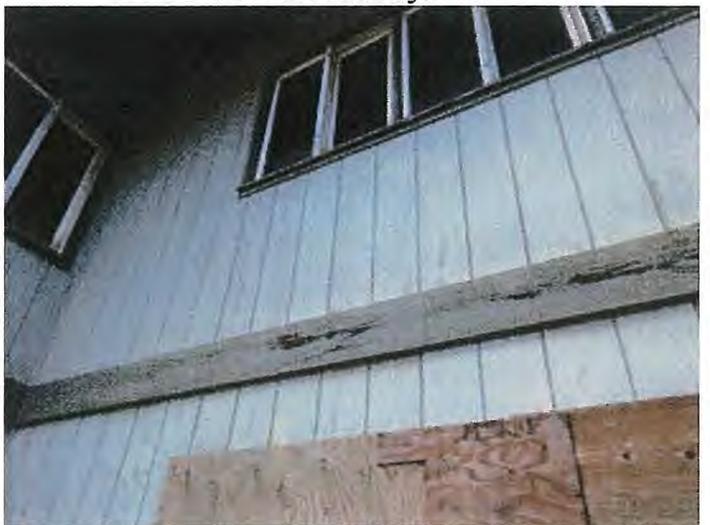
Visible indications of WDO (termite) damage noted. Recommend having a licensed pest contractor evaluate and treat as necessary. Also, recommend having a licensed contractor evaluate and repair/replace damaged material as necessary.

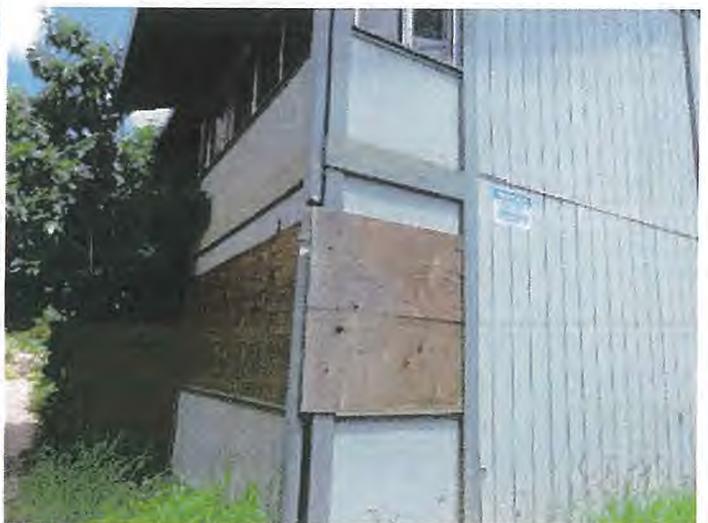
Many of the ground floor windows were broken at the time of inspection.

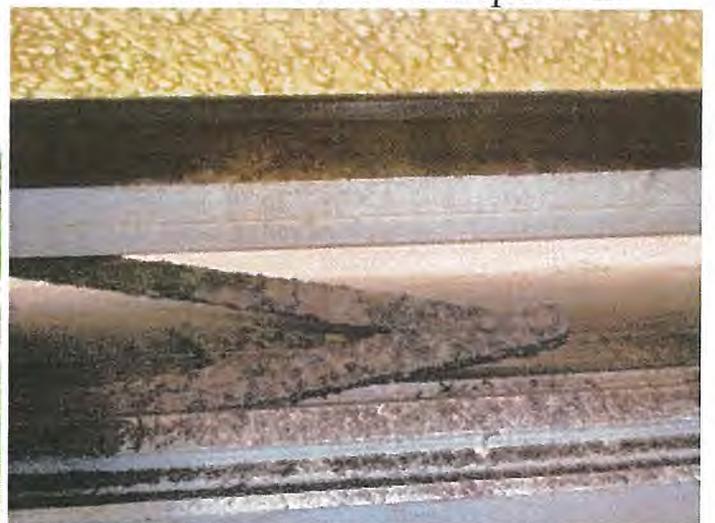
The stair way windows were heavily corroded, damaged and/or inoperable at the time of inspection. Recommend replacement.

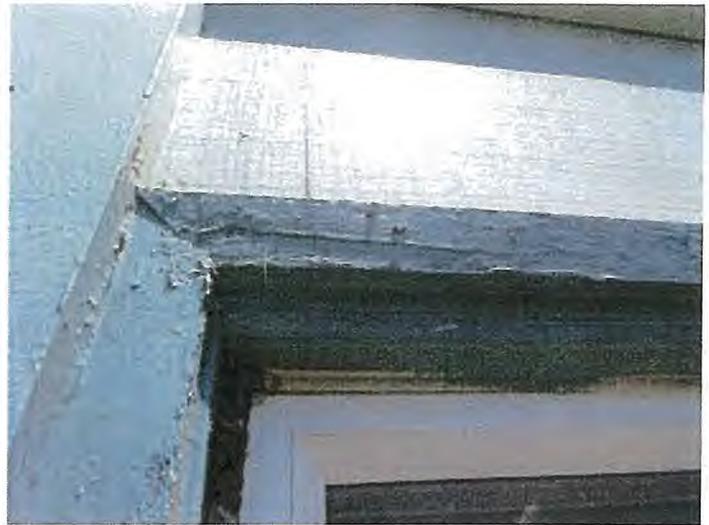
Due to the vegetative contact with exterior siding and finishes, the window trim is moisture/termite damaged at numerous locations. We recommend the removal and replacement of exterior window trim finishes.

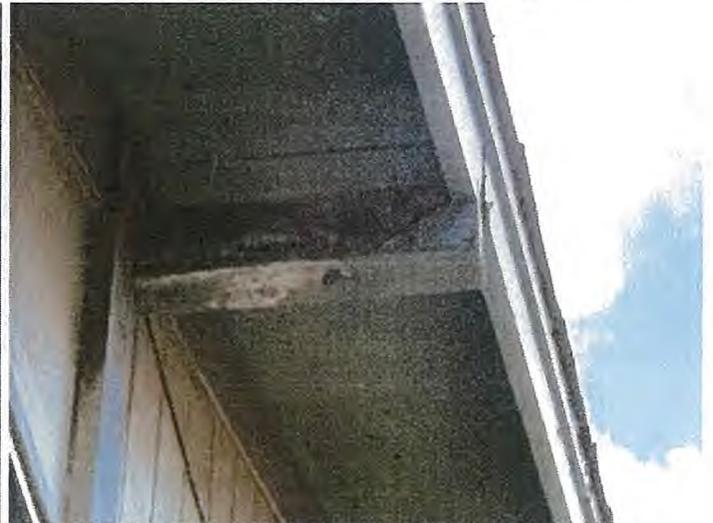
The fascia/soffit areas appeared to be rotted/water damaged/deteriorated at the time of inspection. Recommend having a licensed contractor evaluate and repair/replace as necessary.

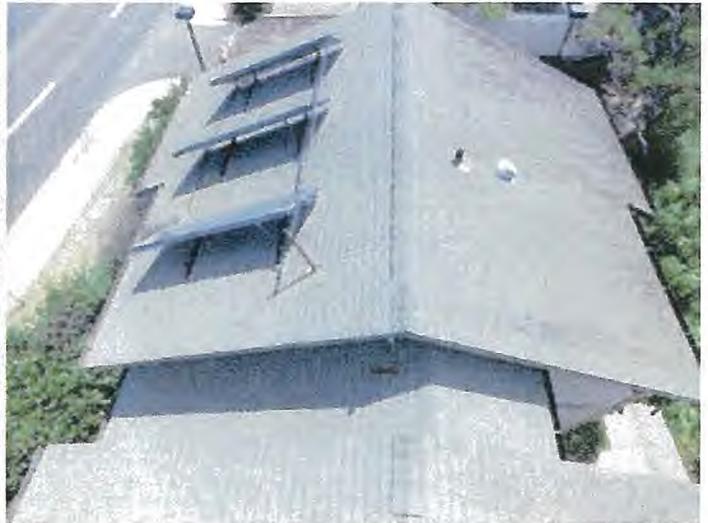
There were numerous areas of missing shingles observed at the roof ridge areas. Recommend repair in conjunction with roof replacement.

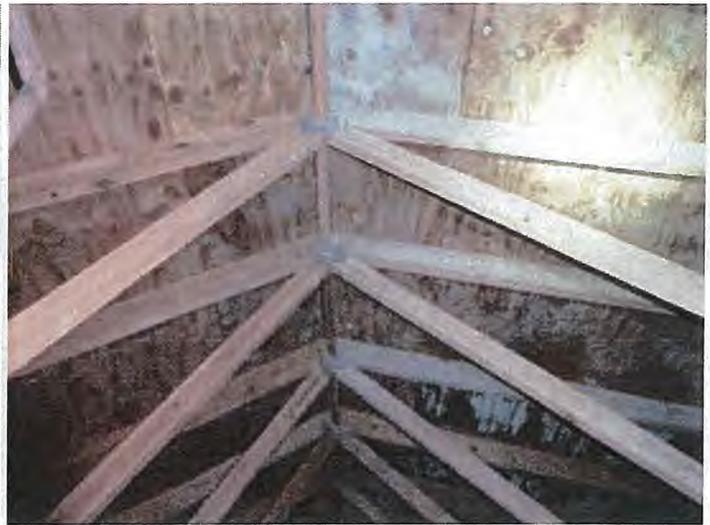
There were visible areas of moisture intrusion observed at the roof sheathing (within the attic spaces) at the time of inspection. This indicated a failed/failing roofing system. Recommend replacement of the installed sheathing and roofing finish.

- We recommend having a licensed roofing contractor evaluate and replace the existing roofing finishes of all three buildings. The structural framing was intact when inspected. Only the roof sheathing and covering needs to be replaced.

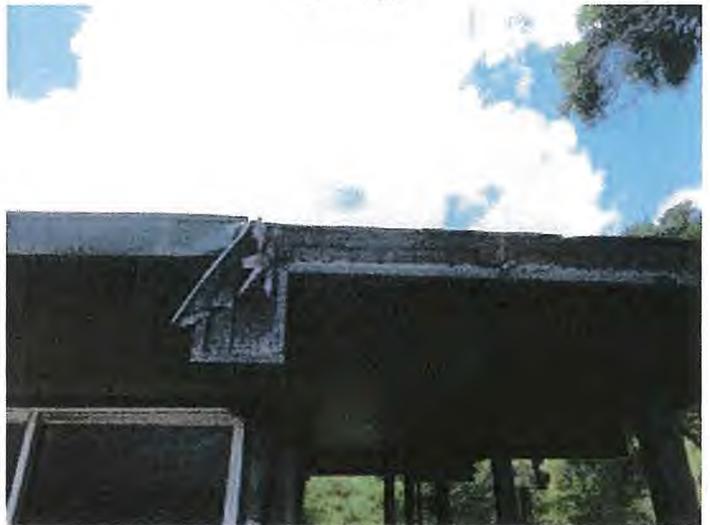
Damaged/broken/missing gutters noted. Recommend having a licensed contractor evaluate and repair/replace as necessary.

- We recommend replacement of the gutter systems in conjunction with roof replacement/repair.
 - Due to the observed conditions of the installed fire suppression system, we recommend having a licensed fire suppression contractor clean, service, inspect and repair the installed system and components.

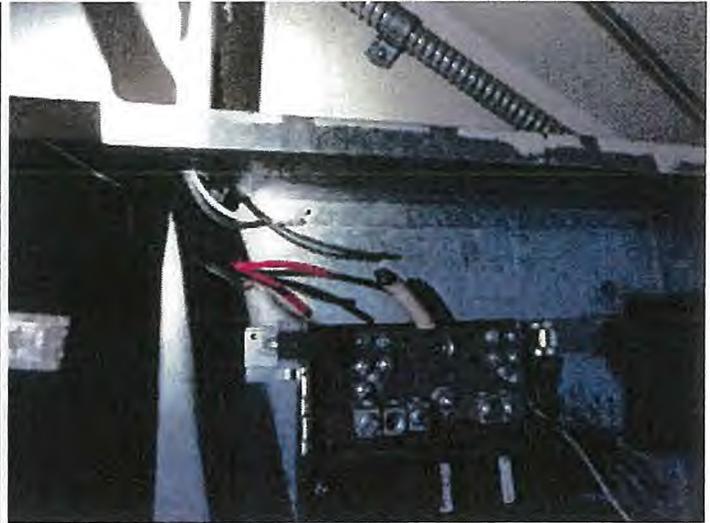
Building B and C: The main service conductors and all electrical branch wiring was cut at the main service panel entrances (located in the respective electrical rooms) when inspected. Recommend having a licensed electrical contractor evaluate and repair electrical service to each building. The installed cabinets, panels and service disconnects appeared serviceable.

- Based on the observed conditions, at the time of the site survey, we recommend the following:
 - We recommend having a licensed electrical contractor evaluate the main electrical service entrance and distribution panel for buildings B and C due to all conductors and grounding conductors being cut at the panels.

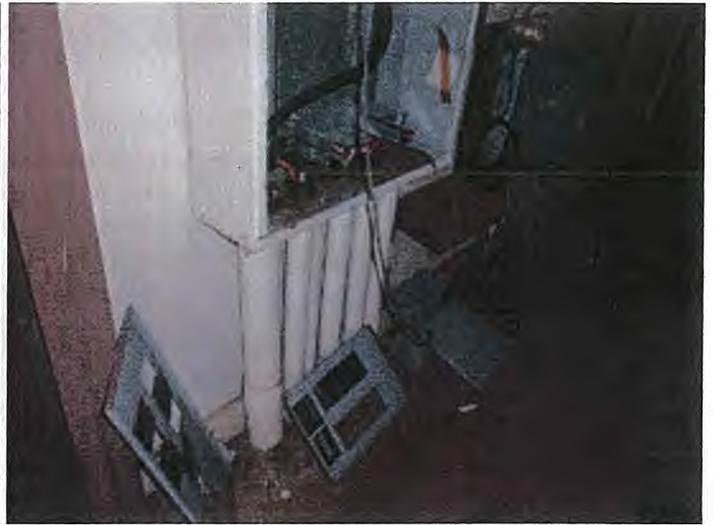
Building B and C: The main service conductors and all electrical branch wiring was cut at the main service panel entrances (located in the respective electrical rooms) when inspected. Recommend having a licensed electrical contractor evaluate and repair electrical service to each building. The installed cabinets, panels and service disconnects appeared serviceable.

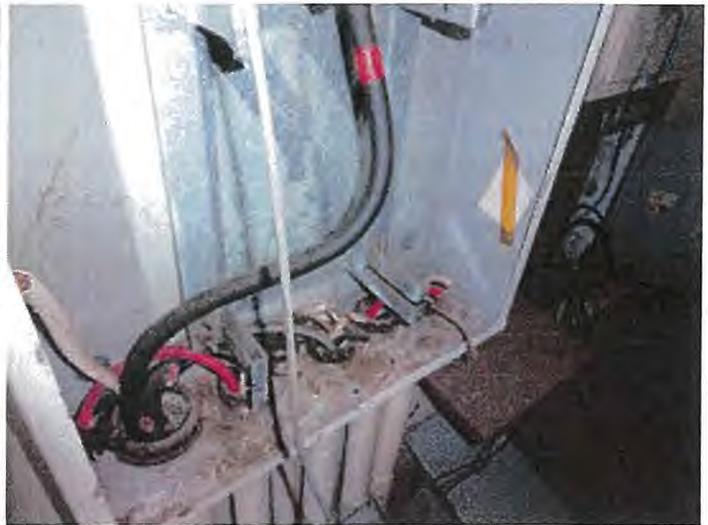
All of the branch wiring to buildings B and C was cut with circuit breakers removed. Recommend having a licensed electrical contractor repair.

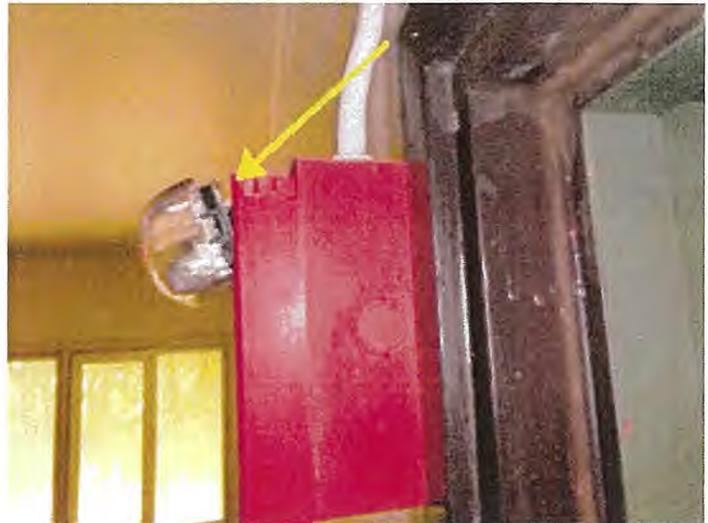
Approximately half of the installed pull stations were damaged when inspected. Recommend replacement/repair.

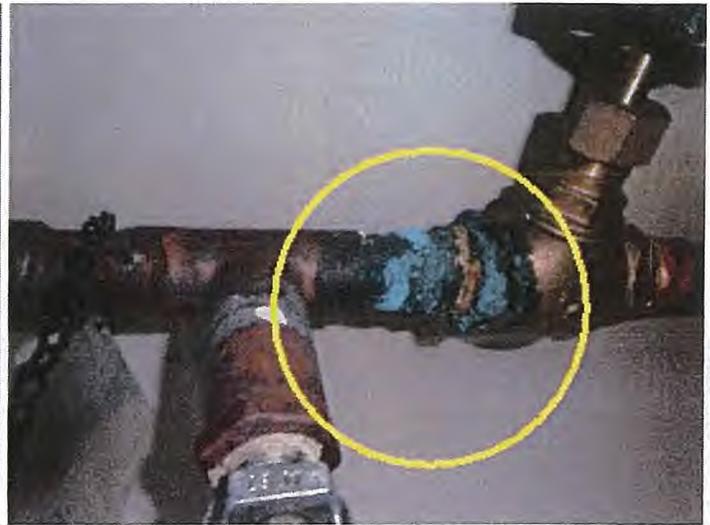
B-101: Fire sprinkler branch pipe and valve located in the hall closet was leaking when inspected.

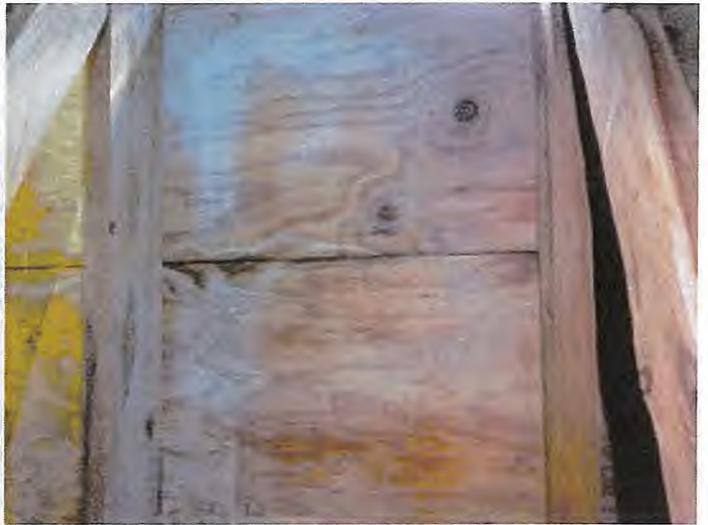
There were visible indications of mold present at all attic areas.

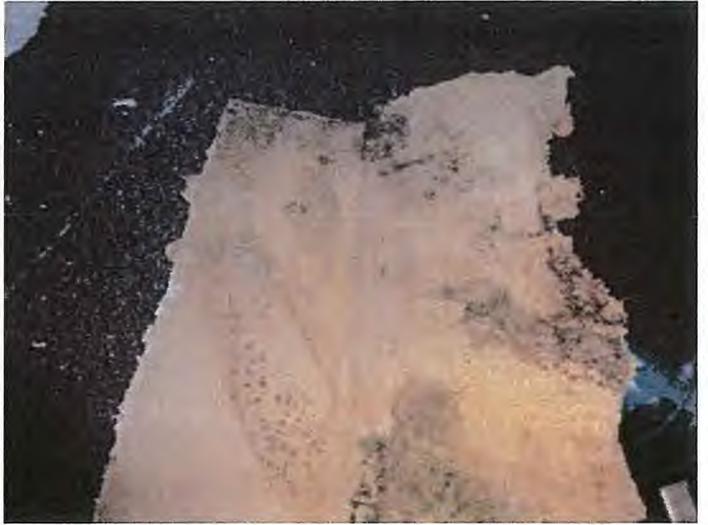
Visible indications of moisture intrusion and mold growth at building B and C interior, bedroom, bathroom and closet wall areas. Recommend removal and replacement of all interior wall finishes of B and C, after removal of all exterior vegetation.

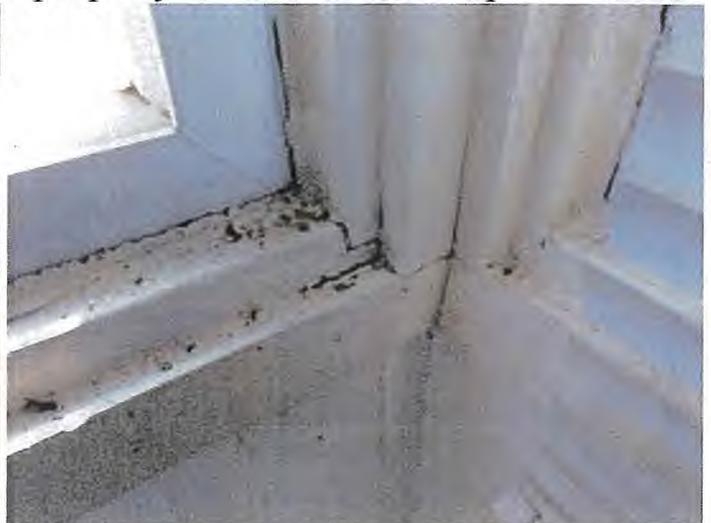
There were visible indications of moisture and termite damage observed at the interior window trim areas. Recommend replacement of all interior window trim and finishes.

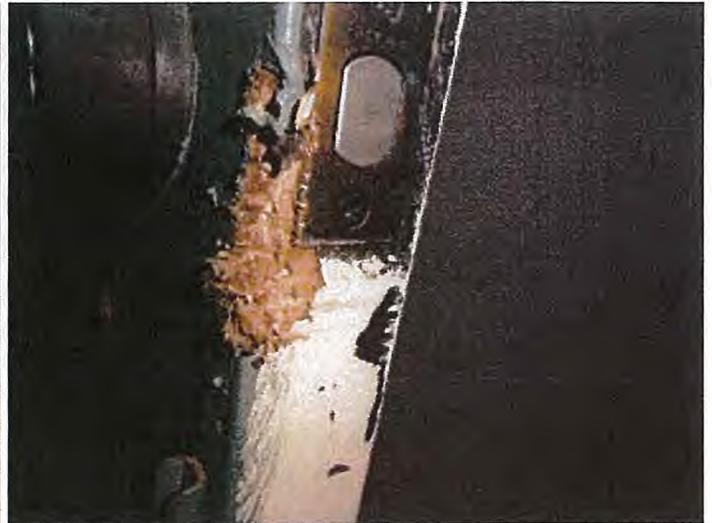
Most of the doors had varying degrees of damage observed when inspected. Based on the observed conditions, we recommend the replacement of all interior doors and trim within the dwelling units.

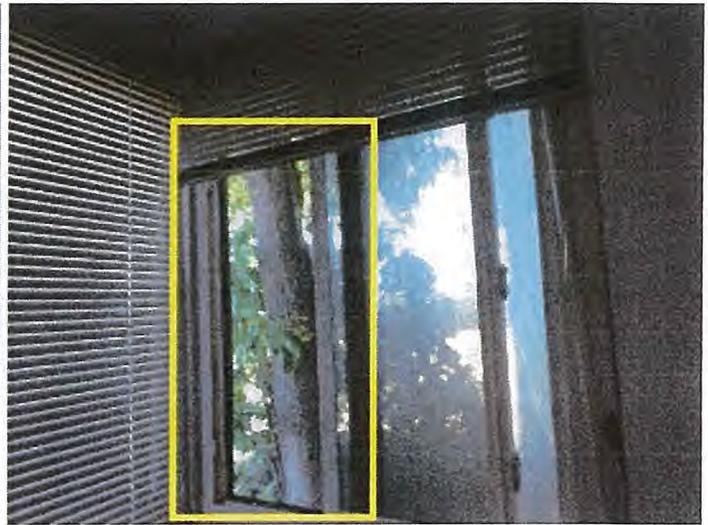
Many of the ground floor windows were broken at the time of inspection. Recommend replacement.

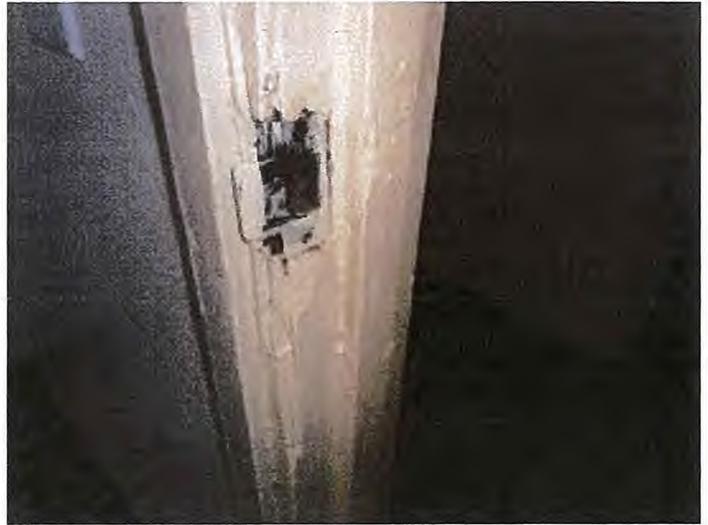
Most of the doors had varying degrees of damage observed when inspected. Based on the observed conditions, we recommend the replacement of all interior doors and trim within the dwelling units.

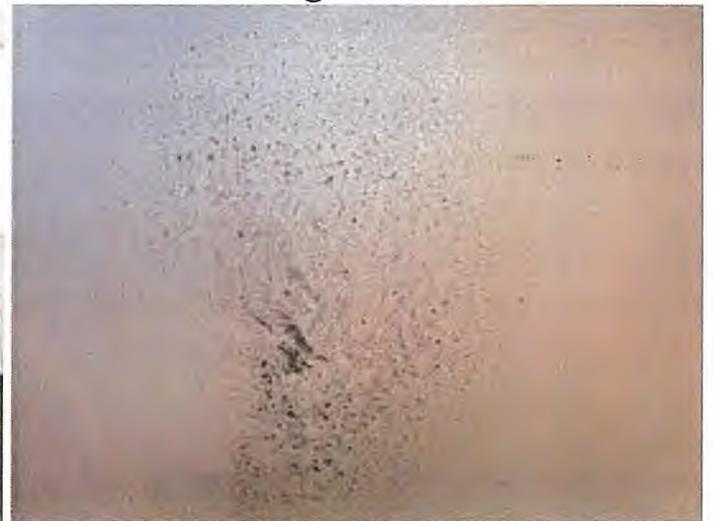
There were visible indications of water intrusion, with mold growth, noted at the ceiling areas of A-201. Recommend having a licensed contractor evaluate and repair as necessary to prevent further damage.

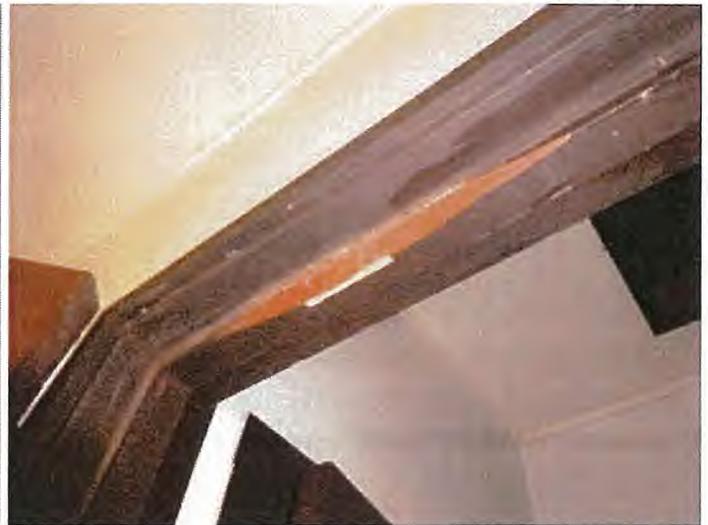
Most of the doors had varying degrees of damage observed when inspected. Based on the observed conditions, we recommend the replacement of all interior doors and trim within the dwelling units.

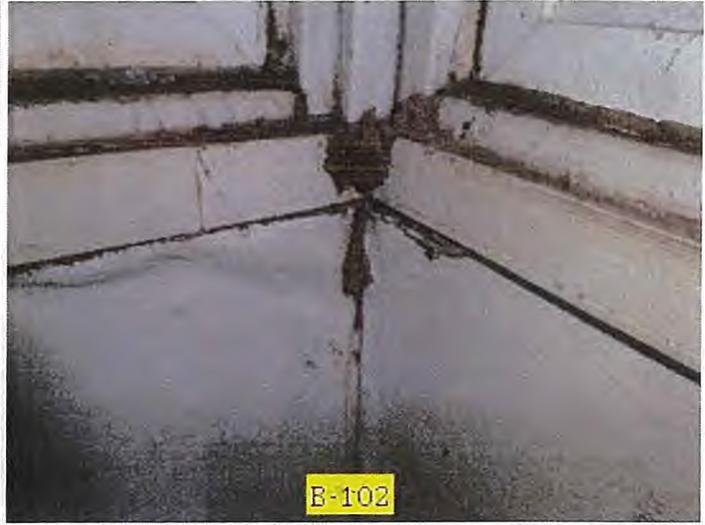
Most of the exterior facing lower interior wall finishes had moisture damage observed. Recommend removal and replacement of affected materials.

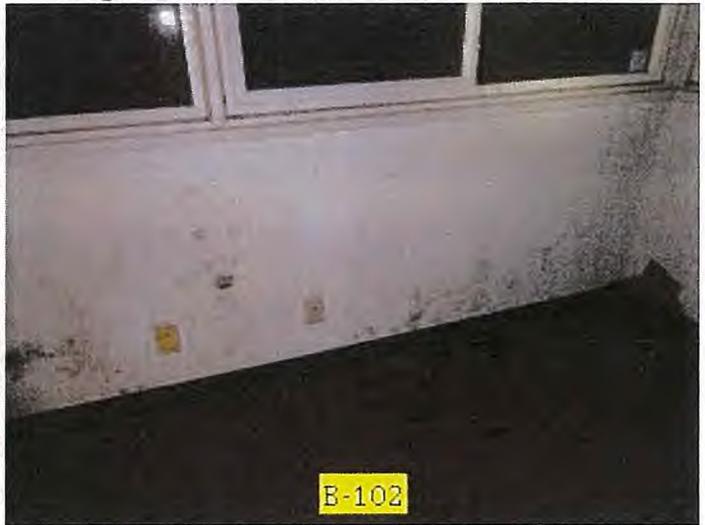
Visible indications of moisture intrusion and mold growth at building B and C interior, bedroom, bathroom and closet wall areas. Recommend removal and replacement of all interior wall finishes of B and C, after removal of all exterior vegetation.

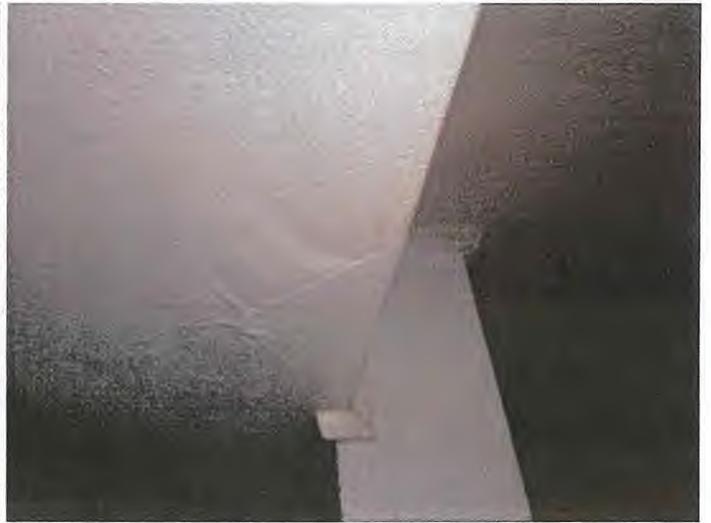
There were visible indications of water intrusion, with mold growth, noted at the ceiling areas of A-201, C-101. Recommend having a licensed contractor evaluate and repair as necessary to prevent further damage.

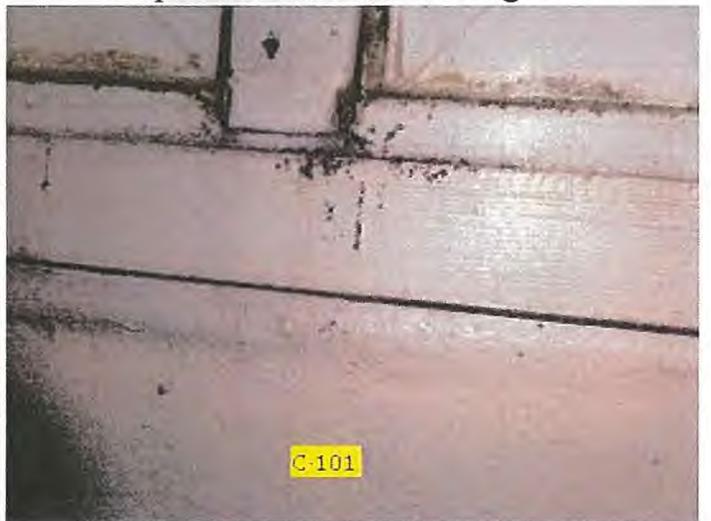
Visible indications of moisture intrusion and mold growth at building B and C interior, bedroom, bathroom and closet wall areas. Recommend removal and replacement of all interior wall finishes of B and C, after removal of all exterior vegetation.

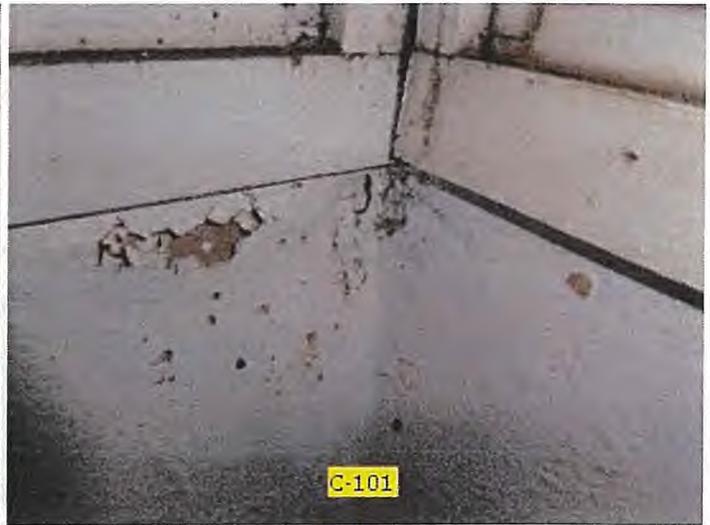
Visible indications of moisture intrusion and mold growth at building B and C interior, bedroom, bathroom and closet wall areas. Recommend removal and replacement of all interior wall finishes of B and C, after removal of all exterior vegetation.

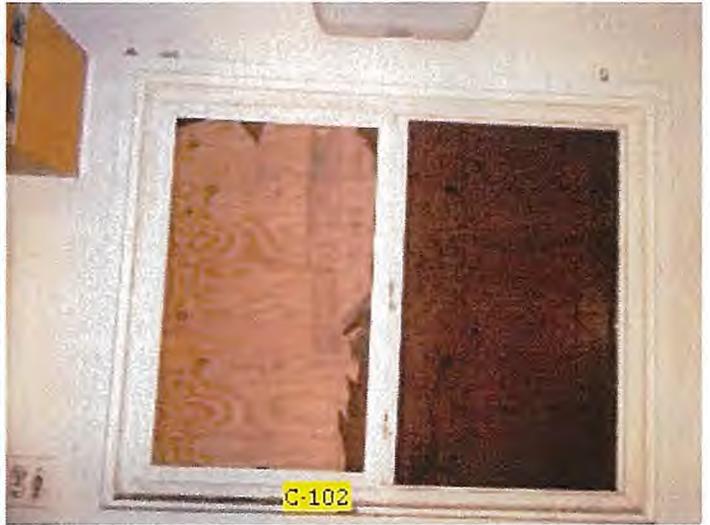
Many of the ground floor windows were broken at the time of inspection. Recommend replacement.

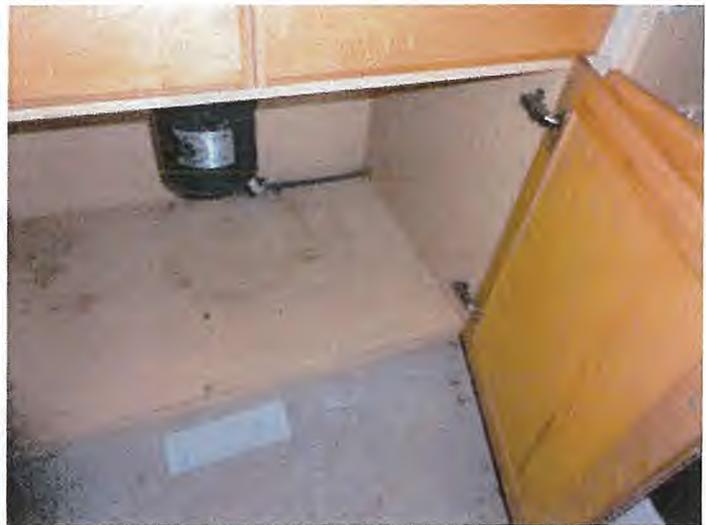
The kitchens of buildings B and C were deteriorated with moisture damage, termite damage and general damage observed at the cabinets, counters and finishes. Recommend the replacement of all dwelling unit kitchens, fixtures and appliances.

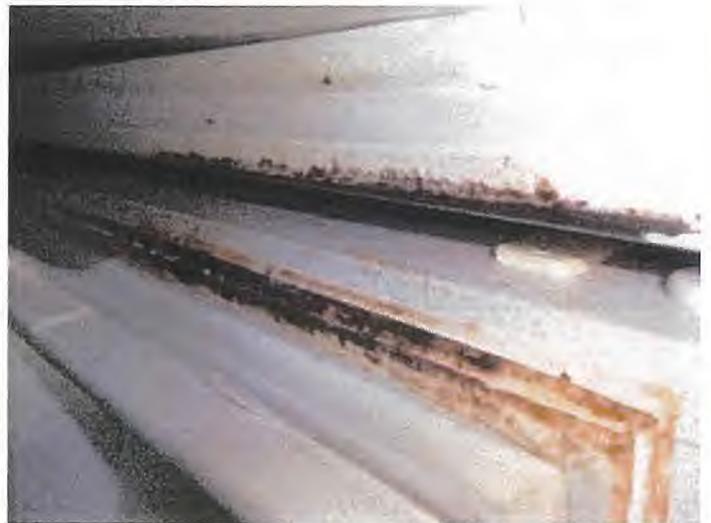
The kitchens of buildings B and C were deteriorated with moisture damage, termite damage and general damage observed at the cabinets, counters and finishes. Recommend the replacement of all dwelling unit kitchens, fixtures and appliances.

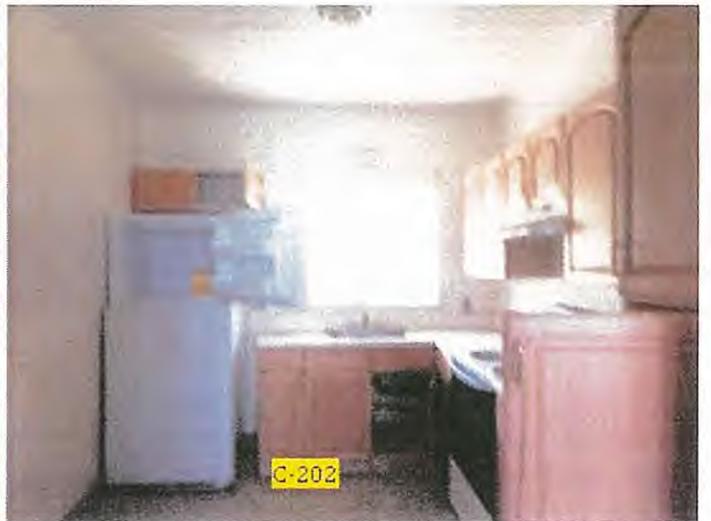
The kitchens of buildings B and C were deteriorated with moisture damage, termite damage and general damage observed at the cabinets, counters and finishes. Recommend the replacement of all dwelling unit kitchens, fixtures and appliances.

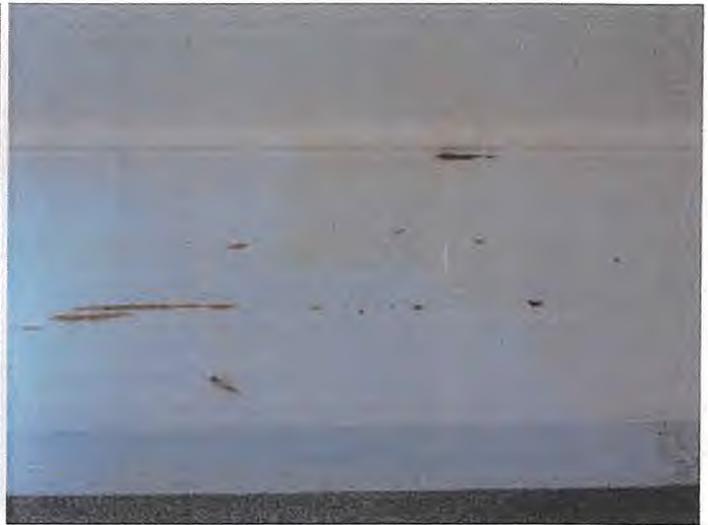
B-201: Ceiling joists were severely termite damaged and need to be repaired/replaced.

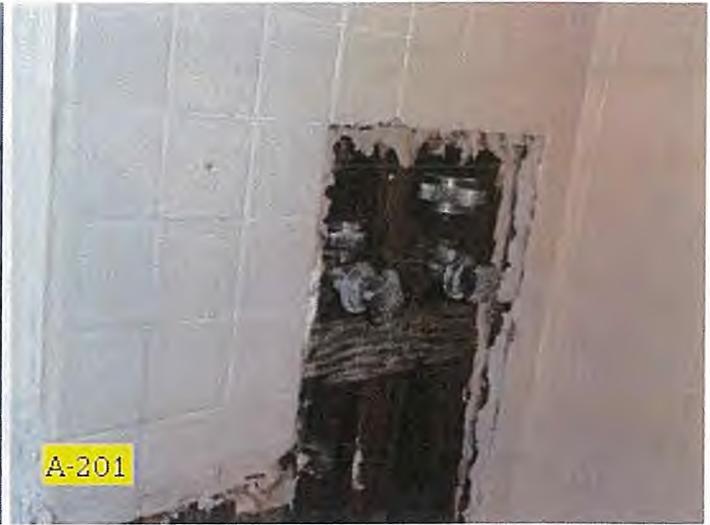
There were visible indications of moisture damage, mold growth, damaged flooring, damaged cabinets and counters, damaged mirrors, damaged toilets and damaged shower compartments observed at the time of inspection. Based on the observed conditions on site, we recommend the replacement of all dwelling unit bathrooms.

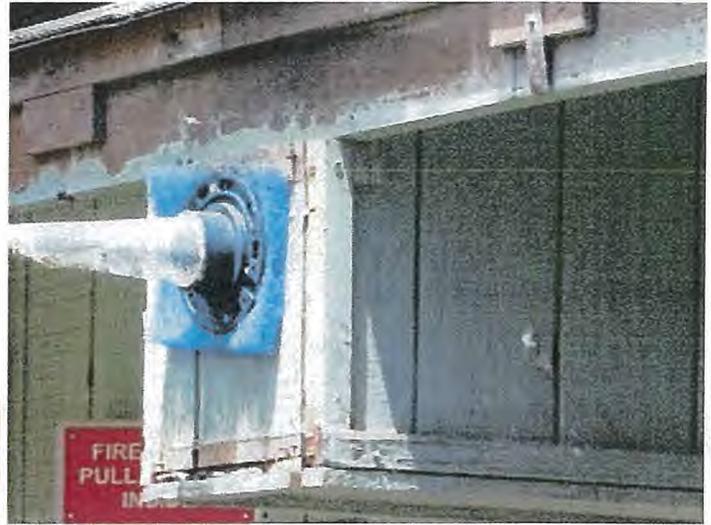
There was a hazardous bee population observed on site at the time of inspection. The single story storage building had sections of front wall removed for past been removal. The left side of the building had extensive and constant activity observed. There were been nests also observed at other exterior and interior locations through out the property.

- We recommend having a licensed pest contractor, specializing in bees, evaluate and remove the extensive bee population.
 - We recommend having a licensed arborist/landscaping contractor evaluate and remove all trees within 10' and bushes within 5' of each building.

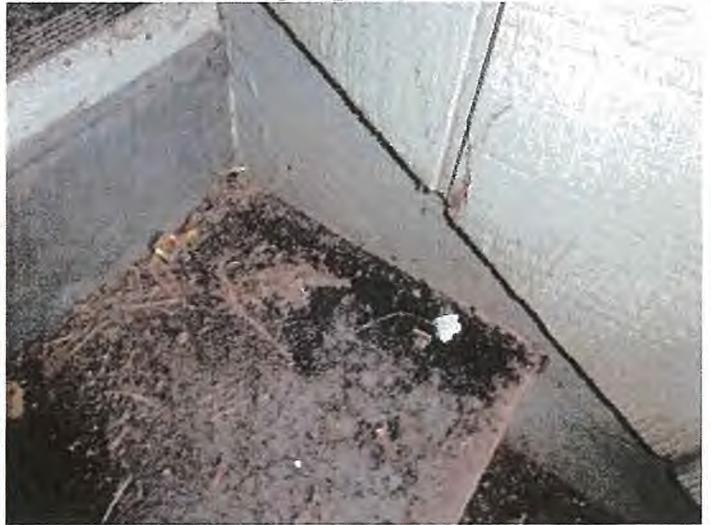
There was moderate/extensive termite/moisture damage observed at the interior and/or exterior areas of the building.

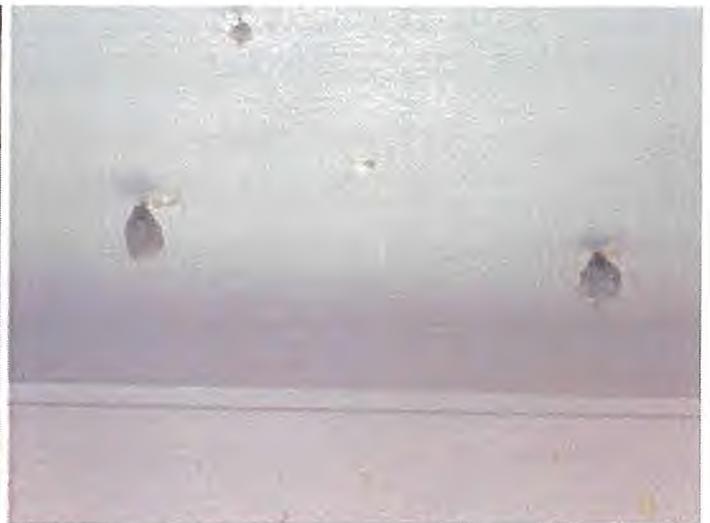
There was a hazardous bee population observed on site at the time of inspection. The single story storage building had sections of front wall removed for past been removal. The left side of the building had extensive and constant activity observed. There were been nests also observed at other exterior and interior locations through out the property.
