**SUBJECT: BILLS 136 (2025) AND 137 (2025), RELATING TO THE  
RENOVATION OF 60 SOUTH CHURCH STREET, WAILUKU,  
HAWAII (BFED-8)**

# Architectural Diagnostics Ltd.

**PROJECT:** 60 S. Church St.  
**SUBJECT:** Waterproofing

**SUBJECT: MOISTURE REPORT – 60 S Church Street-Lower Roof**

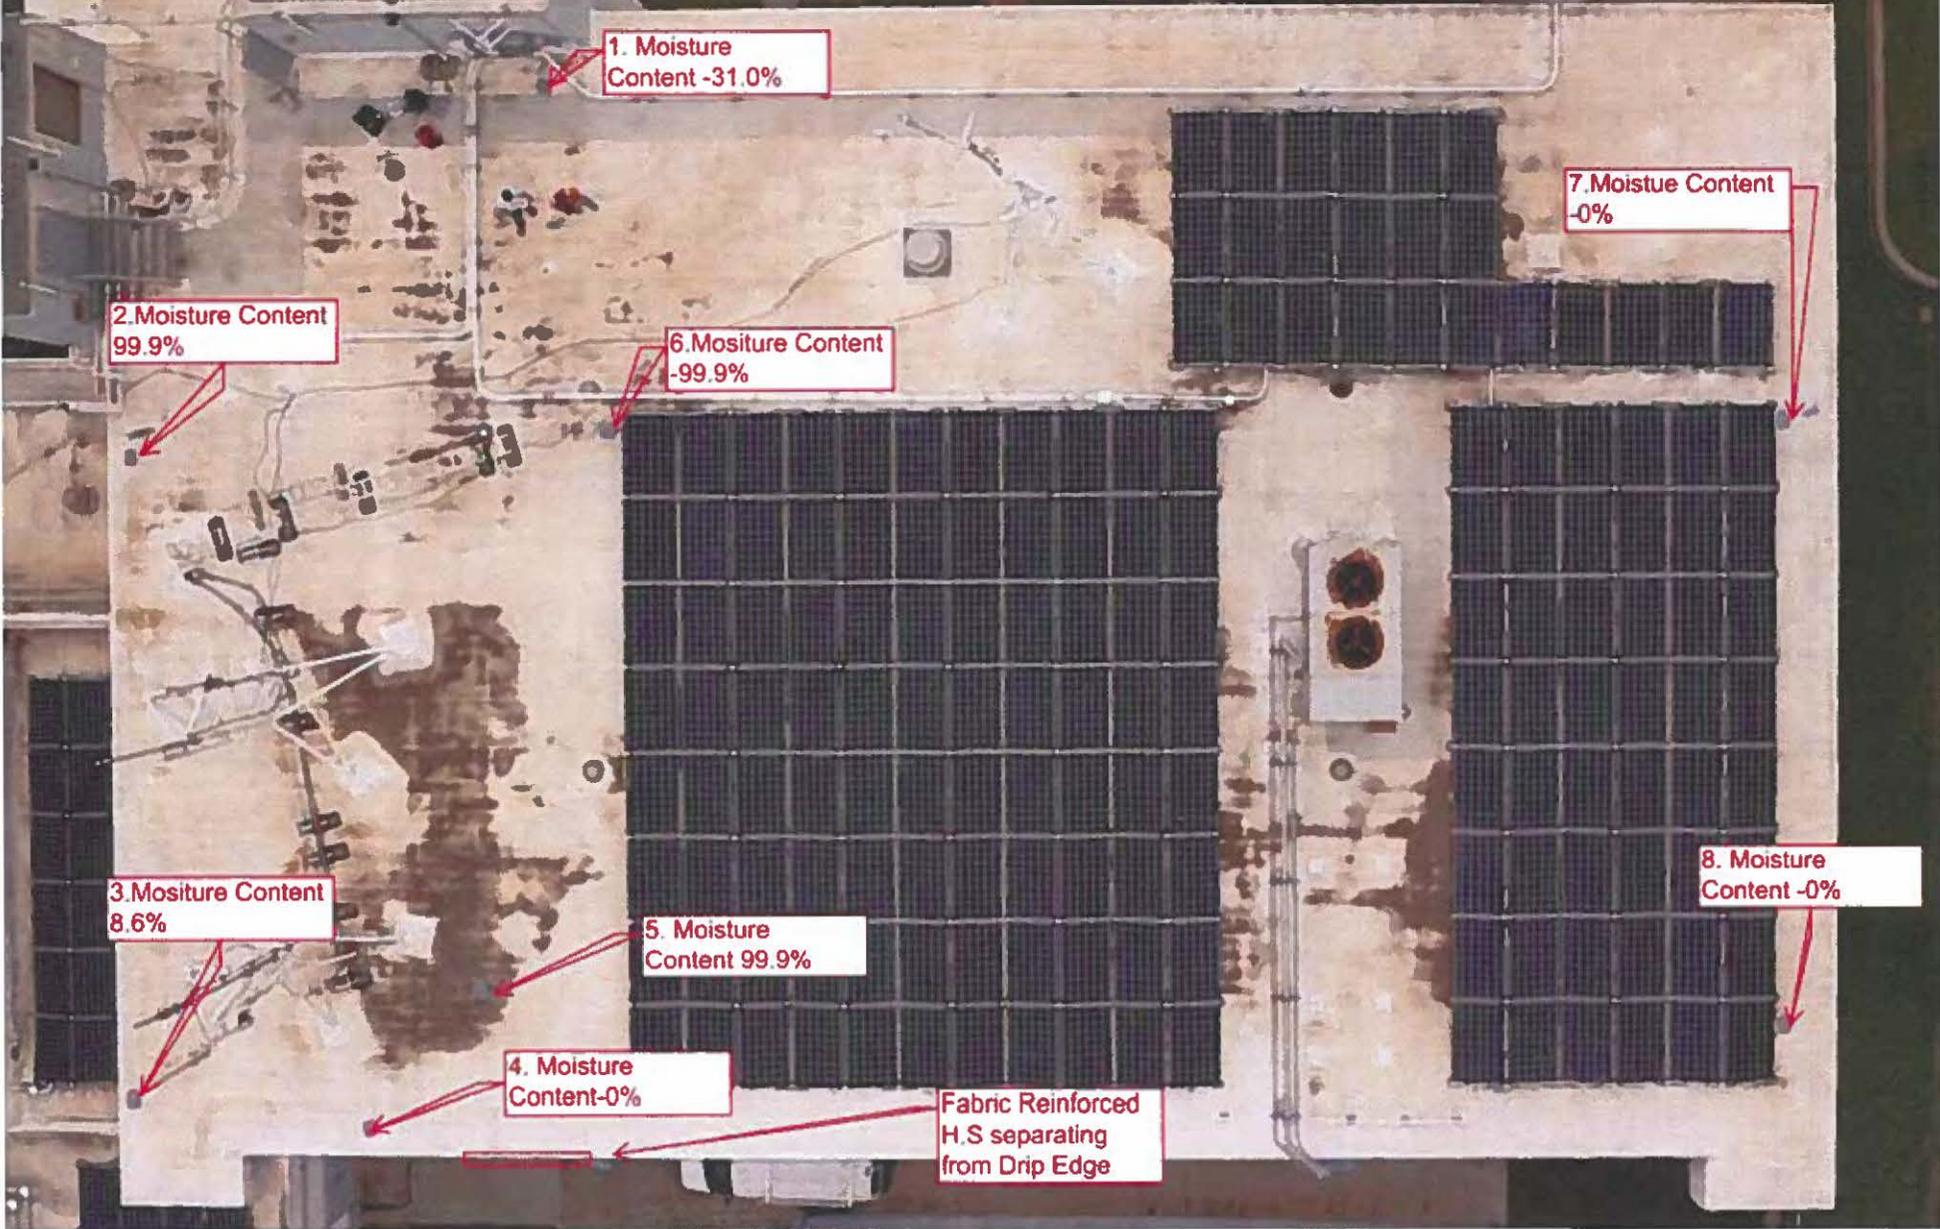
Exhibit -1

4.5 Eight core samples were extracted from the roof, at a variety of areas around the roof (but not under the PV panels). They show:

4.5.2.1 The moisture content at the west end of the roof, between the PV panels and the roof edge is -0-.

4.5.2.2 The moisture content at the southeast corner varies from 31% to 99.9%.

4.5.2.3 The moisture content at the northeast corner varies from 0 to 8.6% but a measurement at the edge of a ponded water area is 99.9%.

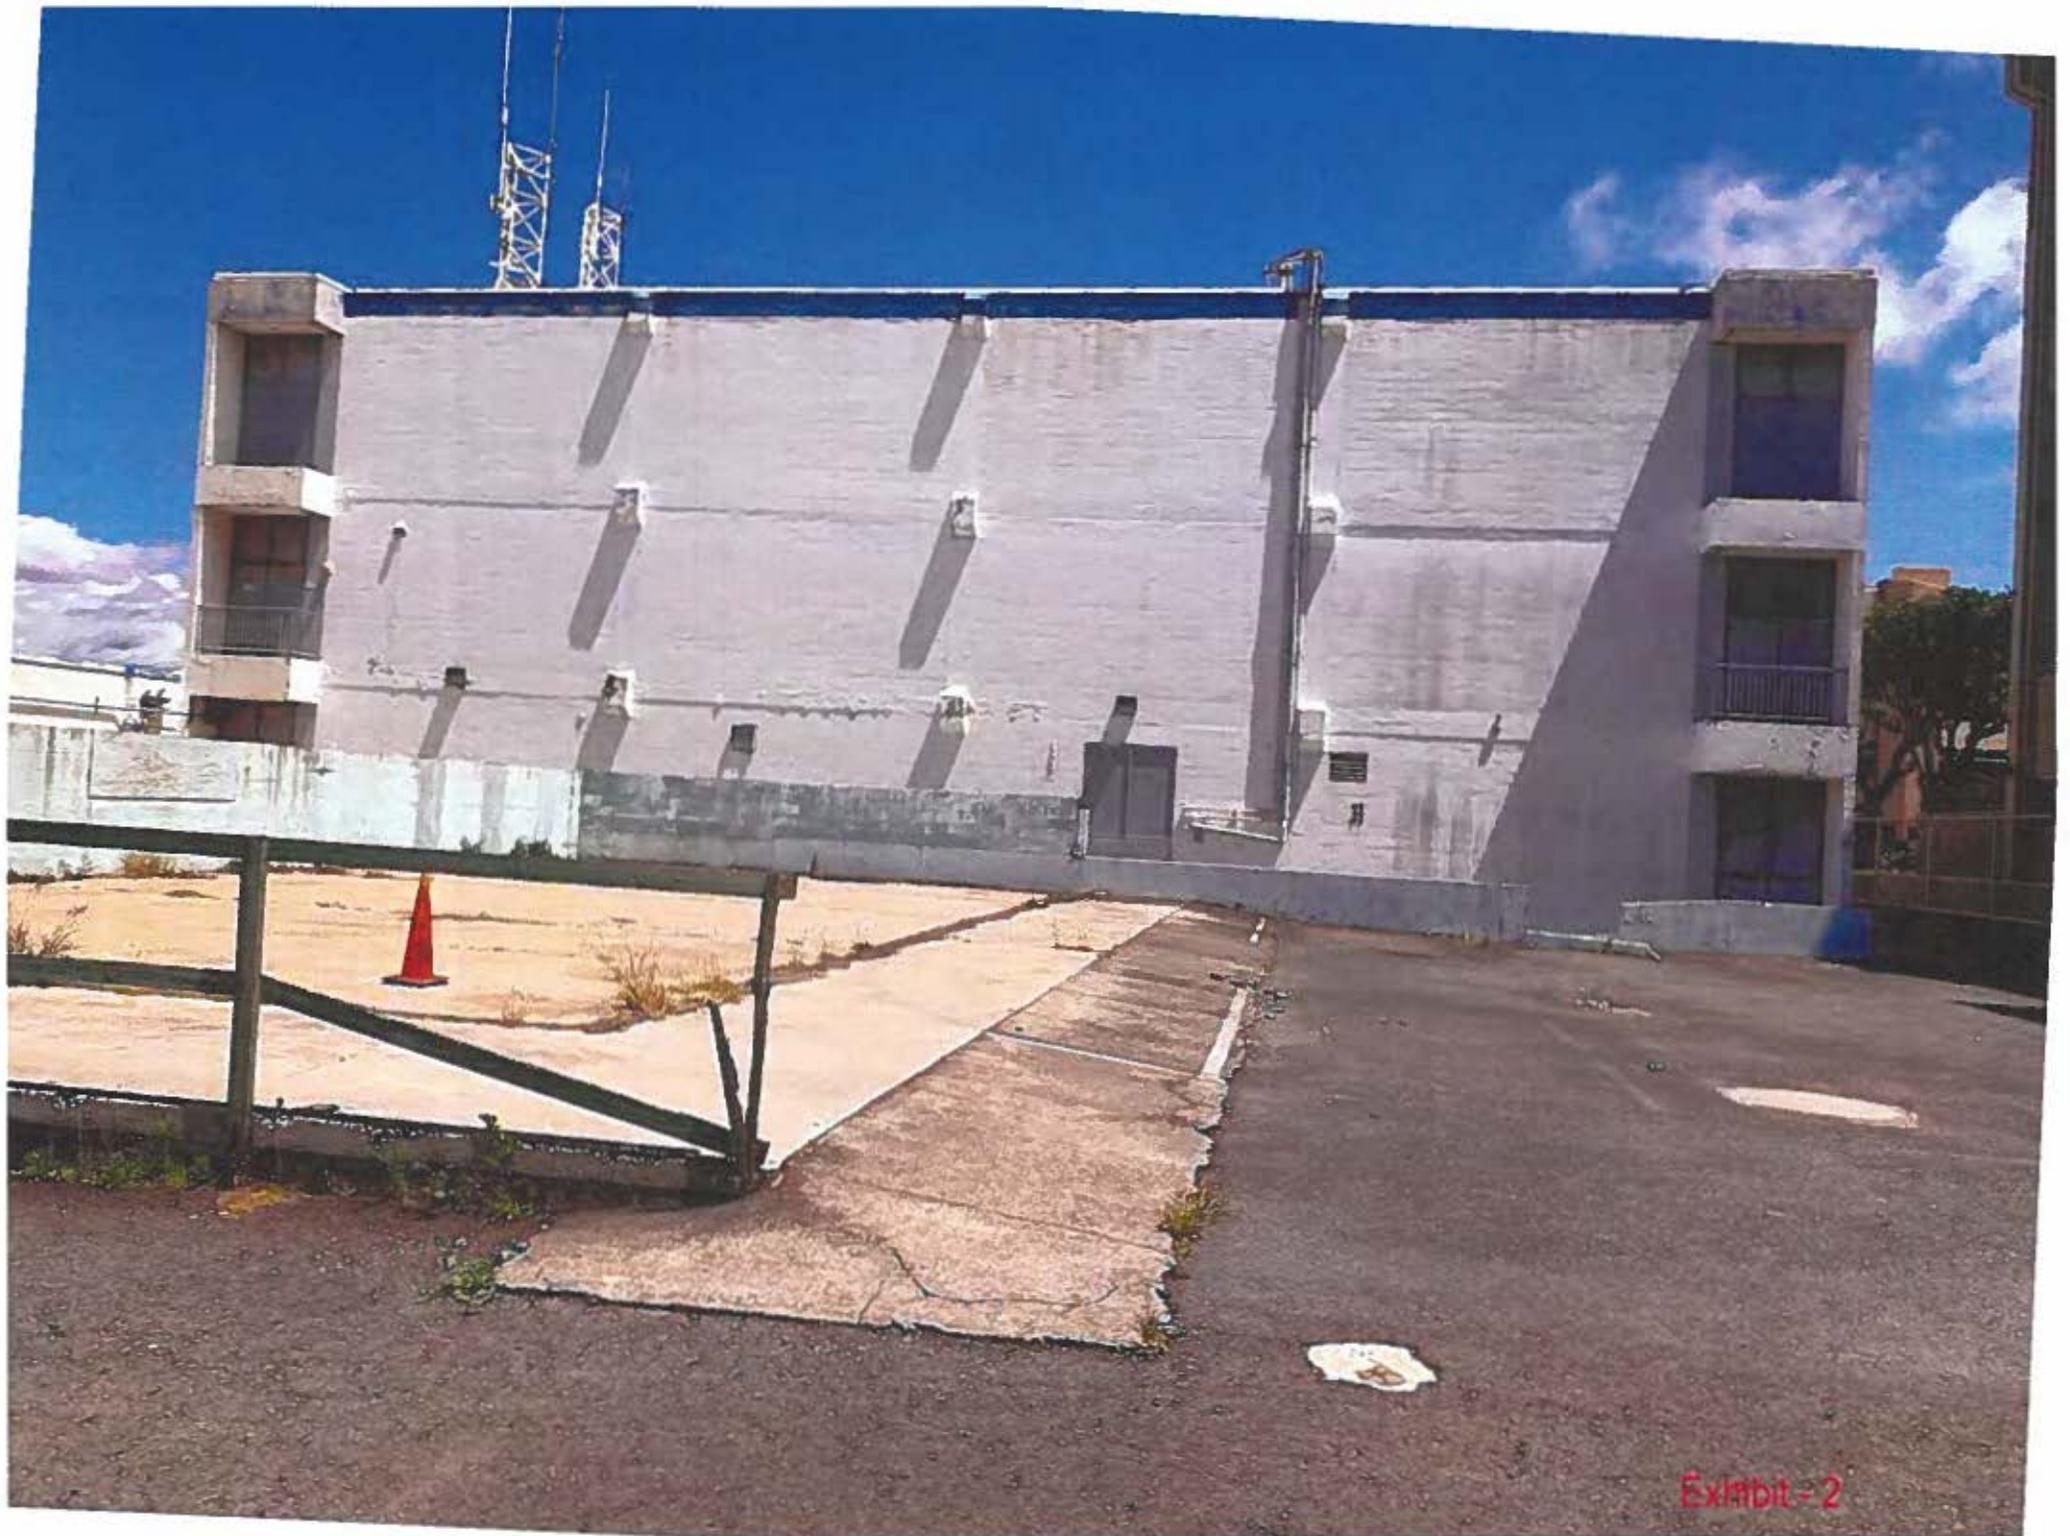
Exhibit - 2

3.1.5 The exterior side of the north wall has 9 corbels to enable a future extension of the building, 3 at the 2<sup>nd</sup> floor, 3 at the 3<sup>rd</sup> floor, 3 at the roof level. They are at beam to column intersections, are 3'-0" high, 20" wide and project 10" out from the face of the building. The 3 at the 2<sup>nd</sup> floor are severely deteriorated. The 3 at the 3<sup>rd</sup> floor line are significantly less so. The 3 at the roof line are even less so (see photos Exhibits 2, 8, 9 & 10).

3.1.7.2 At the corbels, the 3 at the 2<sup>nd</sup> floor line should be chipped off flush with the surrounding and the wall surface repaired to match the adjacent beam and column. The other 6 can remain in place, with the coating removed, then refinished like the rest of the wall (see photos Exhibits 8, 9 & 10).

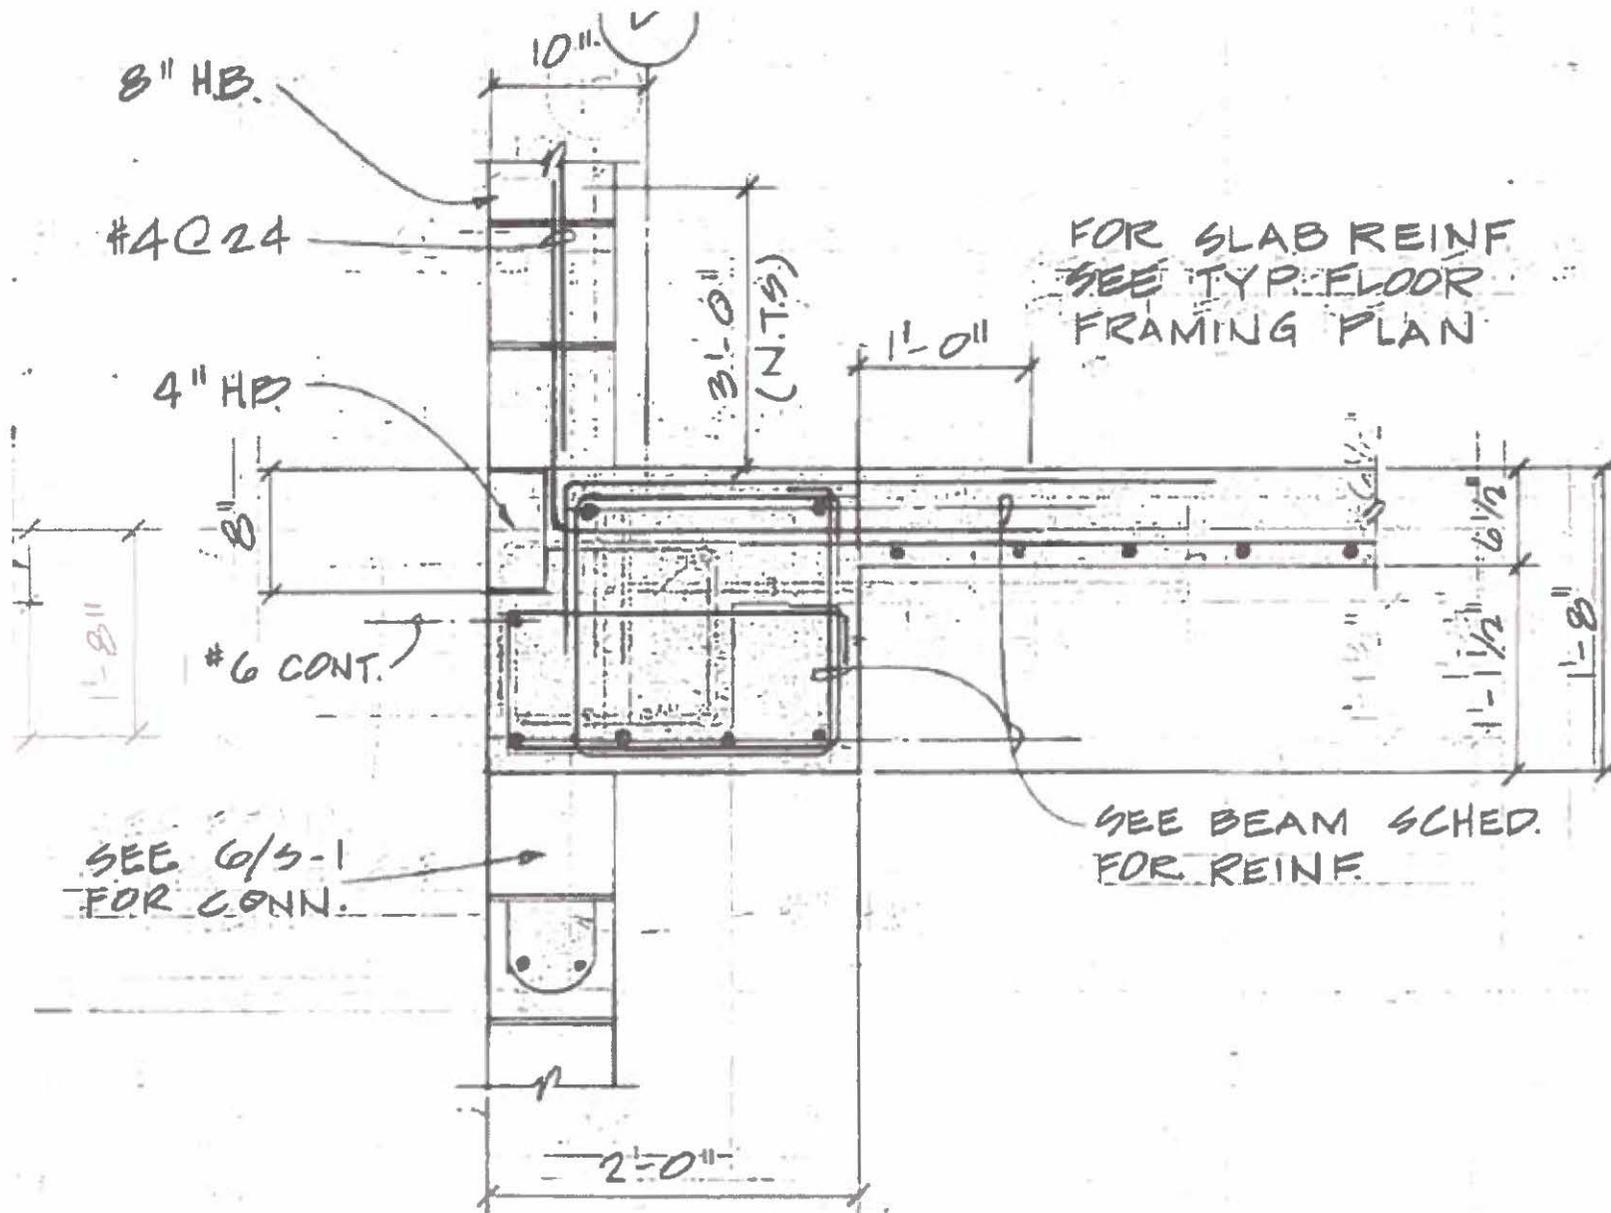
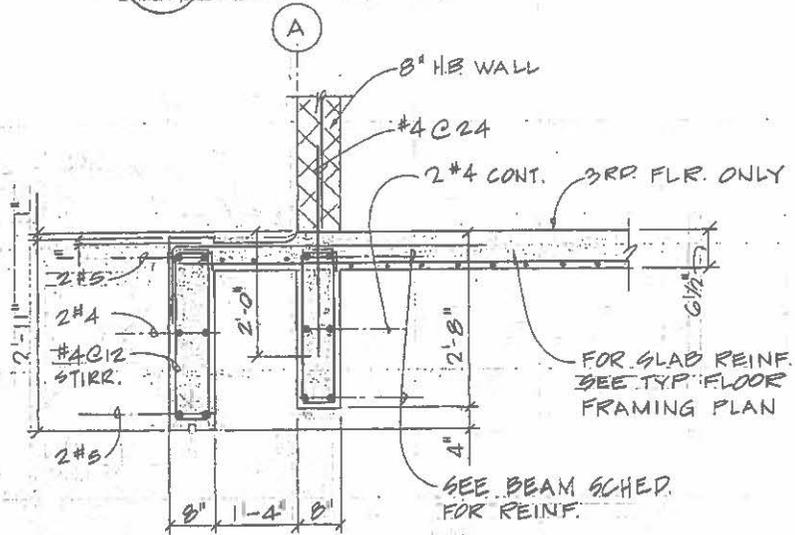
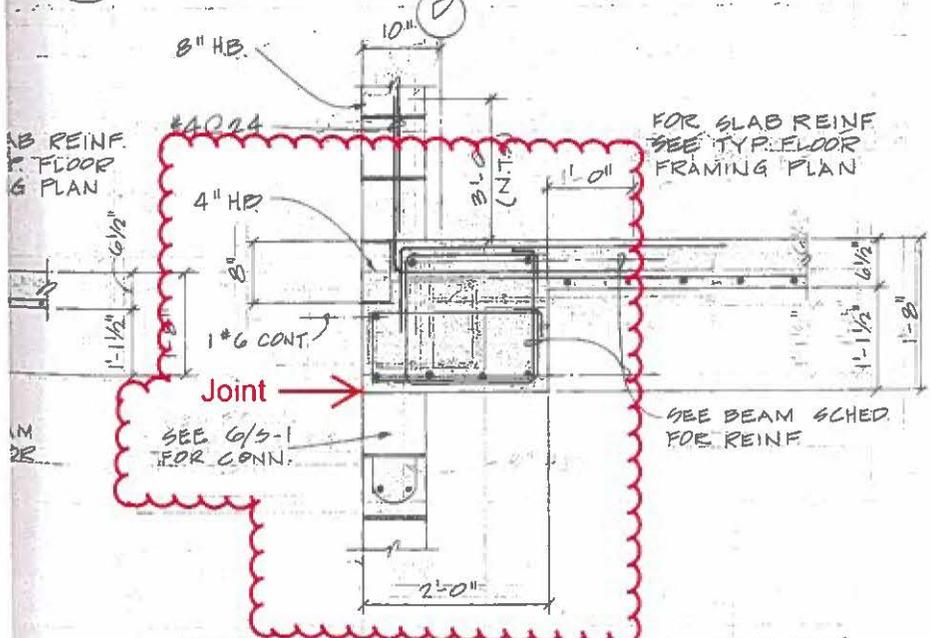
8  
9-4
EXTERIOR BEAM SECT.  
3/4" = 1'-0"

3.1.3 The scored CMU starts 8" below the floor line and extends to the underside of the beam above. To accomplish this, the top of the horizontal concrete beams has a 4" wide x 8" high blockout at the top of the exterior side. A 4" thick block (½ a block) is placed in the blockout, apparently to maintain the 5-score block pattern. Because the bottom of the CMU wall sits in an "L" shaped concrete pocket, it's a watertight condition (see Detail 8/S-4 Exhibit 4).

The detail between the top of the infill wall and the bottom of the beam above, however is considerably less watertight. According to the construction drawing detail at the top of the 1<sup>st</sup>, 2<sup>nd</sup> and 3<sup>rd</sup> floor walls, the CMU walls were built two block courses short of the bottom of the beam above. The vertical reinforcing was then inserted into the empty cells and the grout installed thru the opening left by the missing top blocks. A horizontal bond beam was then constructed along the top of the wall (the next-to-top course) with the horizontal rebar and grout inserted thru last missing CMU course. The top block course was then constructed with a half block on the face and hand-placed concrete on the inside, with an inside form. The installation of that last block course is very difficult and requires careful attention. It is very likely the source of the water coming thru the wall (see joint details - Exhibits 4, 5, 6 & 20).

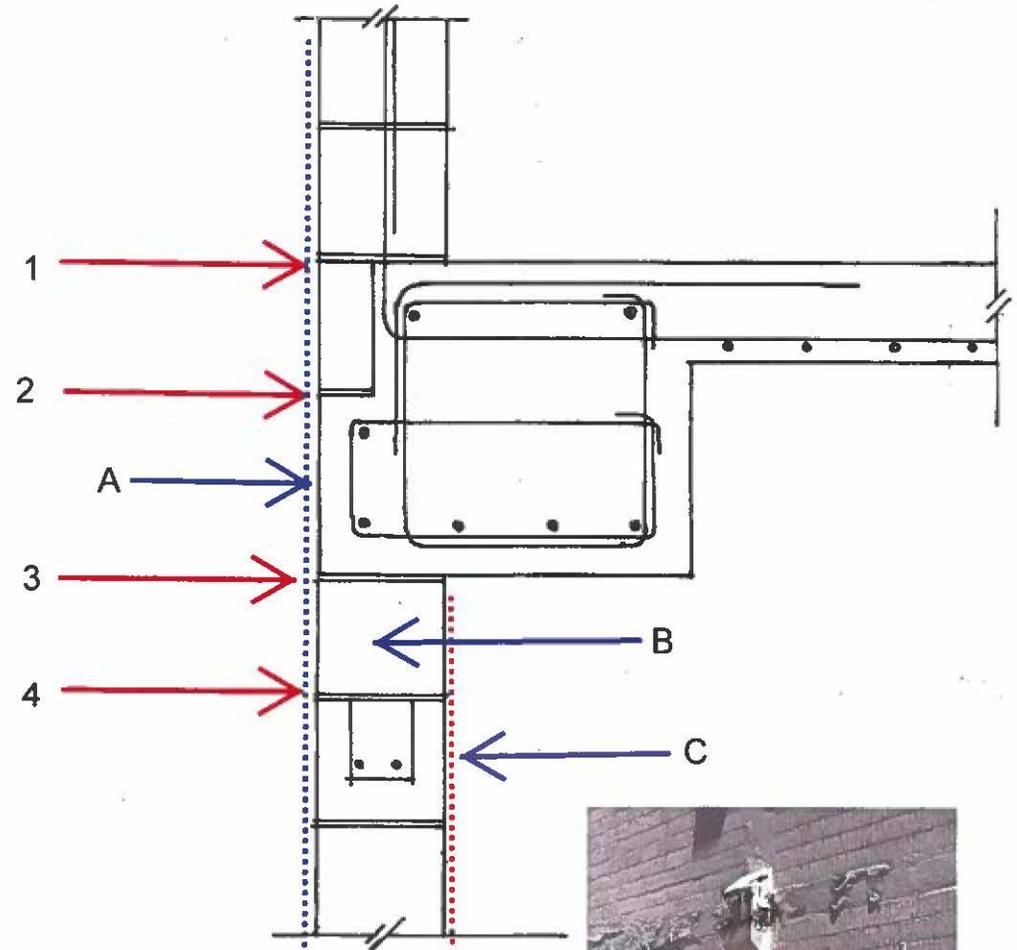
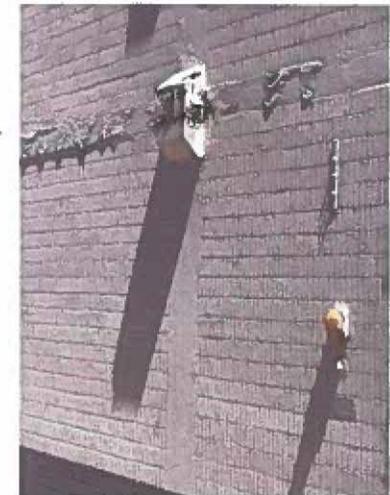
Exhibit 20

- A - Remove blistered paint on concrete columns and beams.
- B - Destructive investigation by drilling holes in the CMU block to determine if the block is filled solid with grout or hollow. Also exploratory investigation of a small section of wall to test ejecting polyurethane grout. We do not know if the CMU walls were constructed prior to pouring the floor and beam?
- C - Remove cement wash and apply Thoroseal, Mapei or Sika waterproofing material on the interior of the block wall above the existing grid ceiling. The cement wash has visible cracks and efflorescence (see photos Exhibits 11& 12).

- Grind and remove the existing mortar joints to a depth of  $\frac{1}{2}$ " -  $\frac{3}{4}$ "
- Clean surface area with air, not water
- Apply Mapei product - Mapeflex P2NS sealant
- Smooth surface and do not to cover the flutes of the CMU block
- Apply 1 coat of Mapei Primer AR and
- Apply 2 coats of Mapei Elastocolor-Coat

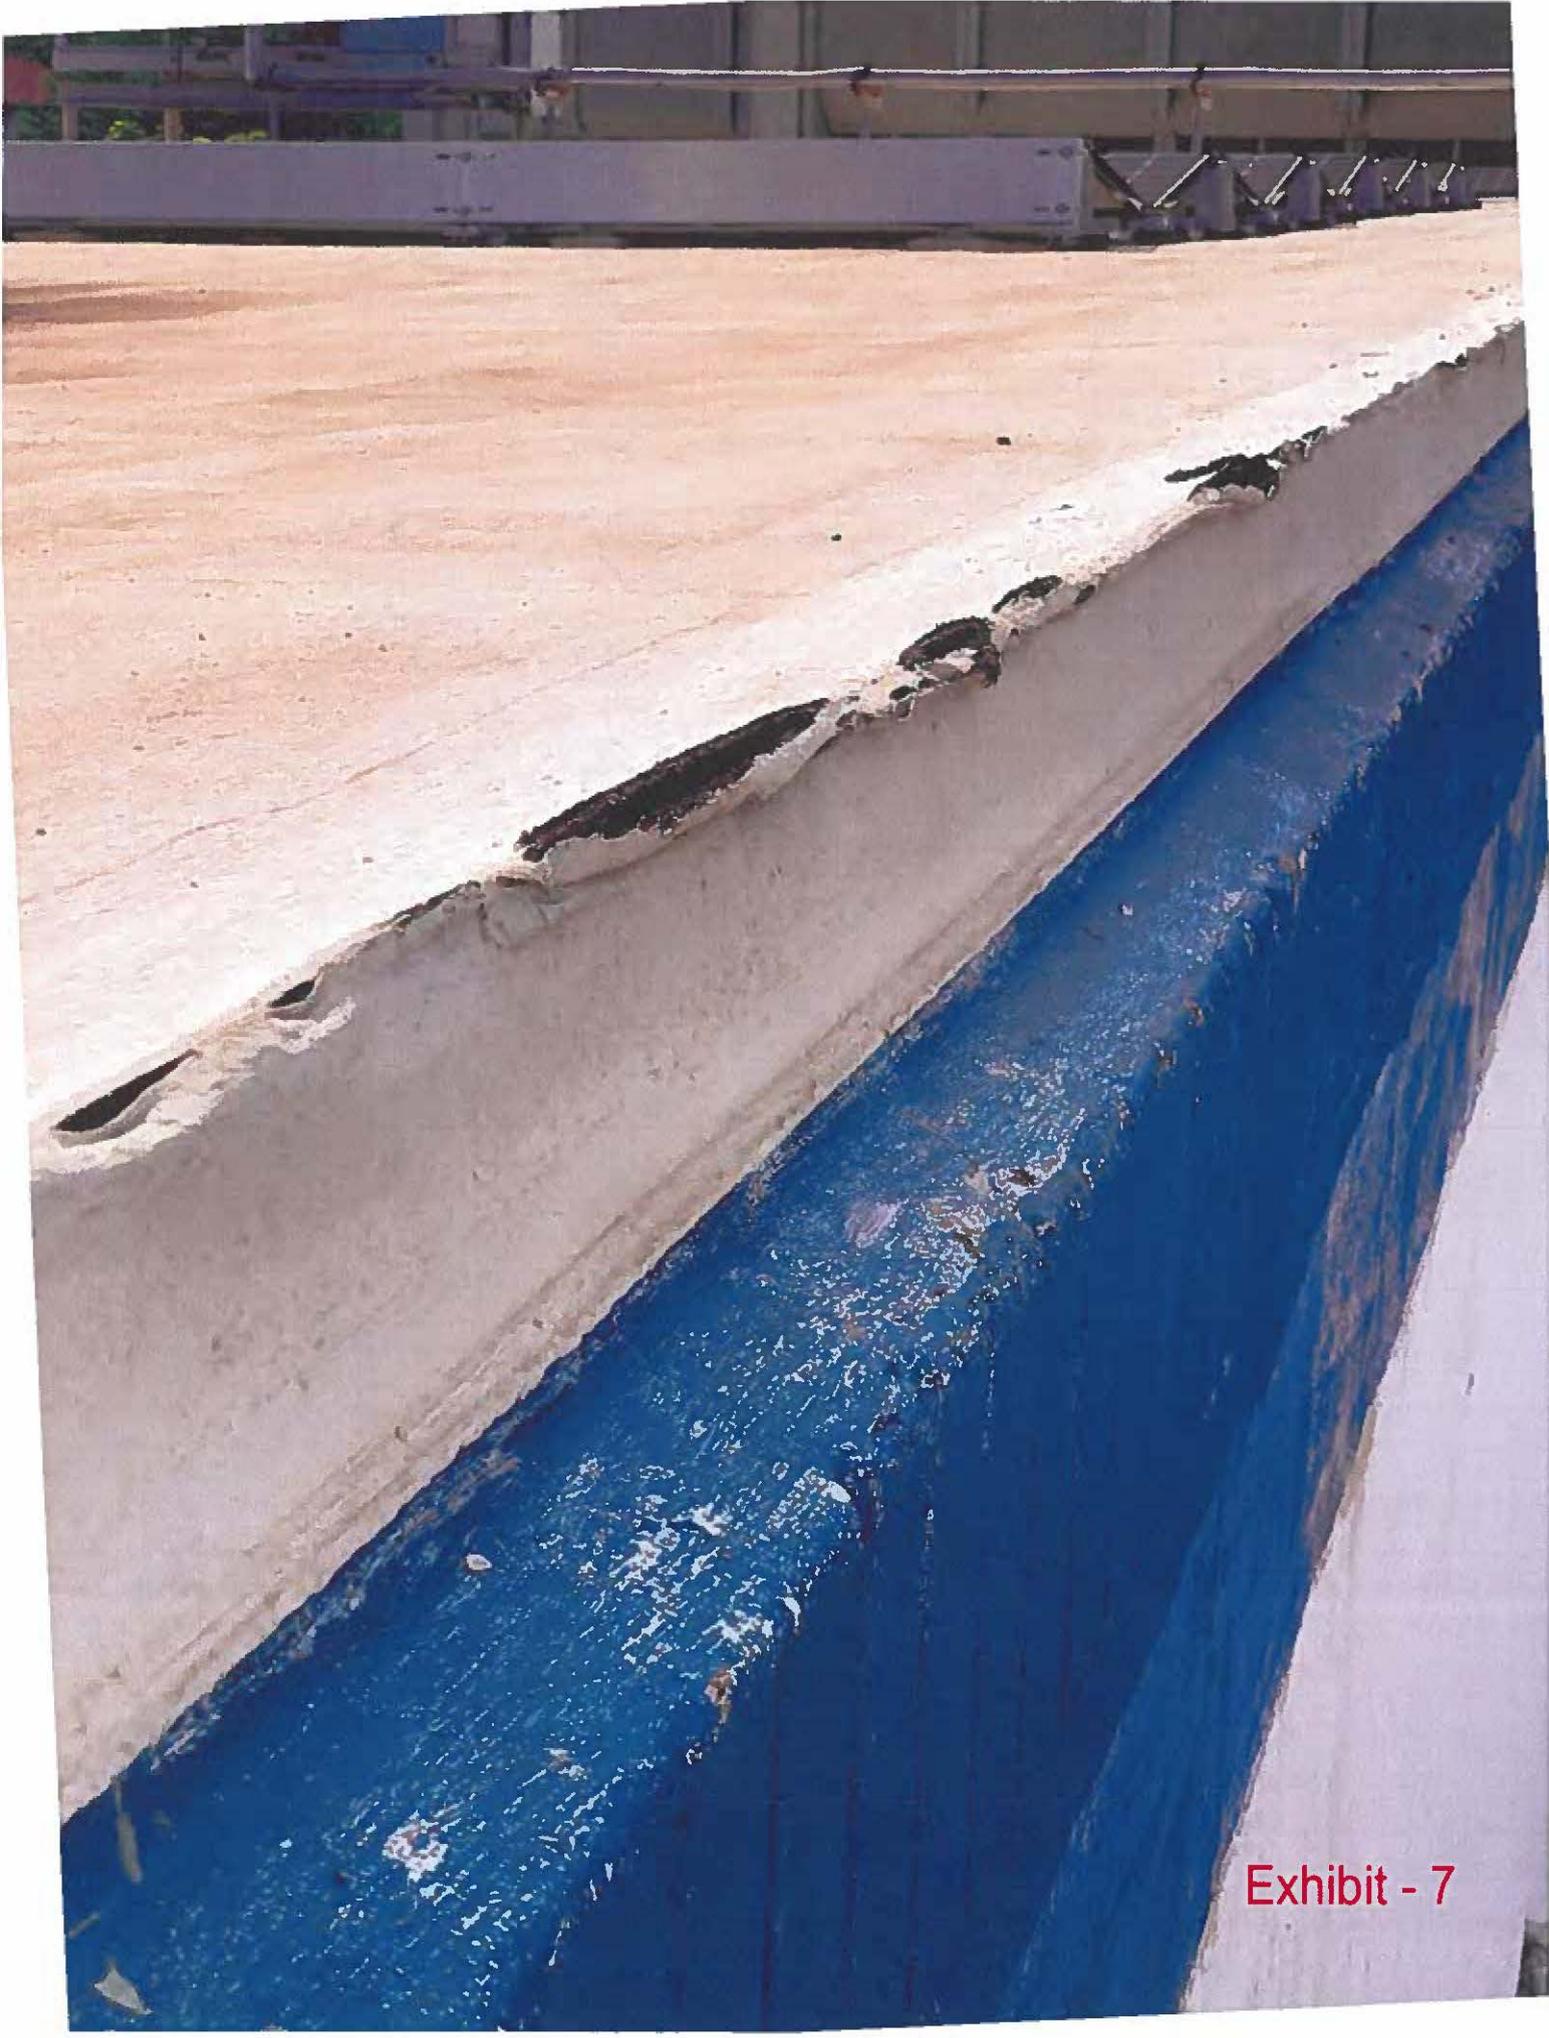
Exhibit - 7

4.5.3 The roof edge flashing along the north edge is torn about 30' west of the east end of the building (see photo Exhibit 7).

- 4.6.2 The exposed portions of the roof (including the 3 little roofs in 4.4 above) should be cleaned by power washing.
- 4.6.3 All visible defects, such as the hole in the north side edge flashing, should be repaired.
- 4.6.4 Install 3 Roof Sentry PV solar roof vents.
- 4.6.5 Coat the exposed areas of the roof, including the 3 little roofs in 4.4 above, and the sloping surface of roof edge detail with a silicone roof coating.

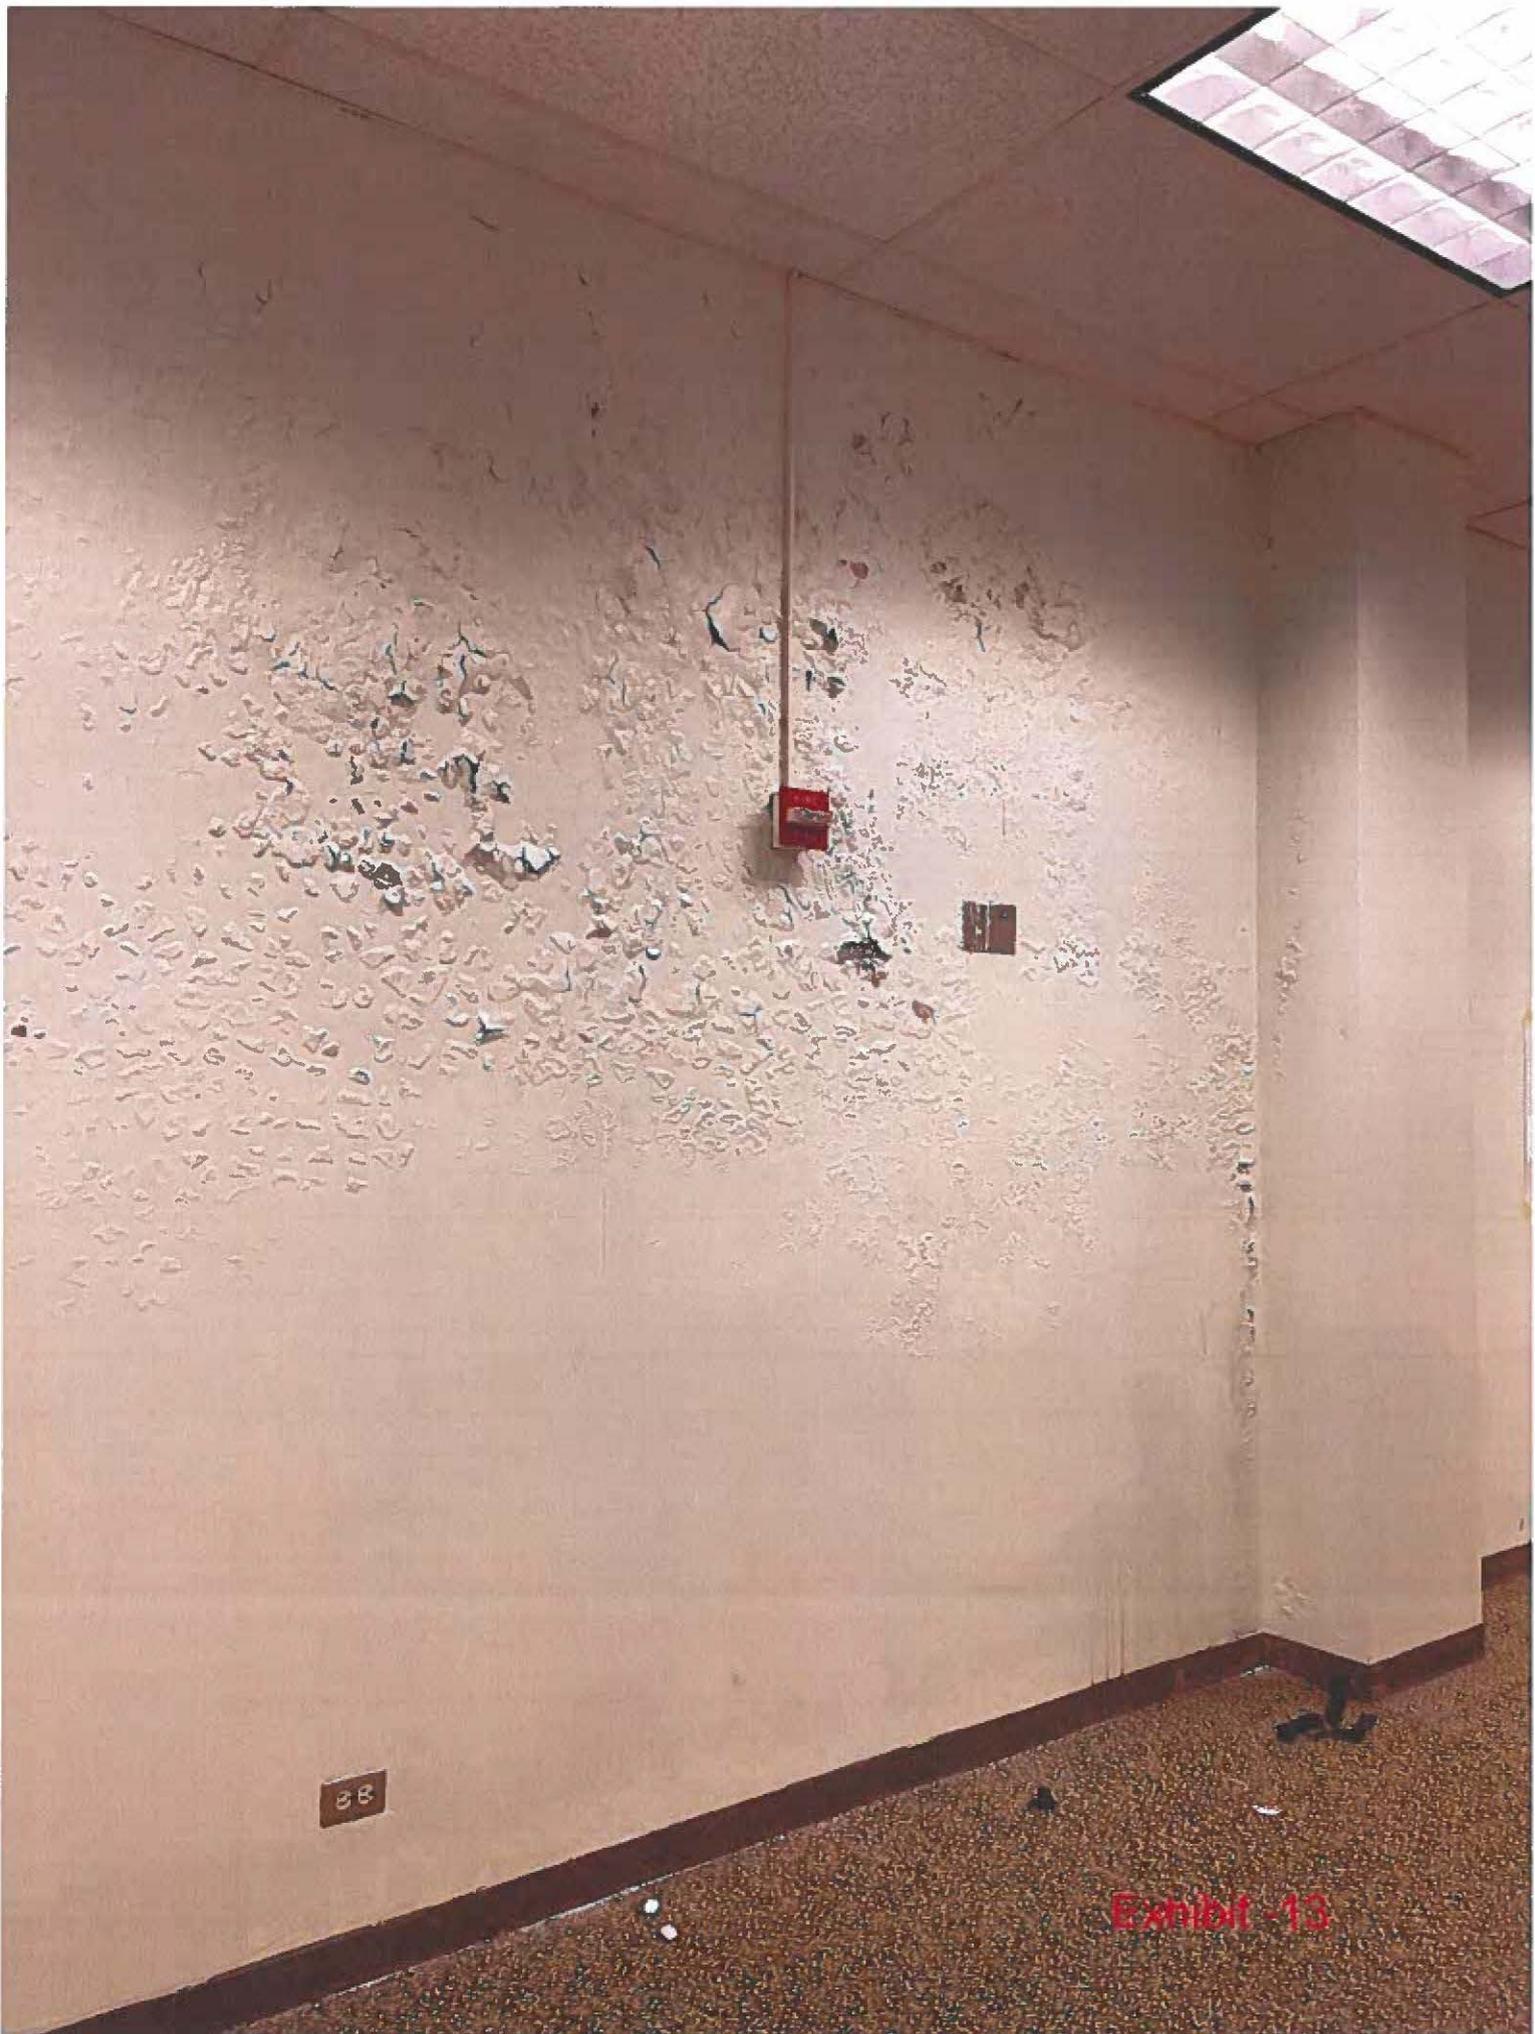
3.2.1 The interior face of the exterior wall is coated with a 1/4" thick plaster skim coat, then painted with at least 3 paint coats. The last paint coat has severe blistering in several areas on the north wall of the 2<sup>nd</sup> floor. The 3<sup>rd</sup> floor is a little less severe, and smaller areas on the south wall, indicating on-going leaks. The 1<sup>st</sup> floor appears to be OK.

3.2.1.2 At the blistered portions of the interior walls, the skim coat plaster appears to be sound, not delaminated.  
The 1<sup>st</sup> coat, a thin film off a medium blue paint, is sound, well adhered, not blistered.  
The 2<sup>nd</sup> coat, a thin film of tan paint, appears to be sound, well adhered, not blistered.  
The final coat, a heavy film of an off-white paint is extensively blistered (see photos Exhibits 13, 14, 15 & 16).

3.2.2.1 Remove the paint where the surface is blistered and at least 12" beyond the blistered edge.

3.2.2.2 Feather the edge of the area where the paint has been removed.

3.2.2.3 Coat the wall with

3.2.2.3.1 A penetrating primer

3.2.2.3.2 An asbestos encapsulant paint such as SerpiFlex Asbestos Encapsulant Formula 2

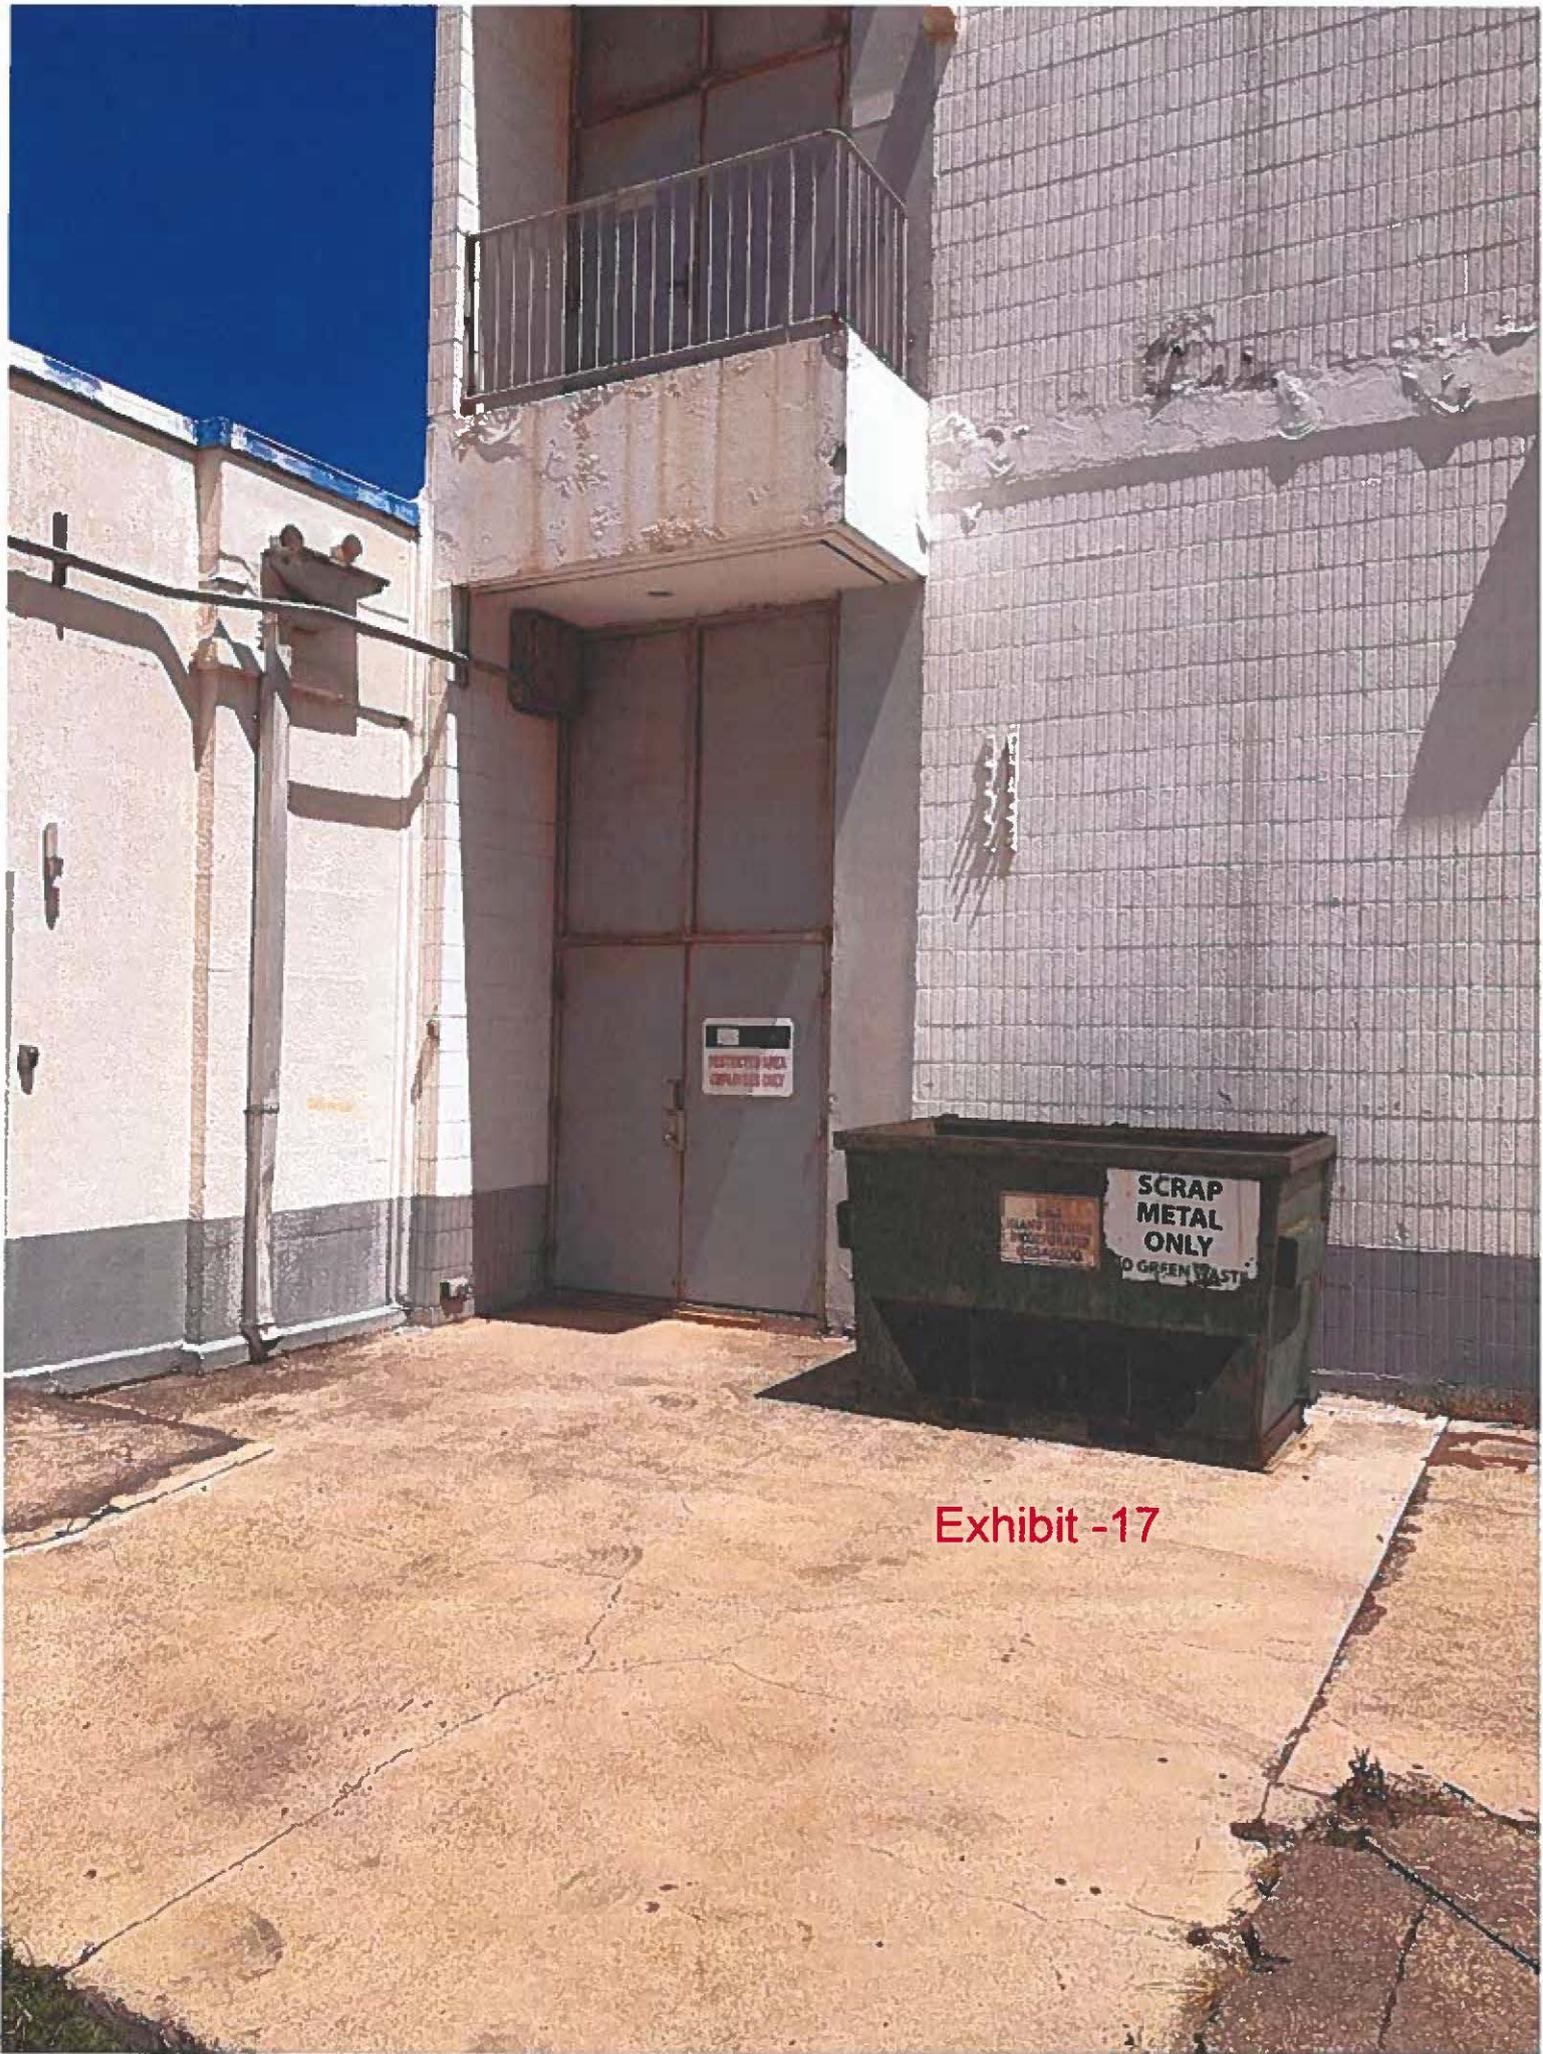
Exhibit -17

3.1.4 The north wall has small balconies (4' x 7') at each end of each floor. Two at the 2<sup>nd</sup> floor, 2 at the 3<sup>rd</sup> floor and 2 at the roof, for a total of 6, including a similar extension at the roof level. All have cracks & spalling (see photo Exhibits 17 & 18).

3.1.7.3 The cracks and spalling on the balcony projections at each floor (including the roof) need to be repaired before repainting.
