**SUBJECT: BILLS 136 (2025) AND 137 (2025), RELATING TO THE  
RENOVATION OF 60 SOUTH CHURCH STREET, WAILUKU,  
HAWAII (BFED-8)**

# Architectural Diagnostics Ltd.

**PROJECT:** 60 S. Church St.  
**SUBJECT:** Waterproofing

**SUBJECT: MOISTURE REPORT – 60 S Church Street-Lower Roof**

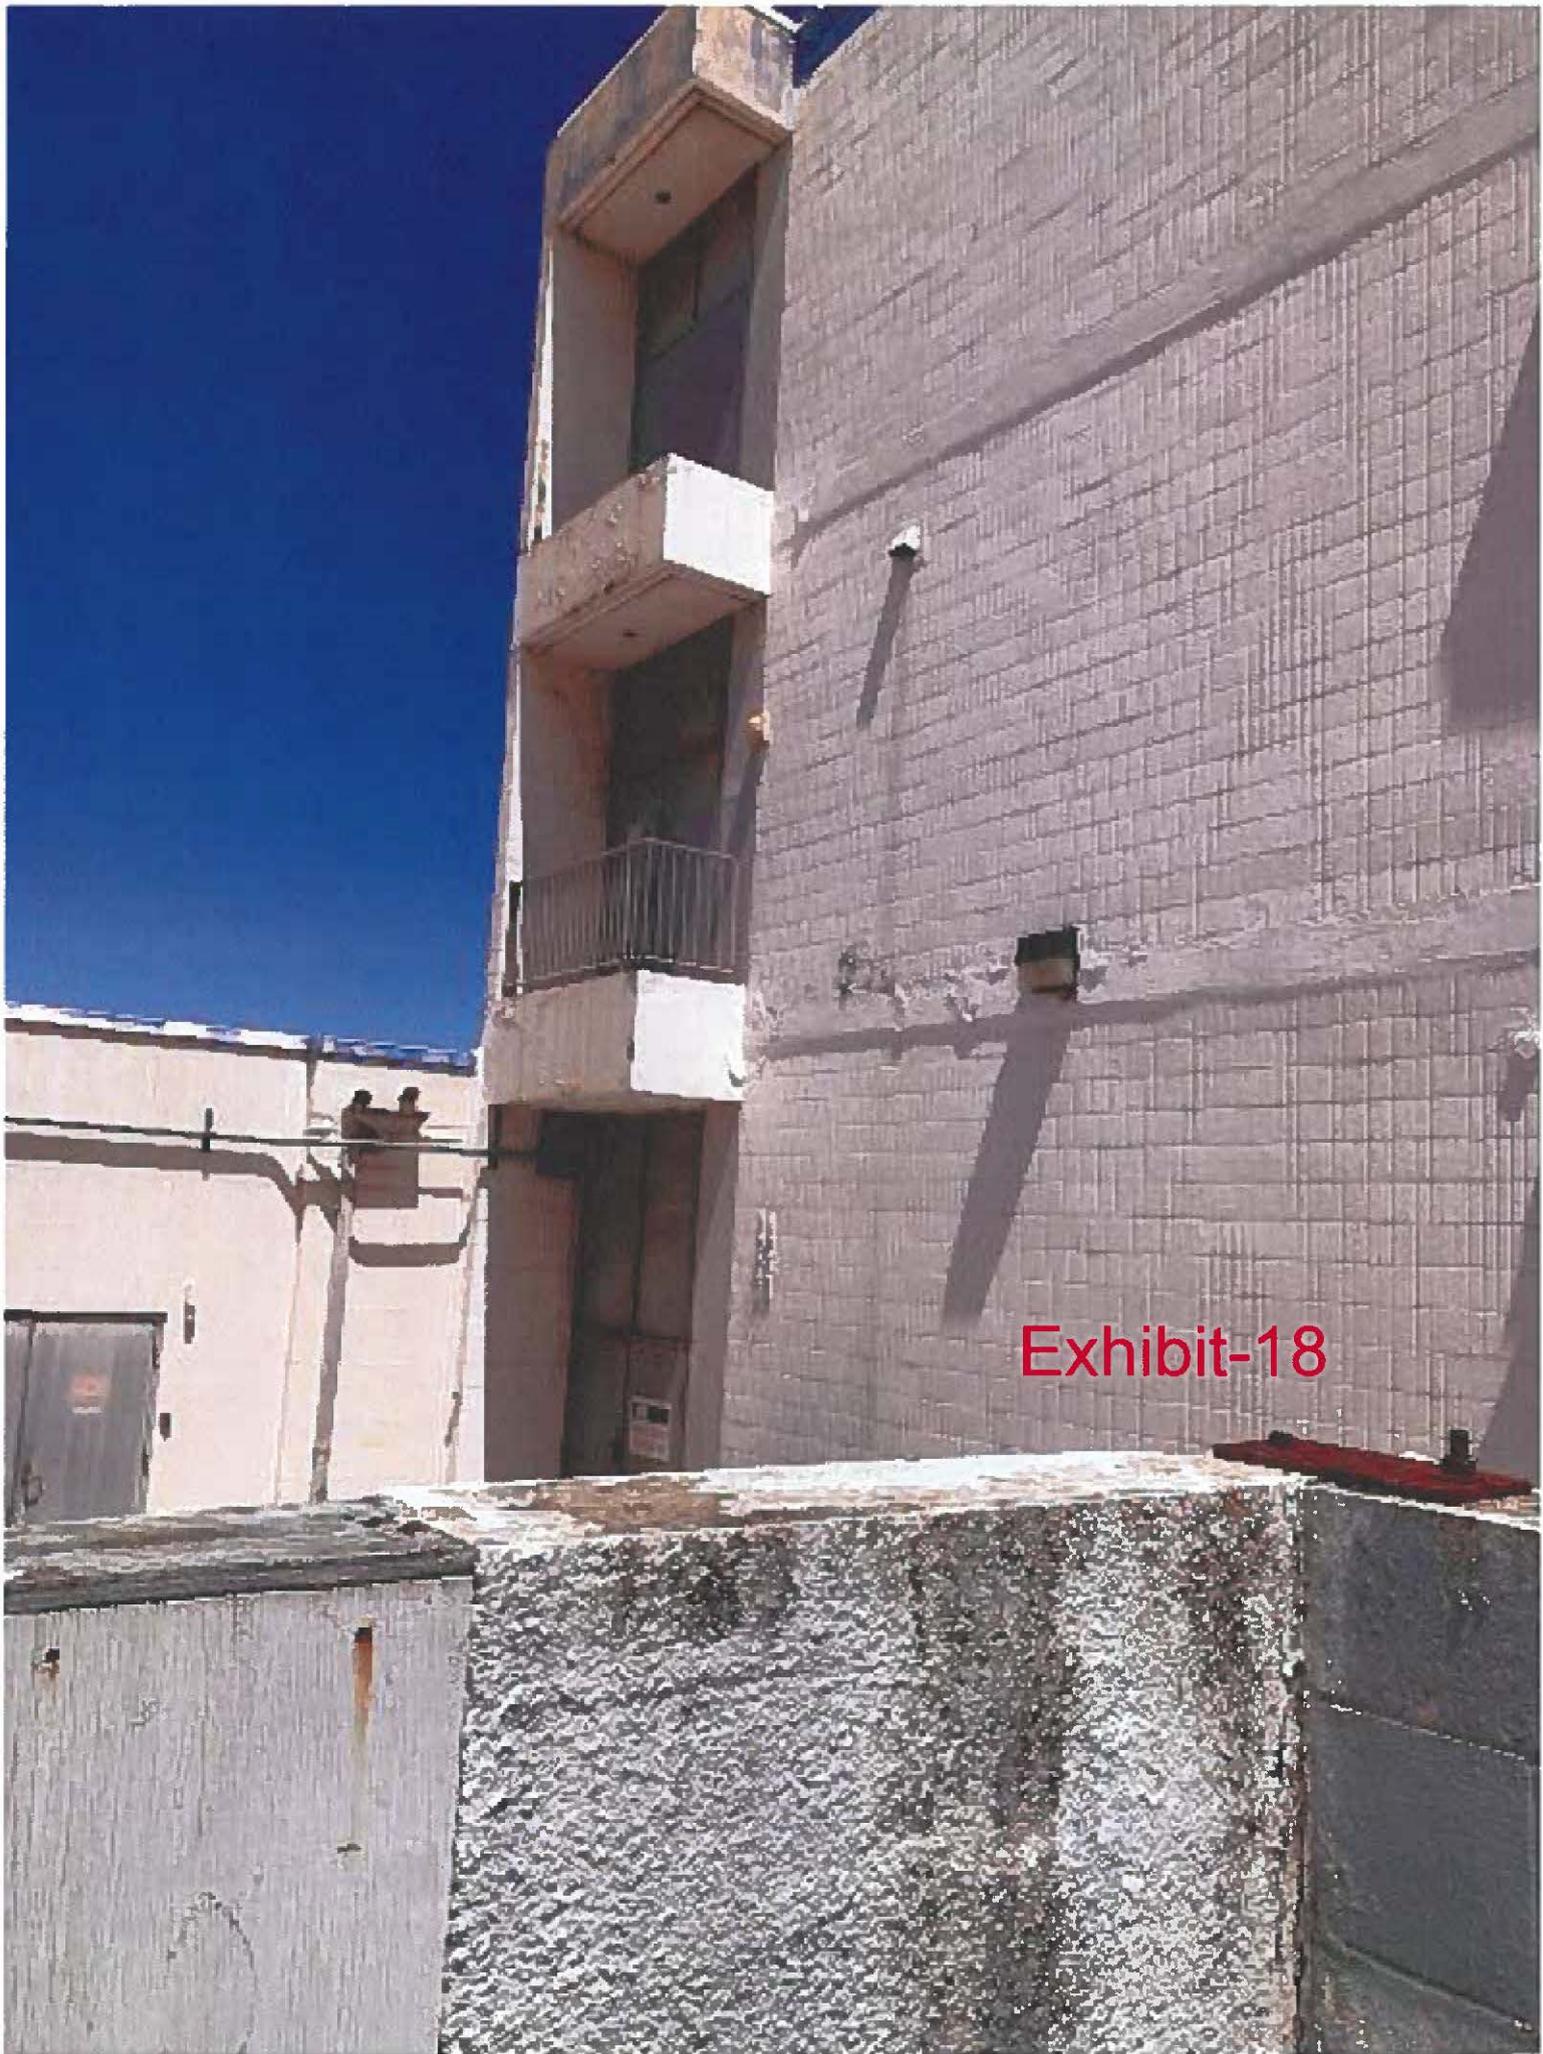
Exhibit-18

3.1.4 The north wall has small balconies (4' x 7') at each end of each floor. Two at the 2<sup>nd</sup> floor, 2 at the 3<sup>rd</sup> floor and 2 at the roof, for a total of 6, including a similar extension at the roof level. All have cracks & spalling (see photo Exhibits 17 & 18).

3.1.7.3 The cracks and spalling on the balcony projections at each floor (including the roof) need to be repaired before repainting.

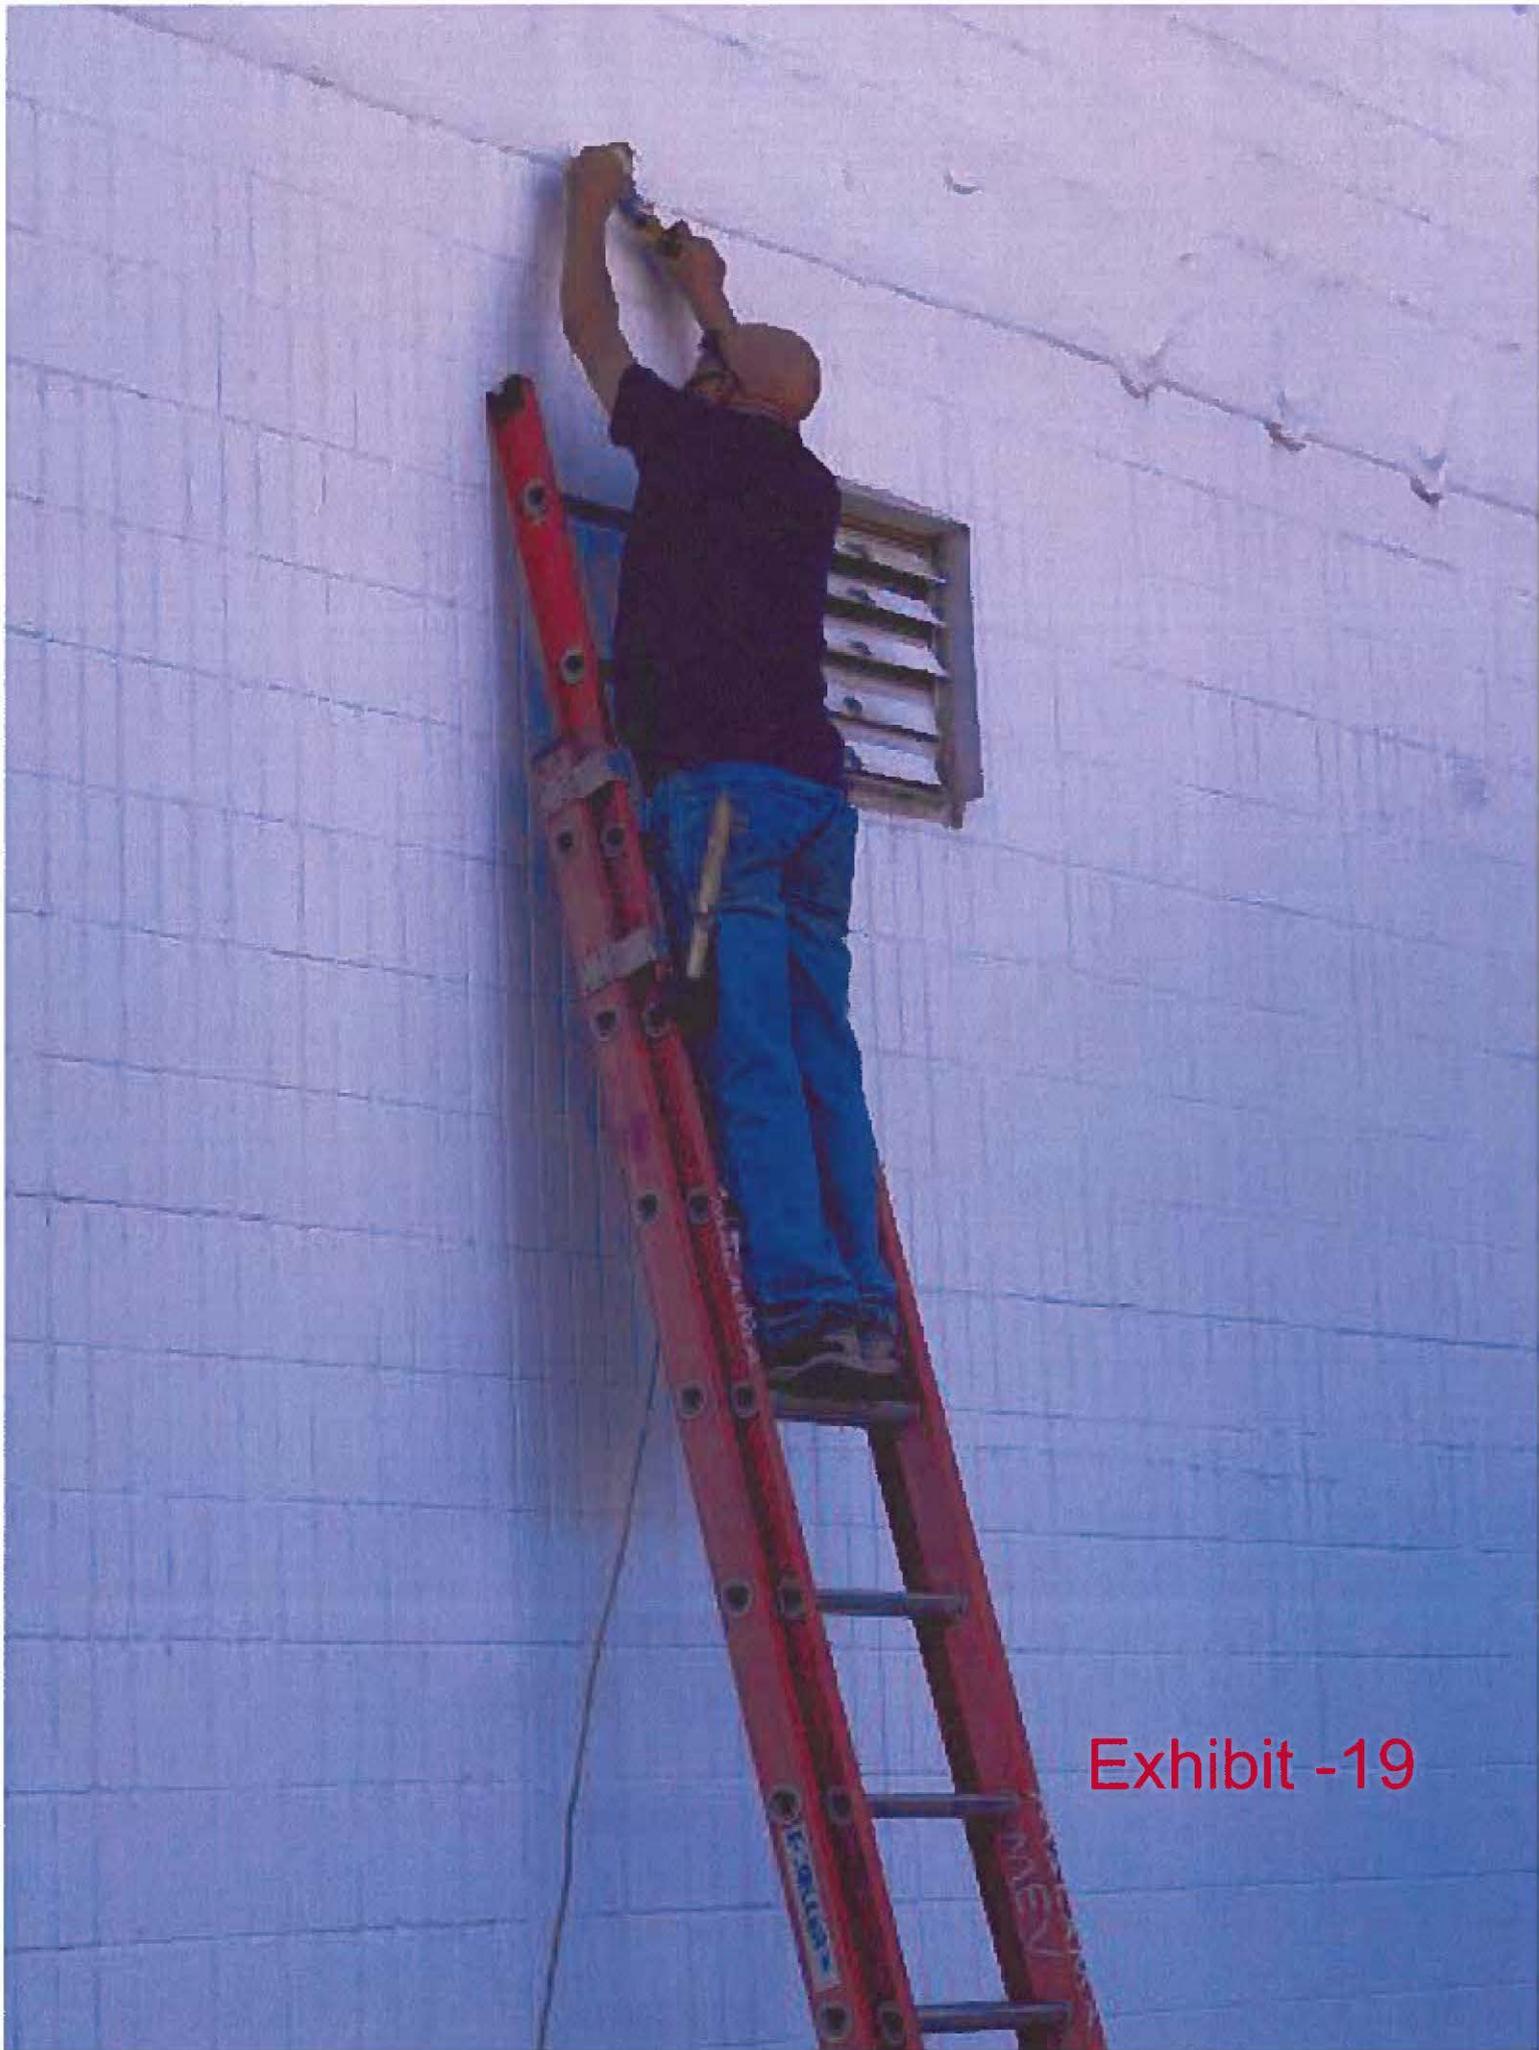
Exhibit -19

3.1.6.2 Portions of the coating, primarily below the 2<sup>nd</sup> floor concrete beam, have large blisters, bags of water between the CMU and the coating. That indicates that the coating is leaking somewhere above the blister (see photo Exhibit 19).

3.1.7.1 Because of the vertical grooves in the exposed surface of the concrete block wall, removing the coating will be very difficult (expensive). The coating on the columns and beams, all loose coating and the coating for 8" above and below the beams (including in the CMU grooves) should be removed to the bare concrete. Then a coating of the specified acrylic wall coating is to be applied.

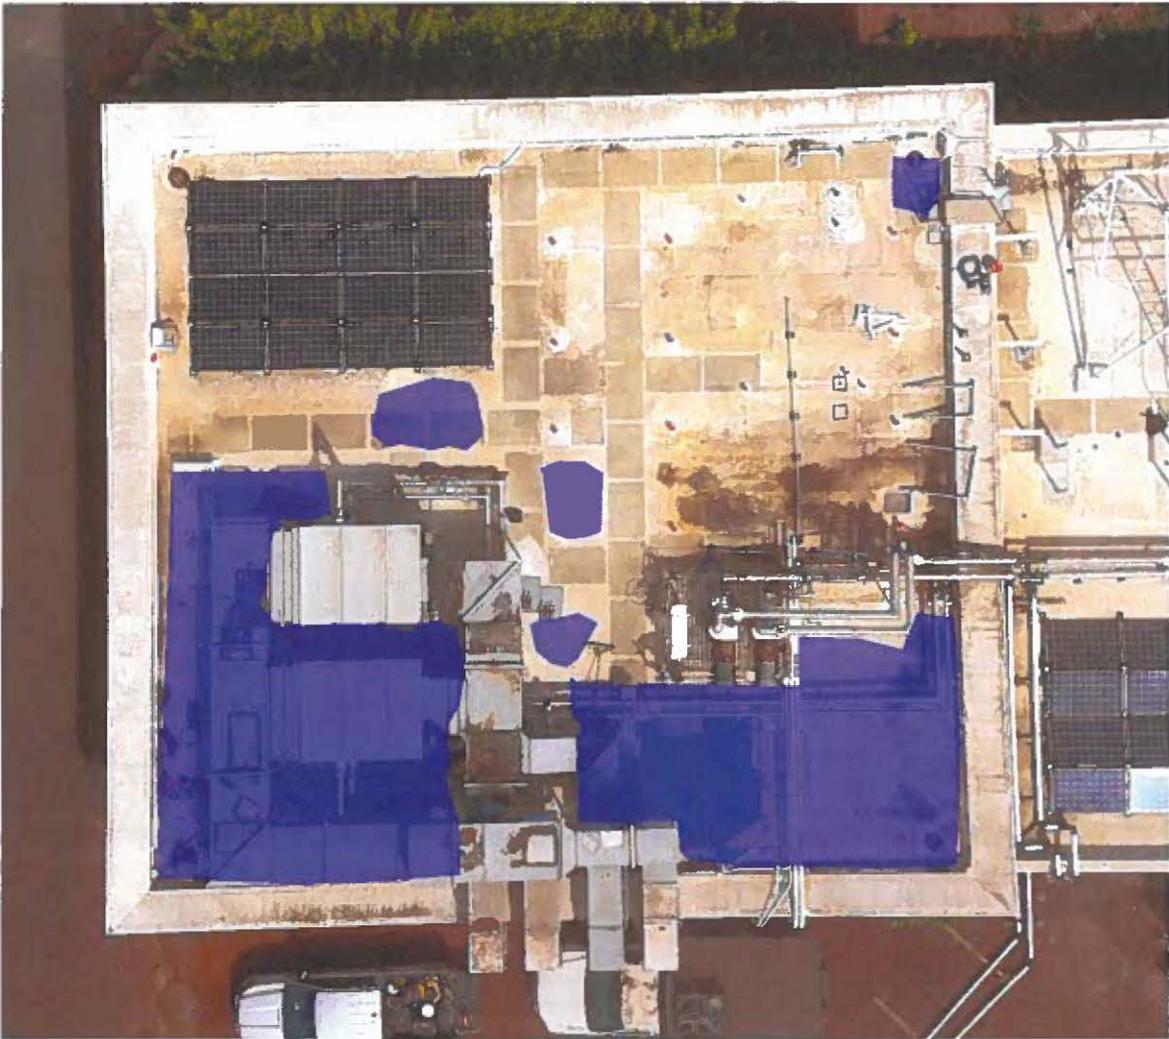
Figure 1-The areas shaded in blue were found to contain moisture.

Due to the amount of moisture in the roof it is advisable to remove all the wet sections through the insulation layer. In lieu of replacing the Hypalon membrane a peel and stick membrane may be used once the insulation has been replaced. ASC (AMERICAN STANDARD COATINGS) will allow a 50 mil application to be applied over the top of the Hypalon membrane including the peel and stick which will then be warranted for 20 years.

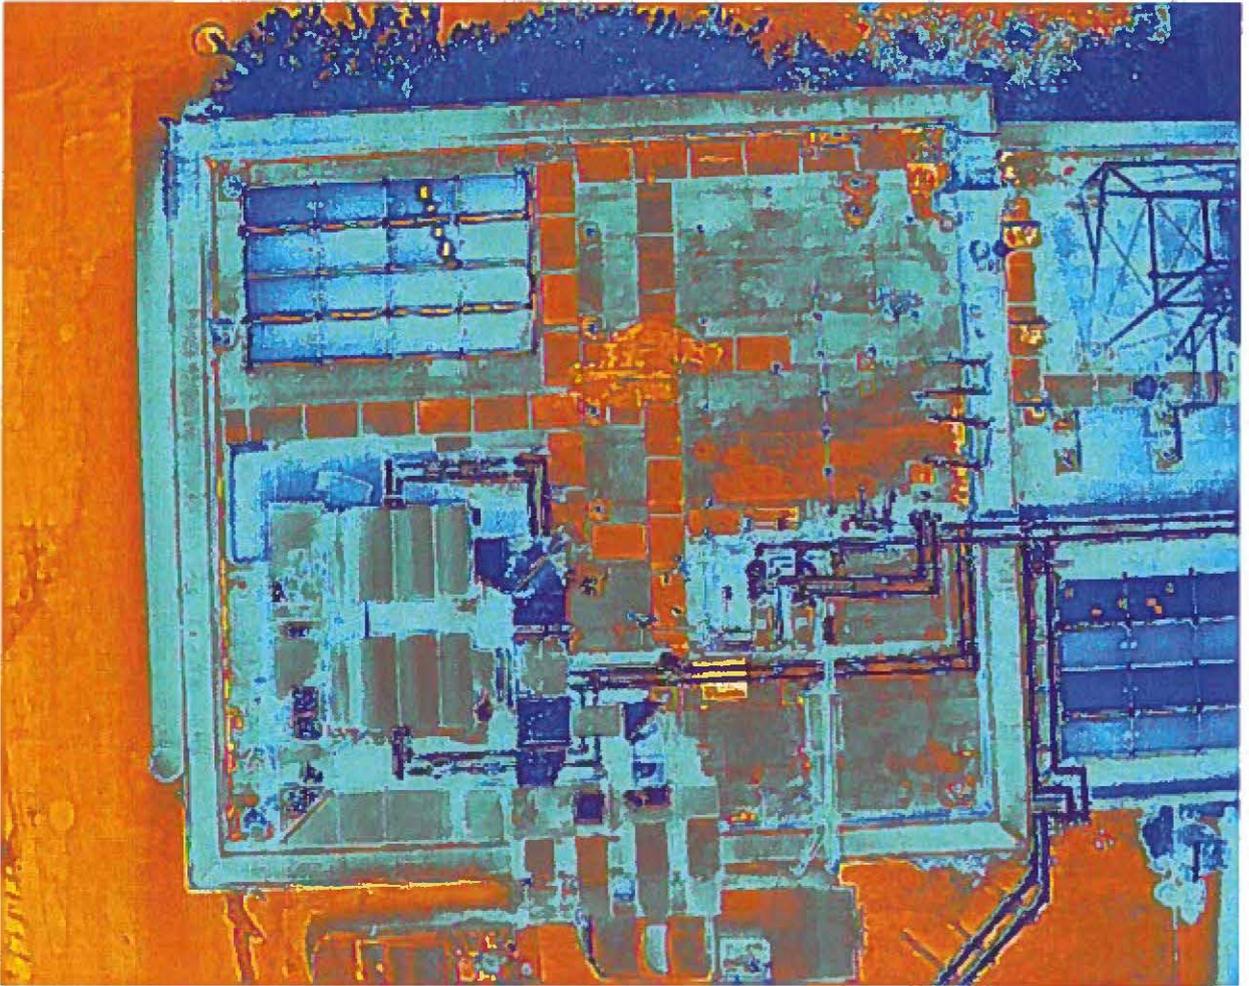
*Figure 2-Thermal image of the roof using a different color palette.*

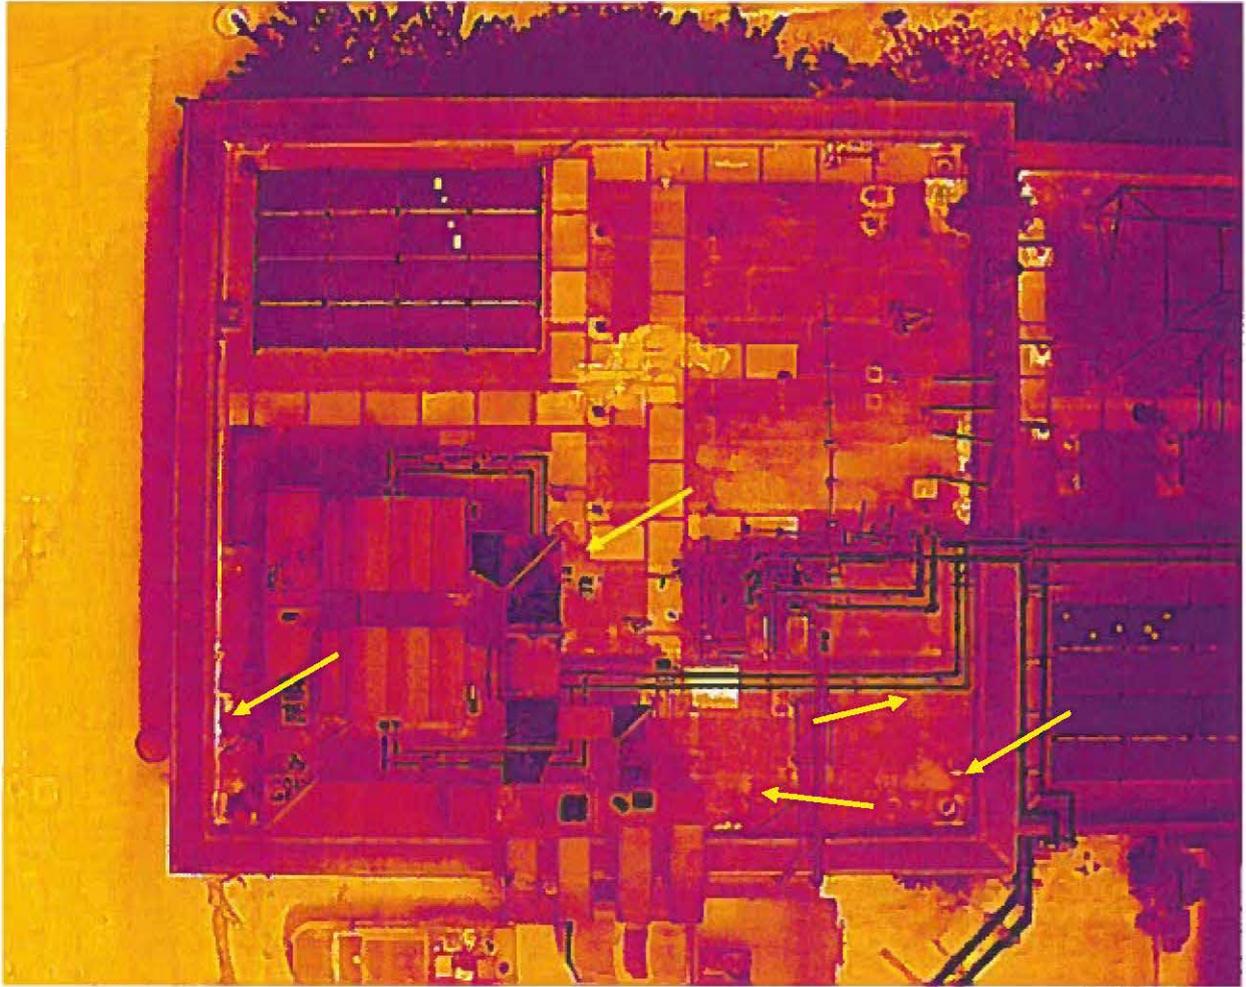
*Figure 3-The arrows indicate the thermal anomalies consistent with the presence of moisture.*
