Structural Condition Analysis and Assessment of Dormitory Facilities

December 17, 2019

Site Located at 820 Ka'ahumanu Avenue, Kahului, Maui 96732 TMK: (2)3-8-07:117

Summary of Structural Field Condition Survey for the Existing University of Hawaii Community College Dorm Campus Buildings and Appurtenances

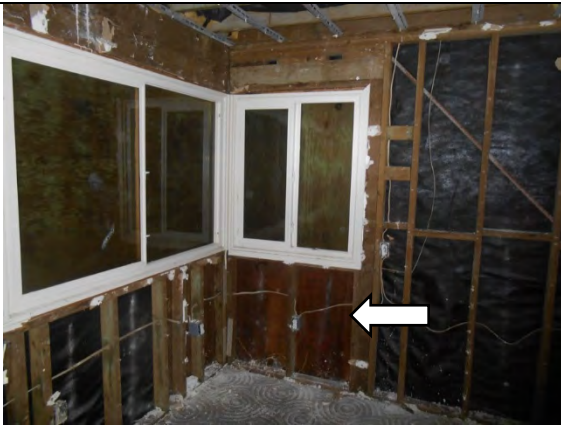
PA1CD.3: At various locations, vegetation is present at interior face of first story walls.

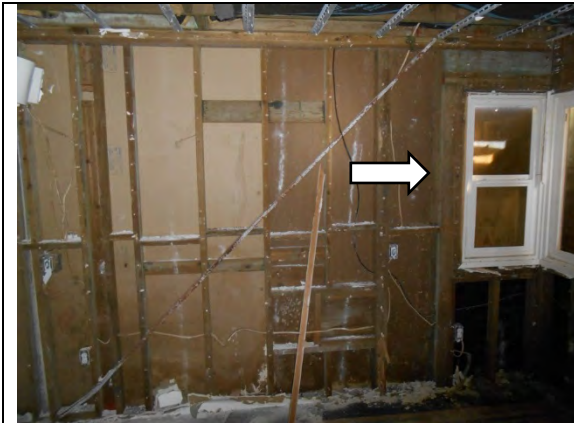
PA1CD.6: At various locations, openings missing king jamb post(s).

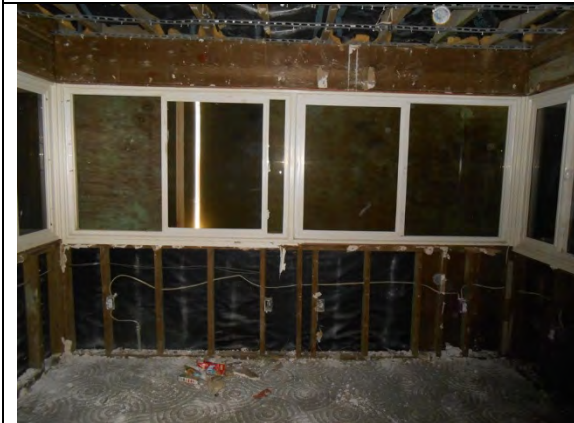
PA1CD.7: At various locations, wide wall opening with single sill plate.

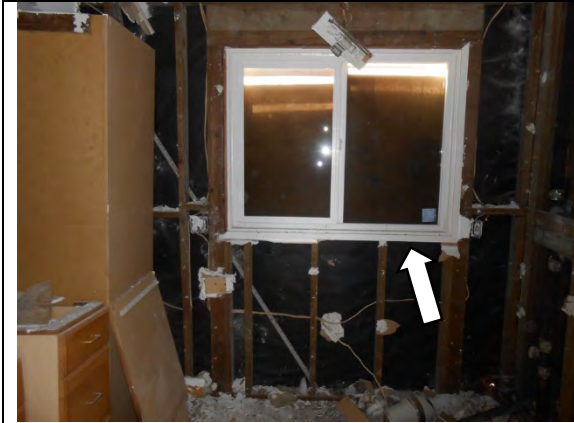
PA1CD.9: At various locations, openings missing sill plate.

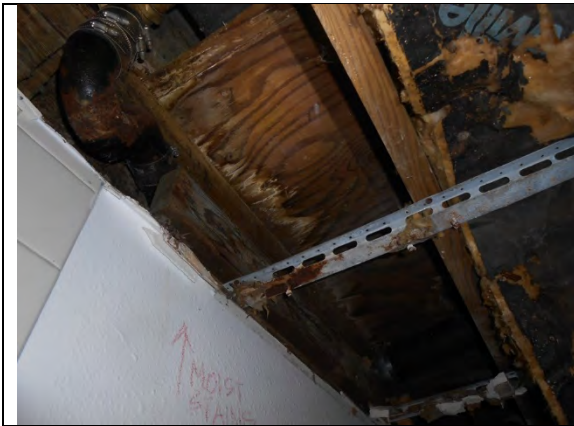
PA2D.1: Moisture stains present on plywood sheathing adjacent to rusty pipe.

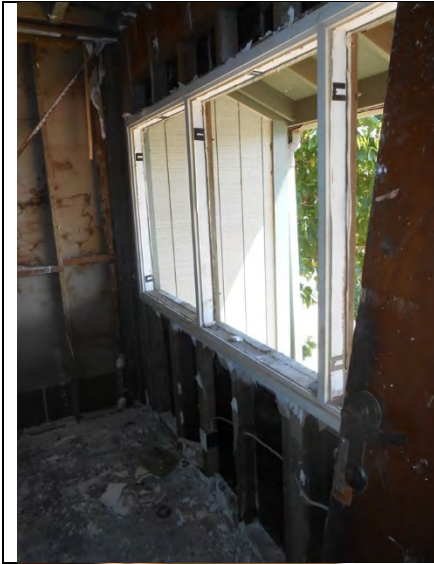
PA2CD.1: Wide opening single sill plate.

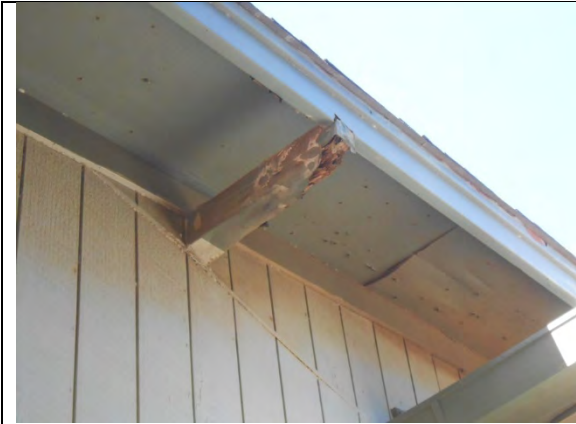
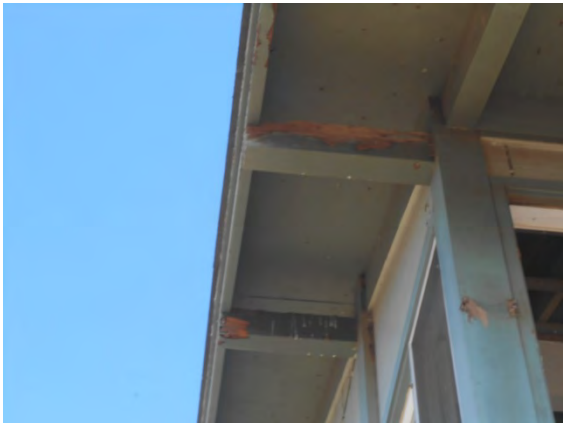
PARD.1: Beam overhang dry rot.

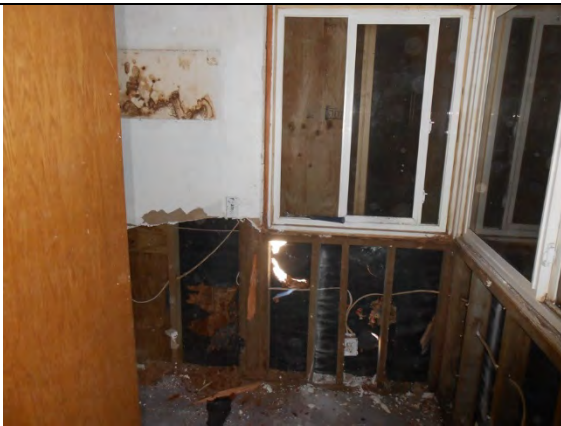
PB1D.2: Siding dry rot.

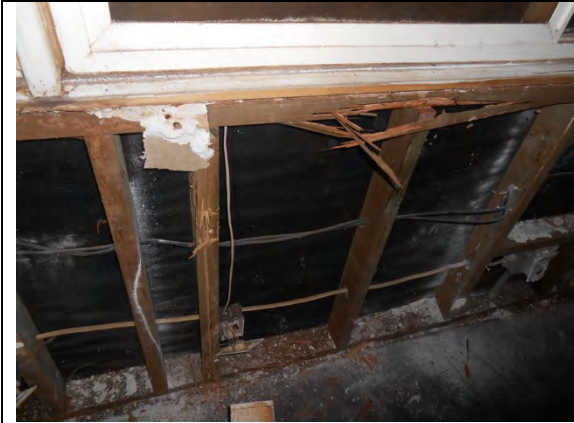
PB1D.4: Stud termite damage. Sill plate termite damage.

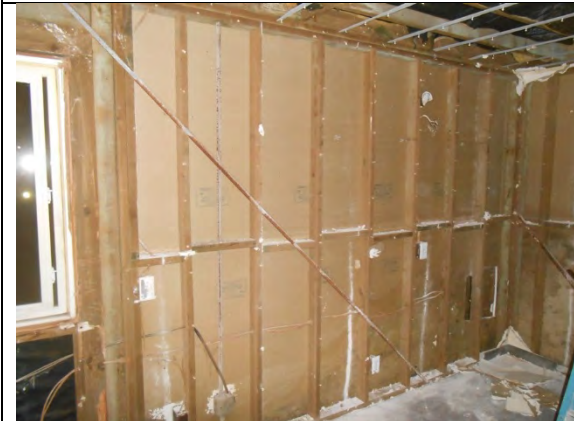
PB1D.6: Rusting steel wall braces.

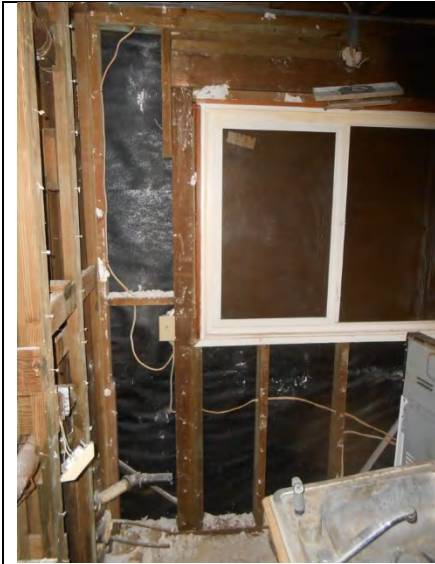
PB1CD.1: Missing opening king post.

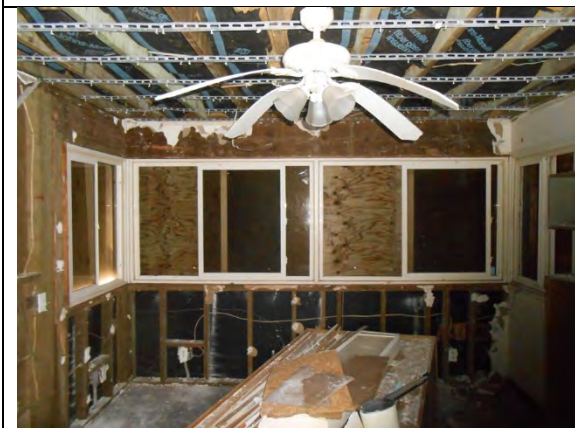
PB1CD.2: Wide opening with single sill plate.

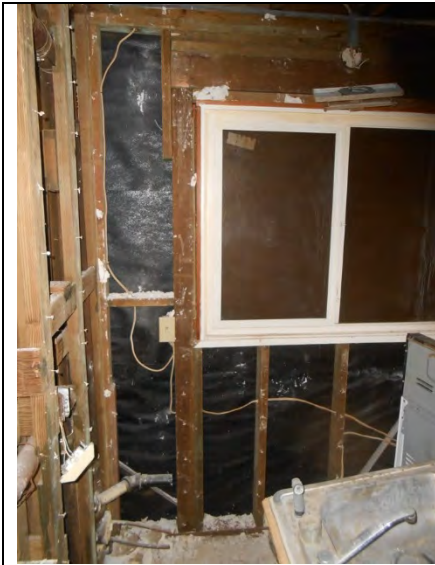
PB1CD.3: Missing opening sill plate.

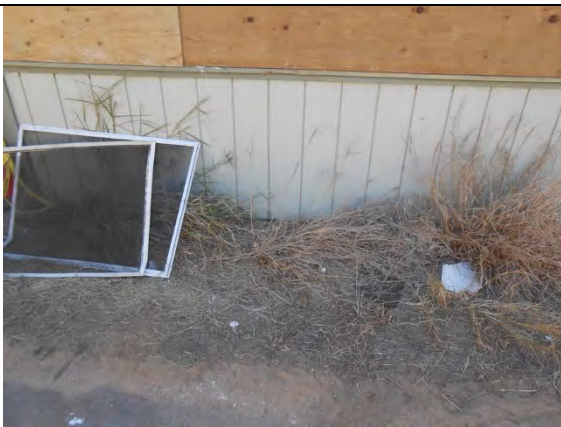
PB1CD.4: Vegetation against building façade.

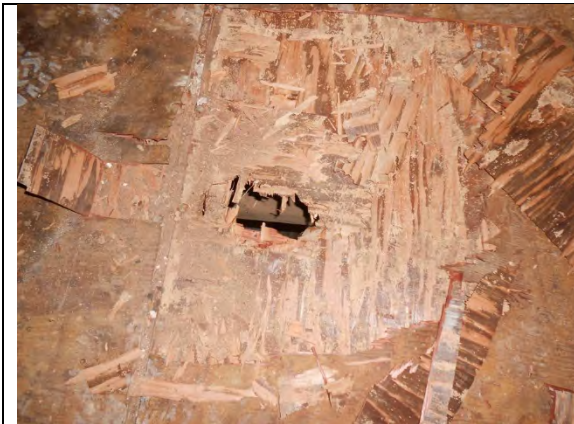
PB2D.1: Floor sheathing dry rot.

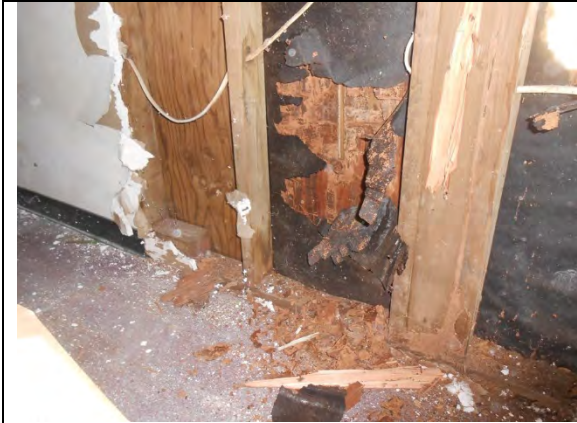
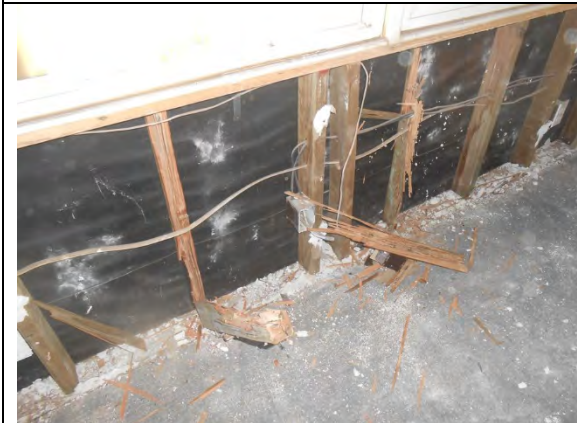
PB2D.4: Stud termite damage.

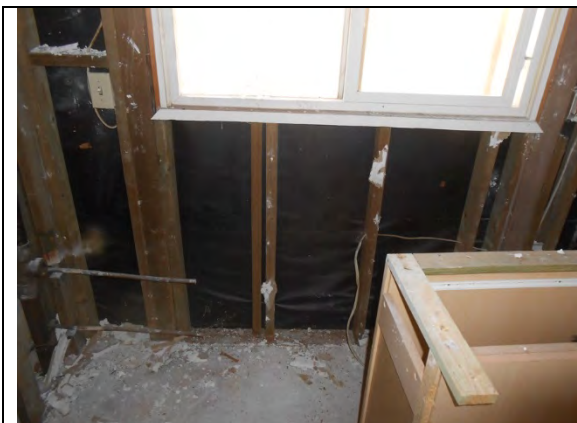
PB2CD.1: Missing wall blocking.

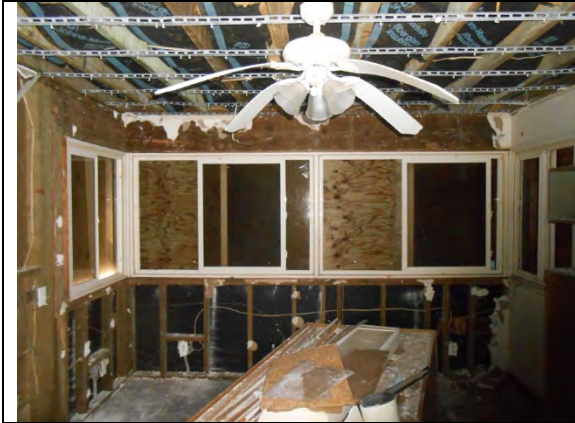
PB2CD.2: Missing blocking

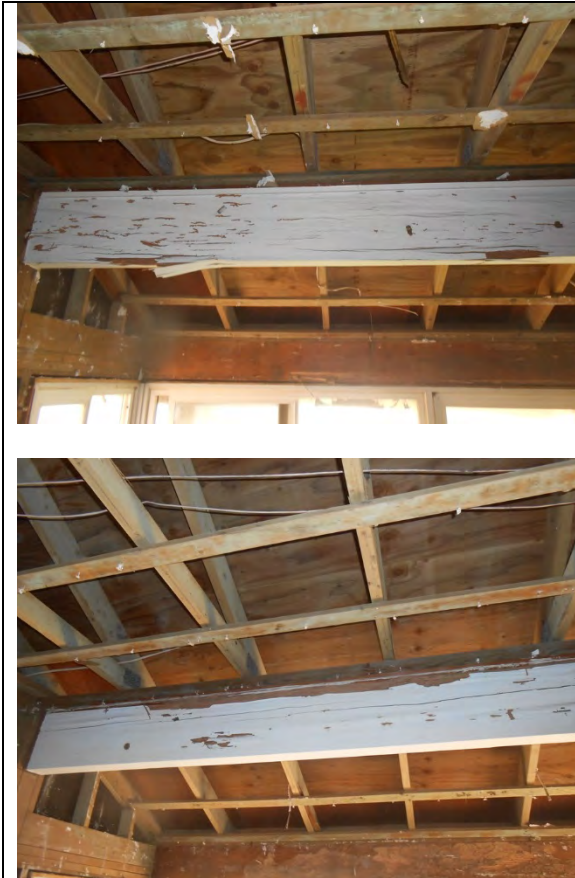
PBRD.1: Beam termite damage.

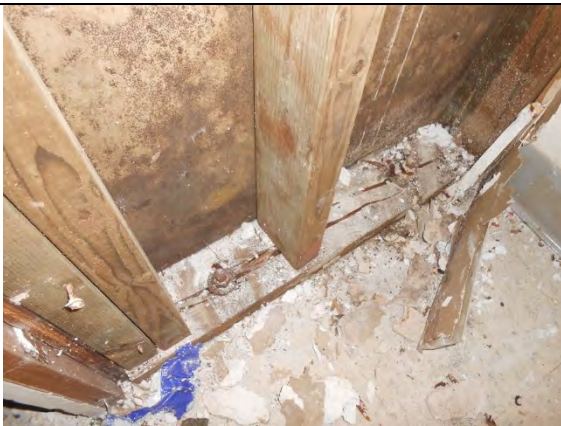
PC1D.2: Split sole plate.

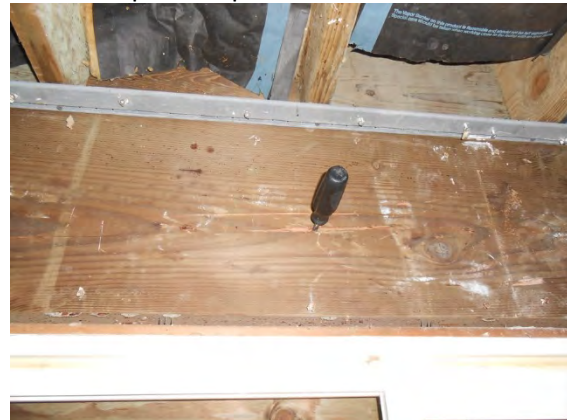
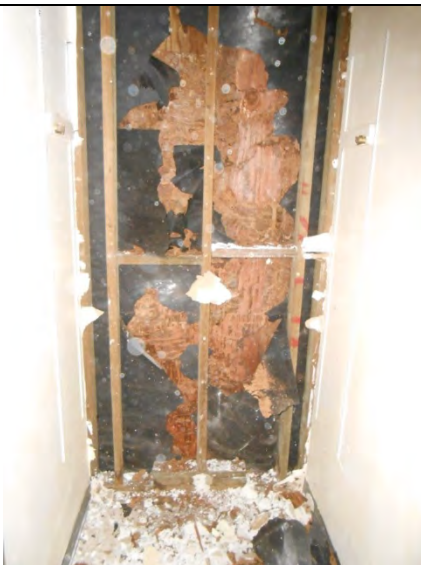
PC1D.3: Siding dry rot.

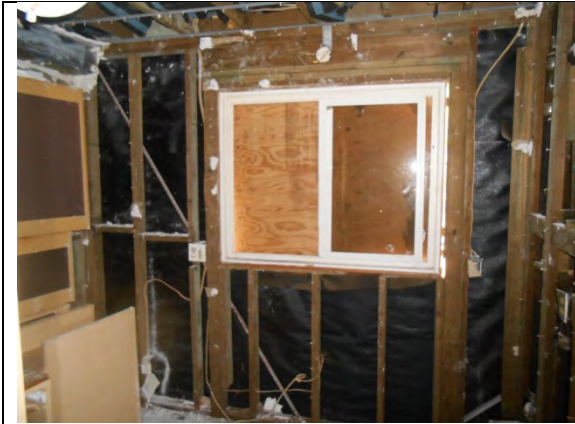
PC1CD.1: Missing opening king post.

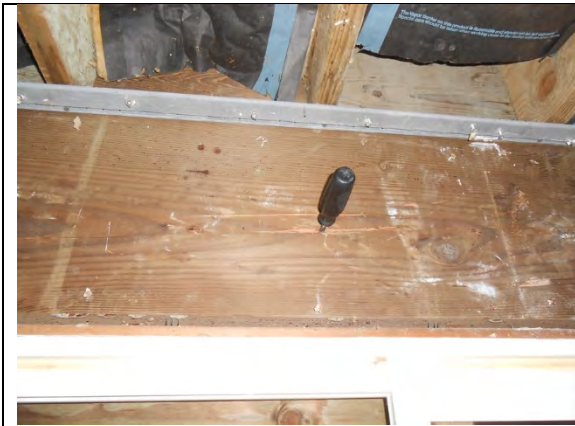
PC2D.1: Beam termite damage.

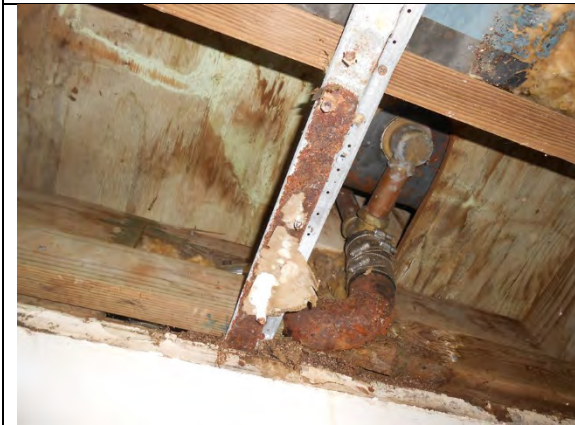
PC2D.2: Moisture damage to floor sheathing adjacent to rusting pipe.

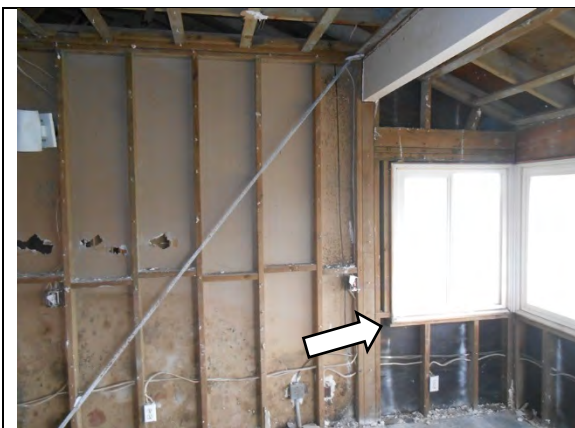
PC2CD. 1: Missing opening king post.

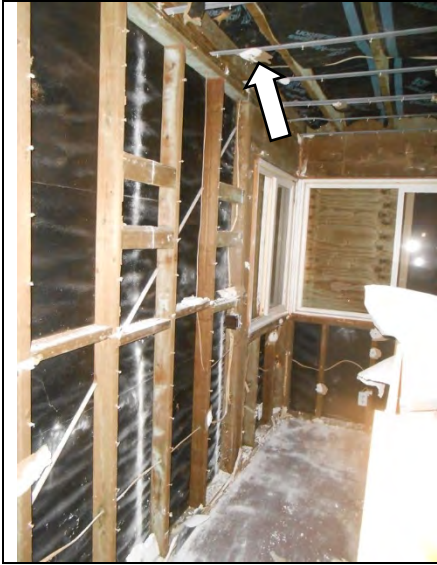
PC2CD.5: Missing wall blocking.

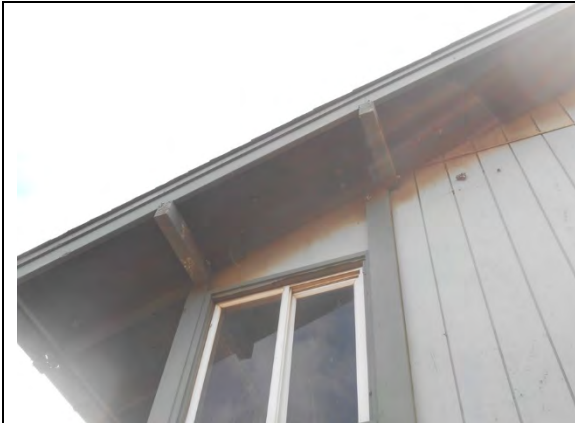
PCRD.1: Beam overhang dry rot.

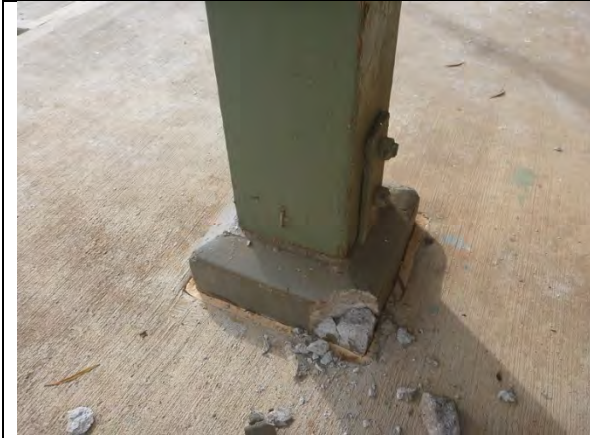
RC1D.1: Minor concrete spall at the northwest corner of the concrete pier at Gridlines '5-D'.

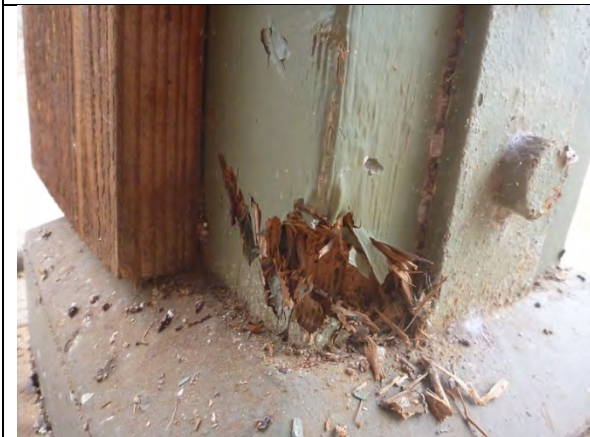
RC1D.2: Post at Gridlines 'D-1'; minor dry rot present at southeast corner of post base

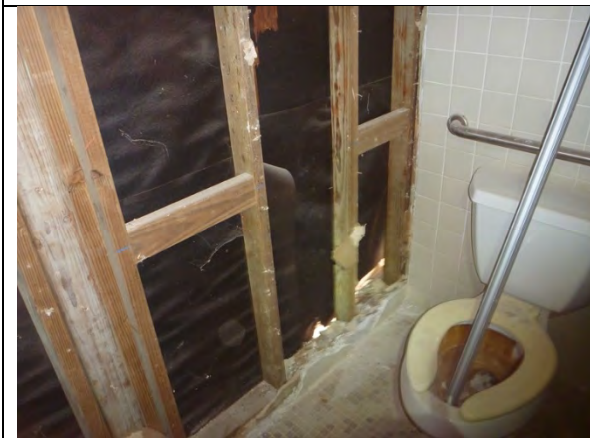
RC1D.3: Damaged siding at southwest corner of women's restroom.

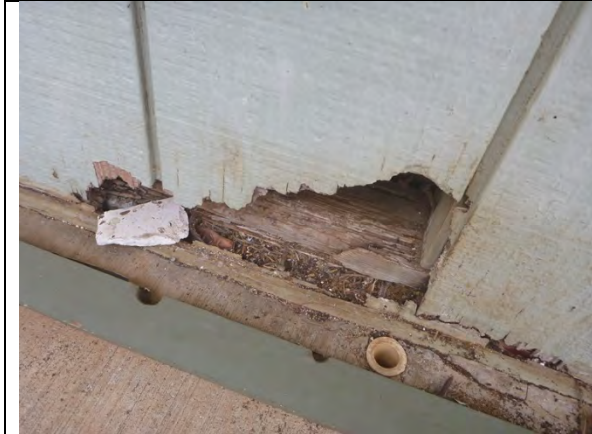
RC1D.4: Sole plate dry rot at heater room.

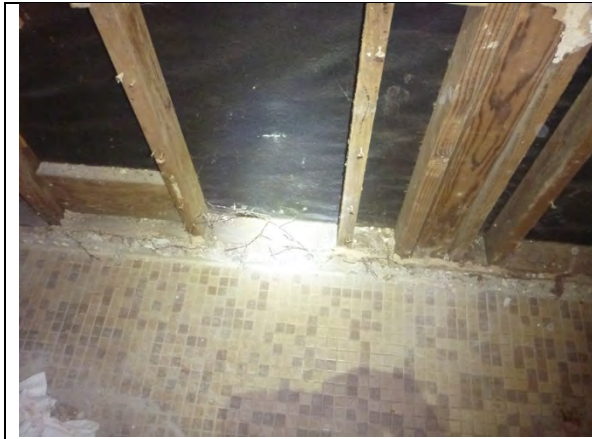
RC1CD.1: At various locations, sole plate anchor rods are installed at more than 32 inches on-center or missing.

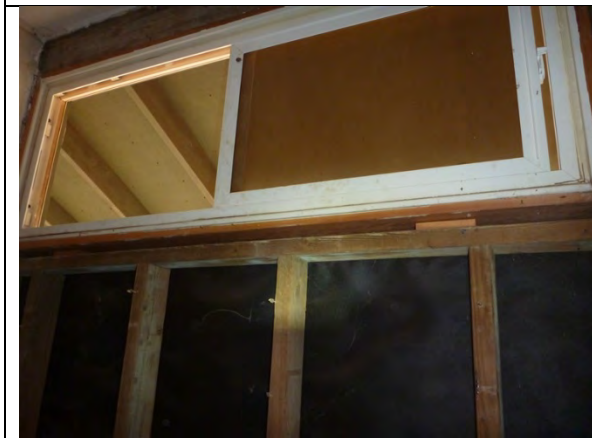
RC1CD.2: At various locations, windows are supported on spaced blocks.

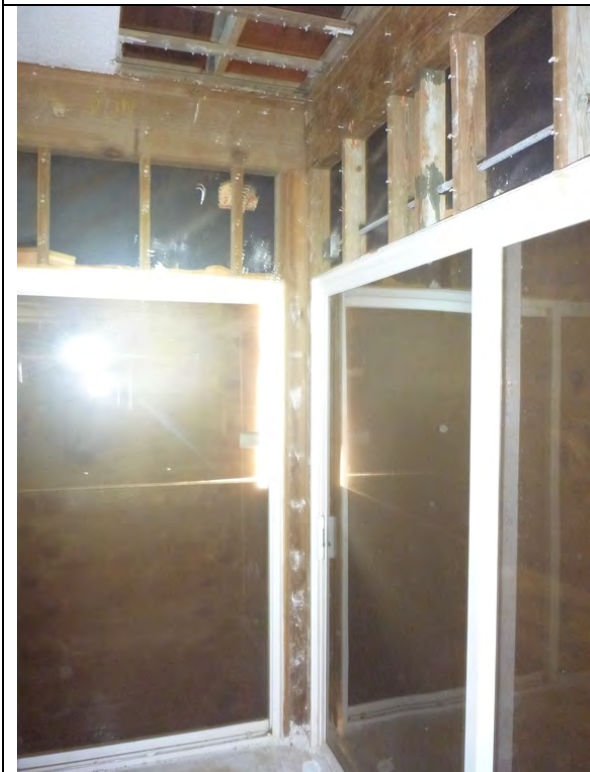
RC1CD.7: Typically, recreational room north, east, and west openings are missing double wood plate above the opening.

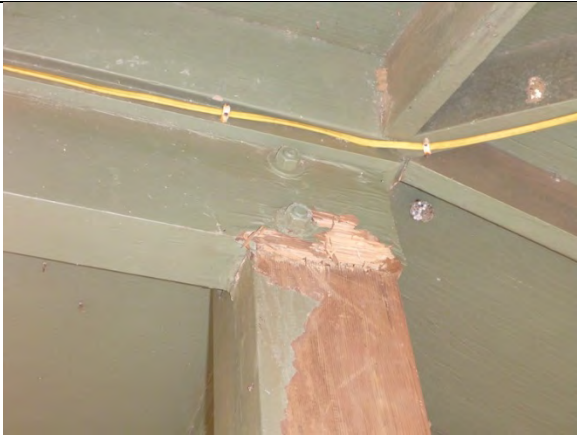
RCRD.1: Moderate termite damage present at beam to column connection at Gridlines '5-D'.

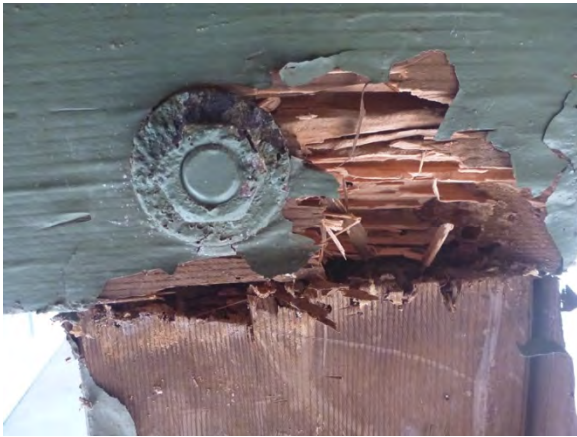
RCRD.2: Region of damaged plywood sheathing.

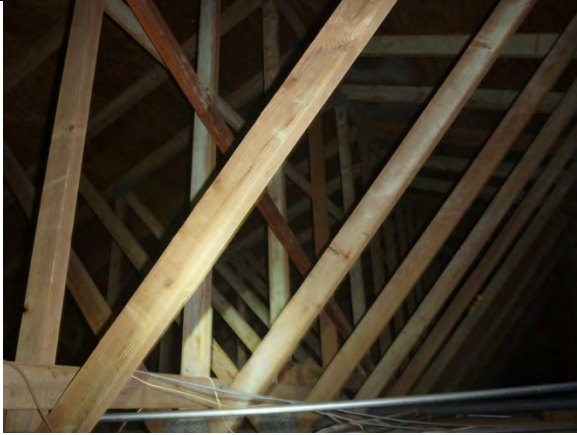
RCRCD.1: Web bracing missing.

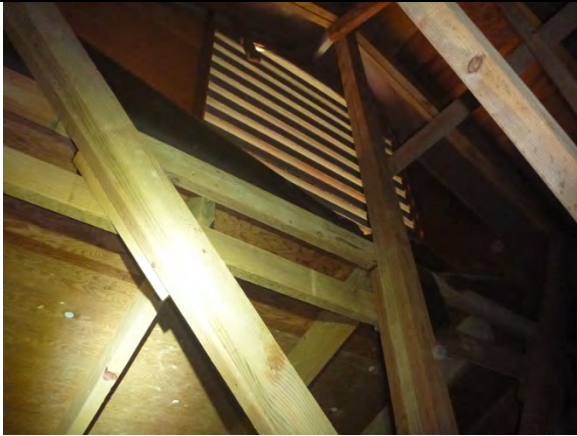
RCRCD.2: Gable end wall missing stud wall framing.

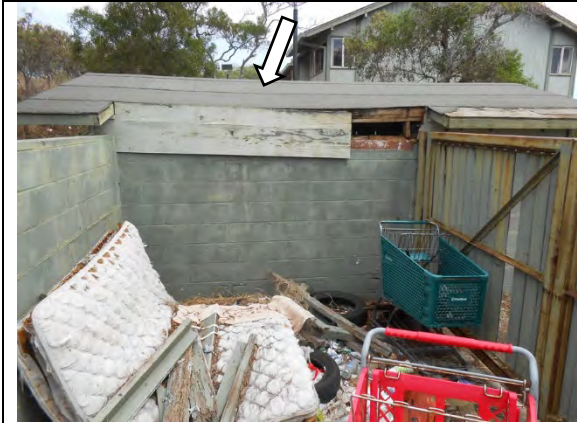
PTESB4: Damaged storage building roof.

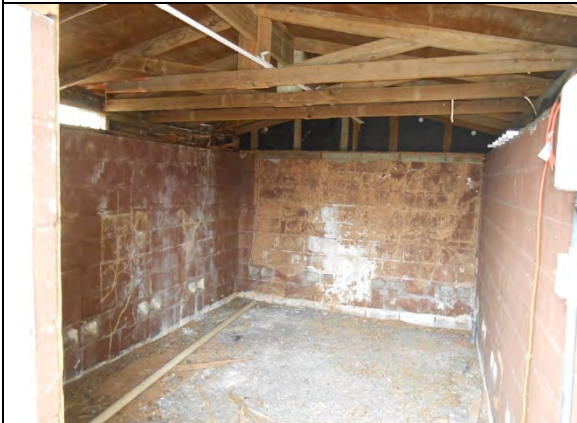
PTESB5: Interior view of storage building.

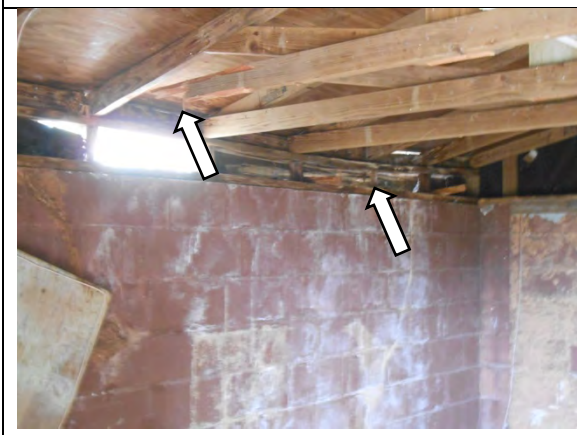
PTESB6: Collapsed storage building south wood framed stem wall. Damaged truss bottom chord.

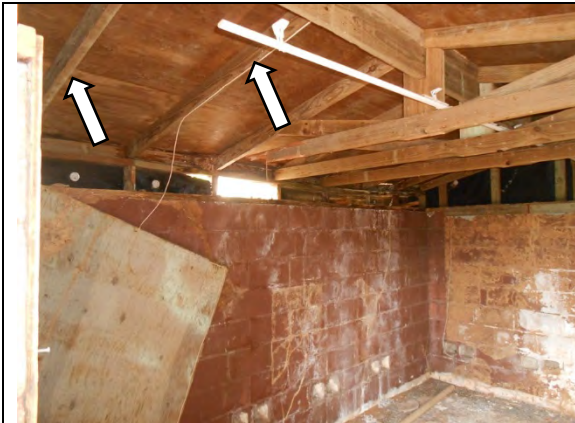
PTESB7: Damaged trusses. Missing truss framing.

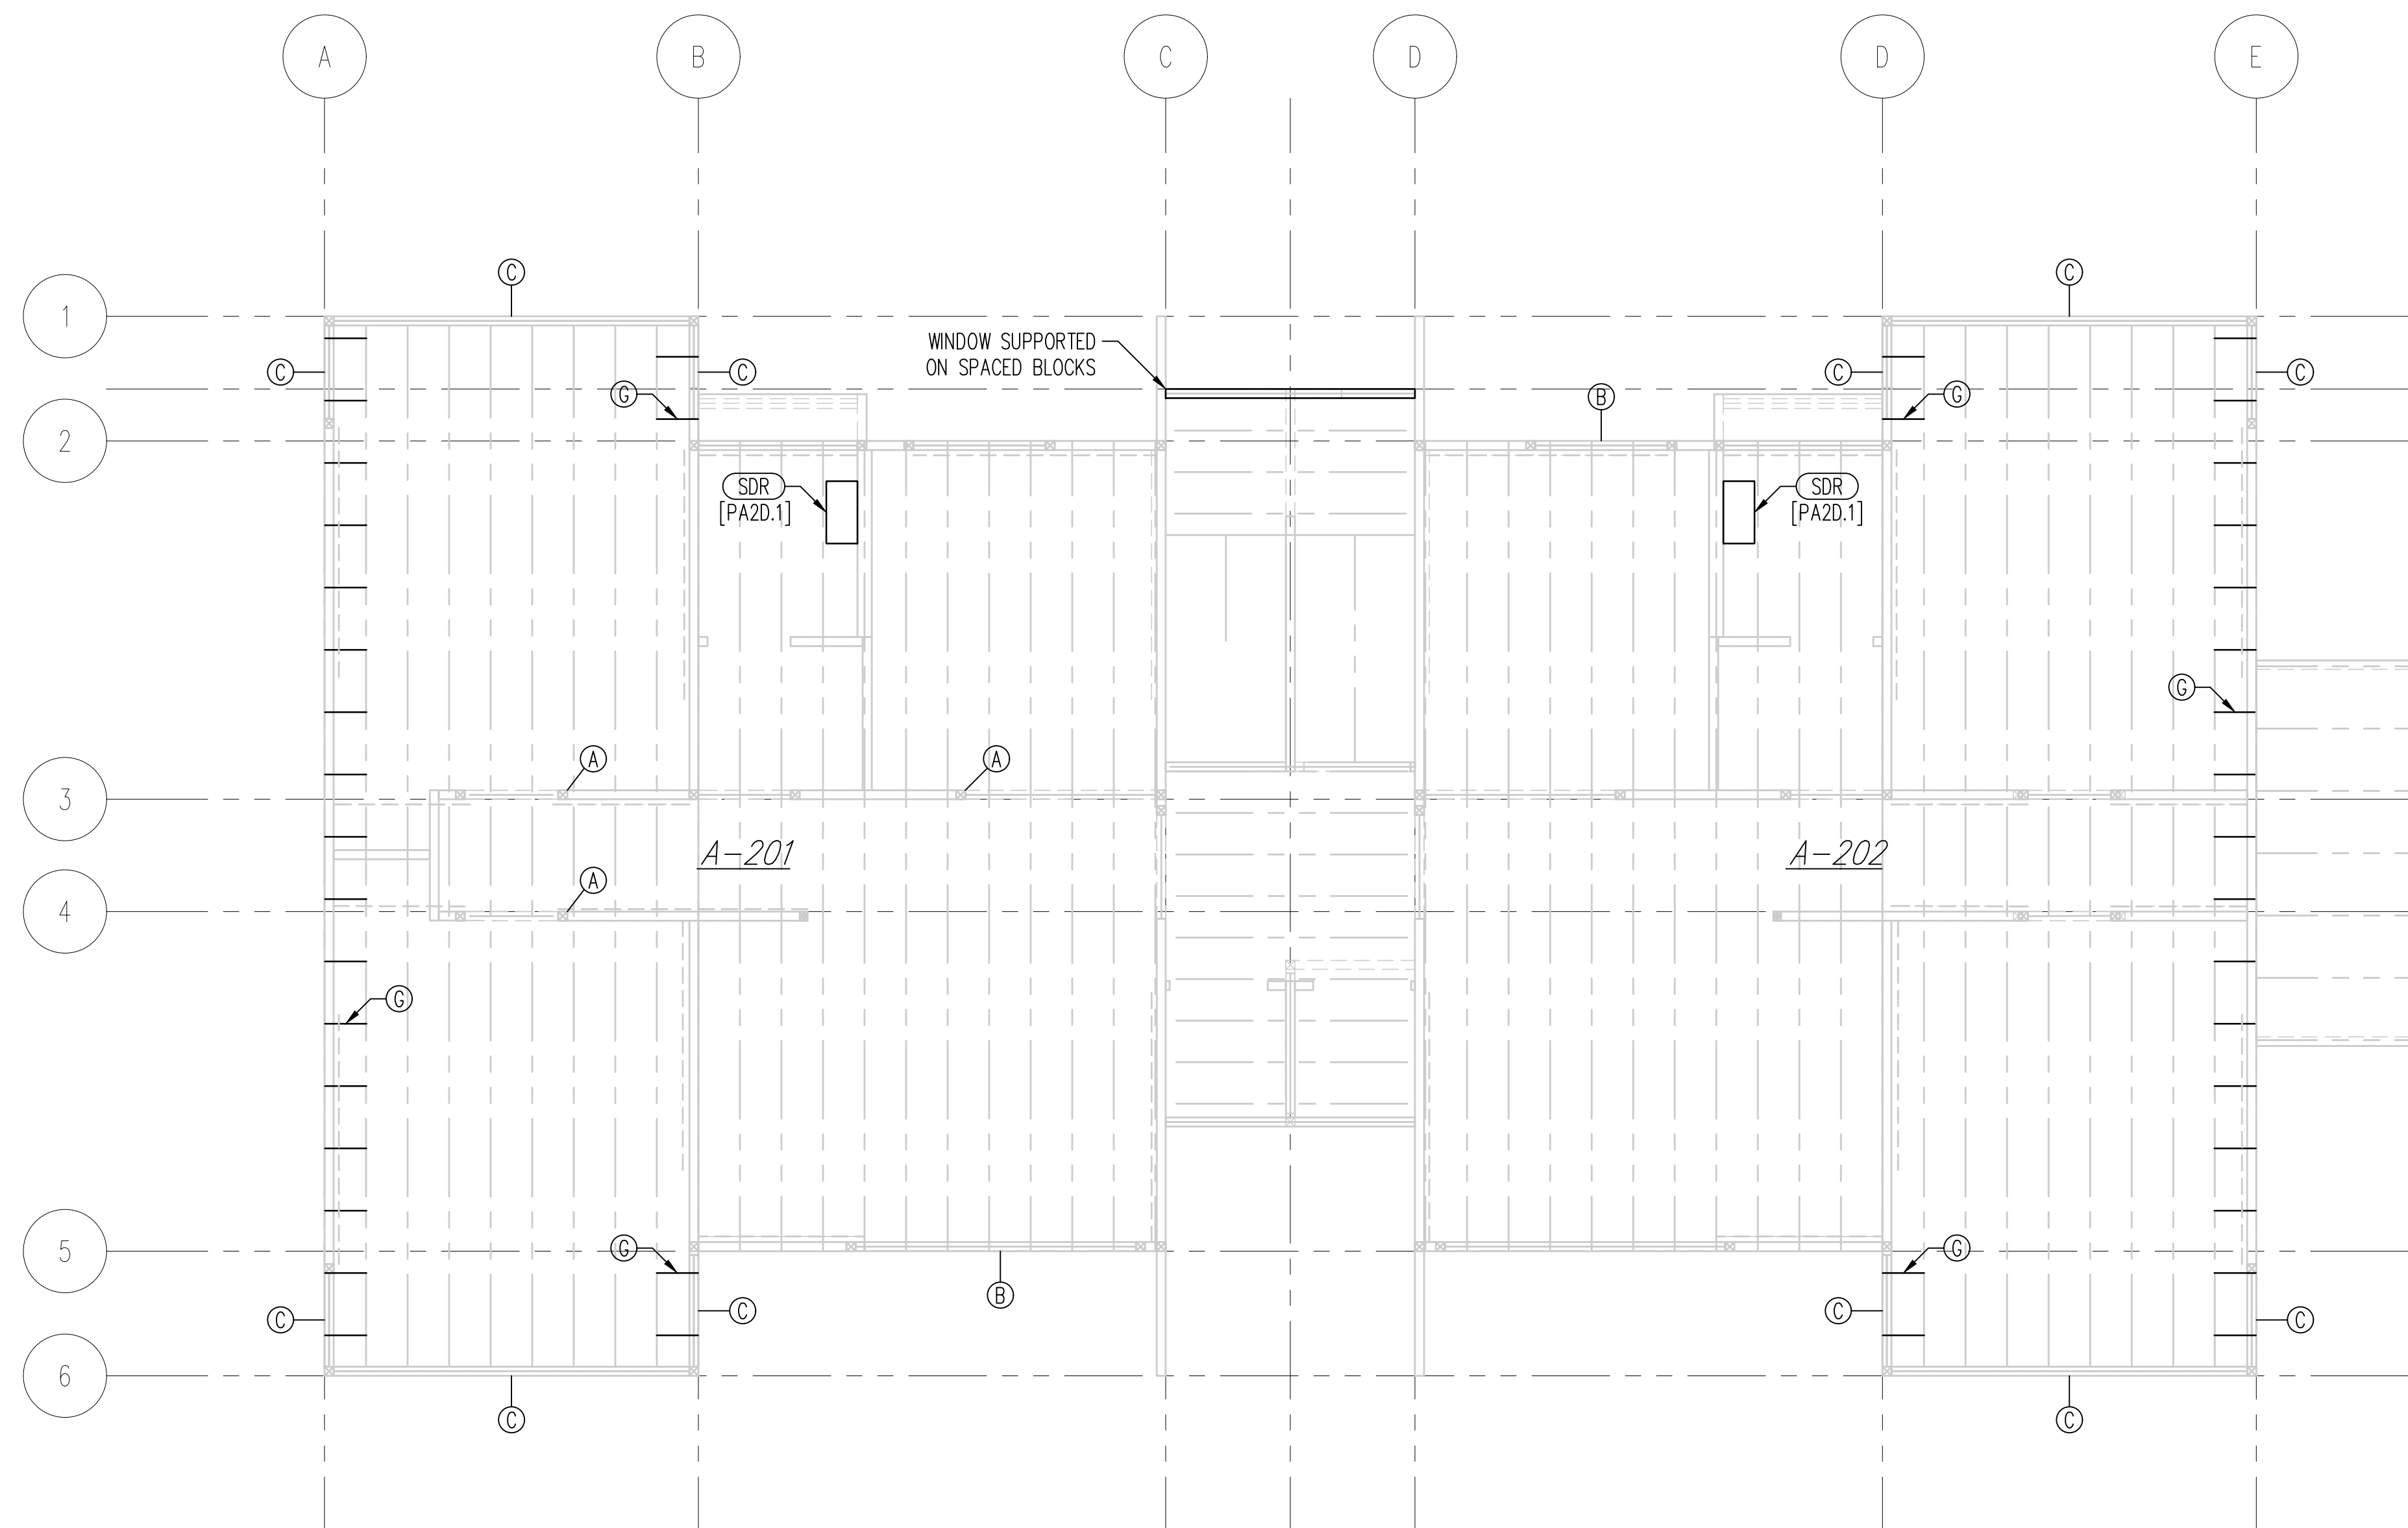
1 EXIST BUILDING A FLOOR FRAMING PLAN
 S-2 1/4" = 1'-0"

GENERAL DAMAGE NOTES:
 1. TYPICALLY, SOLE PLATE NAILING WAS NOT OBSERVED IN-PLACE.

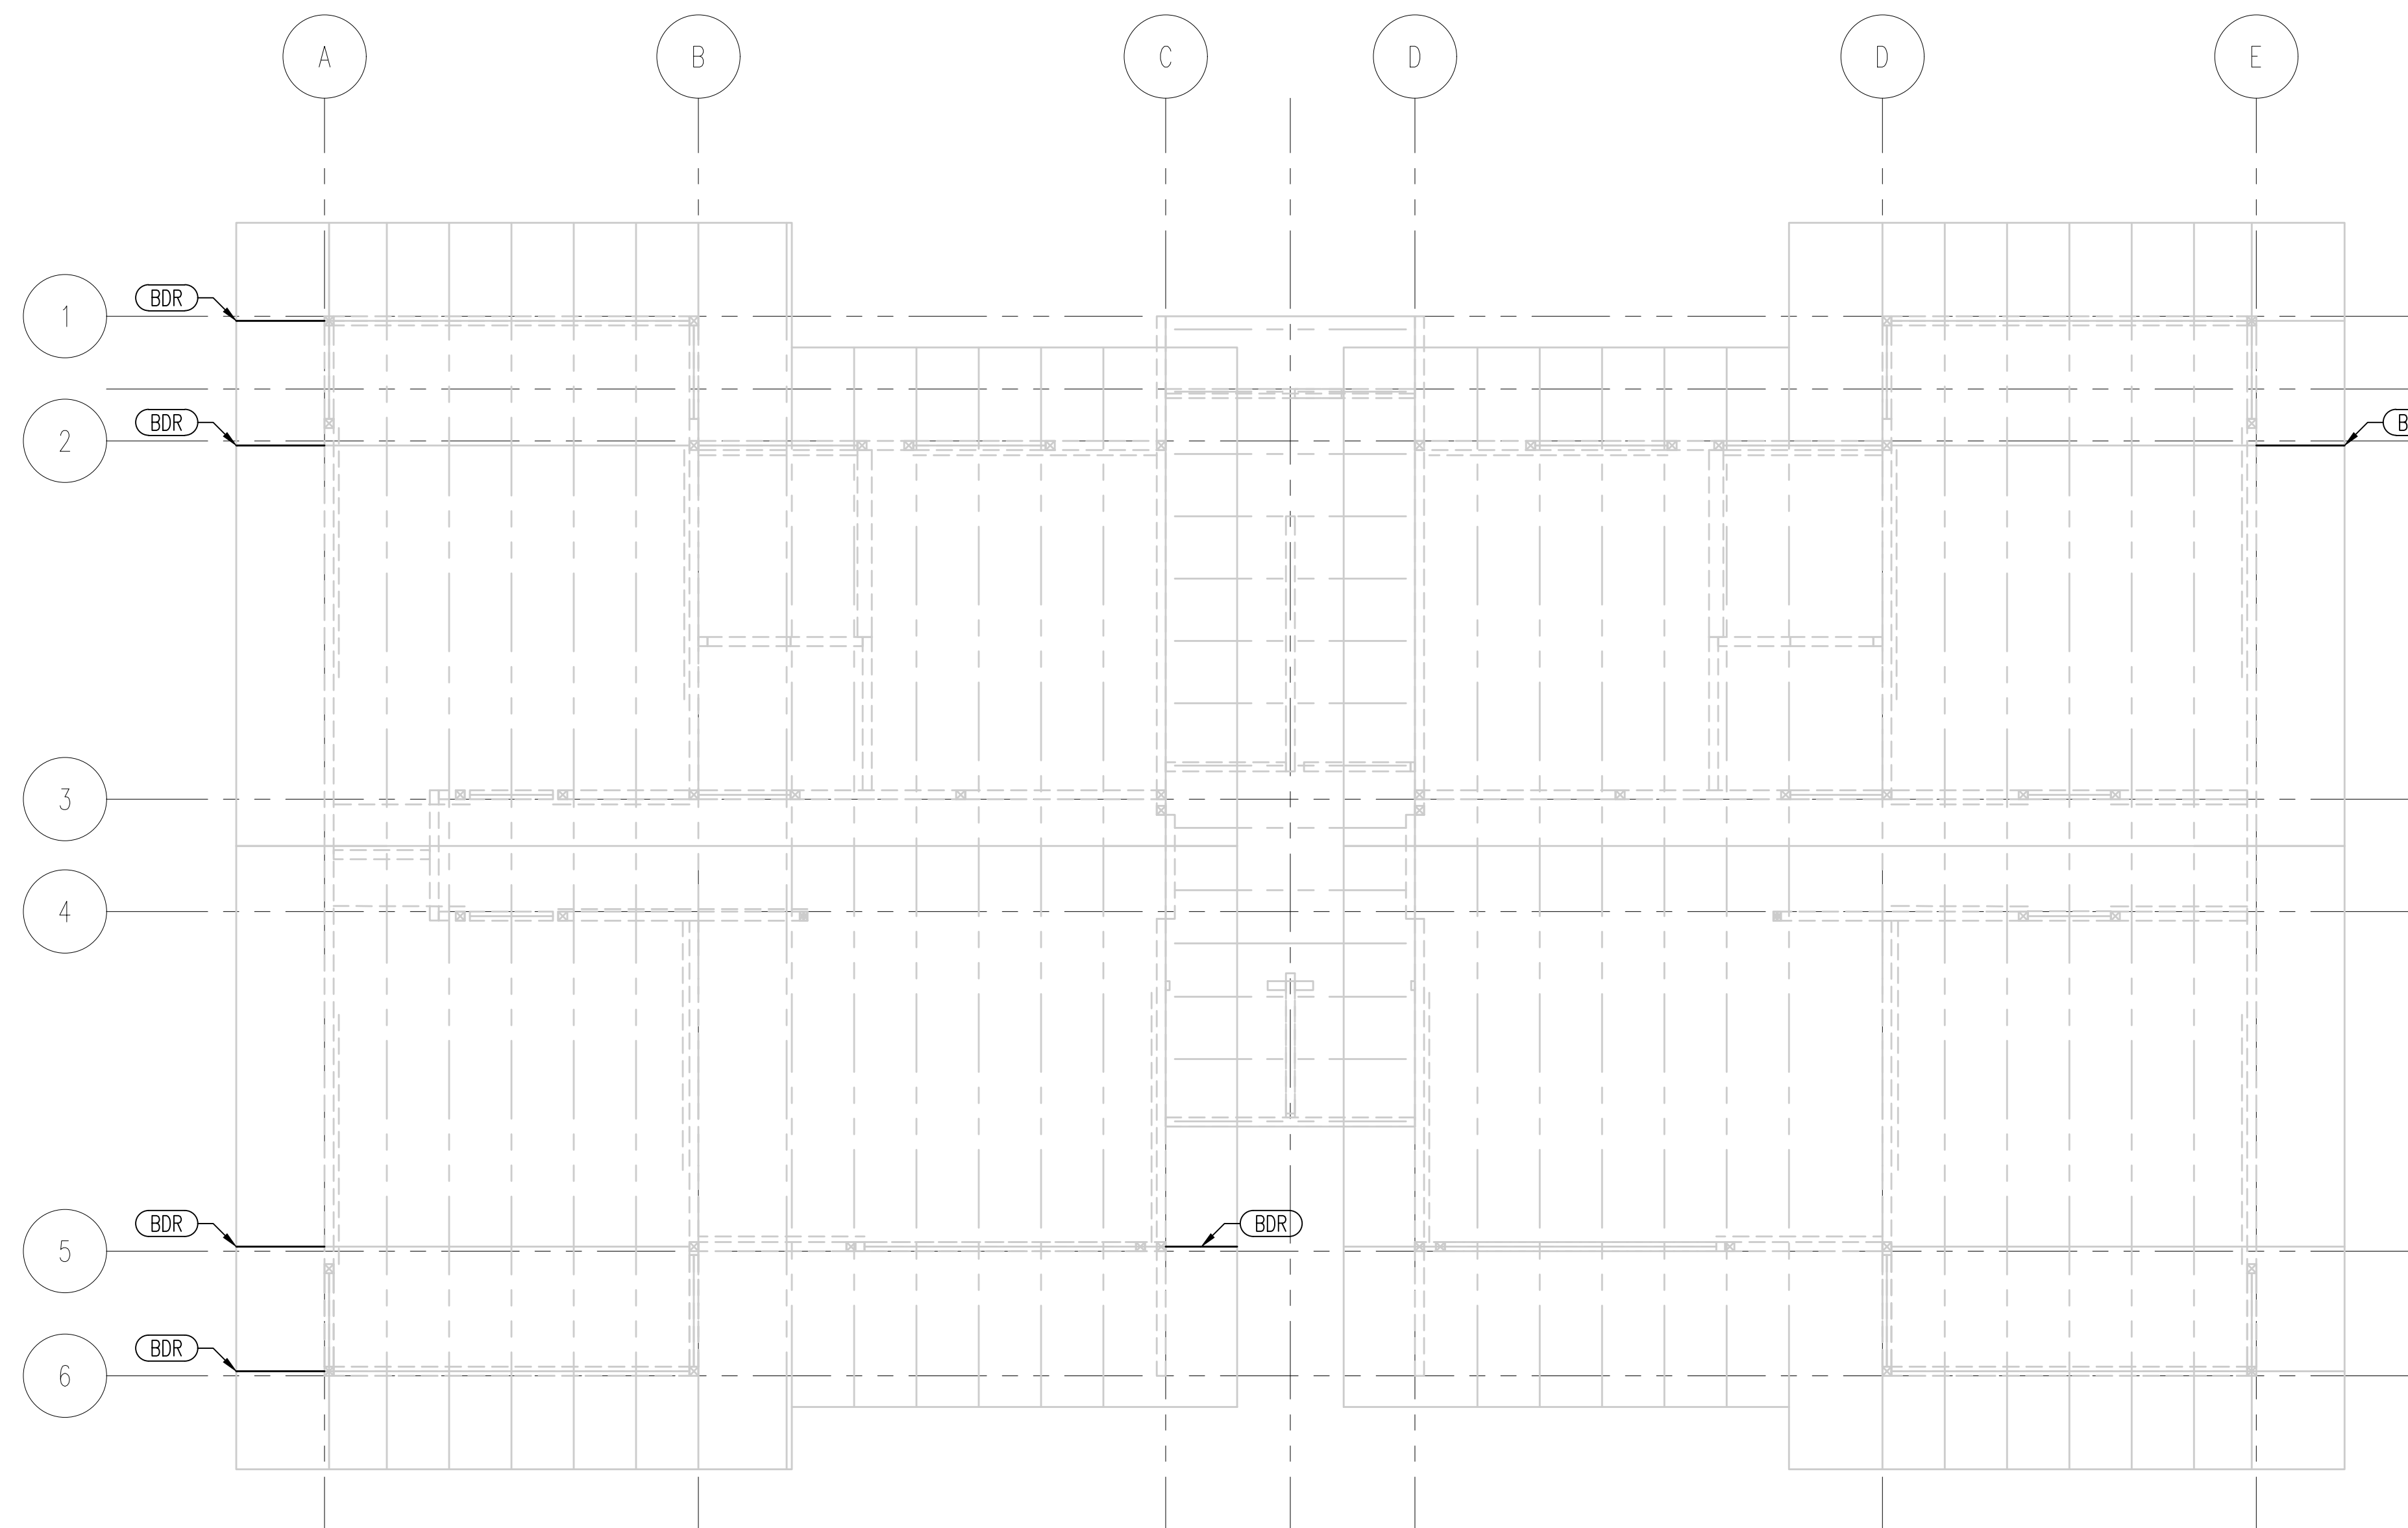
1 EXIST BUILDING A ROOF FRAMING PLAN
S-3 1/4" = 1'-0"

1. TYPICALLY, TRUSS WEB ARE UN-BRACED.
2. AT VARIOUS LOCATIONS, DAYLIGHT IS OBSERVED AT RIDGE.
3. GABLE END WALL IS UN-BRACED.
