Structural Condition Analysis and Assessment of Dormitory Facilities

December 17, 2019

Site Located at 820 Ka'ahumanu Avenue, Kahului, Maui 96732 TMK: (2)3-8-07:117

Summary of Structural Field Condition Survey for the Existing University of Hawaii Community College Dorm Campus Buildings and Appurtenances

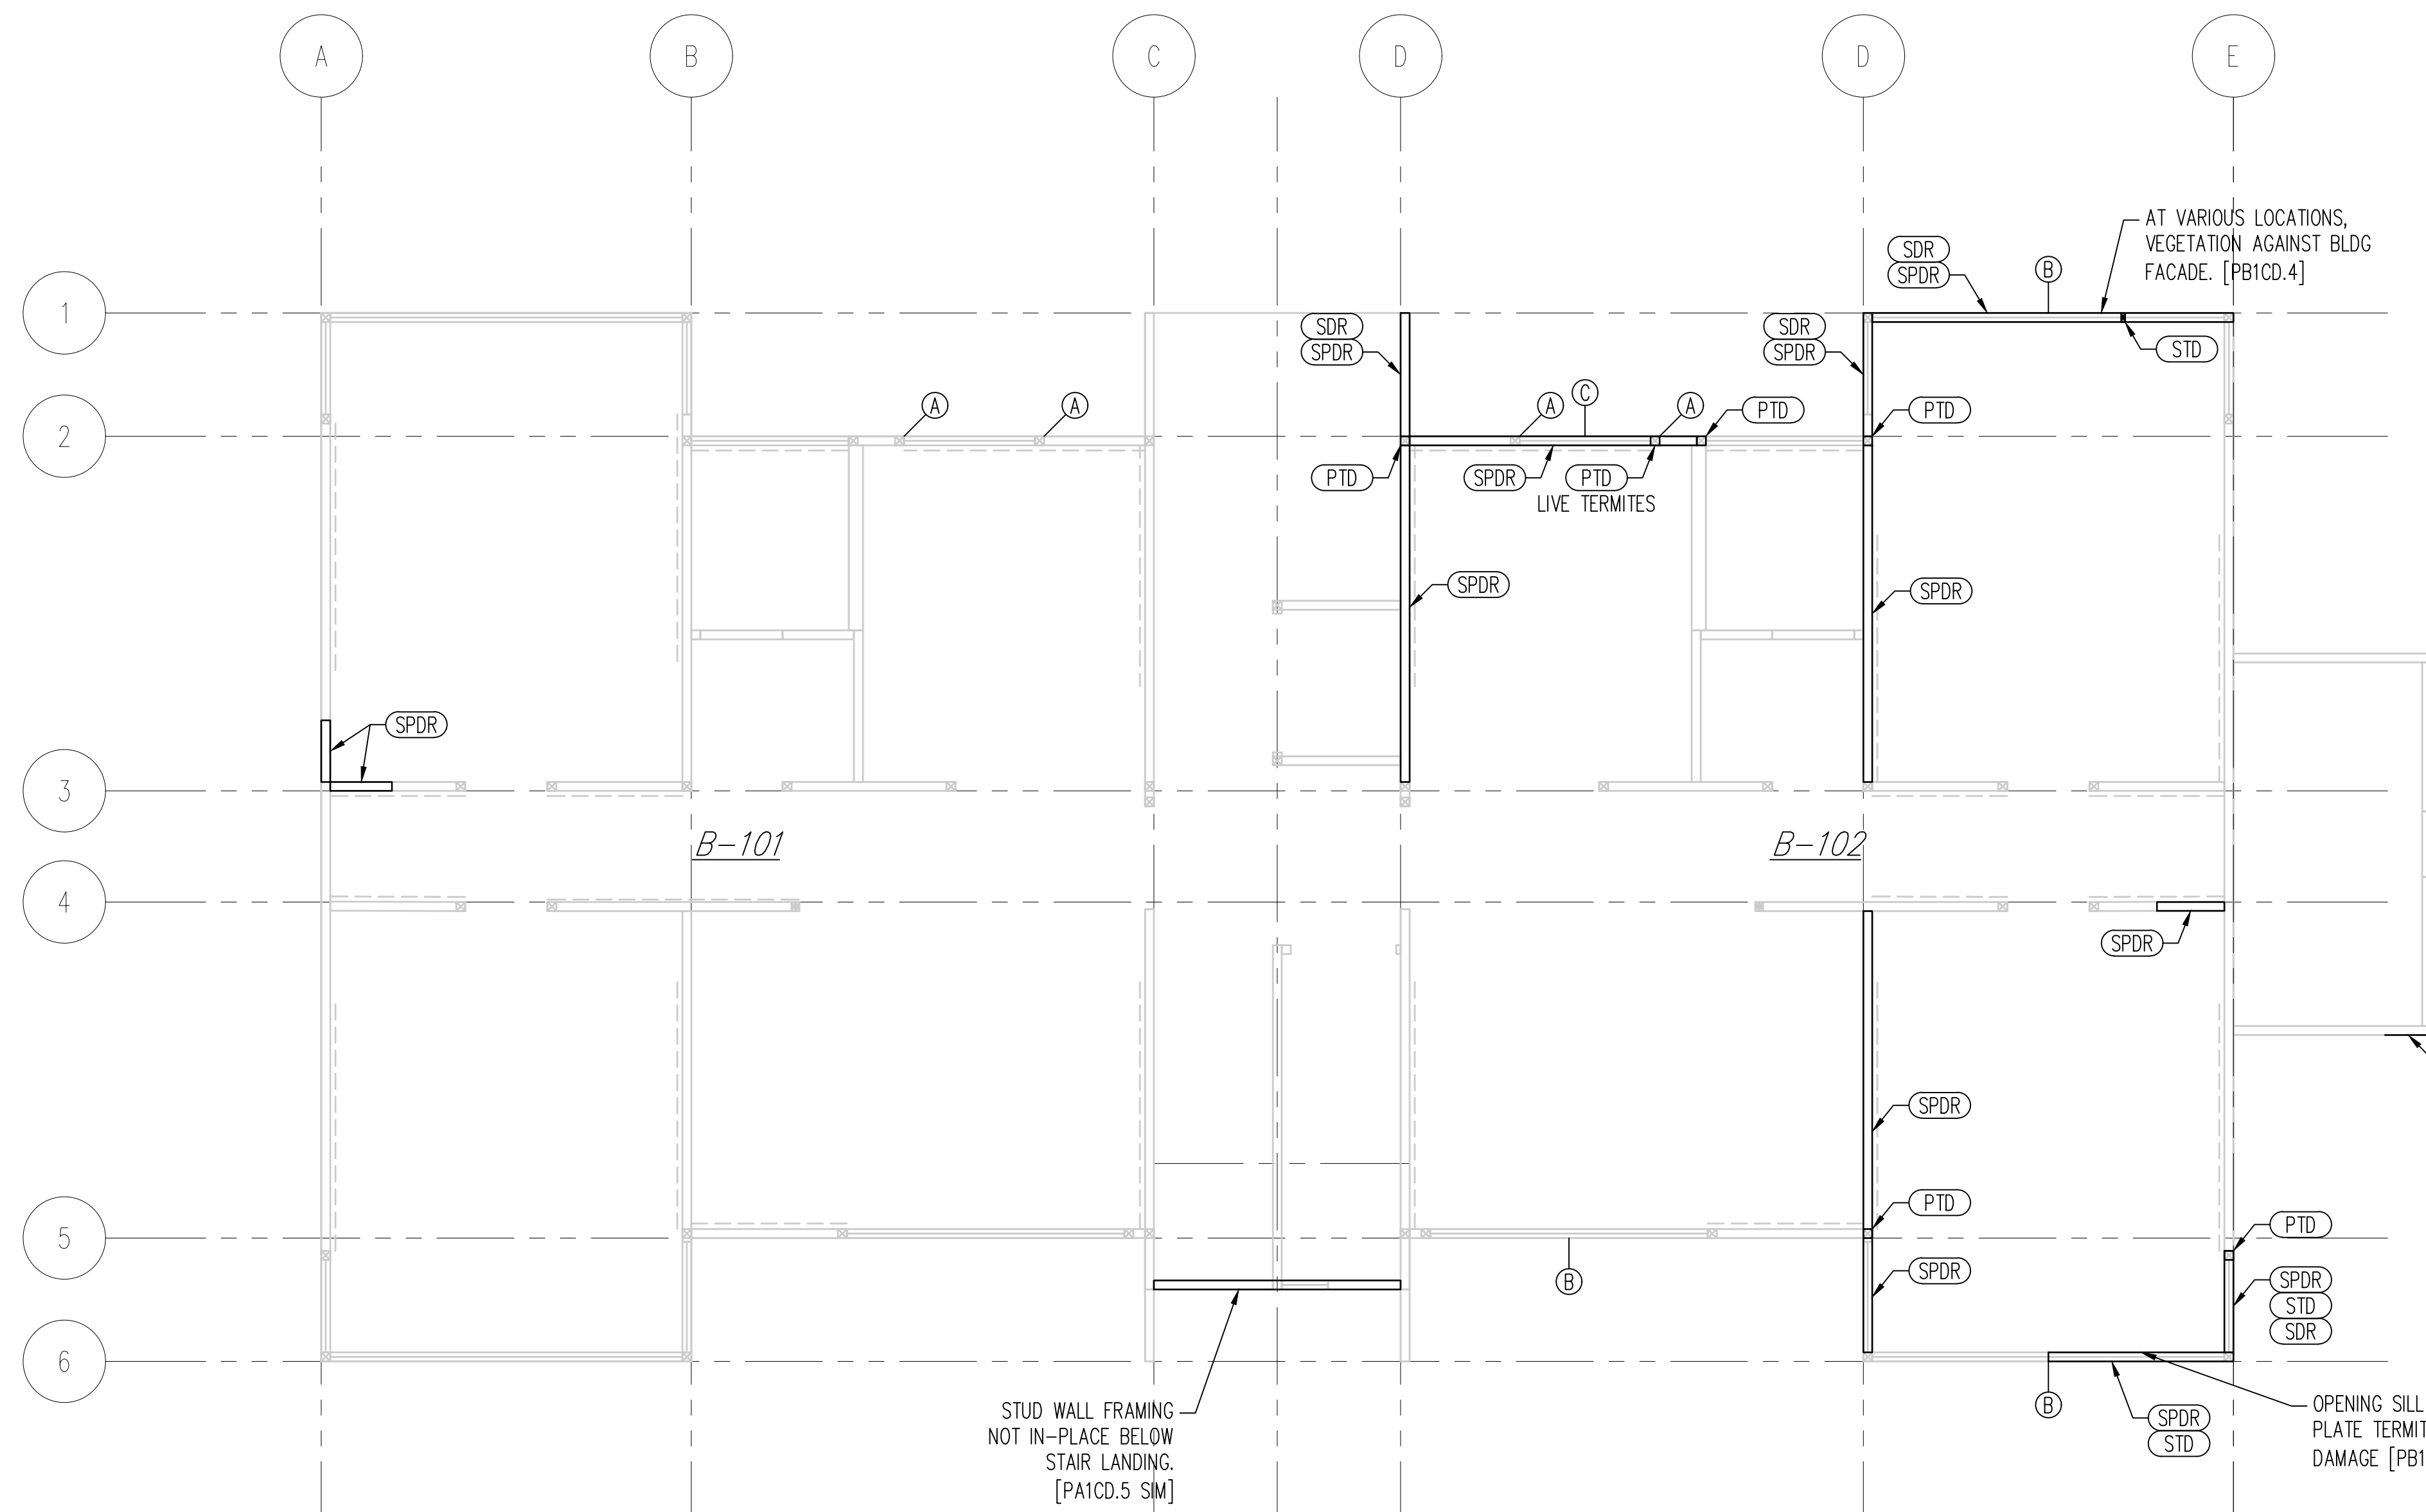
1
S-4
EXIST BUILDING B FOUNDATION PLAN
1/4" = 1'-0"

- GENERAL DAMAGE NOTES:**
1. TYPICALLY, STEEL LET-IN BRACES EXHIBIT MODERATE CORROSION. [PB1D.6]

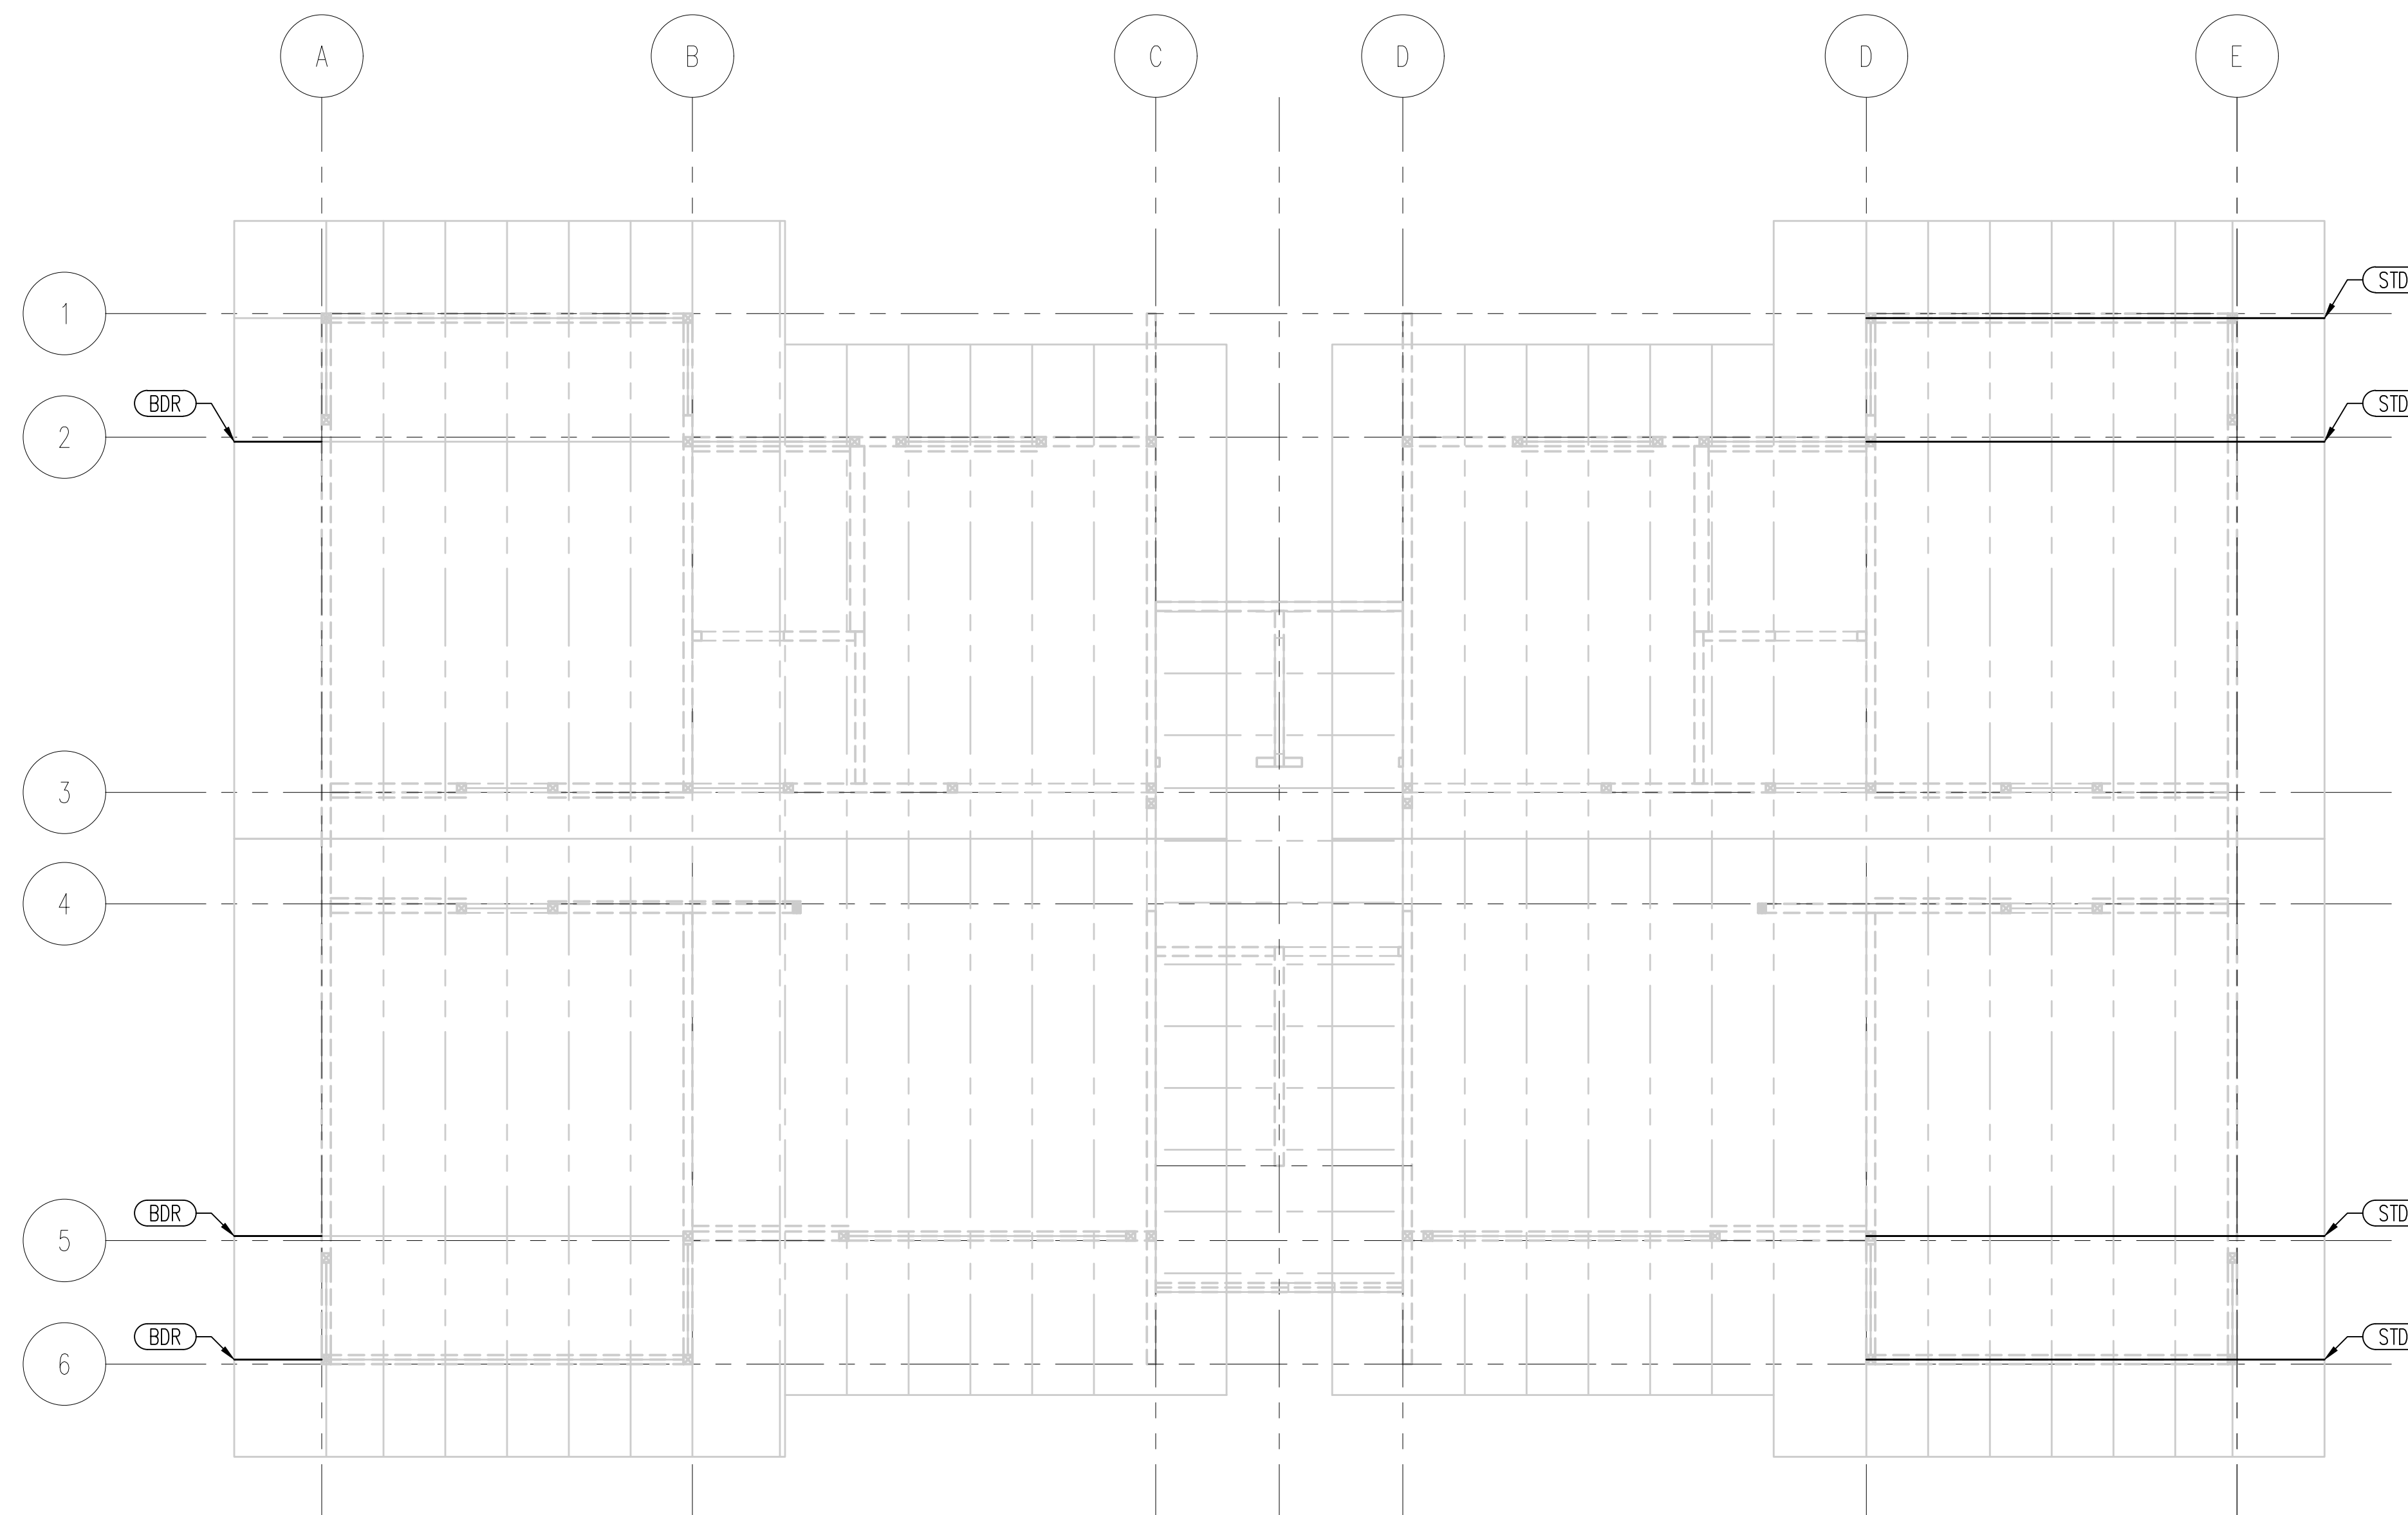
1 EXIST BUILDING B ROOF FRAMING PLAN
S-6 1/4" = 1'-0"

1. TYPICALLY, TRUSS WEB ARE UN-BRACED.
2. AT VARIOUS LOCATIONS, DAYLIGHT IS OBSERVED AT RIDGE.
3. GABLE END WALL IS UN-BRACED.

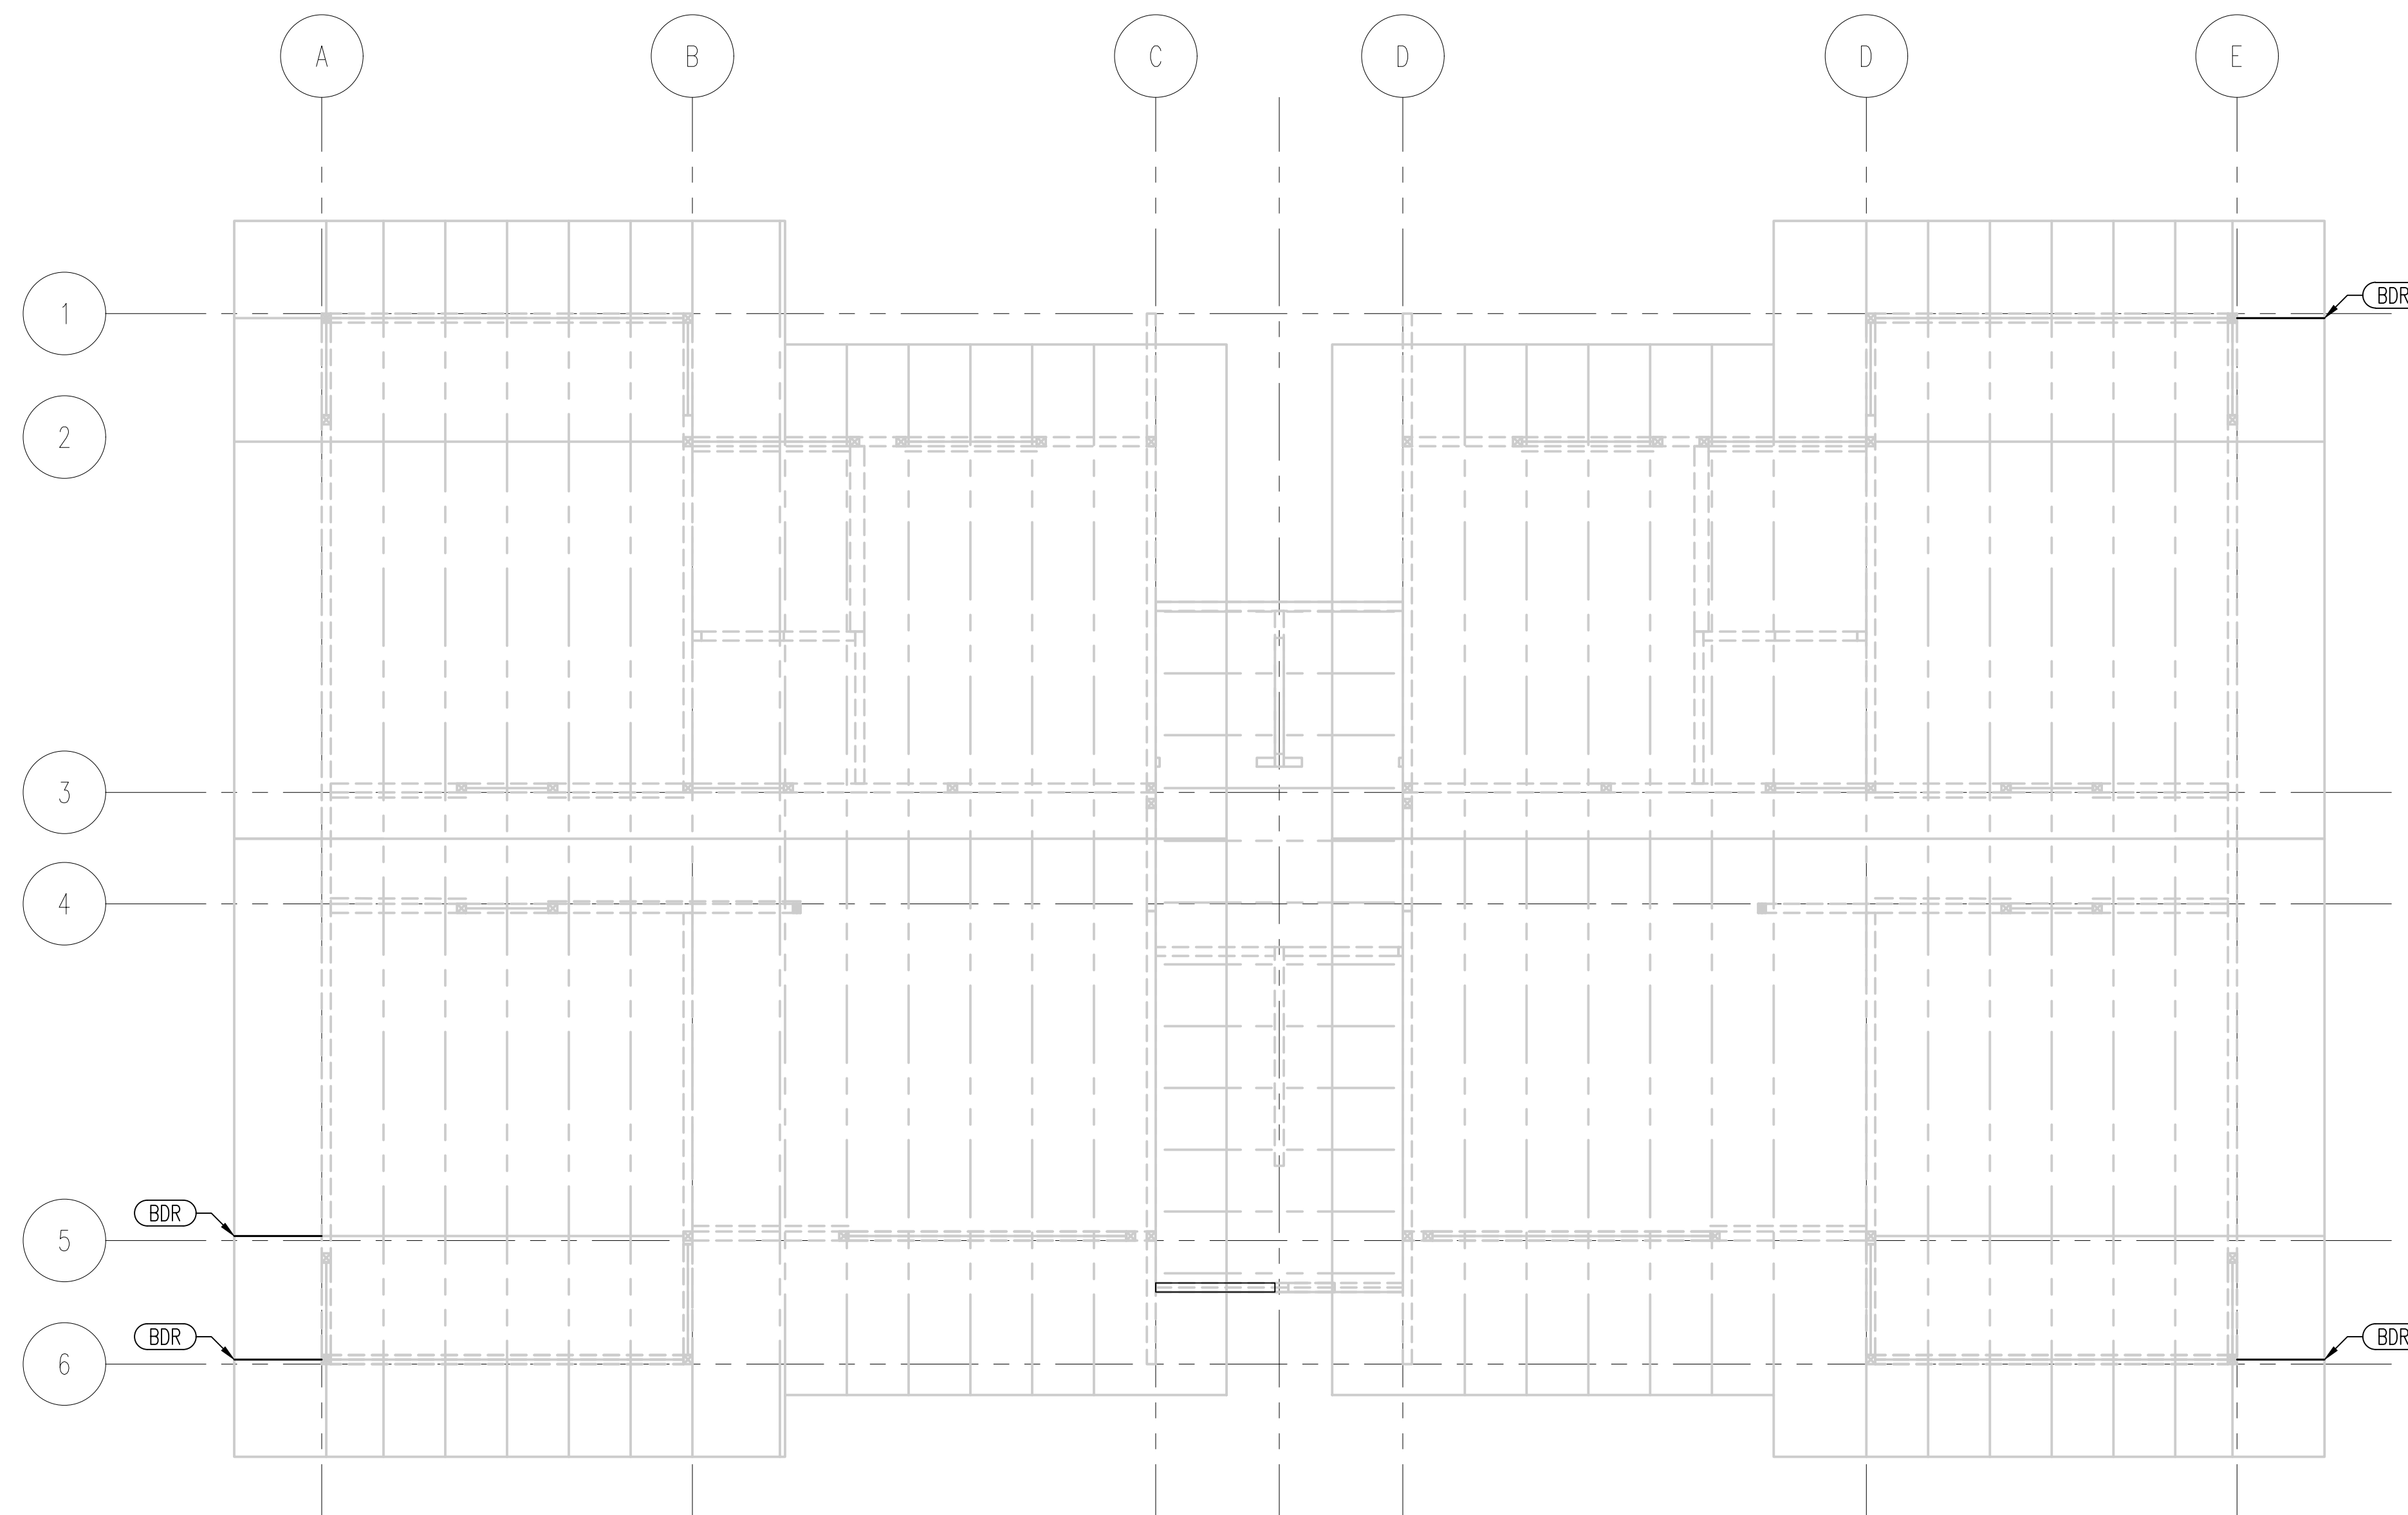
1 EXIST BUILDING C ROOF FRAMING PLAN
S-6 1/4" = 1'-0"

1. TYPICALLY, TRUSS WEB ARE UN-BRACED.
2. AT VARIOUS LOCATIONS, DAYLIGHT IS OBSERVED AT RIDGE.
3. GABLE END WALL IS UN-BRACED.

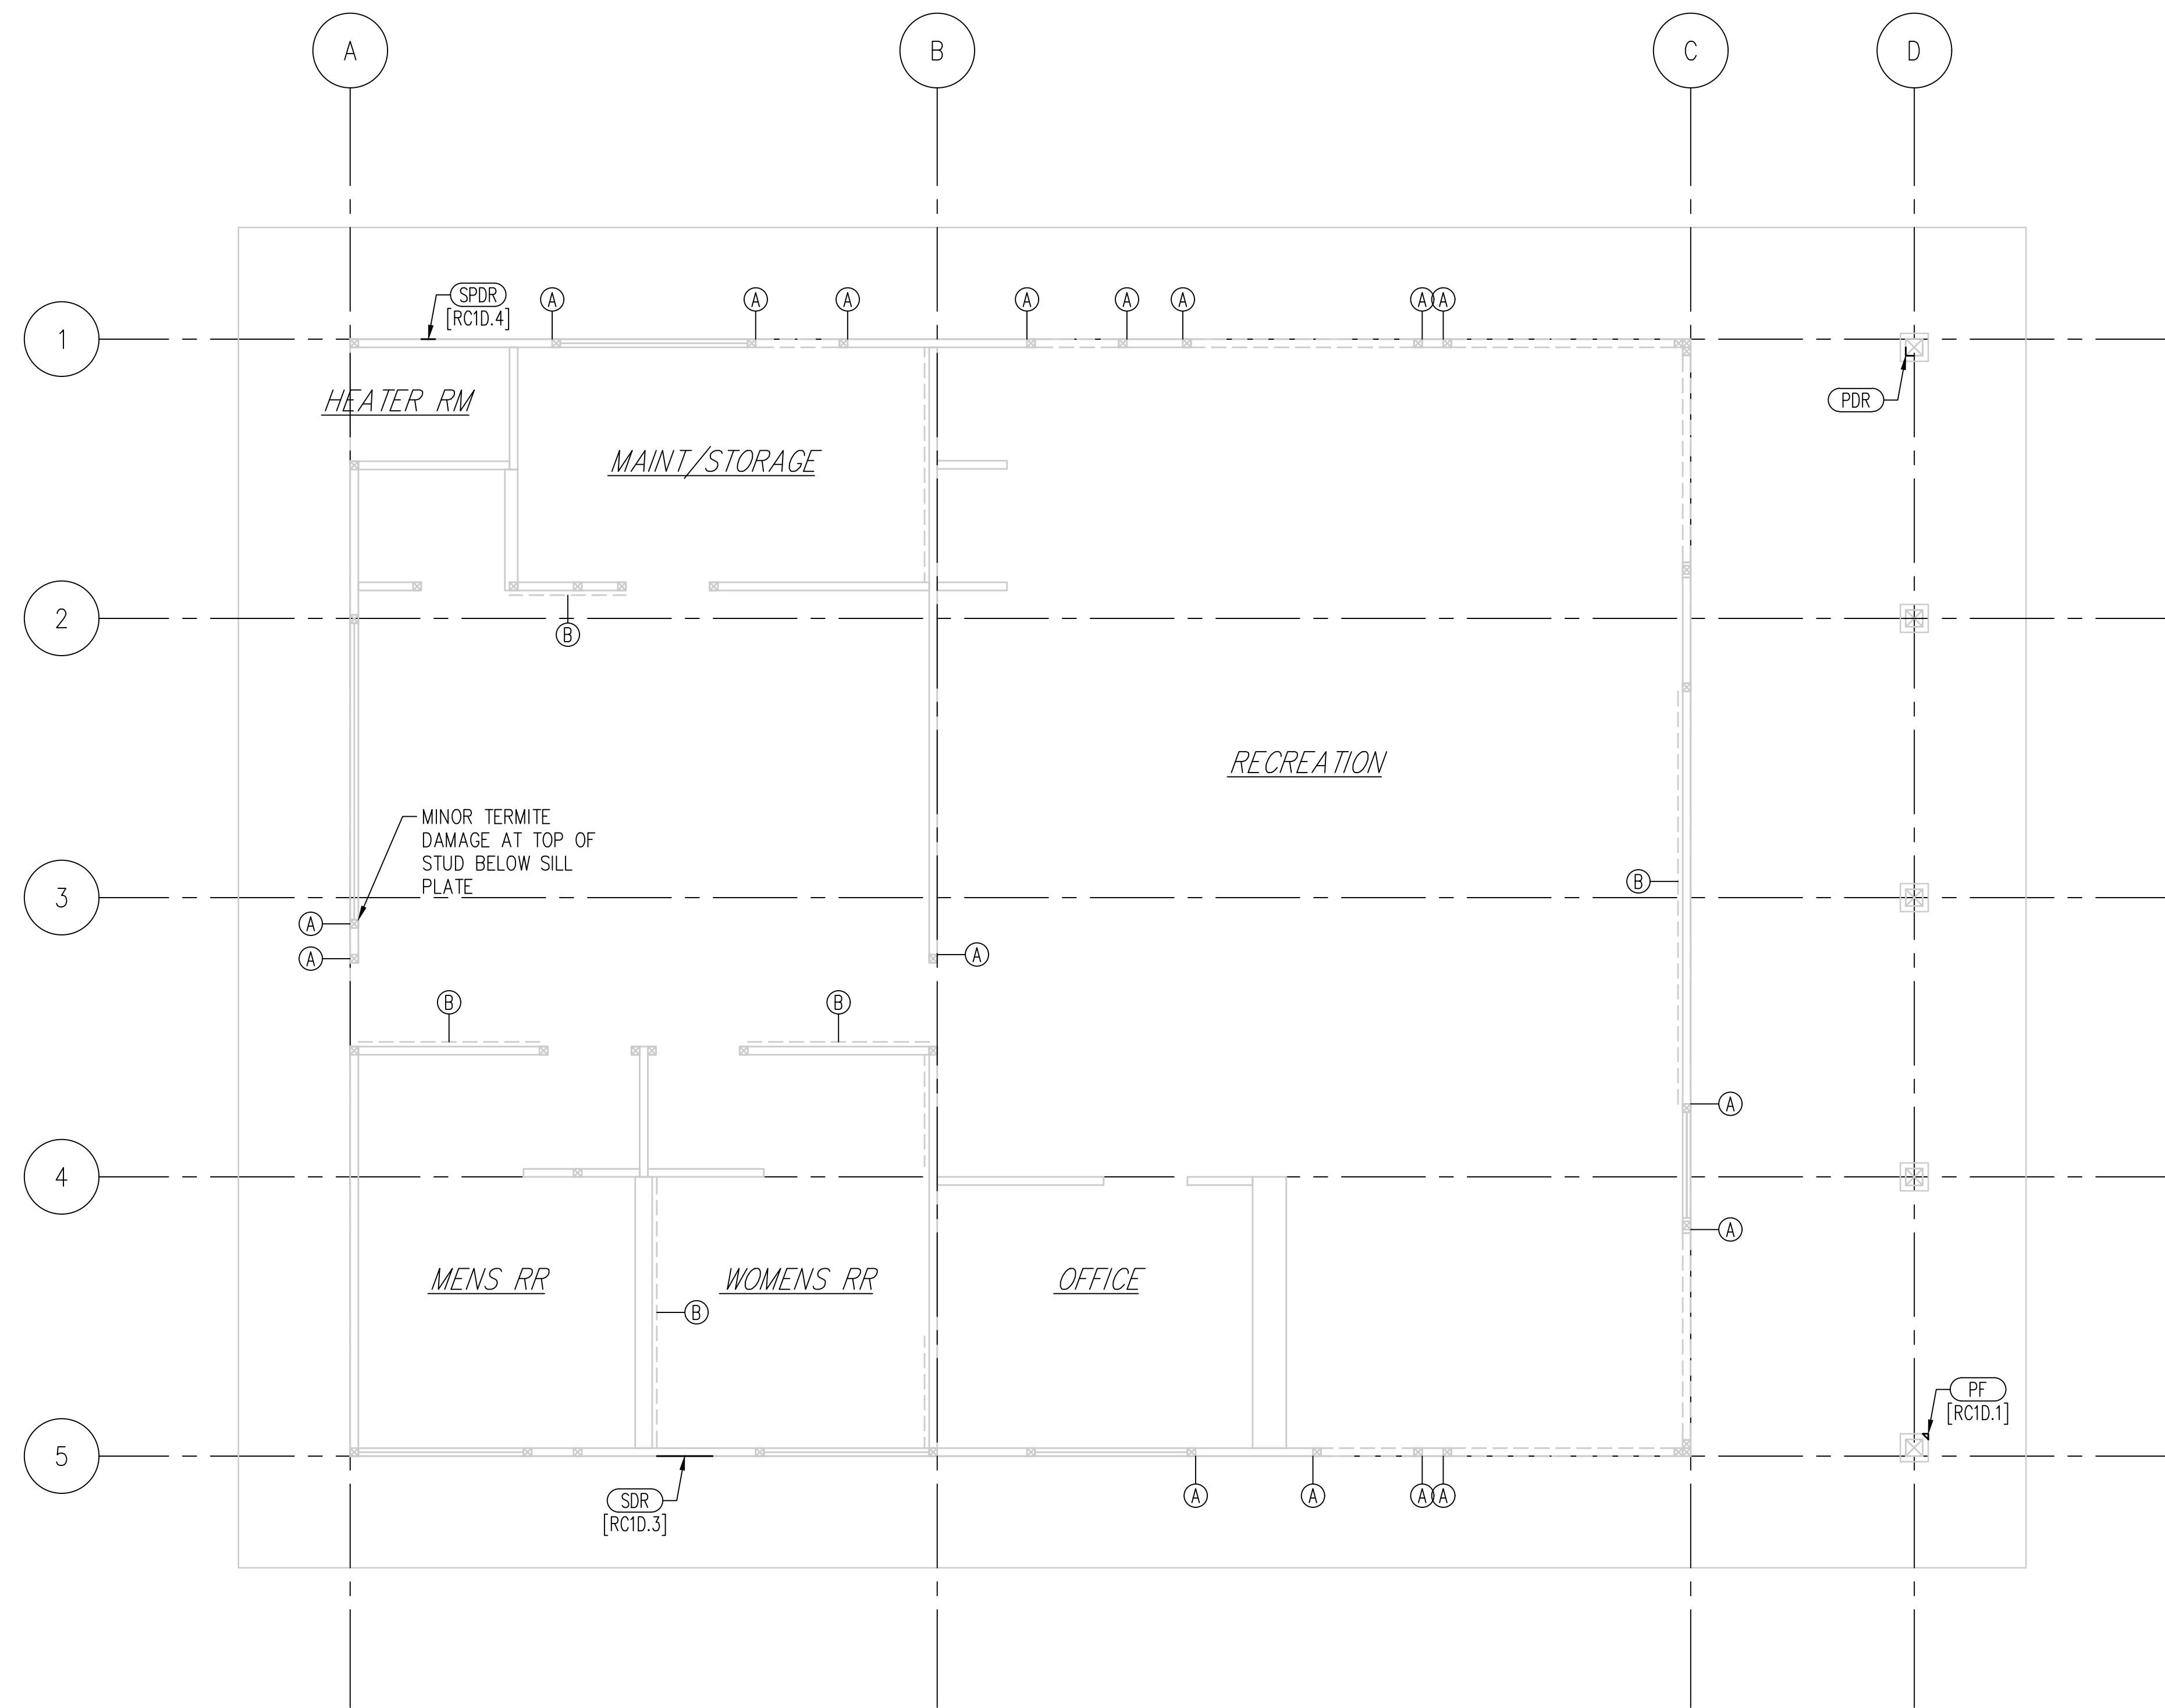
1 EXIST LAUNDRY/RECREATIONAL CENTER BUILDING FOUNDATION PLAN
 S-10 1/4" = 1'-0"

GENERAL CONSTRUCTION DEFECTS NOTES:
 1. TYPICALLY, INTERIOR PARTITION WALL SOLE PLATE ANCHOR RODS ARE MISSING OR INSTALLED @ GREATER THAN 32" OC. [RCID.1]
