**SUBJECT: COUNTY-OWNED PARCEL ON NORTH PAPA AVENUE (KAHULUI)
 (HHT-14)**

Property Condition Report

310 W Kaahumanu Ave, Kahului, HI 96732
Inspection prepared for: Maui County c/o Buddy Almeida
Real Estate Agent: -

Date of Inspection: 3/28/2018 Time: 8:00 AM
Age of Home: 1980 Size: 15000

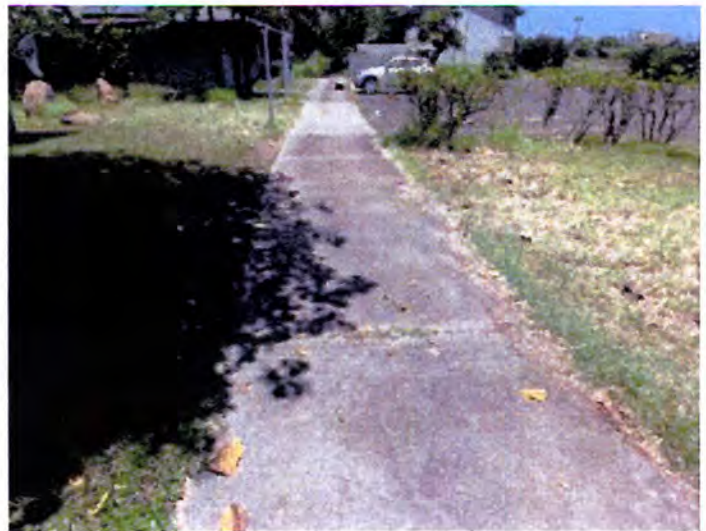
Bldg A hand rail was missing. Recommend installation as required.

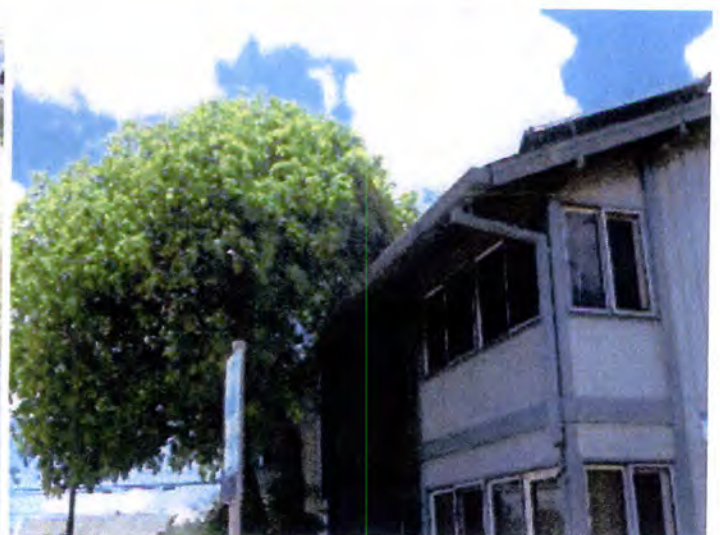
The vegetation was overgrown and causing deterioration/damage to the exterior curtain wall and fixtures.

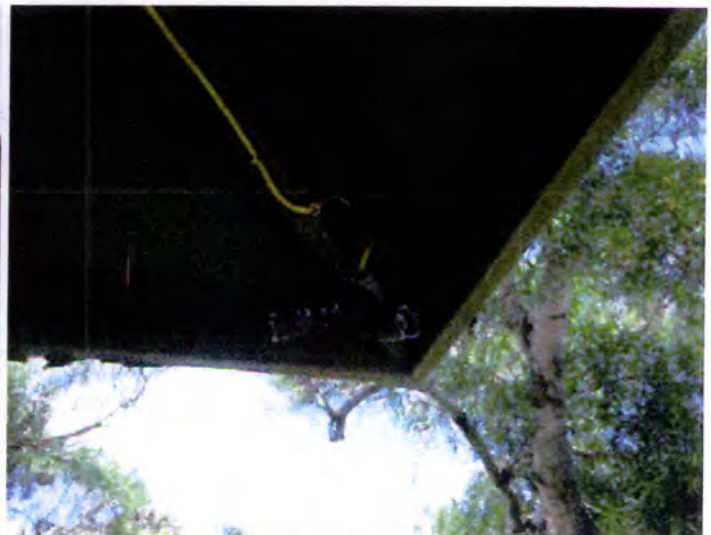
Some of the exterior lighting fixtures were damaged and need to be replaced.

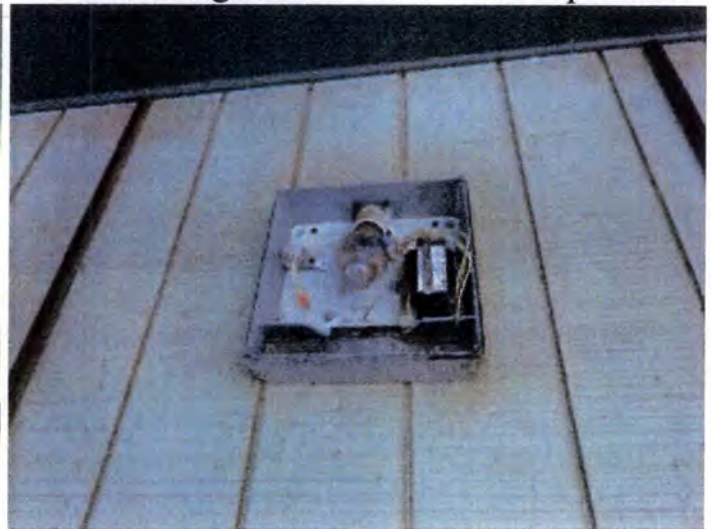
Some of the exterior lighting fixtures were damaged and need to be replaced.

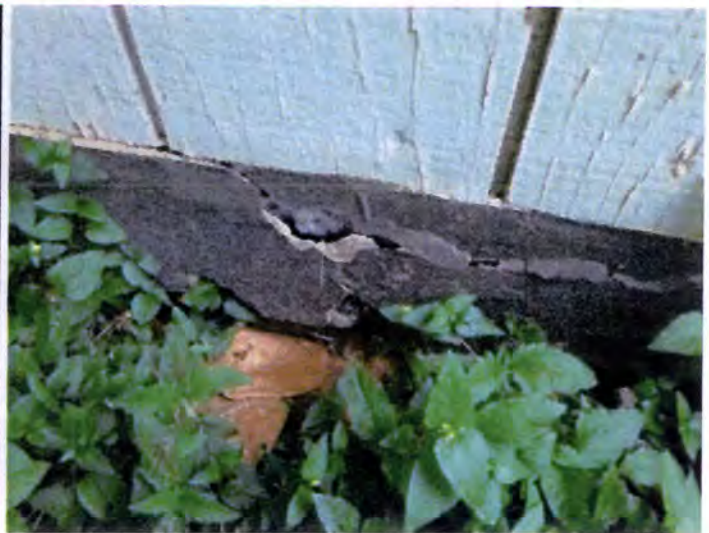
Building A and B: Visible cracks observed at the foundational areas of the buildings. There were separations observed along the defect areas which represent movement between the faults. We recommend having a licensed foundation/masonry contractor evaluate and repair the affected areas as necessary to prevent further damage.

We recommend having a licensed foundation/masonry contractor evaluate and repair the affected areas as necessary to prevent further damage.

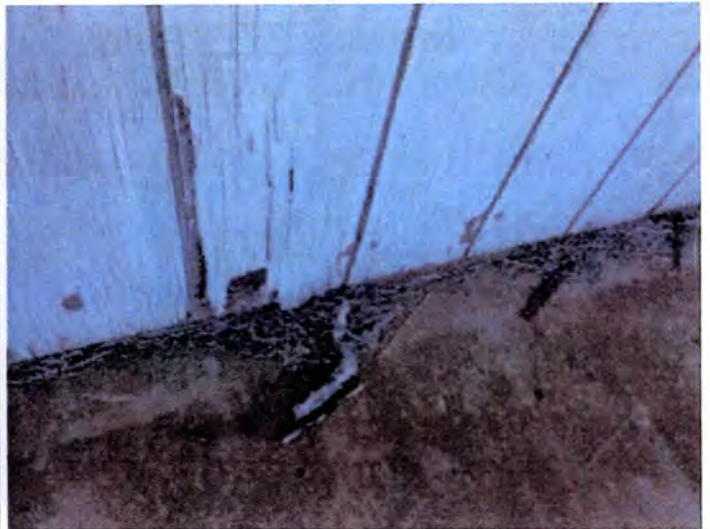
Moisture damage observed at exterior wall areas. Recommend select demolition and replacement of affected ground level exterior siding and finishes.

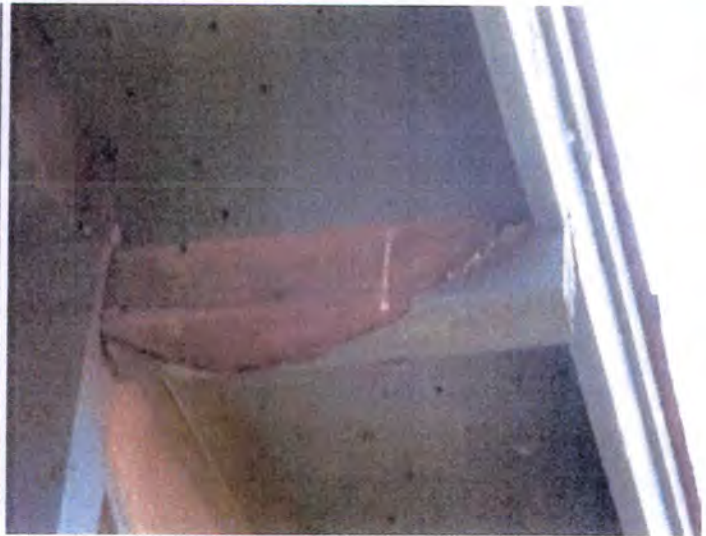
Blistering/peeling/missing paint observed at many exterior trim, fascia and soffit areas. Recommend properly preparing and refinishing exterior finishes.

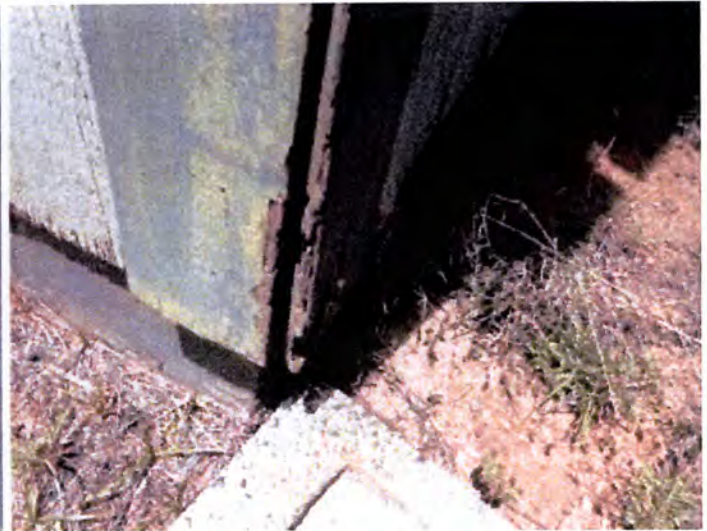
Visible indications of WDO (termite) damage noted. Recommend having a licensed pest contractor evaluate and treat as necessary. Also, recommend having a licensed contractor evaluate and repair/replace damaged material as necessary.

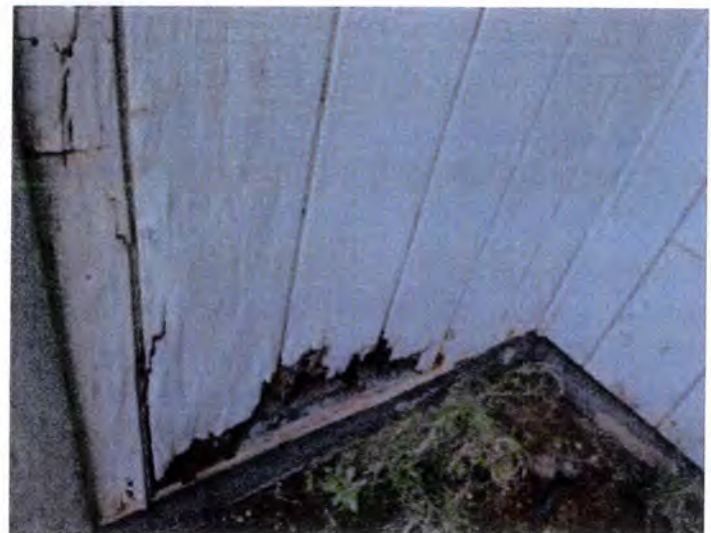
Visible indications of WDO (termite) damage noted. Recommend having a licensed pest contractor evaluate and treat as necessary. Also, recommend having a licensed contractor evaluate and repair/replace damaged material as necessary.

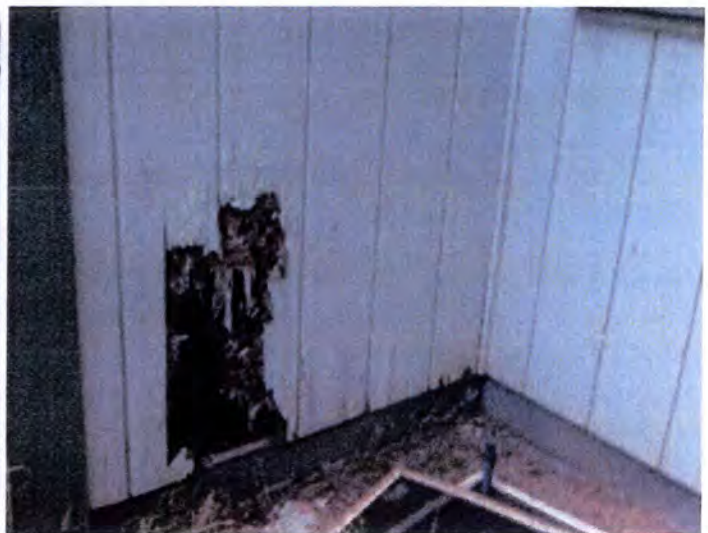
Visible indications of WDO (termite) damage noted. Recommend having a licensed pest contractor evaluate and treat as necessary. Also, recommend having a licensed contractor evaluate and repair/replace damaged material as necessary.

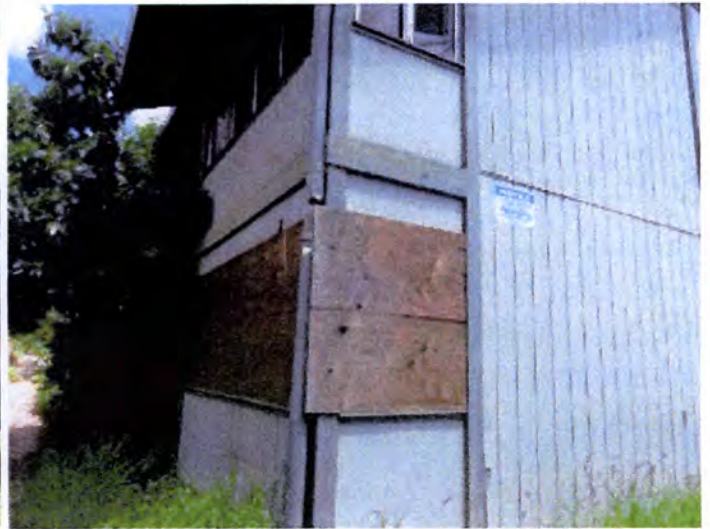
Many of the ground floor windows were broken at the time of inspection.

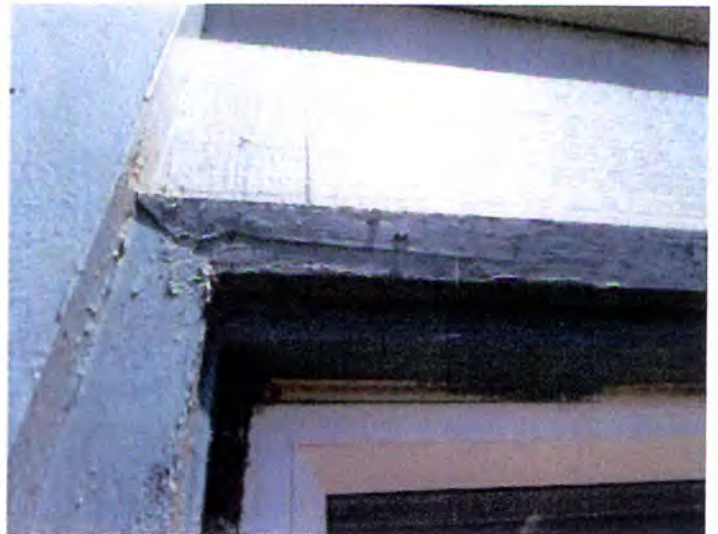
Due to the vegetative contact with exterior siding and finishes, the window trim is moisture/termite damaged at numerous locations. We recommend the removal and replacement of exterior window trim finishes.

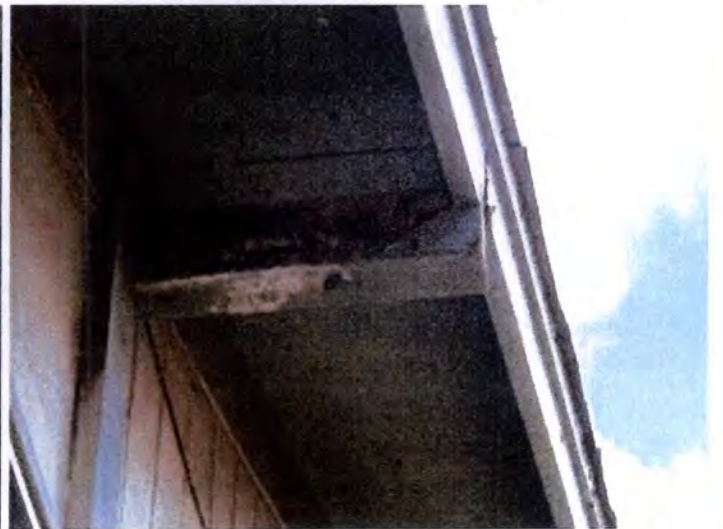
The fascia/soffit areas appeared to be rotted/water damaged/deteriorated at the time of inspection. Recommend having a licensed contractor evaluate and repair/replace as necessary.

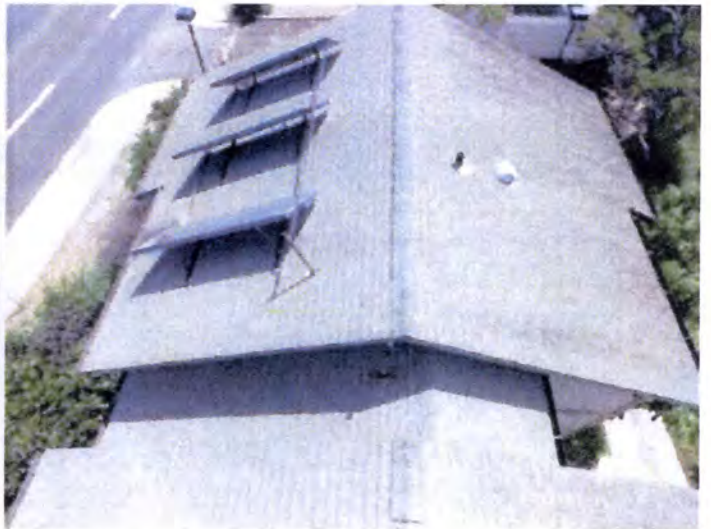
There were numerous areas of missing shingles observed at the roof ridge areas. Recommend repair in conjunction with roof replacement.

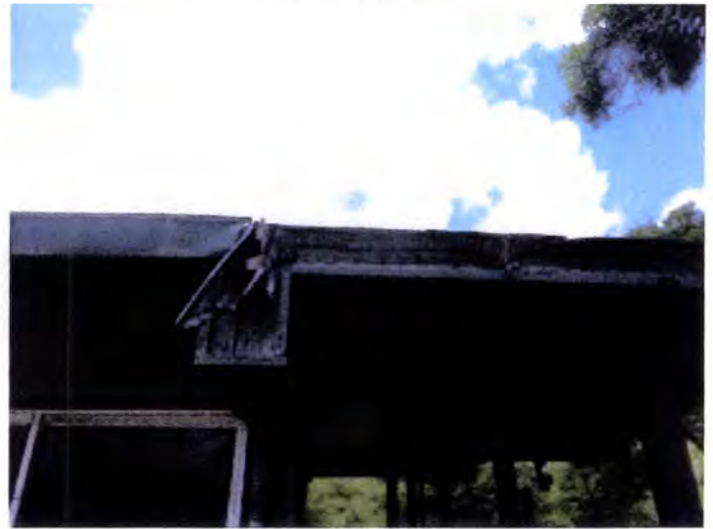
Damaged/broken/missing gutters noted. Recommend having a licensed contractor evaluate and repair/replace as necessary.

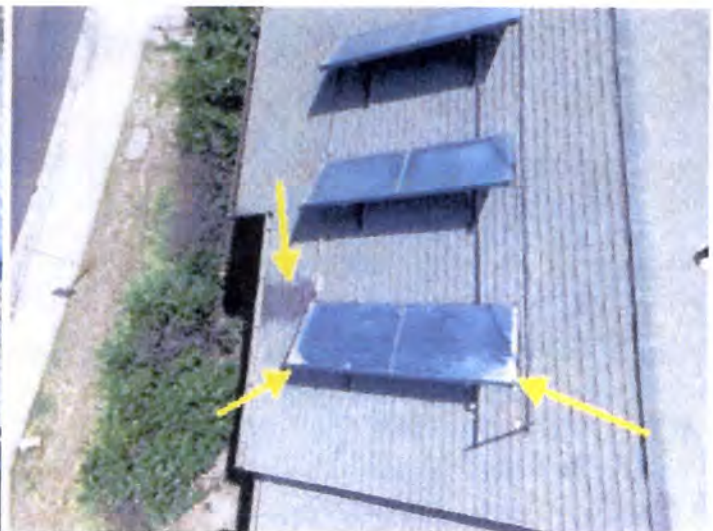
There were solar water heating panels located on the roofing areas of the buildings. There were visible indications of leaks and interior hazing at the panels which is an indication of damage to the environmental seals or panels. These panels did not appear to be in service and should be evaluated by a licensed plumbing contractor prior to use.

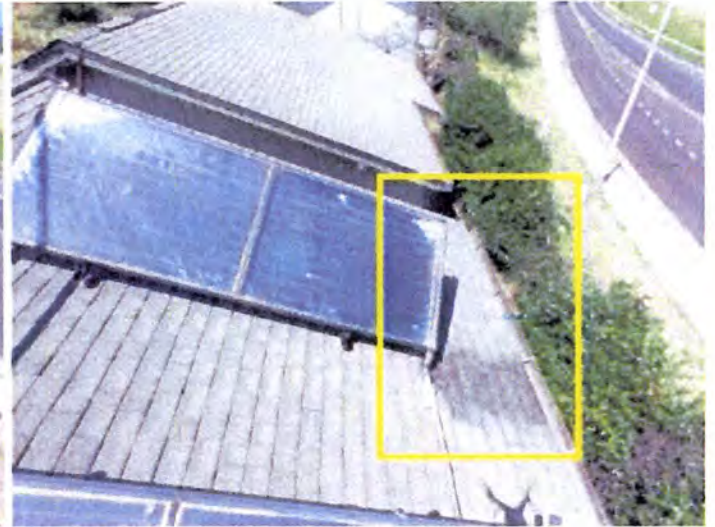
There were solar water heating panels located on the roofing areas of the buildings. There were visible indications of leaks and interior hazing at the panels which is an indication of damage to the environmental seals or panels. These panels did not appear to be in service and should be evaluated by a licensed plumbing contractor prior to use.

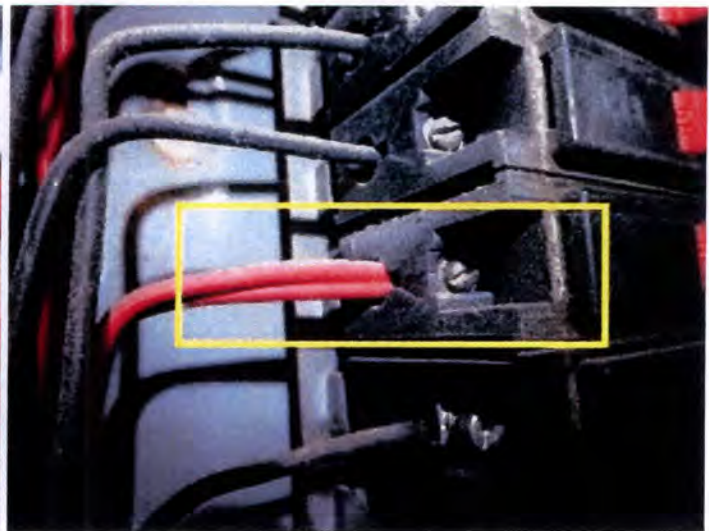
There were double tapped 1-pole circuit breakers noted at the time of inspection.

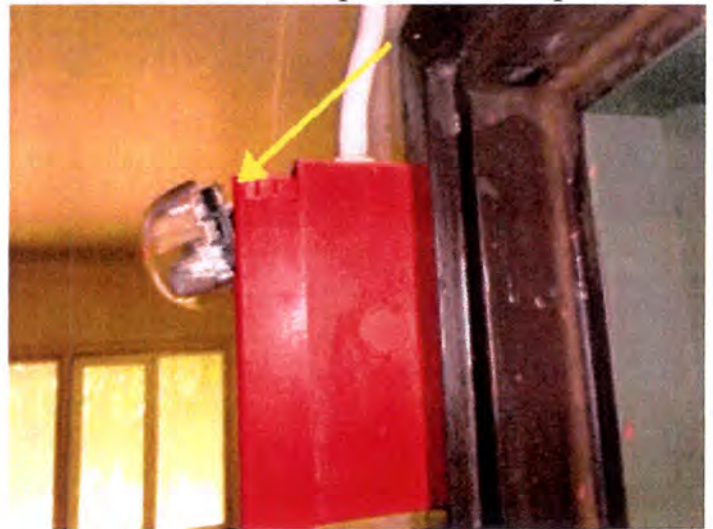
Approximately half of the installed pull stations were damaged when inspected. Recommend replacement/repair.

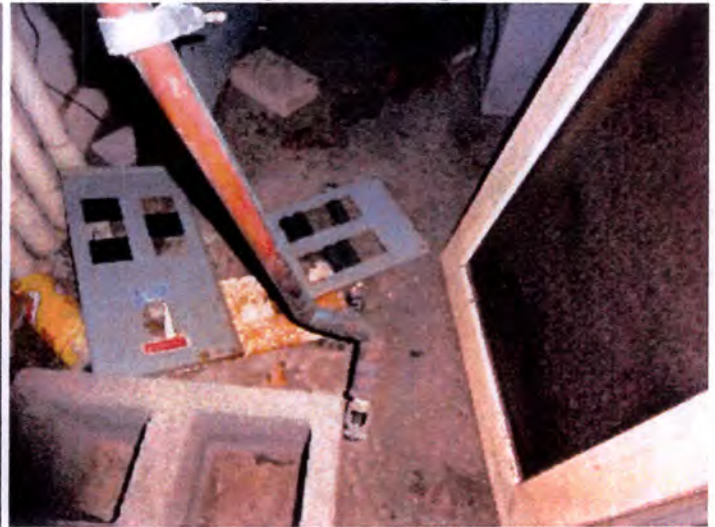
Building B: Sprinkler branch pipe was broken/bent down in the electrical room. Recommend repair.

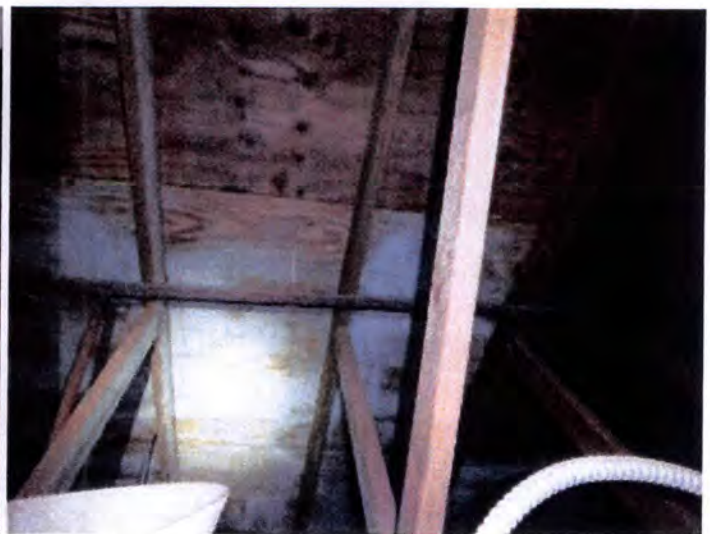
Visible indications of moisture intrusion and mold growth at building B and C interior, bedroom, bathroom and closet wall areas. Recommend removal and replacement of all interior wall finishes of B and C, after removal of all exterior vegetation.

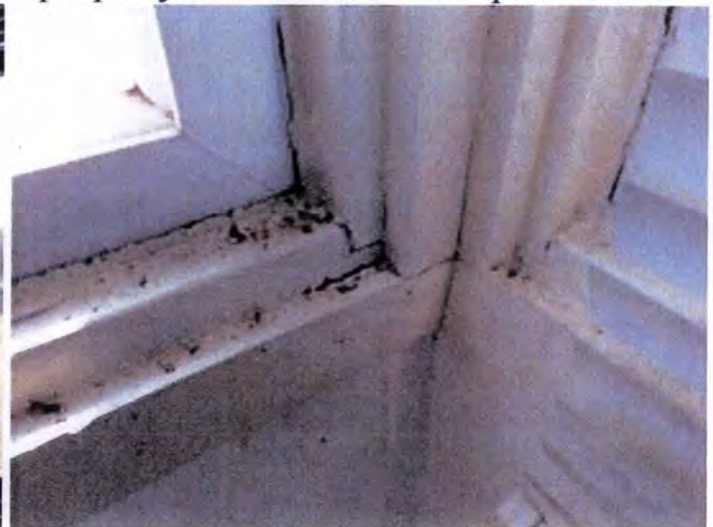
There were visible indications of moisture and termite damage observed at the interior window trim areas. Recommend replacement of all interior window trim and finishes.

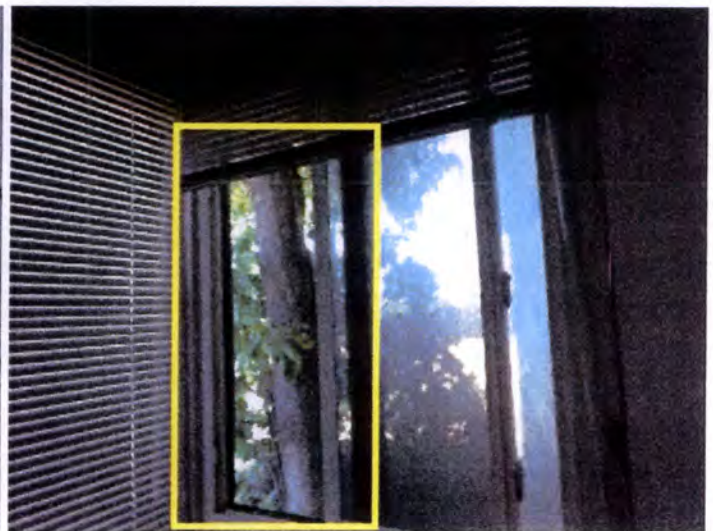
Many of the ground floor windows were broken at the time of inspection. Recommend replacement.

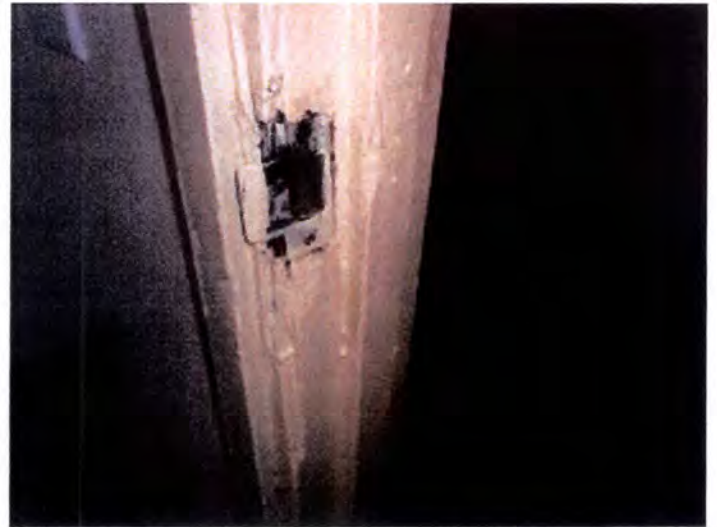
Most of the doors had varying degrees of damage observed when inspected. Based on the observed conditions, we recommend the replacement of all interior doors and trim within the dwelling units.

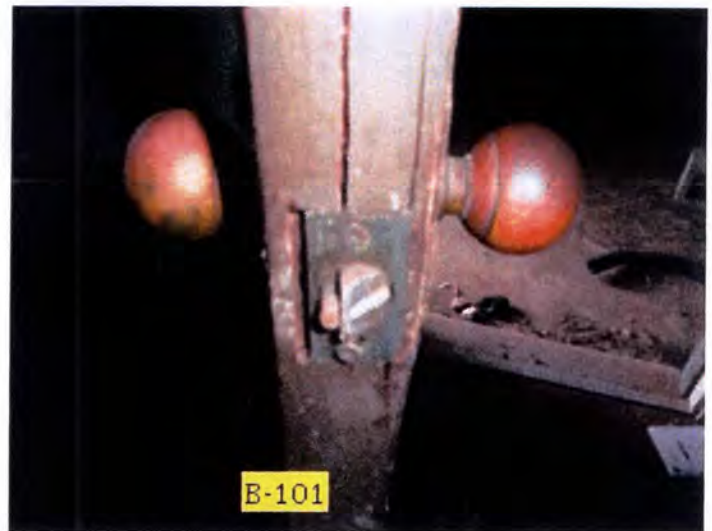
A-202

Most of the doors had varying degrees of damage observed when inspected. Based on the observed conditions, we recommend the replacement of all interior doors and trim within the dwelling units.

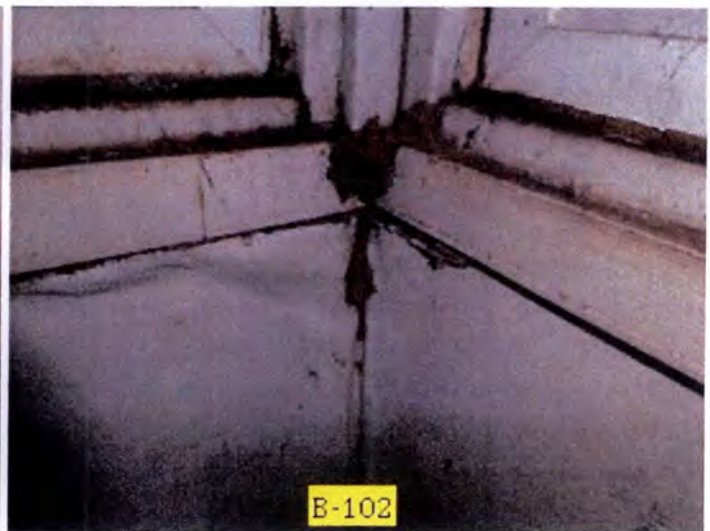
Most of the exterior facing lower interior wall finishes had moisture damage observed. Recommend removal and replacement of affected materials.

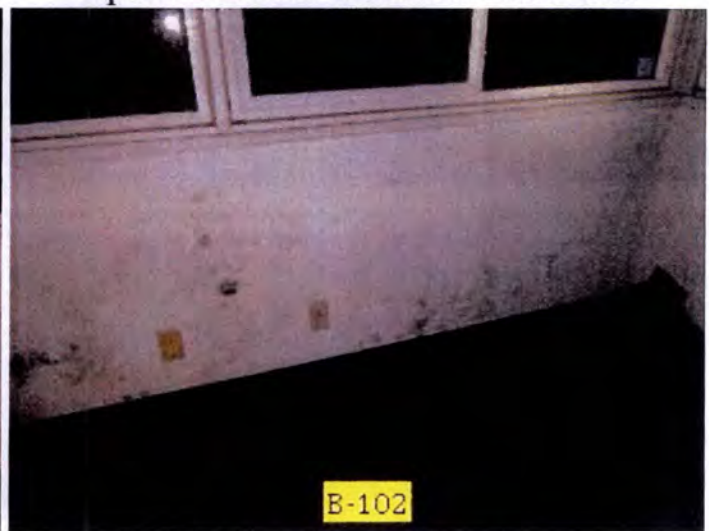
Visible indications of moisture intrusion and mold growth at building B and C interior, bedroom, bathroom and closet wall areas. Recommend removal and replacement of all interior wall finishes of B and C, after removal of all exterior vegetation.

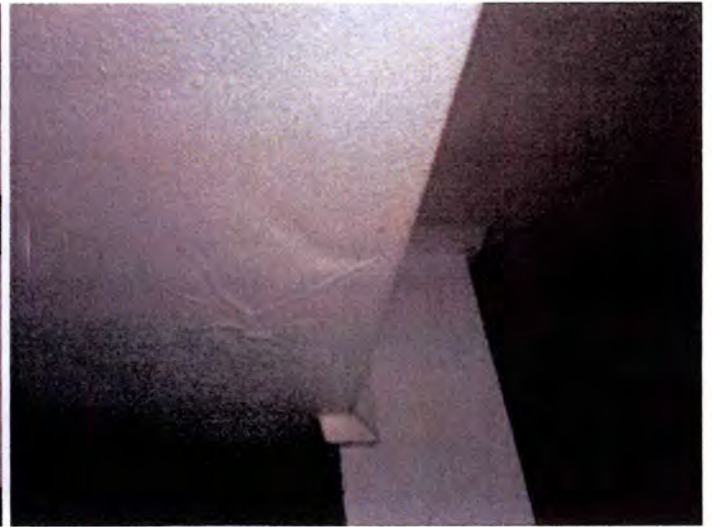
There were visible indications of water intrusion, with mold growth, noted at the ceiling areas of A-201, C-101. Recommend having a licensed contractor evaluate and repair as necessary to prevent further damage.

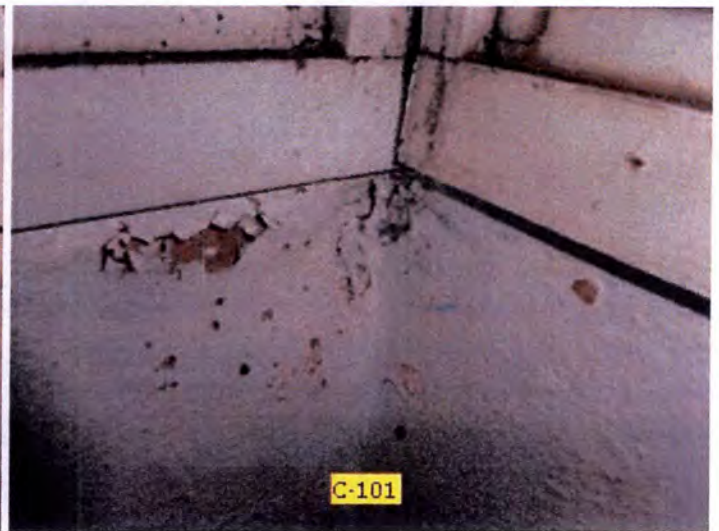
Visible indications of moisture intrusion and mold growth at building B and C interior, bedroom, bathroom and closet wall areas. Recommend removal and replacement of all interior wall finishes of B and C, after removal of all exterior vegetation.

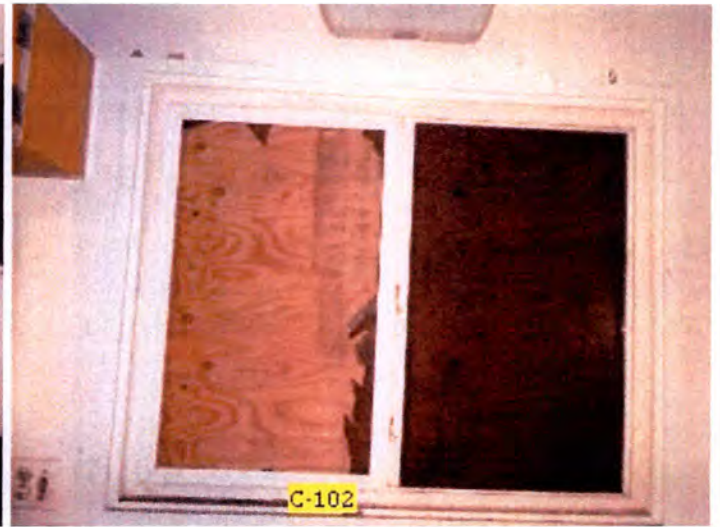
Many of the ground floor windows were broken at the time of inspection. Recommend replacement.

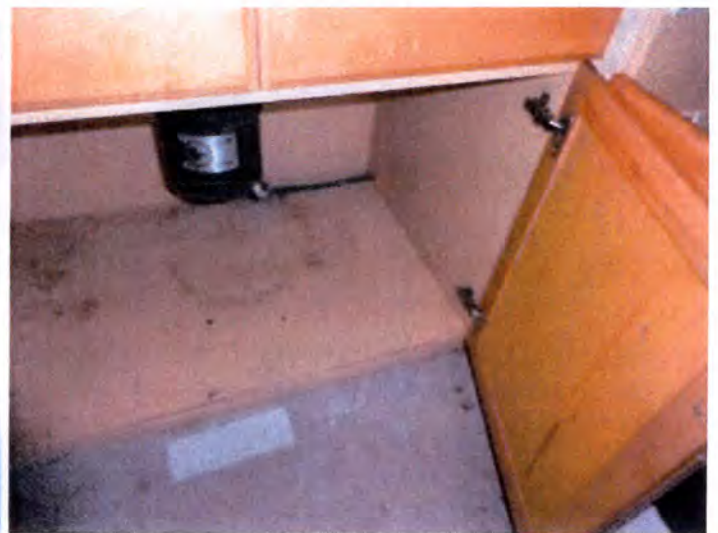
The kitchens of buildings B and C were deteriorated with moisture damage, termite damage and general damage observed at the cabinets, counters and finishes. Recommend the replacement of all dwelling unit kitchens, fixtures and appliances.

- We recommend the removal and replacement of all kitchen and bathroom cabinets, counters, fixtures and appliances throughout all buildings.
 - We recommend the replacement of all installed flooring materials within each building.

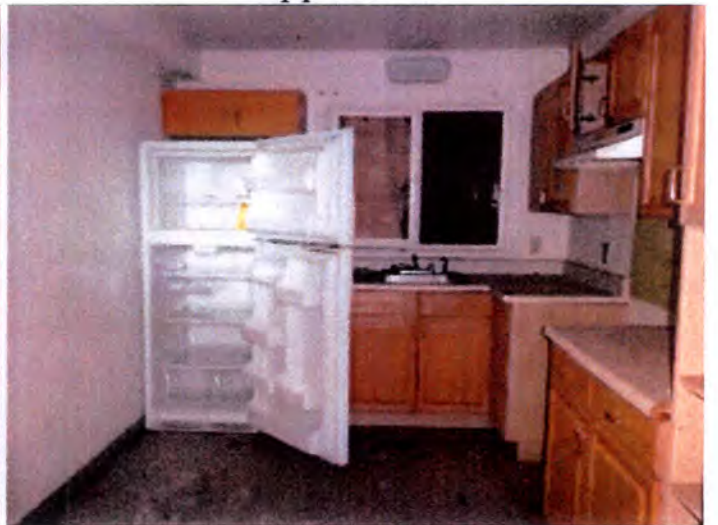
The kitchens of buildings B and C were deteriorated with moisture damage, termite damage and general damage observed at the cabinets, counters and finishes. Recommend the replacement of all dwelling unit kitchens, fixtures and appliances.

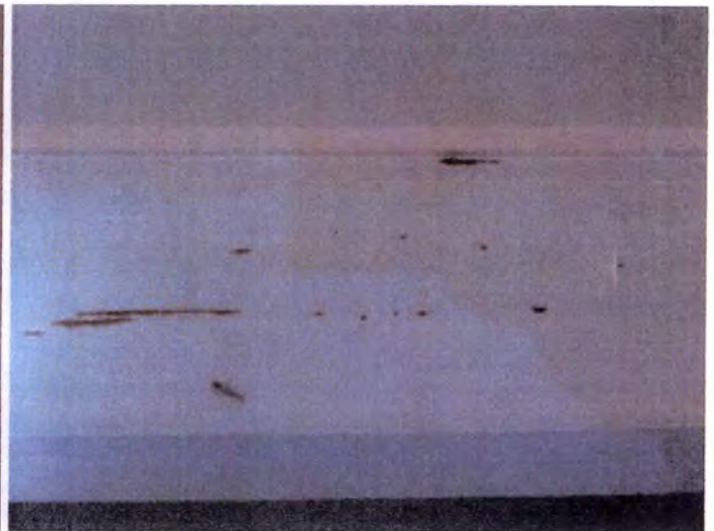
B-201: Ceiling joists were severely termite damaged and need to be repaired/replaced.

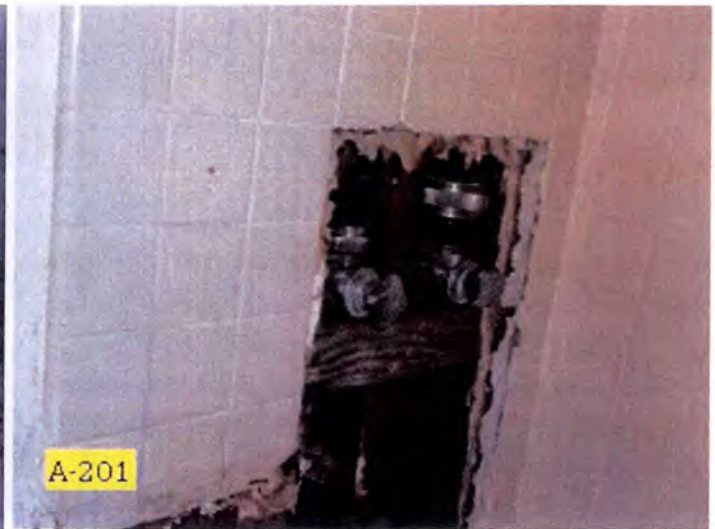
There were visible indications of moisture damage, mold growth, damaged flooring, damaged cabinets and counters, damaged mirrors, damaged toilets and damaged shower compartments observed at the time of inspection. Based on the observed conditions on site, we recommend the replacement of all dwelling unit bathrooms.

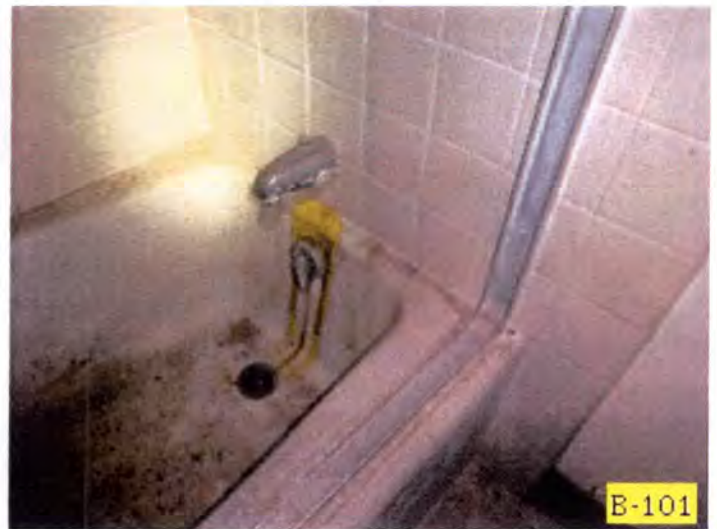
There were visible indications of moisture damage, mold growth, damaged flooring, damaged cabinets and counters, damaged mirrors, damaged toilets and damaged shower compartments observed at the time of inspection. Based on the observed conditions on site, we recommend the replacement of all dwelling unit bathrooms.

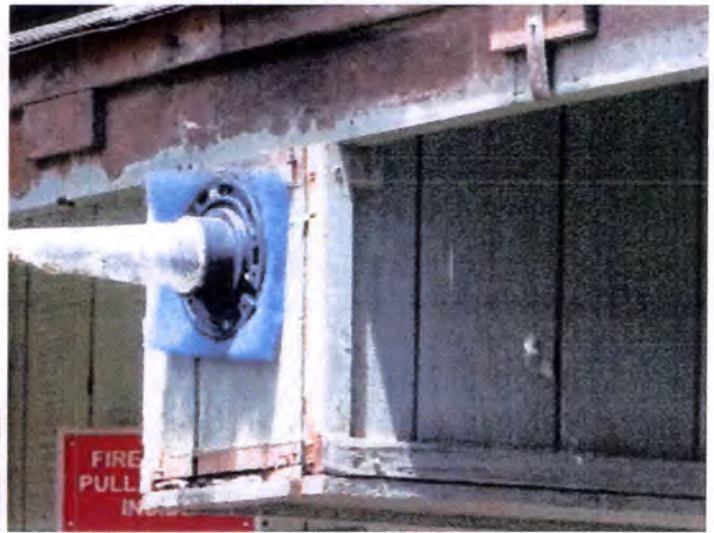
There was a hazardous bee population observed on site at the time of inspection. The single story storage building had sections of front wall removed for past been removal. The left side of the building had extensive and constant activity observed. There were been nests also observed at other exterior and interior locations through out the property.

- We recommend having a licensed pest contractor, specializing in bees, evaluate and remove the extensive bee population.
 - We recommend having a licensed arborist/landscaping contractor evaluate and remove all trees within 10' and bushes within 5' of each building.

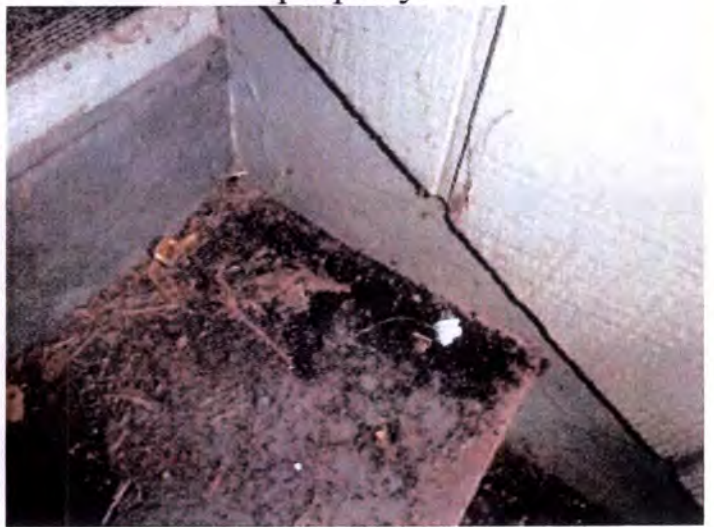
There was moderate/extensive termite/moisture damage observed at the interior and/or exterior areas of the building.
