**SUBJECT: COUNTY-OWNED PARCEL ON NORTH PAPA AVENUE (KAHULUI)
(AH-8)**

Structural Condition Analysis and Assessment of Dormitory Facilities

December 17, 2019

Site Located at 820 Ka'ahumanu Avenue, Kahului, Maui 96732 TMK: (2)3-8-07:117

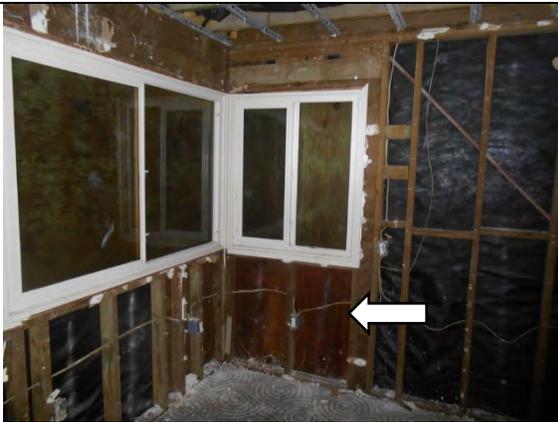
PA1CD.3: At various locations, vegetation is present at interior face of first story walls.

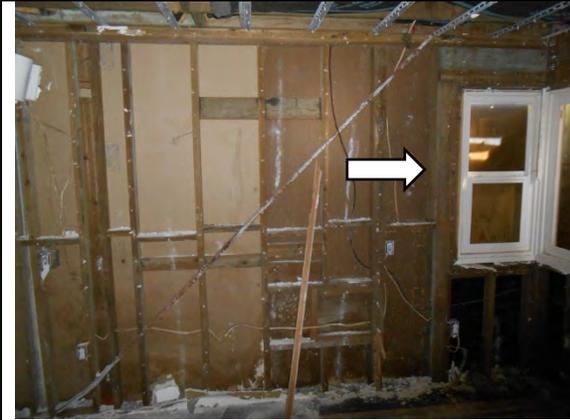
PA1CD.5: Stud wall framing not in-place beneath stair landing at exterior wall.

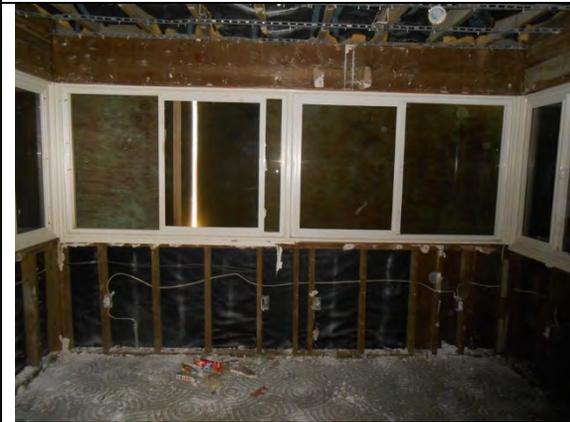
PA1CD.6: At various locations, openings missing king jamb post(s).

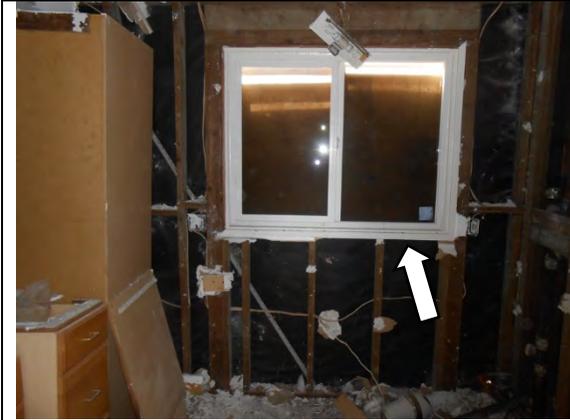
PA1CD.9: At various locations, openings missing sill plate.

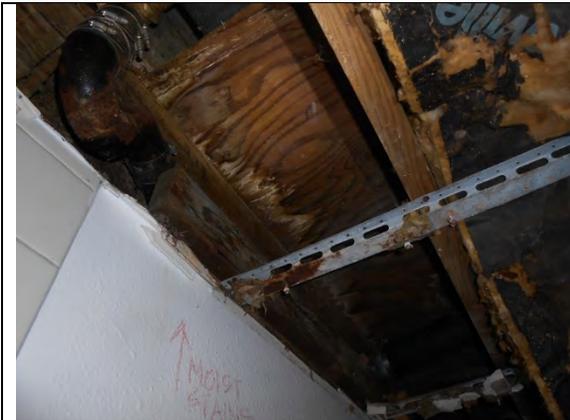
PA2D.1: Moisture stains present on plywood sheathing adjacent to rusty pipe.

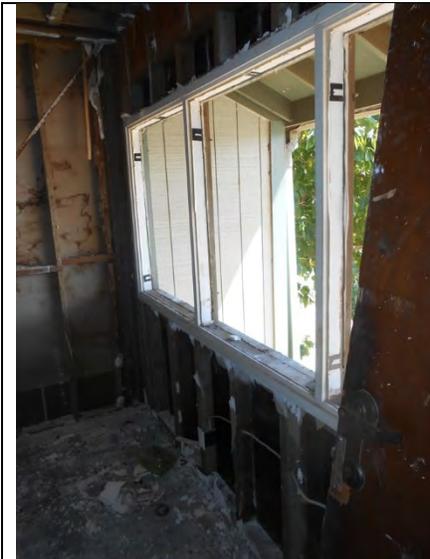
PA2CD.1: Wide opening single sill plate.

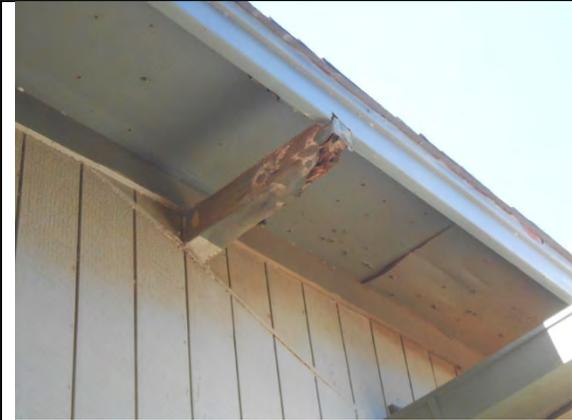
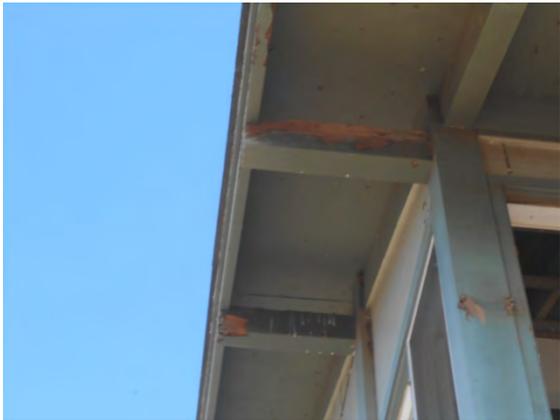
PARD.1: Beam overhang dry rot.

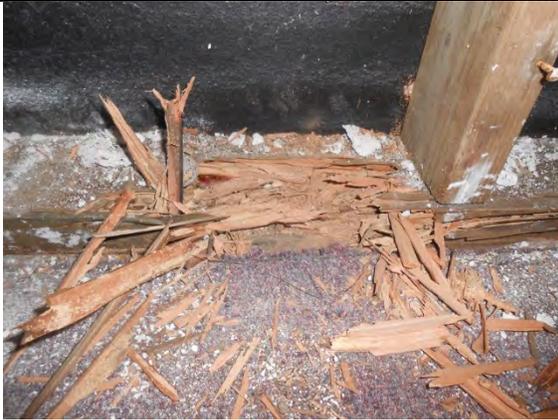
PB1D.1: Sole plate dry rot.

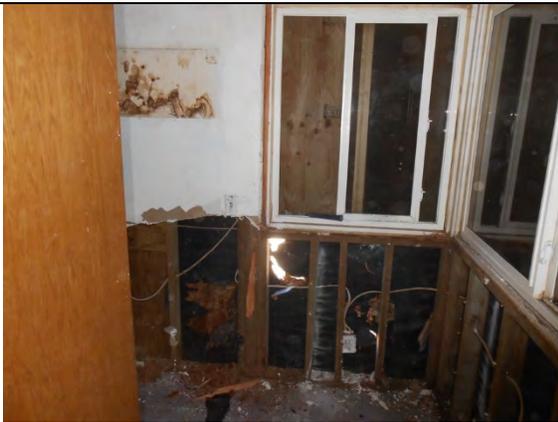
PB1D.2: Siding dry rot.

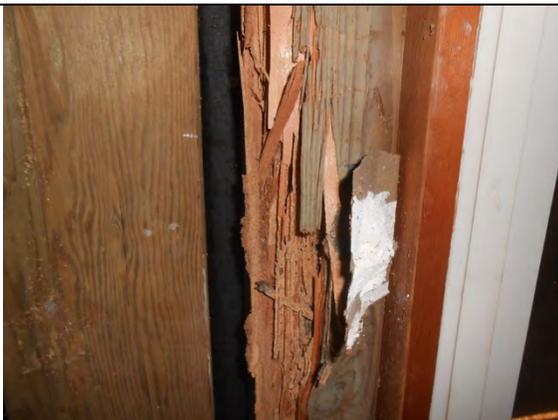
PB1D.3: Post termite damage.

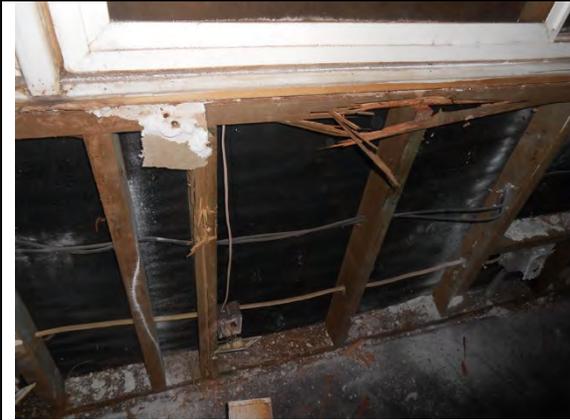
PB1D.4: Stud termite damage. Sill plate termite damage.

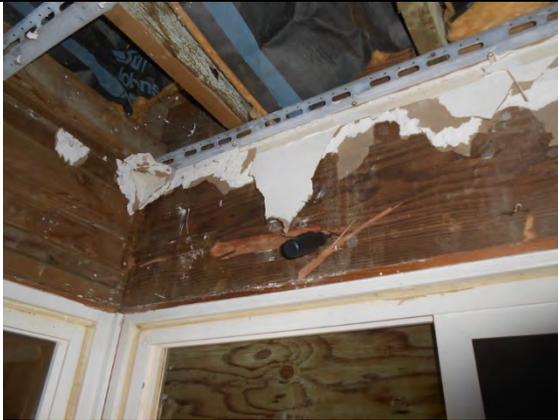
PB1D.5: Beam termite damage.

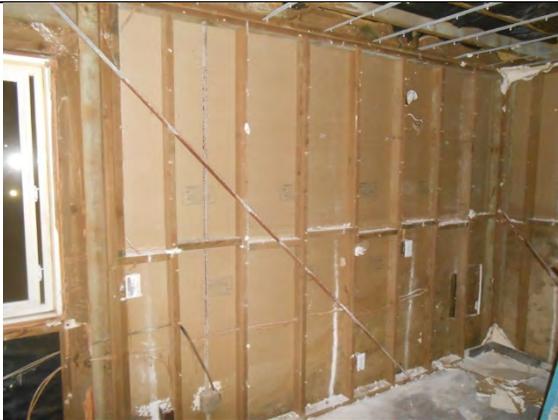
PB1D.6: Rusting steel wall braces.

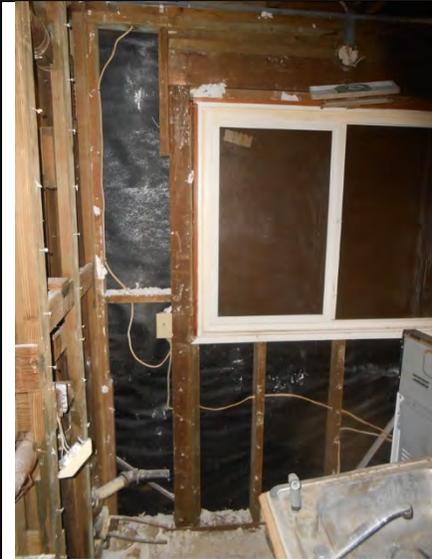
PB1CD.1: Missing opening king post.

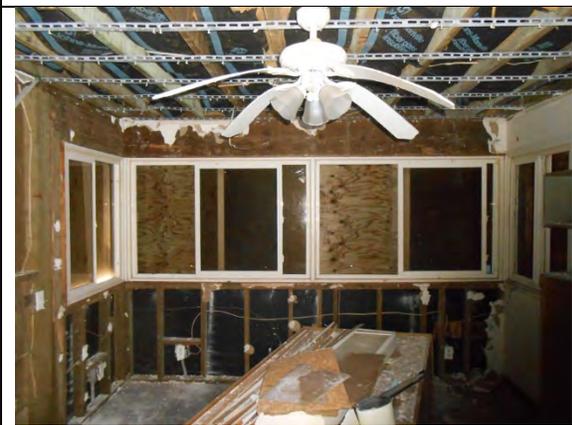
PB1CD.2: Wide opening with single sill plate.

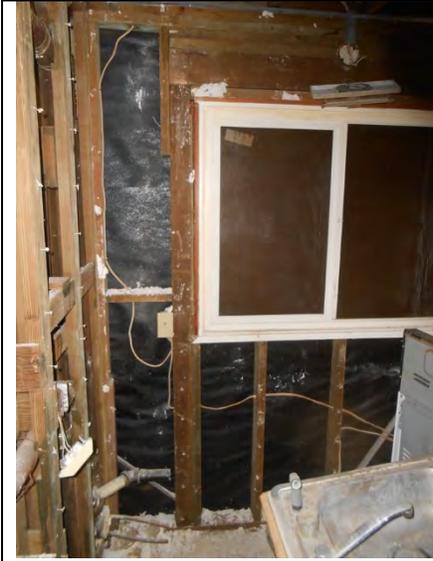
PB1CD.3: Missing opening sill plate.

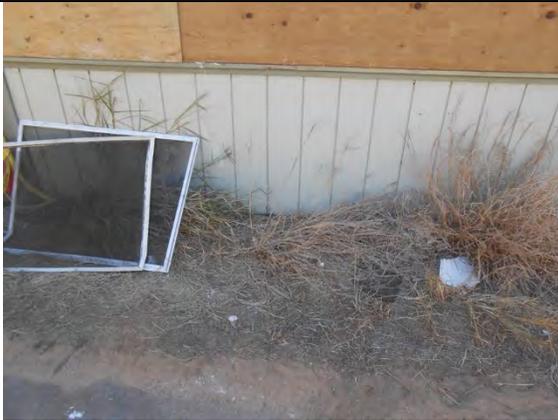
PB1CD.4: Vegetation against building façade.

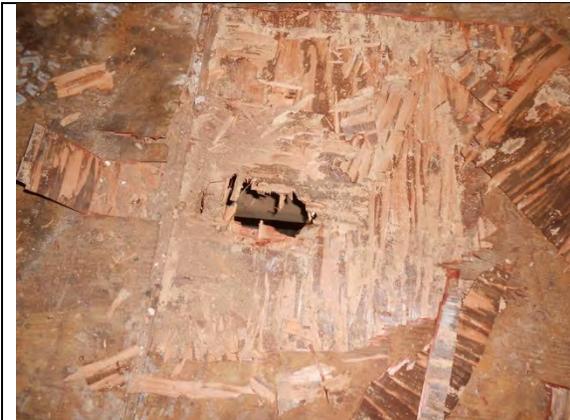
PB2D.1: Floor sheathing dry rot.

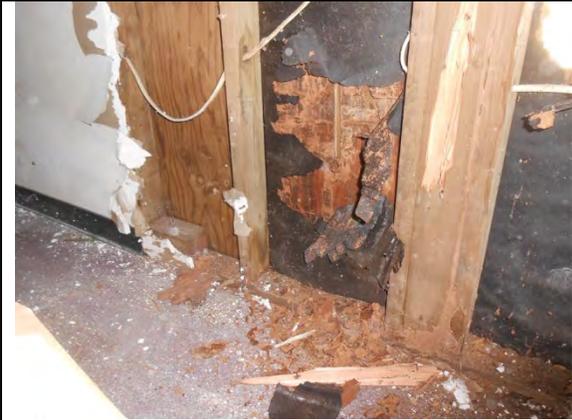
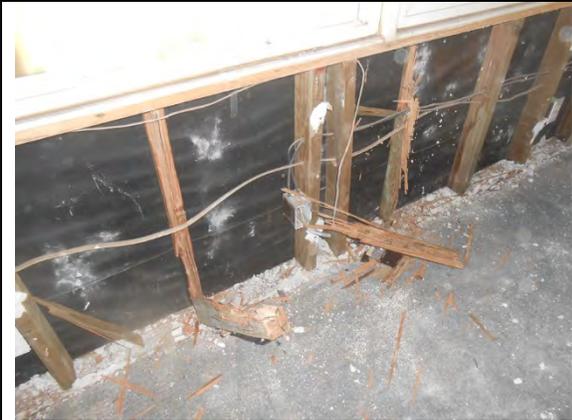
PB2D.4: Stud termite damage.

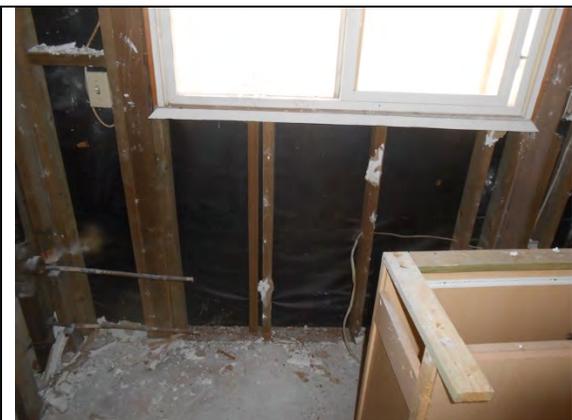
PB2CD.1: Missing wall blocking.

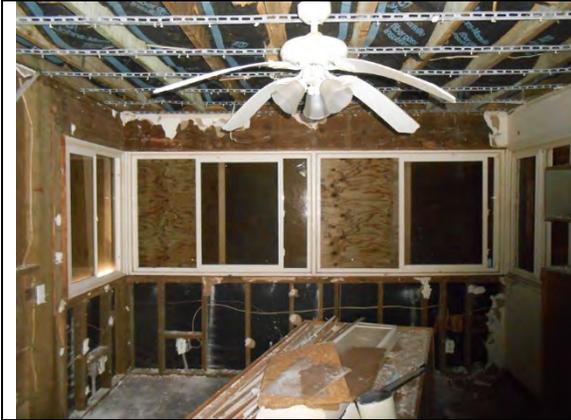
PB2CD.2: Missing blocking

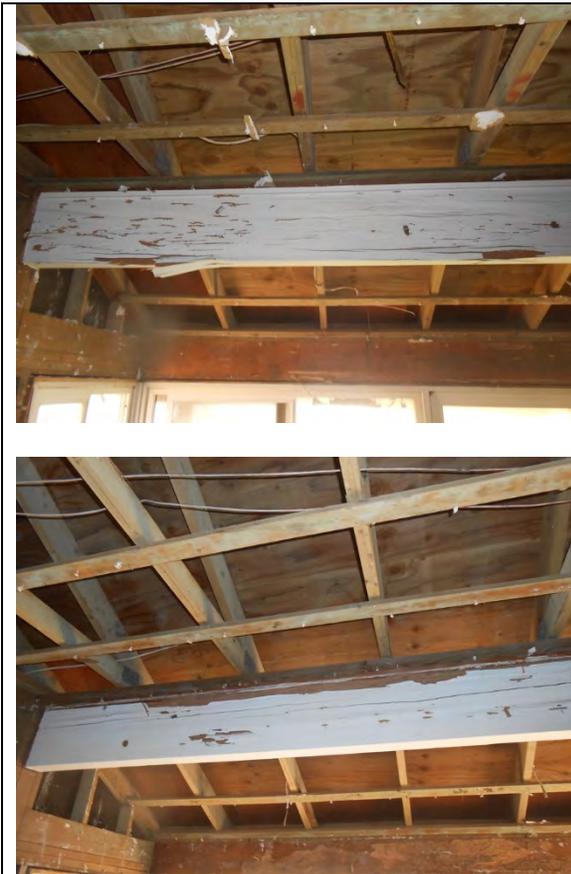
PBRD.1: Beam termite damage.

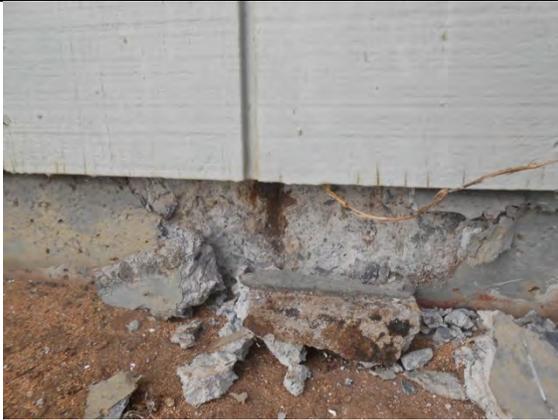
PC1D.1: Concrete spall with exposed corroded reinforcing steel.

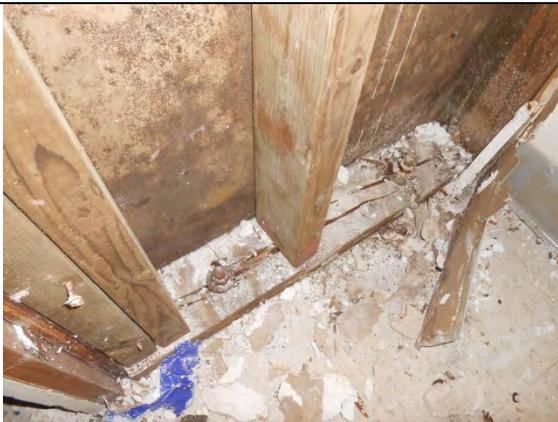
PC1D.2: Split sole plate.

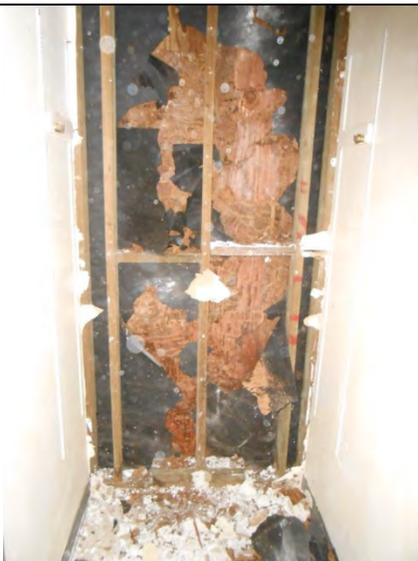
PC1D.3: Siding dry rot.

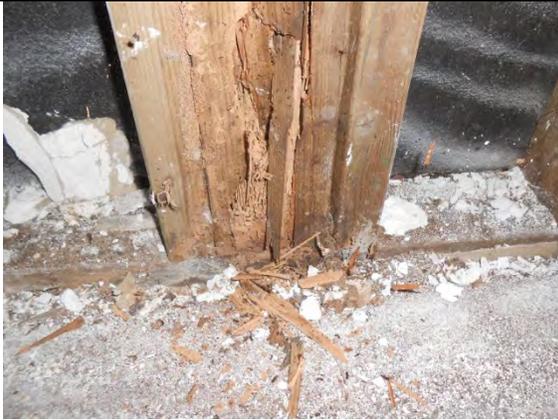
PC1D.4: Post termite damage.

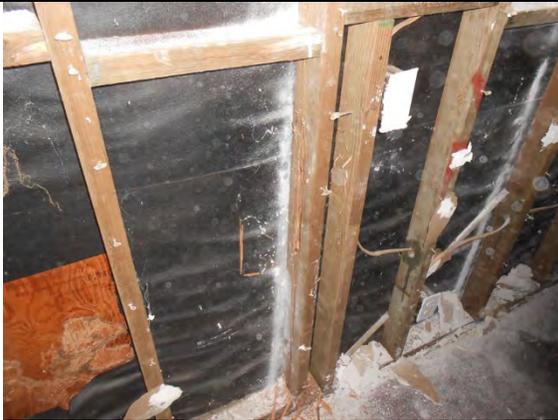
PC1D.5: Stud termite damage.

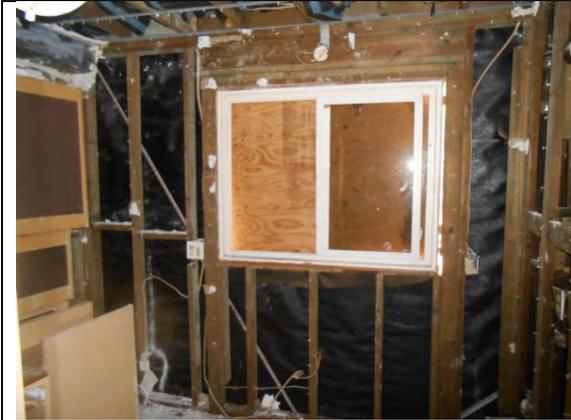
PC1CD.1: Missing opening king post.

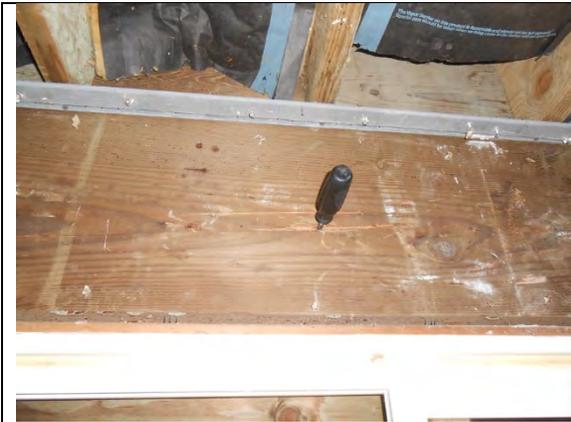
PC2D.1: Beam termite damage.

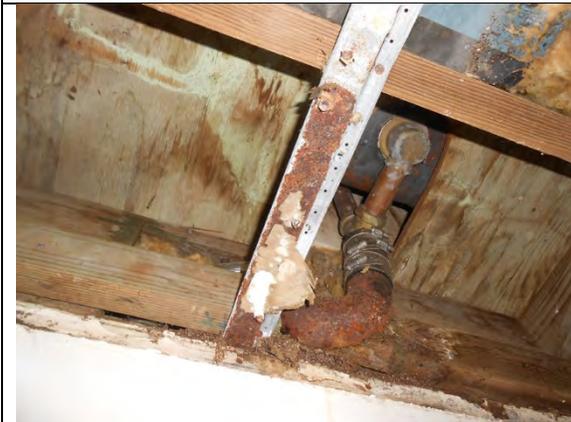
PC2D.2: Moisture damage to floor sheathing adjacent to rusting pipe.

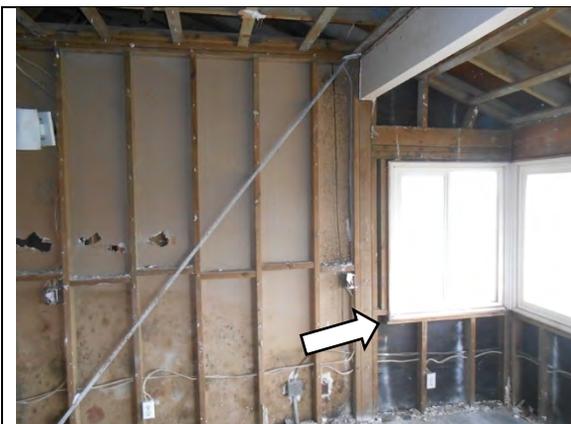
PC2CD. 1: Missing opening king post.

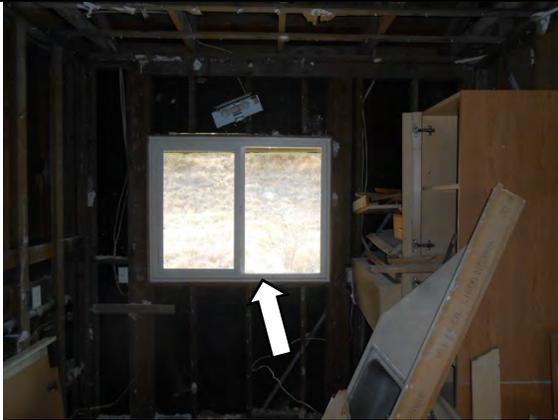
PC2CD.3: Missing opening sill plate.

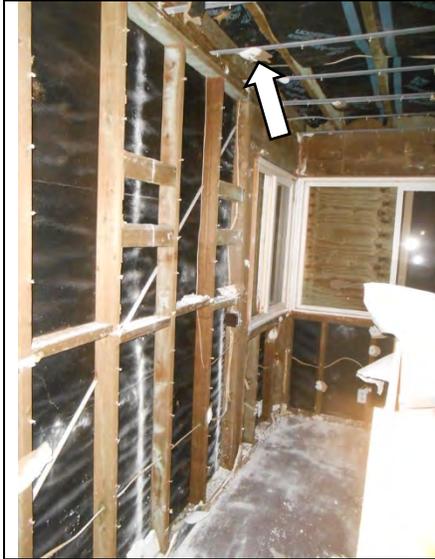
PC2CD.5: Missing wall blocking.

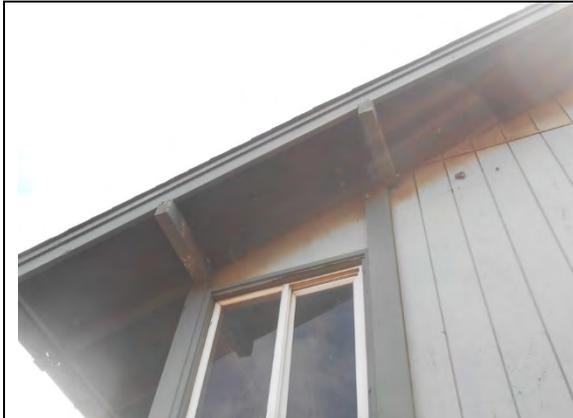
PCRD.1: Beam overhang dry rot.

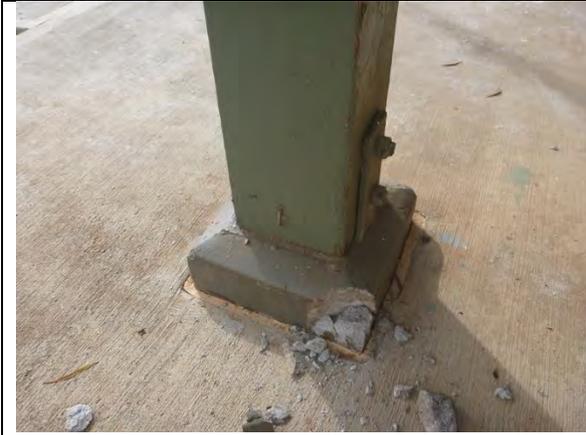
1. The top northwest corner of the concrete pier at Gridline '5-D' is broken off, spalled.
2. At Gridline '5-D', the top of the wood post is damaged by termites. The end of the beam, along Gridline '5', at this location is also damaged by termites.
3. At various locations, exterior sheathing is damaged or missing.
4. Minor dry rot is present at the base of the wood post at Gridline '1-D'.
5. A small region of roof sheathing is moderately damaged adjacent to Gridline's 'B-4'. A depression can be seen from the exterior.

RC1D.1: Minor concrete spall at the northwest corner of the concrete pier at Gridlines '5-D'.

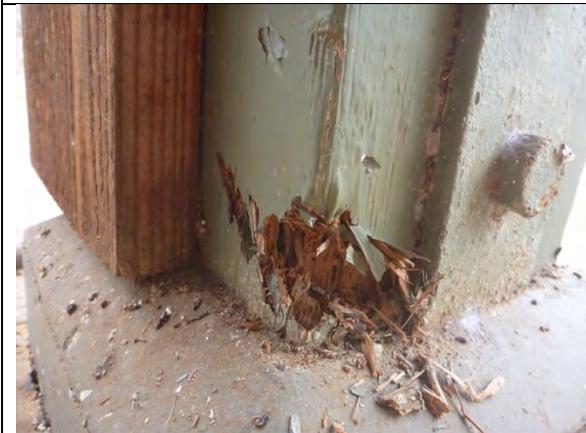
RC1D.2: Post at Gridlines 'D-1'; minor dry rot present at southeast corner of post base

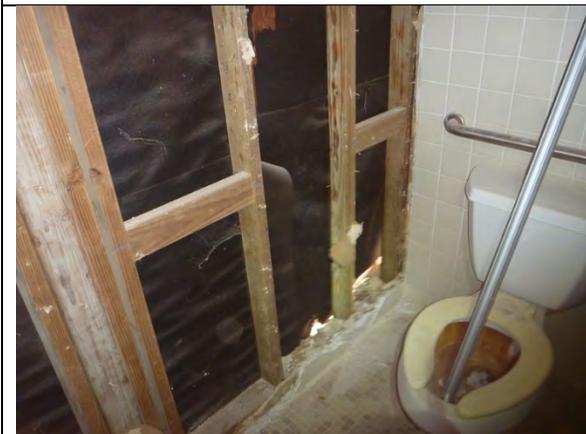
RC1D.3: Damaged siding at southwest corner of women's restroom.

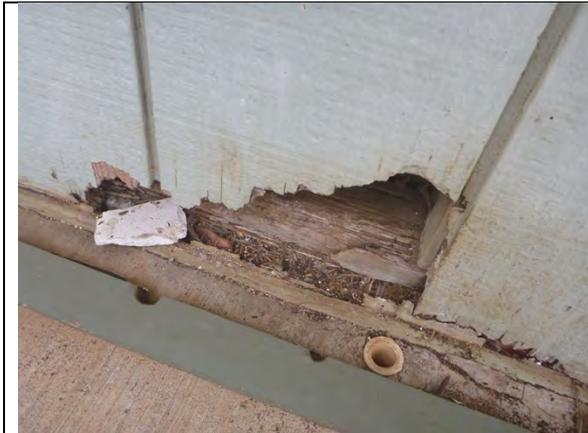
RC1D.4: Sole plate dry rot at heater room.

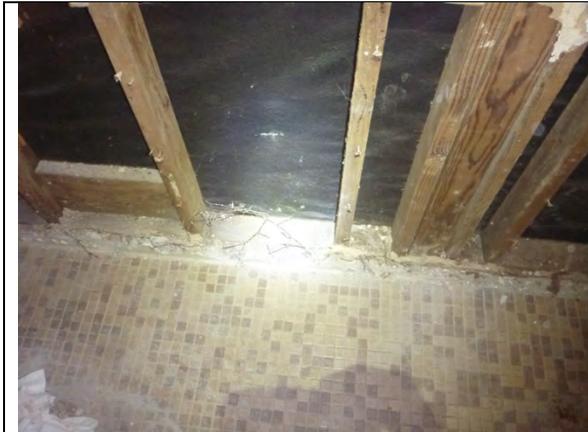
RC1CD.1: At various locations, sole plate anchor rods are installed at more than 32 inches on-center or missing.

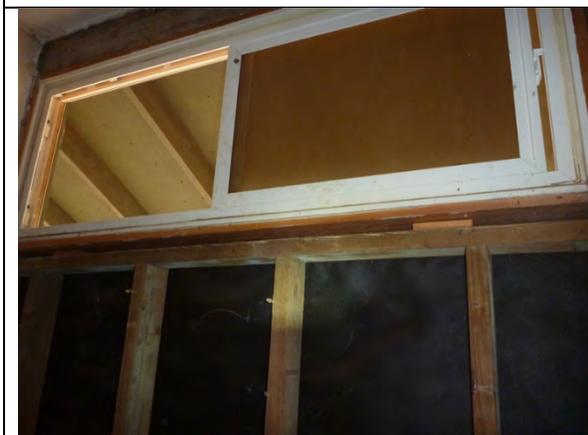
RC1CD.2: At various locations, windows are supported on spaced blocks.

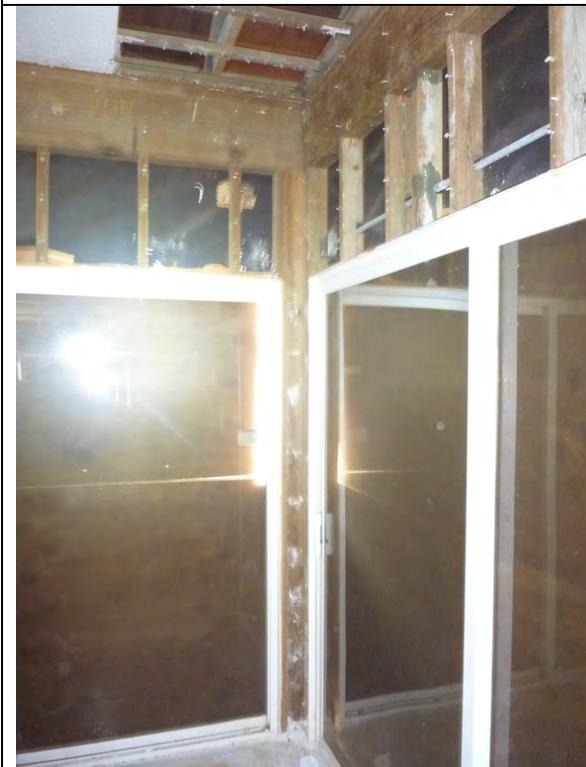
RC1CD.7: Typically, recreational room north, east, and west openings are missing double wood plate above the opening.

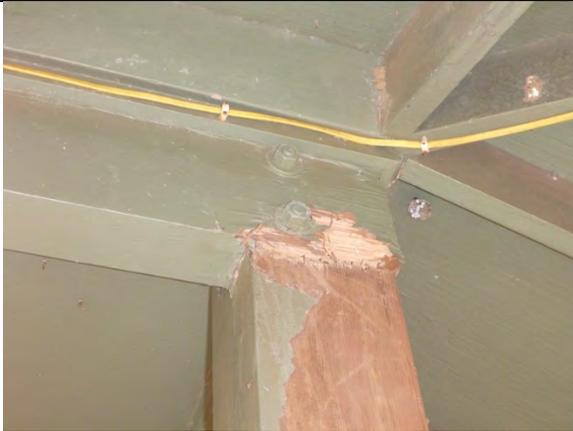
RCRD.1: Moderate termite damage present at beam to column connection at Gridlines '5-D'.

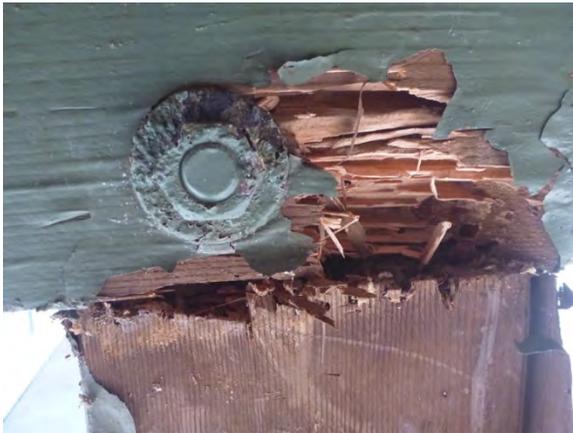
RCRD.2: Region of damaged plywood sheathing.

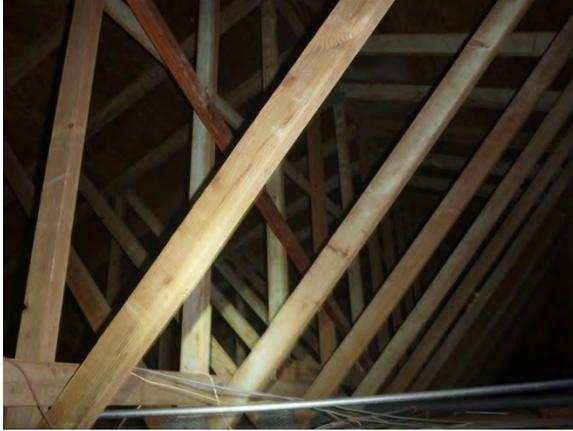
RCRCD.1: Web bracing missing.

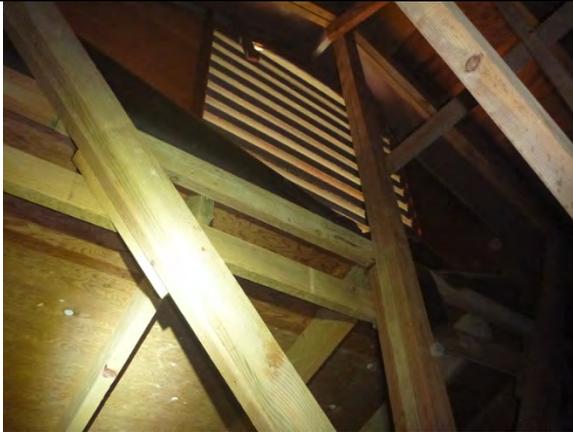
RCRCD.2: Gable end wall missing stud wall framing.

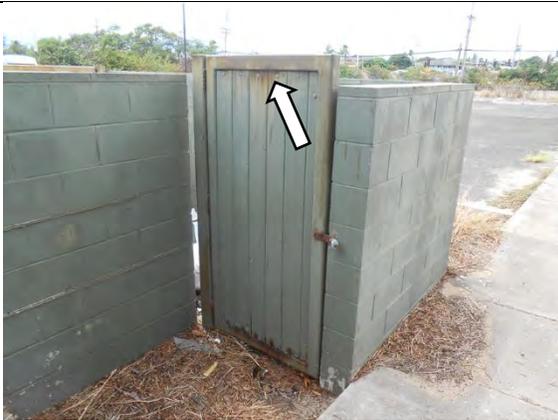
PTESB3: Rusting trash enclosure door.

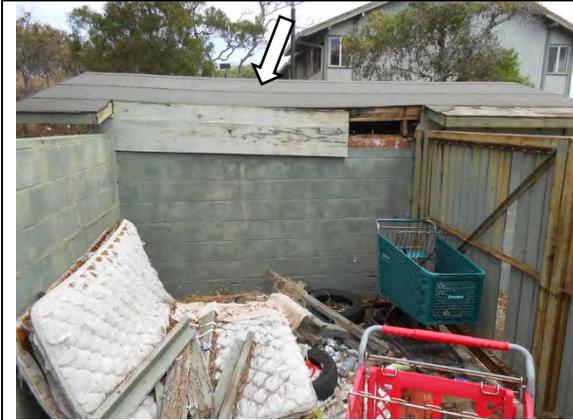
PTESB4: Damaged storage building roof.

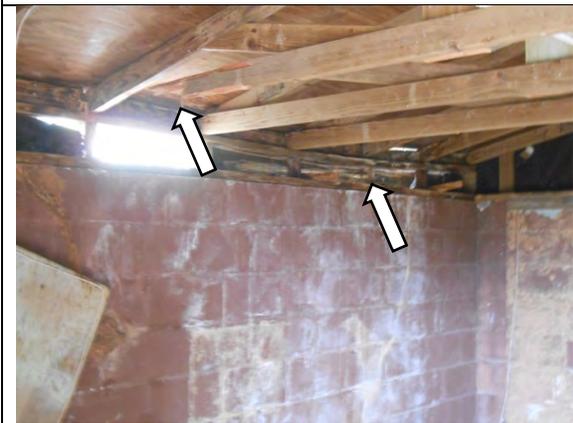
PTESB6: Collapsed storage building south wood framed stem wall. Damaged truss bottom chord.

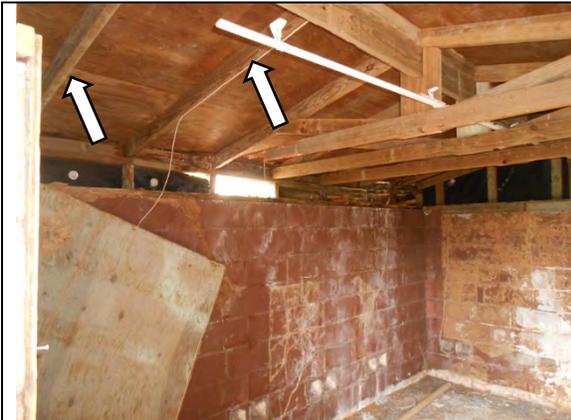
PTESB7: Damaged trusses. Missing truss framing.

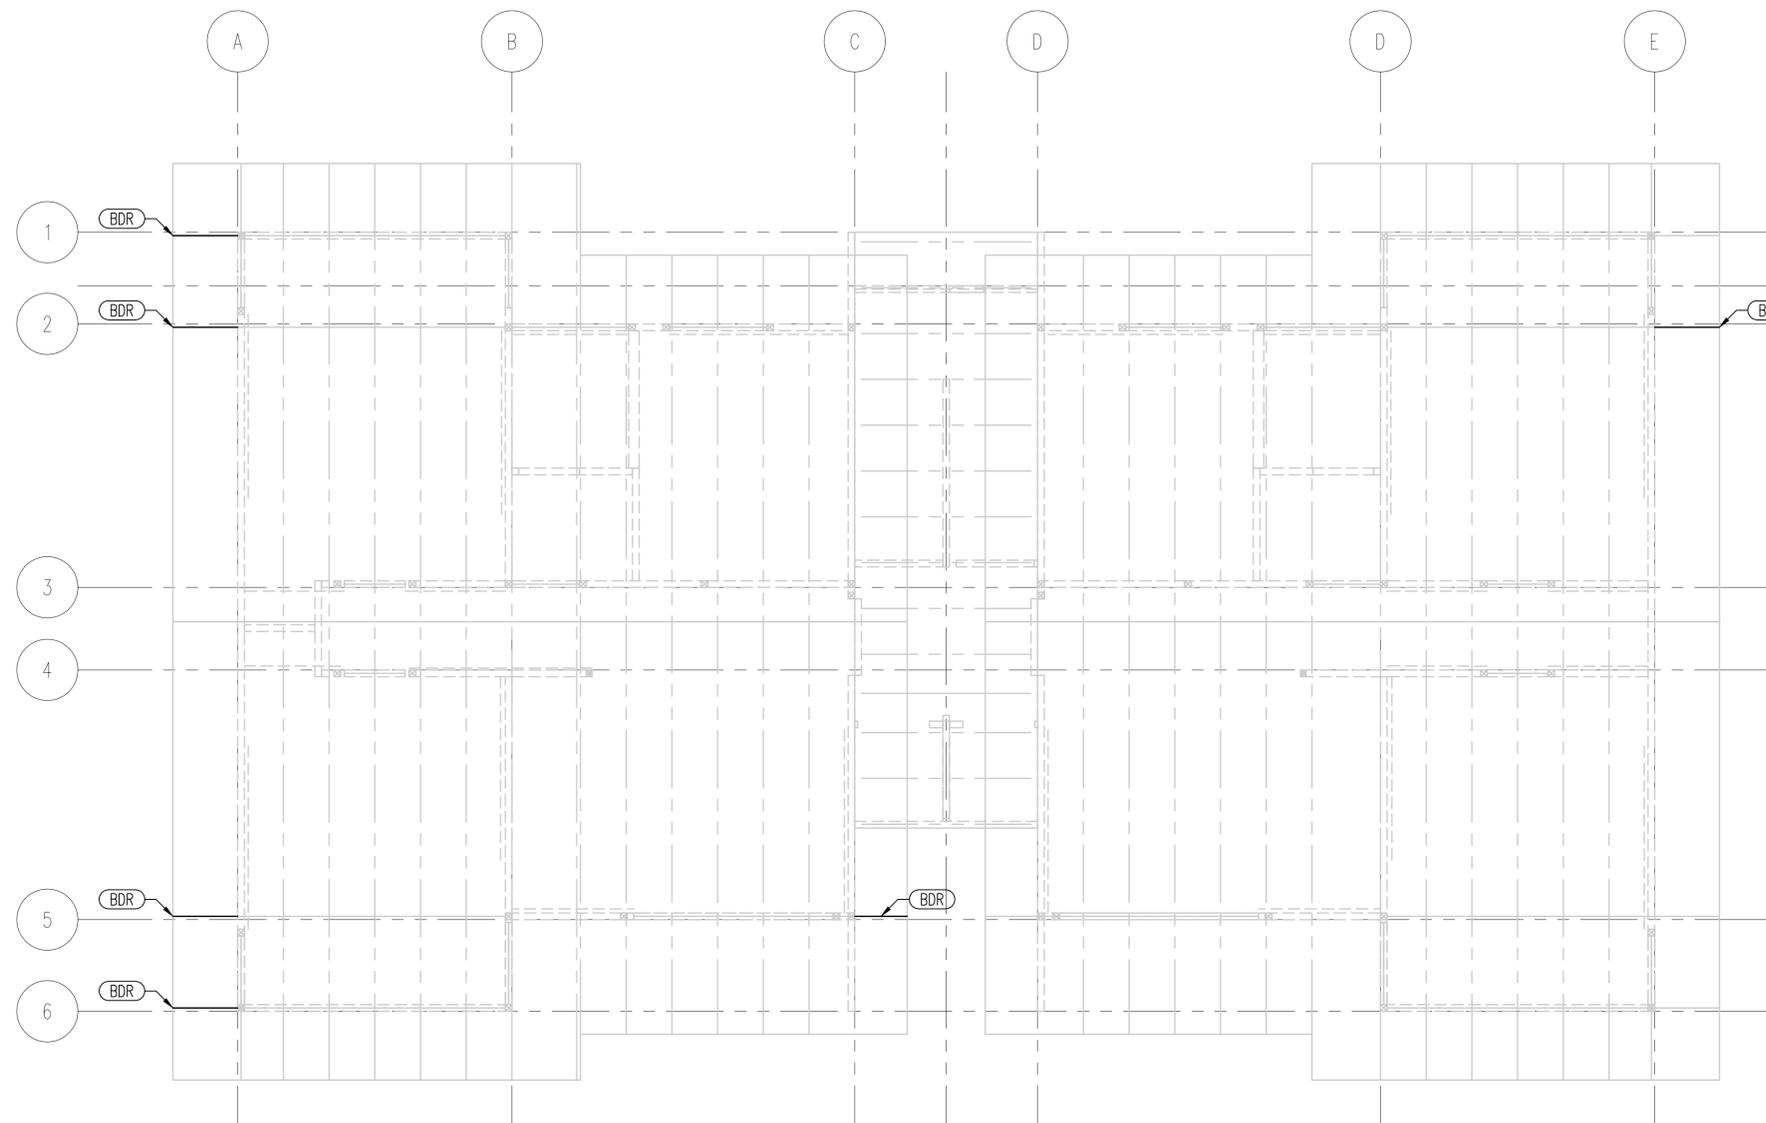
1 EXIST BUILDING A ROOF FRAMING PLAN
S-3 1/4" = 1'-0"

1. TYPICALLY, TRUSS WEB ARE UN-BRACED.
2. AT VARIOUS LOCATIONS, DAYLIGHT IS OBSERVED AT RIDGE.
3. GABLE END WALL IS UN-BRACED.

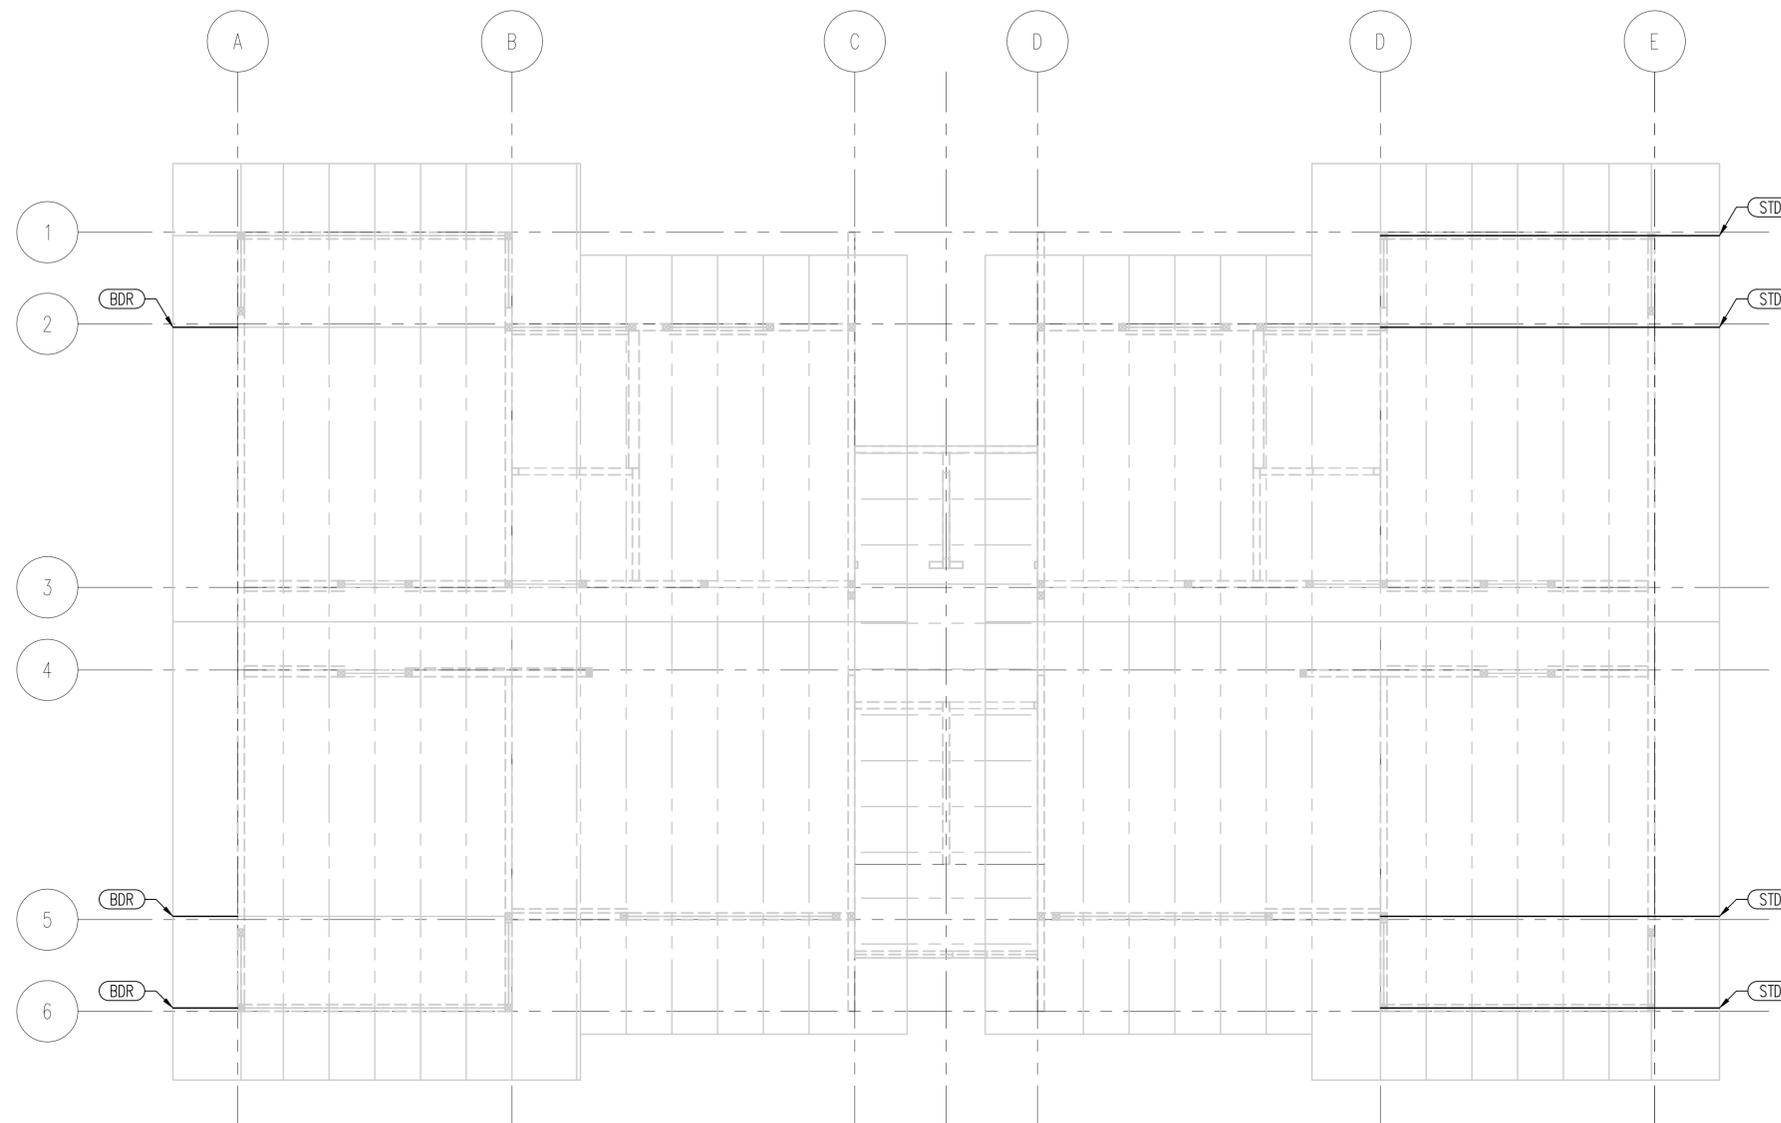
1 EXIST BUILDING B ROOF FRAMING PLAN
S-6 1/4" = 1'-0"

1. TYPICALLY, TRUSS WEB ARE UN-BRACED.
2. AT VARIOUS LOCATIONS, DAYLIGHT IS OBSERVED AT RIDGE.
3. GABLE END WALL IS UN-BRACED.

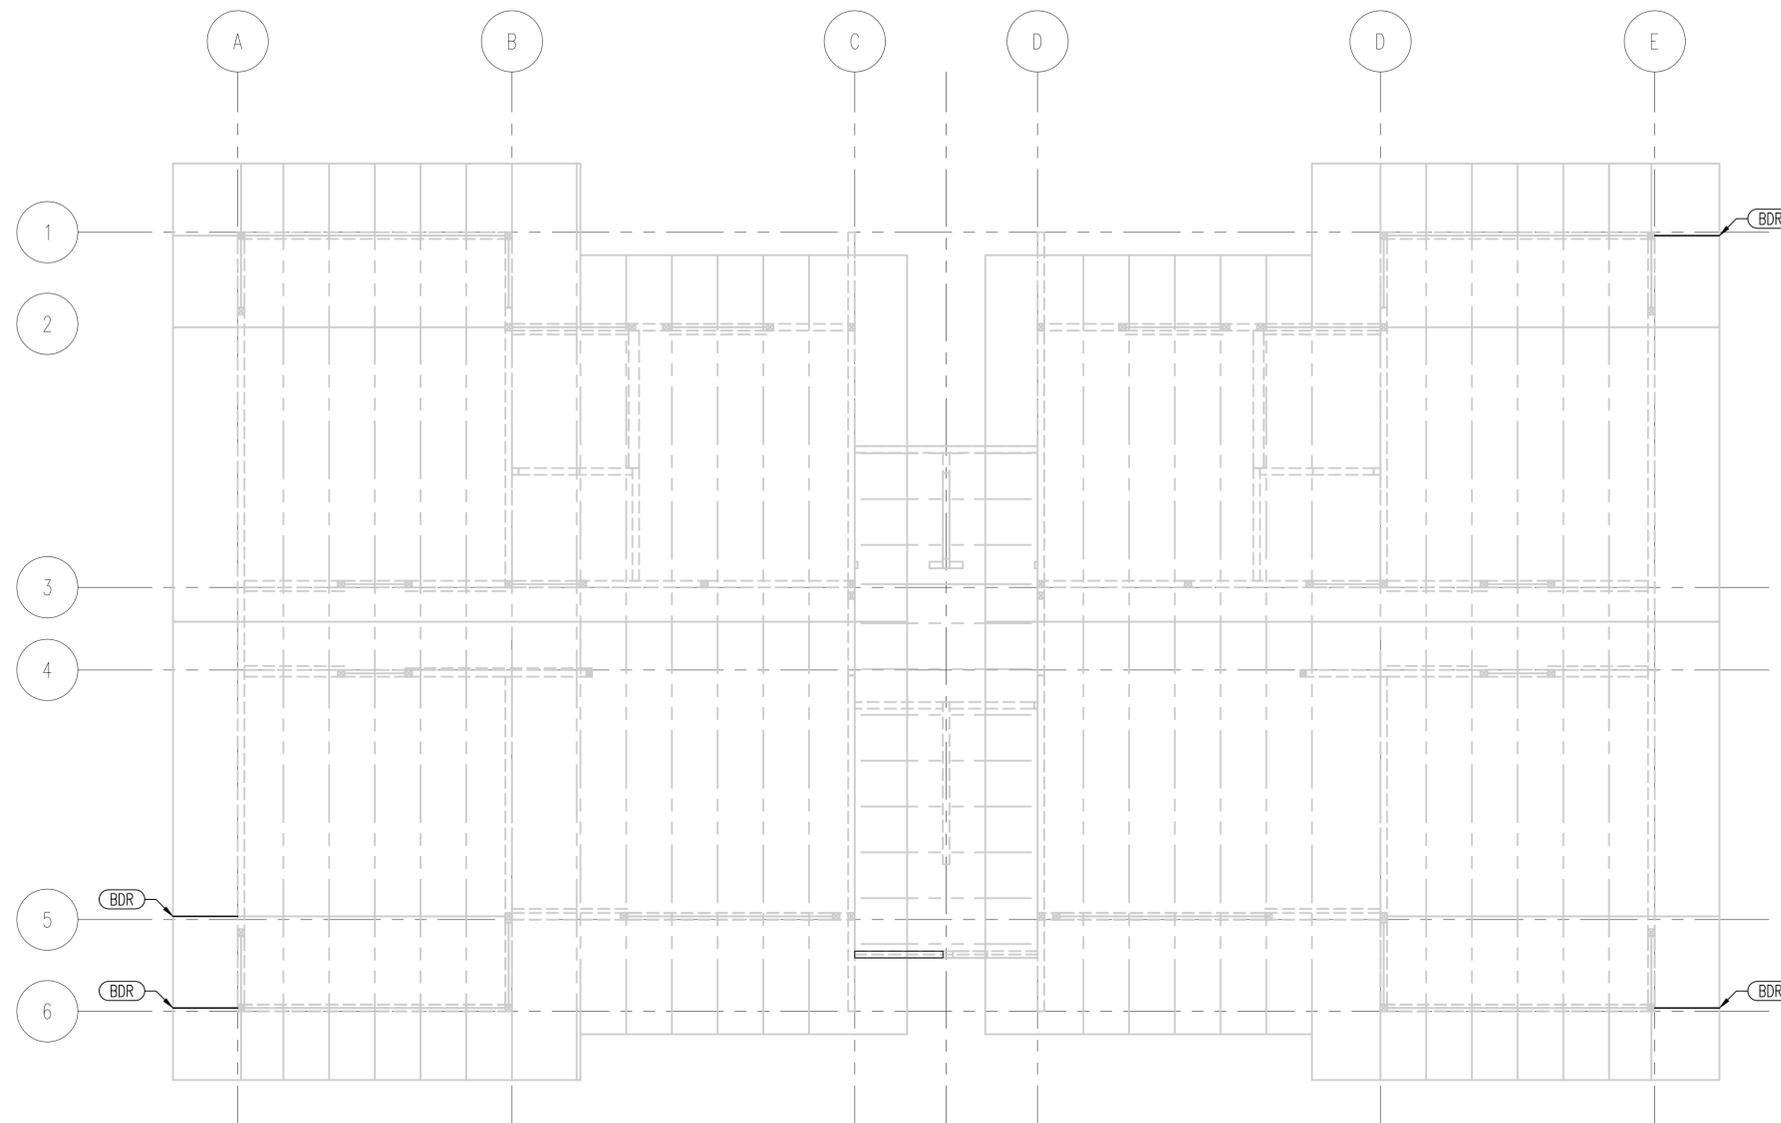
1 EXIST BUILDING C ROOF FRAMING PLAN
S-6 1/4" = 1'-0"

1. TYPICALLY, TRUSS WEB ARE UN-BRACED.
2. AT VARIOUS LOCATIONS, DAYLIGHT IS OBSERVED AT RIDGE.
3. GABLE END WALL IS UN-BRACED.

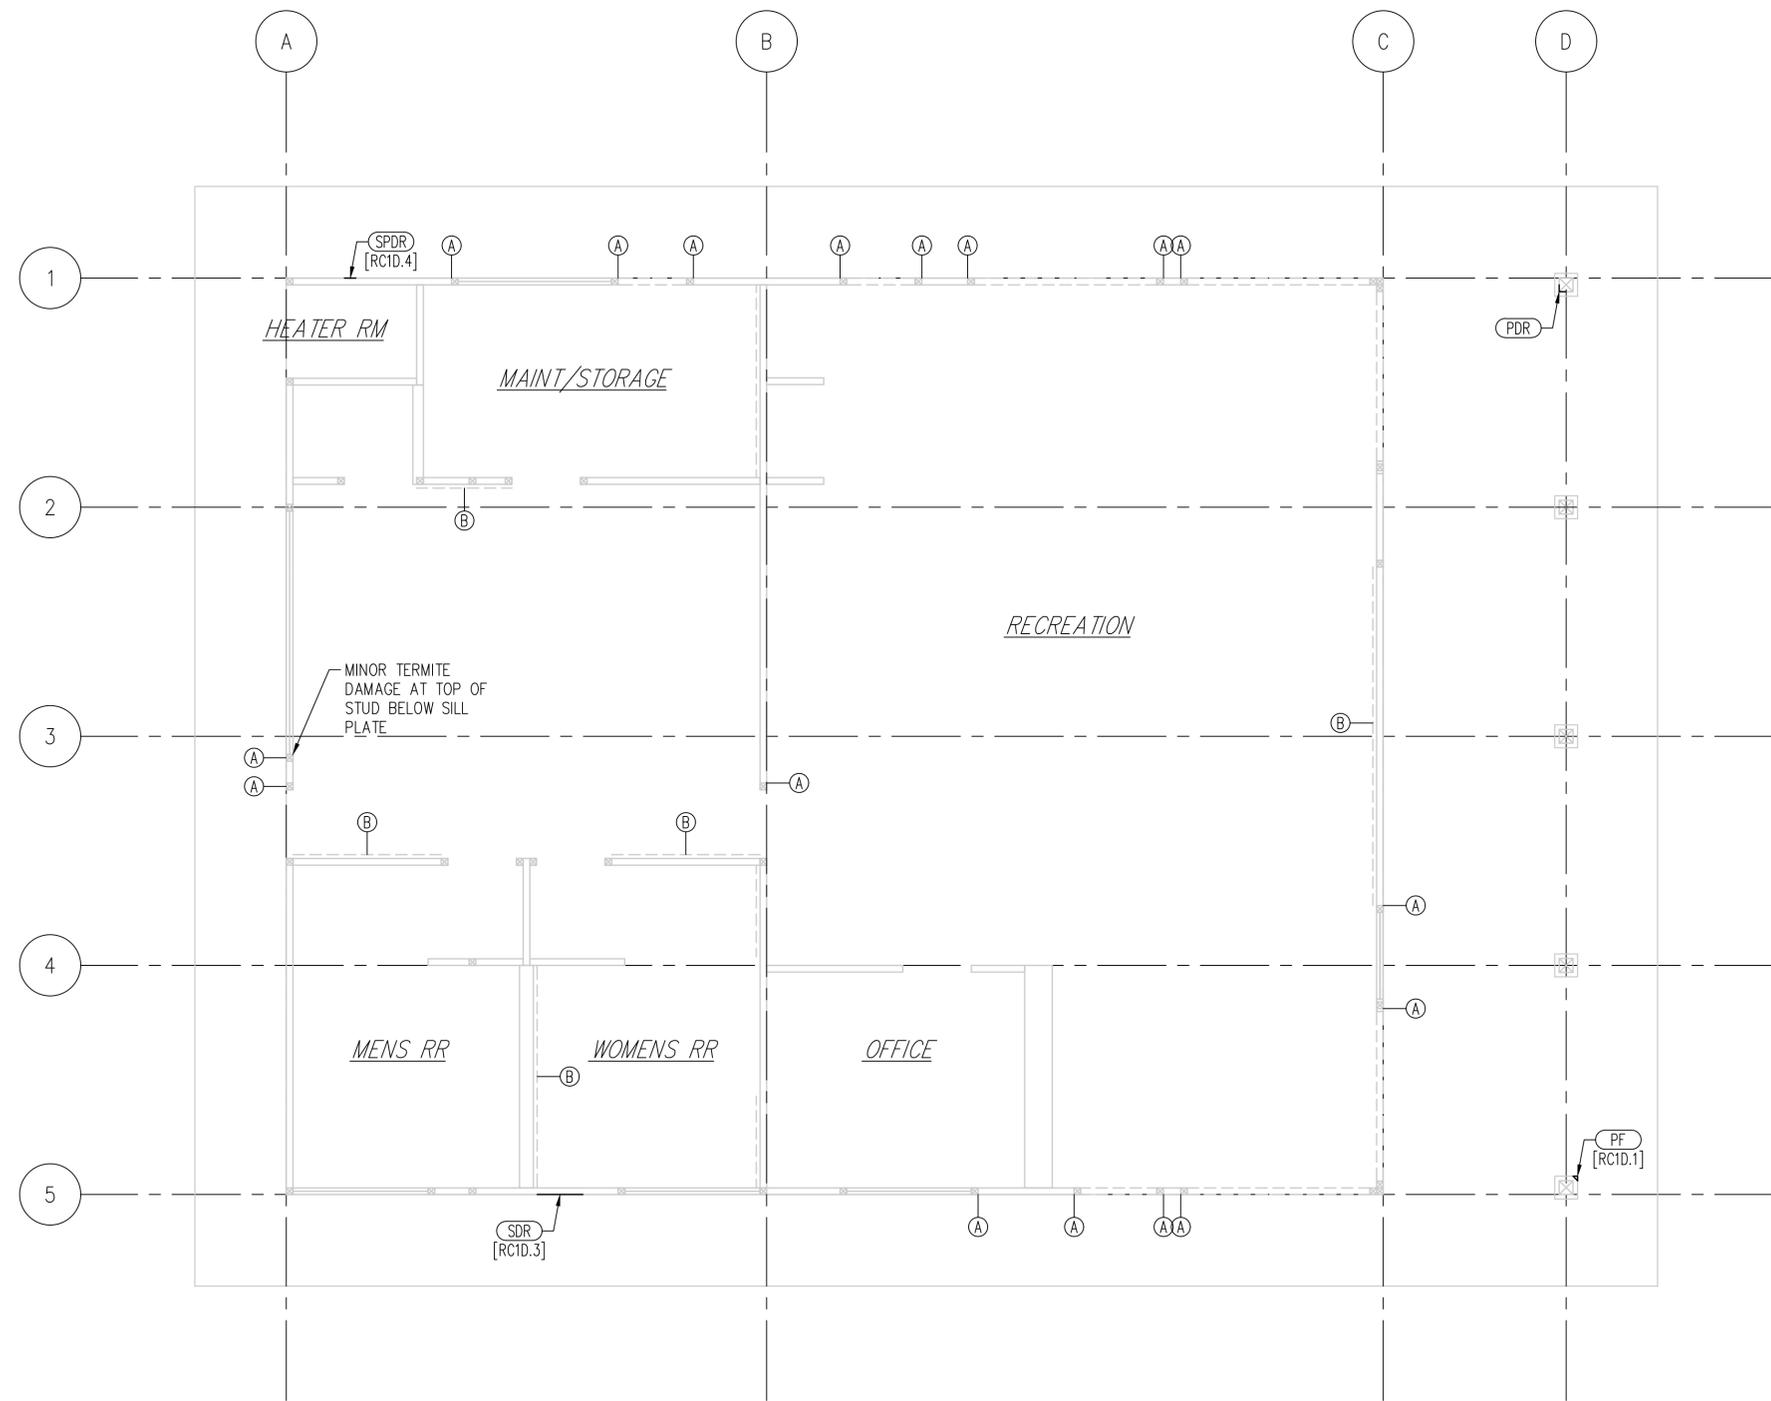
GENERAL CONSTRUCTION DEFECTS NOTES:
 1. TYPICALLY, INTERIOR PARTITION WALL SOLE PLATE ANCHOR RODS ARE MISSING OR INSTALLED @ GREATER THAN 32" OC. [RC1D.1]
