SUBJECT: COUNTY-OWNED PARCEL ON NORTH PAPA AVENUE (KAHULUI) (HHT-14)

UHMC Dorm Project Inspection Report

Carol Reimann, DHHC Director Buddy Almeida, Housing Administrator

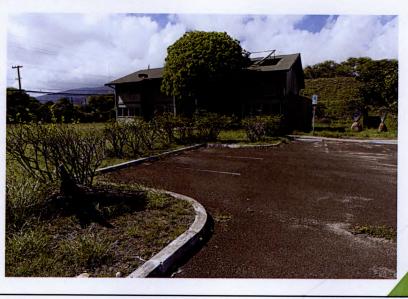
Parking Area: Surface Deteriorated

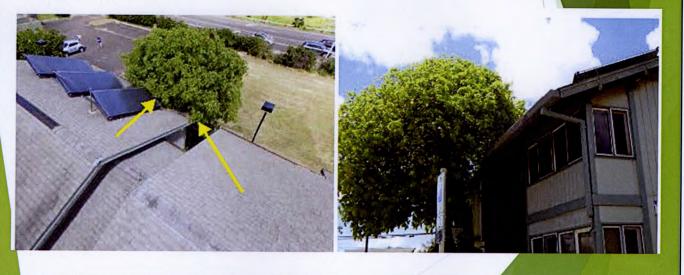
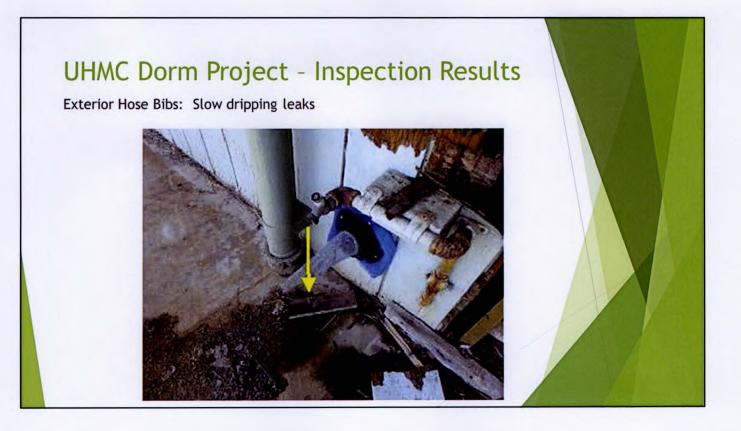
Vegetation: Overgrown, causing deterioration and damage to exterior walls and fixtures

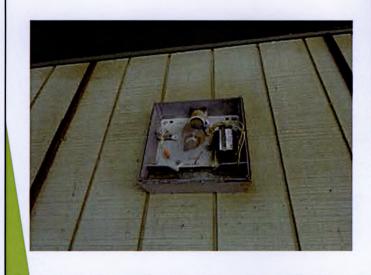
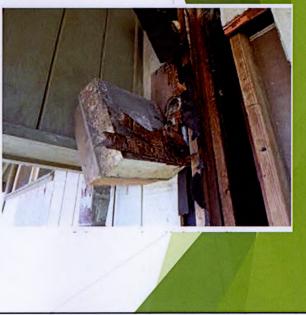
Exterior Lighting: Some damaged

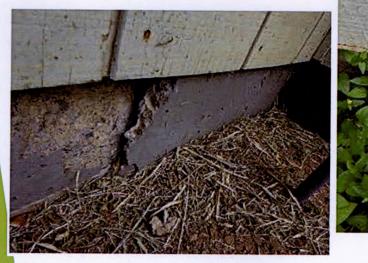
Foundation Areas: Visible cracks in Buildings A & B

Foundation repairs

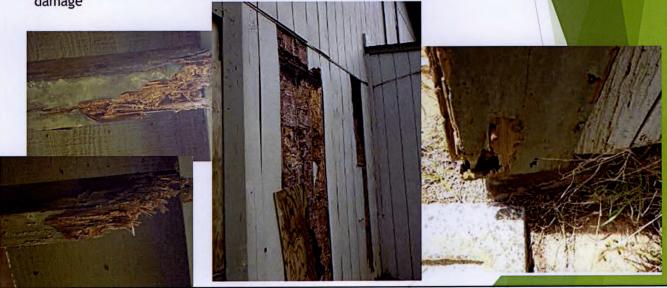
Exterior, Façade & Curtainwall: Rotted, <u>termite damage</u>, moisture damage

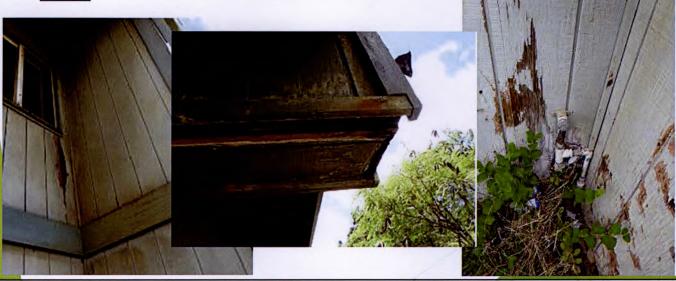
Exterior, Façade & Curtainwall: <u>Rotted</u>, termite damage, <u>moisture</u> <u>damage</u>

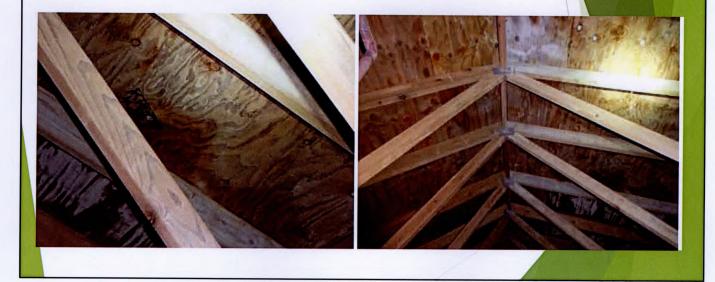
Roofing: Moisture intrusion, missing shingles, gutters damaged/broken/missing

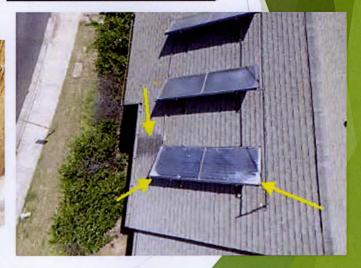
Plumbing: <u>Non-standard repairs</u>, water heating devices terminated with supply cut and electrical connections removed, <u>solar panels damaged & leaking</u>, fixtures in poor condition

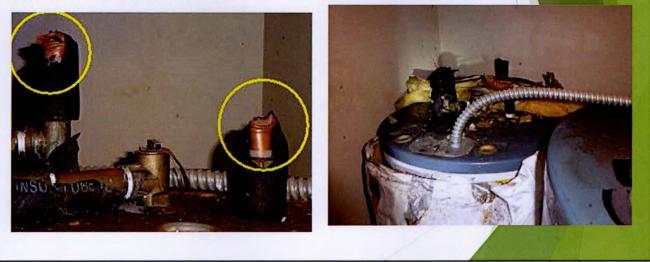
Plumbing: Non-standard repairs, <u>water heating devices terminated with</u> <u>supply cut and electrical connections removed</u>, solar panels damaged & leaking, fixtures in poor condition

All water hearing appliances were terminated with supply and service plumbing cut and electrical connections removed. Recommend having a licensed pumber evaluate and install commercial grade gas on demand hot water hearing systems for each floor of each building

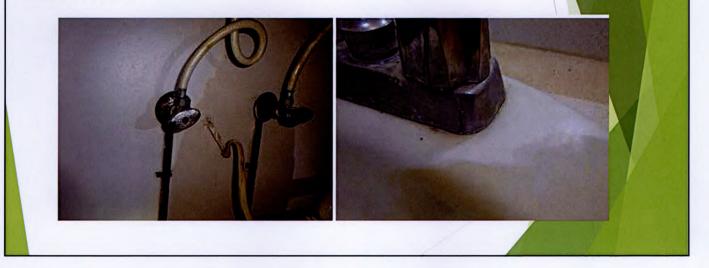
Plumbing: Non-standard repairs, water heating devices terminated with supply cut and electrical connections removed, solar panels damaged & leaking, <u>fixtures</u> in poor condition

Based on observed physical conditions of the installed fixtures, it is recommended to replace all plumbing fixtures and shut off values in all buildings to ensure proper future operation

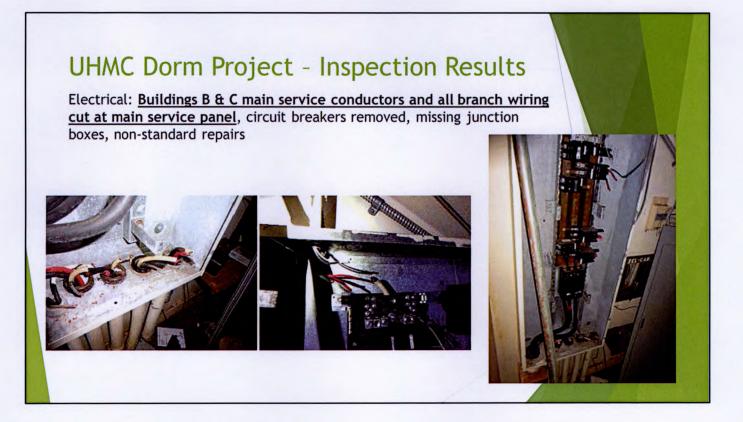
Main service conductors and all electrical branch wiring was cut at the main service panel entrance. Need electrical contractor to evaluate and repair electrical service to each building.

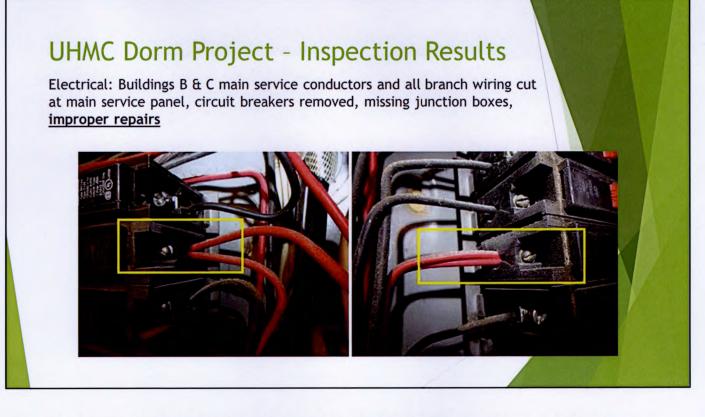
There were double tapped 1-pole circuit breakers noted. This is not consistent with the manufacturer's instructions and the NEC (National electric code). Licensed electrician needed to evaluate and repair/replace as necessary

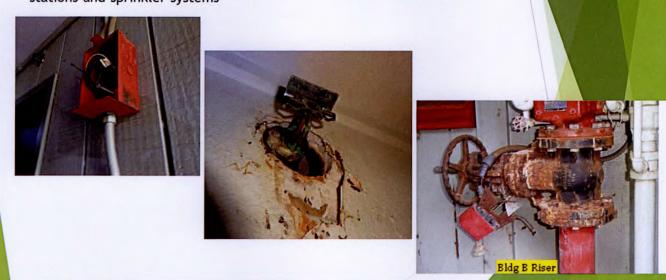
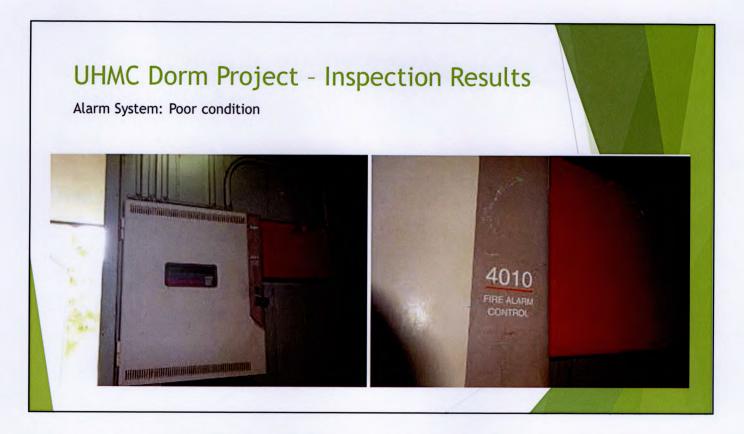
Fire Suppression: Improperly maintained fire suppression risers, pull stations and sprinkler systems

Each building's designated alarm and alarm panel in poor condition.

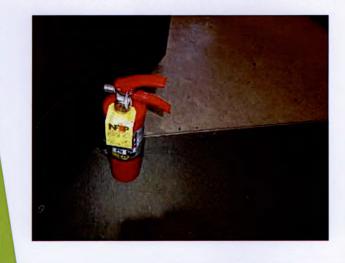
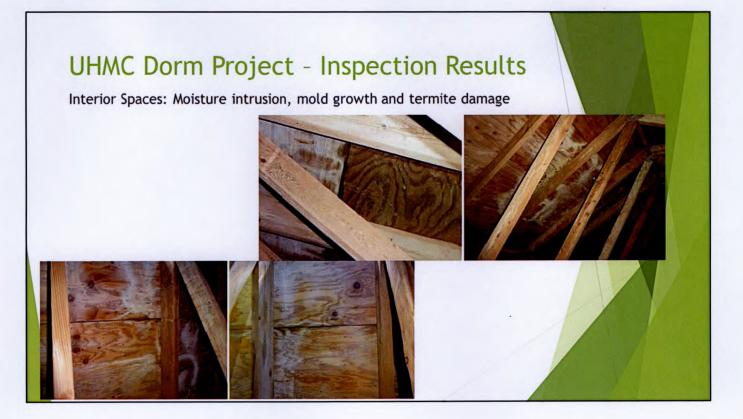
Fire Extinguishers: Most expired and/or missing at required locations

Visible indications of mold present in all attic areas

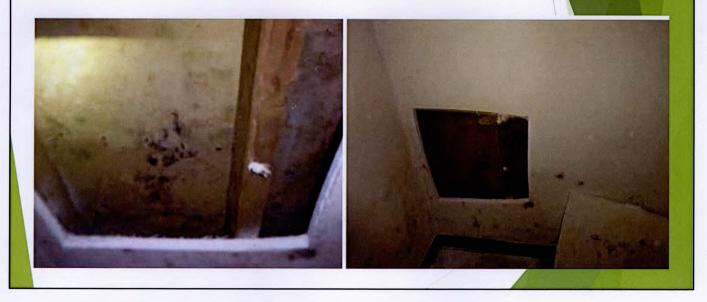
Interior Spaces: Moisture intrusion, mold growth and termite damage

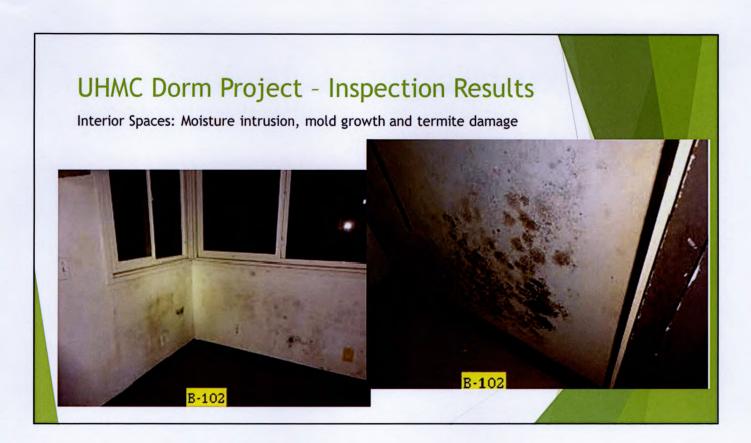
Most of the lower interior wall finishes had moisture damage. In buildings B & C moisture intrusion and mold growth in interior areas, bedroomr, bathrooms and closet areas.

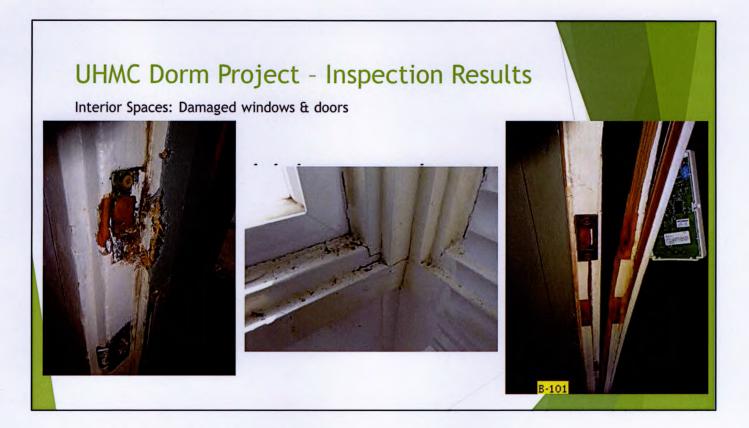
Moisture intrusion and mold growth in interior areas of buildings B & C

Most of the doors had varying degrees of damage. Visible moisture and termite damage at interior window trim areas.

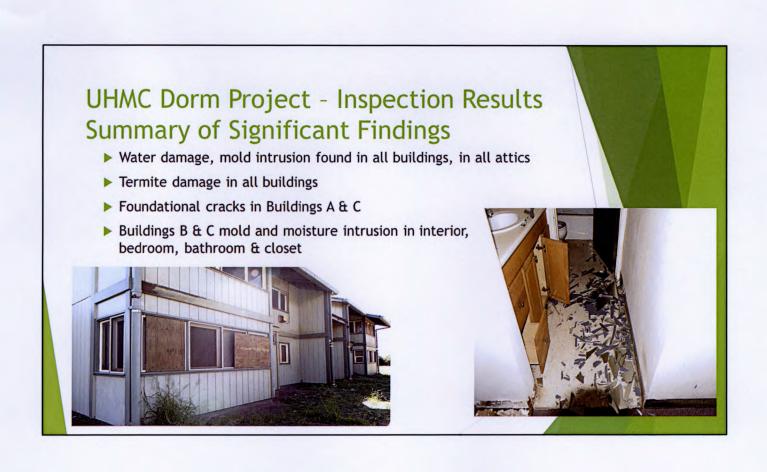
Visible indications of moisture damage, mold growth, damaged flooring, damaged cabinets and counters, damaged mirrors, damaged toilets and damaged shower compartments.
