ATTACHMENT 13C
COUNCIL RESPONSE EM-3 (BF-1)

October 28, 2014

**Subject: Phase I of Post Closure Services for Closed Olowalu Landfill
Olowalu, Maui, Hawaii**

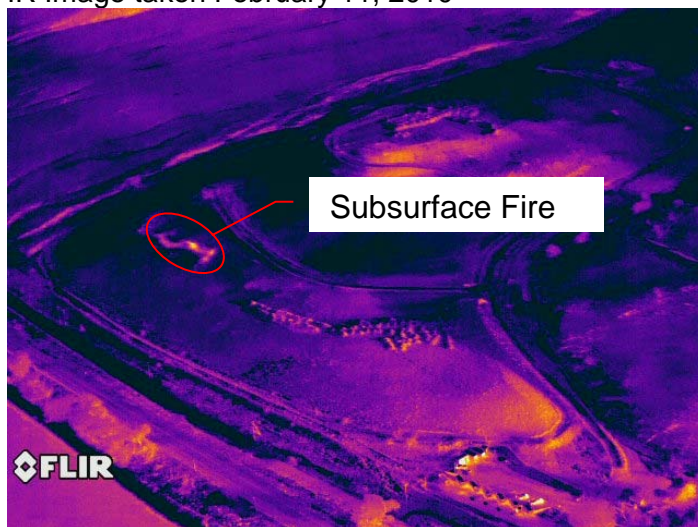
IR Image taken February 11, 2010

were present at the landfill that might indicate that active subsurface landfill fires were present. Photos were taken after the sun had risen. The warmth from the sun had begun to heat the surface of the landfill in some areas making it difficult to identify warmer areas indicative of landfill fires. However, the known subsurface fire area is clearly shown on the south-facing slope of the landfill in the IR survey photo below.

The landfill experienced subsurface fires before closure and subsequently at least as late as 2010. The IR survey was conducted clearly showed the known subsurface landfill fire area on the south-facing slope of the landfill. Gas measurements taken during site reconnaissance did not indicate that subsurface fire conditions were present because CO was not detected in any of the gas probes or the landfill gas system ports. Furthermore, there were no indications of active subsurface fire issues (i.e. sinkholes, fissures, smoke, stressed vegetation) at the landfill.

- An IR survey should be conducted to see if there are indications of subsurface landfill fires. If subsurface landfill fires exist, the landfill should be visually monitored at least quarterly to check for indications of ongoing subsurface landfill fire conditions. Sinkholes and fissures should be covered and compacted with low permeability cover material.
- The landfill gas system should be decommissioned because methane gas is no longer being produced in quantities that warrant a landfill gas system according both the landfill

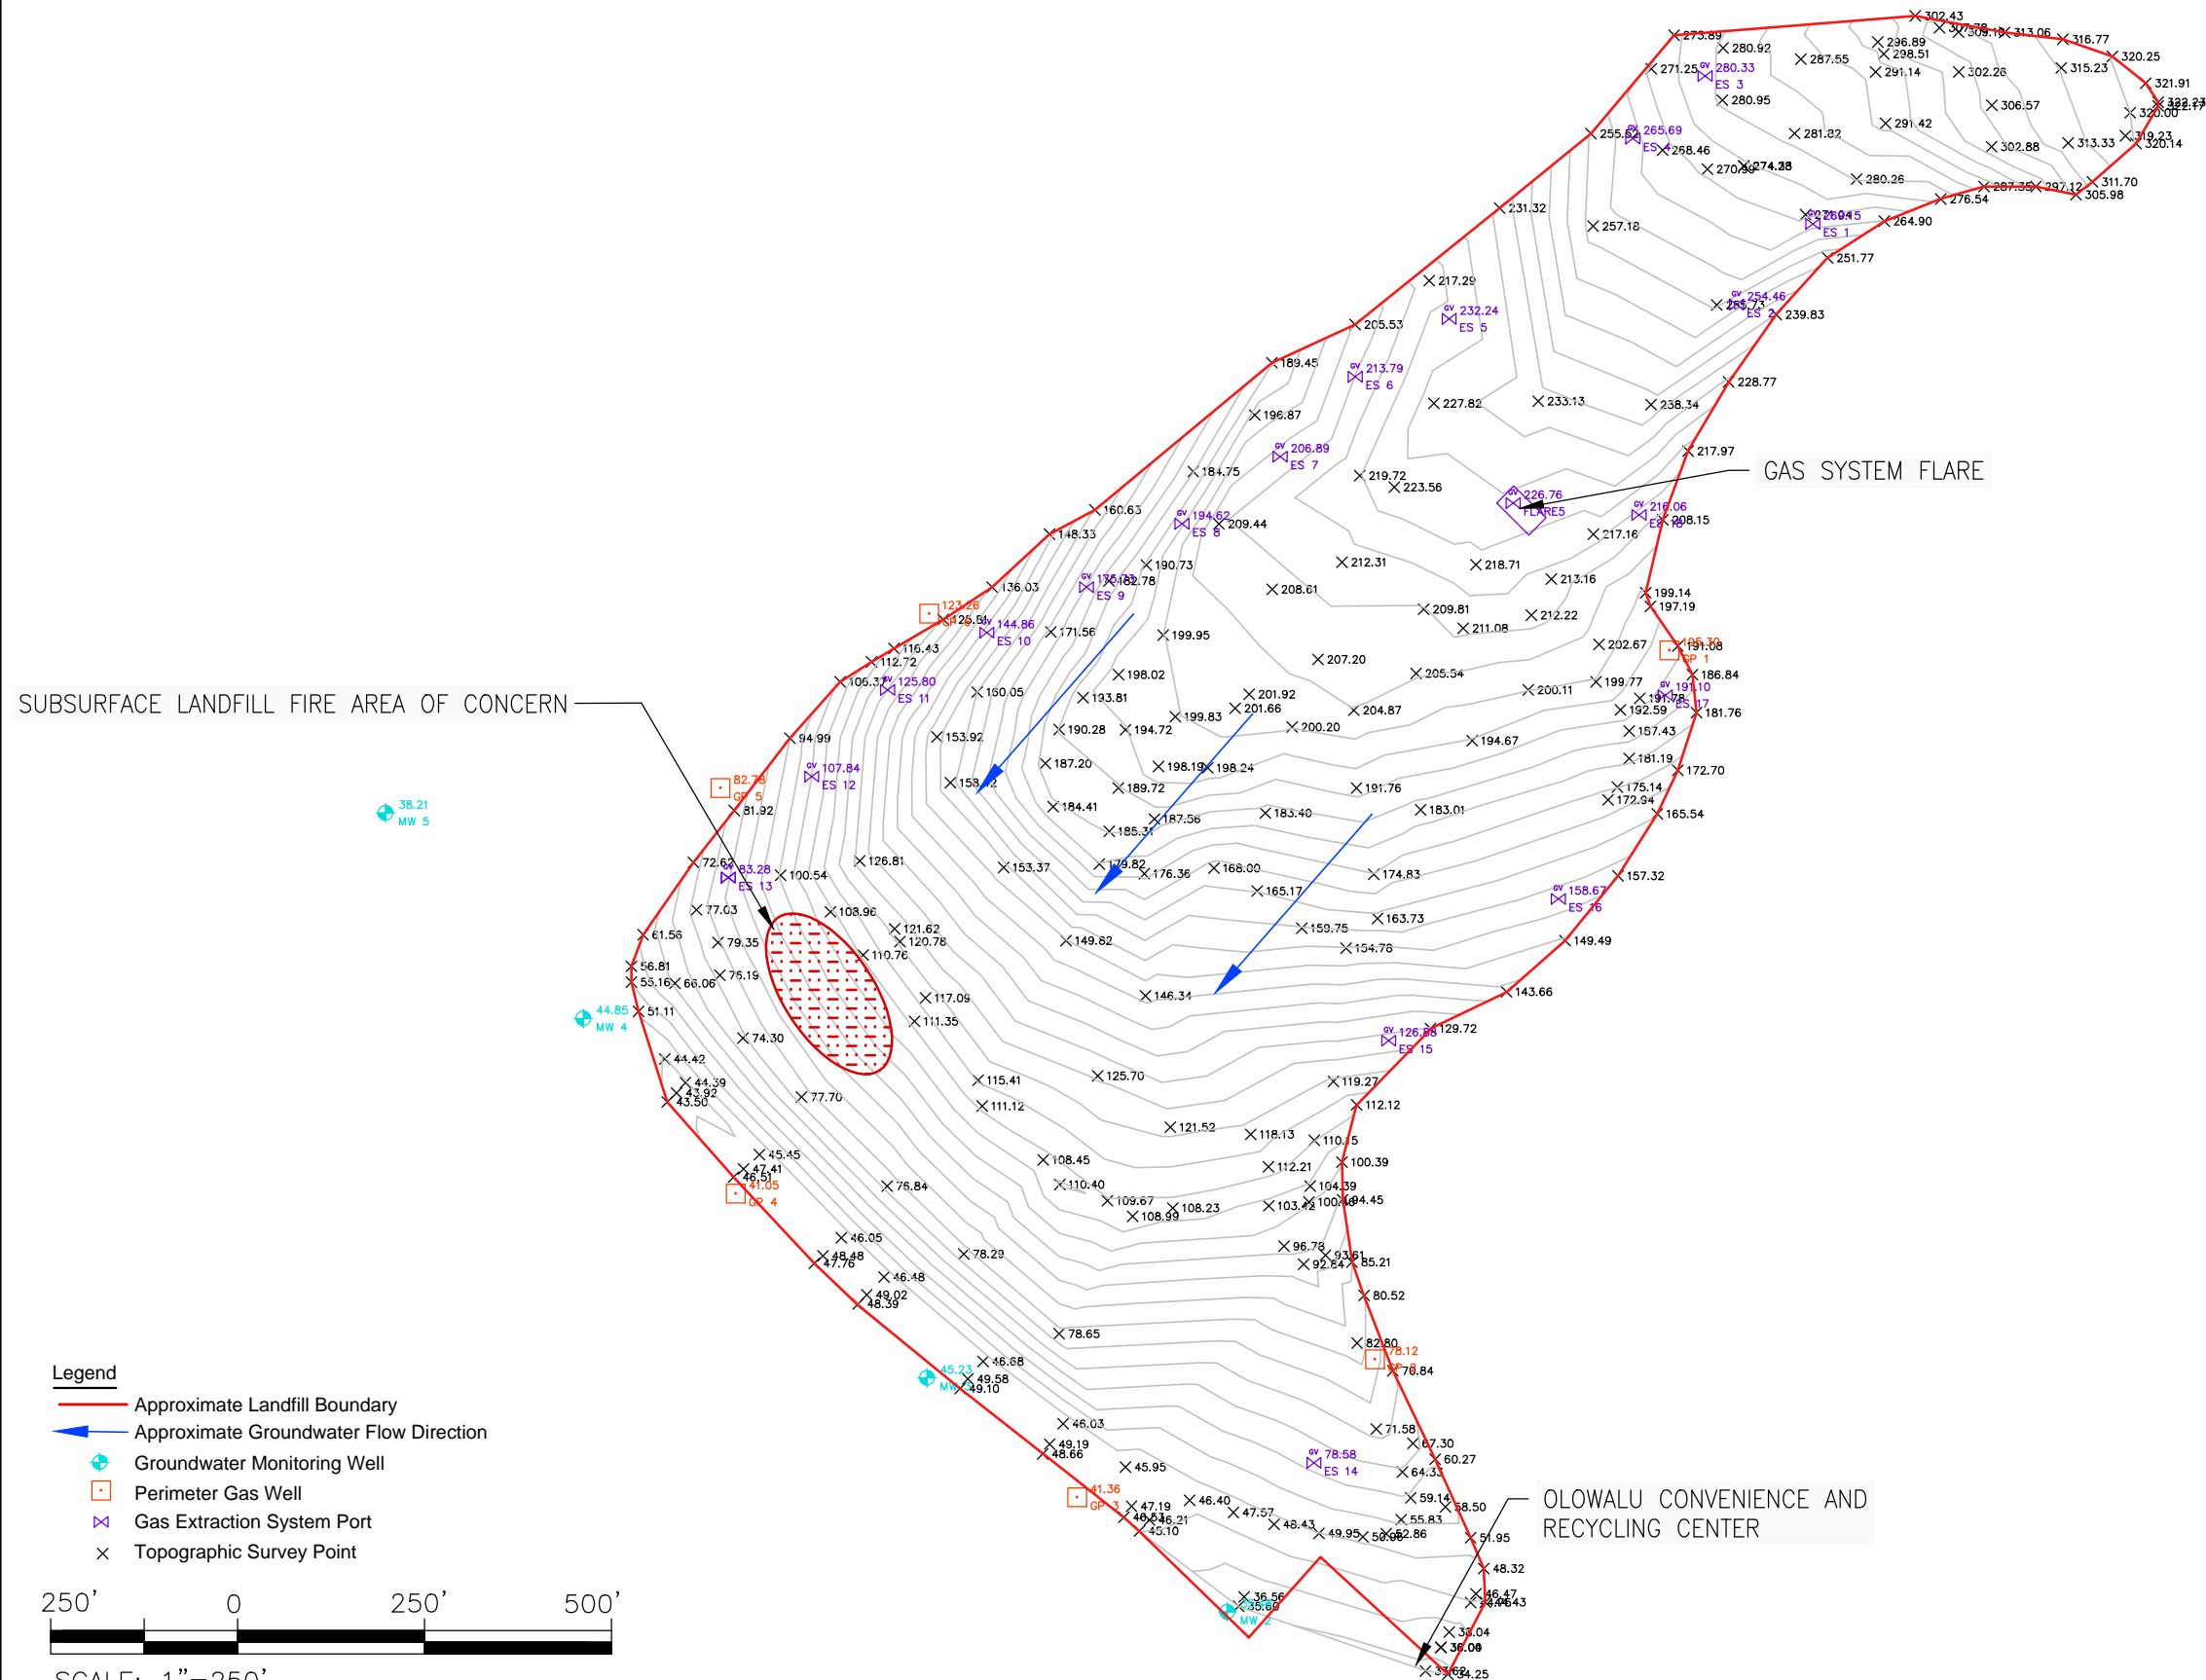
element environmental llc environmental · engineering · water resources	
PROJECT TITLE: PHASE 1 OF POST CLOSURE SERVICES CLOSED OLOWALU LANDFILL OLOWALU, ISLAND OF MAUI, HAWAII	
FIGURE TITLE: SITE MAP AND TOPOGRAPHIC SURVEY	
DATE: OCTOBER 2014	FIGURE NO.: 2

To confirm the calculated volume of the Landfill, E2 used a Trimble® GPS unit to conduct a topographic survey during the January 2014 site visit. The topographic points were compared to the historical 1955/1956 United States Geological Survey (USGS) topo map of the site area. According to the topographic survey, the current total volume of the landfill was calculated to be approximately 1,277,911 cubic yards. The accuracy of the calculated volume may depend on the accuracy of the 1955/56 USGS topographic map used to evaluate the native land surface. The surveyed volume determined by E2 was used to evaluate landfill gas generation. Figure 2 shows the surveyed topography of the site.

Depth to groundwater below the landfill varies across the site. The elevation of the landfill closest to the Honoapiilani Highway is approximately 35 feet above groundwater. The northern most portion of the landfill that extends uphill in the vicinity of the former sludge ponds is approximately 300 feet above the groundwater table (Parametrix, 1991). Groundwater in the vicinity of the landfill generally flows toward the ocean in a southwesterly direction (perpendicular to the shoreline) (Parametrix, Inc. 1994). Figure 2 shows the general groundwater flow direction.

A total of four (4) groundwater monitoring wells remain at the site along the downhill, western boundary of the landfill. All four groundwater monitoring wells were encountered during site reconnaissance in January 2014. The wells were surveyed using a Trimble® GPS unit. Table 1 shows the coordinates and top of casing elevations. Monitoring well locations are shown in Figure 2.

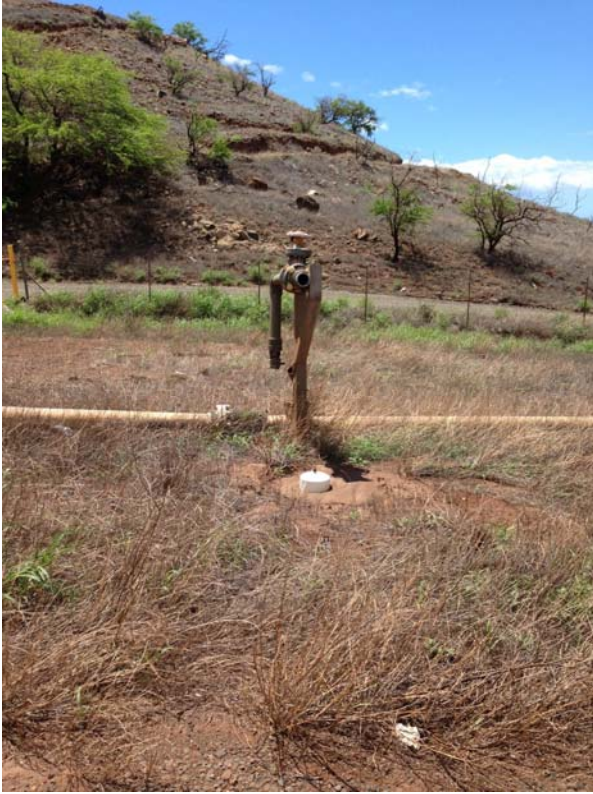
Photo 1: Landfill Gas System Port

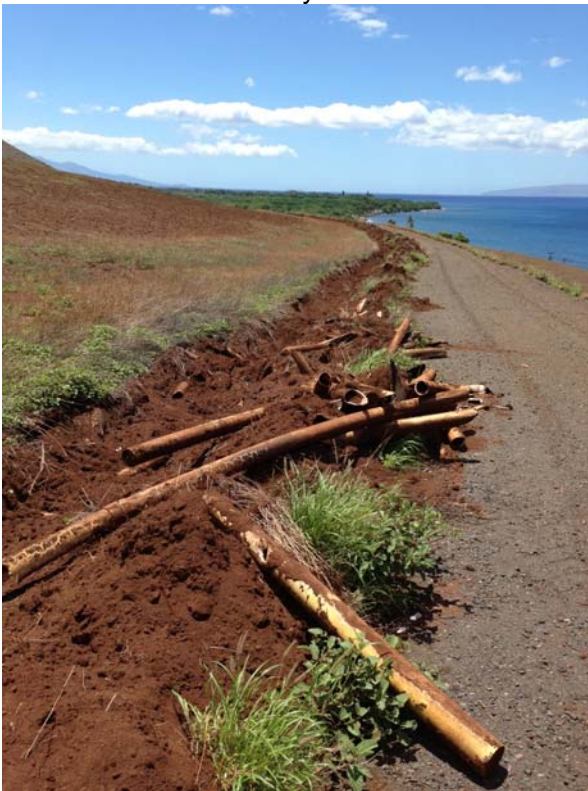
Photo 2: Excavated Gas Collection System

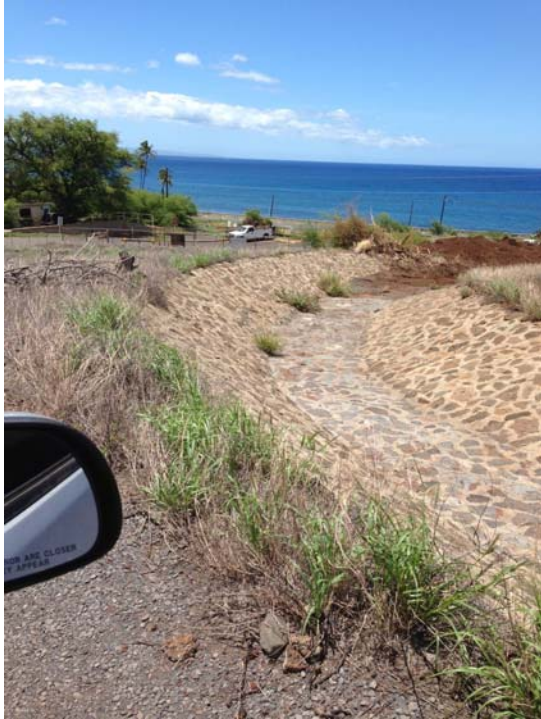
Sediment accumulates in the drainage swales largely due to the lack of vegetation for erosion control and the episodic heavy nature of the storm events. The lack of vegetation coupled with the infrequent heavy storm events erodes the cover material.

Photo 3: Landfill Drainage Swale

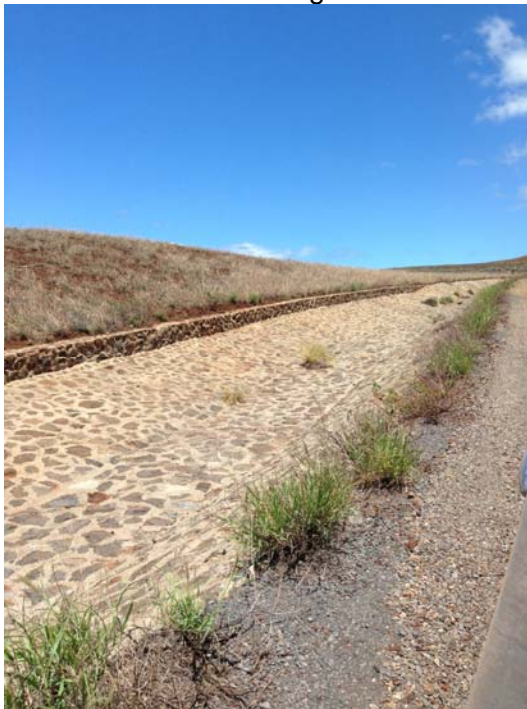
Photo 4: Landfill Drainage Swale

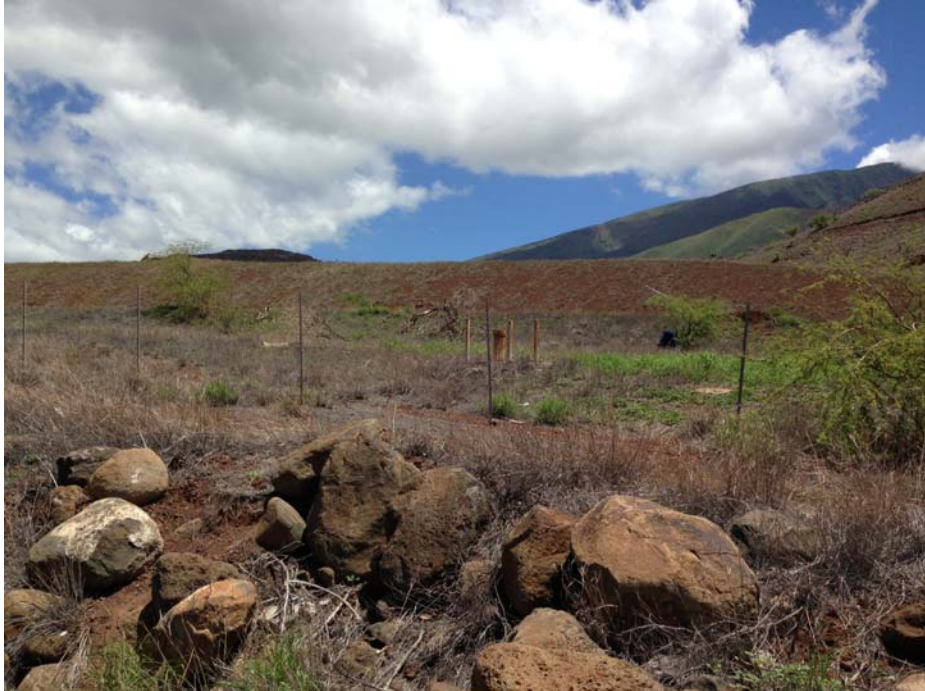
Four groundwater monitoring wells were installed down gradient of the landfill during the landfill's active years. The wells were located and surveyed during site reconnaissance in January 2014. The wells appeared to be good condition. With respect to groundwater, the following conditions exist:

Photo 5: Groundwater Monitoring Well

We do not recommend closure of the groundwater monitoring wells at the site at this time. Due to the close proximity to the ocean, there may be a need in the future to demonstrate that the landfill is not adversely impacting groundwater.

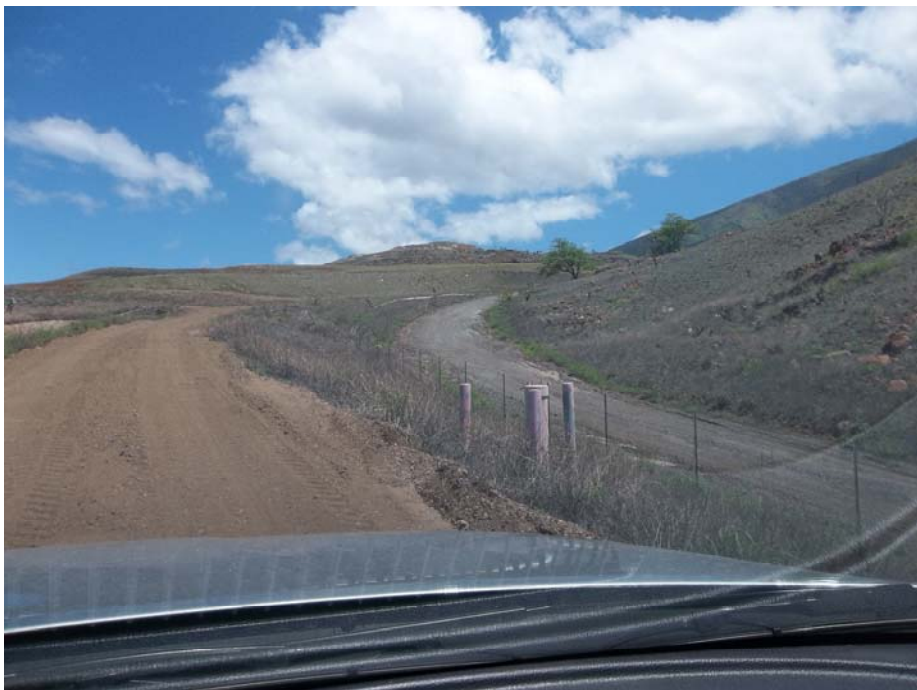
Photo 6: Perimeter Gas Monitoring Well
