ATTACHMENT 13A
COUNCIL RESPONSE EM-3 (BF-1)

October 28, 2014

**Subject: Phase I of Post Closure Services for the Closed Makani Landfill
Makawao, Maui, Hawaii**

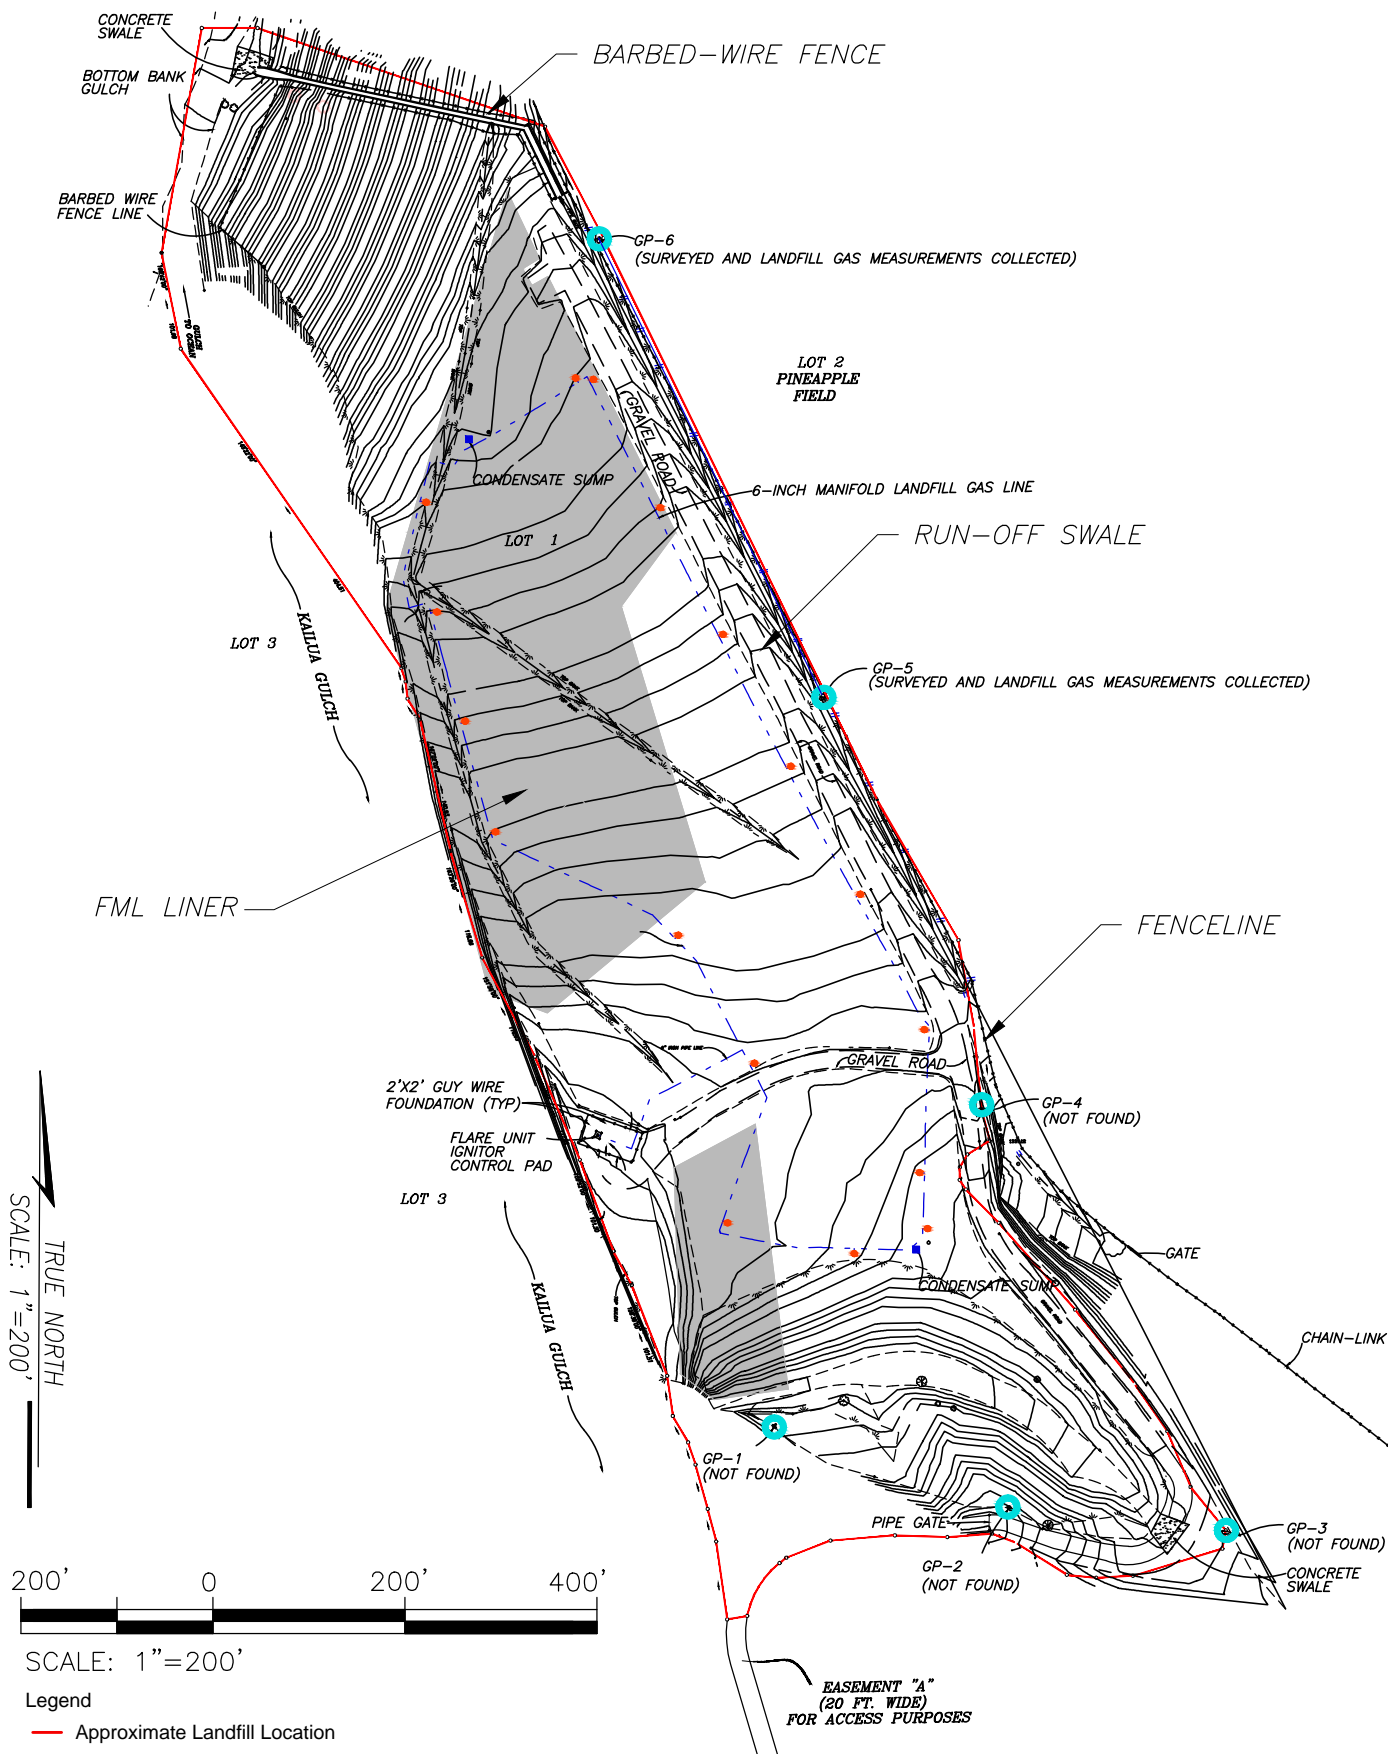
DATE: OCT 2014	PROJECT TITLE: PHASE 1 OF POST CLOSURE SERVICES CLOSED MAKANI LANDFILL MAKAWAO, ISLAND OF MAUI, HAWAII
	FIGURE TITLE: SITE MAP	FIGURE NO.: 2

Originally six (6) perimeter gas monitoring probes (GP-1 through GP-6) were installed at closure. Each well has three nested depths (shallow, middle, deep). Historical monitoring results of perimeter monitoring probes GP-1 through GP-6 do not indicate methane migration. Gas monitoring well locations are shown in Figure 2.

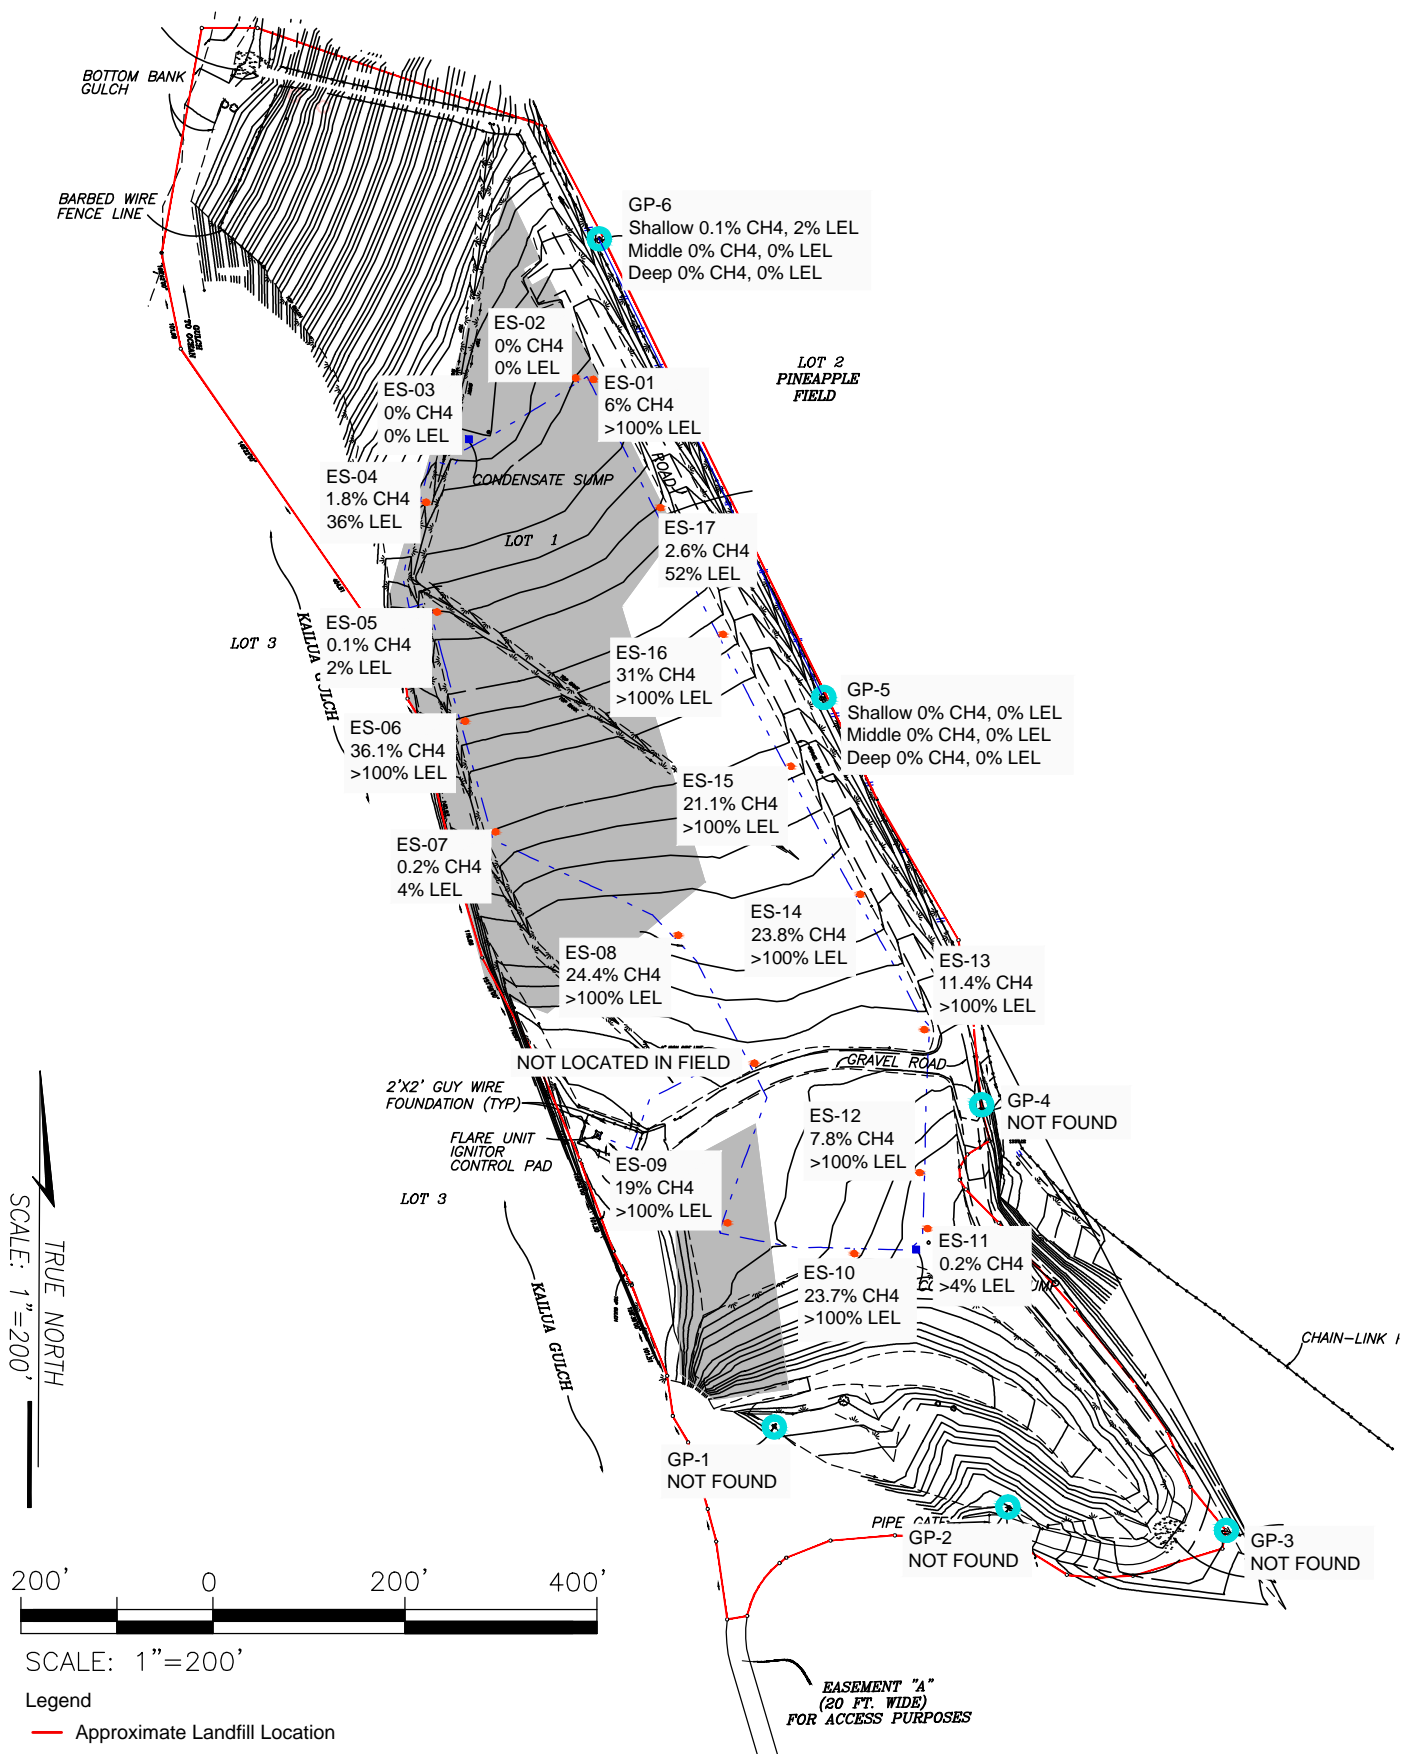
DATE: OCT 2014	PROJECT TITLE: PHASE 1 OF POST CLOSURE SERVICES CLOSED MAKANI LANDFILL MAKAWAO, ISLAND OF MAUI, HAWAII
	FIGURE TITLE: MEASURED METHANE CONCENTRATIONS IN LANDFILL GAS	FIGURE NO.: 3

Landfill gas was monitored in trench connection ports identified during the field survey as ES-01 through ES-17. Methane levels greater 5% by volume and 100% of the lower explosive limit (LEL) were measured in the ports throughout the landfill. Locations of the ports monitored and methane concentrations are shown in Figure 3. All valves in the gas system were in the off position, therefore landfill gas measurements collected in the field were representative of steady state landfill gas concentrations and not landfill gas flow concentrations.

During the January 14, 2014 field survey, two perimeter gas wells (GP-5 and GP-6) were encountered and surveyed during site reconnaissance. E2, with the help of the County, searched for GP-1 through GP-4, but were unable to locate the wells. The perimeter gas probes were monitored using the GEM 2000 Plus landfill gas meter. Methane (CH₄) was detected in the shallow probe at GP-6 at 0.1% volume (2% of the LEL). CH₄ was not detected in GP-5 or the middle and deep probes at GP-6. Table 2 shows the monitoring results and the conditions of the probes. Figure 3 shows the monitoring results on the site map.

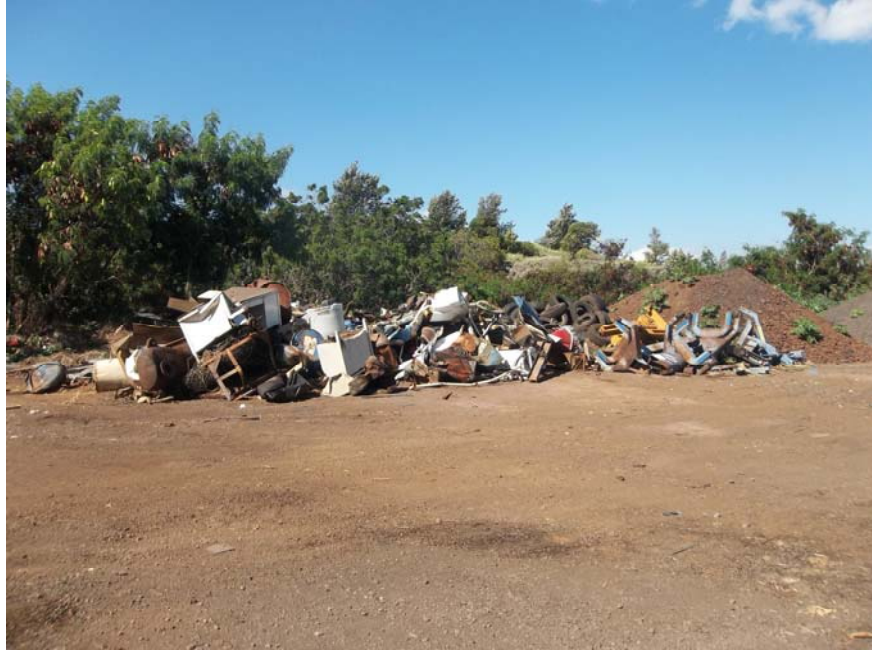
- Stockpiles of soil, sand, boulders for County DOT road construction projects;
- Dilapidated dump trucks;
- Piles of metal and other debris;
- Large metal vats;
- and tires.

Photo C-1: Scrap Metal Piles

- Prepare an HDOH-approved Post-Closure Plan that addresses post closure use as well as maintenance and monitoring requirements.
- Conduct a topographic survey of the property to meet requirements of the Post-Closure Plan.
- Create and implement a policy decision regarding use of site for storage of construction material and equipment by County agencies.
- Remove scrap trash trucks and other debris/solid waste.
- If decision is to use site for storage, initiate concurrent activities (1) permit the proposed use through HDOH; and (2) develop agreements with County agencies outlining acceptable operating guidelines for the site.
- Continue to maintain the gate which blocks vehicular access to the property from the adjacent Ahualani Place.

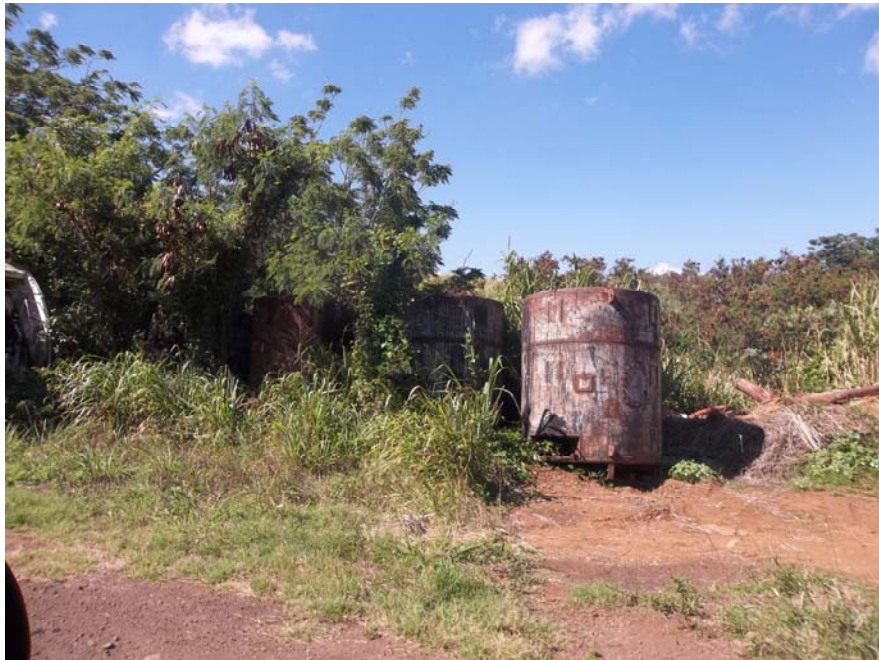
Photo C-2: Large Metal Tanks

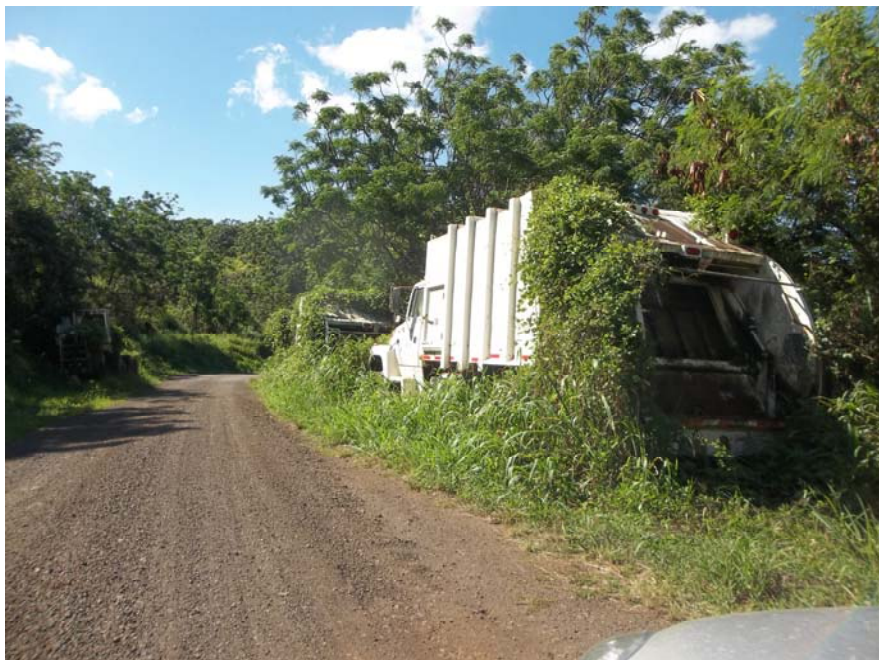
Post-closure uses weren't specified in the landfill's Post Closure Plan. The current post closure use of the site is open space with moderate use as storage of construction materials and dilapidated trash trucks.

Photo C-3: Decommissioned Dump Truck

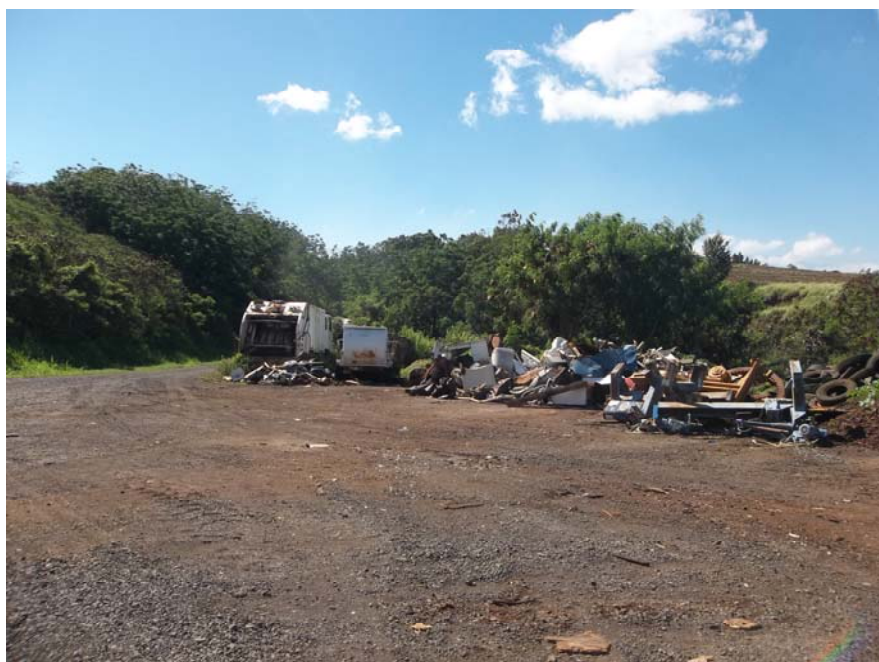
Photo C-4: Decommissioned Dump Truck and Scrap Metal Pile

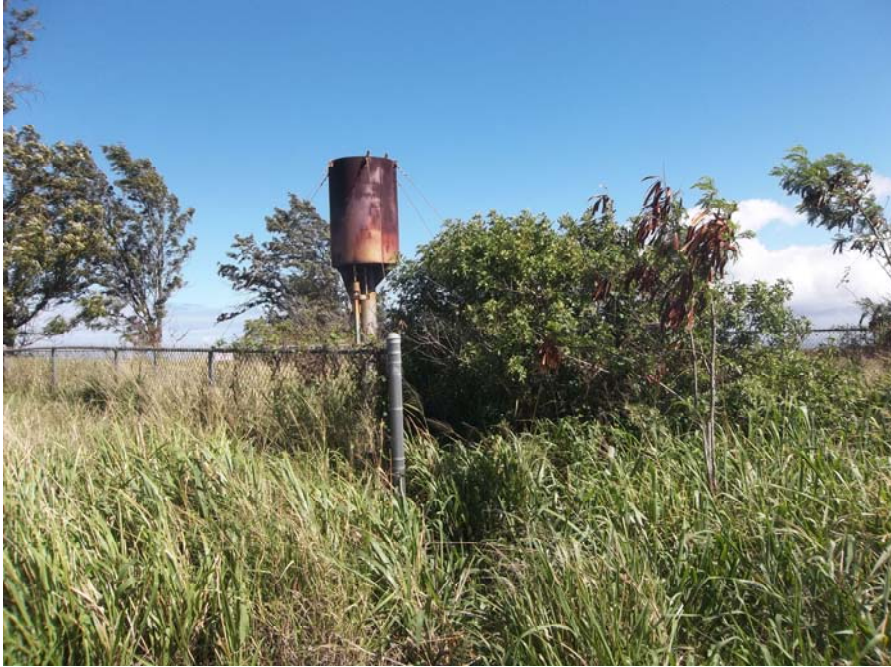
routed to the flare facility via the gas manifold. Condensate knock-outs are located at low points along the manifold (Parametrix, Inc., 1993). During the site survey, the landfill gas system appeared to have been appropriately shut down. All valves and the flare system were in closed position.

Photo C-5: Landfill Gas Flare Facility

- The landfill gas system should be decommissioned because methane gas is no longer being produced in quantities that warrant a landfill gas system. If the system becomes dilapidated, it could be a conduit for oxygen which could fuel future subsurface fires. The landfill gas system should be decommissioned by capping off the risers below ground level at each connection to the manifold and removing the flare and above-ground piping.

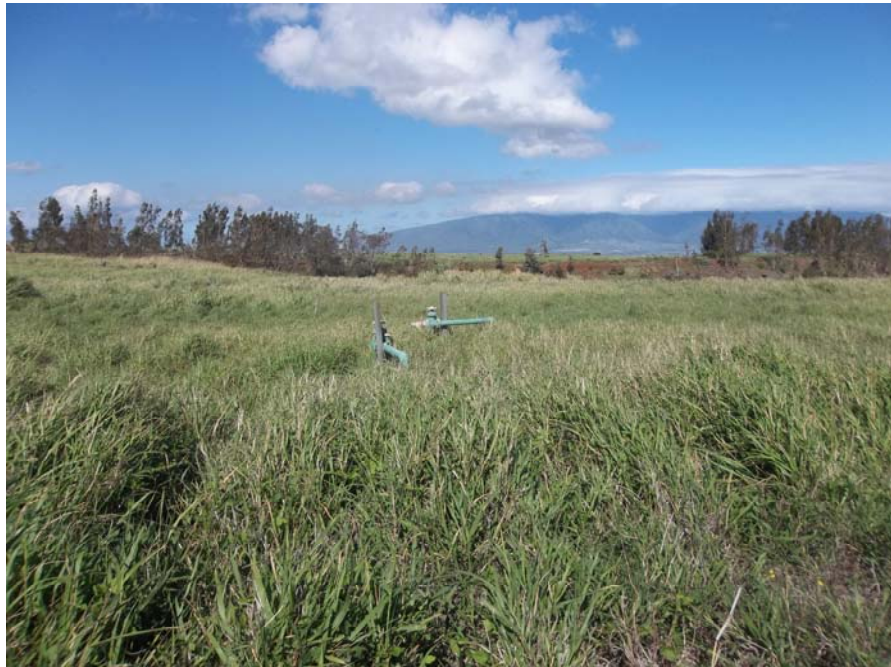
The trenches are connected to the above-ground manifolds with trench completions. The trench completions include a throttling valve and a monitoring port with a ¼-inch labcock valve (Parametrix, Inc., 1993). The landfill gas was measured at the monitoring ports using the GEM 2000 Plus landfill gas meter. Table 2 shows the results of landfill gas monitoring at the trench completion ports and also documents the condition of the trench completions encountered during the field survey.

Photo C-6: Landfill Gas Trench Completions with Throttling Valve and Monitoring Port

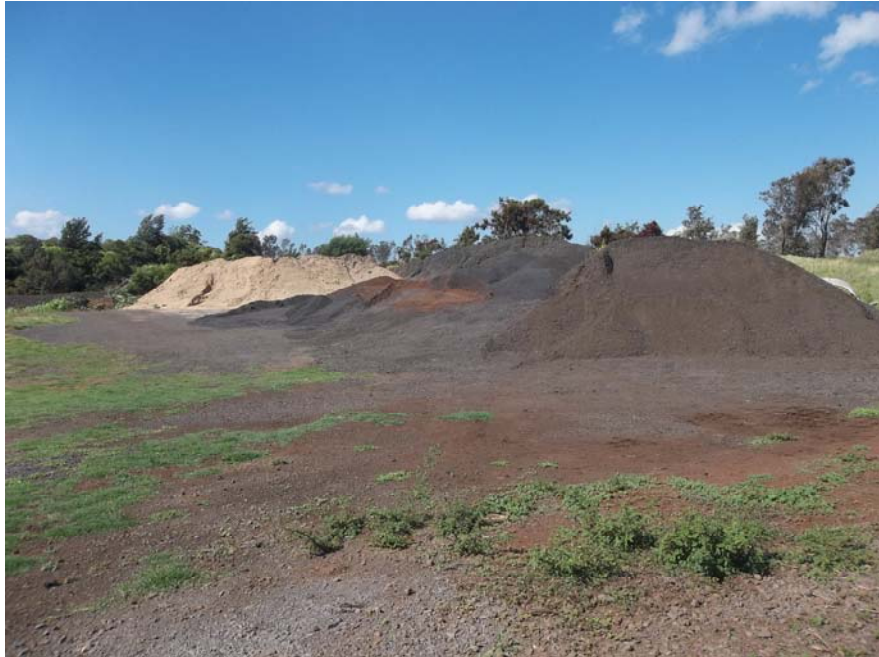
Photo C-7: Material Stockpile

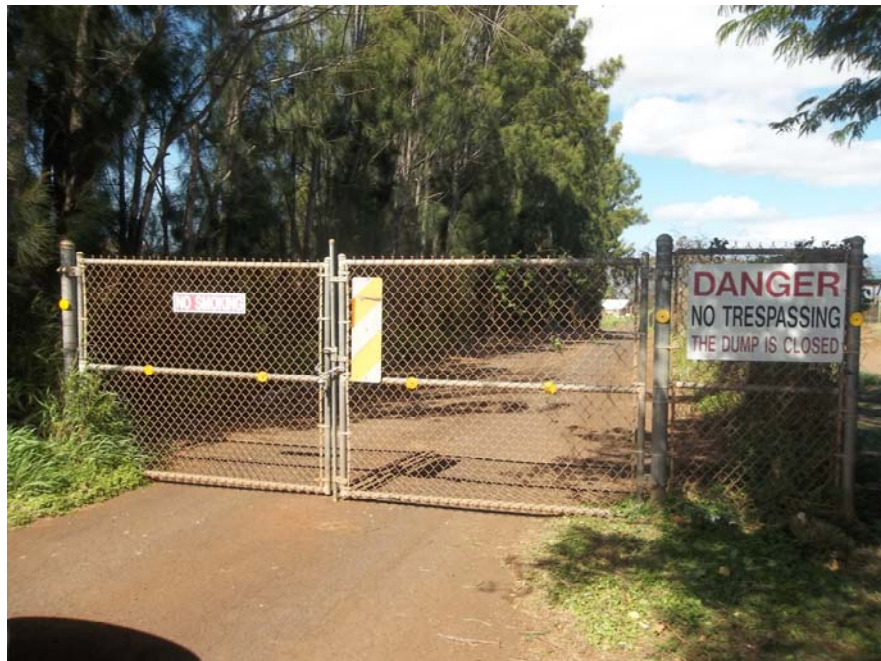
Post-closure use was not addressed in the Post-Closure Plan. The site is currently secured by two locked gates along the landfill's access road and a chain-link fence. During the field investigation the following was stored on site:

The property deed states that the County is to maintain a "steel pipe field gate" which block vehicular access to the property from the adjacent Ahualani Place. The gate must continue to be maintained and secured during post closure use of the landfill.

Photo C-8: Secured Entrance/Exit
