SUBJECT: COUNTY-OWNED PARCEL ON NORTH PAPA AVENUE (KAHULUI)

UHMC Dorm Project Description

UHMC Dorm Project - Inspection Results Summary of Significant Findings

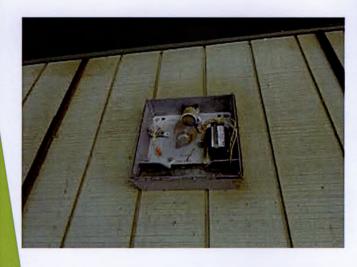
Exterior Lighting: Some damaged

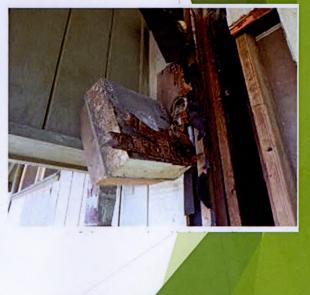
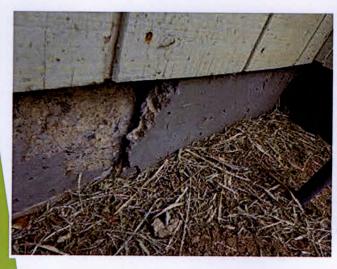
Foundation Areas: Visible cracks in Buildings A & B

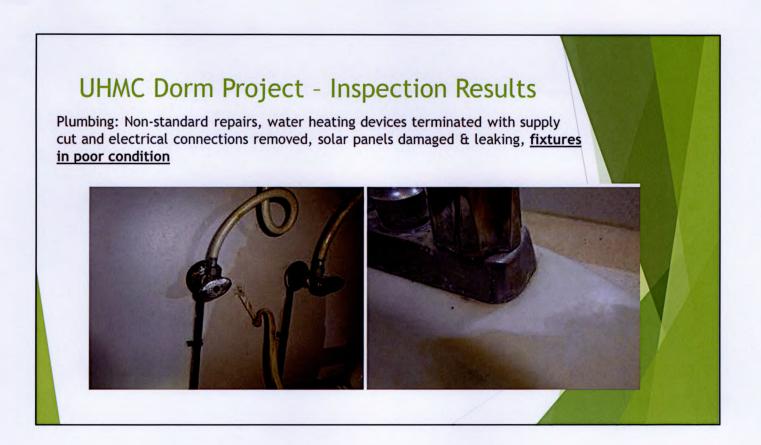
All water hearing appliances were terminated with supply and service plumbing cut and electrical connections removed. Recommend having a licensed pumber evaluate and install commercial grade gas on demand hot water hearing systems for each floor of each building

Based on observed physical conditions of the installed fixtures, it is recommended to replace all plumbing fixtures and shut off valuees in all buildings to ensure proper future operation

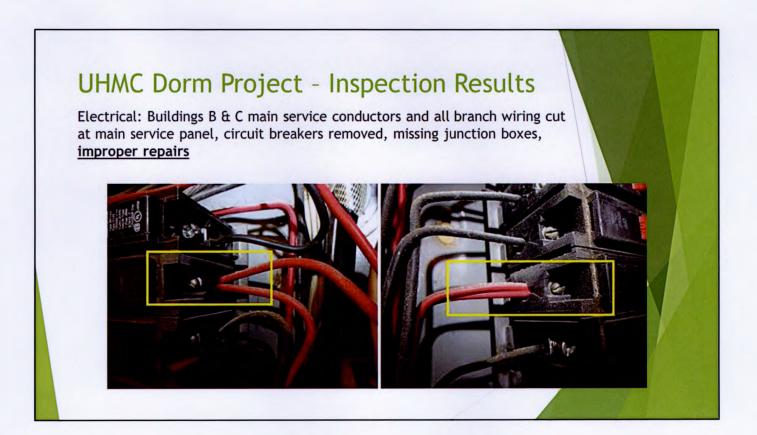
Main service conductors and all electrical branch wiring was cut at the main service panel entrance. Need electrical contractor to evaluate and repair electrical service to each building.

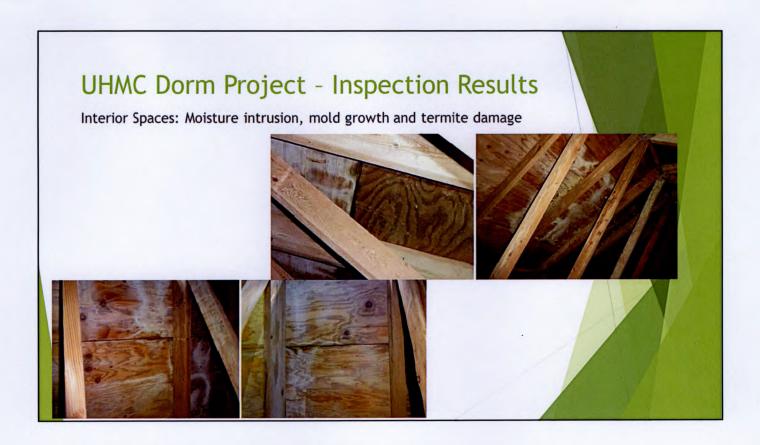
Visible indications of mold present in all attic areas

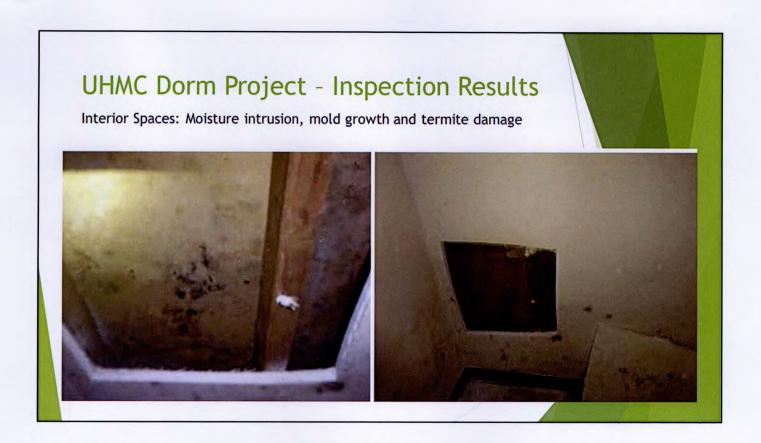
Most of the lower interior wall finishes had moisture damage. In buildings B & C moisture intrusion and mold growth in interior areas, bedroomr, bathrooms and closet areas.

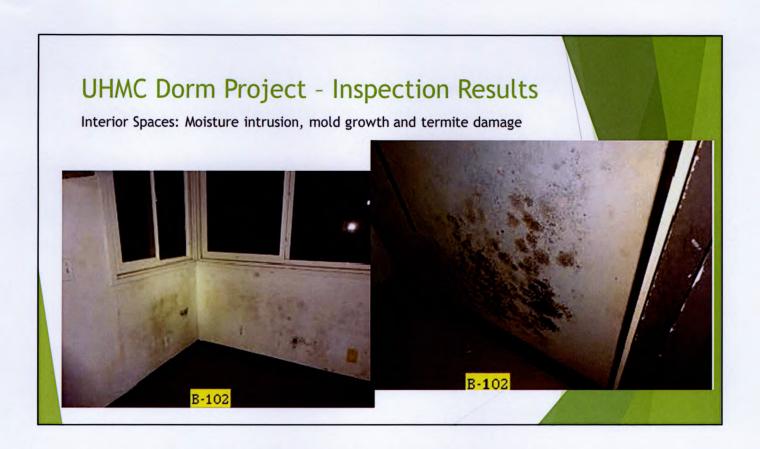
Moisture intrusion and mold growth in interior areas of buildings B & C

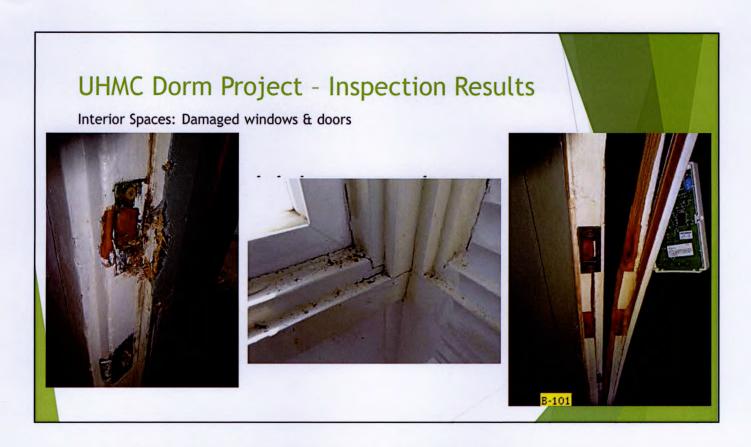
Most of the doors had varying degrees of damage. Visible moisture and termite damage at interior window trim areas.

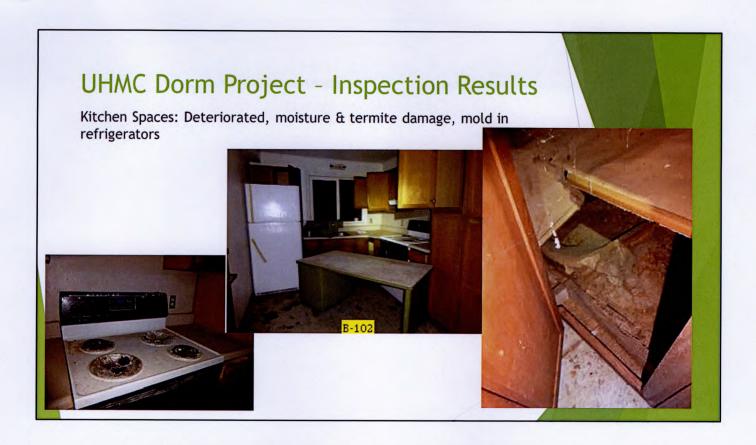
While a few of the kitchens in Building A appeared operable, Buildings B & C were not in good shape

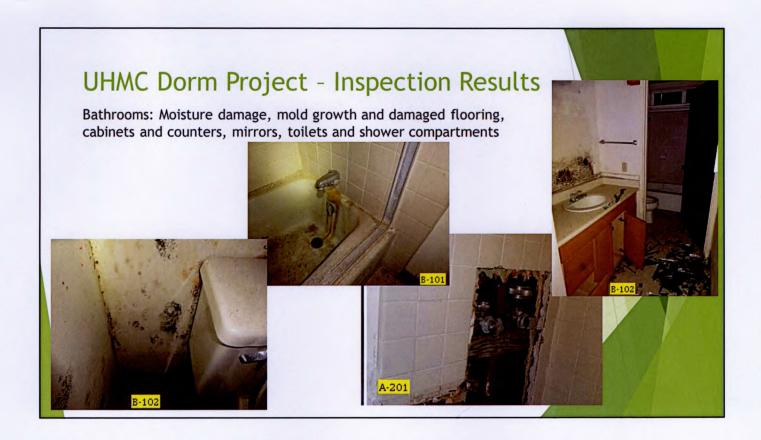
Visible indications of moisture damage, mold growth, damaged flooring, damaged cabinets and counters, damaged mirrors, damaged toilets and damaged shower compartments.
