# Property Condition Assessment

24 North Church Street

24 North Church Street  
Wailuku, Hawaii 96793

**Project No. SF-0002115919**  
**Site Visit Date: April 29, 2025**  
**Report Date: May 30, 2025**

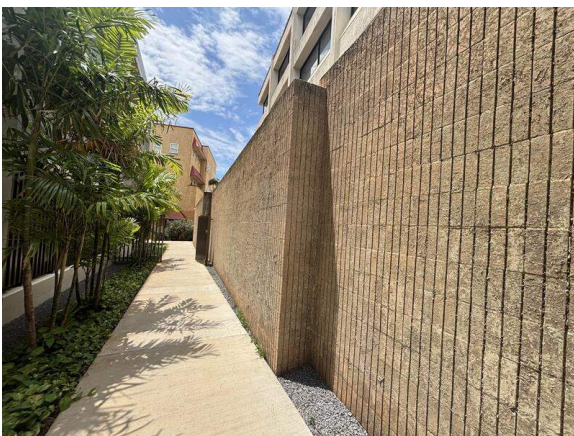
**5** Perimeter site wall

The brick veneer on the outside of the CMU perimeter site walls at the south, east, and north sides of the building are heavily soiled and have deficiencies noted in the grout. The walls should be power washed and brick grout be repointed.

| No. | Deficiency | Description | Unit | Unit Cost | Qty | Total | Deficiency Photo |
|---|---|---|---|---|---|---|---|
| 1 | Allowance to clean and repoint brick veneer at site walls | The brick veneer on the outside of the CMU perimeter site walls at the south, east, and north sides of the building are heavily soiled and have deficiencies noted in the grout. The walls should be power washed and brick grout be repointed. | LF | \$5 | 2000 | \$10,000 | |

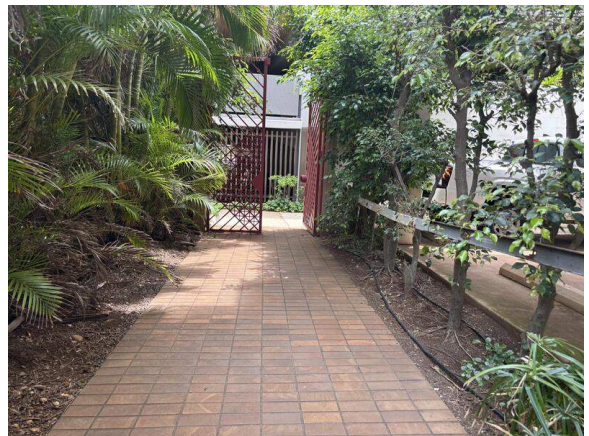
**10** North exterior walkway

| No. | Deficiency | Description | Unit | Unit Cost | Qty | Total | Deficiency Photo |
|---|---|---|---|---|---|---|---|
| 2 | Install new handrails at the north exterior walkway | The handrail at the low sloped walkway at the north side of the site is made out of metal framing and mounted on plants along the walkway. The makeshift rail is a hazard and needs to be replaced with a code compliant handrail. An additional handrail should also be installed on the other side of the walkway. | Allow | \$5,000 | 1 | \$5,000 | |

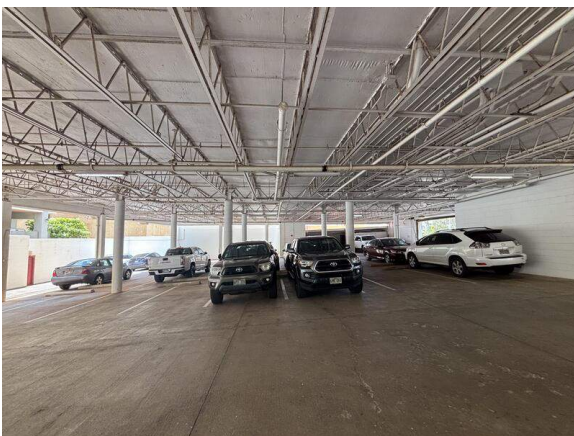
**11** Ground floor parking level

| No. | Deficiency | Description | Unit | Unit Cost | Qty | Total | Deficiency Photo |
|---|---|---|---|---|---|---|---|
| 3 | Allowance to repaint structural steel and exterior metals | The metal open web joists at the underside of the concrete deck at the ground parking level is starting to rust. All of the existing paint and rust should be removed and all exterior metals should be repainted to protect the metal from deteriorating. An opinion of cost is included in the immediate cost table. | Allow | \$6 | 8000 | \$48,000 | |

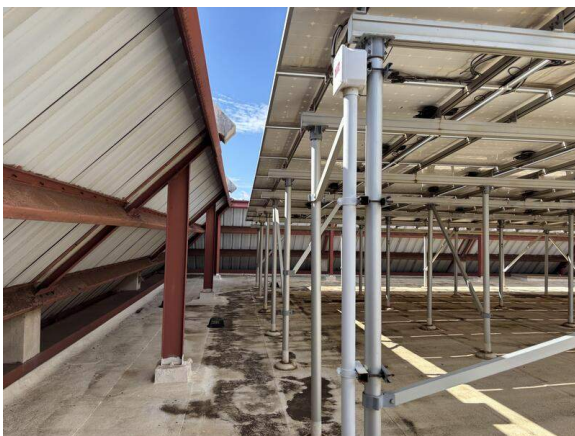
**17** Typical roof perimeter

| No. | Deficiency | Description | Unit | Unit Cost | Qty | Total | Deficiency Photo |
|---|---|---|---|---|---|---|---|
| 8 | Allowance for metal roof panel cleaning, repair, and repaint | The pitched metal paneled roof at the perimeter of the roof has severe corrosion noted at the framing. The paint on the frame is falling/chipping off in most places. An allowance to clean the panels and frames, make necessary repairs/replacements and repaint the panels and frames is included. | Allow | \$10 | 6300 | \$63,000 | |

The roof perimeter has a pitched metal framed and metal paneled system mounted on top of it. Over all the metal panels appear to be in fair condition, the metal framing supporting the panels, however, is in fair to poor condition. The frame is corroding and the paint on the frame is falling/chipping off in most places. The metal frame could be sand blasted and repainted to extend the overall system's life. However, some areas of the frame will likely need replacement or reinforcement. The cost to clean and repaint the system may be more than possibly removing it, which could be an alternative solution. The system is not supporting parts of the building but if not maintained will pose as a hazard due to the panels possibly falling off the roof.

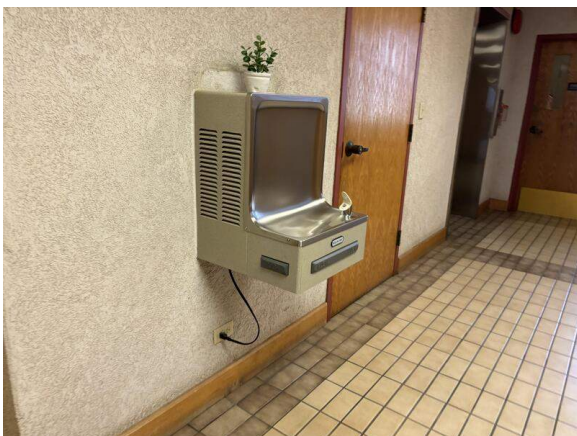
**23** Typical drinking fountain on each floor

Accessibility deficiencies were noted and include items at the restrooms such as missing sink pipe covers; missing signage at elevator door jams on each floor, and the drinking fountains without detectable warnings on each side. It is recommended a full ADA survey be conducted at the property to identify all barriers.

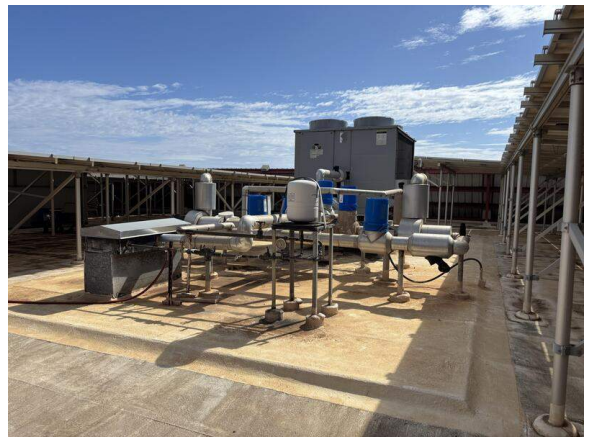
**34 Main condenser at the roof**

The air conditioning system which mainly consists of a roof top chiller that feeds air handlers in the office spaces required replacements at this time. The chiller on the roof is severely corroded and needs to be replaced immediately as sections are being held but by 2 x 2 wood posts. The property reported a new chiller was ordered two weeks prior to our inspection and should be installed sometime this year. Associated piping for the chiller is in good to poor condition. Poor sections of piping are reportedly to be replaced with the new chiller. A fresh air intake system is installed at the roof which consists of two intake units and an exhaust fan. One of the intake units is currently not working. The system appears to be at the end of its useful life and needs to be replaced.

| Item | Quantity | Unit | Unit Cost | Replacement Percent | Immediate Total |
|---|---|---|---|---|---|
| Remove and Replace Chiller and old piping | 1 | Allow | \$206,000.00 | 100% | \$206,000 |

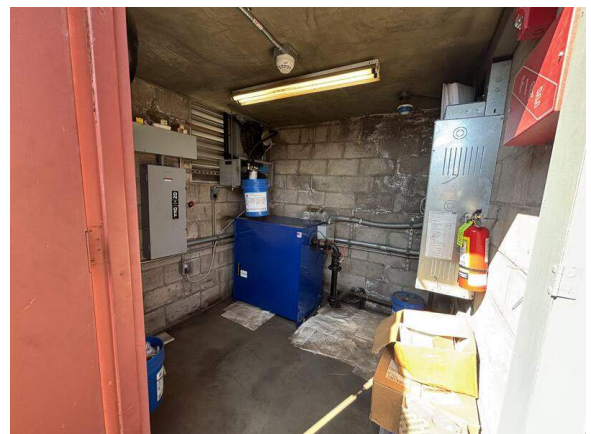
**48 Elevator machine room**

| No. | Deficiency | Description | Unit | Unit Cost | Qty | Total | Deficiency Photo |
|---|---|---|---|---|---|---|---|
| 4 | Allowance to further investigate stairwell roof and repair water damage to CMU walls | Efflorescence was observed at CMU walls in the elevator equipment room and stairwell that goes to the roof. Water could be entering the wall from the roof above. The source of water should be determine prior cleaning and repainting the CMU walls. The roof above the stairwell was not observed during CBRE's site visit and should be surveyed to determine if deficiencies are present. An allowance to survey the roof and clean and seal CMU walls is included. Depending on the the investigation findings, costs may go up or down. | Allow | \$5,000 | 1 | \$5,000 | |

| Item | Quantity | Unit | Unit Cost | Replacement Percent | Immediate Total |
|---|---|---|---|---|---|
| Allowance to repair elevator machine room items | 1 | Allow | \$2,000.00 | 100% | \$2,000 |
