DEPARTMENT OF THE CORPORATION COUNSEL
COUNTY OF MAUI
200 SOUTH HIGH STREET, 3RD FLOOR
WAILUKU, MAUI, HAWAII 96793
EMAIL: CORPCOUN@MAUICOUNTY.GOV

SUBJECT: Litigation Matters
Settlement of Claim: David Gardiner
John Mullen Claim No.: 4070286
Resolution: Authorizing Settlement of Claim No. 4070286 of
David Gardiner

PROPERTY DAMAGE RELEASE

CLAIM FOR DAMAGE OR INJURY

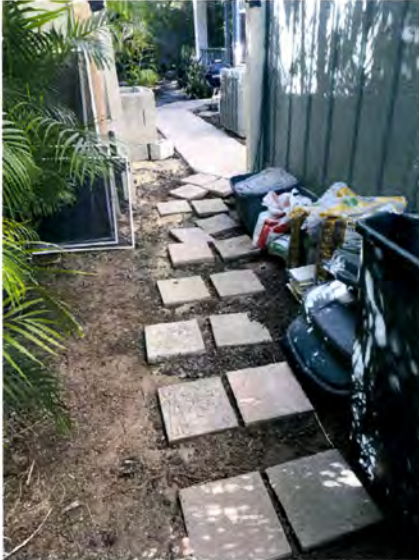
#1 – Landscaping restoration - Restoration work scheduled for mid July 2021
Total estimated expense = \$3302.06 (see invoice below)

All the landscaping bark, underlying topsoil, sand underlying the paving stones and lava pea gravel were washed away.

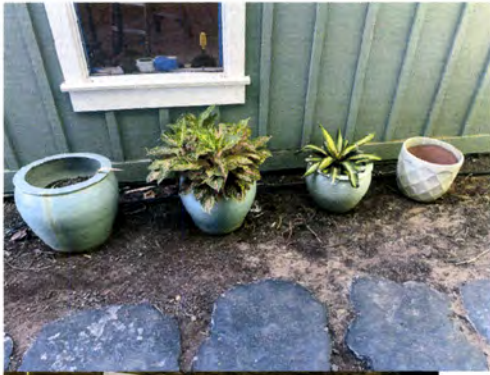
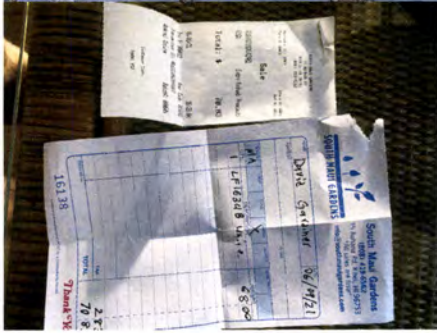
#4 – Plant pot (1)

We had 4 green plant pots. One was washed away in the flood and we replaced it with a new one (forth on the right) that is comparable to the other 3 pots

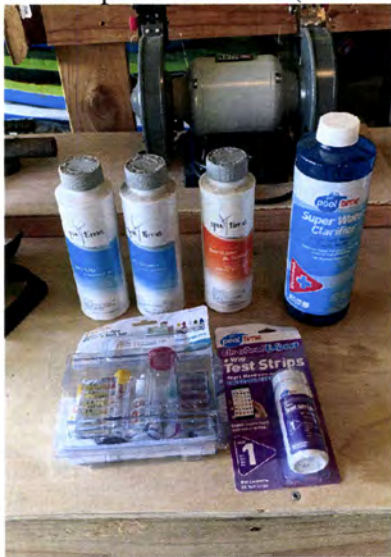
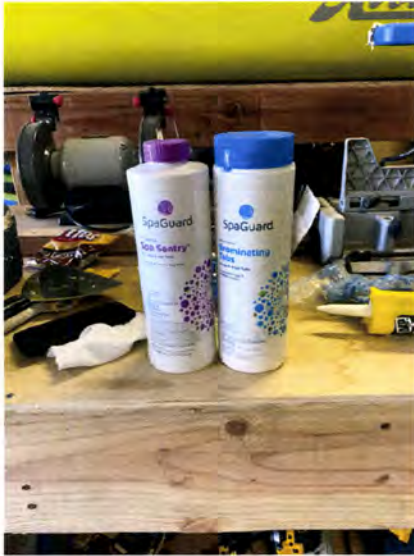
#5 – Spa supplies and test kit

The box that contained the chemicals and test kit for the spa was washed away.

We replaced the following items as illustrated in the photos (Ph Up - Ph Down - Spa shock - Spa clarifier - Chemistry test kit - Ph strips - Spa Sentry Ph buffer - Brominating tablets).
