Subject: **COMMUNITY PLAN AMENDMENT AND CHANGE IN ZONING FOR MAALAEA AGRICULTURAL SUBDIVISION (PSLU-41)**

**POHAKEA WATERSHED / MA'ALAEA BAY  
MAUI COUNTY, HAWAII  
STORMWATER MANAGEMENT PLAN**

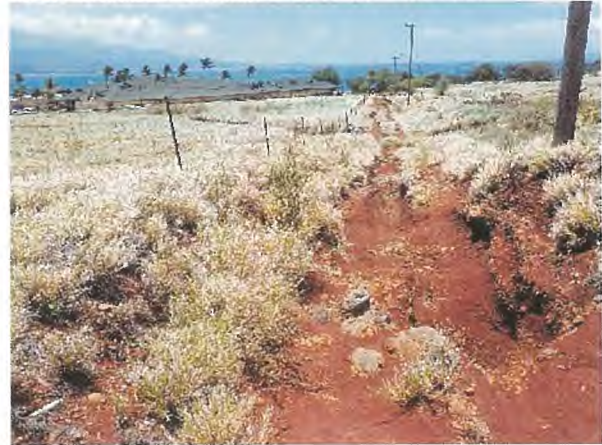
Distribution Lines and Failed Roads

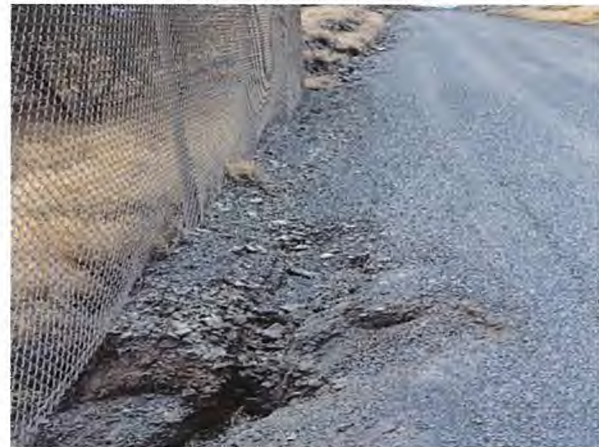
Gravel Loss at Kickouts

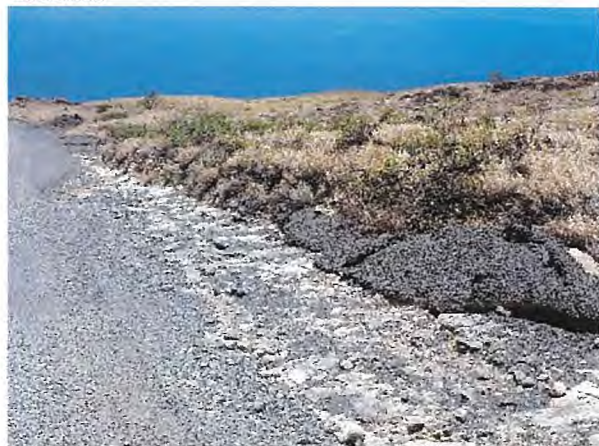
Channelization and Gravel Loss in Swale

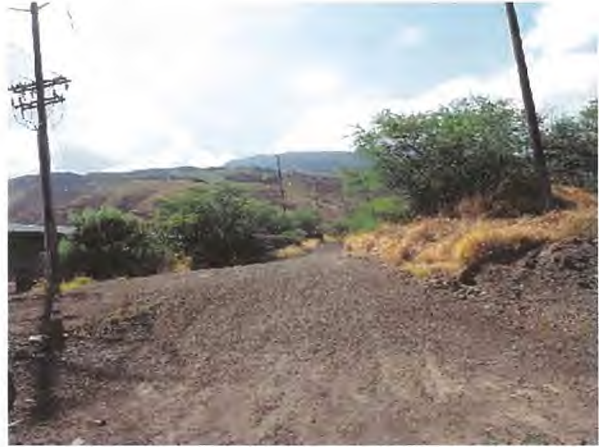
Gravel Roads with Mud and Erosion

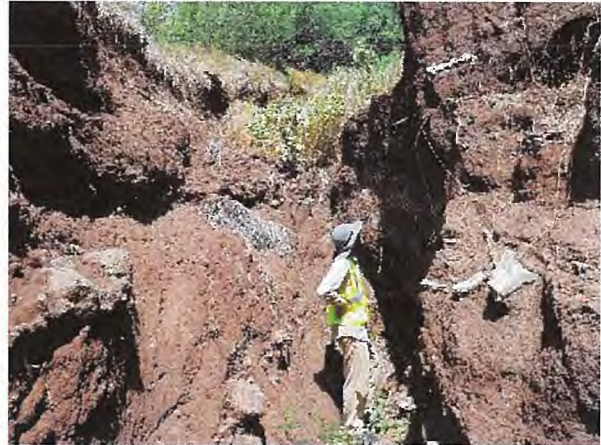
Substantial loss of sediment was observed along the upstream side of the highway where stream flow was directed underneath the highway through box drains and culverts. The constriction point created by these culverts, possibly due to their being undersized, has led to extensive head cutting within the stream channel and loss of many tons of sediment material during times when the streams flow. Head cuts occur when stream force is directed downward due to a constriction of flow (in this case a road culvert), and creates a sheer bluff or cliff known as the knickpoint. The head cutting observed was 'active' in that more stream channel incision, loss of floodplain connectivity, and loss of sediment at an exponential rate will continue and worsen as the knickpoint migrates further upstream each time the stream flows.

Head Cutting

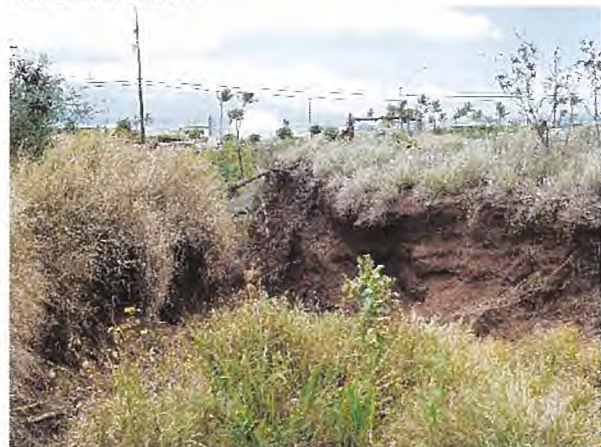
Channelization

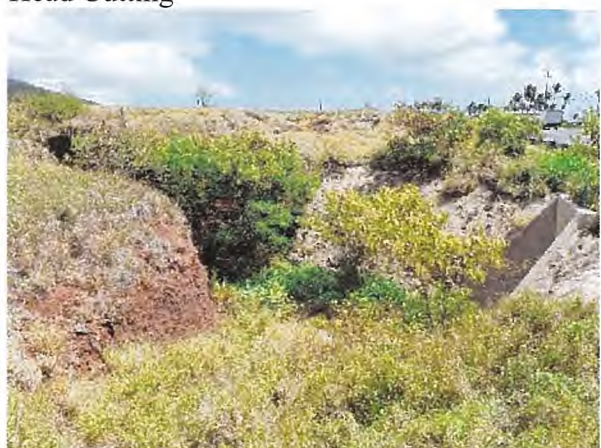
Head Cutting

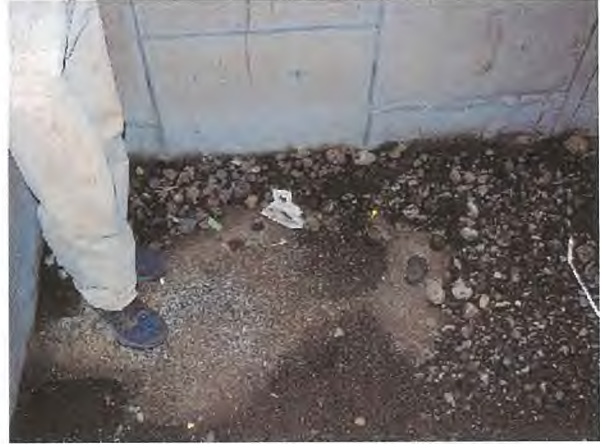
Sediment in Culverts

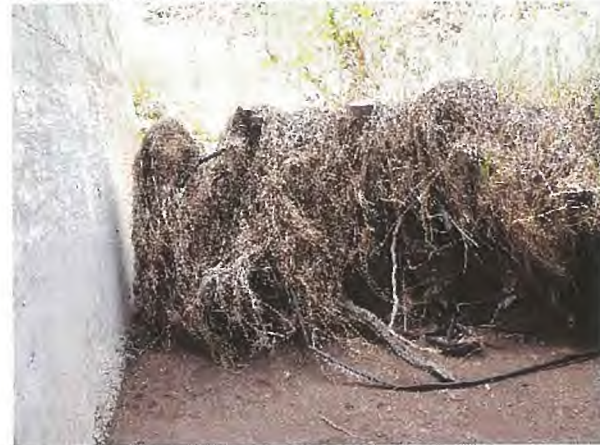
Sediment and Gravel in Culverts

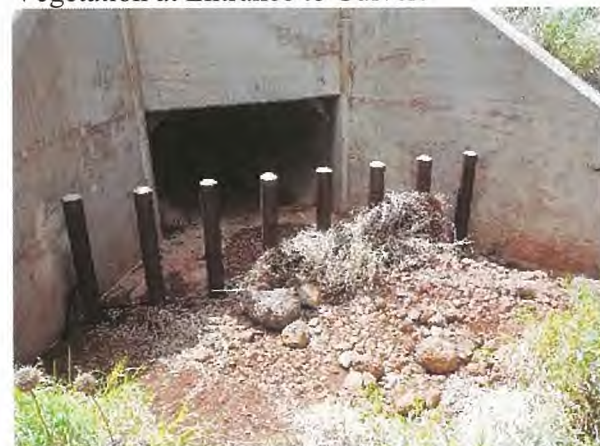
Extent of Vegetation at Entrance to Culvert

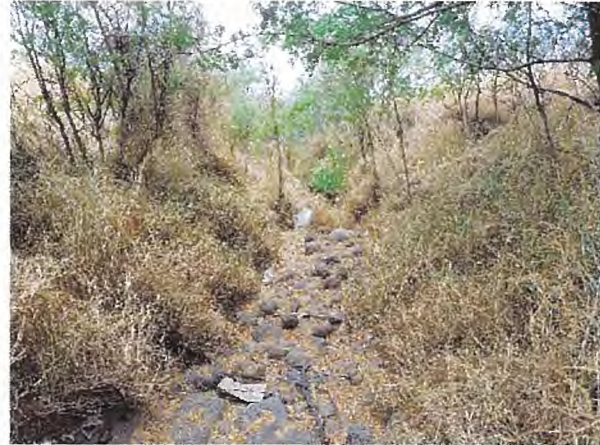
Vegetation and Rubbish in Ditch

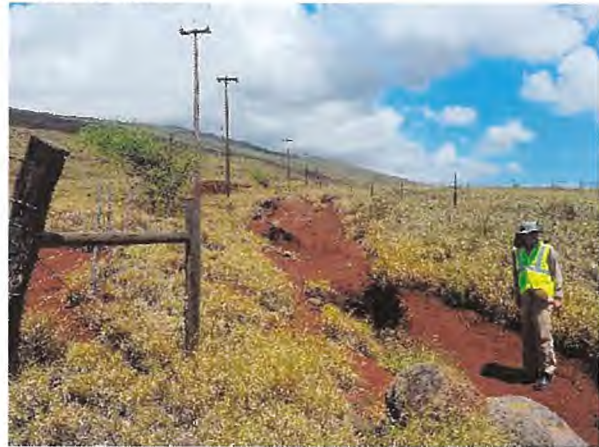
Channelization and Erosion

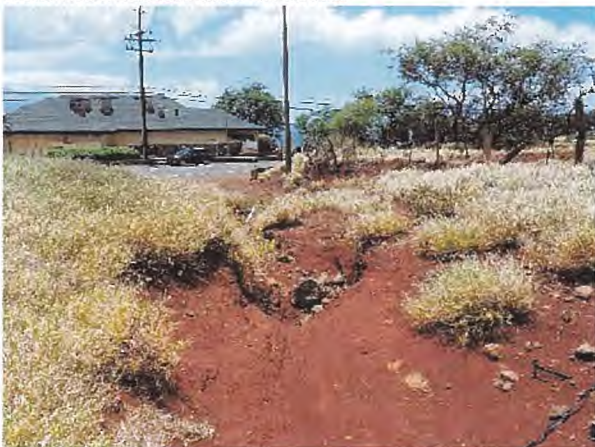
Channelization and Erosion

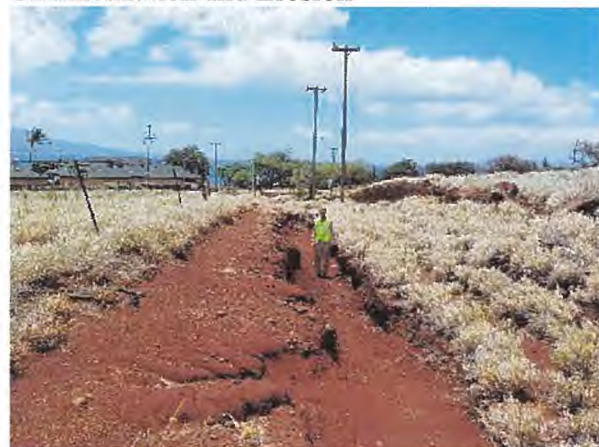
Failed Road with Channelization and Erosion

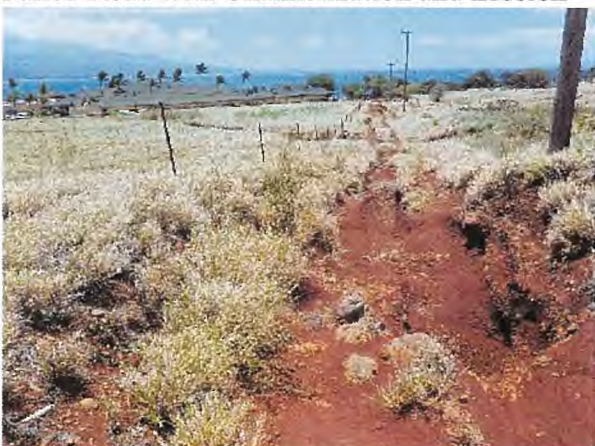
Failed Road with Channelization and Erosion

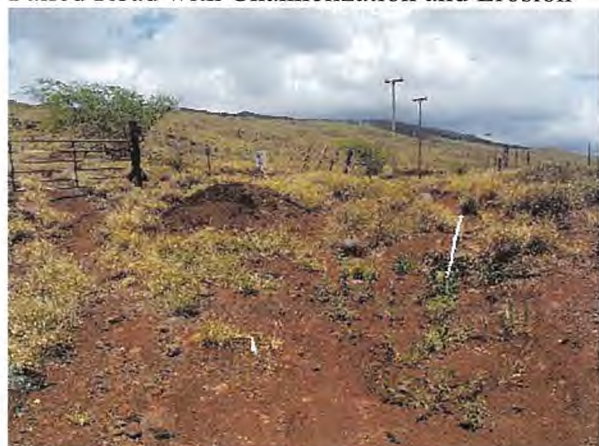
Failed Road with Channelization and Erosion

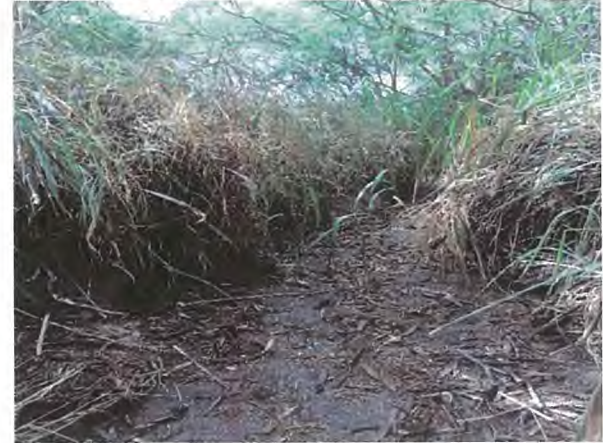
Bank Cutting within Pohakea

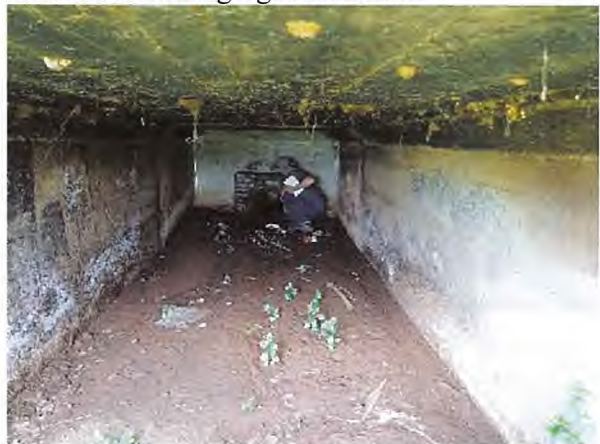
Culvert Outfall to Harbor

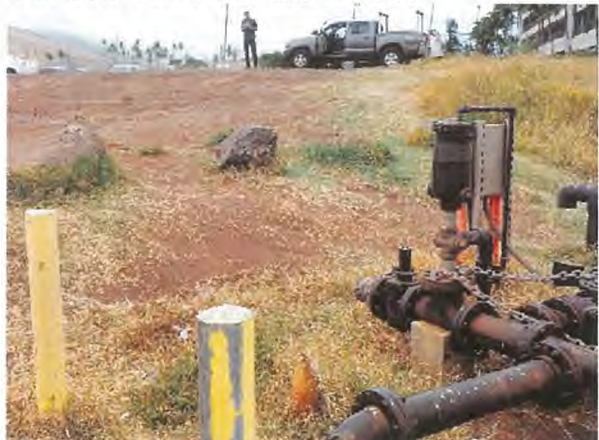
Vacant lots and dirt parking lots are found in the areas adjacent to the harbor. While some of these areas have been improved with a gravel overlay, many are simply bare compacted earth which can easily be transported to the nearby ocean by wind and rain. In particular, the paid parking located near the Pacific Whale Foundation embarkation area and the parking areas at the west (towards Lahaina) end of the harbor are bare dirt right next to the ocean.

Dirt Lots with No BMPs in Place Next to Harbor

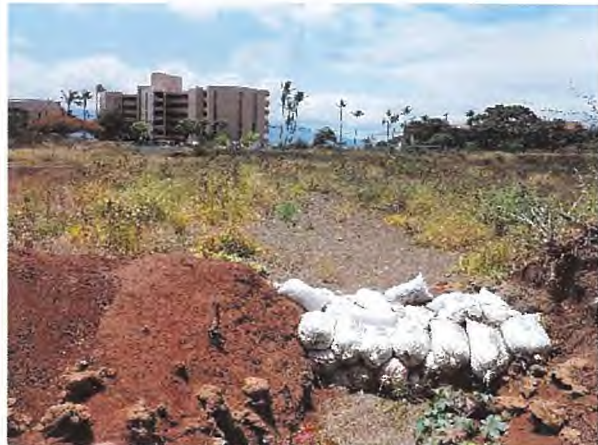
Sand Bags at Failed Control Structure

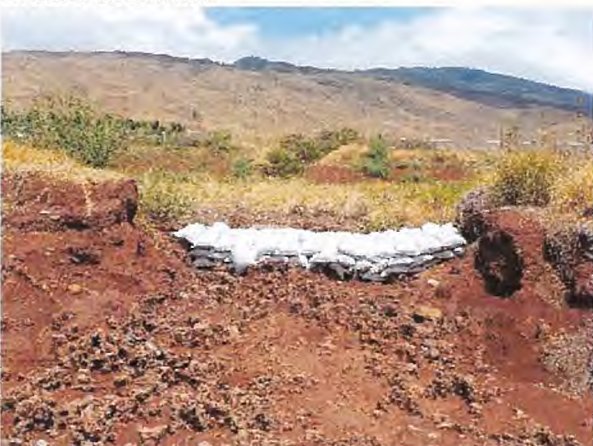
Sand Bags at Channel Outfall to Detention Basin

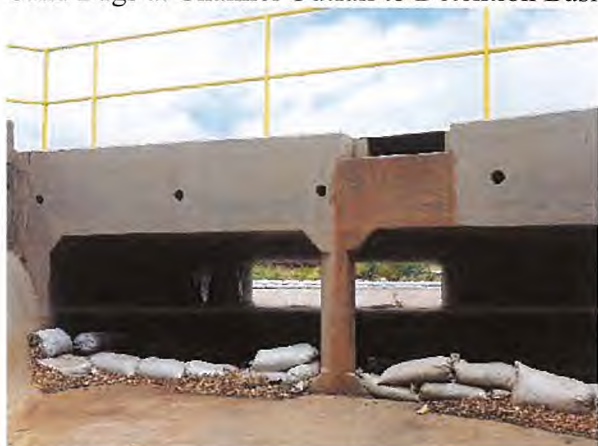
Failed Control Structure
