SUBJECT: COUNTY-OWNED PARCEL ON NORTH PAPA AVENUE (KAHULUI) (HHT-14)

Property Condition Report

310 W Kaahumanu Ave, Kahului, HI 96732 Inspection prepared for: Maui County c/o Buddy Almeida Real Estate Agent: -

Date of Inspection: 3/28/2018 Time: 8:00 AM Age of Home: 1980 Size: 15000 This is a commercial property condition assessment to determine of three (3) former UH dormitories are suitable for housing. This inspection includes invasive and non-invasive inspection methods as well as sampling for asbestos and lead based paint.

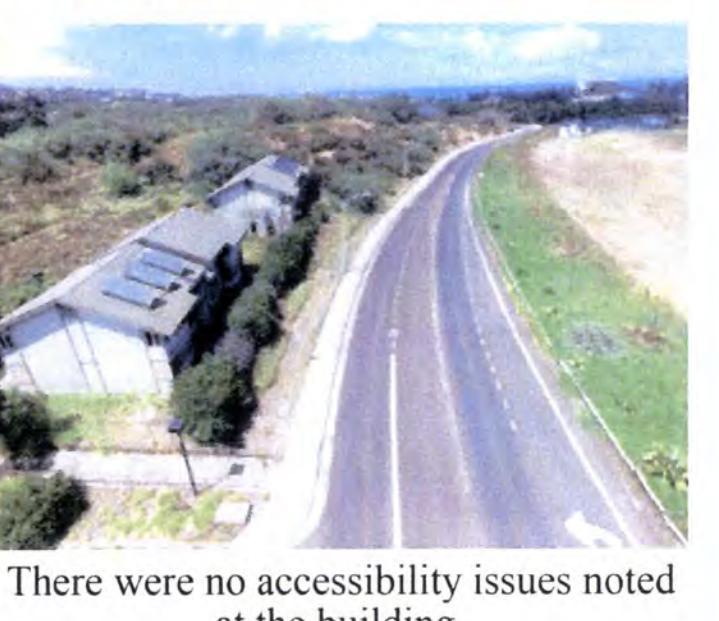
There were no noted obstructions below There were no accessibility issues noted at the building.

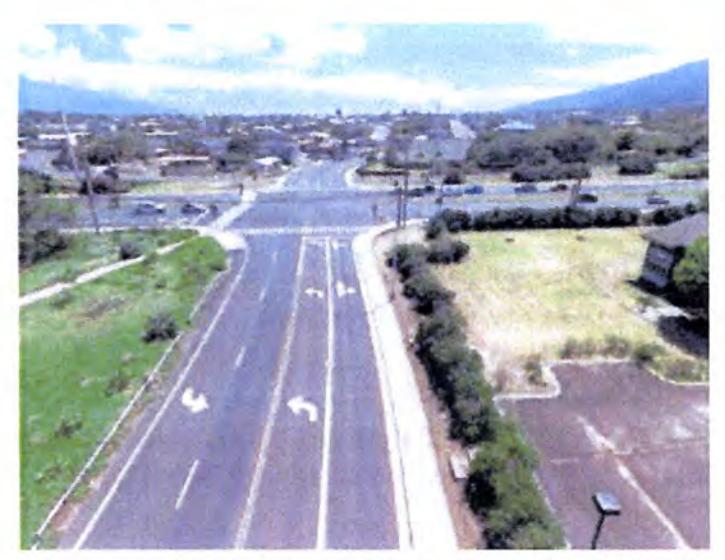
There were no noted obstructions below the 13'-6" minimum.

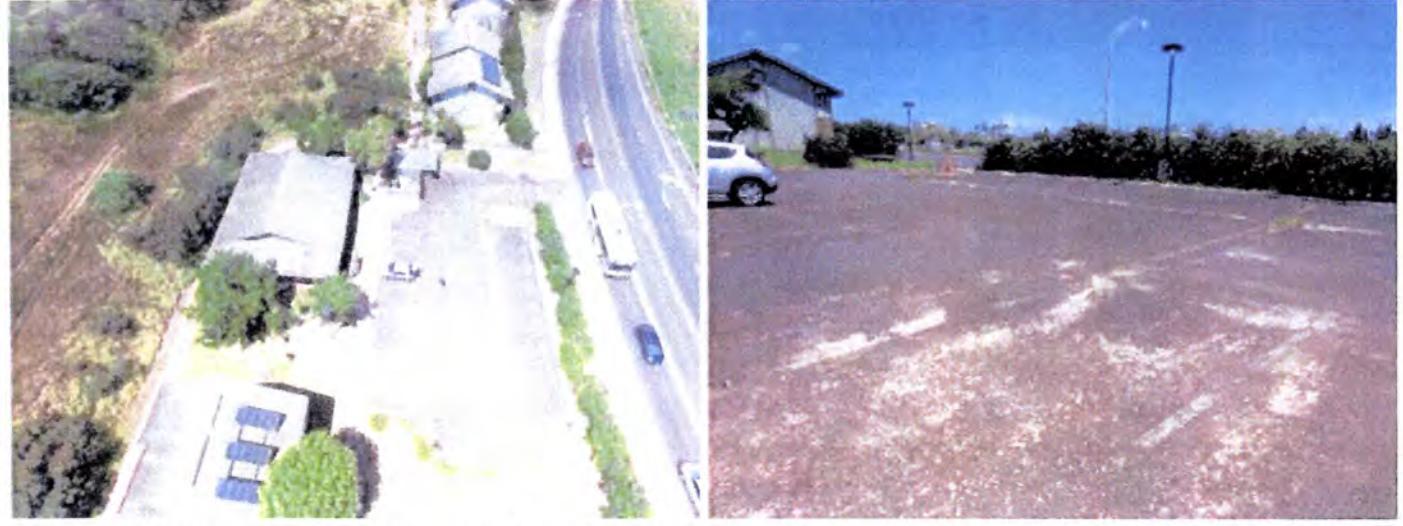
The parking area surface was deteriorated The parking area surface was deteriorated with lines weathered to the point of not providing clear lanes for parking use. Recommend having the parking area resurfaced and striped to ensure proper identification of parking stalls.

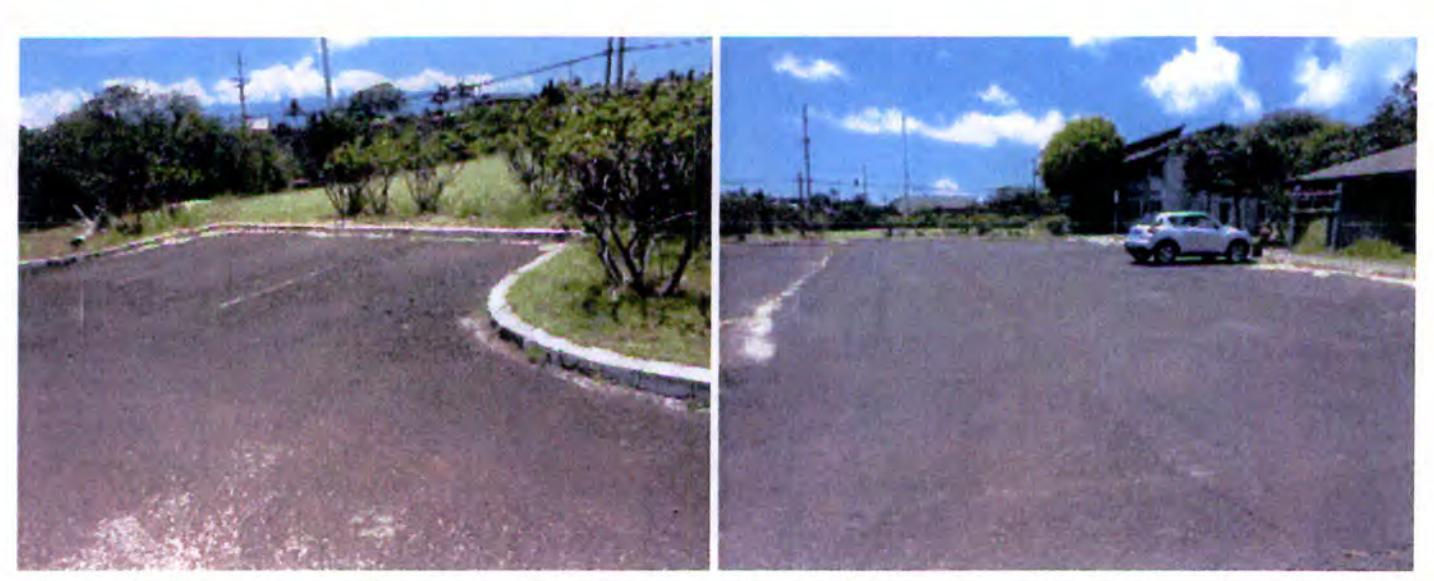
The parking area surface was deteriorated The parking area surface was deteriorated with lines weathered to the point of not providing clear lanes for parking use. Recommend having the parking area resurfaced and striped to ensure proper identification of parking stalls.

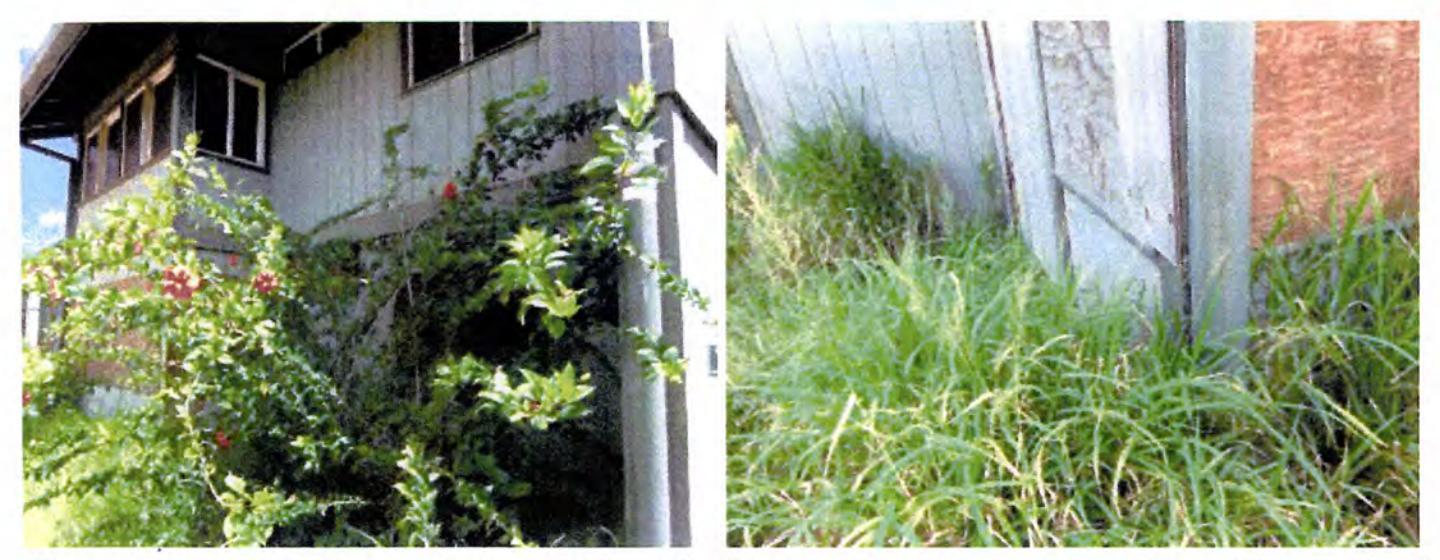
There were numerous trees contacting the Vegetation was overgrown and in need of building curtain walls and roof areas. removal in many areas.

building curtain walls and root areas. These areas appeared to have damage/deterioration noted at the time of inspection. Recommend having a licensed landscape contractor/arborist evaluate and trim vegetation and trees as necessary.

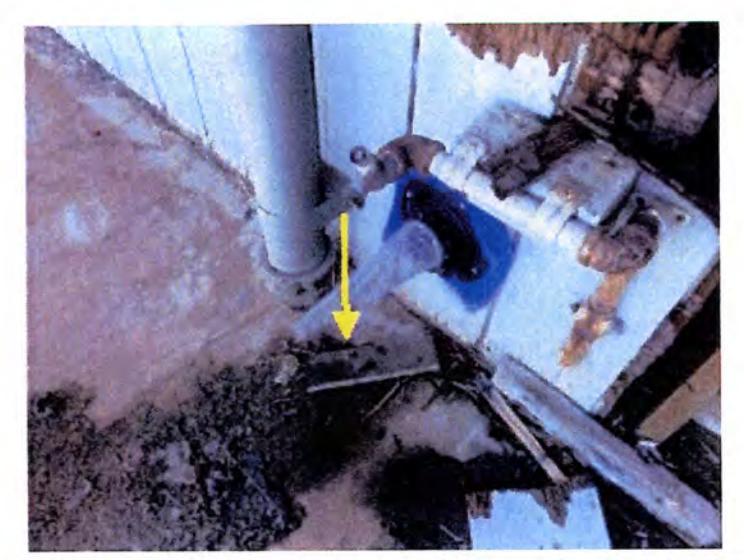
Some of the exterior hose bibs had slow dripping leaks observed at the time of inspection. Recommend repair.

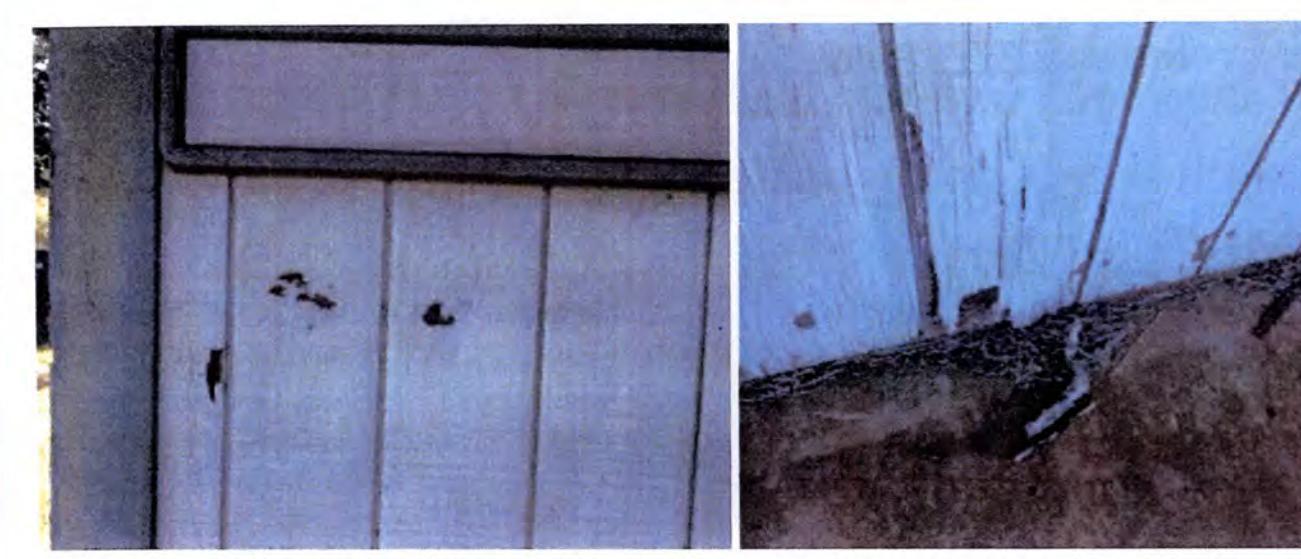
Visible indications of WDO (termite) Moisture damage observed at exterior damage noted. Recommend having a wall areas. Recommend select demolition licensed pest contractor evaluate and treat and replacement of affected ground level as necessary. Also, recommend having a exterior siding and finishes.

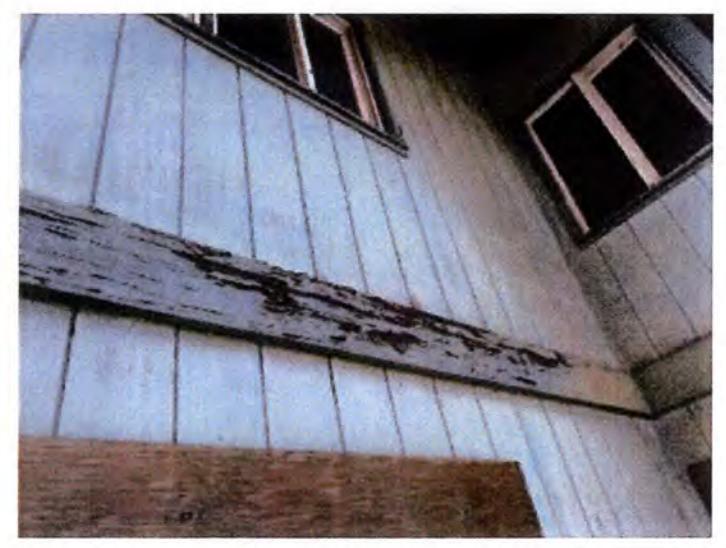
Blistering/peeling/missing paint observed at many exterior trim, fascia and soffit areas. Recommend properly preparing and refinishing exterior finishes.

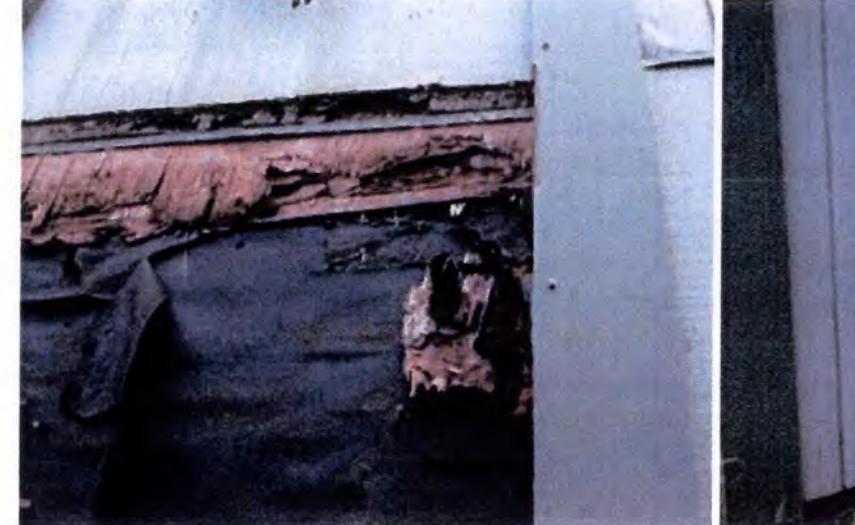
Visible indications of WDO (termite) damage noted. Recommend having a licensed pest contractor evaluate and treat as necessary. Also, recommend having a licensed contractor evaluate and repair/replace damaged material as necessary.

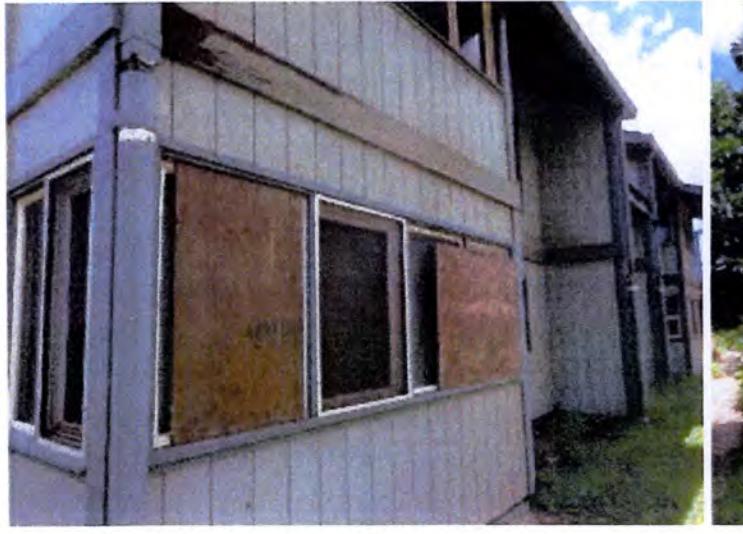
broken at the time of inspection.

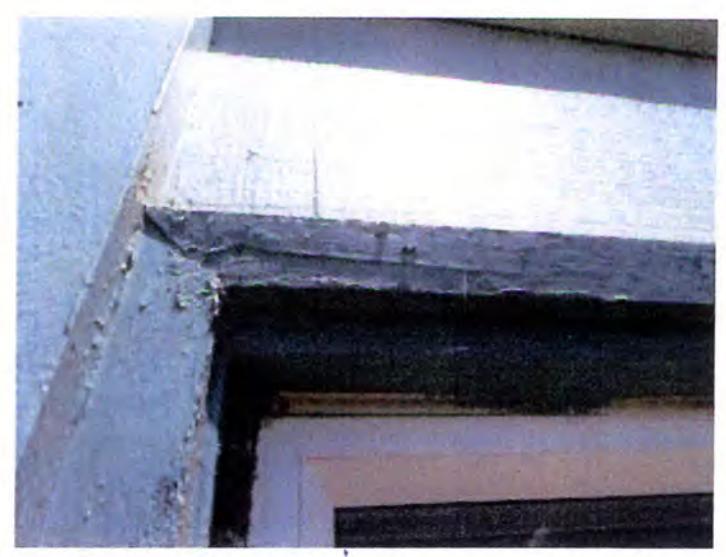
Due to the vegetative contact with exterior siding and finishes, the window trim is moisture/termite damaged at removal and replacement of exterior window trim finishes.

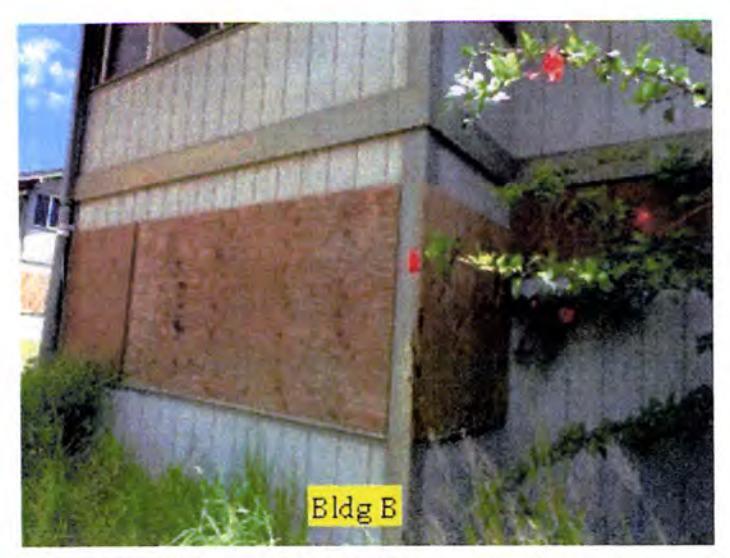
broken at the time of inspection.

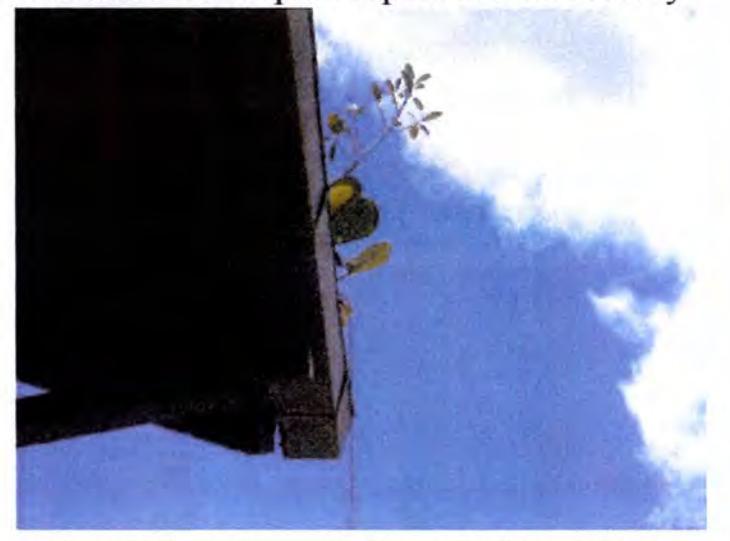
Vegetation growth observed in gutters. Recommend clearing.

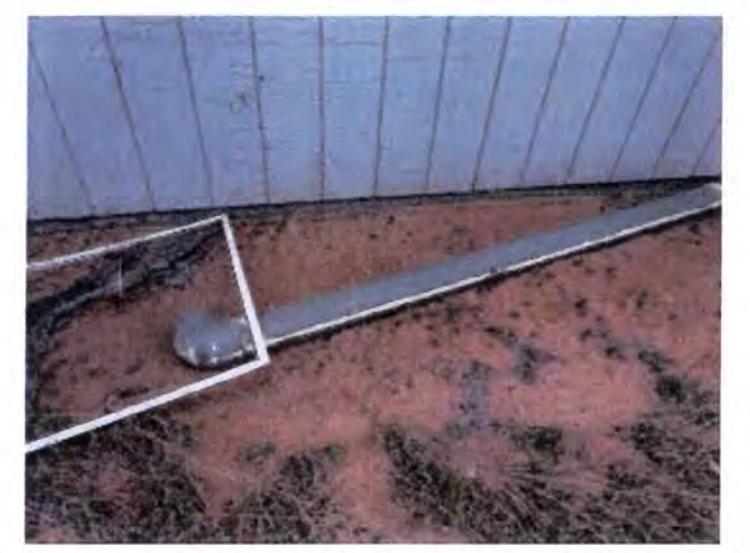
Damaged/broken/missing gutters noted. Recommend having a licensed contractor evaluate and repair/replace as necessary.

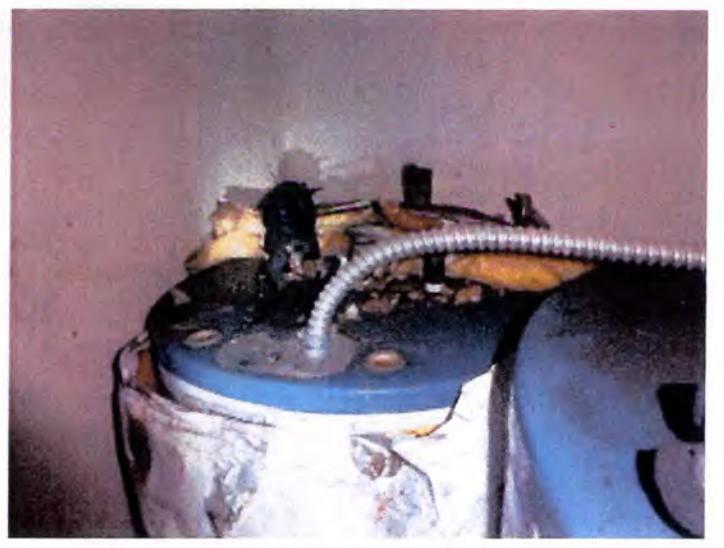
All water heating appliances were terminated with supply and service plumbing cut and electrical connections removed. Recommend having a licensed plumber evaluate and install commercial grade gas on demand hot water heating systems for each floor of each building.

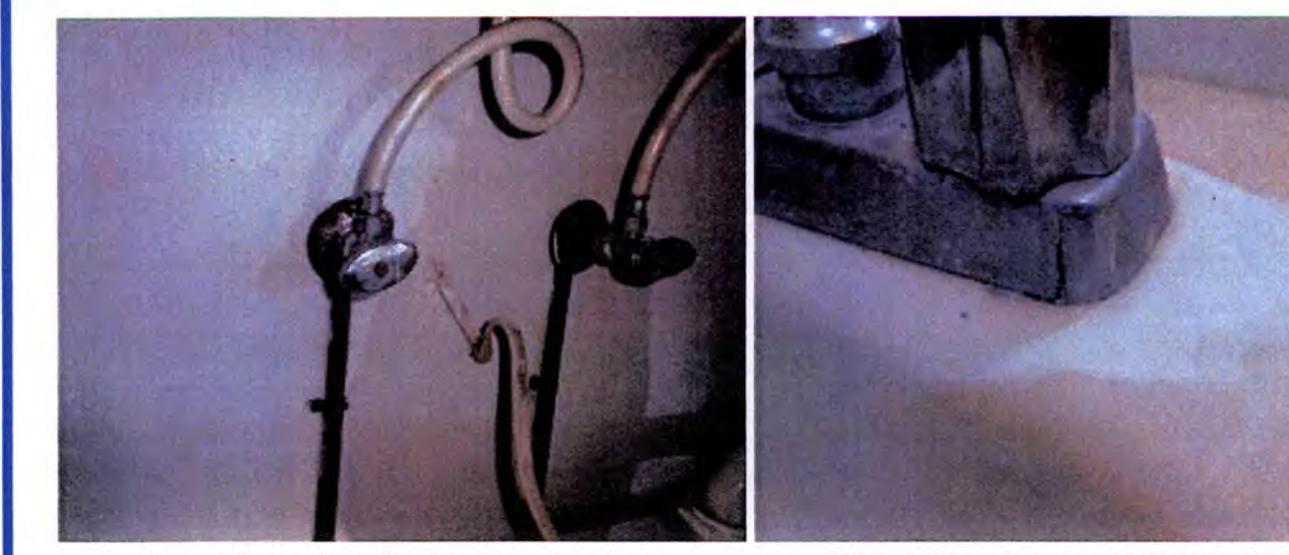
Based on the observed physical conditions of the installed fixtures, we recommend the replacement of all plumbing fixtures and shut off valves in all buildings to ensure proper future operation.

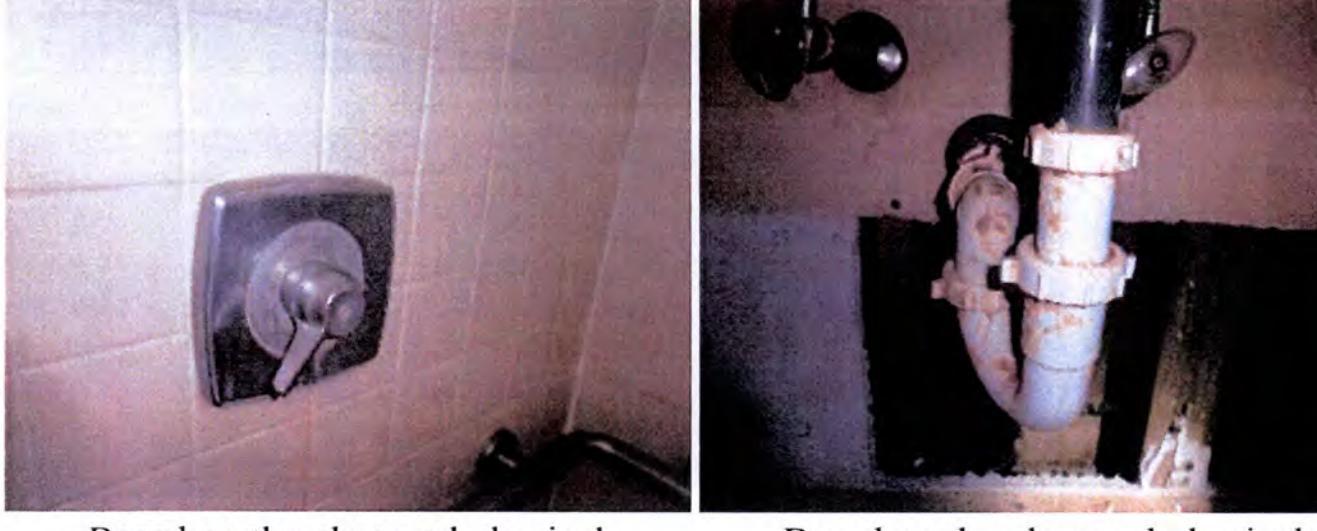
Based on the observed physical conditions of the installed fixtures, we recommend the replacement of all plumbing fixtures and shut off valves in all buildings to ensure proper future operation. Based on the observed physical conditions of the installed fixtures, we recommend the replacement of all plumbing fixtures and shut off valves in all buildings to ensure proper future operation.

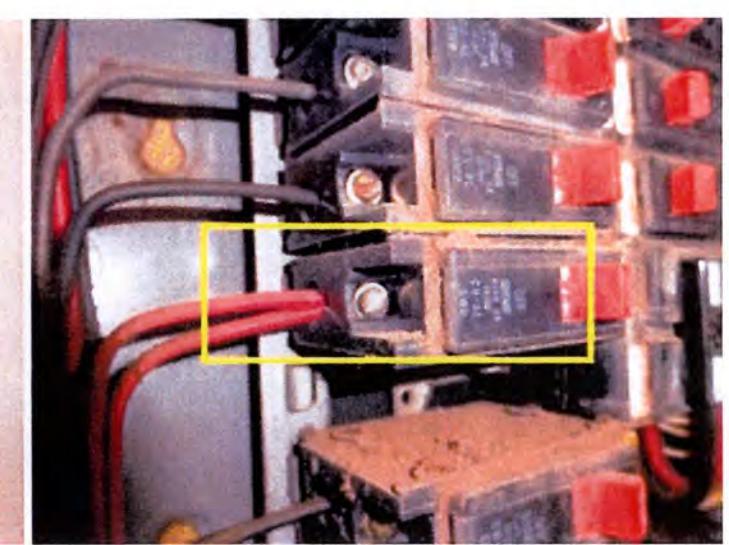
There were double tapped 1-pole circuit breakers noted at the time of inspection. This is not consistent with the manufacturer's instructions and the NEC. We recommend having a licensed electrician evaluate and repair/replace as necessary.

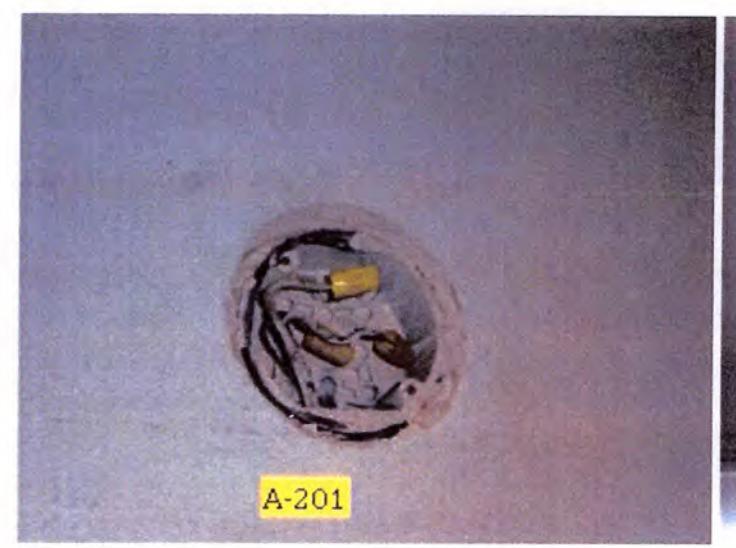
There were missing junction box covers noted at the following locations: attic spaces and front exterior of store.

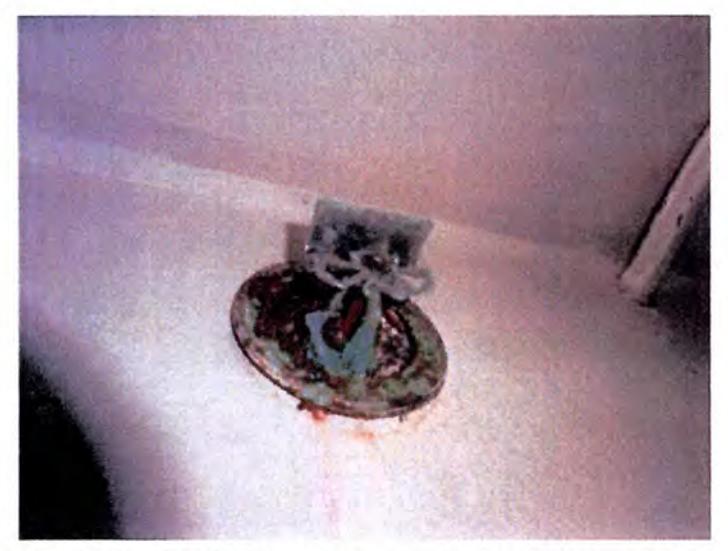
B-102: Sprinkler head was leaking when inspected.

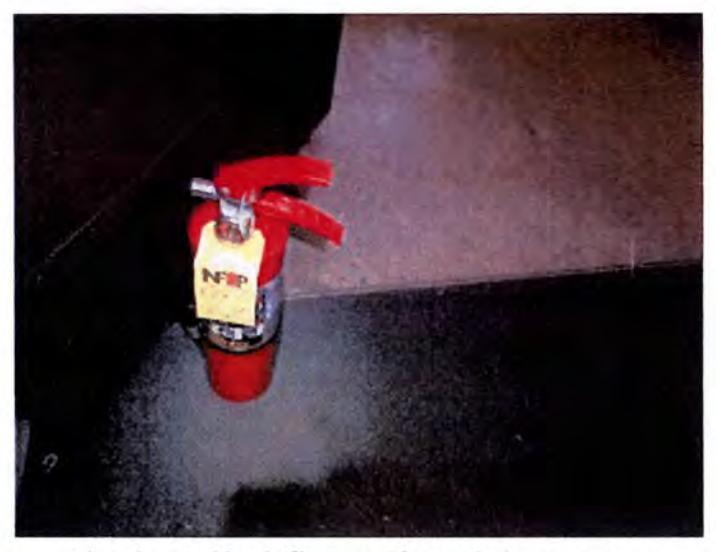
The installed fire extinguishers were expired inspection and servicing placards at the time of inspection. We recommend having a licensed fire extinguisher contractor evaluate and be contracted to service and inspect the existing items as required.

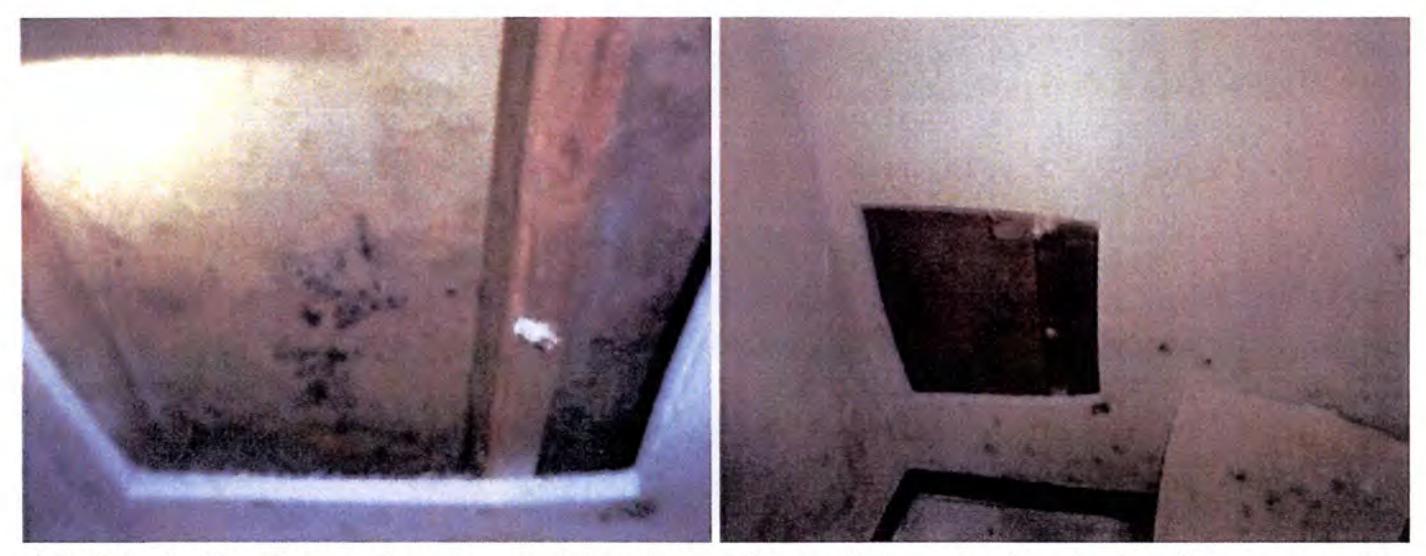
and mold growth at building B and C interior, bedroom, bathroom and closet wall areas. Recommend removal and replacement of all interior wall finishes of B and C, after removal of all exterior vegetation.

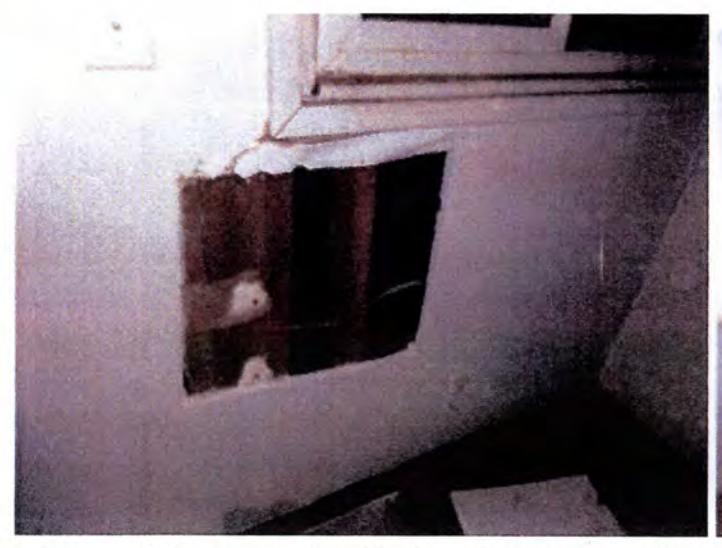
Most of the exterior facing lower interior wall finishes had moisture damage observed. Recommend removal and replacement of affected materials.

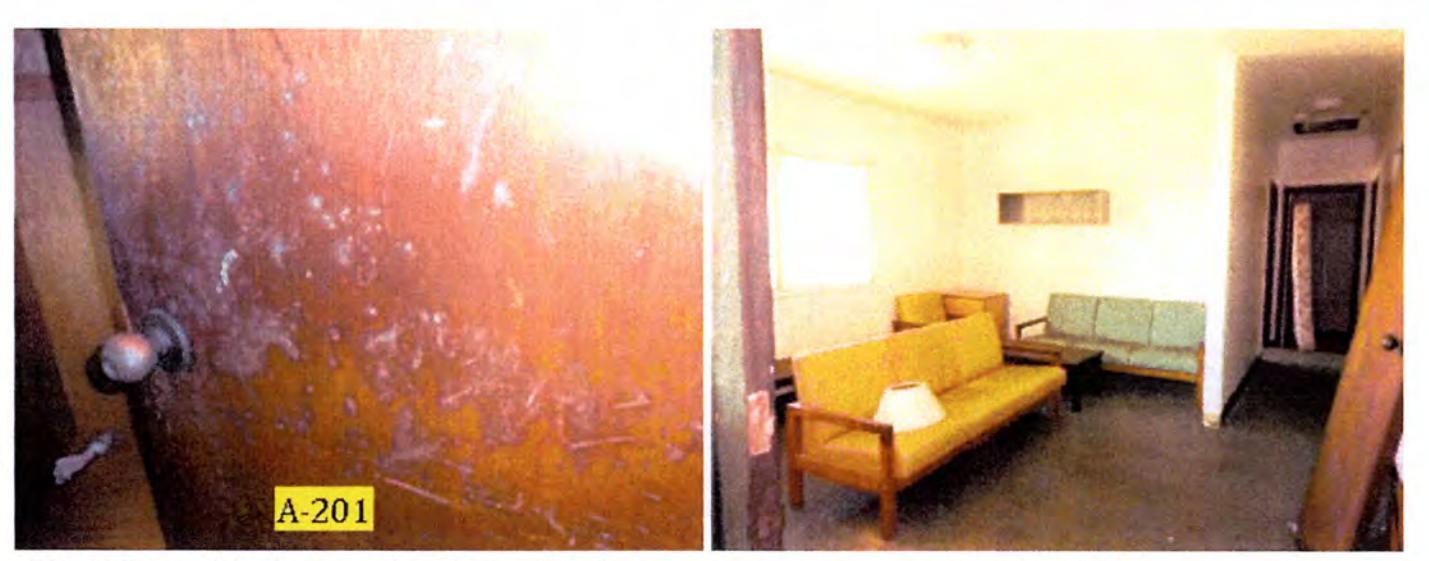
Visible mold observed at interior doors.

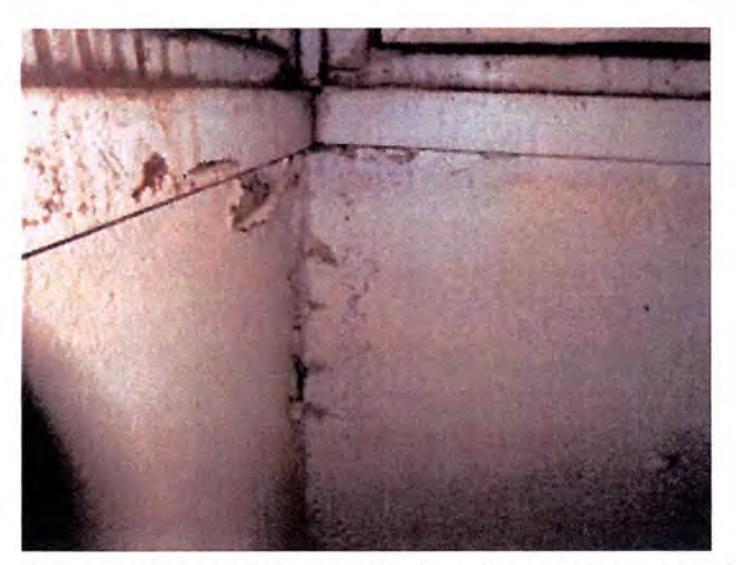
wall finishes had moisture damage observed. Recommend removal and replacement of affected materials.

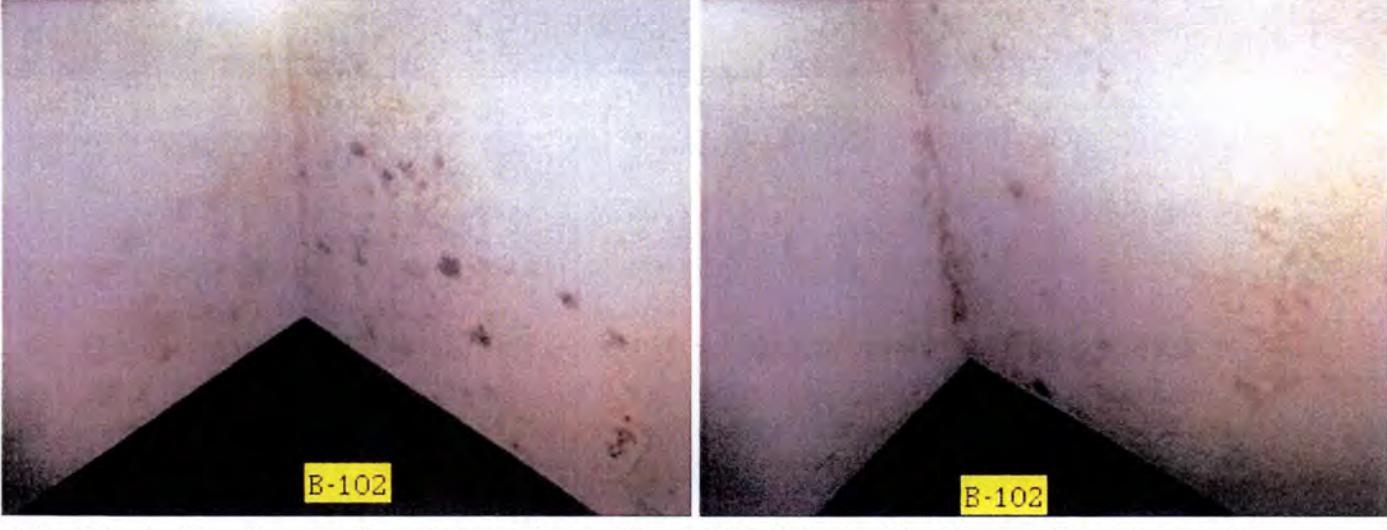
Visible indications of moisture intrusion and mold growth at building B and C interior, bedroom, bathroom and closet wall areas. Recommend removal and replacement of all interior wall finishes of B and C, after removal of all exterior vegetation.

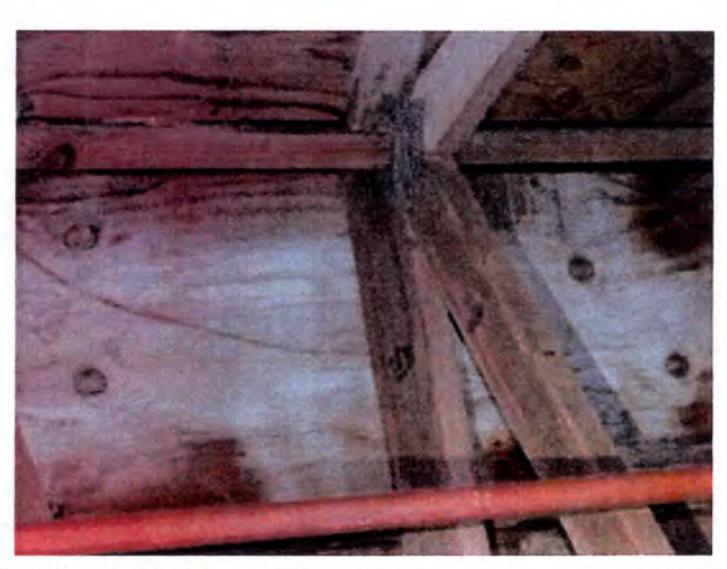
There were visible indications of mold present at all attic areas.

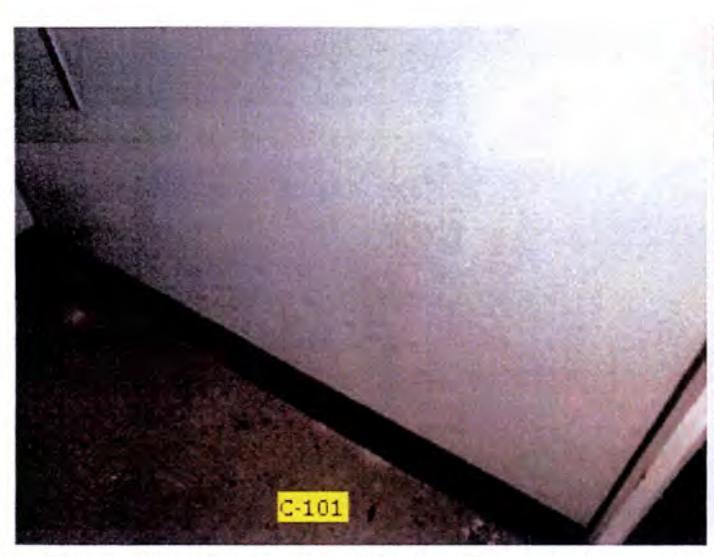
Most of the exterior facing lower interior wall finishes had moisture damage observed. Recommend removal and replacement of affected materials.

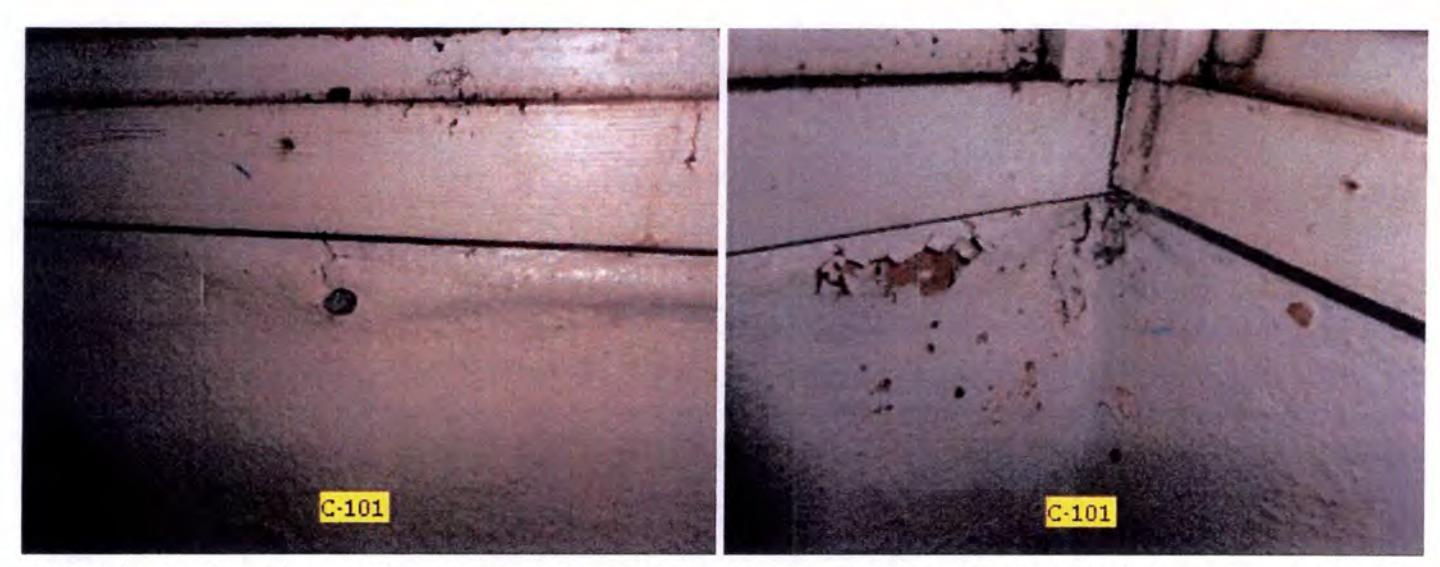
and mold growth at building B and C interior, bedroom, bathroom and closet wall areas. Recommend removal and replacement of all interior wall finishes of B and C, after removal of all exterior vegetation.

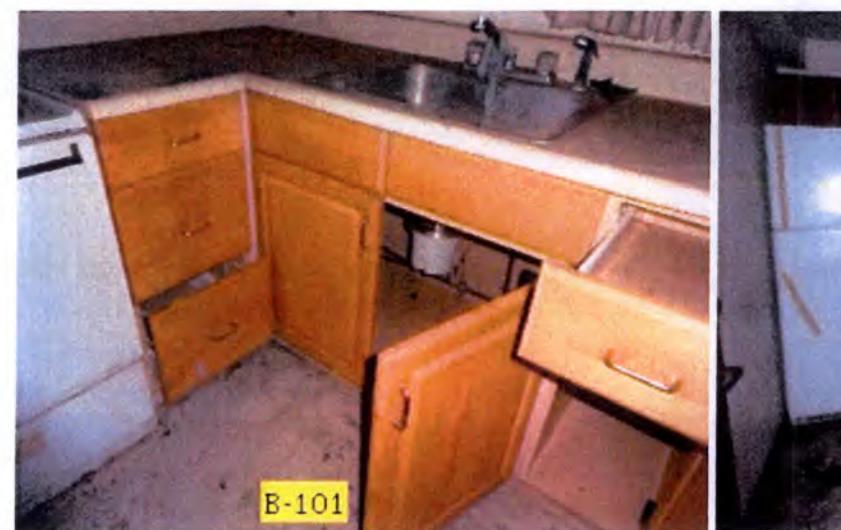
The kitchens of buildings B and C were Building B and C ovens did not appear to deteriorated with moisture damage, termite damage and general damage observed at the cabinets, counters and finishes. Recommend the replacement of all dwelling unit kitchens, fixtures and appliances.

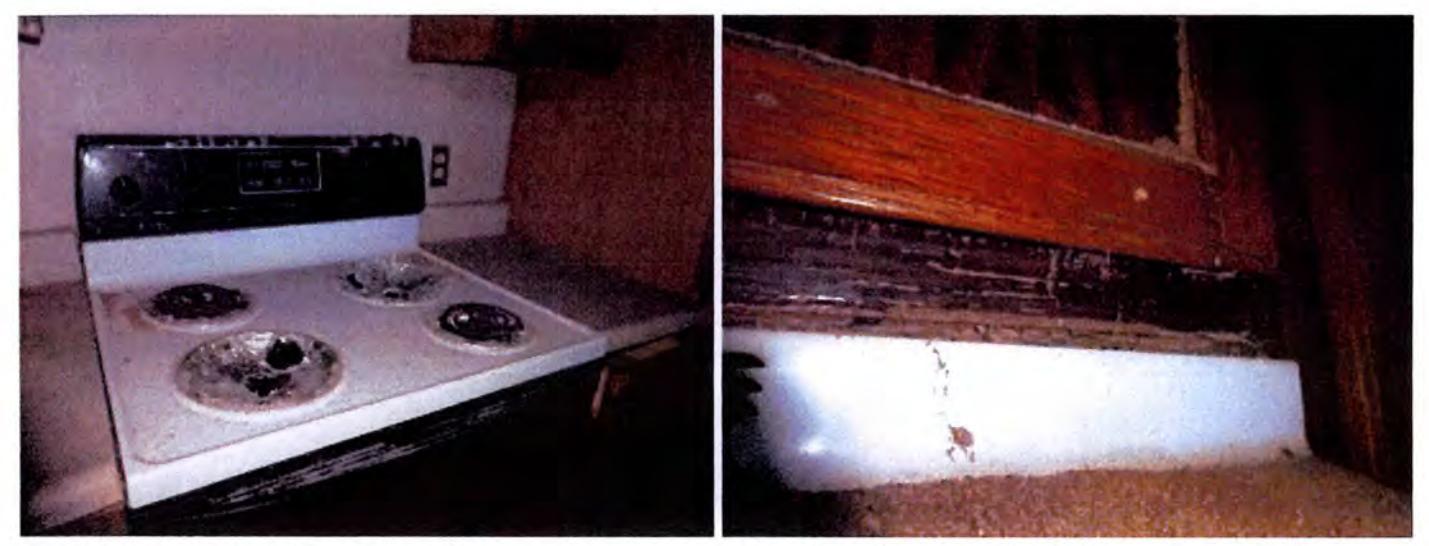
Building B and C ovens did not appear to The kitchens of buildings B and C were be functional condition at the time of inspection. Recommend replacement.

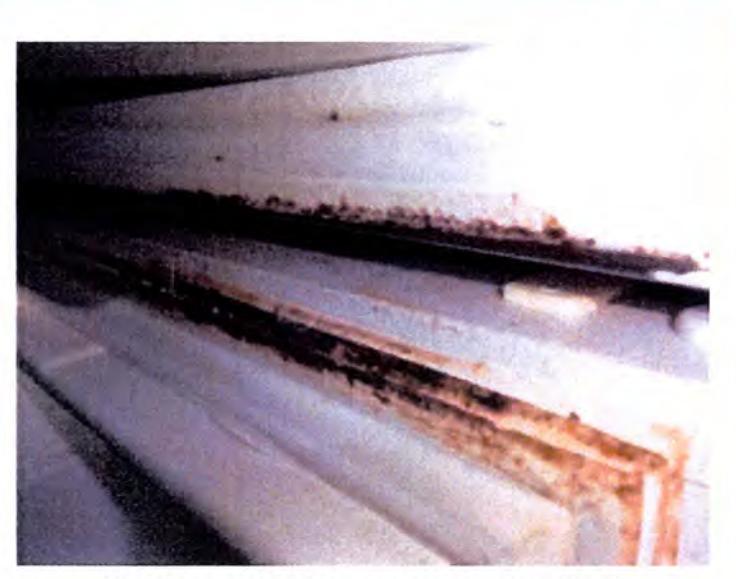
Recommend replacement of all refrigeration units located in the kitchens. The appliances in building A did not cool when turned on and the appliances in B and C had mold growth observed.

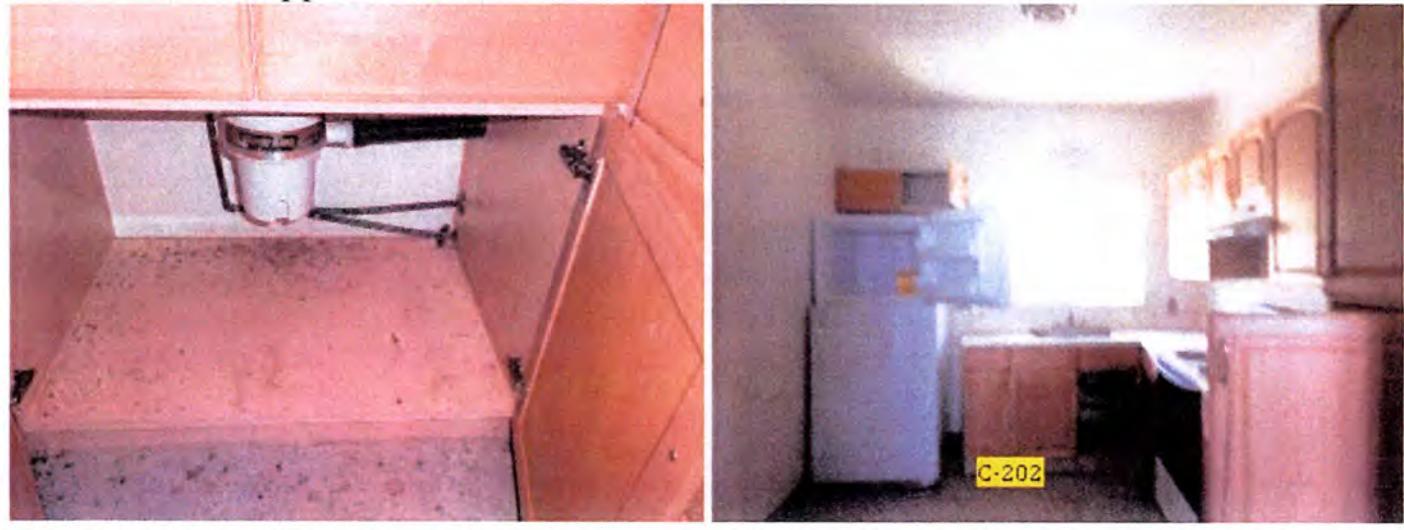
The kitchens of buildings B and C were deteriorated with moisture damage, termite damage and general damage observed at the cabinets, counters and finishes. Recommend the replacement of finishes. Recommend the replacement of all dwelling unit kitchens, fixtures and appliances.

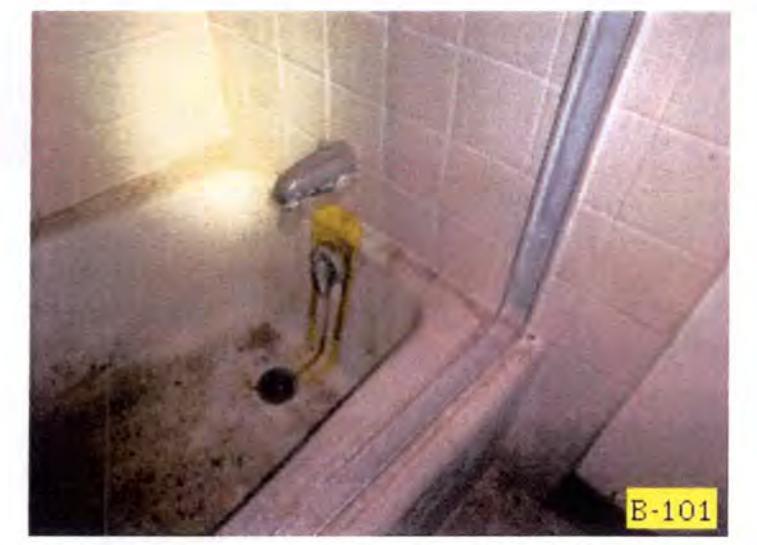
There were visible indications of moisture damage, mold growth, damaged moisture damage, mold growth, damaged flooring, damaged cabinets and counters, flooring, damaged cabinets and counters, damaged mirrors, damaged toilets and damaged shower compartments observed damaged shower compartments observed at the time of inspection. Based on the observed conditions on site, we recommend the replacement of all dwelling unit bathrooms.

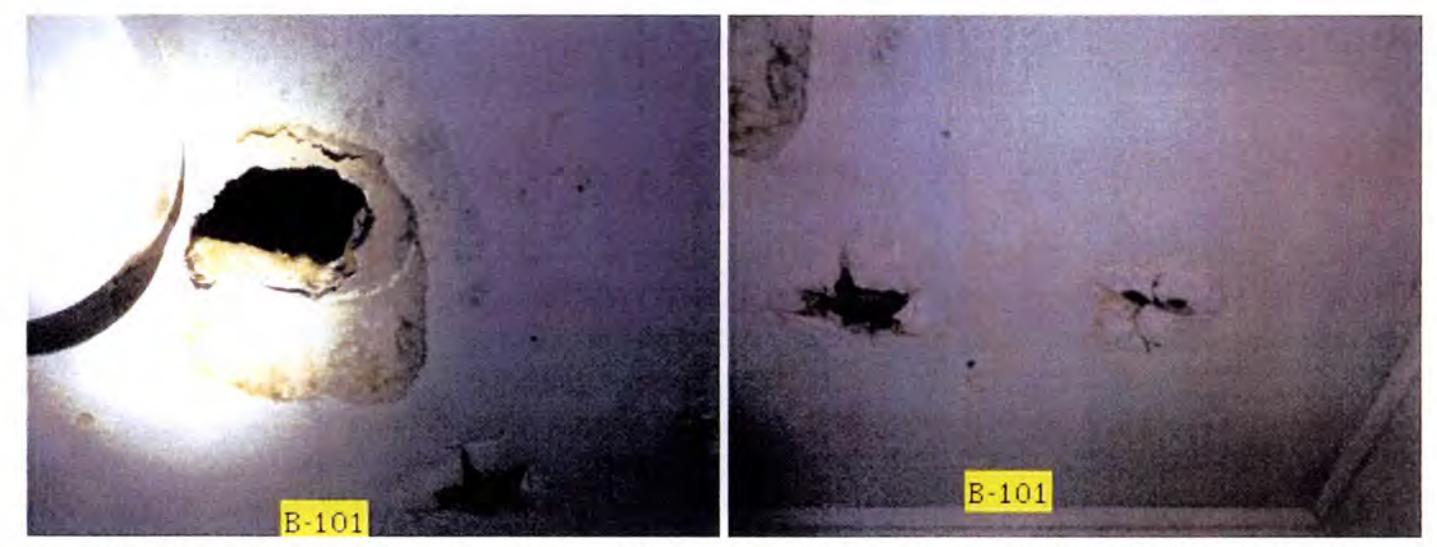
There were visible indications of moisture damage, mold growth, damaged flooring, damaged cabinets and counters, damaged mirrors, damaged toilets and damaged shower compartments observed at the time of inspection. Based on the observed conditions on site, we recommend the replacement of all dwelling unit bathrooms. There were visible indications of moisture damage, mold growth, damaged flooring, damaged cabinets and counters, damaged mirrors, damaged toilets and damaged shower compartments observed at the time of inspection. Based on the observed conditions on site, we recommend the replacement of all dwelling unit bathrooms.

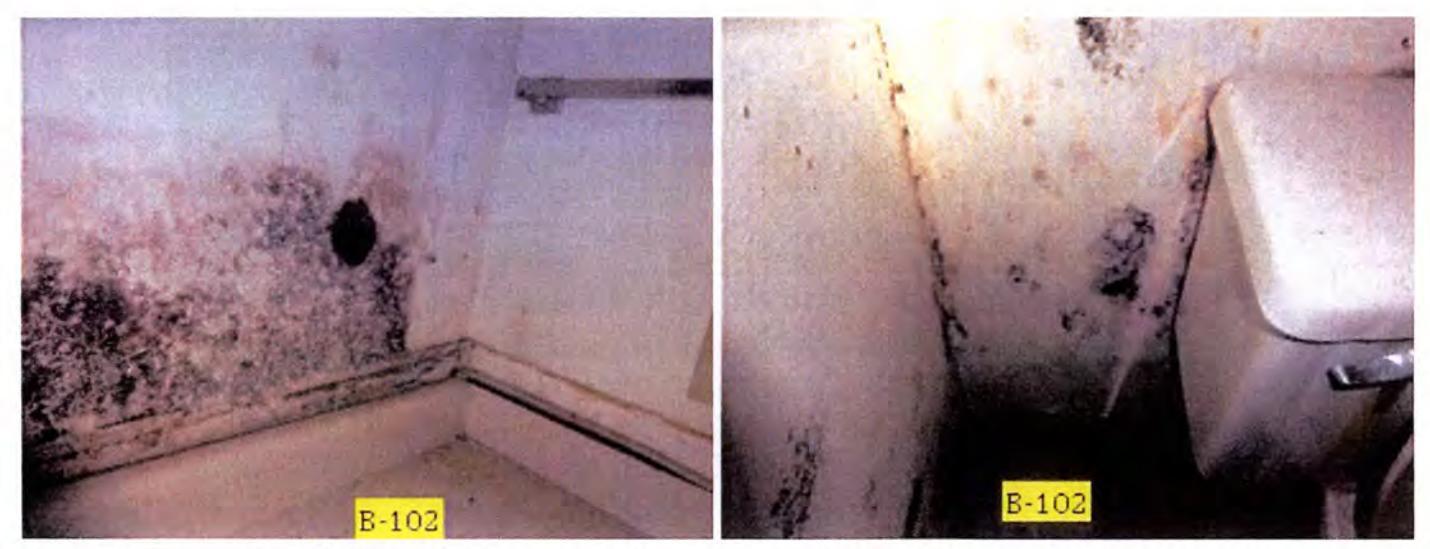
There were visible indications of moisture damage, mold growth, damaged flooring, damaged cabinets and counters, damaged mirrors, damaged toilets and damaged shower compartments observed at the time of inspection. Based on the observed conditions on site, we recommend the replacement of all dwelling unit bathrooms. There were visible indications of moisture damage, mold growth, damaged flooring, damaged cabinets and counters, damaged mirrors, damaged toilets and damaged shower compartments observed at the time of inspection. Based on the observed conditions on site, we recommend the replacement of all dwelling unit bathrooms.

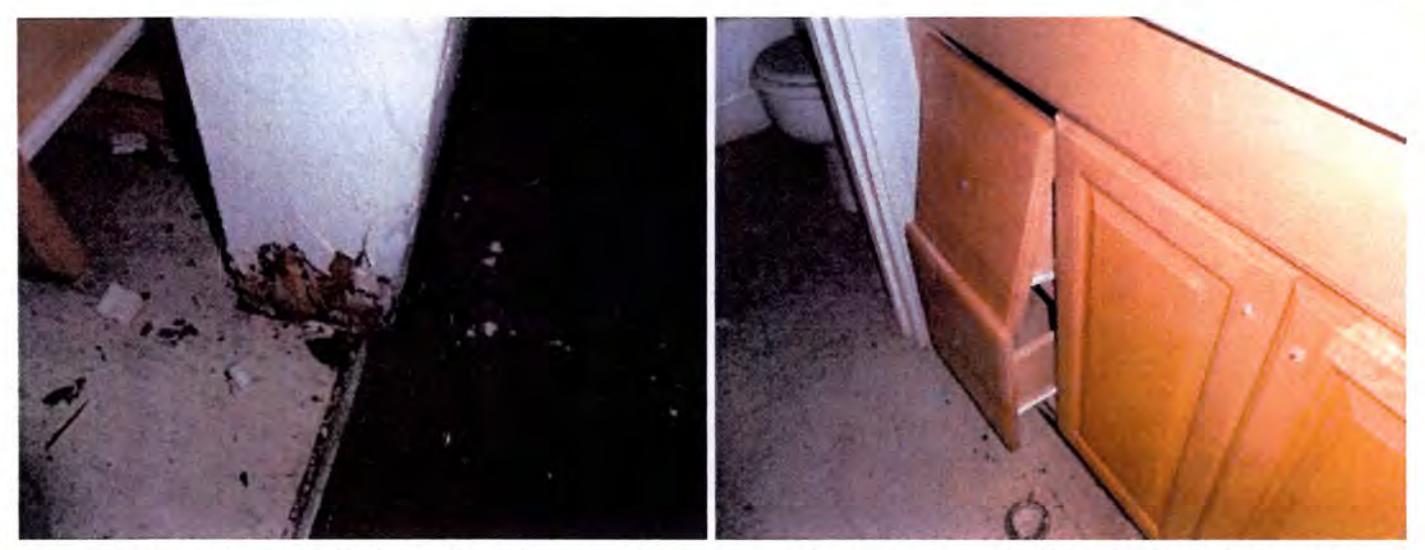
There were visible indications of moisture damage, mold growth, damaged moisture damage, mold growth, damaged flooring, damaged cabinets and counters, damaged mirrors, damaged toilets and damaged shower compartments observed at the time of inspection. Based on the observed conditions on site, we recommend the replacement of all dwelling unit bathrooms. There were visible indications of moisture damage, mold growth, damaged moisture damage, mold growth, damaged flooring, damaged cabinets and counters, damaged mirrors, damaged toilets and damaged shower compartments observed at the time of inspection. Based on the observed conditions on site, we recommend the replacement of all dwelling unit bathrooms.
