SUBJECT: COUNTY-OWNED PARCEL ON NORTH PAPA AVENUE (KAHULUI) (HHT-14)

Property Condition Report

310 W Kaahumanu Ave, Kahului, HI 96732 Inspection prepared for: Maui County c/o Buddy Almeida Real Estate Agent: -

Date of Inspection: 3/28/2018 Time: 8:00 AM Age of Home: 1980 Size: 15000 This is a commercial property condition assessment to determine of three (3) former UH dormitories are suitable for housing. This inspection includes invasive and non-invasive inspection methods as well as sampling for asbestos and lead based paint.

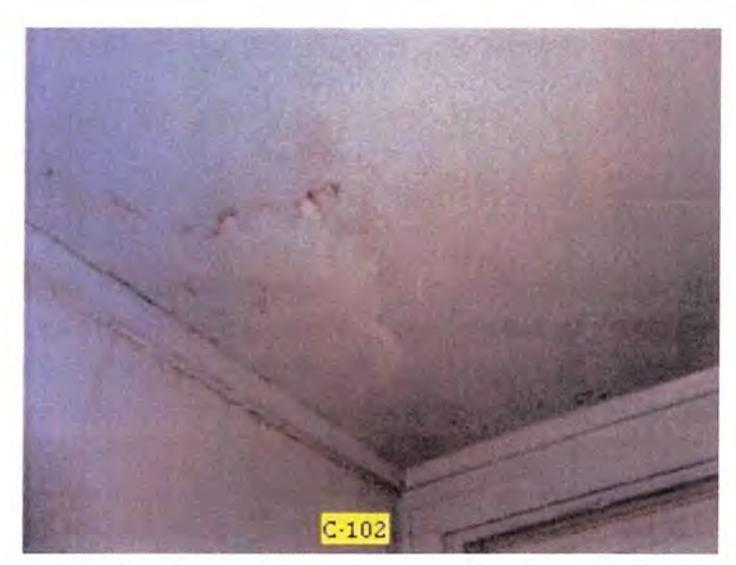
There were visible indications of moisture damage, mold growth, damaged flooring, damaged cabinets and counters, damaged mirrors, damaged toilets and damaged shower compartments observed at the time of inspection. Based on the observed conditions on site, we recommend the replacement of all dwelling unit bathrooms.
