# Archaeological Inventory Survey for the Proposed Mokuhinia Wetland Restoration Project

UPDATE ON PROGRESS AND RESULTS FOR MAUI COUNTY COUNCIL'S  
ECONOMIC DEVELOPMENT, ENERGY, AGRICULTURE, AND RECREATION  
COMMITTEE

COUNTY OF MAUI AND CULTURAL SURVEYS HAWAI'I

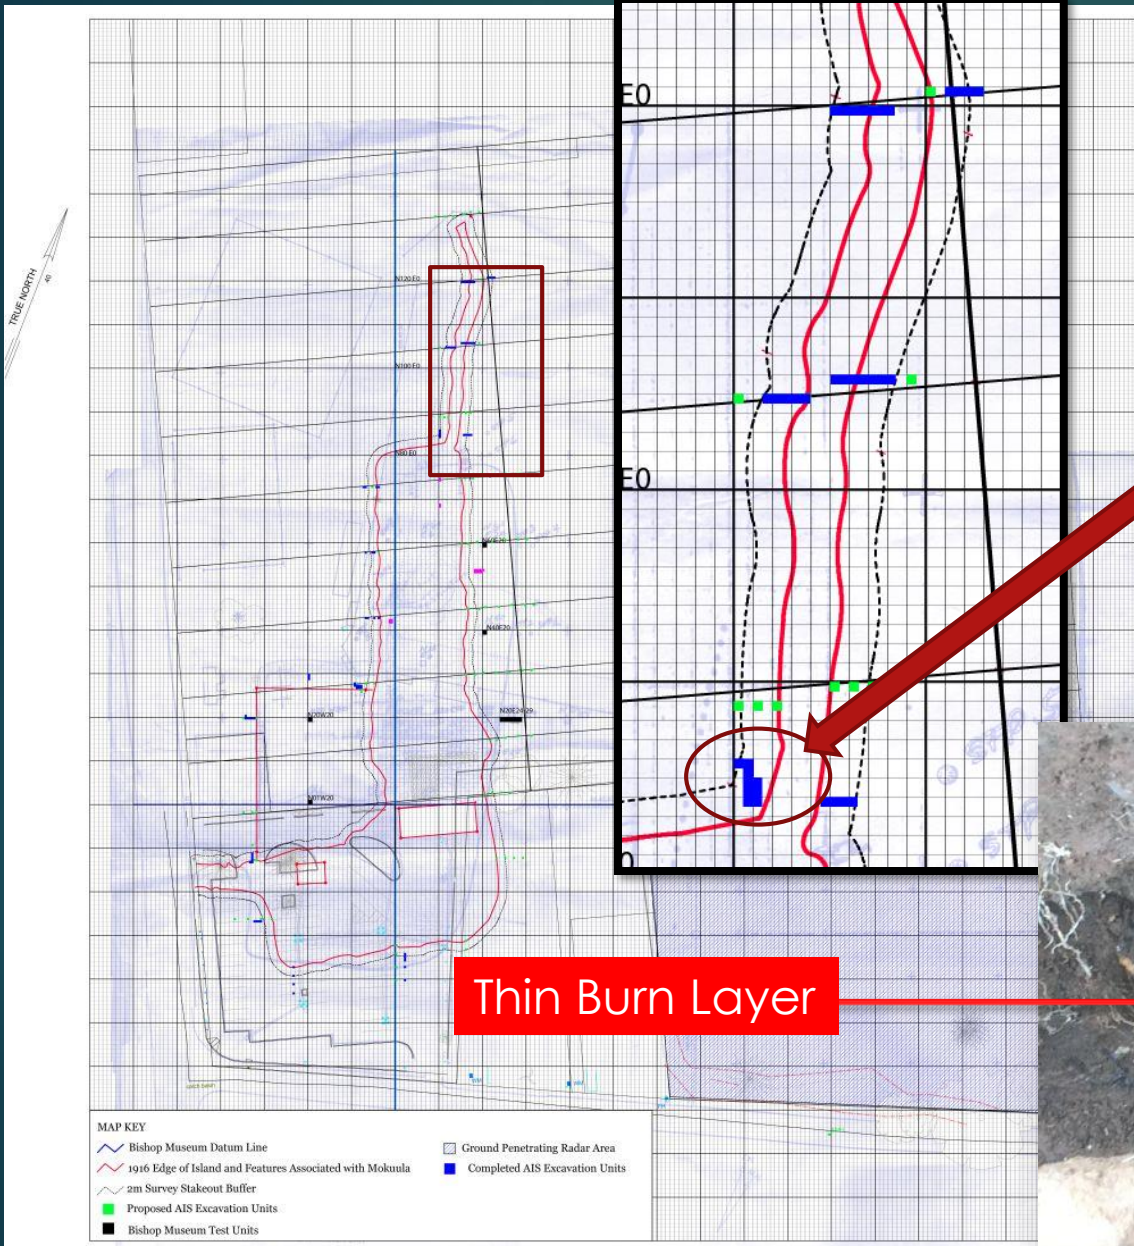
Thin Burn Layer

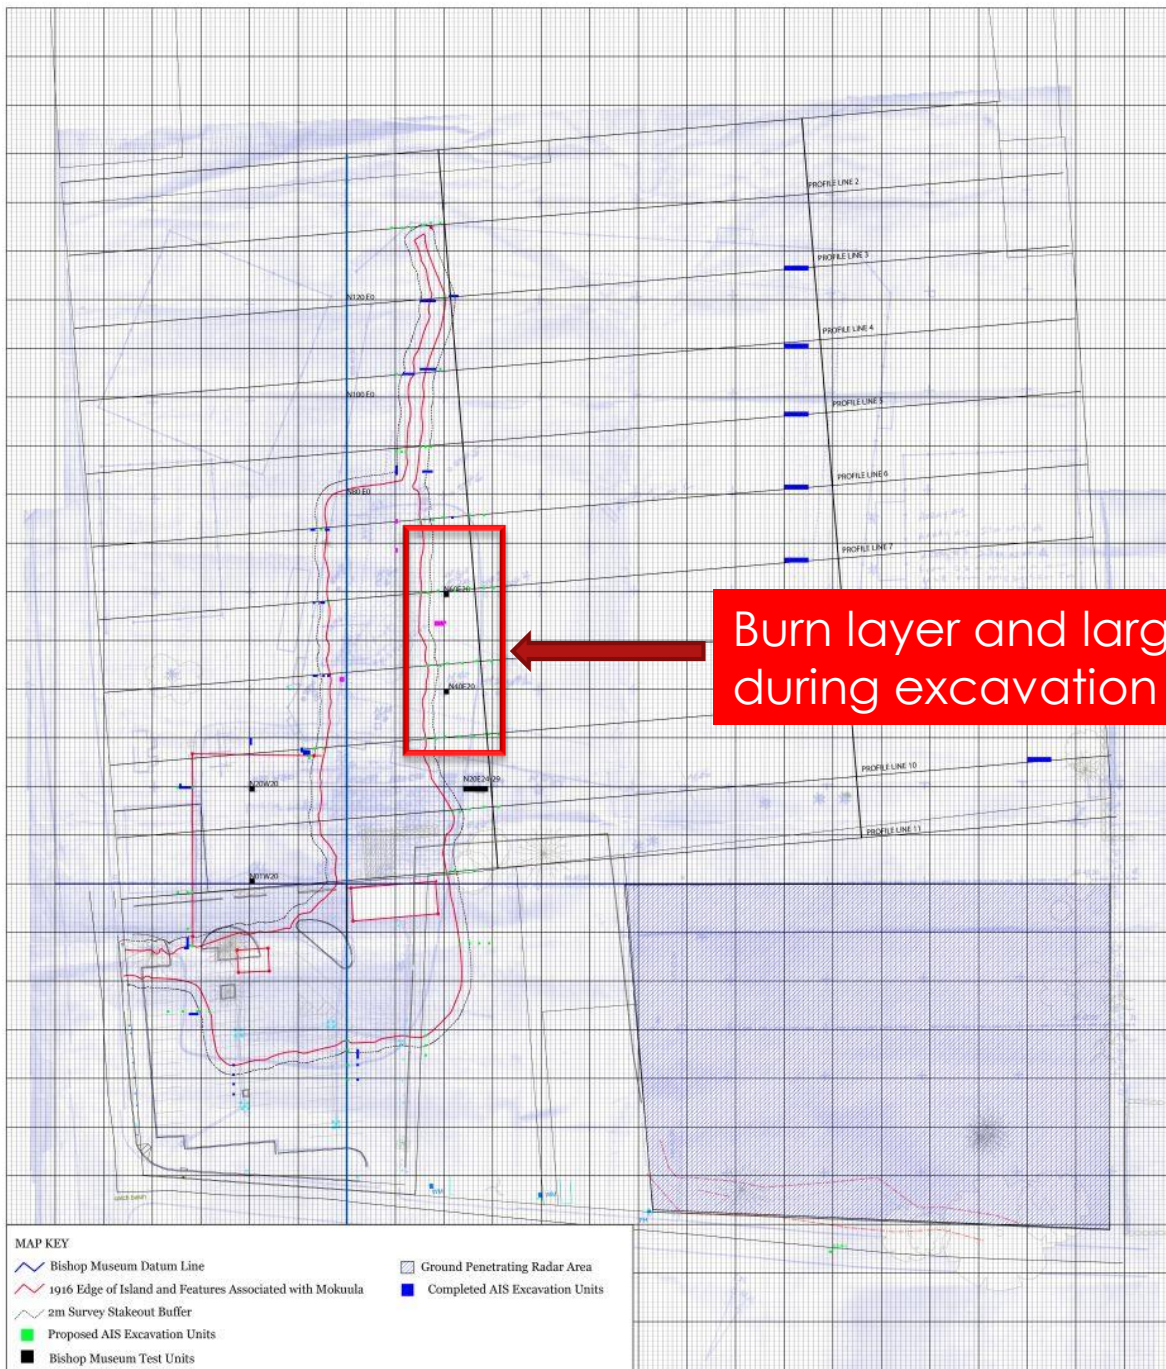
Burn layer and large burnt logs uncovered during excavation
