**SUBJECT: COUNTY-OWNED PARCEL ON NORTH PAPA AVENUE (KAHULUI)  
 (HHT-14)**

# UHMC Dorm Project Inspection Report

## UHMC Dorm Project Description

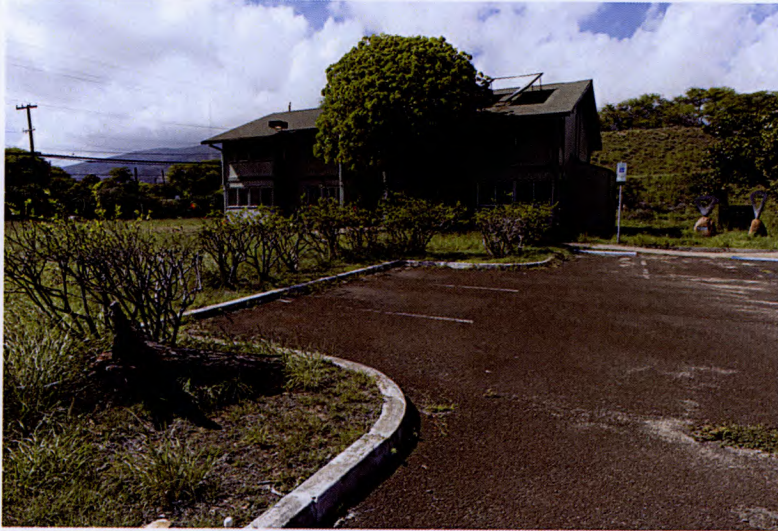
Parking Area: Surface Deteriorated

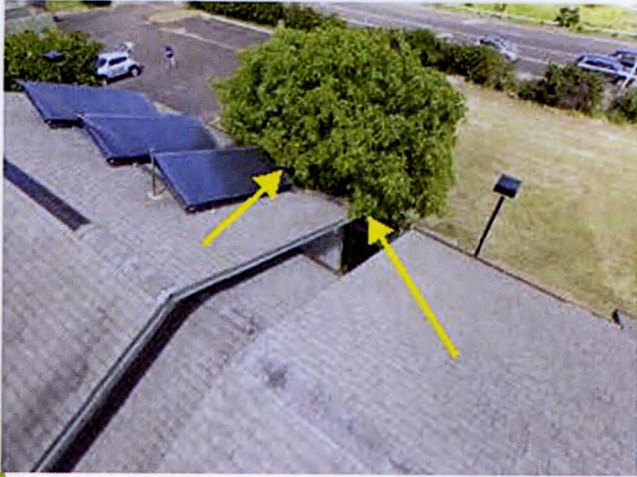
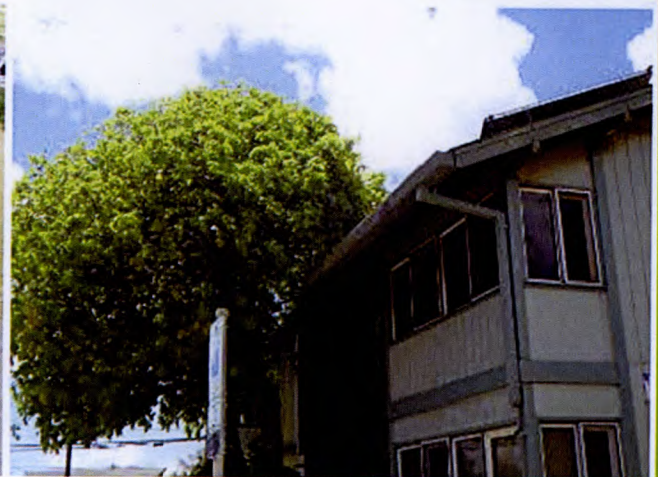
Vegetation: Overgrown, causing deterioration and damage to exterior walls and fixtures

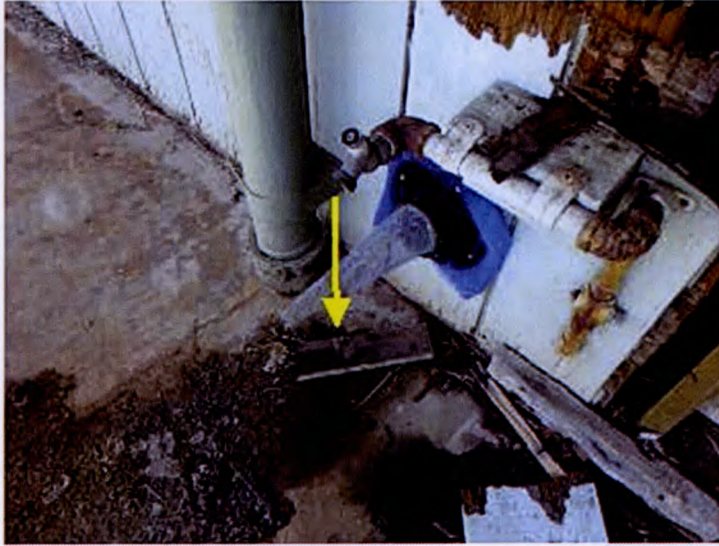
Exterior Hose Bibs: Slow dripping leaks

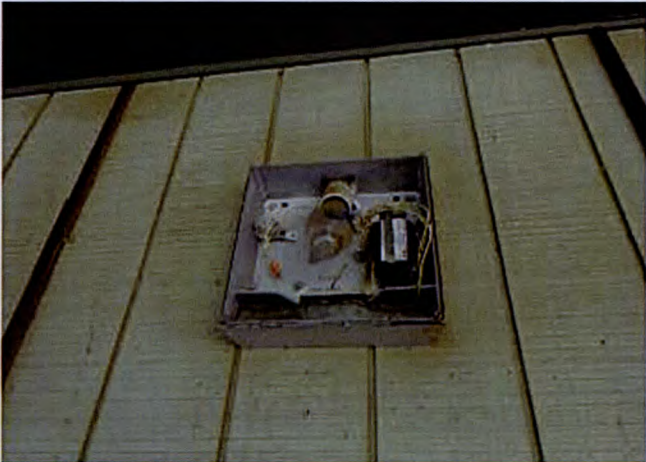
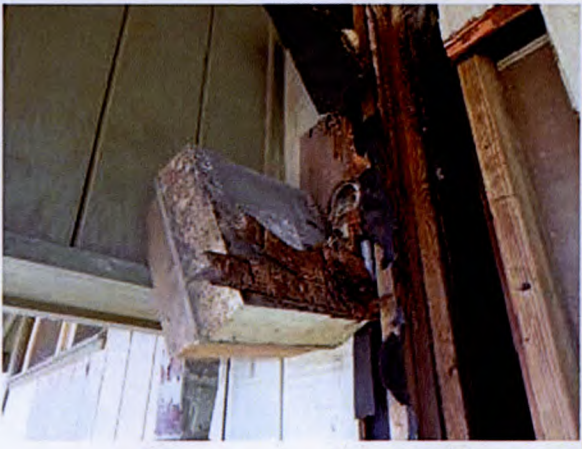
Exterior Lighting: Some damaged

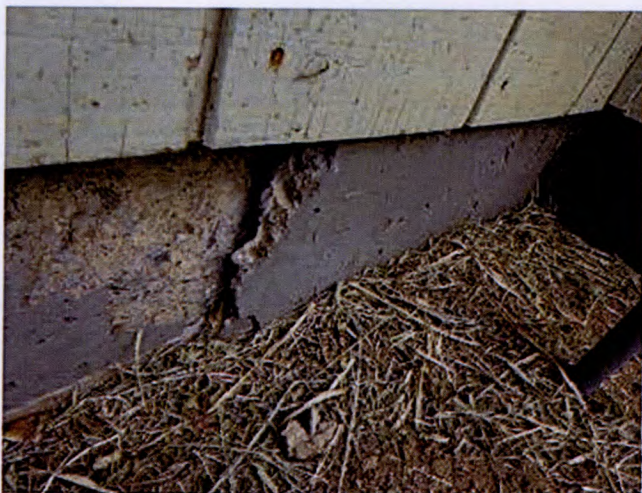
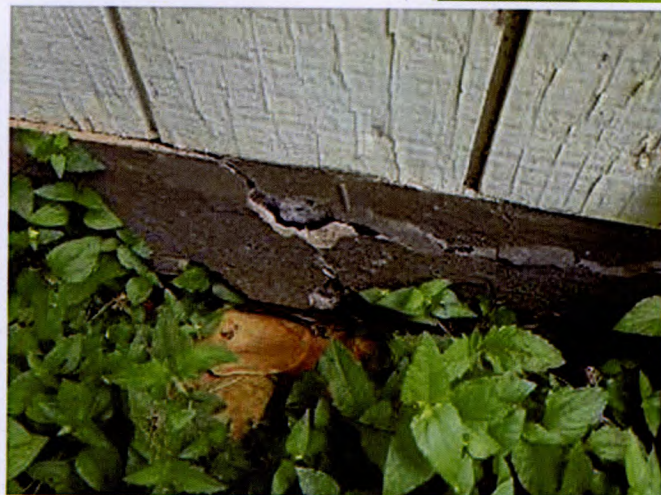
Foundation Areas: Visible cracks in Buildings A & B

- ▶ Foundation repairs
- ▶ Beams and rafters evaluated for termite damage and replaced as needed
- ▶ All dry wall treated for moisture damage and mold intrusion in all attics and living areas

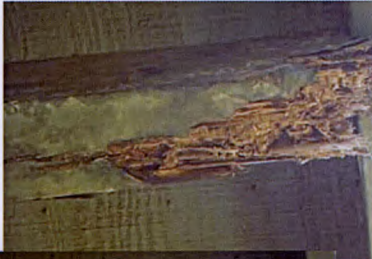
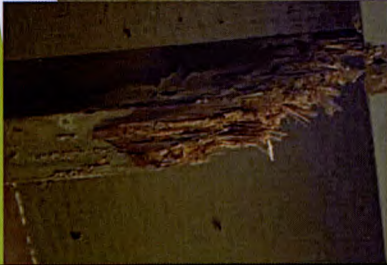
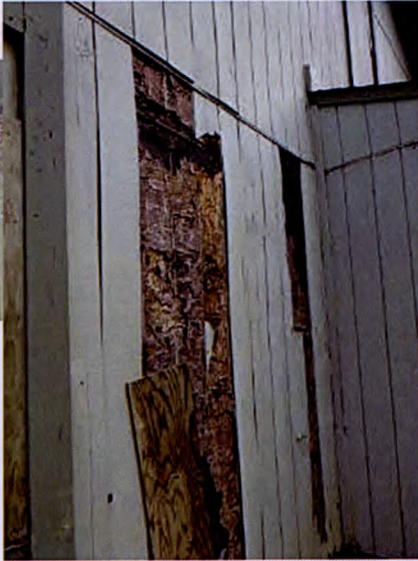
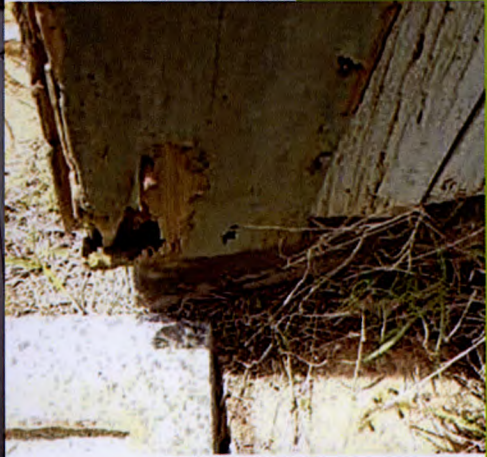
Exterior, Façade & Curtainwall: Rotted, termite damage, moisture damage

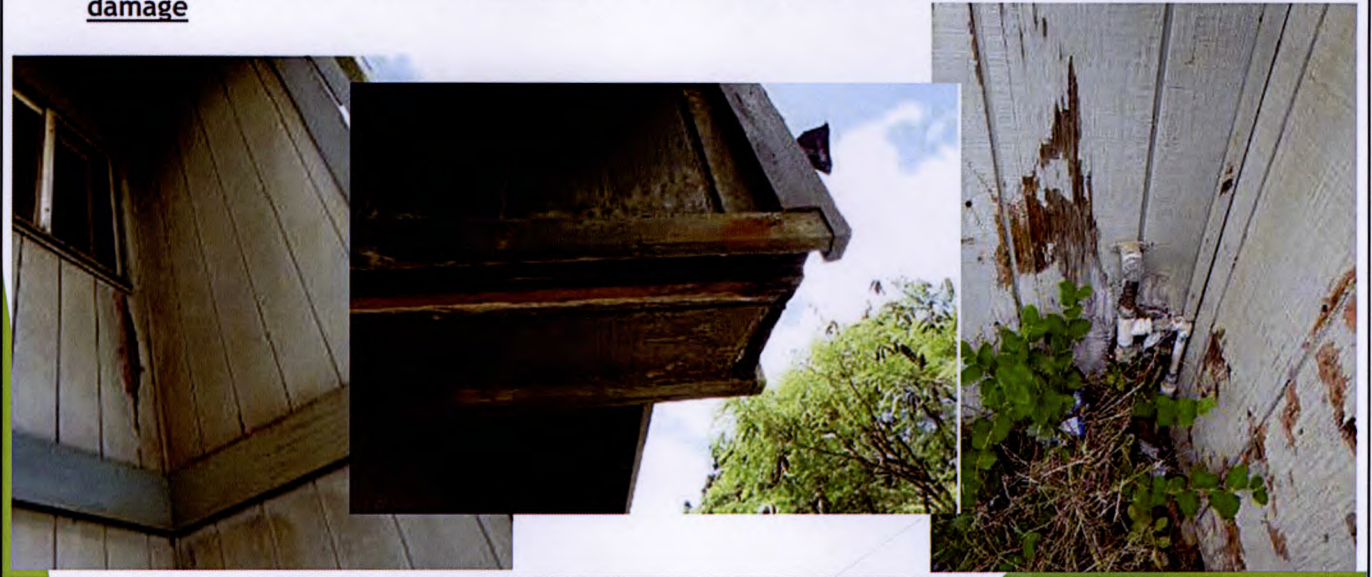
Exterior, Façade & Curtainwall: Rotted, termite damage, moisture damage

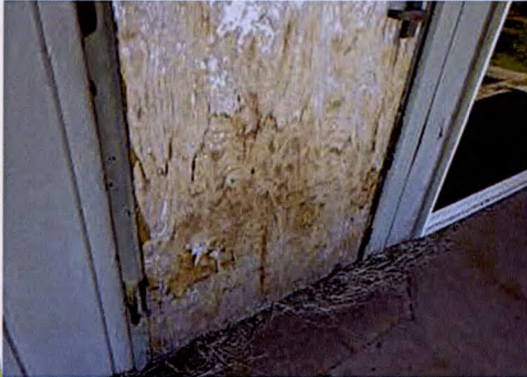
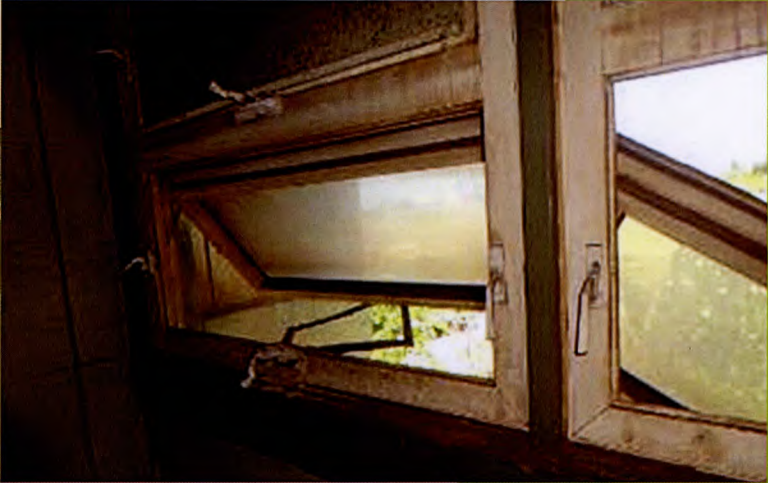
Fenestration (Exterior Doors/Windows): Termite, moisture damage, corroded, damaged & most inoperable

- ▶ Replace all exterior doors, framing and trim for all buildings
- ▶ Replace all interior doors and trim within dwelling units
- ▶ Replace all interior window trim and finishes

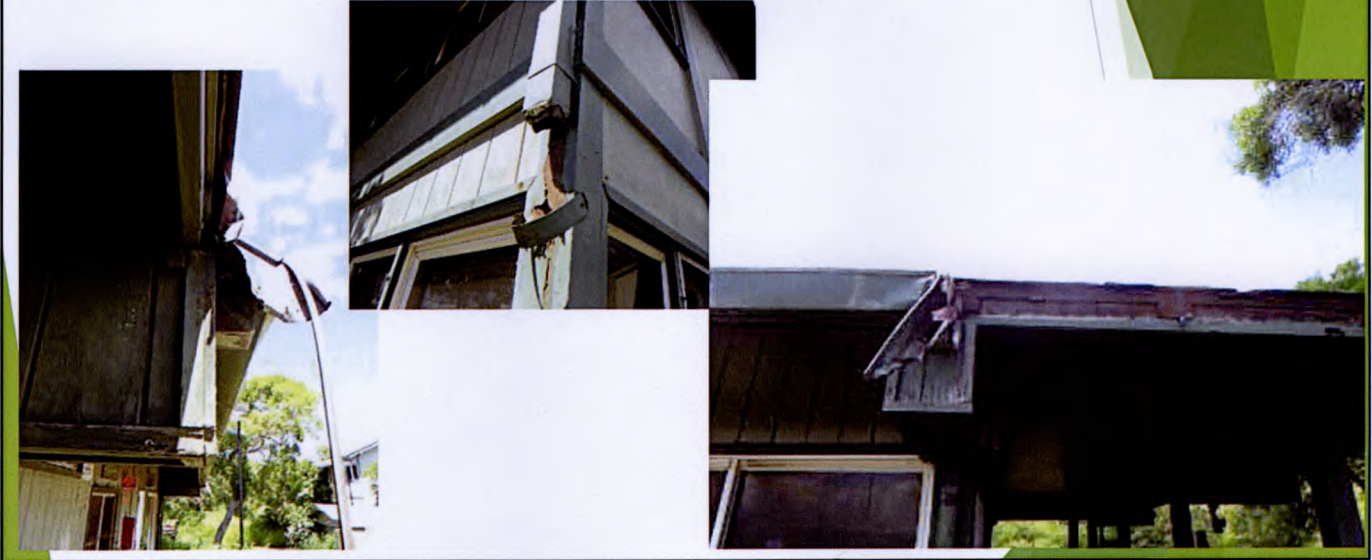
Roofing: Moisture intrusion, missing shingles, gutters damaged/broken/missing

- ▶ Plumbing, electrical and fire suppression systems brought up to code
- ▶ Replace installed sheathing and roofing finish
- ▶ Replacement of all gutter systems

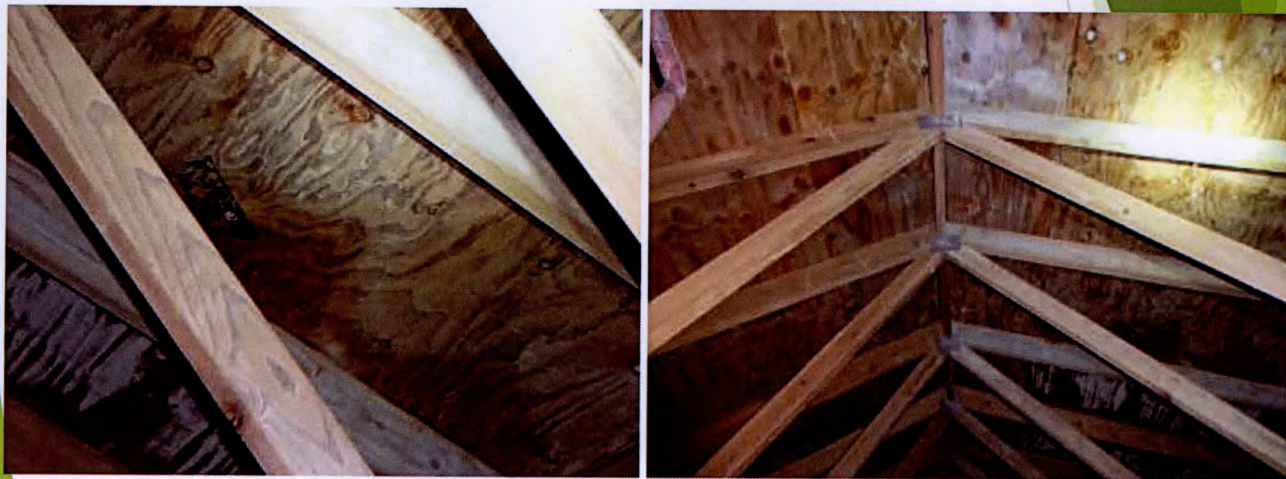
Roofing: Moisture intrusion, missing shingles, gutters damaged/broken/missing

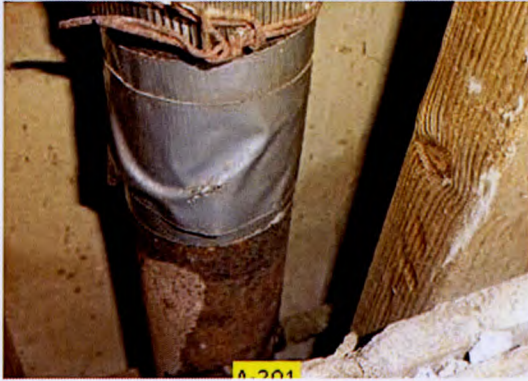
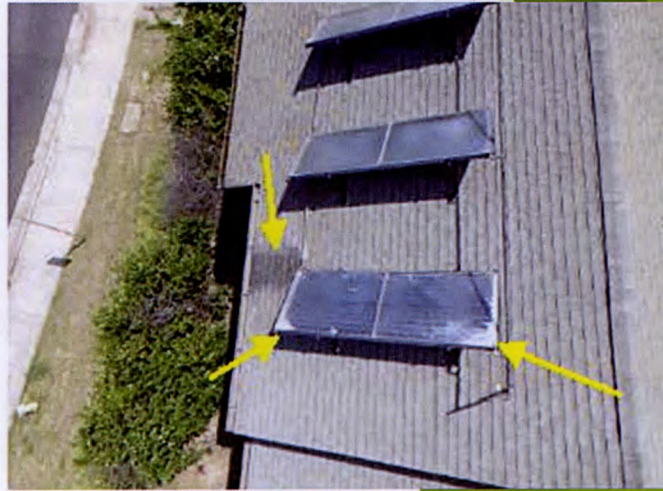
Plumbing: Non-standard repairs, water heating devices terminated with supply cut and electrical connections removed, solar panels damaged & leaking, fixtures in poor condition

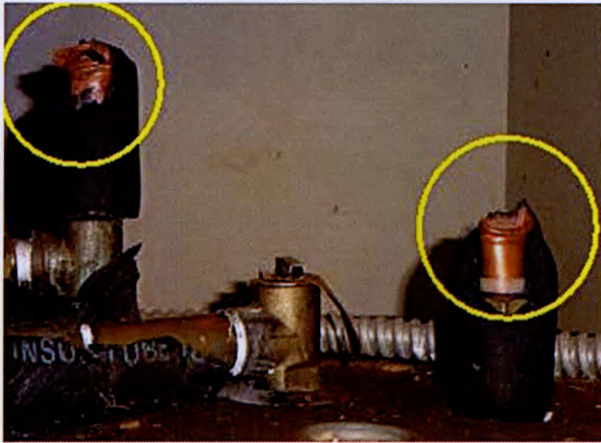
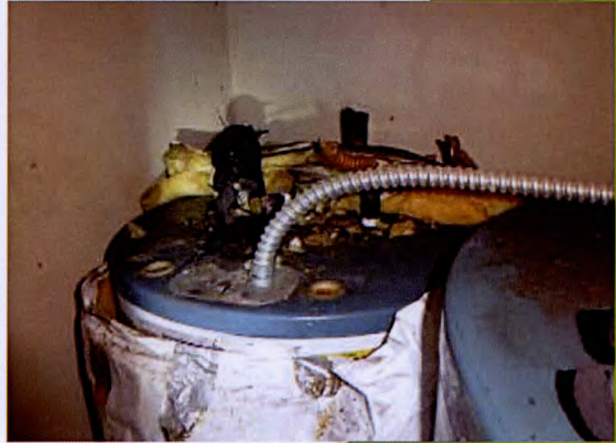
Plumbing: Non-standard repairs, water heating devices terminated with supply cut and electrical connections removed, solar panels damaged & leaking, fixtures in poor condition

All water heating appliances were terminated with supply and service plumbing cut and electrical connections removed. Recommend having a licensed plumber evaluate and install commercial grade gas on demand hot water heating systems for each floor of each building

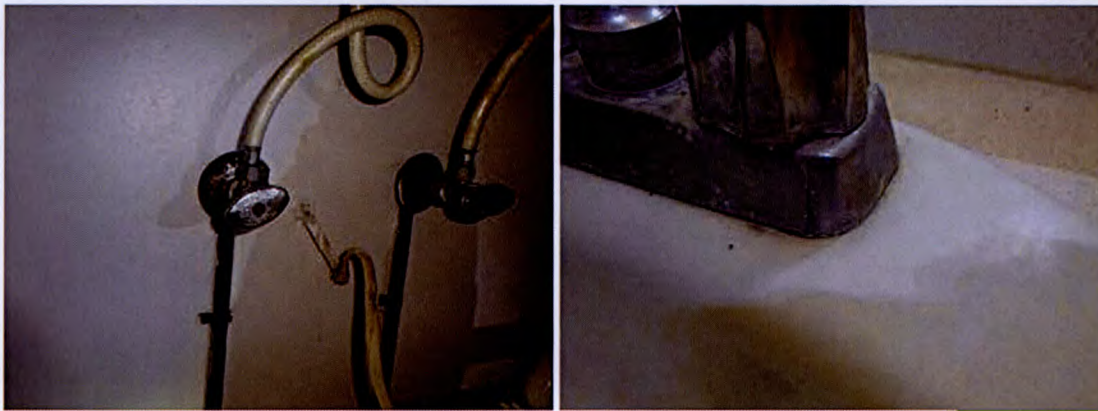
Plumbing: Non-standard repairs, water heating devices terminated with supply cut and electrical connections removed, solar panels damaged & leaking, fixtures in poor condition

Based on observed physical conditions of the installed fixtures, it is recommended to replace all plumbing fixtures and shut off valves in all buildings to ensure proper future operation

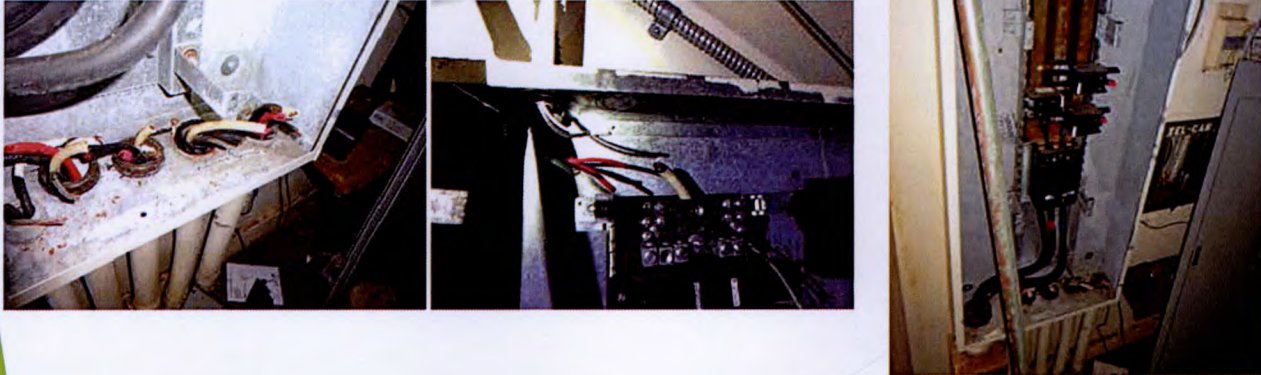
Electrical: Buildings B & C main service conductors and all branch wiring cut at main service panel, circuit breakers removed, missing junction boxes, non-standard repairs

Main service conductors and all electrical branch wiring was cut at the main service panel entrance. Need electrical contractor to evaluate and repair electrical service to each building.

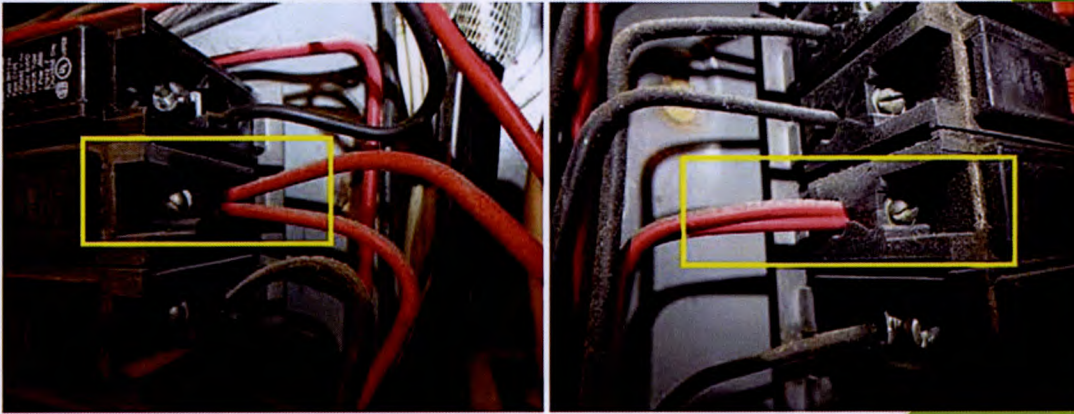
Electrical: Buildings B & C main service conductors and all branch wiring cut at main service panel, circuit breakers removed, missing junction boxes, improper repairs

There were double tapped 1-pole circuit breakers noted. This is not consistent with the manufacturer's instructions and the NEC (National electric code). Licensed electrician needed to evaluate and repair/replace as necessary

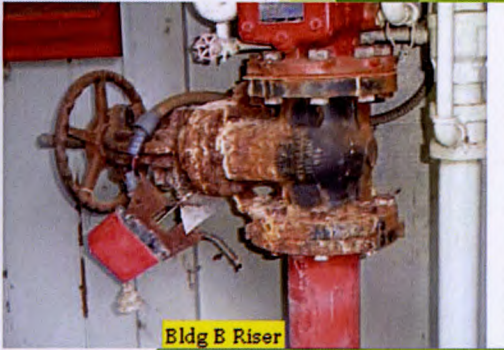
Fire Suppression: Improperly maintained fire suppression risers, pull stations and sprinkler systems

- ▶ Overhaul of fire suppression system
- ▶ Overhaul of alarm system
- ▶ Overhaul of smoke detection system
- ▶ All fire extinguishers need replacement
- ▶ Kitchens and bathroom fixtures/cabinets/appliances need to be replaced

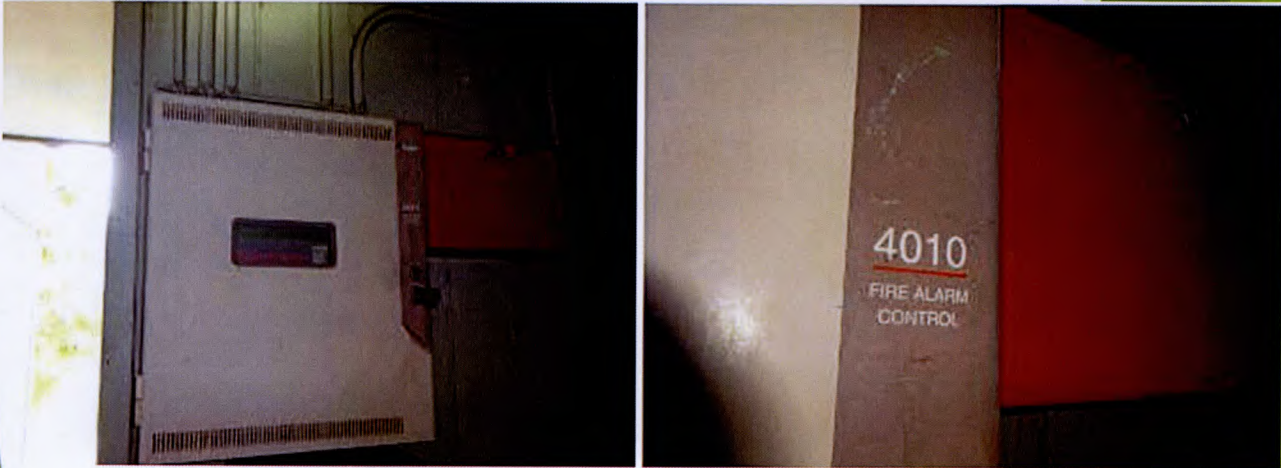
Alarm System: Poor condition

Each building's designated alarm and alarm panel in poor condition.

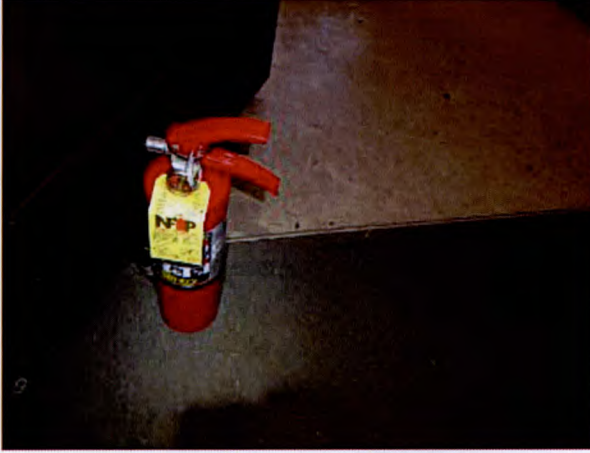
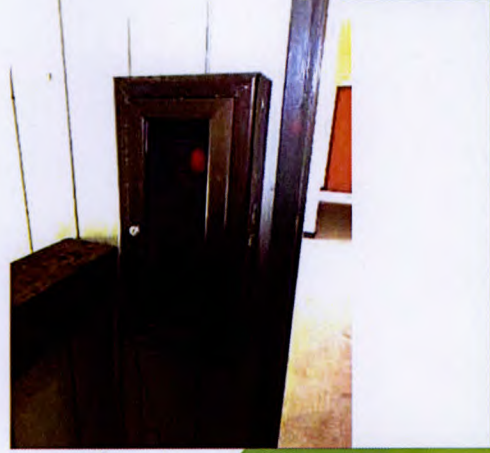
Smoke Detectors: None

Fire Extinguishers: Most expired and/or missing at required locations

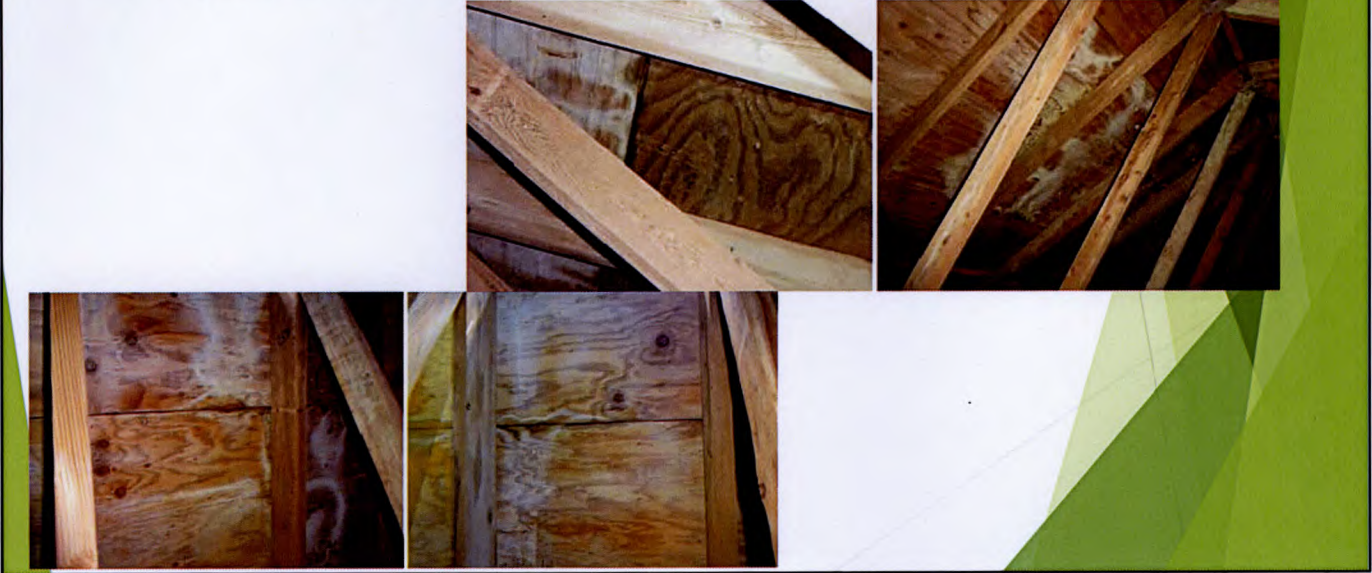
Interior Spaces: Moisture intrusion, mold growth and termite damage

Visible indications of mold present in all attic areas

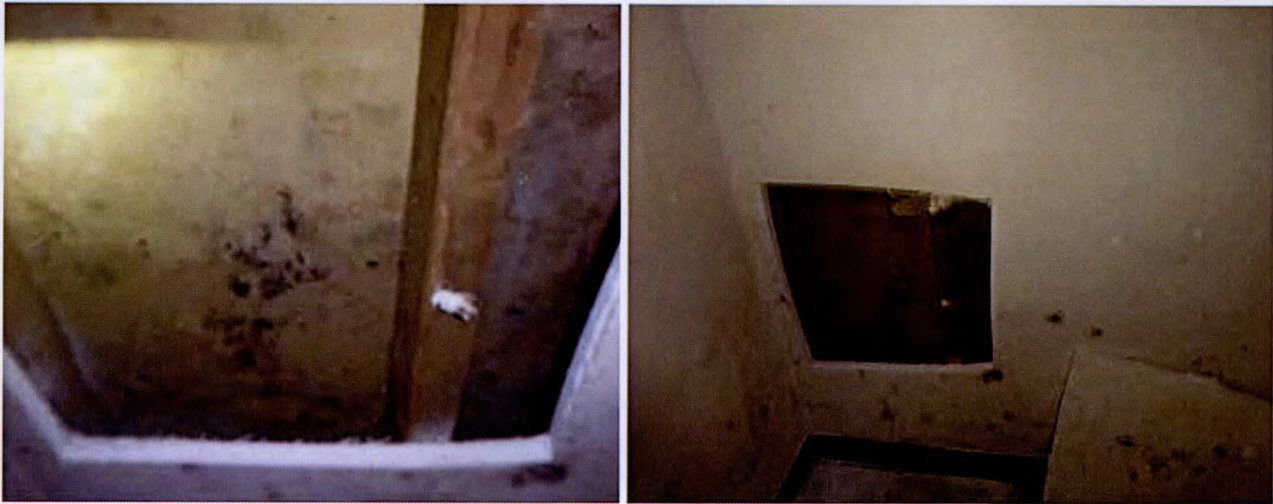
Interior Spaces: Moisture intrusion, mold growth and termite damage

Most of the lower interior wall finishes had moisture damage. In buildings B & C moisture intrusion and mold growth in interior areas, bedroomr, bathrooms and closet areas.

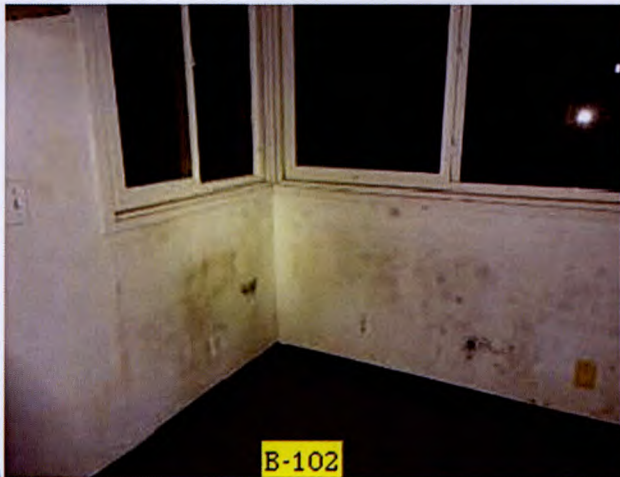
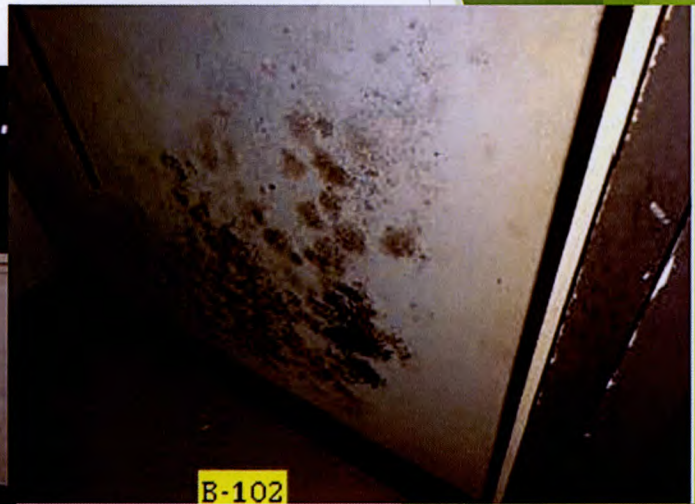
Interior Spaces: Moisture intrusion, mold growth and termite damage

Moisture intrusion and mold growth in interior areas of buildings B & C

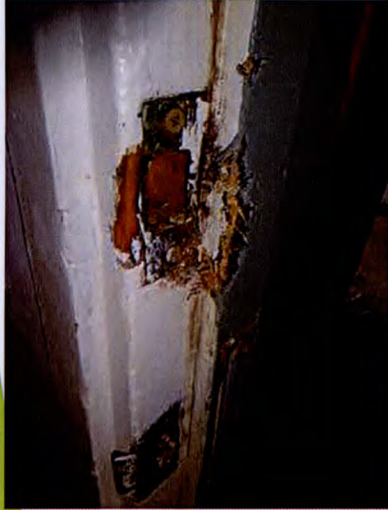
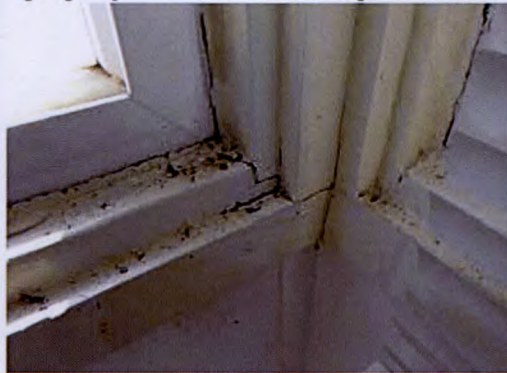
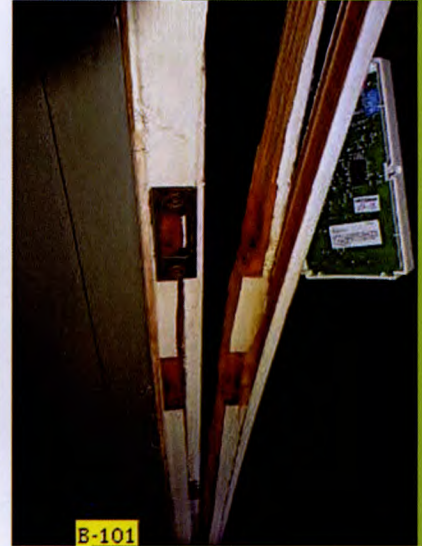
Interior Spaces: Damaged windows & doors

Most of the doors had varying degrees of damage. Visible moisture and termite damage at interior window trim areas.

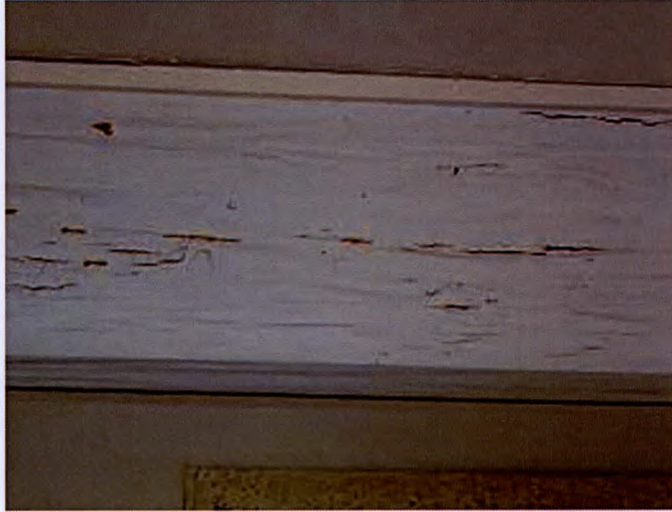
Interior Spaces: Bedroom ceiling joists severely termite damaged in Building B,

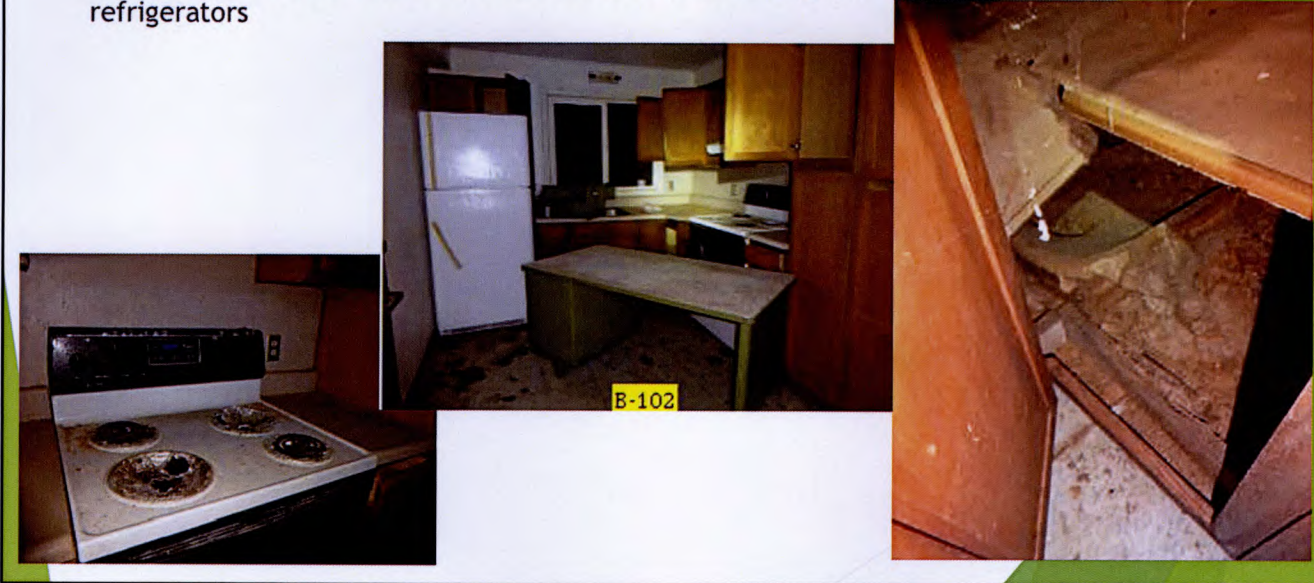
Kitchen Spaces: Deteriorated, moisture & termite damage, mold in refrigerators

While a few of the kitchens in Building A appeared operable, Buildings B & C were not in good shape

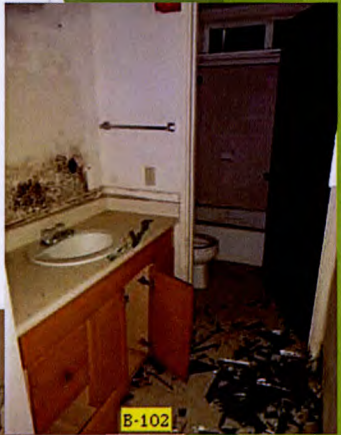
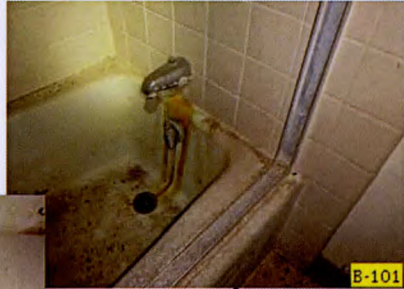
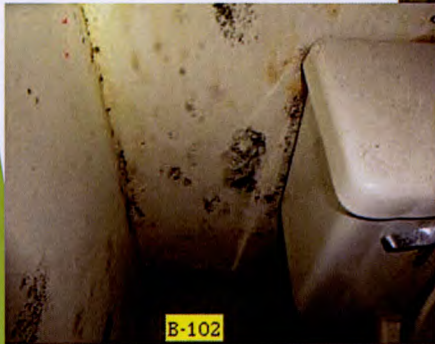
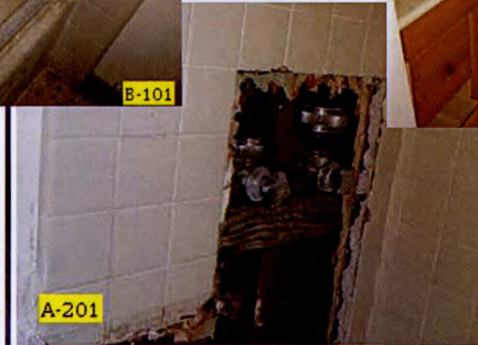
Bathrooms: Moisture damage, mold growth and damaged flooring, cabinets and counters, mirrors, toilets and shower compartments

Visible indications of moisture damage, mold growth, damaged flooring, damaged cabinets and counters, damaged mirrors, damaged toilets and damaged shower compartments.

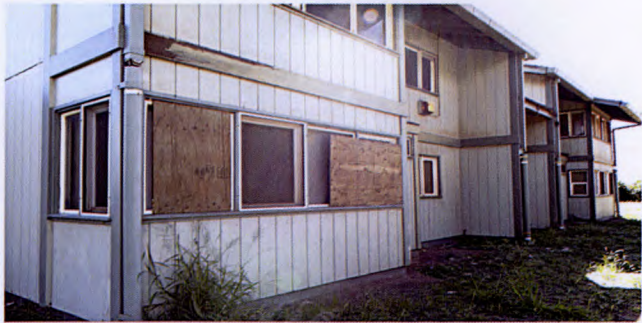
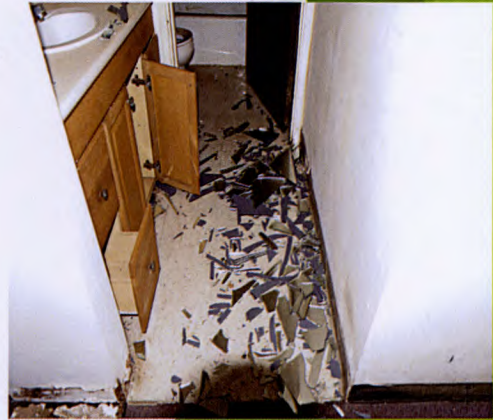
- ▶ Water damage, mold intrusion found in all buildings, in all attics
- ▶ Termite damage in all buildings
- ▶ Foundational cracks in Buildings A & C
- ▶ Buildings B & C mold and moisture intrusion in interior, bedroom, bathroom & closet
