SUBJECT: Litigation Matters
Settlement of Subrogation Claim: First Insurance Company of
Hawaii, Ltd.
John Mullen Claim No.: 4073176
Resolution: Authorizing Settlement of Claim No. 4073176 of First
Insurance Company of Hawaii, Ltd. on Behalf of Its Insured Anita
Mosuela

RELEASE OF PROPERTY DAMAGE CLAIM

Synopsis (Accident Description. Refer to units by #):

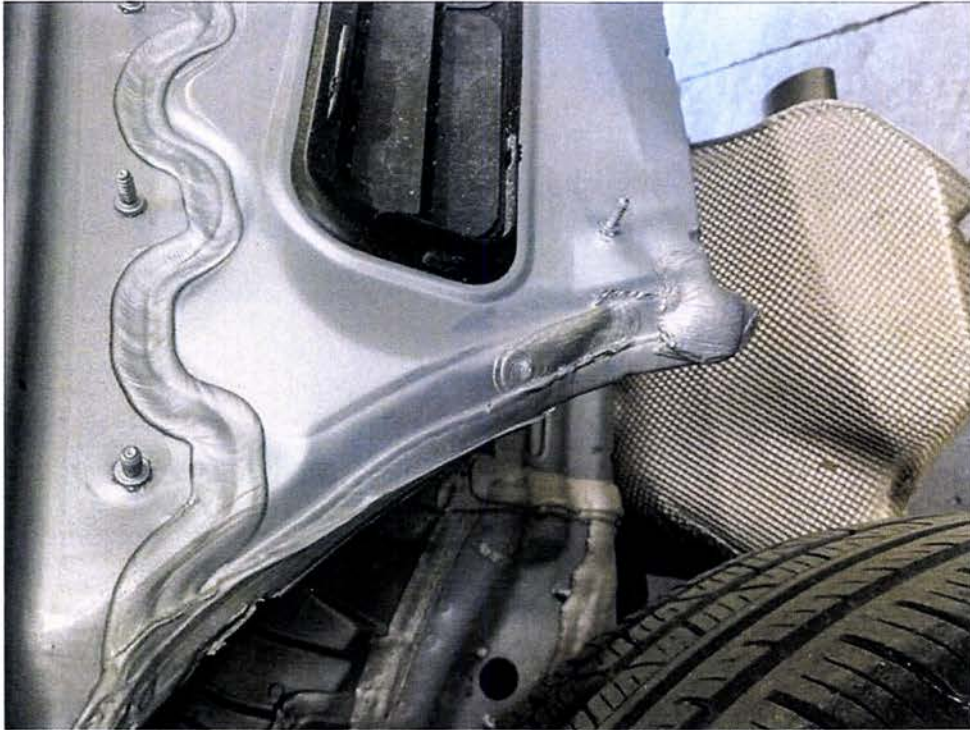
hidden damages

Line	Oper	Description	Part Number	Qty	Extended Price \$	Labor	Paint
Changed Items							
7		R&I LT Flare w/o GLC63				-0.3	
7	*	S01 R&I LT Flare w/o GLC63				<u>0.8</u>	
		NOTE: necessary to clean & retape					
9	*	Rpr LT Outer rocker pnl				<u>-10.0</u>	-2.1
		NOTE: rear section caved in -- shop to advise if more time needed after teardown					
9	*	S01 Rpr LT Outer rocker pnl				<u>15.0</u>	2.1
		NOTE: rear section caved in -- shop to advise if more time needed after teardown -- shop found b-pillar caved in around lower door hinge & repairs on rocker panel involved extensive repairs on multiple bodylines -- see photos					
29	*	Rpr LT Quarter panel				<u>-4.0</u>	-2.8
		NOTE: upper area above rear bumper caved in from impact -- shop to advise if hidden damages found behind mldg or bumper					
30	*	S01 Rpr LT Quarter panel				<u>5.0</u>	2.8
		NOTE: upper area above rear bumper caved in from impact -- shop to advise if hidden damages found behind mldg or bumper -- upper damages larger than estimated -- see photos
