SUBJECT: **TRANSMITTAL OF INFORMATIONAL DOCUMENTS RELATING
TO THE WAIKAPU DEVELOPMENT VENTURE WORKFORCE
HOUSING PROJECT** (AH-1(6))

**FINAL ARCHAEOLOGICAL INVENTORY SURVEY
OF A 50-ACRE PARCEL OF LAND
WAIKAPU AND WAILUKU *AHUPUA*'A, WAILUKU DISTRICT MAUI ISLAND
TMK [2] 3-5-002:011 and 012 (formerly 3-5-002:001 pors.)**

REVISED MAY 2016

**Archaeological Services Hawaii, LLC
16 South Market Street, Suite G
Wailuku, Hawaii 96793**

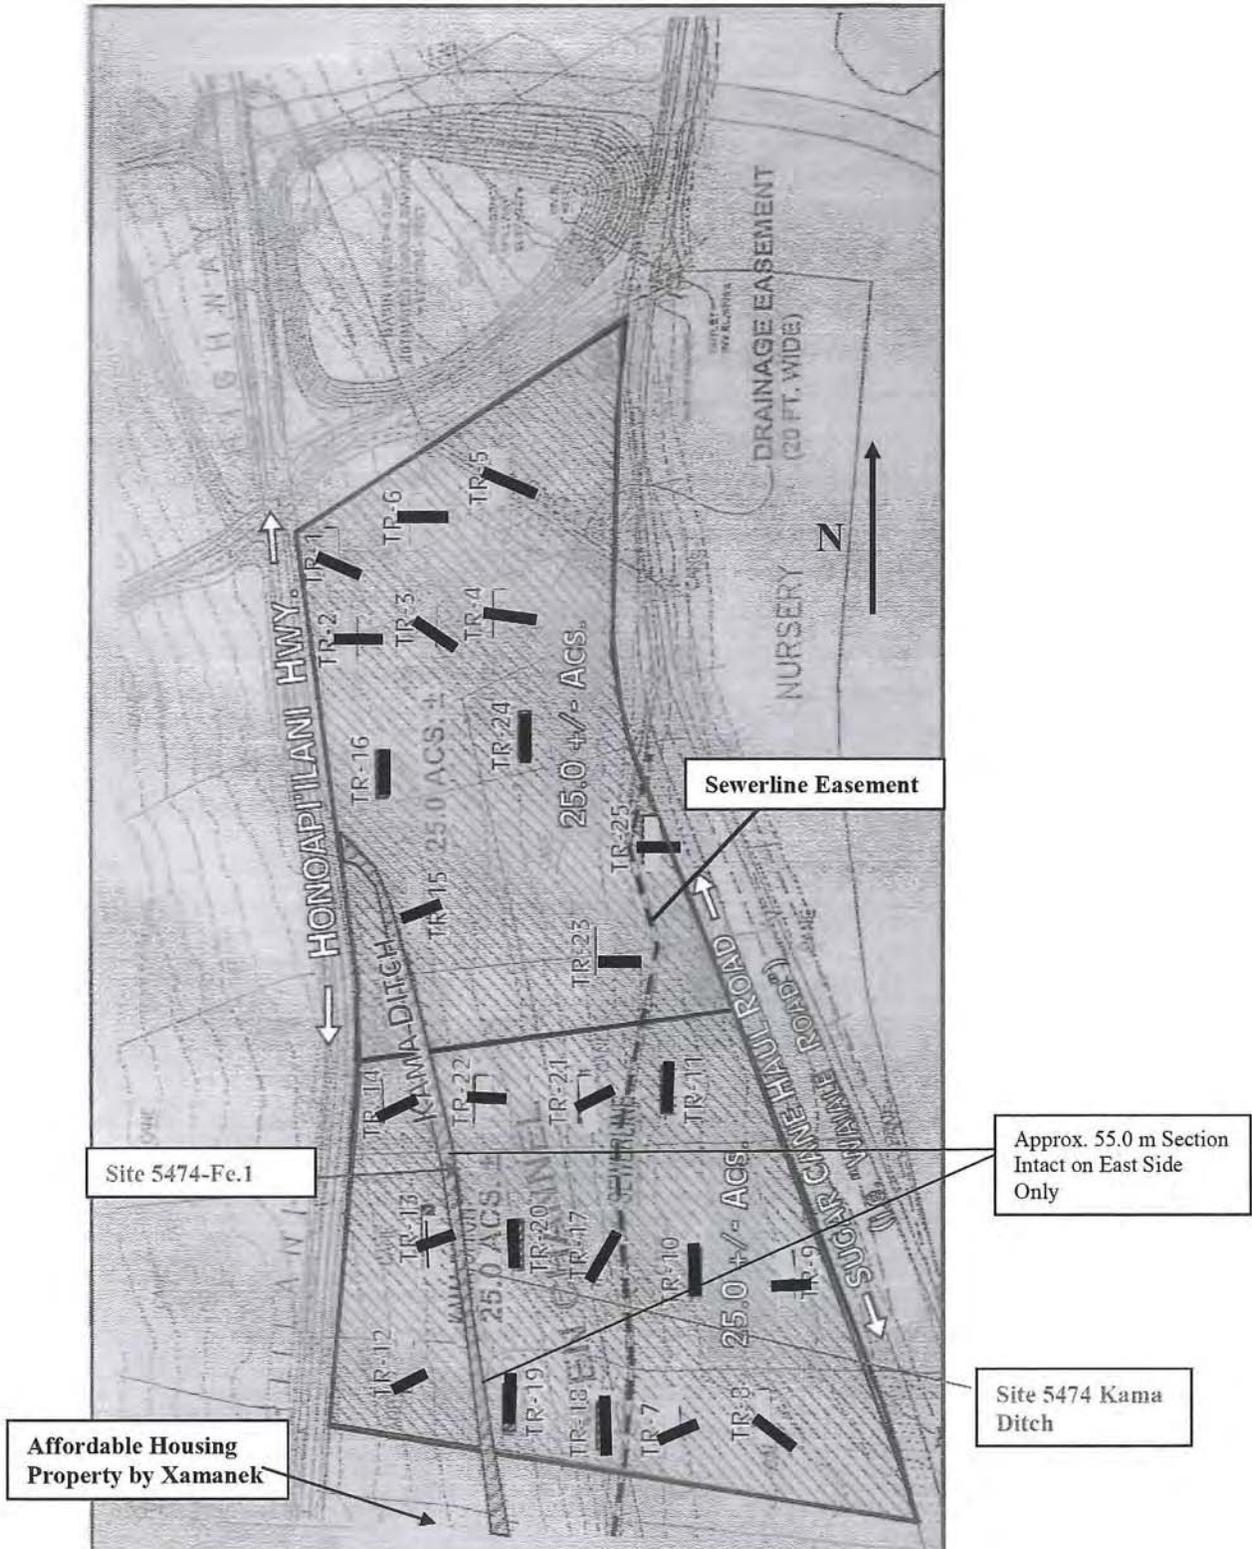
Figure 5. Topographic Map Showing TR's 1-25, Site 50-50-04-5474 and Waiale Housing to South

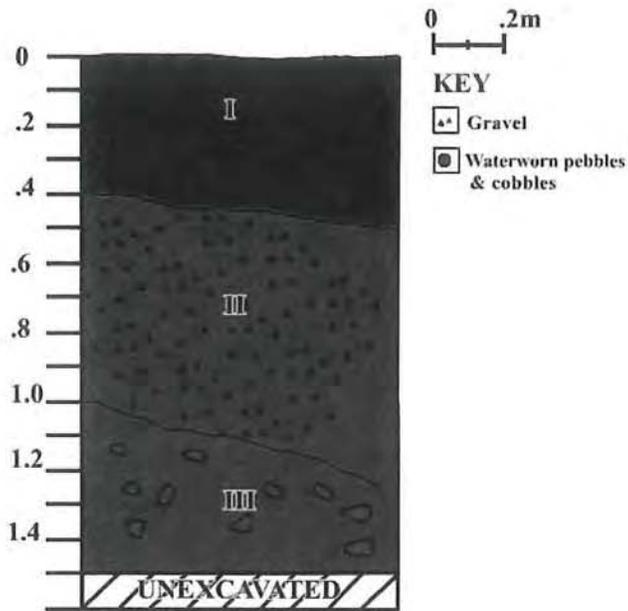
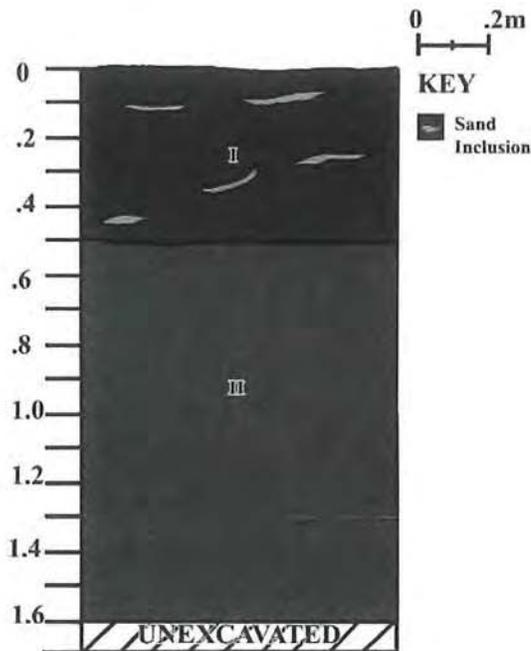
Figure 7. Representative Stratigraphic Profiles for Trenches 1-5, (top) TR2 North Wall (bottom) TR4 South Wall

Backhoe Trench 5 (TR5), was placed in the northeast portion of the project area along the lower slope, and placed c. 100 m east of Trench 4. Trench 5 measured 6.2 m long by .8 m wide and 1.5 deep, and orientated east/west on a slight slope towards the east. Layer I contained the plow zone with evidence of past and recent agricultural disturbance, fallow vegetables and fruit were noted in the area. Two stratigraphic layers were revealed in TR5 same as Trench 4 (Fig. 8).

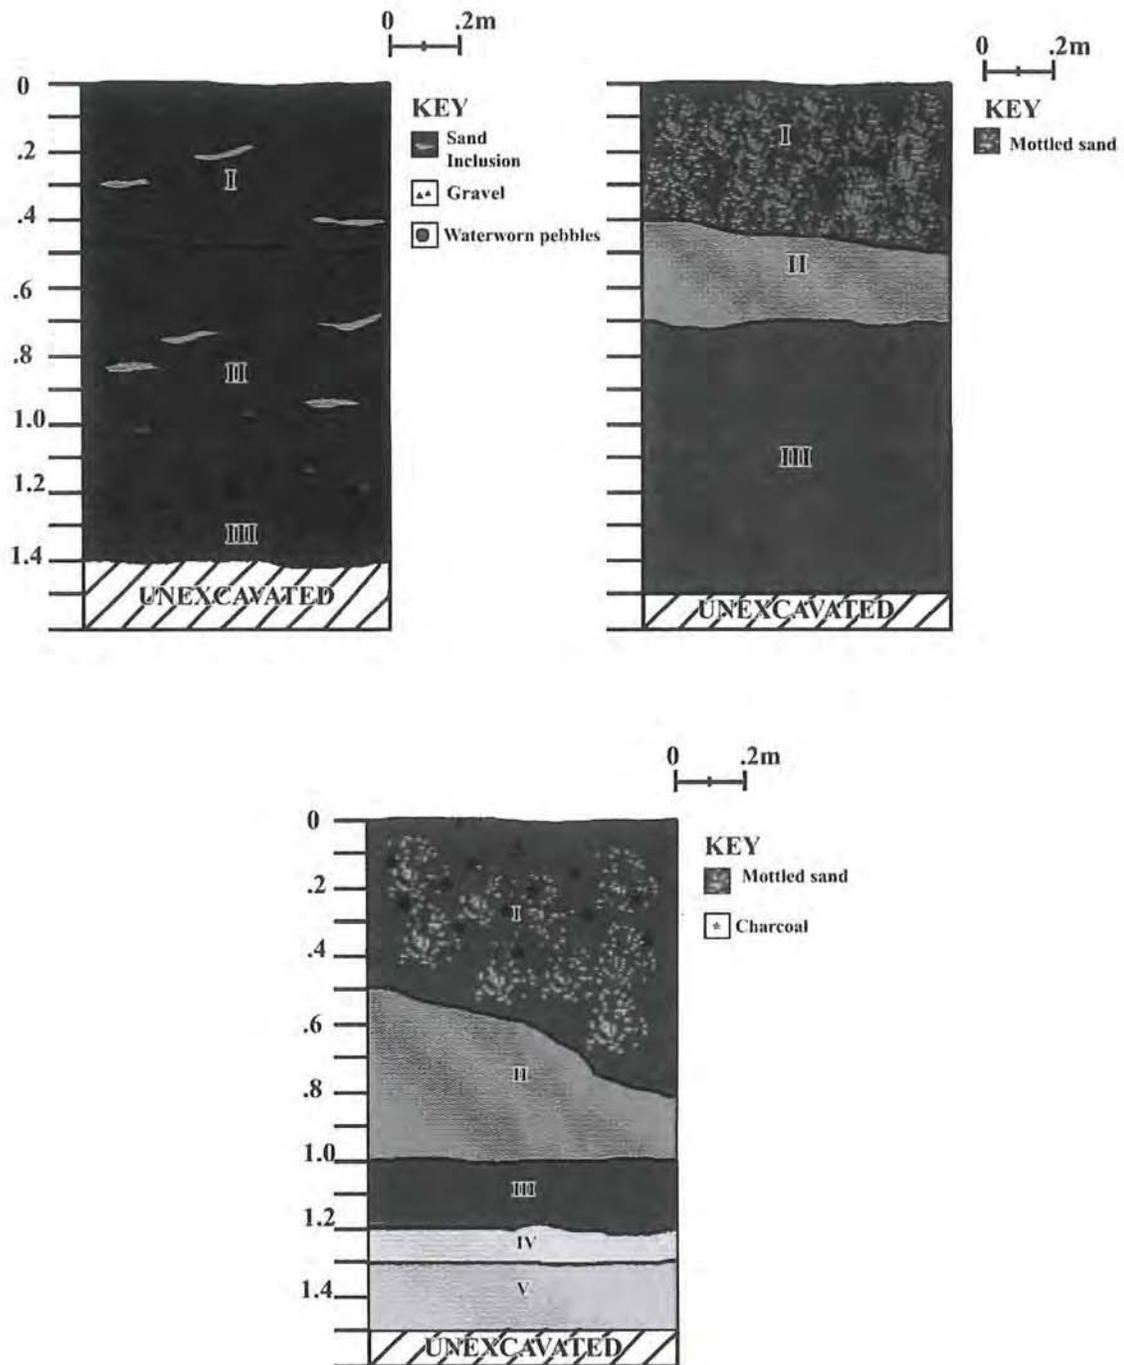
Figure 11. Representative Stratigraphic Profiles for Trenches 6 through 10, (top left) TR7 South Wall, (top right) TR9 South Wall and (bottom) TR10 West Wall

Backhoe Trench 7 (TR7), was placed in the southeast portion of the project area, along the southern boundary, east of the existing sewerline easement in an area previously sand mined. Trench 7 measured 5.5 m long by .8 m wide and 1.4 deep, and orientated east / west. Surface area was relatively flat with scattered modern historic debris. Three stratigraphic layers were revealed in TR7, and a concentration of riverbed pebbles and cobbles were noted in the north face (Fig. 11).

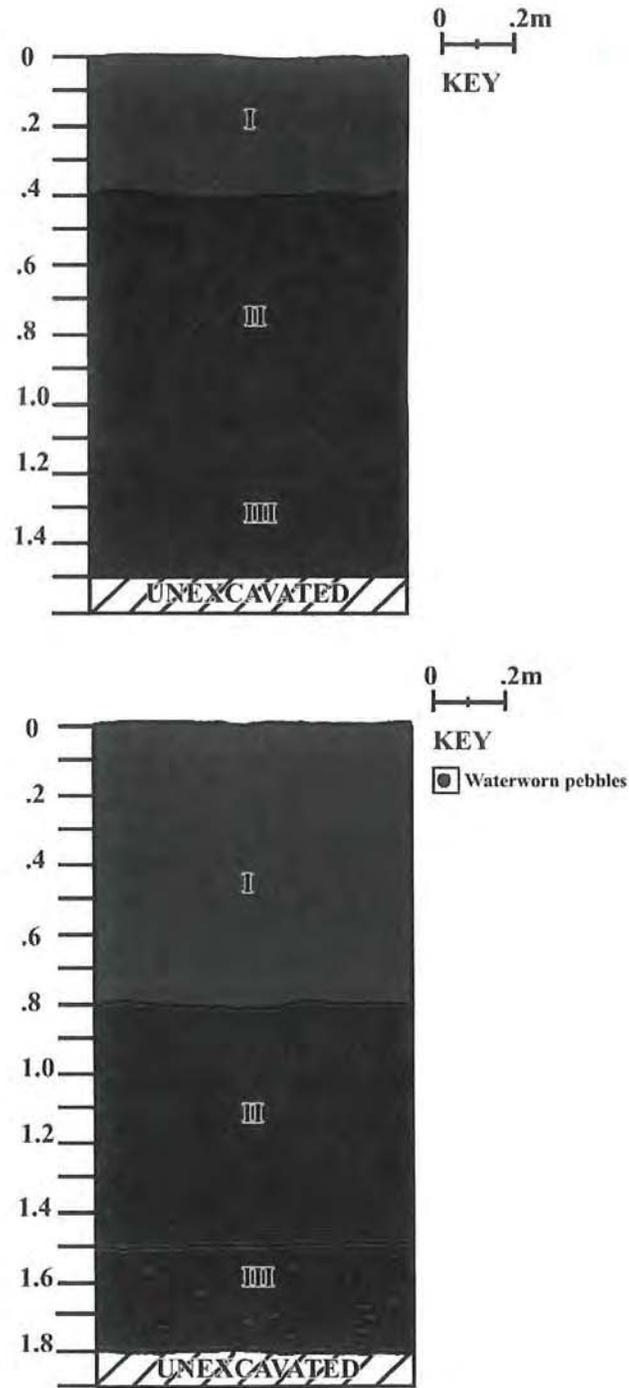
Figure 13. Representative Stratigraphic Profiles for Trenches 11-15 (top) TR11 South Wall and (bottom) TR12 North Wall

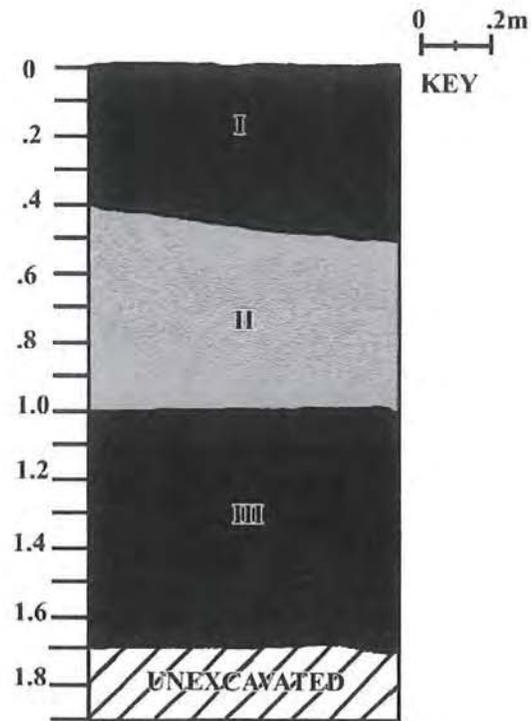
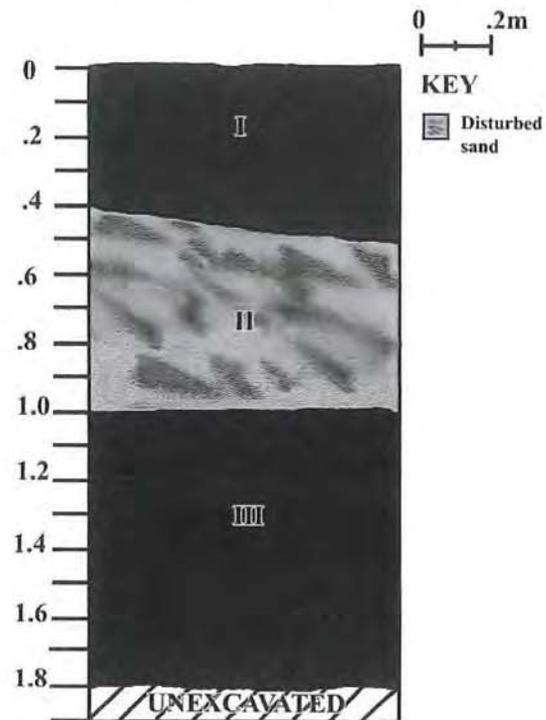
Figure 16. Representative Stratigraphic Profiles for Trenches 16 through 20, (top) TR17 East Wall, (bottom) TR18 East Wall

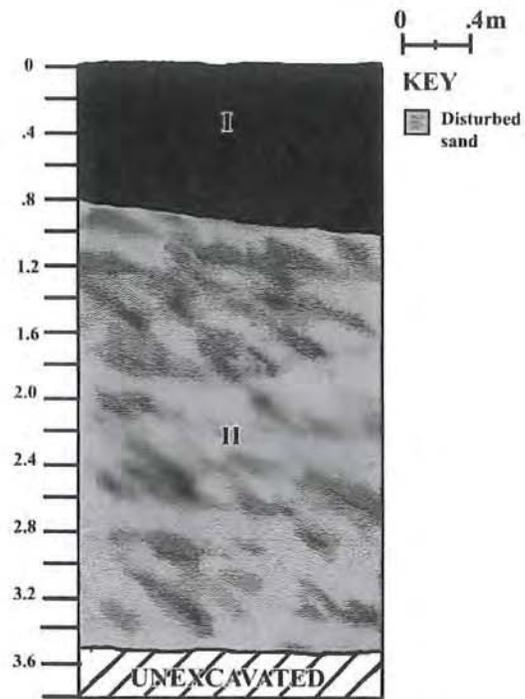
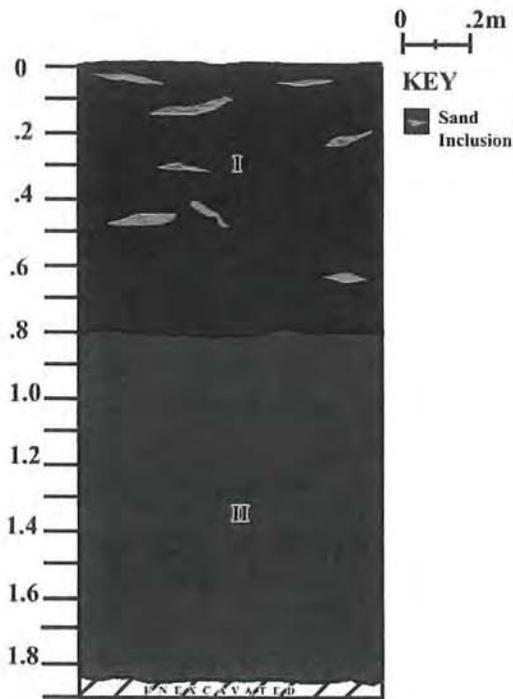
Figure 18. Representative Stratigraphic Profiles for Trenches 21-25 (top) TR23 East Wall (bottom) TR25 North Wall

Backhoe Trench 23 (TR23) was placed along the same elevation contour as Trenches 17, 18, and 21, in the central portion of the project area, located west of the existing sewer easement. Backhoe Trench 23 (TR23), measured 6.5 m long by .8 m wide and 2.5 deep. A two stratigraphic sequence was revealed in Trench 23, the same Layer I and Layer II as found in TR's 17 through 22 (Figs. 18 and 19). BOE was terminated in sterile substratum Layer II (Aeolian dune).

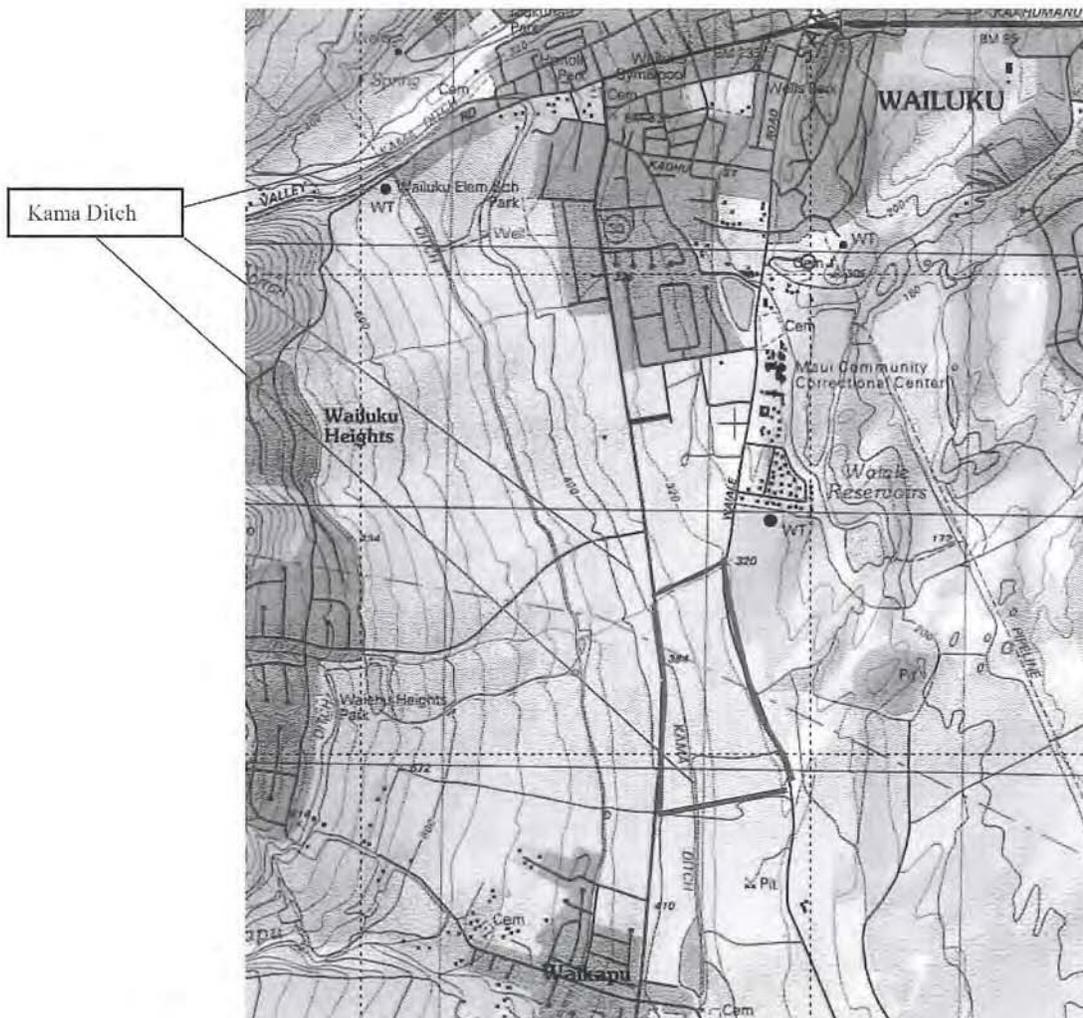
Figure 21. Enlarged USGS Map Showing Kama Ditch from South side of Iao Stream to its Terminus at Reservoir by Waikapū

Results of the current investigation identified a segment of historic property State Site 50-50-04-5474, the Kama Ditch, as well as an associated metal sluice gate designated Feature 1 (see Figs 1 and 21). As exhibited below, the current configuration of Kama Ditch commences along the south side of Iao Stream and follows the stream east where it eventually turns southward flowing along the approximate 380 ft. elevation line, through the project area terminating at the Reservoir by Waikapū.

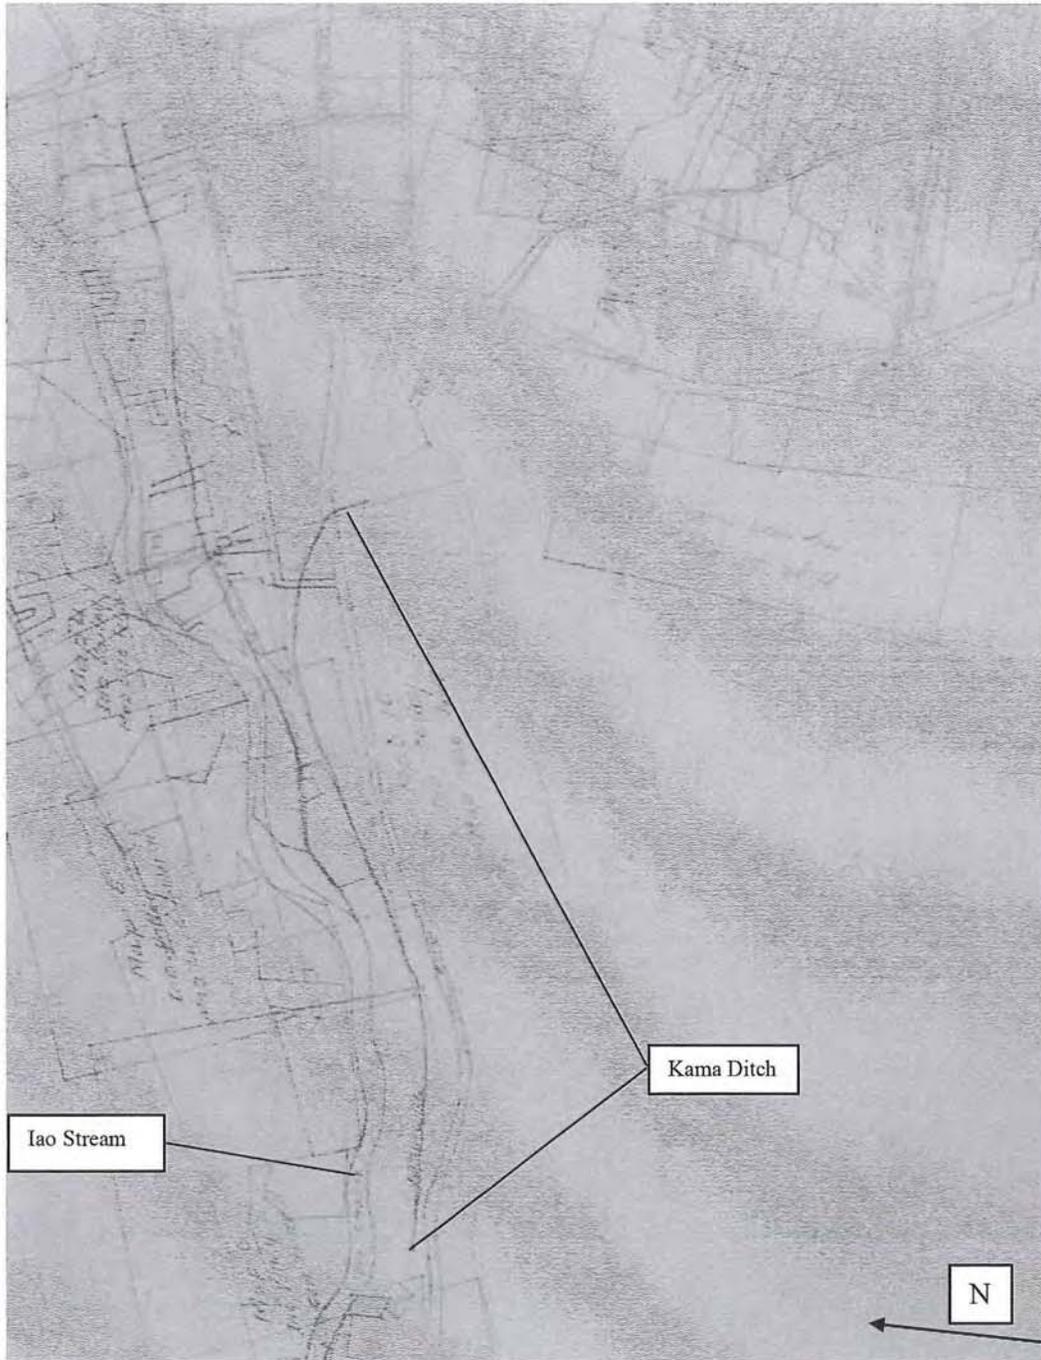
Figure 24. Enlarged Key Map of Wailuku (Fig. 23) Showing Iao Stream, Kama Ditch-Site 5474 and Old Mill Ditch

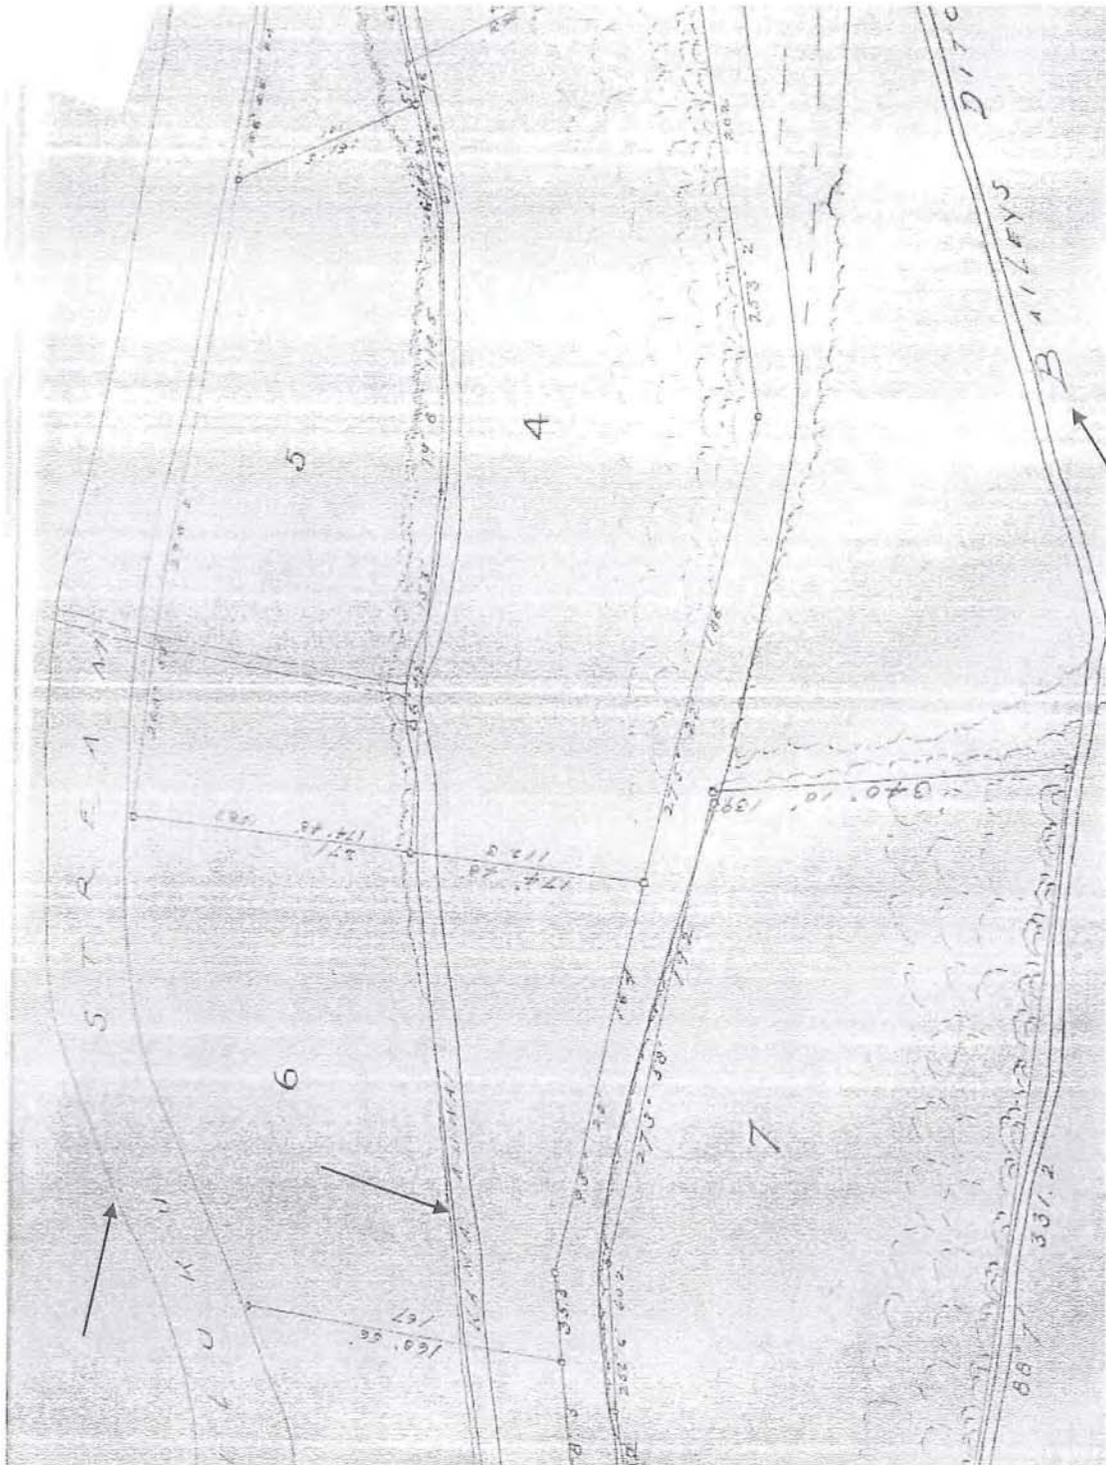
Figure 26. Enlarged Central Section of Wailuku Sugar Co. Map from 1907 (Fig.25) Showing Kama Auwai and Bailey's Ditch (note map designates Iao Stream as Wailuku Stream). Photo Copy courtesy of Baily House Museum as Original Map is no Longer Available

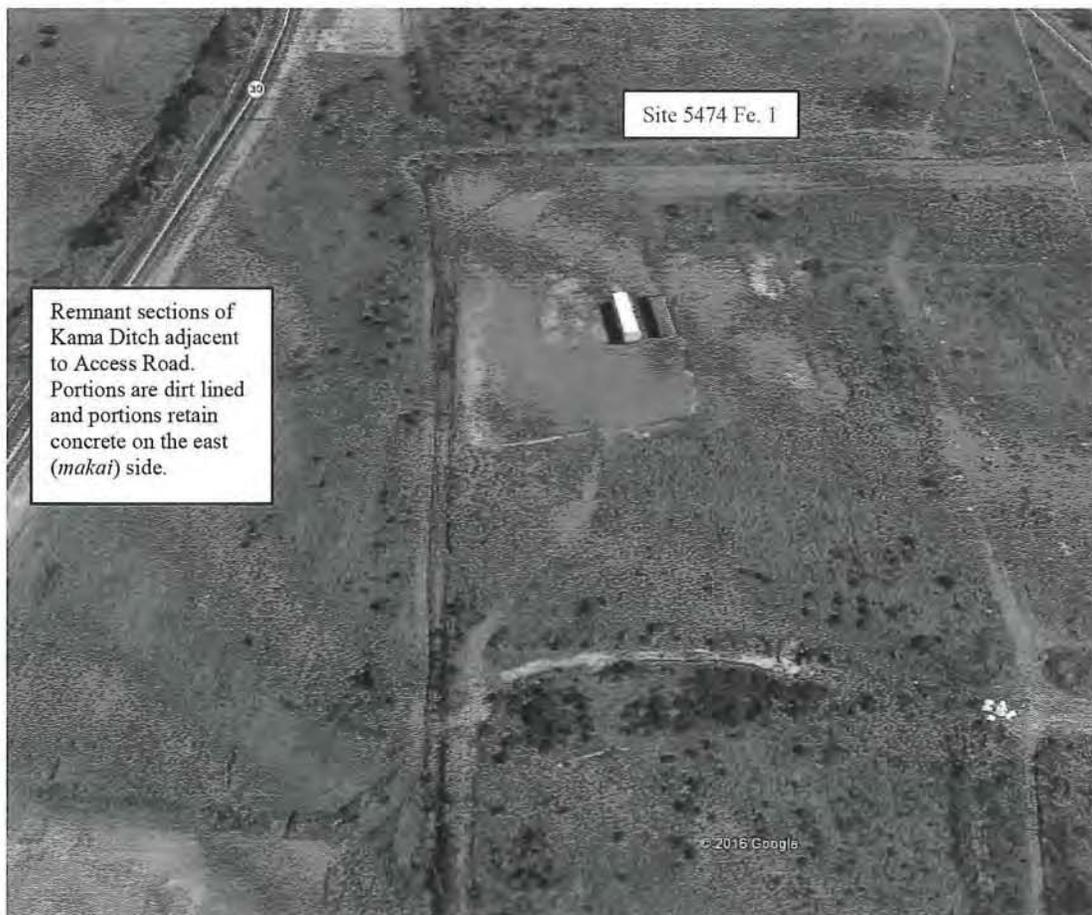
Figure 28. Aerial Photograph of Southwestern Quadrant of Project Area Showing

During the current course of work, the condition of Site 5474 ranged from poor to good with the overall condition as fair. The Kama Ditch was either dirt lined or concrete lined; however the majority, particularly on the northern end and western (*mauka*) side is either pushed up or removed by prior grading with the central portions infilled with vegetation and or soil (Figs. 28-31). The concrete lined portion when extant is along the east side intermittently for approximately 55.0 m. It averages 2.80 m wide by 0.60 m (top of silt) to 1.5 m deep. A metal sluice gate, designated Feature 1 was noted along the eastern side of the ditch approximately 60 m north of the southern boundary. The sluice gate is constructed of sheet metal and measures 0.43 m to 1.0 m long by 0.58 m wide by 0.04 m thick, and when operational, would release water to irrigate the fields below or *makai*. Unfortunately, Site 5474 has been severely damaged through prior grubbing and grading activities, abandonment and natural erosional forces. Site 5474 has been adequately documented at the inventory level and requires no further work beyond construction monitoring during removal.

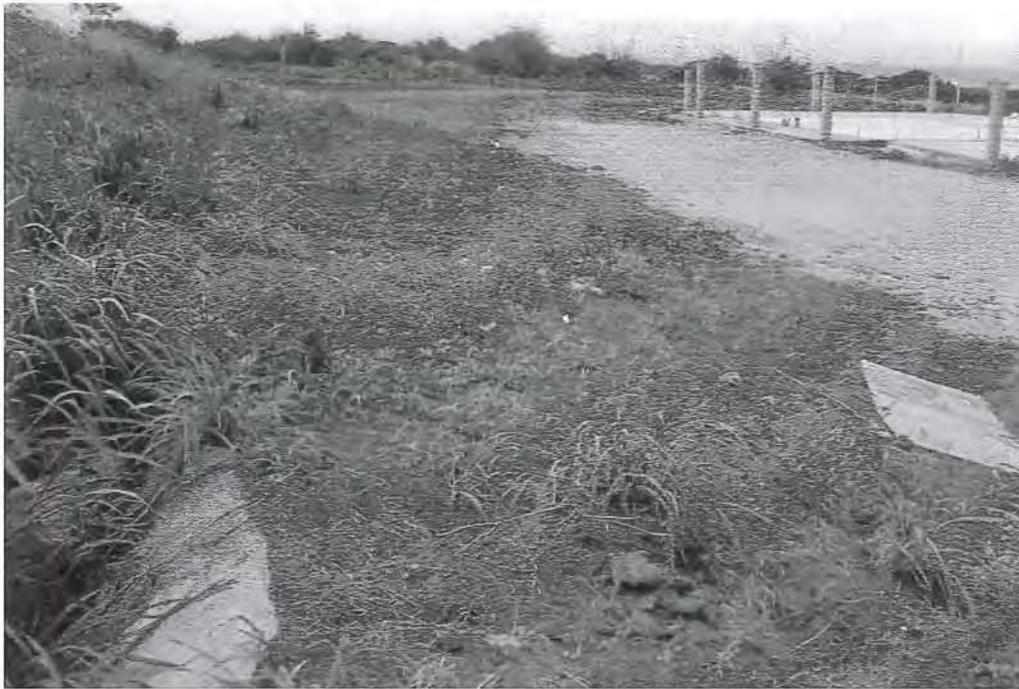
Figure 29. Photograph of Site 5474 Kama Ditch (View to North)

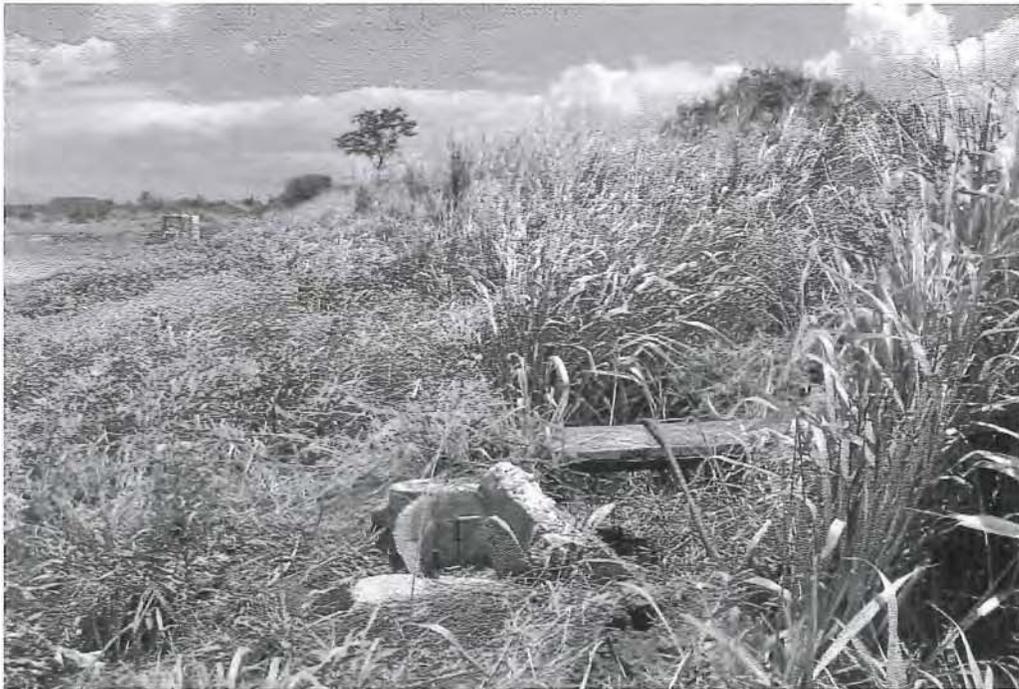
Figure 30. Overview Photograph of Project Area and Site 5474 (Kama Ditch) Feature 1 (Sluice Gate) along Southwest Side (View to South)

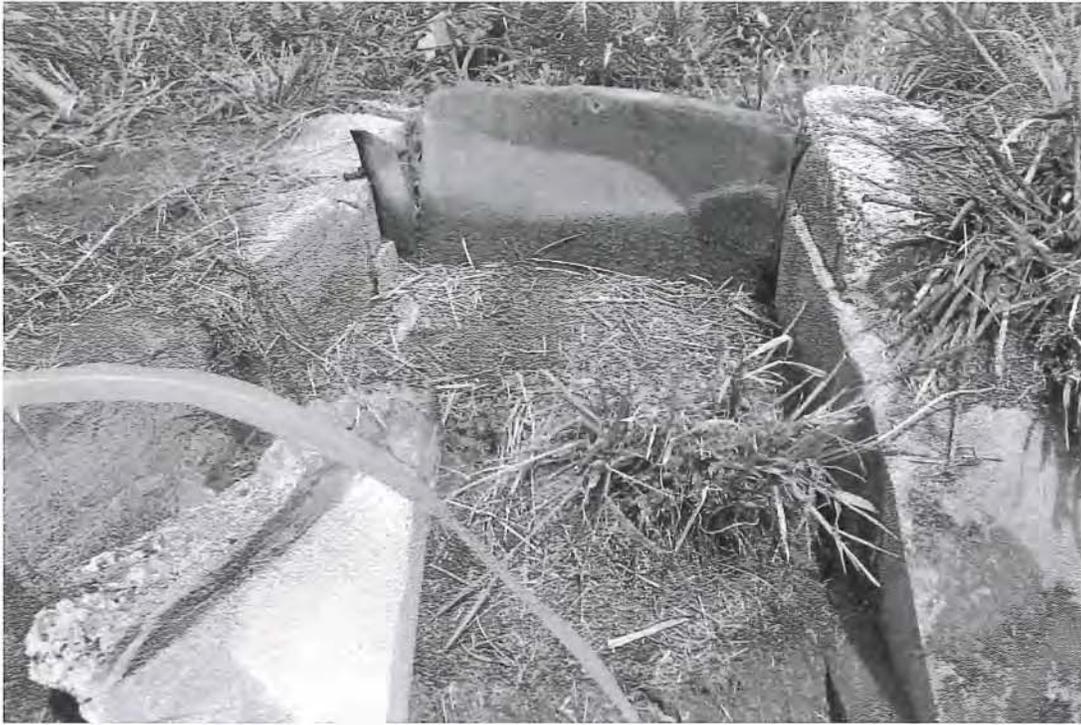
**Figure 31. Photograph of Site 5474 Feature 1 Metal Sluice Gate of Kama Ditch-Note infill of Silt
(View to East)**

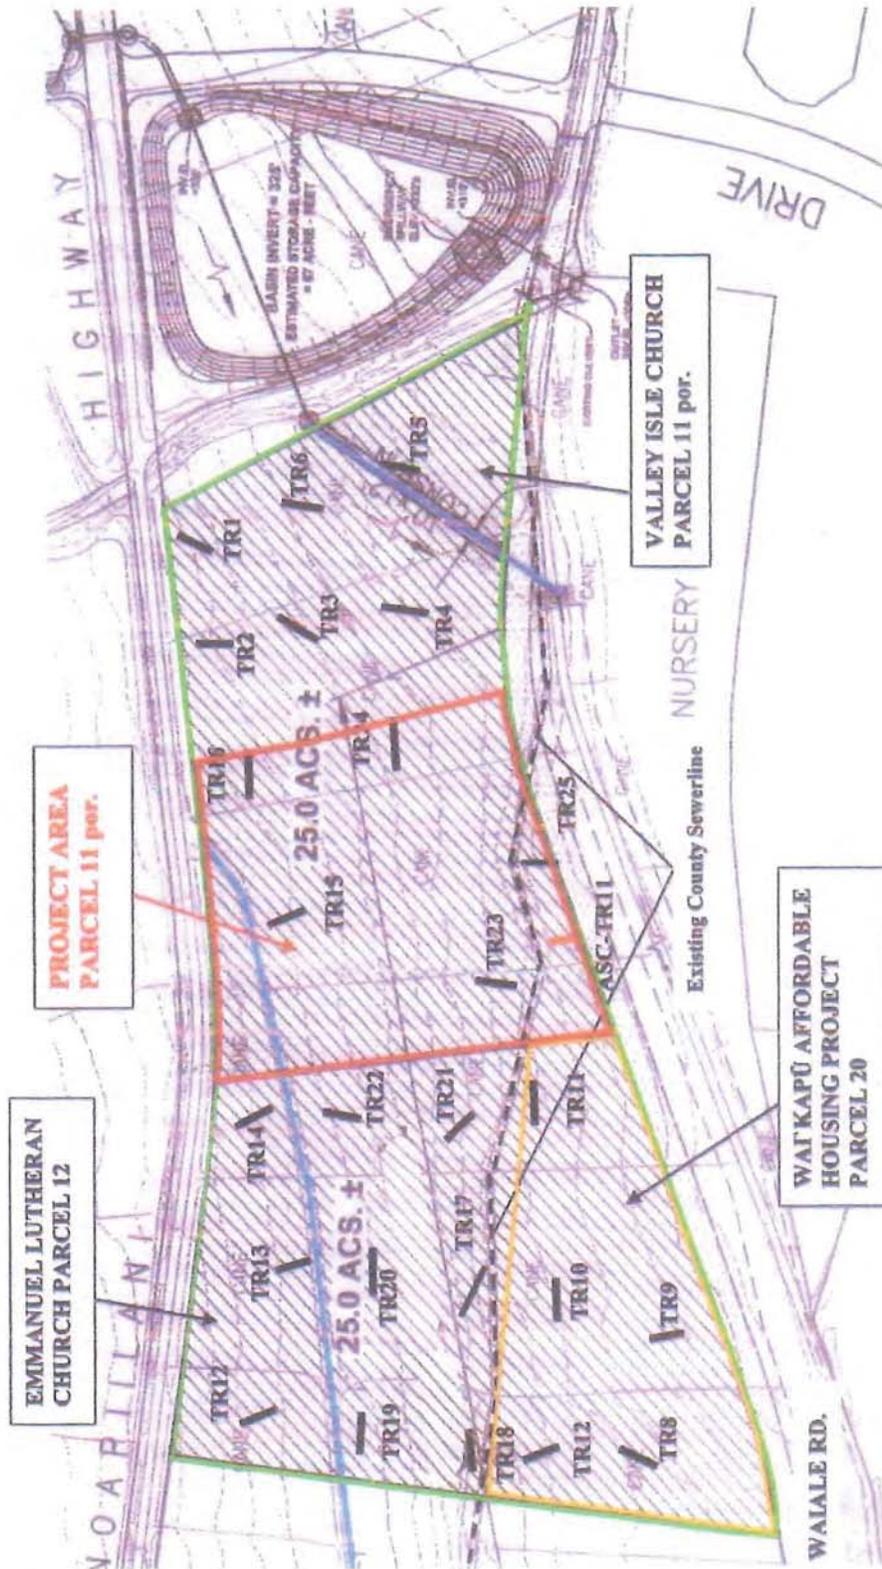
Figure 4. Topo Map Showing Project Area (red), AIS Study Area (green), TR's 1-25, and Site 50-50-04-5474 and Easements
