UHMC Dorm Project Inspection Report

Carol Reimann, DHHC Director

UHMC Dorm Project Description

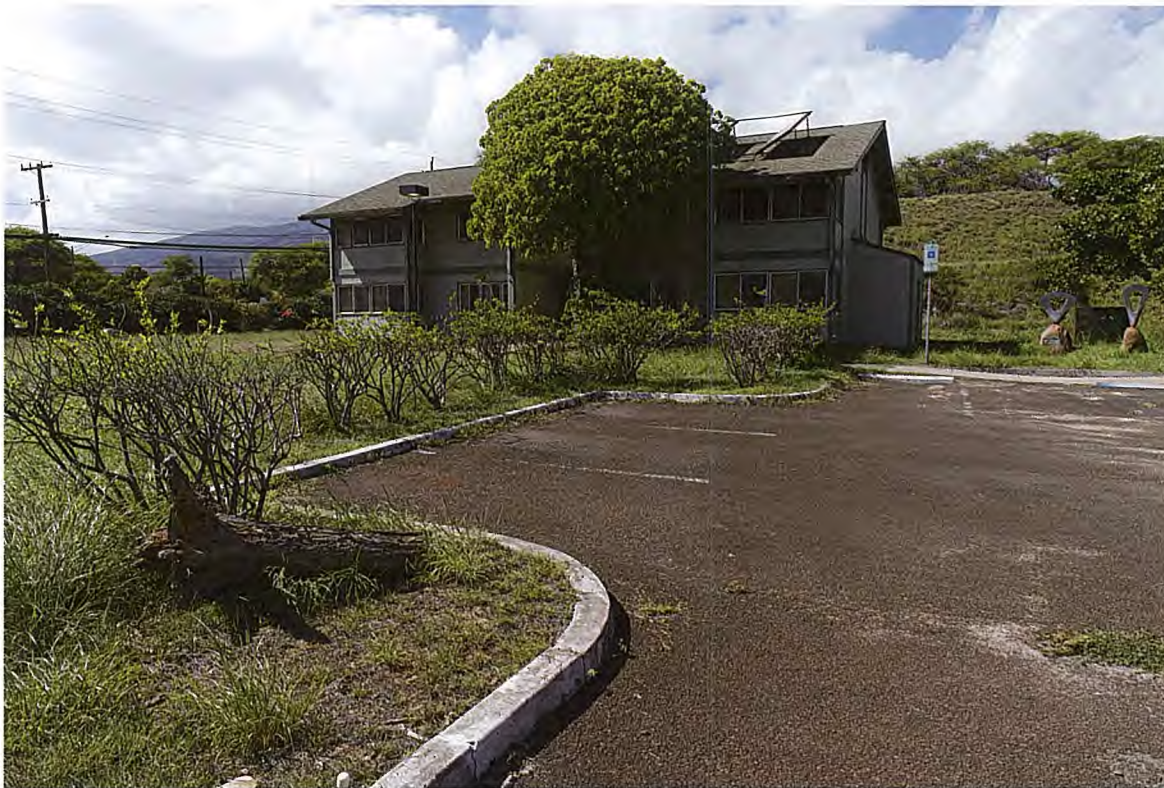
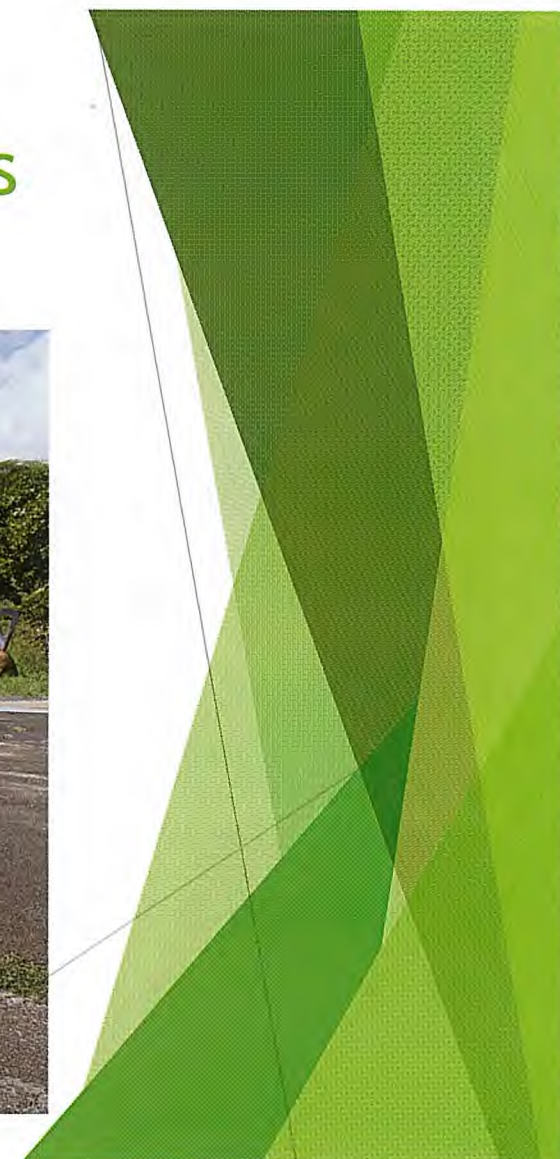
Parking Area: Surface Deteriorated

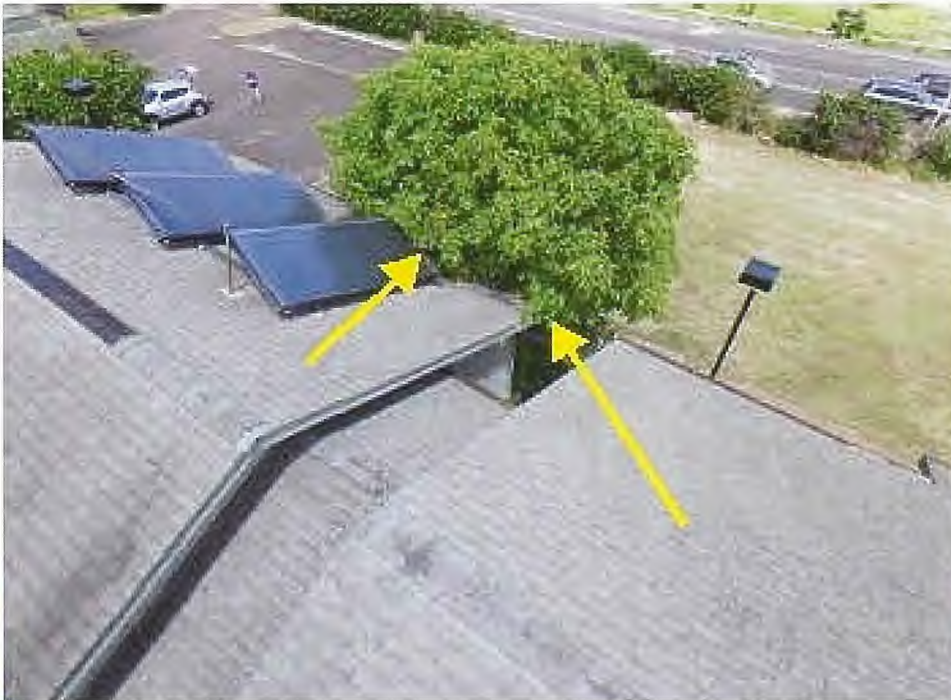
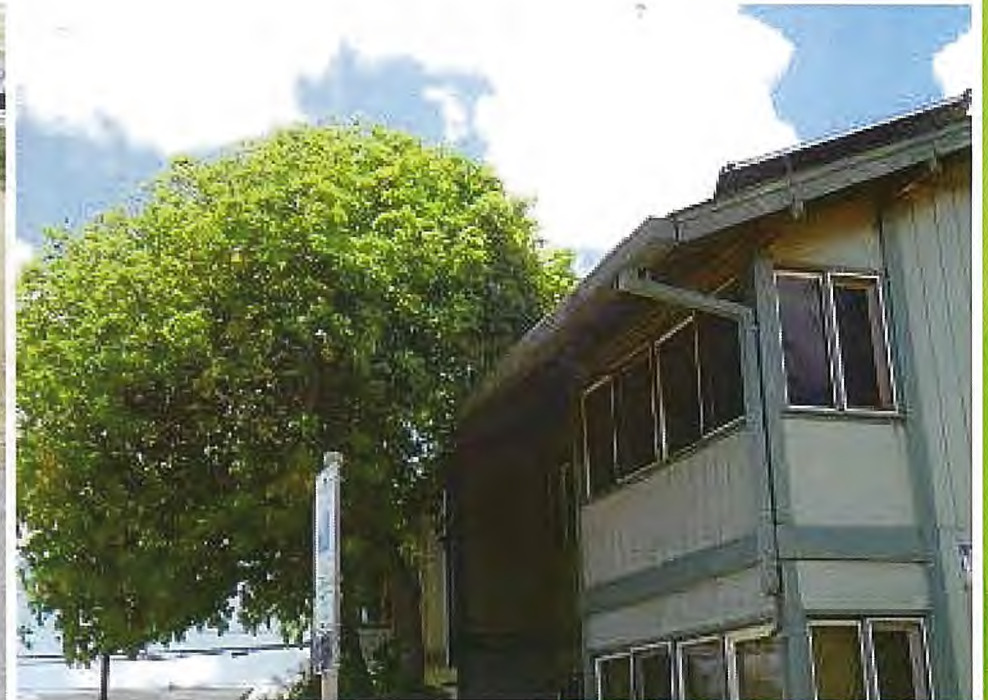
Vegetation: Overgrown, causing deterioration and damage to exterior walls and fixtures

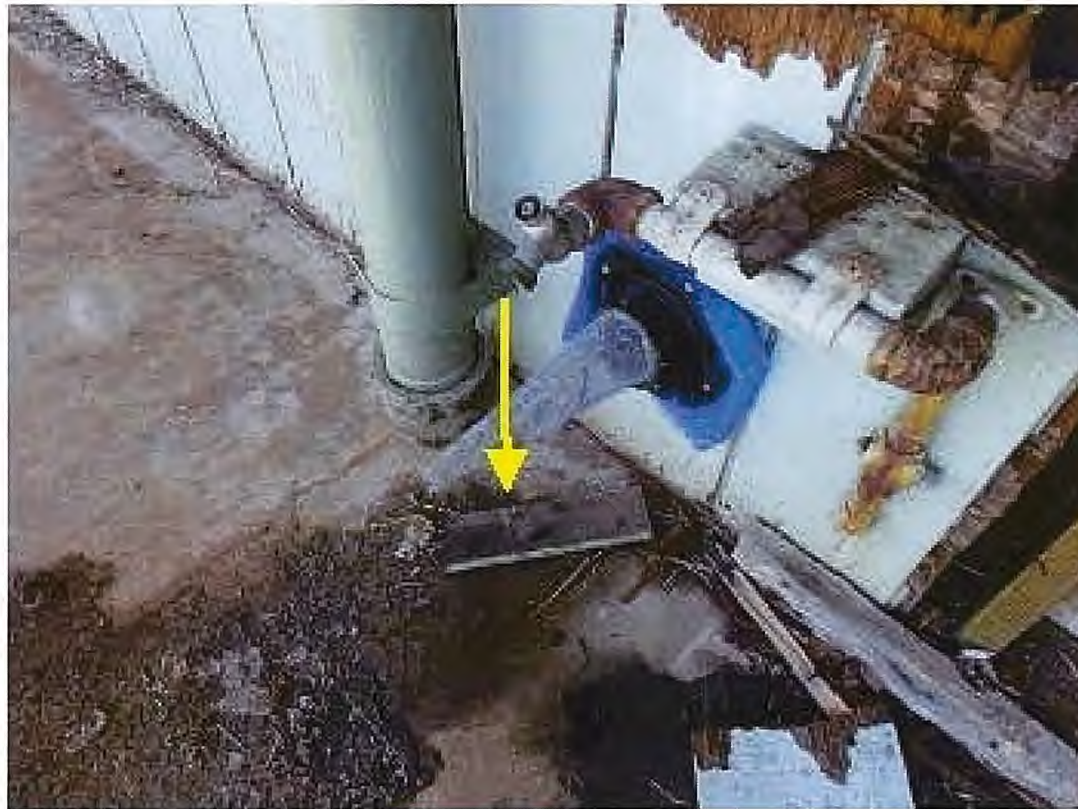
Exterior Hose Bibs: Slow dripping leaks

- ▶ Replace all plumbing fixtures (faucets, valves, showers, pipes)

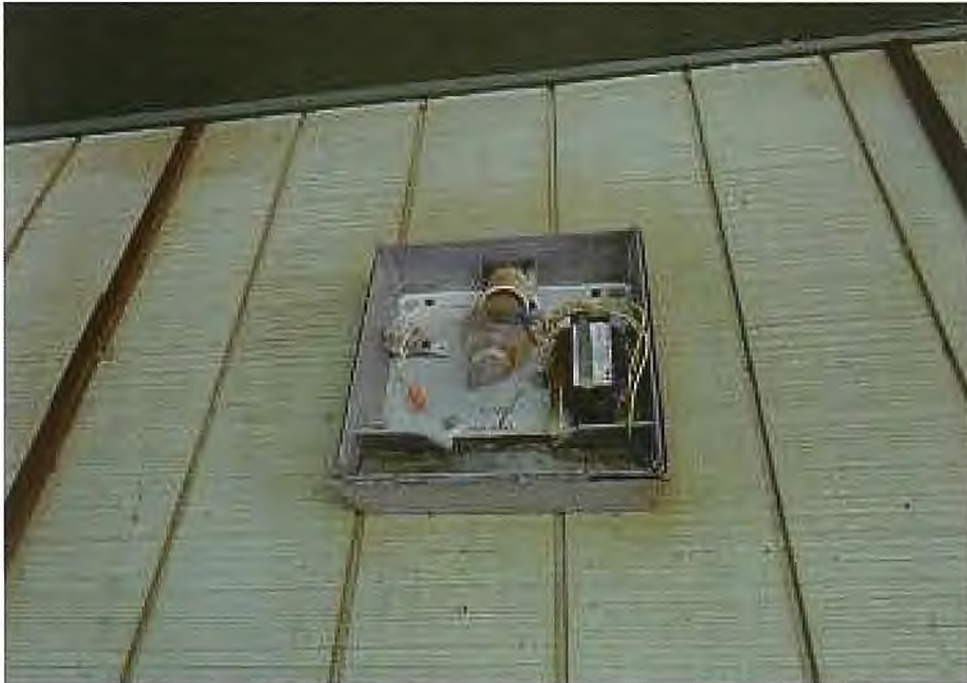
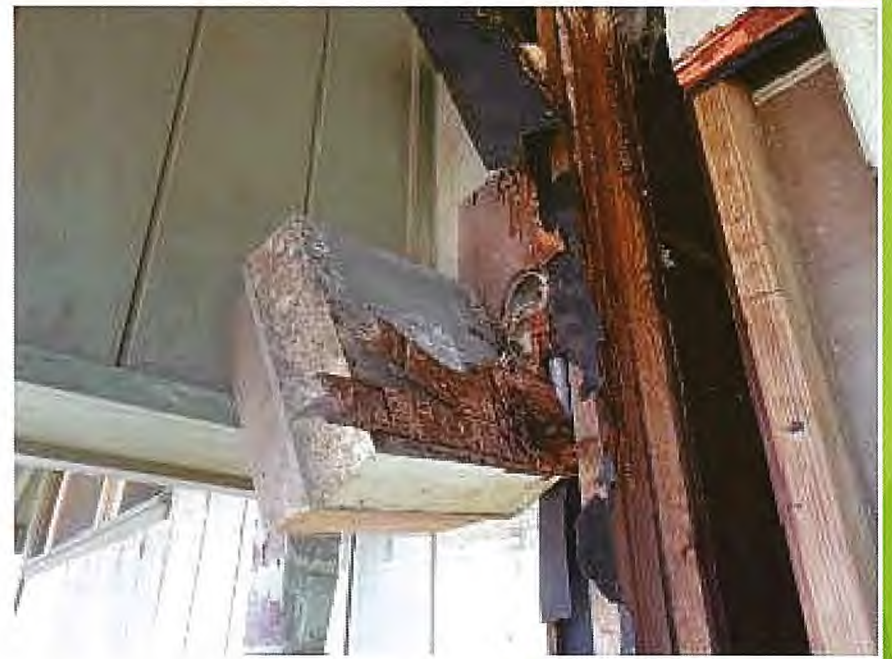
Exterior Lighting: Some damaged

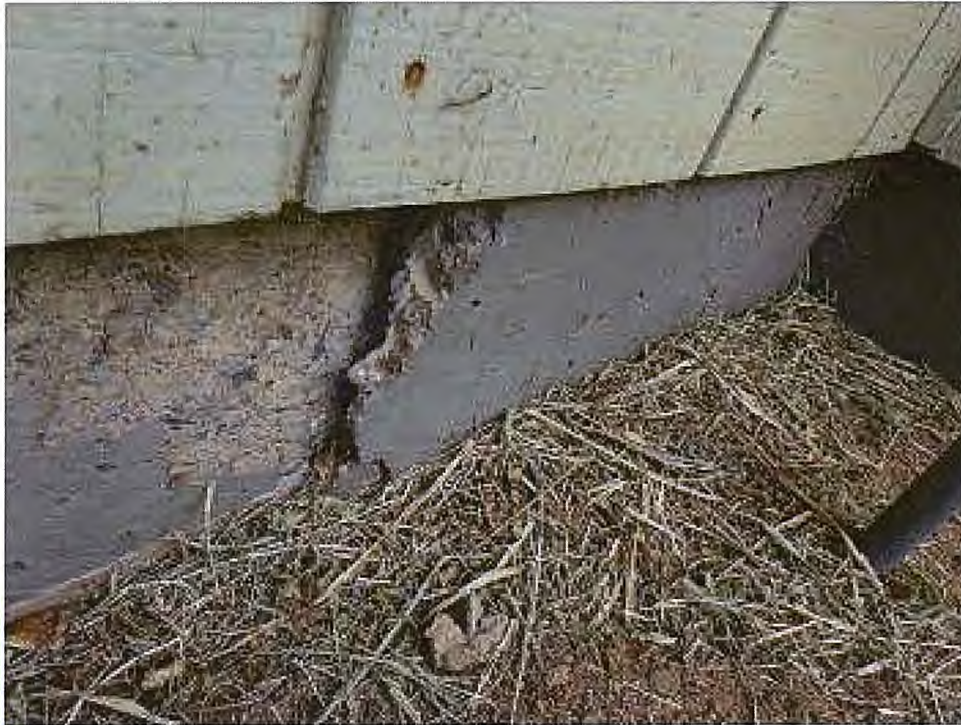
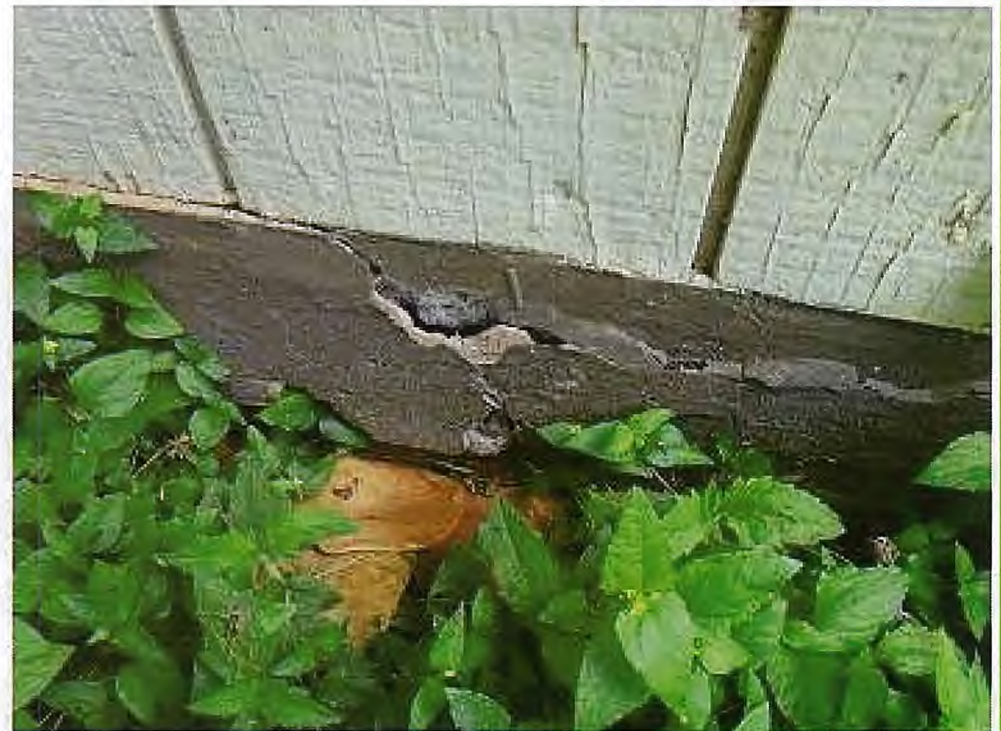
Foundation Areas: Visible cracks in Buildings A & B

- ▶ Foundation repairs
- ▶ Beams and rafters evaluated for termite damage and replaced as needed
- ▶ All dry wall treated for moisture damage and mold intrusion in all attics and living areas

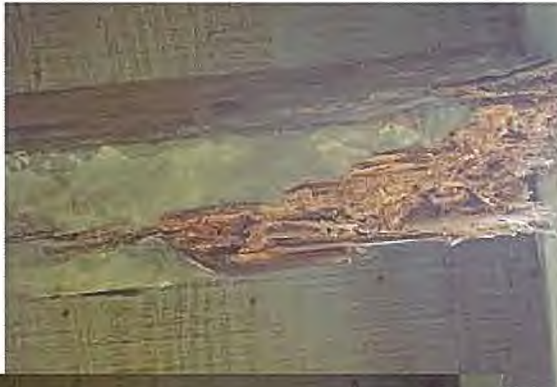
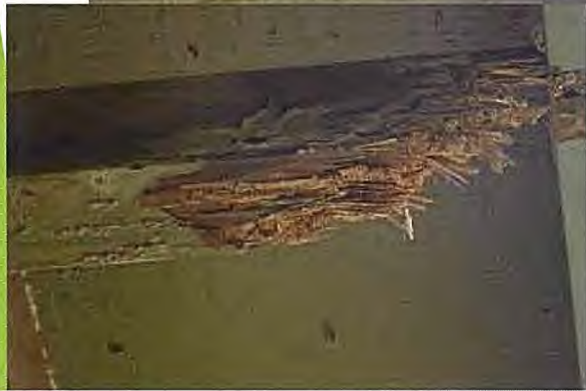
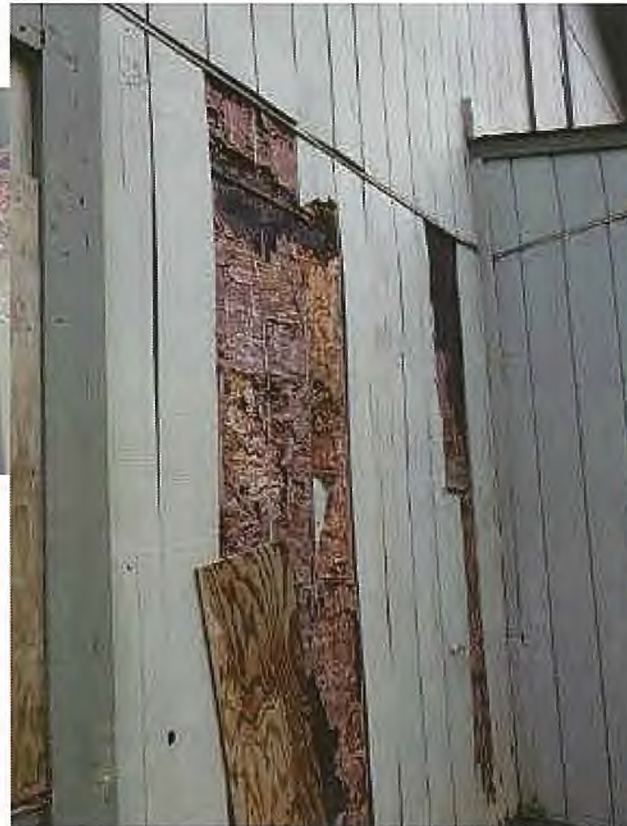
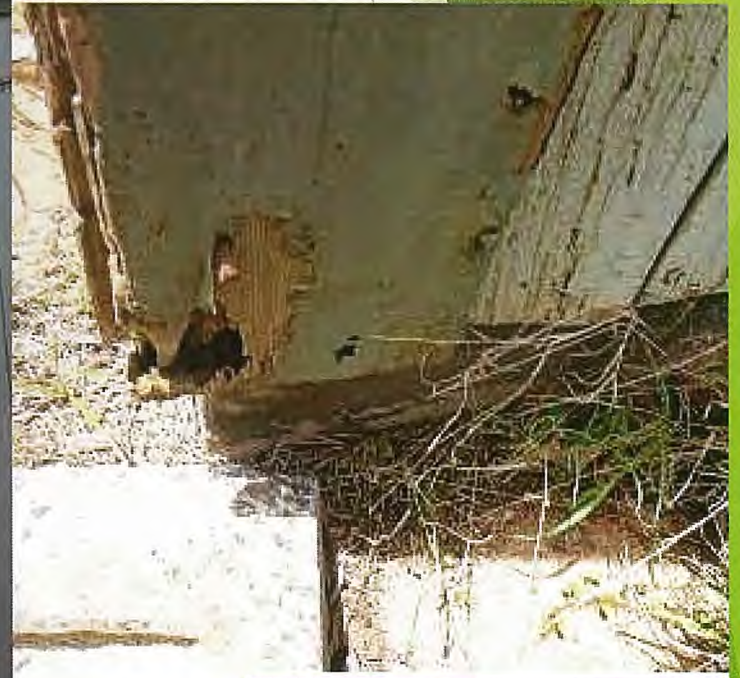
Exterior, Façade & Curtainwall: Rotted, termite damage, moisture damage

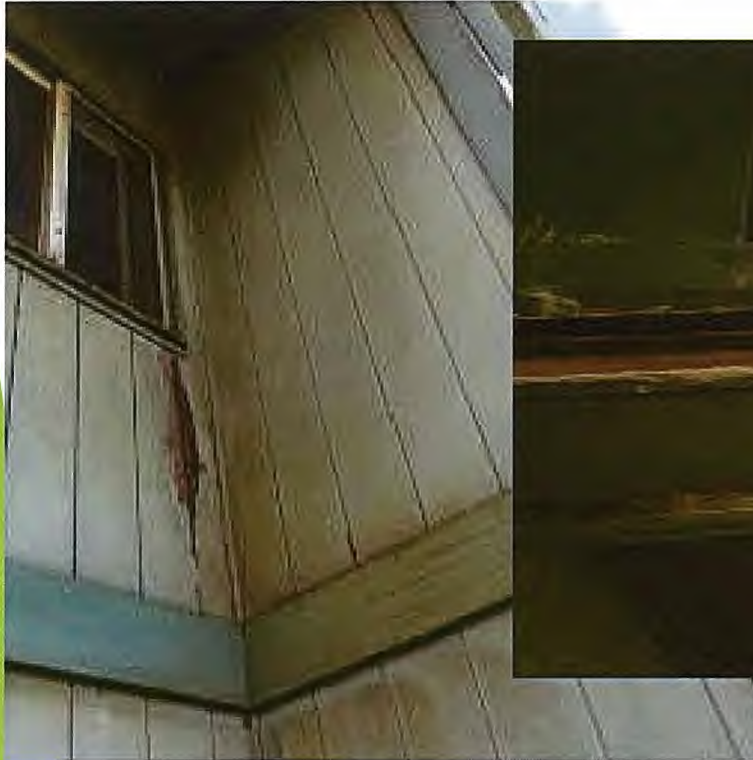
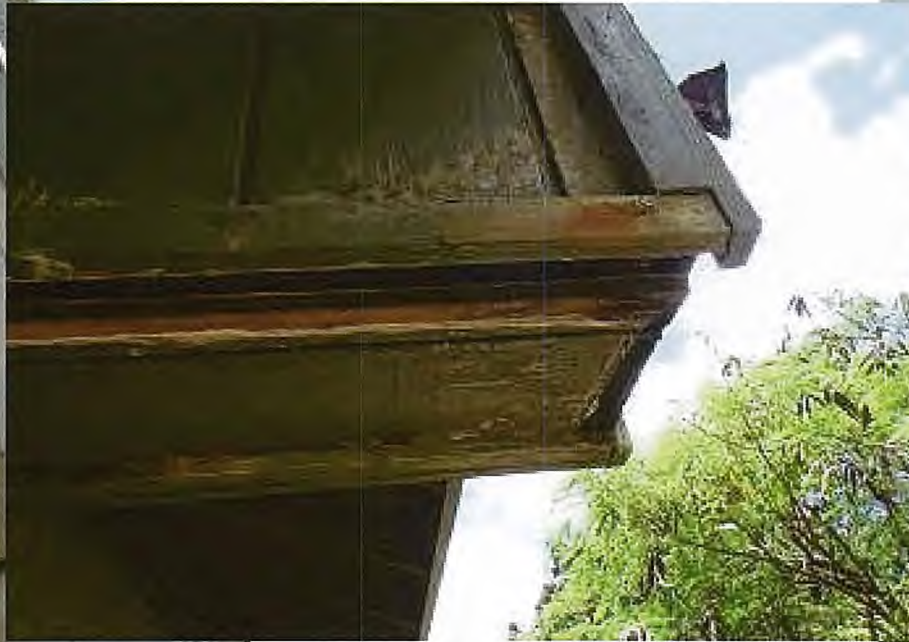
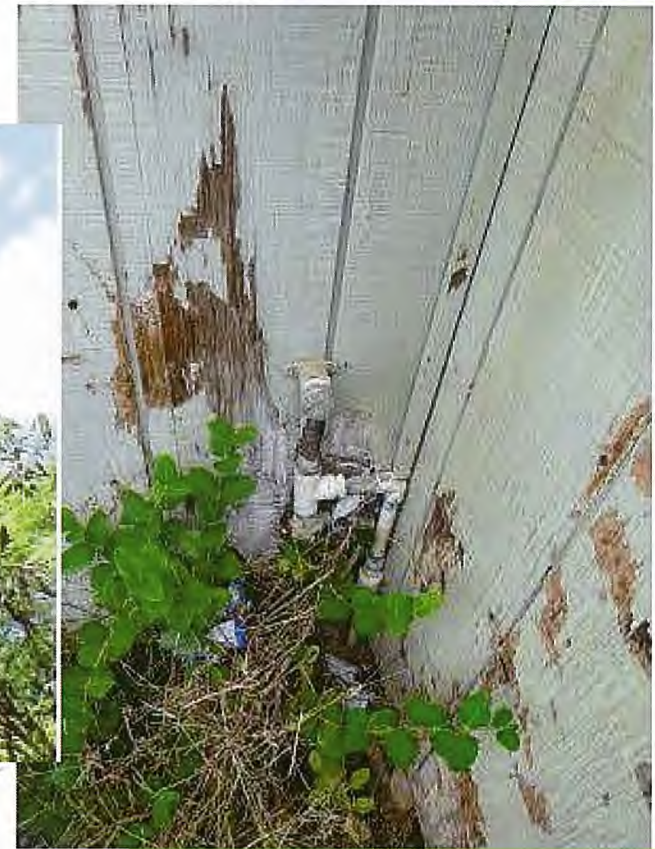
Exterior, Façade & Curtainwall: Rotted, termite damage, moisture damage

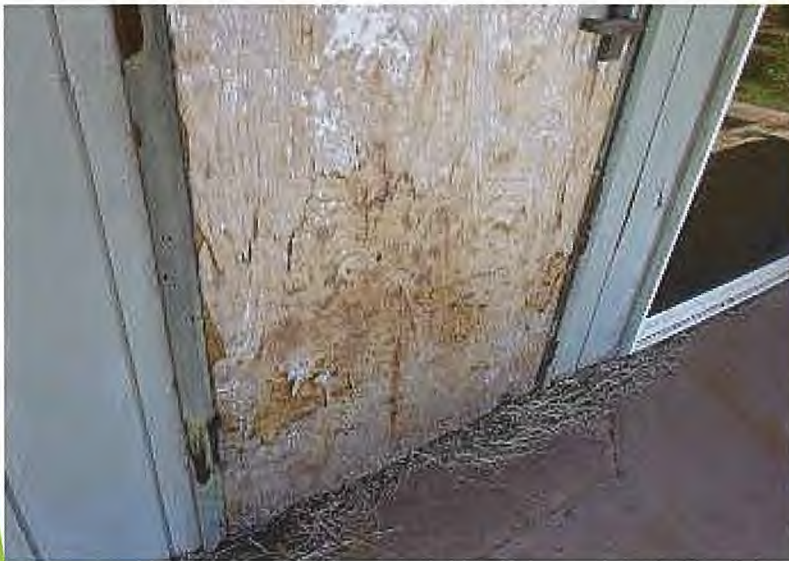
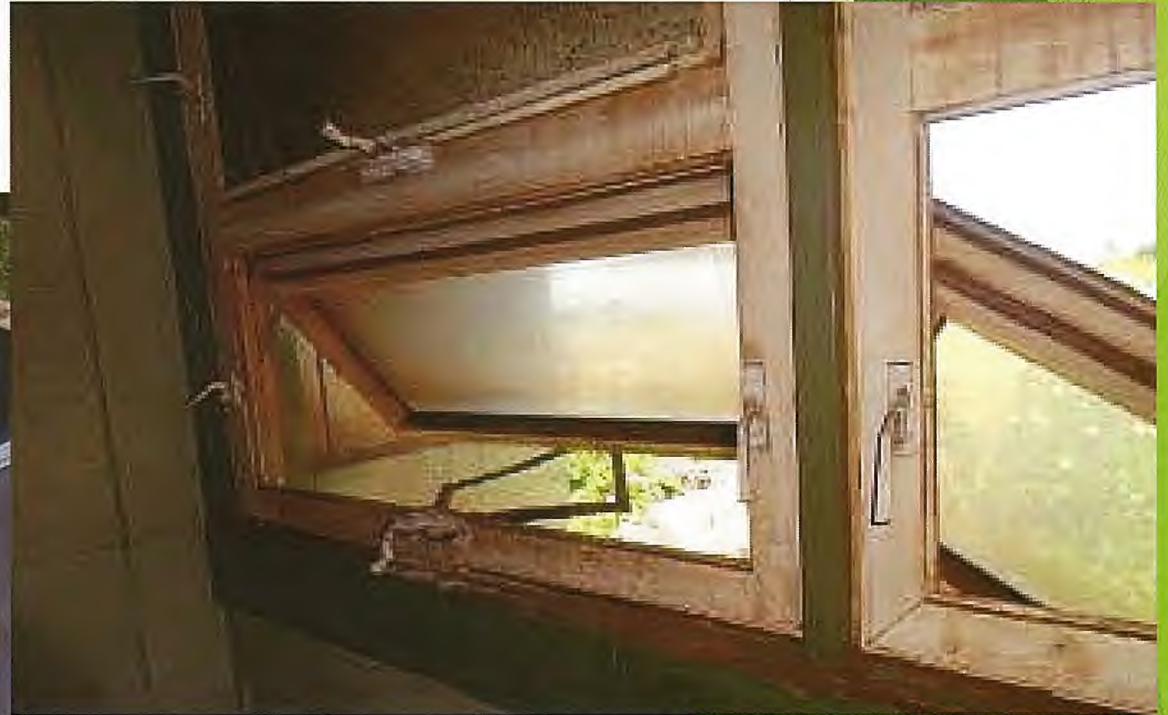
Fenestration (Exterior Doors/Windows): Termite, moisture damage, corroded, damaged & most inoperable

- ▶ Replace all exterior doors, framing and trim for all buildings
- ▶ Replace all interior doors and trim within dwelling units
- ▶ Replace all interior window trim and finishes

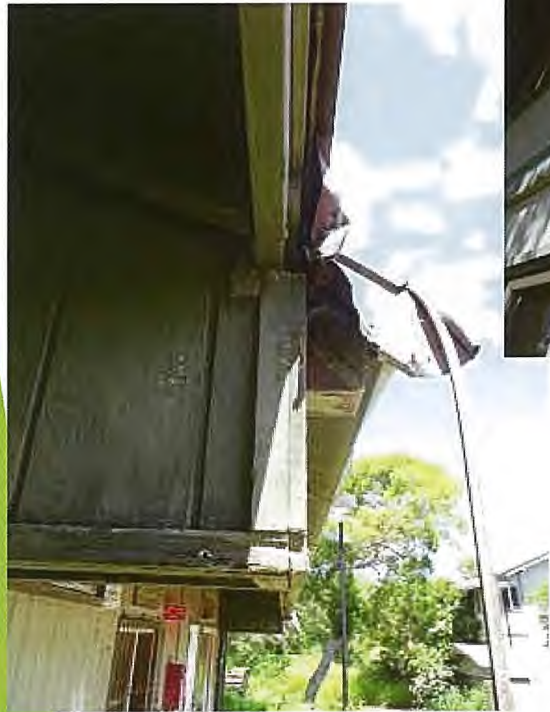
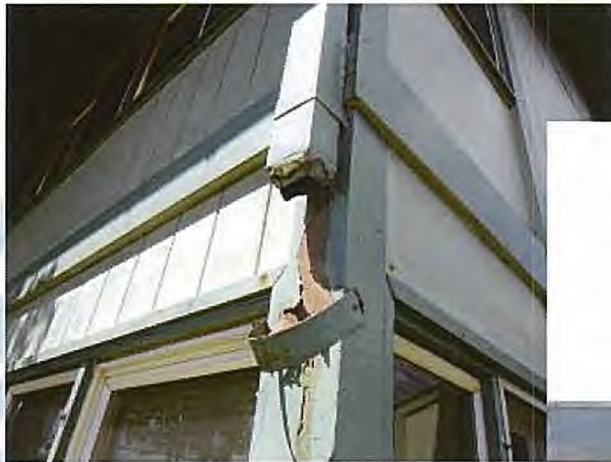
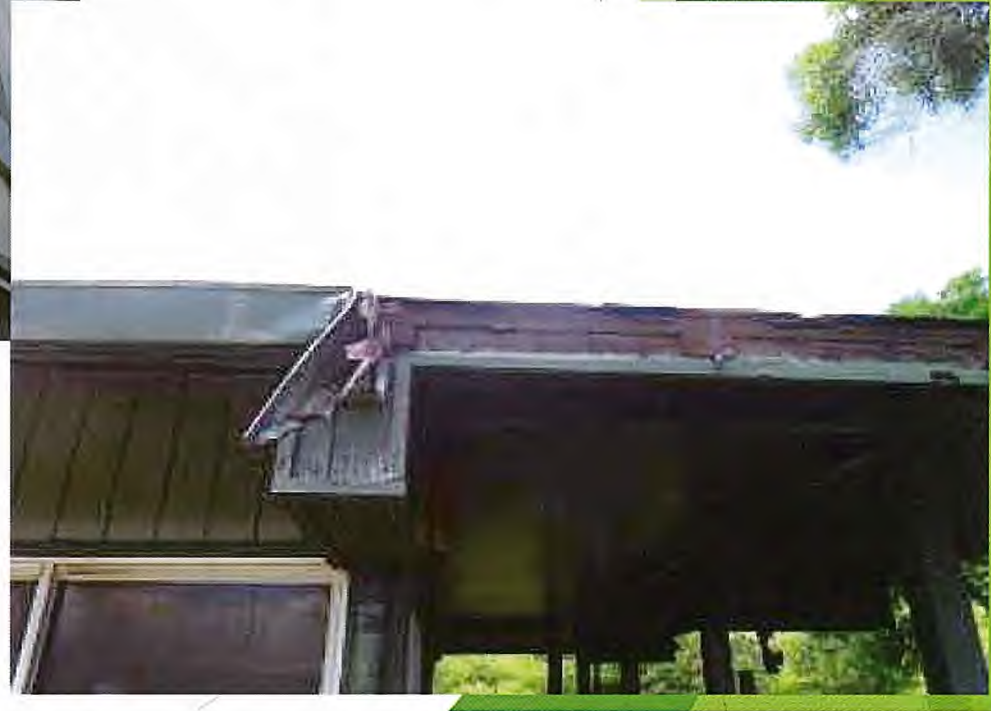
Roofing: Moisture intrusion, missing shingles, gutters damaged/broken/missing

- ▶ Plumbing, electrical and fire suppression systems brought up to code
- ▶ Replace installed sheathing and roofing finish
- ▶ Replacement of all gutter systems

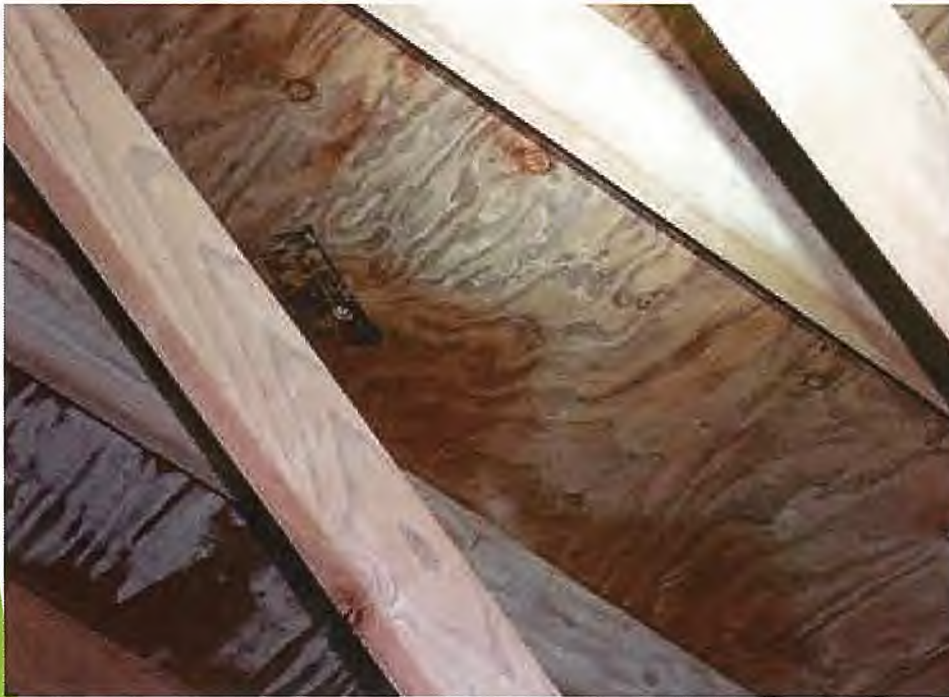
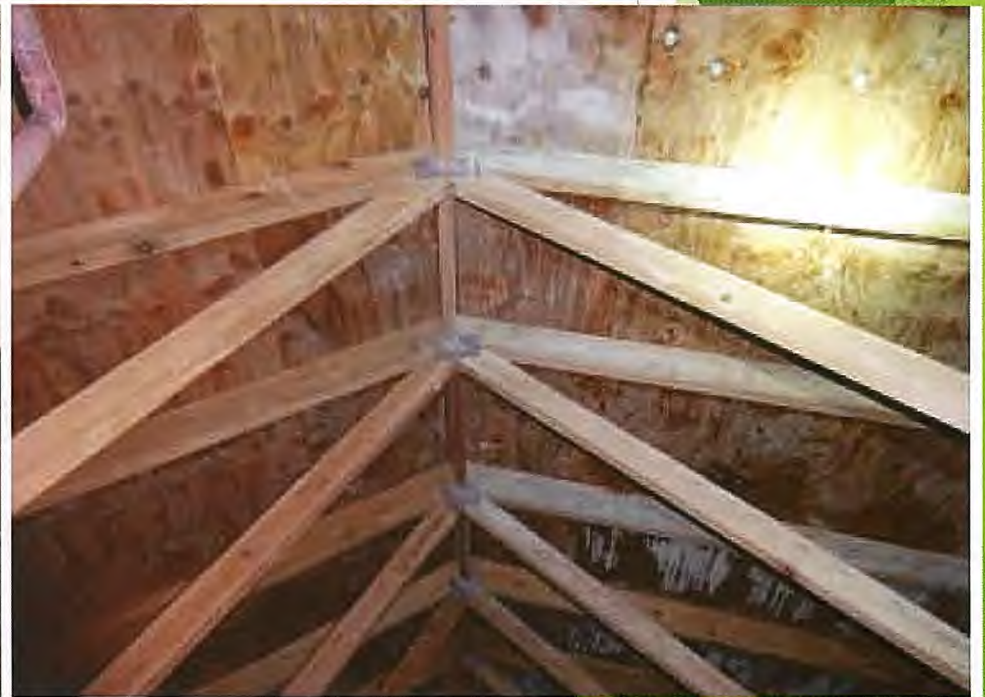
Roofing: Moisture intrusion, missing shingles, gutters damaged/broken/missing

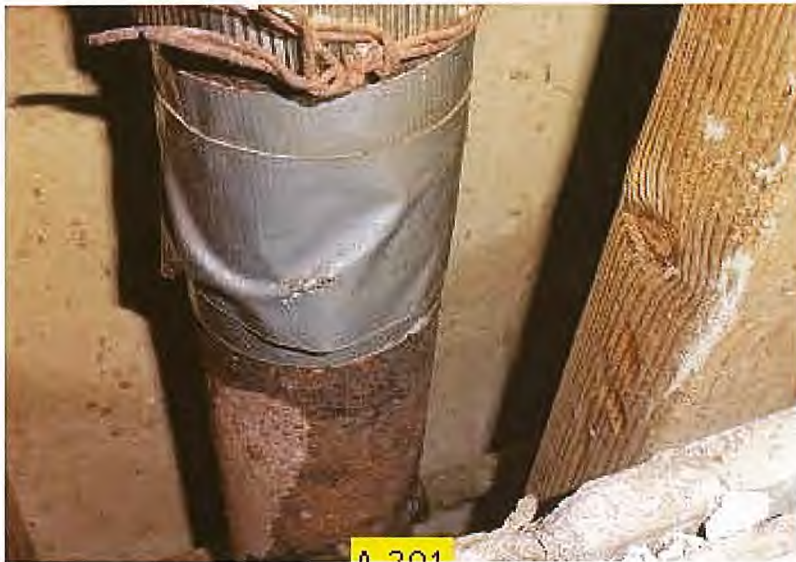
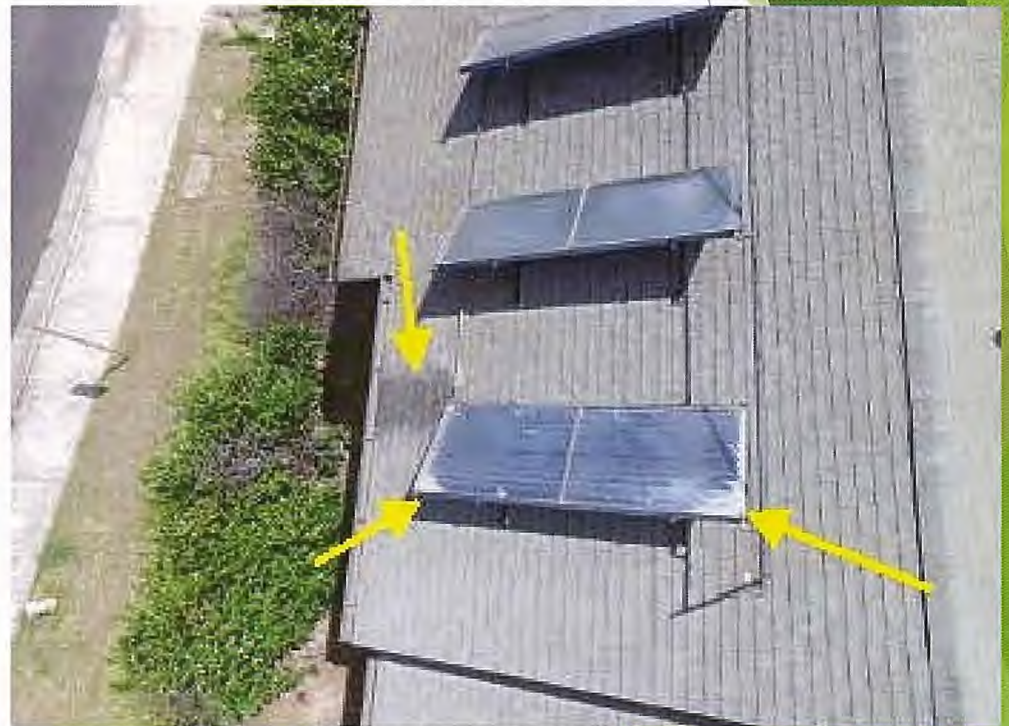
Plumbing: Non-standard repairs, water heating devices terminated with supply cut and electrical connections removed, solar panels damaged & leaking, fixtures in poor condition

- ▶ Replacement of all installed flooring materials
- ▶ Non-standard plumbing repairs conducted and need to be addressed
- ▶ Non-standard electrical repairs conducted and need to be addressed

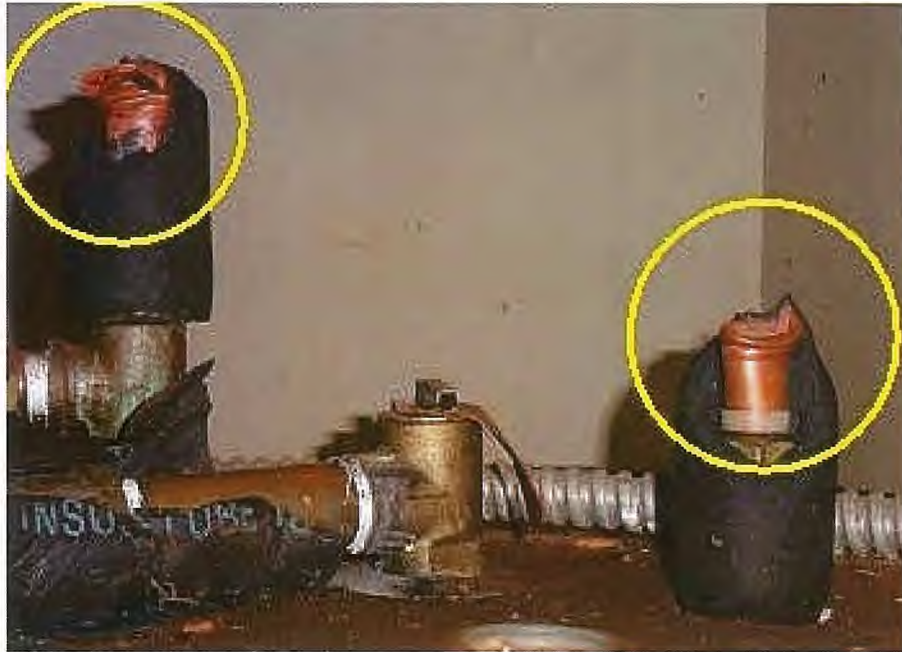
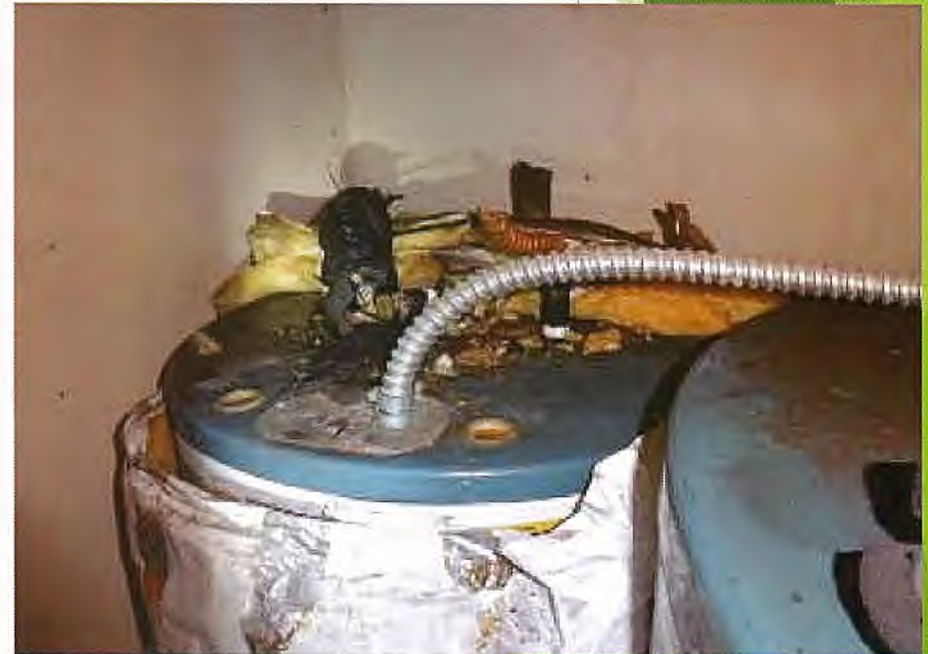
Plumbing: Non-standard repairs, water heating devices terminated with supply cut and electrical connections removed, solar panels damaged & leaking, fixtures in poor condition

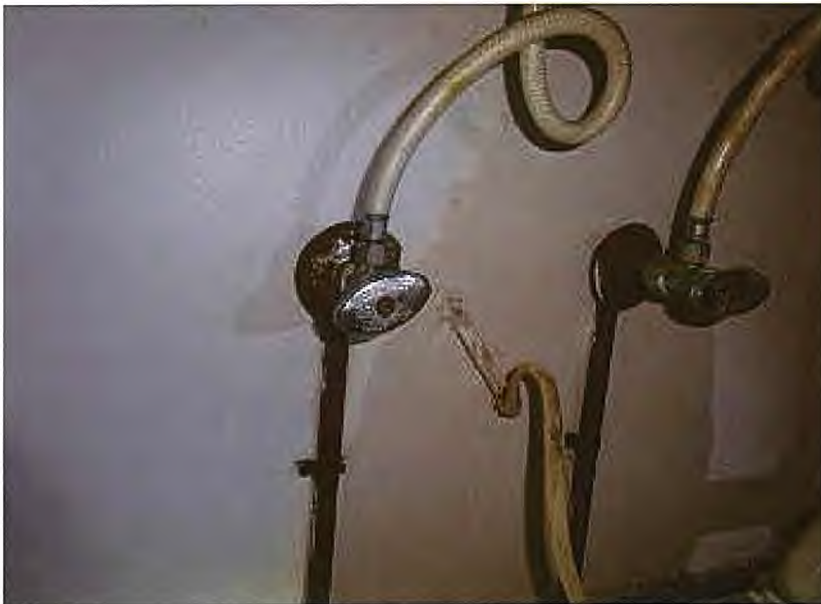
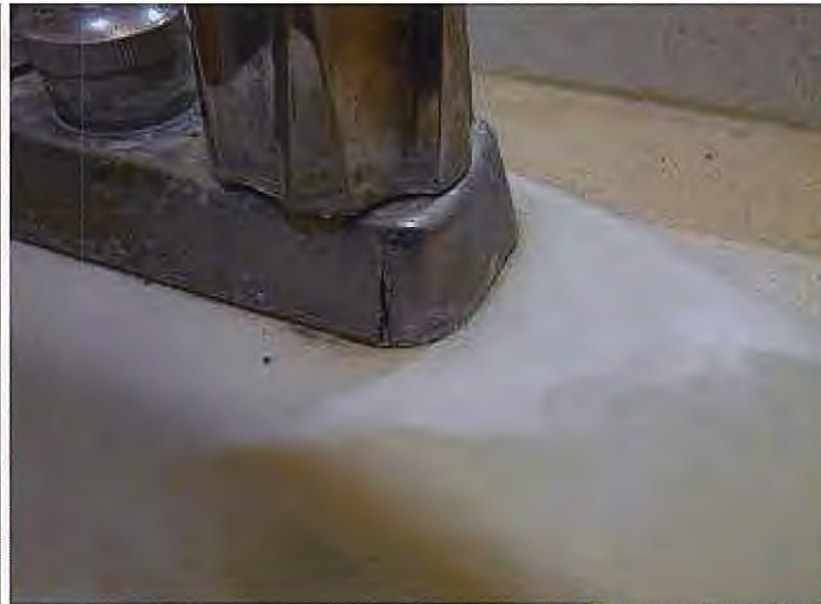
Plumbing: Non-standard repairs, water heating devices terminated with supply cut and electrical connections removed, solar panels damaged & leaking, fixtures in poor condition

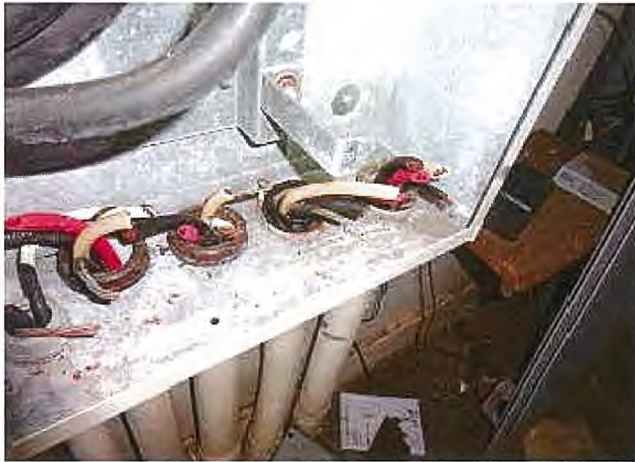
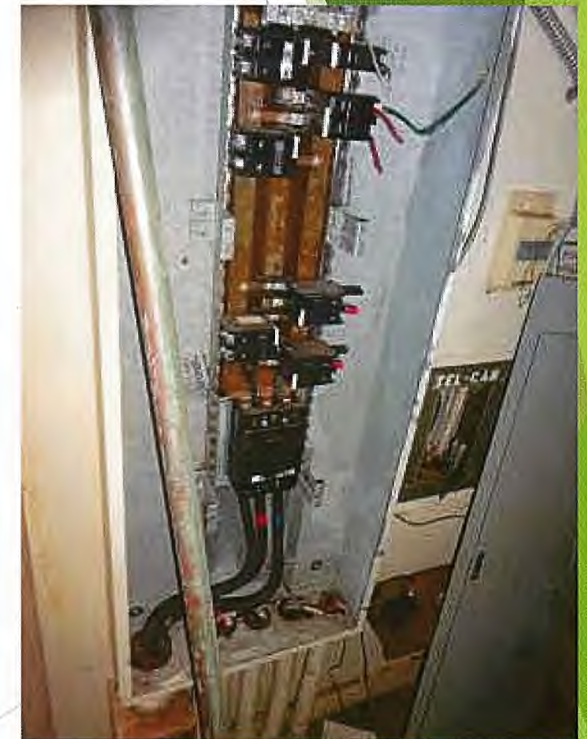
Electrical: Buildings B & C main service conductors and all branch wiring cut at main service panel, circuit breakers removed, missing junction boxes, non-standard repairs

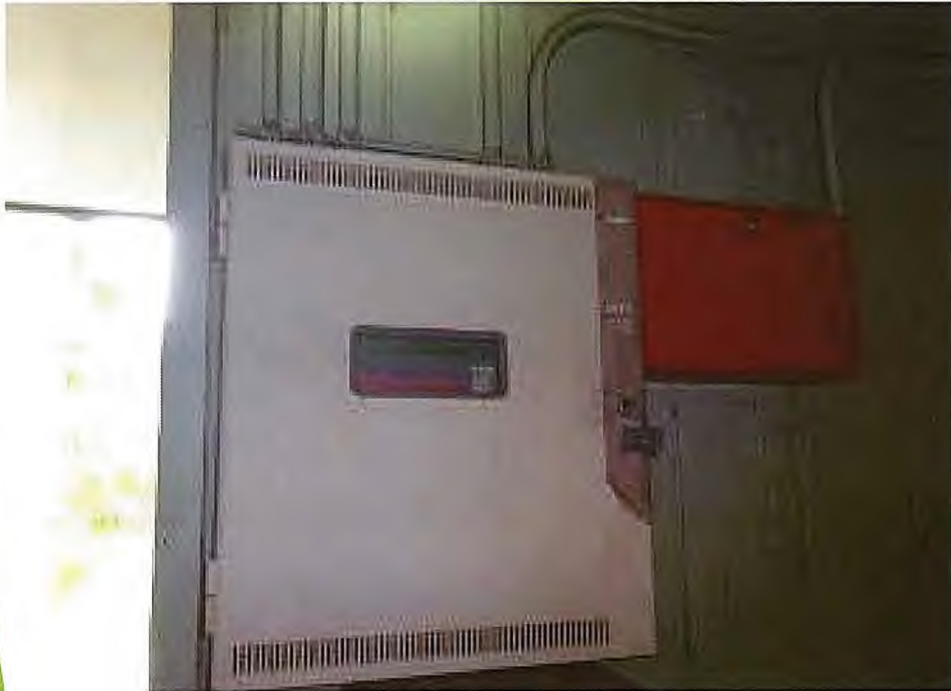
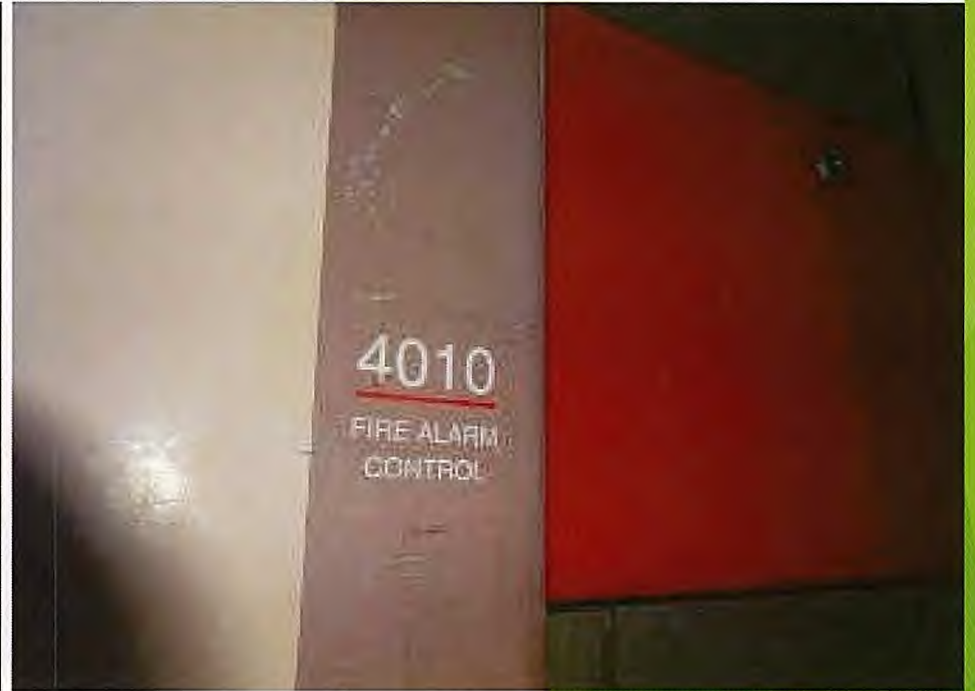
Alarm System: Poor condition

- ▶ Overhaul of fire suppression system
- ▶ Overhaul of alarm system
- ▶ Overhaul of smoke detection system
- ▶ All fire extinguishers need replacement
- ▶ Kitchens and bathroom fixtures/cabinets/appliances need to be replaced

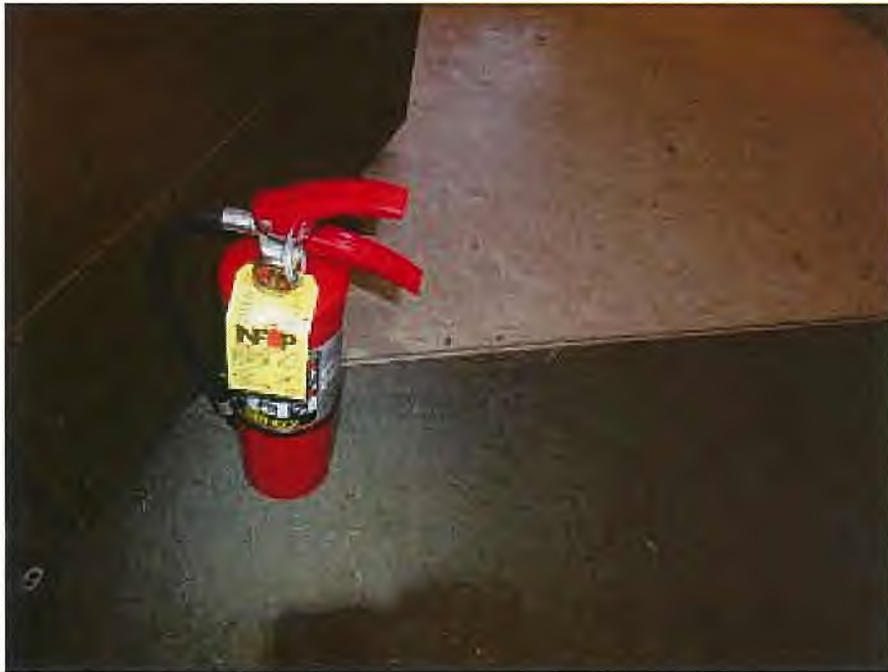
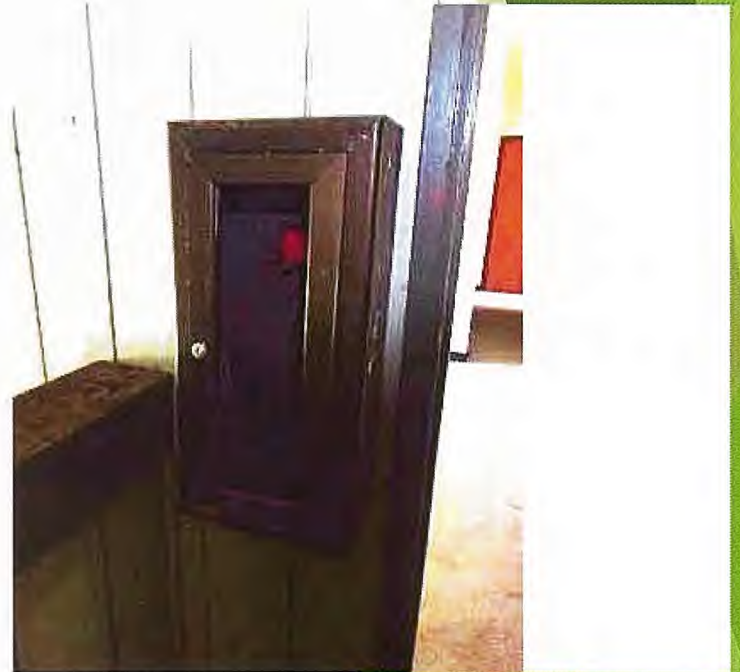
Smoke Detectors: None

Fire Extinguishers: Most expired and/or missing at required locations

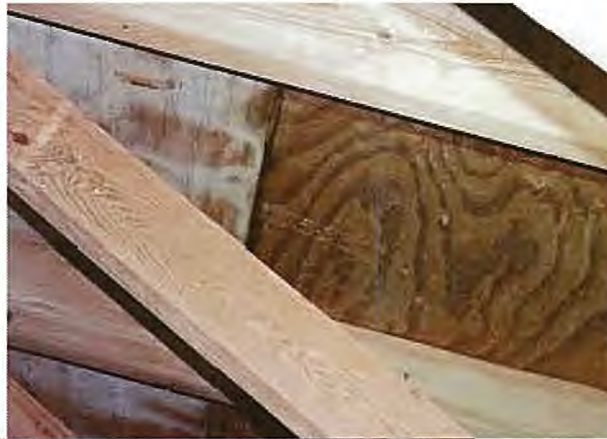
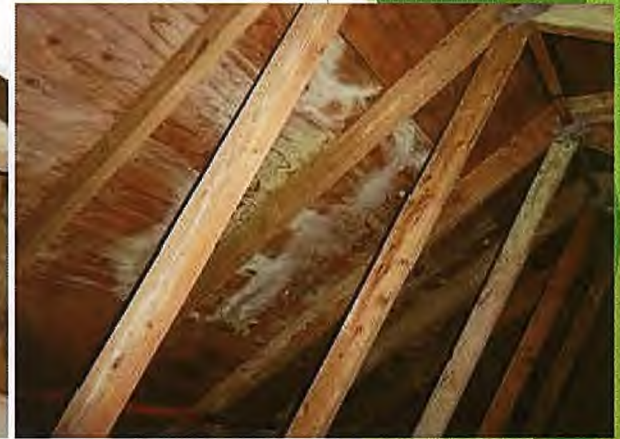
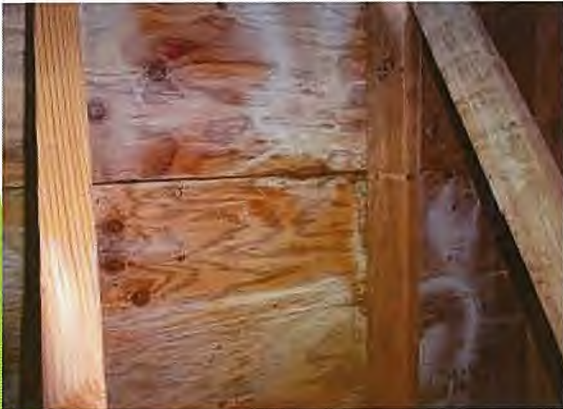
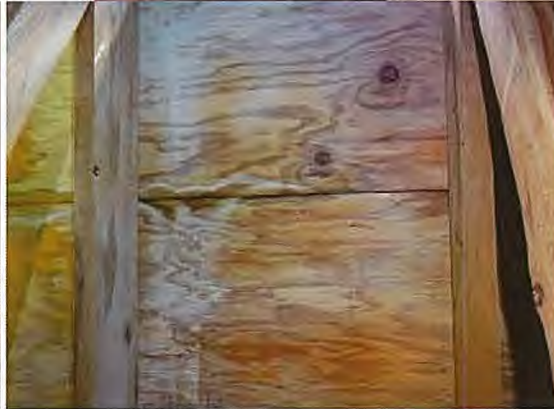
Interior Spaces: Moisture intrusion, mold growth and termite damage
