UHMC Dorm Project Inspection Report

Carol Reimann, DHHC Director

UHMC Dorm Project Description

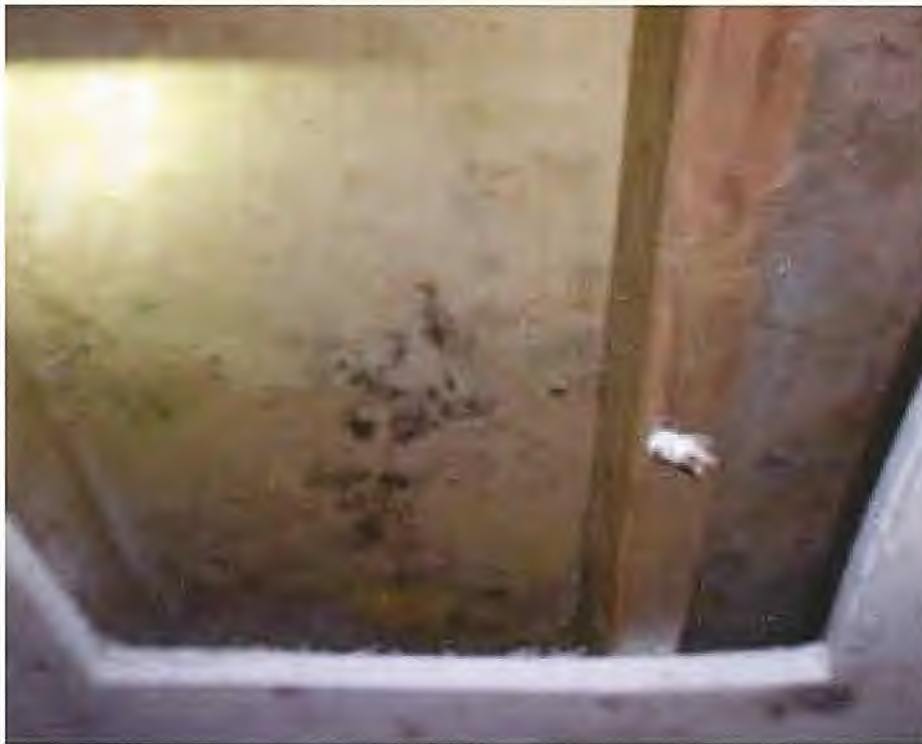
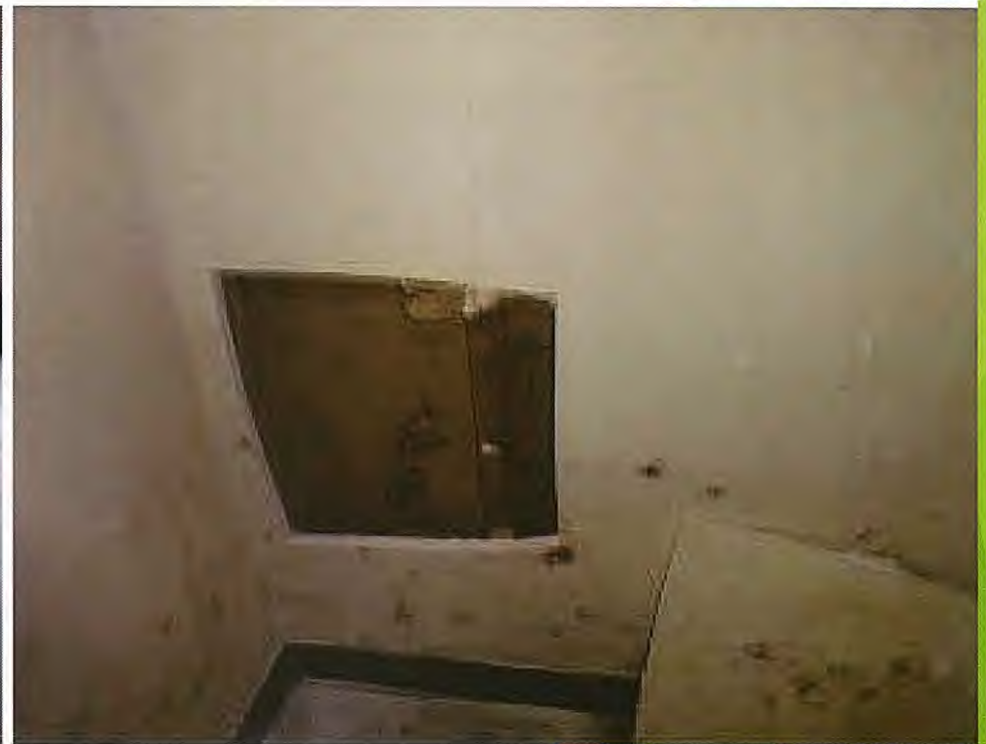
Interior Spaces: Moisture intrusion, mold growth and termite damage

- ▶ Foundation repairs
- ▶ Beams and rafters evaluated for termite damage and replaced as needed
- ▶ All dry wall treated for moisture damage and mold intrusion in all attics and living areas

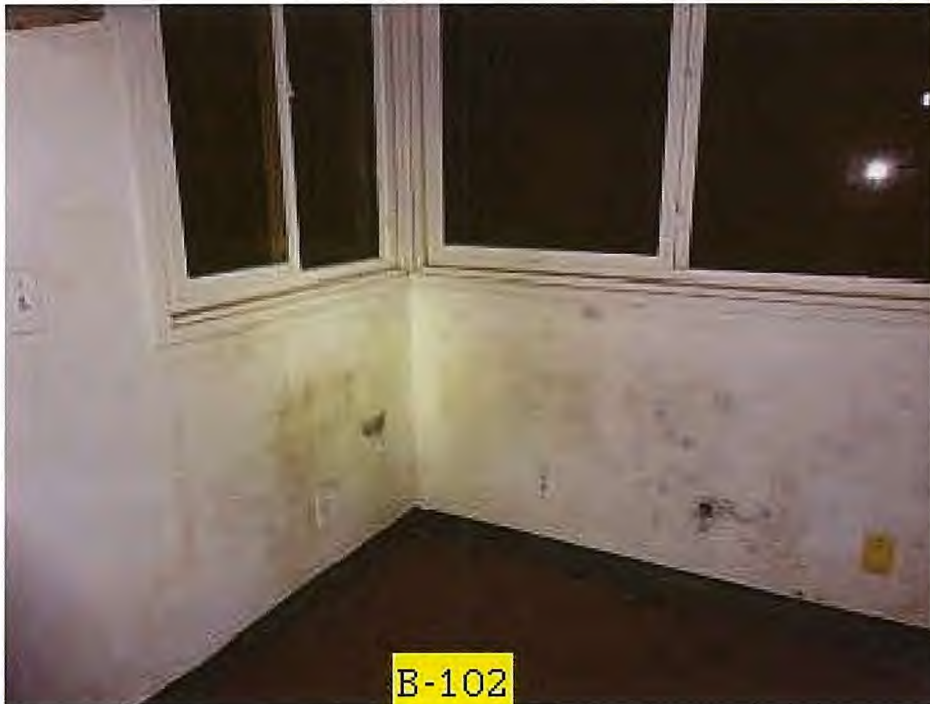
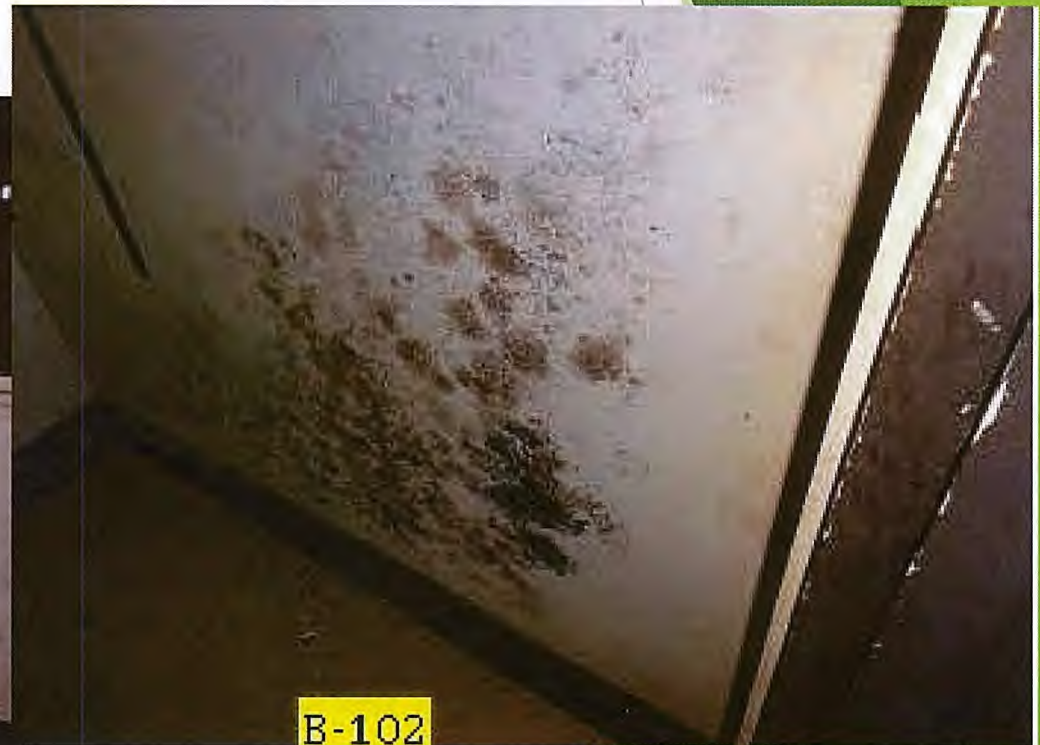
Interior Spaces: Moisture intrusion, mold growth and termite damage

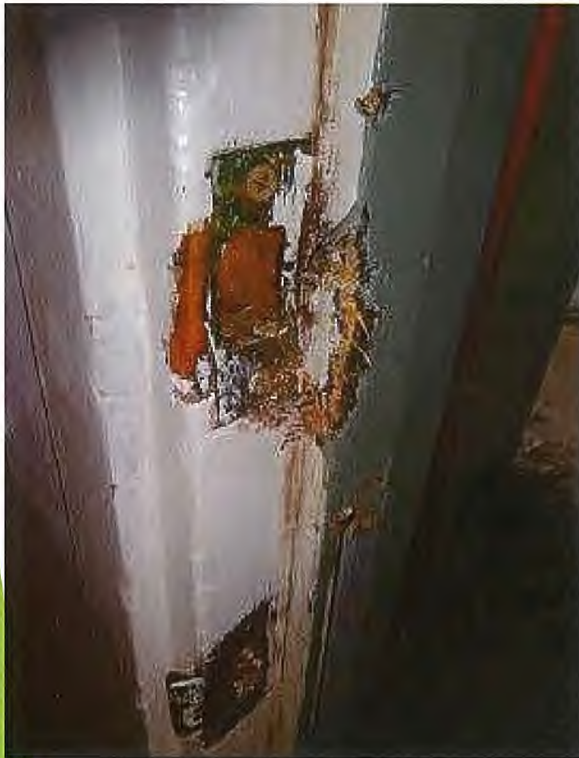
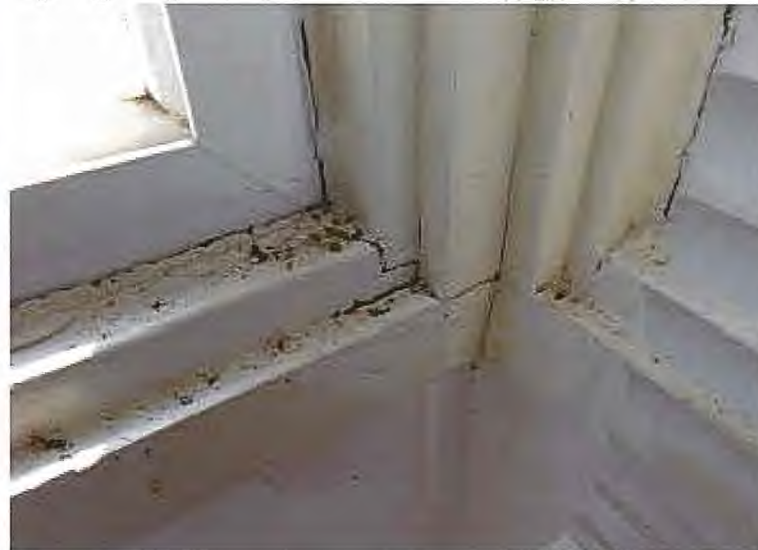
Interior Spaces: Damaged windows & doors

- ▶ Replace all exterior doors, framing and trim for all buildings
- ▶ Replace all interior doors and trim within dwelling units
- ▶ Replace all interior window trim and finishes

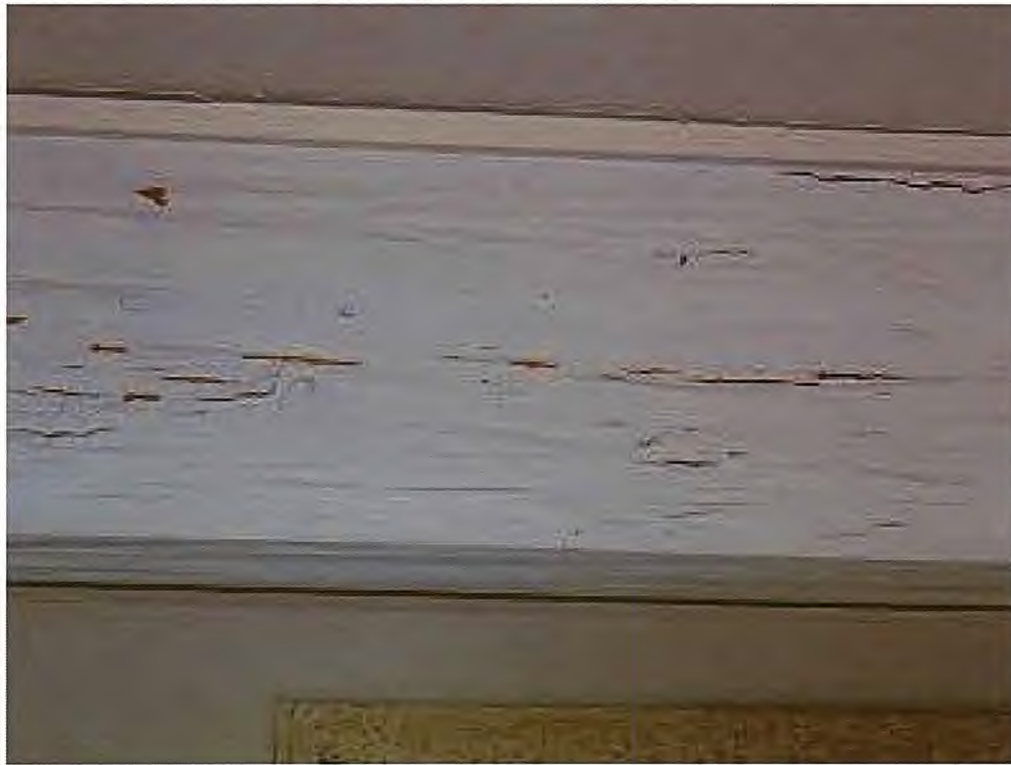
Interior Spaces: Bedroom ceiling joists severely termite damaged in Building B,

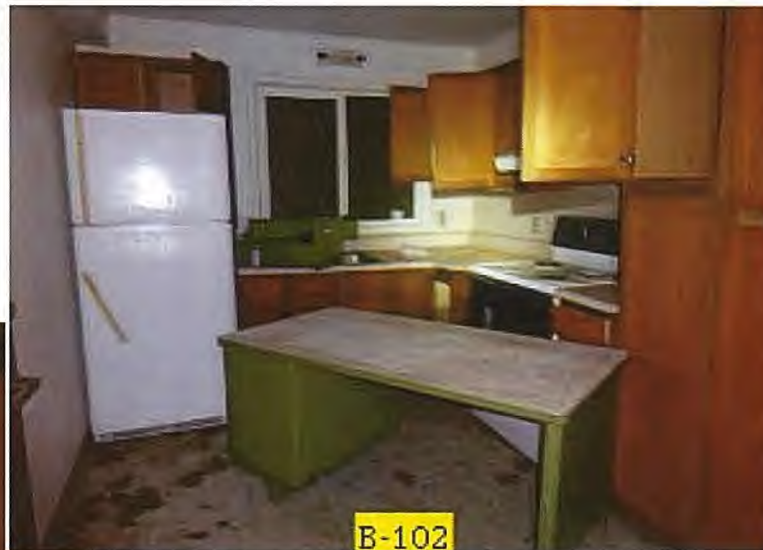
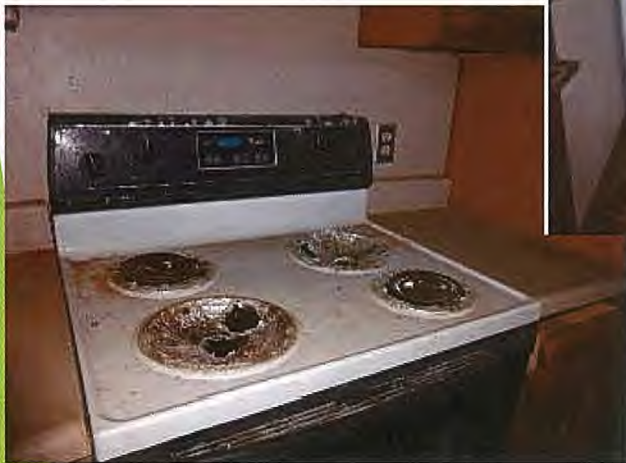
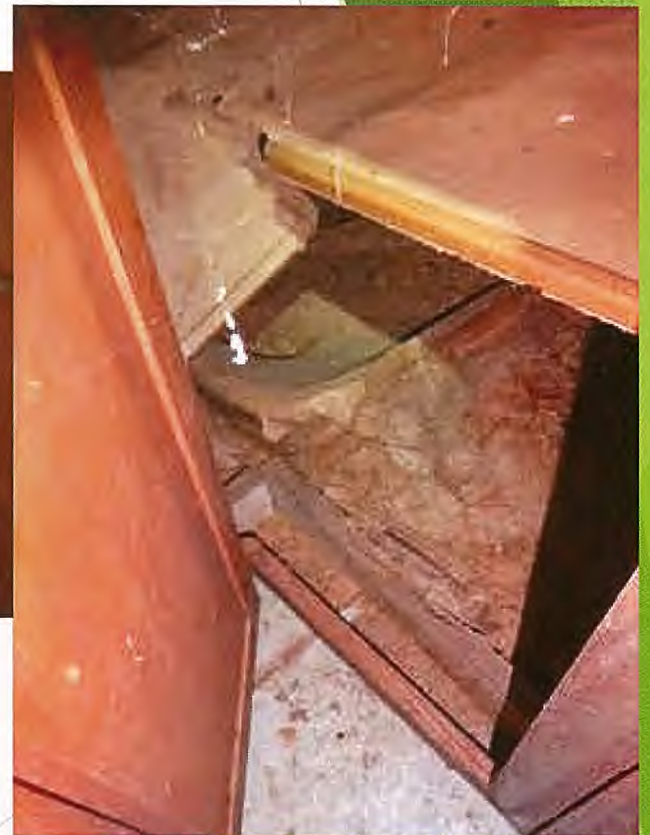
Kitchen Spaces: Deteriorated, moisture & termite damage, mold in refrigerators

- ▶ Overhaul of fire suppression system
- ▶ Overhaul of alarm system
- ▶ Overhaul of smoke detection system
- ▶ All fire extinguishers need replacement
- ▶ Kitchens and bathroom fixtures/cabinets/appliances need to be replaced

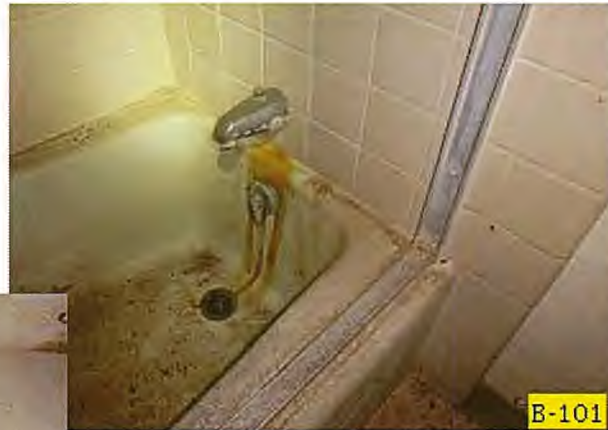
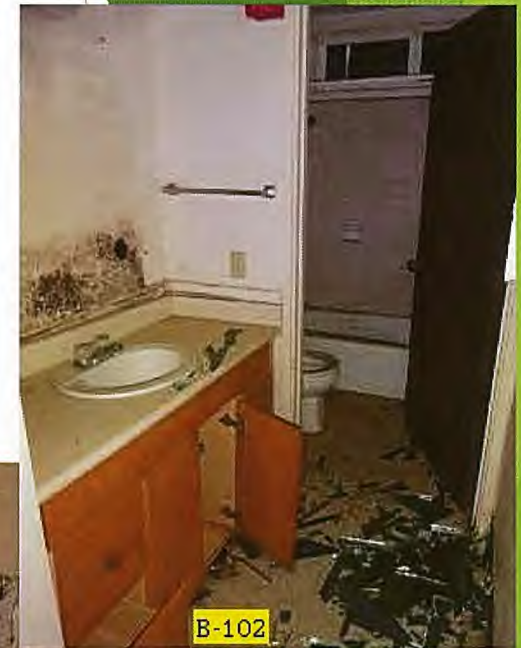
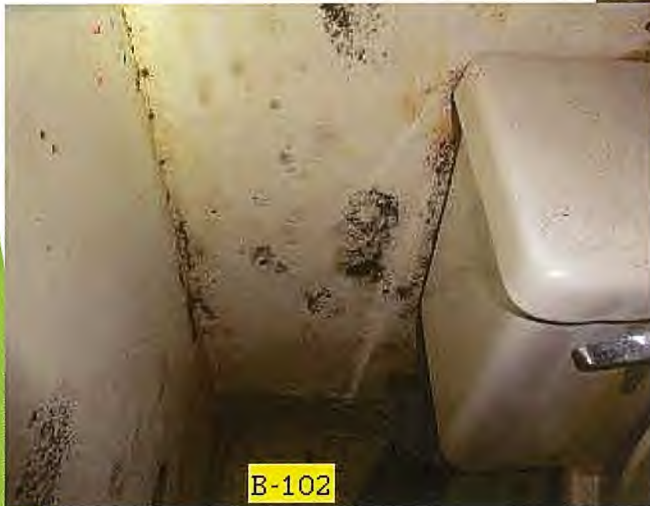
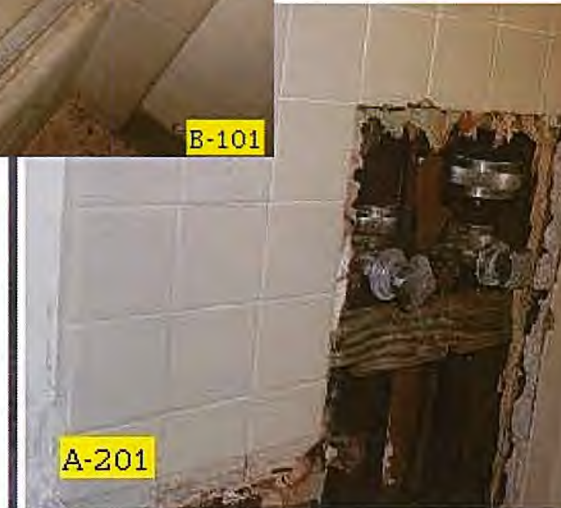
Bathrooms: Moisture damage, mold growth and damaged flooring, cabinets and counters, mirrors, toilets and shower compartments

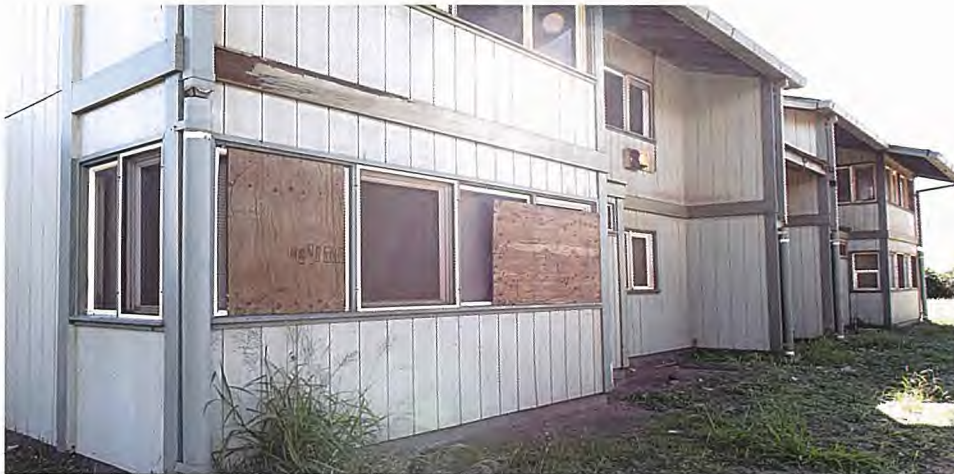
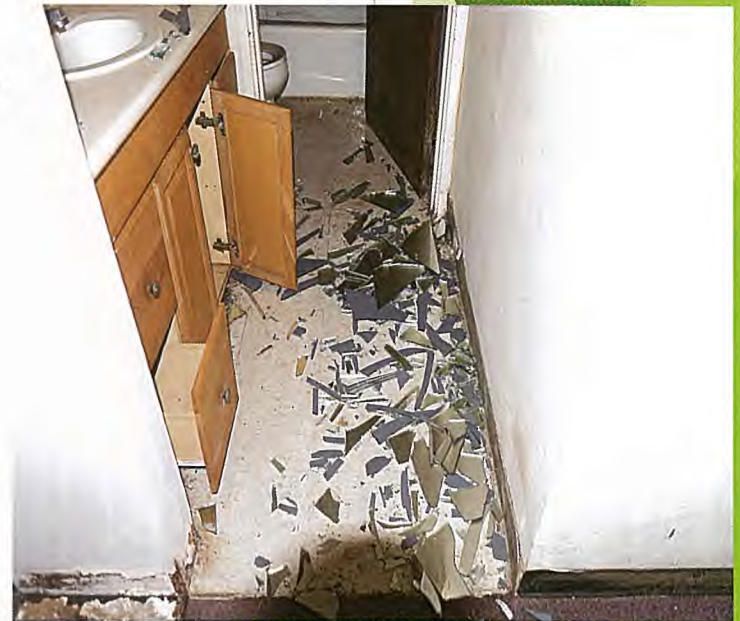
- ▶ Water damage, mold intrusion found in all buildings, in all attics
- ▶ Termite damage in all buildings
- ▶ Foundational cracks in Buildings A & C
- ▶ Buildings B & C mold and moisture intrusion in interior, bedroom, bathroom & closet
