# **Change in Zoning Annual Compliance Report**

**PARCEL H-2 (LOT 19)  
(TMK No. (2)2-1-005:085)**

**Prepared by  
H2R, LLC**

Archaeological Inventory Survey Report  
H2 Residential Project, Maluaka Ahupua'a  
Honua'ula, Maui  
September 2021

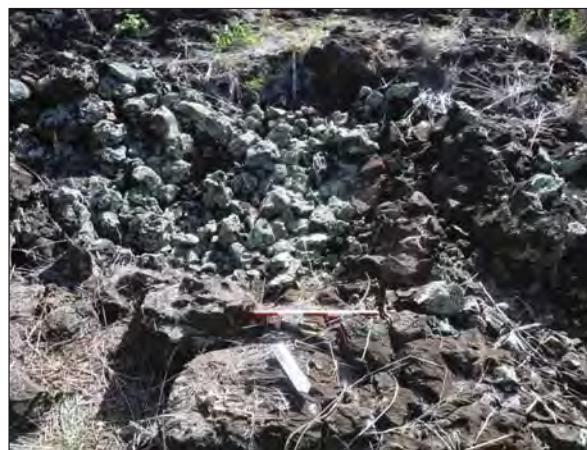
Figure 85. SIHP 50-50-14-06373, Feature 8 modified depression (view to southwest).

Feature 8 (Figure 85) is a modified depression measuring 3 m long (NE/SW) × 2.5 m wide (NW/SE) with a depth at 0.7 m. It is located near the northwestern corner of Feature 3. This portion of the exposed bedrock outcrop forms a natural depression that has been filled with subangular *pāhoehoe* cobbles and boulders. The surface of the fill is uneven. This feature was originally recorded by Rotunno-Hazuka et al. (2008a). No cultural material was observed in or around this feature, which is in poor condition due to tumble.

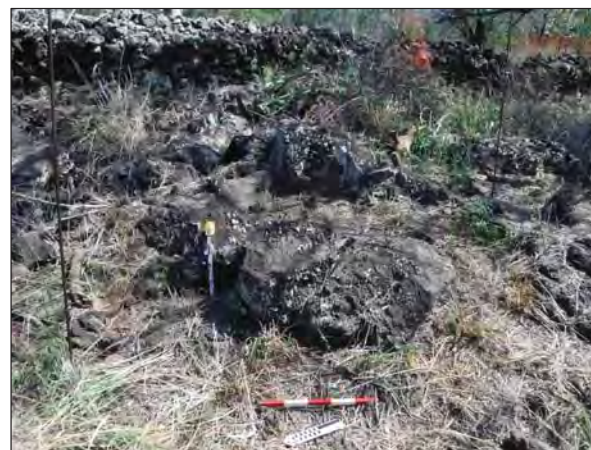
Figure 109. SIHP 50-50-14-06377, Feature 4 terrace (view to southeast).

This is a newly recorded feature. The terrace likely functioned as a small agricultural feature that was possibly utilized as a planting area. No cultural materials were observed on or near this feature, which is in poor condition due to tumble.

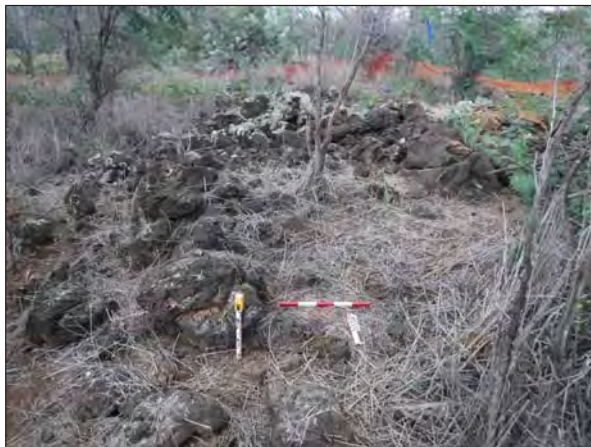
Figure 123. SIHP 50-50-14-06379, Feature 4, U-shaped wall (view to north).

(2008a) site map shows a large cactus obscuring the feature. Feature 4 was likely used for temporary habitation, along with the other features at the site. It is in fair condition due to wall tumble.

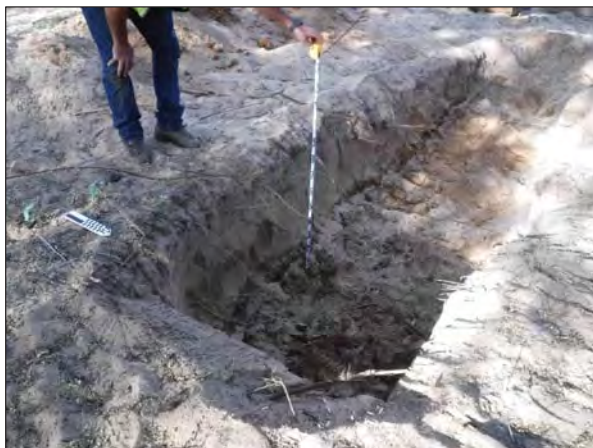
Figure 164. Trench 1 south wall profile, oblique view (view to southwest).

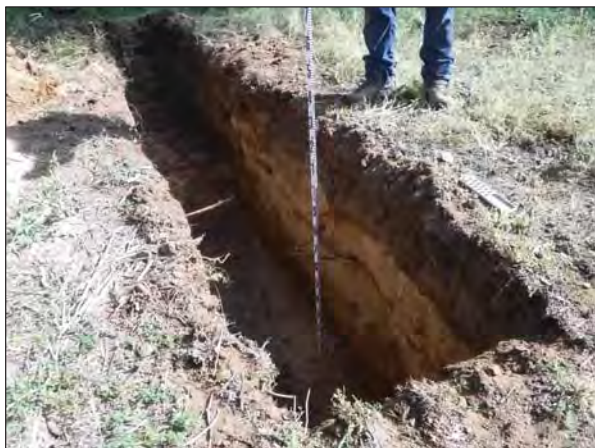
Figure 167. Trench 2 east wall profile, oblique view (view to east).

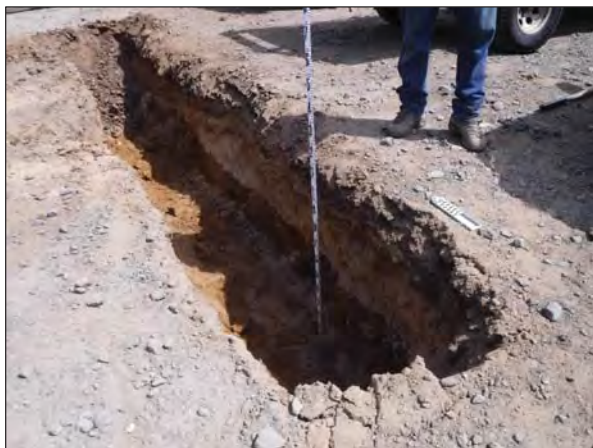
Figure 170. Trench 3, east wall profile, oblique view (view to east).

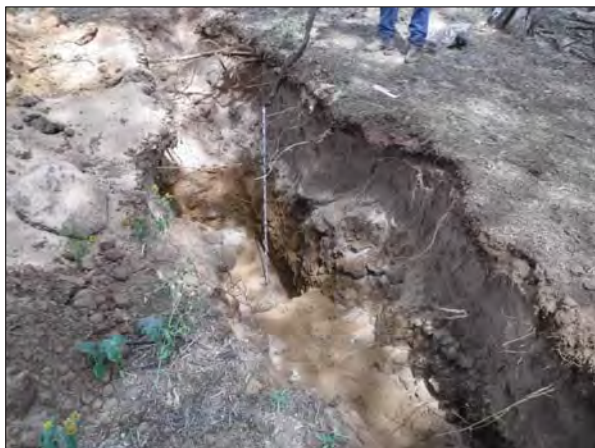
Figure 173. Trench 4 east wall profile, oblique view (view to east).

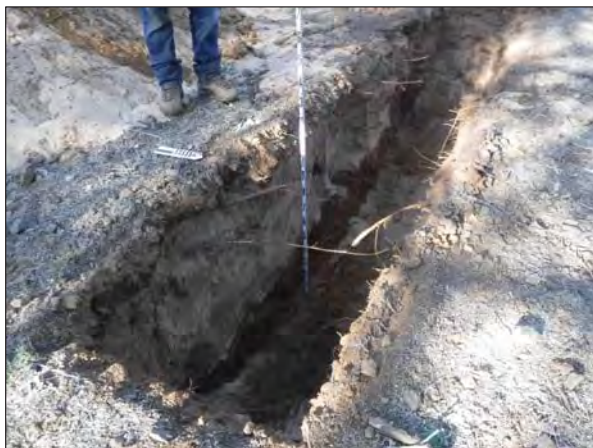
Figure 176. Trench 5 south wall profile, oblique view (view to southwest).

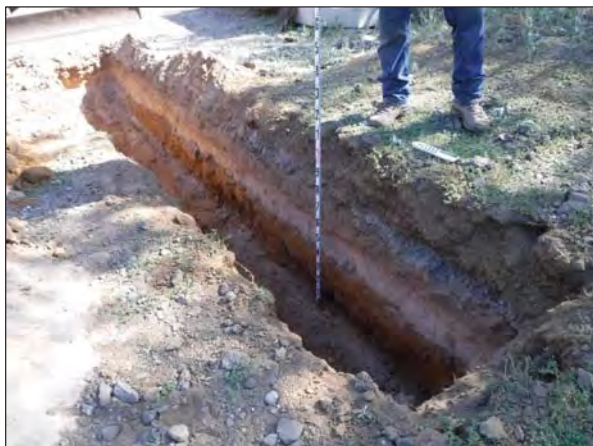
Figure 179. Trench 6 east wall profile, oblique view (view to northeast).

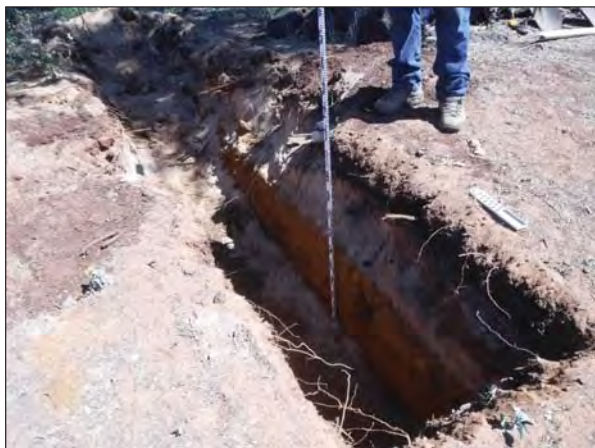
Figure 182. Trench 7 east wall profile, oblique view (view to northeast).

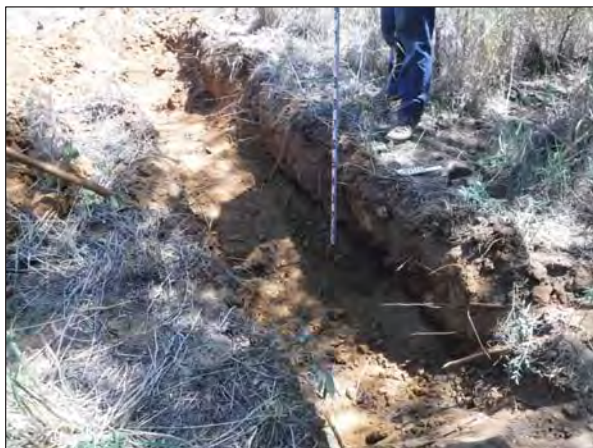
Figure 185. Trench 8 south wall profile, oblique view (view to southeast).

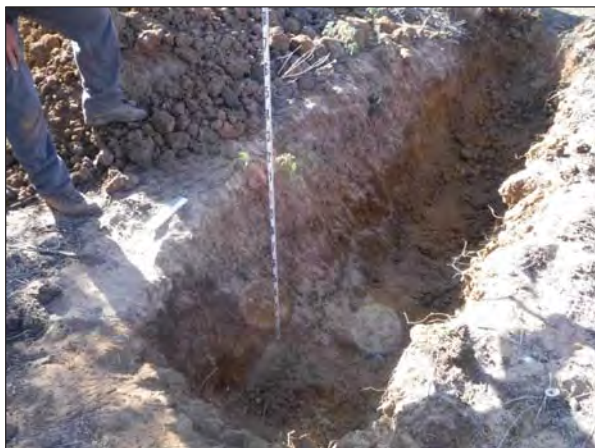
Figure 188. Trench 9 east wall profile, oblique view (view to southeast).

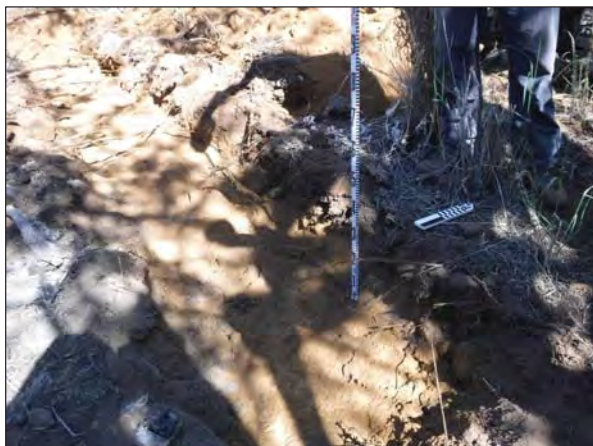
Figure 191. Trench 10 north wall profile, oblique view (view to northwest).

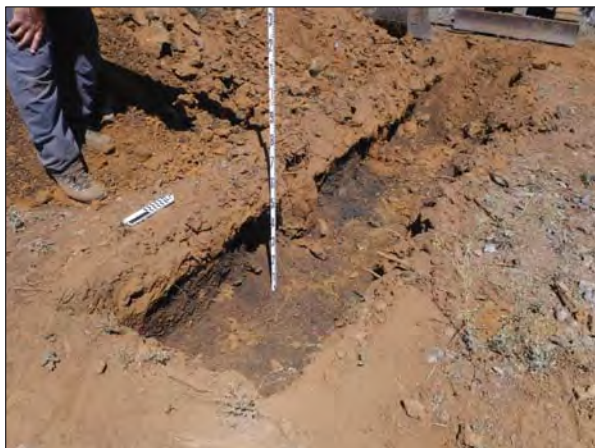
Figure 194. Trench 11 west wall profile, oblique view (view to northwest).

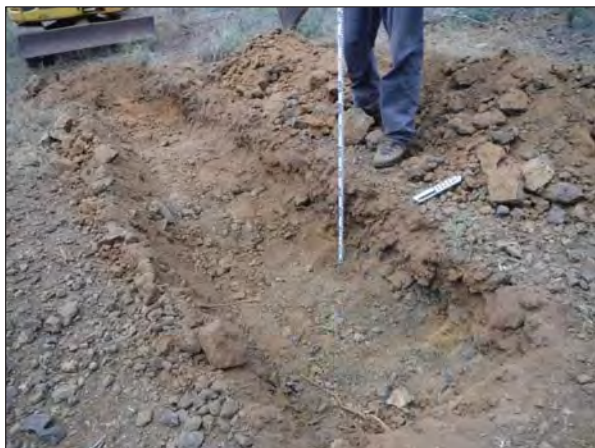
**Figure 197. Trench 12 north wall profile, oblique view (view to northwest).**
