ATTACHMENT 13D
COUNCIL RESPONSE EM-3 (BF-1)

**Subject: Phase I of Post Closure Services for the Closed Kalamaula Landfill
Island of Molokai, Hawaii**

Element Environmental, LLC (E2) is pleased to submit this letter report documenting Phase 1 of post closure services for Kalamaula Landfill. E2, along with A-Mehr Inc., have been retained by the County of Maui (hereafter referred to as the County), Department of Environmental Management to facilitate post-closure planning services for the Closed Kalamaula Landfill on the Island of Molokai, Hawaii (Figure 1).

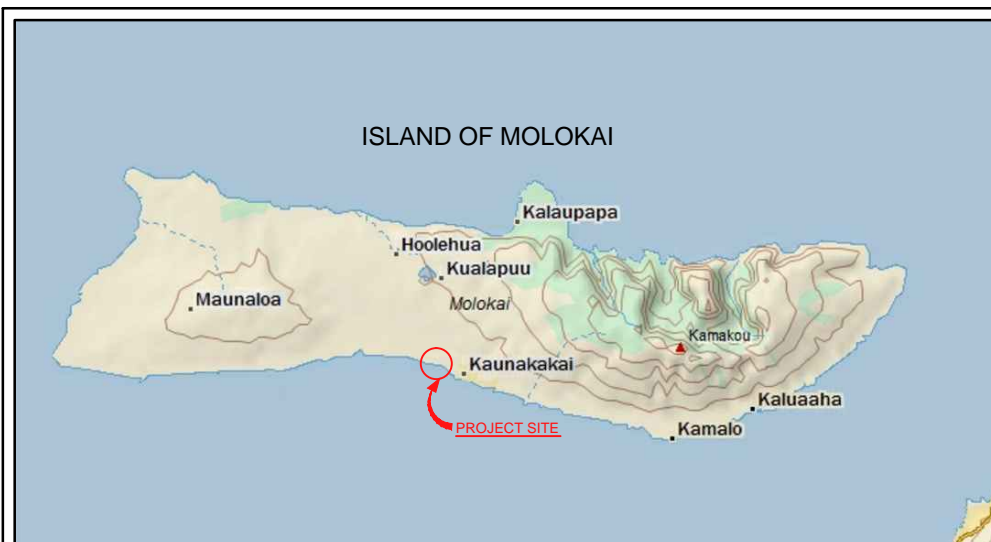
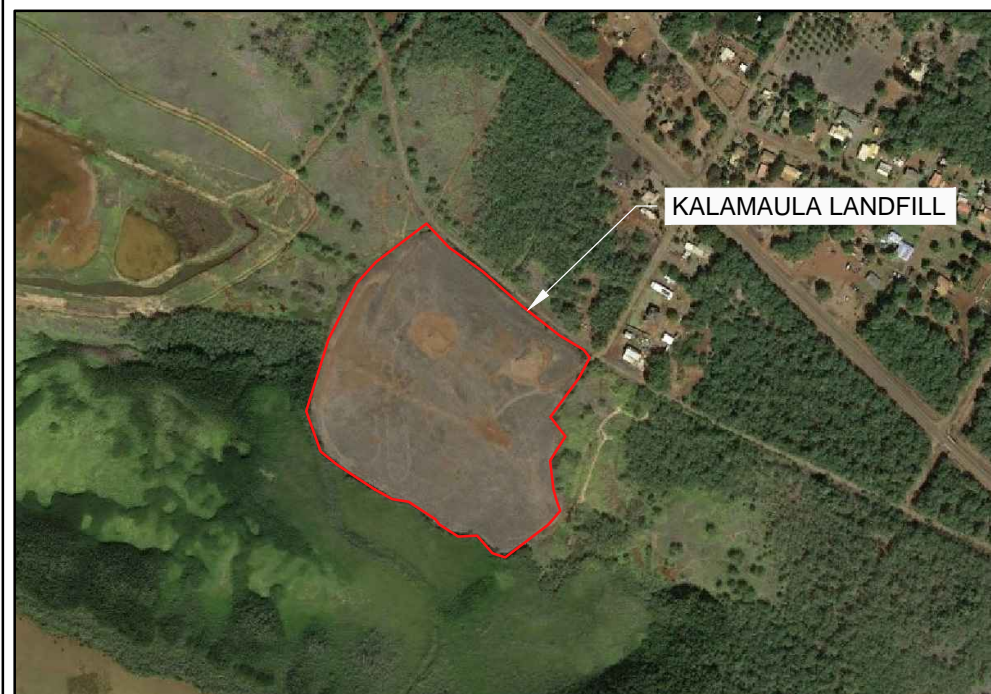
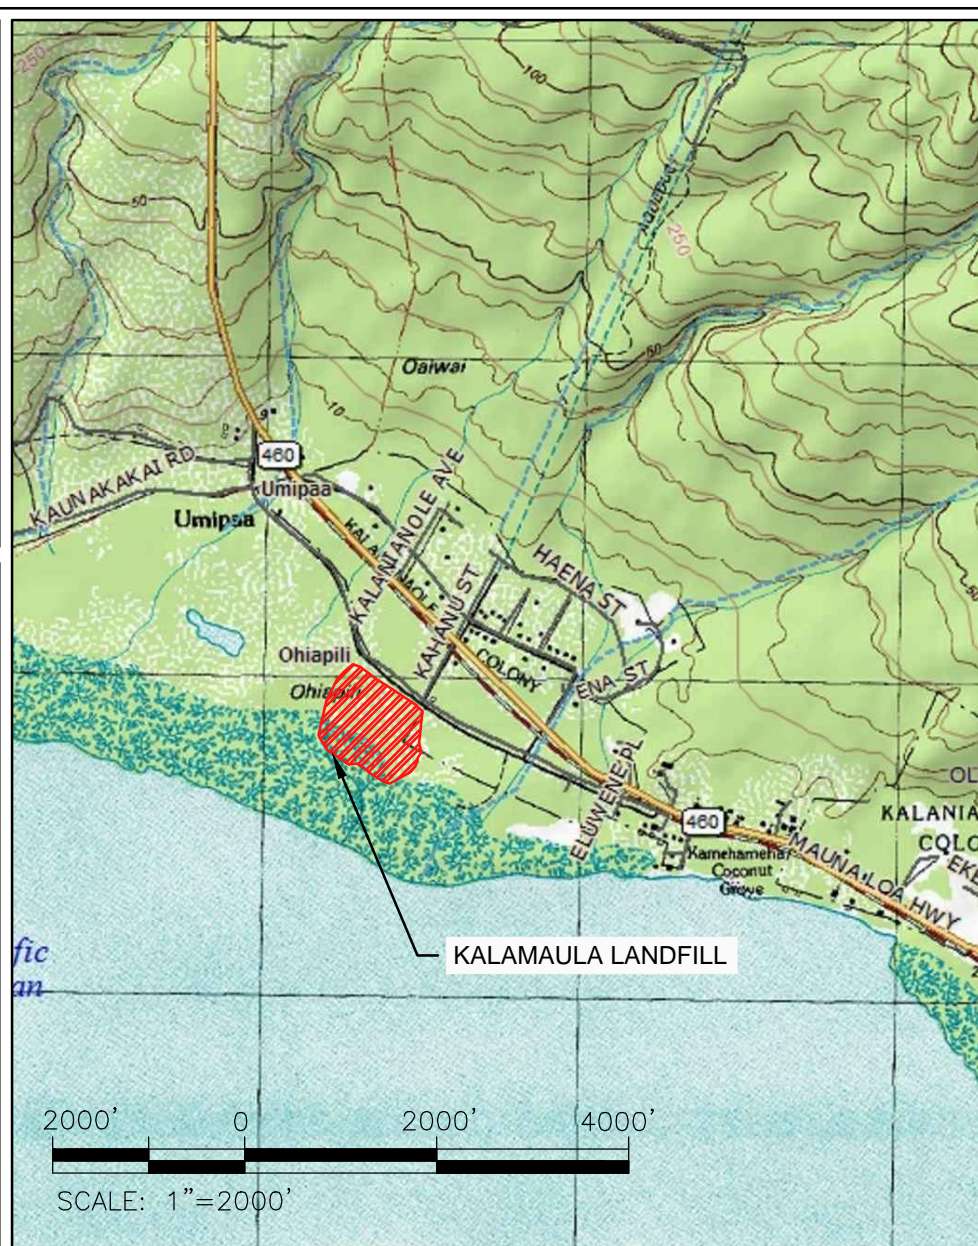
Figure 2: Site Map

Groundwater monitoring wells installed for the hydrogeological assessment except for MW-8 were located during site reconnaissance and are shown in Figure 2, Site Plan. Wells monitored for the wetlands monitoring plan were not encountered during the field investigation except for what we believe to be KMW-2; however the well was not labeled. One leachate well was located in the middle to the landfill. The coordinates, elevation, and conditions of the wells found during the field investigation are shown in Table 1.

Post-closure landfill gas monitoring results were not encountered during site investigation activities. According to the Post-Closure Maintenance and Monitoring Plan, three (3) landfill gas probes installed were supposed to be monitored over the first year. If the results were below federal allowable limits, then the frequency would be reduced to semi-annual monitoring for a period of five years. Post closure landfill gas data was not encountered in either the HDOH files or the County's files; however two landfill gas probes were found along the northern edge of the site. Seven landfill gas vents were found around the landfill. Probes and vents are shown in Figure 2.

During site reconnaissance, gas probes and vents were identified in the field. Landfill gas features encountered during the survey are identified in Figure 2. The coordinates, elevation, and conditions of the vents and gas probes found during the field investigation are shown in Table 2.

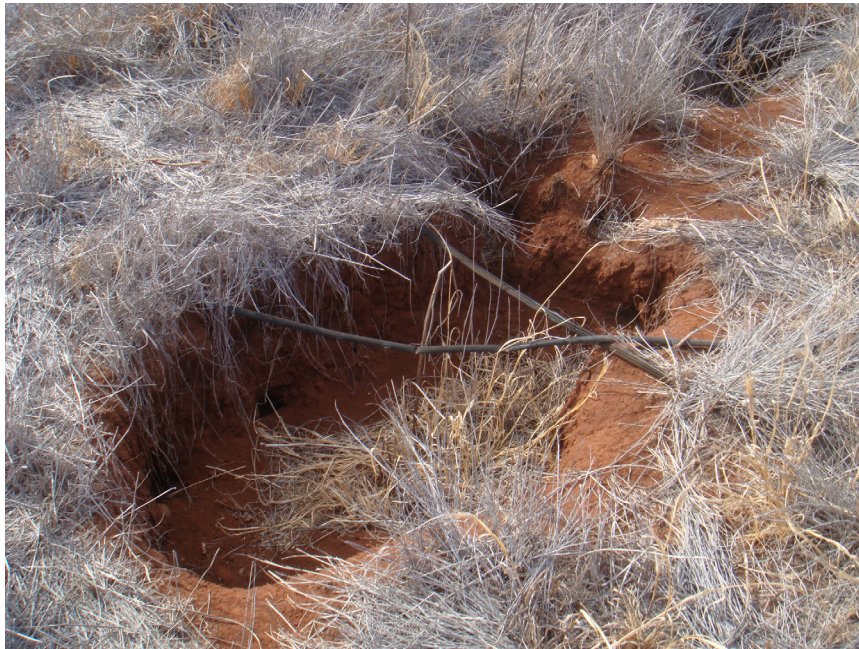
The condition of the cover as of October 2013 is shown in Attachment B. At that time we observed areas that were bare of vegetation, significant erosion on side slopes, and sinkholes resulting in exposure of the underlying PVC geomembrane in some areas. Surface water has also been observed ponded on the top deck which has led to undermining the final cover. The vegetative soil layer showed cracks and water marks, and the vegetation was sparse in areas where water had collected in the past. The PVC liner did not appear to be damaged in areas where erosion had occurred.

Photo 1: Large Sinkhole

- Acquire the services of a licensed surveyor to perform a topographic survey of the site. If the survey is done by aerial photography it would be advisable to cut any tall grass areas on the top deck to improve accuracy.
- Design a remedial closure plan that includes removal of geomembrane from sideslopes, adding soil and regrading the top deck to provide a minimum slope of 3%, an effective surface water management system, and vegetation. The top layer of soil should be suitable to sustain vegetation on the surface of the landfill and be underlain by a low-permeability soil (i.e. 10^{-6} centimeter/second).
- Obtain HDOH approval of the remedial closure plan.
- In the interim period before a comprehensive plan is implemented, continue to repair eroded areas as needed and take interim measures to manage surface water.

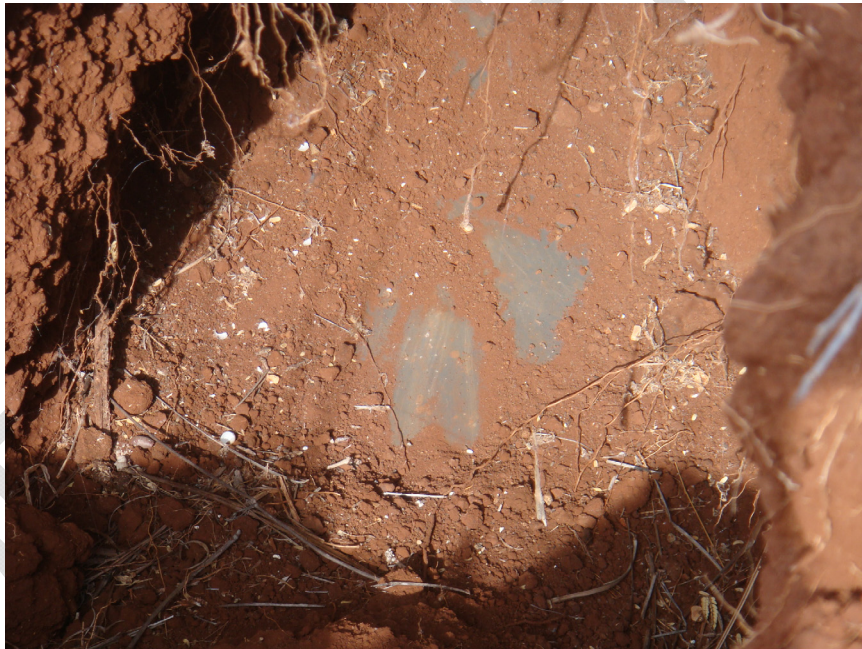
The major cause of erosion is likely the result of the ponding of surface water on the top deck. Normal and expected settlement has caused ponding and is due to the landfill decomposition and consolidation of the refuse. The ponding promotes infiltration of surface water down to the PVC-soil interface and allows water to drain along the interface at the sideslopes. The cover system is not designed to accommodate this kind of drainage, and the result is excessive erosion and loss of the vegetative layer in areas where it occurs. There is also evidence of burrowing rodents creating paths for surface water to enter directly into the soil/liner interface at the top of slopes, resulting in subsurface erosion channels that emerge at the toe of sideslopes.

Photo 2: Exposed Liner in Sinkhole

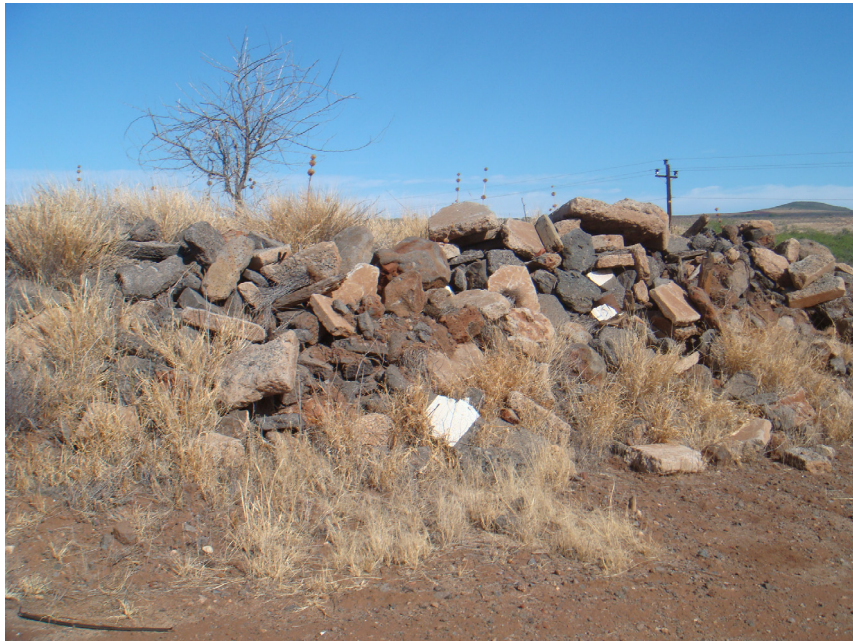
Photo 3: Asphalt and Concrete Stockpile

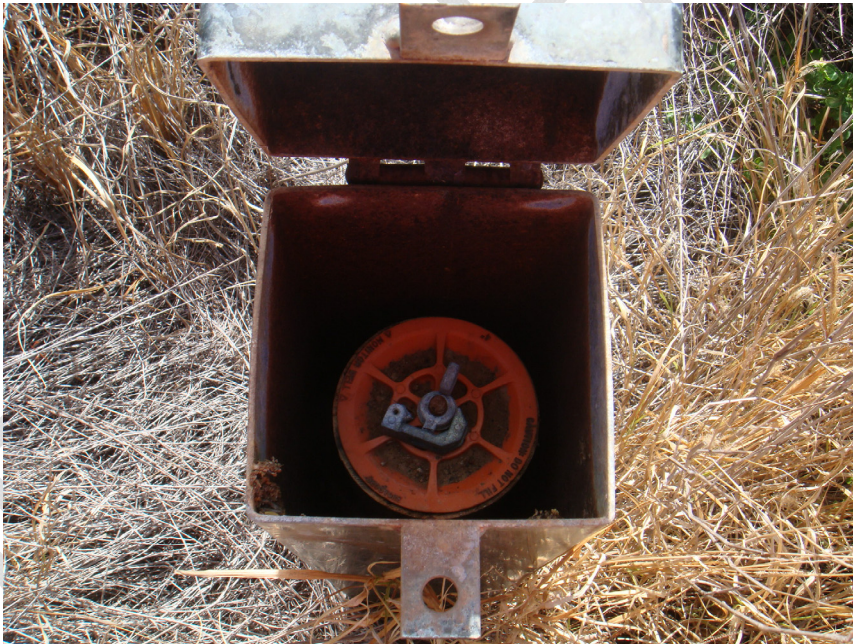
Monitoring Well	Easting UTM	Northing UTM	Elevation Feet msl	Well Condition
MW-1	1510447.106	278888.116	76.32	Vault good, no lock, well cap good.
MW-2	1510147.519	278572.6667	88.52	Vault good, no lock, cap decent condition, metal is rusted, rubber is old and cracking
MW-3	1509993.684	278344.4466	82.62	Vault has surficial rust, but adequate, cap decent condition, metal is rusted, rubber is old and cracking.
MW-4	1509711.356	278509.6152	96.37	Vault has surficial rust, but adequate, cap decent condition, metal is rusted, rubber is old and cracking, settlement has occurred around the well.
MW-5	1509552.097	278891.2969	98.72	Vault good, no lock, cap decent condition, metal is rusted, rubber is old and cracking.
MW-6	1509853.868	279341.5499	93.84	Vault damaged, missing lid, rusted, well cap damaged.
MW-7	1509884.23	279327.9036	94.50	Vault good, well cap good; however loose fit and will not tighten.
Leachate Well	1509894.9090	278817.2651'	100.37	Vault good, no lock, cap decent condition, metal is rusted, rubber is old and cracking.

Photo 4: Groundwater Monitoring Well

We recommend that the existing wells be evaluated, repaired and secured or closed in place. We recommend that the County obtain approval from HDOH prior to decommissioning the groundwater monitoring wells.

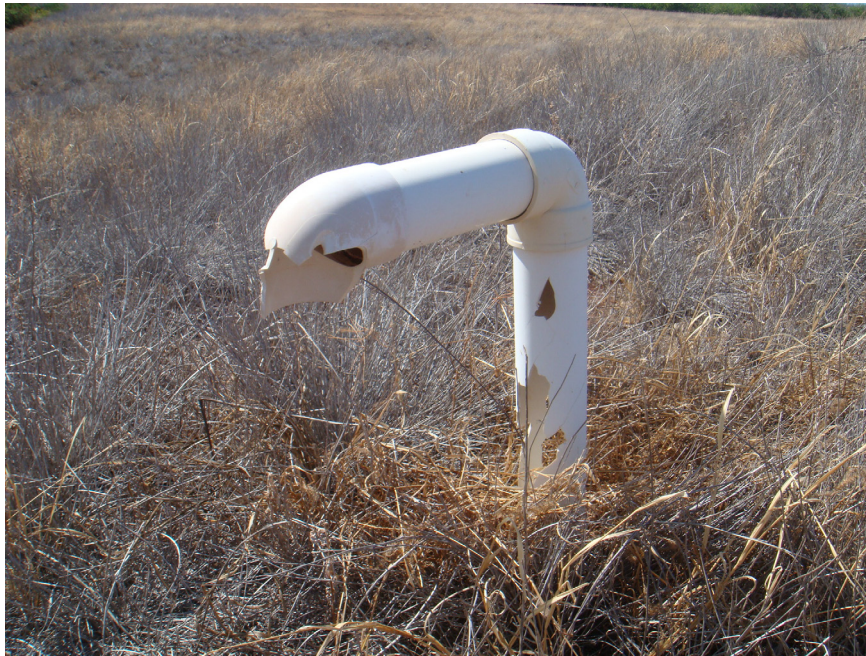
Gas Probe/Vent ID	Easting UTM	Northing UTM	Elevation Feet msl	Gas Probe/Vent Condition
Vent-1	1510278.3610	278760.2529	89.26	Pipe is cracked
Vent-2	1509823.0580	278444.5252	97.35	Good condition
Vent-3	1509497.7350	278795.3256	94.75	Good condition
Vent-4	1509805.4420	279193.0087	110.07	Good condition
Vent-5	1509715.6240	279047.7940	110.12	Good condition
Vent-6	1509984.5670	278829.8599	109.33	Good condition
Vent-7	1510177.7090	279024.9714	113.43	Good condition
Gas Probe-2	1509989.9940	279319.3248	87.10	Good condition
Gas Probe-3	1510210.1470	279132.1973'	85.10	Good condition

Photo 5: Damaged Landfill Gas Vent Pipe

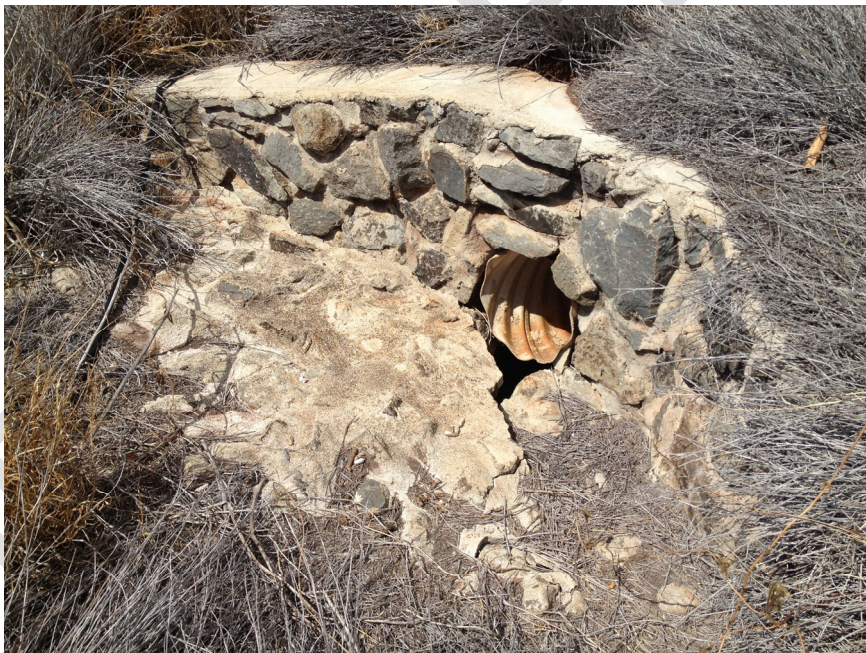
Photo 6: Storm Water Drainage Structure

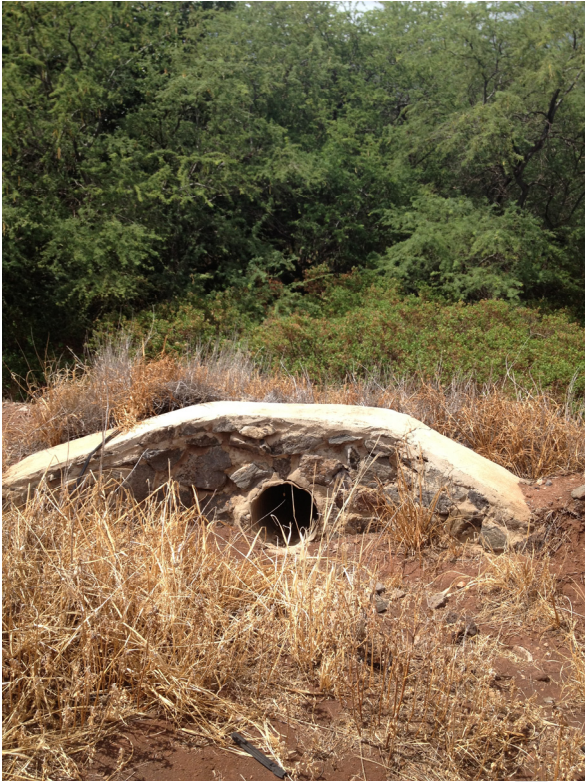
Photo 7: Storm Water Drainage Structure

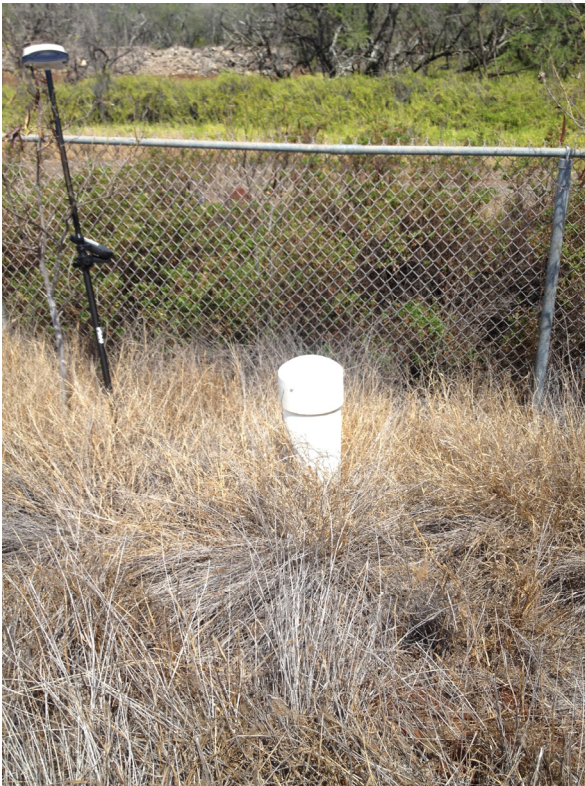
Photo 8: Landfill Gas Probe
