ATTACHMENT 13B COUNCIL RESPONSE EM-3 (BF-1)

Subject: Phase I of Post Closure Services for the Closed Waikapu Landfill

Waikapu, Maui, Hawaii

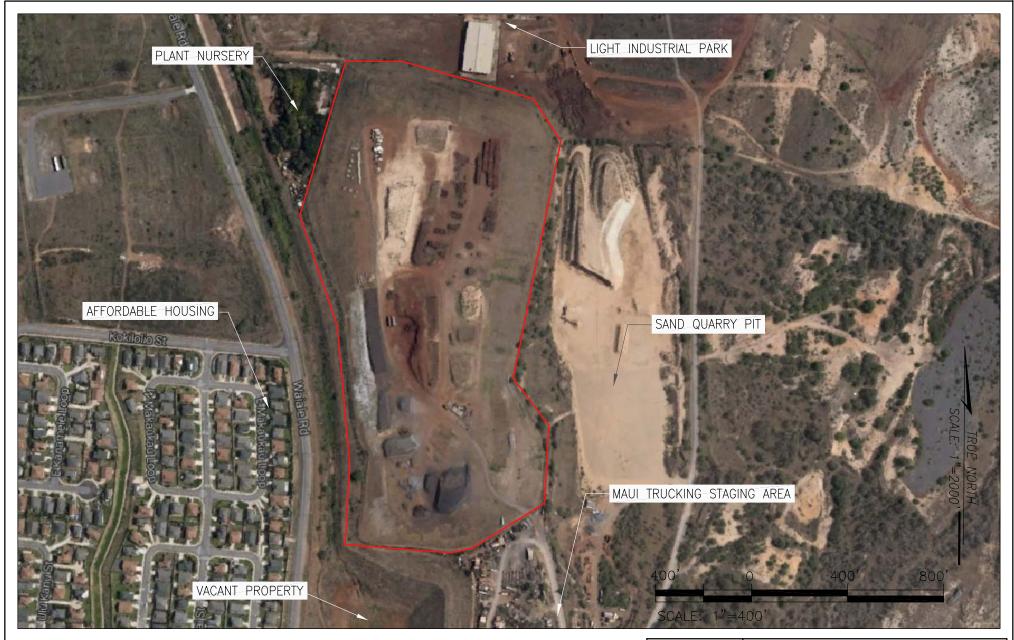
ADJACENT PROPERTIES

The closed Waikapu Landfill is located near Waikapu on the Island of Maui, Hawaii (Figure 1). The adjacent property to the north is a light industrial park developed by Maui Lani Partners. Businesses in the light industrial park include Paradise Beverages' warehouse, a gas station, a convenience store, Oceanic Cable, and GP Roadways. Adjacent to the west of the light industrial park and northwest of the landfill is a plant nursery. East of the closed landfill is a sand quarry pit. Maui Trucking stages equipment, vehicles and containers at the adjacent property to the southwest. Vacant land is located adjacent to the Maui Trucking base yard and south of Waikapu Landfill. The closed landfill is bound by Waiale Road to the east. An affordable housing neighborhood is located on the west side of Waiale Road across from the closed landfill. Figure 2 identifies adjacent properties.

Four gas wells (A through D) were installed onsite during landfill closure. Gas monitoring well locations are shown in Figure 2. Gas Well C, located near the northwestern edge of the landfill, was observed at the site during this site reconnaissance visit in August 2013; however, it was not encountered during the field survey in January 2014. None of the other wells (A, B, or D) were encountered during site reconnaissance. The County believes that the wells were inadvertently buried or destroyed.

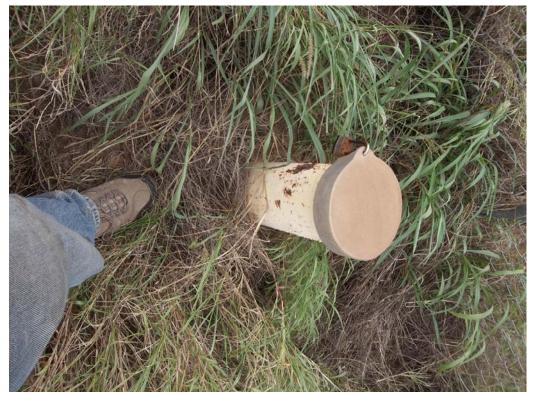
Photo 1: Groundwater Monitoring Well MW-2

MW-1 (the cross gradient well) could not be located during either site visit. The County believes that the well has been buried. MW-2, which is downgradient of the southern portion of the landfill, was encountered during both site visits and surveyed using a Trimble® GPS unit. The coordinates and elevation are as follows:

We recommend closing the existing wells onsite upon approval from HDOH.

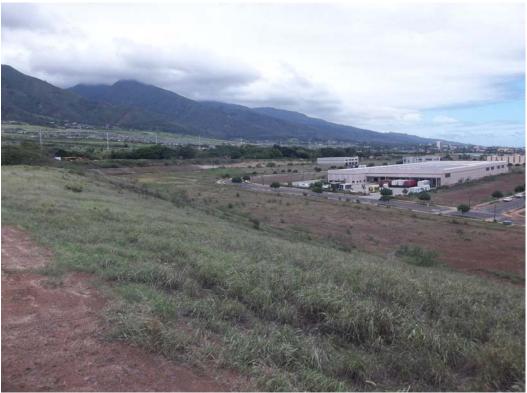
Photo 2: Vegetated Side Slopes

The top of the landfill is flat with side-slopes varying from 20-50%. On-site drainage systems do not direct sheet-flow to swales or ditches nor is off-site storm water directed away from the landfill by the use of ditches. The slopes are vegetated with grass. Vegetation is thicker during the rainy season (winter) and more sparsely vegetated in the dry season (summer).

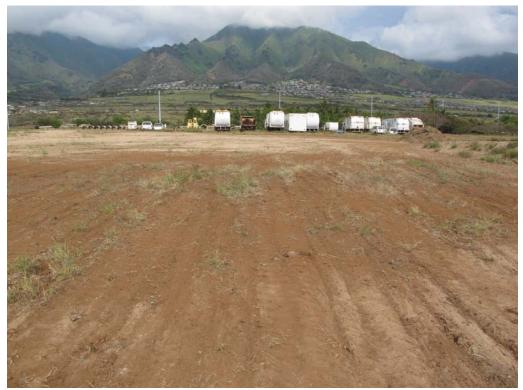
Photo 3: Stored Equipment, Sparse Vegetation on Top Deck

The top deck of the landfill is currently being used to store construction materials and equipment. Much of the top deck area is bare and does not have adequate vegetation to control erosion. The grass cover on the landfill slopes is adequate. The final cover material is highly permeable material spread over the interim cover material to a depth of two feet deep.

- Obtain a current (less than five years old) topographic survey that will identify areas where surface water could pond. If areas exist with insufficient drainage, these areas should be re-graded to improve drainage, decrease storm water ponding and infiltration.
- Correct drainage as needed. Use the topographic maps for analysis and design. Add fill were required.
- Complete test pits on the top deck of the landfill to verify the average depth of cover.
- Conduct a landscape architect study to develop a suitable post-closure vegetation plan for long-term, low maintenance plan consistent with post-closure uses.

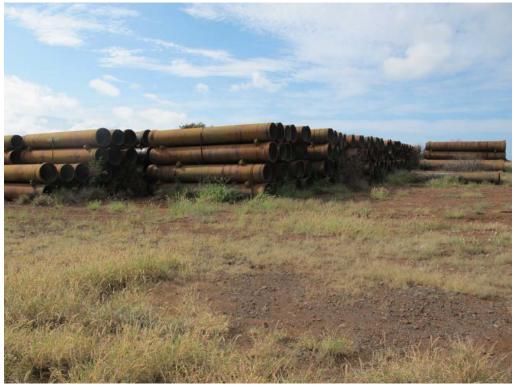
Photo 4: Conduit Storage, Sparse Vegetation

The landfill is currently used for stockpiling and storage of materials. The majority of the material stockpiled on the top of the landfill surface is stored for the County Department of Department of Public Works (DPW). Figure 3 identifies the materials and stockpiles stored on the landfill as of April 2013. The piles were generally the same during the field investigations conducted by E2 in January 2014.

- Remove stockpiled materials and prohibit the use or any activities at the landfill.
- Construct improvements based on the recommendations provided in the discussion on final cover and storm water drainage.
