# *Actions to Improve the Impaired Status of Māʻālaea Bay*

Prepared for Maui County Council  
Climate Action, Resilience and Environment Committee  
February 3, 2021

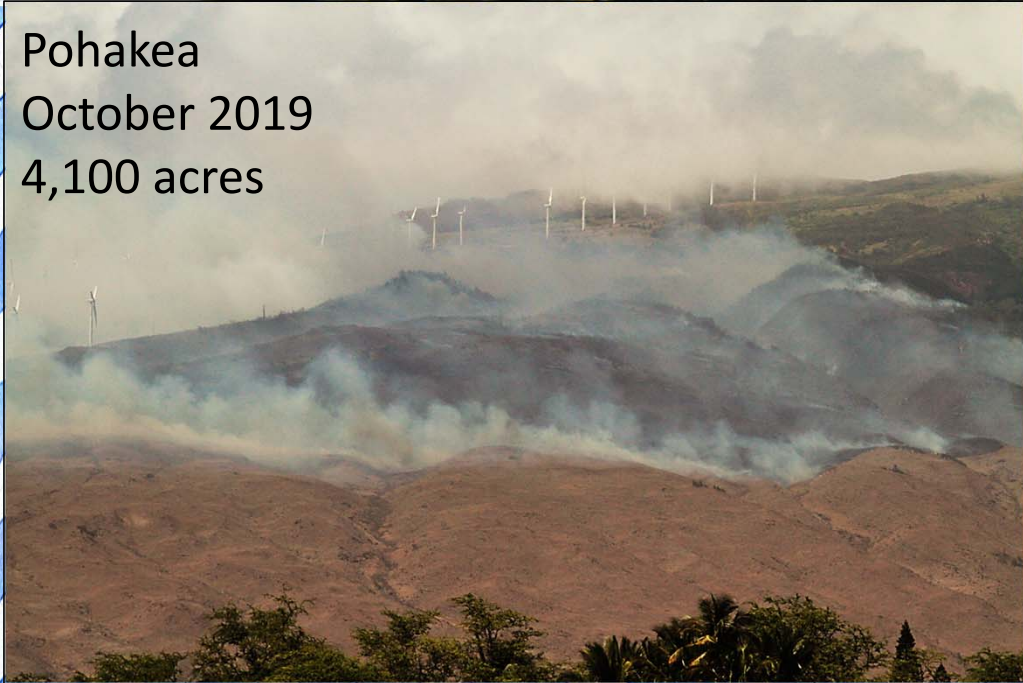
Pohakea  
October 2019  
4,100 acres

- **11 Fires in 20 years**
- **Env. damage**
- **Threatens human life, property, access routes, energy, and economy**
- **Major harbor and visitor attractions**

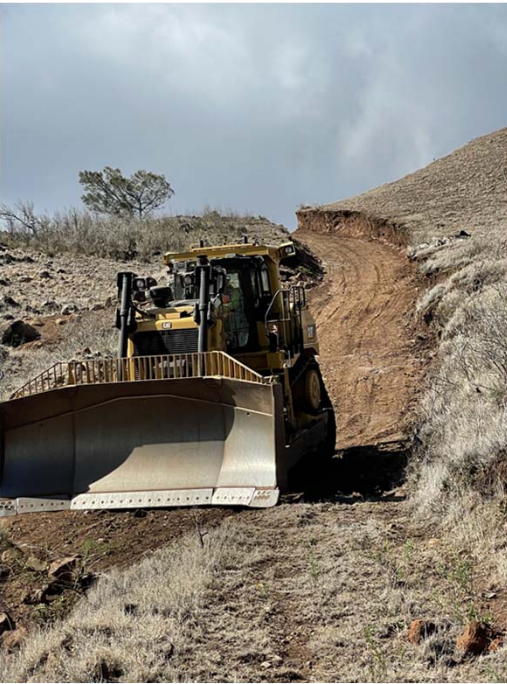
**Repair kickouts and waterbars**

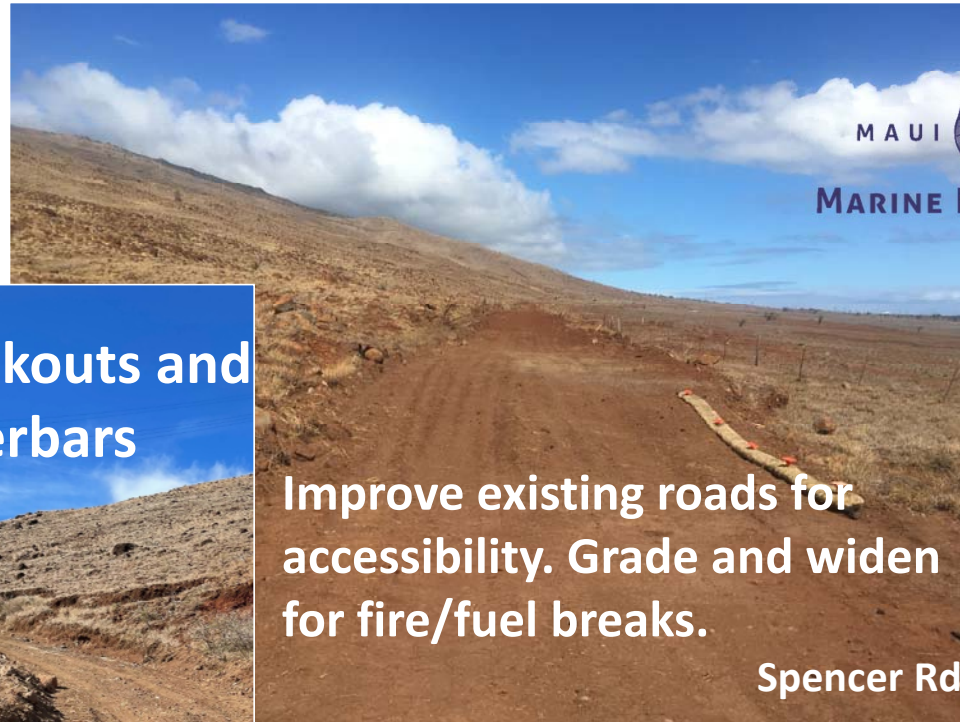
**Spencer Rd**

**Improve existing roads for accessibility. Grade and widen for fire/fuel breaks.**

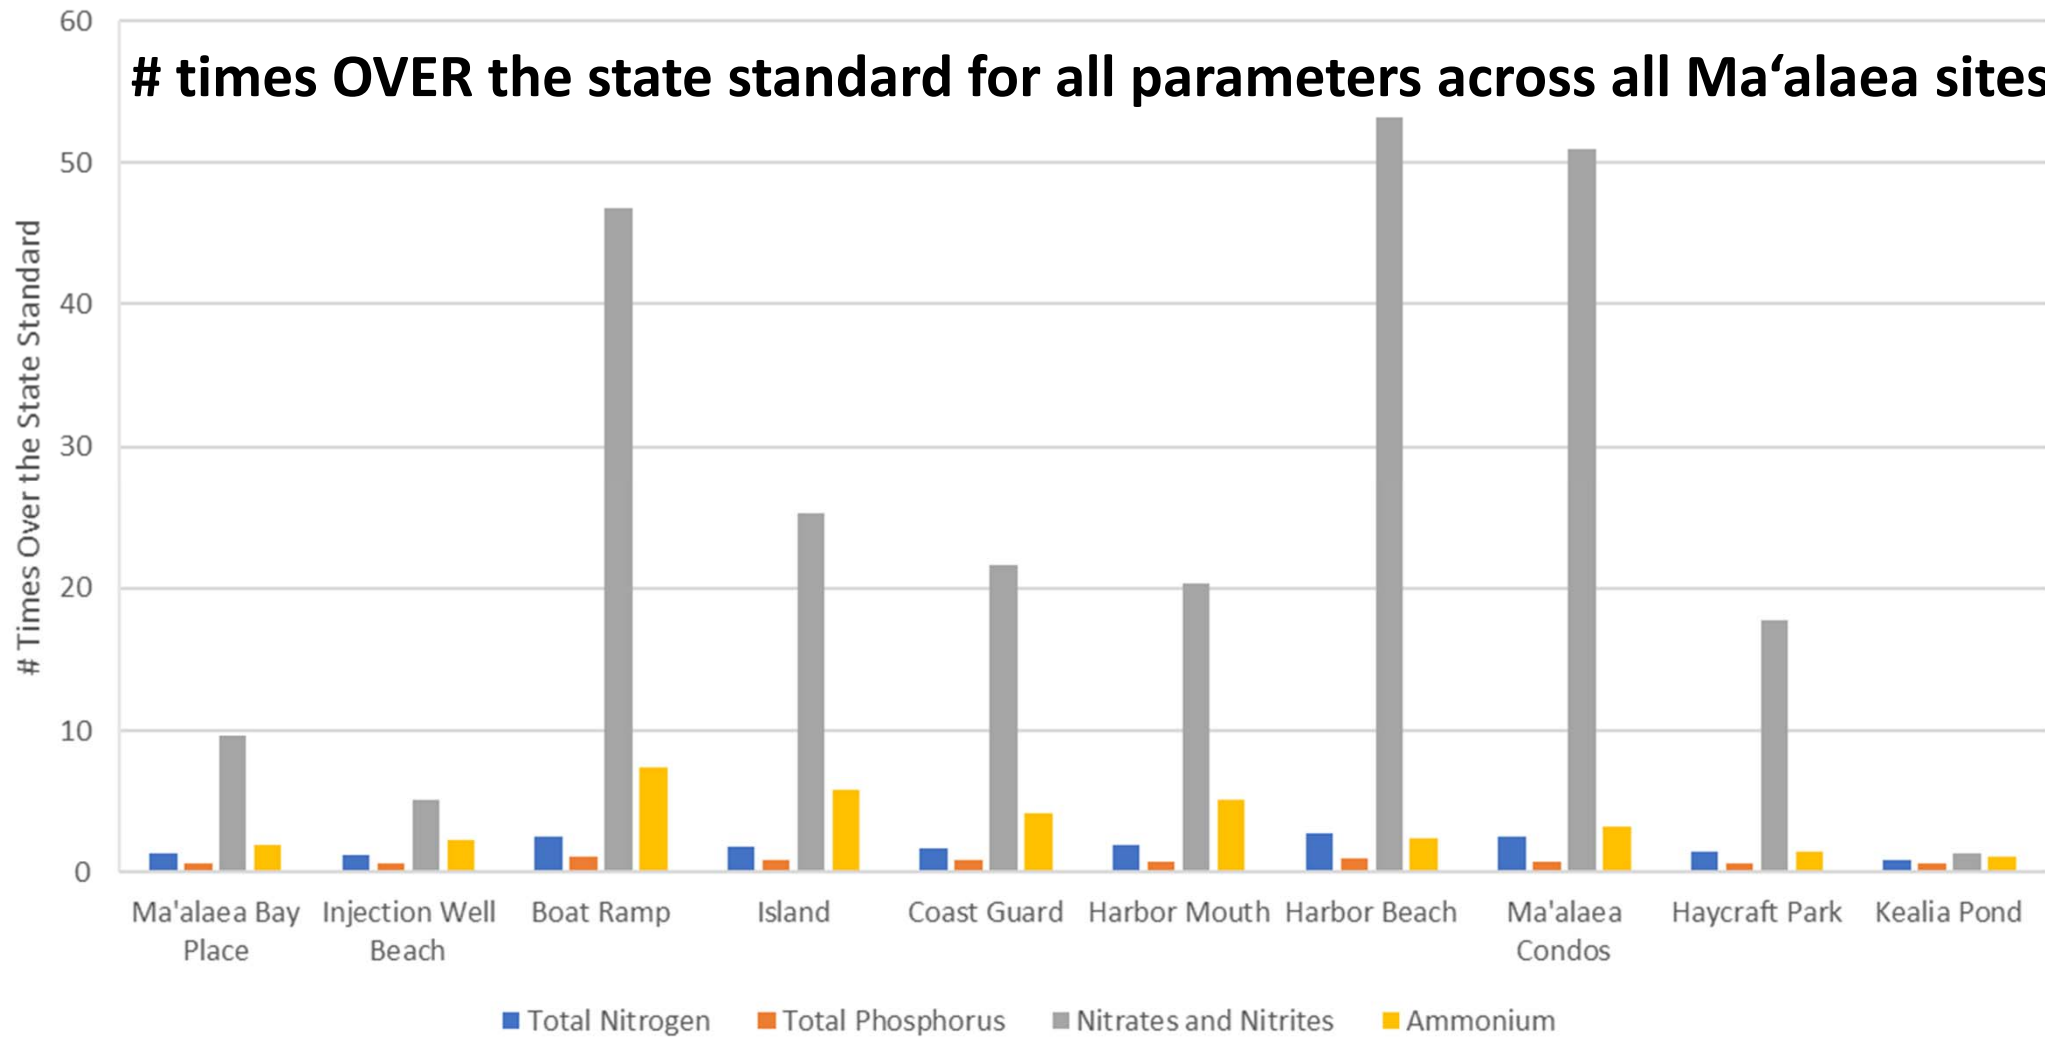
Ma'alaea Sites and Nutrients Compared to State Standards 11/15/18 - 9/30/20

**# times OVER the state standard for all parameters across all Ma'alaea sites**

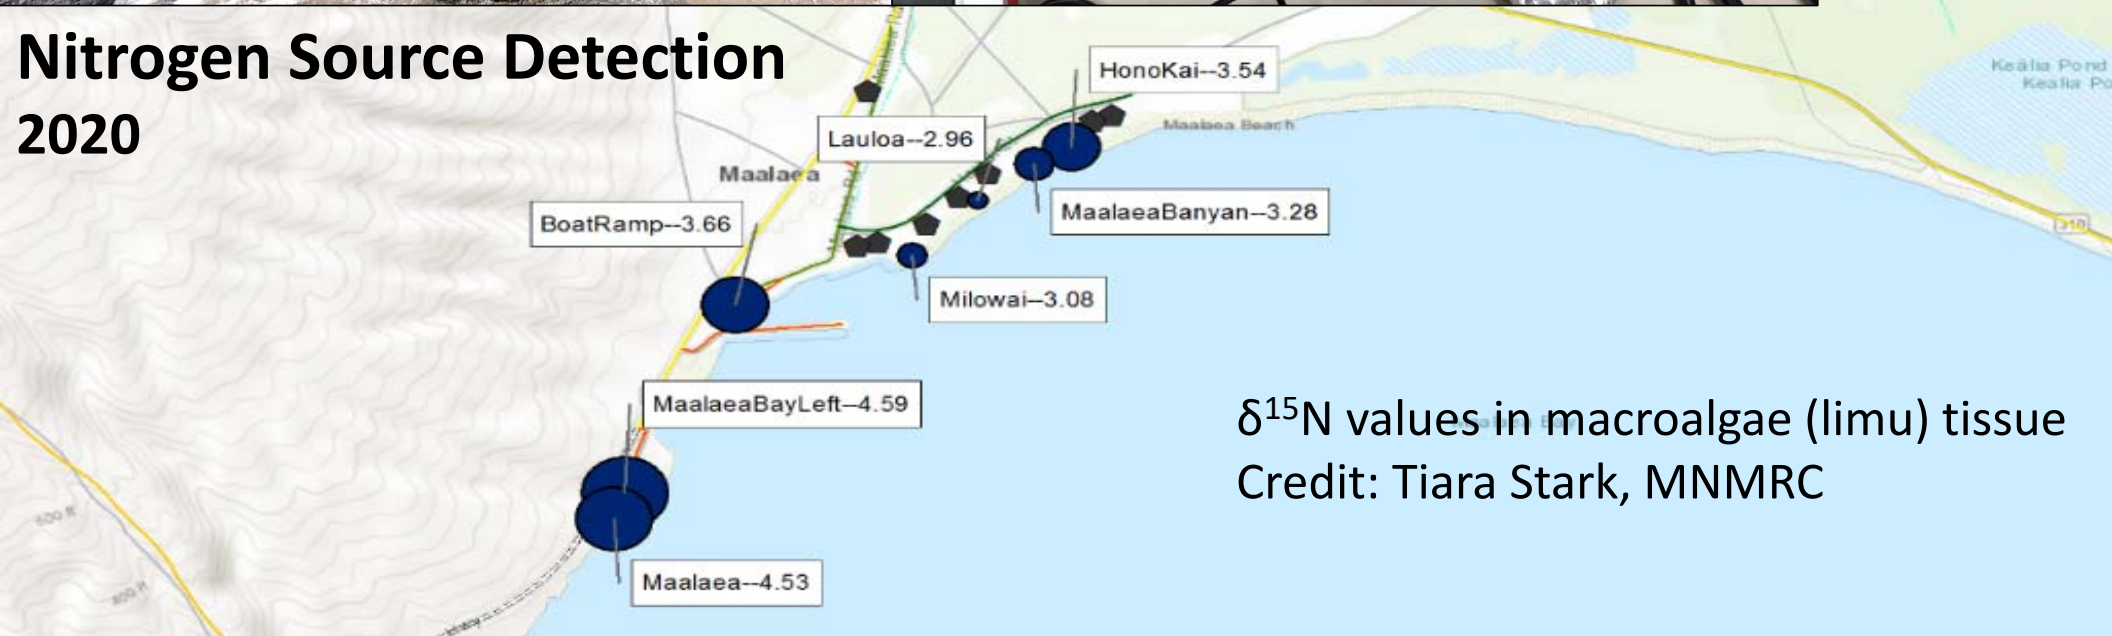
# Nitrogen Source Detection 2020

$\delta^{15}\text{N}$  values in macroalgae (limu) tissue  
Credit: Tiara Stark, MNMRC
