Structural Condition Analysis and Assessment of Dormitory Facilities

December 17, 2019

Site Located at 820 Ka'ahumanu Avenue, Kahului, Maui 96732 TMK: (2)3-8-07:117

Summary of Structural Field Condition Survey for the Existing University of Hawaii Community College Dorm Campus Buildings and Appurtenances

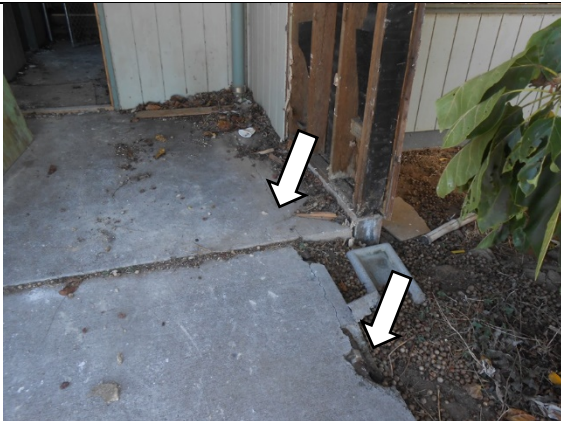
PA1D.5: Cracked exterior slab at rusting drain-pipe.

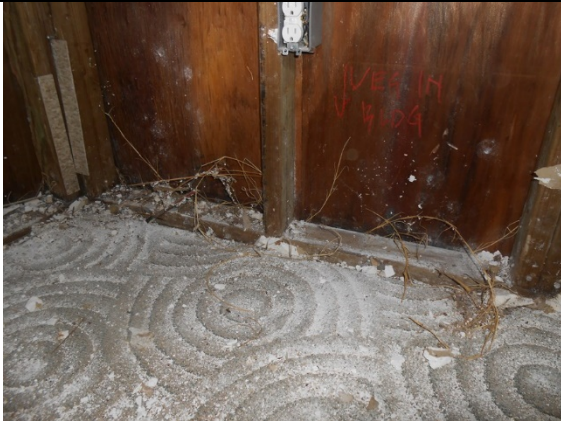
PA1CD.3: At various locations, vegetation is present at interior face of first story walls.

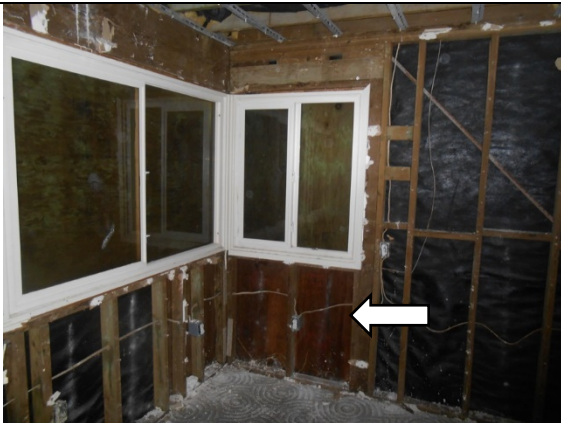
PA1CD.4: Building paper missing at interior face of wall sheathing.

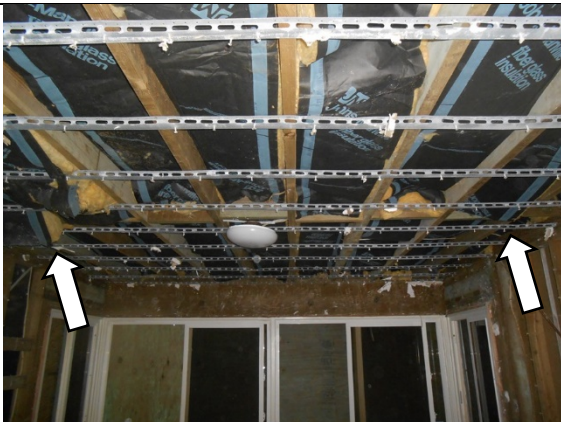
PA2CD.3: Missing wall blocking.

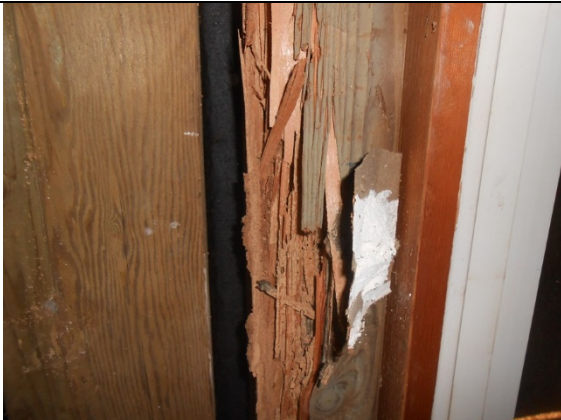
PB1D.3: Post termite damage.

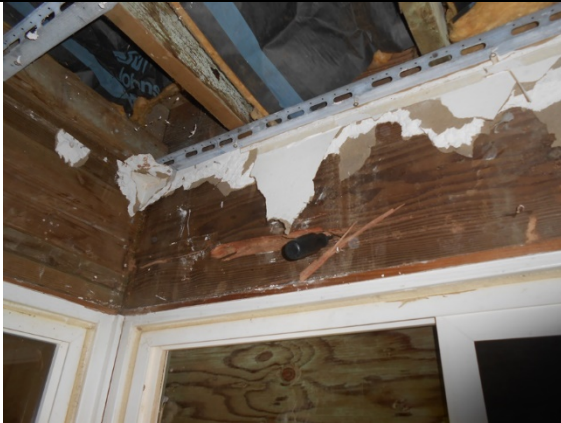
PB1D.5: Beam termite damage.

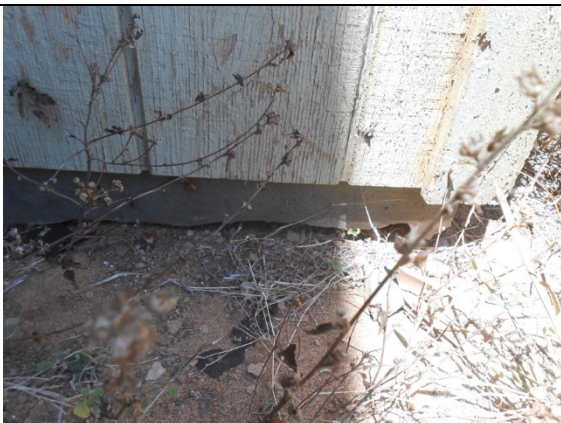
PB1CD.5: Exposed bottom of footing.

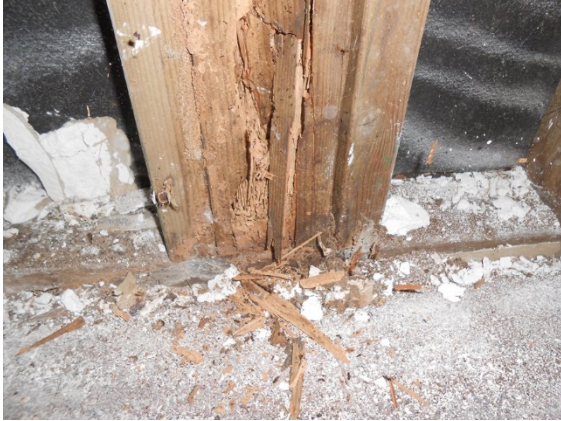
PC1D.4: Post termite damage.

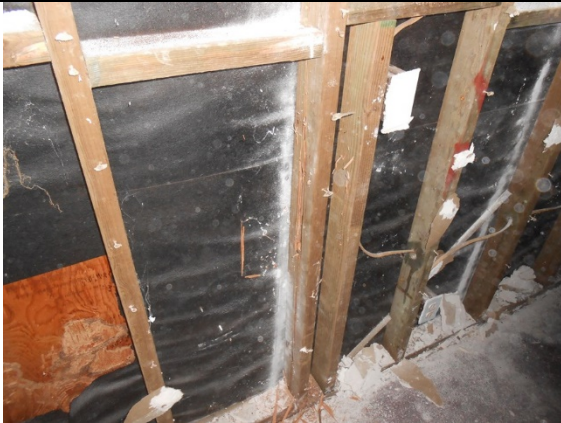
PC1D.5: Stud termite damage.

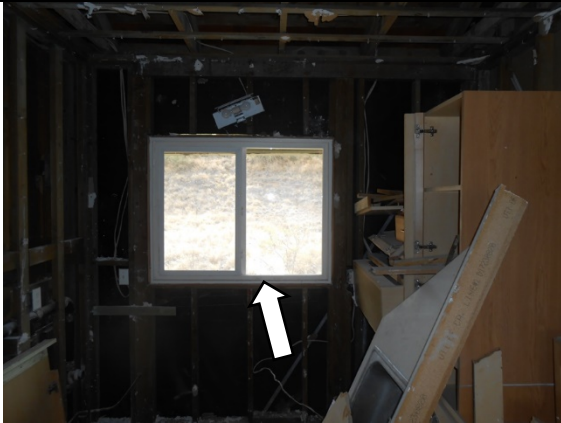
PC2CD.3: Missing opening sill plate.

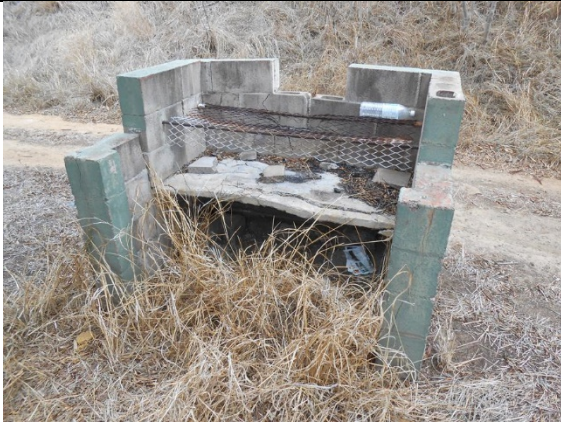
PBP1: Damaged concrete masonry unit barbecue pit. Missing blocks, cracked masonry, and warped concrete fire slab.

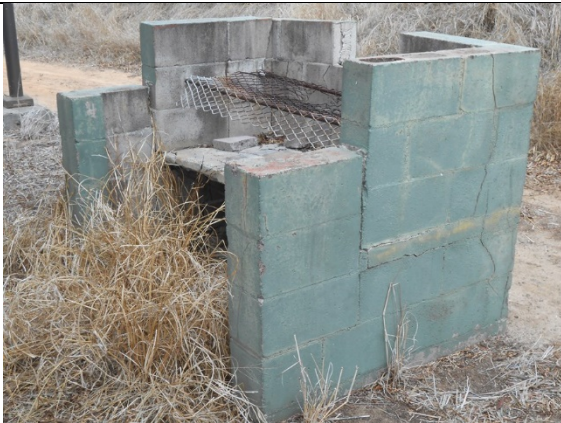
PBP2: Damaged concrete masonry unit barbecue pit. Missing blocks, cracked masonry, and warped concrete fire slab.
