**SUBJECT: COUNTY-OWNED PARCEL ON NORTH PAPA AVENUE (KAHULUI)  
(HHT-14)**

## Property Condition Report

310 W Kaahumanu Ave, Kahului, HI 96732  
Inspection prepared for: Maui County c/o Buddy Almeida  
Real Estate Agent: -

This is a commercial property condition assessment to determine if three (3) former UH dormitories are suitable for housing. This inspection includes invasive and non-invasive inspection methods as well as sampling for asbestos and lead based paint.

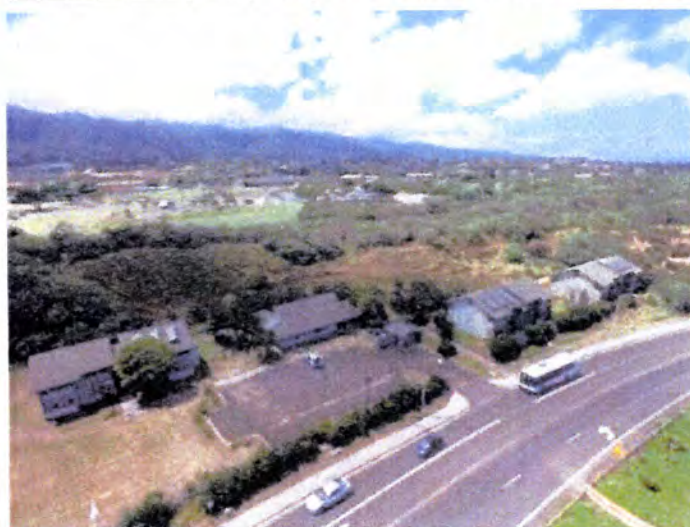
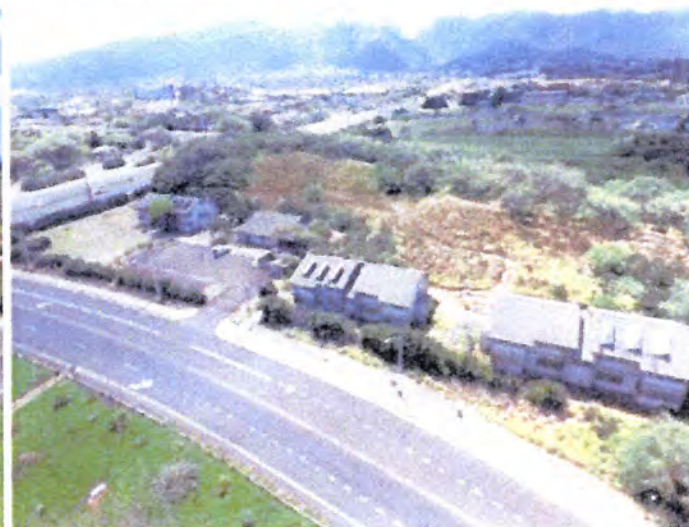
The topography of the property was generally flat.

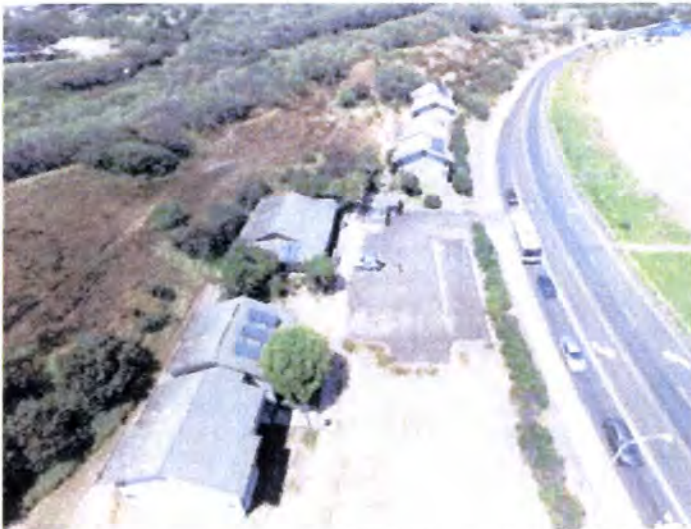
There were no noted obstructions below the 13'-6" minimum.

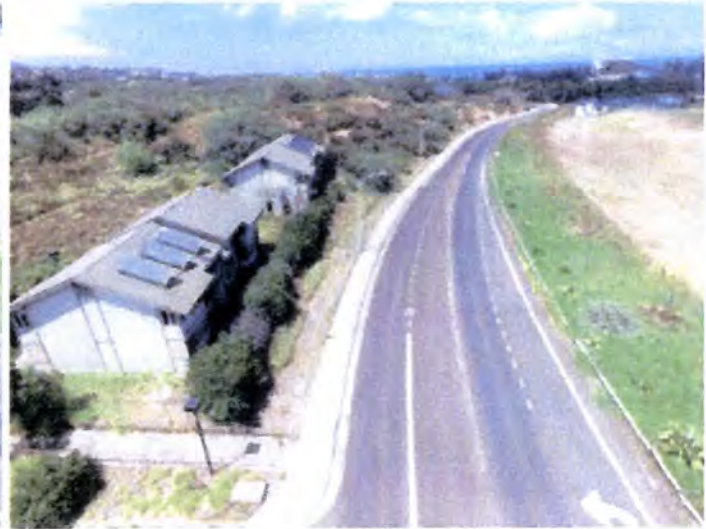
There were no accessibility issues noted at the building.

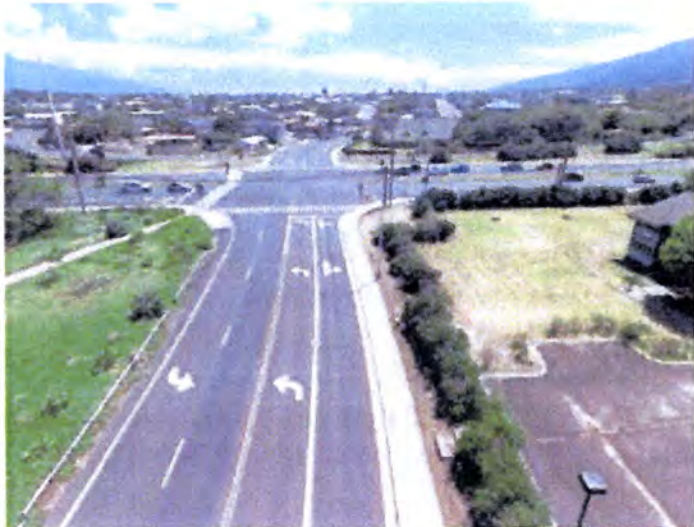
There were no noted obstructions below the 13'-6" minimum.

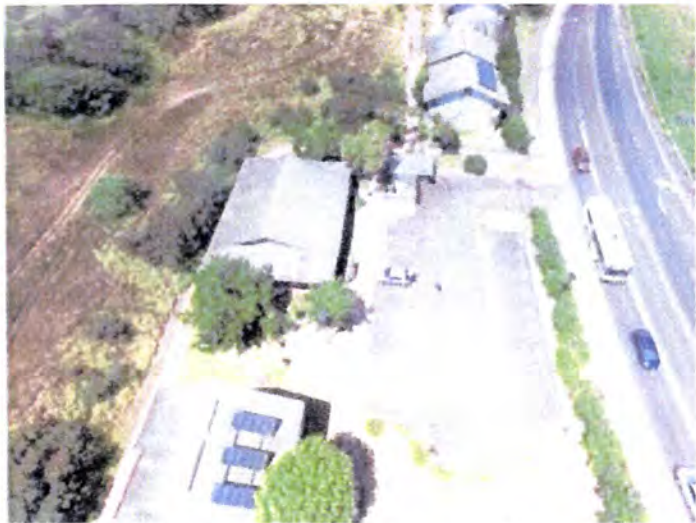
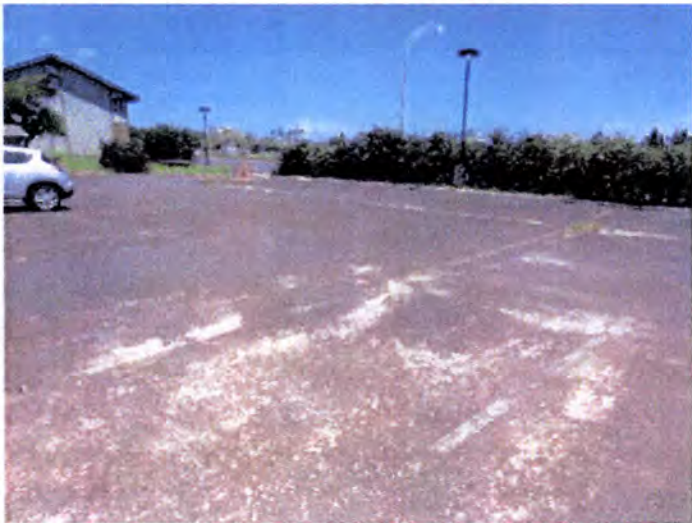
The parking area surface was deteriorated with lines weathered to the point of not providing clear lanes for parking use. Recommend having the parking area resurfaced and striped to ensure proper identification of parking stalls.

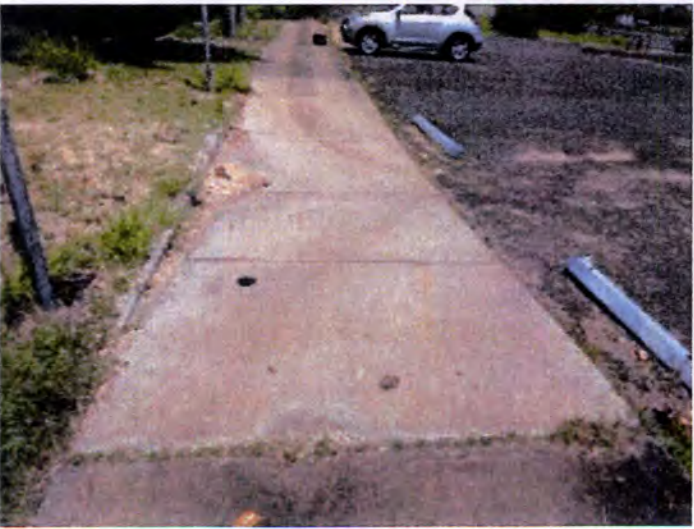
The sidewalks appeared to be intact and functioning properly at the time of inspection.

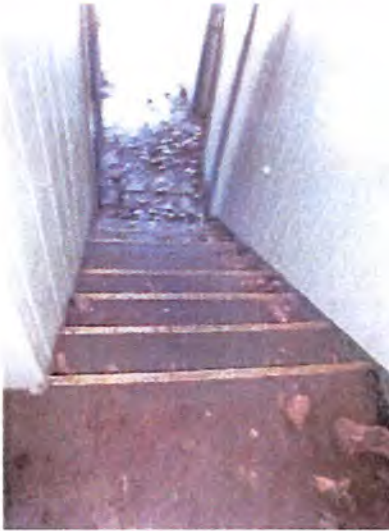
Bldg A hand rail was missing.  
Recommend installation as required.

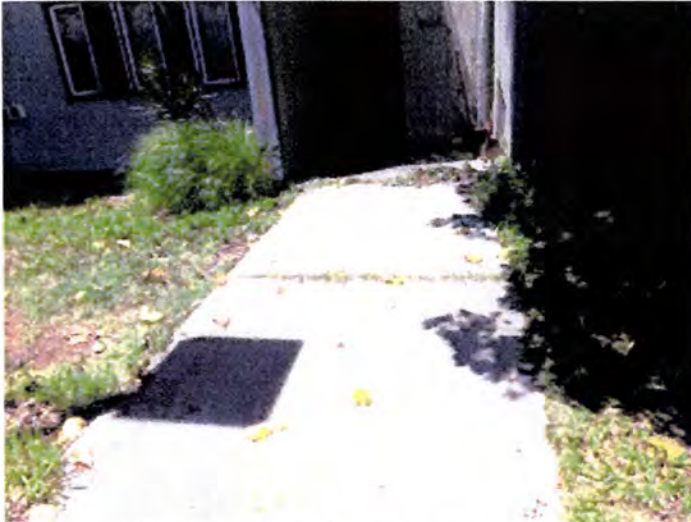
Concrete sidewalks noted.

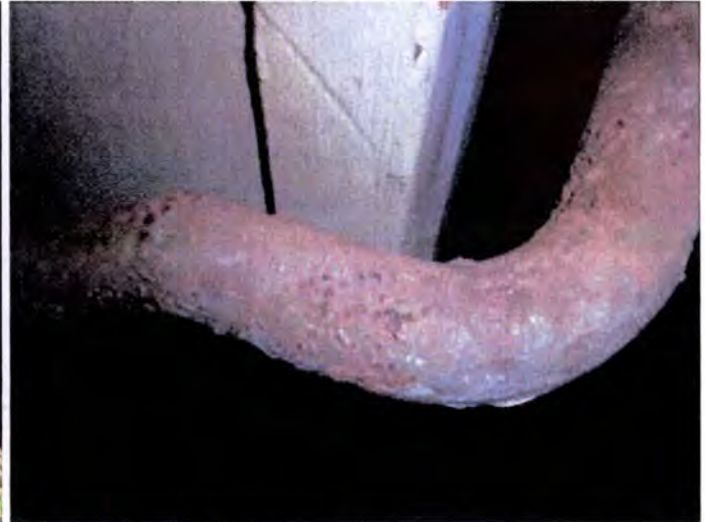
Exterior stair handrails were corroded  
and need to be cleaned, treated and  
refinished.

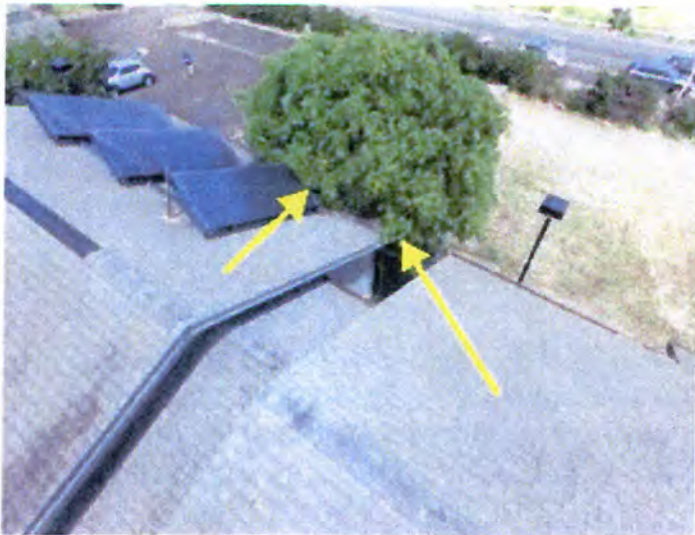
The vegetation was overgrown and causing deterioration/damage to the exterior curtain wall and fixtures.

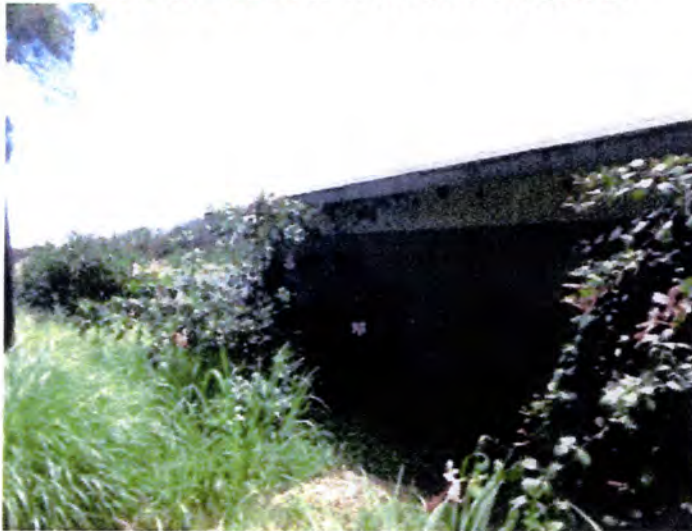
Vegetation was overgrown and in need of removal in many areas.

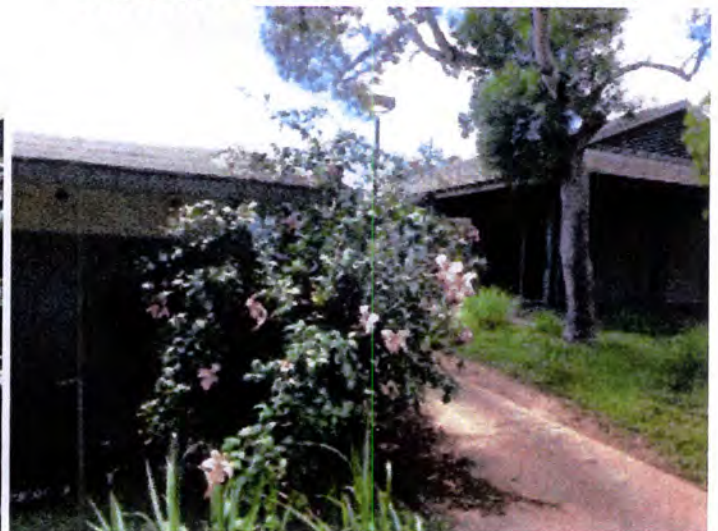
Vegetation was overgrown and in need of removal in many areas.

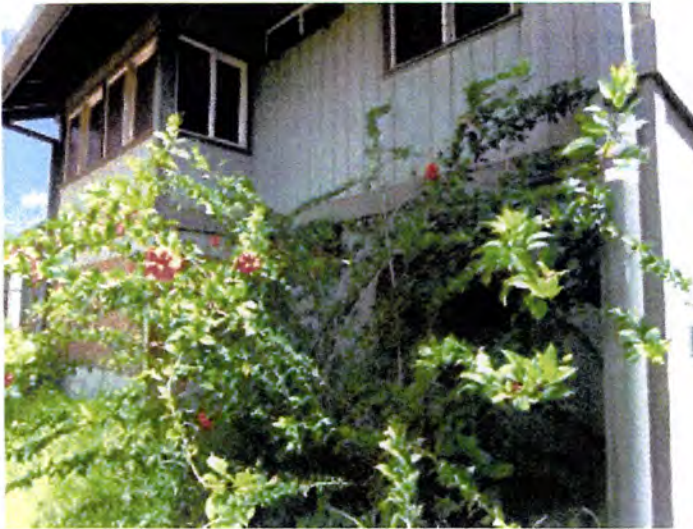
There were numerous trees contacting the building curtain walls and roof areas. Vegetation was overgrown and in need of removal in many areas.

These areas appeared to have damage/deterioration noted at the time of inspection. Recommend having a licensed landscape contractor/arborist evaluate and trim vegetation and trees as necessary.

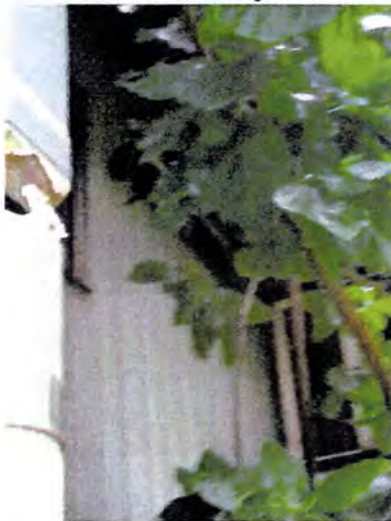
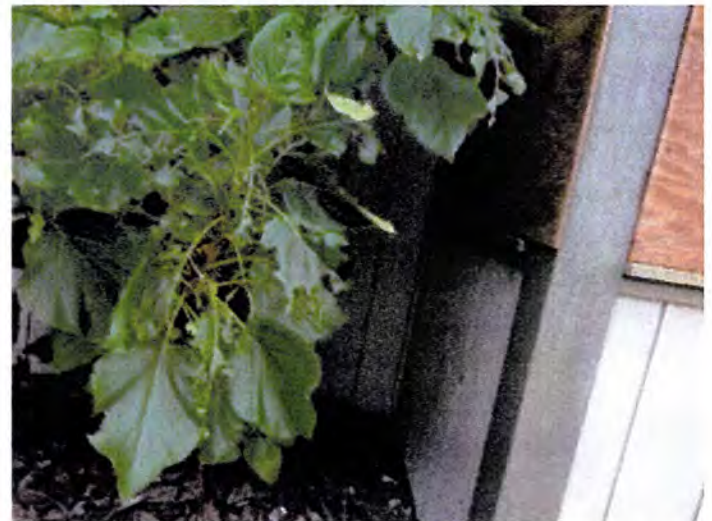
There were numerous trees contacting the building curtain walls and roof areas. Vegetation was overgrown and in need of removal in many areas.

These areas appeared to have damage/deterioration noted at the time of inspection. Recommend having a licensed landscape contractor/arborist evaluate and trim vegetation and trees as necessary.

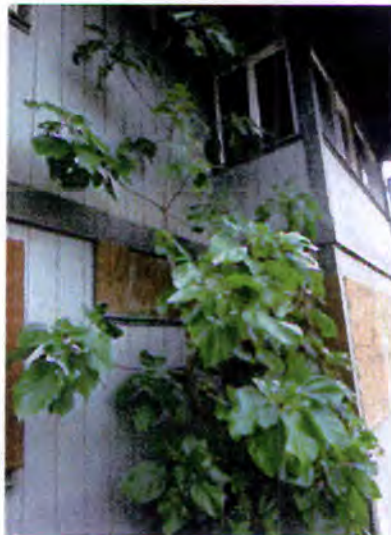
There were numerous trees contacting the building curtain walls and roof areas. These areas appeared to have damage/deterioration noted at the time of inspection. Recommend having a licensed landscape contractor/arborist evaluate and trim vegetation and trees as necessary.

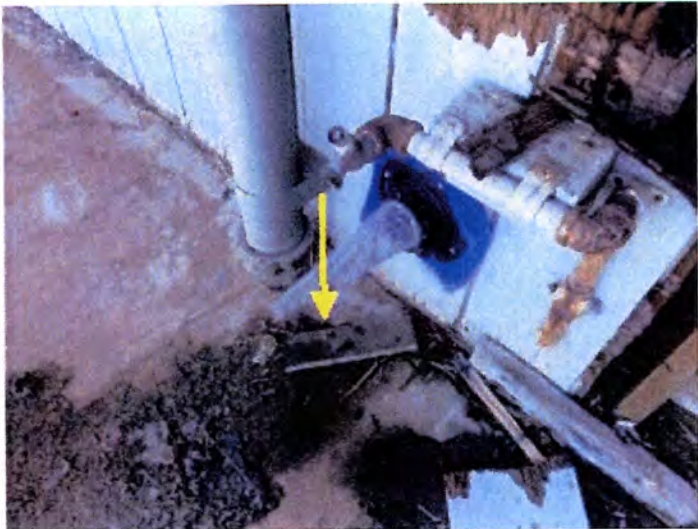
Some of the exterior hose bibs had slow dripping leaks observed at the time of inspection. Recommend repair.

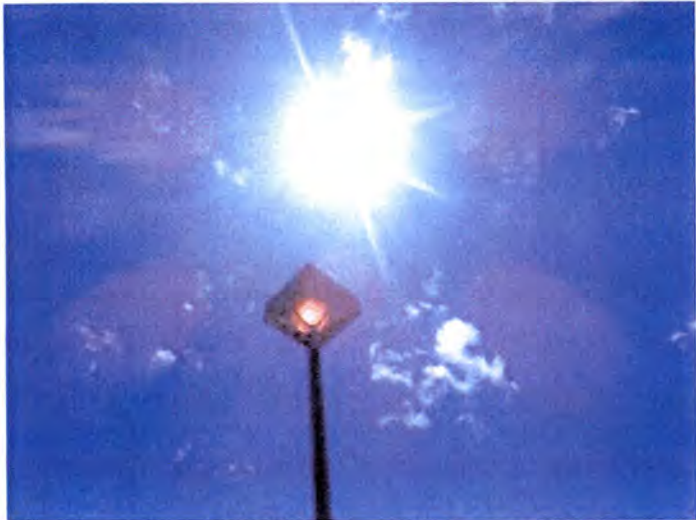
Exterior lighting was functional at the time of inspection. Replacement of fixtures will be on an as needed basis only.

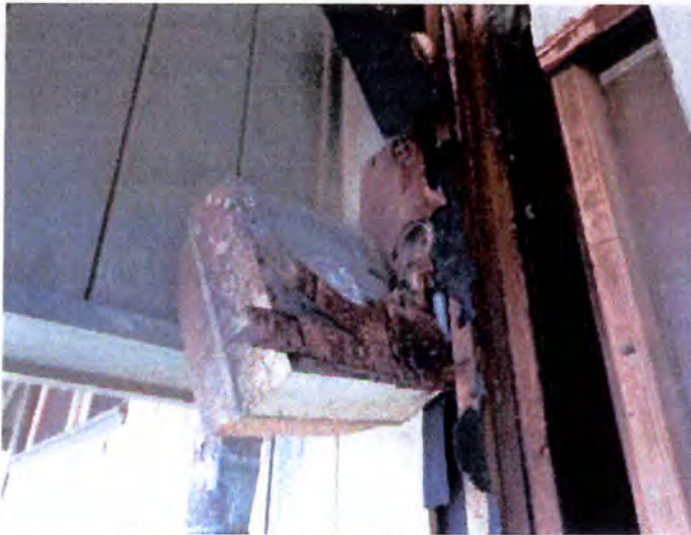
Some of the exterior lighting fixtures were damaged and need to be replaced.

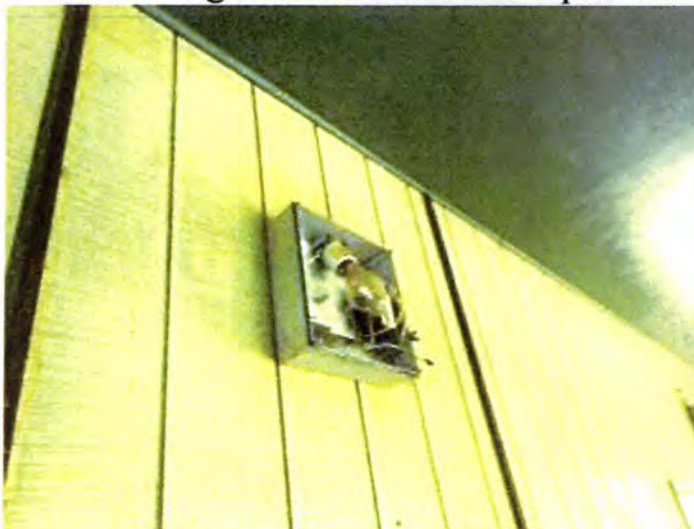
Some of the exterior lighting fixtures were damaged and need to be replaced.

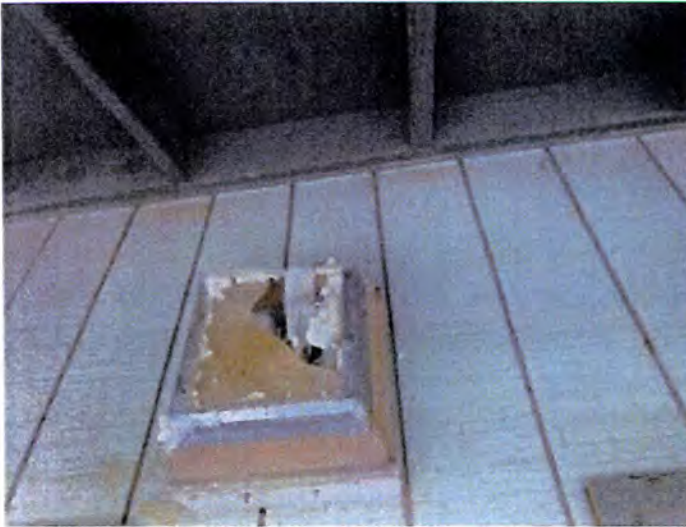
Some of the exterior lighting fixtures were damaged and need to be replaced.

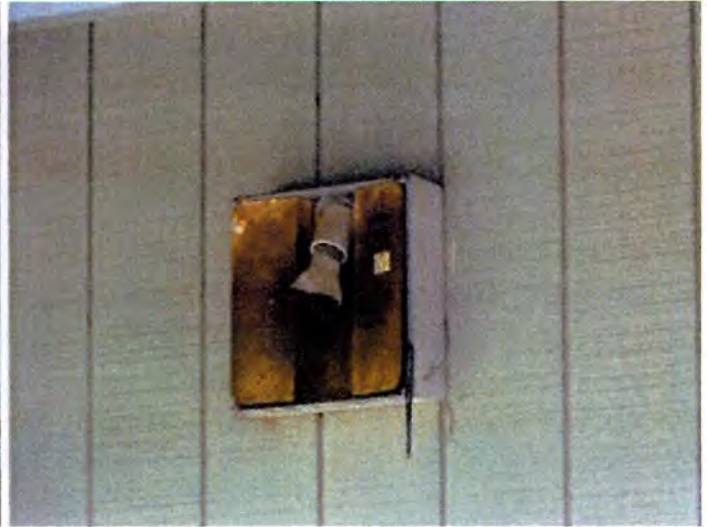
Some of the exterior lighting fixtures were damaged and need to be replaced.

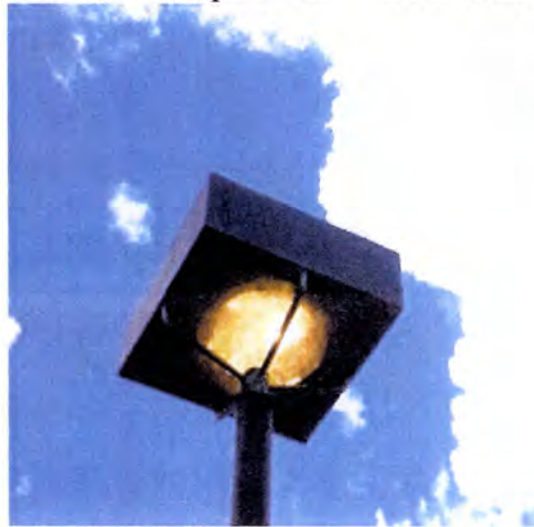
Exterior lighting was functional at the time of inspection. Replacement of fixtures will be on an as needed basis only.

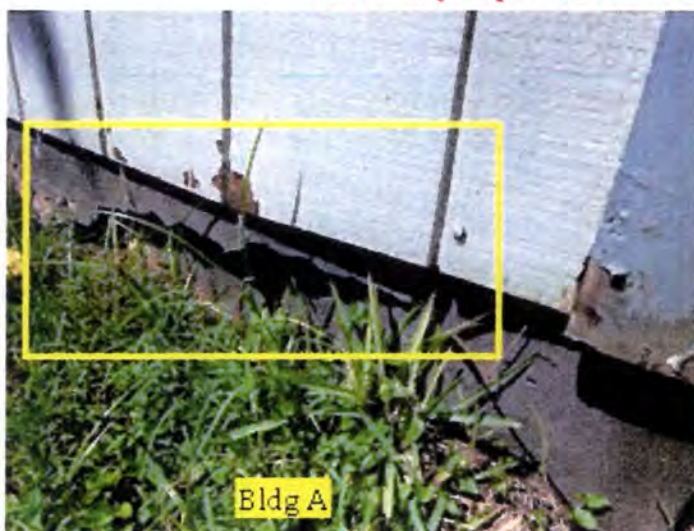
Bldg A

Building A and B: Visible cracks observed at the foundational areas of the buildings. There were separations observed along the defect areas which represent movement between the faults.

We recommend having a licensed foundation/masonry contractor evaluate and repair the affected areas as necessary to prevent further damage.

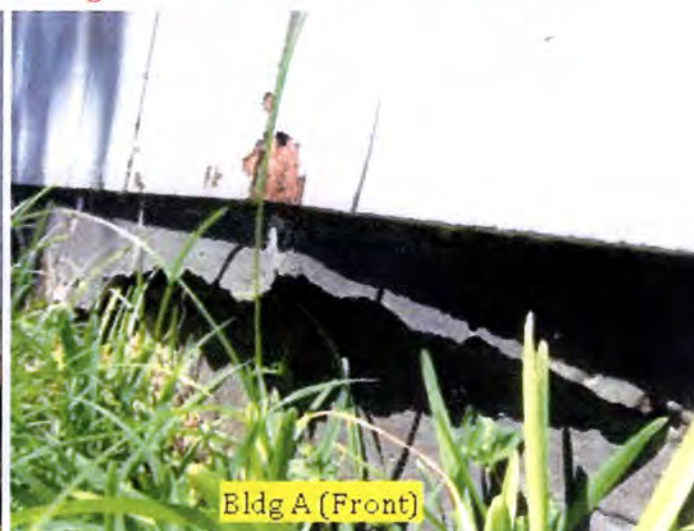
Bldg A (Front)

Building A and B: Visible cracks observed at the foundational areas of the buildings. There were separations observed along the defect areas which represent movement between the faults.

We recommend having a licensed foundation/masonry contractor evaluate and repair the affected areas as necessary to prevent further damage.

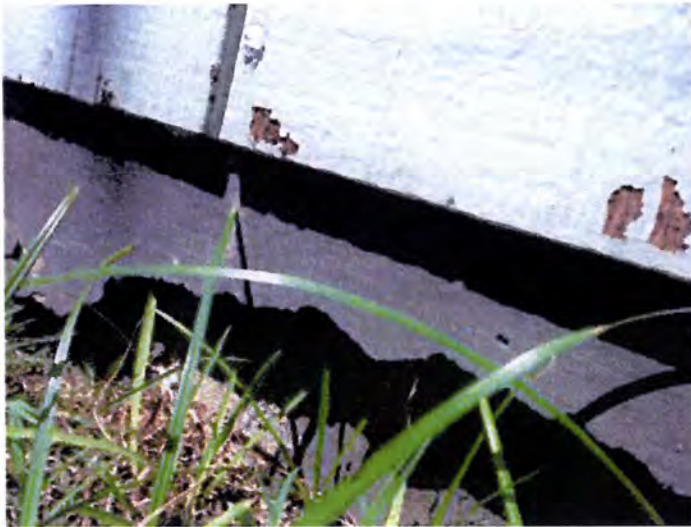
Building A and B: Visible cracks observed at the foundational areas of the buildings. There were separations observed along the defect areas which represent movement between the faults.

We recommend having a licensed foundation/masonry contractor evaluate and repair the affected areas as necessary to prevent further damage.

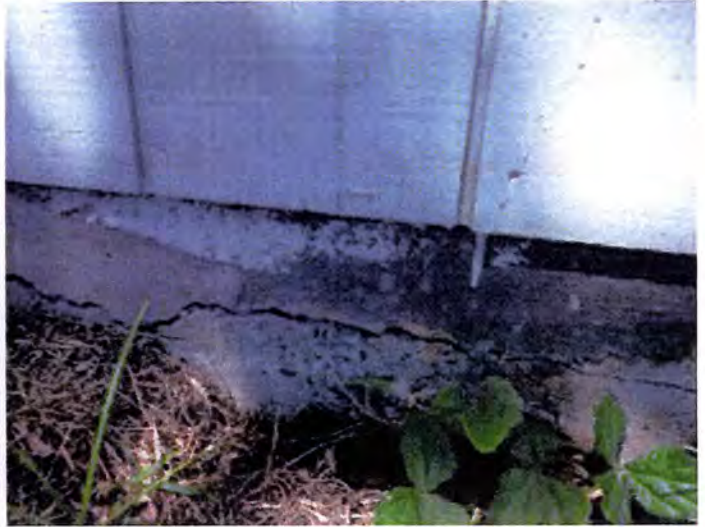
Building A and B: Visible cracks observed at the foundational areas of the buildings. There were separations observed along the defect areas which represent movement between the faults.

We recommend having a licensed foundation/masonry contractor evaluate and repair the affected areas as necessary to prevent further damage.

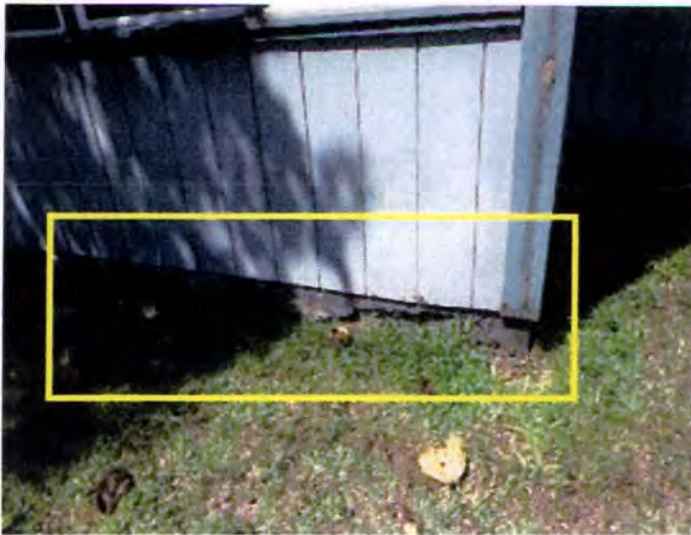
Building A and B: Visible cracks observed at the foundational areas of the buildings. There were separations observed along the defect areas which represent movement between the faults.

We recommend having a licensed foundation/masonry contractor evaluate and repair the affected areas as necessary to prevent further damage.

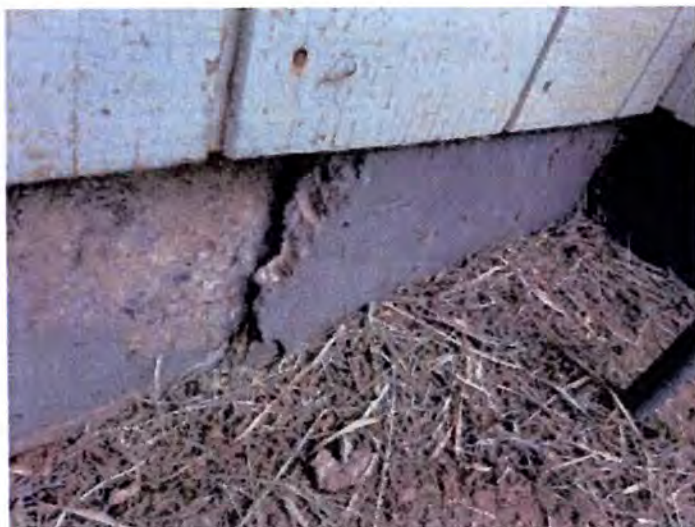
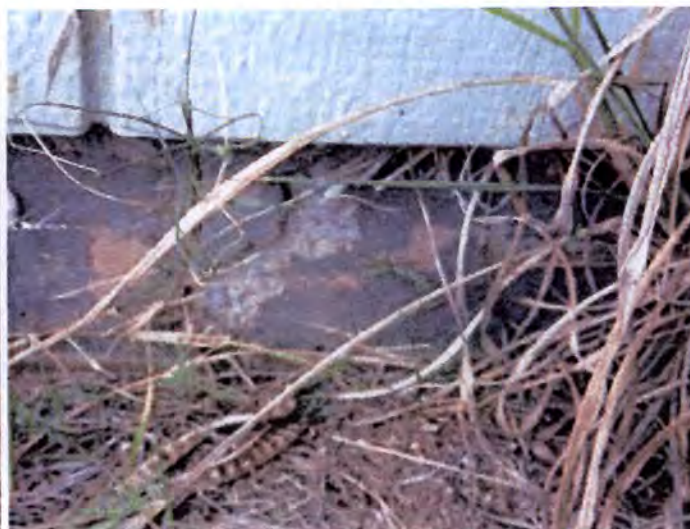
Building A and B: Visible cracks observed at the foundational areas of the buildings. There were separations observed along the defect areas which represent movement between the faults.

We recommend having a licensed foundation/masonry contractor evaluate and repair the affected areas as necessary to prevent further damage.

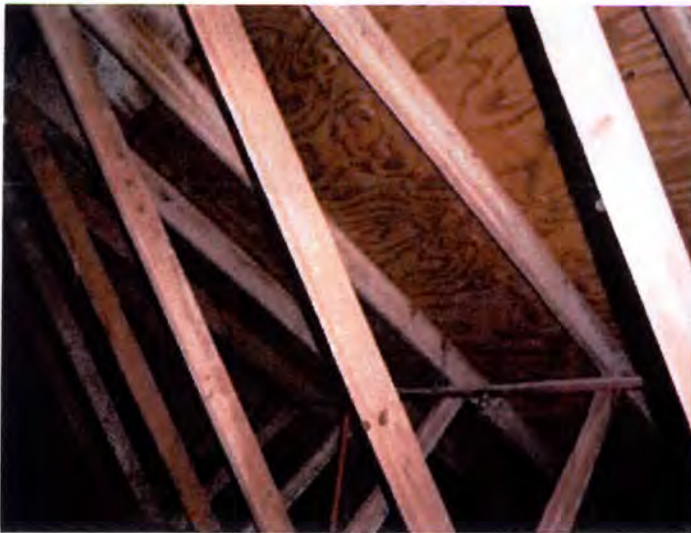
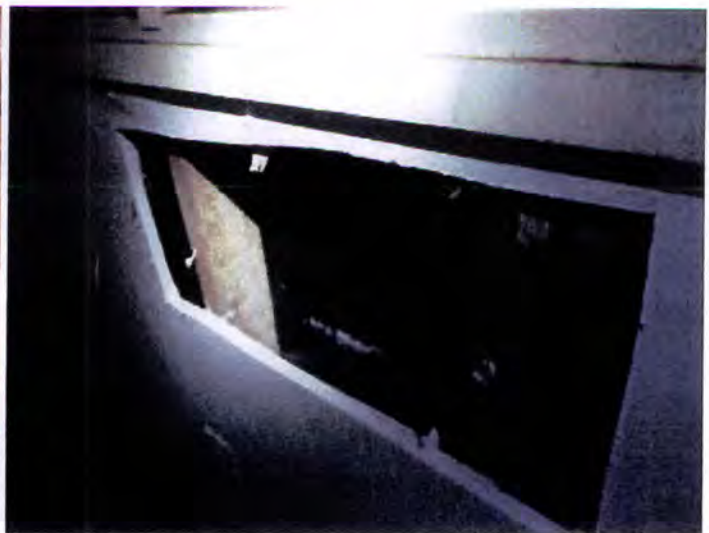
Visible and accessible framing areas were inspected for termite and/or moisture damage and appeared to be intact and functional at the time of inspection. Any replacement of framing members will be select demo of individual components and not greater than 20% of installed materials. This only pertains to the three primary residential structures and not the single story storage building.

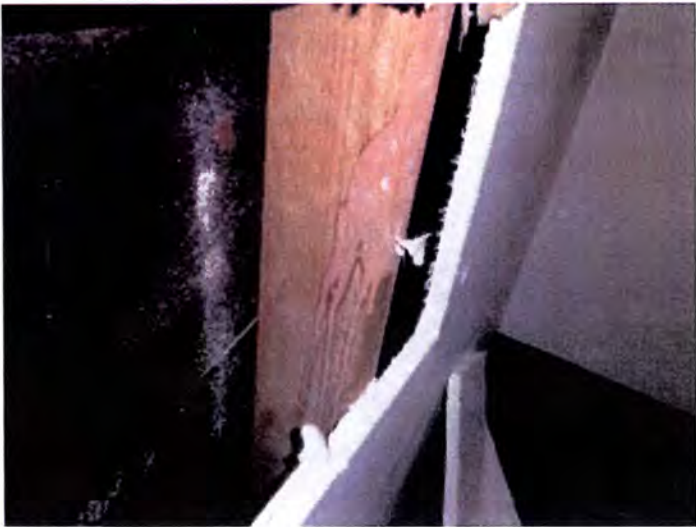
No more than two access holes were cut into the interior wall finishes of each building to determine the condition of the wall framing members. These openings were made at the areas of visible moisture/termite/mold damage. The underlying framing appeared to be intact and functional when inspected.

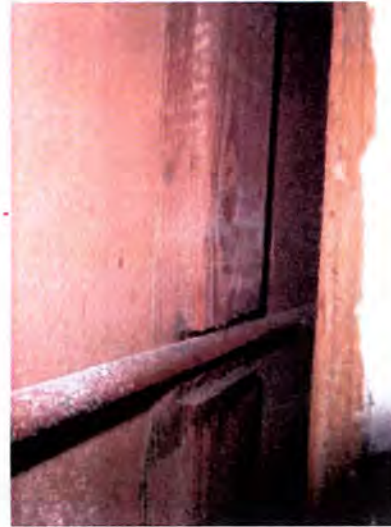
No more than two access holes were cut into the interior wall finishes of each building to determine the condition of the wall framing members. These openings were made at the areas of visible moisture/termite/mold damage. The underlying framing appeared to be intact and functional when inspected.

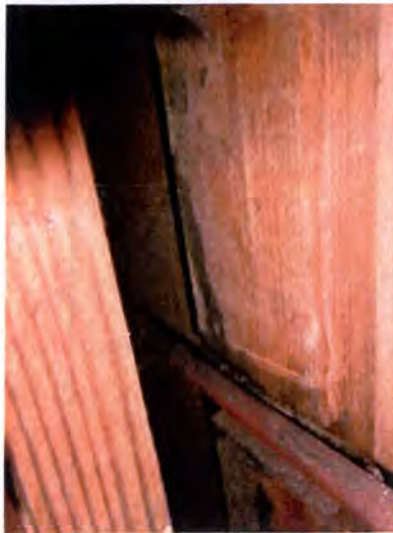
Visible and accessible framing areas were inspected for termite and/or moisture damage and appeared to be intact and functional at the time of inspection. Any replacement of framing members will be select demo of individual components and not greater than 20% of installed materials. This only pertains to the three primary residential structures and not the single story storage building.

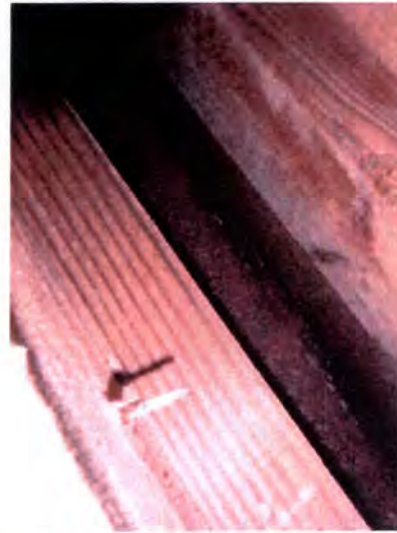
No more than two access holes were cut into the interior wall finishes of each building to determine the condition of the wall framing members. These openings were made at the areas of visible moisture/termite/mold damage. The underlying framing appeared to be intact and functional when inspected.

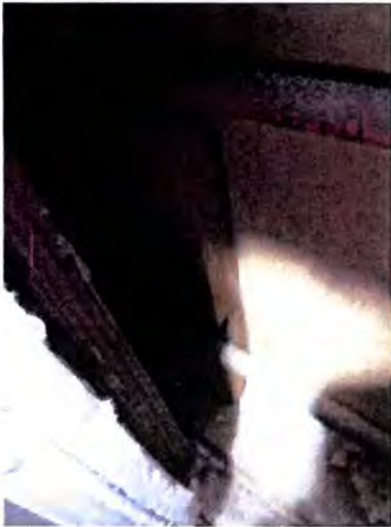
Visible and accessible framing areas were inspected for termite and/or moisture damage and appeared to be intact and functional at the time of inspection. Any replacement of framing members will be select demo of individual components and not greater than 20% of installed materials. This only pertains to the three primary residential structures and not the single story storage building.

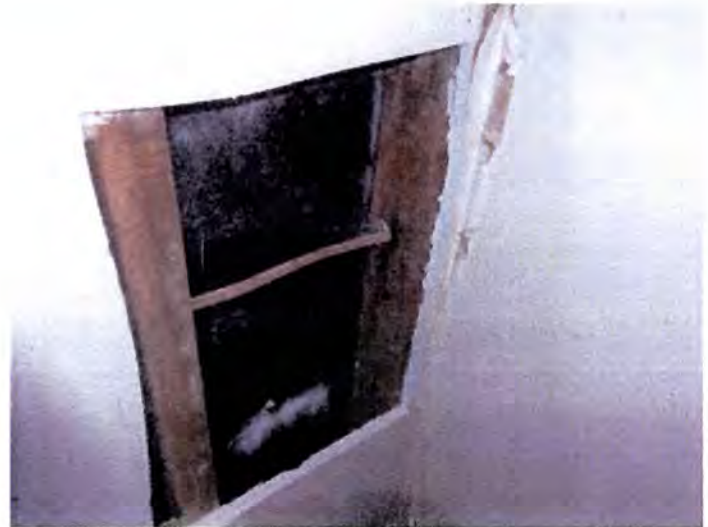
No more than two access holes were cut into the interior wall finishes of each building to determine the condition of the wall framing members. These openings were made at the areas of visible moisture/termite/mold damage. The underlying framing appeared to be intact and functional when inspected.

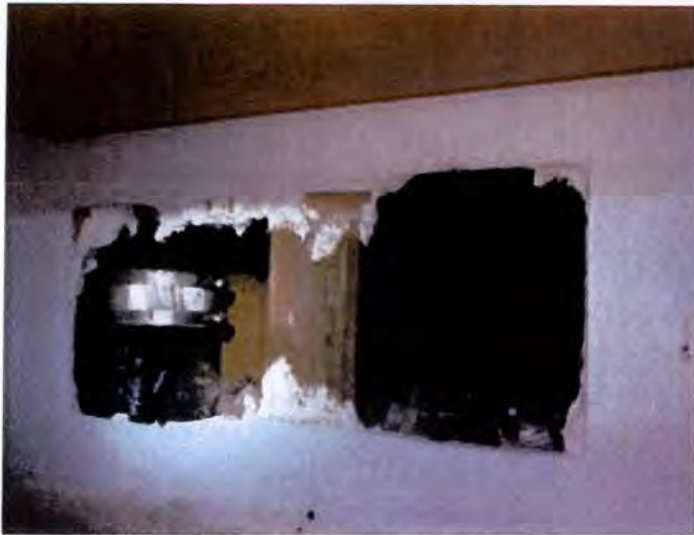
Visible and accessible framing areas were inspected for termite and/or moisture damage and appeared to be intact and functional at the time of inspection. Any replacement of framing members will be select demo of individual components and not greater than 20% of installed materials. This only pertains to the three primary residential structures and not the single story storage building.

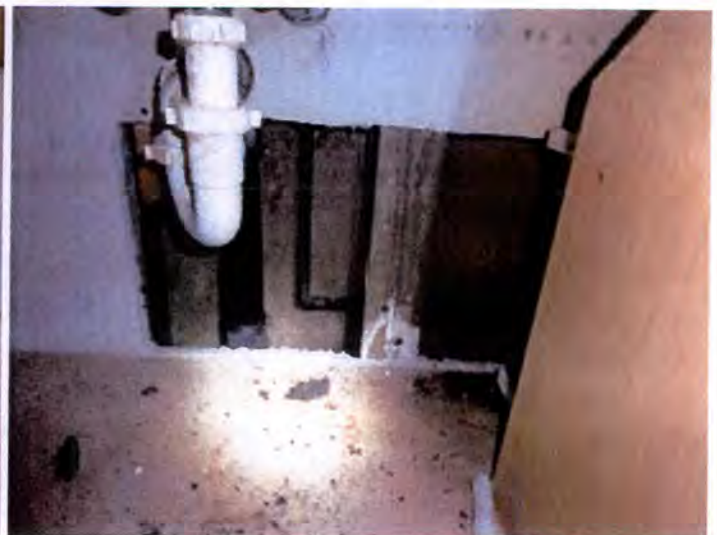
Visible and accessible framing areas were inspected for termite and/or moisture damage and appeared to be intact and functional at the time of inspection. Any replacement of framing members will be select demo of individual components and not greater than 20% of installed materials. This only pertains to the three primary residential structures and not the single story storage building.

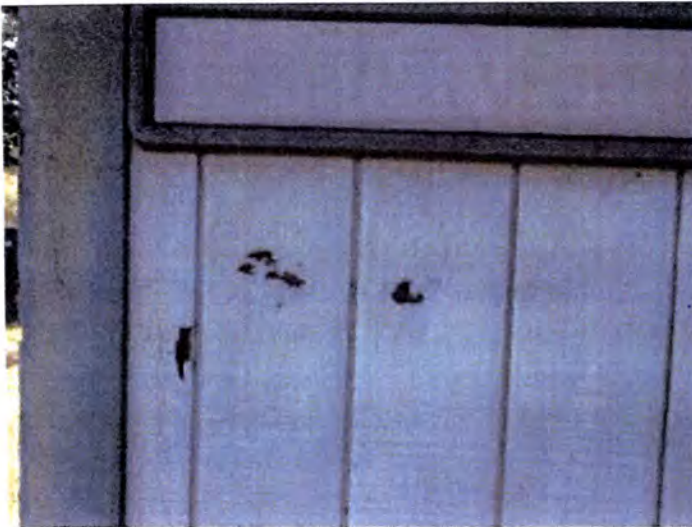
Visible indications of WDO (termite) damage noted. Recommend having a licensed pest contractor evaluate and treat as necessary. Also, recommend having a licensed contractor evaluate and repair/replace damaged material as necessary.

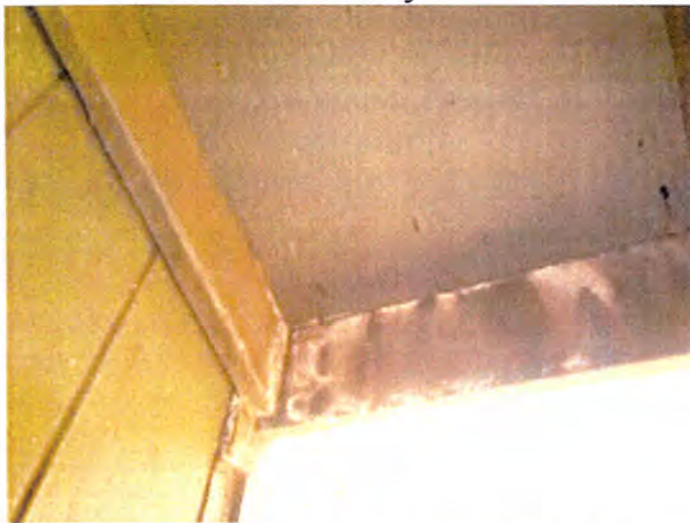
The fascia/soffit areas appeared to be rotted/water damaged/deteriorated at the time of inspection. Recommend having a licensed contractor evaluate and repair/replace as necessary.

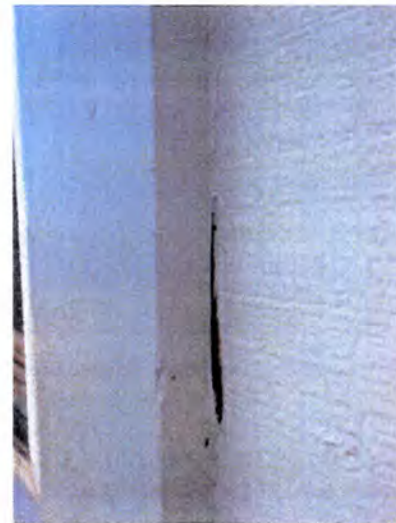
Visible indications of WDO (termite) damage noted. Recommend having a licensed pest contractor evaluate and treat as necessary. Also, recommend having a licensed contractor evaluate and repair/replace damaged material as necessary.

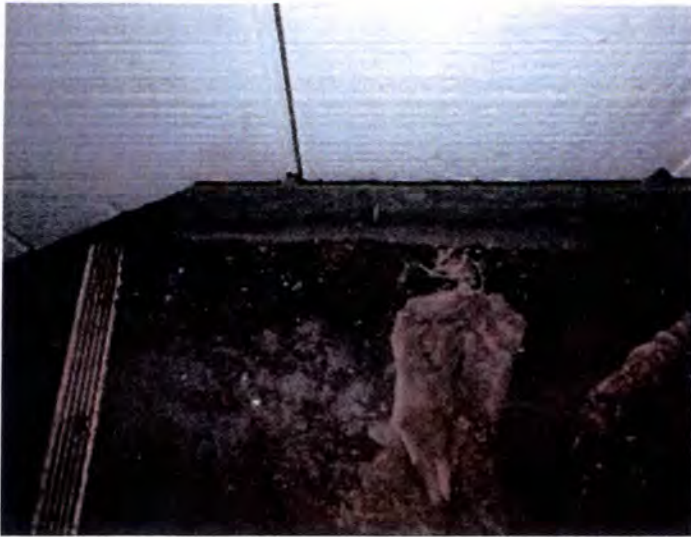
There were visible indications of WDO (Wood Destroying Organism) damage noted at the fascia and soffit areas. Recommend having a licensed contractor evaluate and repair/replace as necessary.

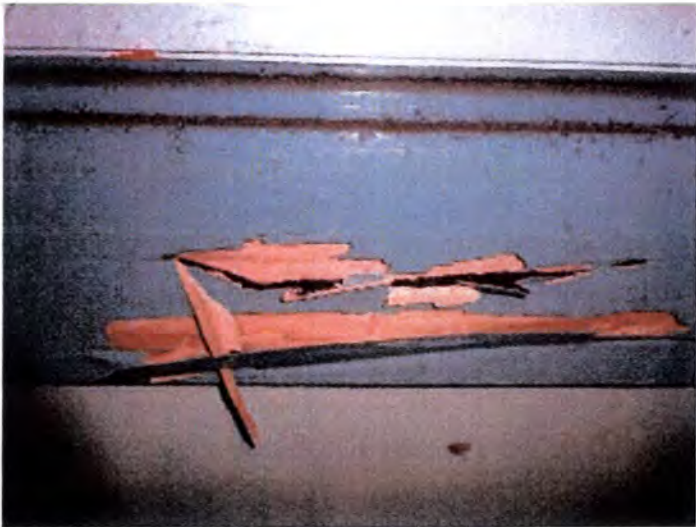
There were visible indications of WDO (Wood Destroying Organism) damage noted at the fascia and soffit areas. Recommend having a licensed contractor evaluate and repair/replace as necessary.

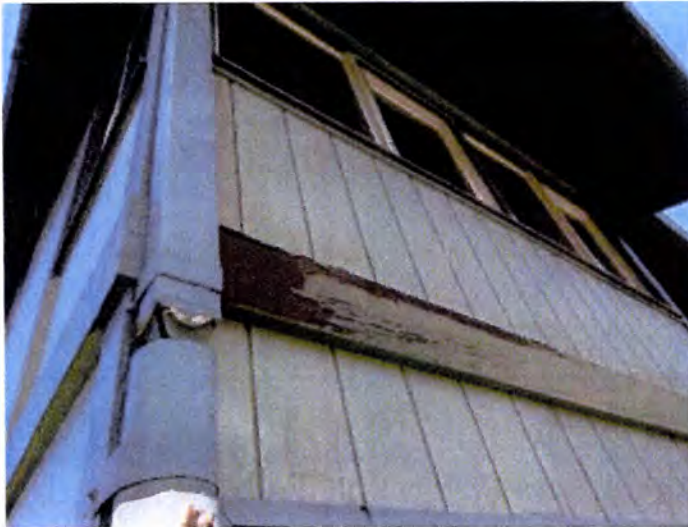
Blistering/peeling/missing paint observed at many exterior trim, fascia and soffit areas. Recommend properly preparing and refinishing exterior finishes.

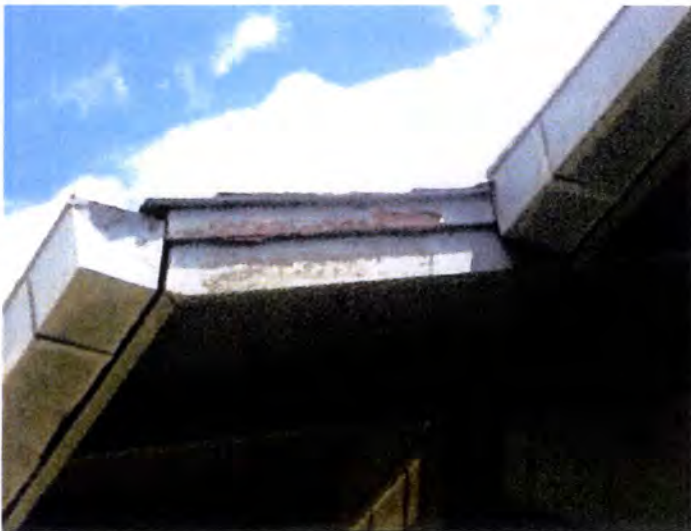
Blistering/peeling/missing paint observed at many exterior trim, fascia and soffit areas. Recommend properly preparing and refinishing exterior finishes.

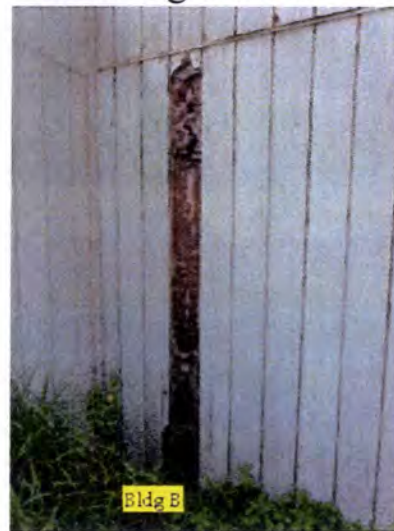
Visible indications of WDO (termite) damage noted. Recommend having a licensed pest contractor evaluate and treat as necessary. Also, recommend having a licensed contractor evaluate and repair/replace damaged material as necessary.

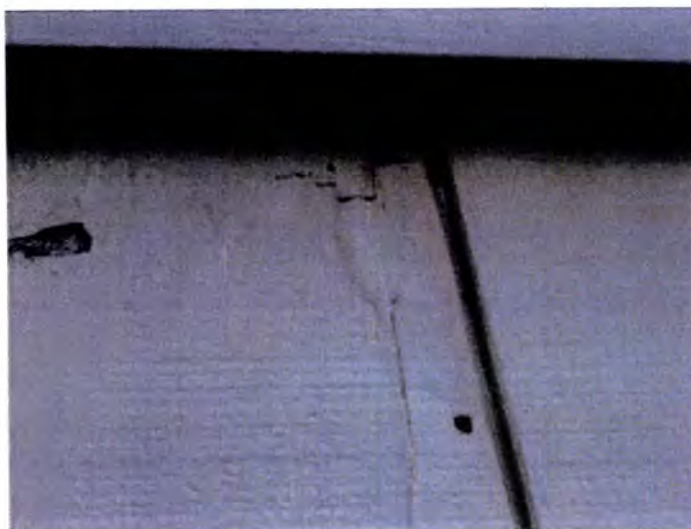
Visible indications of WDO (termite) damage noted. Recommend having a licensed pest contractor evaluate and treat as necessary. Also, recommend having a licensed contractor evaluate and repair/replace damaged material as necessary.

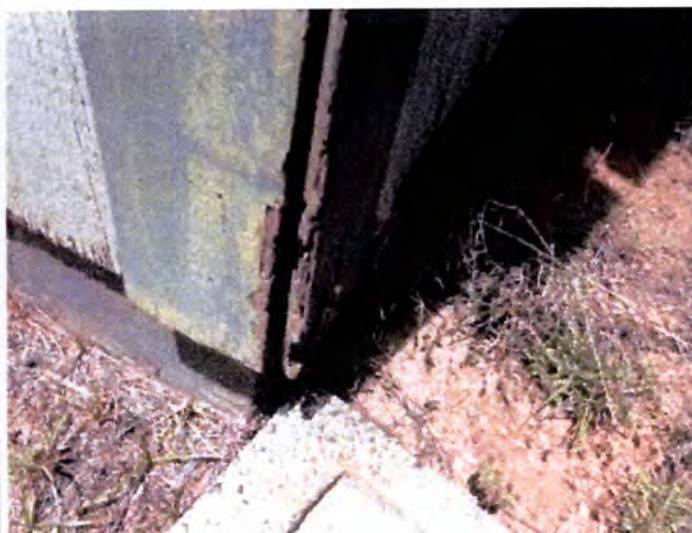
Visible indications of WDO (termite) damage noted. Recommend having a licensed pest contractor evaluate and treat as necessary. Also, recommend having a licensed contractor evaluate and repair/replace damaged material as necessary.

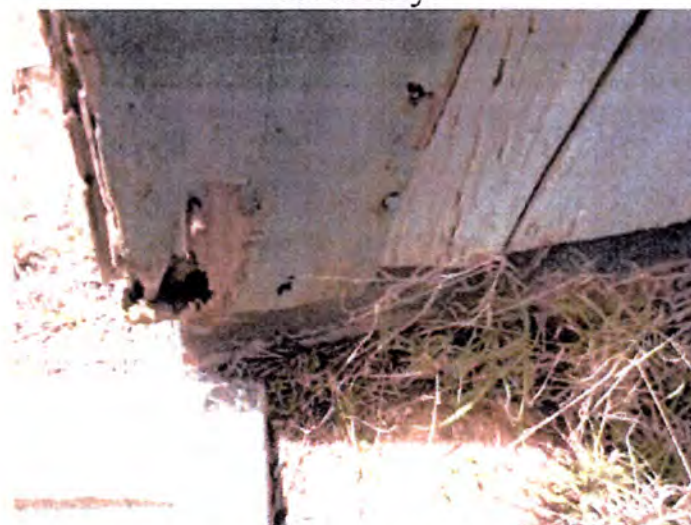
Visible indications of WDO (termite) damage noted. Recommend having a licensed pest contractor evaluate and treat as necessary. Also, recommend having a licensed contractor evaluate and repair/replace damaged material as necessary.

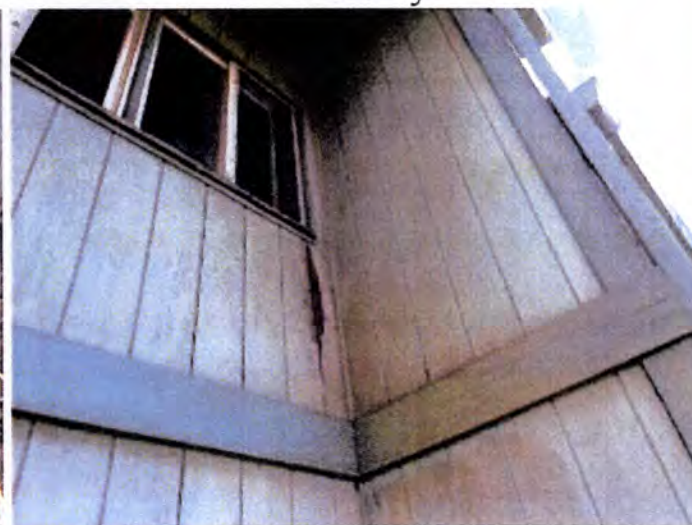
Moisture damage observed at exterior wall areas. Recommend select demolition and replacement of affected ground level exterior siding and finishes.

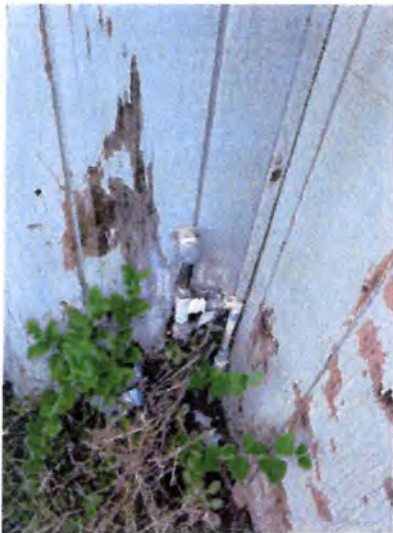
Moisture damage observed at exterior wall areas. Recommend select demolition and replacement of affected ground level exterior siding and finishes.

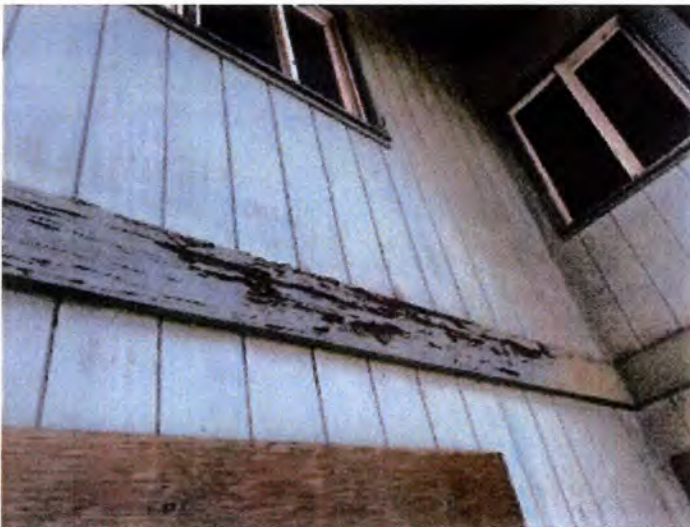
Blistering/peeling/missing paint observed at many exterior trim, fascia and soffit areas. Recommend properly preparing and refinishing exterior finishes.

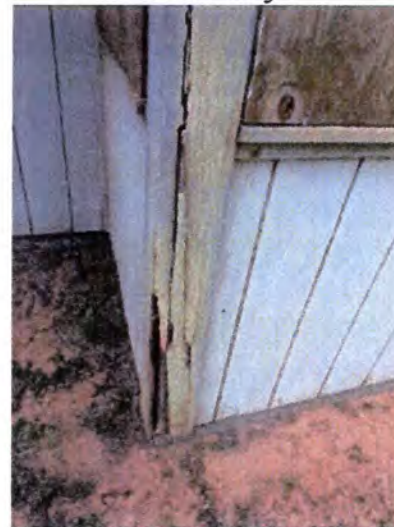
Visible indications of WDO (termite) damage noted. Recommend having a licensed pest contractor evaluate and treat as necessary. Also, recommend having a licensed contractor evaluate and repair/replace damaged material as necessary.

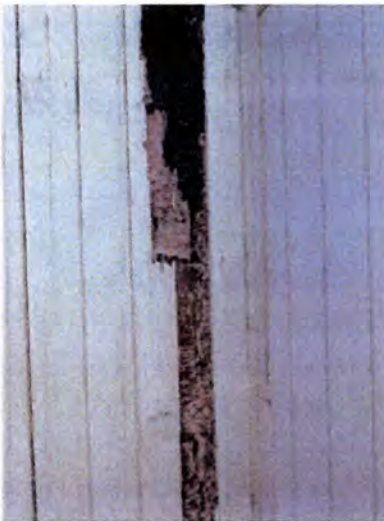
Visible indications of WDO (termite) damage noted. Recommend having a licensed pest contractor evaluate and treat as necessary. Also, recommend having a licensed contractor evaluate and repair/replace damaged material as necessary.

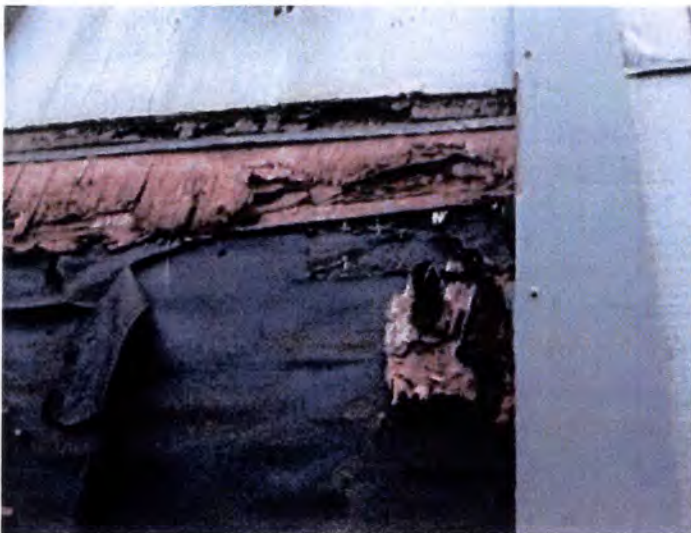
Visible indications of WDO (termite) damage noted. Recommend having a licensed pest contractor evaluate and treat as necessary. Also, recommend having a licensed contractor evaluate and repair/replace damaged material as necessary.
