**SUBJECT: COUNTY-OWNED PARCEL ON NORTH PAPA AVENUE (KAHULUI)  
(HHT-14)**

## Property Condition Report

310 W Kaahumanu Ave, Kahului, HI 96732  
Inspection prepared for: Maui County c/o Buddy Almeida  
Real Estate Agent: -

This is a commercial property condition assessment to determine if three (3) former UH dormitories are suitable for housing. This inspection includes invasive and non-invasive inspection methods as well as sampling for asbestos and lead based paint.

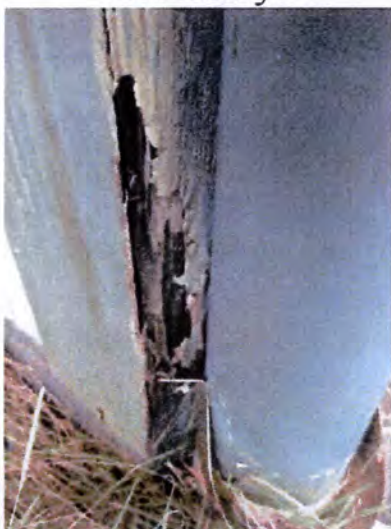
Visible indications of WDO (termite) damage noted. Recommend having a licensed pest contractor evaluate and treat as necessary. Also, recommend having a licensed contractor evaluate and repair/replace damaged material as necessary.

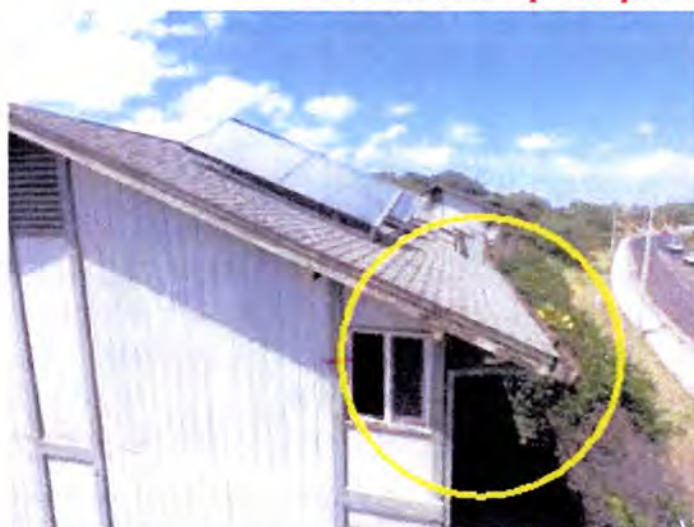
The fascia/soffit areas appeared to be rotted/water damaged/deteriorated at the time of inspection. Recommend having a licensed contractor evaluate and repair/replace as necessary.

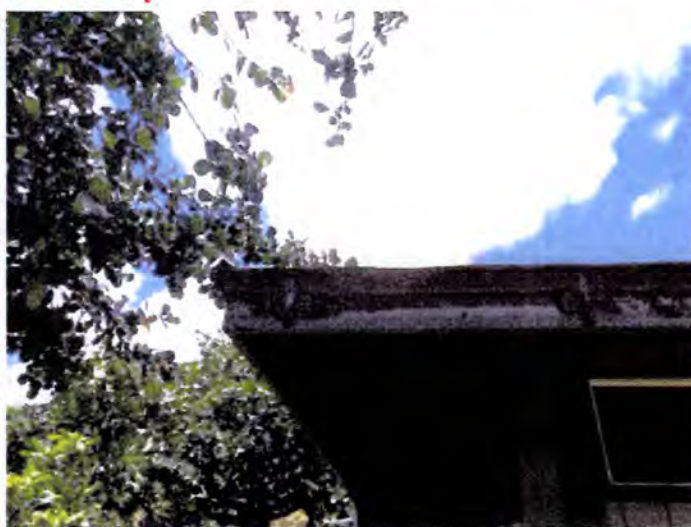
The fascia/soffit areas appeared to be rotted/water damaged/deteriorated at the time of inspection. Recommend having a licensed contractor evaluate and repair/replace as necessary.

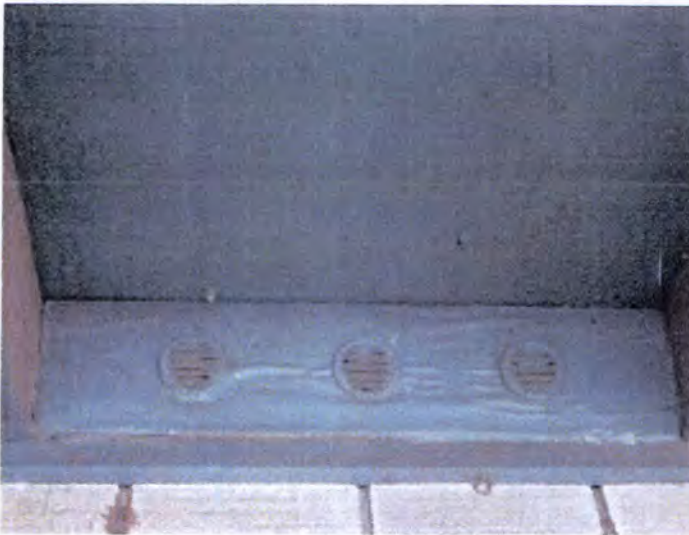
There were visible indications of WDO (Wood Destroying Organism) damage noted at the fascia and soffit areas. Recommend having a licensed contractor evaluate and repair/replace as necessary.

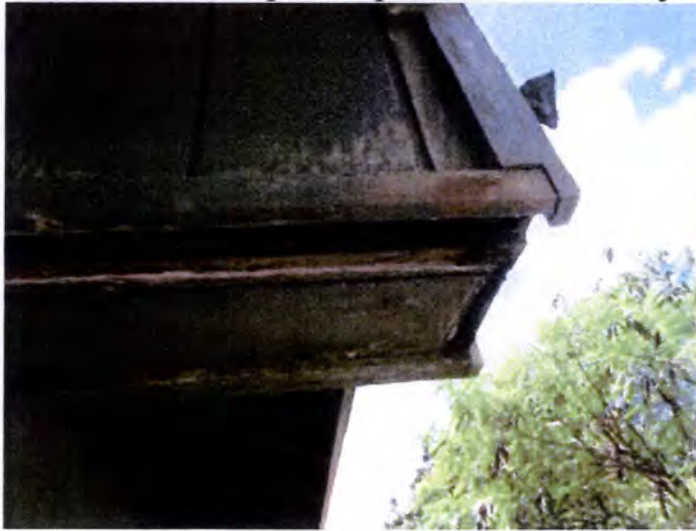
The fascia/soffit areas appeared to be rotted/water damaged/deteriorated at the time of inspection. Recommend having a licensed contractor evaluate and repair/replace as necessary.

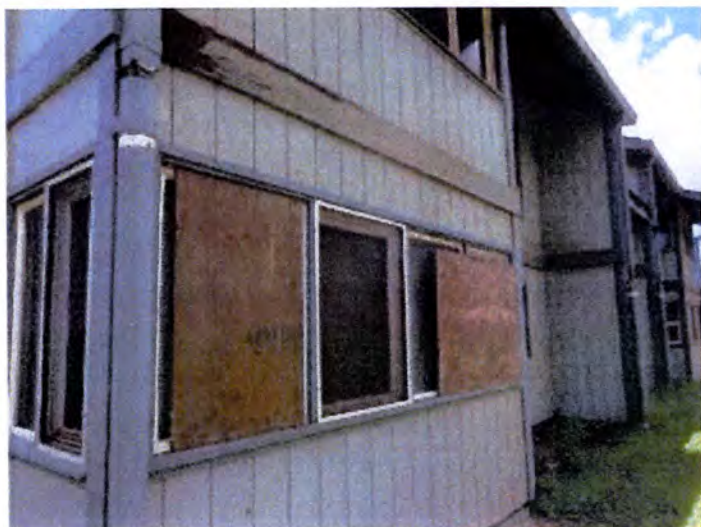
Many of the ground floor windows were broken at the time of inspection.

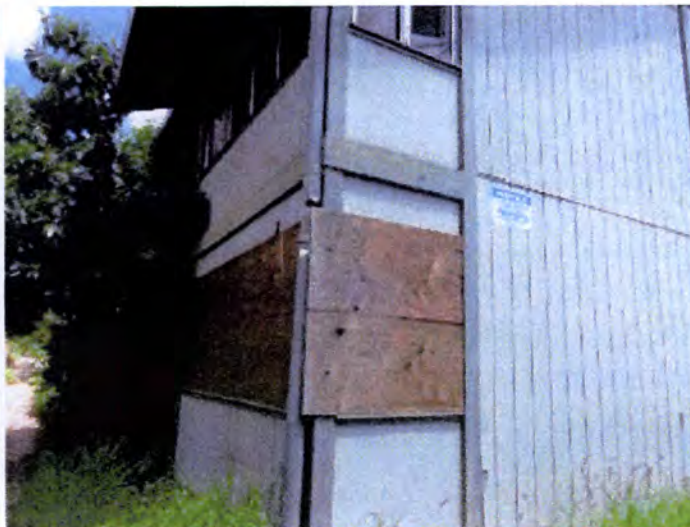
Many of the ground floor windows were broken at the time of inspection.

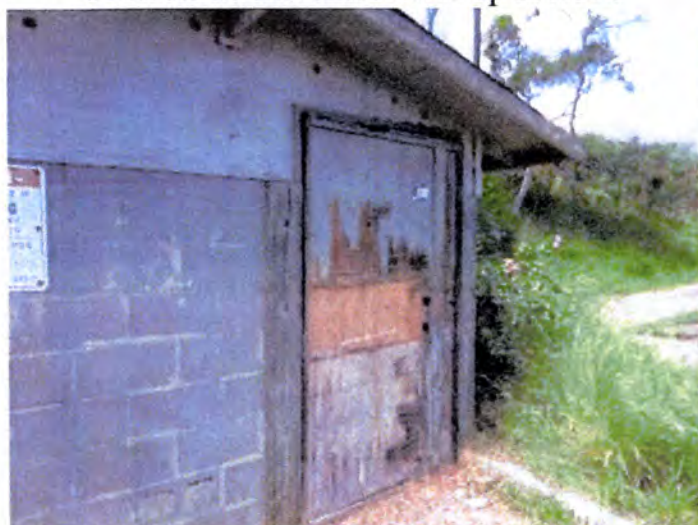
The exterior doors were termite damaged or deteriorated to the point of being inoperable. We recommend replacement of all exterior doors, framing and trim for all buildings.

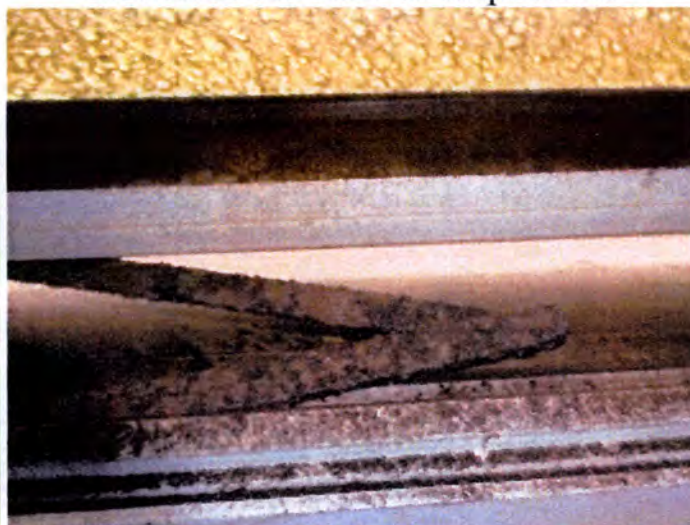
The stair way windows were heavily corroded, damaged and/or inoperable at the time of inspection. Recommend replacement.

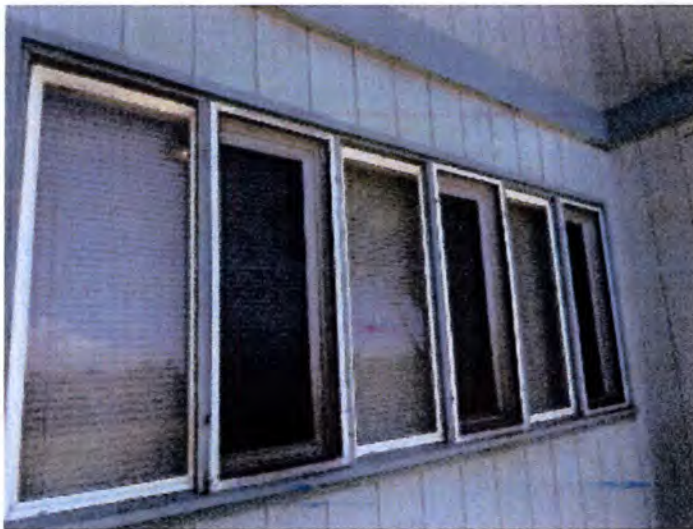
Vinyl framed windows noted

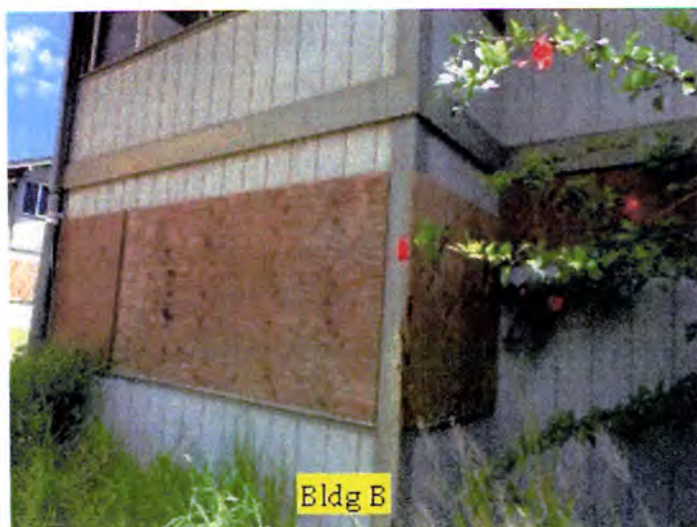
Many of the ground floor windows were broken at the time of inspection.

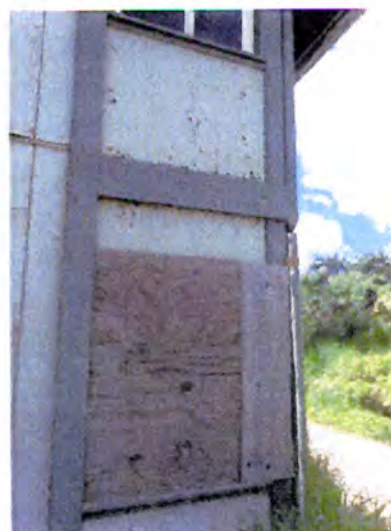
Many of the ground floor windows were broken at the time of inspection.

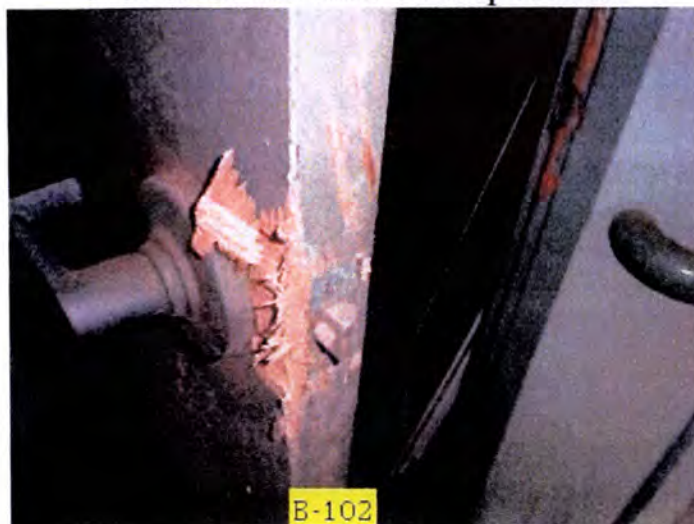
The exterior doors were termite damaged or deteriorated to the point of being inoperable. We recommend replacement of all exterior doors, framing and trim for all buildings.

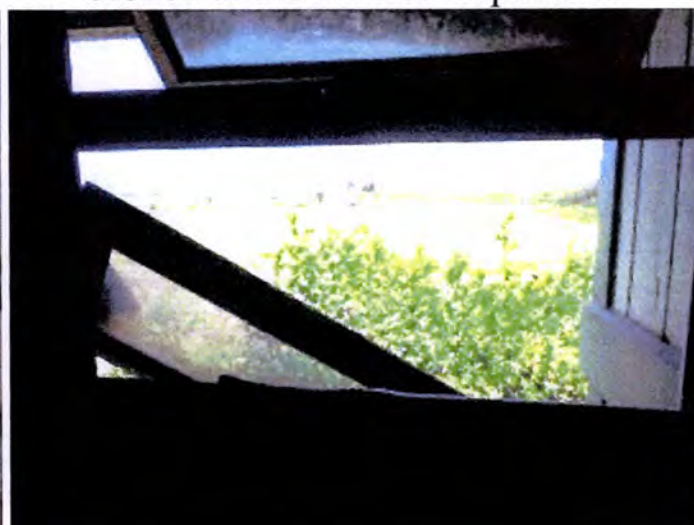
The stair way windows were heavily corroded, damaged and/or inoperable at the time of inspection. Recommend replacement.

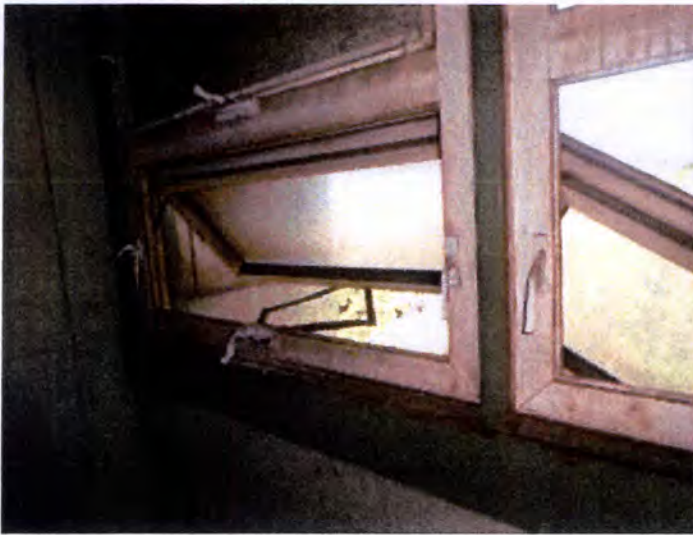
The stair way windows were heavily corroded, damaged and/or inoperable at the time of inspection. Recommend replacement.

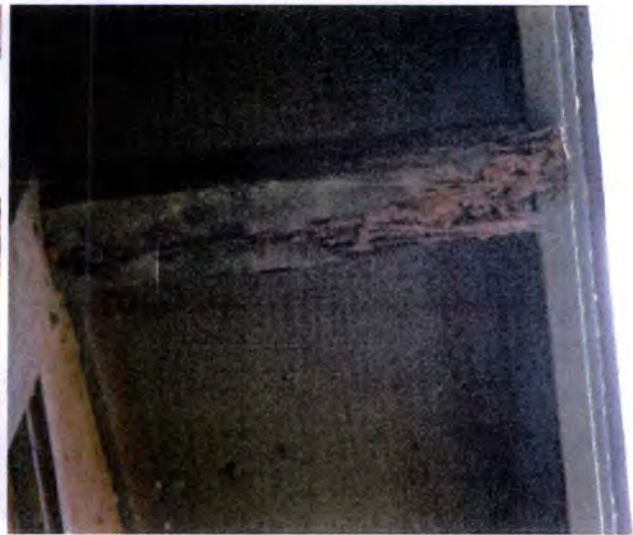
There were visible indications of WDO (Wood Destroying Organism) damage noted at the fascia and soffit areas. Recommend having a licensed contractor evaluate and repair/replace as necessary.

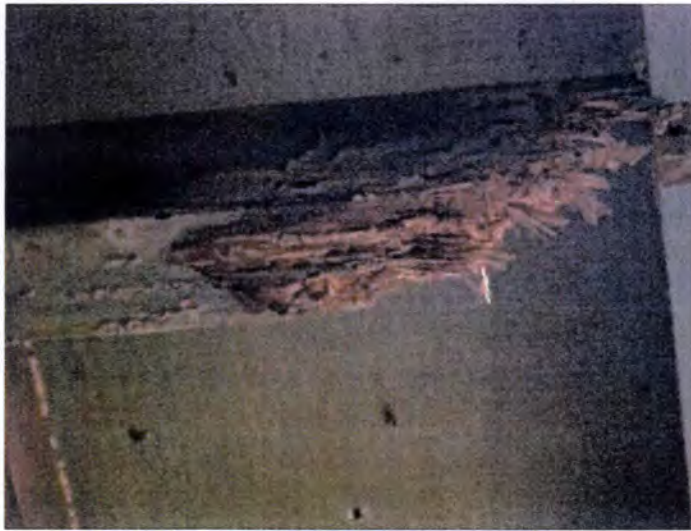
There were visible indications of WDO (Wood Destroying Organism) damage noted at the fascia and soffit areas. Recommend having a licensed contractor evaluate and repair/replace as necessary.

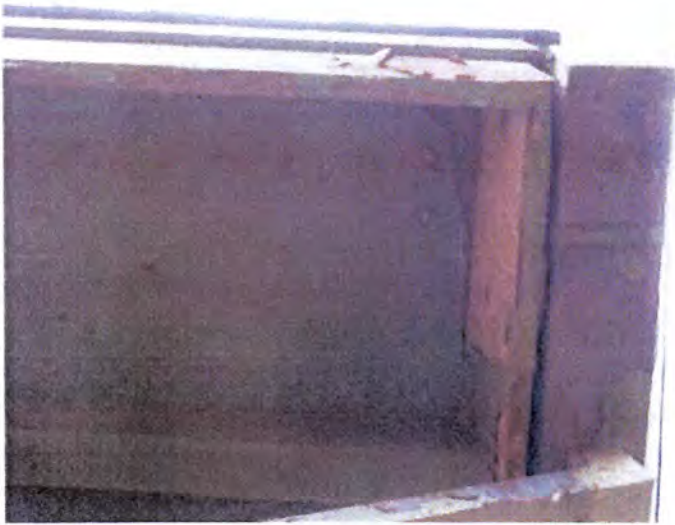
The fascia/soffit areas appeared to be rotted/water damaged/deteriorated at the time of inspection. Recommend having a licensed contractor evaluate and repair/replace as necessary.

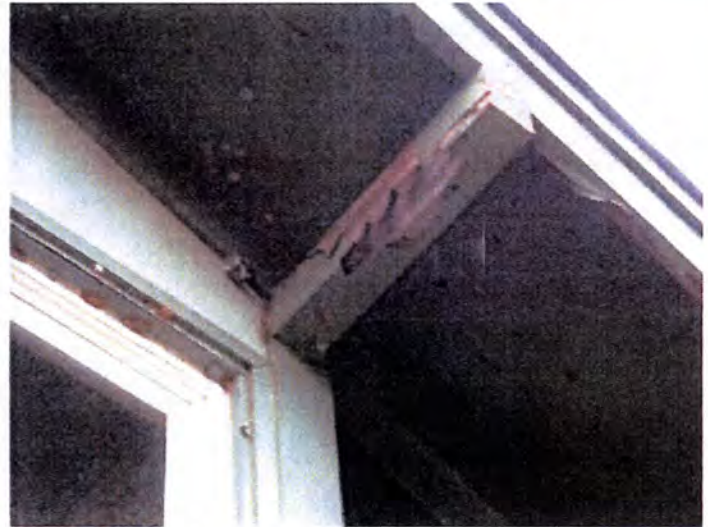
The fascia/soffit areas appeared to be rotted/water damaged/deteriorated at the time of inspection. Recommend having a licensed contractor evaluate and repair/replace as necessary.

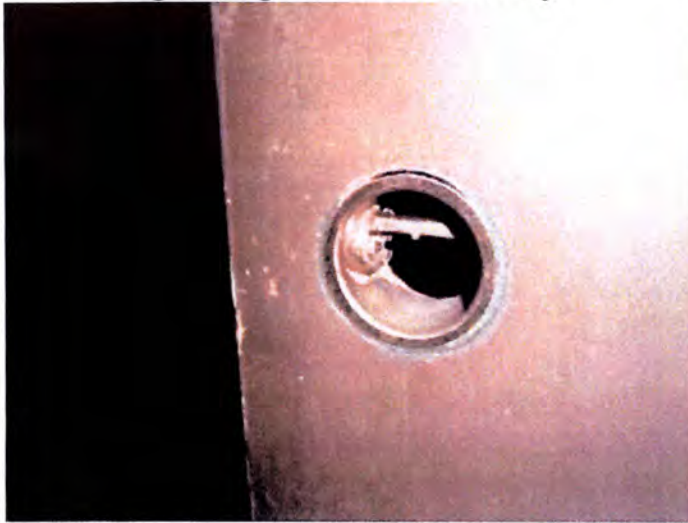
The exterior doors were termite damaged or deteriorated to the point of being inoperable. We recommend replacement of all exterior doors, framing and trim for all buildings.

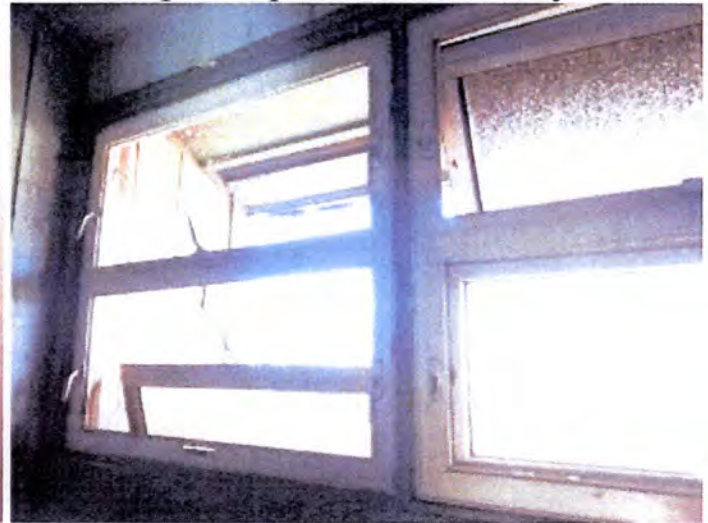
The stair way windows were heavily corroded, damaged and/or inoperable at the time of inspection. Recommend replacement.

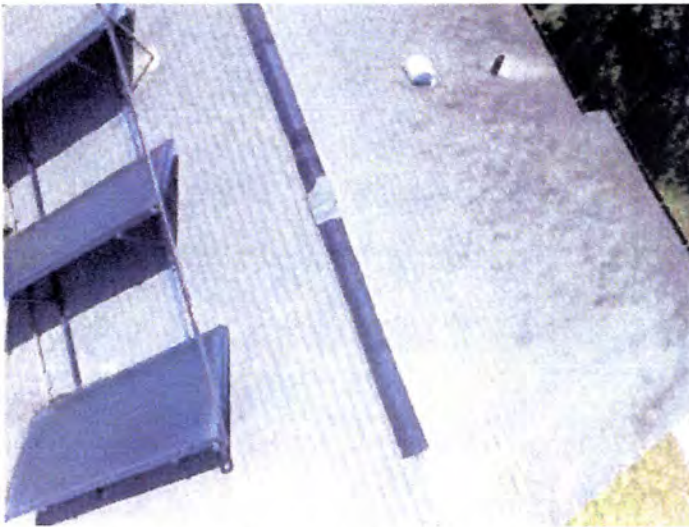
There were numerous areas of missing shingles observed at the roof ridge areas. Recommend repair in conjunction with roof replacement.

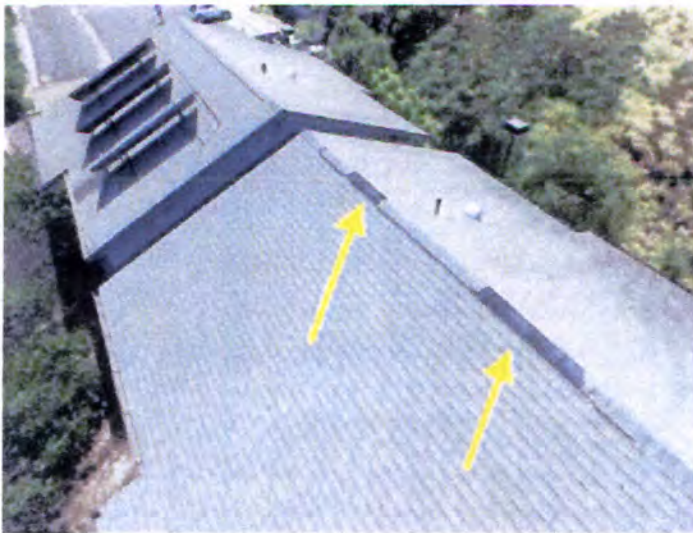
There were numerous areas of missing shingles observed at the roof ridge areas. Recommend repair in conjunction with roof replacement.

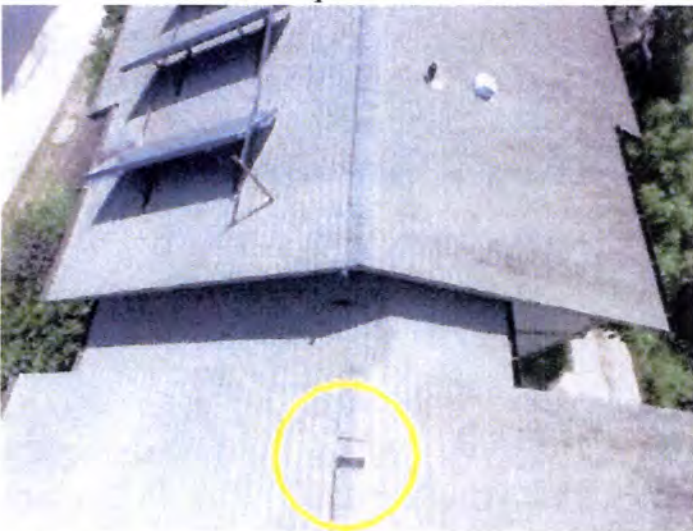
There were numerous areas of missing shingles observed at the roof ridge areas. Recommend repair in conjunction with roof replacement.

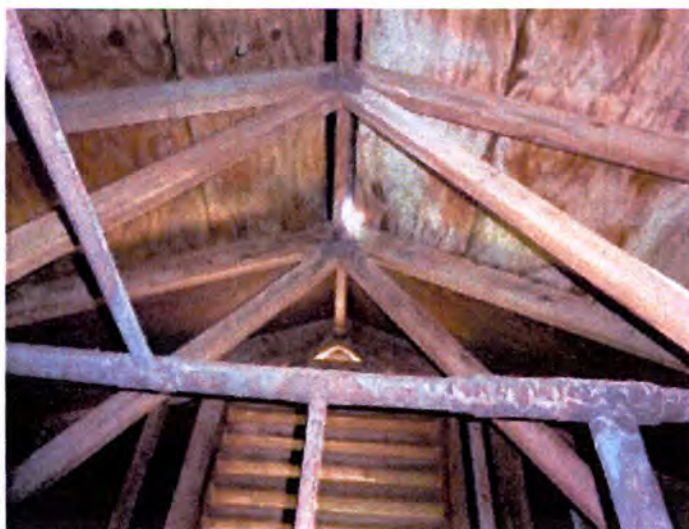
There were visible areas of moisture intrusion observed at the roof sheathing (within the attic spaces) at the time of inspection. This indicated a failed/failing roofing system. Recommend replacement of the installed sheathing and roofing finish.

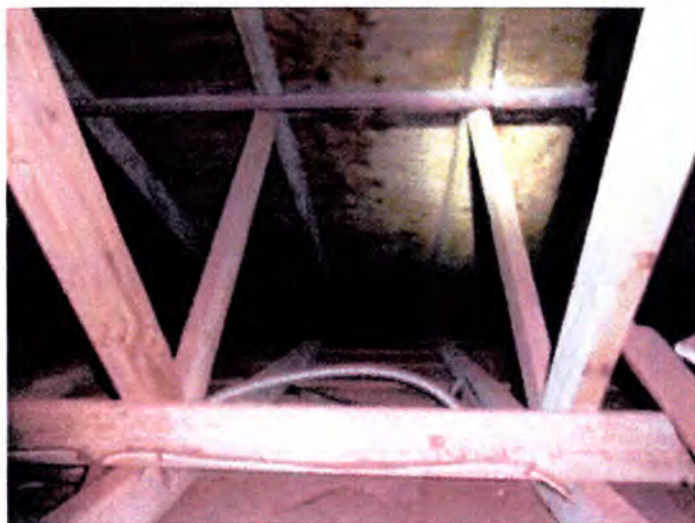
There were visible areas of moisture intrusion observed at the roof sheathing (within the attic spaces) at the time of inspection. This indicated a failed/failing roofing system. Recommend replacement of the installed sheathing and roofing finish.

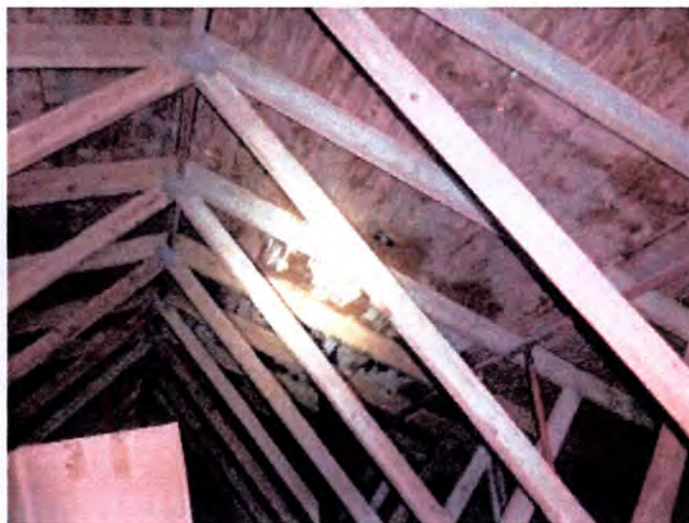
There were visible areas of moisture intrusion observed at the roof sheathing (within the attic spaces) at the time of inspection. This indicated a failed/failing roofing system. Recommend replacement of the installed sheathing and roofing finish.

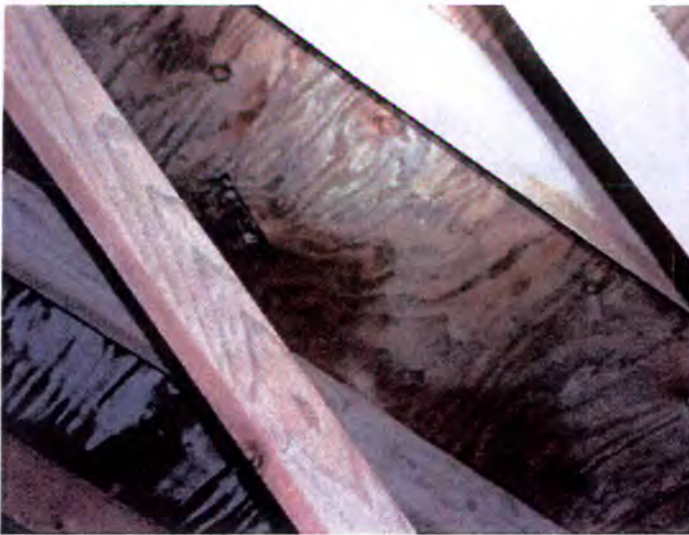
There were visible areas of moisture intrusion observed at the roof sheathing (within the attic spaces) at the time of inspection. This indicated a failed/failing roofing system. Recommend replacement of the installed sheathing and roofing finish.

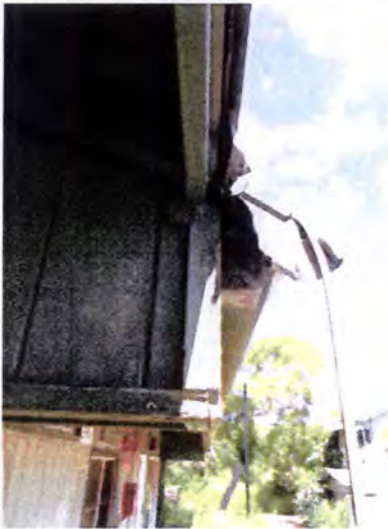
Damaged/broken/missing gutters noted. Recommend having a licensed contractor evaluate and repair/replace as necessary.

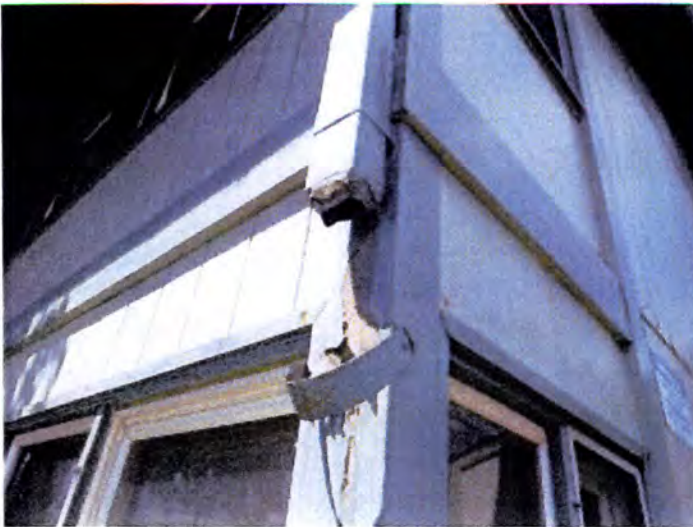
Damaged/broken/missing gutters noted.  
Recommend having a licensed contractor  
evaluate and repair/replace as necessary.

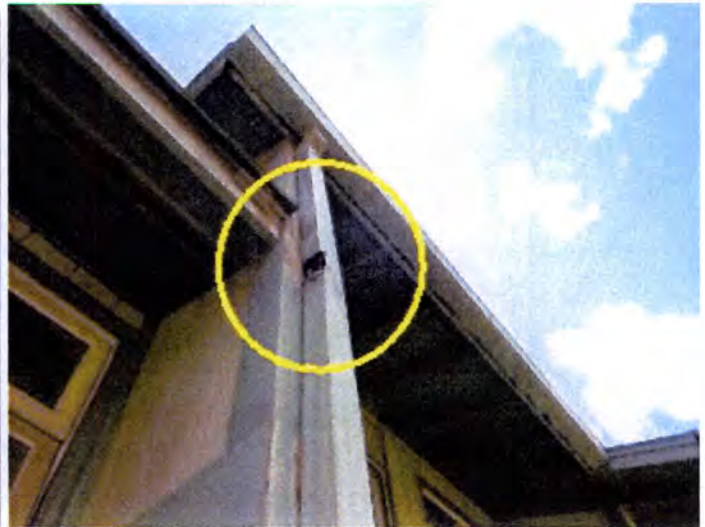
Damaged/broken/missing gutters noted.  
Recommend having a licensed contractor  
evaluate and repair/replace as necessary.

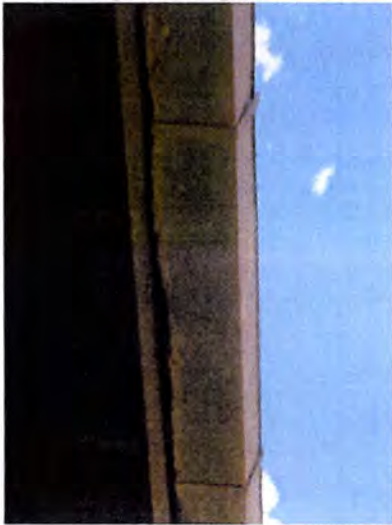
Damaged/broken/missing gutters noted.  
Recommend having a licensed contractor  
evaluate and repair/replace as necessary.

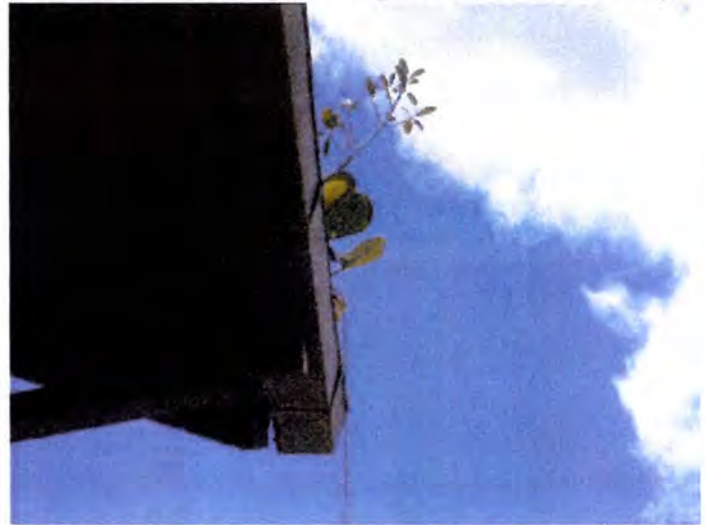
Vegetation growth observed in gutters.  
Recommend clearing.

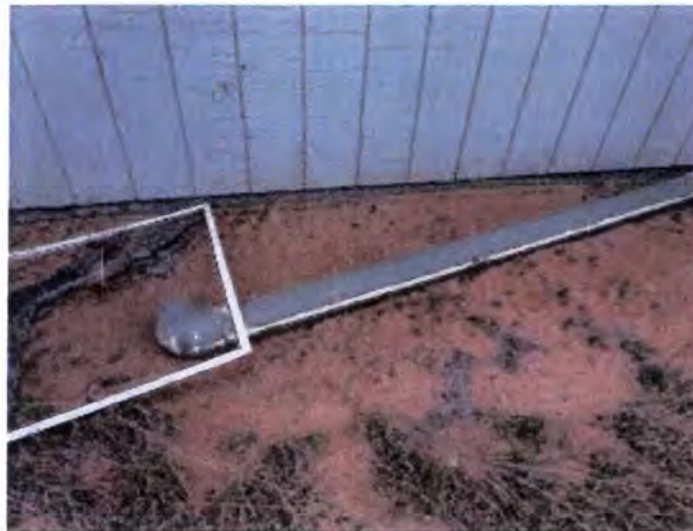
Damaged/broken/missing gutters noted. Recommend having a licensed contractor evaluate and repair/replace as necessary.

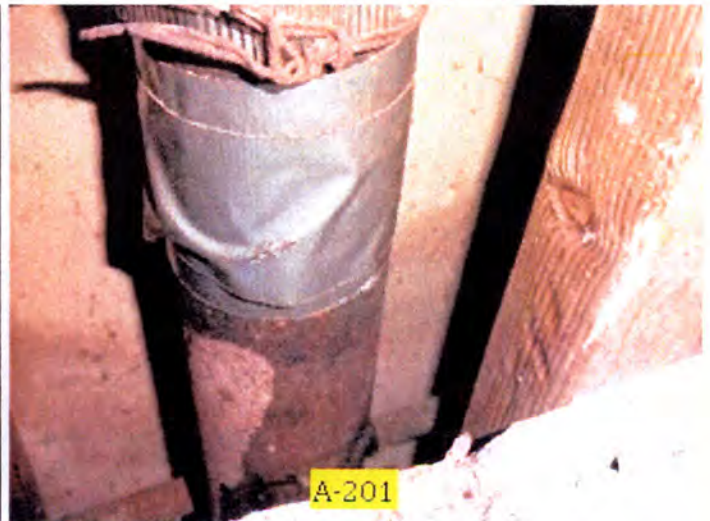
Non standard repairs observed at plumbing connections. Recommend repair.

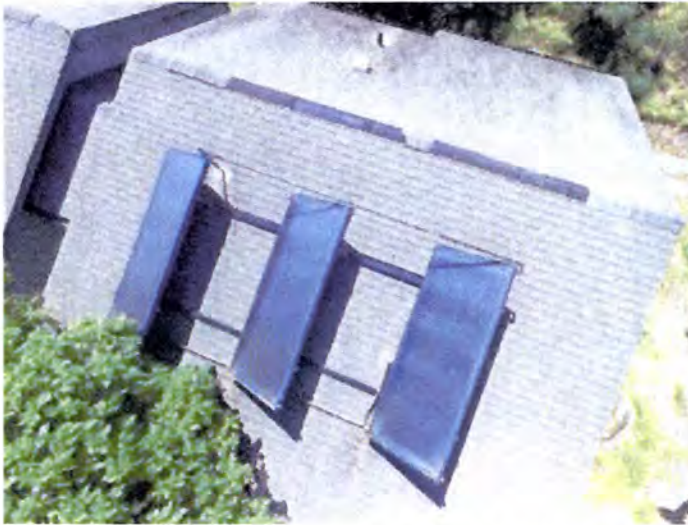
There were solar water heating panels located on the roofing areas of the buildings. There were visible indications of leaks and interior hazing at the panels which is an indication of damage to the environmental seals or panels. These panels did not appear to be in service and should be evaluated by a licensed plumbing contractor prior to use.

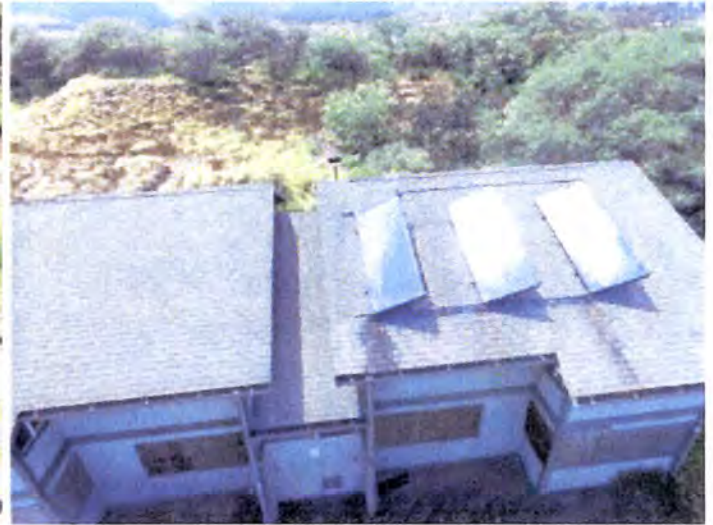
There were solar water heating panels located on the roofing areas of the buildings. There were visible indications of leaks and interior hazing at the panels which is an indication of damage to the environmental seals or panels. These panels did not appear to be in service and should be evaluated by a licensed plumbing contractor prior to use.

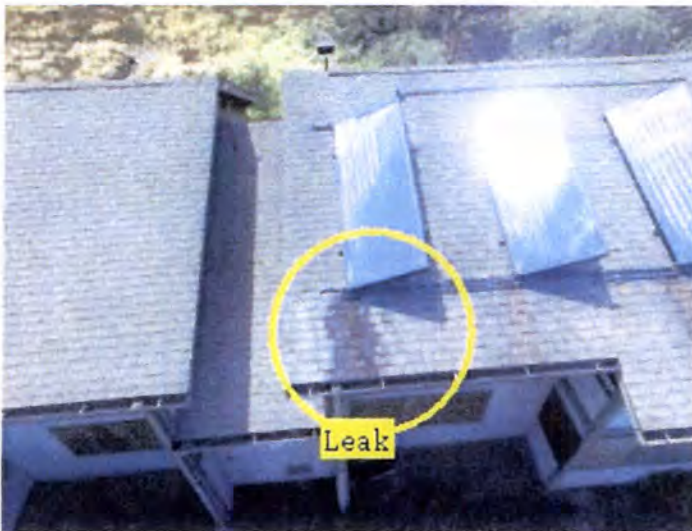
There were solar water heating panels located on the roofing areas of the buildings. There were visible indications of leaks and interior hazing at the panels which is an indication of damage to the environmental seals or panels. These panels did not appear to be in service and should be evaluated by a licensed plumbing contractor prior to use.

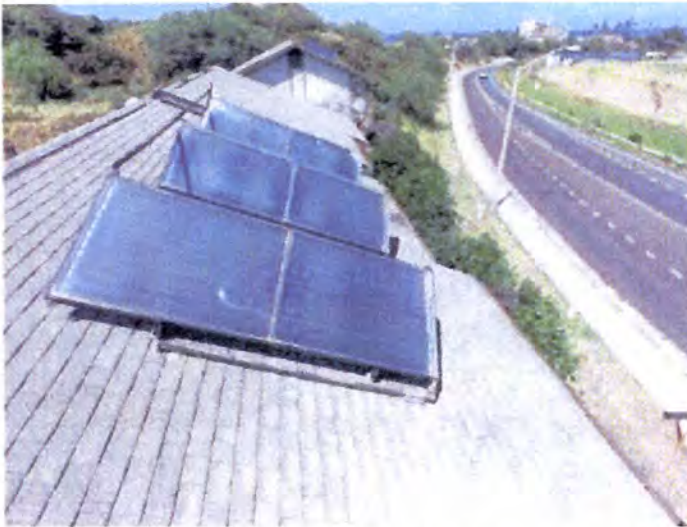
There were solar water heating panels located on the roofing areas of the buildings. There were visible indications of leaks and interior hazing at the panels which is an indication of damage to the environmental seals or panels. These panels did not appear to be in service and should be evaluated by a licensed plumbing contractor prior to use.

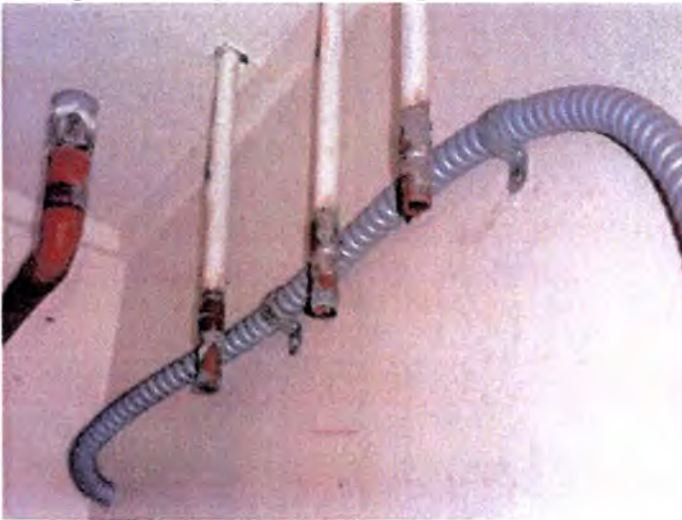
All water heating appliances were terminated with supply and service plumbing cut and electrical connections removed. Recommend having a licensed plumber evaluate and install commercial grade gas on demand hot water heating systems for each floor of each building.

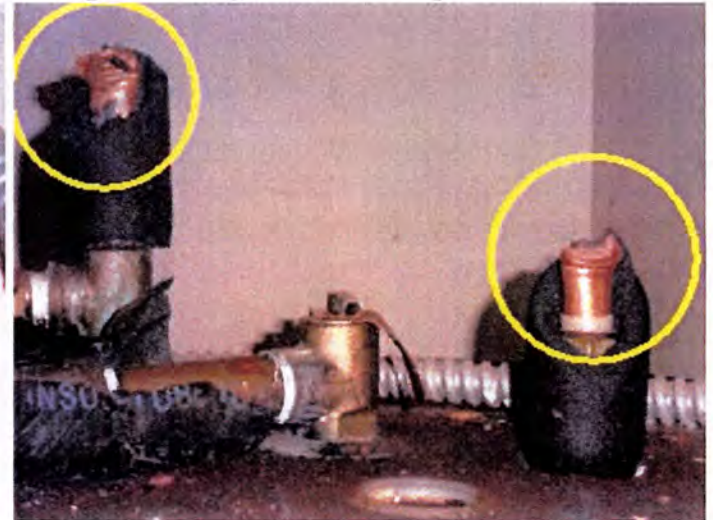
All water heating appliances were terminated with supply and service plumbing cut and electrical connections removed. Recommend having a licensed plumber evaluate and install commercial grade gas on demand hot water heating systems for each floor of each building.

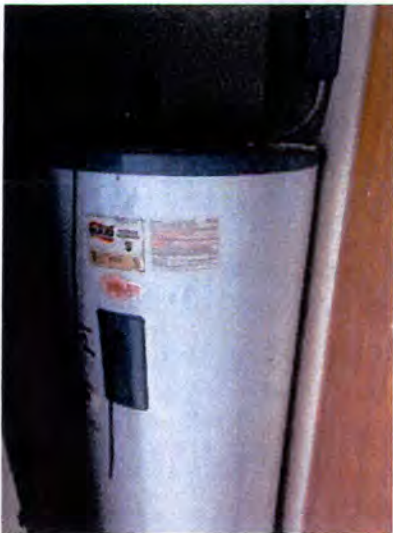
All water heating appliances were terminated with supply and service plumbing cut and electrical connections removed. Recommend having a licensed plumber evaluate and install commercial grade gas on demand hot water heating systems for each floor of each building.

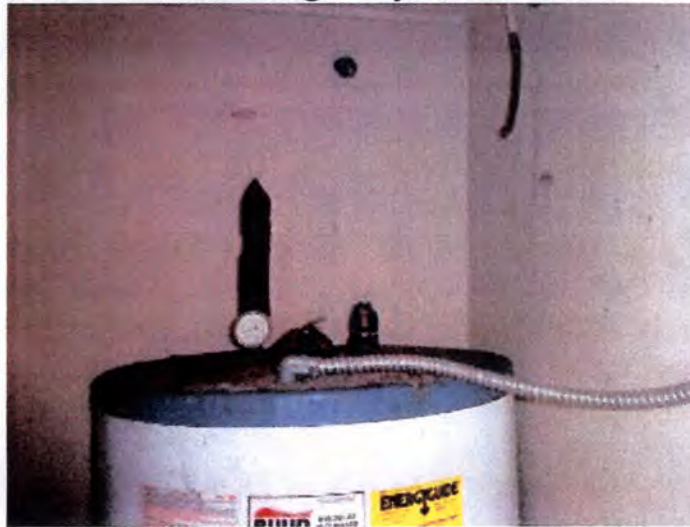
All water heating appliances were terminated with supply and service plumbing cut and electrical connections removed. Recommend having a licensed plumber evaluate and install commercial grade gas on demand hot water heating systems for each floor of each building.

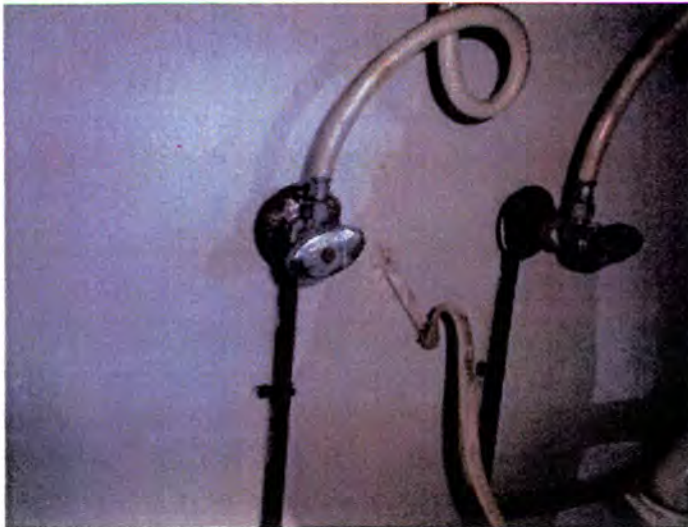
Based on the observed physical conditions of the installed fixtures, we recommend the replacement of all plumbing fixtures and shut off valves in all buildings to ensure proper future operation.

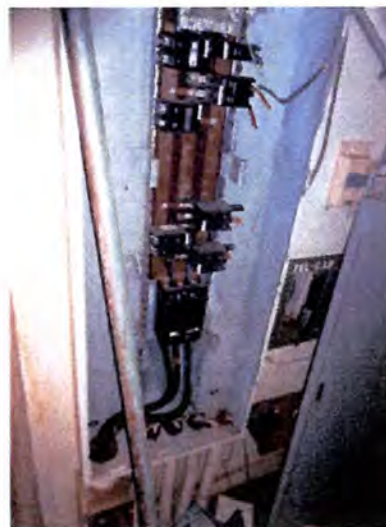
Building B and C: The main service conductors and all electrical branch wiring was cut at the main service panel entrances (located in the respective electrical rooms) when inspected. Recommend having a licensed electrical contractor evaluate and repair electrical service to each building. The installed cabinets, panels and service disconnects appeared serviceable.

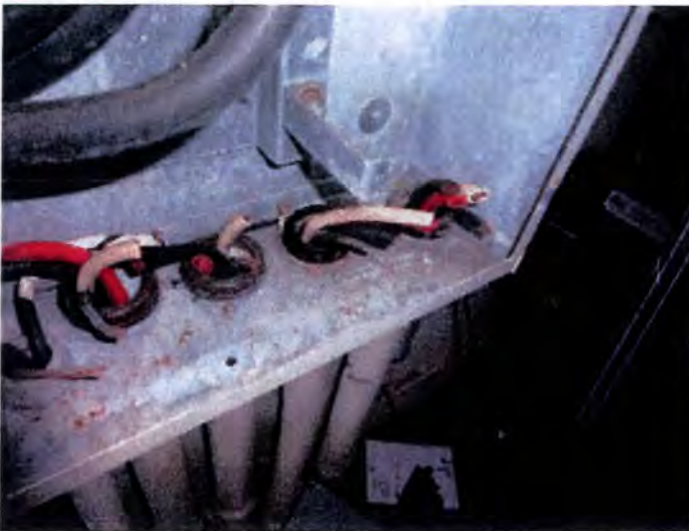
Building B and C: The main service conductors and all electrical branch wiring was cut at the main service panel entrances (located in the respective electrical rooms) when inspected. Recommend having a licensed electrical contractor evaluate and repair electrical service to each building. The installed cabinets, panels and service disconnects appeared serviceable.

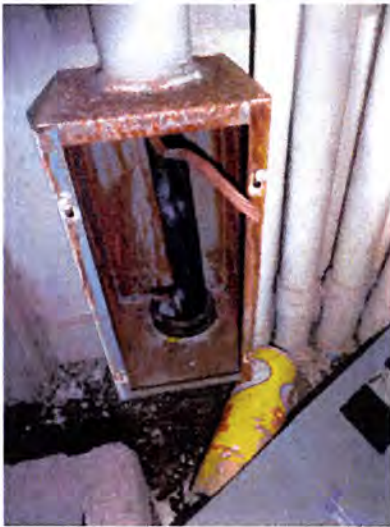
Building B and C: The main service conductors and all electrical branch wiring was cut at the main service panel entrances (located in the respective electrical rooms) when inspected. Recommend having a licensed electrical contractor evaluate and repair electrical service to each building. The installed cabinets, panels and service disconnects appeared serviceable.

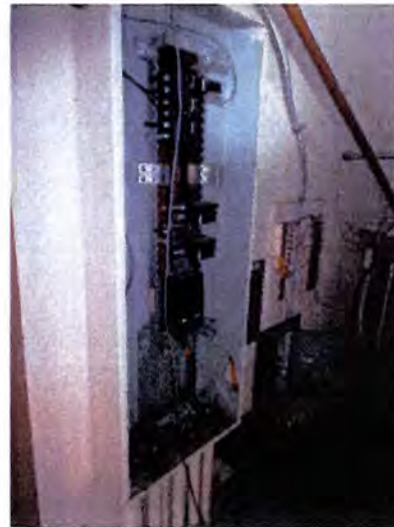
Building B and C: The main service conductors and all electrical branch wiring was cut at the main service panel entrances (located in the respective electrical rooms) when inspected. Recommend having a licensed electrical contractor evaluate and repair electrical service to each building. The installed cabinets, panels and service disconnects appeared serviceable.

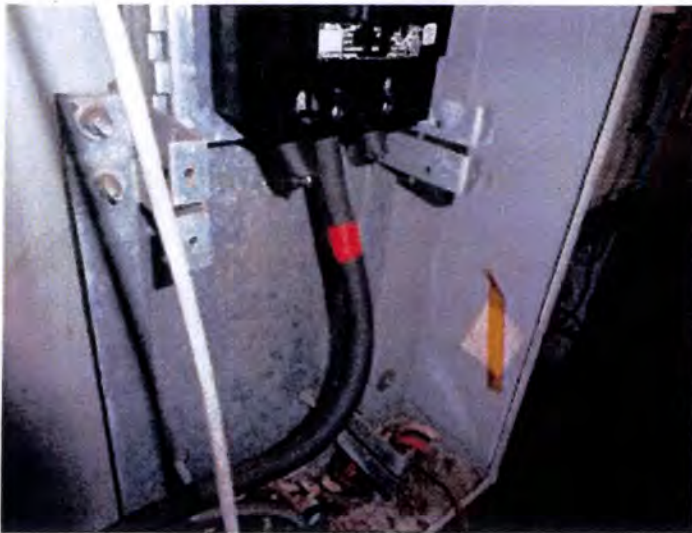
Building B and C: The main service conductors and all electrical branch wiring was cut at the main service panel entrances (located in the respective electrical rooms) when inspected. Recommend having a licensed electrical contractor evaluate and repair electrical service to each building. The installed cabinets, panels and service disconnects appeared serviceable.

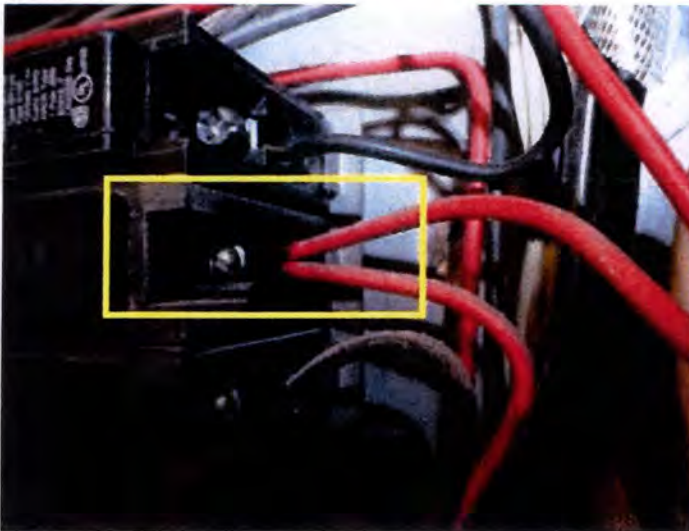
There were double tapped 1-pole circuit breakers noted at the time of inspection.

This is not consistent with the manufacturer's instructions and the NEC.

We recommend having a licensed electrician evaluate and repair/replace as necessary.

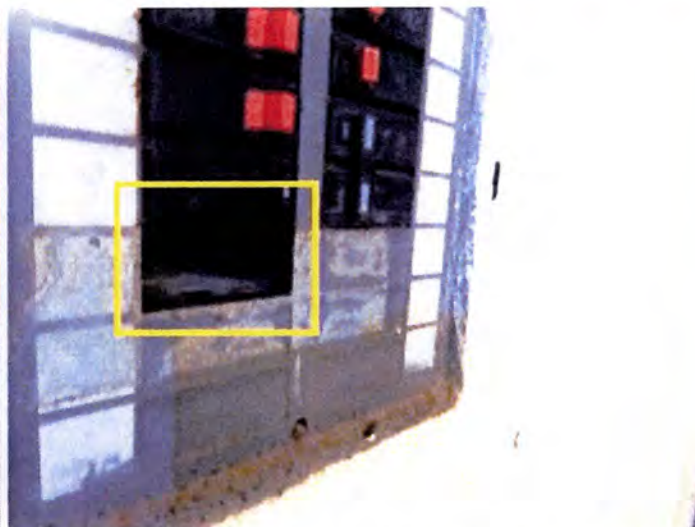
There appeared to be open knock outs/twist outs within a metal electrical cabinet. Any unused openings, other than those intended for the operation of equipment, those intended for mounting purposes, or those permitted as part of the design for listed equipment, shall be closed to afford protection substantially equivalent to the wall of the equipment. (NEC 110.12(A)). Recommend having a licensed electrician replace the plastic plugs with metallic ones.

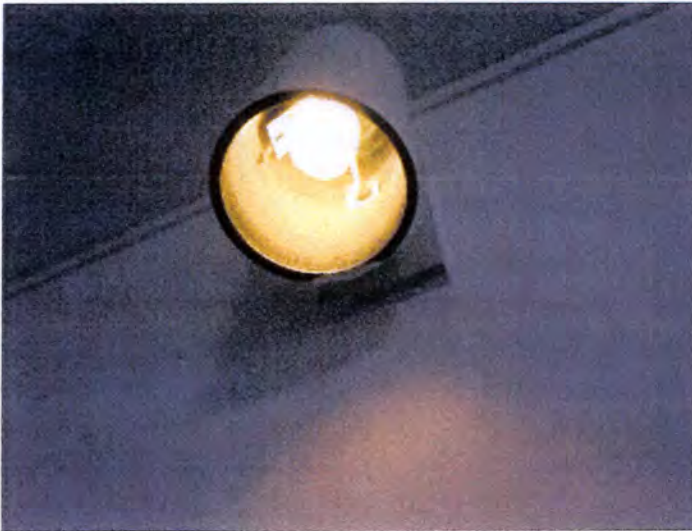
Building A's tested receptacles, switches and lights operated properly at the time of inspection. There were missing bulbs observed but power was present at the fixtures.

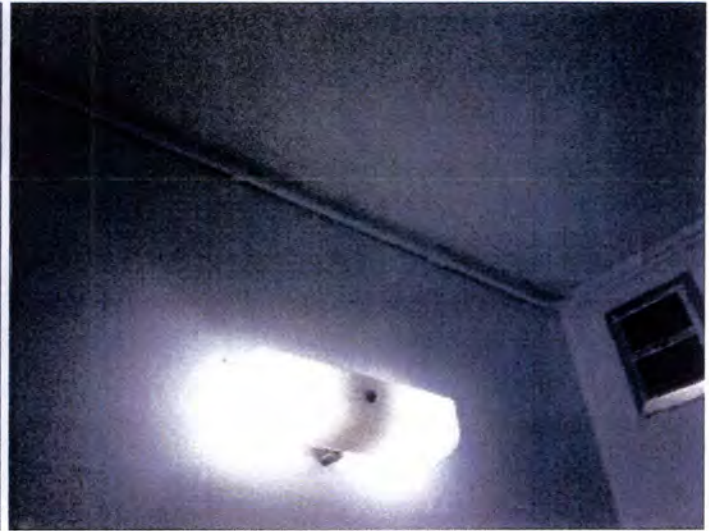
Building A's tested receptacles, switches and lights operated properly at the time of inspection. There were missing bulbs observed but power was present at the fixtures.

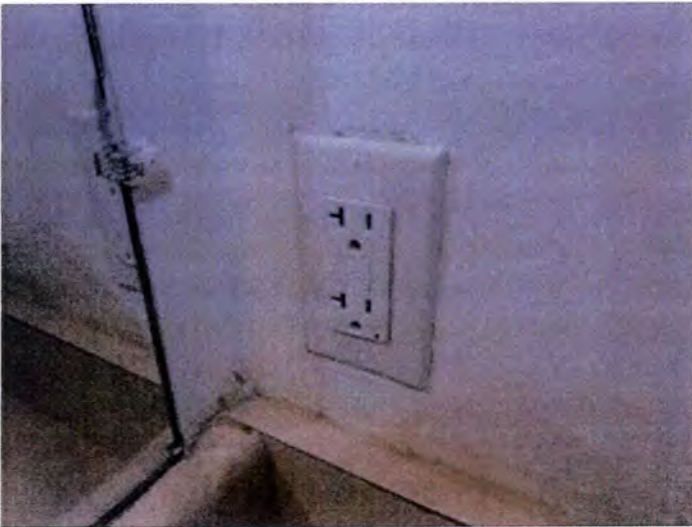
Building A's tested receptacles, switches and lights operated properly at the time of inspection. There were missing bulbs observed but power was present at the fixtures.

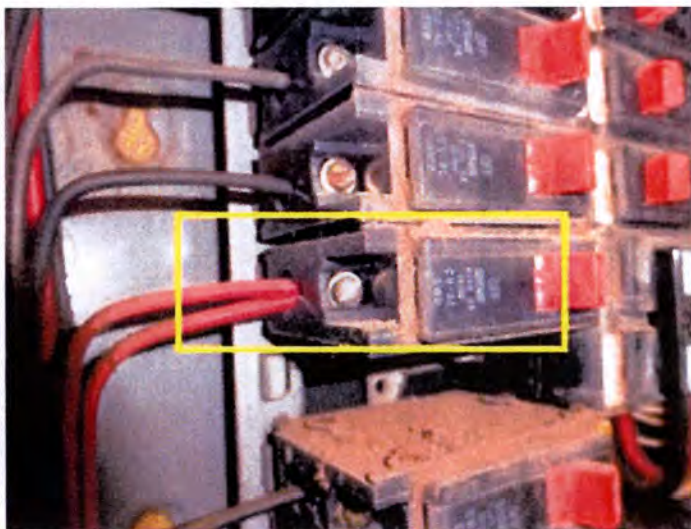
There were double tapped 1-pole circuit breakers noted at the time of inspection.

This is not consistent with the manufacturer's instructions and the NEC.

We recommend having a licensed electrician evaluate and repair/replace as necessary.

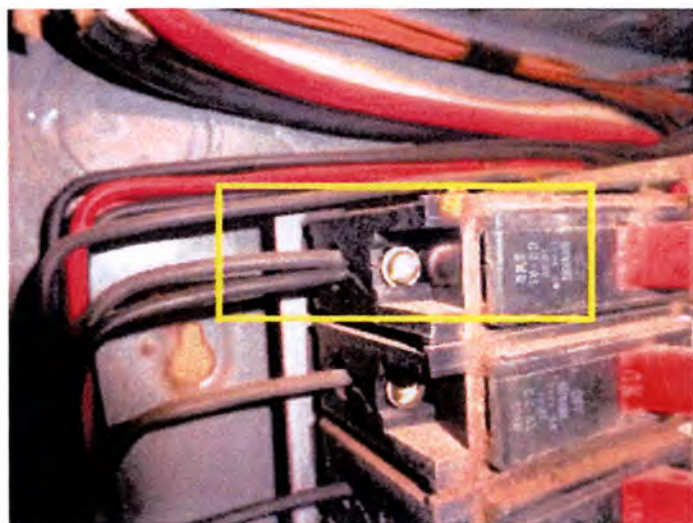
There were double tapped 1-pole circuit breakers noted at the time of inspection.

This is not consistent with the manufacturer's instructions and the NEC.

We recommend having a licensed electrician evaluate and repair/replace as necessary.

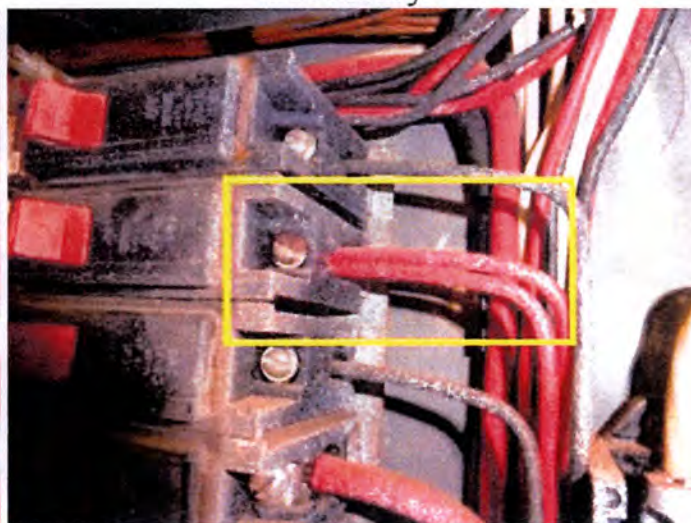
There were double tapped 1-pole circuit breakers noted at the time of inspection.

This is not consistent with the manufacturer's instructions and the NEC.

We recommend having a licensed electrician evaluate and repair/replace as necessary.
