**SUBJECT: COUNTY-OWNED PARCEL ON NORTH PAPA AVENUE (KAHULUI)  
(HHT-14)**

## Property Condition Report

310 W Kaahumanu Ave, Kahului, HI 96732  
Inspection prepared for: Maui County c/o Buddy Almeida  
Real Estate Agent: -

This is a commercial property condition assessment to determine if three (3) former UH dormitories are suitable for housing. This inspection includes invasive and non-invasive inspection methods as well as sampling for asbestos and lead based paint.

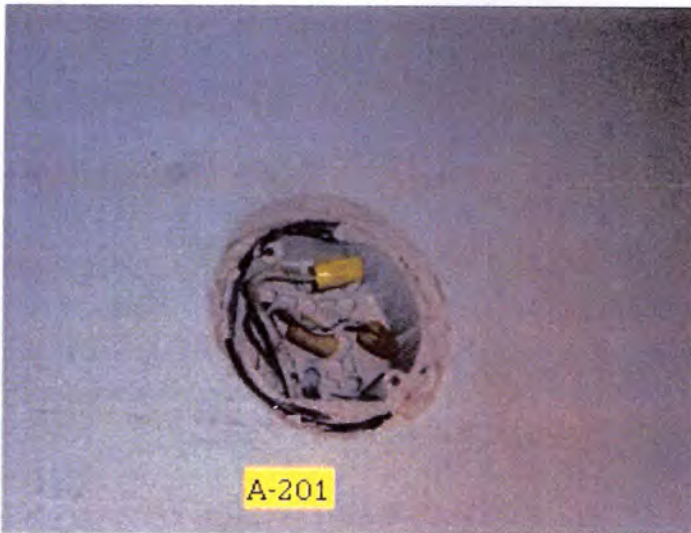
There were missing junction box covers noted at the following locations: attic spaces and front exterior of store.

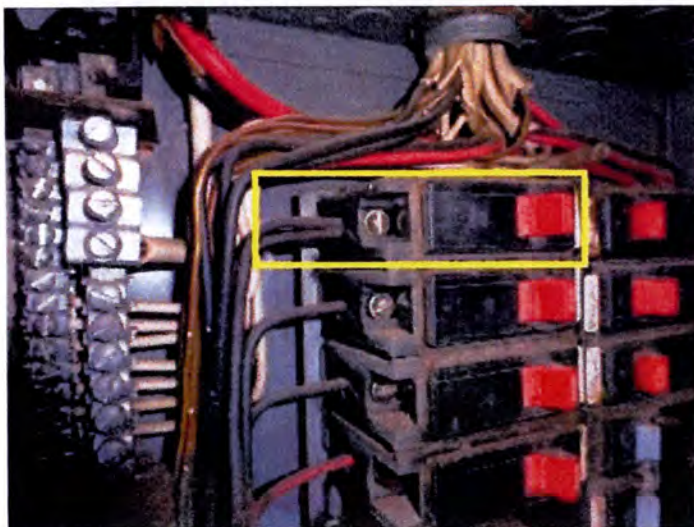
There were double tapped 1-pole circuit breakers noted at the time of inspection.

This is not consistent with the manufacturer's instructions and the NEC.

We recommend having a licensed electrician evaluate and repair/replace as necessary.

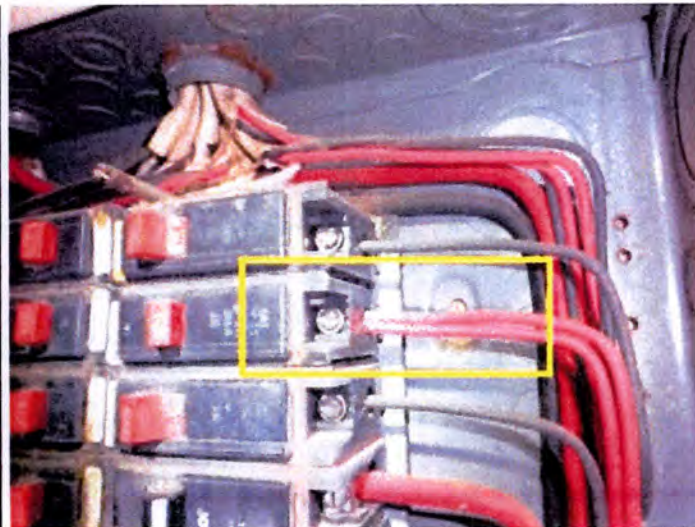
There were double tapped 1-pole circuit breakers noted at the time of inspection.

This is not consistent with the manufacturer's instructions and the NEC.

We recommend having a licensed electrician evaluate and repair/replace as necessary.

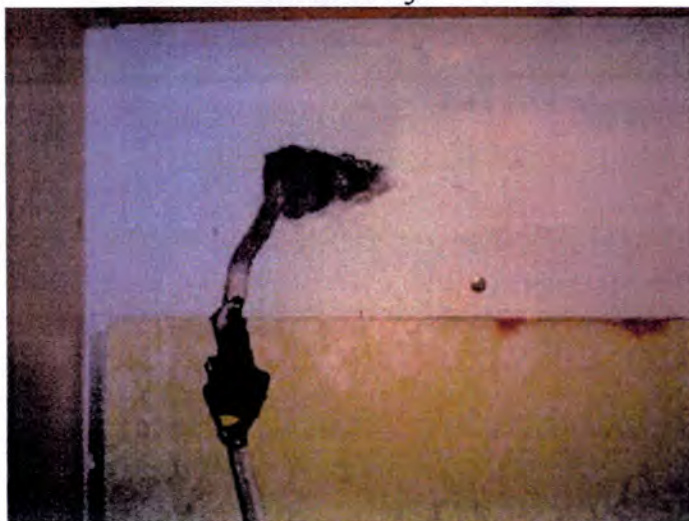
There were improperly terminated splices at the following locations: B-201

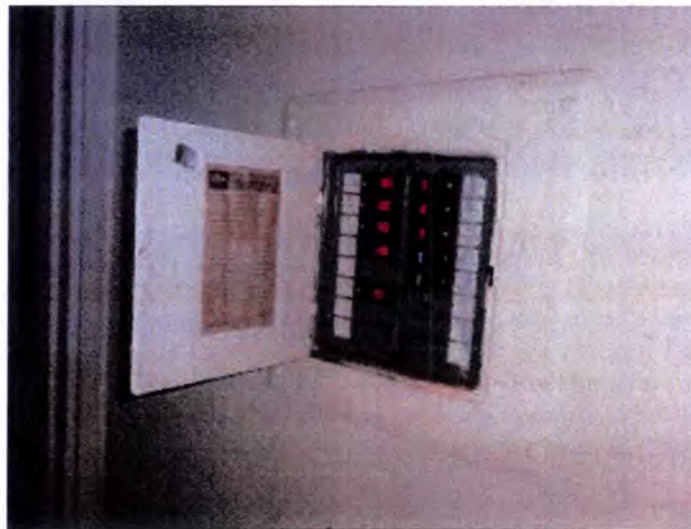
All of the branch wiring to buildings B and C was cut with circuit breakers removed. Recommend having a licensed electrical contractor repair.

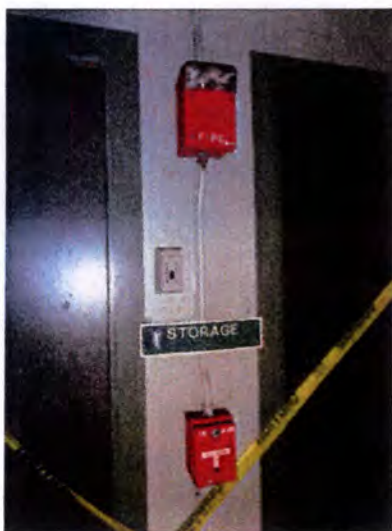
Approximately half of the installed pull stations were damaged when inspected. Recommend replacement/repair.

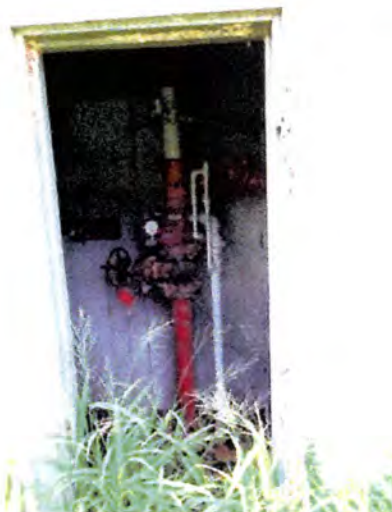
The installed risers and associated equipment appeared to be damaged/improperly maintained when inspected. Recommend having a licensed fire suppression contractor evaluate, service, test and inspect the entire fire suppression system.

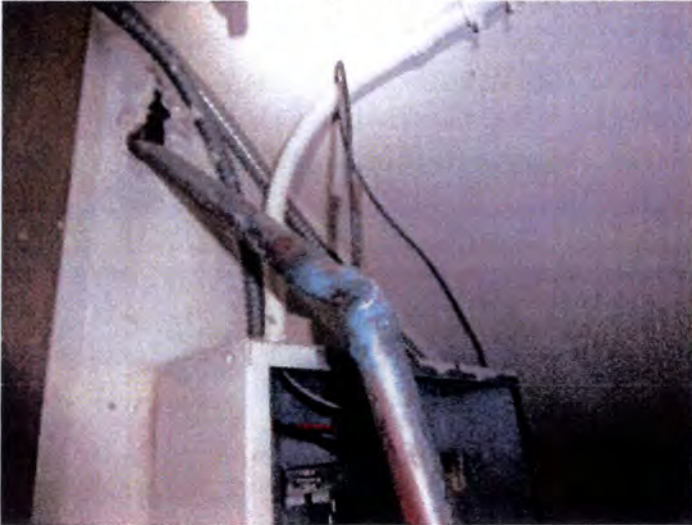
Building B: Sprinkler branch pipe was broken/bent down in the electrical room.  
Recommend repair.

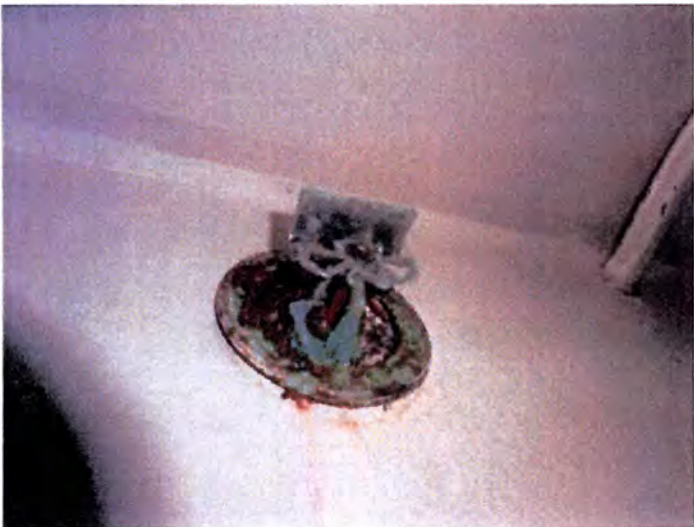
The installed risers and associated equipment appeared to be damaged/improperly maintained when inspected. Recommend having a licensed fire suppression contractor evaluate, service, test and inspect the entire fire suppression system.

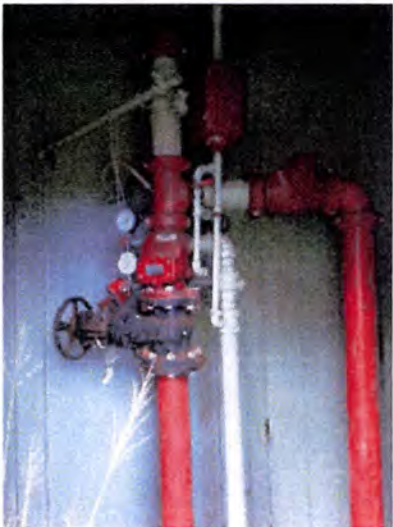
Sprinkler Systems: due to the system not having been properly serviced at required intervals, adequacy or performance questionable.

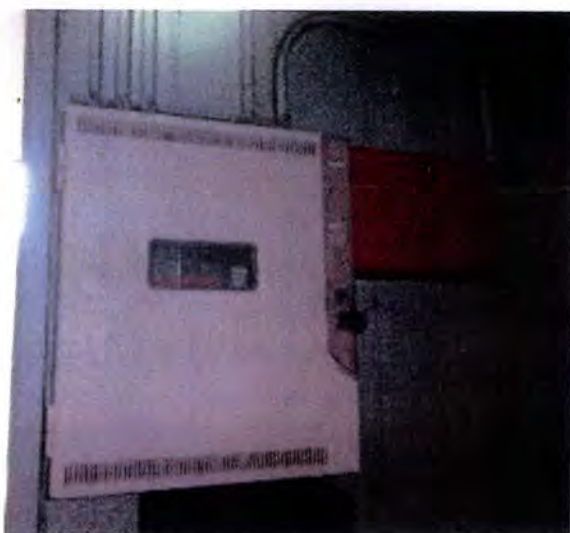
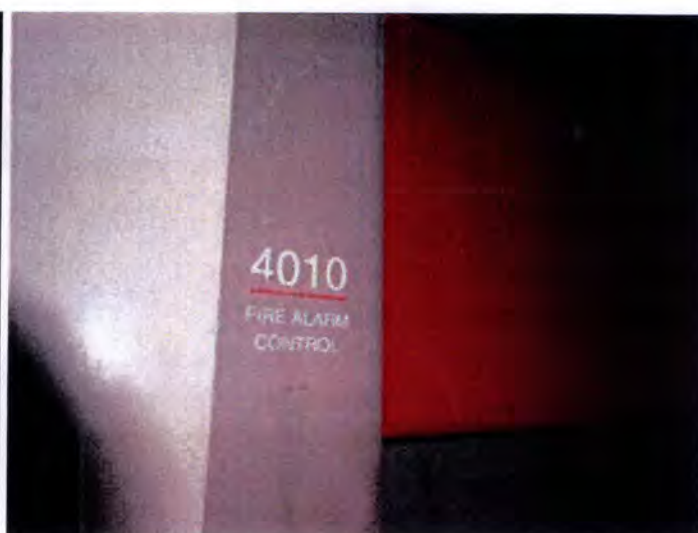
Each building had a designated alarm and alarm panel which was located on the ground floor. Based on the observed conditions of installed equipment, we recommend having the installed equipment repaired and/or replaced by a licensed security contractor as desired.

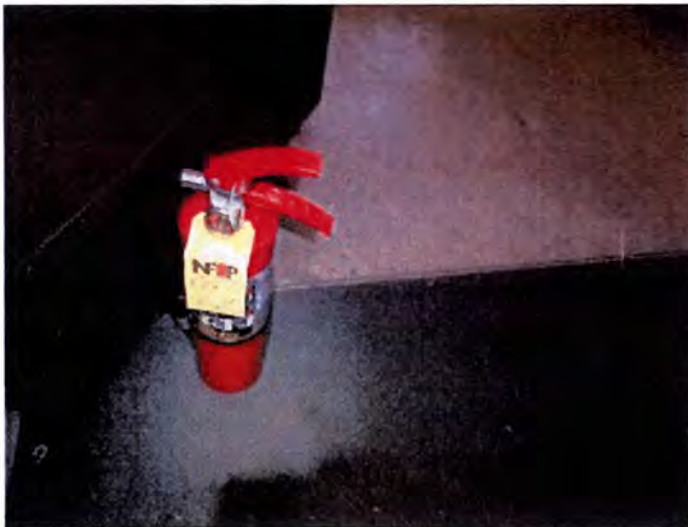
The installed fire extinguishers were expired inspection and servicing placards at the time of inspection. We recommend having a licensed fire extinguisher contractor evaluate and be contracted to service and inspect the existing items as required.

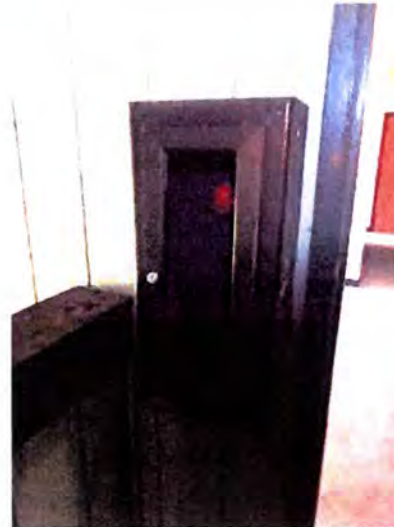
Most of the fire extinguishers were missing at required locations.

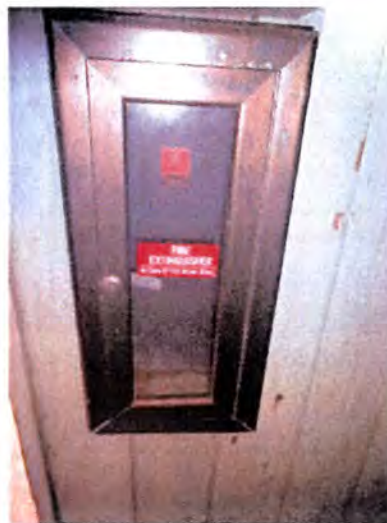
Most of the fire extinguishers were missing at required locations.

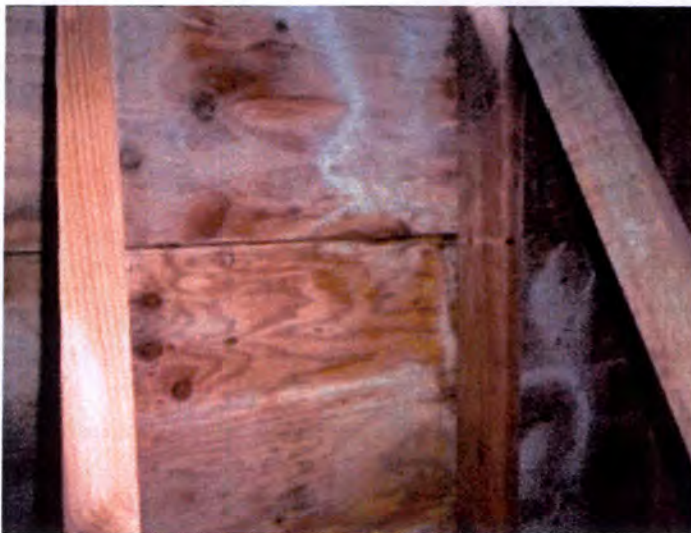
There were visible indications of mold present at all attic areas.

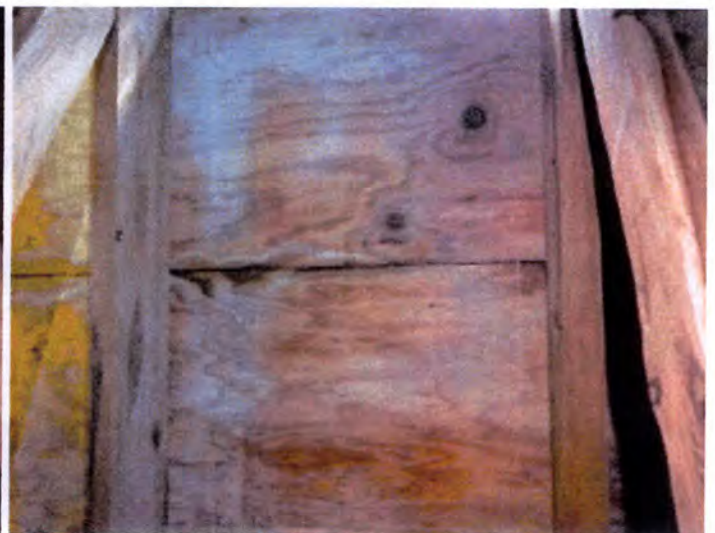
There were visible indications of mold present at all attic areas.

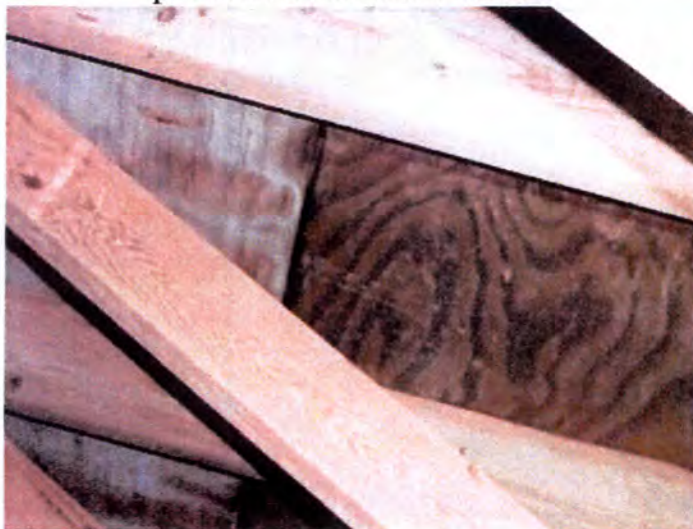
There were visible indications of mold present at all attic areas.

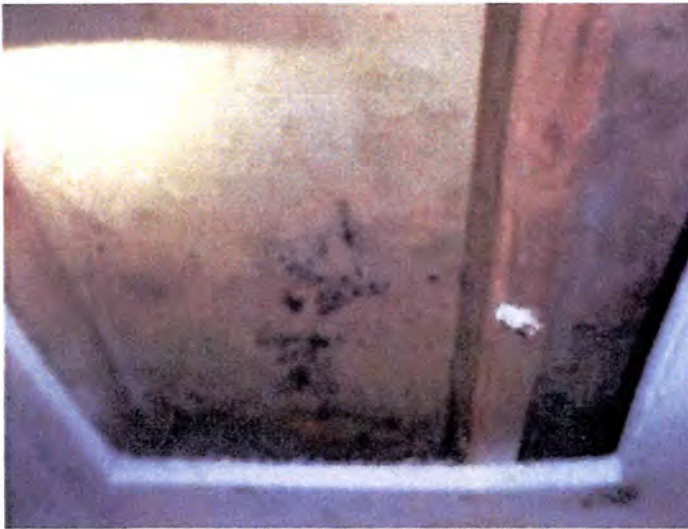
There were visible indications of mold present at all attic areas.

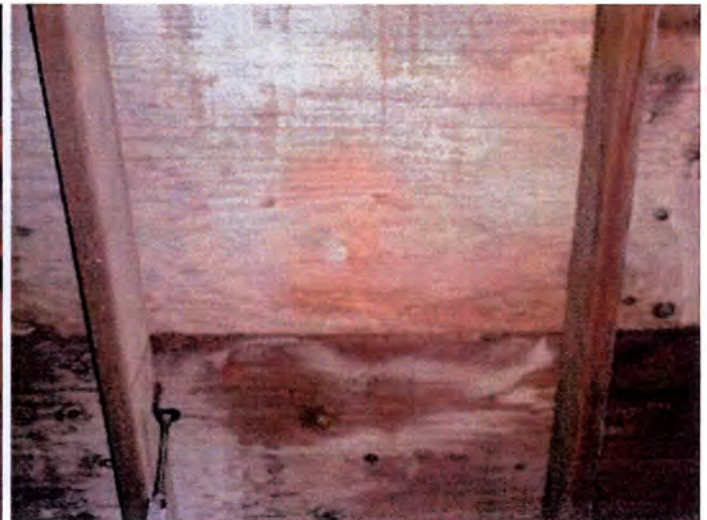
There were visible indications of mold present at all attic areas.

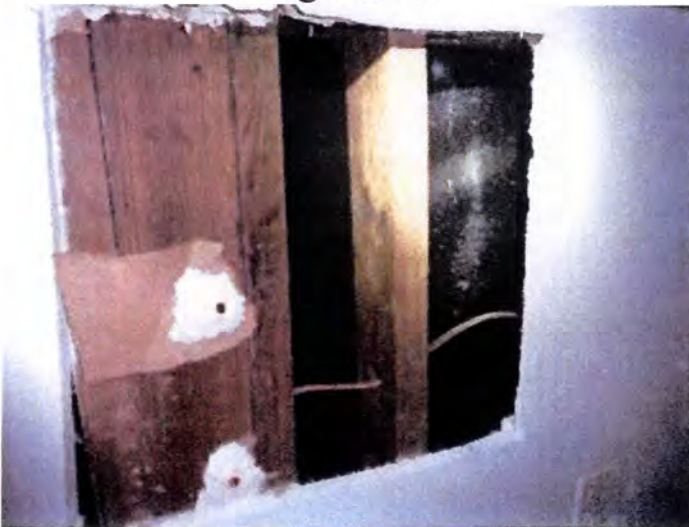
Visible indications of moisture intrusion and mold growth at building B and C interior, bedroom, bathroom and closet wall areas. Recommend removal and replacement of all interior wall finishes of B and C, after removal of all exterior vegetation.

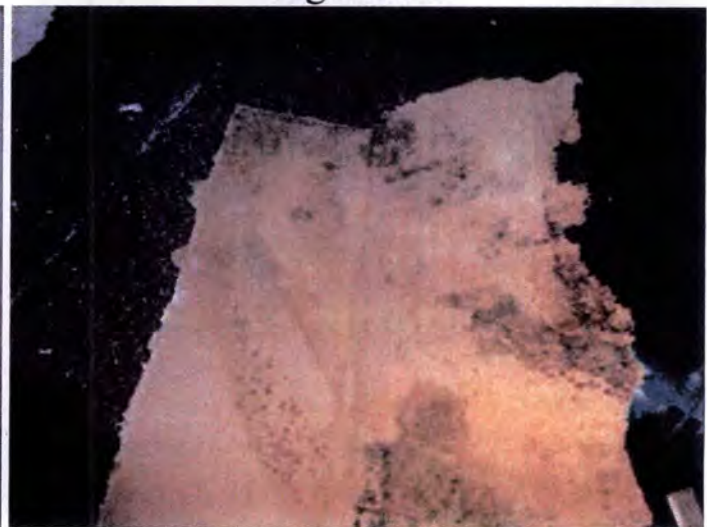
Visible indications of moisture intrusion and mold growth at building B and C interior, bedroom, bathroom and closet wall areas. Recommend removal and replacement of all interior wall finishes of B and C, after removal of all exterior vegetation.

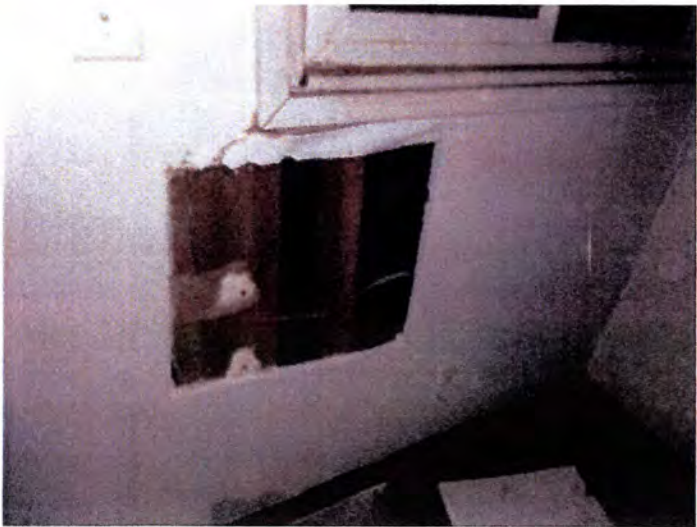
Visible indications of moisture intrusion and mold growth at building B and C interior, bedroom, bathroom and closet wall areas. Recommend removal and replacement of all interior wall finishes of B and C, after removal of all exterior vegetation.

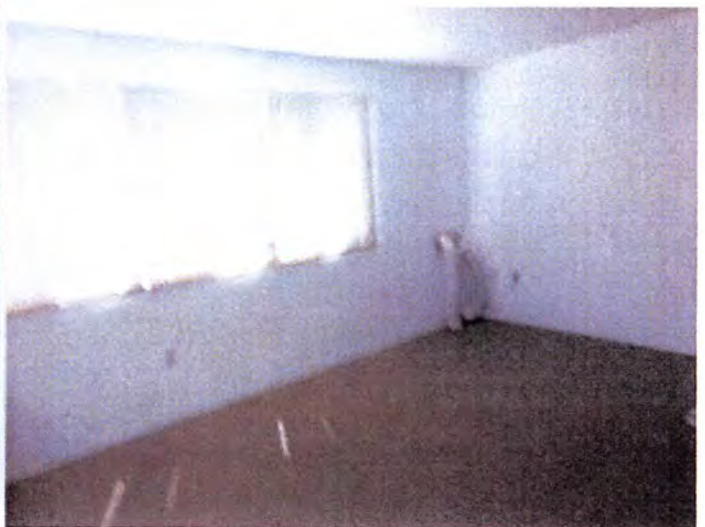
Most of the exterior facing lower interior wall finishes had moisture damage observed. Recommend removal and replacement of affected materials.

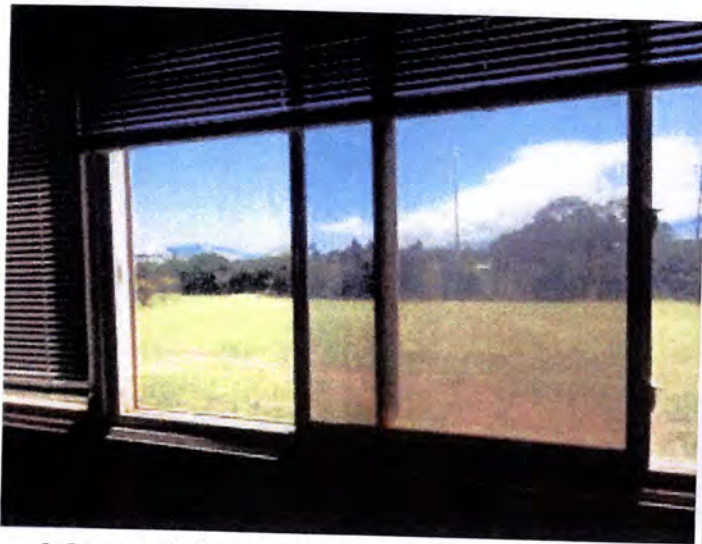
There were visible indications of moisture and termite damage observed at the interior window trim areas. Recommend replacement of all interior window trim and finishes.

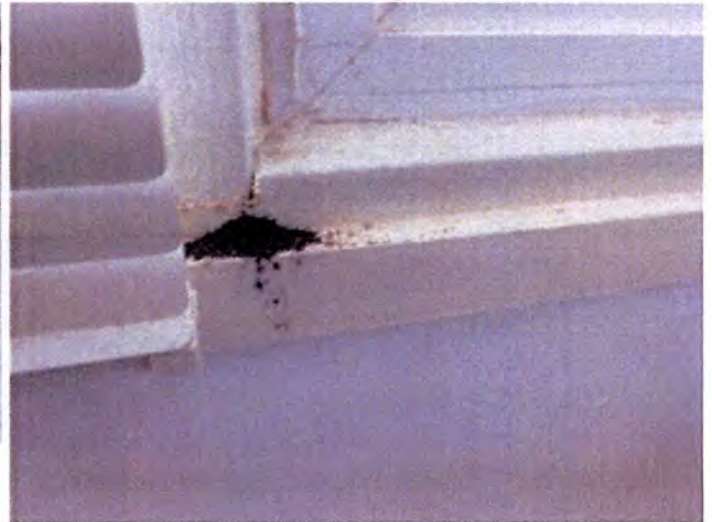
Most of the exterior facing lower interior wall finishes had moisture damage observed. Recommend removal and replacement of affected materials.

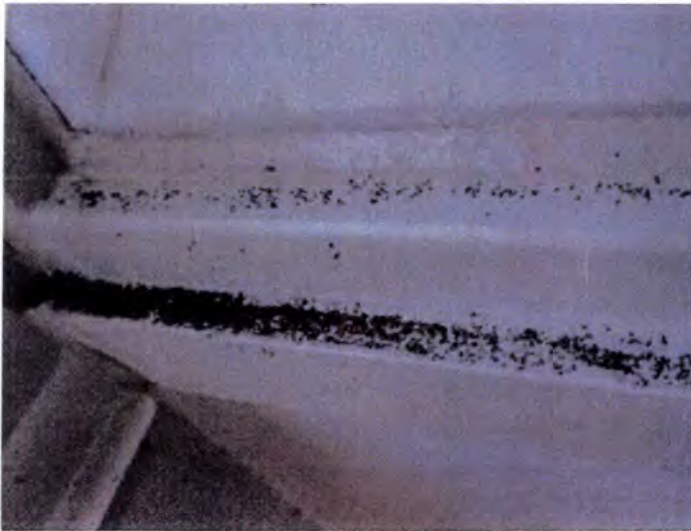
There were visible indications of moisture and termite damage observed at the interior window trim areas. Recommend replacement of all interior window trim and finishes.

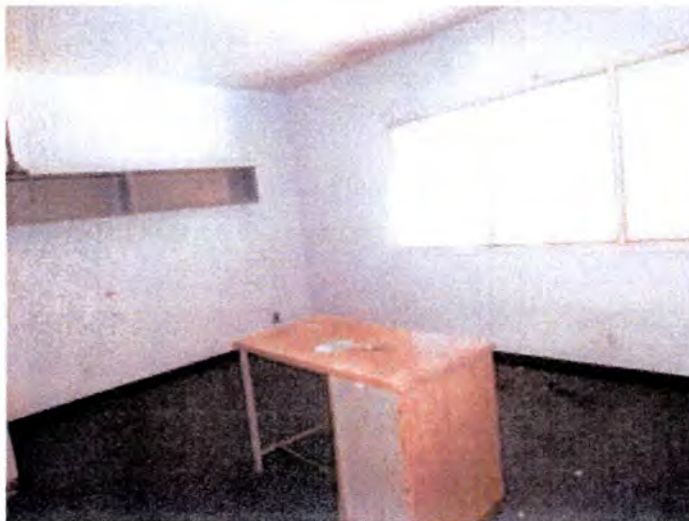
Visible indications of moisture intrusion and mold growth at building B and C interior, bedroom, bathroom and closet wall areas. Recommend removal and replacement of all interior wall finishes of B and C, after removal of all exterior vegetation.

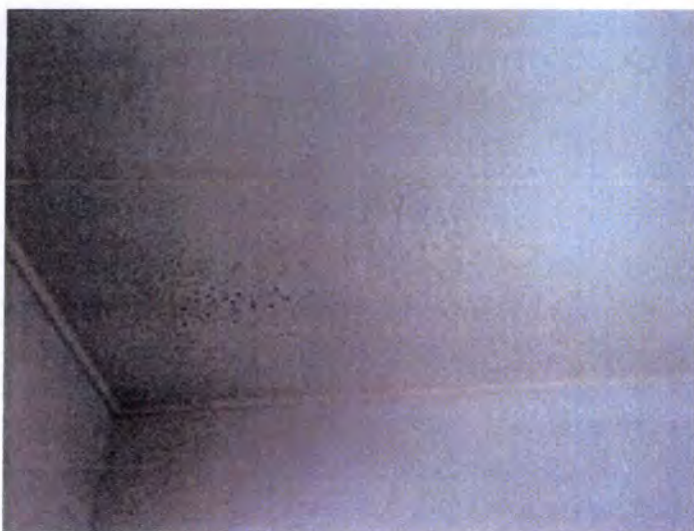
There were visible indications of water intrusion, with mold growth, noted at the ceiling areas of A-201. Recommend having a licensed contractor evaluate and repair as necessary to prevent further damage.

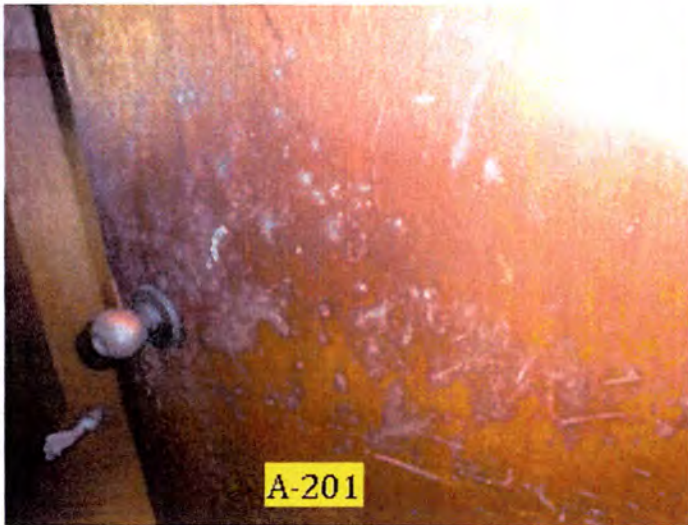
Most of the doors had varying degrees of damage observed when inspected. Based on the observed conditions, we recommend the replacement of all interior doors and trim within the dwelling units.

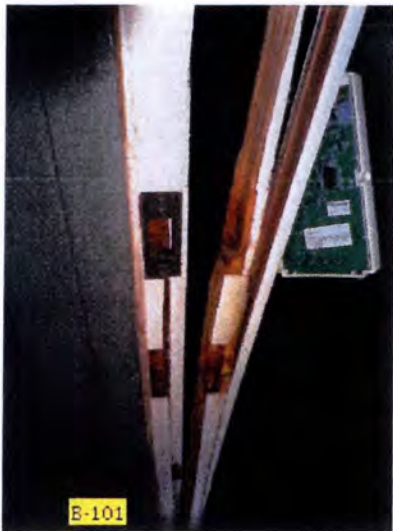
Most of the doors had varying degrees of damage observed when inspected. Based on the observed conditions, we recommend the replacement of all interior doors and trim within the dwelling units.

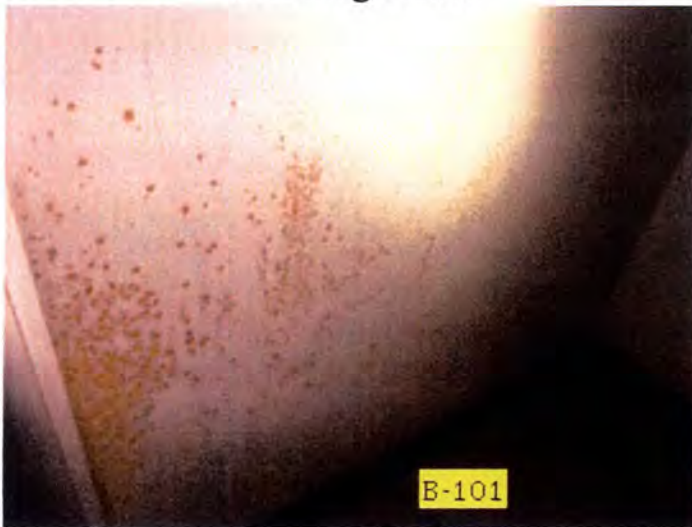
Visible indications of moisture intrusion and mold growth at building B and C interior, bedroom, bathroom and closet wall areas. Recommend removal and replacement of all interior wall finishes of B and C, after removal of all exterior vegetation.

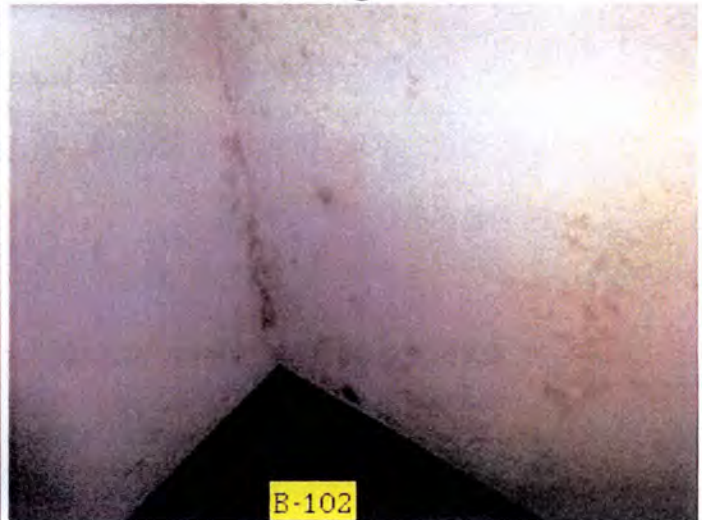
Visible indications of moisture intrusion and mold growth at building B and C interior, bedroom, bathroom and closet wall areas. Recommend removal and replacement of all interior wall finishes of B and C, after removal of all exterior vegetation.

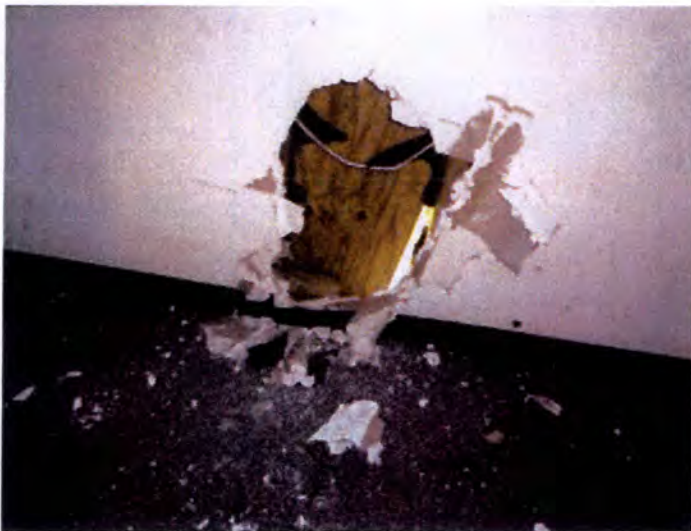
Visible indications of moisture intrusion and mold growth at building B and C interior, bedroom, bathroom and closet wall areas. Recommend removal and replacement of all interior wall finishes of B and C, after removal of all exterior vegetation.

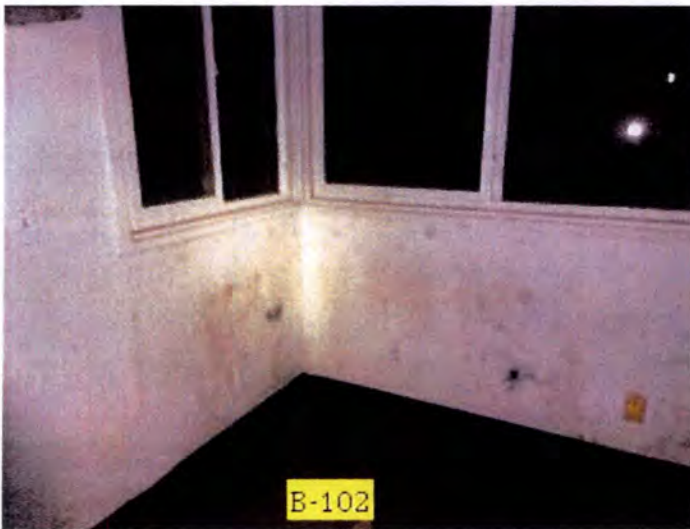
Most of the exterior facing lower interior wall finishes had moisture damage observed. Recommend removal and replacement of affected materials.

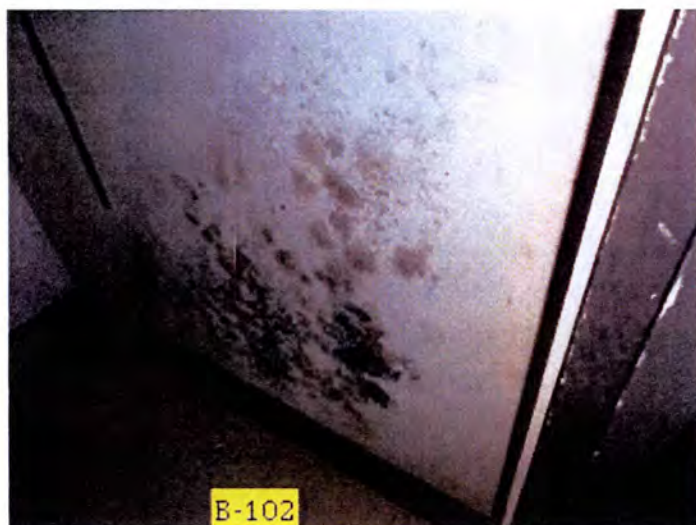
Visible indications of moisture intrusion and mold growth at building B and C interior, bedroom, bathroom and closet wall areas. Recommend removal and replacement of all interior wall finishes of B and C, after removal of all exterior vegetation.

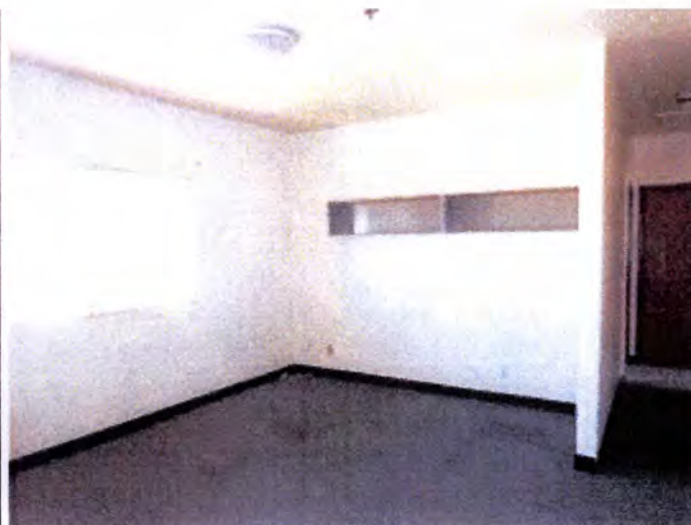
Visible indications of moisture intrusion and mold growth at building B and C interior, bedroom, bathroom and closet wall areas. Recommend removal and replacement of all interior wall finishes of B and C, after removal of all exterior vegetation.

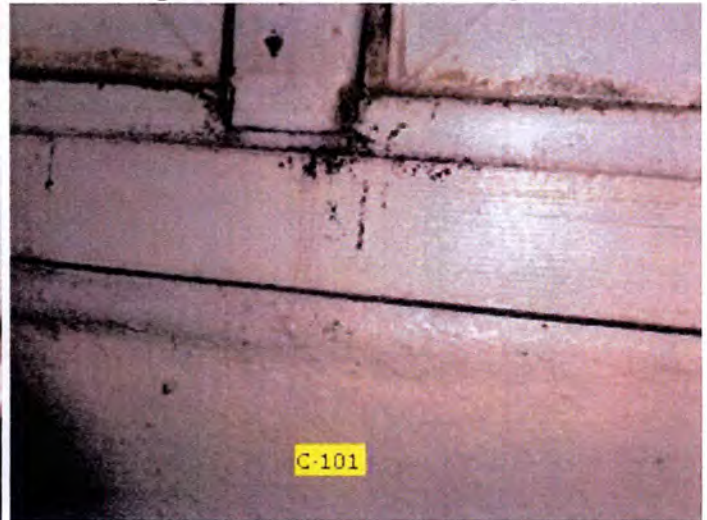
Most of the exterior facing lower interior wall finishes had moisture damage observed. Recommend removal and replacement of affected materials.

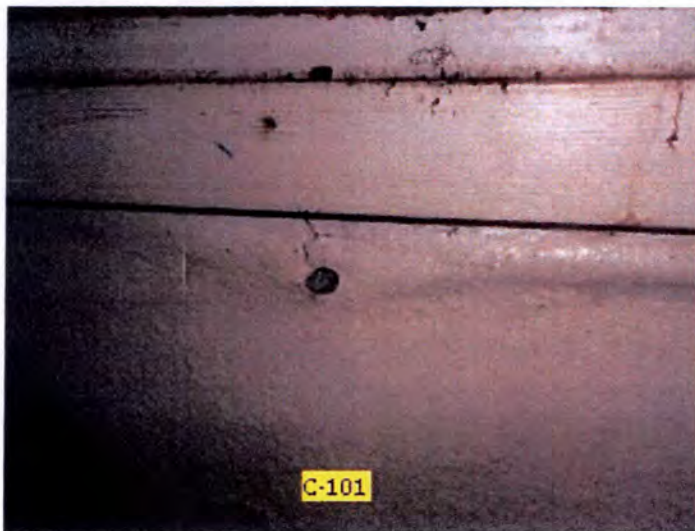
Visible indications of moisture intrusion and mold growth at building B and C interior, bedroom, bathroom and closet wall areas. Recommend removal and replacement of all interior wall finishes of B and C, after removal of all exterior vegetation.

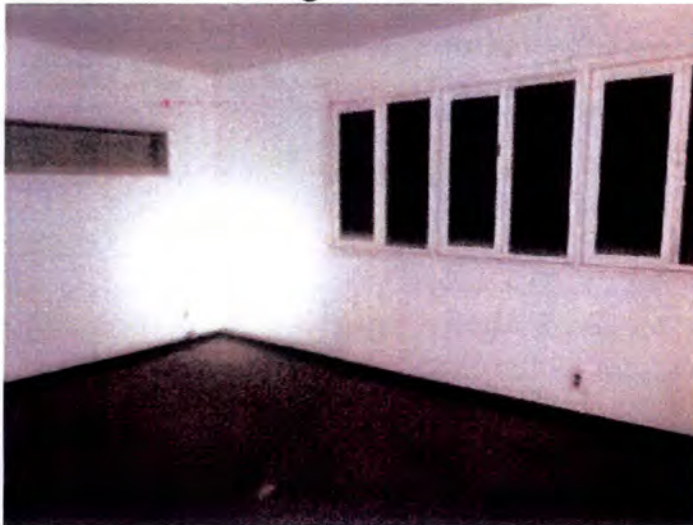
Most of the exterior facing lower interior wall finishes had moisture damage observed. Recommend removal and replacement of affected materials.

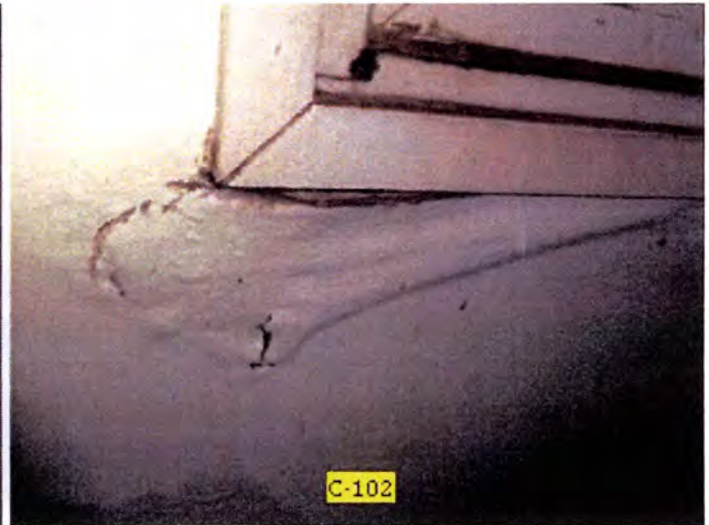
Visible indications of moisture intrusion and mold growth at building B and C interior, bedroom, bathroom and closet wall areas. Recommend removal and replacement of all interior wall finishes of B and C, after removal of all exterior vegetation.

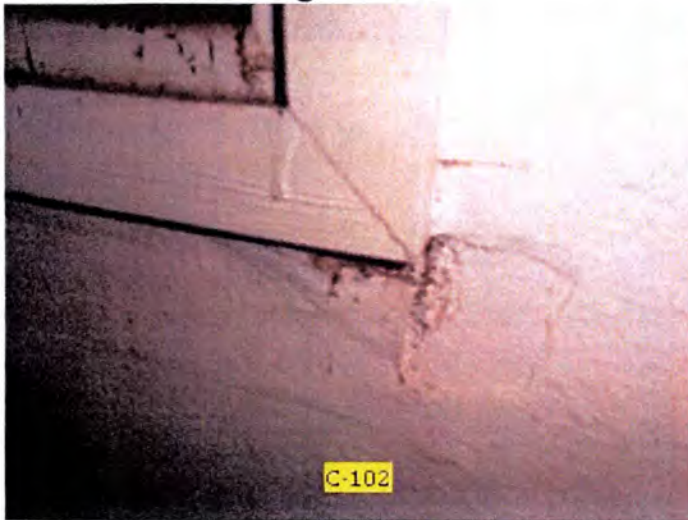
Most of the exterior facing lower interior wall finishes had moisture damage observed. Recommend removal and replacement of affected materials.

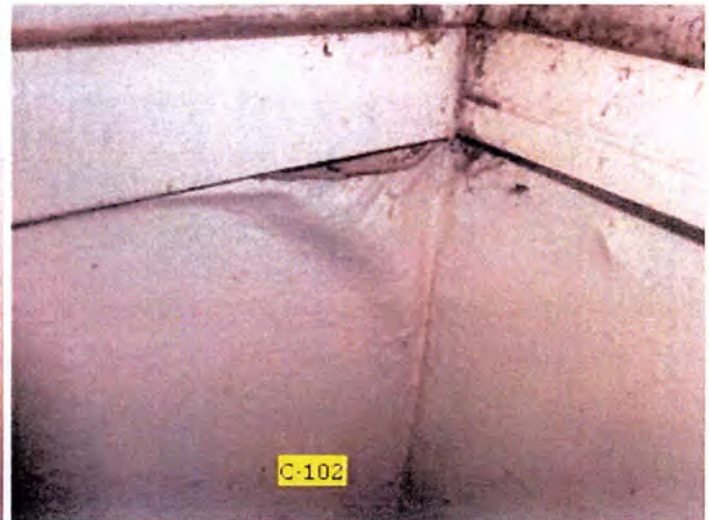
Most of the exterior facing lower interior wall finishes had moisture damage observed. Recommend removal and replacement of affected materials.

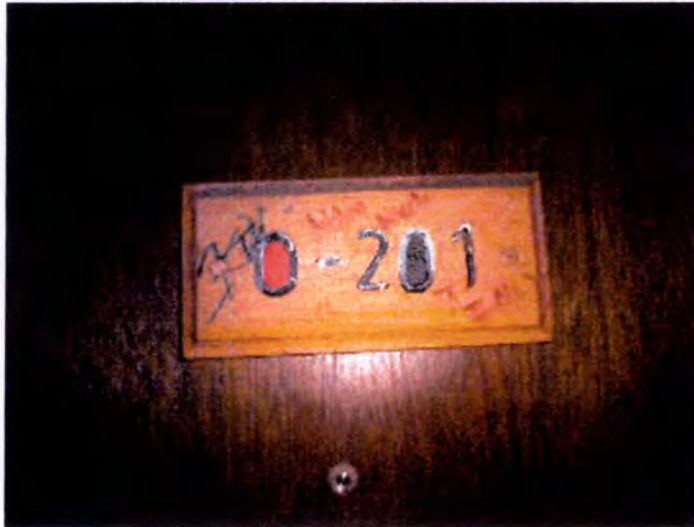
Visible mold observed at interior doors.

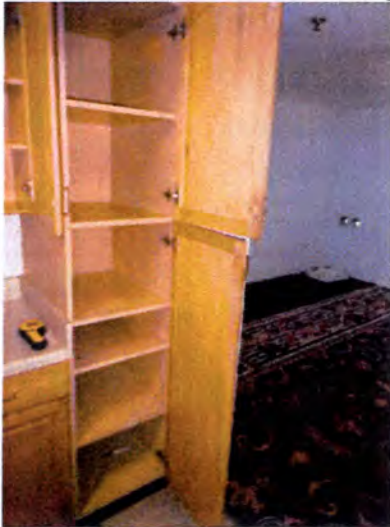
The kitchens in building A appeared to be functional at the time of inspection.

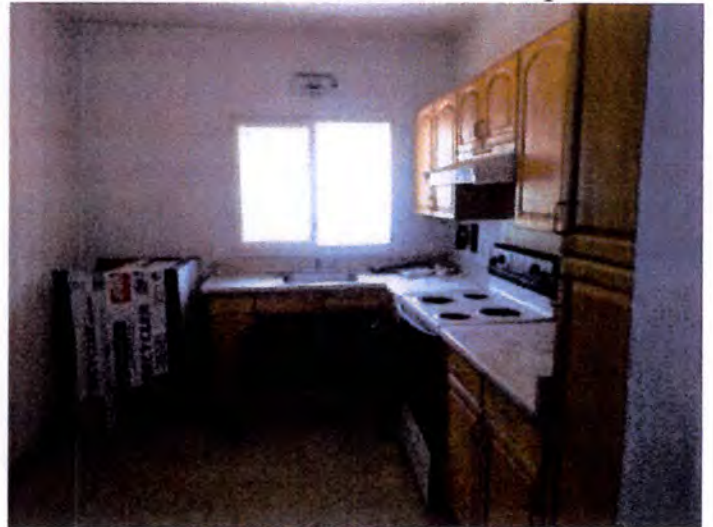
The kitchens in building A appeared to be functional at the time of inspection.

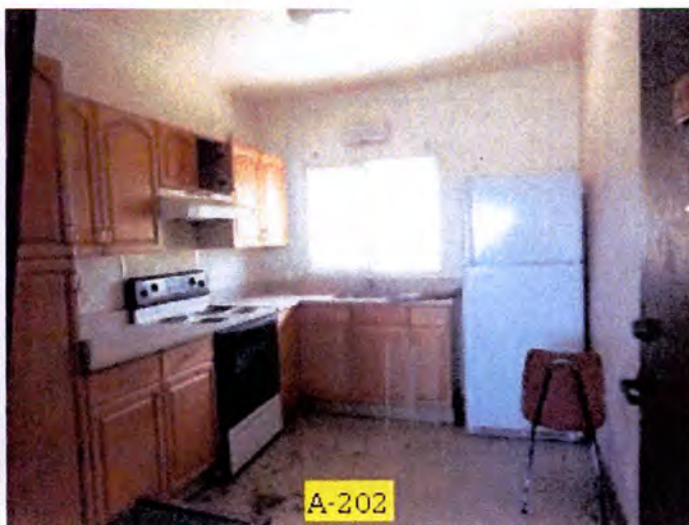
The kitchens in building A appeared to be functional at the time of inspection.

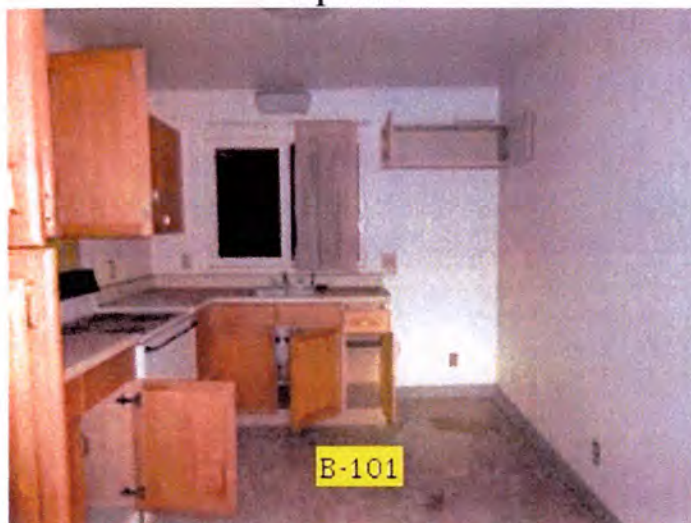
The kitchens of buildings B and C were deteriorated with moisture damage, termite damage and general damage observed at the cabinets, counters and finishes. Recommend the replacement of all dwelling unit kitchens, fixtures and appliances.

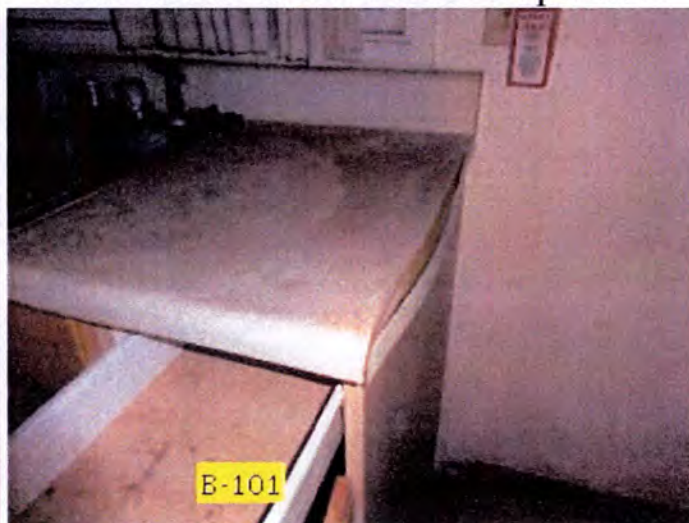
The kitchens of buildings B and C were deteriorated with moisture damage, termite damage and general damage observed at the cabinets, counters and finishes. Recommend the replacement of all dwelling unit kitchens, fixtures and appliances.

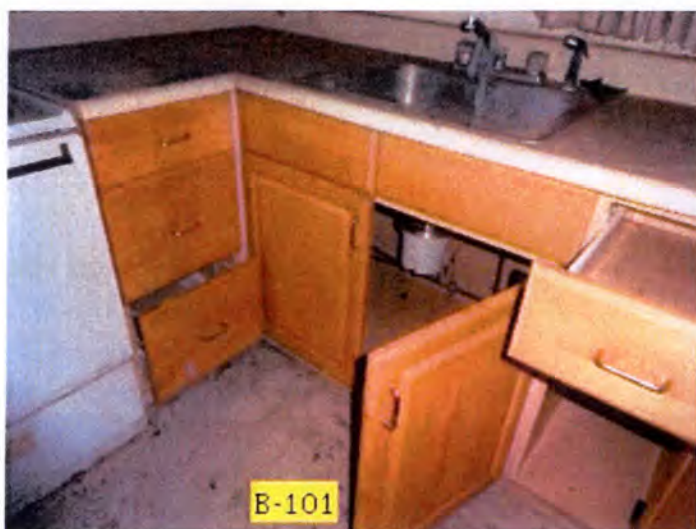
The kitchens of buildings B and C were deteriorated with moisture damage, termite damage and general damage observed at the cabinets, counters and finishes. Recommend the replacement of all dwelling unit kitchens, fixtures and appliances.

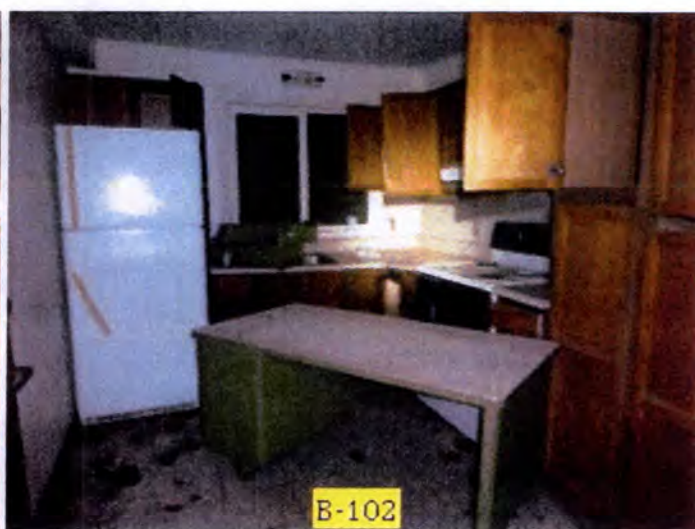
Building B and C ovens did not appear to be functional condition at the time of inspection. Recommend replacement.

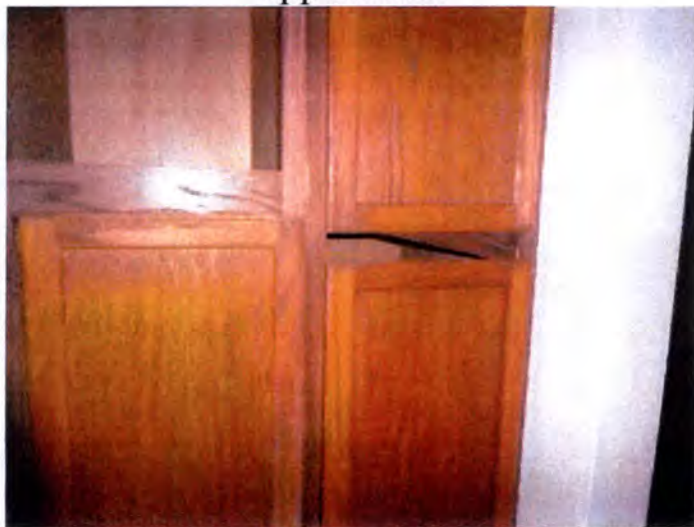
The kitchens of buildings B and C were deteriorated with moisture damage, termite damage and general damage observed at the cabinets, counters and finishes. Recommend the replacement of all dwelling unit kitchens, fixtures and appliances.

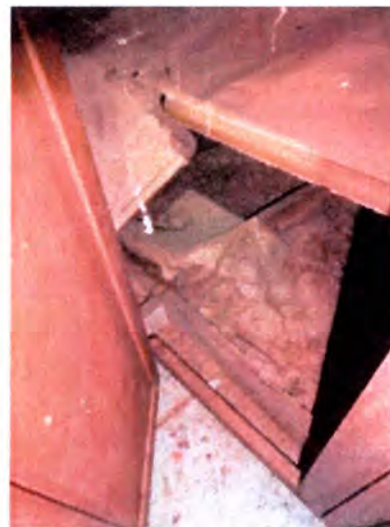
The kitchens of buildings B and C were deteriorated with moisture damage, termite damage and general damage observed at the cabinets, counters and finishes. Recommend the replacement of all dwelling unit kitchens, fixtures and appliances.

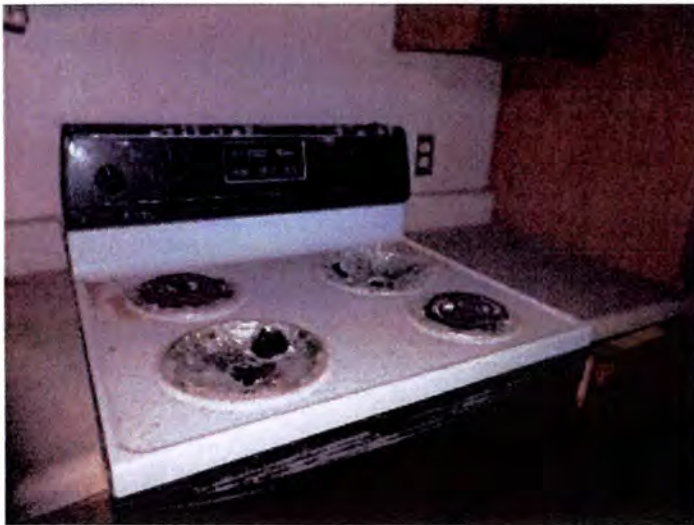
Building B and C ovens did not appear to be functional condition at the time of inspection. Recommend replacement.

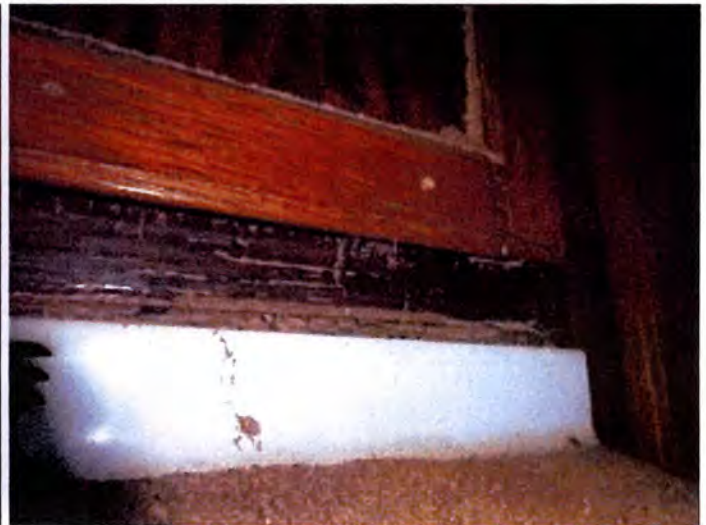
The kitchens of buildings B and C were deteriorated with moisture damage, termite damage and general damage observed at the cabinets, counters and finishes. Recommend the replacement of all dwelling unit kitchens, fixtures and appliances.

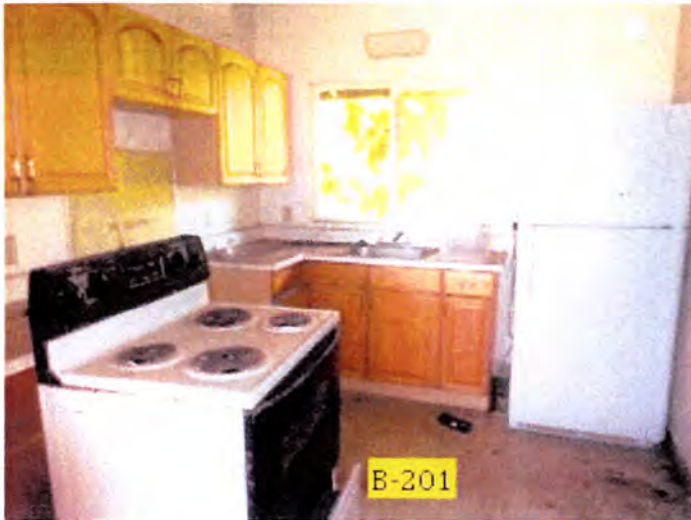
The kitchens of buildings B and C were deteriorated with moisture damage, termite damage and general damage observed at the cabinets, counters and finishes. Recommend the replacement of all dwelling unit kitchens, fixtures and appliances.

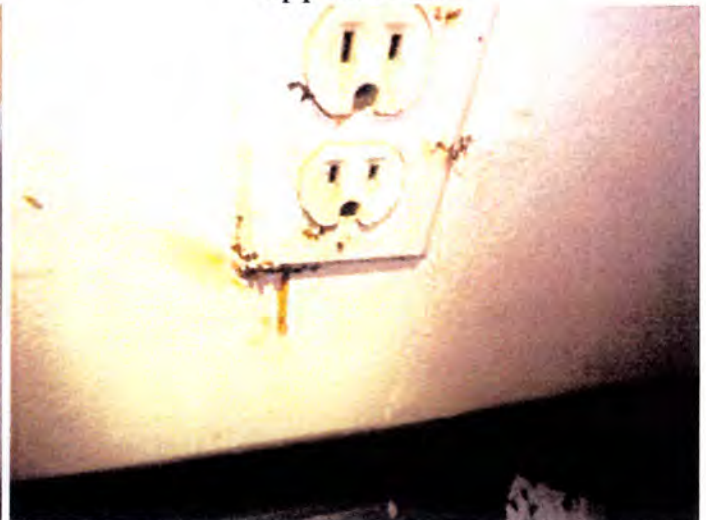
The kitchens of buildings B and C were deteriorated with moisture damage, termite damage and general damage observed at the cabinets, counters and finishes. Recommend the replacement of all dwelling unit kitchens, fixtures and appliances.

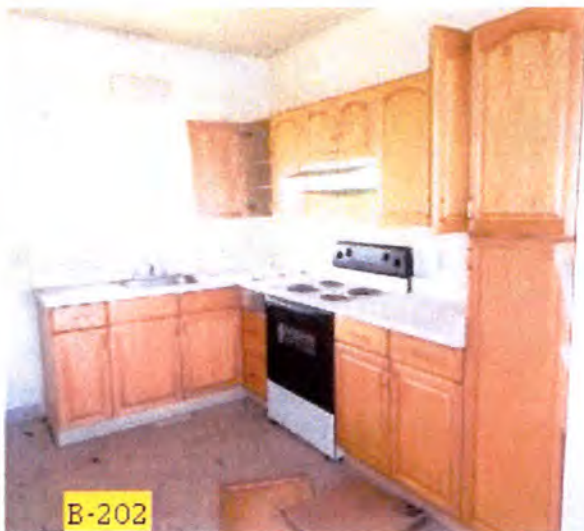
The kitchens of buildings B and C were deteriorated with moisture damage, termite damage and general damage observed at the cabinets, counters and finishes. Recommend the replacement of all dwelling unit kitchens, fixtures and appliances.
