**SUBJECT: COUNTY-OWNED PARCEL ON NORTH PAPA AVENUE (KAHULUI)  
(HHT-14)**

## Property Condition Report

310 W Kaahumanu Ave, Kahului, HI 96732  
Inspection prepared for: Maui County c/o Buddy Almeida  
Real Estate Agent: -

This is a commercial property condition assessment to determine if three (3) former UH dormitories are suitable for housing. This inspection includes invasive and non-invasive inspection methods as well as sampling for asbestos and lead based paint.

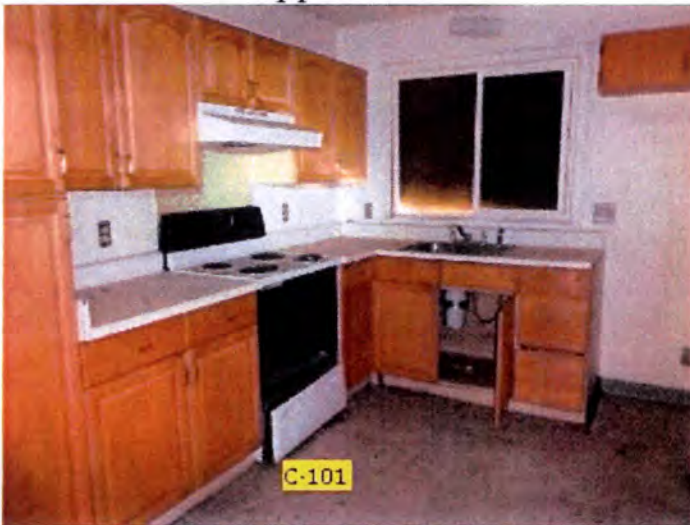
The kitchens of buildings B and C were deteriorated with moisture damage, termite damage and general damage observed at the cabinets, counters and finishes. Recommend the replacement of all dwelling unit kitchens, fixtures and appliances.

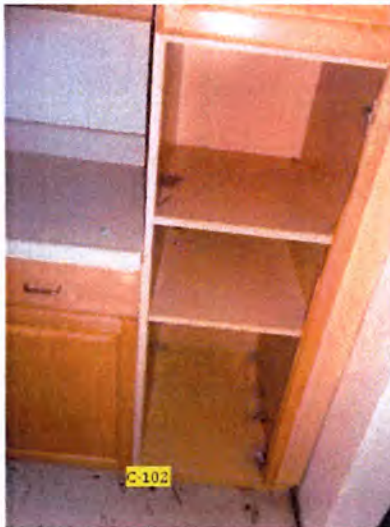
The kitchens of buildings B and C were deteriorated with moisture damage, termite damage and general damage observed at the cabinets, counters and finishes. Recommend the replacement of all dwelling unit kitchens, fixtures and appliances.

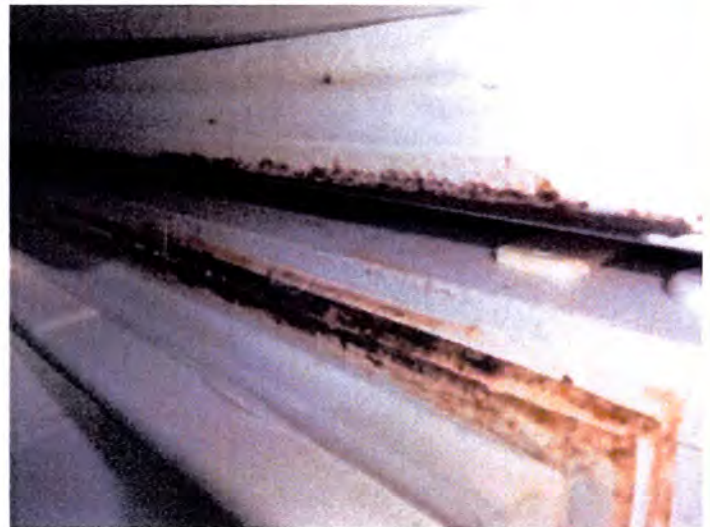
Recommend replacement of all refrigeration units located in the kitchens. The appliances in building A did not cool when turned on and the appliances in B and C had mold growth observed.

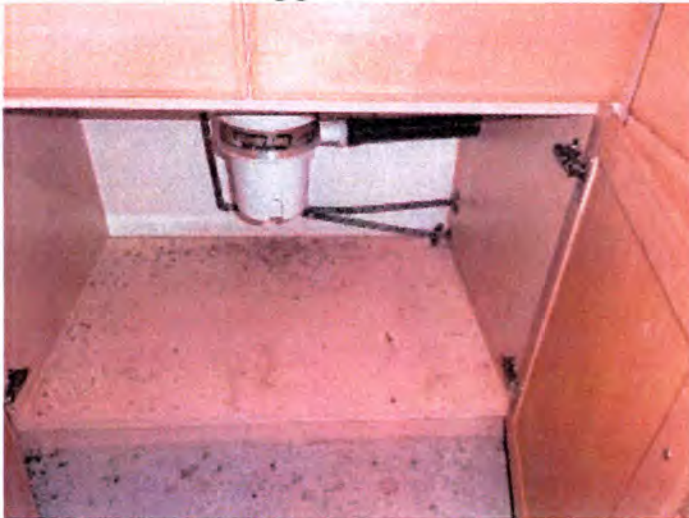
The kitchens of buildings B and C were deteriorated with moisture damage, termite damage and general damage observed at the cabinets, counters and finishes. Recommend the replacement of all dwelling unit kitchens, fixtures and appliances.

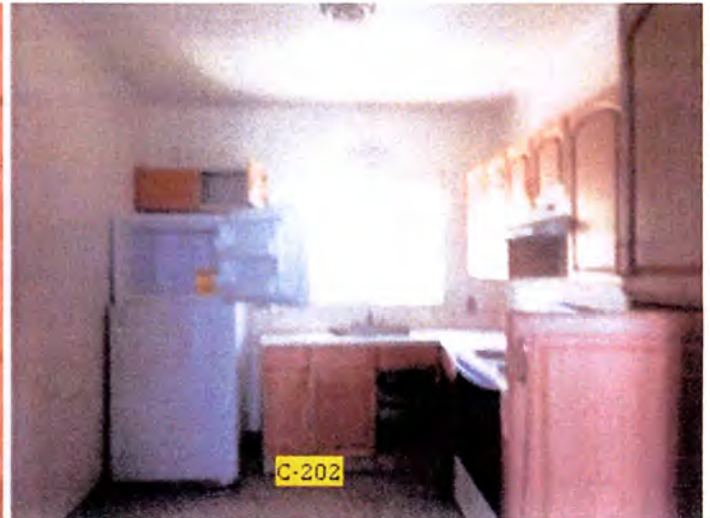
The kitchens of buildings B and C were deteriorated with moisture damage, termite damage and general damage observed at the cabinets, counters and finishes. Recommend the replacement of all dwelling unit kitchens, fixtures and appliances.

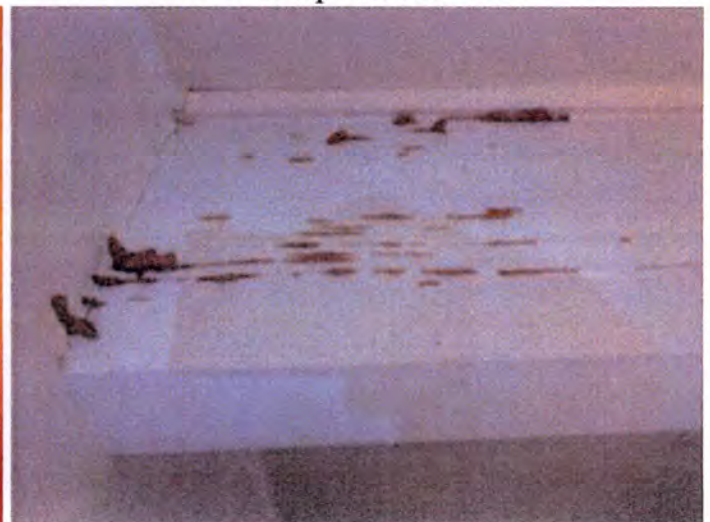
B-201: Ceiling joists were severely termite damaged and need to be repaired/replaced.

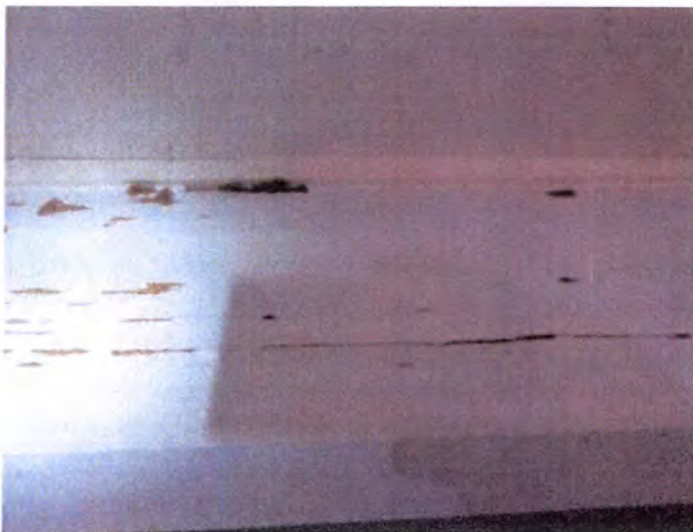
B-201: Ceiling joists were severely termite damaged and need to be repaired/replaced.

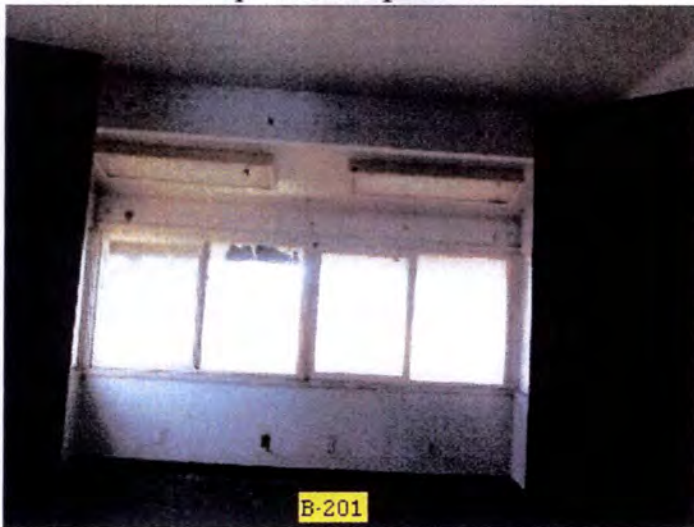
Each dwelling unit was serviced by two (2) sleeping rooms at the time of inspection.

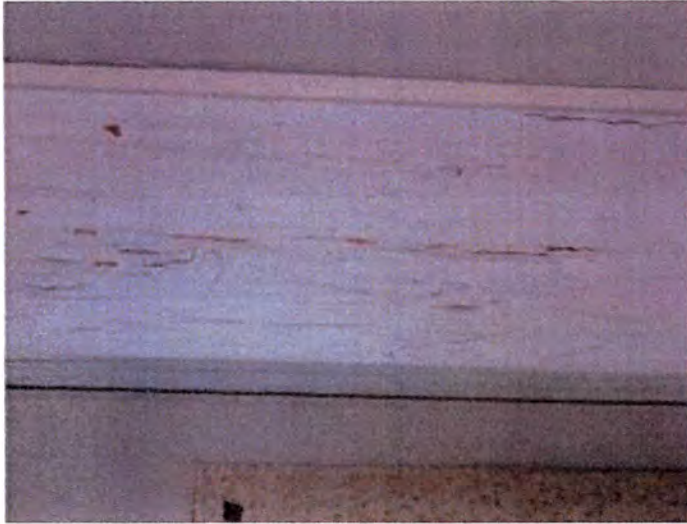
B-201: Ceiling joists were severely termite damaged and need to be repaired/replaced.

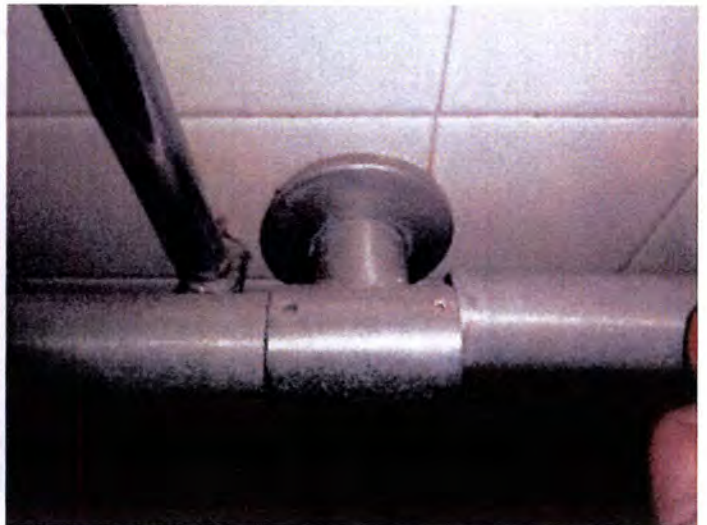
Bldg A bathroom hand rails need to be repaired.

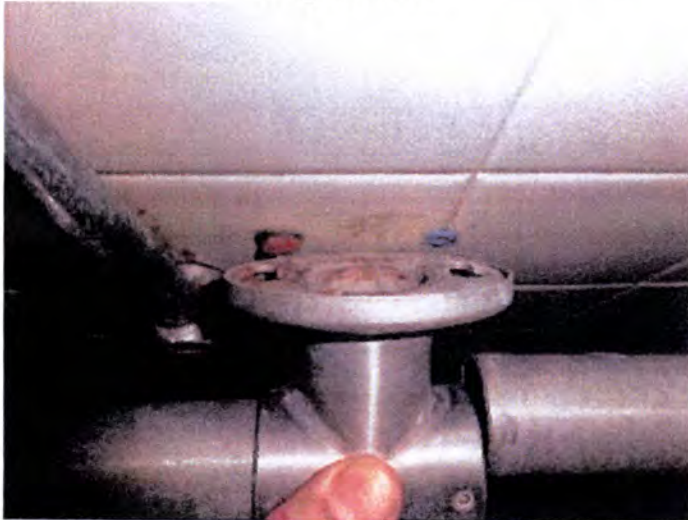
Bldg A bathroom hand rails need to be repaired.

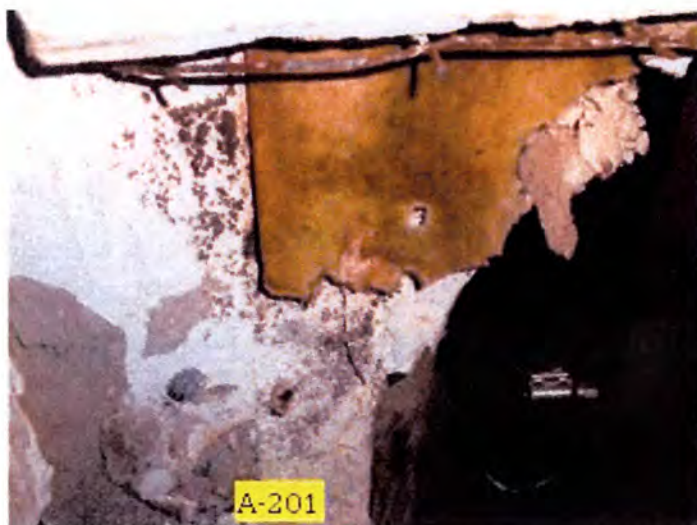
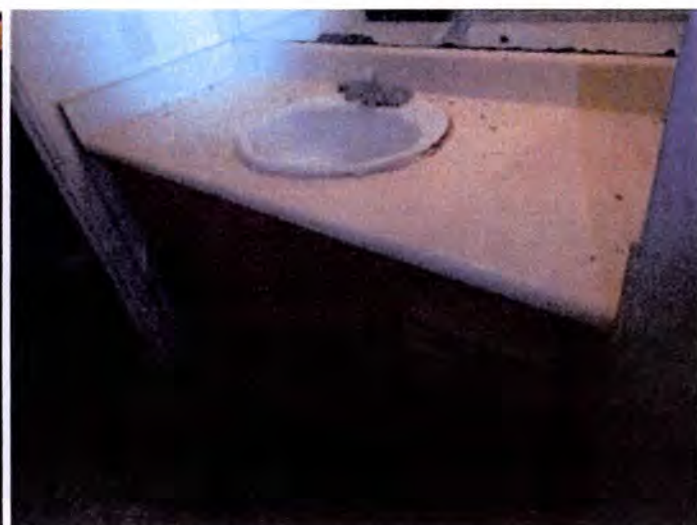
There were visible indications of moisture damage, mold growth, damaged flooring, damaged cabinets and counters, damaged mirrors, damaged toilets and damaged shower compartments observed at the time of inspection. Based on the observed conditions on site, we recommend the replacement of all dwelling unit bathrooms.

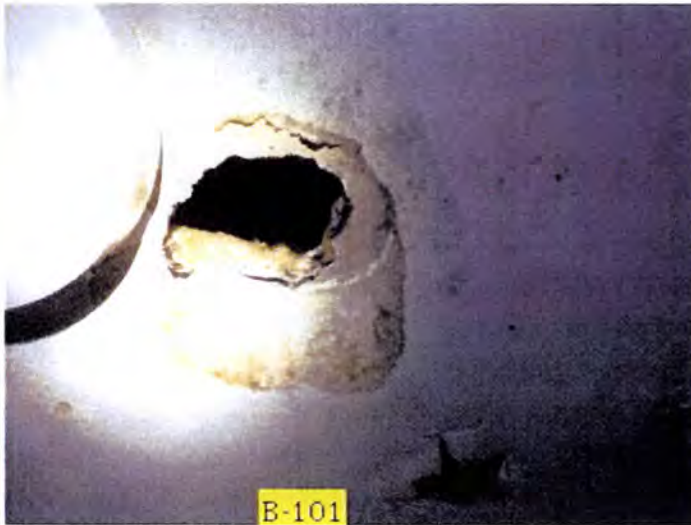
There were visible indications of moisture damage, mold growth, damaged flooring, damaged cabinets and counters, damaged mirrors, damaged toilets and damaged shower compartments observed at the time of inspection. Based on the observed conditions on site, we recommend the replacement of all dwelling unit bathrooms.

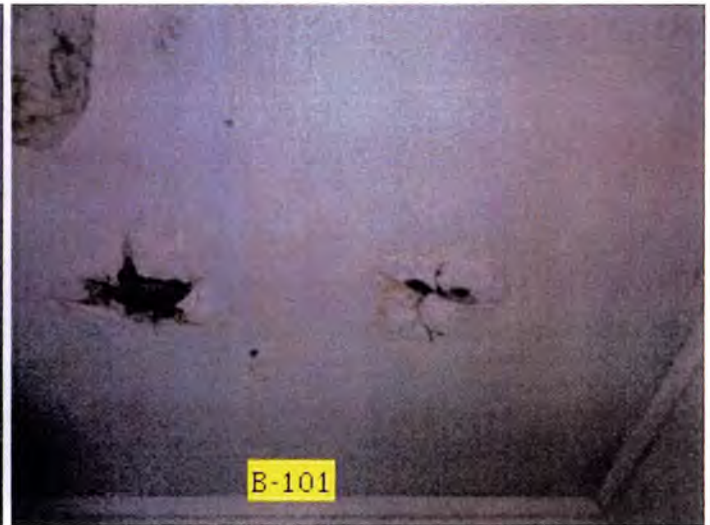
There were visible indications of moisture damage, mold growth, damaged flooring, damaged cabinets and counters, damaged mirrors, damaged toilets and damaged shower compartments observed at the time of inspection. Based on the observed conditions on site, we recommend the replacement of all dwelling unit bathrooms.

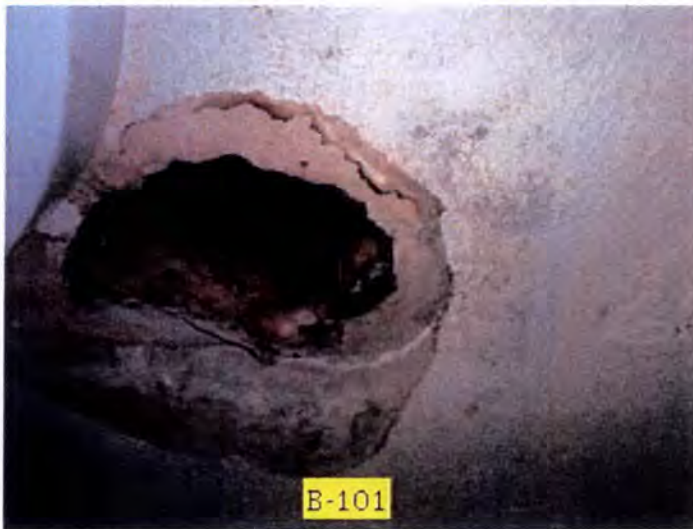
There were visible indications of moisture damage, mold growth, damaged flooring, damaged cabinets and counters, damaged mirrors, damaged toilets and damaged shower compartments observed at the time of inspection. Based on the observed conditions on site, we recommend the replacement of all dwelling unit bathrooms.

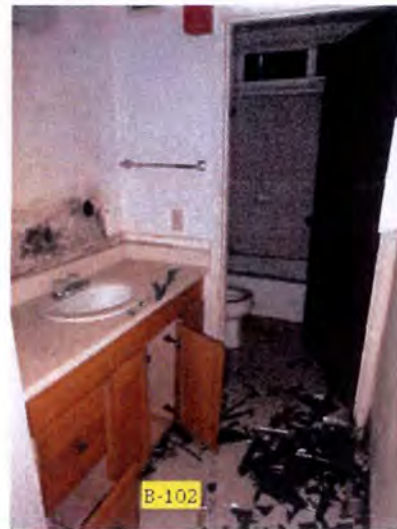
There were visible indications of moisture damage, mold growth, damaged flooring, damaged cabinets and counters, damaged mirrors, damaged toilets and damaged shower compartments observed at the time of inspection. Based on the observed conditions on site, we recommend the replacement of all dwelling unit bathrooms.

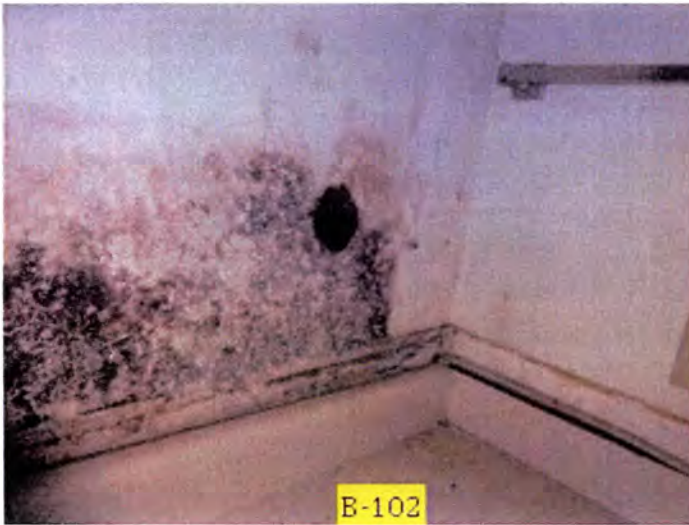
There were visible indications of moisture damage, mold growth, damaged flooring, damaged cabinets and counters, damaged mirrors, damaged toilets and damaged shower compartments observed at the time of inspection. Based on the observed conditions on site, we recommend the replacement of all dwelling unit bathrooms.

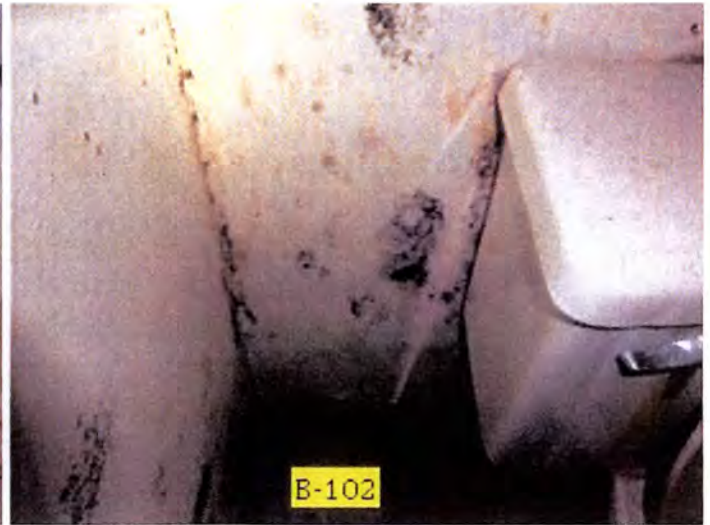
There were visible indications of moisture damage, mold growth, damaged flooring, damaged cabinets and counters, damaged mirrors, damaged toilets and damaged shower compartments observed at the time of inspection. Based on the observed conditions on site, we recommend the replacement of all dwelling unit bathrooms.

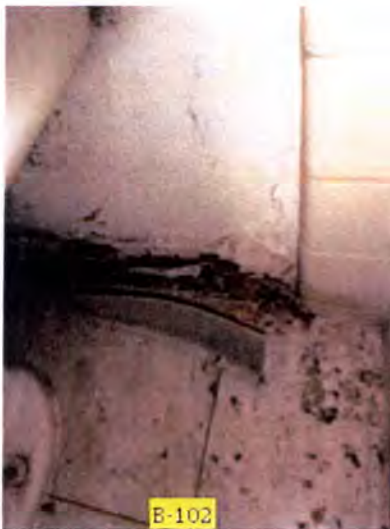
There were visible indications of moisture damage, mold growth, damaged flooring, damaged cabinets and counters, damaged mirrors, damaged toilets and damaged shower compartments observed at the time of inspection. Based on the observed conditions on site, we recommend the replacement of all dwelling unit bathrooms.

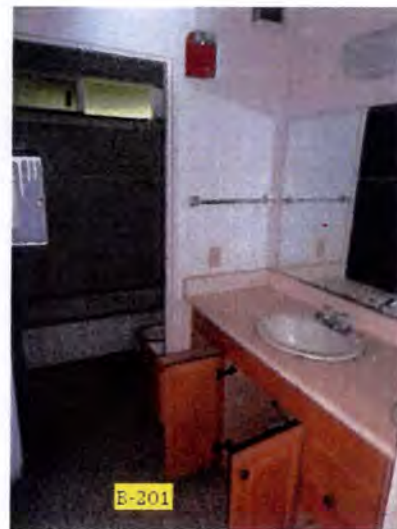
There were visible indications of moisture damage, mold growth, damaged flooring, damaged cabinets and counters, damaged mirrors, damaged toilets and damaged shower compartments observed at the time of inspection. Based on the observed conditions on site, we recommend the replacement of all dwelling unit bathrooms.

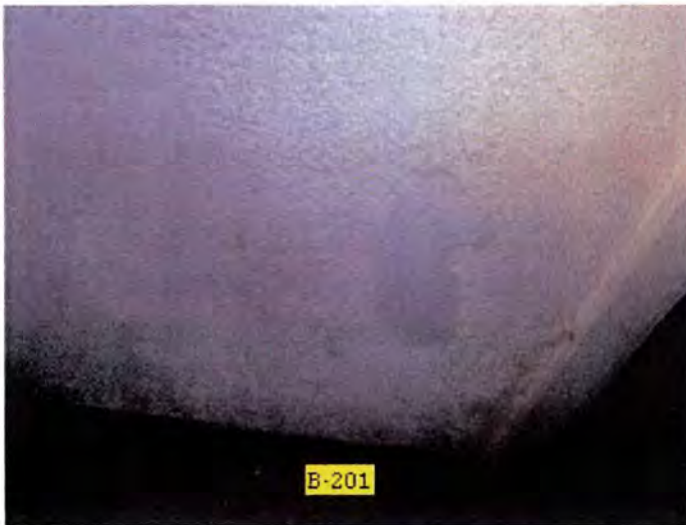
There were visible indications of moisture damage, mold growth, damaged flooring, damaged cabinets and counters, damaged mirrors, damaged toilets and damaged shower compartments observed at the time of inspection. Based on the observed conditions on site, we recommend the replacement of all dwelling unit bathrooms.

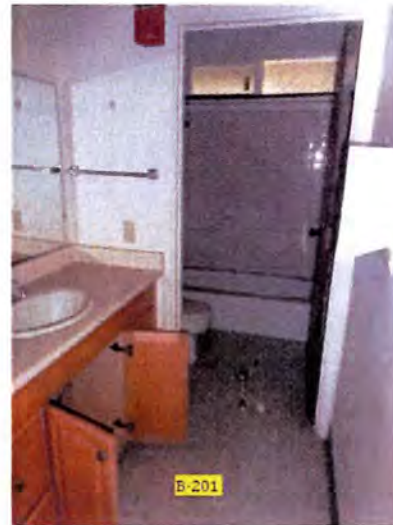
There were visible indications of moisture damage, mold growth, damaged flooring, damaged cabinets and counters, damaged mirrors, damaged toilets and damaged shower compartments observed at the time of inspection. Based on the observed conditions on site, we recommend the replacement of all dwelling unit bathrooms.

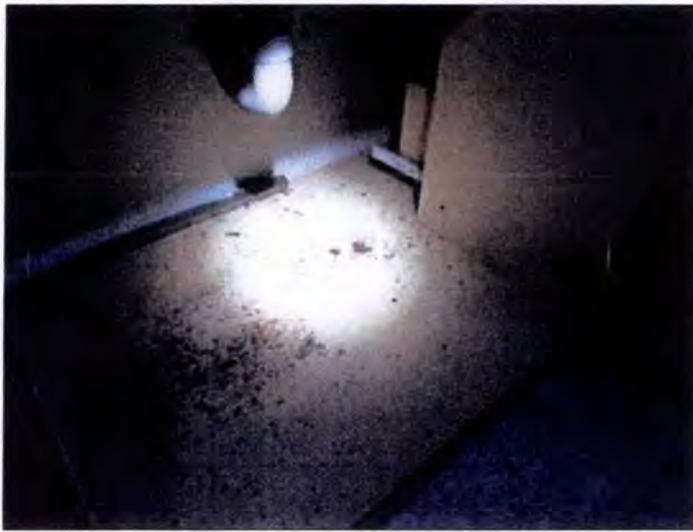
There were visible indications of moisture damage, mold growth, damaged flooring, damaged cabinets and counters, damaged mirrors, damaged toilets and damaged shower compartments observed at the time of inspection. Based on the observed conditions on site, we recommend the replacement of all dwelling unit bathrooms.

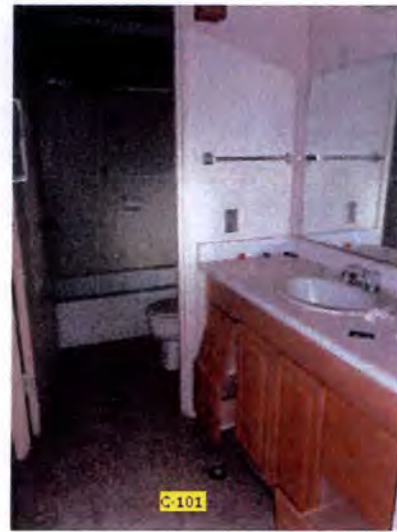
There were visible indications of moisture damage, mold growth, damaged flooring, damaged cabinets and counters, damaged mirrors, damaged toilets and damaged shower compartments observed at the time of inspection. Based on the observed conditions on site, we recommend the replacement of all dwelling unit bathrooms.

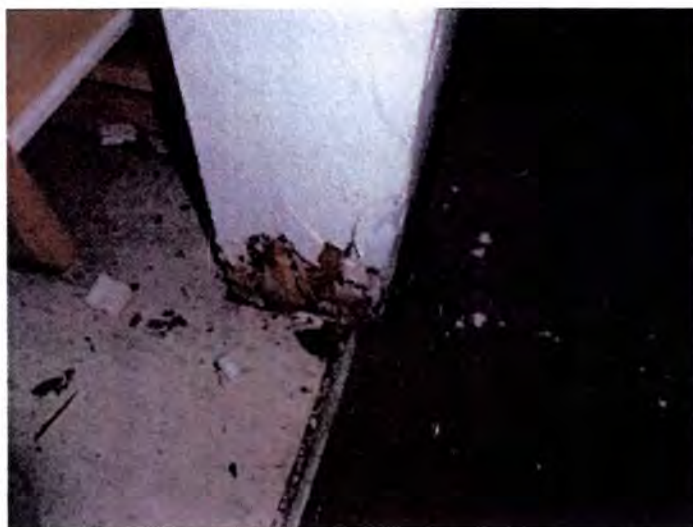
There were visible indications of moisture damage, mold growth, damaged flooring, damaged cabinets and counters, damaged mirrors, damaged toilets and damaged shower compartments observed at the time of inspection. Based on the observed conditions on site, we recommend the replacement of all dwelling unit bathrooms.

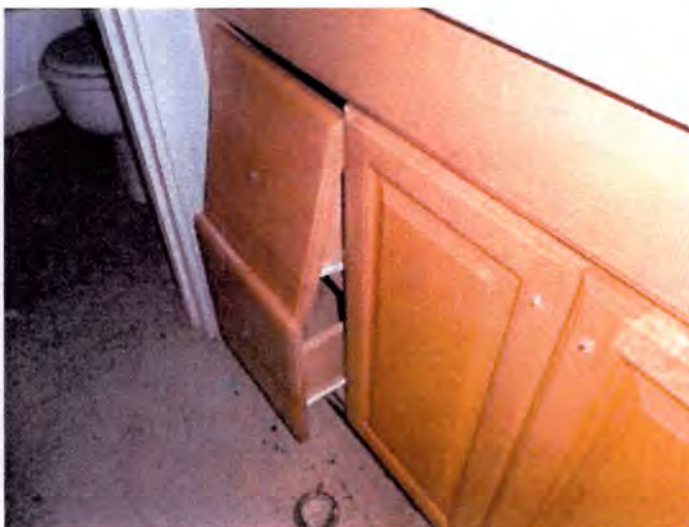
There were visible indications of moisture damage, mold growth, damaged flooring, damaged cabinets and counters, damaged mirrors, damaged toilets and damaged shower compartments observed at the time of inspection. Based on the observed conditions on site, we recommend the replacement of all dwelling unit bathrooms.

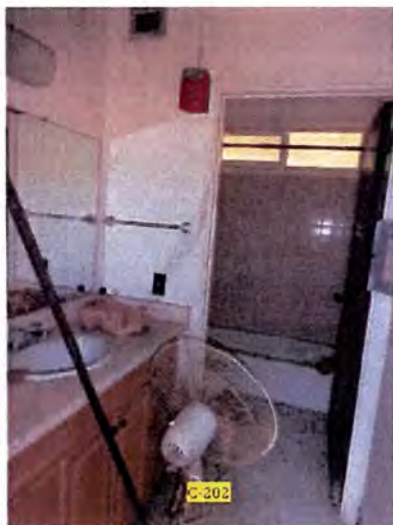
There were visible indications of moisture damage, mold growth, damaged flooring, damaged cabinets and counters, damaged mirrors, damaged toilets and damaged shower compartments observed at the time of inspection. Based on the observed conditions on site, we recommend the replacement of all dwelling unit bathrooms.

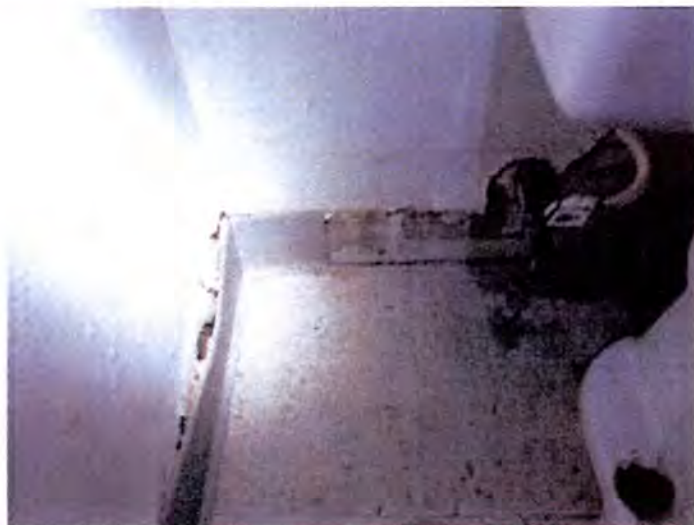
There were visible indications of moisture damage, mold growth, damaged flooring, damaged cabinets and counters, damaged mirrors, damaged toilets and damaged shower compartments observed at the time of inspection. Based on the observed conditions on site, we recommend the replacement of all dwelling unit bathrooms.

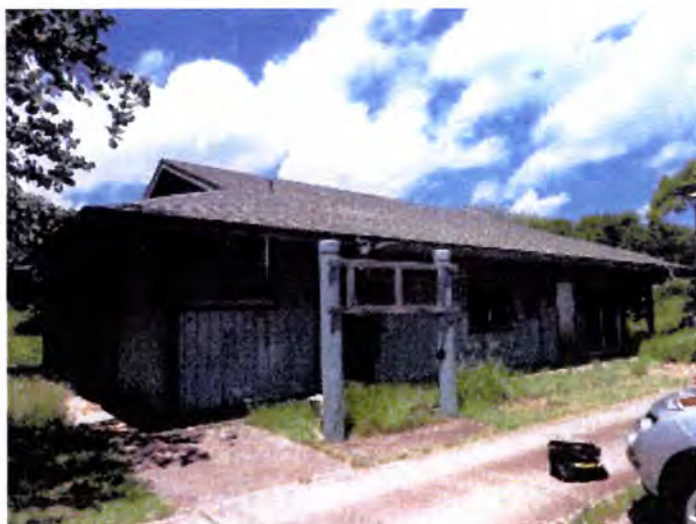
There was a hazardous bee population observed on site at the time of inspection. The single story storage building had sections of front wall removed for past been removal. The left side of the building had extensive and constant activity observed. There were been nests also observed at other exterior and interior locations through out the property.

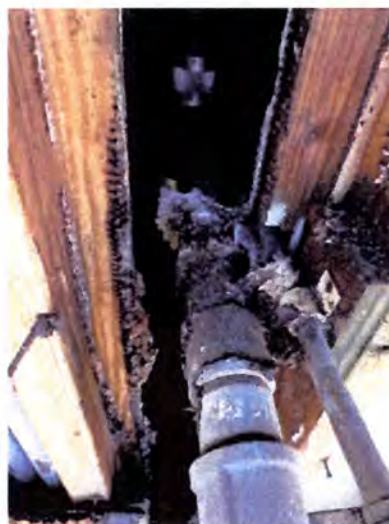
There was a hazardous bee population observed on site at the time of inspection. The single story storage building had sections of front wall removed for past been removal. The left side of the building had extensive and constant activity observed. There were been nests also observed at other exterior and interior locations through out the property.

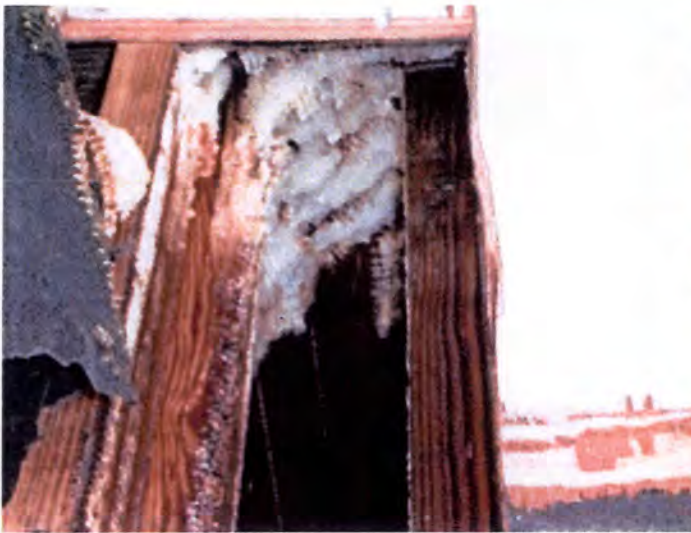
There was a hazardous bee population observed on site at the time of inspection. The single story storage building had sections of front wall removed for past been removal. The left side of the building had extensive and constant activity observed. There were been nests also observed at other exterior and interior locations through out the property.

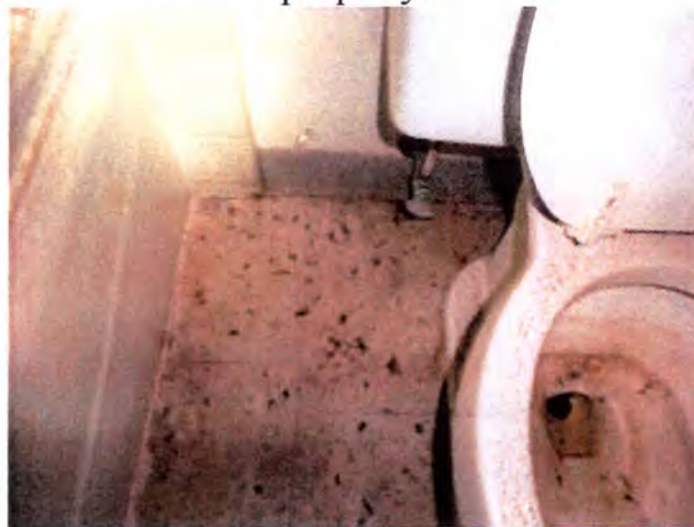
There was extensive pest (ie: cockroach) infestation observed at the interior and/or exterior areas of the building.

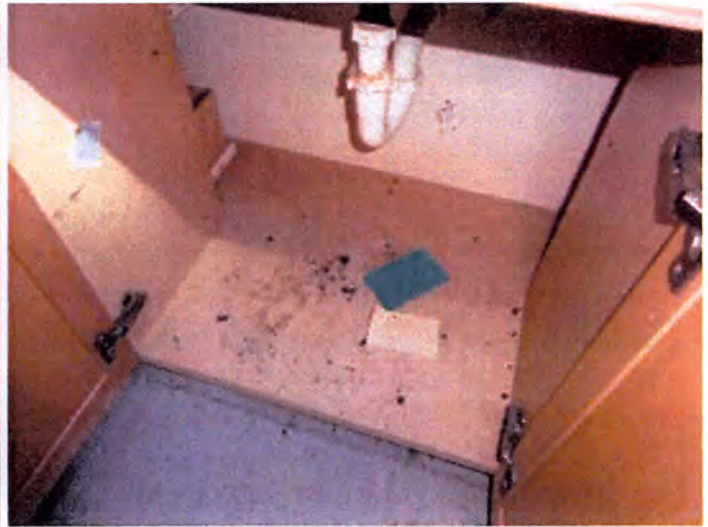
There was extensive pest (ie: cockroach) infestation observed at the interior and/or exterior areas of the building.

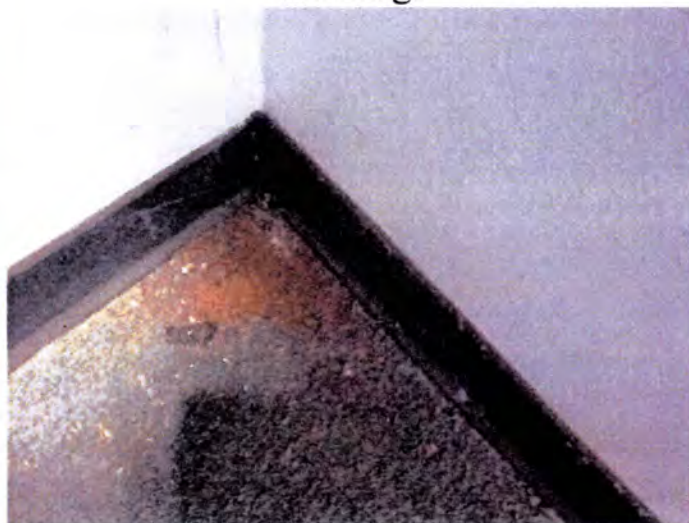
There was moderate/extensive termite/moisture damage observed at the interior and/or exterior areas of the building.

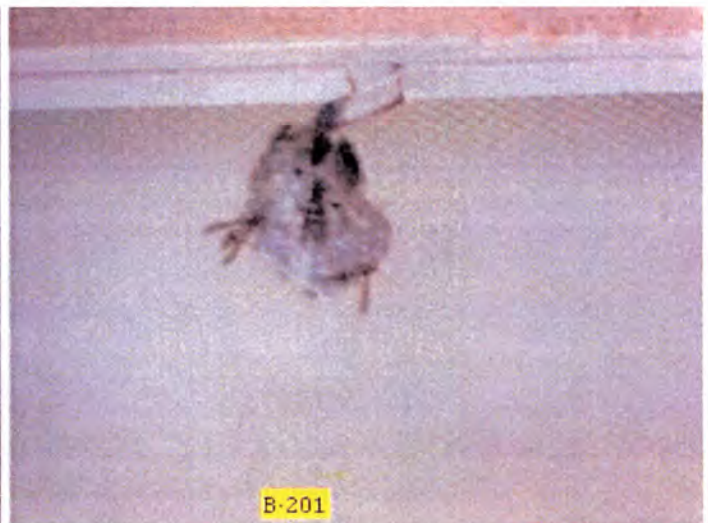
There was a hazardous bee population observed on site at the time of inspection. The single story storage building had sections of front wall removed for past been removal. The left side of the building had extensive and constant activity observed. There were been nests also observed at other exterior and interior locations through out the property.

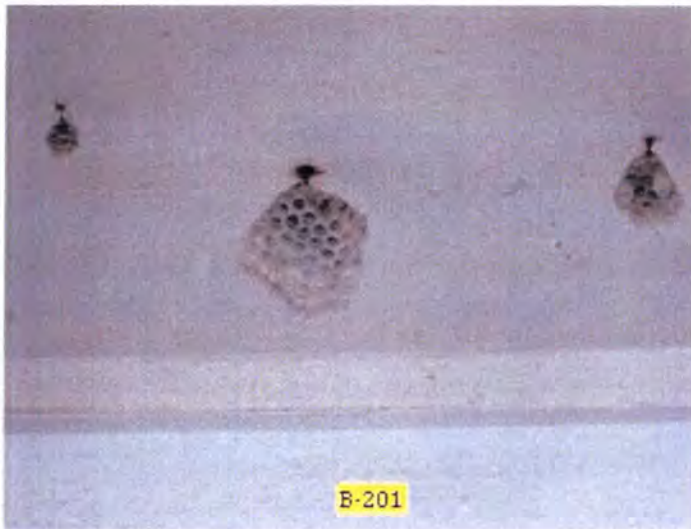
There was a hazardous bee population observed on site at the time of inspection. The single story storage building had sections of front wall removed for past been removal. The left side of the building had extensive and constant activity observed. There were been nests also observed at other exterior and interior locations through out the property.

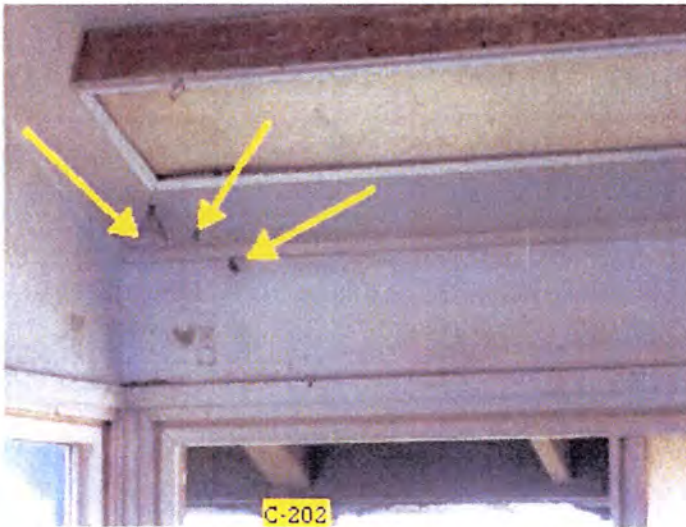
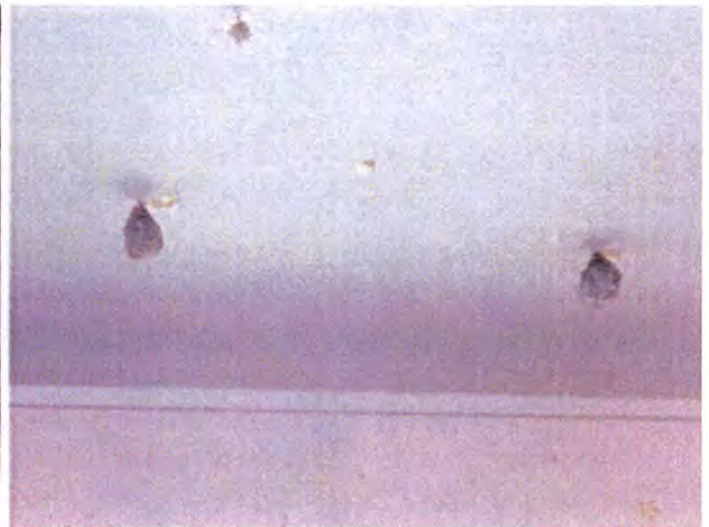
There was a hazardous bee population observed on site at the time of inspection. The single story storage building had sections of front wall removed for past been removal. The left side of the building had extensive and constant activity observed. There were been nests also observed at other exterior and interior locations through out the property.

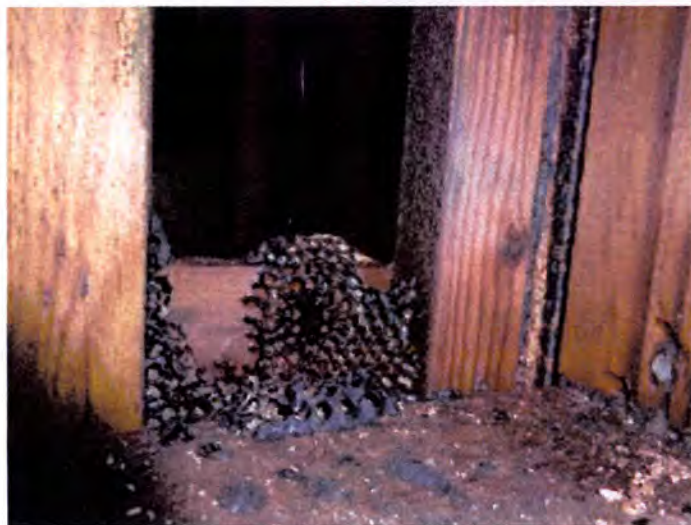
Some of the areas were inaccessible due to the presence of a robust bee population outside and inside of the buildings.

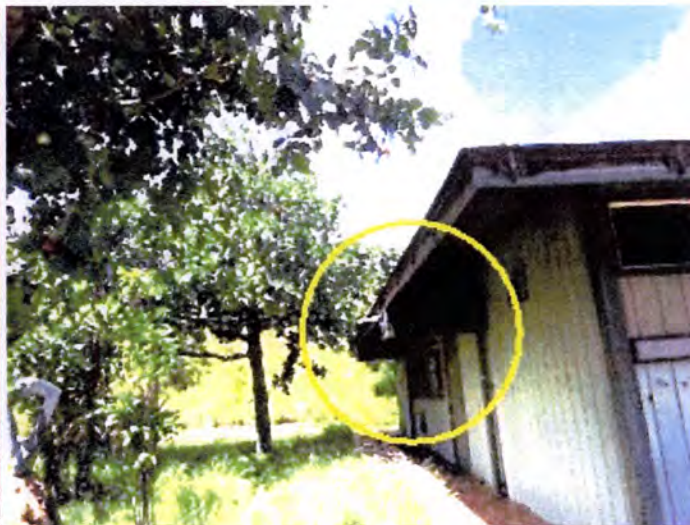
Some of the areas were inaccessible due to the presence of a robust bee population outside and inside of the buildings.

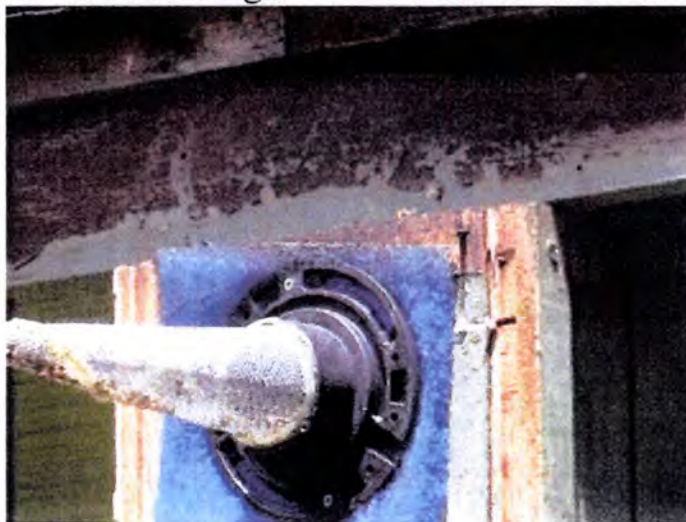
Some of the areas were inaccessible due to the presence of a robust bee population outside and inside of the buildings.
