Property Condition Report

310 W Kaahumanu Ave, Kahului, HI 96732
Inspection prepared for: Maui County c/o Buddy Almeida
Real Estate Agent: -

Date of Inspection: 3/28/2018 Time: 8:00 AM
Age of Home: 1980 Size: 15000

This is a commercial property condition assessment to determine if three (3) former UH dormitories are suitable for housing. This inspection includes invasive and non-invasive inspection methods as well as sampling for asbestos and lead based paint.

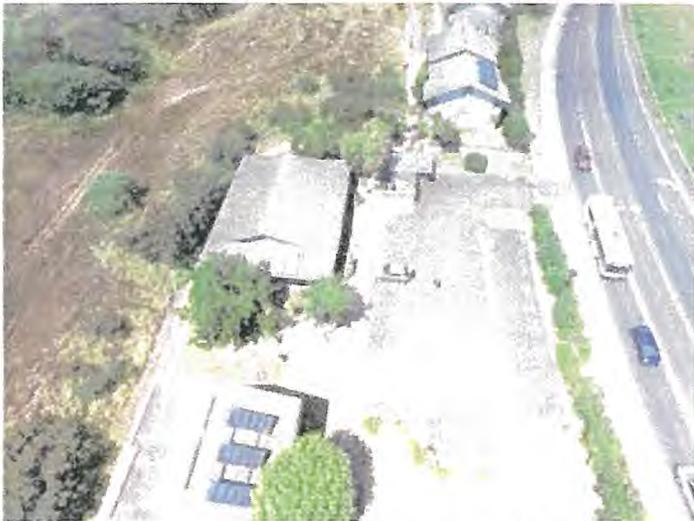
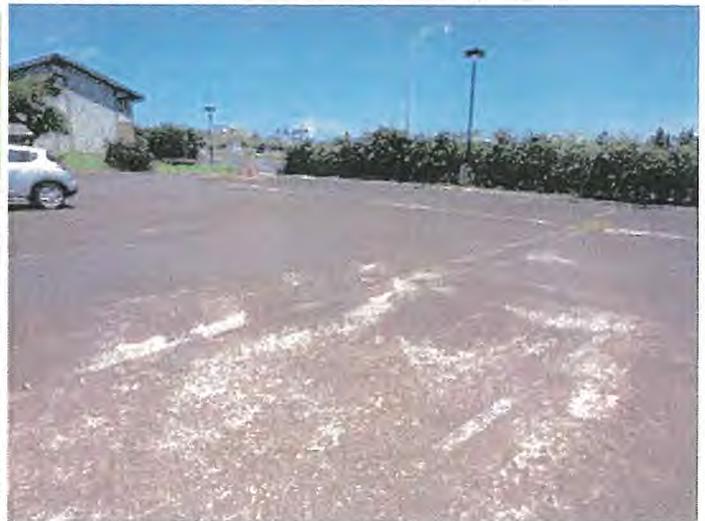
The parking area surface was deteriorated with lines weathered to the point of not providing clear lanes for parking use. Recommend having the parking area resurfaced and striped to ensure proper identification of parking stalls.

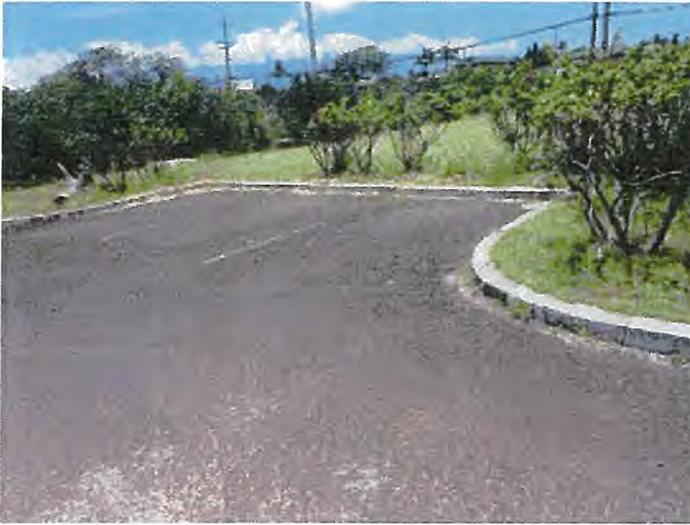
The parking area surface was deteriorated with lines weathered to the point of not providing clear lanes for parking use. Recommend having the parking area resurfaced and striped to ensure proper identification of parking stalls.

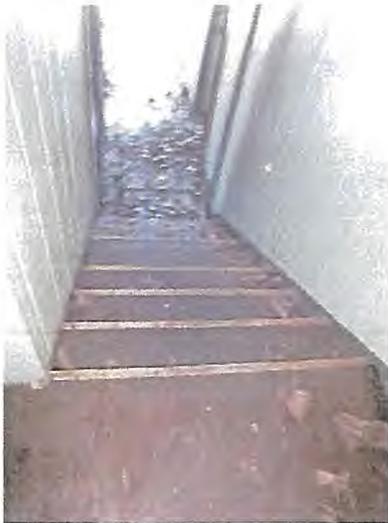
Bldg A hand rail was missing. Recommend installation as required.

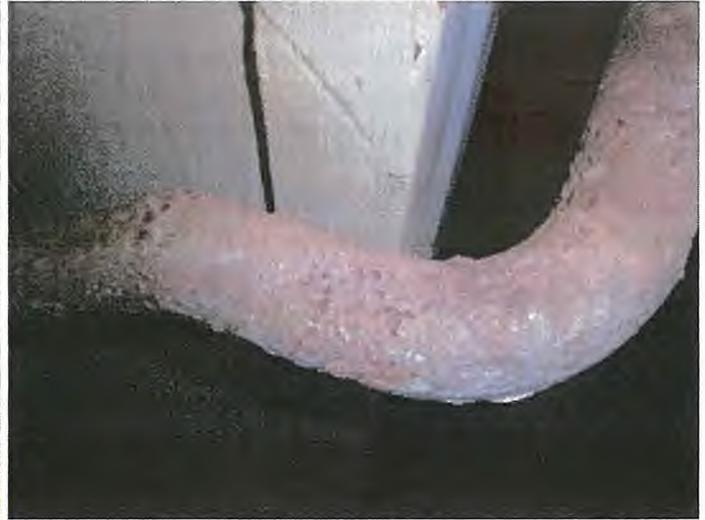
Exterior stair handrails were corroded and need to be cleaned, treated and refinished.

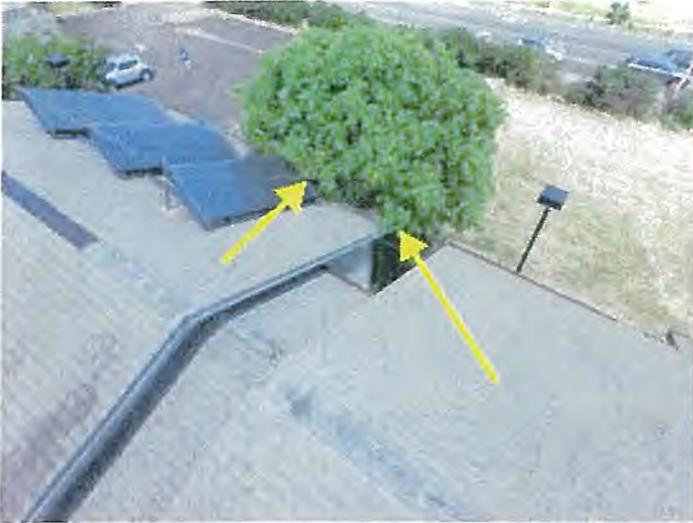
The vegetation was overgrown and causing deterioration/damage to the exterior curtain wall and fixtures.

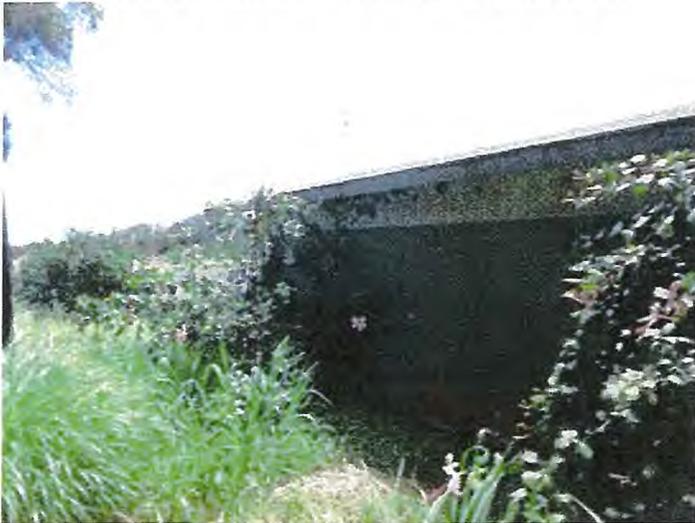
Vegetation was overgrown and in need of removal in many areas.

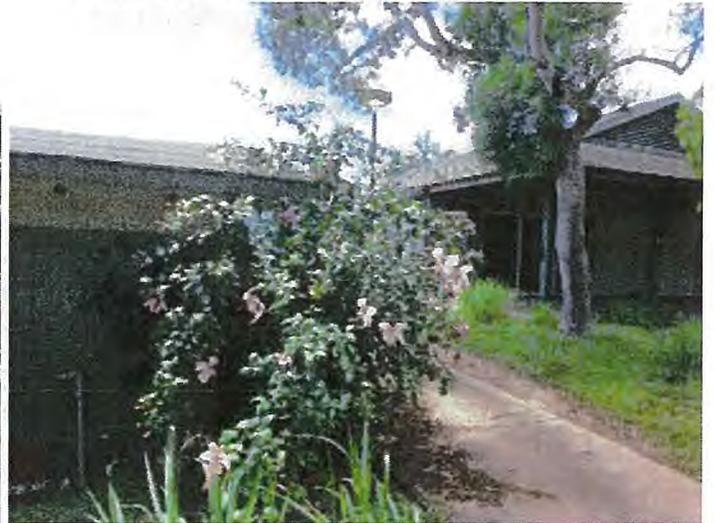
Vegetation was overgrown and in need of removal in many areas.

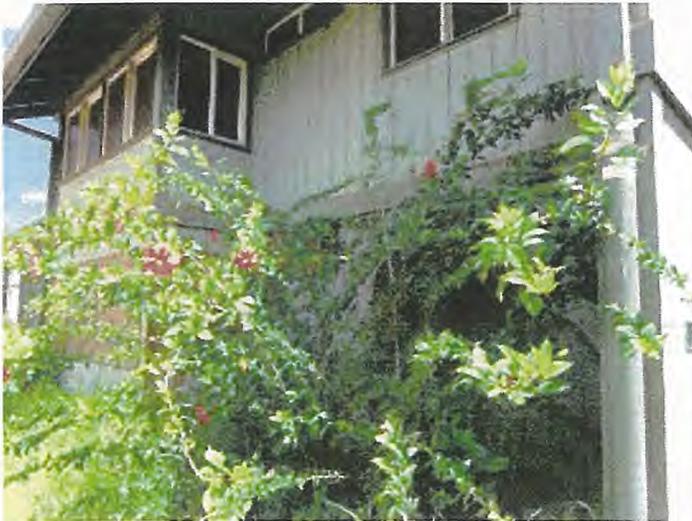
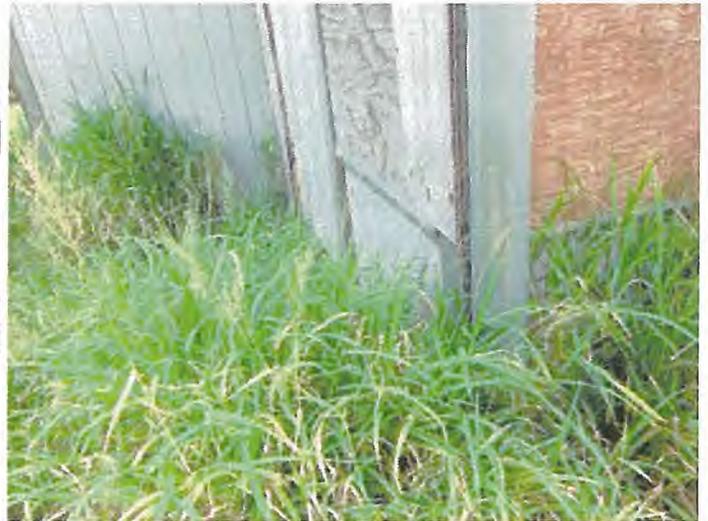
There were numerous trees contacting the building curtain walls and roof areas. Vegetation was overgrown and in need of removal in many areas.

These areas appeared to have damage/deterioration noted at the time of inspection. Recommend having a licensed landscape contractor/arborist evaluate and trim vegetation and trees as necessary.

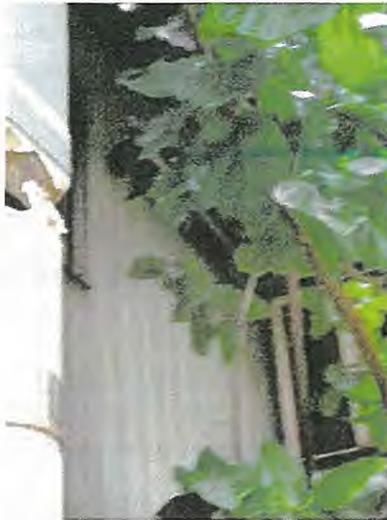
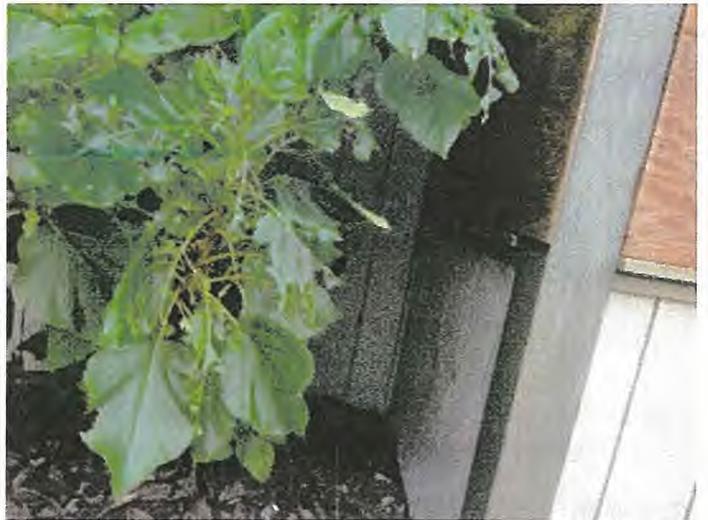
There were numerous trees contacting the building curtain walls and roof areas. Vegetation was overgrown and in need of removal in many areas.

These areas appeared to have damage/deterioration noted at the time of inspection. Recommend having a licensed landscape contractor/arborist evaluate and trim vegetation and trees as necessary.

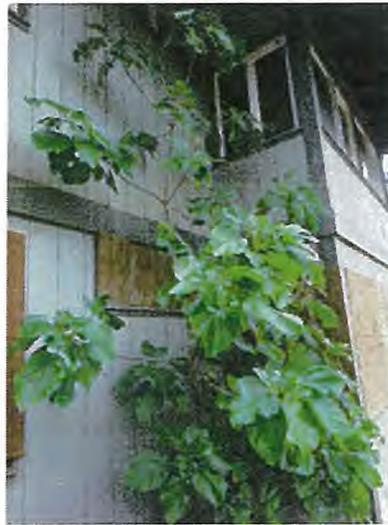
There were numerous trees contacting the building curtain walls and roof areas. These areas appeared to have damage/deterioration noted at the time of inspection. Recommend having a licensed landscape contractor/arborist evaluate and trim vegetation and trees as necessary.

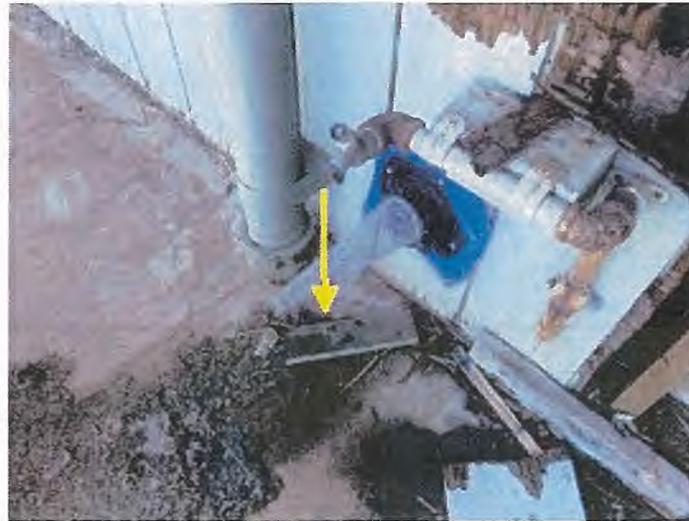
Some of the exterior hose bibs had slow dripping leaks observed at the time of inspection. Recommend repair.

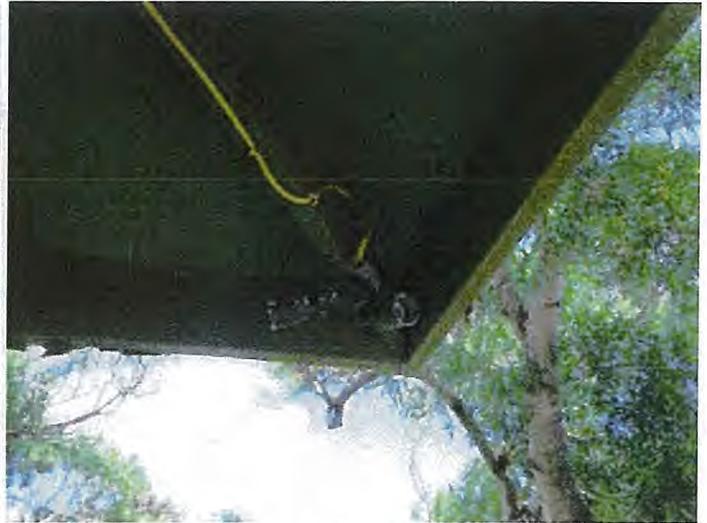
Some of the exterior lighting fixtures were damaged and need to be replaced.

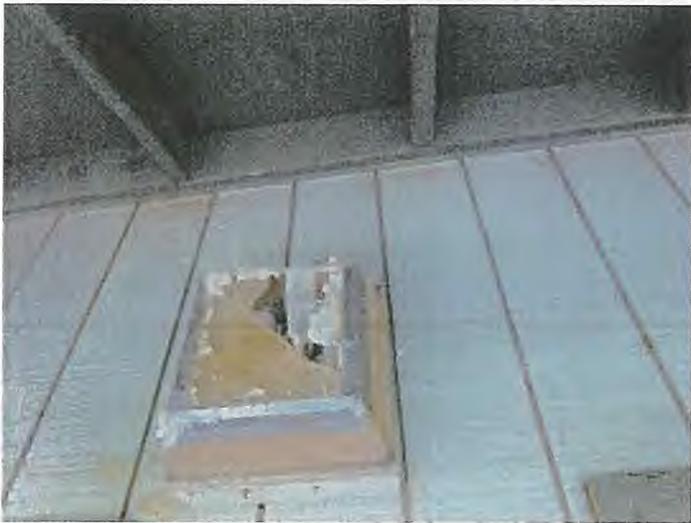
Some of the exterior lighting fixtures were damaged and need to be replaced.

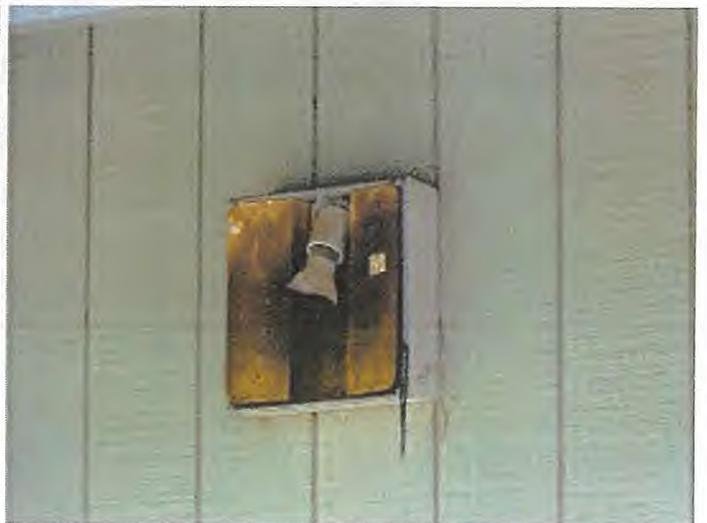
Some of the exterior lighting fixtures were damaged and need to be replaced.

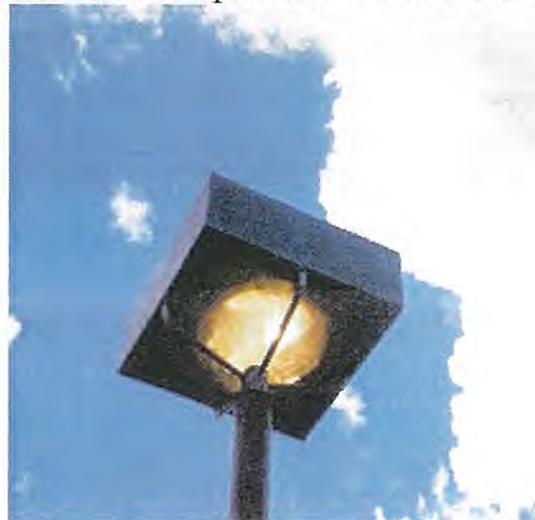
Some of the exterior lighting fixtures were damaged and need to be replaced.

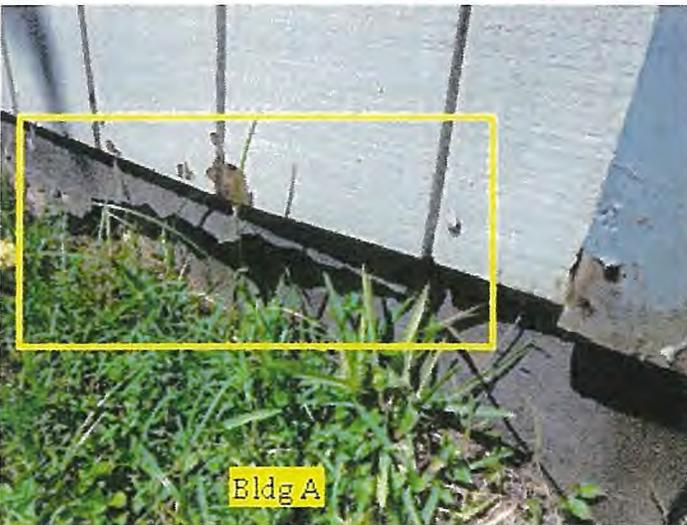
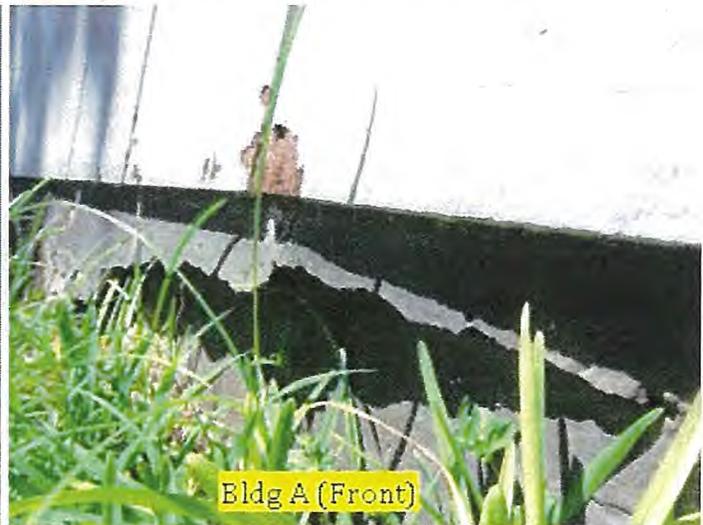
Building A and B: Visible cracks observed at the foundational areas of the buildings. There were separations observed along the defect areas which represent movement between the faults. We recommend having a licensed foundation/masonry contractor evaluate and repair the affected areas as necessary to prevent further damage.

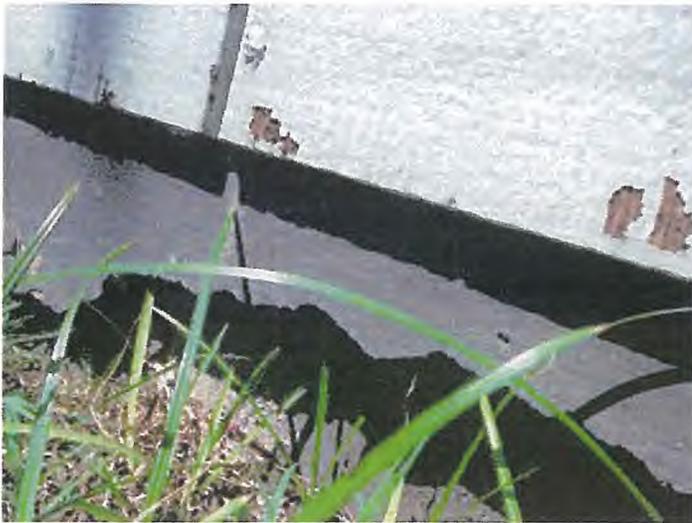
Building A and B: Visible cracks observed at the foundational areas of the buildings. There were separations observed along the defect areas which represent movement between the faults.

We recommend having a licensed foundation/masonry contractor evaluate and repair the affected areas as necessary to prevent further damage.

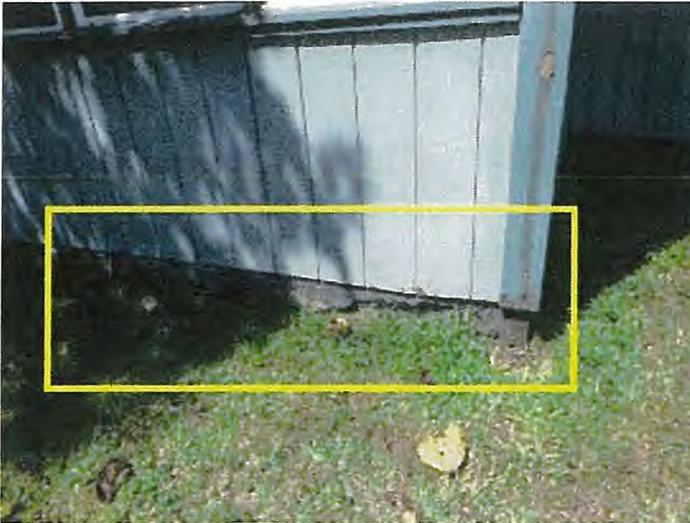
Building A and B: Visible cracks observed at the foundational areas of the buildings. There were separations observed along the defect areas which represent movement between the faults.

We recommend having a licensed foundation/masonry contractor evaluate and repair the affected areas as necessary to prevent further damage.

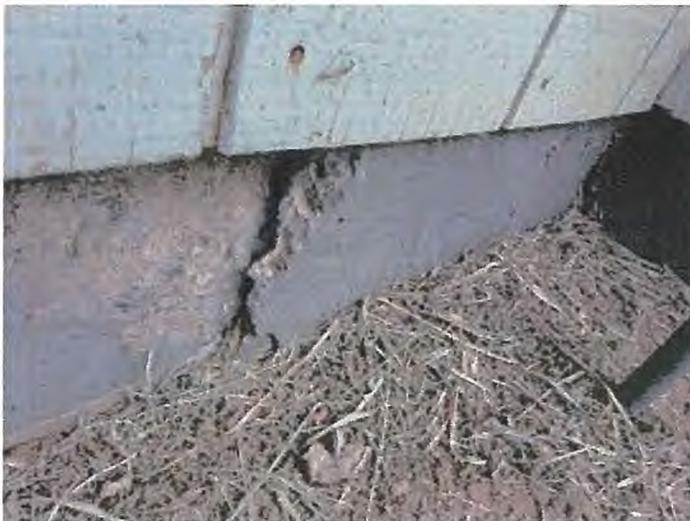
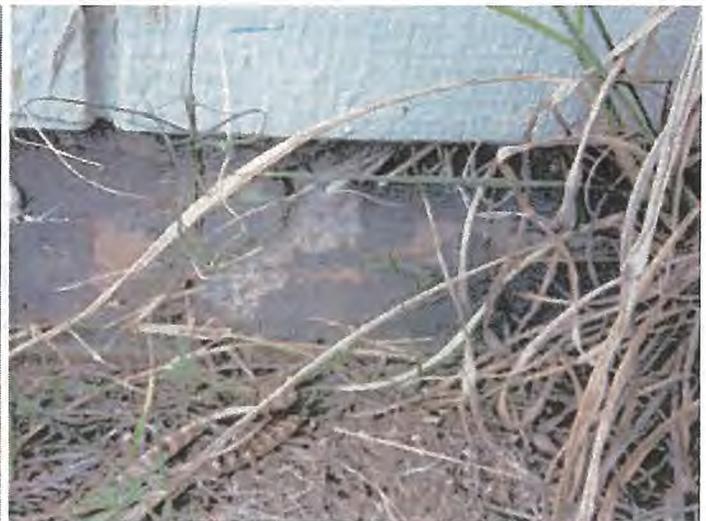
Building A and B: Visible cracks observed at the foundational areas of the buildings. There were separations observed along the defect areas which represent movement between the faults. We recommend having a licensed foundation/masonry contractor evaluate and repair the affected areas as necessary to prevent further damage.

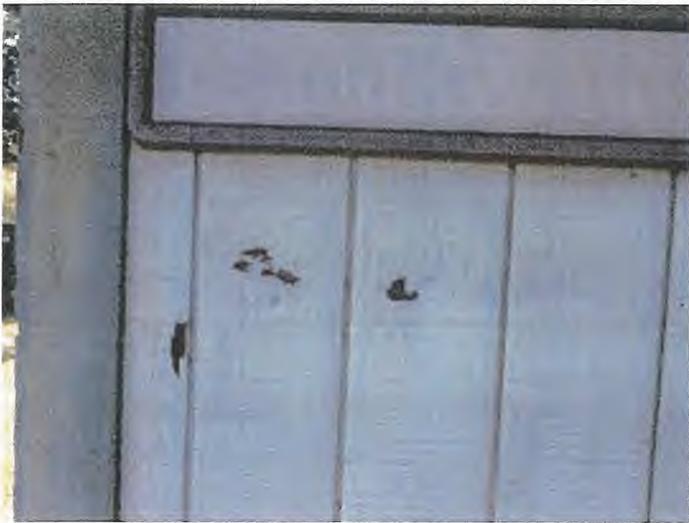
Visible indications of WDO (termite) damage noted. Recommend having a licensed pest contractor evaluate and treat as necessary. Also, recommend having a licensed contractor evaluate and repair/replace damaged material as necessary.

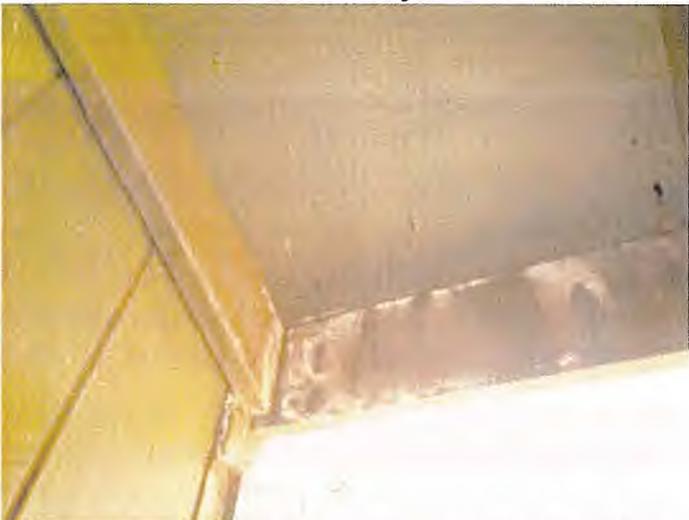
The fascia/soffit areas appeared to be rotted/water damaged/deteriorated at the time of inspection. Recommend having a licensed contractor evaluate and repair/replace as necessary.

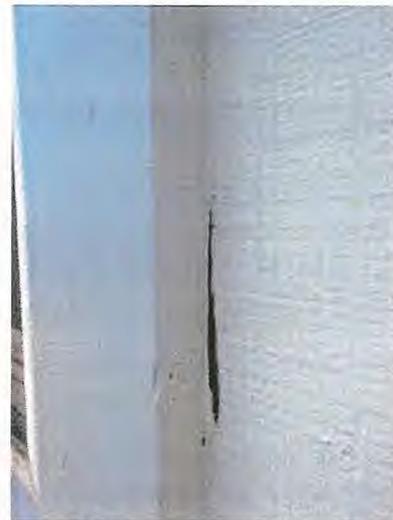
Visible indications of WDO (termite) damage noted. Recommend having a licensed pest contractor evaluate and treat as necessary. Also, recommend having a licensed contractor evaluate and repair/replace damaged material as necessary.

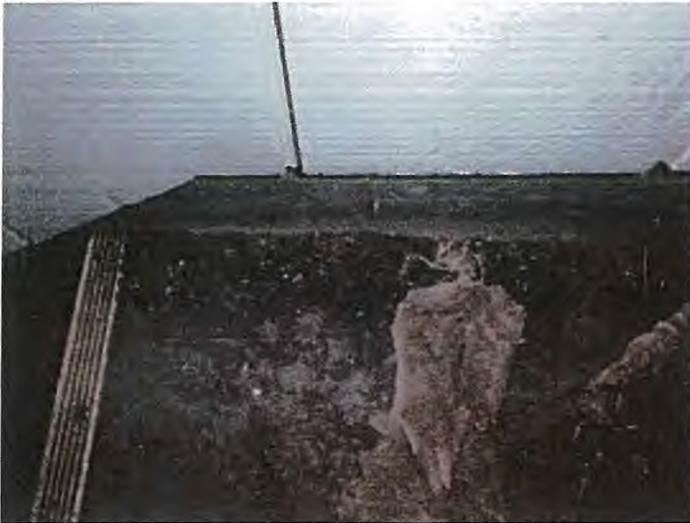
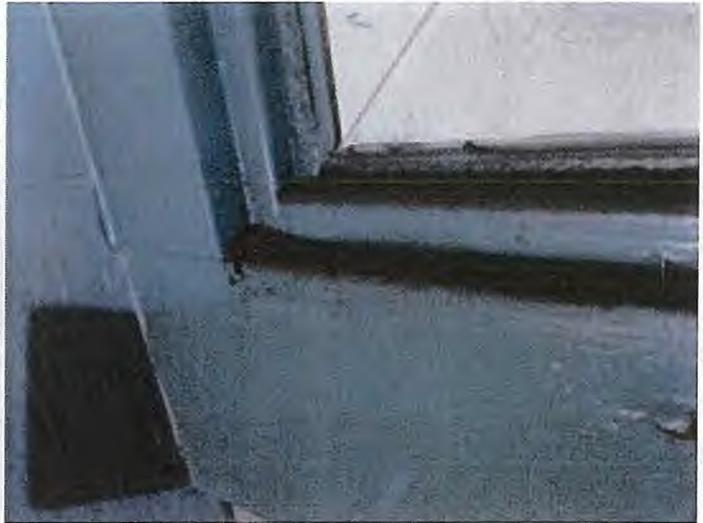
There were visible indications of WDO (Wood Destroying Organism) damage noted at the fascia and soffit areas. Recommend having a licensed contractor evaluate and repair/replace as necessary.

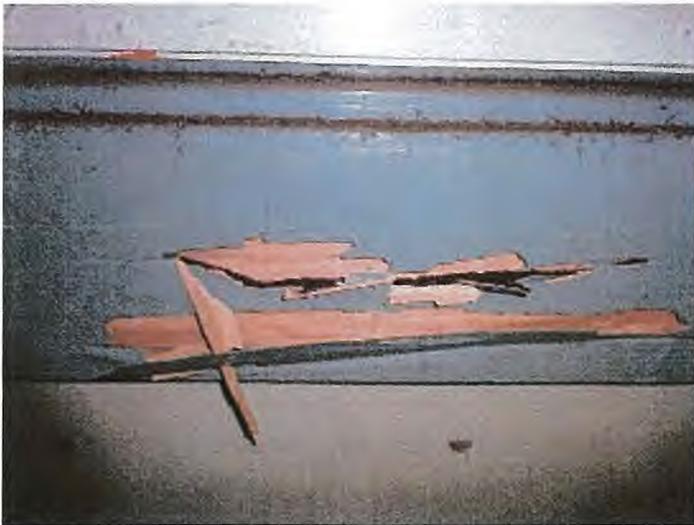
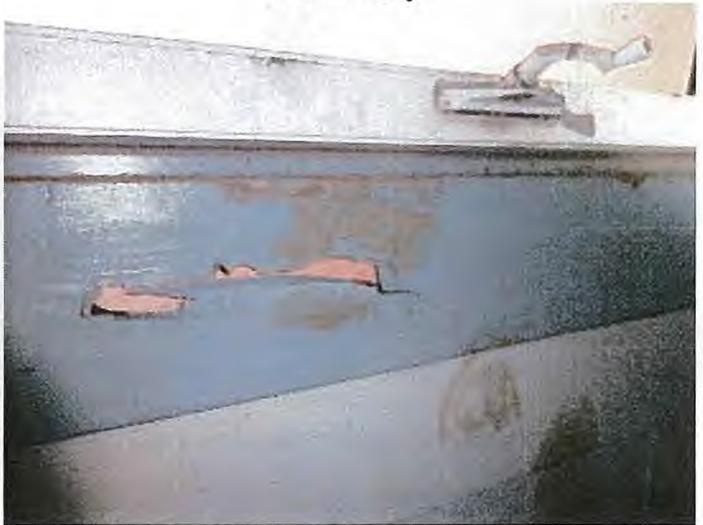
There were visible indications of WDO (Wood Destroying Organism) damage noted at the fascia and soffit areas. Recommend having a licensed contractor evaluate and repair/replace as necessary.

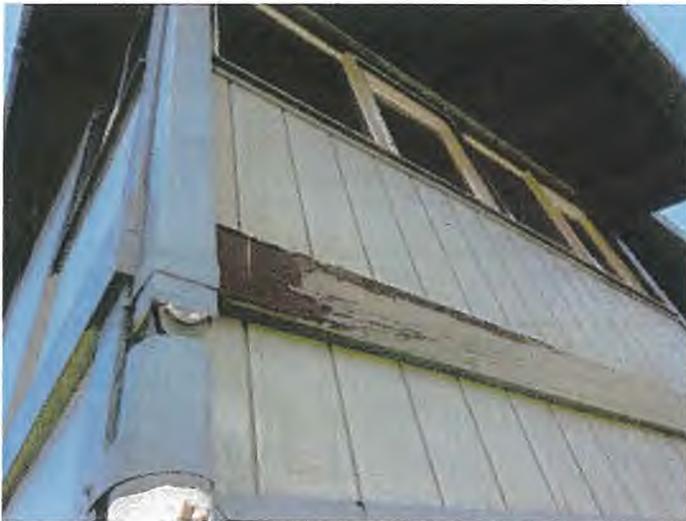
Blistering/peeling/missing paint observed at many exterior trim, fascia and soffit areas. Recommend properly preparing and refinishing exterior finishes.

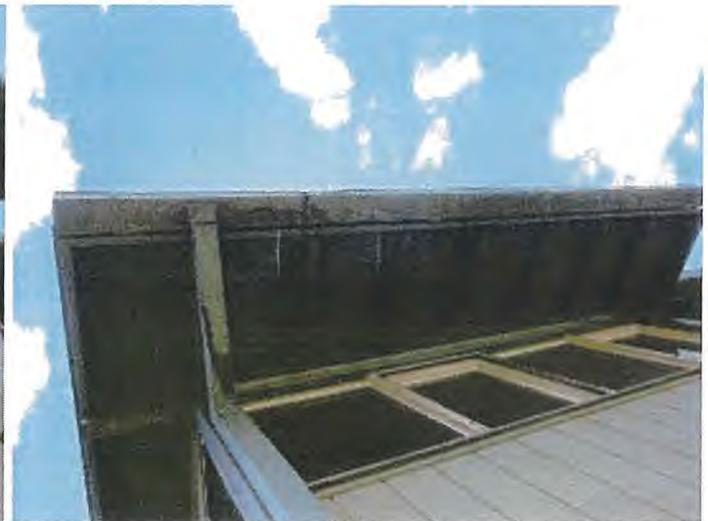
Moisture damage observed at exterior wall areas. Recommend select demolition and replacement of affected ground level exterior siding and finishes.

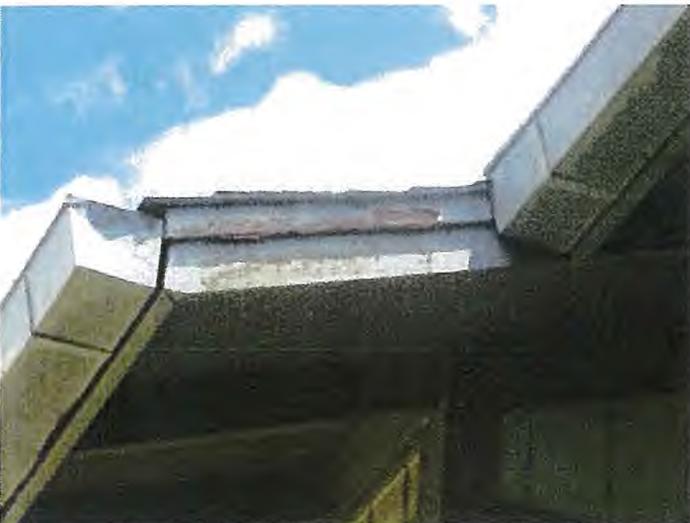
Blistering/peeling/missing paint observed at many exterior trim, fascia and soffit areas. Recommend properly preparing and refinishing exterior finishes.

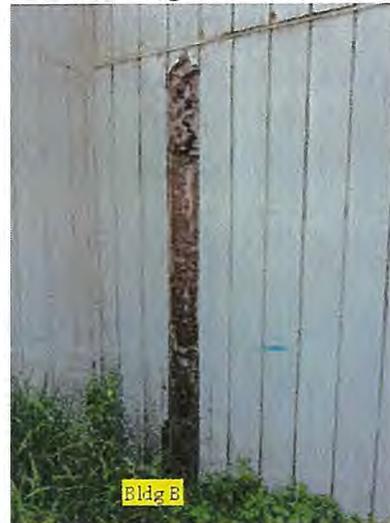
Visible indications of WDO (termite) damage noted. Recommend having a licensed pest contractor evaluate and treat as necessary. Also, recommend having a licensed contractor evaluate and repair/replace damaged material as necessary.

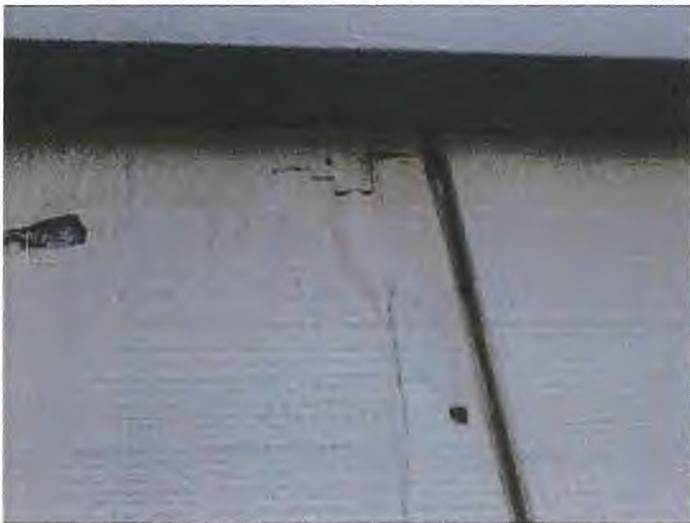
Visible indications of WDO (termite) damage noted. Recommend having a licensed pest contractor evaluate and treat as necessary. Also, recommend having a licensed contractor evaluate and repair/replace damaged material as necessary.

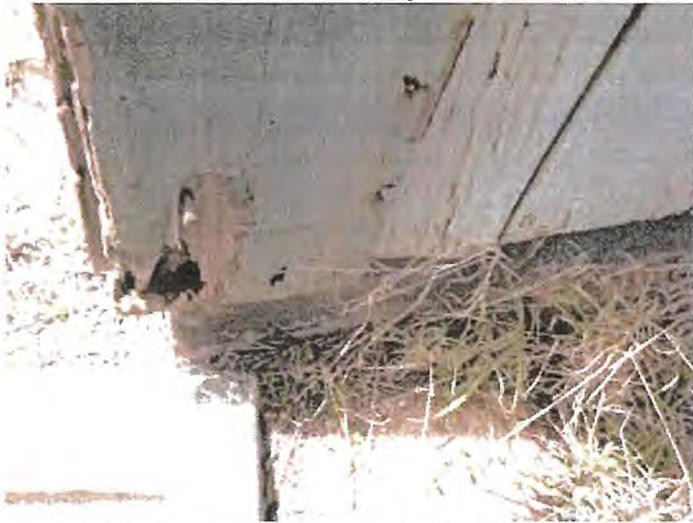
Visible indications of WDO (termite) damage noted. Recommend having a licensed pest contractor evaluate and treat as necessary. Also, recommend having a licensed contractor evaluate and repair/replace damaged material as necessary.

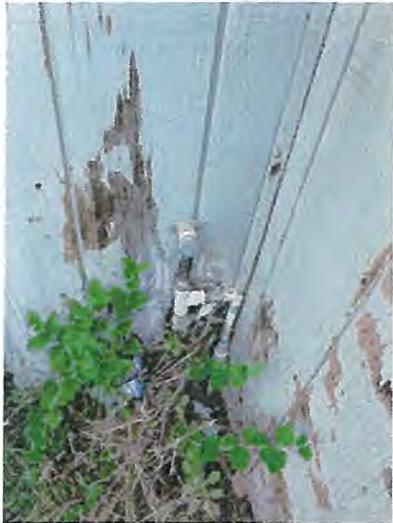
Moisture damage observed at exterior wall areas. Recommend select demolition and replacement of affected ground level exterior siding and finishes.

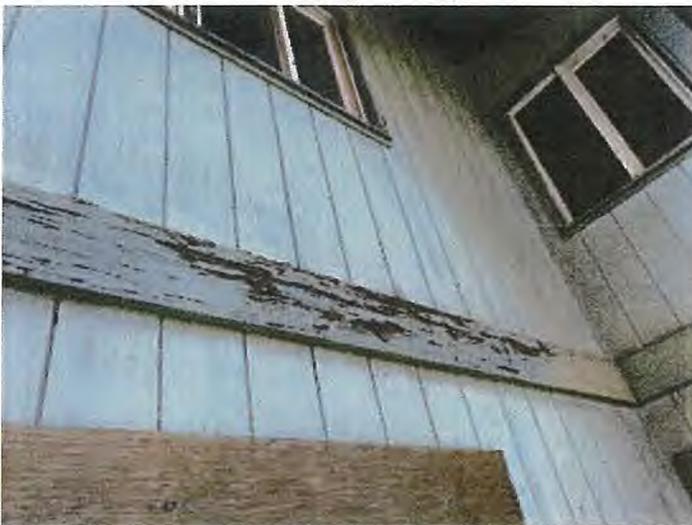
Blistering/peeling/missing paint observed at many exterior trim, fascia and soffit areas. Recommend properly preparing and refinishing exterior finishes.

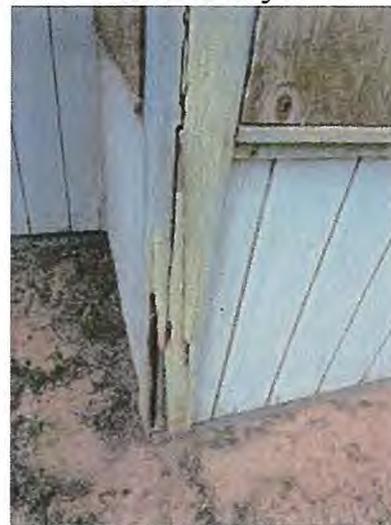
Visible indications of WDO (termite) damage noted. Recommend having a licensed pest contractor evaluate and treat as necessary. Also, recommend having a licensed contractor evaluate and repair/replace damaged material as necessary.

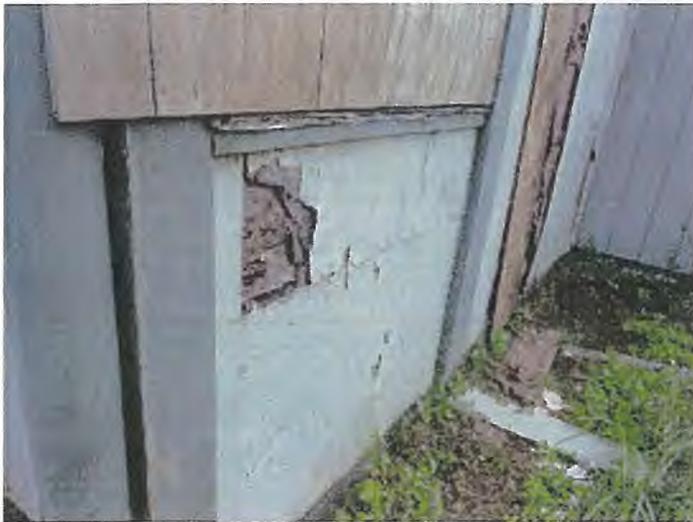
Moisture damage observed at exterior wall areas. Recommend select demolition and replacement of affected ground level exterior siding and finishes.

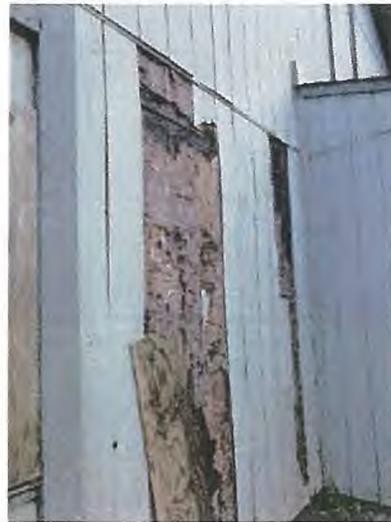
Visible indications of WDO (termite) damage noted. Recommend having a licensed pest contractor evaluate and treat as necessary. Also, recommend having a licensed contractor evaluate and repair/replace damaged material as necessary.

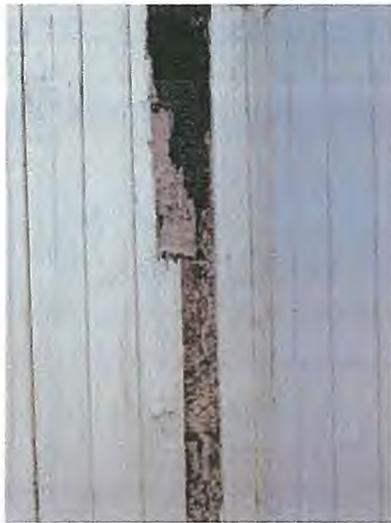
Visible indications of WDO (termite) damage noted. Recommend having a licensed pest contractor evaluate and treat as necessary. Also, recommend having a licensed contractor evaluate and repair/replace damaged material as necessary.

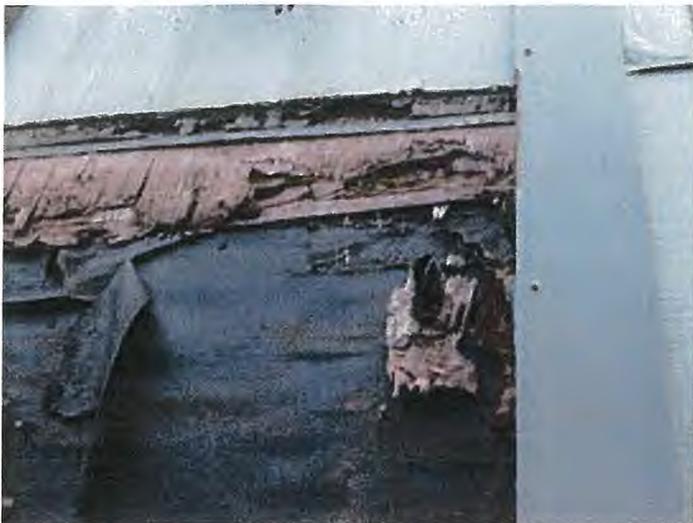
Visible indications of WDO (termite) damage noted. Recommend having a licensed pest contractor evaluate and treat as necessary. Also, recommend having a licensed contractor evaluate and repair/replace damaged material as necessary.

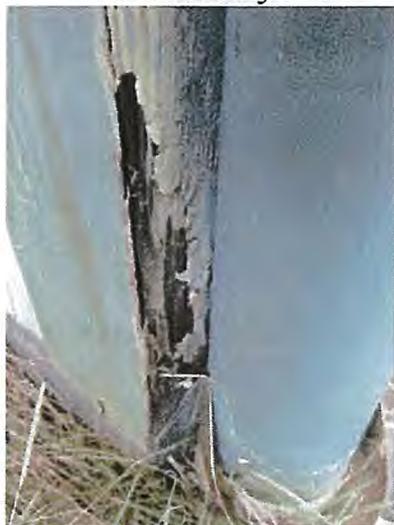
Visible indications of WDO (termite) damage noted. Recommend having a licensed pest contractor evaluate and treat as necessary. Also, recommend having a licensed contractor evaluate and repair/replace damaged material as necessary.

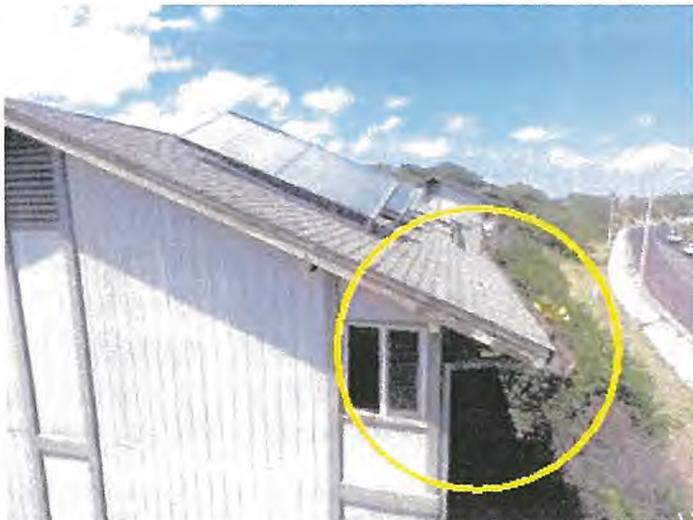
The fascia/soffit areas appeared to be rotted/water damaged/deteriorated at the time of inspection. Recommend having a licensed contractor evaluate and repair/replace as necessary.

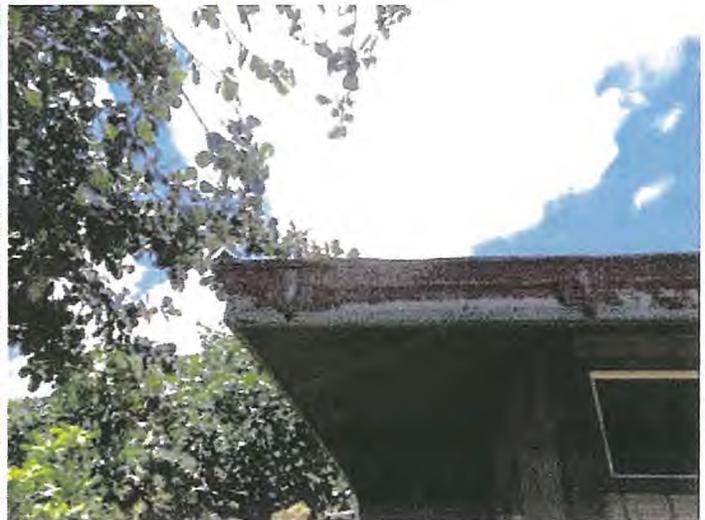
The fascia/soffit areas appeared to be rotted/water damaged/deteriorated at the time of inspection. Recommend having a licensed contractor evaluate and repair/replace as necessary.

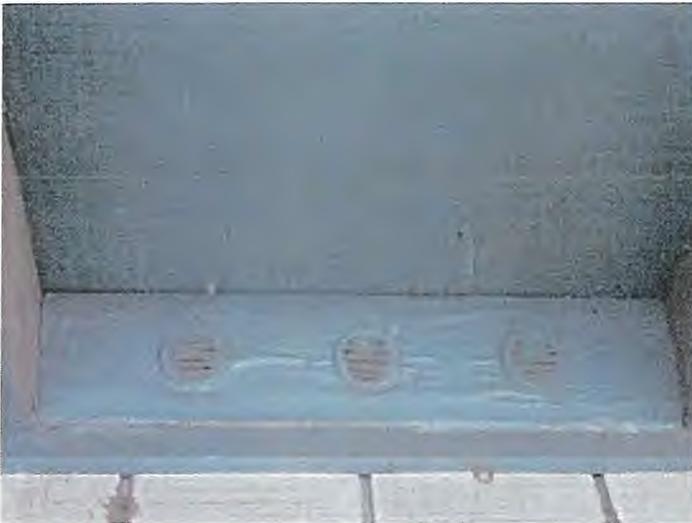
There were visible indications of WDO (Wood Destroying Organism) damage noted at the fascia and soffit areas. Recommend having a licensed contractor evaluate and repair/replace as necessary.

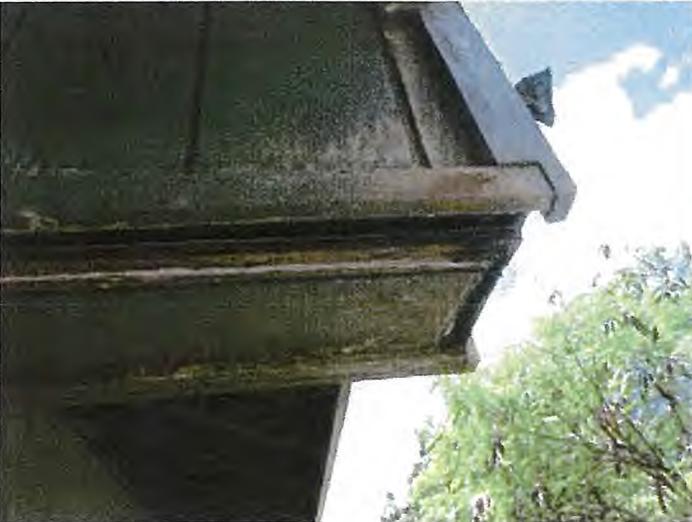
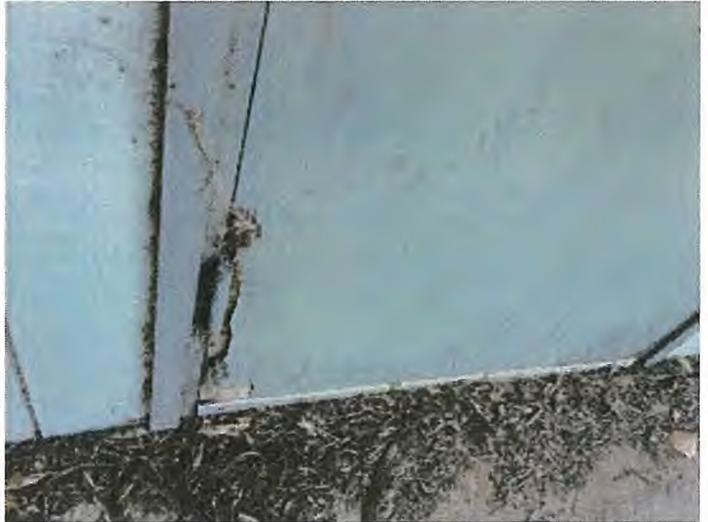
The fascia/soffit areas appeared to be rotted/water damaged/deteriorated at the time of inspection. Recommend having a licensed contractor evaluate and repair/replace as necessary.

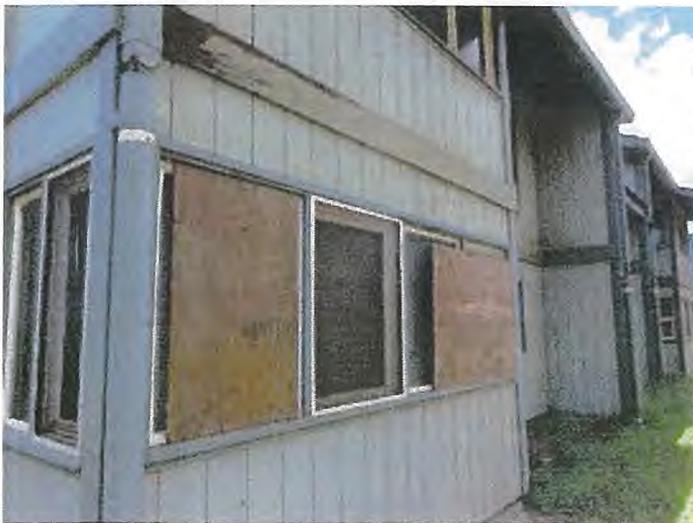
Many of the ground floor windows were broken at the time of inspection.

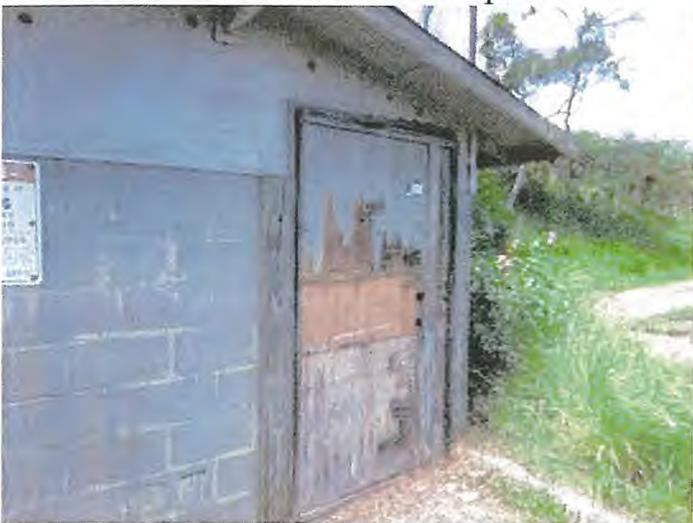
The exterior doors were termite damaged or deteriorated to the point of being inoperable. We recommend replacement of all exterior doors, framing and trim for all buildings.

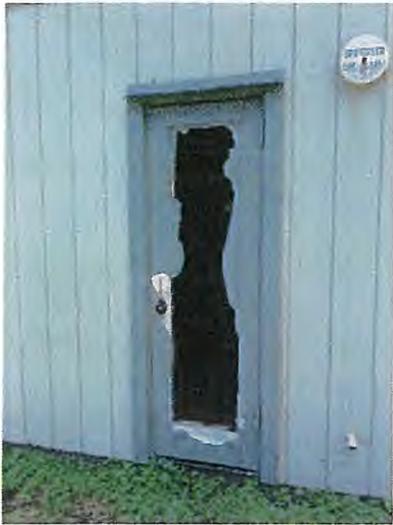
The exterior doors were termite damaged or deteriorated to the point of being inoperable. We recommend replacement of all exterior doors, framing and trim for all buildings.

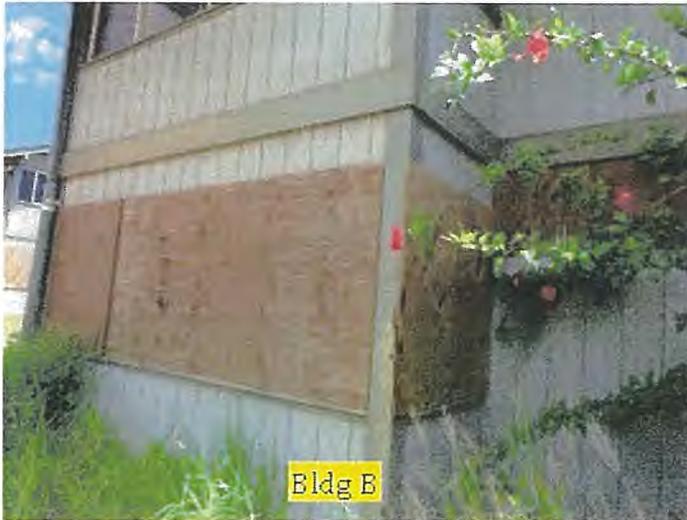
Many of the ground floor windows were broken at the time of inspection.

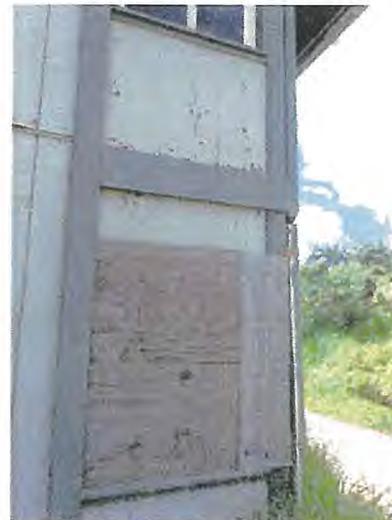
Many of the ground floor windows were broken at the time of inspection.

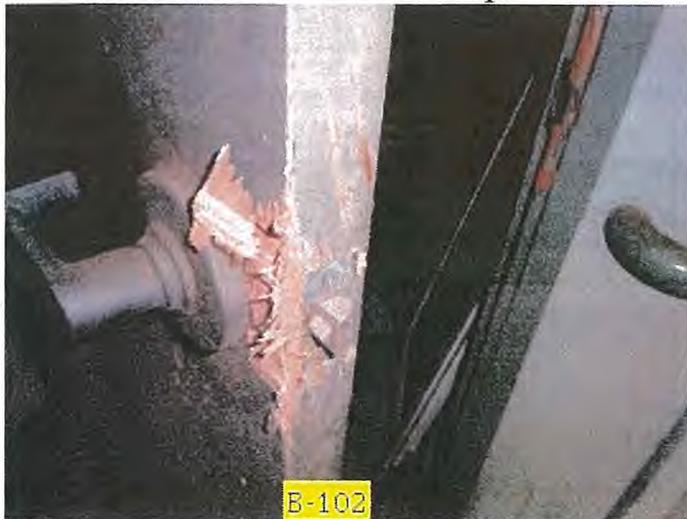
The exterior doors were termite damaged or deteriorated to the point of being inoperable. We recommend replacement of all exterior doors, framing and trim for all buildings.

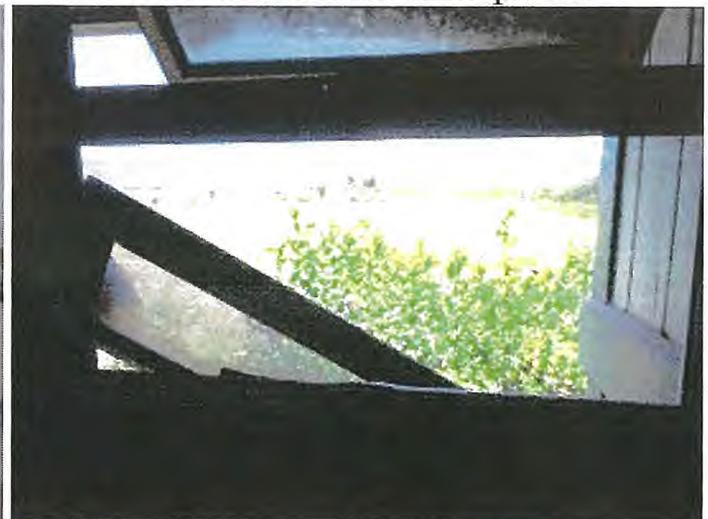
The stair way windows were heavily corroded, damaged and/or inoperable at the time of inspection. Recommend replacement.

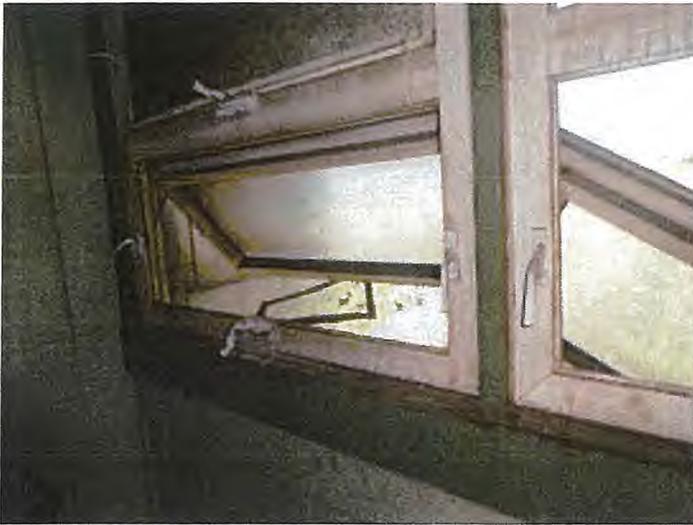
The stair way windows were heavily corroded, damaged and/or inoperable at the time of inspection. Recommend replacement.

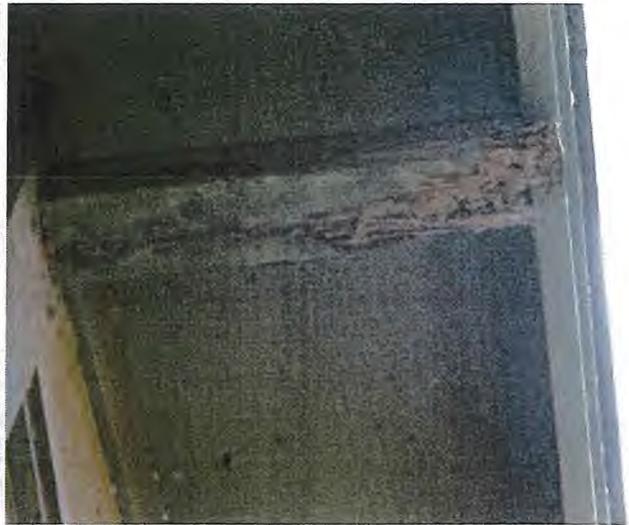
There were visible indications of WDO (Wood Destroying Organism) damage noted at the fascia and soffit areas. Recommend having a licensed contractor evaluate and repair/replace as necessary.

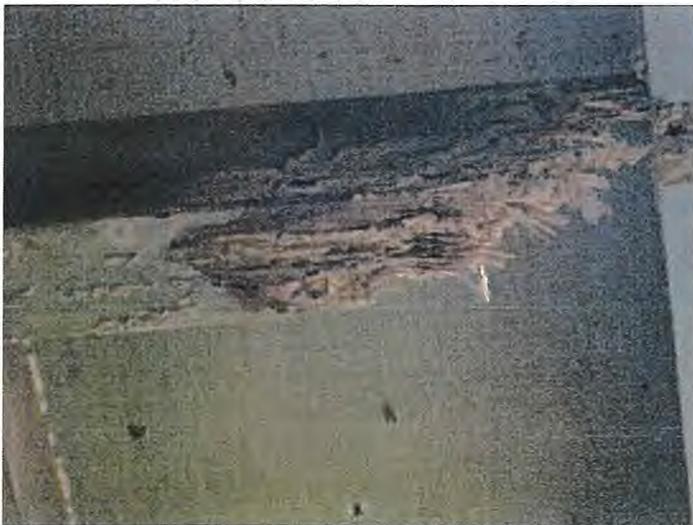
There were visible indications of WDO (Wood Destroying Organism) damage noted at the fascia and soffit areas. Recommend having a licensed contractor evaluate and repair/replace as necessary.

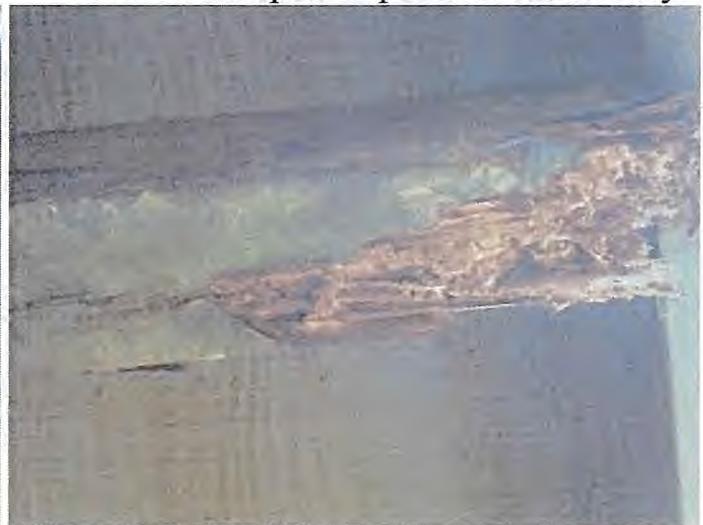
There were visible indications of WDO (Wood Destroying Organism) damage noted at the fascia and soffit areas. Recommend having a licensed contractor evaluate and repair/replace as necessary.
