Property Condition Report

310 W Kaahumanu Ave, Kahului, HI 96732
Inspection prepared for: Maui County c/o Buddy Almeida
Real Estate Agent: -

Date of Inspection: 3/28/2018 Time: 8:00 AM
Age of Home: 1980 Size: 15000

This is a commercial property condition assessment to determine if three (3) former UH dormitories are suitable for housing. This inspection includes invasive and non-invasive inspection methods as well as sampling for asbestos and lead based paint.

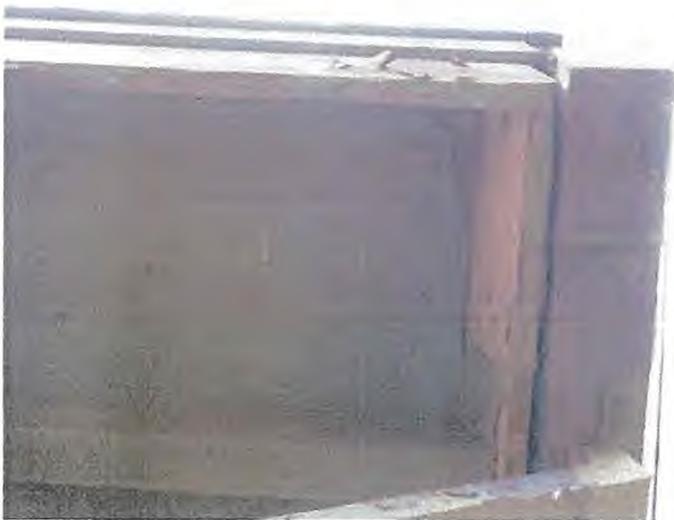
The fascia/soffit areas appeared to be rotted/water damaged/deteriorated at the time of inspection. Recommend having a licensed contractor evaluate and repair/replace as necessary.

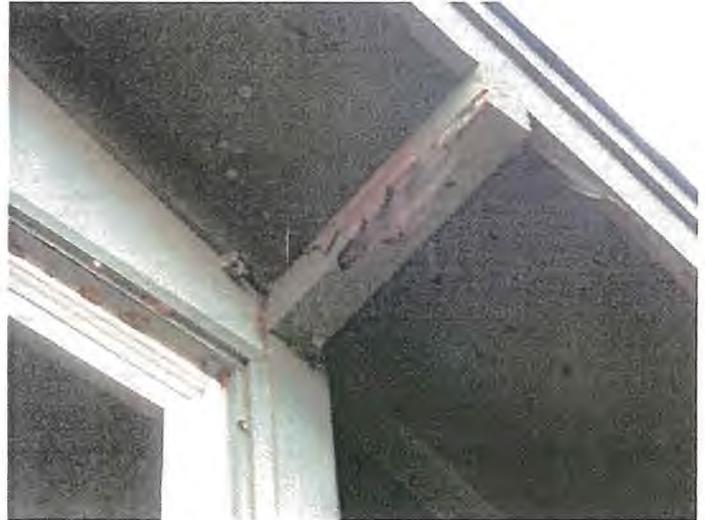
The fascia/soffit areas appeared to be rotted/water damaged/deteriorated at the time of inspection. Recommend having a licensed contractor evaluate and repair/replace as necessary.

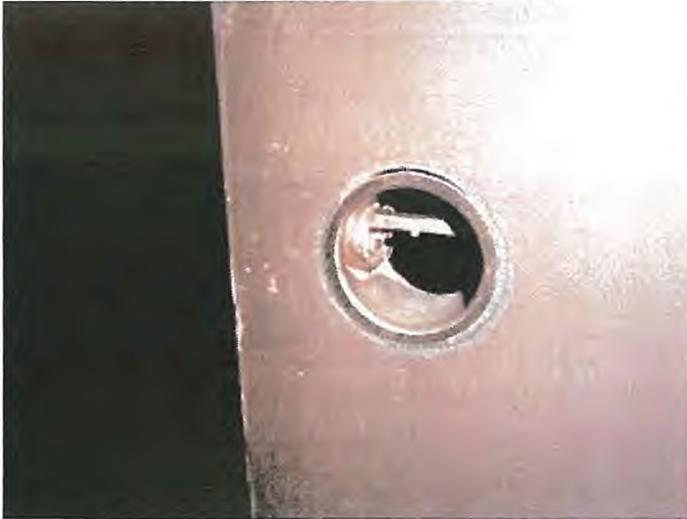
The exterior doors were termite damaged or deteriorated to the point of being inoperable. We recommend replacement of all exterior doors, framing and trim for all buildings.

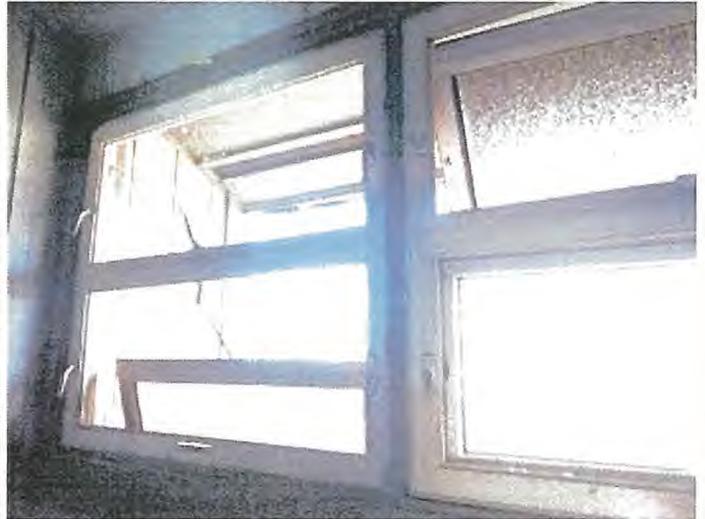
The stair way windows were heavily corroded, damaged and/or inoperable at the time of inspection. Recommend replacement.

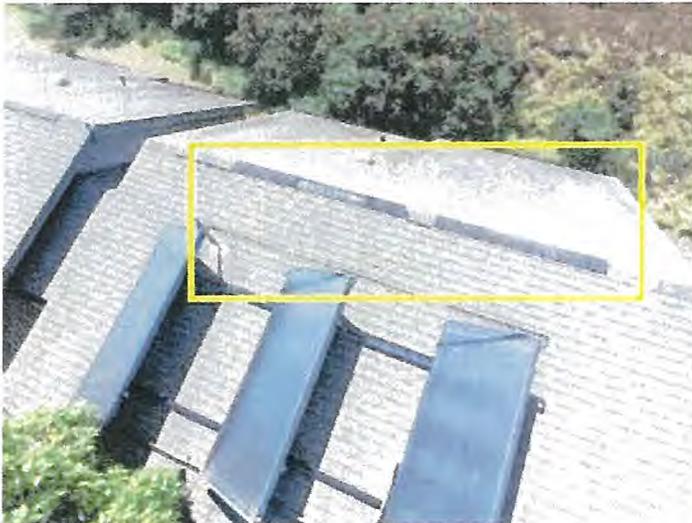
There were numerous areas of missing shingles observed at the roof ridge areas. Recommend repair in conjunction with roof replacement.

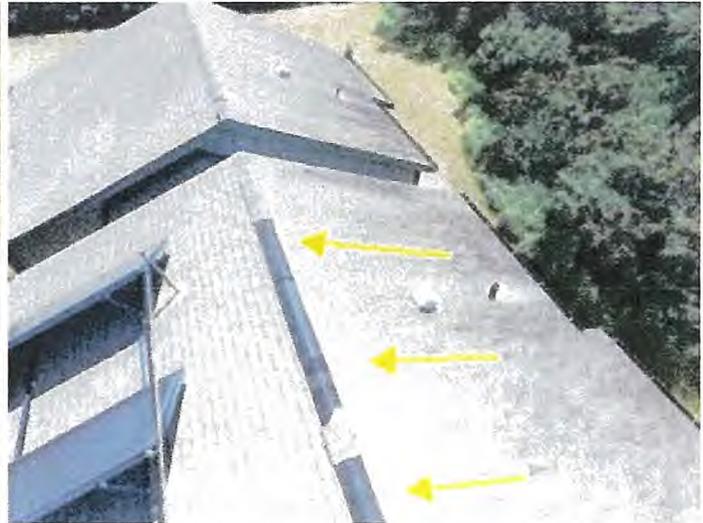
There were numerous areas of missing shingles observed at the roof ridge areas. Recommend repair in conjunction with roof replacement.

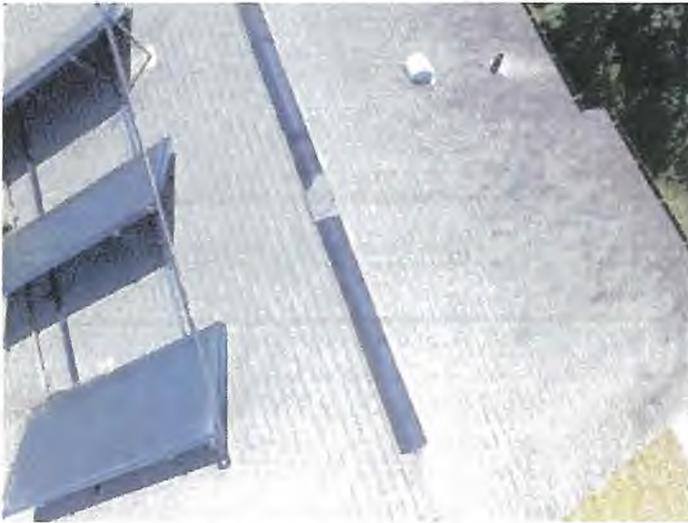
There were numerous areas of missing shingles observed at the roof ridge areas. Recommend repair in conjunction with roof replacement.

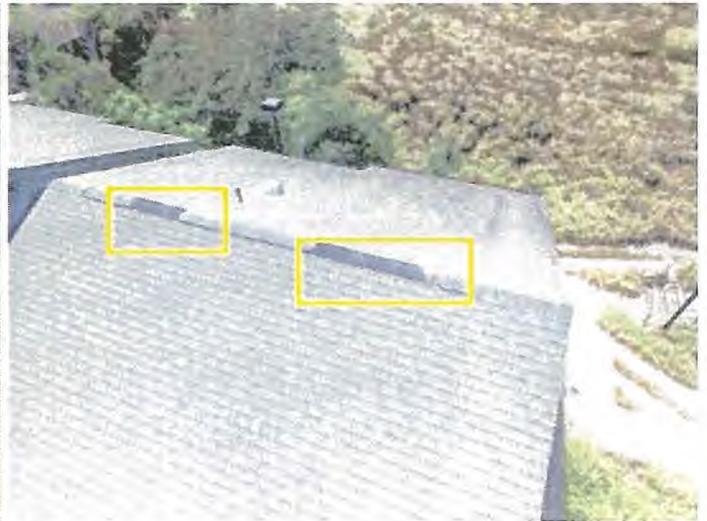
There were numerous areas of missing shingles observed at the roof ridge areas. Recommend repair in conjunction with roof replacement.

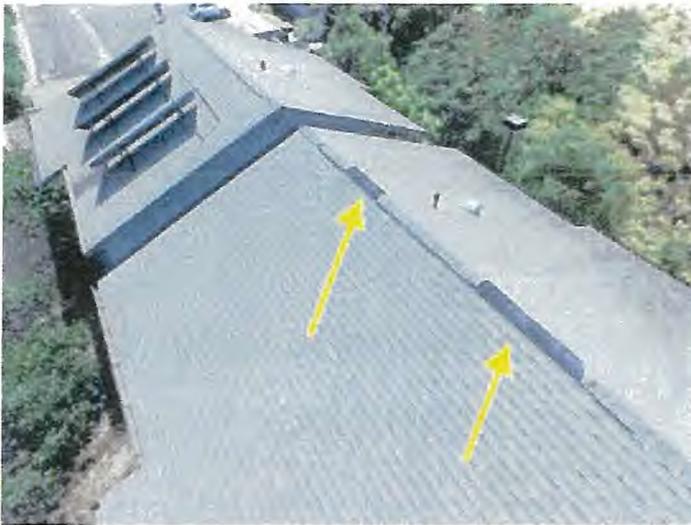
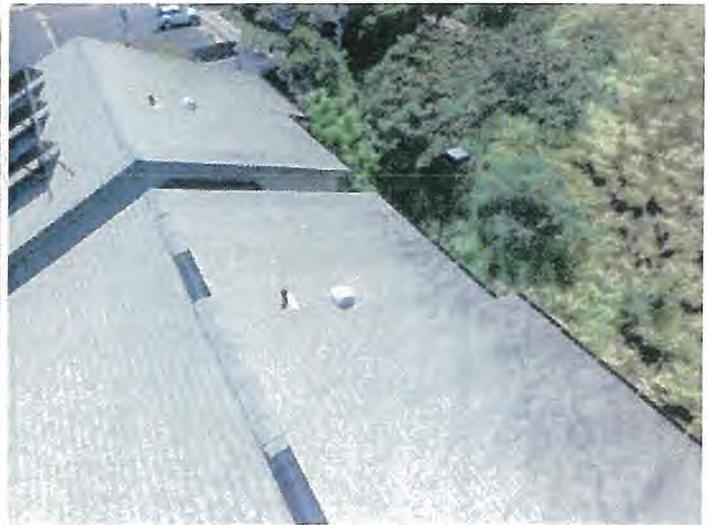
There were numerous areas of missing shingles observed at the roof ridge areas. Recommend repair in conjunction with roof replacement.

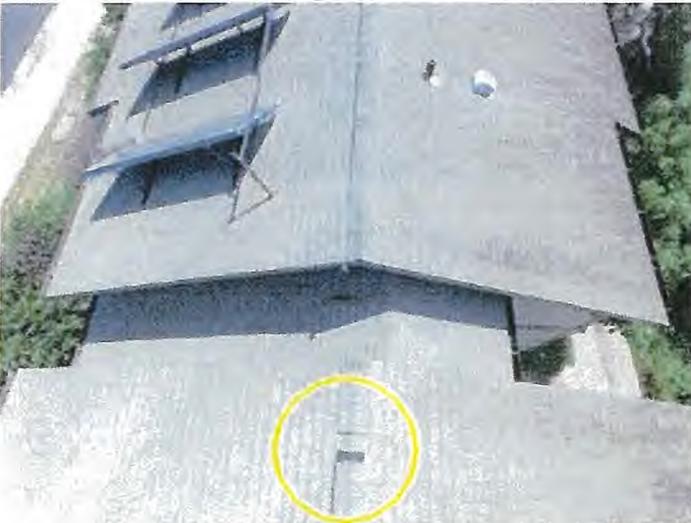
There were numerous areas of missing shingles observed at the roof ridge areas. Recommend repair in conjunction with roof replacement.

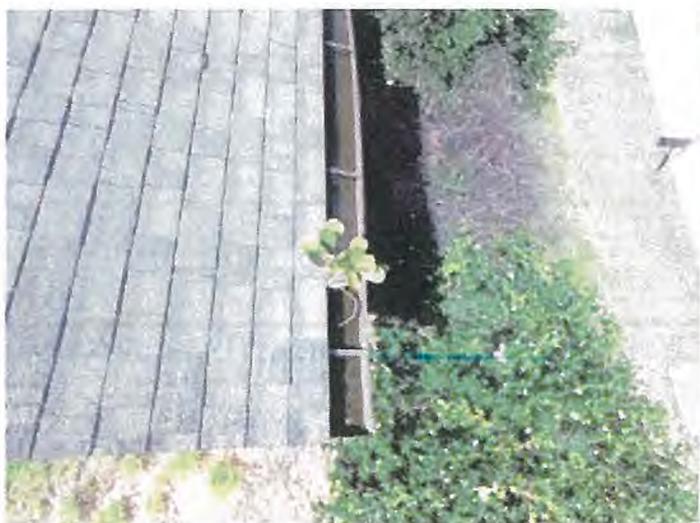
Damaged/broken/missing gutters noted. Recommend having a licensed contractor evaluate and repair/replace as necessary.

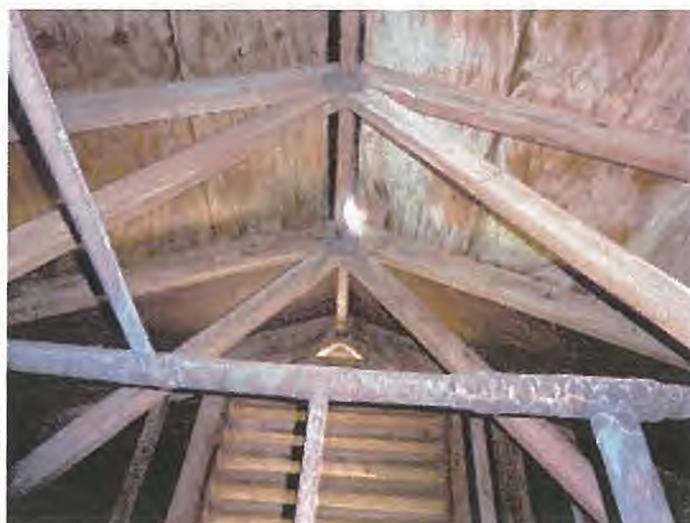
There were visible areas of moisture intrusion observed at the roof sheathing (within the attic spaces) at the time of inspection. This indicated a failed/failing roofing system. Recommend replacement of the installed sheathing and roofing finish.

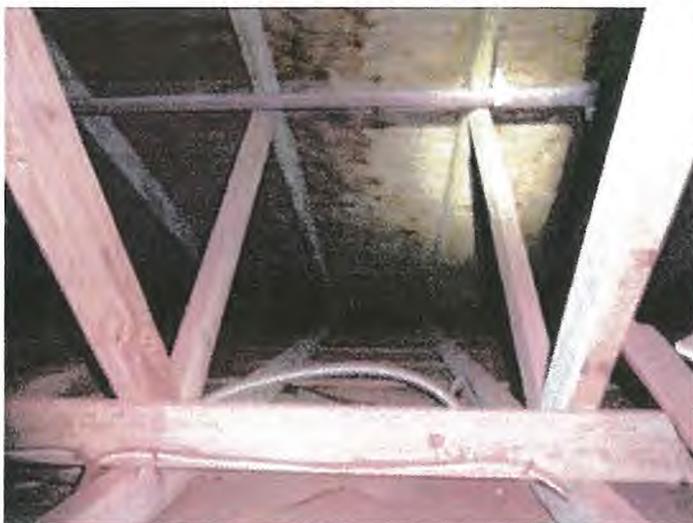
There were visible areas of moisture intrusion observed at the roof sheathing (within the attic spaces) at the time of inspection. This indicated a failed/failing roofing system. Recommend replacement of the installed sheathing and roofing finish.

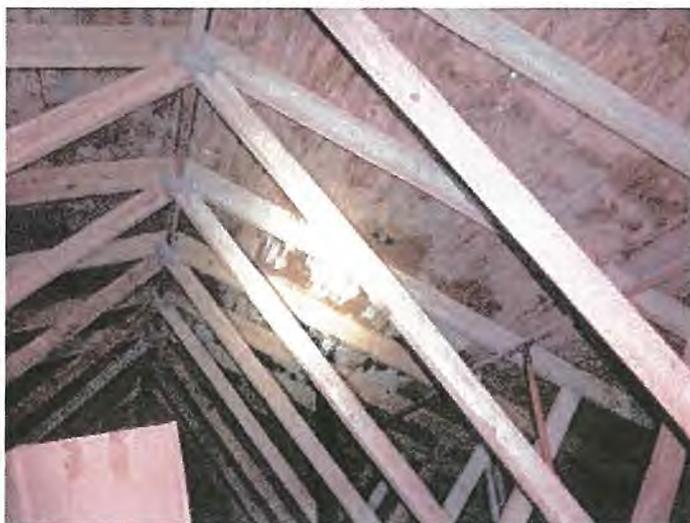
There were visible areas of moisture intrusion observed at the roof sheathing (within the attic spaces) at the time of inspection. This indicated a failed/failing roofing system. Recommend replacement of the installed sheathing and roofing finish.

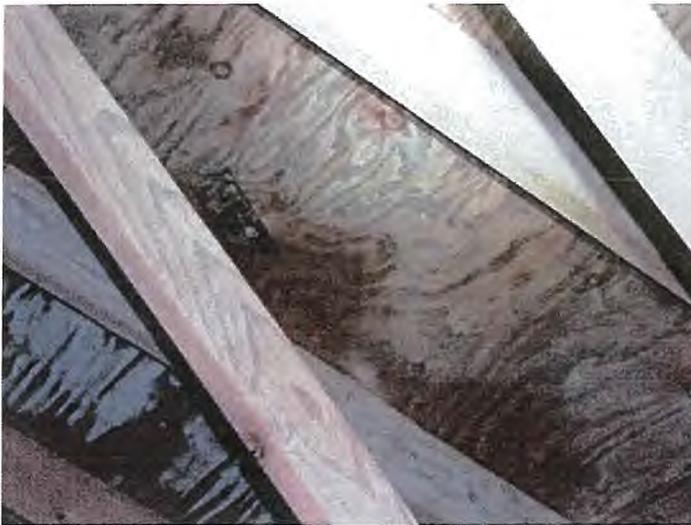
There were visible areas of moisture intrusion observed at the roof sheathing (within the attic spaces) at the time of inspection. This indicated a failed/failing roofing system. Recommend replacement of the installed sheathing and roofing finish.

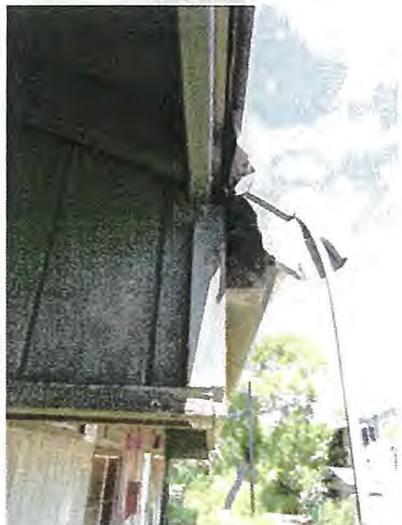
Damaged/broken/missing gutters noted. Recommend having a licensed contractor evaluate and repair/replace as necessary.

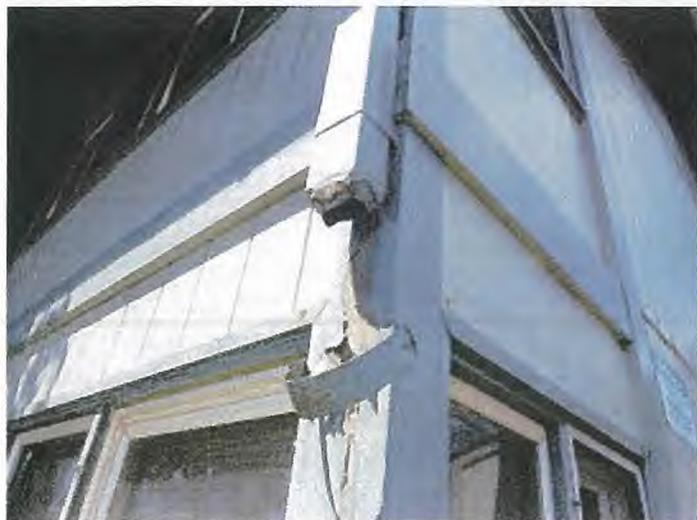
Damaged/broken/missing gutters noted. Recommend having a licensed contractor evaluate and repair/replace as necessary.

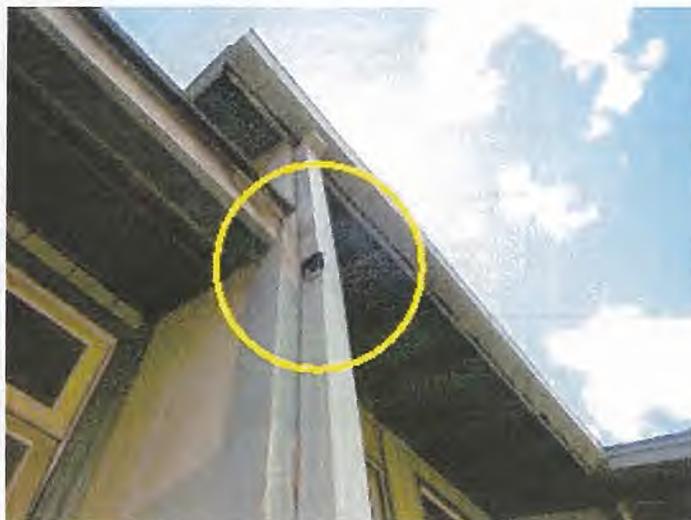
Damaged/broken/missing gutters noted. Recommend having a licensed contractor evaluate and repair/replace as necessary.

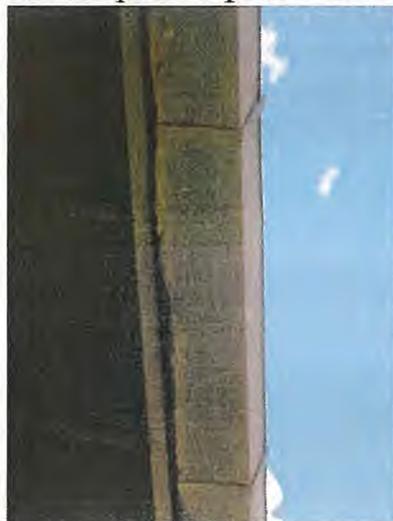
Damaged/broken/missing gutters noted. Recommend having a licensed contractor evaluate and repair/replace as necessary.

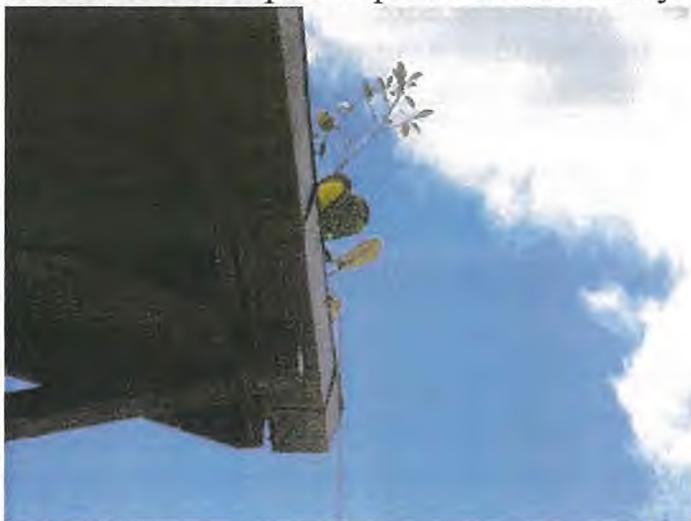
Vegetation growth observed in gutters. Recommend clearing.

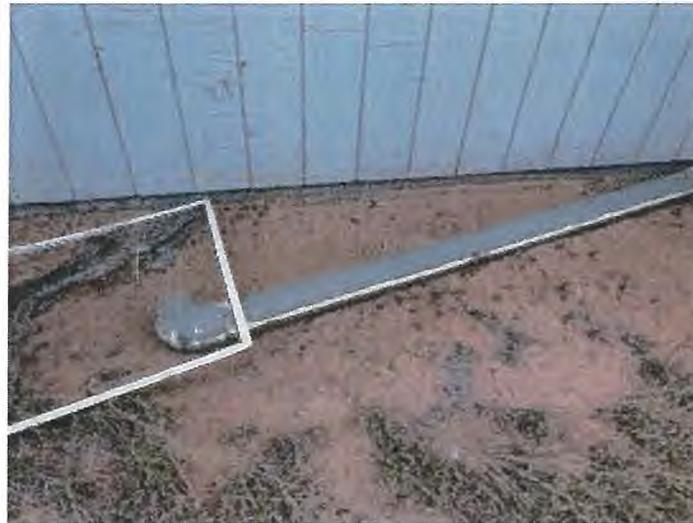
Damaged/broken/missing gutters noted. Recommend having a licensed contractor evaluate and repair/replace as necessary.

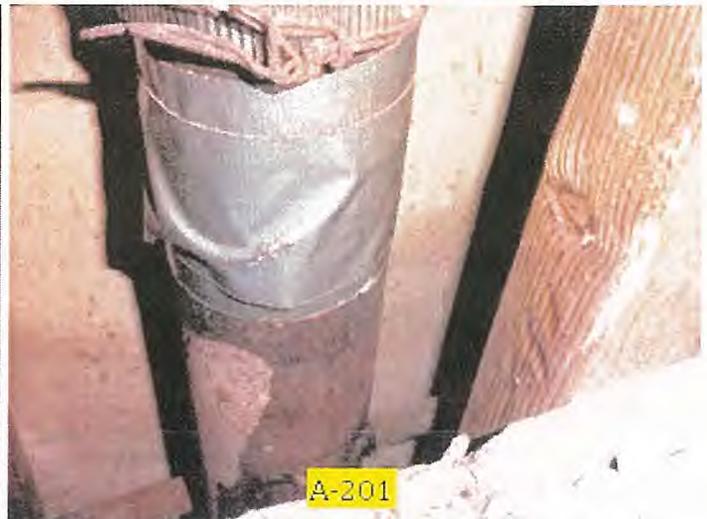
Non standard repairs observed at plumbing connections. Recommend repair.

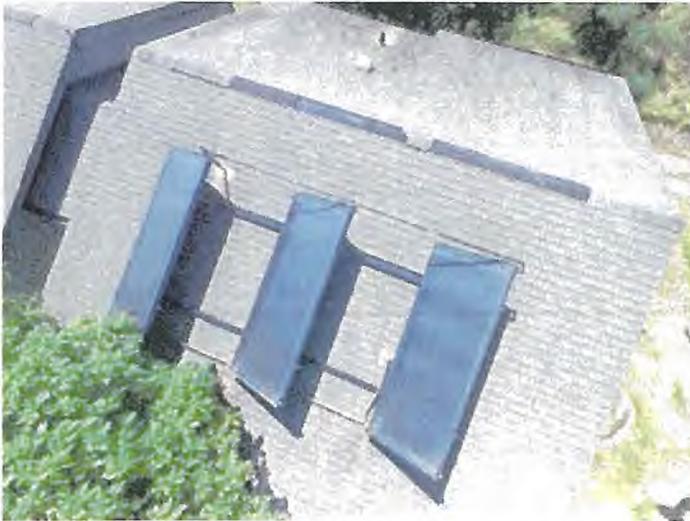
There were solar water heating panels located on the roofing areas of the buildings. There were visible indications of leaks and interior hazing at the panels which is an indication of damage to the environmental seals or panels. These panels did not appear to be in service and should be evaluated by a licensed plumbing contractor prior to use.

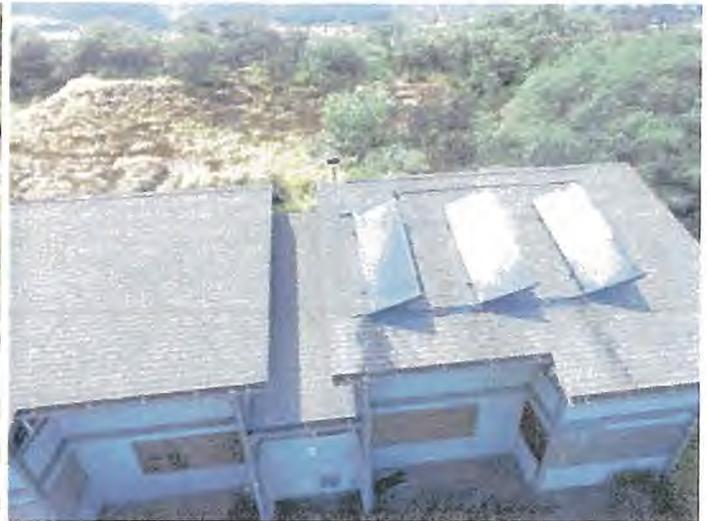
There were solar water heating panels located on the roofing areas of the buildings. There were visible indications of leaks and interior hazing at the panels which is an indication of damage to the environmental seals or panels. These panels did not appear to be in service and should be evaluated by a licensed plumbing contractor prior to use.

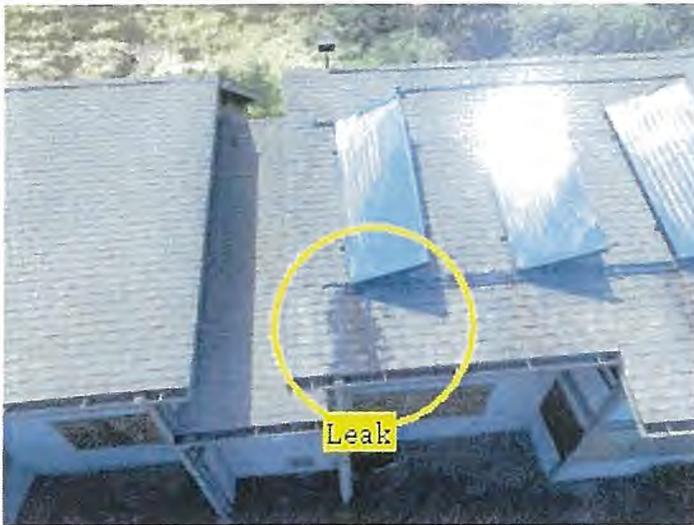
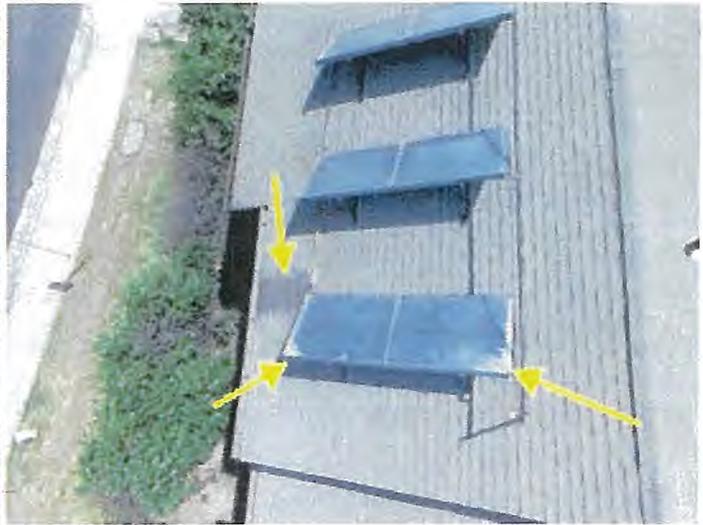
There were solar water heating panels located on the roofing areas of the buildings. There were visible indications of leaks and interior hazing at the panels which is an indication of damage to the environmental seals or panels. These panels did not appear to be in service and should be evaluated by a licensed plumbing contractor prior to use.

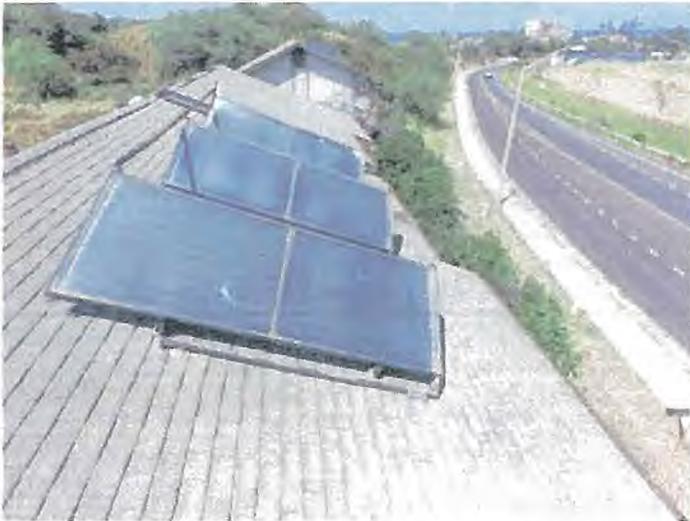
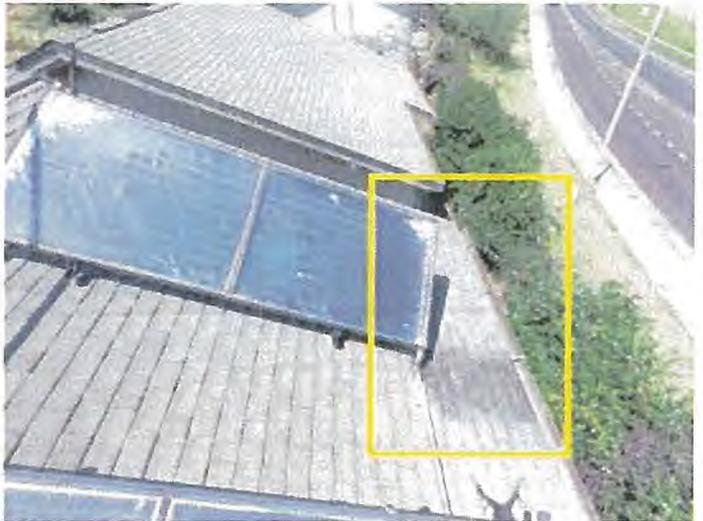
There were solar water heating panels located on the roofing areas of the buildings. There were visible indications of leaks and interior hazing at the panels which is an indication of damage to the environmental seals or panels. These panels did not appear to be in service and should be evaluated by a licensed plumbing contractor prior to use.

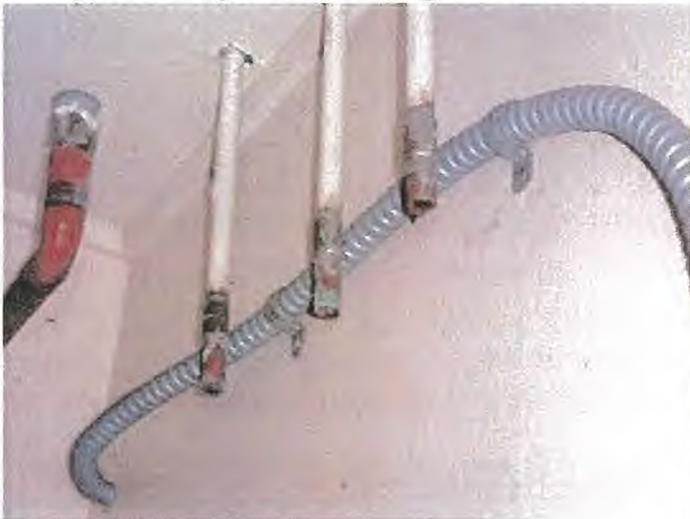
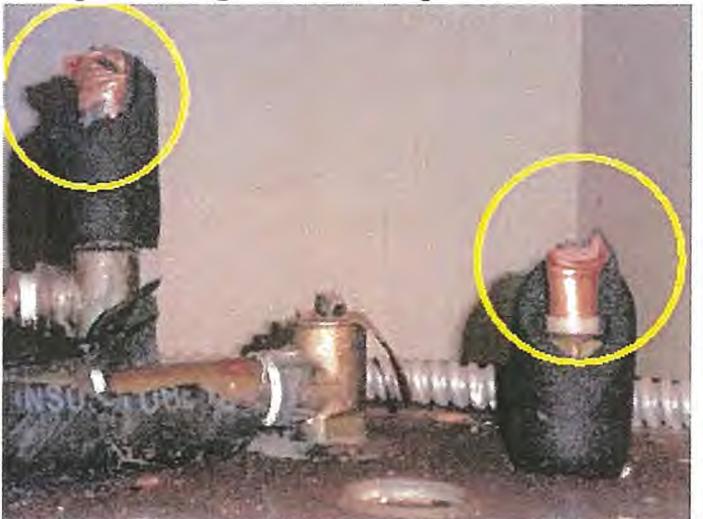
All water heating appliances were terminated with supply and service plumbing cut and electrical connections removed. Recommend having a licensed plumber evaluate and install commercial grade gas on demand hot water heating systems for each floor of each building.

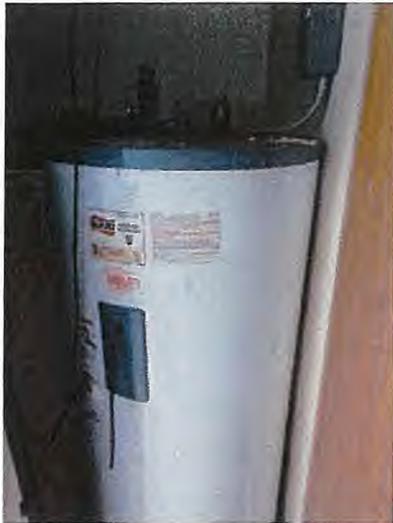
All water heating appliances were terminated with supply and service plumbing cut and electrical connections removed. Recommend having a licensed plumber evaluate and install commercial grade gas on demand hot water heating systems for each floor of each building.

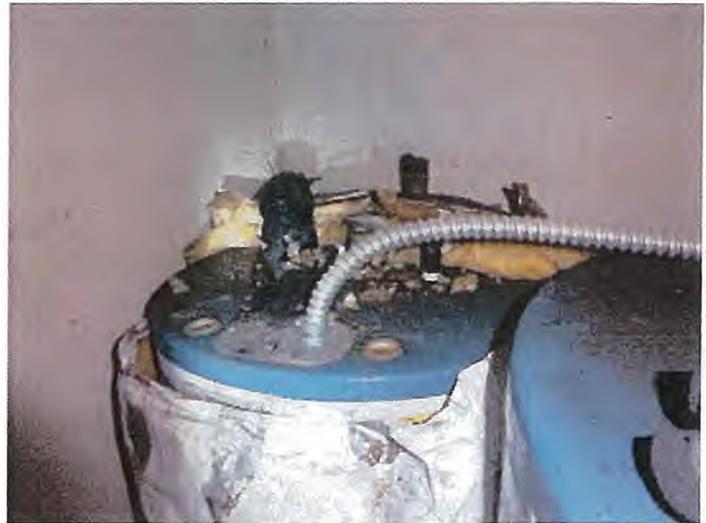
All water heating appliances were terminated with supply and service plumbing cut and electrical connections removed. Recommend having a licensed plumber evaluate and install commercial grade gas on demand hot water heating systems for each floor of each building.

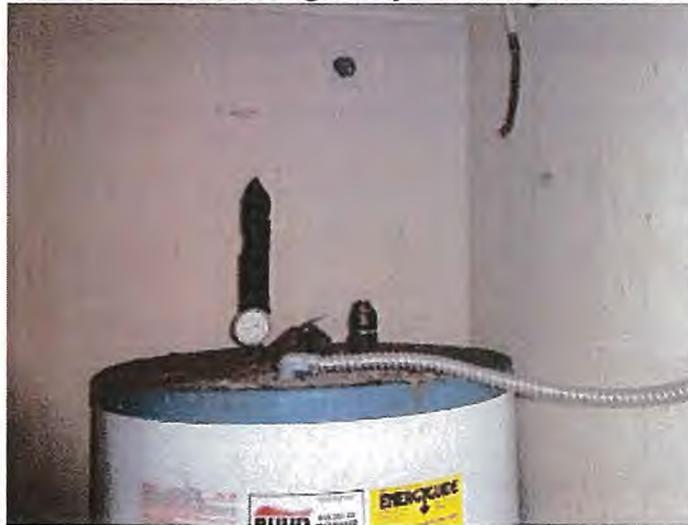
All water heating appliances were terminated with supply and service plumbing cut and electrical connections removed. Recommend having a licensed plumber evaluate and install commercial grade gas on demand hot water heating systems for each floor of each building.

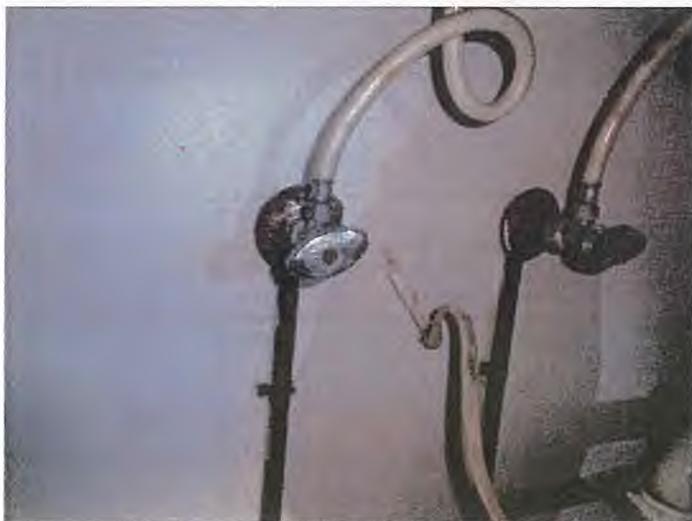
Based on the observed physical conditions of the installed fixtures, we recommend the replacement of all plumbing fixtures and shut off valves in all buildings to ensure proper future operation.

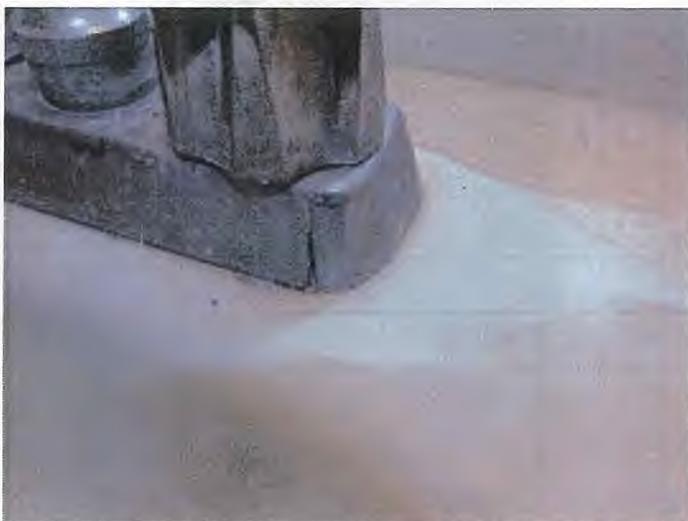
Based on the observed physical conditions of the installed fixtures, we recommend the replacement of all plumbing fixtures and shut off valves in all buildings to ensure proper future operation.

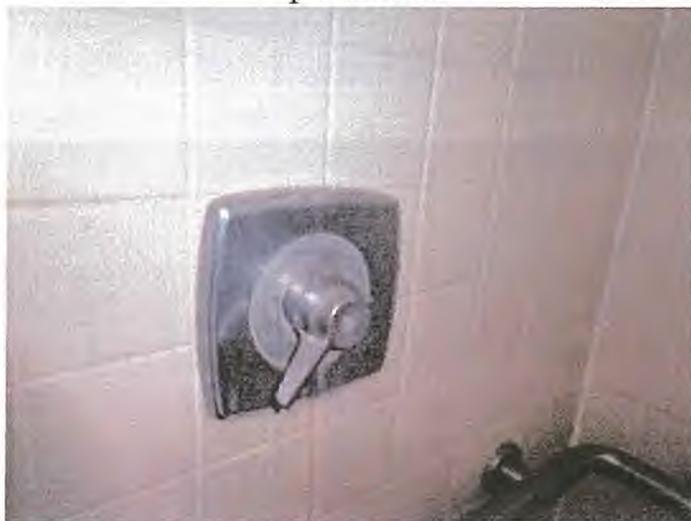
Based on the observed physical conditions of the installed fixtures, we recommend the replacement of all plumbing fixtures and shut off valves in all buildings to ensure proper future operation.

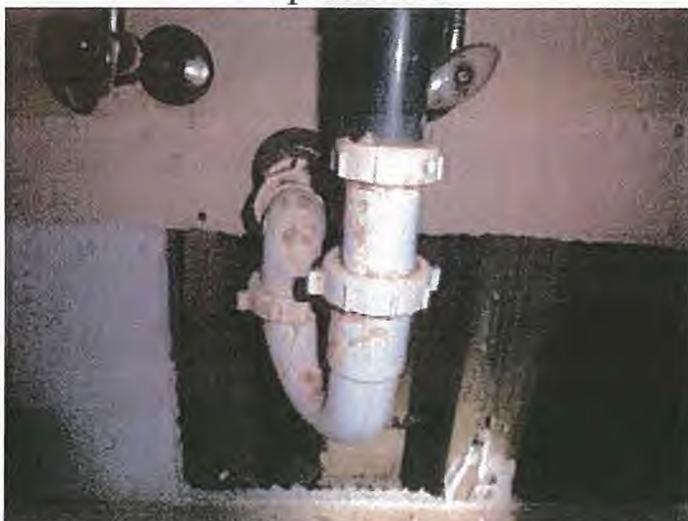
Based on the observed physical conditions of the installed fixtures, we recommend the replacement of all plumbing fixtures and shut off valves in all buildings to ensure proper future operation.

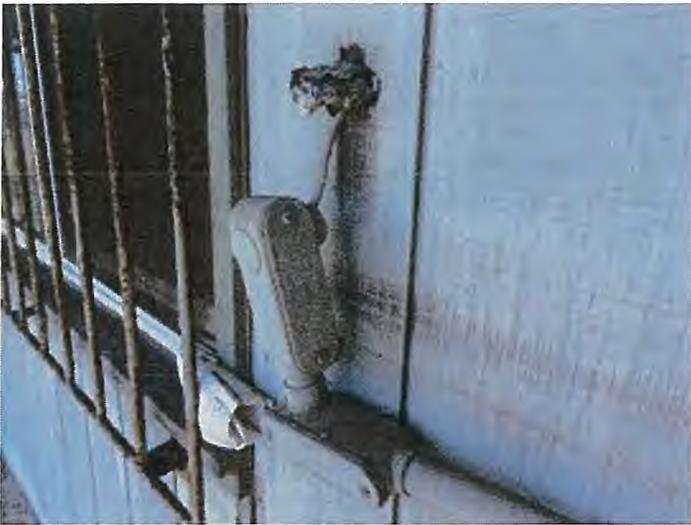
Storage bldg: Exterior conduit was damaged/detached from the bend box. Recommend repair.

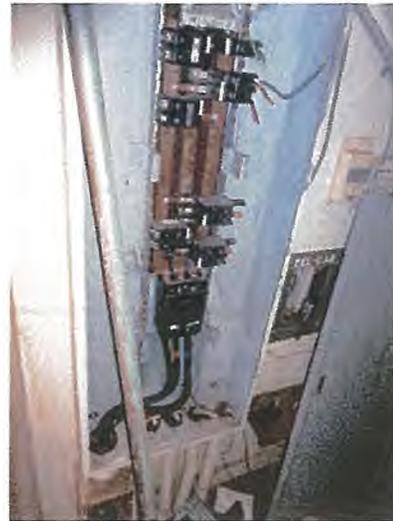
Building B and C: The main service conductors and all electrical branch wiring was cut at the main service panel entrances (located in the respective electrical rooms) when inspected. Recommend having a licensed electrical contractor evaluate and repair electrical service to each building. The installed cabinets, panels and service disconnects appeared serviceable.

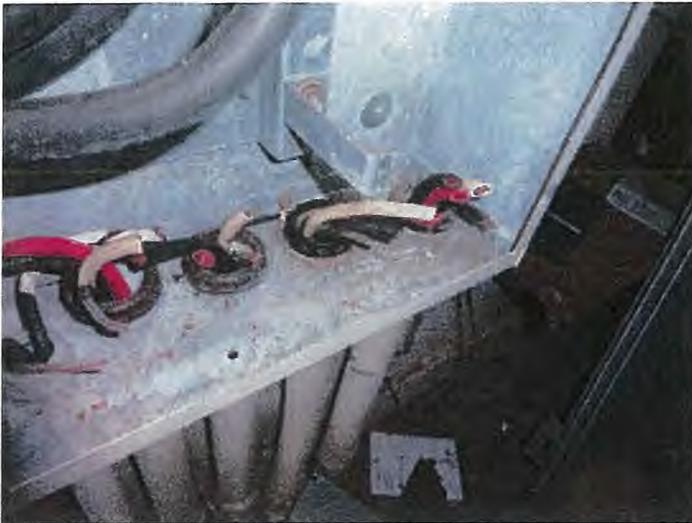
Building B and C: The main service conductors and all electrical branch wiring was cut at the main service panel entrances (located in the respective electrical rooms) when inspected. Recommend having a licensed electrical contractor evaluate and repair electrical service to each building. The installed cabinets, panels and service disconnects appeared serviceable.

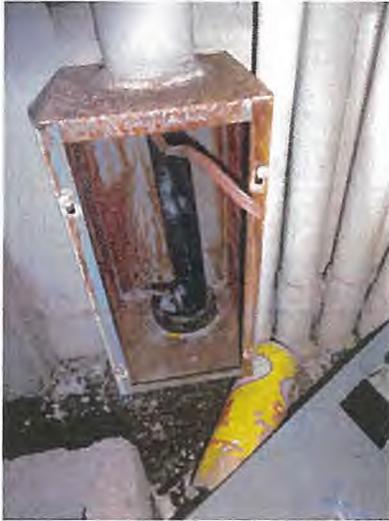
Building B and C: The main service conductors and all electrical branch wiring was cut at the main service panel entrances (located in the respective electrical rooms) when inspected. Recommend having a licensed electrical contractor evaluate and repair electrical service to each building. The installed cabinets, panels and service disconnects appeared serviceable.

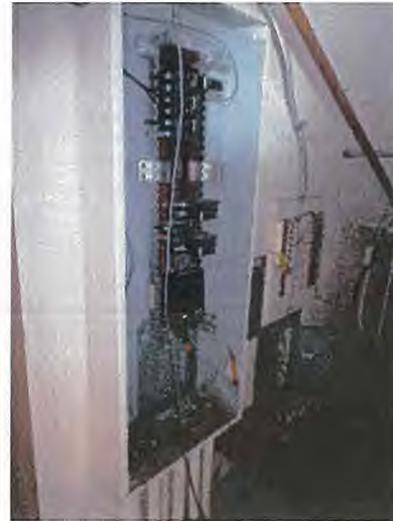
Building B and C: The main service conductors and all electrical branch wiring was cut at the main service panel entrances (located in the respective electrical rooms) when inspected. Recommend having a licensed electrical contractor evaluate and repair electrical service to each building. The installed cabinets, panels and service disconnects appeared serviceable.

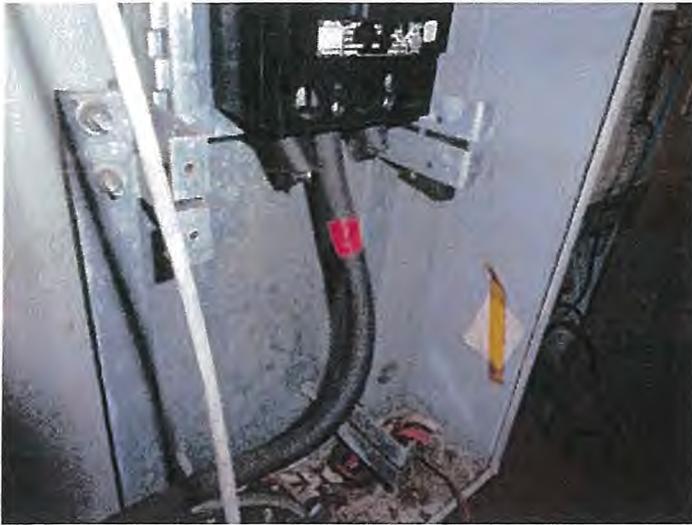
Building B and C: The main service conductors and all electrical branch wiring was cut at the main service panel entrances (located in the respective electrical rooms) when inspected. Recommend having a licensed electrical contractor evaluate and repair electrical service to each building. The installed cabinets, panels and service disconnects appeared serviceable.

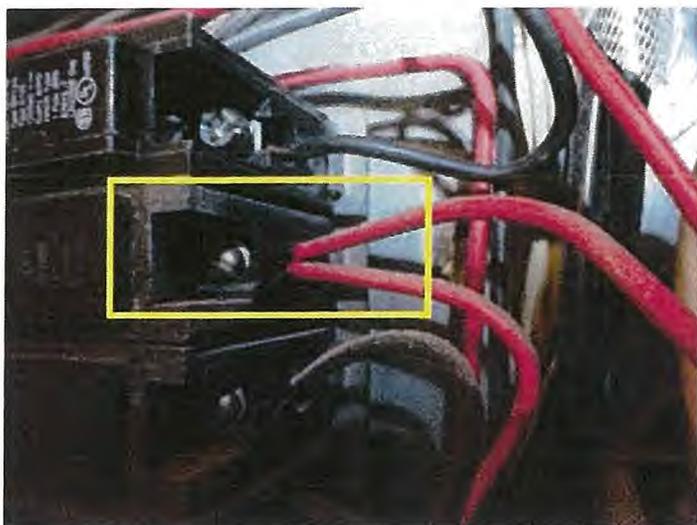
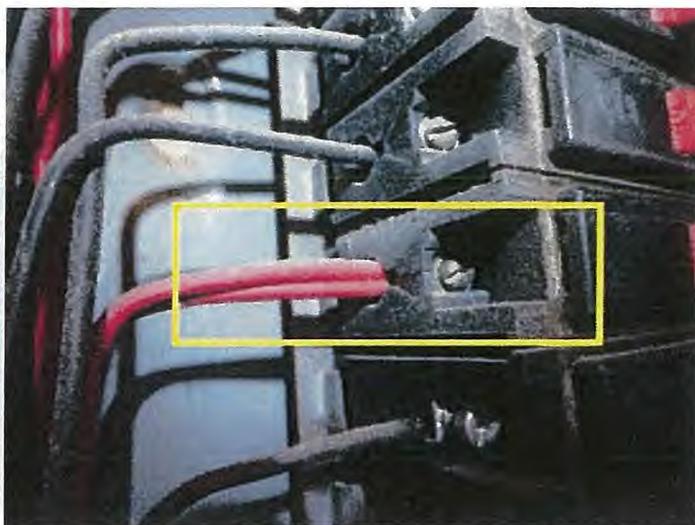
- **There were double tapped 1-pole circuit breakers noted at the time of inspection. This is not consistent with the manufacturer's instructions and the **NEC**. We recommend having a licensed electrician evaluate and repair/replace as necessary.**

There were double tapped 1-pole circuit breakers noted at the time of inspection.

This is not consistent with the manufacturer's instructions and the NEC.

We recommend having a licensed electrician evaluate and repair/replace as necessary.

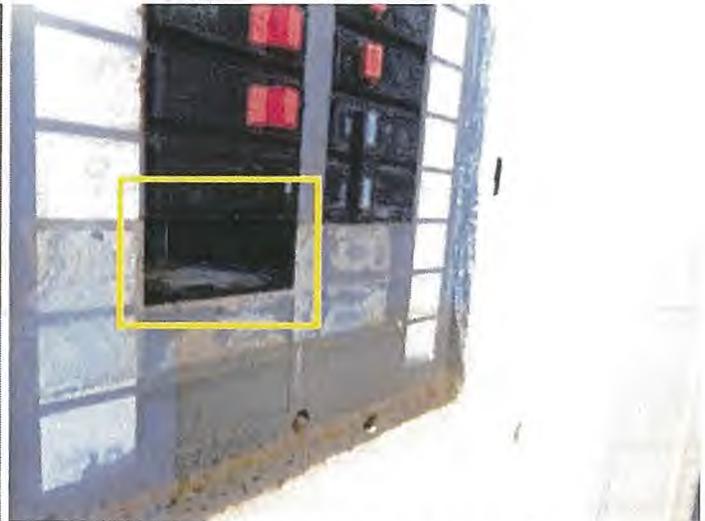
- **There appeared to be open knock outs/twist outs within a metal electrical cabinet. Any unused openings, other than those intended for the operation of equipment, those intended for mounting purposes, or those permitted as part of the design for **lsted** equipment, shall be closed to afford protection substantially equivalent to the wall of the equipment. (NEC 110.12(A). Recommend having a licensed electrician replace the plastic plugs with metallic ones.**

There appeared to be open knock outs/twist outs within a metal electrical cabinet. Any unused openings, other than those intended for the operation of equipment, those intended for mounting purposes, or those permitted as part of the design for listed equipment, shall be closed to afford protection substantially equivalent to the wall of the equipment. (NEC 110.12(A)). Recommend having a licensed electrician replace the plastic plugs with metallic ones.

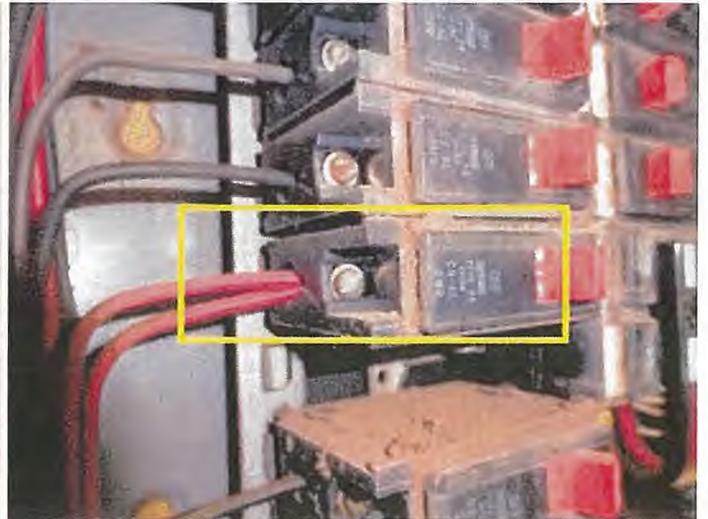
There were double tapped 1-pole circuit breakers noted at the time of inspection. This is not consistent with the manufacturer's instructions and the NEC. We recommend having a licensed electrician evaluate and repair/replace as necessary.

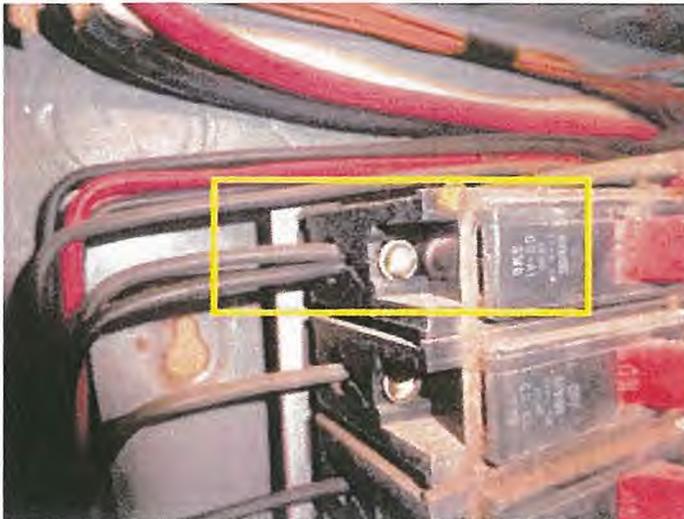
There were double tapped 1-pole circuit breakers noted at the time of inspection. This is not consistent with the manufacturer's instructions and the NEC. We recommend having a licensed electrician evaluate and repair/replace as necessary.

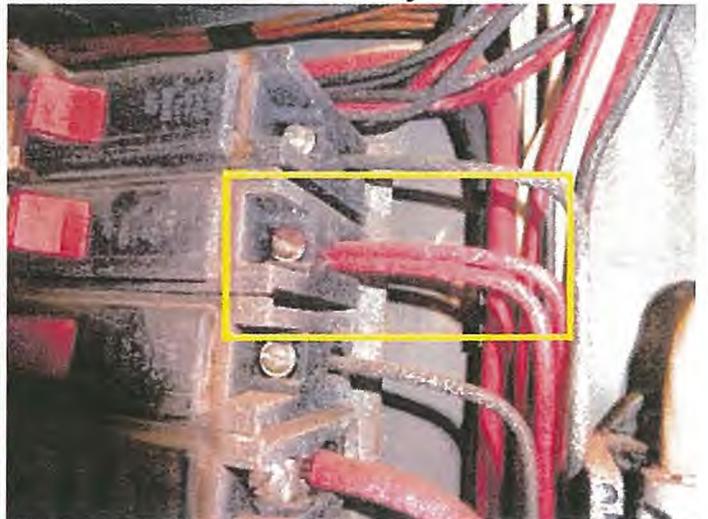
There were double tapped 1-pole circuit breakers noted at the time of inspection. This is not consistent with the manufacturer's instructions and the NEC. We recommend having a licensed electrician evaluate and repair/replace as necessary.

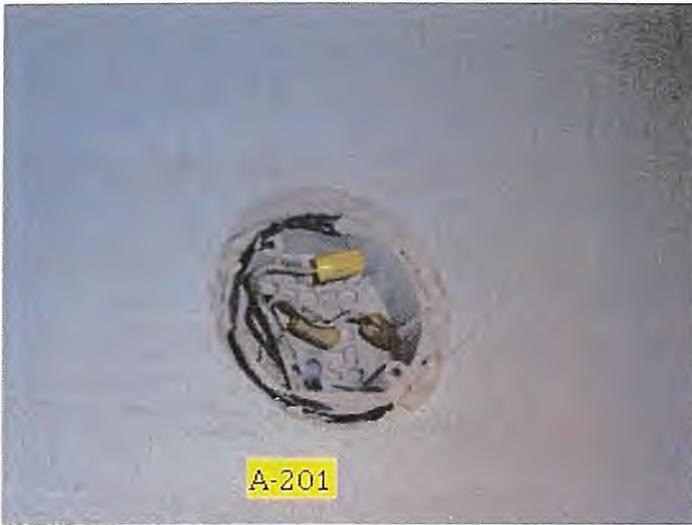
- ***** **LABELING** *****
- **Panels were not properly labeled as required.**
- **** **JUNCTION BOXES / SPLICES** ****
- **There were missing junction box covers noted at the following locations: attic spaces and front exterior of store.**

There were missing junction box covers noted at the following locations: attic spaces and front exterior of store.

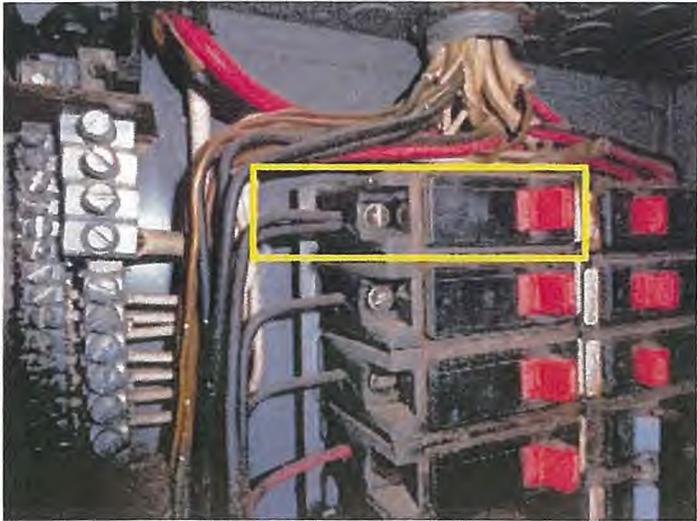
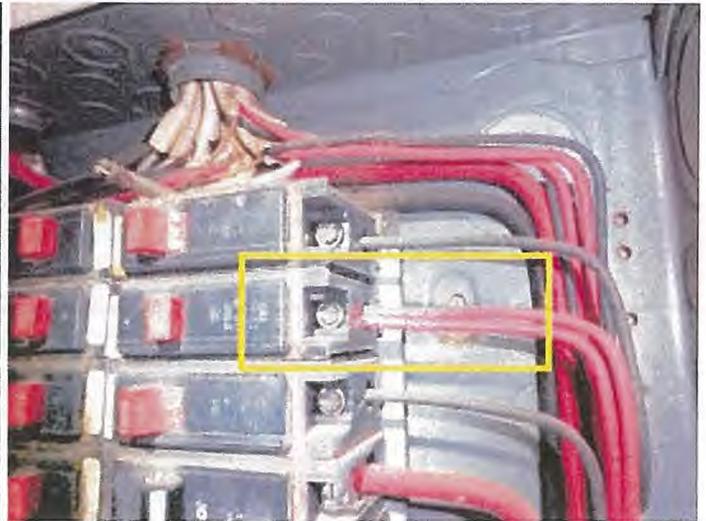
There were double tapped 1-pole circuit breakers noted at the time of inspection.

We recommend having a licensed electrician evaluate and repair/replace as necessary.

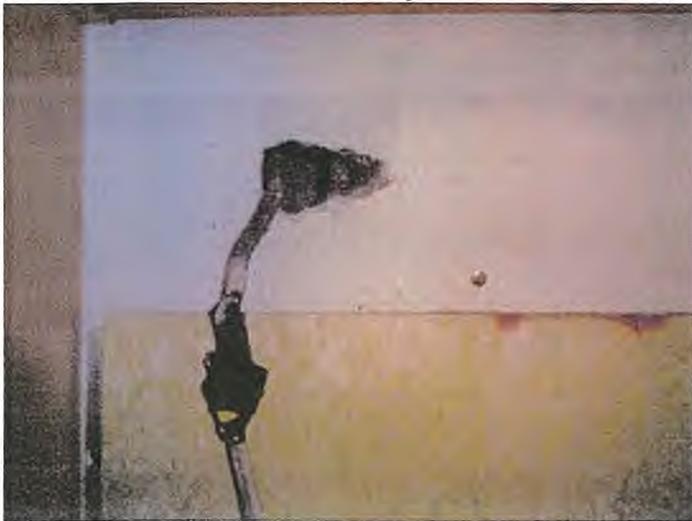
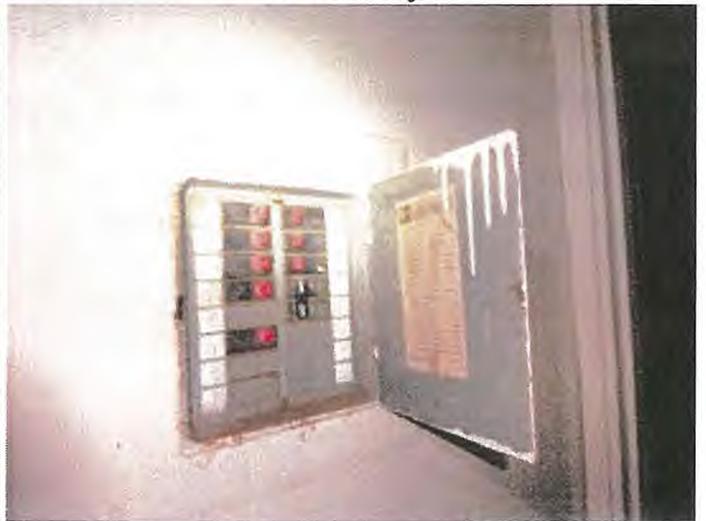
- **There were improperly terminated splices at the following locations: B-201**

There were improperly terminated splices at the following locations: B-201

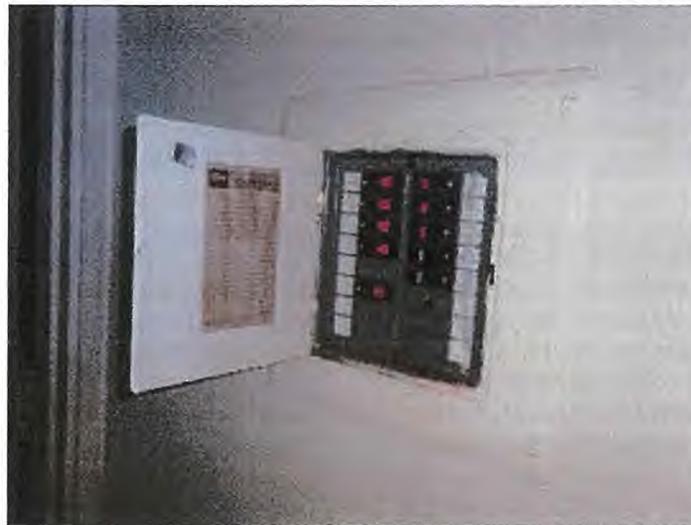
- **** **PANEL CONDITION** ****
- **All of the branch wiring to buildings B and C was cut with circuit breakers removed. Recommend having a licensed electrical contractor repair.**

All of the branch wiring to buildings B and C was cut with circuit breakers removed. Recommend having a licensed electrical contractor repair.

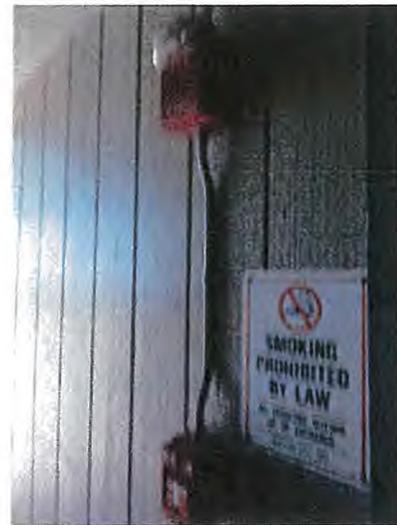
- **** PULL STATIONS ****
- **Approximately half of the installed pull stations were damaged when inspected. Recommend replacement/repair.**
- **** SPRINKLERS ****

Approximately half of the installed pull stations were damaged when inspected. Recommend replacement/repair.
