Property Condition Report

310 W Kaahumanu Ave, Kahului, HI 96732
Inspection prepared for: Maui County c/o Buddy Almeida
Real Estate Agent: -

Date of Inspection: 3/28/2018 Time: 8:00 AM
Age of Home: 1980 Size: 15000

This is a commercial property condition assessment to determine if three (3) former UH dormitories are suitable for housing. This inspection includes invasive and non-invasive inspection methods as well as sampling for asbestos and lead based paint.

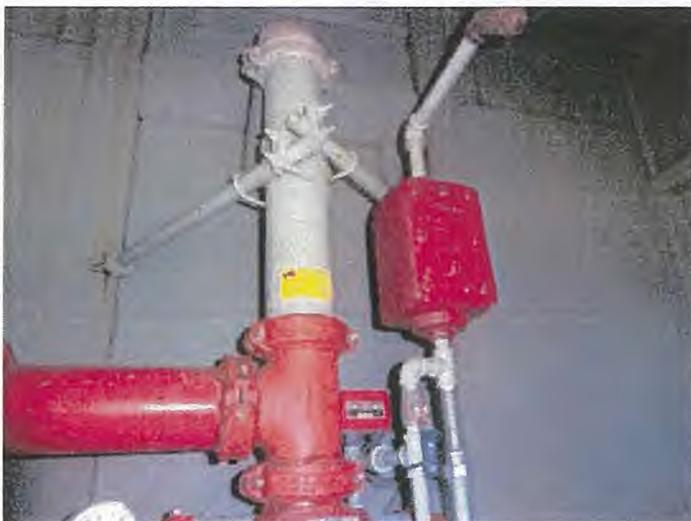
- **Sprinkler Systems: due to the system not having been properly serviced at required intervals, adequacy or performance questionable.**
- **Building B: Sprinkler branch pipe was broken/bent down in the electrical room. Recommend repair.**

Sprinkler Systems: due to the system not having been properly serviced at required intervals, adequacy or performance questionable.

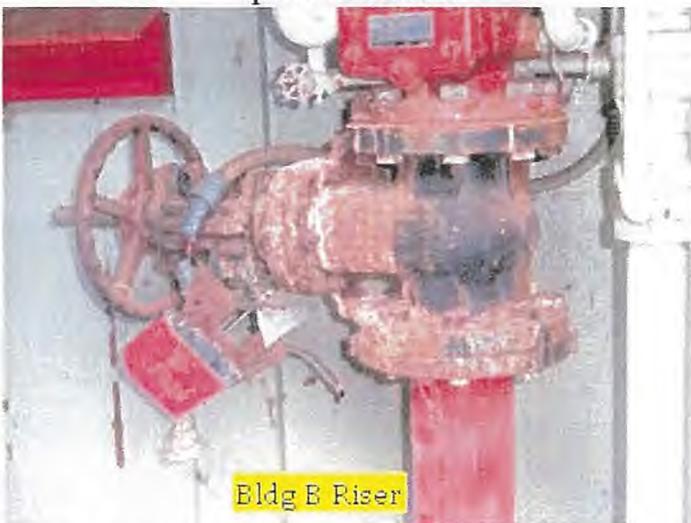
- **** RISER ****
- The fire suppression risers were located at the end of each building.
- **** RISER ****
- **The installed risers and associated equipment appeared to be damaged/improperly maintained when inspected. Recommend having a licensed fire suppression contractor evaluate, service, test and inspect the entire fire suppression system.**

The installed risers and associated equipment appeared to be damaged/improperly maintained when inspected. Recommend having a licensed fire suppression contractor evaluate, service, test and inspect the entire fire suppression system.

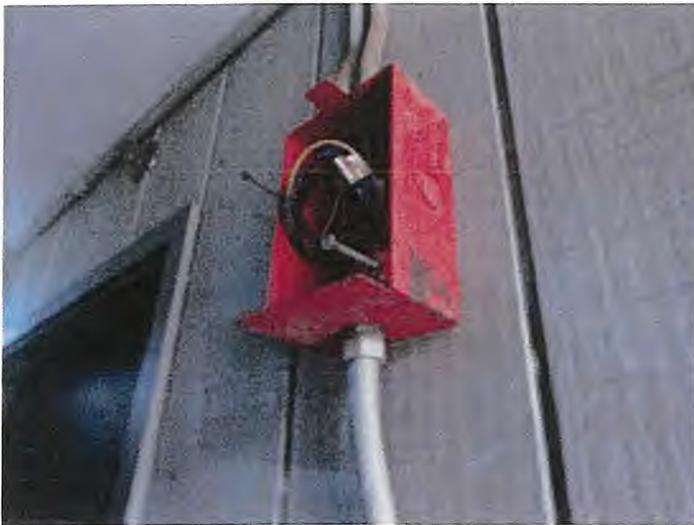
Approximately half of the installed pull stations were damaged when inspected. Recommend replacement/repair.

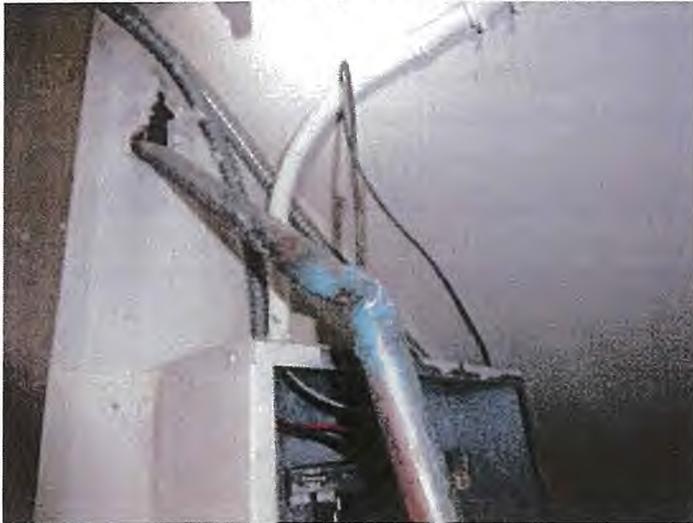
Building B: Sprinkler branch pipe was broken/bent down in the electrical room. Recommend repair.

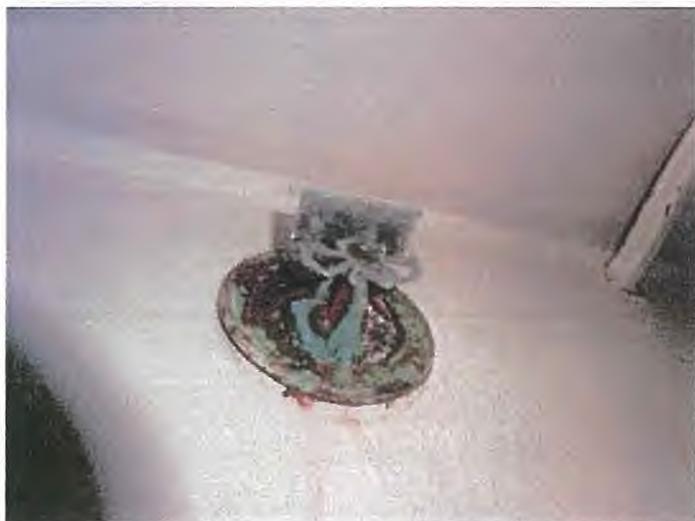
- **B-101: Fire sprinkler branch pipe and valve located in the hall closet was leaking when inspected.**
- **B-102: Sprinkler head was leaking when inspected.**

B-102: Sprinkler head was leaking when inspected.

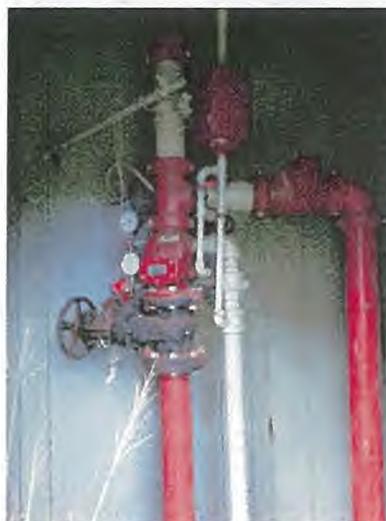
The installed risers and associated equipment appeared to be damaged/improperly maintained when inspected. Recommend having a licensed fire suppression contractor evaluate, service, test and inspect the entire fire suppression system.

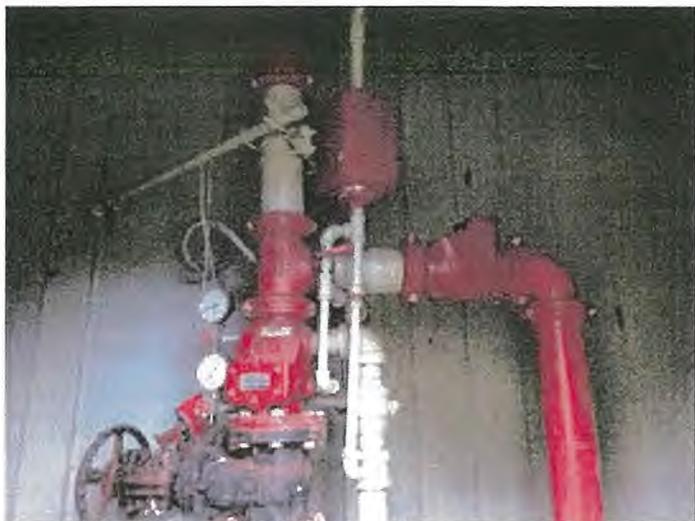
Sprinkler Systems: due to the system not having been properly serviced at required intervals, adequacy or performance questionable.

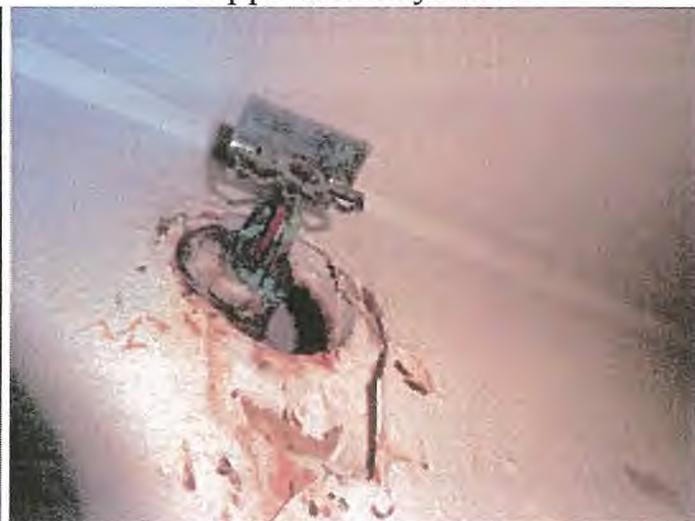
- **C-101: Sprinkler head was leaking when inspected.**

C-101: Sprinkler head was leaking when inspected.

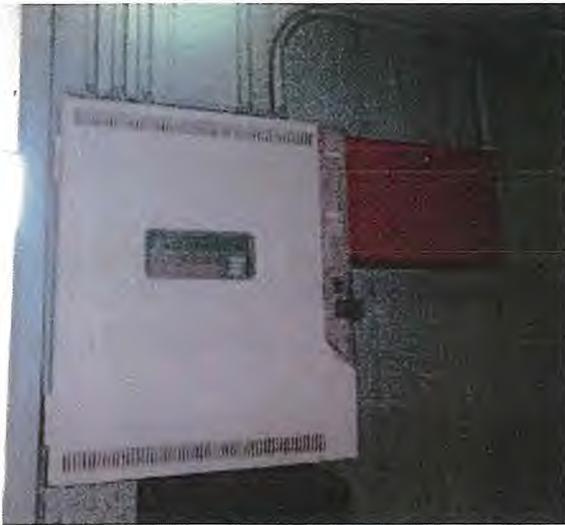
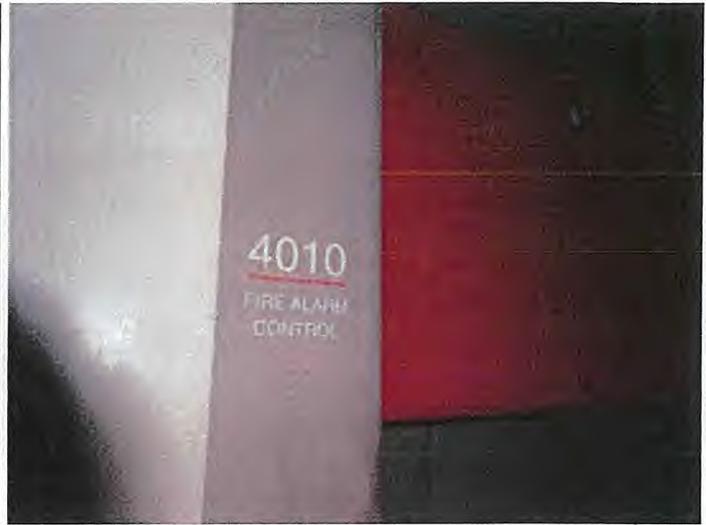
Each building had a designated alarm and alarm panel which was located on the ground floor. Based on the observed conditions of installed equipment, we recommend having the installed equipment repaired and/or replaced by a licensed security contractor as desired.

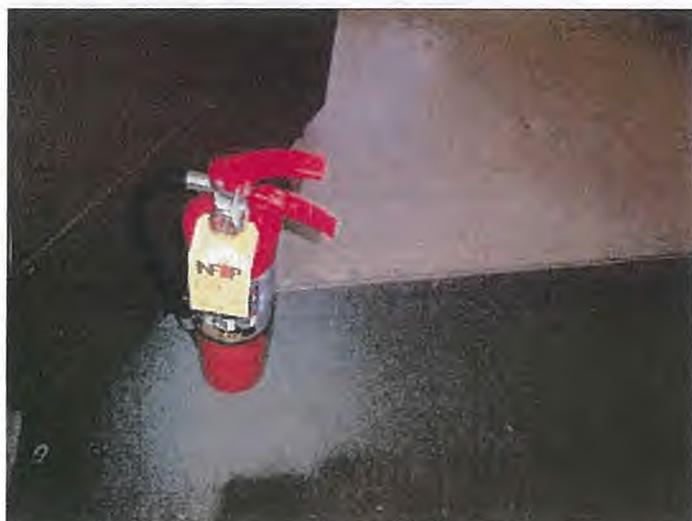
- The installed fire extinguishers were expired inspection and servicing placards at the time of inspection. We recommend having a licensed fire extinguisher contractor evaluate and be contracted to service and inspect the existing items as required.
- Most of the fire extinguishers were missing at required locations.

The installed fire extinguishers were expired inspection and servicing placards at the time of inspection. We recommend having a licensed fire extinguisher contractor evaluate and be contracted to service and inspect the existing items as required.

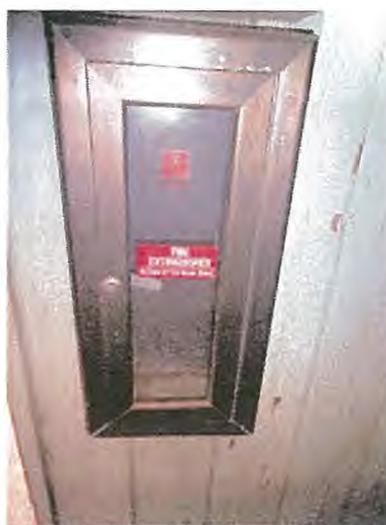
Most of the fire extinguishers were missing at required locations.

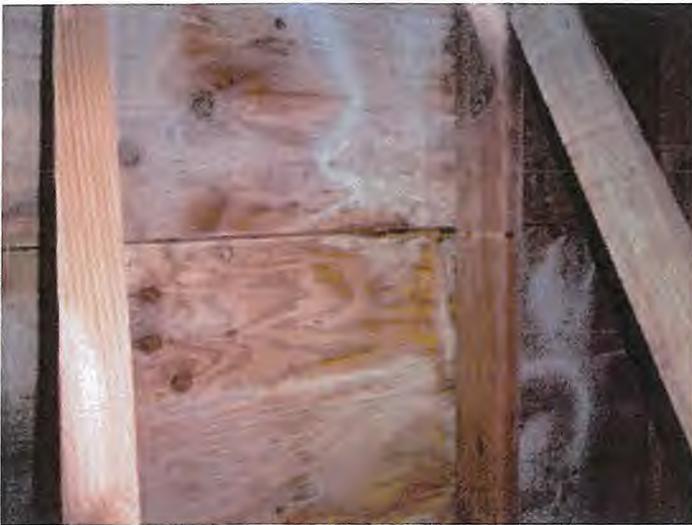
There were visible indications of mold present at all attic areas.

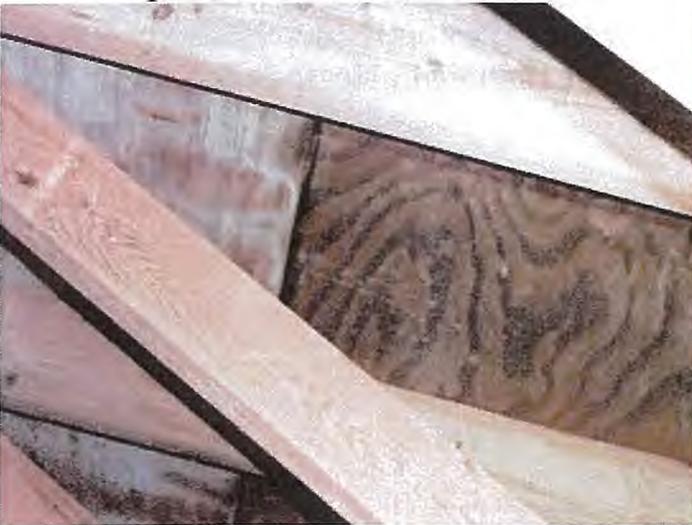
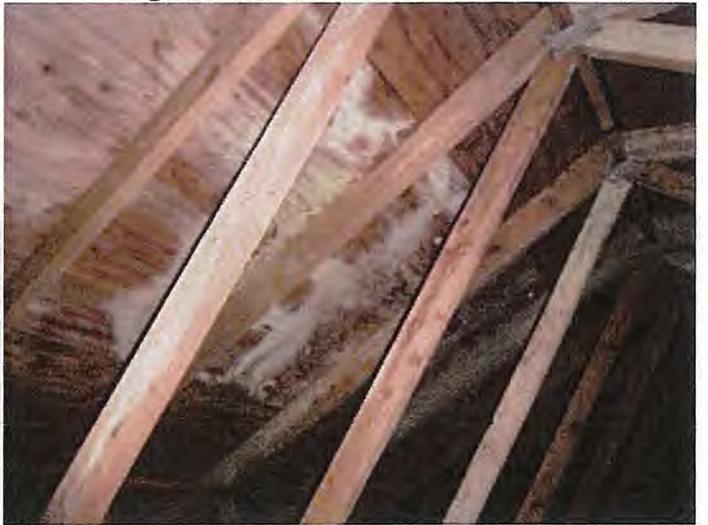
There were visible indications of mold present at all attic areas.

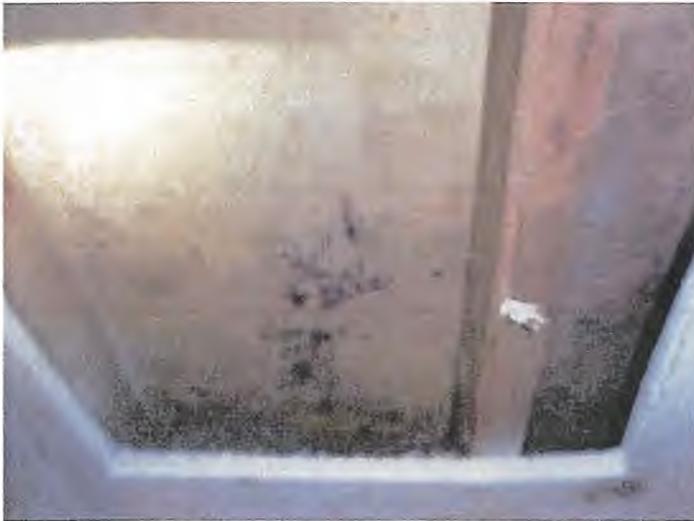
Visible indications of moisture intrusion and mold growth at building B and C interior, bedroom, bathroom and closet wall areas. Recommend removal and replacement of all interior wall finishes of B and C, after removal of all exterior vegetation.

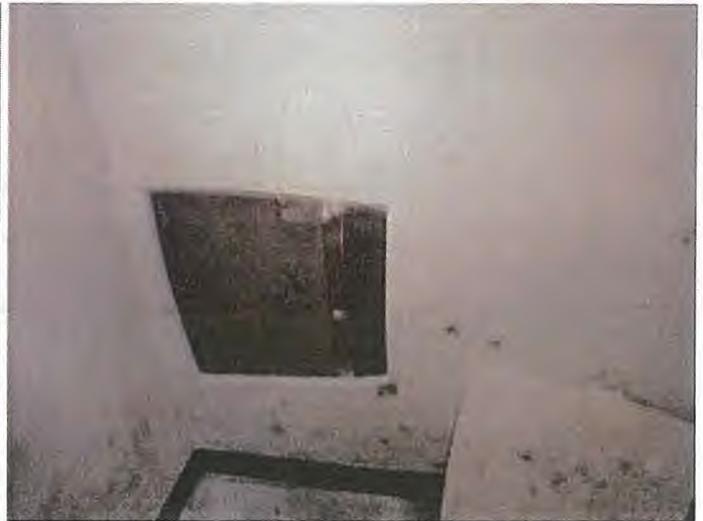
Most of the exterior facing lower interior wall finishes had moisture damage observed. Recommend removal and replacement of affected materials.

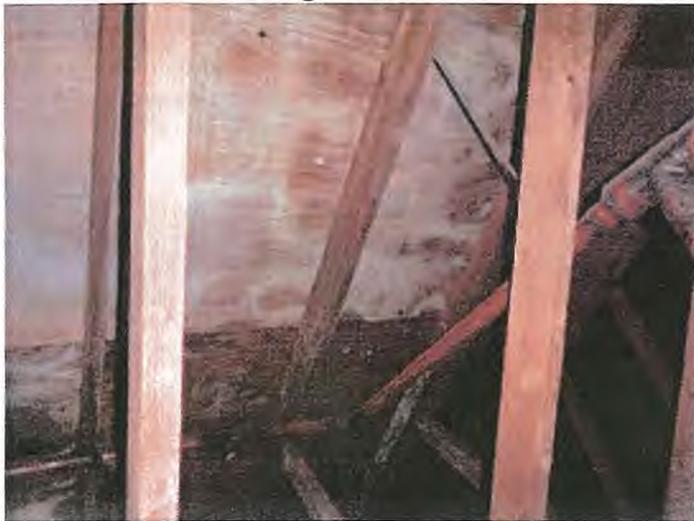
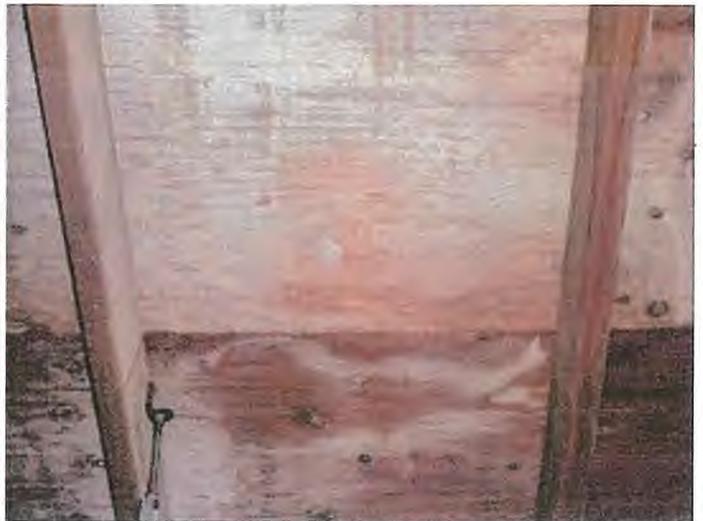
There were visible indications of mold present at all attic areas.

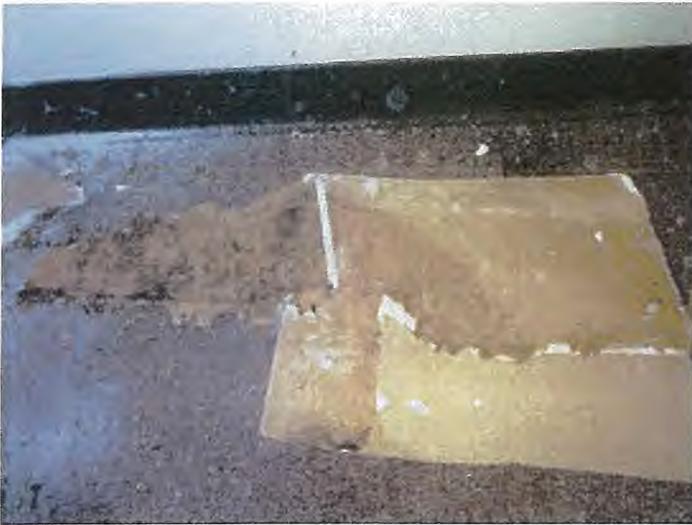
Visible indications of moisture intrusion and mold growth at building B and C interior, bedroom, bathroom and closet wall areas. Recommend removal and replacement of all interior wall finishes of B and C, after removal of all exterior vegetation.

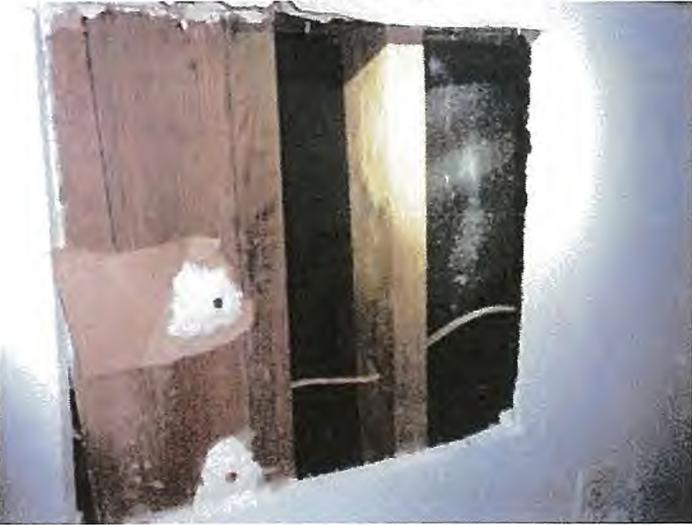
Visible indications of moisture intrusion and mold growth at building B and C interior, bedroom, bathroom and closet wall areas. Recommend removal and replacement of all interior wall finishes of B and C, after removal of all exterior vegetation.

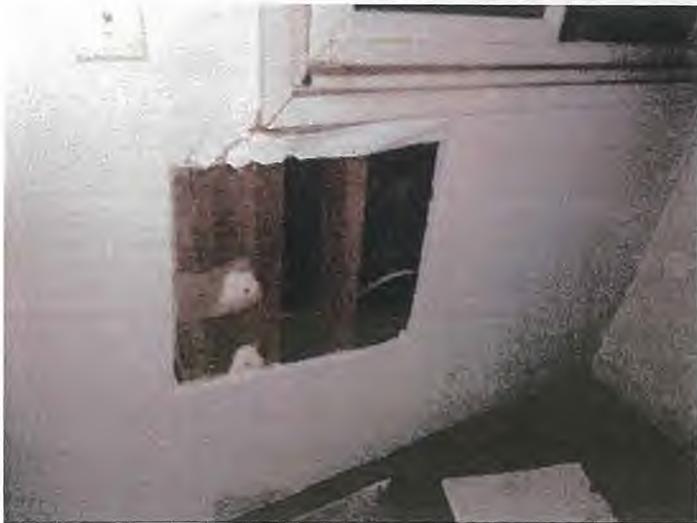
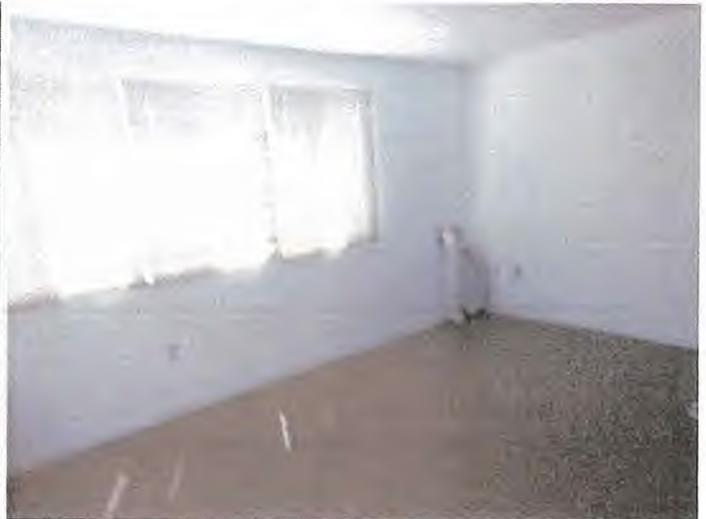
A-102

Most of the exterior facing lower interior wall finishes had moisture damage observed. Recommend removal and replacement of affected materials.

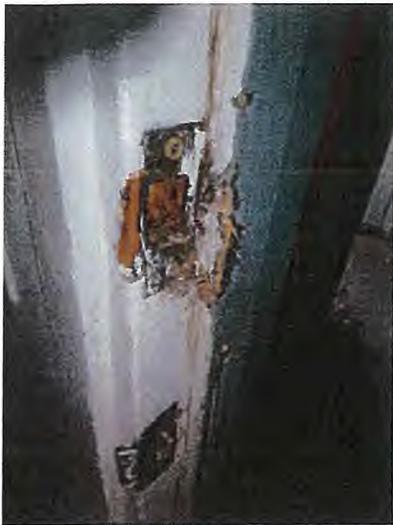
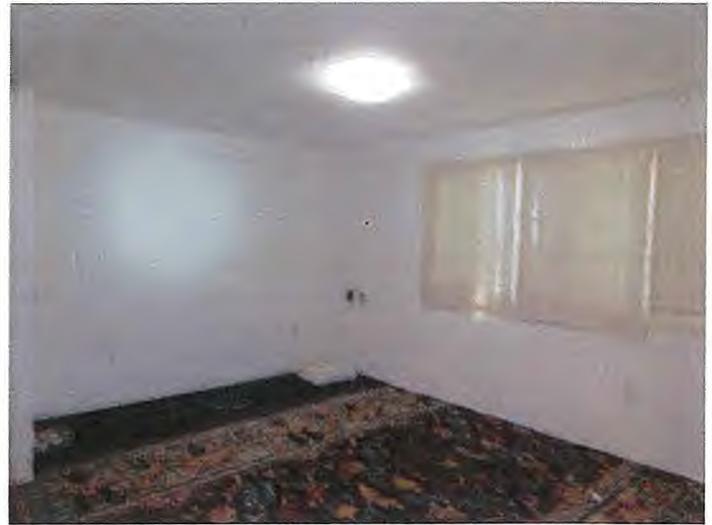
A-101

Most of the doors had varying degrees of damage observed when inspected. Based on the observed conditions, we recommend the replacement of all interior doors and trim within the dwelling units.

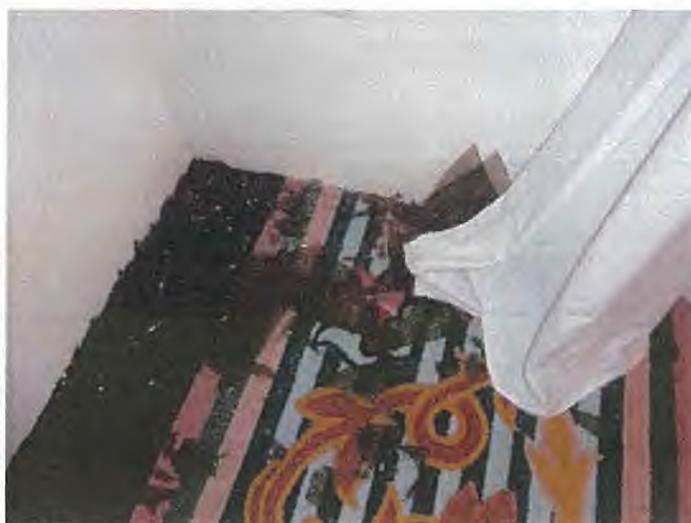
Most of the exterior facing lower interior wall finishes had moisture damage observed. Recommend removal and replacement of affected materials.

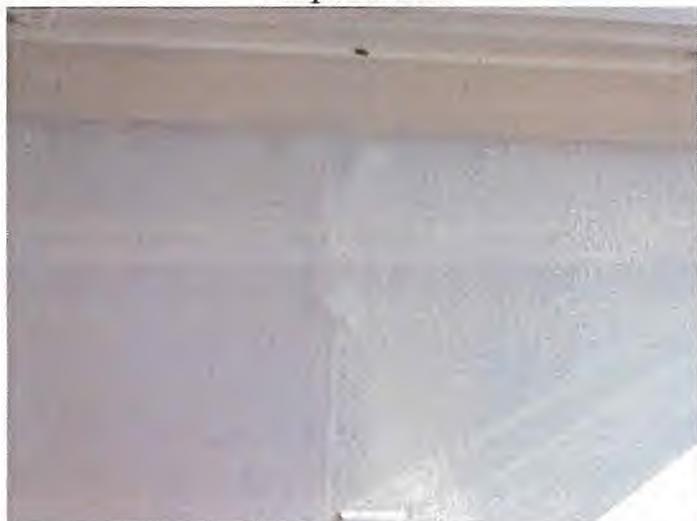
There were visible indications of moisture and termite damage observed at the interior window trim areas. Recommend replacement of all interior window trim and finishes.

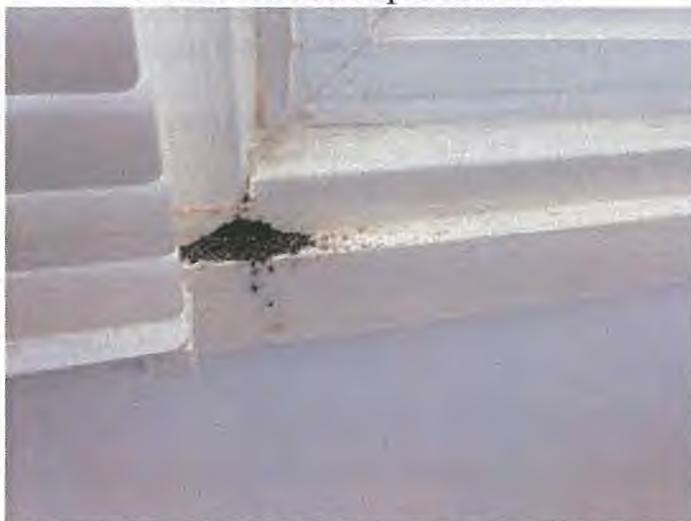
There were visible indications of moisture and termite damage observed at the interior window trim areas. Recommend replacement of all interior window trim and finishes.

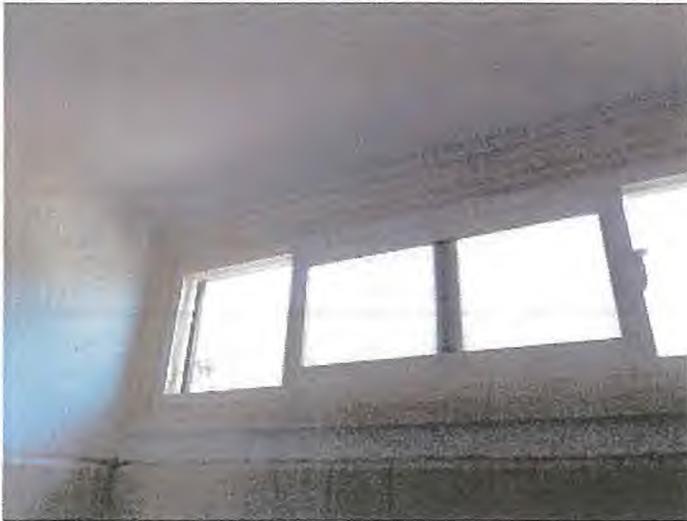
Visible indications of moisture intrusion and mold growth at building B and C interior, bedroom, bathroom and closet wall areas. Recommend removal and replacement of all interior wall finishes of B and C, after removal of all exterior vegetation.

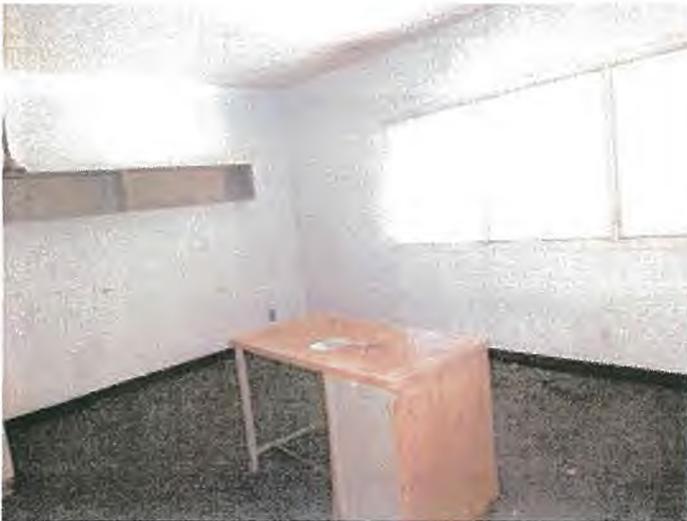
A-201

There were visible indications of water intrusion, with mold growth, noted at the ceiling areas of A-201. Recommend having a licensed contractor evaluate and repair as necessary to prevent further damage.

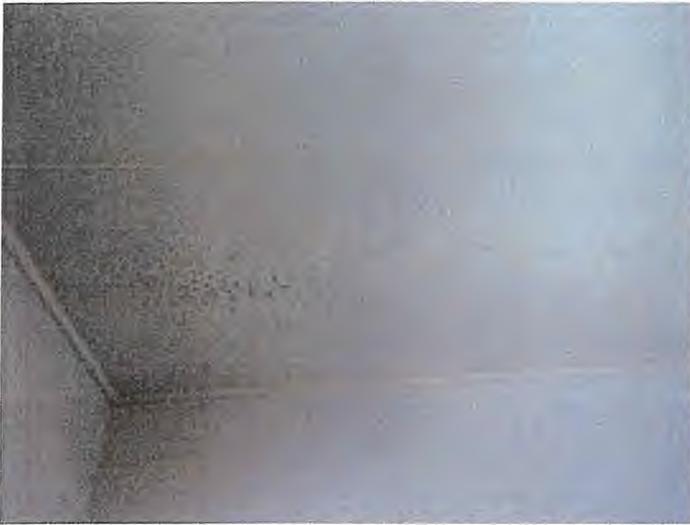
There were visible indications of water intrusion, with mold growth, noted at the ceiling areas of A-201. Recommend having a licensed contractor evaluate and repair as necessary to prevent further damage.

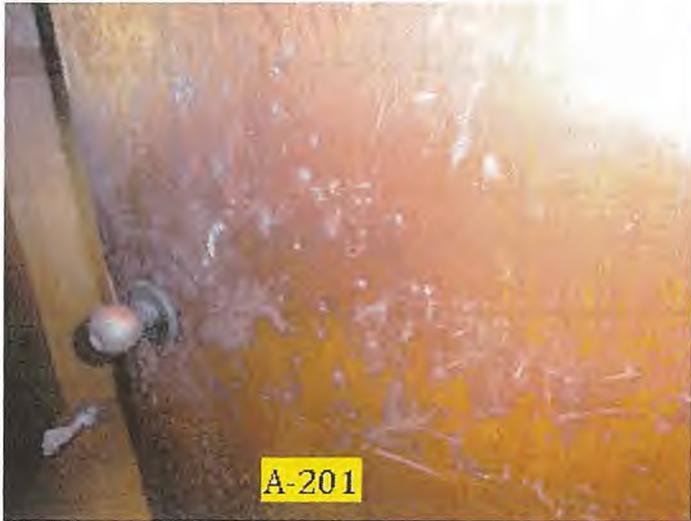
Visible mold observed at interior doors.

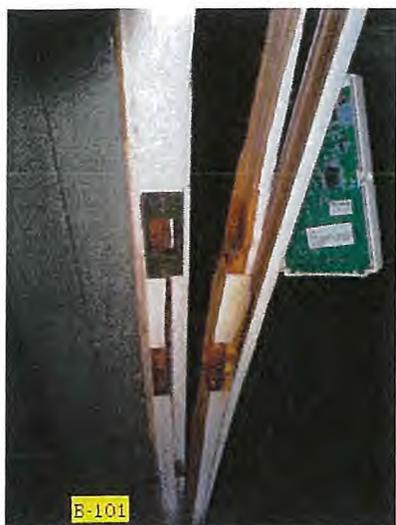
A-202

Most of the doors had varying degrees of damage observed when inspected. Based on the observed conditions, we recommend the replacement of all interior doors and trim within the dwelling units.

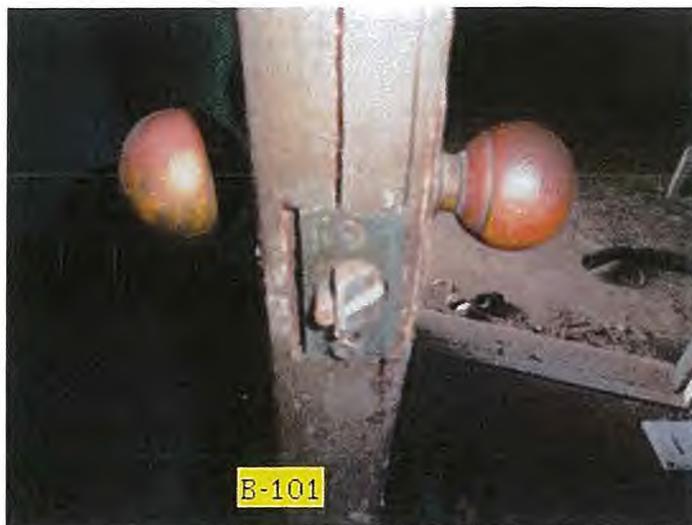
Most of the doors had varying degrees of damage observed when inspected. Based on the observed conditions, we recommend the replacement of all interior doors and trim within the dwelling units.

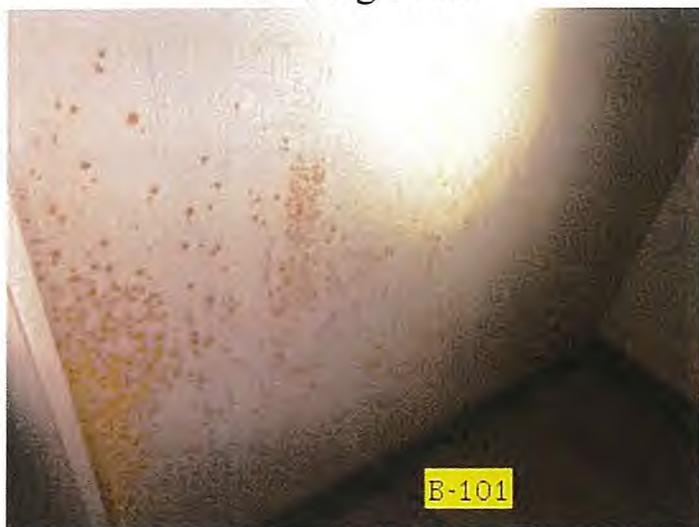
Visible indications of moisture intrusion and mold growth at building B and C interior, bedroom, bathroom and closet wall areas. Recommend removal and replacement of all interior wall finishes of B and C, after removal of all exterior vegetation.

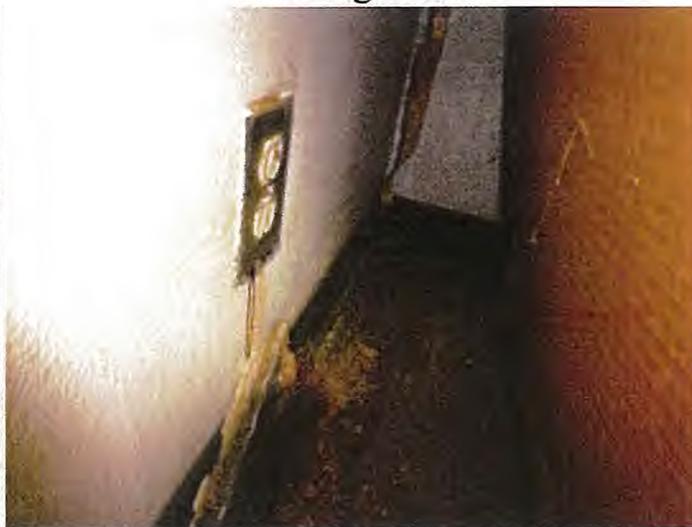
Visible indications of moisture intrusion and mold growth at building B and C interior, bedroom, bathroom and closet wall areas. Recommend removal and replacement of all interior wall finishes of B and C, after removal of all exterior vegetation.

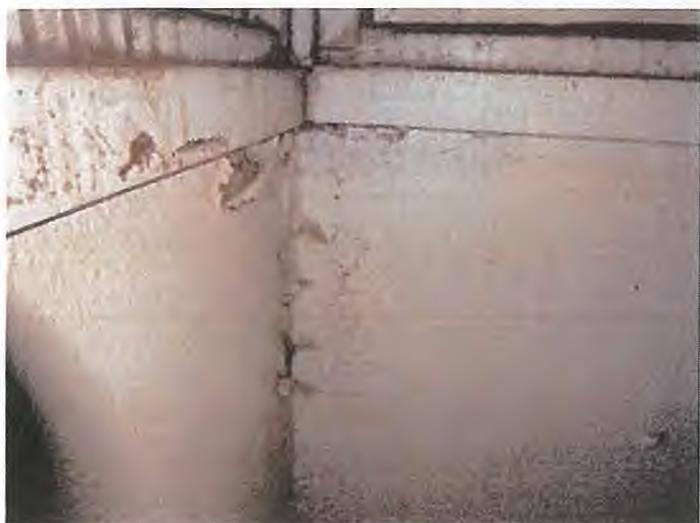
Most of the exterior facing lower interior wall finishes had moisture damage observed. Recommend removal and replacement of affected materials.

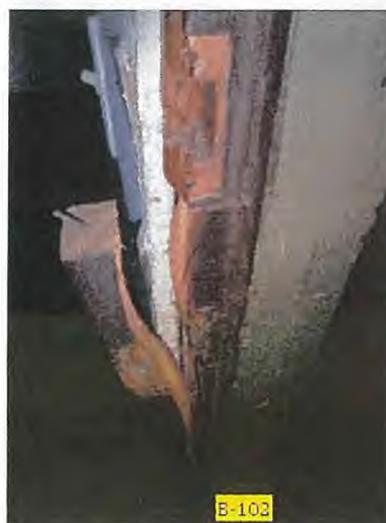
Most of the doors had varying degrees of damage observed when inspected. Based on the observed conditions, we recommend the replacement of all interior doors and trim within the dwelling units.

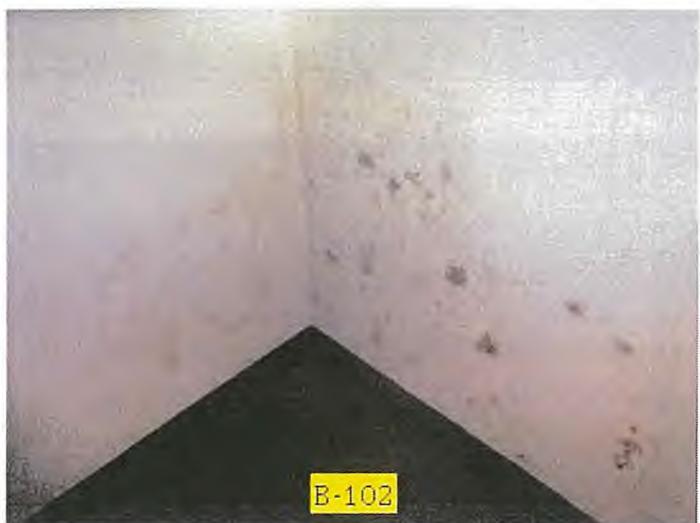
Visible indications of moisture intrusion and mold growth at building B and C interior, bedroom, bathroom and closet wall areas. Recommend removal and replacement of all interior wall finishes of B and C, after removal of all exterior vegetation.

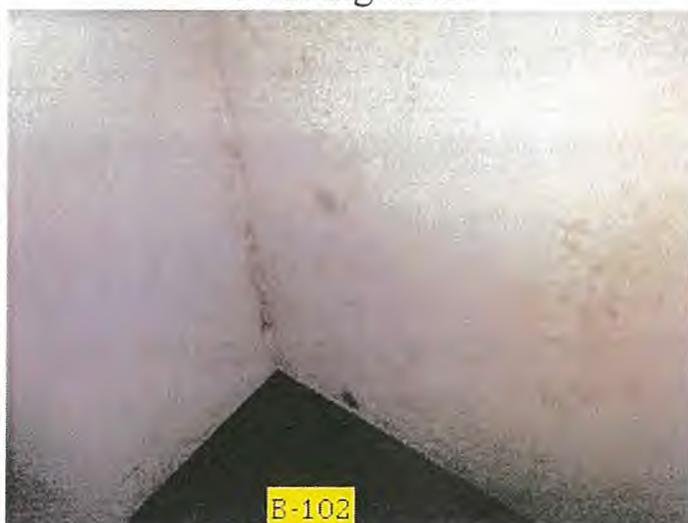
Visible indications of moisture intrusion and mold growth at building B and C interior, bedroom, bathroom and closet wall areas. Recommend removal and replacement of all interior wall finishes of B and C, after removal of all exterior vegetation.

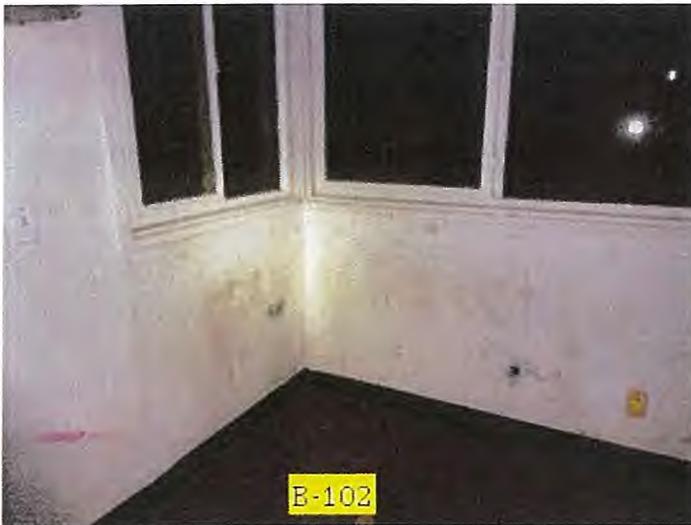
Most of the exterior facing lower interior wall finishes had moisture damage observed. Recommend removal and replacement of affected materials.

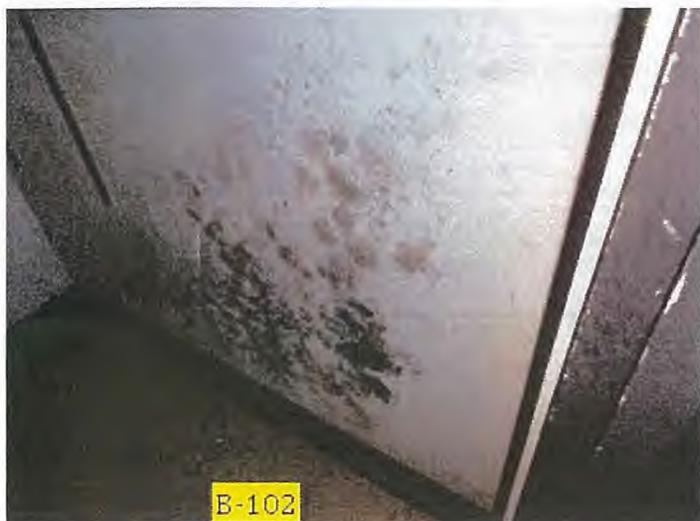
Visible indications of moisture intrusion and mold growth at building B and C interior, bedroom, bathroom and closet wall areas. Recommend removal and replacement of all interior wall finishes of B and C, after removal of all exterior vegetation.

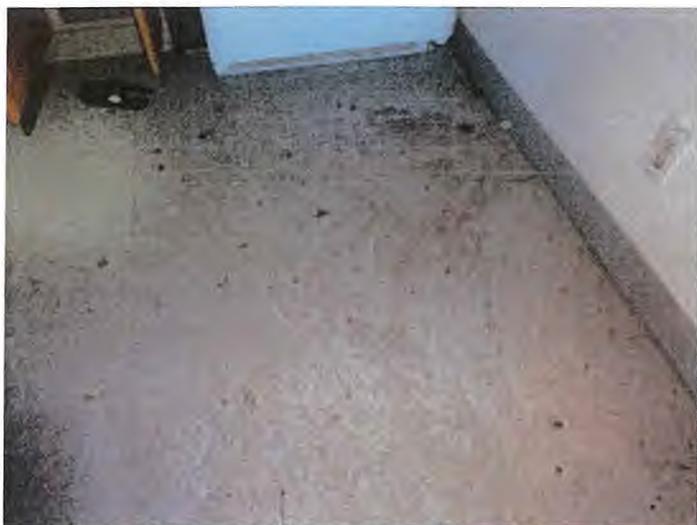
Most of the flooring in buildings B and C were damaged and should be replaced after completion of renovations.

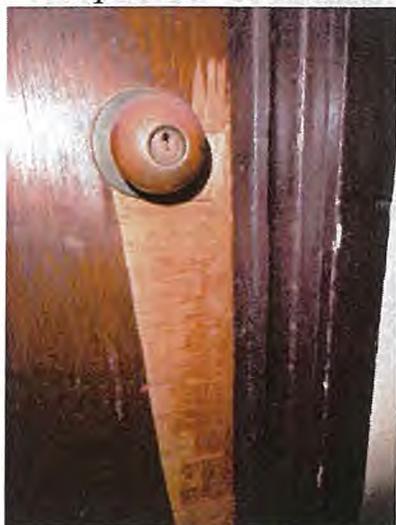
B-201

Most of the doors had varying degrees of damage observed when inspected. Based on the observed conditions, we recommend the replacement of all interior doors and trim within the dwelling units.

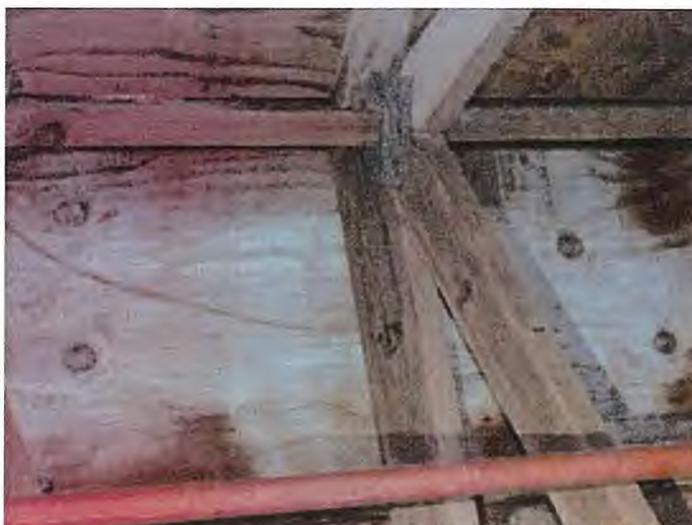
There were visible indications of mold present at all attic areas.

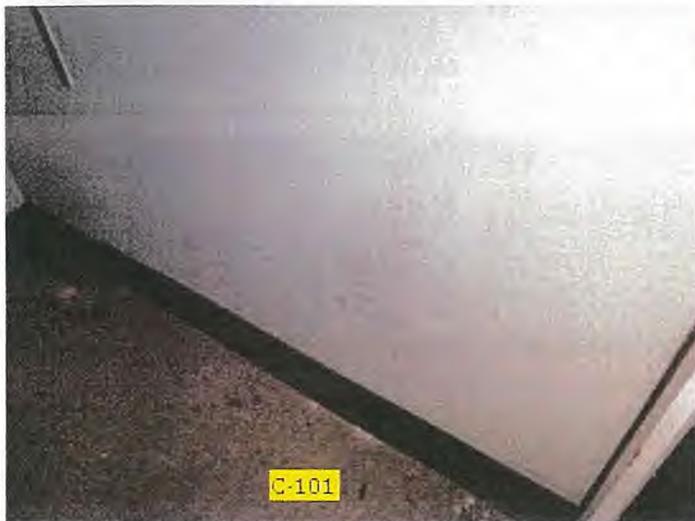
Most of the exterior facing lower interior wall finishes had moisture damage observed. Recommend removal and replacement of affected materials.

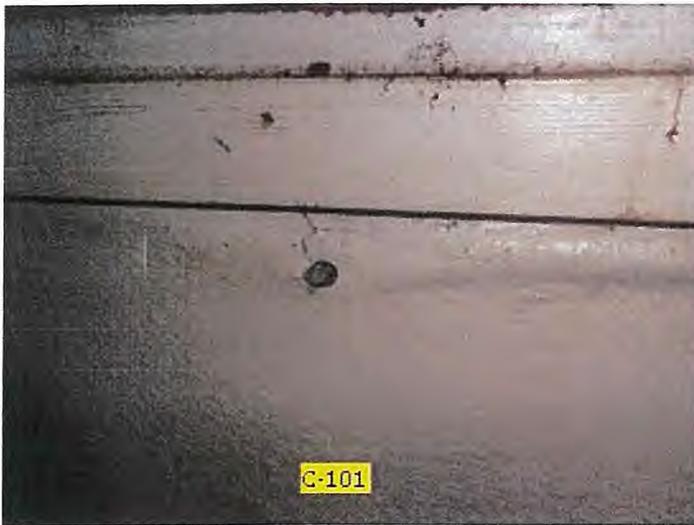
Visible indications of moisture intrusion and mold growth at building B and C interior, bedroom, bathroom and closet wall areas. Recommend removal and replacement of all interior wall finishes of B and C, after removal of all exterior vegetation.

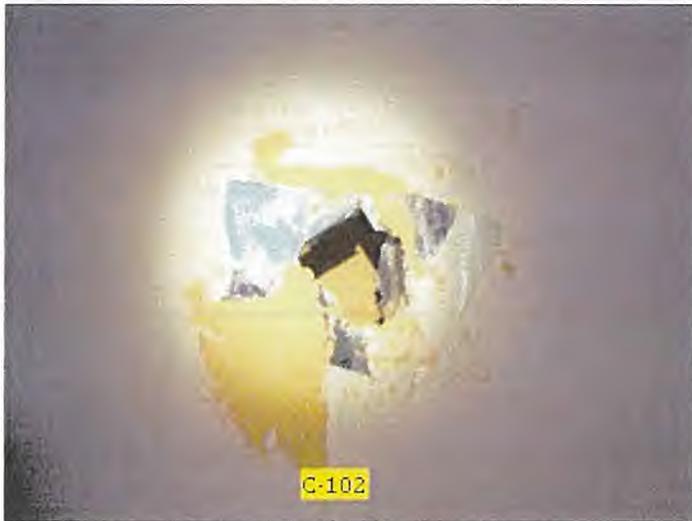
Visible indications of moisture intrusion and mold growth at building B and C interior, bedroom, bathroom and closet wall areas. Recommend removal and replacement of all interior wall finishes of B and C, after removal of all exterior vegetation.

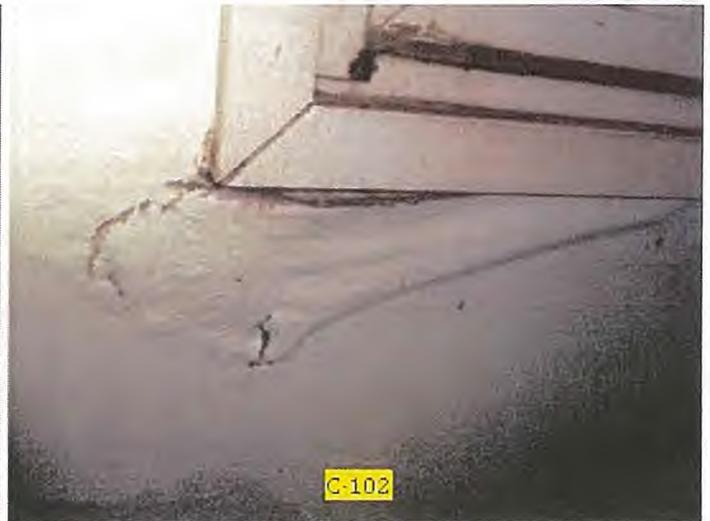
Most of the exterior facing lower interior wall finishes had moisture damage observed. Recommend removal and replacement of affected materials.

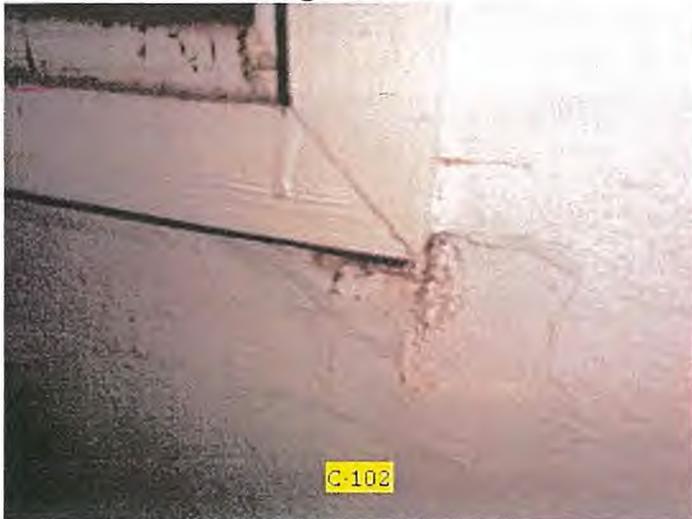
Most of the exterior facing lower interior wall finishes had moisture damage observed. Recommend removal and replacement of affected materials.

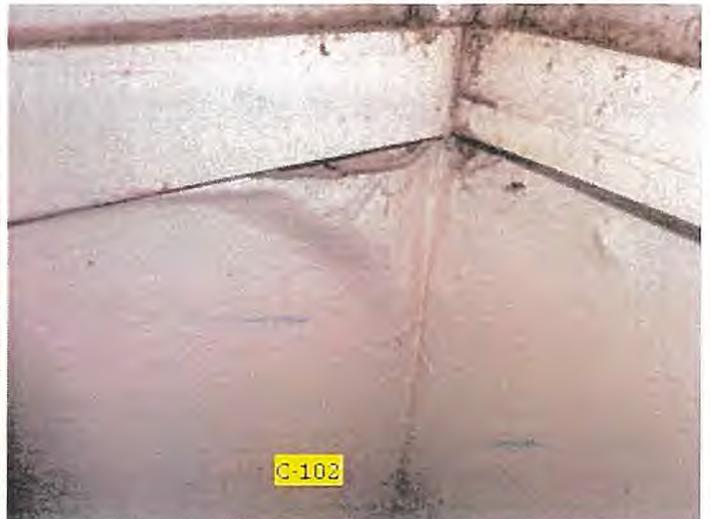
Most of the exterior facing lower interior wall finishes had moisture damage observed. Recommend removal and replacement of affected materials.

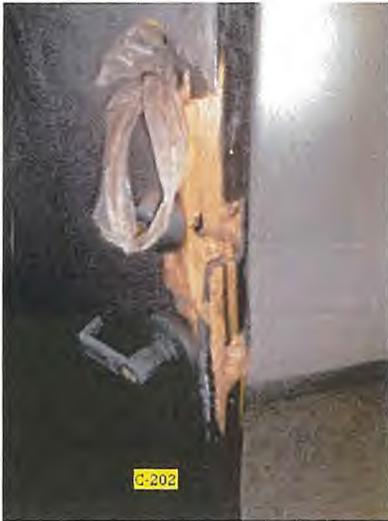
C-202

Most of the doors had varying degrees of damage observed when inspected. Based on the observed conditions, we recommend the replacement of all interior doors and trim within the dwelling units.

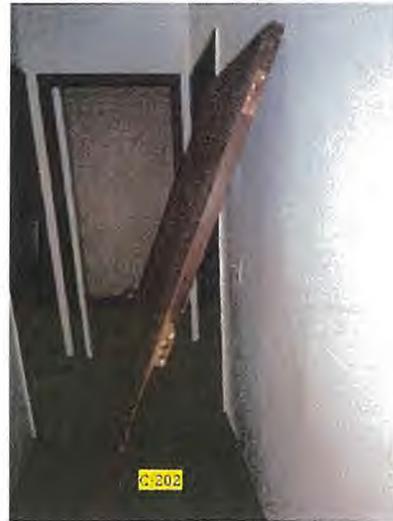
Most of the doors had varying degrees of damage observed when inspected. Based on the observed conditions, we recommend the replacement of all interior doors and trim within the dwelling units.

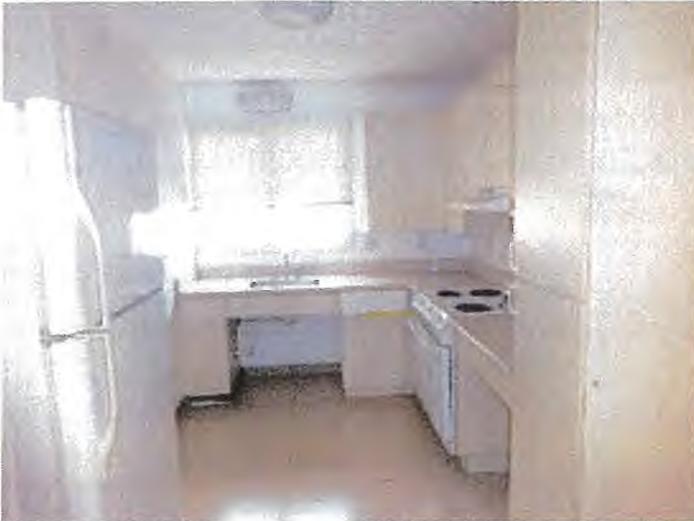
The kitchens in building A appeared to be functional at the time of inspection.

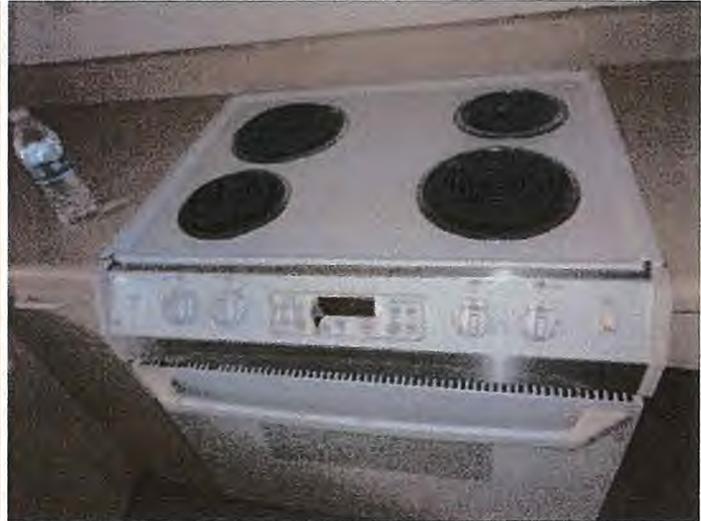
The kitchens in building A appeared to be functional at the time of inspection.

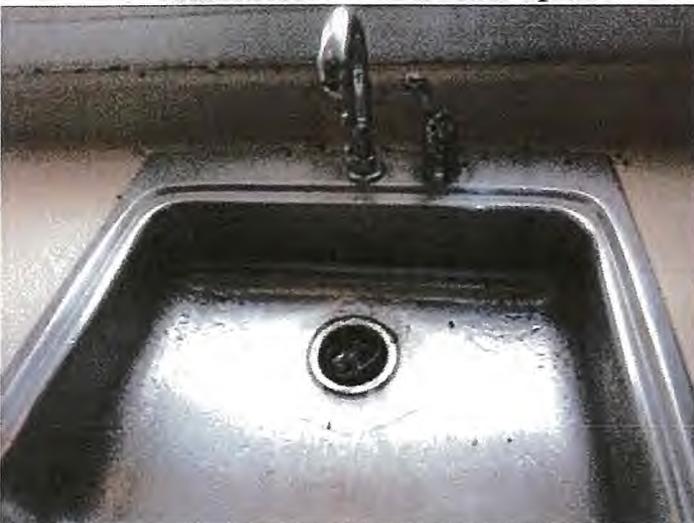
The kitchens in building A appeared to be functional at the time of inspection.

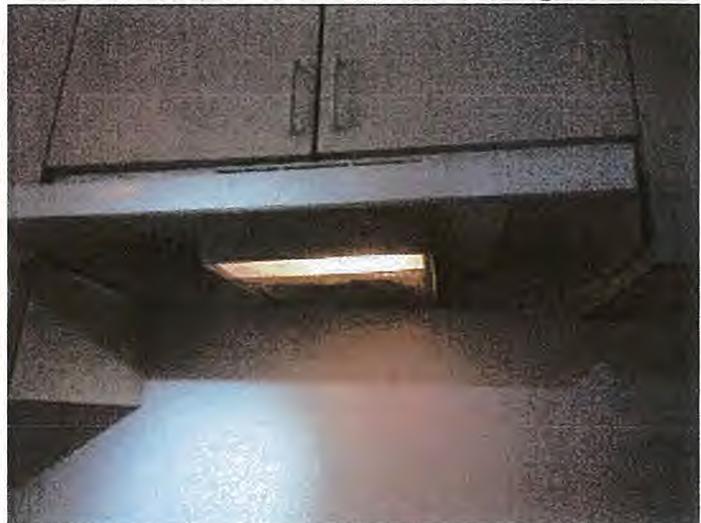
The kitchens in building A appeared to be functional at the time of inspection.

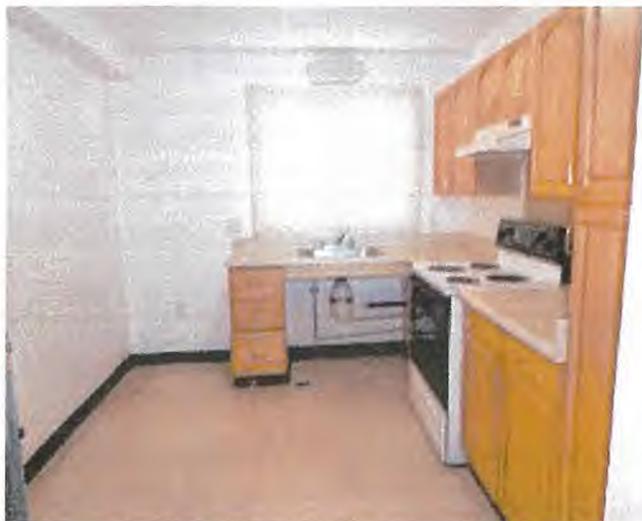
The kitchens in building A appeared to be functional at the time of inspection.

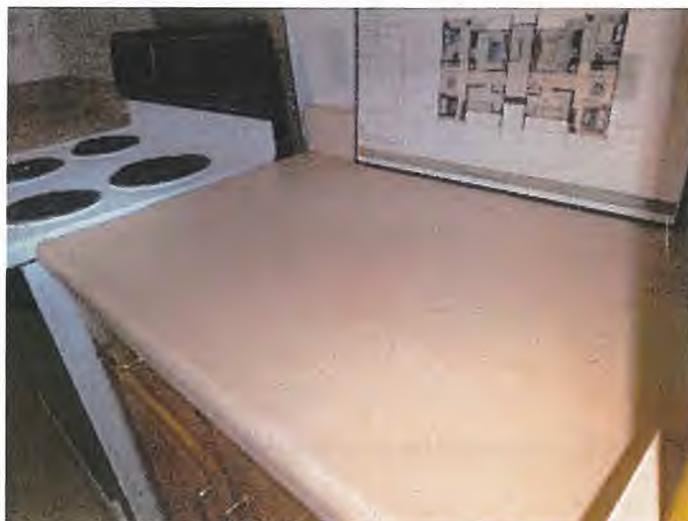
The kitchens in building A appeared to be functional at the time of inspection.
