Property Condition Report

310 W Kaahumanu Ave, Kahului, HI 96732
Inspection prepared for: Maui County c/o Buddy Almeida
Real Estate Agent: -

Date of Inspection: 3/28/2018 Time: 8:00 AM
Age of Home: 1980 Size: 15000

This is a commercial property condition assessment to determine if three (3) former UH dormitories are suitable for housing. This inspection includes invasive and non-invasive inspection methods as well as sampling for asbestos and lead based paint.

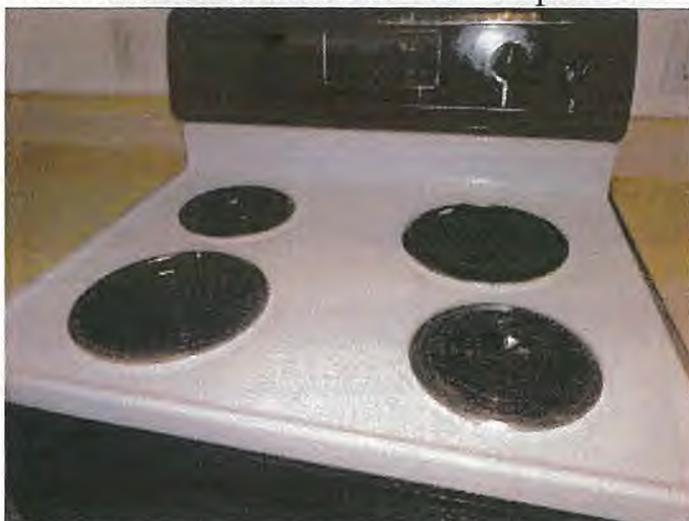
The kitchens in building A appeared to be functional at the time of inspection.

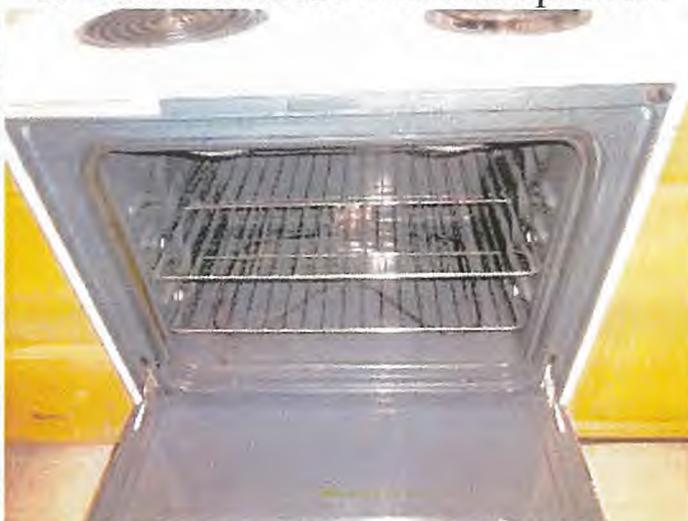
The kitchens in building A appeared to be functional at the time of inspection.

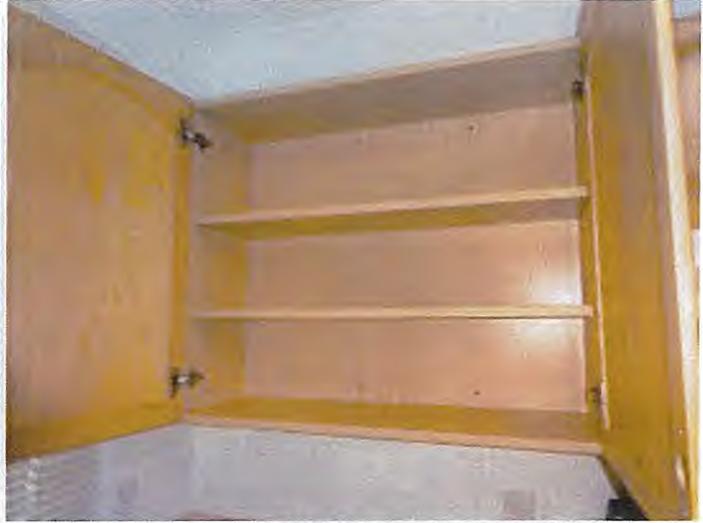
The kitchens in building A appeared to be functional at the time of inspection.

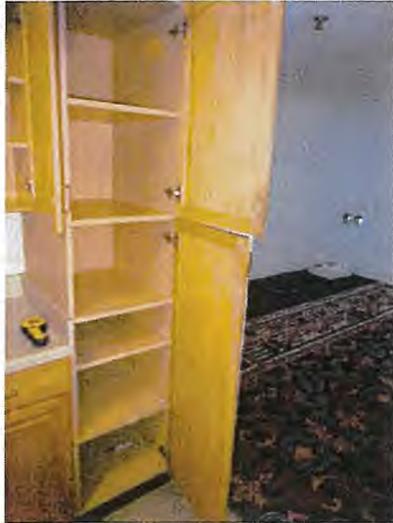
The kitchens in building A appeared to be functional at the time of inspection.

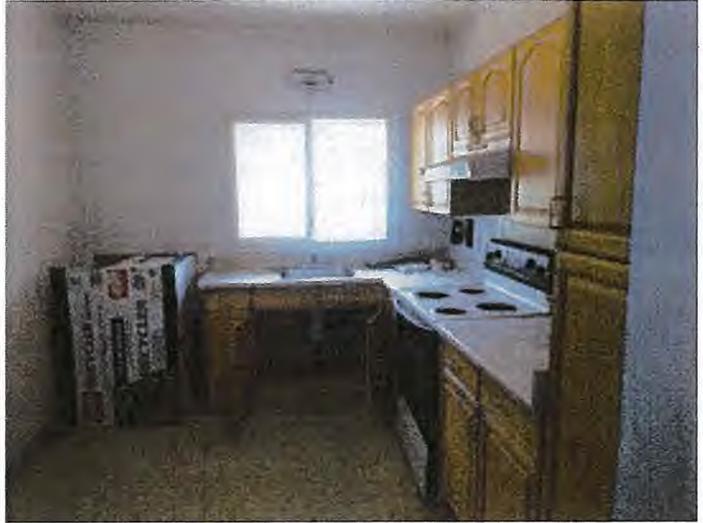
The kitchens in building A appeared to be functional at the time of inspection.

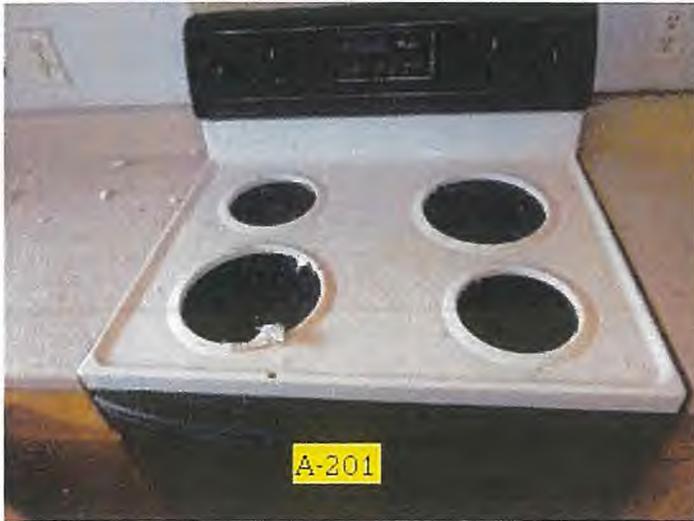
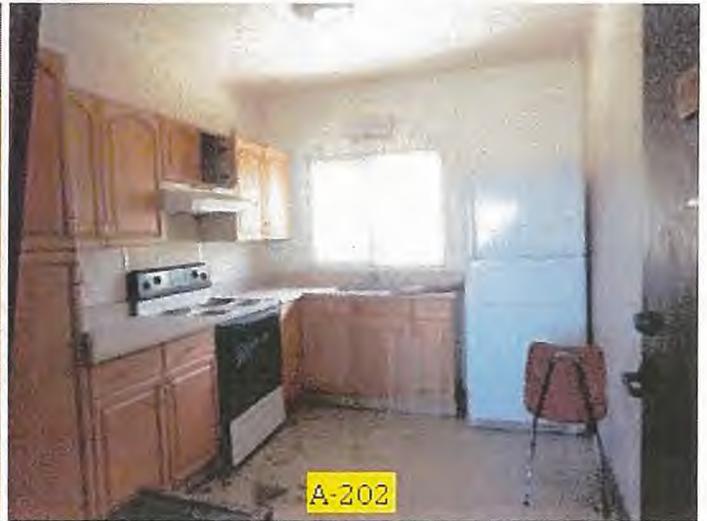
The kitchens in building A appeared to be functional at the time of inspection.

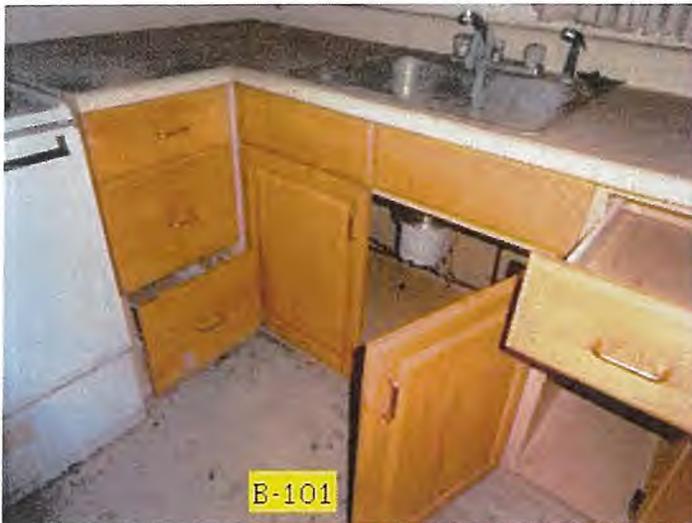
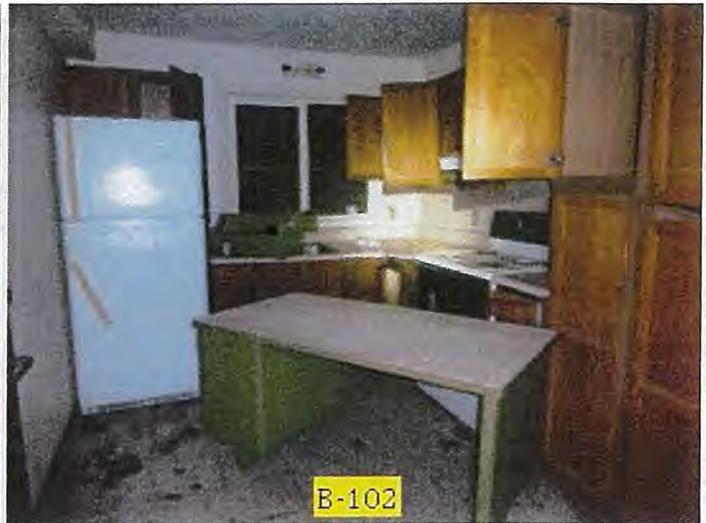
The kitchens of buildings B and C were deteriorated with moisture damage, termite damage and general damage observed at the cabinets, counters and finishes. Recommend the replacement of all dwelling unit kitchens, fixtures and appliances.

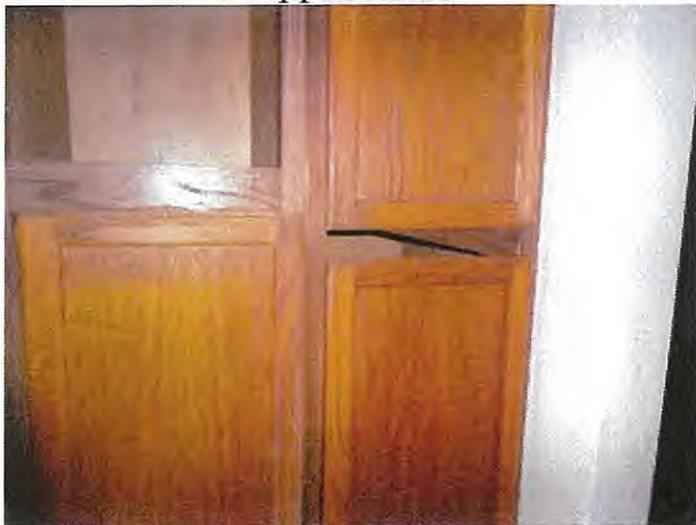
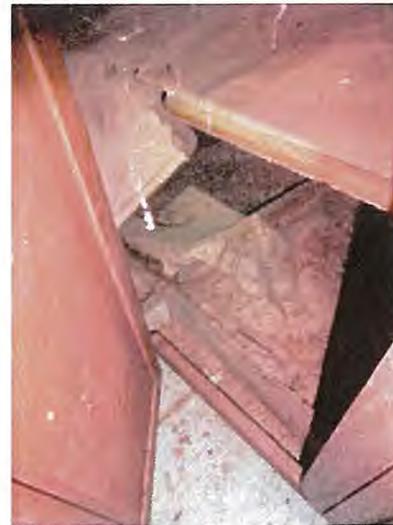
The kitchens of buildings B and C were deteriorated with moisture damage, termite damage and general damage observed at the cabinets, counters and finishes. Recommend the replacement of all dwelling unit kitchens, fixtures and appliances.

Building B and C ovens did not appear to be functional condition at the time of inspection. Recommend replacement.

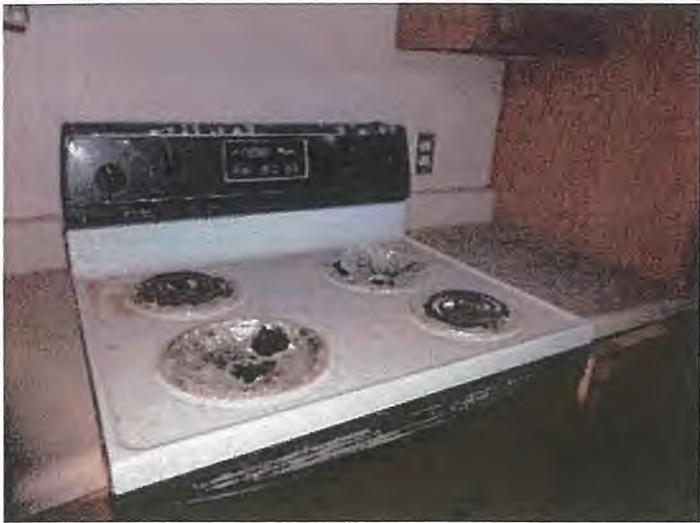
The kitchens of buildings B and C were deteriorated with moisture damage, termite damage and general damage observed at the cabinets, counters and finishes. Recommend the replacement of all dwelling unit kitchens, fixtures and appliances.

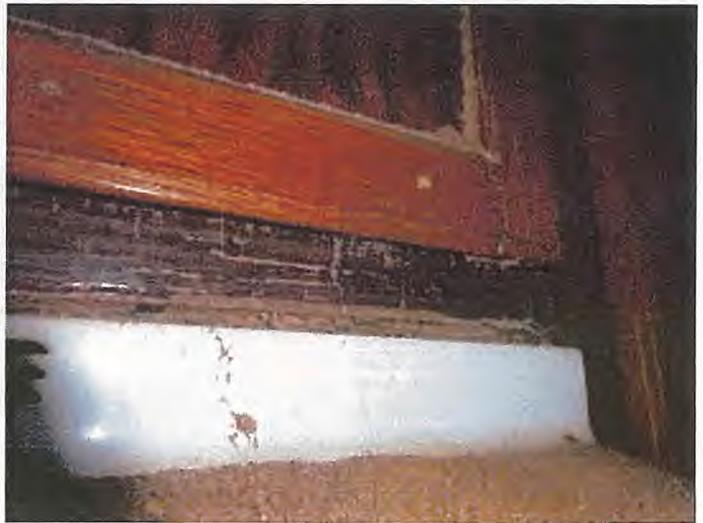
Building B and C ovens did not appear to be functional condition at the time of inspection. Recommend replacement.

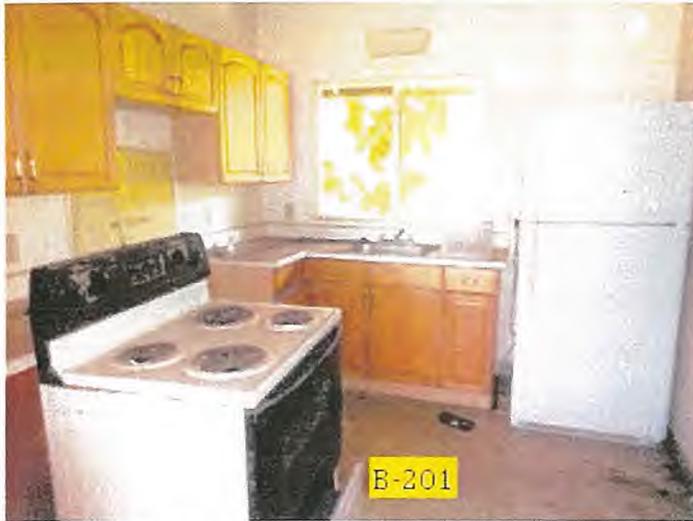
The kitchens of buildings B and C were deteriorated with moisture damage, termite damage and general damage observed at the cabinets, counters and finishes. Recommend the replacement of all dwelling unit kitchens, fixtures and appliances.

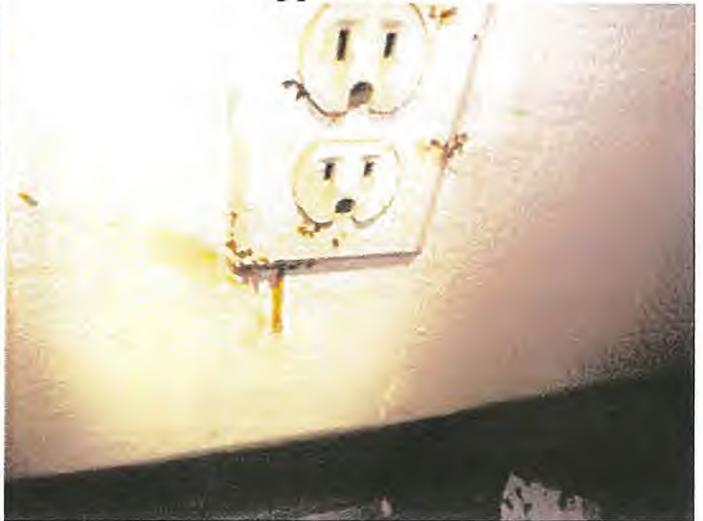
The kitchens of buildings B and C were deteriorated with moisture damage, termite damage and general damage observed at the cabinets, counters and finishes. Recommend the replacement of all dwelling unit kitchens, fixtures and appliances.

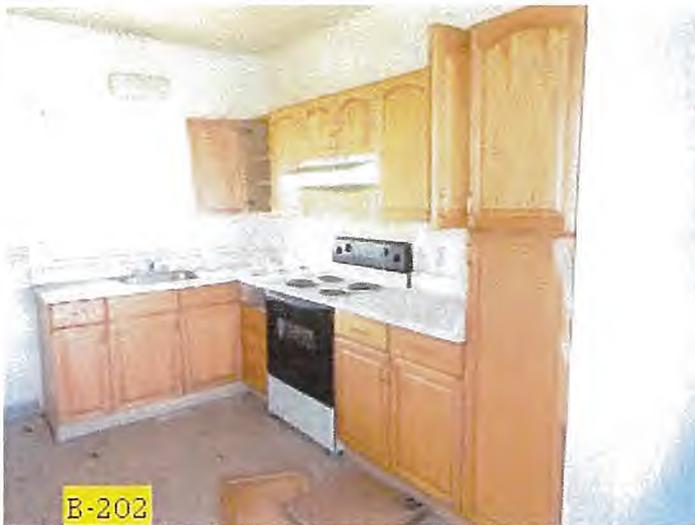
The kitchens of buildings B and C were deteriorated with moisture damage, termite damage and general damage observed at the cabinets, counters and finishes. Recommend the replacement of all dwelling unit kitchens, fixtures and appliances.

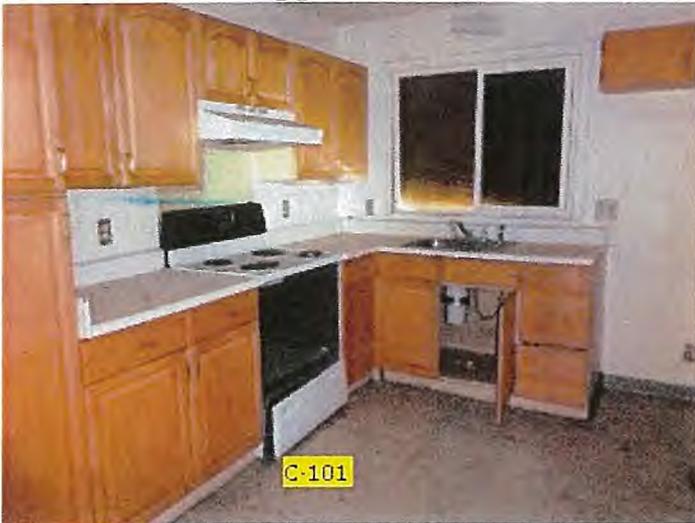
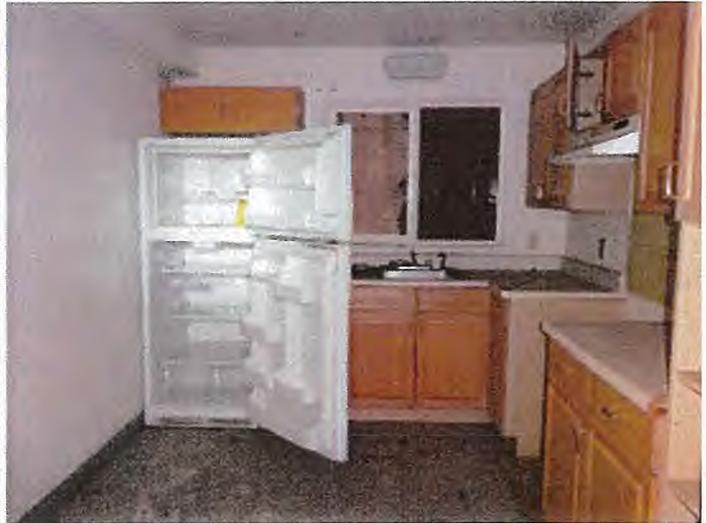
The kitchens of buildings B and C were deteriorated with moisture damage, termite damage and general damage observed at the cabinets, counters and finishes. Recommend the replacement of all dwelling unit kitchens, fixtures and appliances.

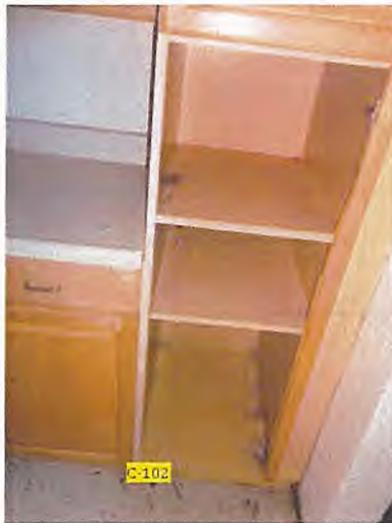
The kitchens of buildings B and C were deteriorated with moisture damage, termite damage and general damage observed at the cabinets, counters and finishes. Recommend the replacement of all dwelling unit kitchens, fixtures and appliances.

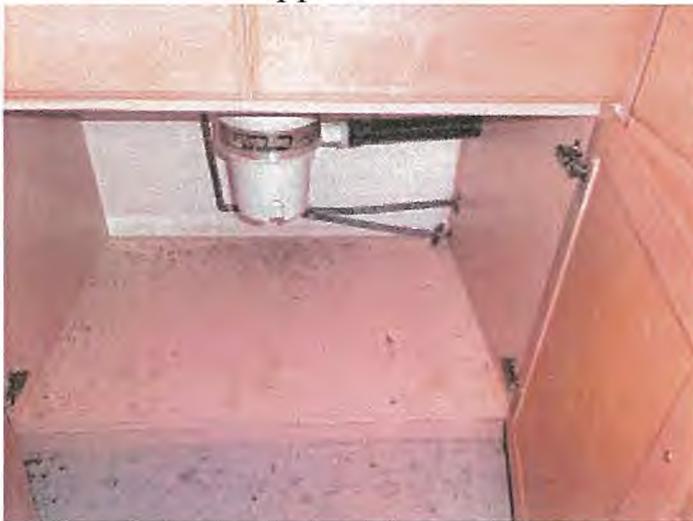
The kitchens of buildings B and C were deteriorated with moisture damage, termite damage and general damage observed at the cabinets, counters and finishes. Recommend the replacement of all dwelling unit kitchens, fixtures and appliances.

Recommend replacement of all refrigeration units located in the kitchens. The appliances in building A did not cool when turned on and the appliances in B and C had mold growth observed.

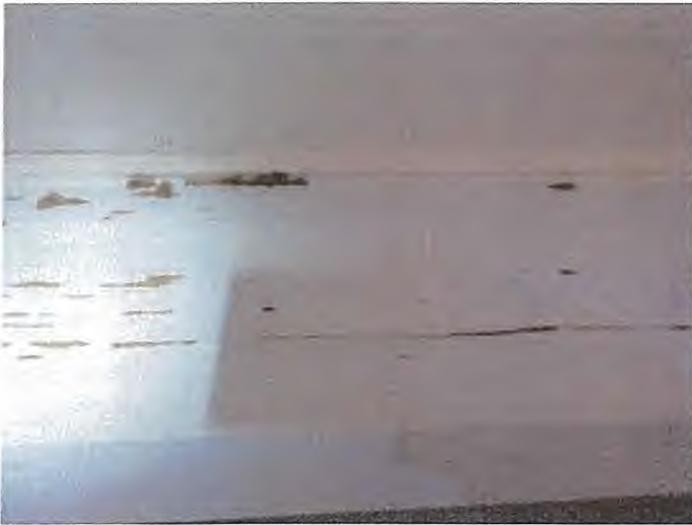
B-201: Ceiling joists were severely termite damaged and need to be repaired/replaced.

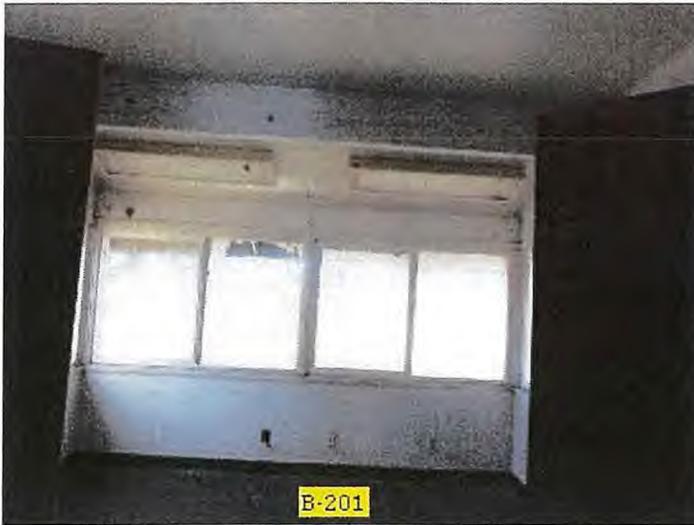
B-201: Ceiling joists were severely termite damaged and need to be repaired/replaced.

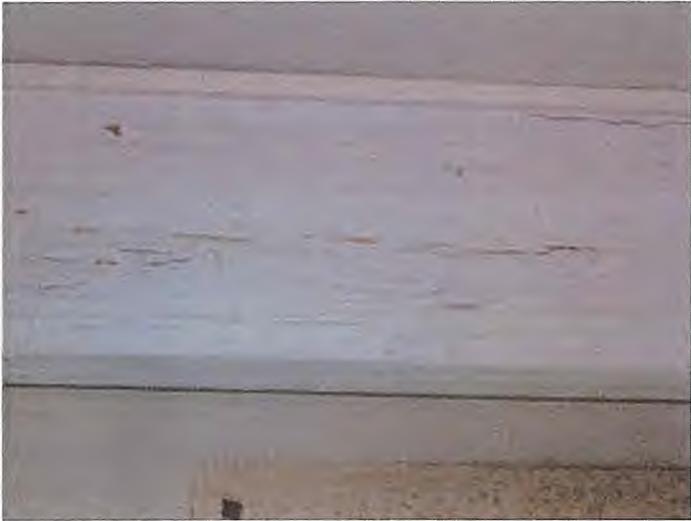
B-201: Ceiling joists were severely termite damaged and need to be repaired/replaced.

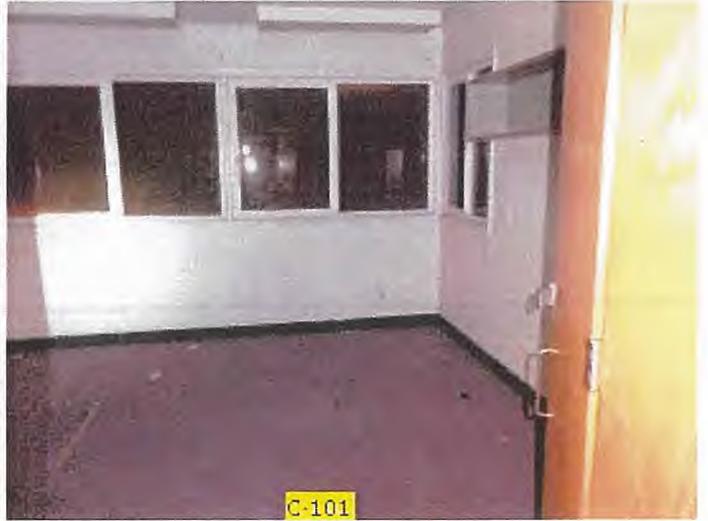
Each dwelling unit was serviced by two (2) sleeping rooms at the time of inspection.

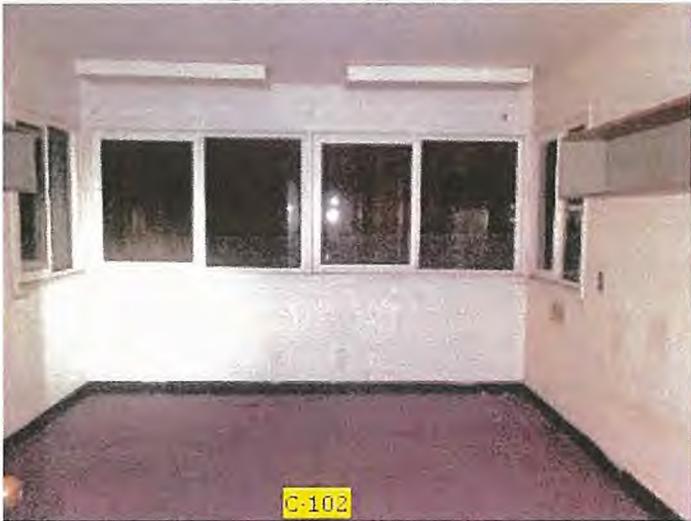
Each dwelling unit was serviced by two (2) sleeping rooms at the time of inspection.

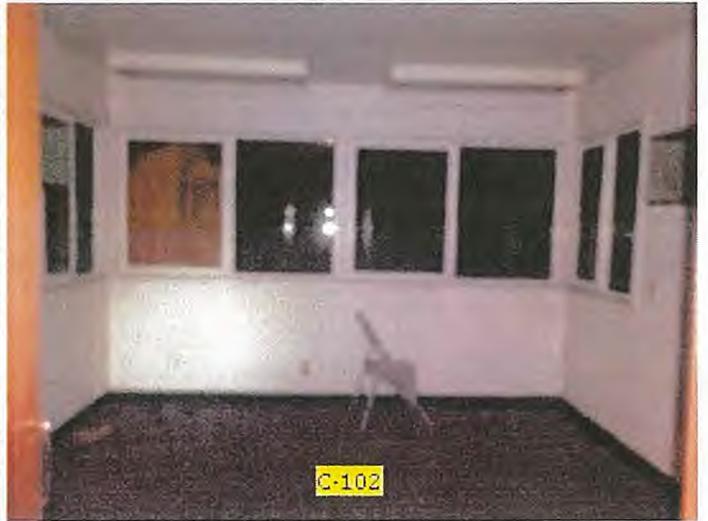
Each dwelling unit was serviced by two (2) sleeping rooms at the time of inspection.

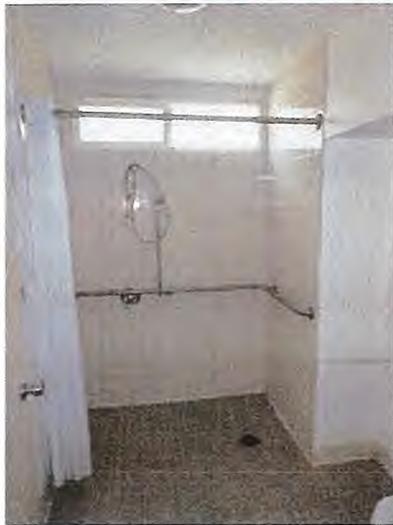
Building A ground floor bathrooms appeared to be in functional condition at the time of inspection.

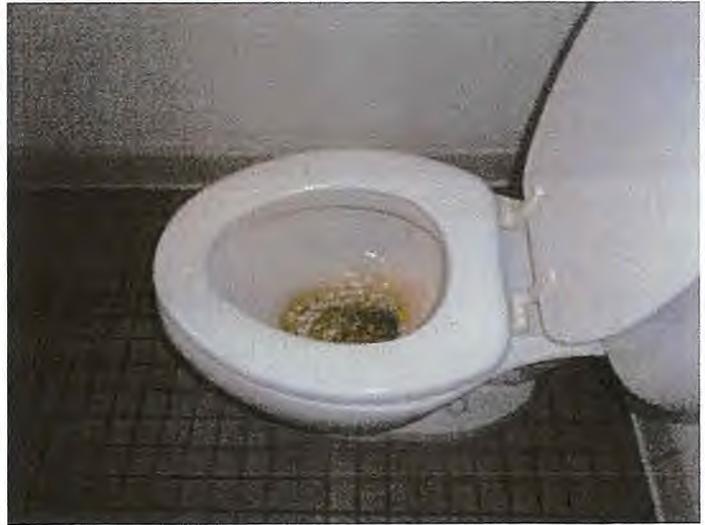
Building A bathrooms appeared to be in functional condition at the time of inspection.

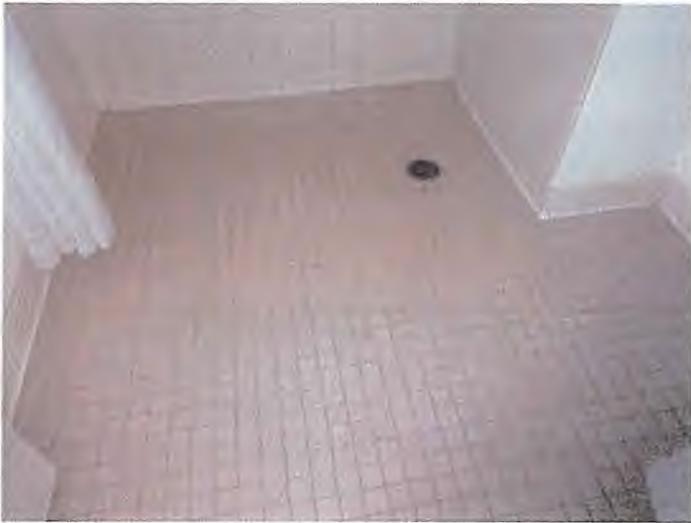
Building A bathrooms appeared to be in functional condition at the time of inspection.

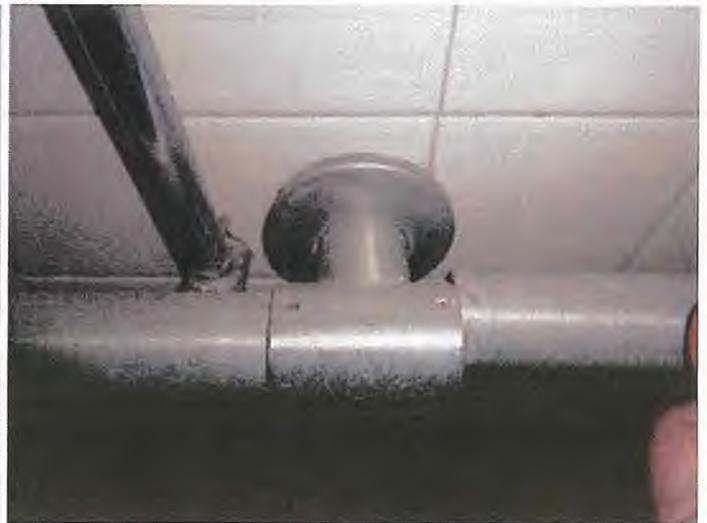
Bldg A bathroom hand rails need to be repaired.

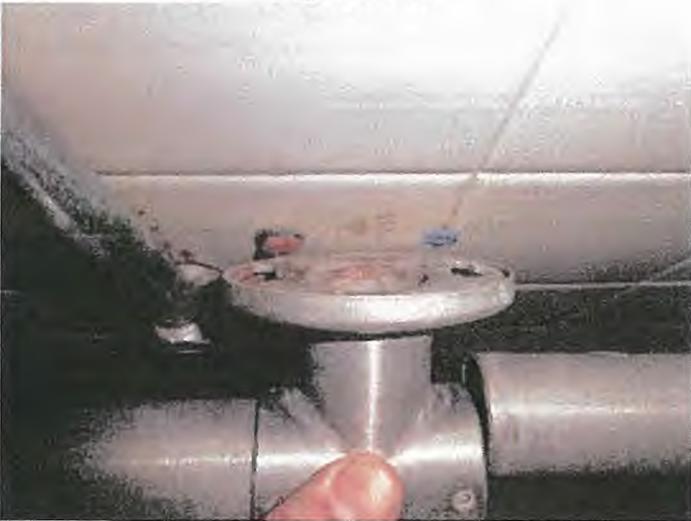
Bldg A bathroom hand rails need to be repaired.

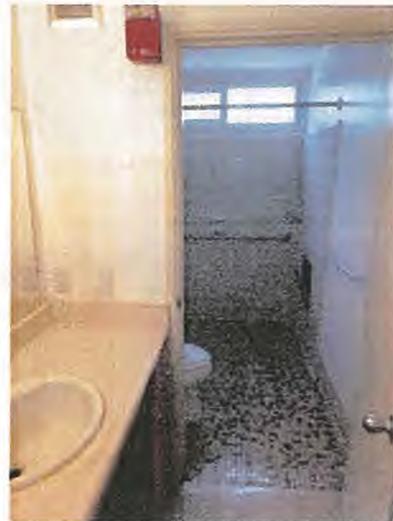
Building A ground floor bathrooms appeared to be in functional condition at the time of inspection.

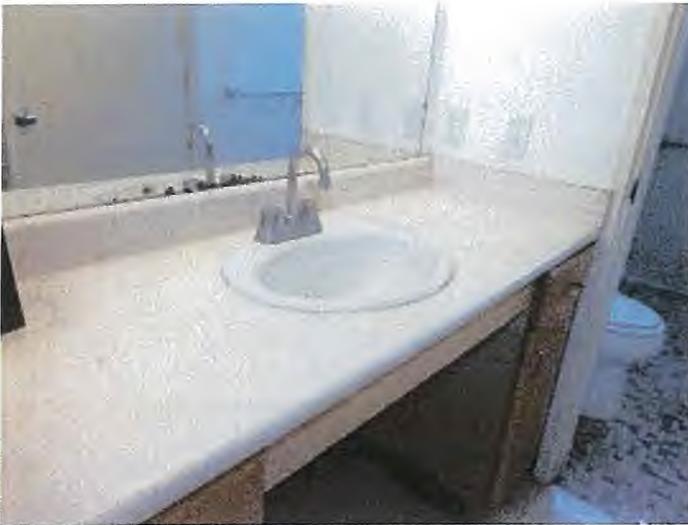
Building A bathrooms appeared to be in functional condition at the time of inspection.

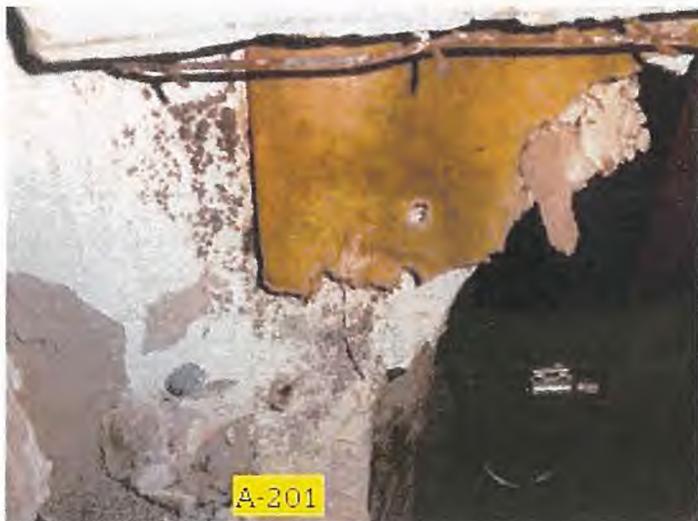
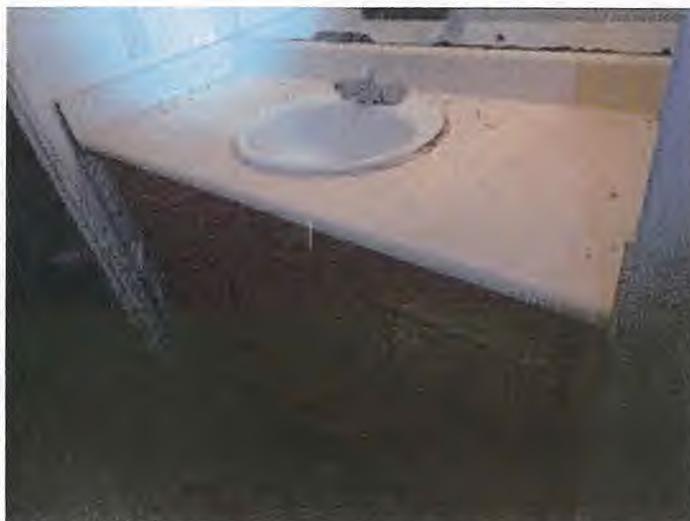
There were visible indications of moisture damage, mold growth, damaged flooring, damaged cabinets and counters, damaged mirrors, damaged toilets and damaged shower compartments observed at the time of inspection. Based on the observed conditions on site, we recommend the replacement of all dwelling unit bathrooms.

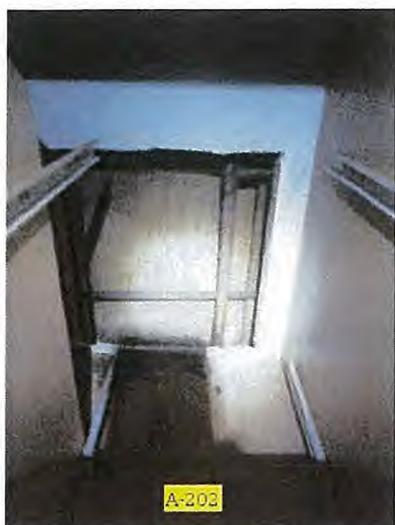
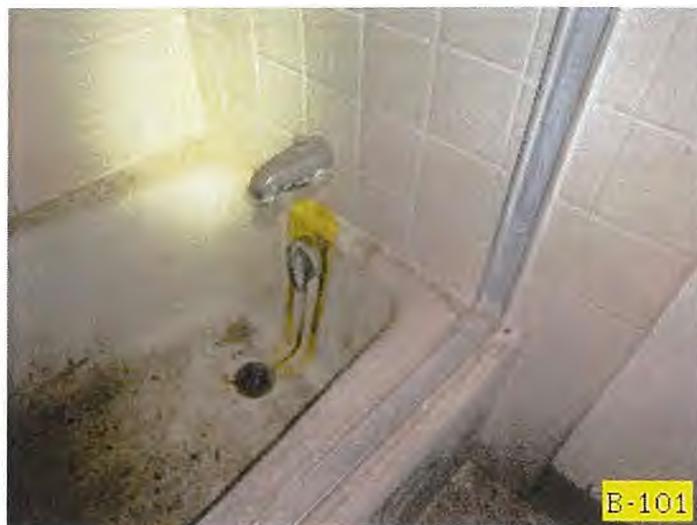
There were visible indications of moisture damage, mold growth, damaged flooring, damaged cabinets and counters, damaged mirrors, damaged toilets and damaged shower compartments observed at the time of inspection. Based on the observed conditions on site, we recommend the replacement of all dwelling unit bathrooms.

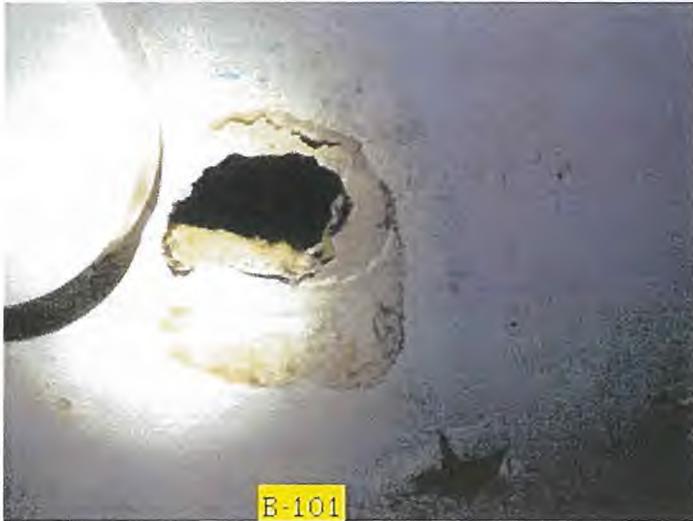
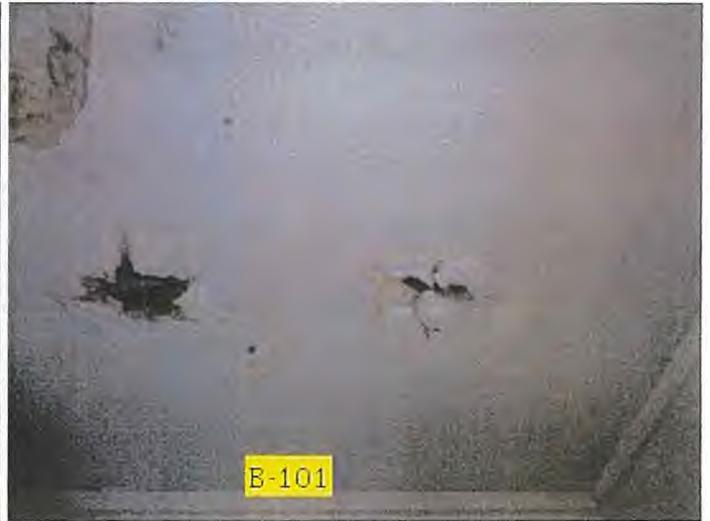
There were visible indications of moisture damage, mold growth, damaged flooring, damaged cabinets and counters, damaged mirrors, damaged toilets and damaged shower compartments observed at the time of inspection. Based on the observed conditions on site, we recommend the replacement of all dwelling unit bathrooms.

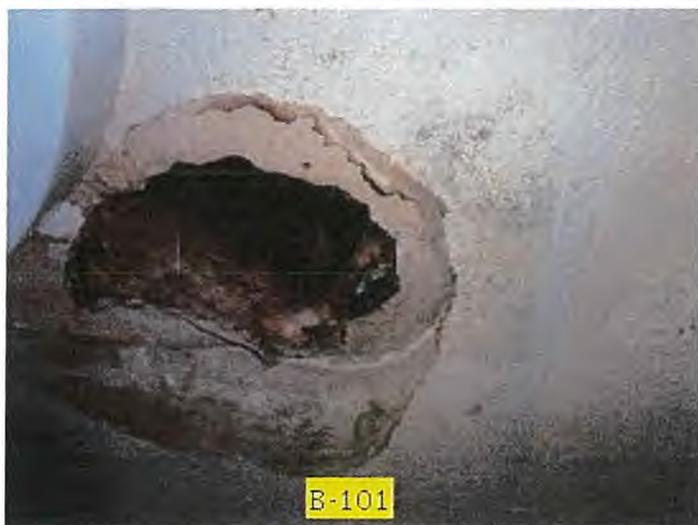
There were visible indications of moisture damage, mold growth, damaged flooring, damaged cabinets and counters, damaged mirrors, damaged toilets and damaged shower compartments observed at the time of inspection. Based on the observed conditions on site, we recommend the replacement of all dwelling unit bathrooms.

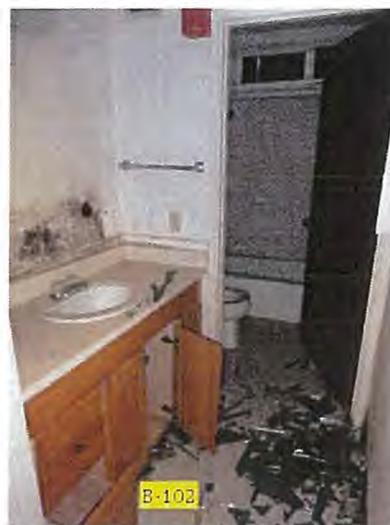
There were visible indications of moisture damage, mold growth, damaged flooring, damaged cabinets and counters, damaged mirrors, damaged toilets and damaged shower compartments observed at the time of inspection. Based on the observed conditions on site, we recommend the replacement of all dwelling unit bathrooms.

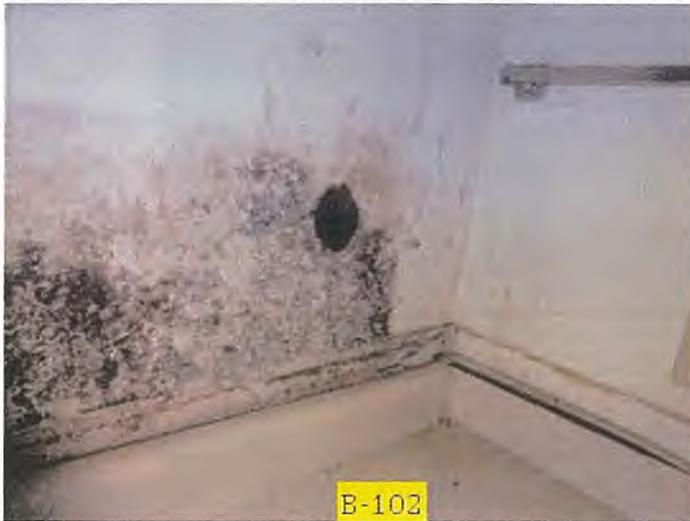
There were visible indications of moisture damage, mold growth, damaged flooring, damaged cabinets and counters, damaged mirrors, damaged toilets and damaged shower compartments observed at the time of inspection. Based on the observed conditions on site, we recommend the replacement of all dwelling unit bathrooms.

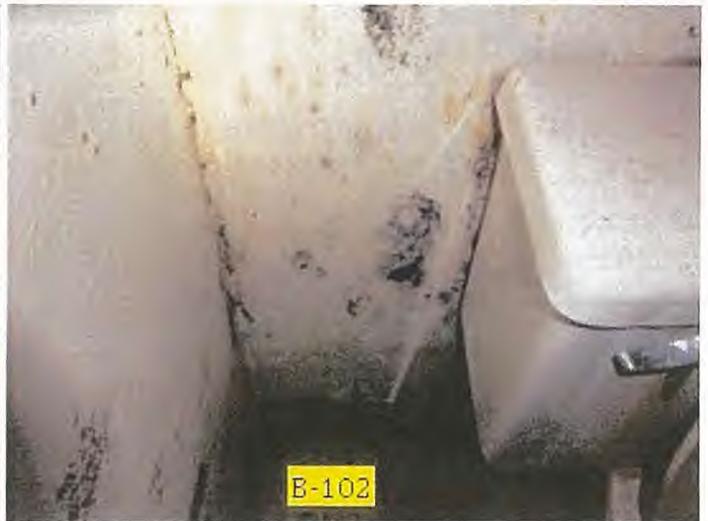
There were visible indications of moisture damage, mold growth, damaged flooring, damaged cabinets and counters, damaged mirrors, damaged toilets and damaged shower compartments observed at the time of inspection. Based on the observed conditions on site, we recommend the replacement of all dwelling unit bathrooms.

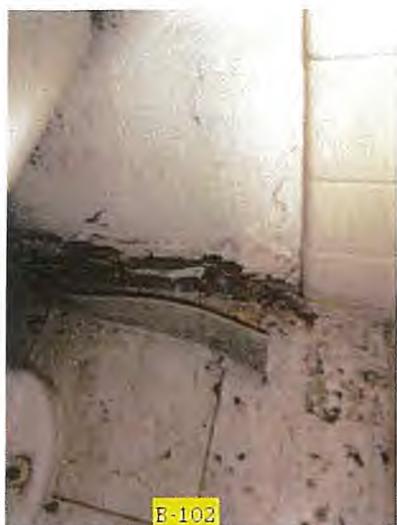
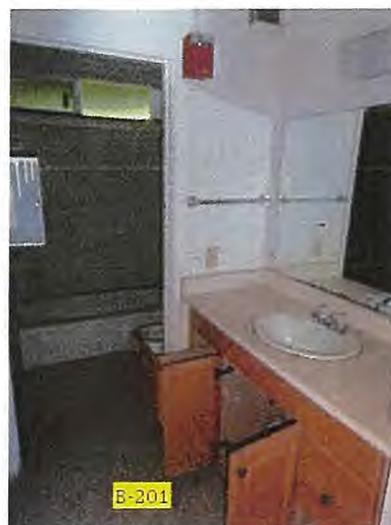
There were visible indications of moisture damage, mold growth, damaged flooring, damaged cabinets and counters, damaged mirrors, damaged toilets and damaged shower compartments observed at the time of inspection. Based on the observed conditions on site, we recommend the replacement of all dwelling unit bathrooms.

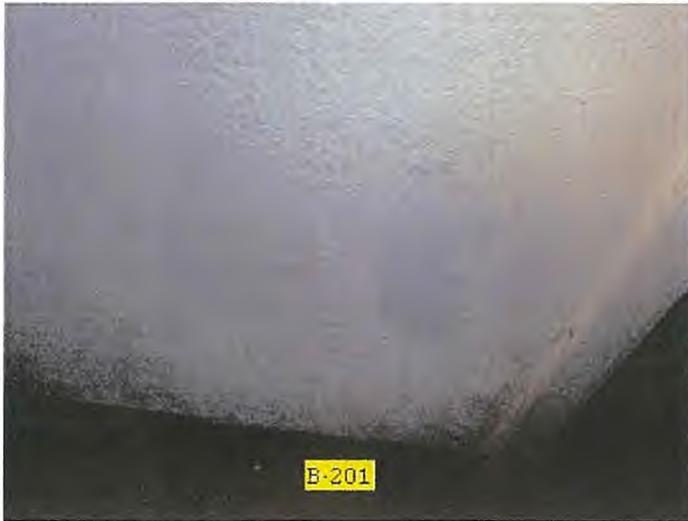
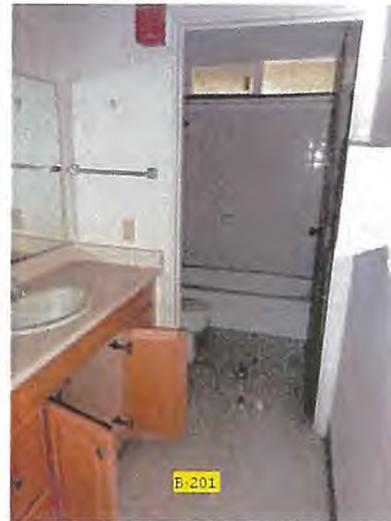
There were visible indications of moisture damage, mold growth, damaged flooring, damaged cabinets and counters, damaged mirrors, damaged toilets and damaged shower compartments observed at the time of inspection. Based on the observed conditions on site, we recommend the replacement of all dwelling unit bathrooms.

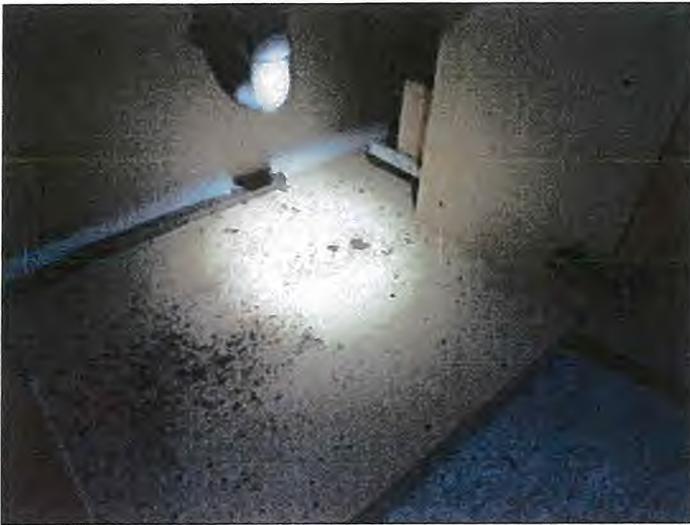
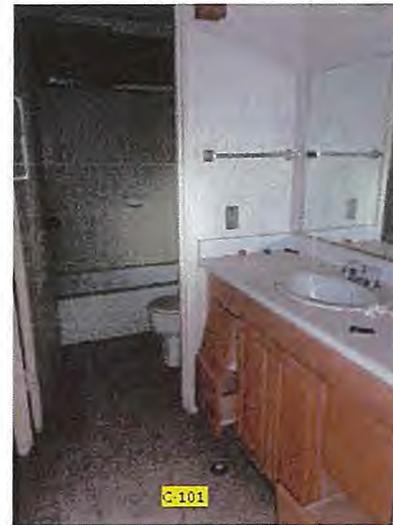
There were visible indications of moisture damage, mold growth, damaged flooring, damaged cabinets and counters, damaged mirrors, damaged toilets and damaged shower compartments observed at the time of inspection. Based on the observed conditions on site, we recommend the replacement of all dwelling unit bathrooms.

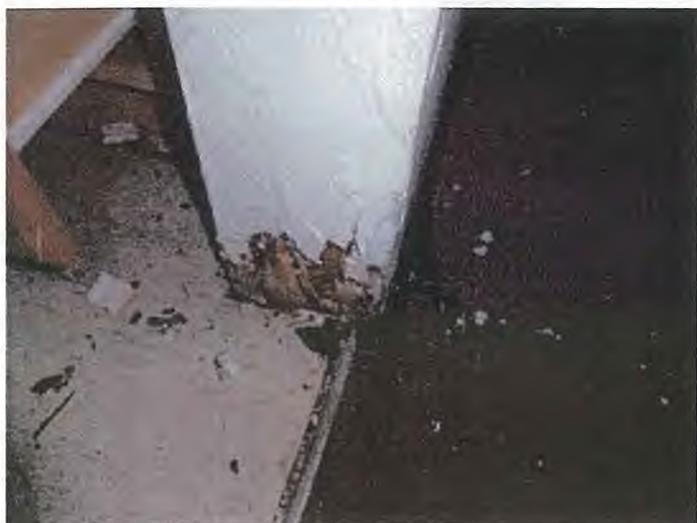
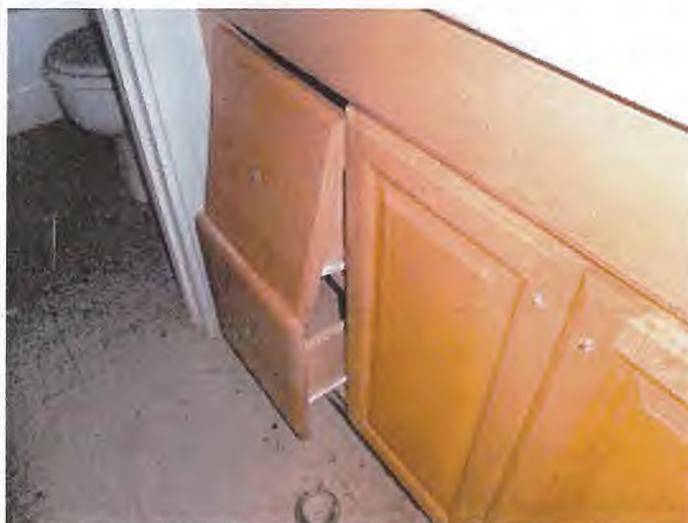
There were visible indications of moisture damage, mold growth, damaged flooring, damaged cabinets and counters, damaged mirrors, damaged toilets and damaged shower compartments observed at the time of inspection. Based on the observed conditions on site, we recommend the replacement of all dwelling unit bathrooms.

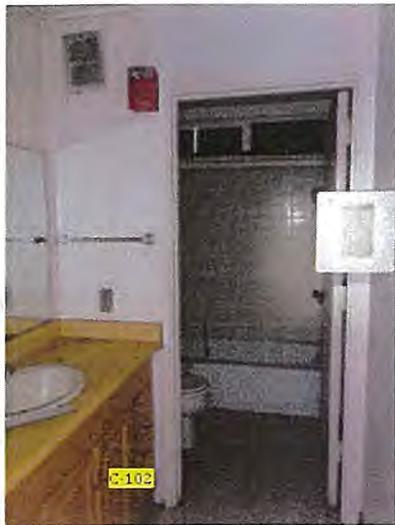
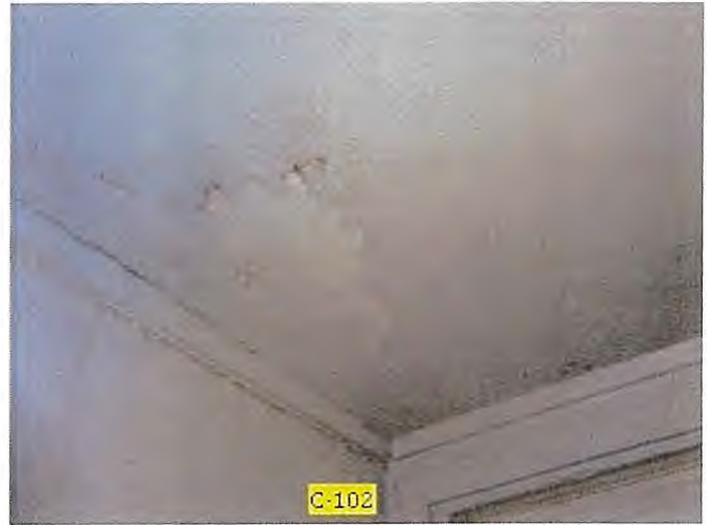
There were visible indications of moisture damage, mold growth, damaged flooring, damaged cabinets and counters, damaged mirrors, damaged toilets and damaged shower compartments observed at the time of inspection. Based on the observed conditions on site, we recommend the replacement of all dwelling unit bathrooms.

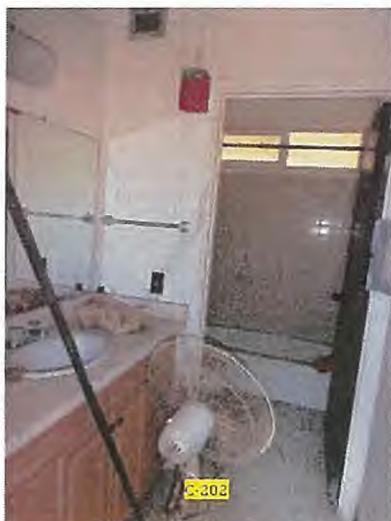
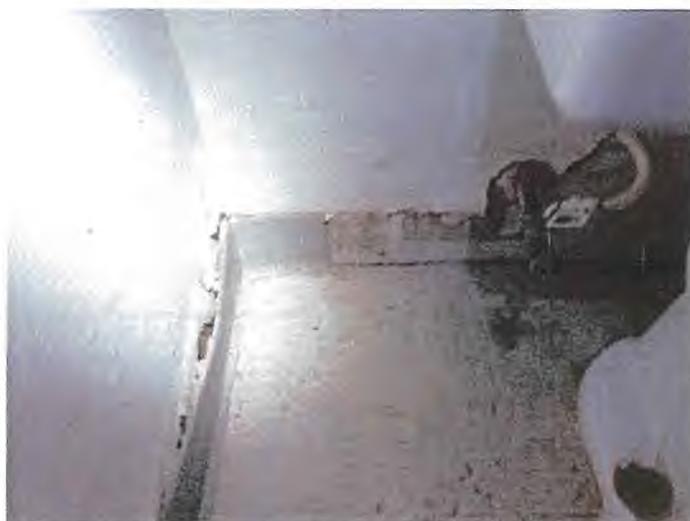
There were visible indications of moisture damage, mold growth, damaged flooring, damaged cabinets and counters, damaged mirrors, damaged toilets and damaged shower compartments observed at the time of inspection. Based on the observed conditions on site, we recommend the replacement of all dwelling unit bathrooms.

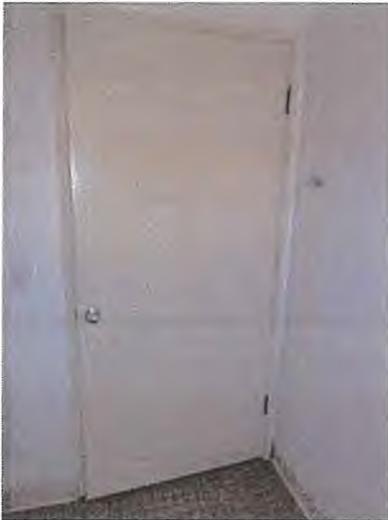
The interior doors conformed to ADA width and swing requirements. 4.13.5 Clear Width. Doorways shall have a minimum clear opening of 32 in (815 mm) with the door open 90 degrees, measured between the face of the door and the opposite stop.

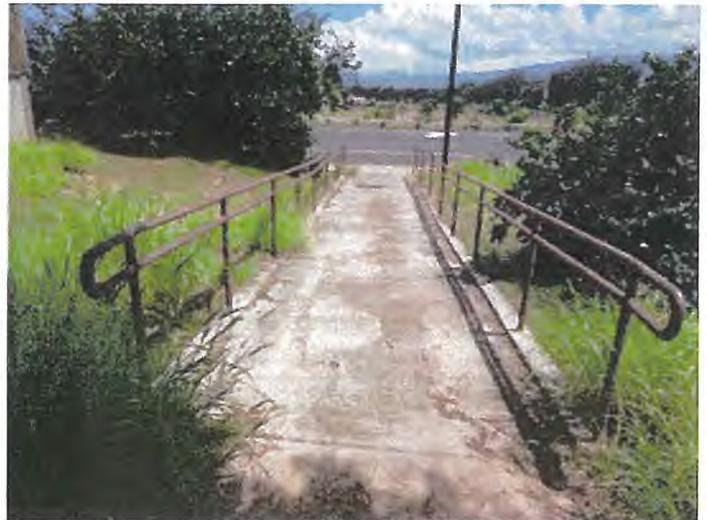
There was an ADA conforming ramp noted to allow access to the different levels of the floor area. 405.5 Clear Width. The clear width of a ramp run and, where handrails are provided, the clear width between handrails shall be 36 inches (915 mm) minimum. 405.7 Landings. Ramps shall have landings at the top and the bottom of each ramp run. Landings shall comply with 405.7.

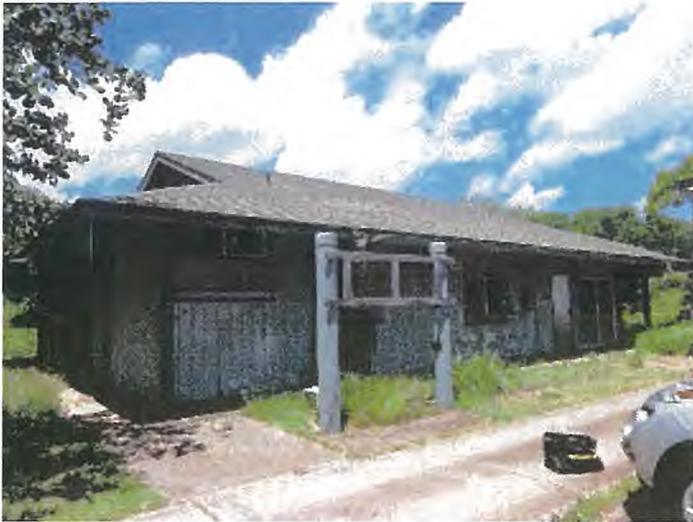
There was a hazardous bee population observed on site at the time of inspection. The single story storage building had sections of front wall removed for past been removal. The left side of the building had extensive and constant activity observed. There were been nests also observed at other exterior and interior locations through out the property.

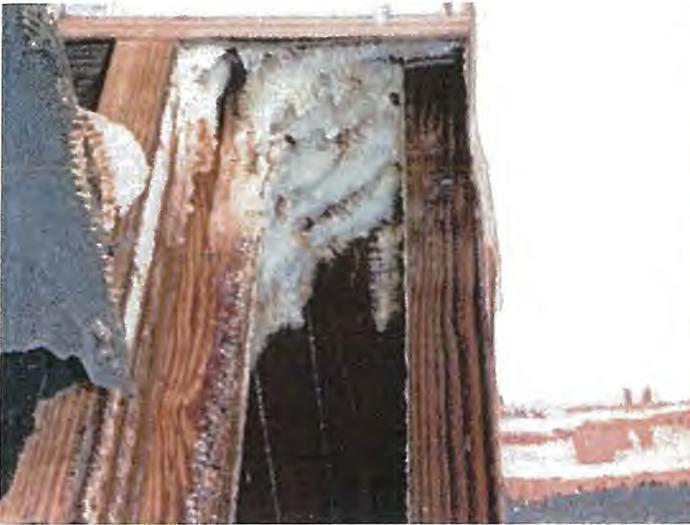
There was a hazardous bee population observed on site at the time of inspection. The single story storage building had sections of front wall removed for past been removal. The left side of the building had extensive and constant activity observed. There were been nests also observed at other exterior and interior locations through out the property.

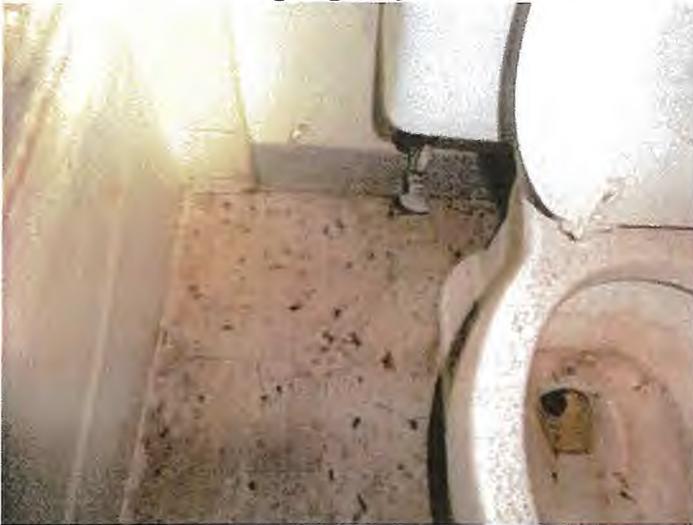
There was a hazardous bee population observed on site at the time of inspection. The single story storage building had sections of front wall removed for past been removal. The left side of the building had extensive and constant activity observed. There were been nests also observed at other exterior and interior locations through out the property.

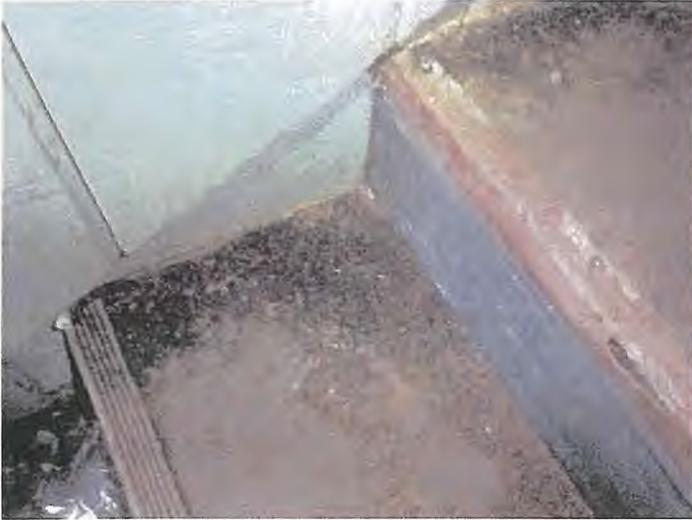
There was moderate/extensive termite/moisture damage observed at the interior and/or exterior areas of the building.
