Property Condition Report

310 W Kaahumanu Ave, Kahului, HI 96732
Inspection prepared for: Maui County c/o Buddy Almeida
Real Estate Agent: -

Date of Inspection: 3/28/2018 Time: 8:00 AM
Age of Home: 1980 Size: 15000

This is a commercial property condition assessment to determine if three (3) former UH dormitories are suitable for housing. This inspection includes invasive and non-invasive inspection methods as well as sampling for asbestos and lead based paint.

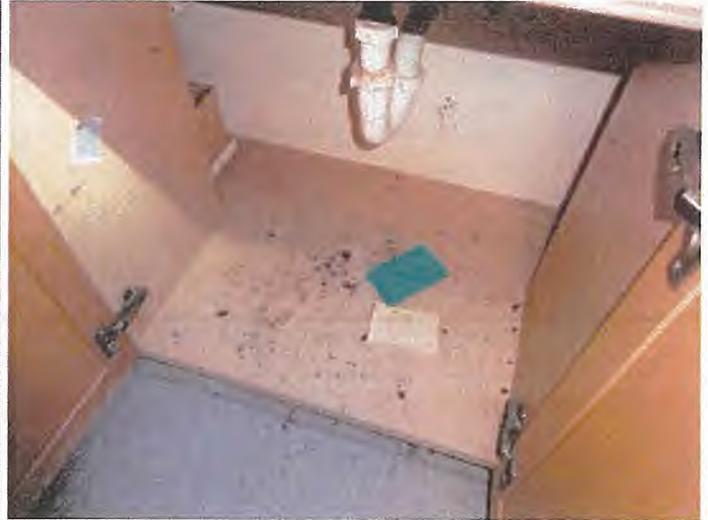
There was moderate/extensive termite/moisture damage observed at the interior and/or exterior areas of the building.

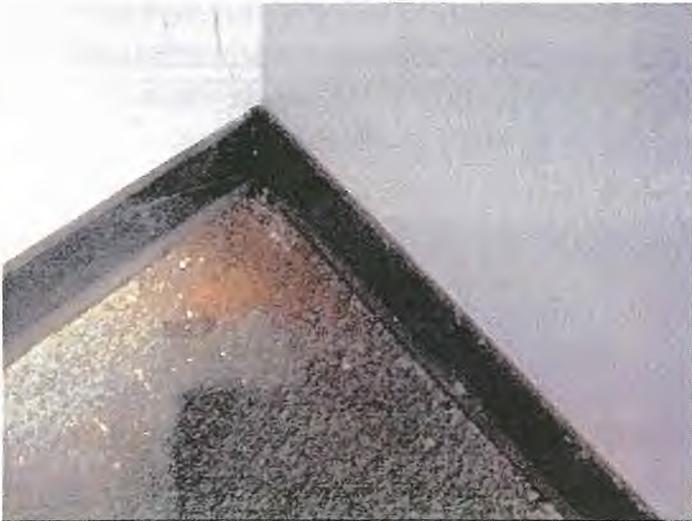
There was extensive pest (ie: cockroach) infestation observed at the interior and/or exterior areas of the building.

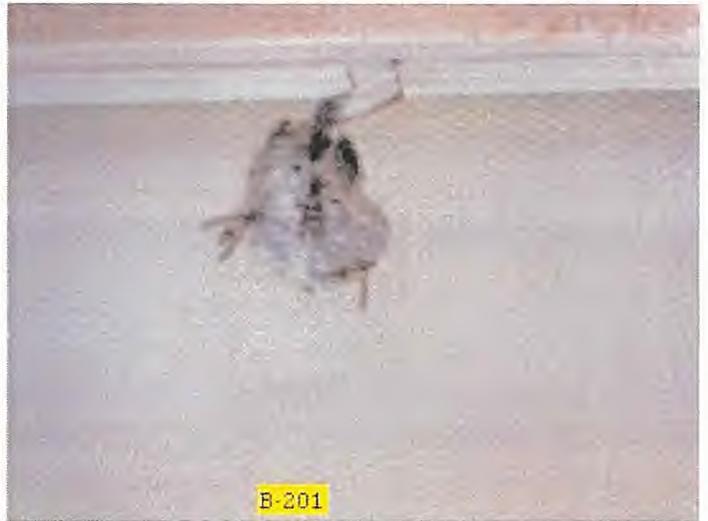
There was moderate/extensive termite/moisture damage observed at the interior and/or exterior areas of the building.

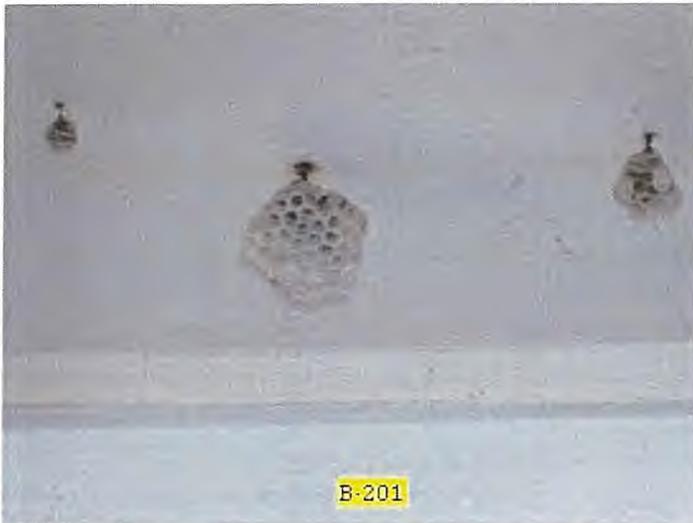
There was a hazardous bee population observed on site at the time of inspection. The single story storage building had sections of front wall removed for past been removal. The left side of the building had extensive and constant activity observed. There were been nests also observed at other exterior and interior locations through out the property.

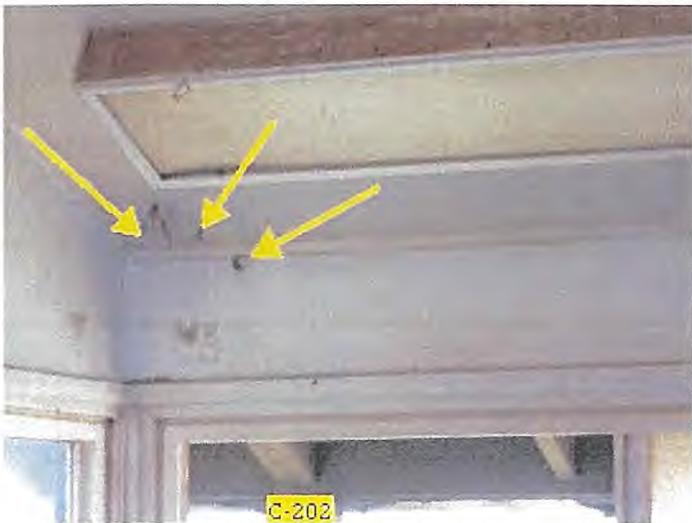
C-202

There was a hazardous bee population observed on site at the time of inspection. The single story storage building had sections of front wall removed for past been removal. The left side of the building had extensive and constant activity observed. There were been nests also observed at other exterior and interior locations through out the property.

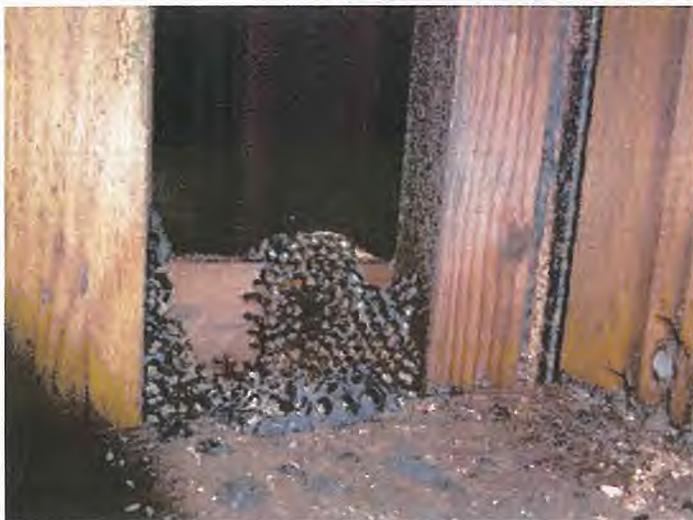
- Some of the areas were inaccessible due to the presence of a robust bee population outside and inside of the buildings.

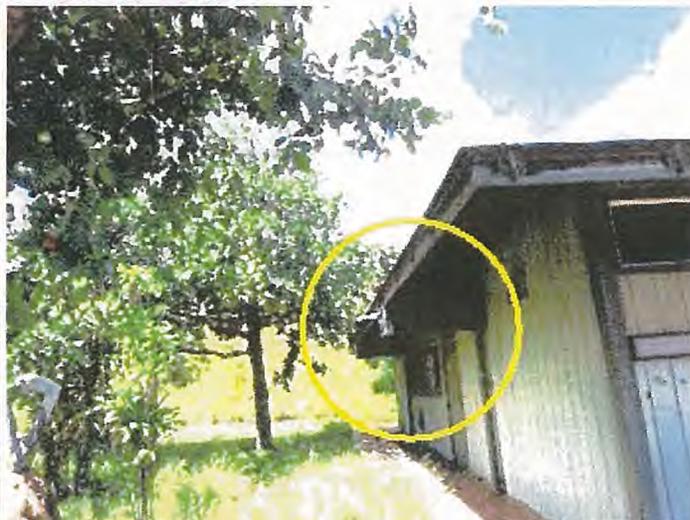
Some of the areas were inaccessible due to the presence of a robust bee population outside and inside of the buildings.
