**SUBJECT: BILLS 136 (2025) AND 137 (2025), RELATING TO THE  
RENOVATION OF 60 SOUTH CHURCH STREET, WAILUKU,  
HAWAII (BFED-8)**

# Architectural Diagnostics Ltd.

**PROJECT:** 60 S. Church St.  
**SUBJECT:** Waterproofing

**SUBJECT: MOISTURE REPORT – 60 S Church Street-Lower Roof**

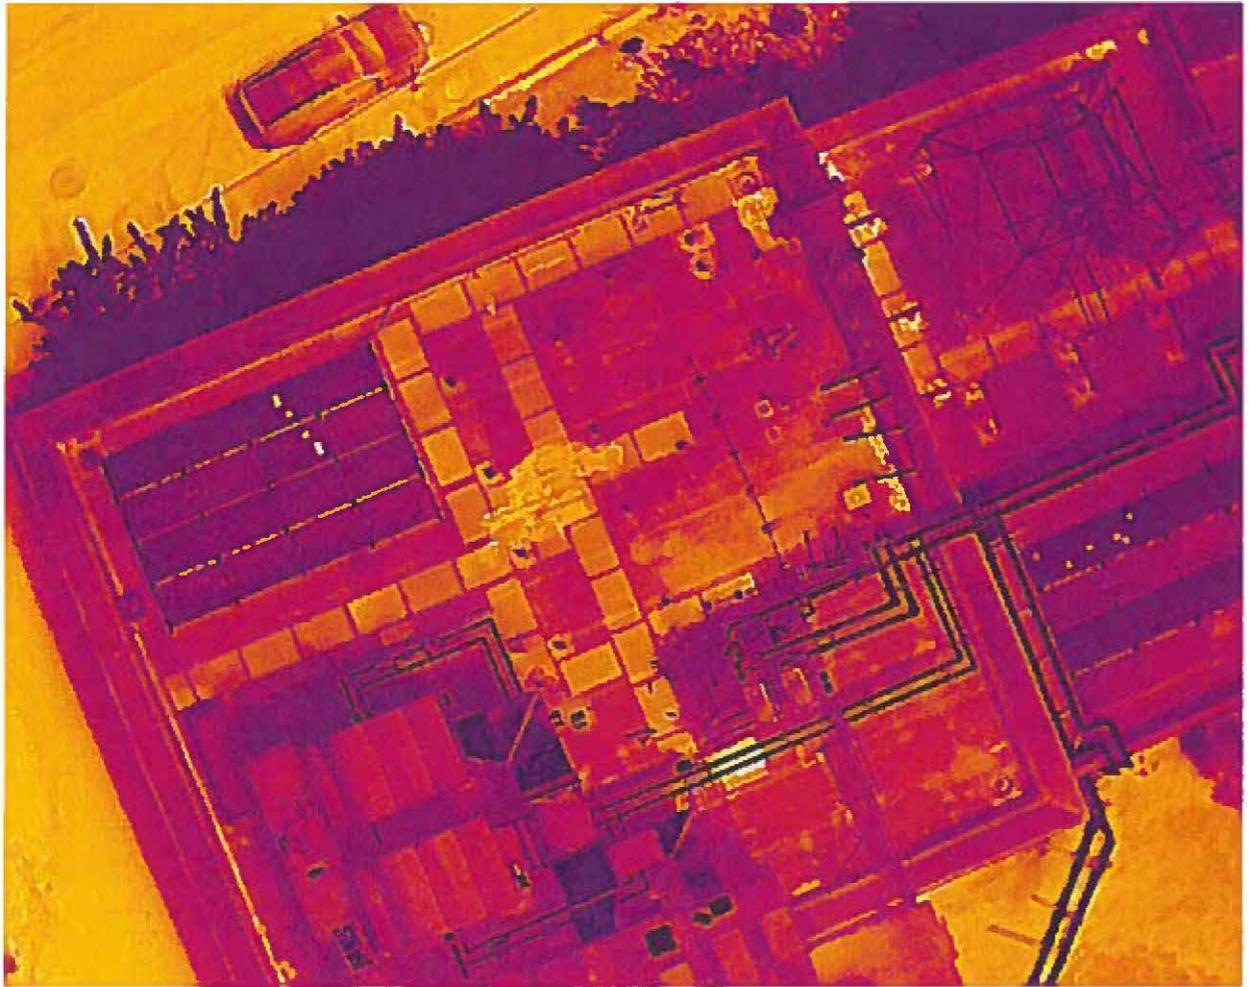
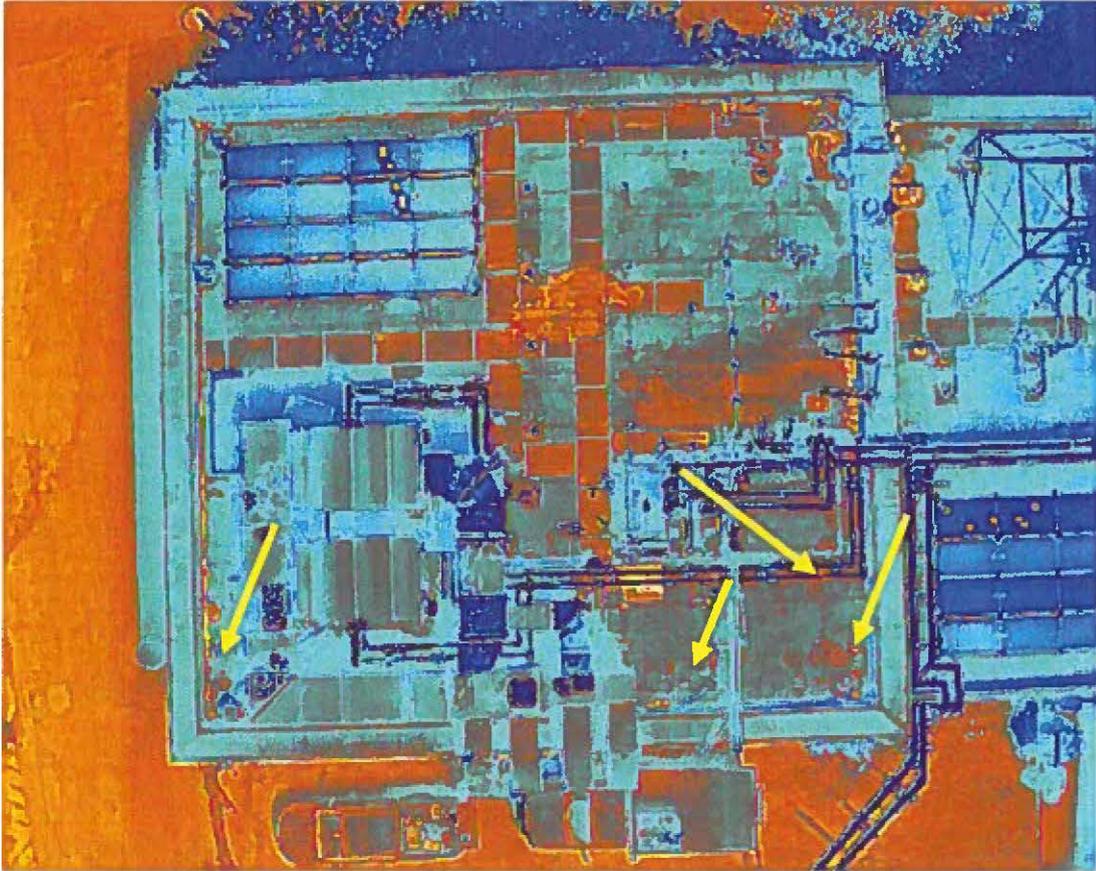
*Figure 3-The arrows indicate the thermal anomalies consistent with the presence of moisture.*

Due to the amount of moisture in the roof it is advisable to remove all the wet sections through the insulation layer. In lieu of replacing the Hypalon membrane a peel and stick membrane may be used once the insulation has been replaced. ASC (AMERICAN STANDARD COATINGS) will allow a 50 mil application to be applied over the top of the Hypalon membrane including the peel and stick which will then be warranted for 20 years.

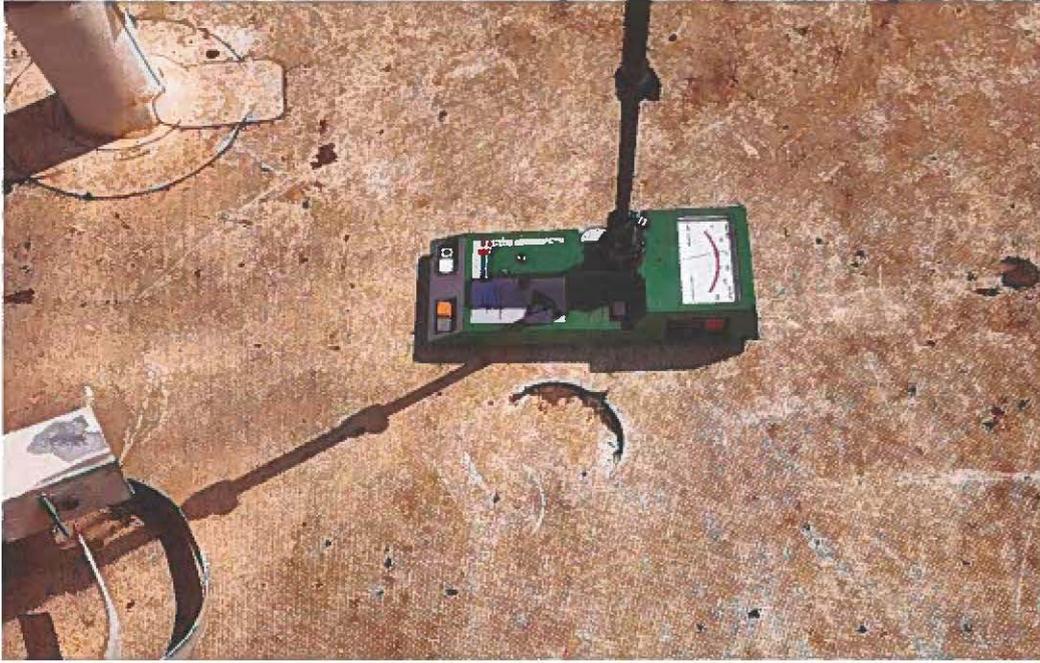
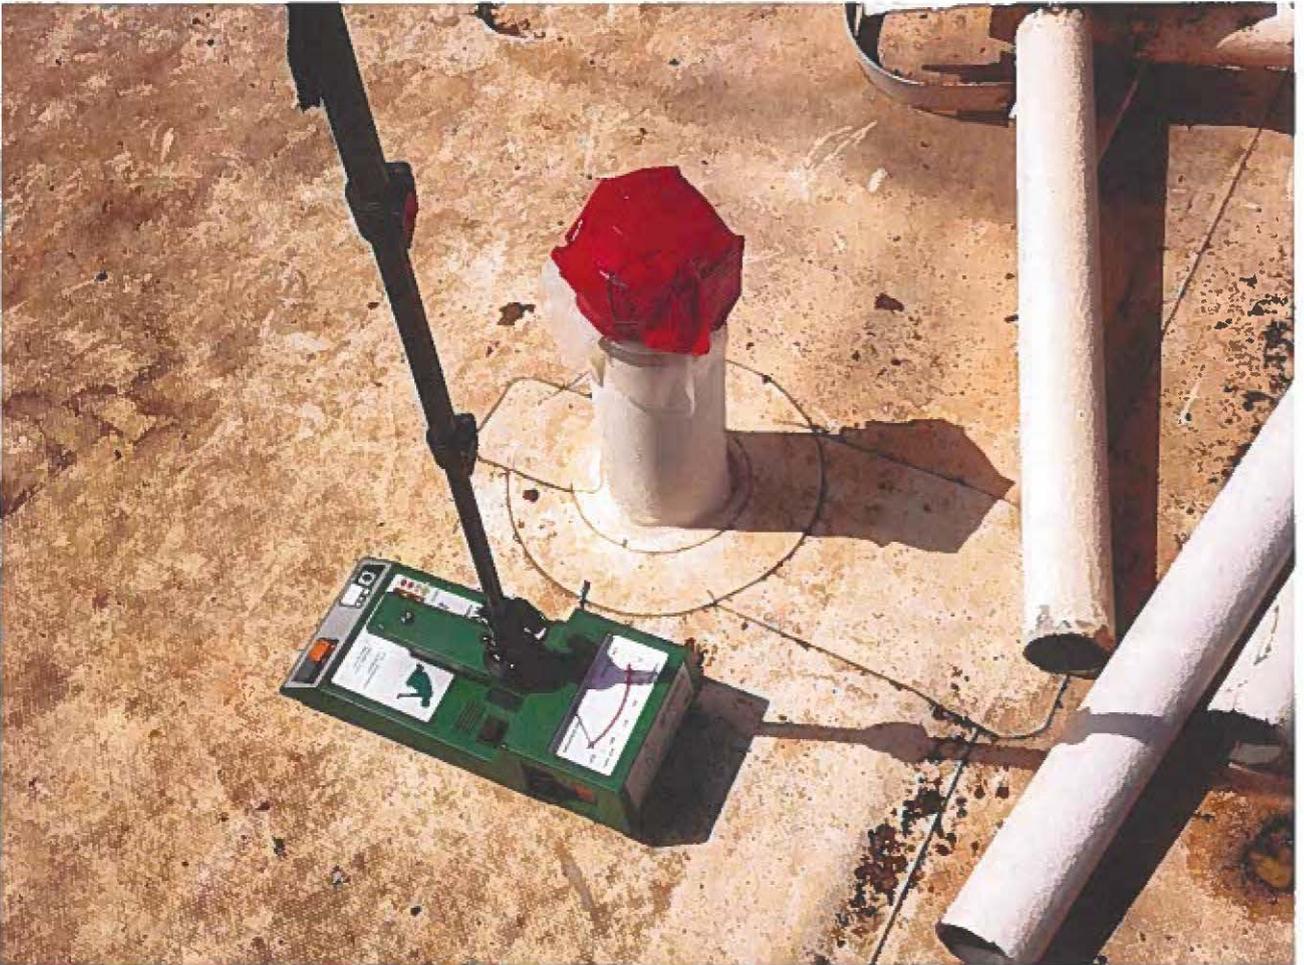
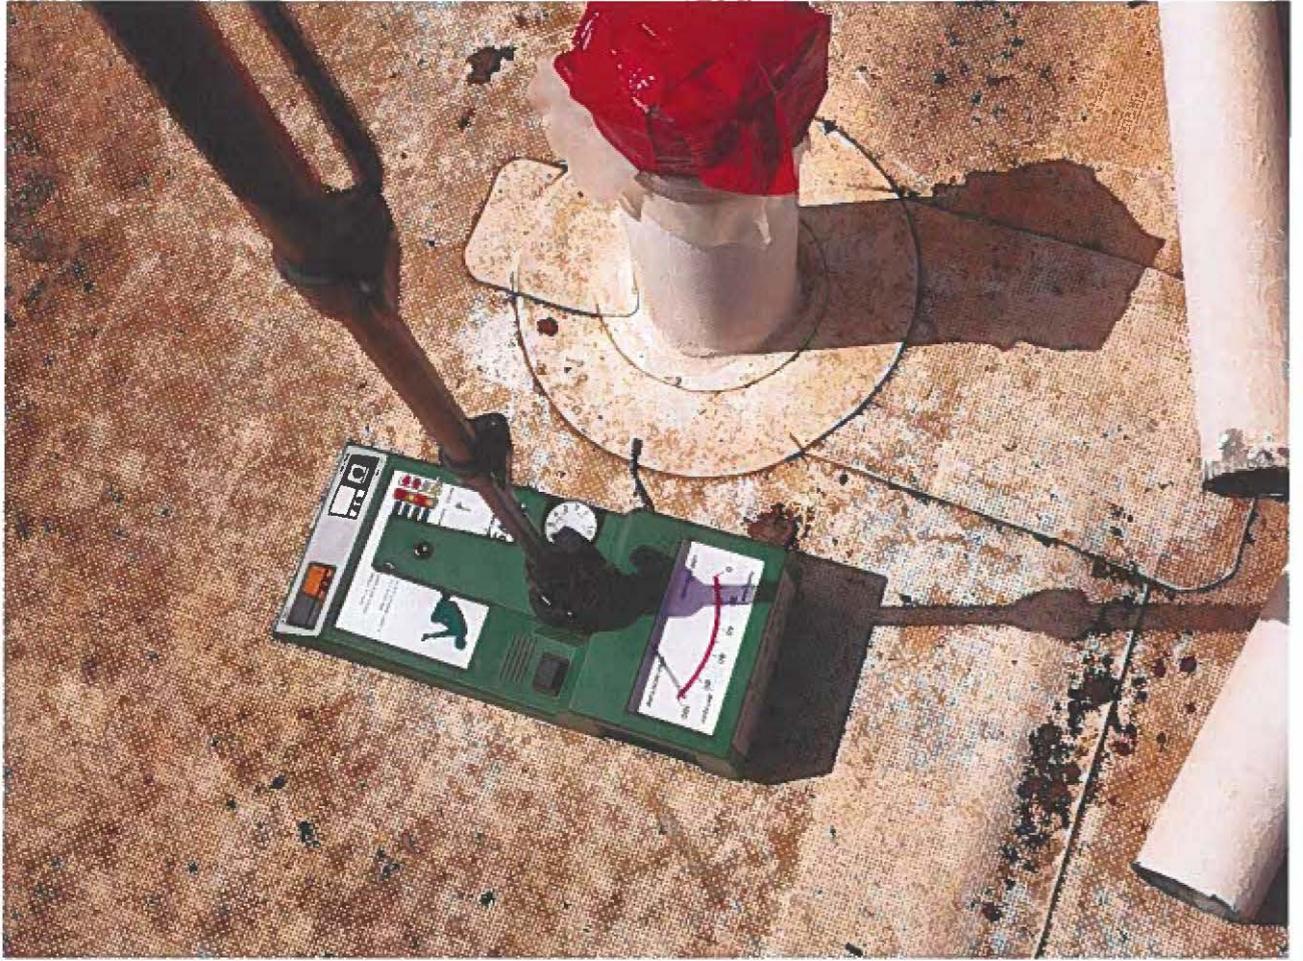
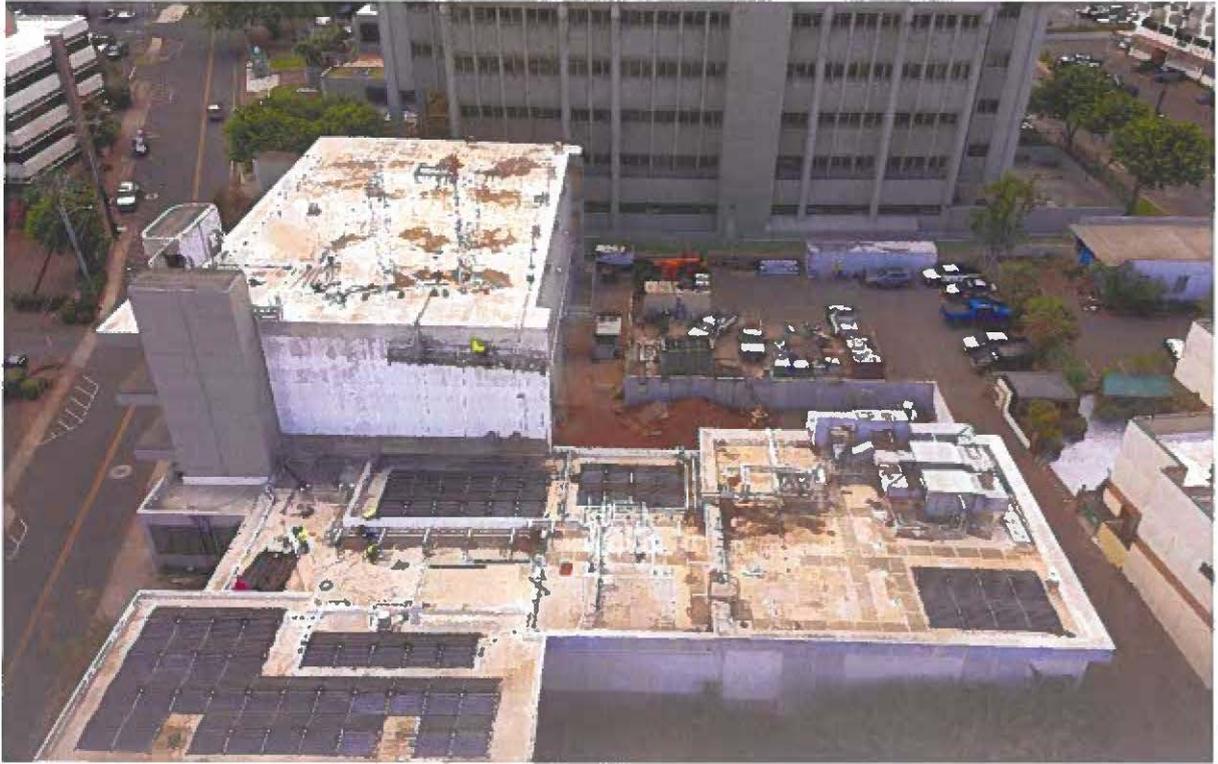
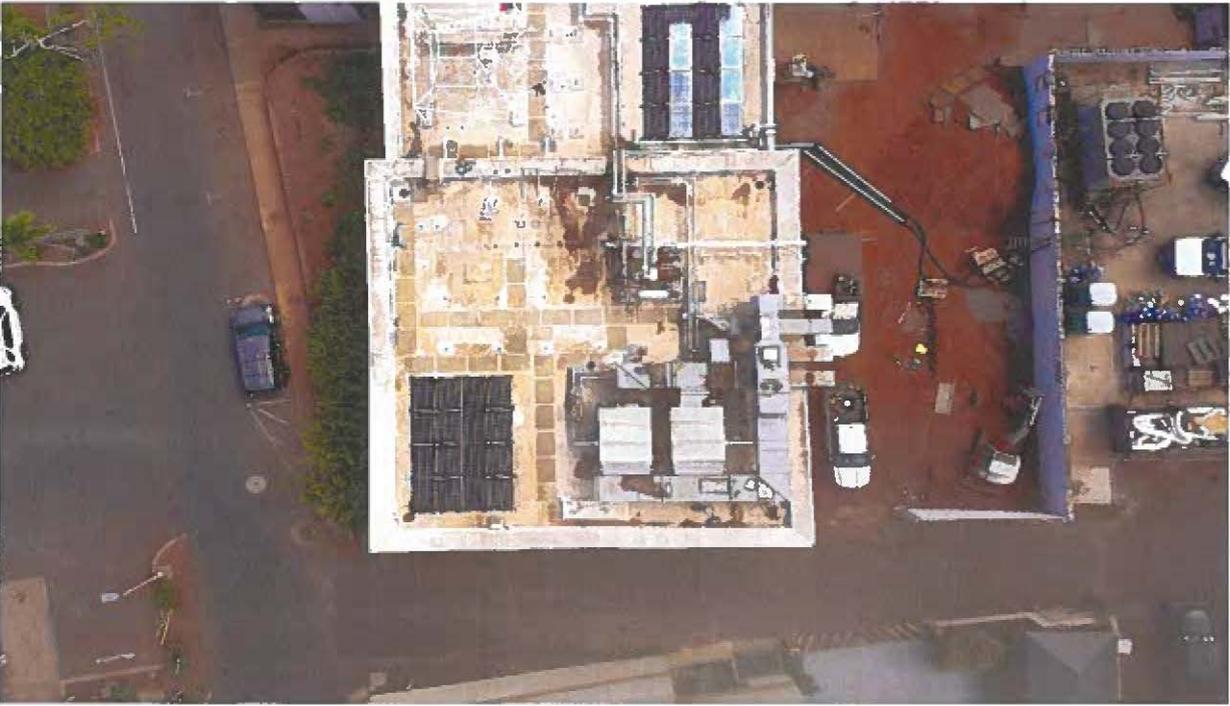
Photographs

The Hypalon single ply membrane installed over the mechanical building exhibits significant signs of aging. The membrane is notably dry, with perceptible cracking underfoot—typical indicators of a Hypalon system that has been in service for an extended duration. Following the thermal survey, a Tramex RWS Impedance scanner was utilized to confirm thermal anomalies and assess the presence of moisture within the roofing system. Results indicate that approximately 60% of the roof remains dry, while the remaining areas registered a consistent 100% reading on the Tramex gauge, suggesting elevated moisture levels. The region beneath the currently operational chiller unit appears to contain the majority of this moisture. Additionally, ceiling observations from below this area provide clear evidence of moisture intrusion.
