Subject: **COMMUNITY PLAN AMENDMENT AND CHANGE IN ZONING FOR MAALAEA AGRICULTURAL SUBDIVISION (PSLU-41)**

**POHAKEA WATERSHED / MA'ALAEA BAY  
MAUI COUNTY, HAWAII  
STORMWATER MANAGEMENT PLAN**

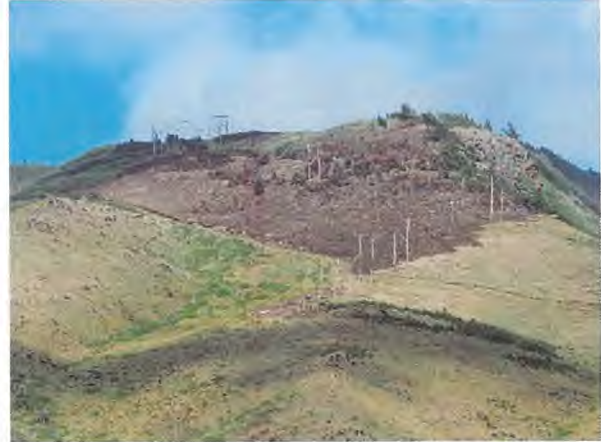
Fire Lines Associated with Powerlines

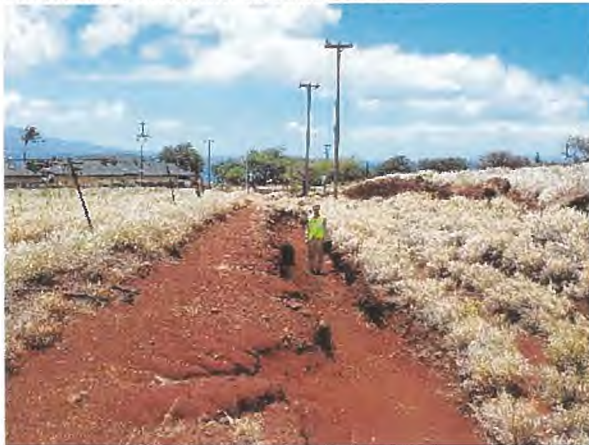
Distribution Lines and Failed Roads

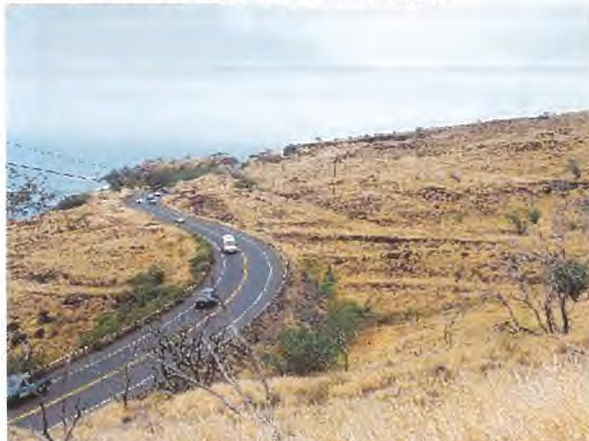
Transmission Lines along the Pali

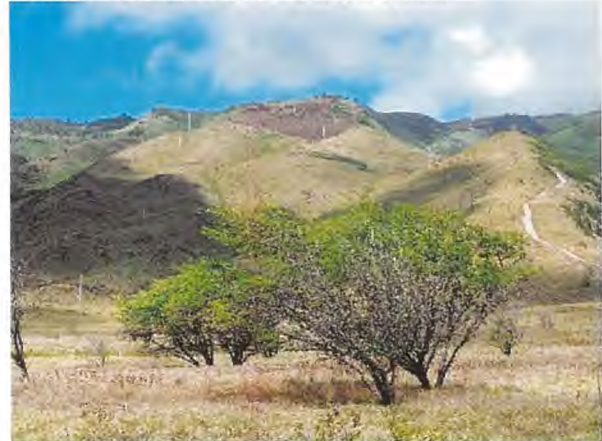
Transmission Corridor and Evidence of Fire

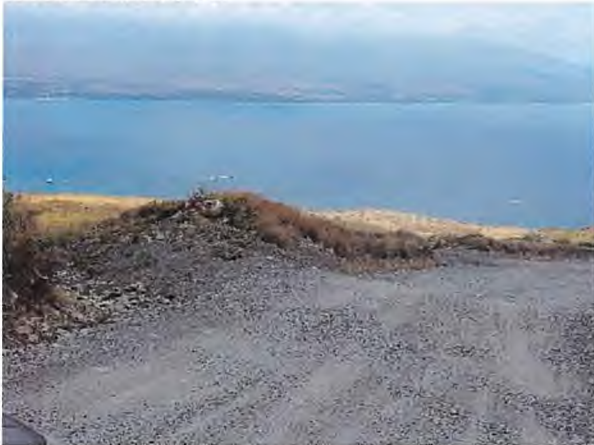
Water Bars and Kickouts

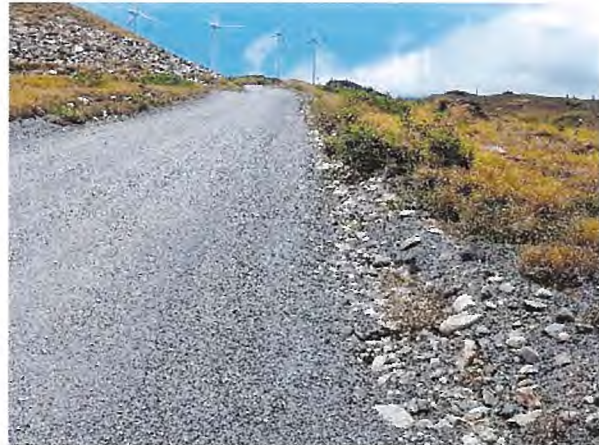
Well Maintained Road with Swale

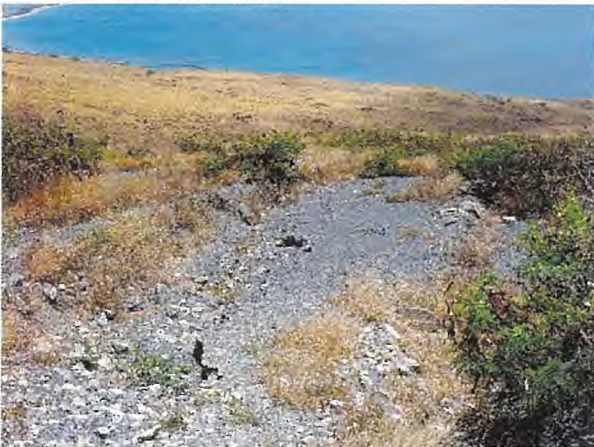
Gravel Loss at Kickouts

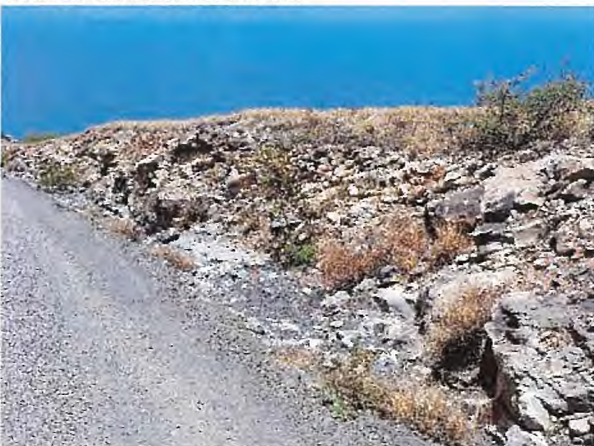
Channelization and Gravel Loss in Swale

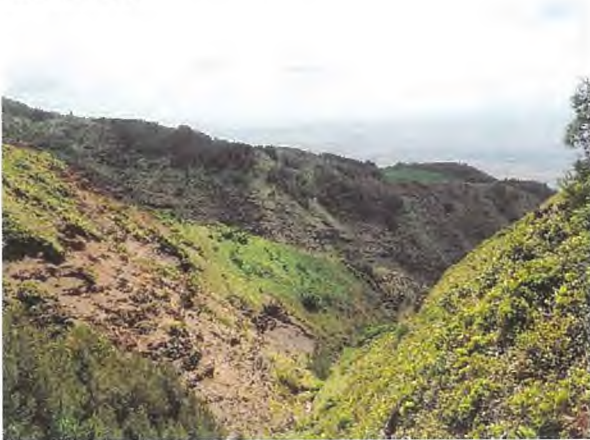
Loss of Vegetation

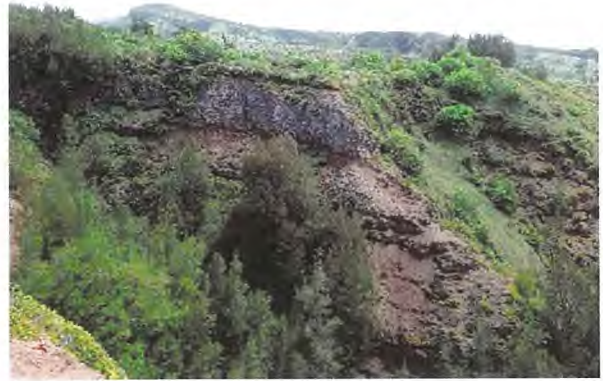
Loss of Vegetation

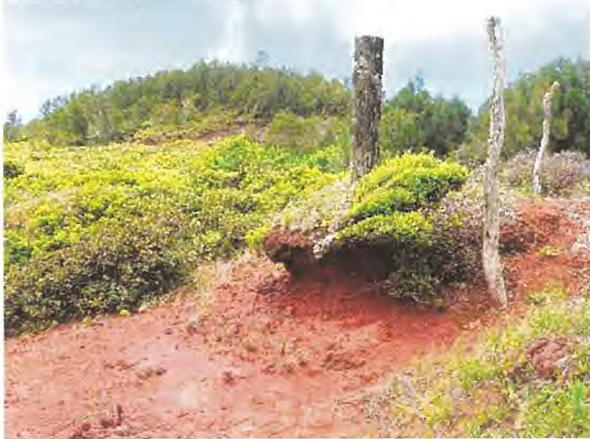
Soil Loss and Remaining Vegetation

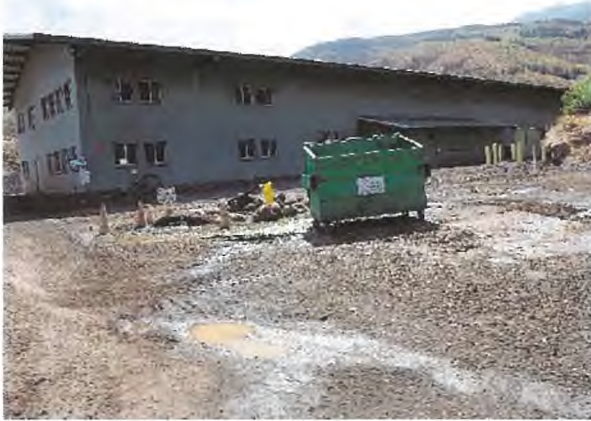
Gravel Roads with Mud and Erosion

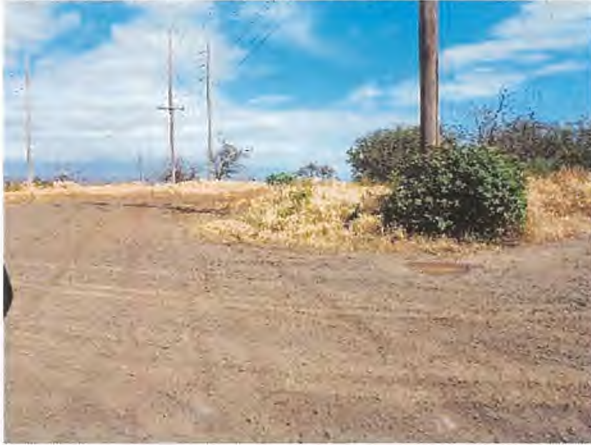
Gravel Roads Near Ditches

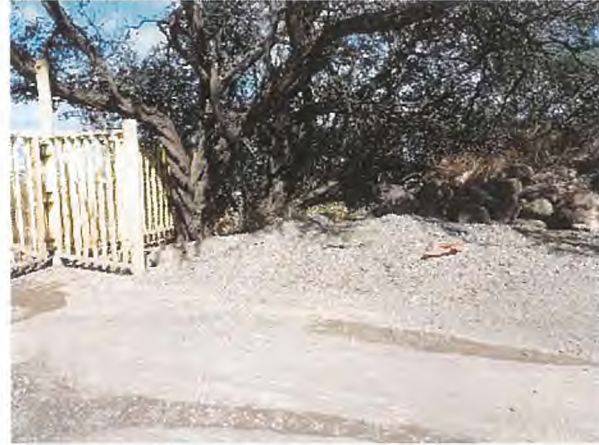
Gravel Piles Near Entrance

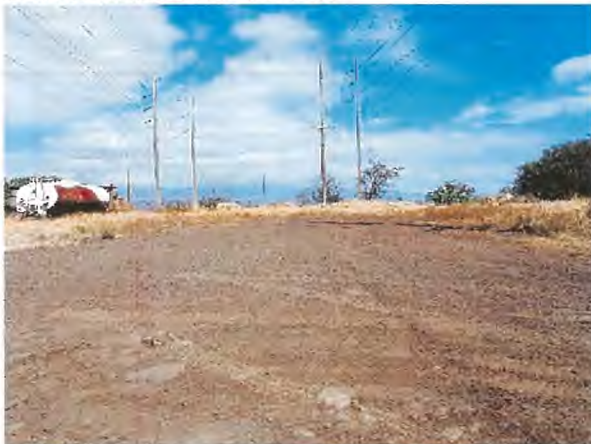
Well Maintained Gravel Roads

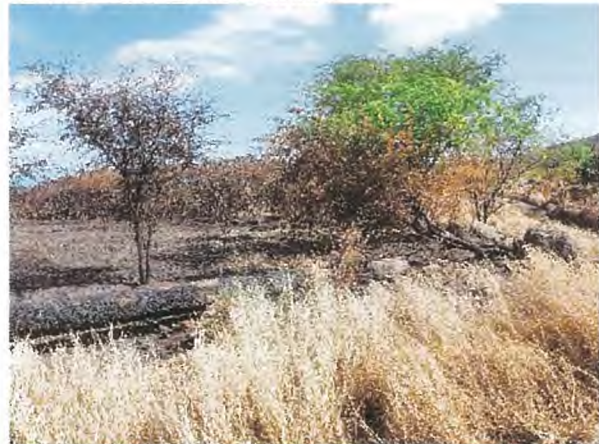
Evidence of Fire Near Entrance

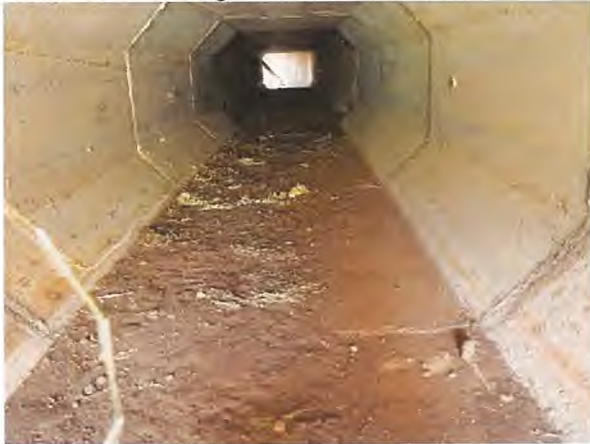
Sediment in Culverts

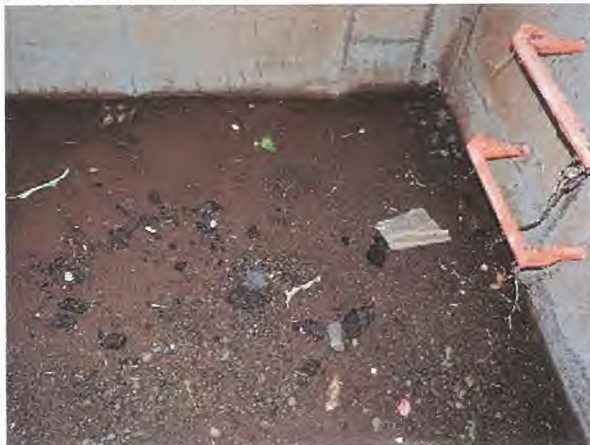
Sediment and Gravel in Culverts

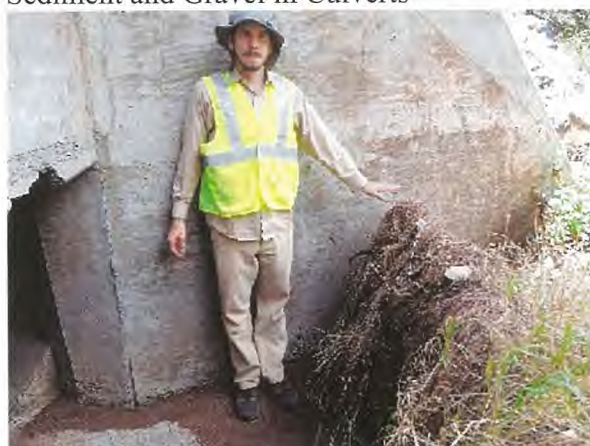
Extent of Vegetation at Entrance to Culvert

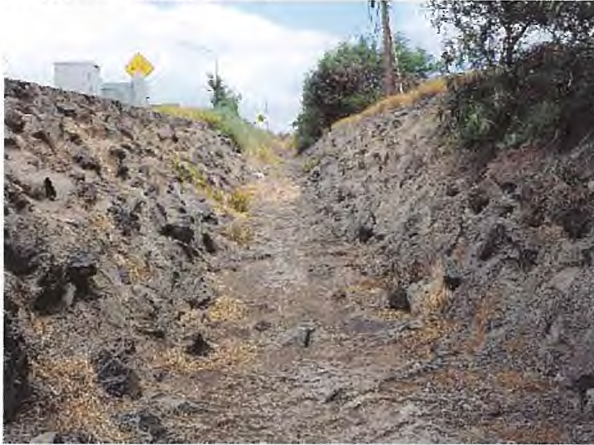
Waihe'e Makai Ditch – Armored and Box Cut

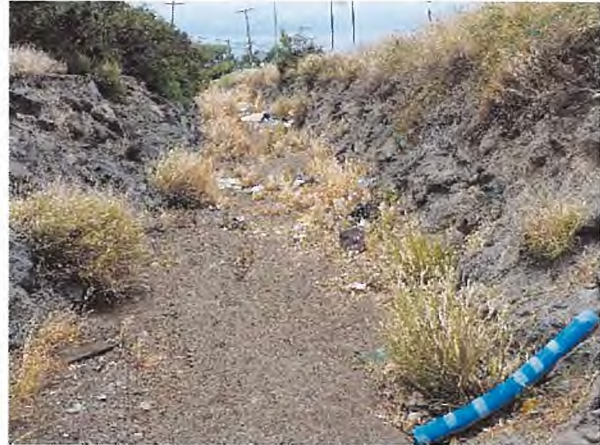
Rubbish in Ditch

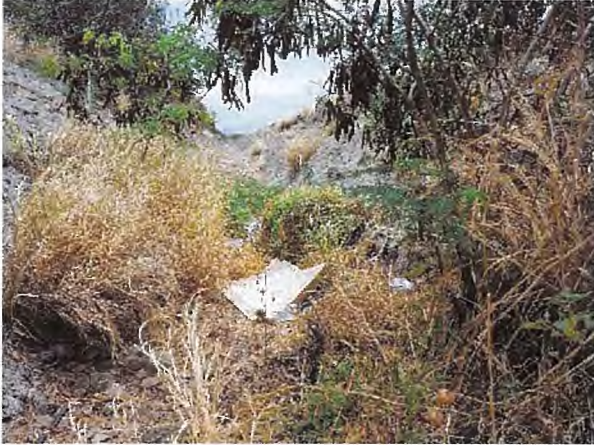
Vegetation and Rubbish in Ditch

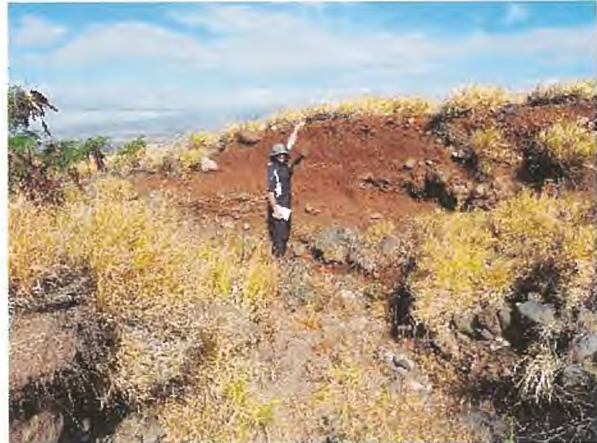
Extent of Erosion

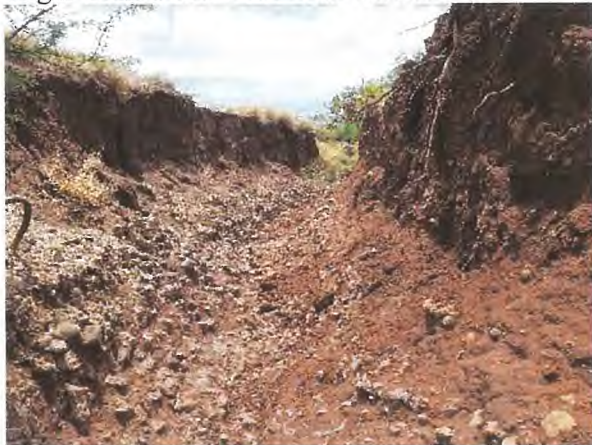
Highly Eroded Stream Channel
