Structural Condition Analysis and Assessment of Dormitory Facilities

December 17, 2019

Site Located at 820 Ka'ahumanu Avenue, Kahului, Maui 96732 TMK: (2)3-8-07:117

Summary of Structural Field Condition Survey for the Existing University of Hawaii Community College Dorm Campus Buildings and Appurtenances

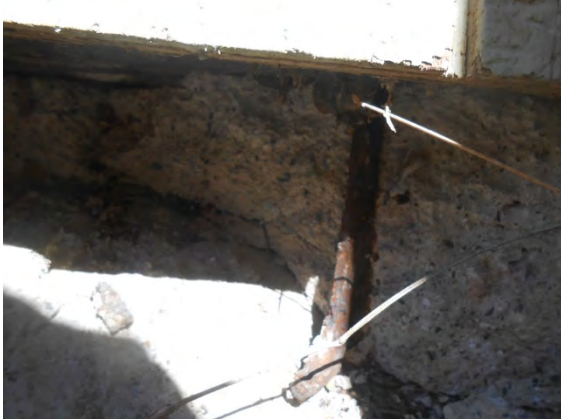
PA1D.3: Concrete spall with exposed corroded sole plate anchor rod.

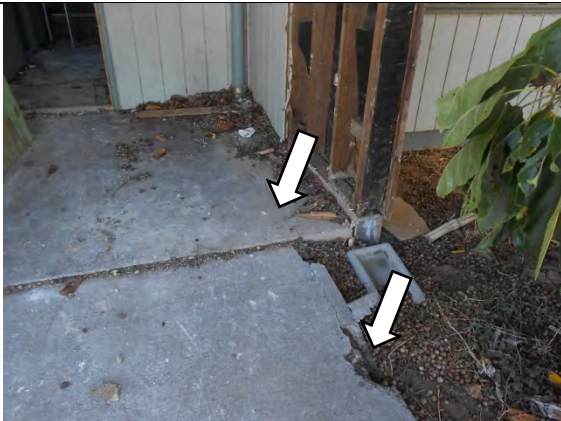
PA1D.5: Cracked exterior slab at rusting drain-pipe.

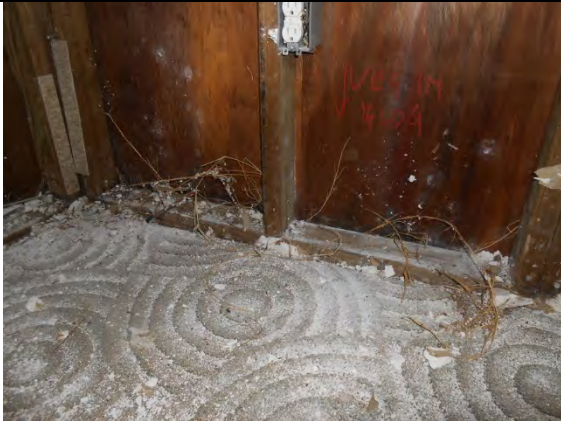
PA1CD.3: At various locations, vegetation is present at interior face of first story walls.

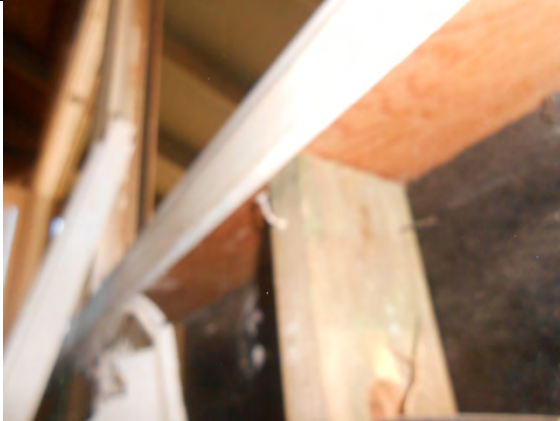
PA2CD.2: Missing opening sill plate. Window supported on studs.

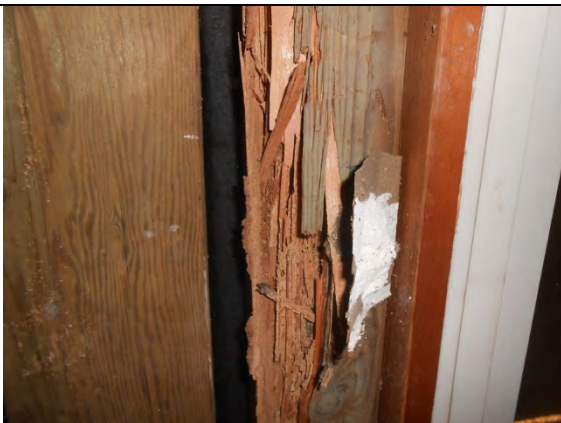
PB1D.3: Post termite damage.

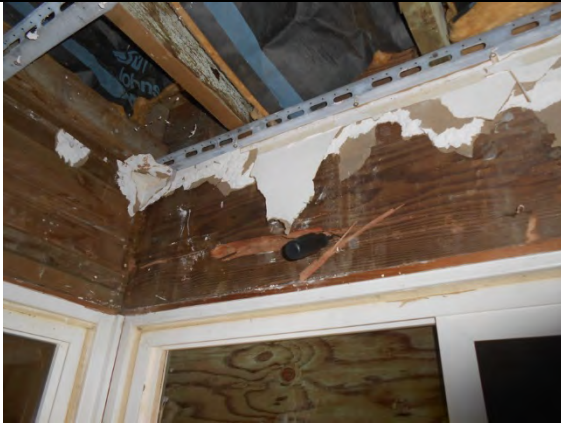
PB1D.5: Beam termite damage.

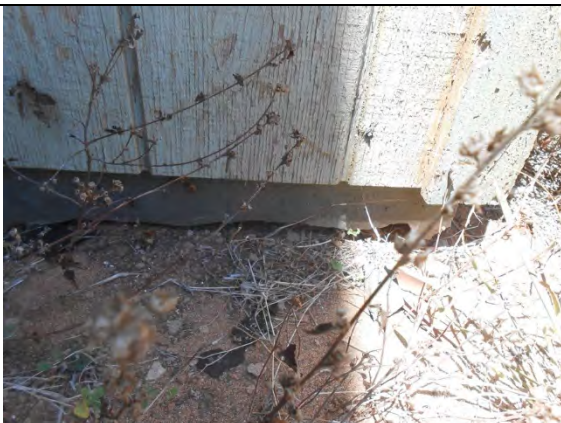
PB1CD.5: Exposed bottom of footing.

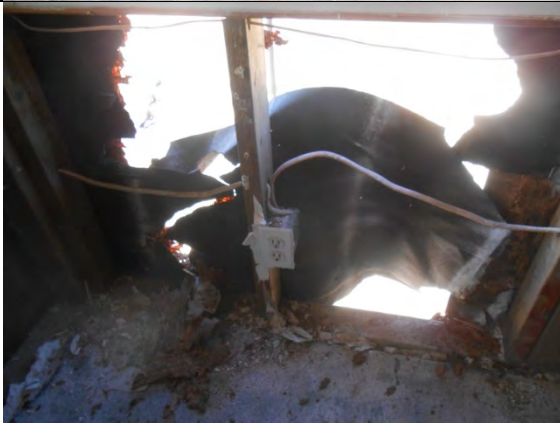
PB2D.3: Sheathing dry rot.

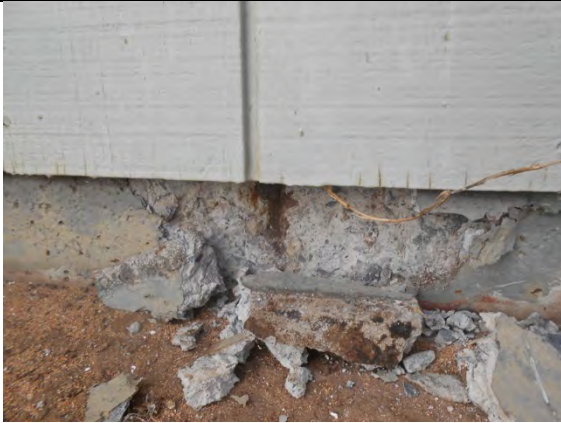
PC1D.1: Concrete spall with exposed corroded reinforcing steel.

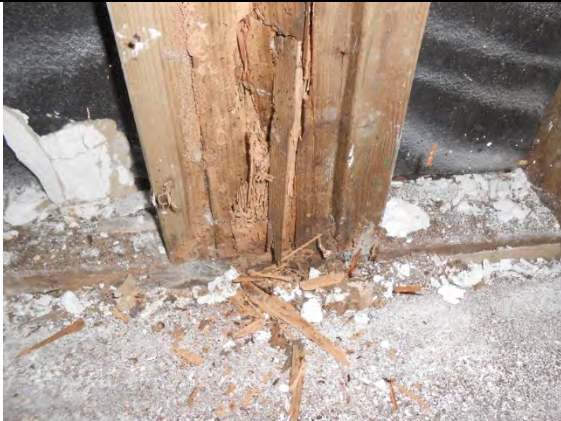
PC1D.4: Post termite damage.

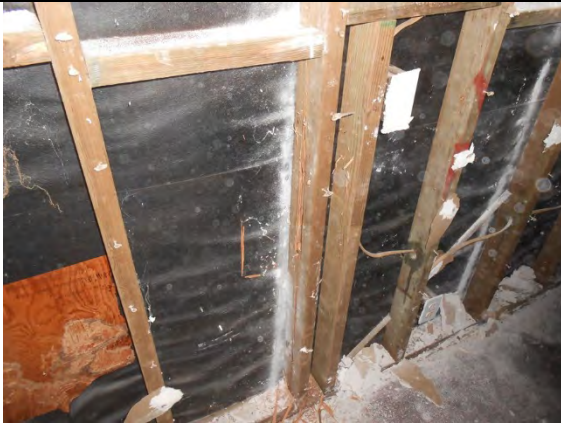
PC1D.5: Stud termite damage.

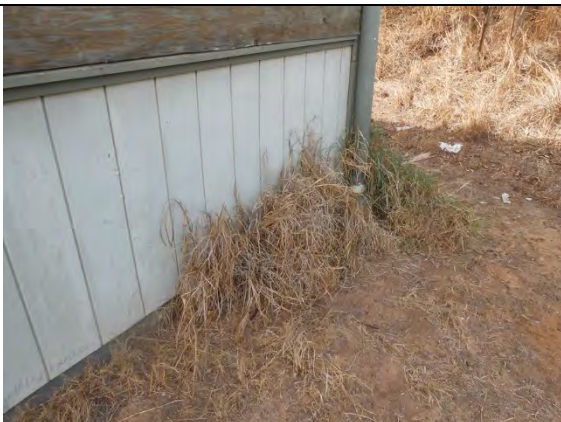
PC1CD.3: At various locations, vegetation against building façade.

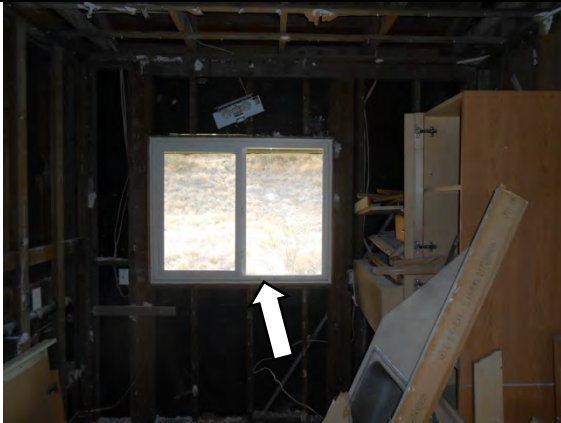
PC2CD.3: Missing opening sill plate.

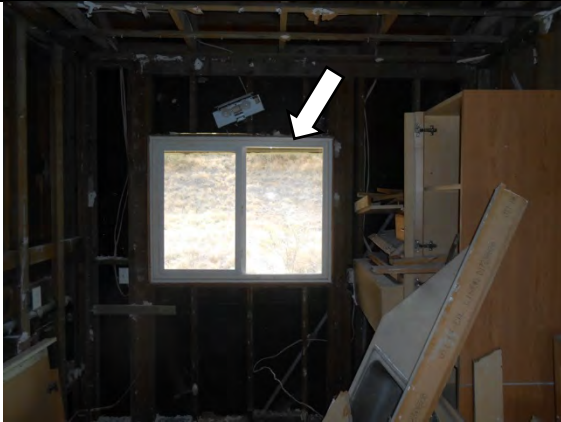
PC2CD.4: Missing opening header.

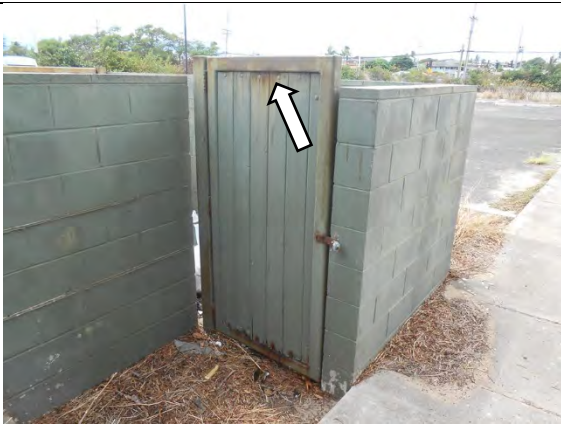
PTESB3: Rusting trash enclosure door.

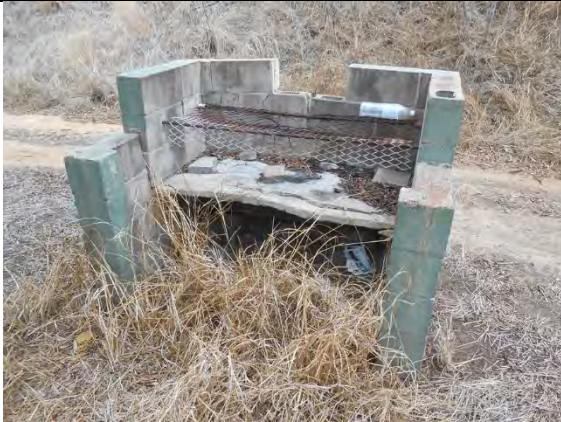
PBP1: Damaged concrete masonry unit barbecue pit. Missing blocks, cracked masonry, and warped concrete fire slab.

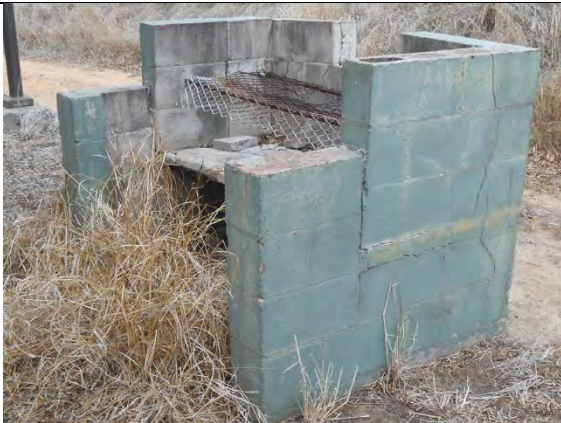
PBP2: Damaged concrete masonry unit barbecue pit. Missing blocks, cracked masonry, and warped concrete fire slab.
