**SUBJECT: COUNTY-OWNED PARCEL ON NORTH PAPA AVENUE (KAHULUI)
 (HHT-14)**

Property Condition Report

310 W Kaahumanu Ave, Kahului, HI 96732
Inspection prepared for: Maui County c/o Buddy Almeida
Real Estate Agent: -

Date of Inspection: 3/28/2018 Time: 8:00 AM
Age of Home: 1980 Size: 15000

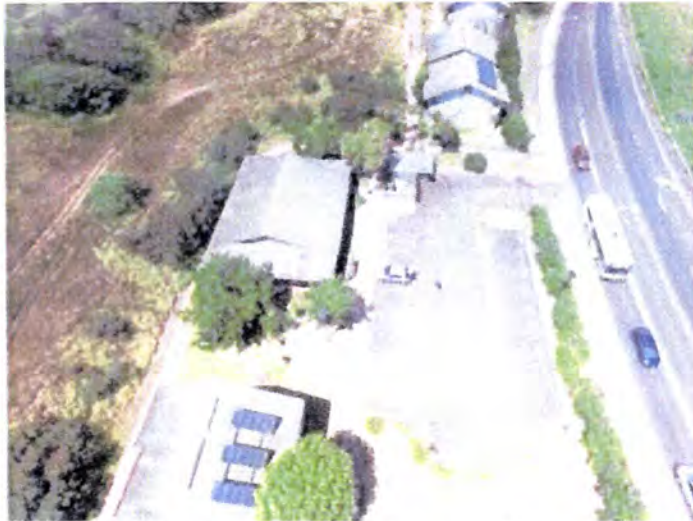
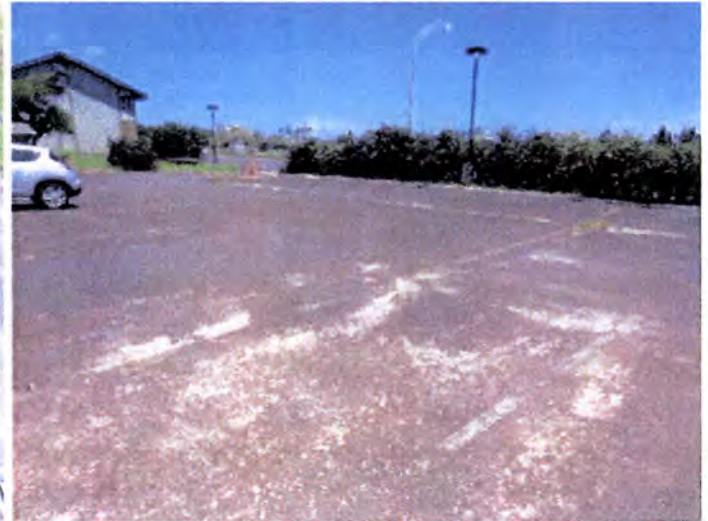
The parking area surface was deteriorated with lines weathered to the point of not providing clear lanes for parking use. Recommend having the parking area resurfaced and striped to ensure proper identification of parking stalls.

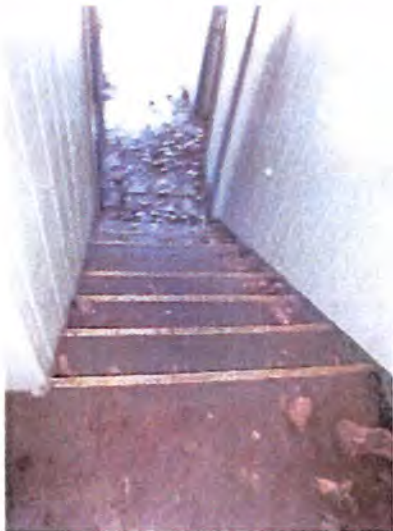
Bldg A hand rail was missing. Recommend installation as required.

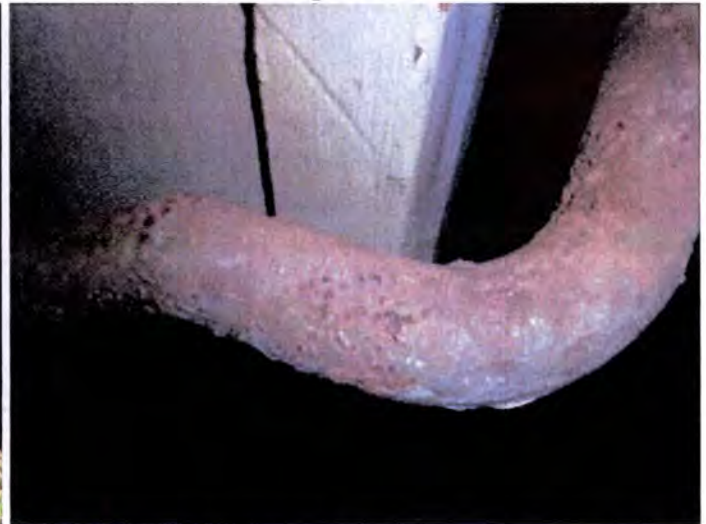
Exterior stair handrails were corroded and need to be cleaned, treated and refinished.

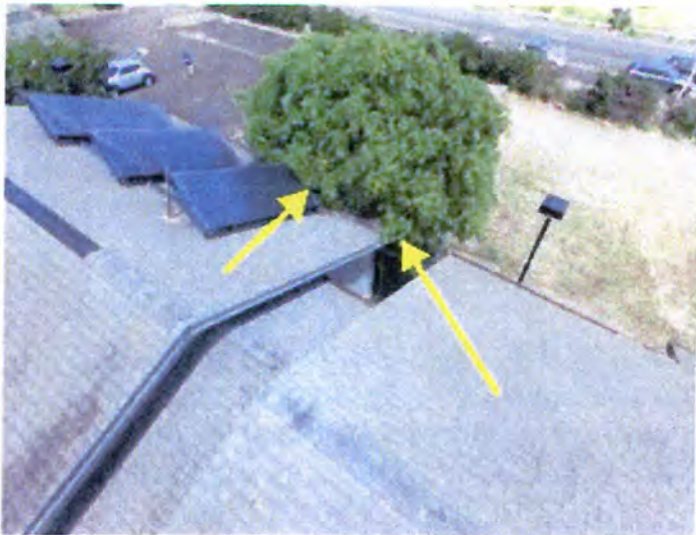
The vegetation was overgrown and causing deterioration/damage to the exterior curtain wall and fixtures.

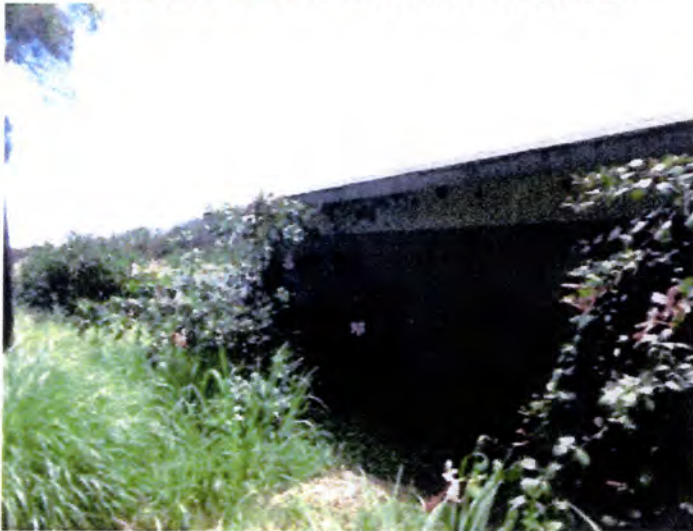
Vegetation was overgrown and in need of removal in many areas.

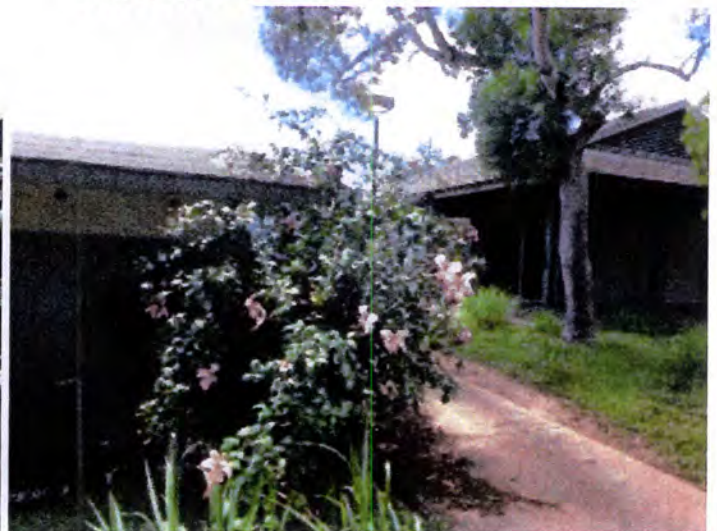
Vegetation was overgrown and in need of removal in many areas.

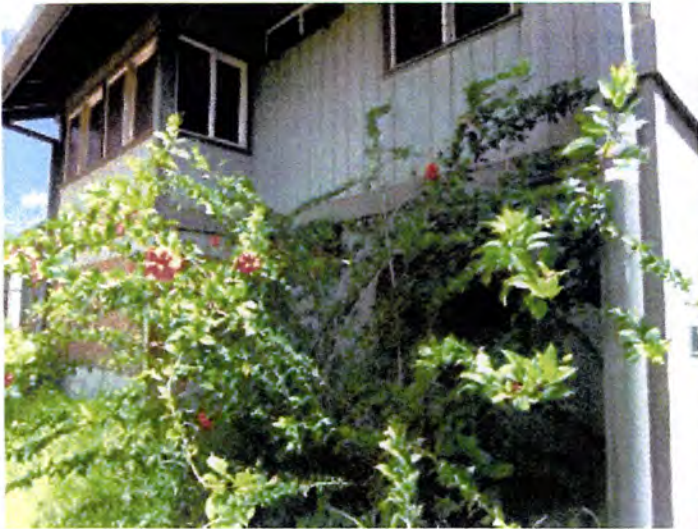
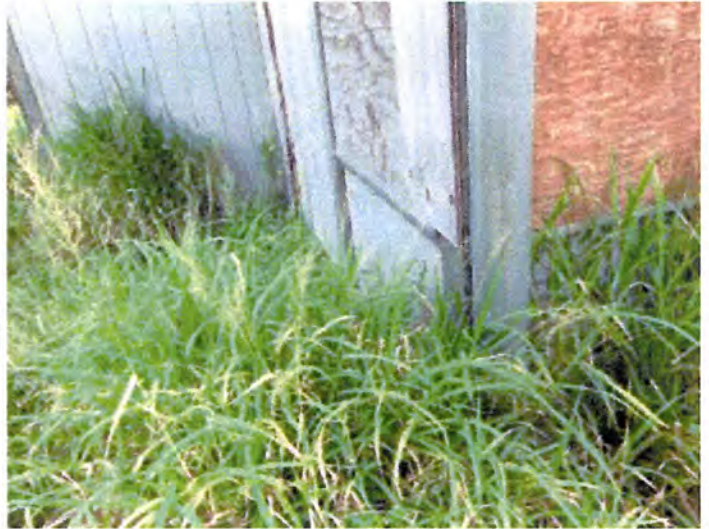
There were numerous trees contacting the building curtain walls and roof areas.

Vegetation was overgrown and in need of removal in many areas.

These areas appeared to have damage/deterioration noted at the time of inspection. Recommend having a licensed landscape contractor/arborist evaluate and trim vegetation and trees as necessary.

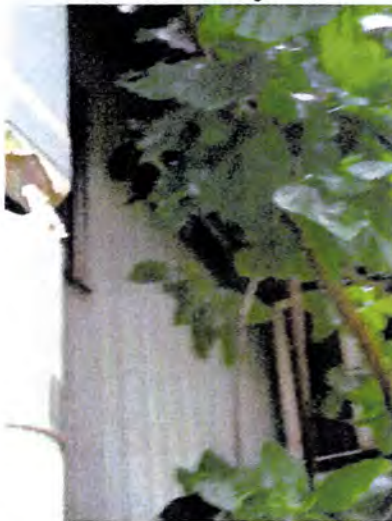
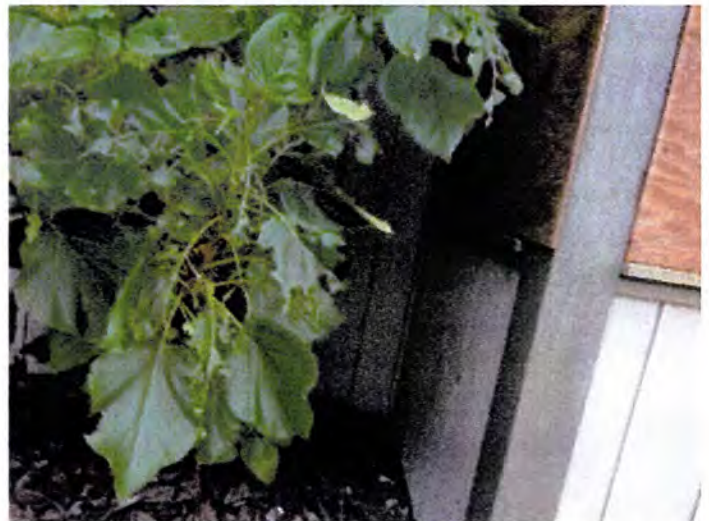
There were numerous trees contacting the building curtain walls and roof areas.

Vegetation was overgrown and in need of removal in many areas.

These areas appeared to have damage/deterioration noted at the time of inspection. Recommend having a licensed landscape contractor/arborist evaluate and trim vegetation and trees as necessary.

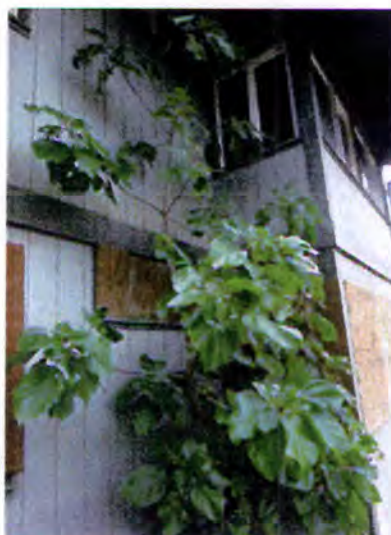
There were numerous trees contacting the building curtain walls and roof areas. These areas appeared to have damage/deterioration noted at the time of inspection. Recommend having a licensed landscape contractor/arborist evaluate and trim vegetation and trees as necessary.

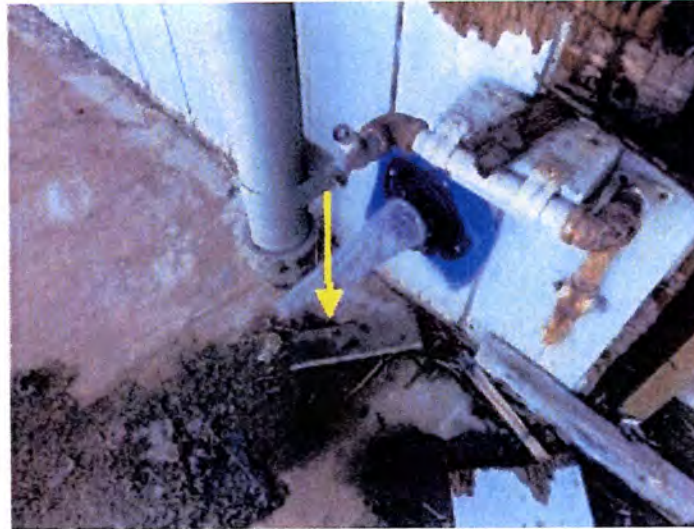
Some of the exterior hose bibs had slow dripping leaks observed at the time of inspection. Recommend repair.

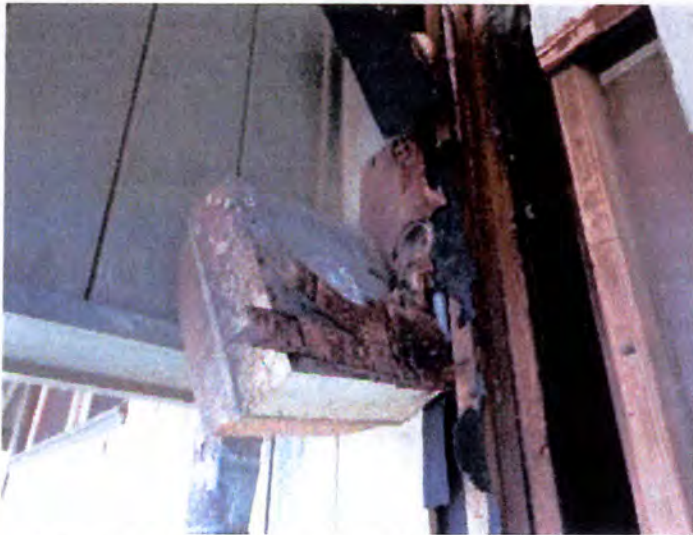
Some of the exterior lighting fixtures were damaged and need to be replaced.

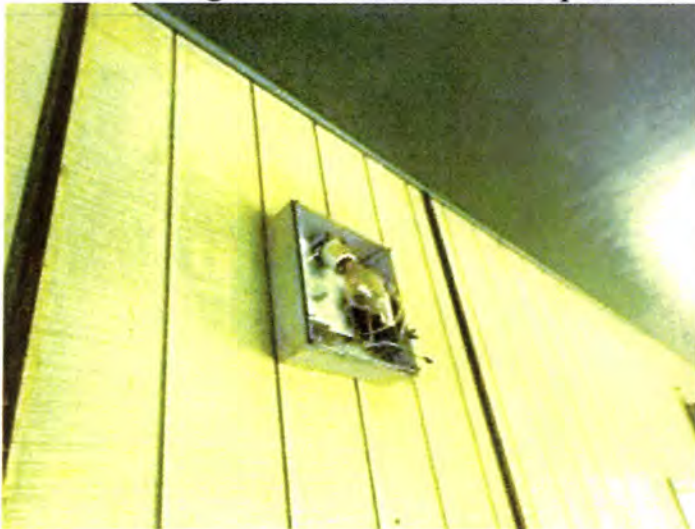
Some of the exterior lighting fixtures were damaged and need to be replaced.

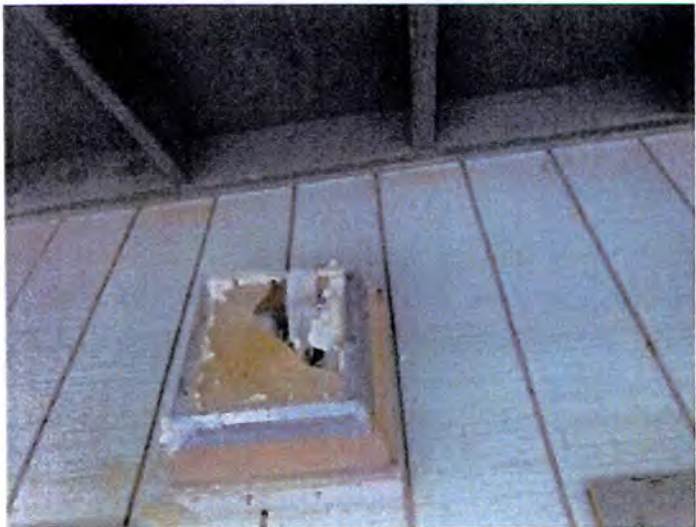
Some of the exterior lighting fixtures were damaged and need to be replaced.

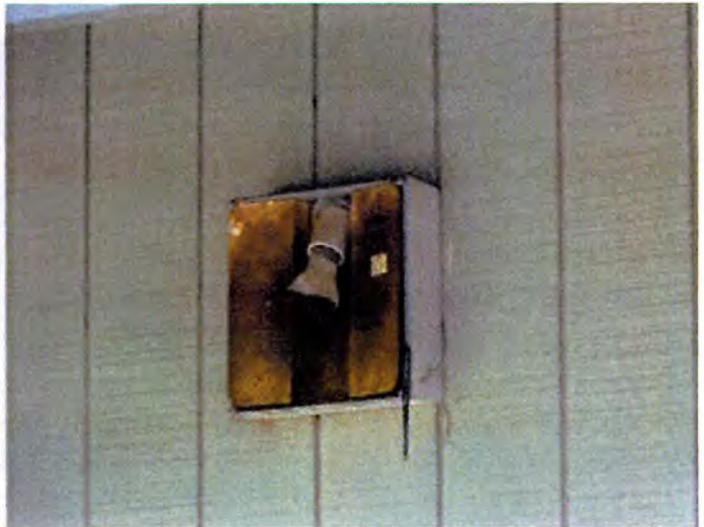
Some of the exterior lighting fixtures were damaged and need to be replaced.

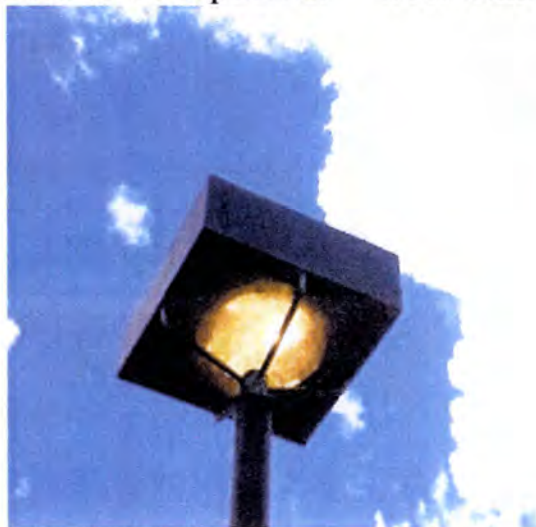
Exterior lighting was functional at the time of inspection. Replacement of fixtures will be on an as needed basis only.

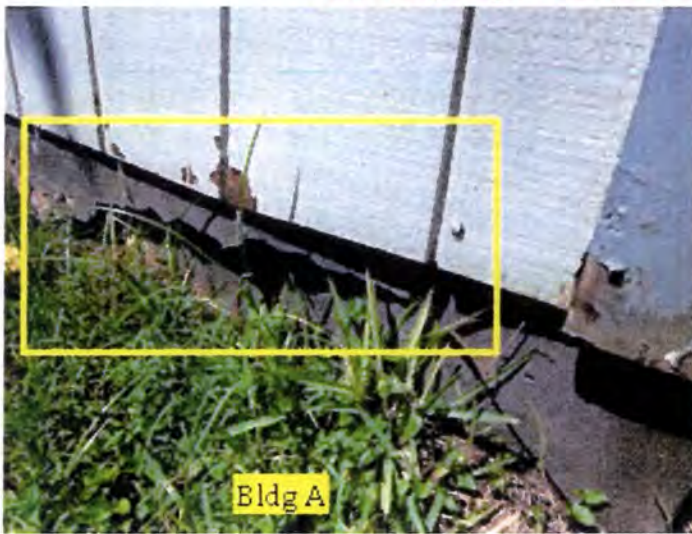
Bldg A

Building A and B: Visible cracks observed at the foundational areas of the buildings. There were separations observed along the defect areas which represent movement between the faults. We recommend having a licensed foundation/masonry contractor evaluate and repair the affected areas as necessary to prevent further damage.

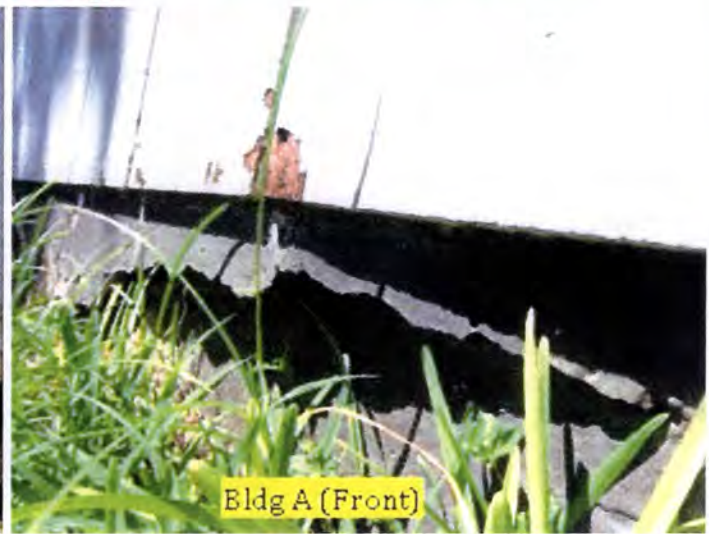
Bldg A (Front)

Building A and B: Visible cracks observed at the foundational areas of the buildings. There were separations observed along the defect areas which represent movement between the faults. We recommend having a licensed foundation/masonry contractor evaluate and repair the affected areas as necessary to prevent further damage.

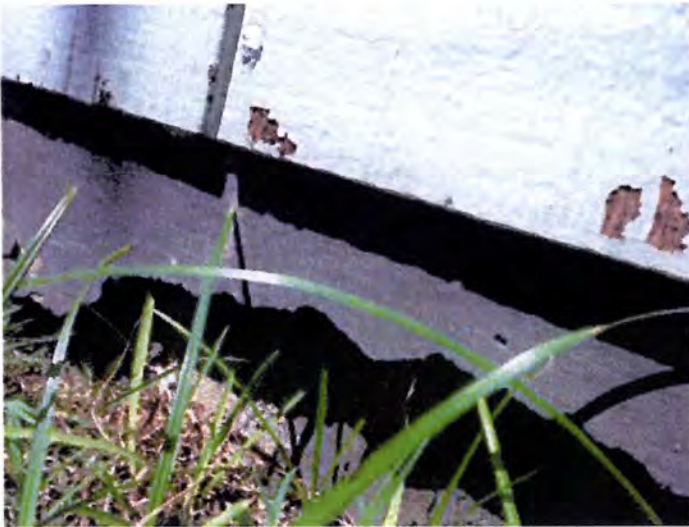
Building A and B: Visible cracks observed at the foundational areas of the buildings. There were separations observed along the defect areas which represent movement between the faults.

We recommend having a licensed foundation/masonry contractor evaluate and repair the affected areas as necessary to prevent further damage.

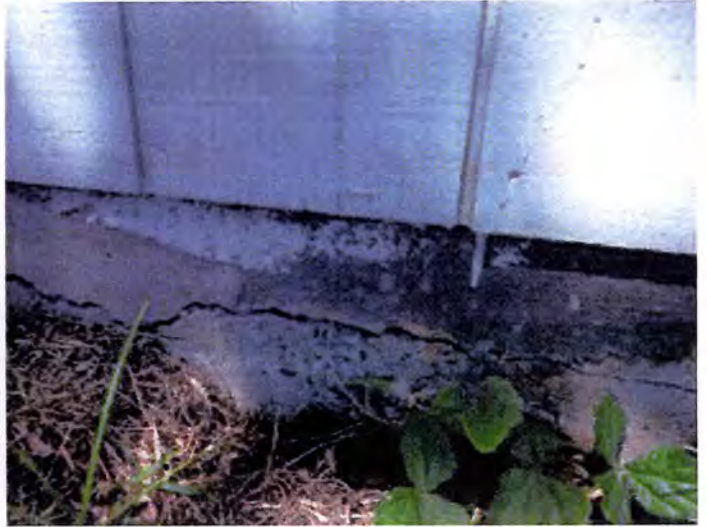
Building A and B: Visible cracks observed at the foundational areas of the buildings. There were separations observed along the defect areas which represent movement between the faults.

We recommend having a licensed foundation/masonry contractor evaluate and repair the affected areas as necessary to prevent further damage.

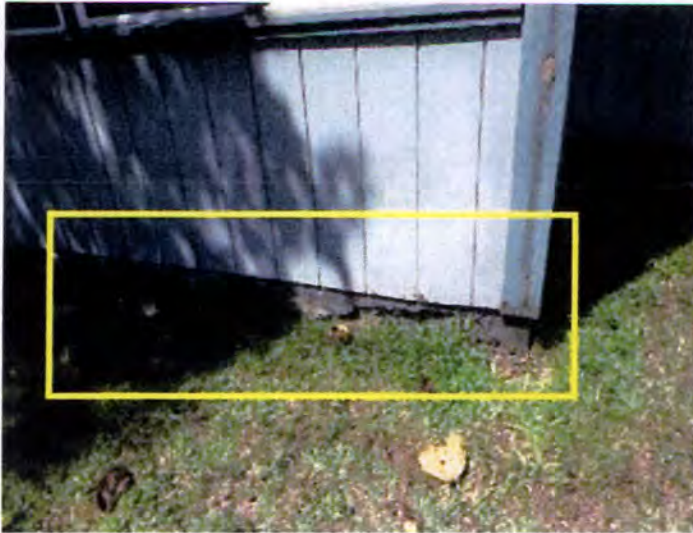
Building A and B: Visible cracks observed at the foundational areas of the buildings. There were separations observed along the defect areas which represent movement between the faults. We recommend having a licensed foundation/masonry contractor evaluate and repair the affected areas as necessary to prevent further damage.

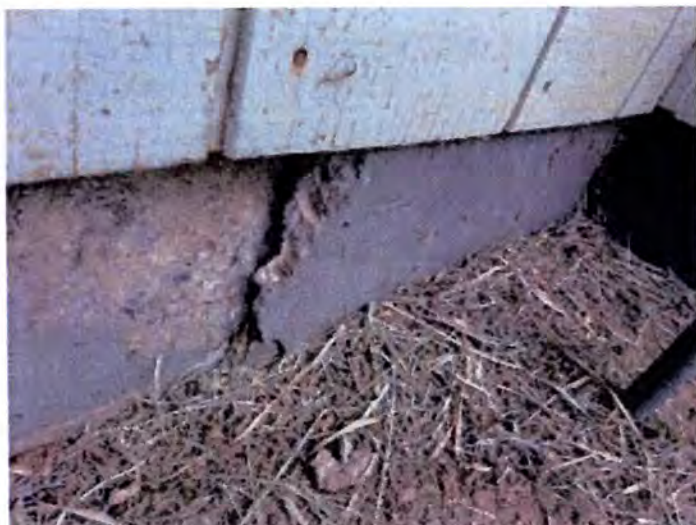
Building A and B: Visible cracks observed at the foundational areas of the buildings. There were separations observed along the defect areas which represent movement between the faults.

We recommend having a licensed foundation/masonry contractor evaluate and repair the affected areas as necessary to prevent further damage.

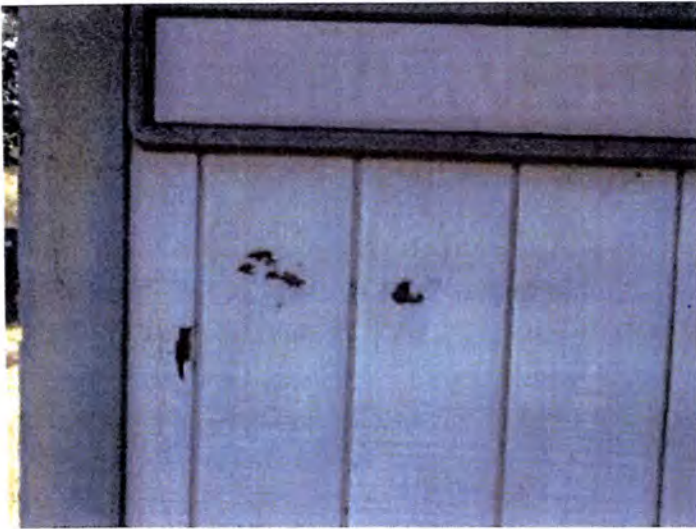
Visible indications of WDO (termite) damage noted. Recommend having a licensed pest contractor evaluate and treat as necessary. Also, recommend having a licensed contractor evaluate and repair/replace damaged material as necessary.

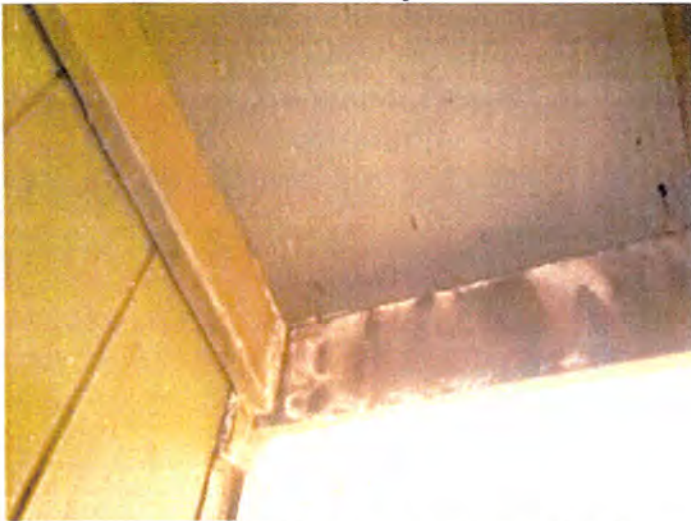
The fascia/soffit areas appeared to be rotted/water damaged/deteriorated at the time of inspection. Recommend having a licensed contractor evaluate and repair/replace as necessary.

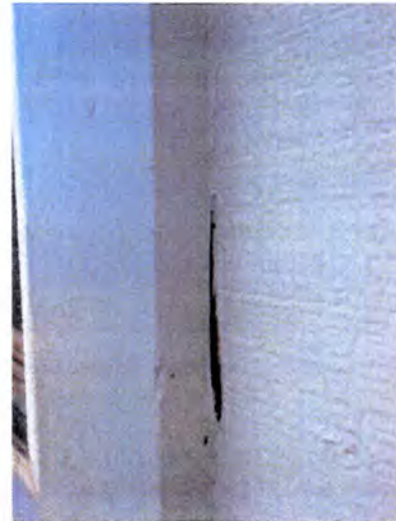
Visible indications of WDO (termite) damage noted. Recommend having a licensed pest contractor evaluate and treat as necessary. Also, recommend having a licensed contractor evaluate and repair/replace damaged material as necessary.

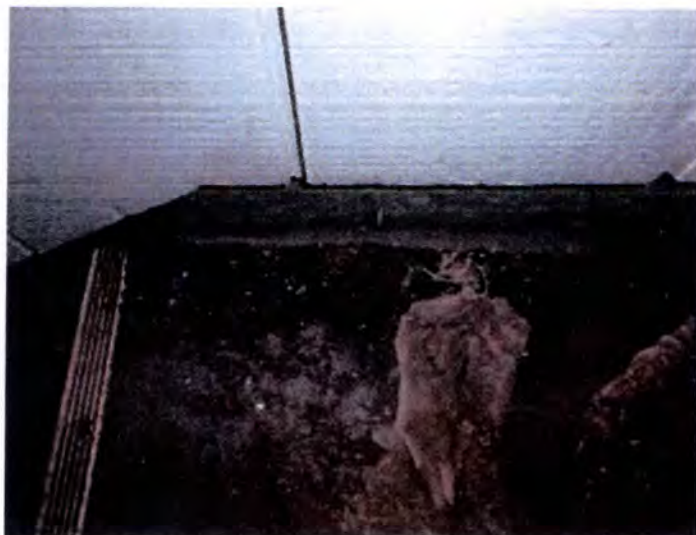
There were visible indications of WDO (Wood Destroying Organism) damage noted at the fascia and soffit areas. Recommend having a licensed contractor evaluate and repair/replace as necessary.

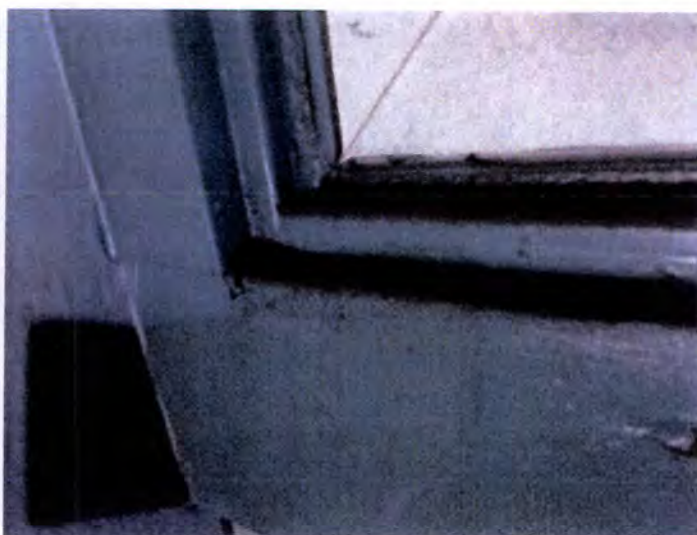
Visible indications of WDO (termite) damage noted. Recommend having a licensed pest contractor evaluate and treat as necessary. Also, recommend having a licensed contractor evaluate and repair/replace damaged material as necessary.

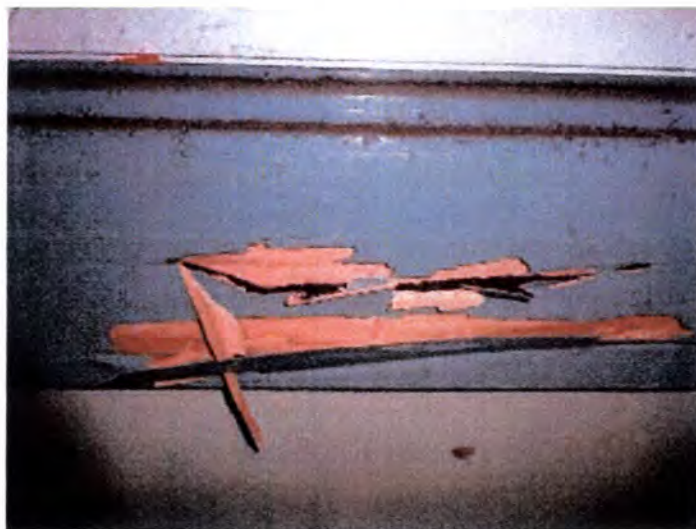
There were visible indications of WDO (Wood Destroying Organism) damage noted at the fascia and soffit areas. Recommend having a licensed contractor evaluate and repair/replace as necessary.

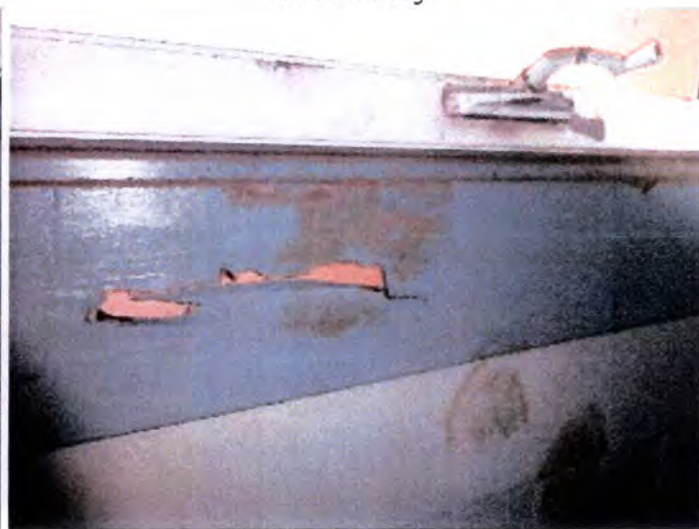
Visible indications of WDO (termite) damage noted. Recommend having a licensed pest contractor evaluate and treat as necessary. Also, recommend having a licensed contractor evaluate and repair/replace damaged material as necessary.

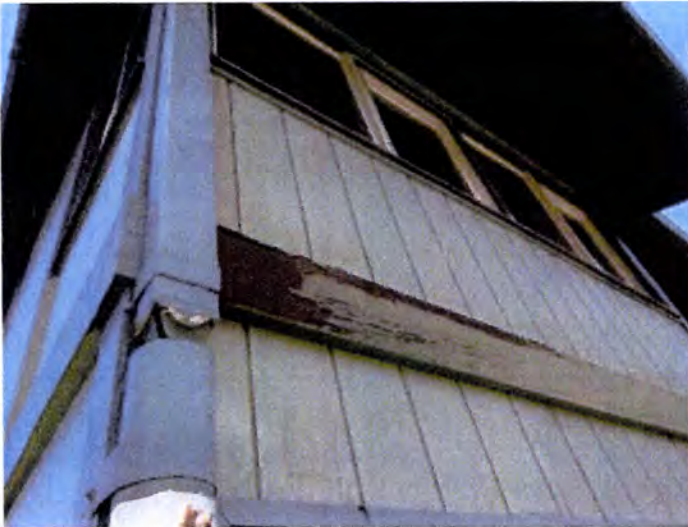
Blistering/peeling/missing paint observed at many exterior trim, fascia and soffit areas. Recommend properly preparing and refinishing exterior finishes.

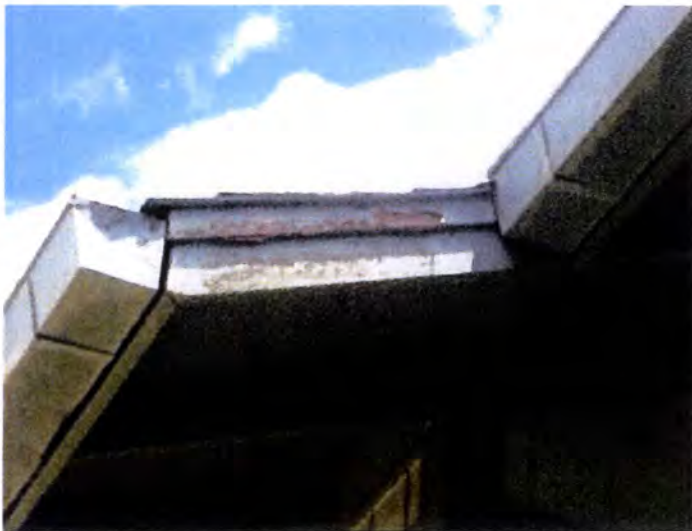
Blistering/peeling/missing paint observed at many exterior trim, fascia and soffit areas. Recommend properly preparing and refinishing exterior finishes.

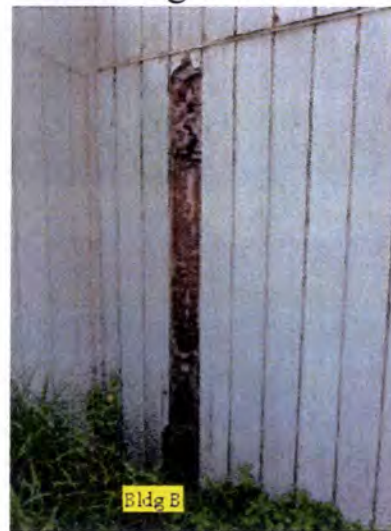
Visible indications of WDO (termite) damage noted. Recommend having a licensed pest contractor evaluate and treat as necessary. Also, recommend having a licensed contractor evaluate and repair/replace damaged material as necessary.

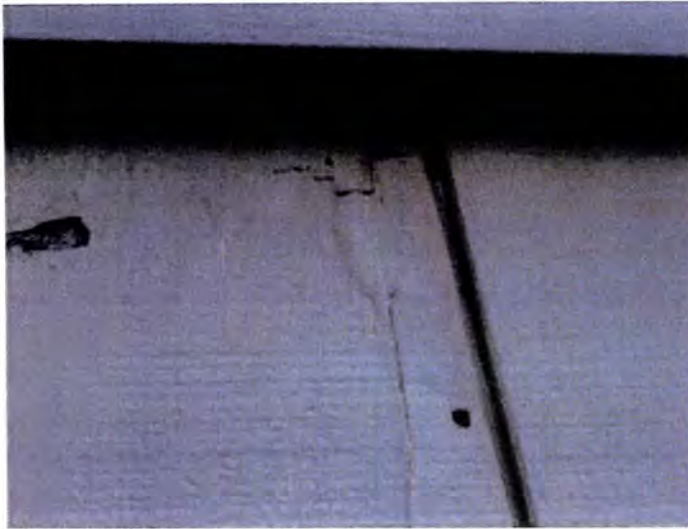
Visible indications of WDO (termite) damage noted. Recommend having a licensed pest contractor evaluate and treat as necessary. Also, recommend having a licensed contractor evaluate and repair/replace damaged material as necessary.

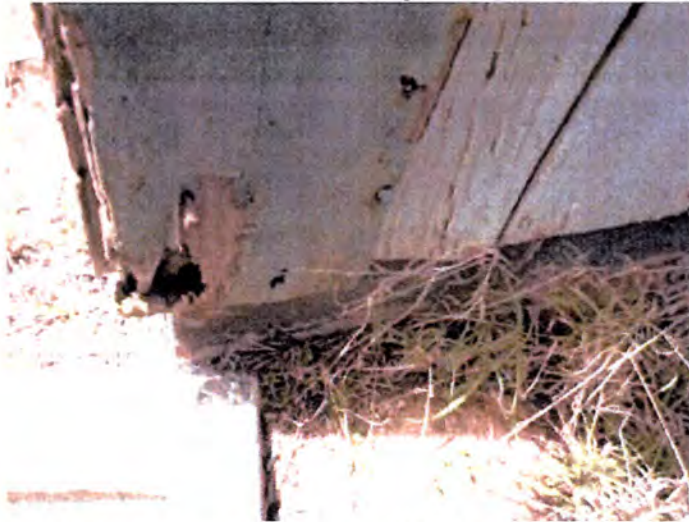
Visible indications of WDO (termite) damage noted. Recommend having a licensed pest contractor evaluate and treat as necessary. Also, recommend having a licensed contractor evaluate and repair/replace damaged material as necessary.

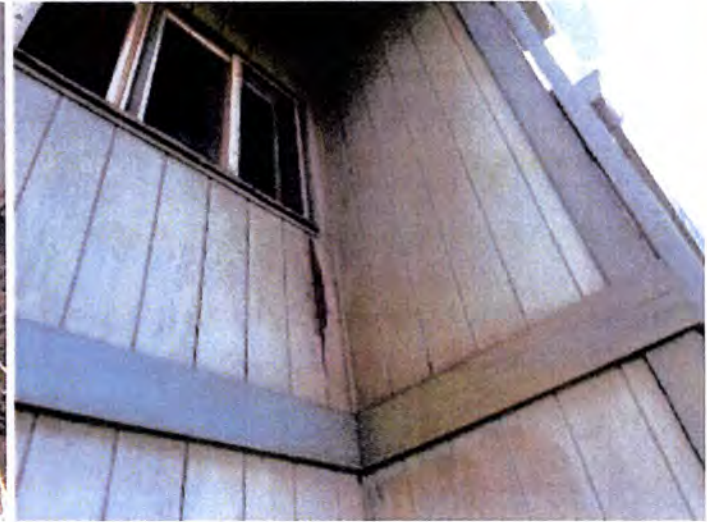
Moisture damage observed at exterior wall areas. Recommend select demolition and replacement of affected ground level exterior siding and finishes.

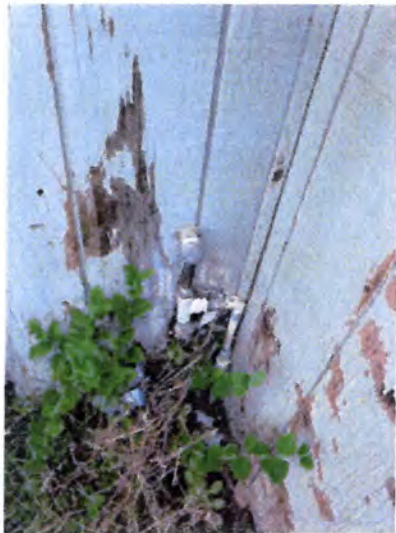
Moisture damage observed at exterior wall areas. Recommend select demolition and replacement of affected ground level exterior siding and finishes.

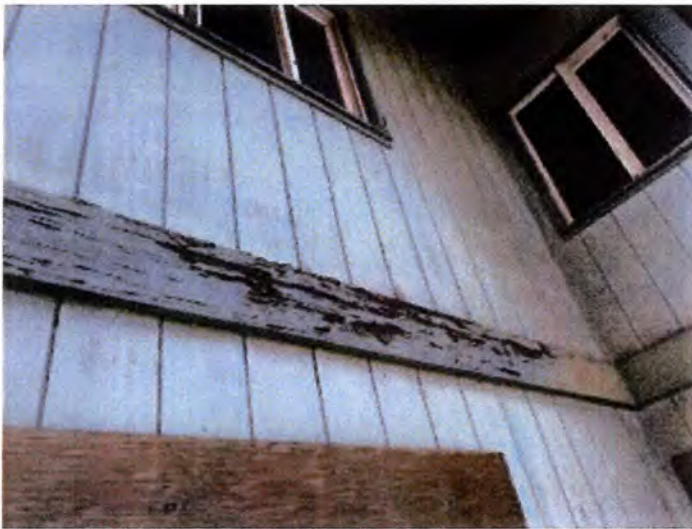
Blistering/peeling/missing paint observed at many exterior trim, fascia and soffit areas. Recommend properly preparing and refinishing exterior finishes.

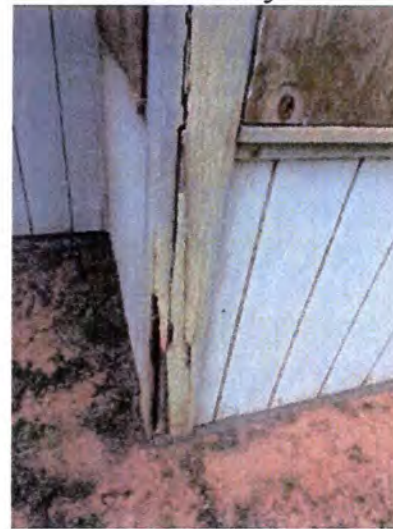
Visible indications of WDO (termite) damage noted. Recommend having a licensed pest contractor evaluate and treat as necessary. Also, recommend having a licensed contractor evaluate and repair/replace damaged material as necessary.

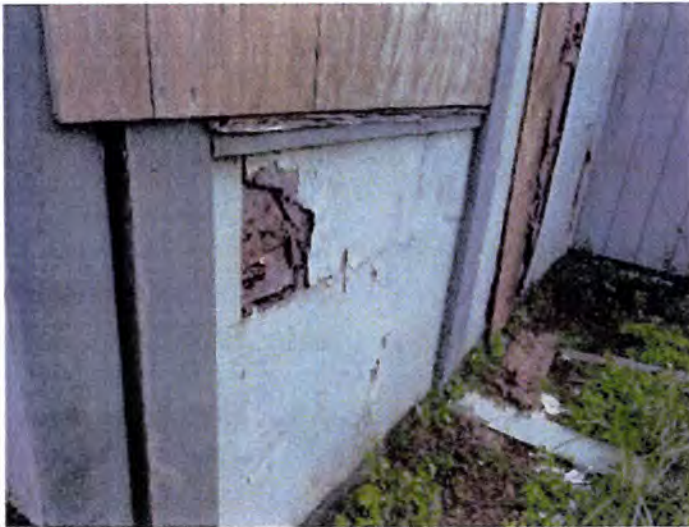
Moisture damage observed at exterior wall areas. Recommend select demolition and replacement of affected ground level exterior siding and finishes.

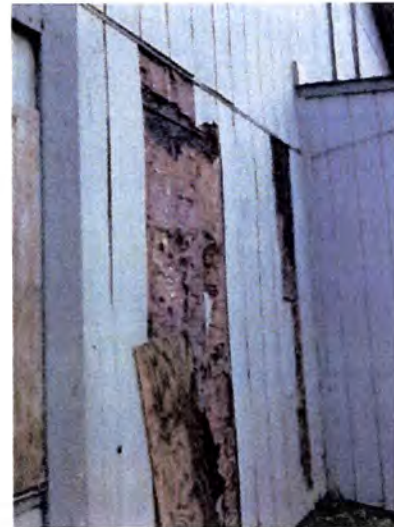
Visible indications of WDO (termite) damage noted. Recommend having a licensed pest contractor evaluate and treat as necessary. Also, recommend having a licensed contractor evaluate and repair/replace damaged material as necessary.

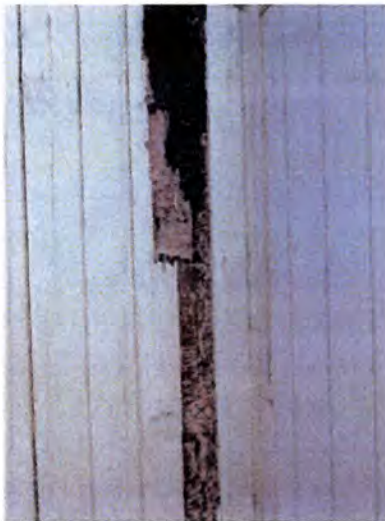
Visible indications of WDO (termite) damage noted. Recommend having a licensed pest contractor evaluate and treat as necessary. Also, recommend having a licensed contractor evaluate and repair/replace damaged material as necessary.

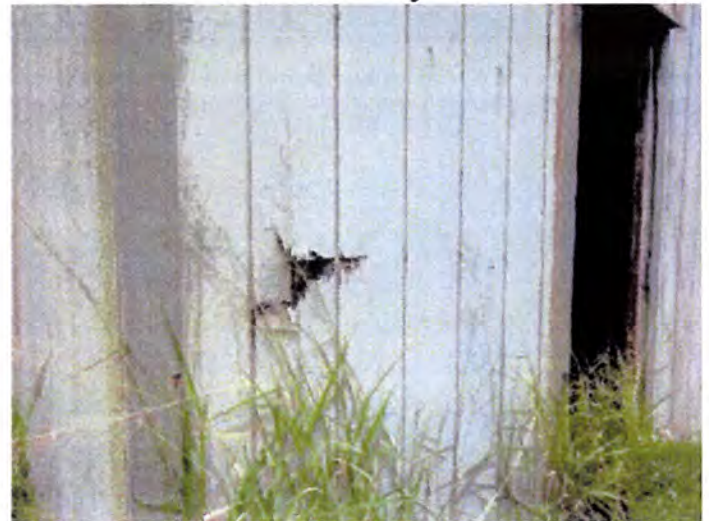
Visible indications of WDO (termite) damage noted. Recommend having a licensed pest contractor evaluate and treat as necessary. Also, recommend having a licensed contractor evaluate and repair/replace damaged material as necessary.

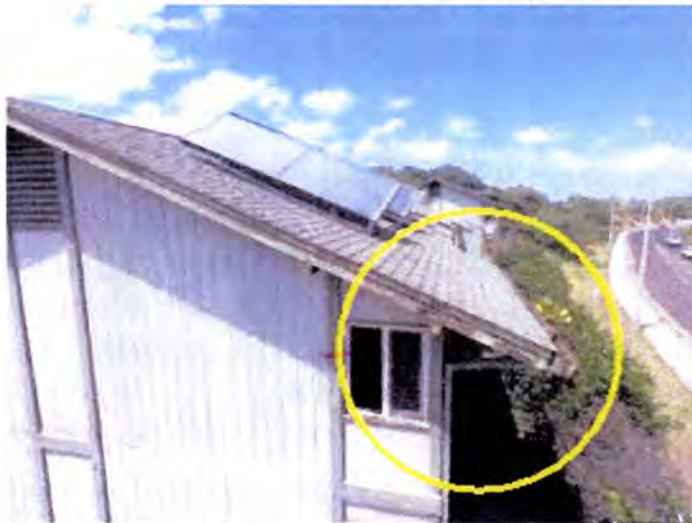
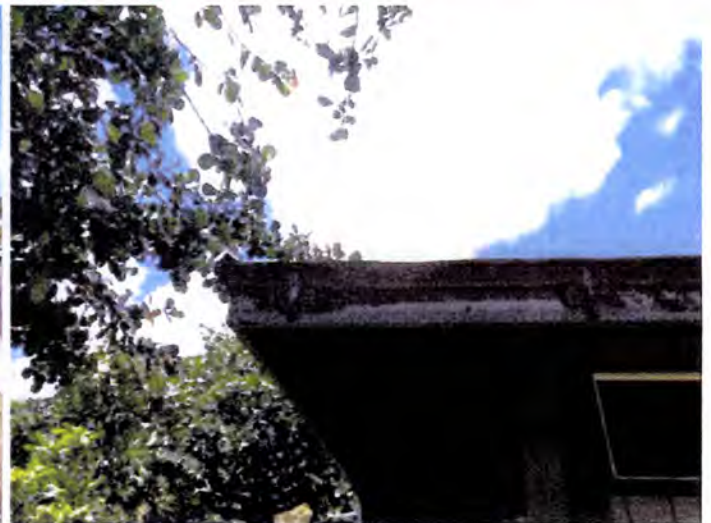
The fascia/soffit areas appeared to be rotted/water damaged/deteriorated at the time of inspection. Recommend having a licensed contractor evaluate and repair/replace as necessary.

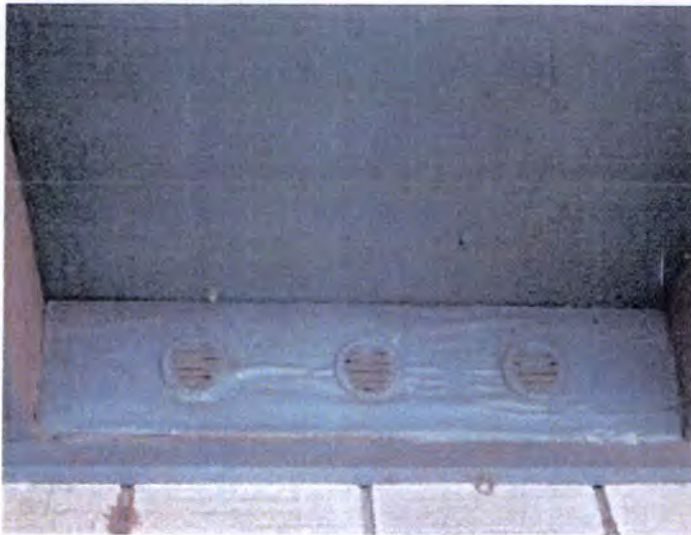
There were visible indications of WDO (Wood Destroying Organism) damage noted at the fascia and soffit areas. Recommend having a licensed contractor evaluate and repair/replace as necessary.

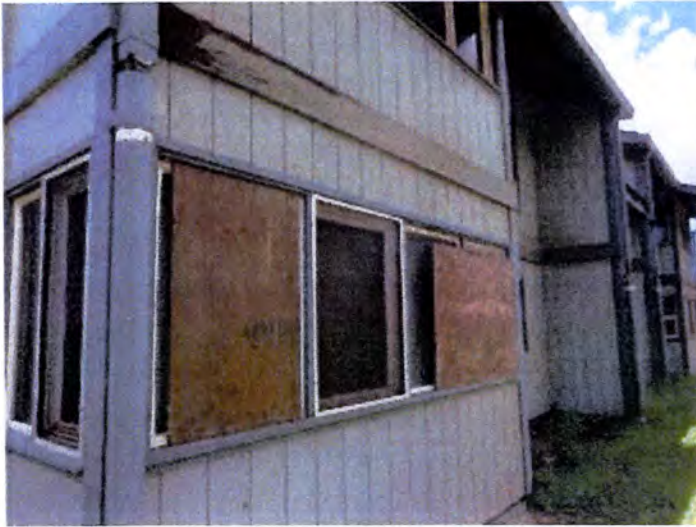
Many of the ground floor windows were broken at the time of inspection.

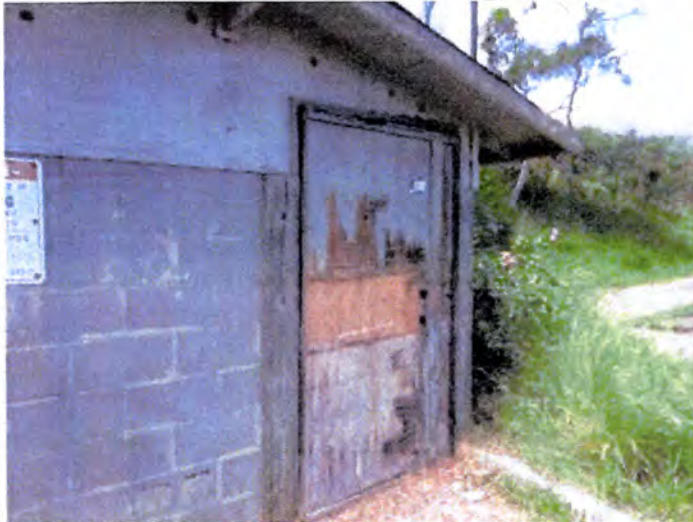
The exterior doors were termite damaged or deteriorated to the point of being inoperable. We recommend replacement of all exterior doors, framing and trim for all buildings.

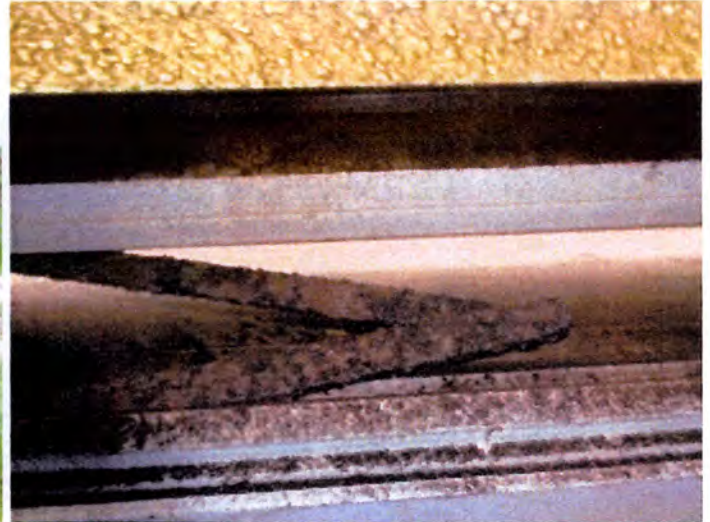
The stair way windows were heavily corroded, damaged and/or inoperable at the time of inspection. Recommend replacement.

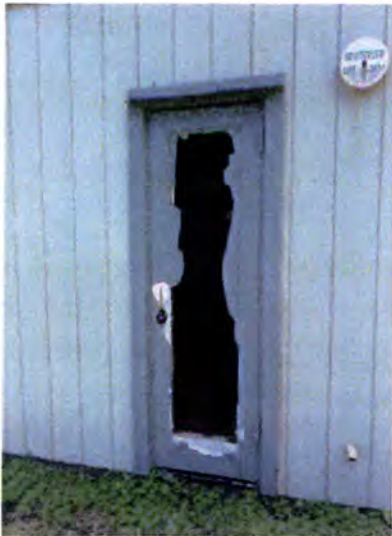
The exterior doors were termite damaged or deteriorated to the point of being inoperable. We recommend replacement of all exterior doors, framing and trim for all buildings.

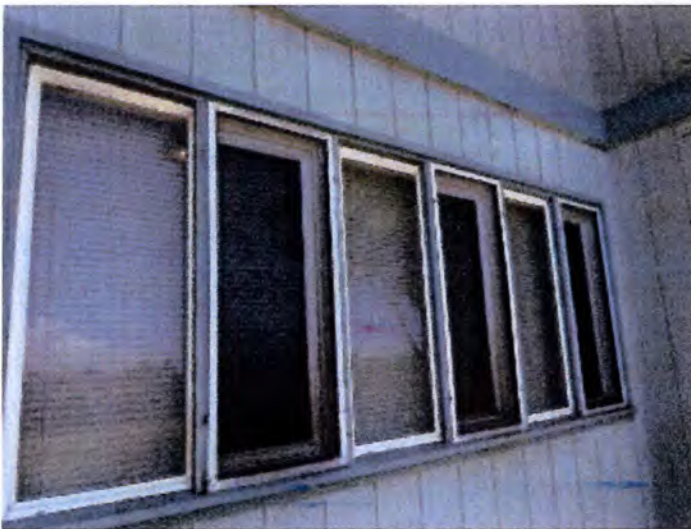
Vinyl framed windows noted

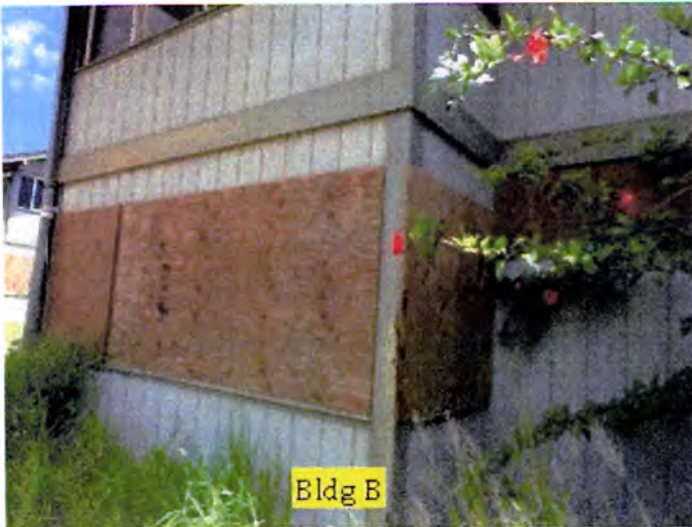
Many of the ground floor windows were broken at the time of inspection.

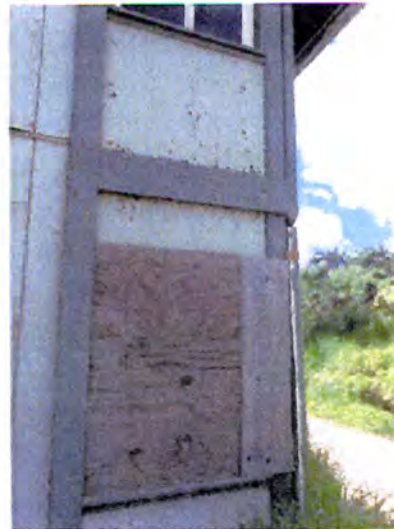
Many of the ground floor windows were broken at the time of inspection.

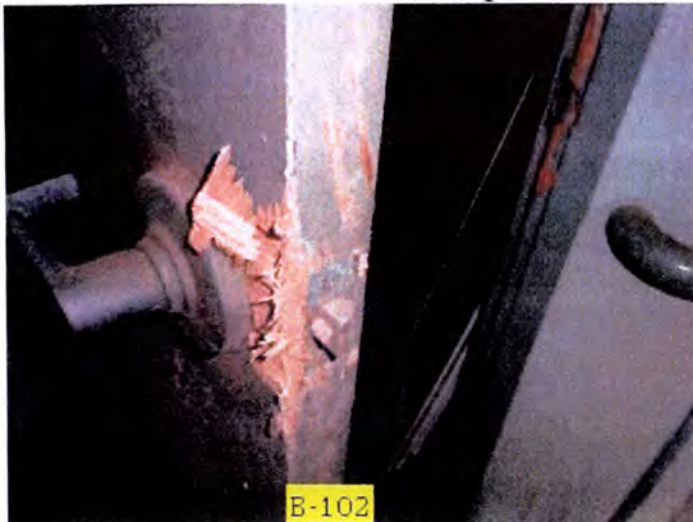
The exterior doors were termite damaged or deteriorated to the point of being inoperable. We recommend replacement of all exterior doors, framing and trim for all buildings.

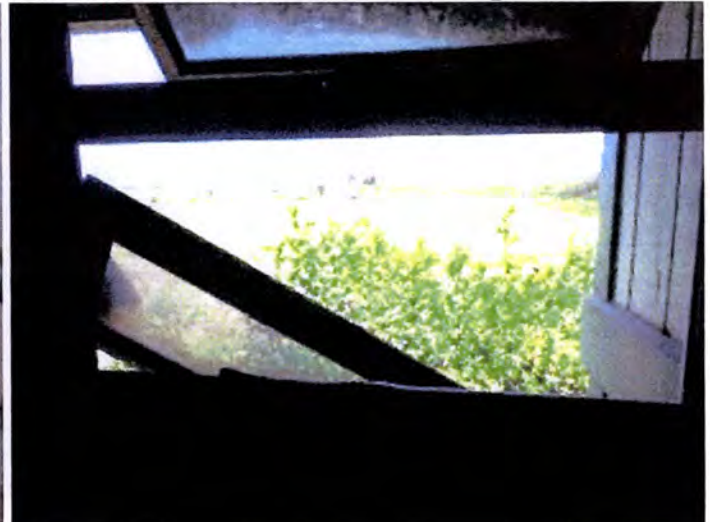
The stair way windows were heavily corroded, damaged and/or inoperable at the time of inspection. Recommend replacement.

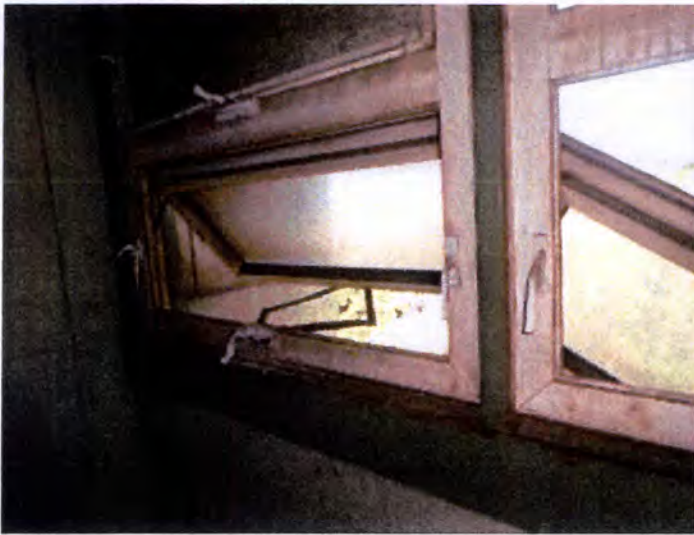
The stair way windows were heavily corroded, damaged and/or inoperable at the time of inspection. Recommend replacement.

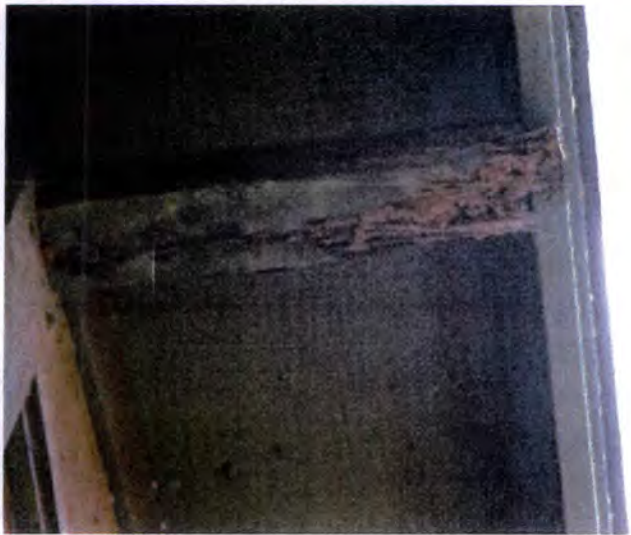
There were visible indications of WDO (Wood Destroying Organism) damage noted at the fascia and soffit areas. Recommend having a licensed contractor evaluate and repair/replace as necessary.

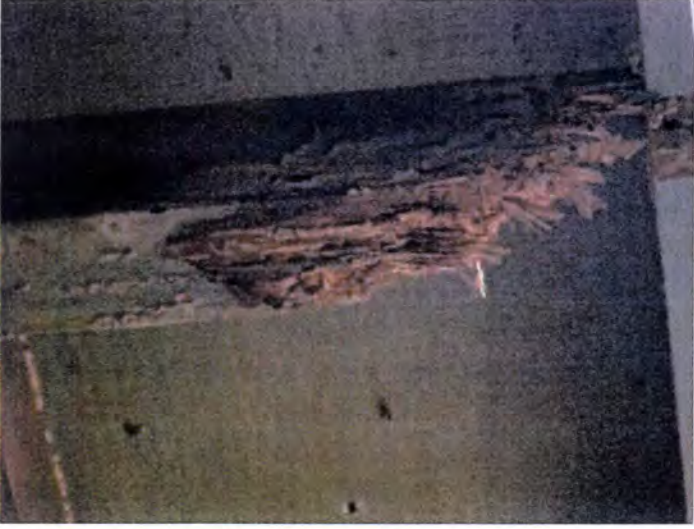
There were visible indications of WDO (Wood Destroying Organism) damage noted at the fascia and soffit areas. Recommend having a licensed contractor evaluate and repair/replace as necessary.
