**SUBJECT: COUNTY-OWNED PARCEL ON NORTH PAPA AVENUE (KAHULUI)
 (HHT-14)**

Property Condition Report

310 W Kaahumanu Ave, Kahului, HI 96732
Inspection prepared for: Maui County c/o Buddy Almeida
Real Estate Agent: -

Date of Inspection: 3/28/2018 Time: 8:00 AM
Age of Home: 1980 Size: 15000

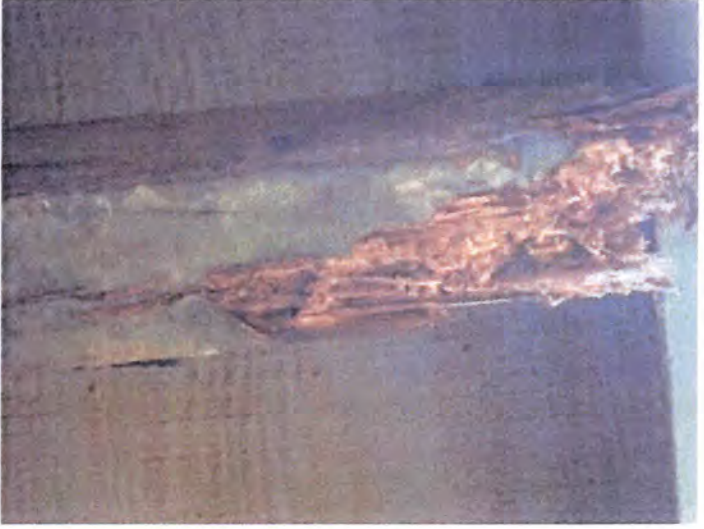
There were visible indications of WDO (Wood Destroying Organism) damage noted at the fascia and soffit areas. Recommend having a licensed contractor evaluate and repair/replace as necessary.

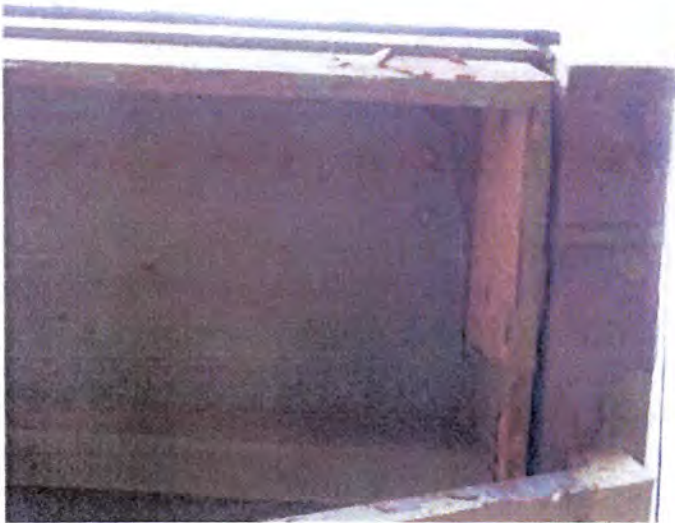
The fascia/soffit areas appeared to be rotted/water damaged/deteriorated at the time of inspection. Recommend having a licensed contractor evaluate and repair/replace as necessary.

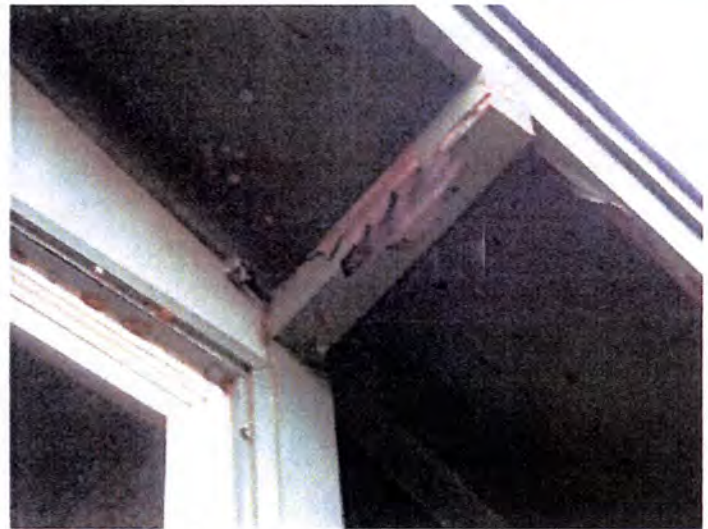
The fascia/soffit areas appeared to be rotted/water damaged/deteriorated at the time of inspection. Recommend having a licensed contractor evaluate and repair/replace as necessary.

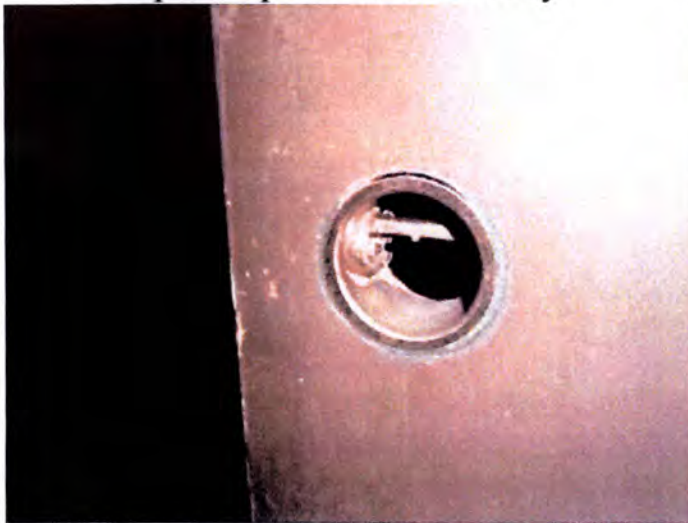
The exterior doors were termite damaged or deteriorated to the point of being inoperable. We recommend replacement of all exterior doors, framing and trim for all buildings.

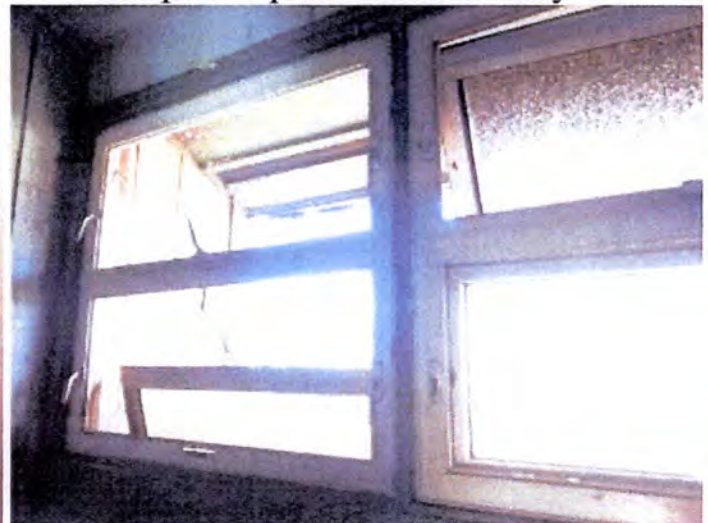
The stair way windows were heavily corroded, damaged and/or inoperable at the time of inspection. Recommend replacement.

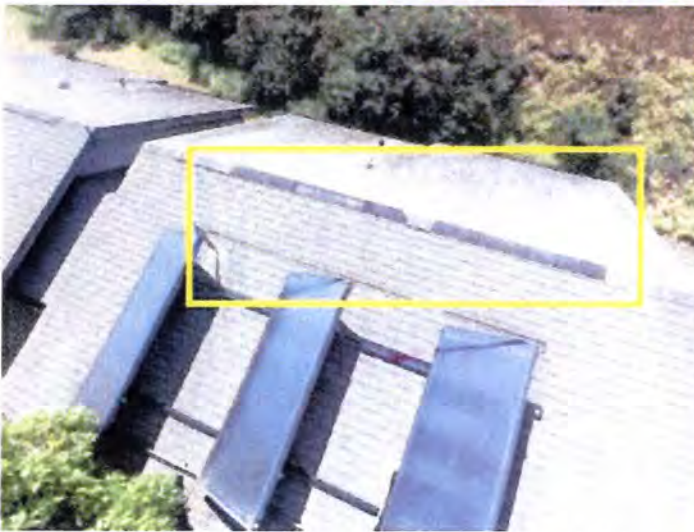
There were numerous areas of missing shingles observed at the roof ridge areas. Recommend repair in conjunction with roof replacement.

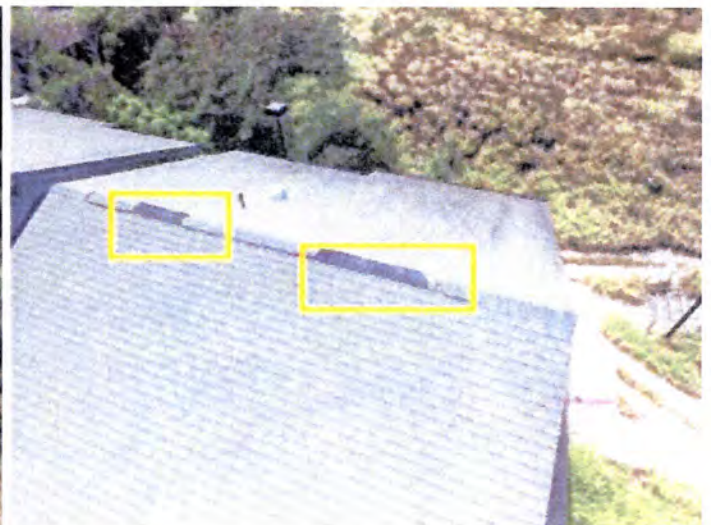
There were numerous areas of missing shingles observed at the roof ridge areas. Recommend repair in conjunction with roof replacement.

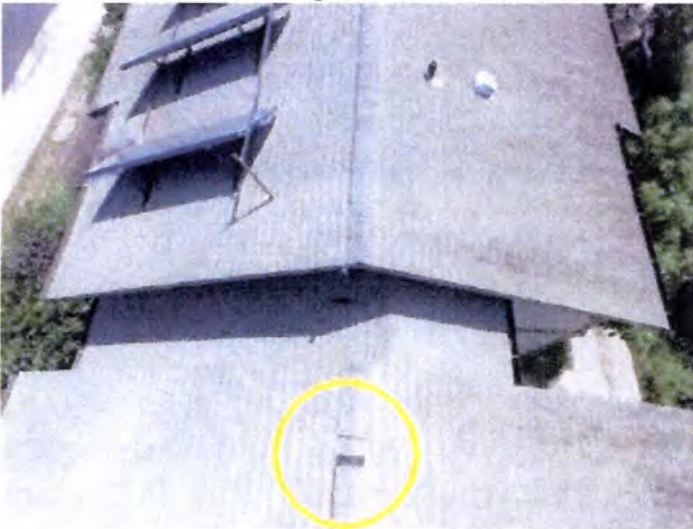
There were numerous areas of missing shingles observed at the roof ridge areas. Recommend repair in conjunction with roof replacement.

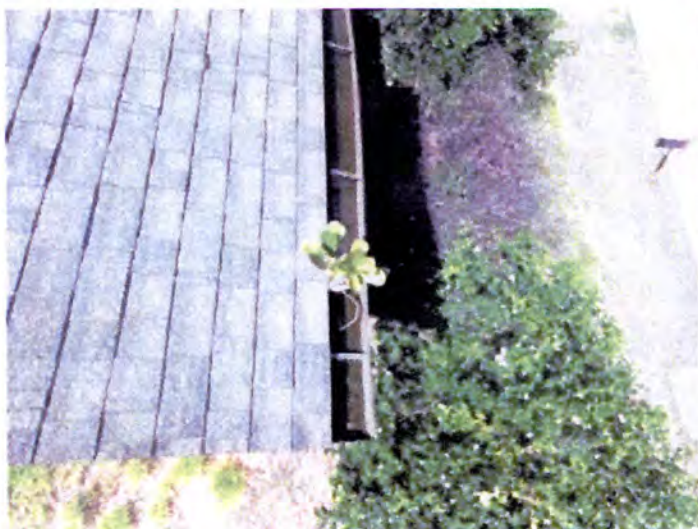
Damaged/broken/missing gutters noted. Recommend having a licensed contractor evaluate and repair/replace as necessary.

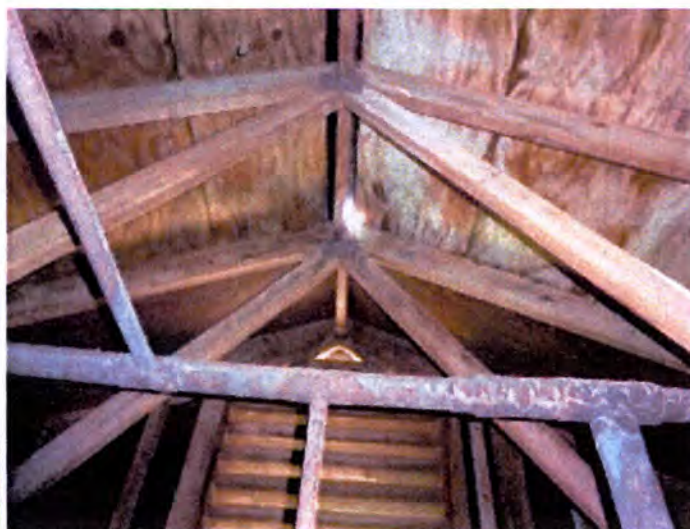
There were visible areas of moisture intrusion observed at the roof sheathing (within the attic spaces) at the time of inspection. This indicated a failed/failing roofing system. Recommend replacement of the installed sheathing and roofing finish.

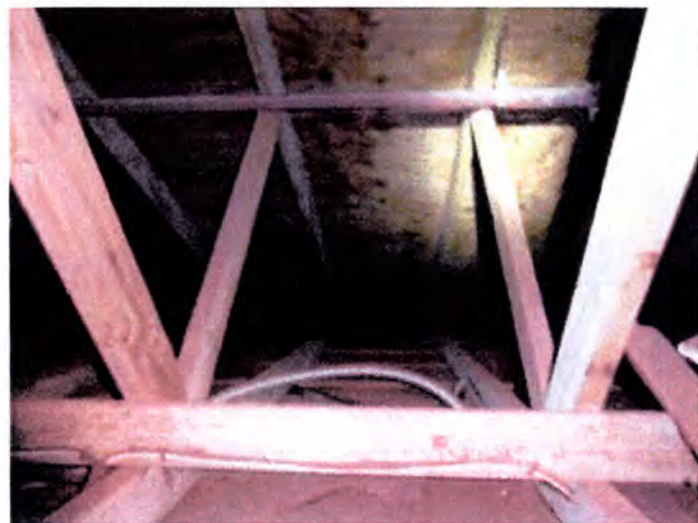
There were visible areas of moisture intrusion observed at the roof sheathing (within the attic spaces) at the time of inspection. This indicated a failed/failing roofing system. Recommend replacement of the installed sheathing and roofing finish.

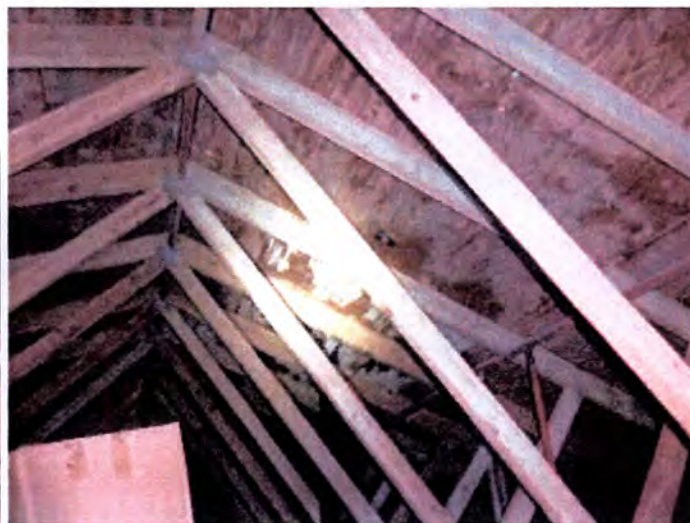
There were visible areas of moisture intrusion observed at the roof sheathing (within the attic spaces) at the time of inspection. This indicated a failed/failing roofing system. Recommend replacement of the installed sheathing and roofing finish.

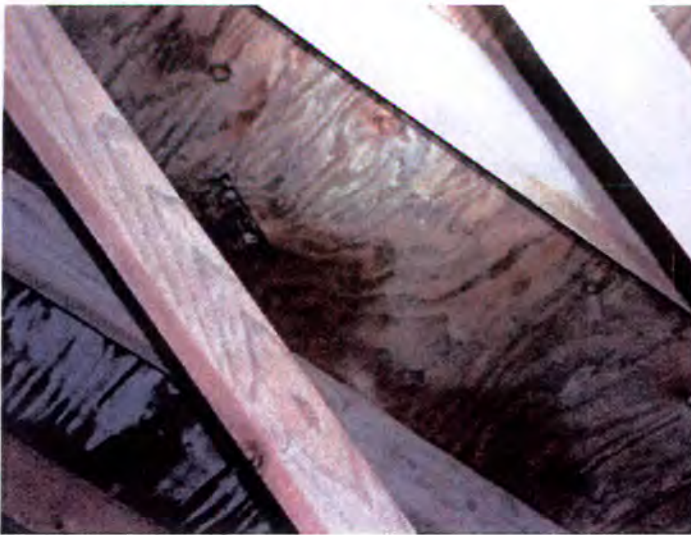
There were visible areas of moisture intrusion observed at the roof sheathing (within the attic spaces) at the time of inspection. This indicated a failed/failing roofing system. Recommend replacement of the installed sheathing and roofing finish.

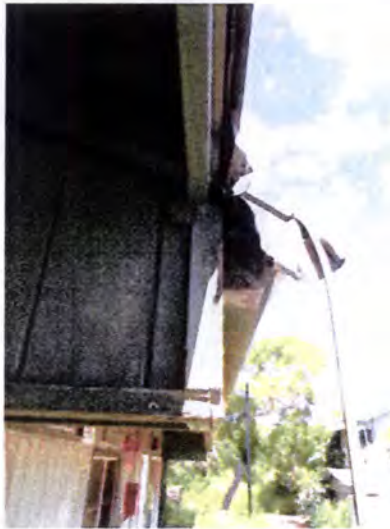
Damaged/broken/missing gutters noted. Recommend having a licensed contractor evaluate and repair/replace as necessary.

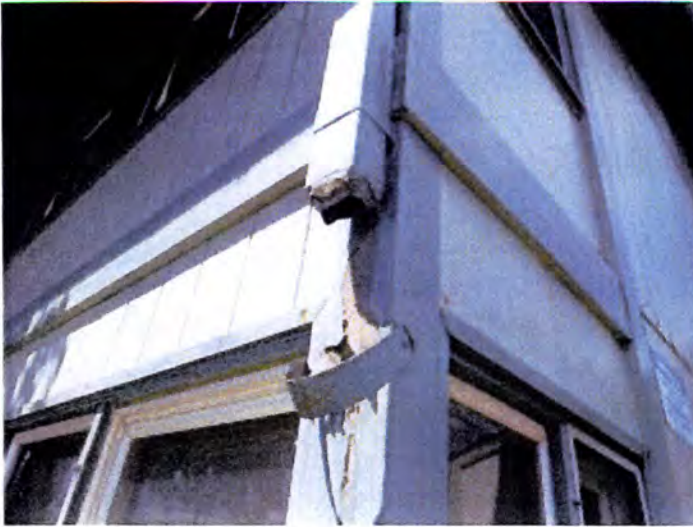
Damaged/broken/missing gutters noted. Recommend having a licensed contractor evaluate and repair/replace as necessary.

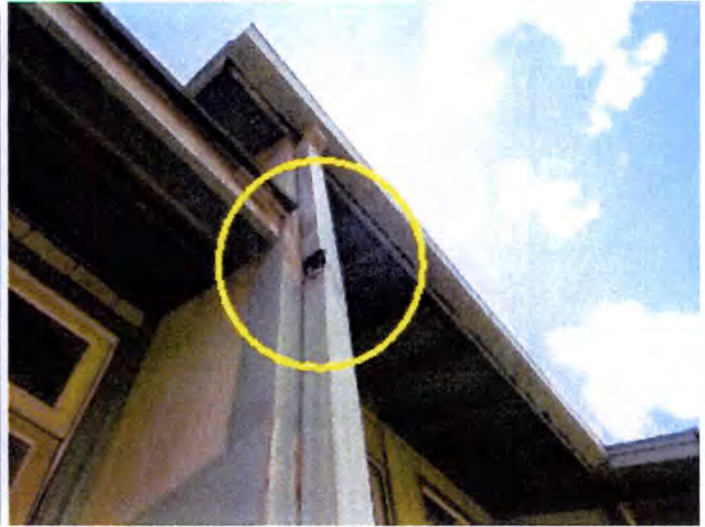
Damaged/broken/missing gutters noted. Recommend having a licensed contractor evaluate and repair/replace as necessary.

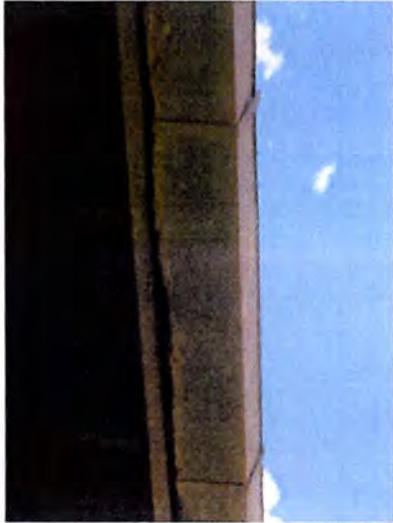
Damaged/broken/missing gutters noted. Recommend having a licensed contractor evaluate and repair/replace as necessary.

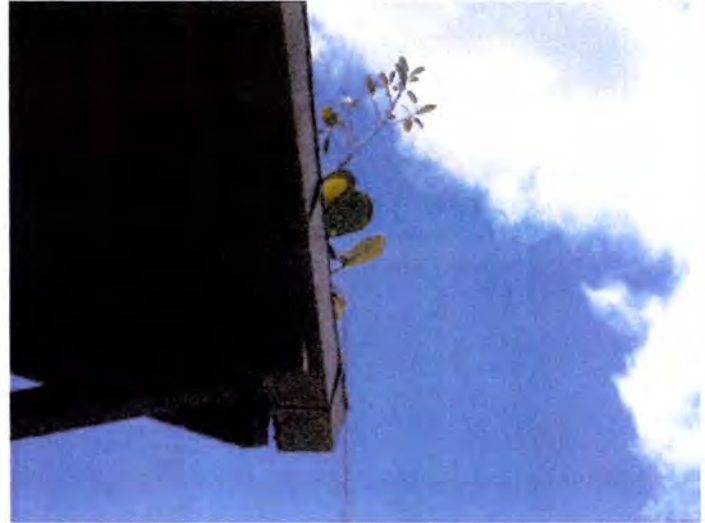
Vegetation growth observed in gutters. Recommend clearing.

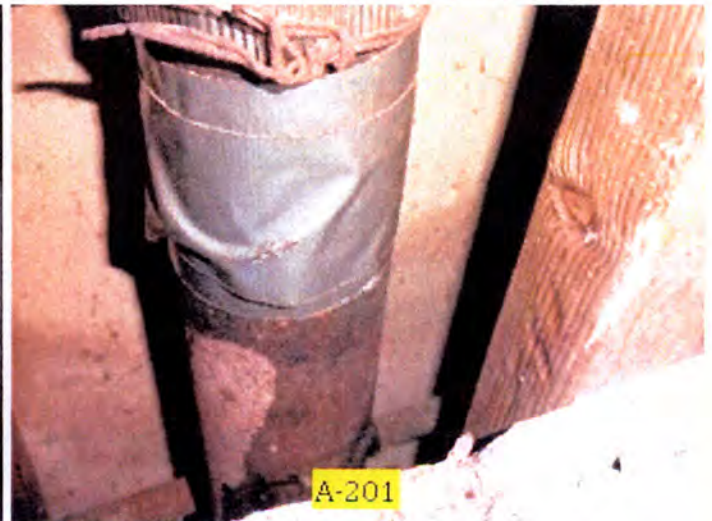
Non standard repairs observed at plumbing connections. Recommend repair.

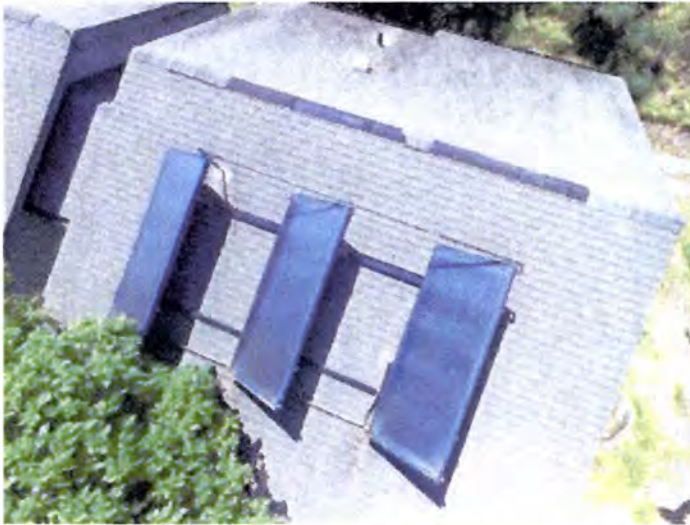
There were solar water heating panels located on the roofing areas of the buildings. There were visible indications of leaks and interior hazing at the panels which is an indication of damage to the environmental seals or panels. These panels did not appear to be in service and should be evaluated by a licensed plumbing contractor prior to use.

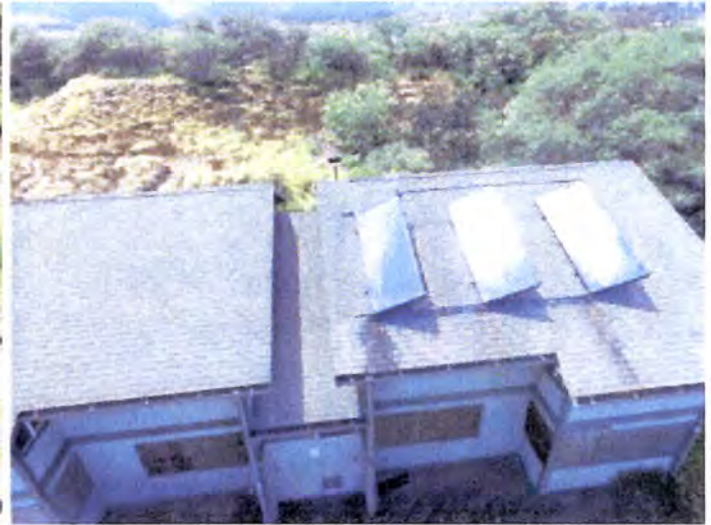
There were solar water heating panels located on the roofing areas of the buildings. There were visible indications of leaks and interior hazing at the panels which is an indication of damage to the environmental seals or panels. These panels did not appear to be in service and should be evaluated by a licensed plumbing contractor prior to use.

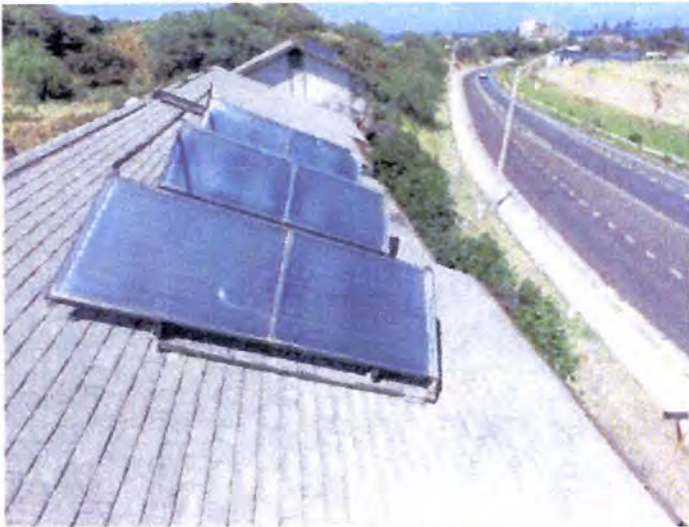
There were solar water heating panels located on the roofing areas of the buildings. There were visible indications of leaks and interior hazing at the panels which is an indication of damage to the environmental seals or panels. These panels did not appear to be in service and should be evaluated by a licensed plumbing contractor prior to use.

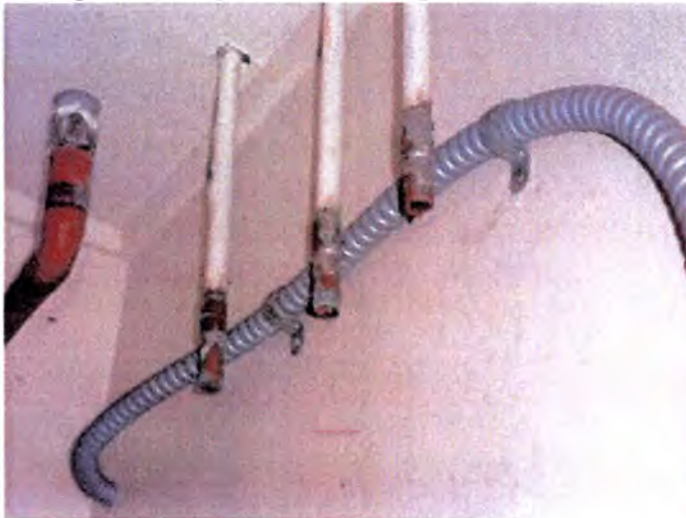
All water heating appliances were terminated with supply and service plumbing cut and electrical connections removed. Recommend having a licensed plumber evaluate and install commercial grade gas on demand hot water heating systems for each floor of each building.

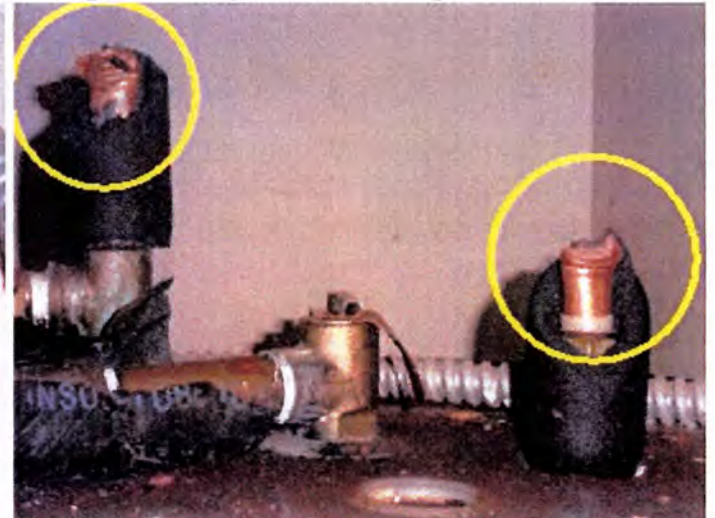
All water heating appliances were terminated with supply and service plumbing cut and electrical connections removed. Recommend having a licensed plumber evaluate and install commercial grade gas on demand hot water heating systems for each floor of each building.

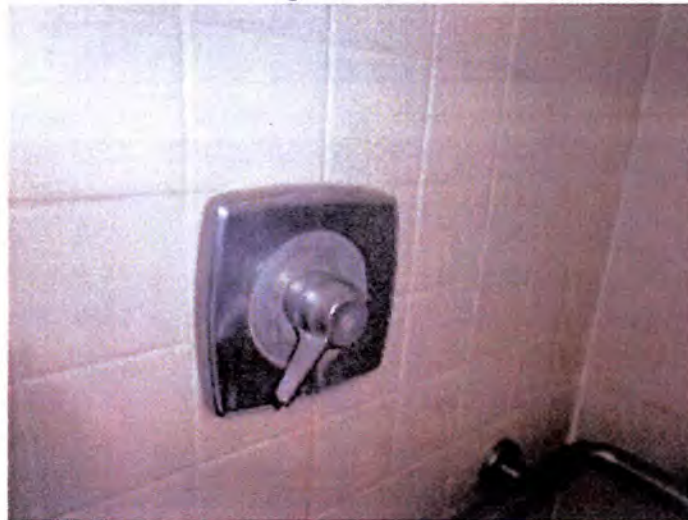
Based on the observed physical conditions of the installed fixtures, we recommend the replacement of all plumbing fixtures and shut off valves in all buildings to ensure proper future operation.

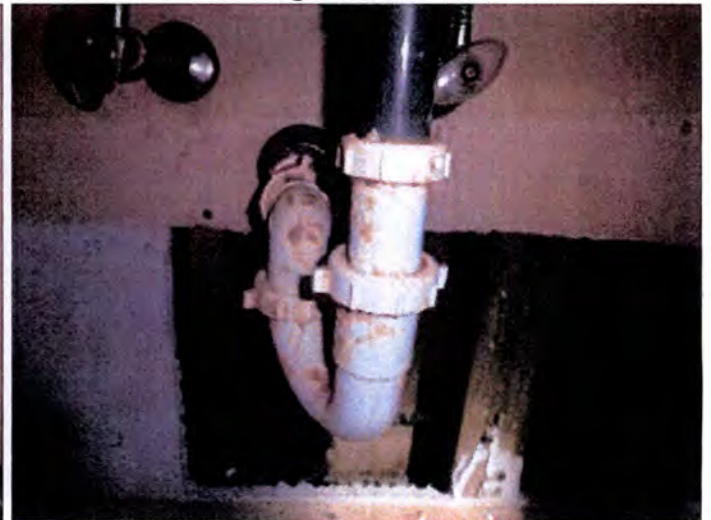
Based on the observed physical conditions of the installed fixtures, we recommend the replacement of all plumbing fixtures and shut off valves in all buildings to ensure proper future operation.

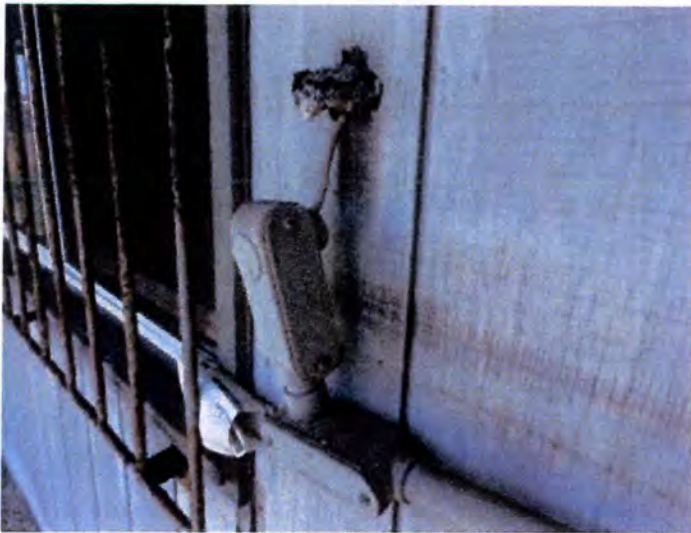
Storage bldg: Exterior conduit was damaged/detached from the bend box. Recommend repair.

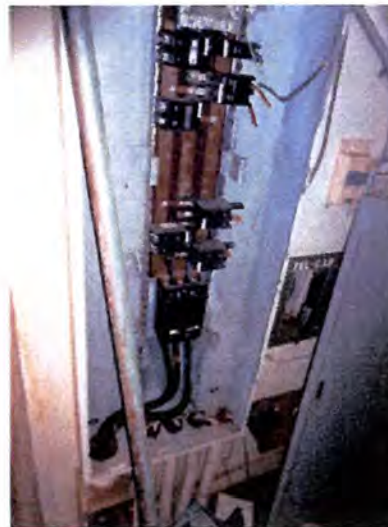
Building B and C: The main service conductors and all electrical branch wiring was cut at the main service panel entrances (located in the respective electrical rooms) when inspected. Recommend having a licensed electrical contractor evaluate and repair electrical service to each building. The installed cabinets, panels and service disconnects appeared serviceable.

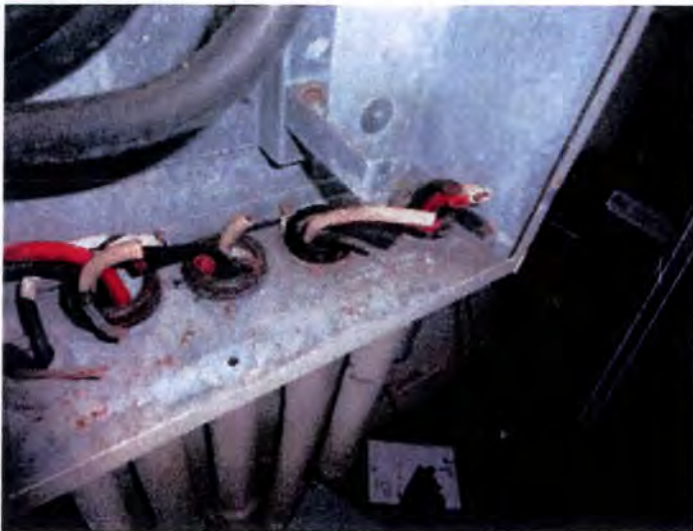
Building B and C: The main service conductors and all electrical branch wiring was cut at the main service panel entrances (located in the respective electrical rooms) when inspected. Recommend having a licensed electrical contractor evaluate and repair electrical service to each building. The installed cabinets, panels and service disconnects appeared serviceable.

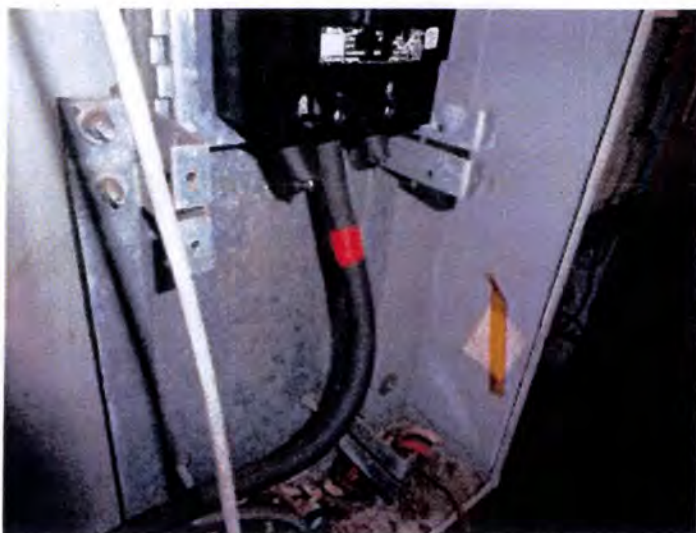
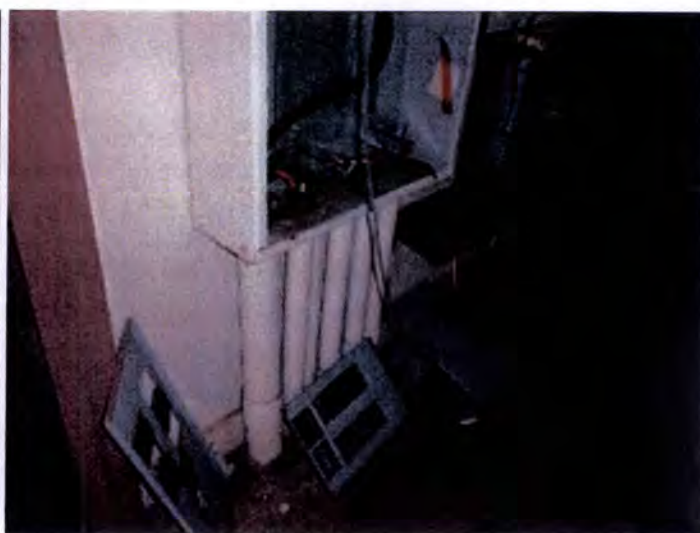
Building B and C: The main service conductors and all electrical branch wiring was cut at the main service panel entrances (located in the respective electrical rooms) when inspected. Recommend having a licensed electrical contractor evaluate and repair electrical service to each building. The installed cabinets, panels and service disconnects appeared serviceable.

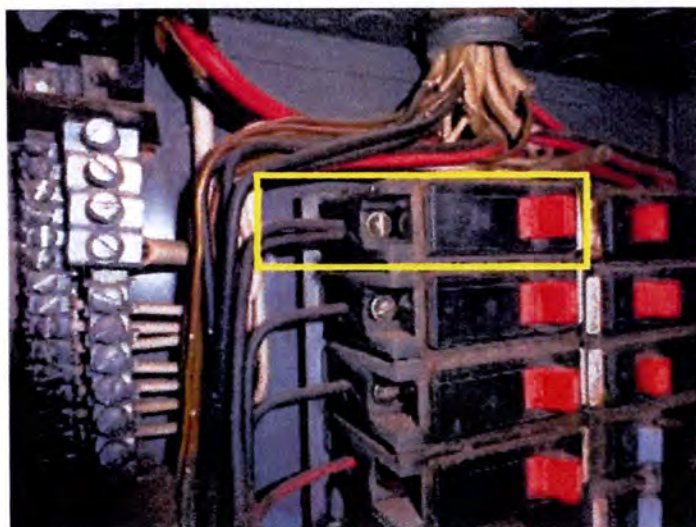
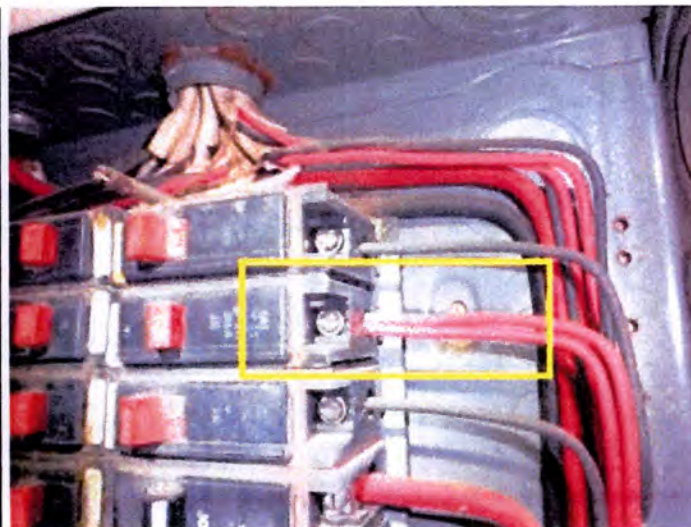
There were double tapped 1-pole circuit breakers noted at the time of inspection.

We recommend having a licensed electrician evaluate and repair/replace as necessary.

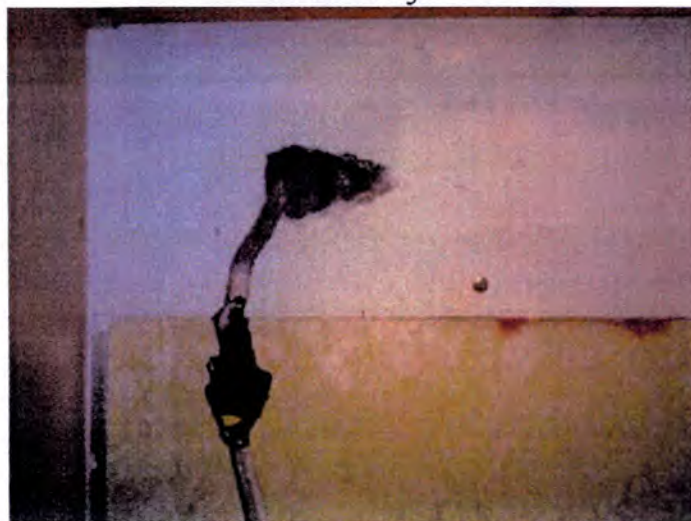
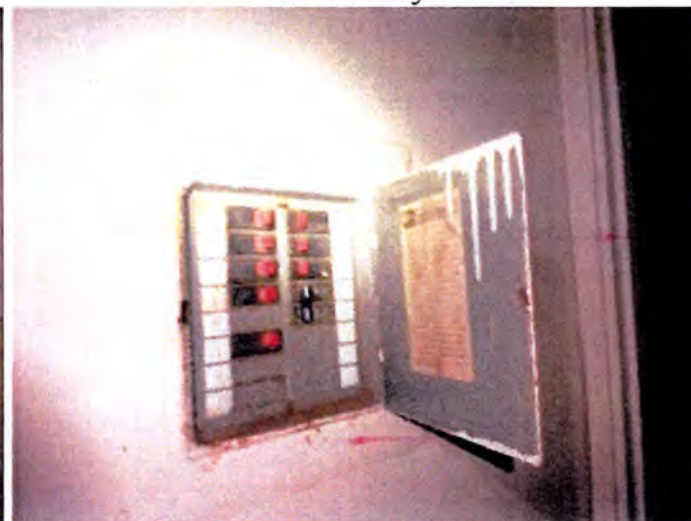
There were improperly terminated splices at the following locations: B-201

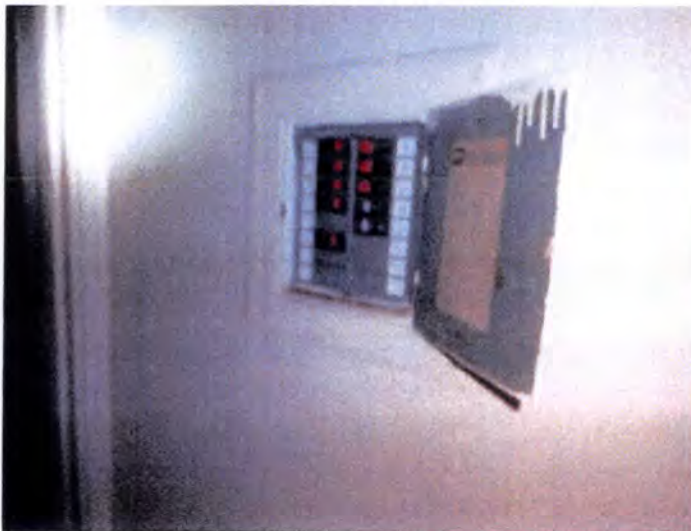
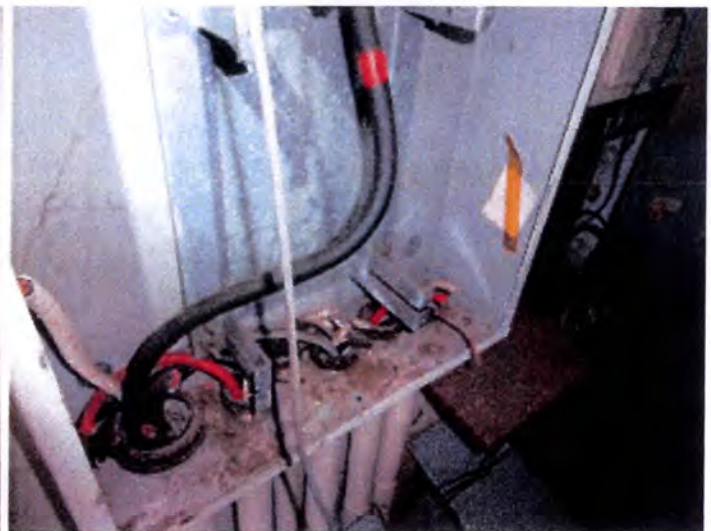
All of the branch wiring to buildings B and C was cut with circuit breakers removed. Recommend having a licensed electrical contractor repair.

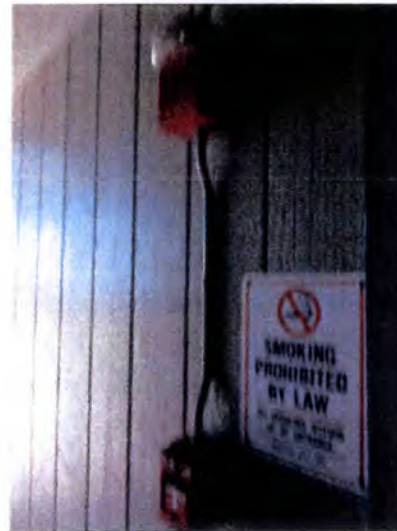
Approximately half of the installed pull stations were damaged when inspected. Recommend replacement/repair.

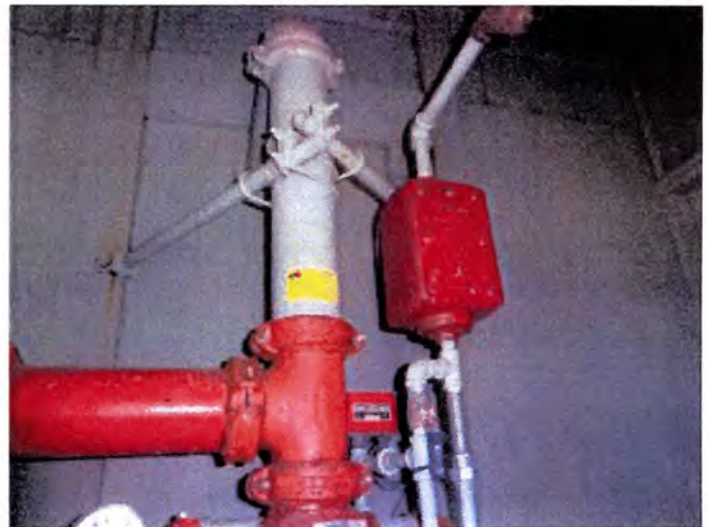
Sprinkler Systems: due to the system not having been properly serviced at required intervals, adequacy or performance questionable.

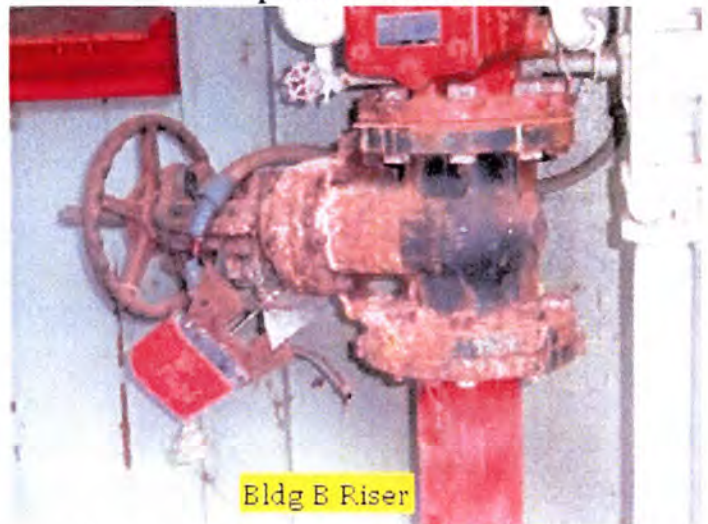
The installed risers and associated equipment appeared to be damaged/improperly maintained when inspected. Recommend having a licensed fire suppression contractor evaluate, service, test and inspect the entire fire suppression system.

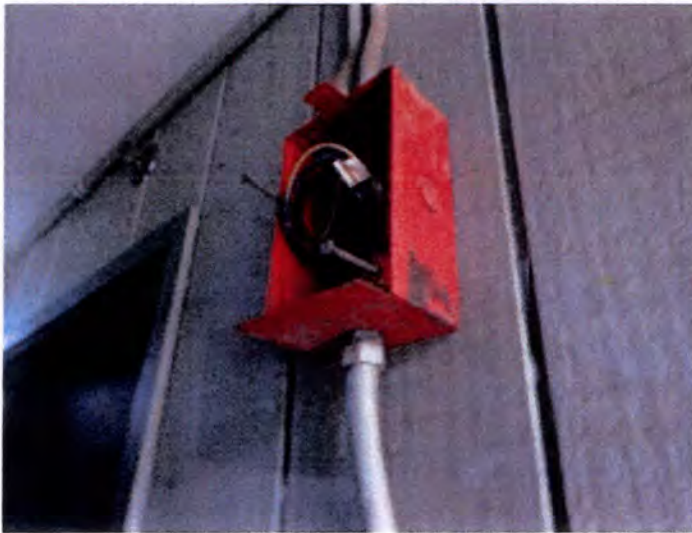
Approximately half of the installed pull stations were damaged when inspected. Recommend replacement/repair.

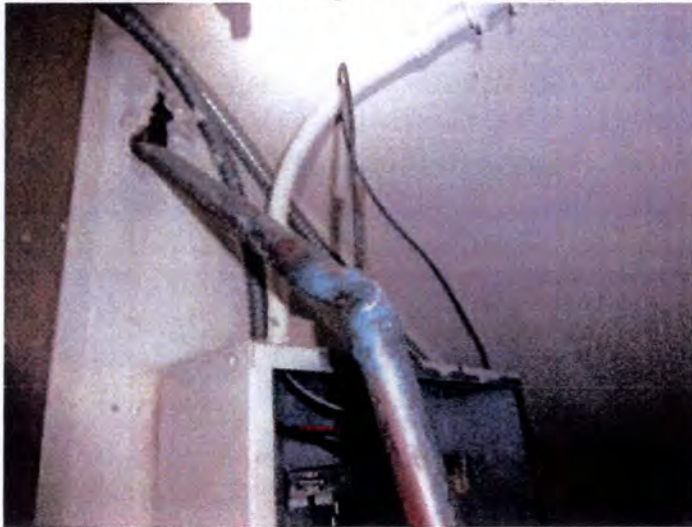
Building B: Sprinkler branch pipe was broken/bent down in the electrical room. Recommend repair.

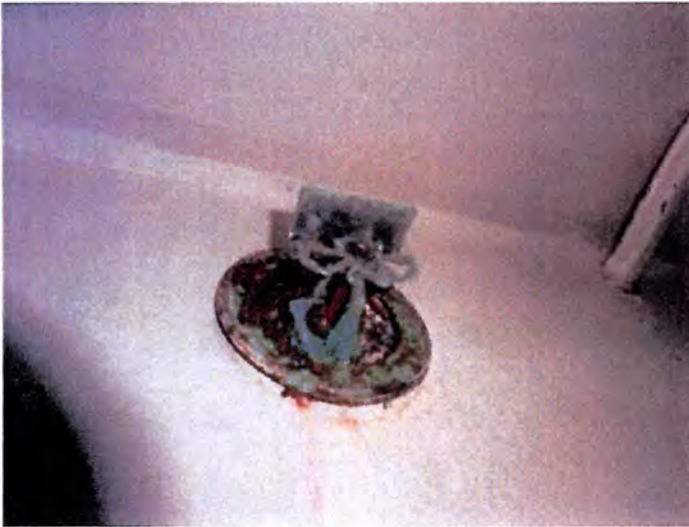
B-102: Sprinkler head was leaking when inspected.

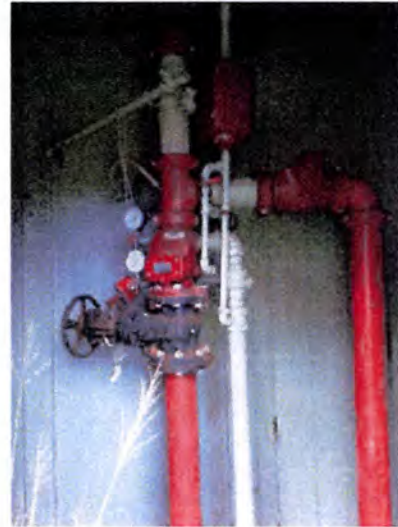
The installed risers and associated equipment appeared to be damaged/improperly maintained when inspected. Recommend having a licensed fire suppression contractor evaluate, service, test and inspect the entire fire suppression system.

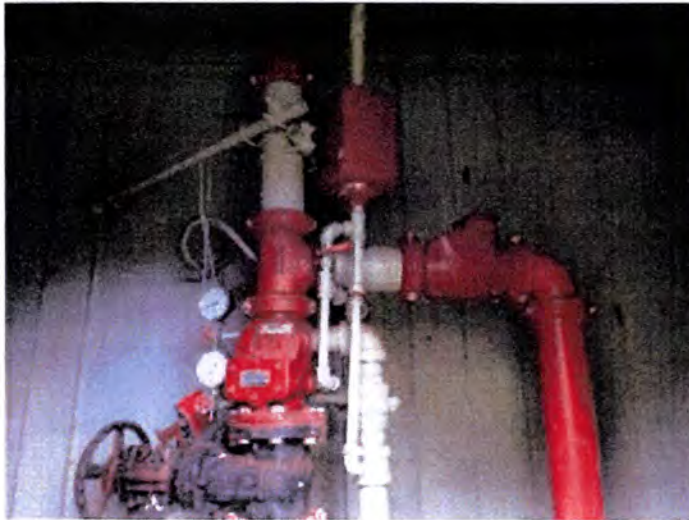
Sprinkler Systems: due to the system not having been properly serviced at required intervals, adequacy or performance questionable.

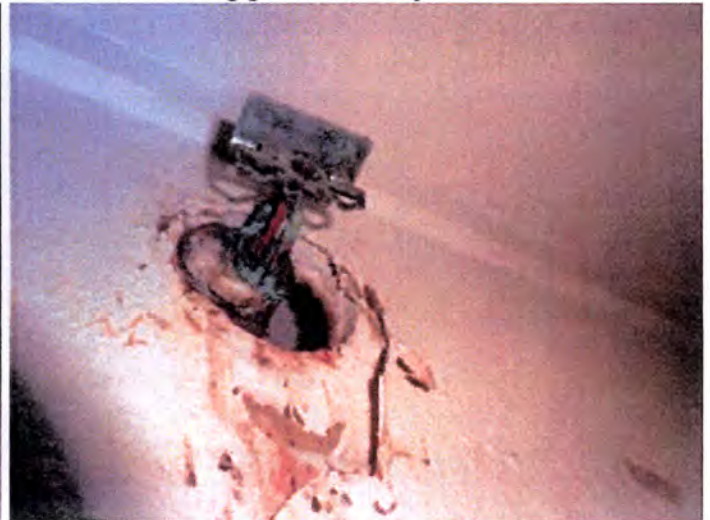
C-101: Sprinkler head was leaking when inspected.

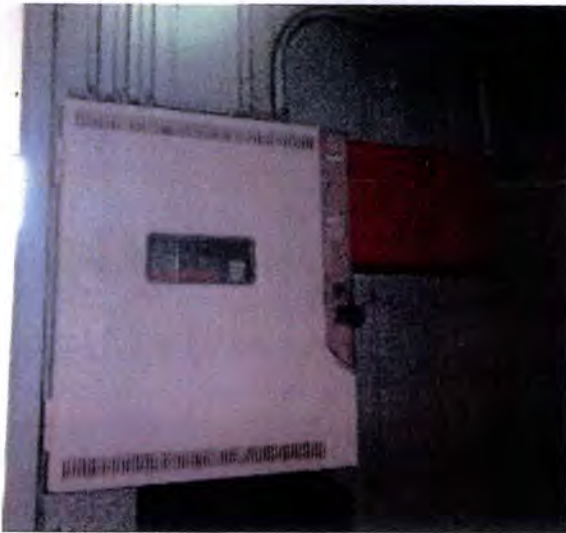
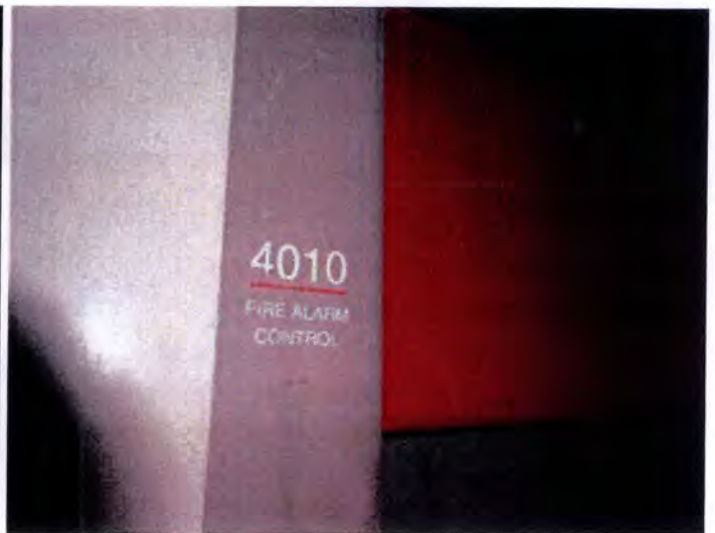
Each building had a designated alarm and alarm panel which was located on the ground floor. Based on the observed conditions of installed equipment, we recommend having the installed equipment repaired and/or replaced by a licensed security contractor as desired.

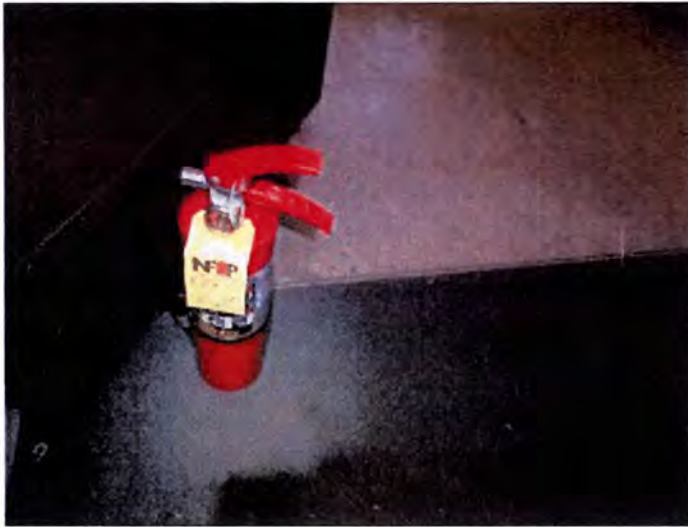
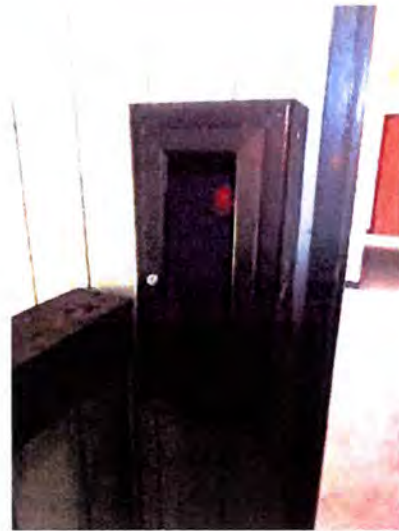
The installed fire extinguishers were expired inspection and servicing placards at the time of inspection. We recommend having a licensed fire extinguisher contractor evaluate and be contracted to service and inspect the existing items as required.

Most of the fire extinguishers were missing at required locations.

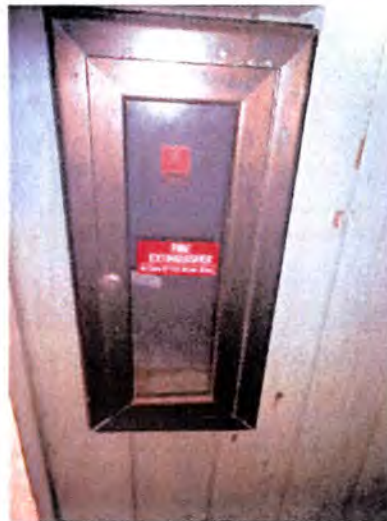
Most of the fire extinguishers were missing at required locations.

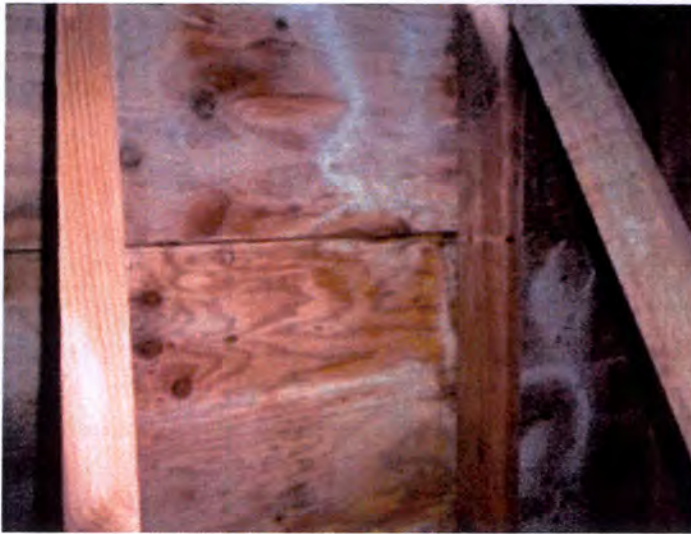
There were visible indications of mold present at all attic areas.

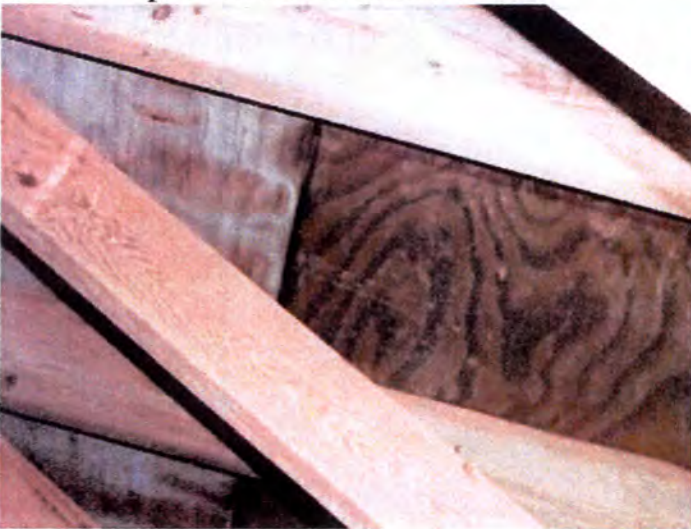
There were visible indications of mold present at all attic areas.

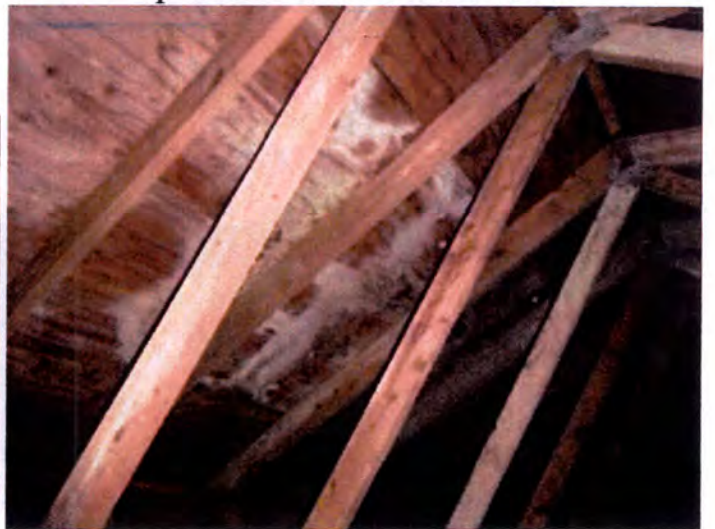
There were visible indications of mold present at all attic areas.

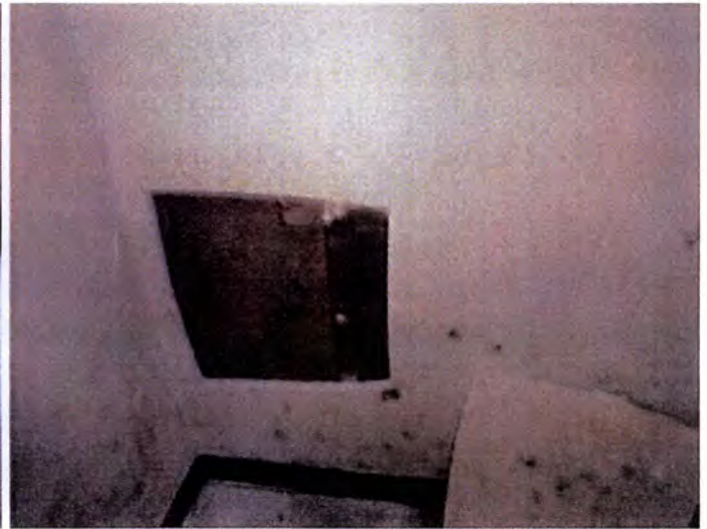
Visible indications of moisture intrusion and mold growth at building B and C interior, bedroom, bathroom and closet wall areas. Recommend removal and replacement of all interior wall finishes of B and C, after removal of all exterior vegetation.

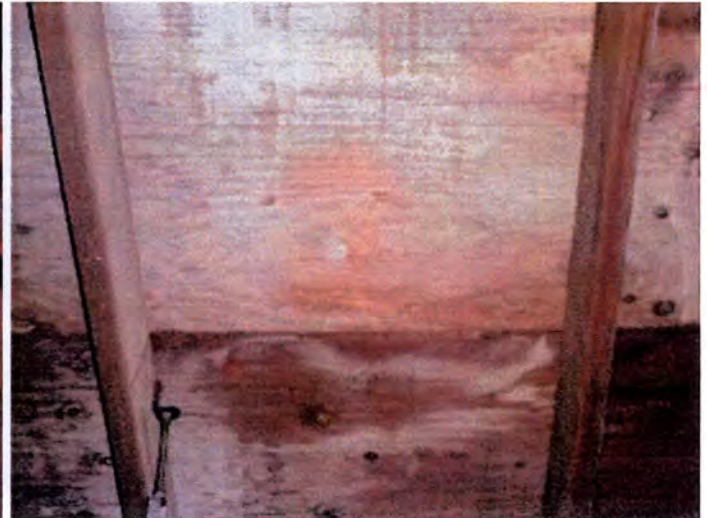
There were visible indications of mold present at all attic areas.

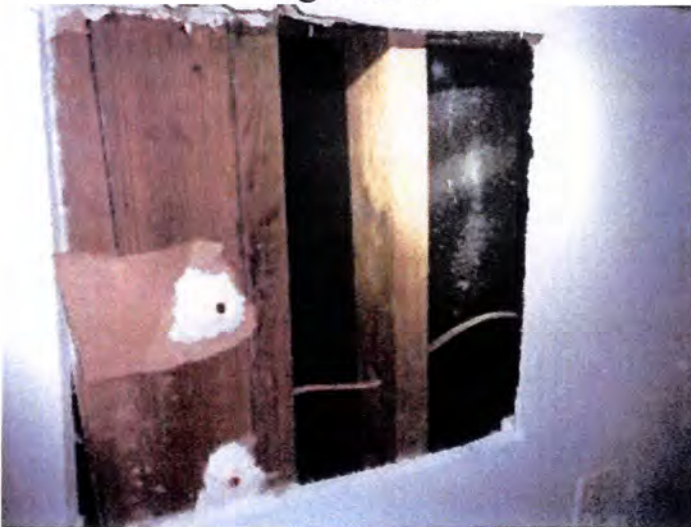
Visible indications of moisture intrusion and mold growth at building B and C interior, bedroom, bathroom and closet wall areas. Recommend removal and replacement of all interior wall finishes of B and C, after removal of all exterior vegetation.

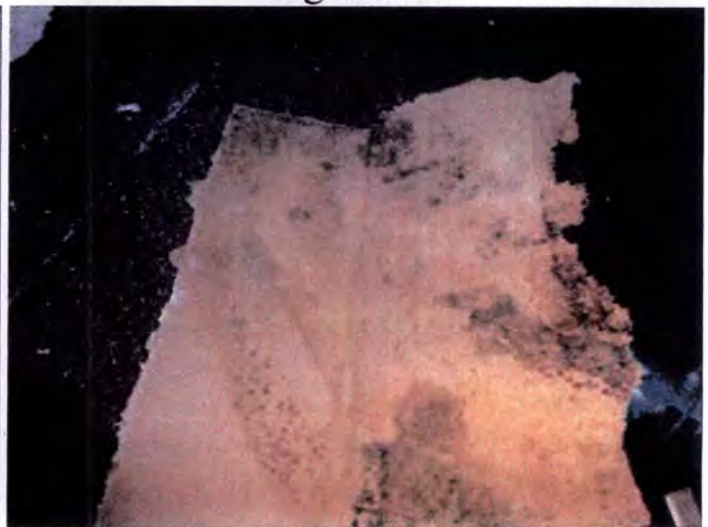
Visible indications of moisture intrusion and mold growth at building B and C interior, bedroom, bathroom and closet wall areas. Recommend removal and replacement of all interior wall finishes of B and C, after removal of all exterior vegetation.
