**SUBJECT: COUNTY-OWNED PARCEL ON NORTH PAPA AVENUE (KAHULUI)
 (HHT-14)**

Property Condition Report

310 W Kaahumanu Ave, Kahului, HI 96732
Inspection prepared for: Maui County c/o Buddy Almeida
Real Estate Agent: -

Date of Inspection: 3/28/2018 Time: 8:00 AM
Age of Home: 1980 Size: 15000

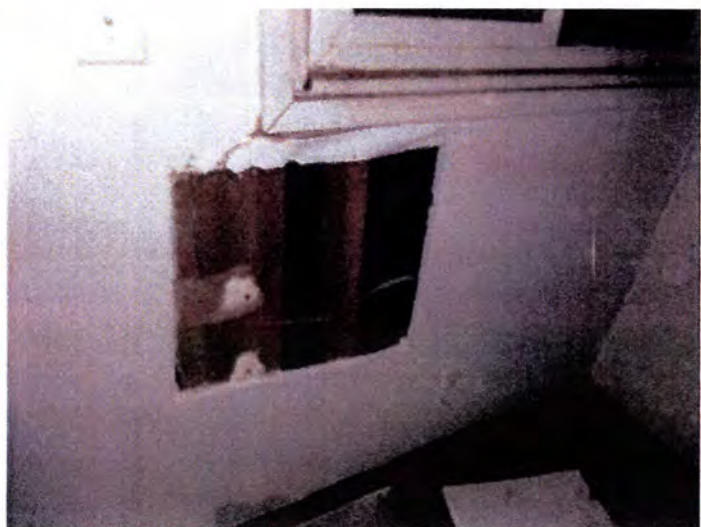
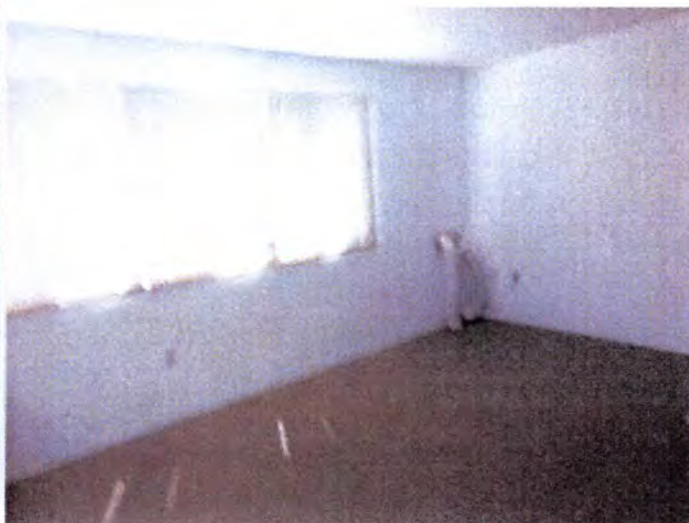
Visible indications of moisture intrusion and mold growth at building B and C interior, bedroom, bathroom and closet wall areas. Recommend removal and replacement of all interior wall finishes of B and C, after removal of all exterior vegetation.

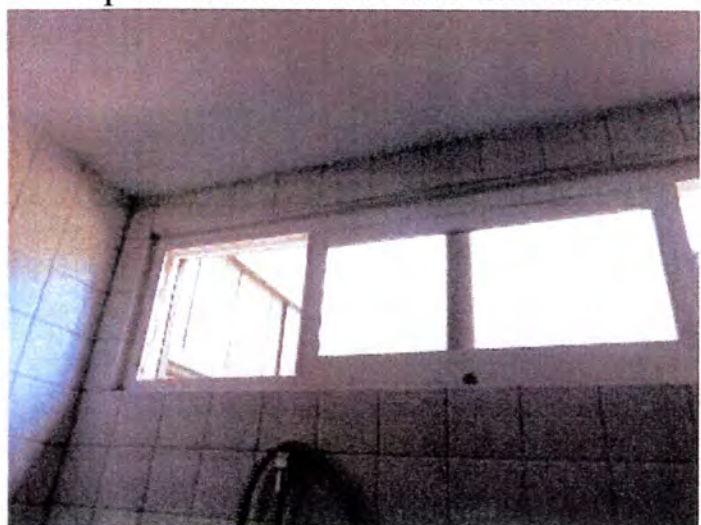
A-102

Most of the exterior facing lower interior wall finishes had moisture damage observed. Recommend removal and replacement of affected materials.

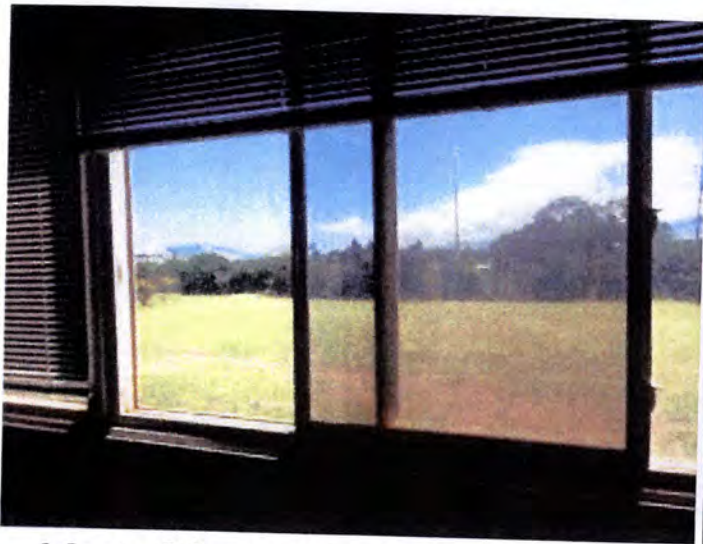
There were visible indications of moisture and termite damage observed at the interior window trim areas. Recommend replacement of all interior window trim and finishes.

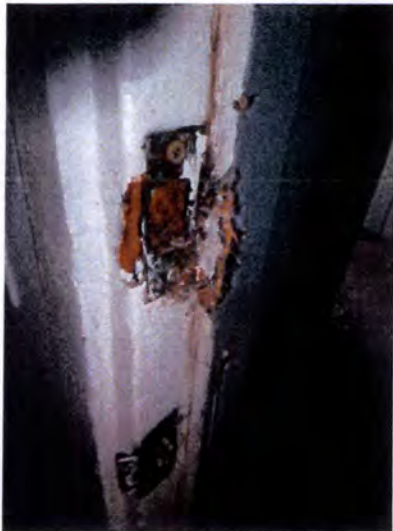
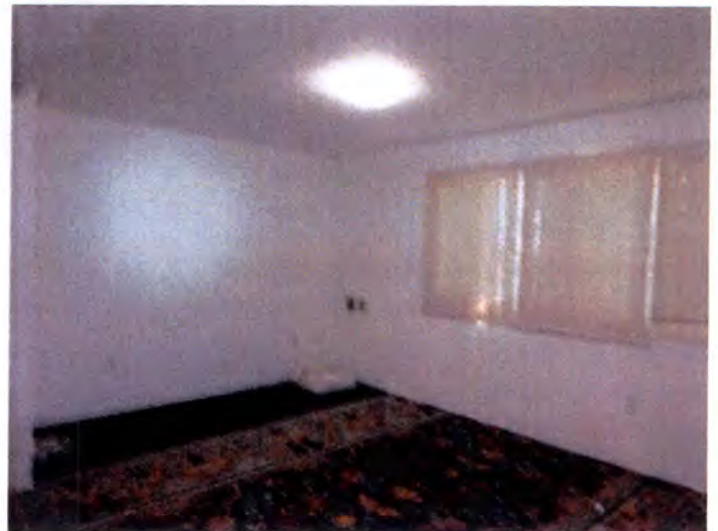
There were visible indications of moisture and termite damage observed at the interior window trim areas. Recommend replacement of all interior window trim and finishes.

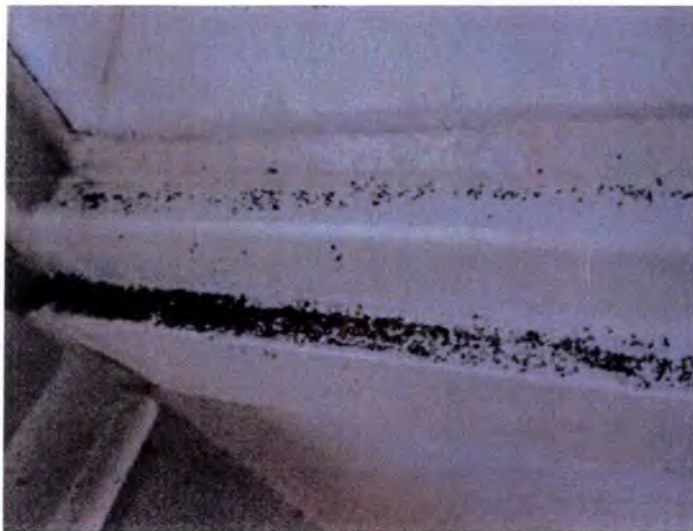
There were visible indications of moisture and termite damage observed at the interior window trim areas. Recommend replacement of all interior window trim and finishes.

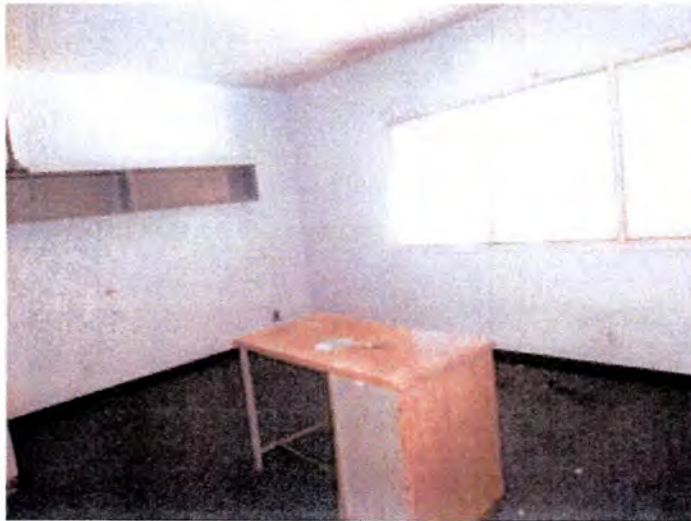
Visible indications of moisture intrusion and mold growth at building B and C interior, bedroom, bathroom and closet wall areas. Recommend removal and replacement of all interior wall finishes of B and C, after removal of all exterior vegetation.

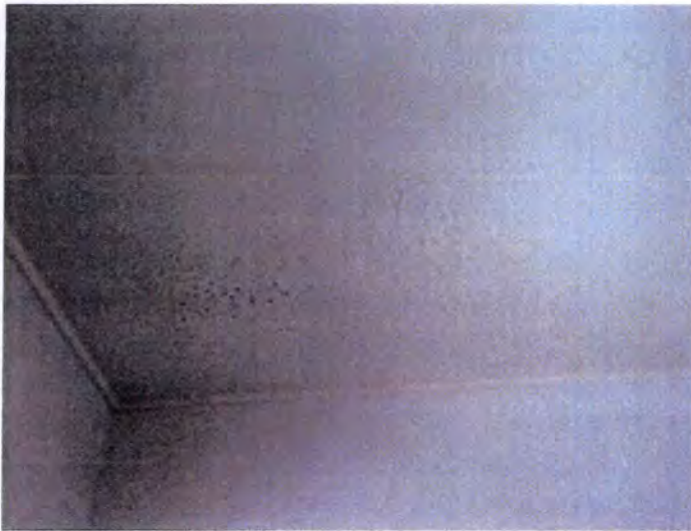
A-201

There were visible indications of water intrusion, with mold growth, noted at the ceiling areas of A-201. Recommend having a licensed contractor evaluate and repair as necessary to prevent further damage.

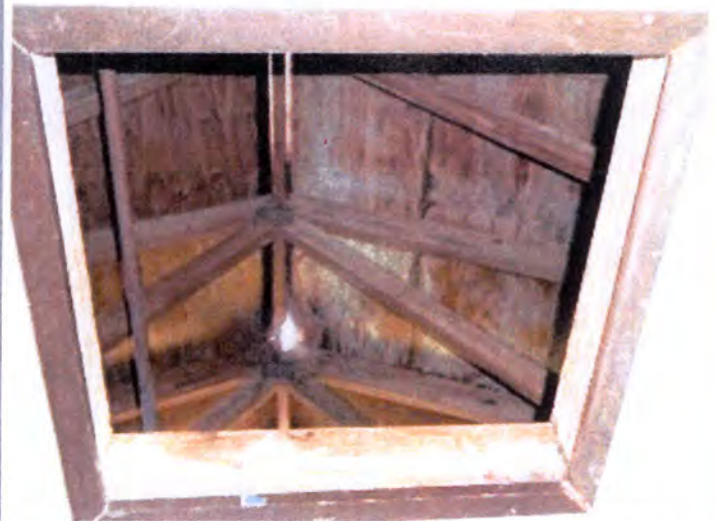
There were visible indications of water intrusion, with mold growth, noted at the ceiling areas of A-201. Recommend having a licensed contractor evaluate and repair as necessary to prevent further damage.

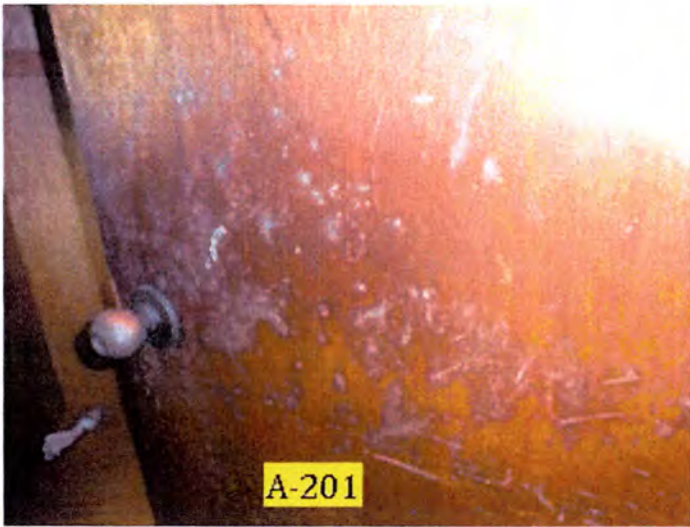
Most of the doors had varying degrees of damage observed when inspected. Based on the observed conditions, we recommend the replacement of all interior doors and trim within the dwelling units.

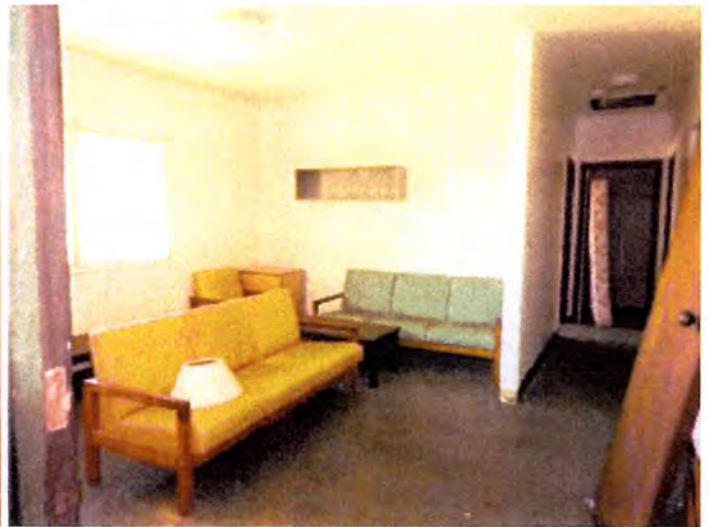
A-201

Visible mold observed at interior doors.

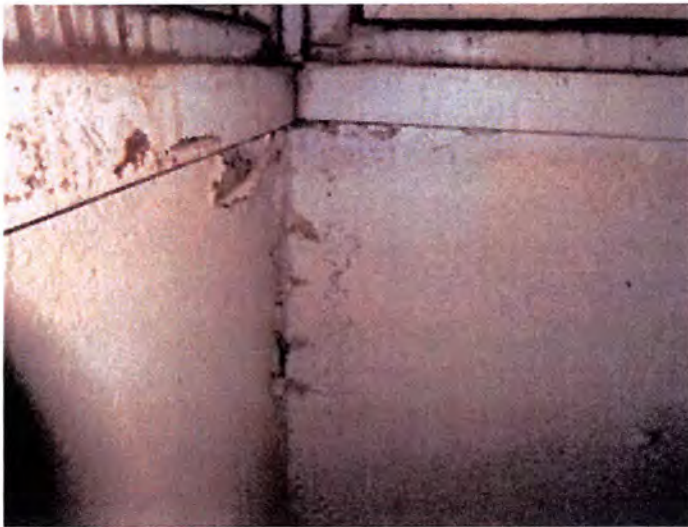
Visible indications of moisture intrusion and mold growth at building B and C interior, bedroom, bathroom and closet wall areas. Recommend removal and replacement of all interior wall finishes of B and C, after removal of all exterior vegetation.

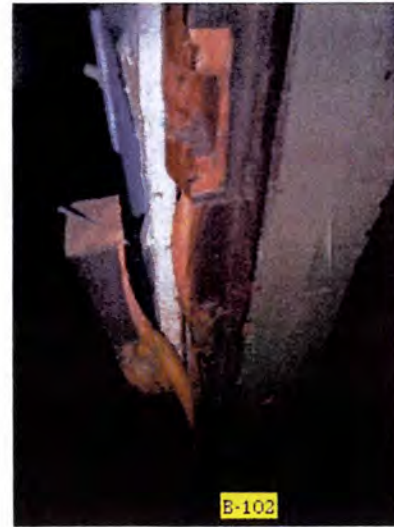
Most of the exterior facing lower interior wall finishes had moisture damage observed. Recommend removal and replacement of affected materials.

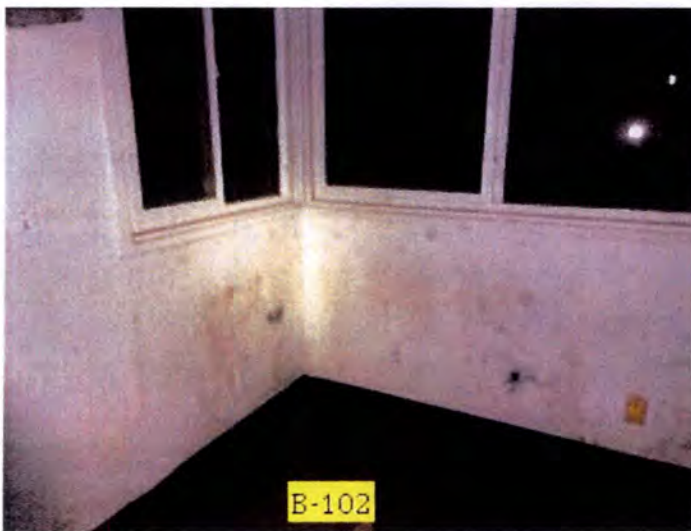
Most of the exterior facing lower interior wall finishes had moisture damage observed. Recommend removal and replacement of affected materials.

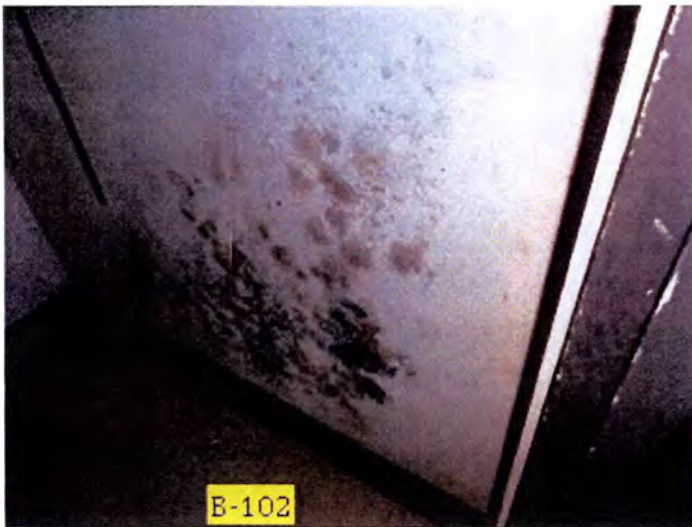
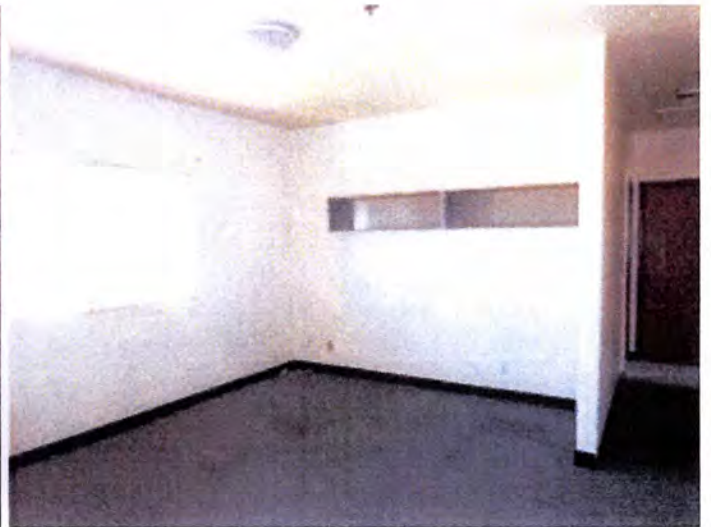
Visible indications of moisture intrusion and mold growth at building B and C interior, bedroom, bathroom and closet wall areas. Recommend removal and replacement of all interior wall finishes of B and C, after removal of all exterior vegetation.

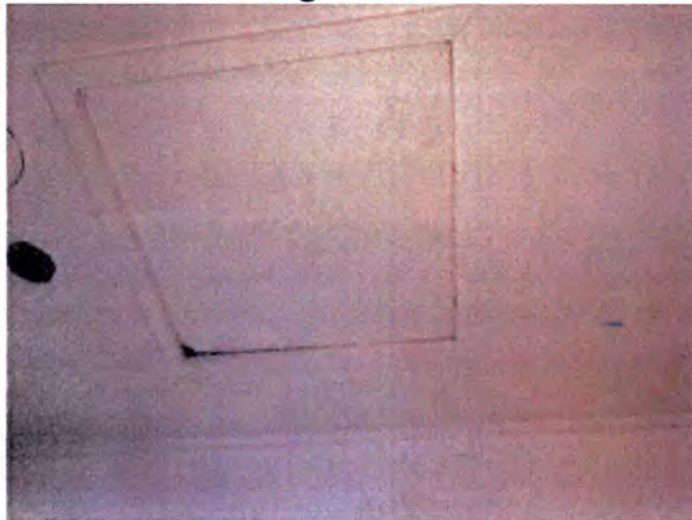
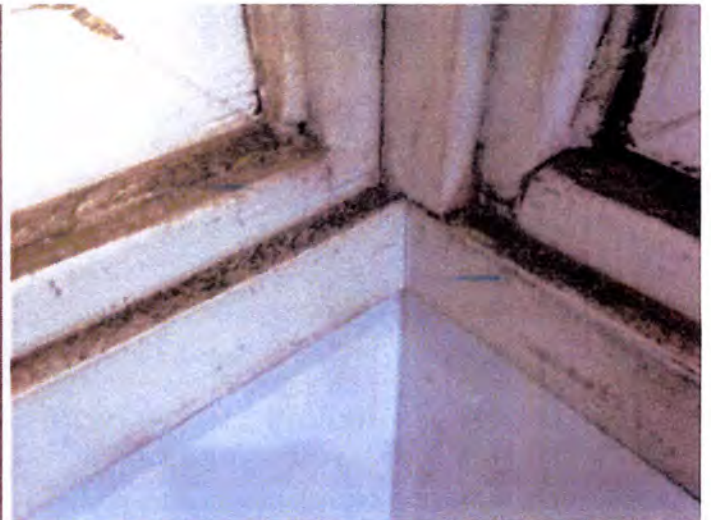
B-201

Visible indications of moisture intrusion and mold growth at building B and C interior, bedroom, bathroom and closet wall areas. Recommend removal and replacement of all interior wall finishes of B and C, after removal of all exterior vegetation.

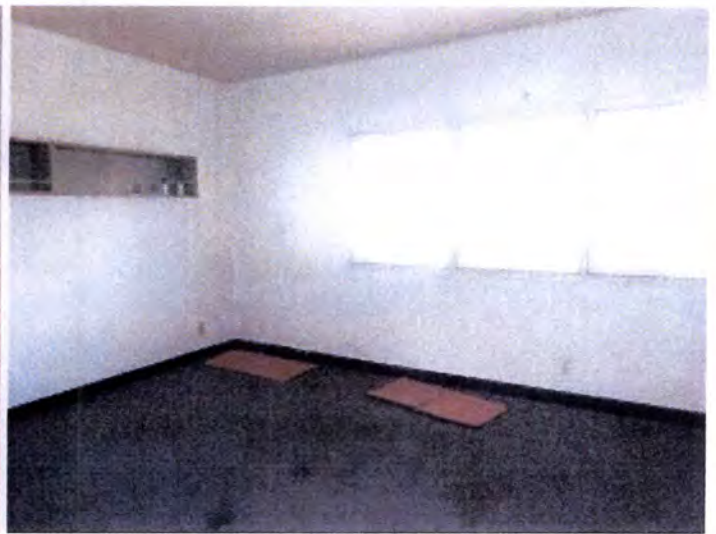
There were visible indications of moisture and termite damage observed at the interior window trim areas. Recommend replacement of all interior window trim and finishes.

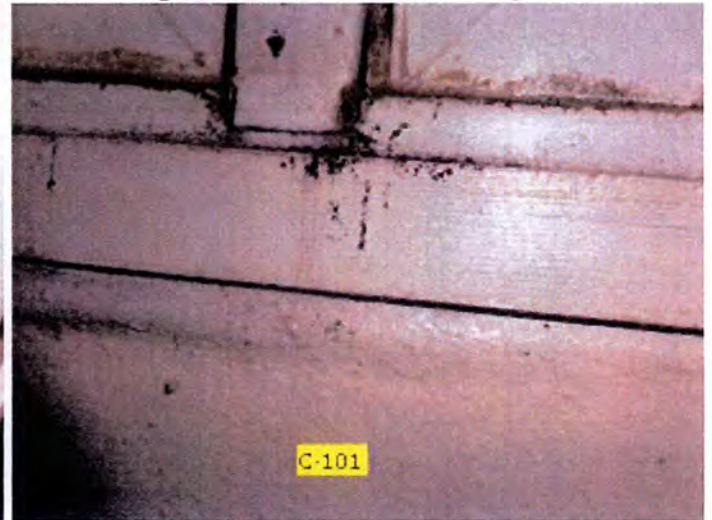
Most of the exterior facing lower interior wall finishes had moisture damage observed. Recommend removal and replacement of affected materials.

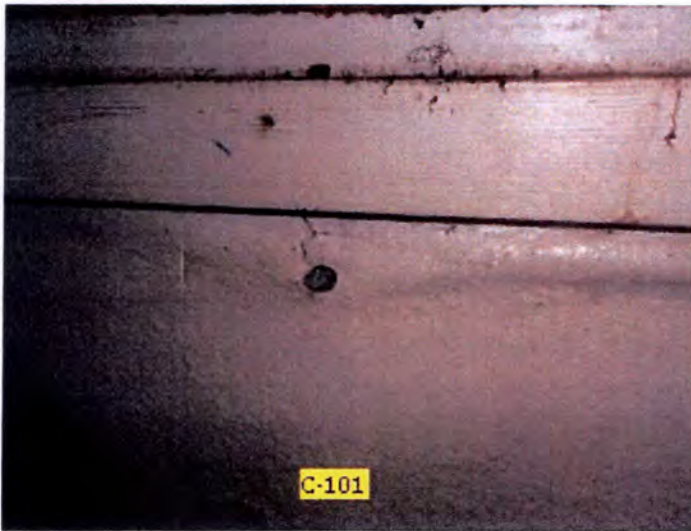
Visible indications of moisture intrusion and mold growth at building B and C interior, bedroom, bathroom and closet wall areas. Recommend removal and replacement of all interior wall finishes of B and C, after removal of all exterior vegetation.

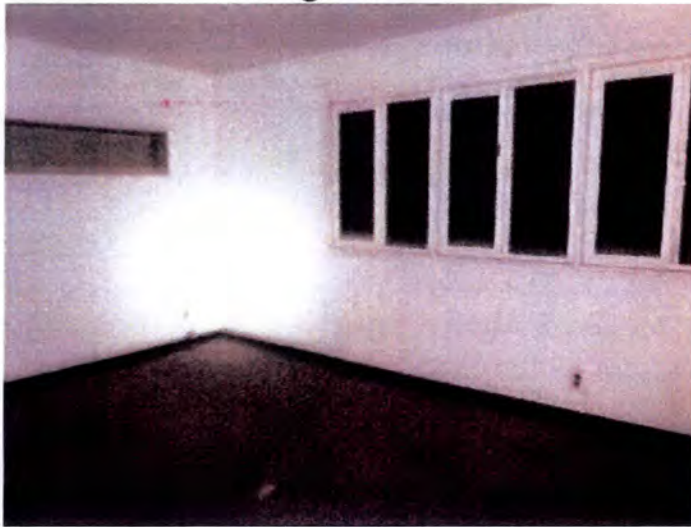
Most of the exterior facing lower interior wall finishes had moisture damage observed. Recommend removal and replacement of affected materials.

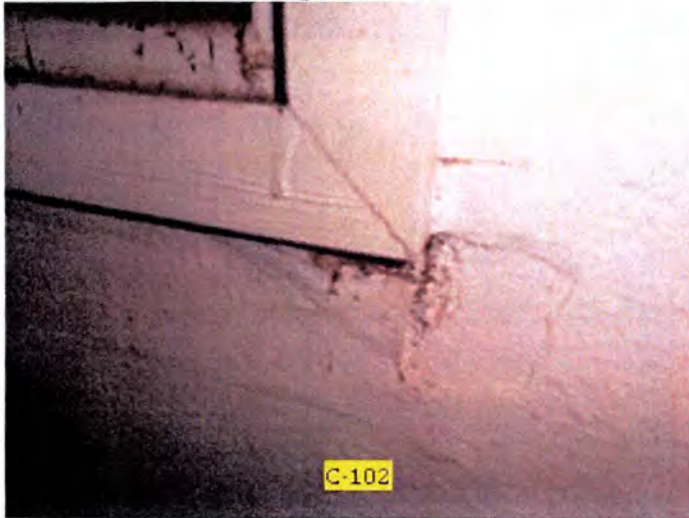
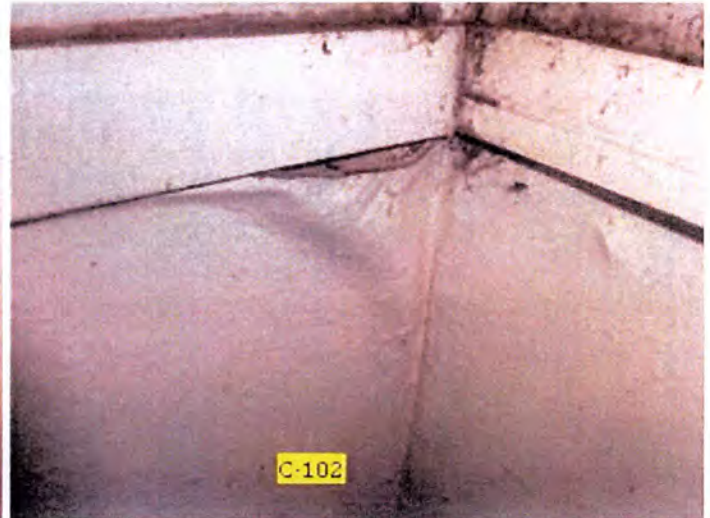
Visible indications of moisture intrusion and mold growth at building B and C interior, bedroom, bathroom and closet wall areas. Recommend removal and replacement of all interior wall finishes of B and C, after removal of all exterior vegetation.

Most of the exterior facing lower interior wall finishes had moisture damage observed. Recommend removal and replacement of affected materials.

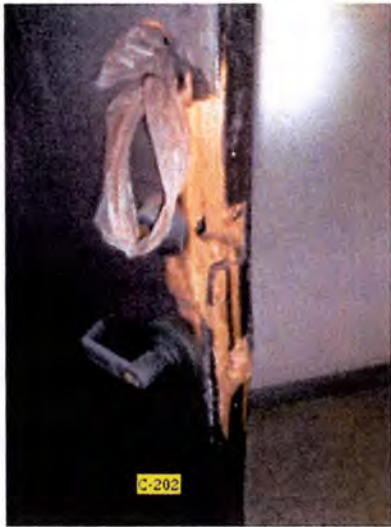
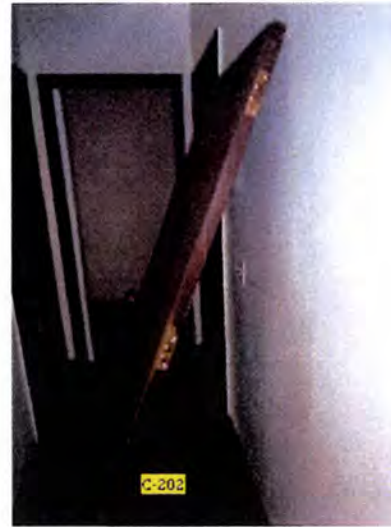
C-202

Most of the doors had varying degrees of damage observed when inspected. Based on the observed conditions, we recommend the replacement of all interior doors and trim within the dwelling units.

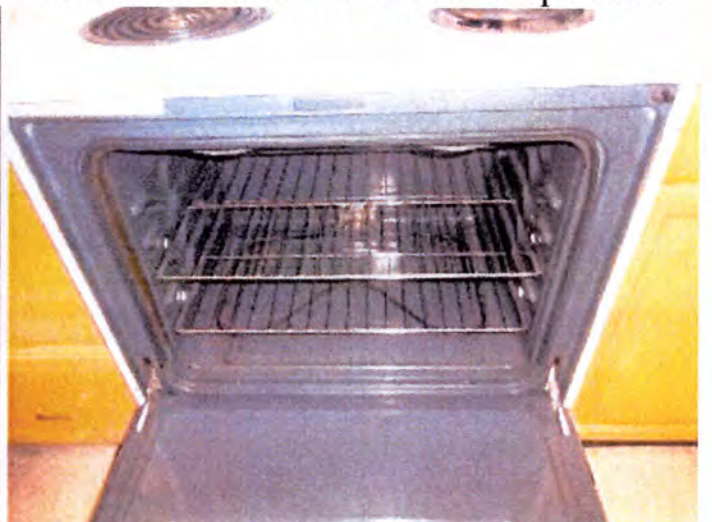
The kitchens in building A appeared to be functional at the time of inspection.

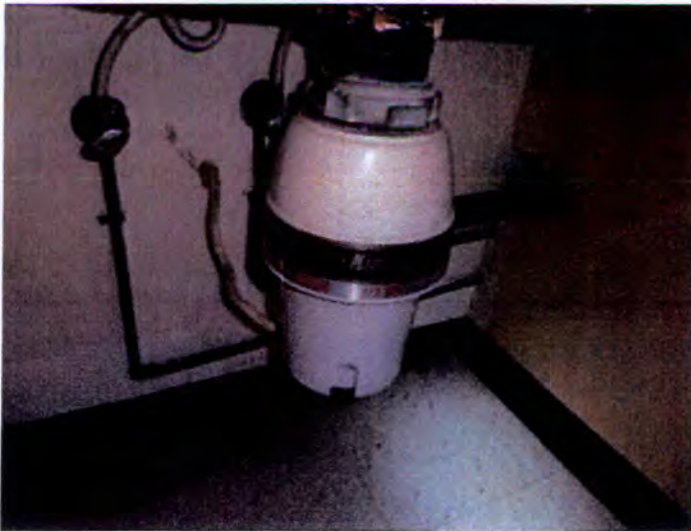
The kitchens in building A appeared to be functional at the time of inspection.

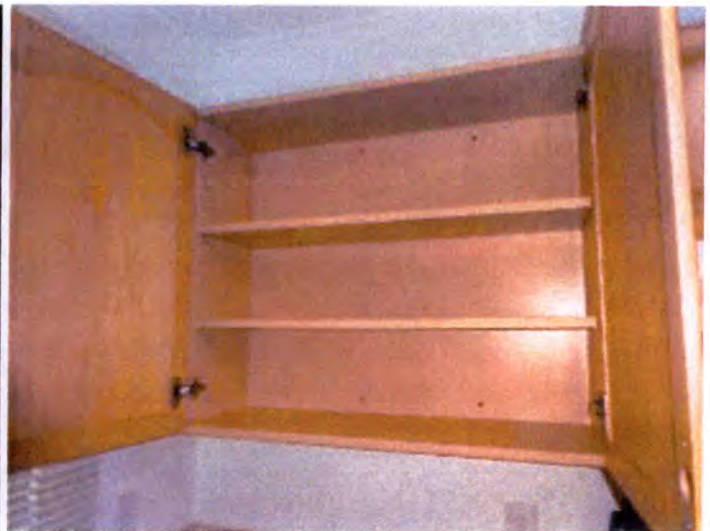
The kitchens in building A appeared to be functional at the time of inspection.

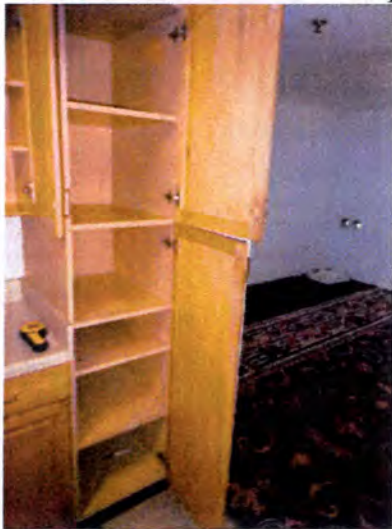
The kitchens in building A appeared to be functional at the time of inspection.

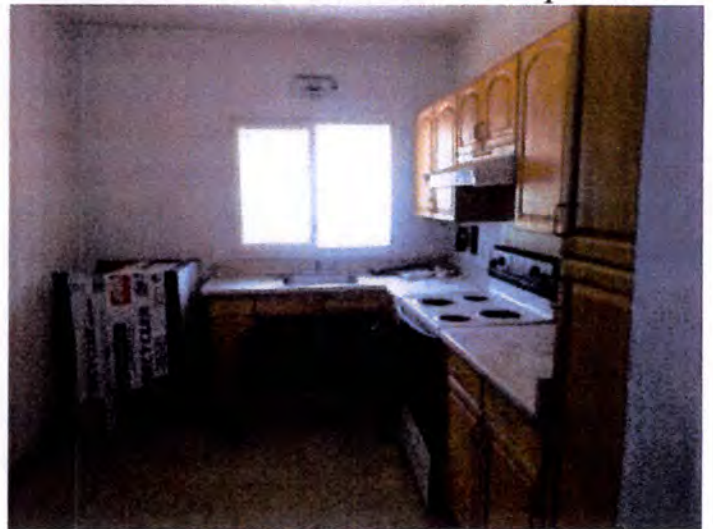
The kitchens in building A appeared to be functional at the time of inspection.

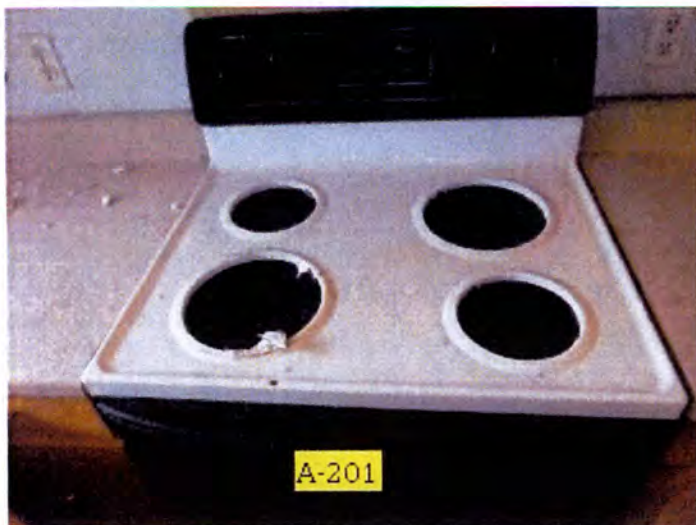
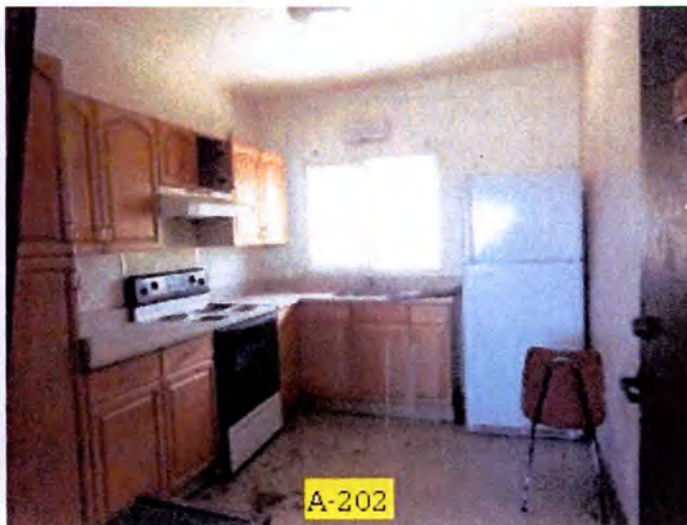
The kitchens in building A appeared to be functional at the time of inspection.

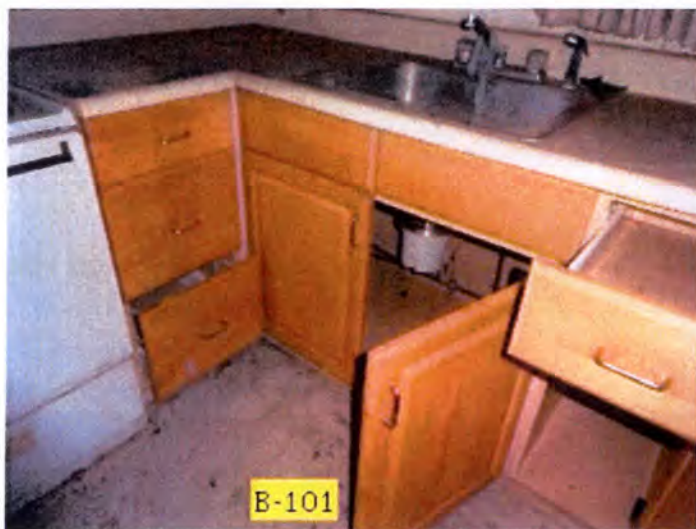
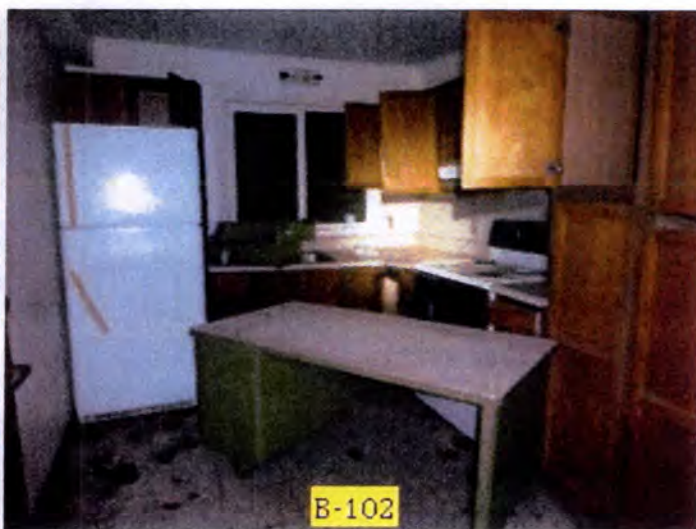
The kitchens of buildings B and C were deteriorated with moisture damage, termite damage and general damage observed at the cabinets, counters and finishes. Recommend the replacement of all dwelling unit kitchens, fixtures and appliances.

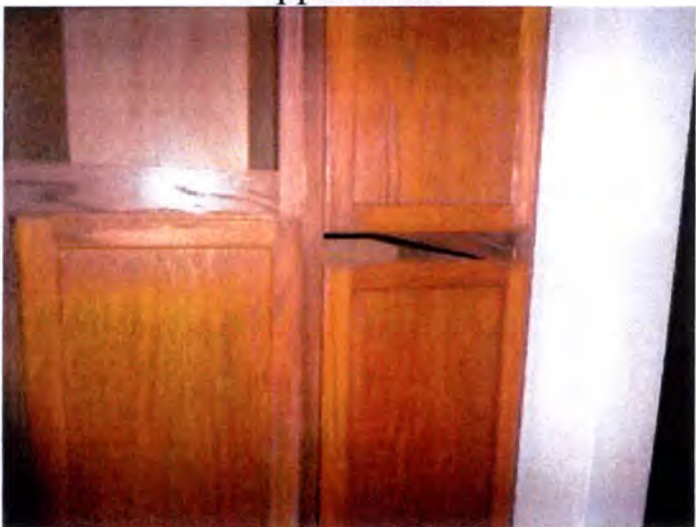
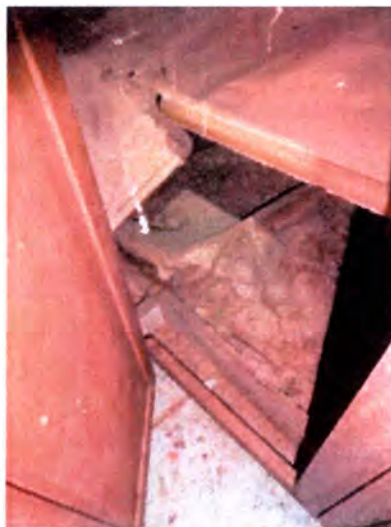
The kitchens of buildings B and C were deteriorated with moisture damage, termite damage and general damage observed at the cabinets, counters and finishes. Recommend the replacement of all dwelling unit kitchens, fixtures and appliances.

Building B and C ovens did not appear to be functional condition at the time of inspection. Recommend replacement.

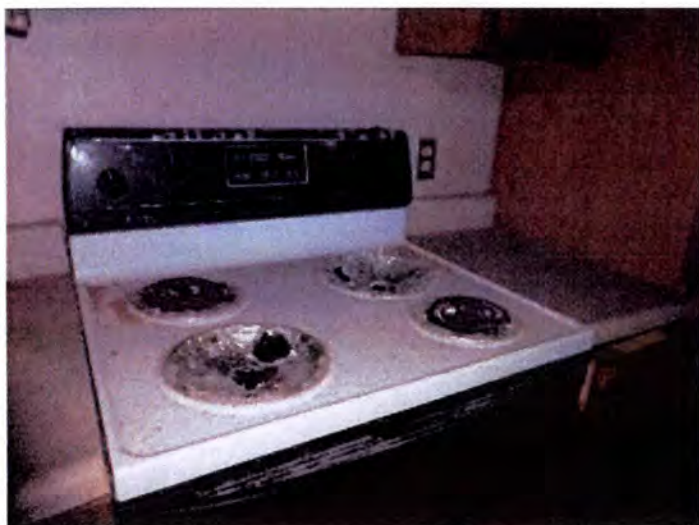
The kitchens of buildings B and C were deteriorated with moisture damage, termite damage and general damage observed at the cabinets, counters and finishes. Recommend the replacement of all dwelling unit kitchens, fixtures and appliances.

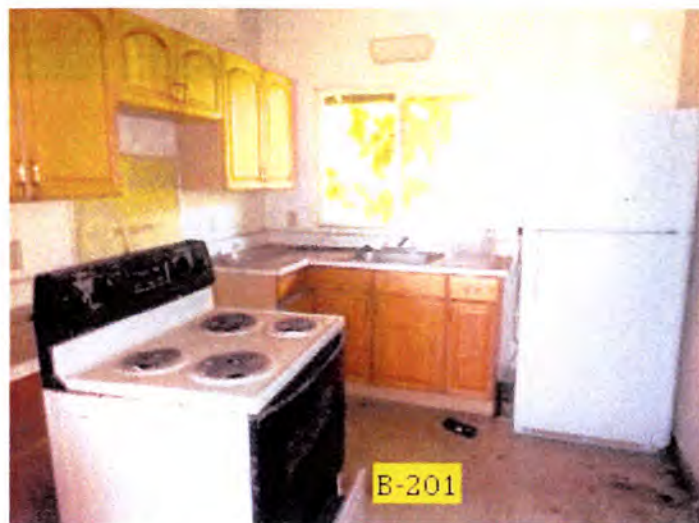
The kitchens of buildings B and C were deteriorated with moisture damage, termite damage and general damage observed at the cabinets, counters and finishes. Recommend the replacement of all dwelling unit kitchens, fixtures and appliances.

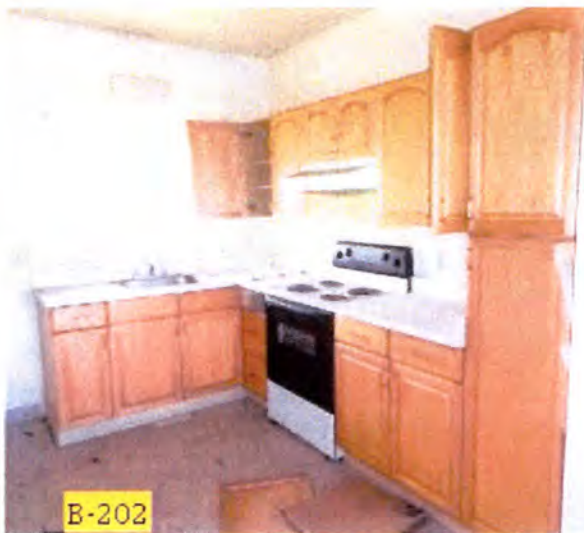
The kitchens of buildings B and C were deteriorated with moisture damage, termite damage and general damage observed at the cabinets, counters and finishes. Recommend the replacement of all dwelling unit kitchens, fixtures and appliances.

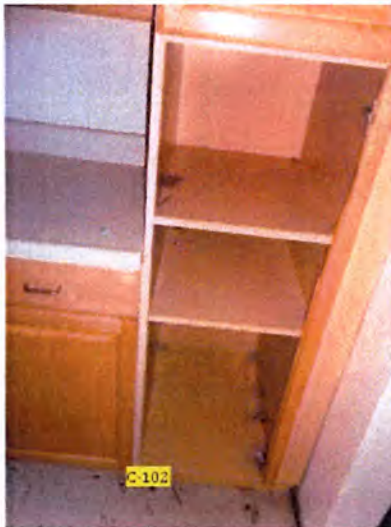
The kitchens of buildings B and C were deteriorated with moisture damage, termite damage and general damage observed at the cabinets, counters and finishes. Recommend the replacement of all dwelling unit kitchens, fixtures and appliances.

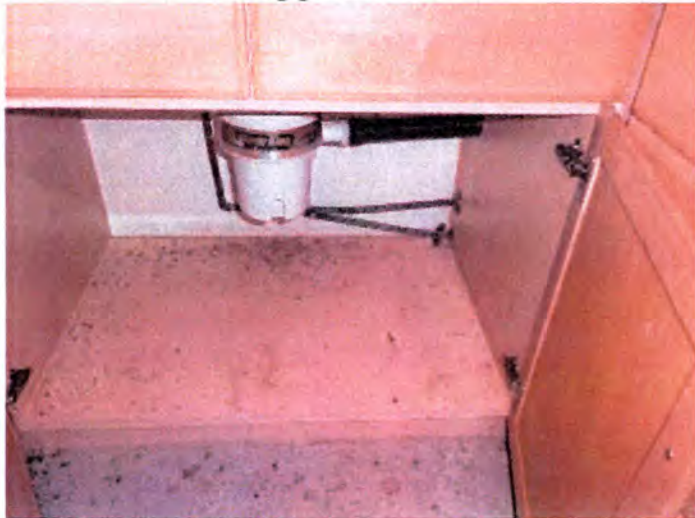
The kitchens of buildings B and C were deteriorated with moisture damage, termite damage and general damage observed at the cabinets, counters and finishes. Recommend the replacement of all dwelling unit kitchens, fixtures and appliances.

Recommend replacement of all refrigeration units located in the kitchens. The appliances in building A did not cool when turned on and the appliances in B and C had mold growth observed.

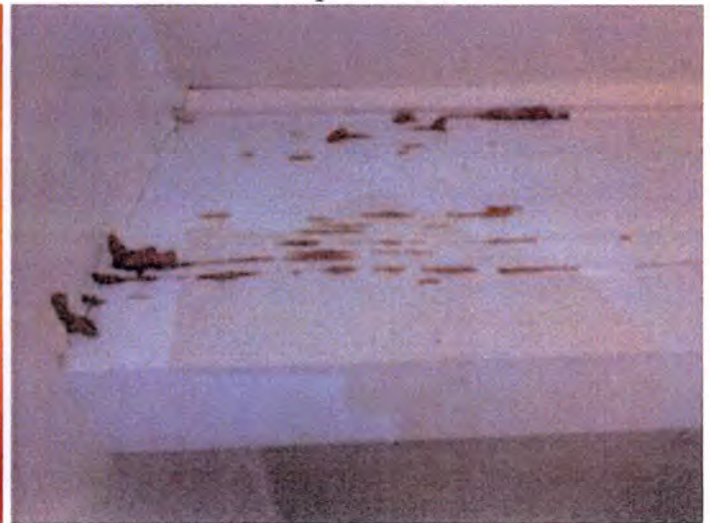
B-201: Ceiling joists were severely termite damaged and need to be repaired/replaced.

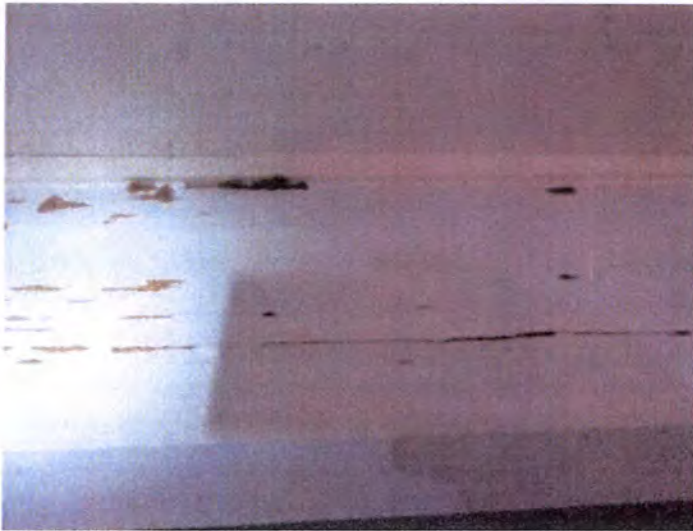
B-201: Ceiling joists were severely termite damaged and need to be repaired/replaced.

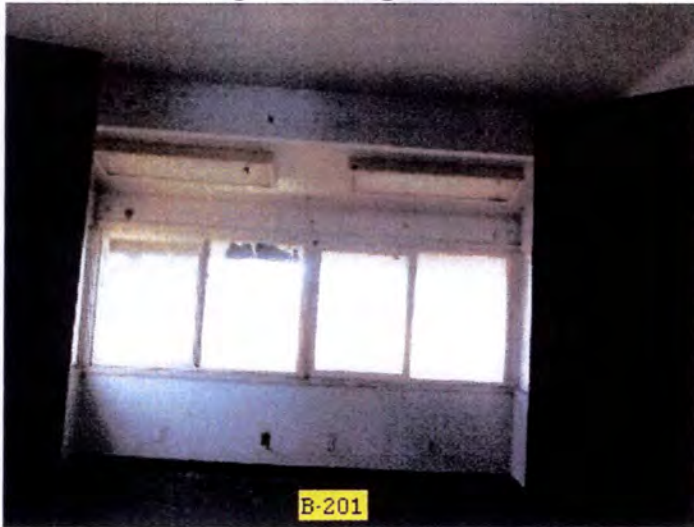
B-201: Ceiling joists were severely termite damaged and need to be repaired/replaced.

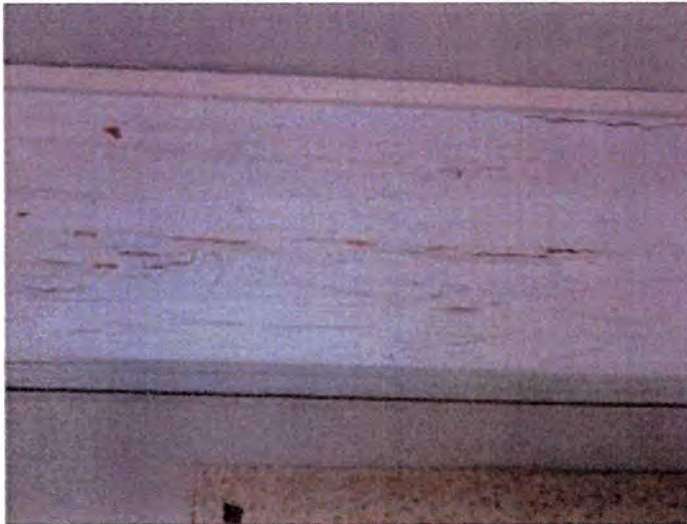
B-201: Ceiling joists were severely termite damaged and need to be repaired/replaced.

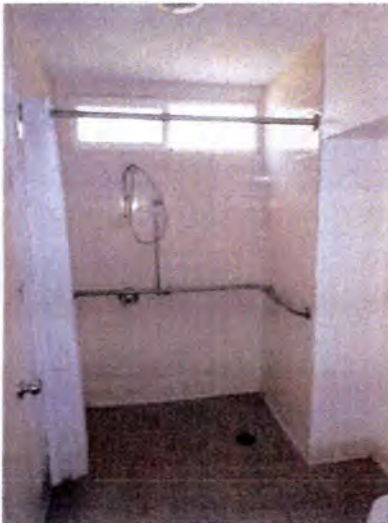
Building A ground floor bathrooms appeared to be in functional condition at the time of inspection.

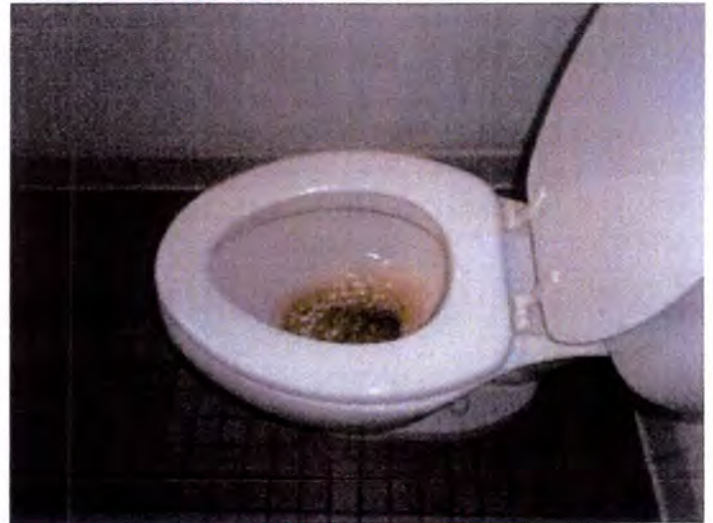
Building A bathrooms appeared to be in functional condition at the time of inspection.

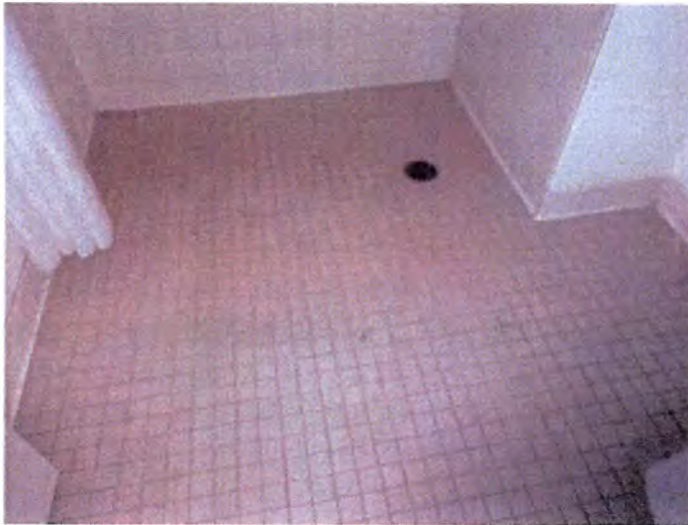
Building A bathrooms appeared to be in functional condition at the time of inspection.

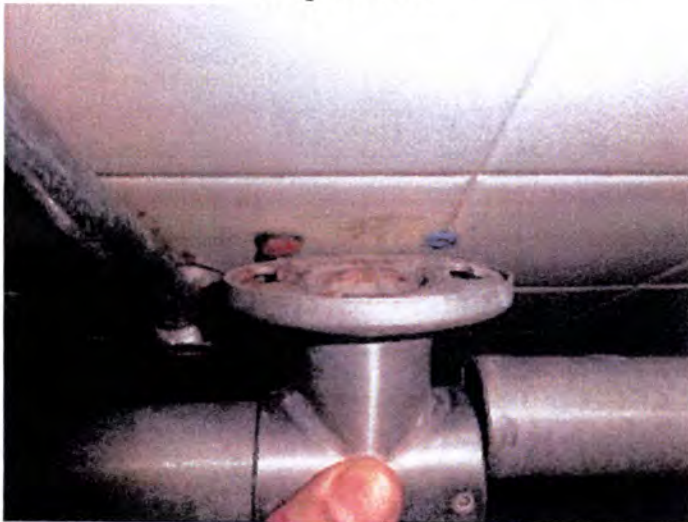
Bldg A bathroom hand rails need to be repaired.

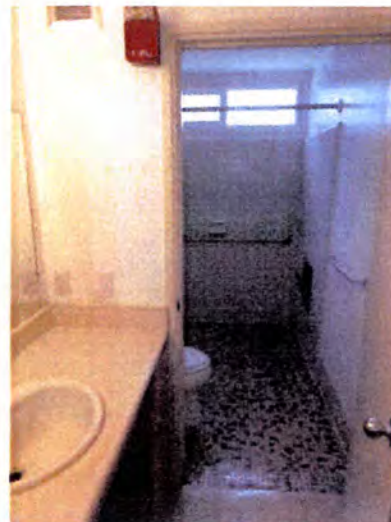
Building A ground floor bathrooms appeared to be in functional condition at the time of inspection.

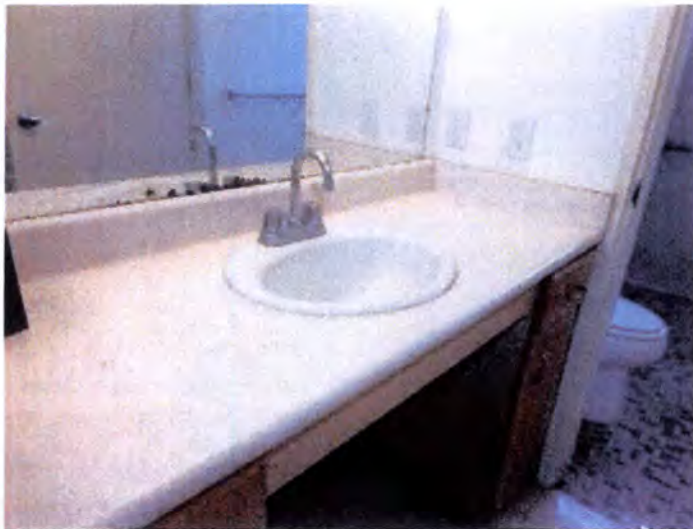
Building A bathrooms appeared to be in functional condition at the time of inspection.

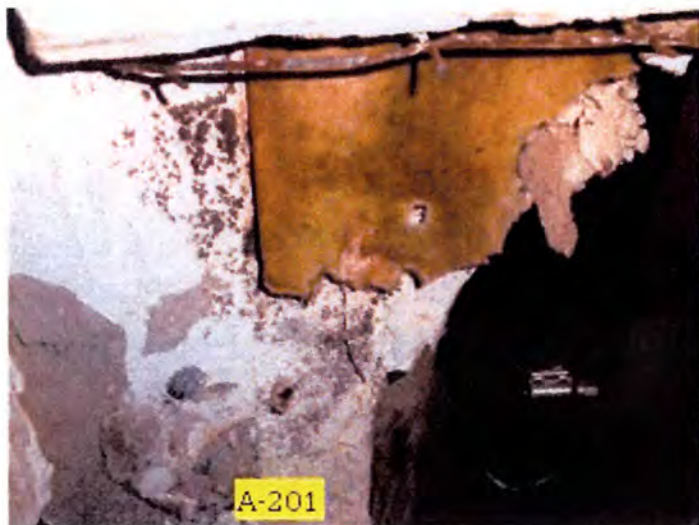
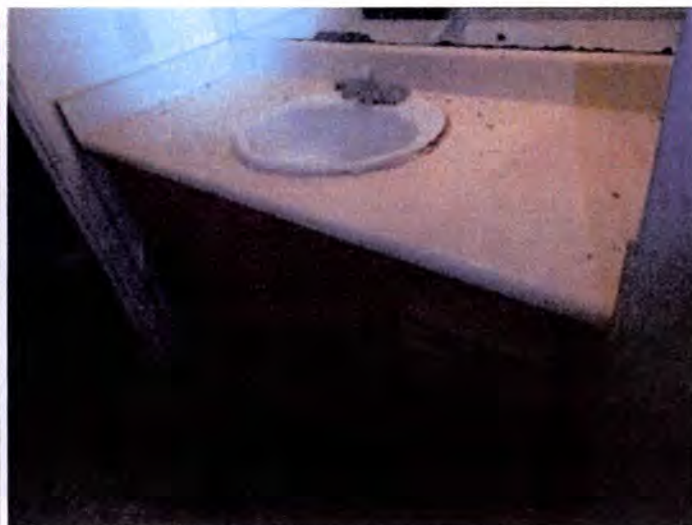
There were visible indications of moisture damage, mold growth, damaged flooring, damaged cabinets and counters, damaged mirrors, damaged toilets and damaged shower compartments observed at the time of inspection. Based on the observed conditions on site, we recommend the replacement of all dwelling unit bathrooms.

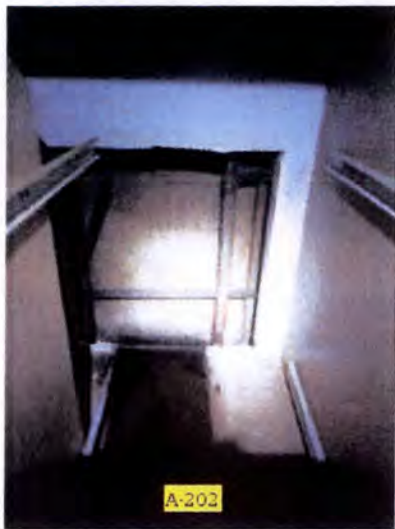
There were visible indications of moisture damage, mold growth, damaged flooring, damaged cabinets and counters, damaged mirrors, damaged toilets and damaged shower compartments observed at the time of inspection. Based on the observed conditions on site, we recommend the replacement of all dwelling unit bathrooms.

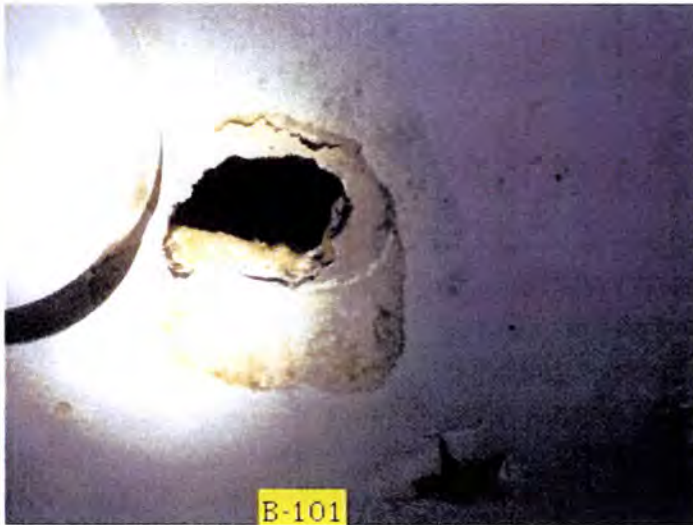
There were visible indications of moisture damage, mold growth, damaged flooring, damaged cabinets and counters, damaged mirrors, damaged toilets and damaged shower compartments observed at the time of inspection. Based on the observed conditions on site, we recommend the replacement of all dwelling unit bathrooms.

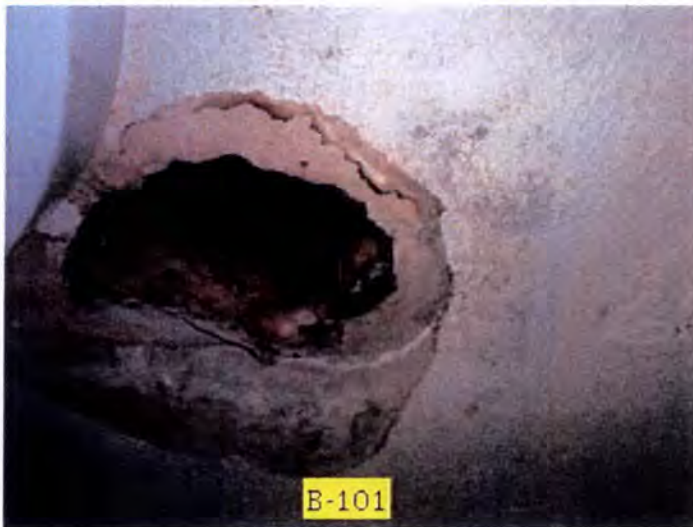
There were visible indications of moisture damage, mold growth, damaged flooring, damaged cabinets and counters, damaged mirrors, damaged toilets and damaged shower compartments observed at the time of inspection. Based on the observed conditions on site, we recommend the replacement of all dwelling unit bathrooms.

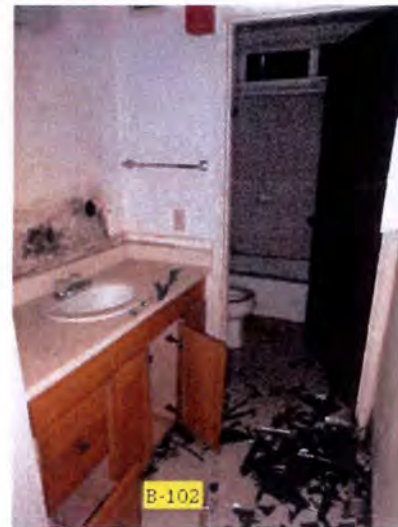
There were visible indications of moisture damage, mold growth, damaged flooring, damaged cabinets and counters, damaged mirrors, damaged toilets and damaged shower compartments observed at the time of inspection. Based on the observed conditions on site, we recommend the replacement of all dwelling unit bathrooms.
