**SUBJECT: COUNTY-OWNED PARCEL ON NORTH PAPA AVENUE (KAHULUI)
 (HHT-14)**

Property Condition Report

310 W Kaahumanu Ave, Kahului, HI 96732
Inspection prepared for: Maui County c/o Buddy Almeida
Real Estate Agent: -

Date of Inspection: 3/28/2018 Time: 8:00 AM
Age of Home: 1980 Size: 15000

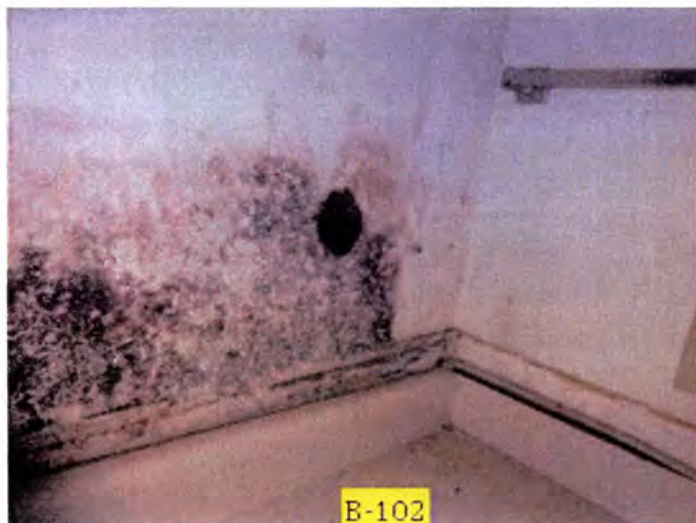
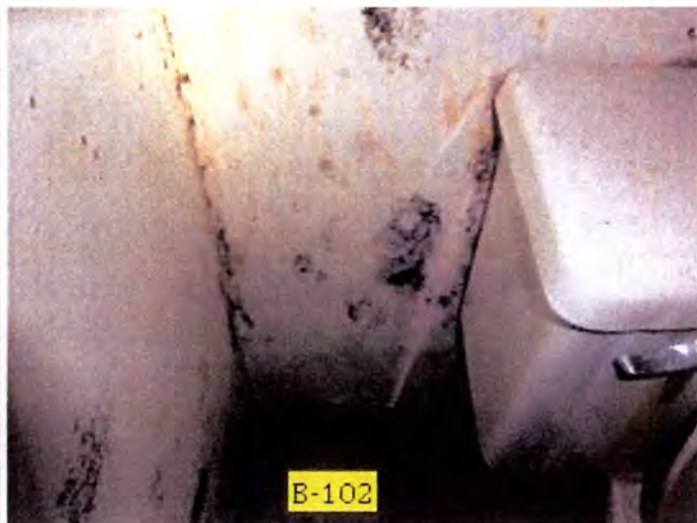
There were visible indications of moisture damage, mold growth, damaged flooring, damaged cabinets and counters, damaged mirrors, damaged toilets and damaged shower compartments observed at the time of inspection. Based on the observed conditions on site, we recommend the replacement of all dwelling unit bathrooms.

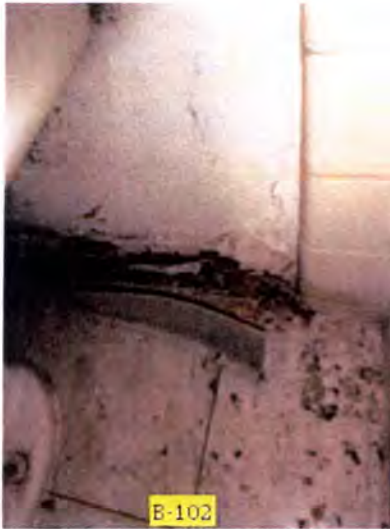
There were visible indications of moisture damage, mold growth, damaged flooring, damaged cabinets and counters, damaged mirrors, damaged toilets and damaged shower compartments observed at the time of inspection. Based on the observed conditions on site, we recommend the replacement of all dwelling unit bathrooms.

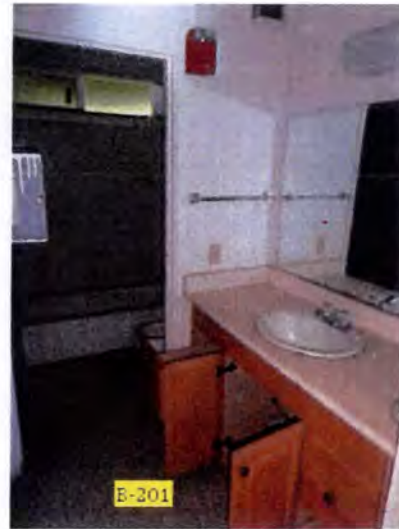
There were visible indications of moisture damage, mold growth, damaged flooring, damaged cabinets and counters, damaged mirrors, damaged toilets and damaged shower compartments observed at the time of inspection. Based on the observed conditions on site, we recommend the replacement of all dwelling unit bathrooms.

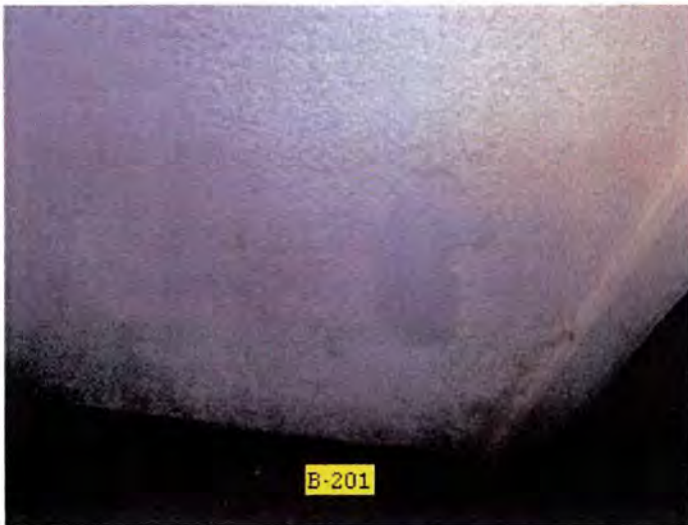
There were visible indications of moisture damage, mold growth, damaged flooring, damaged cabinets and counters, damaged mirrors, damaged toilets and damaged shower compartments observed at the time of inspection. Based on the observed conditions on site, we recommend the replacement of all dwelling unit bathrooms.

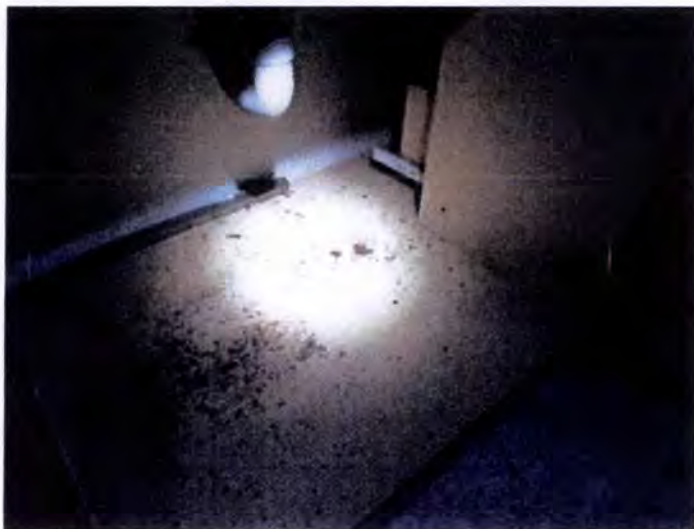
There were visible indications of moisture damage, mold growth, damaged flooring, damaged cabinets and counters, damaged mirrors, damaged toilets and damaged shower compartments observed at the time of inspection. Based on the observed conditions on site, we recommend the replacement of all dwelling unit bathrooms.

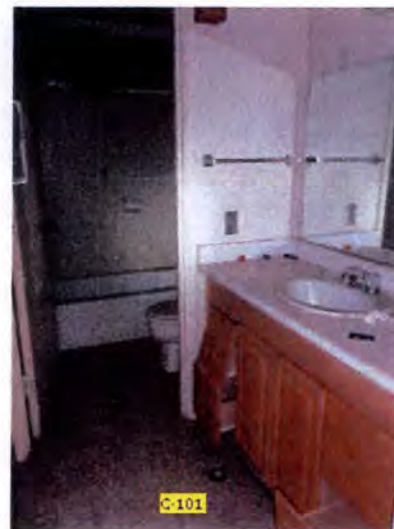
There were visible indications of moisture damage, mold growth, damaged flooring, damaged cabinets and counters, damaged mirrors, damaged toilets and damaged shower compartments observed at the time of inspection. Based on the observed conditions on site, we recommend the replacement of all dwelling unit bathrooms.

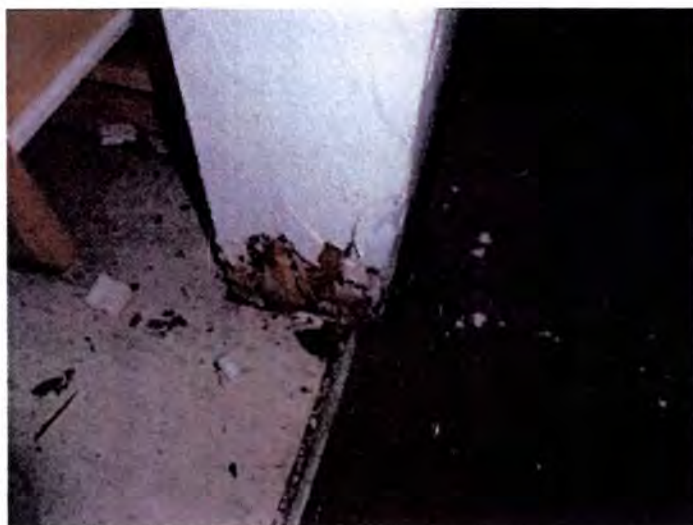
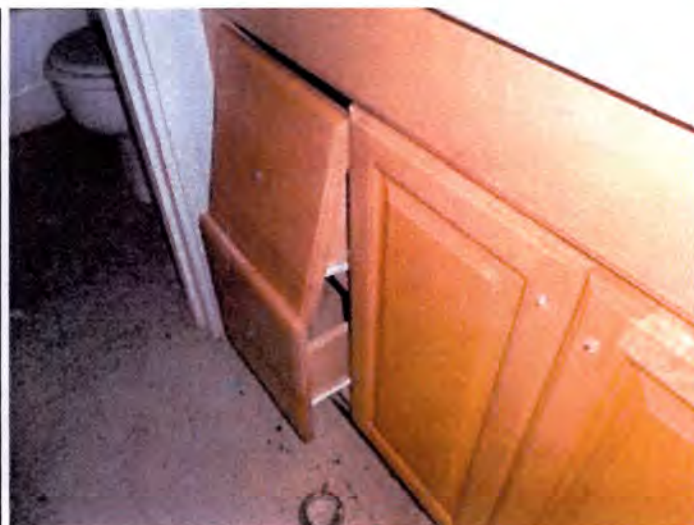
There were visible indications of moisture damage, mold growth, damaged flooring, damaged cabinets and counters, damaged mirrors, damaged toilets and damaged shower compartments observed at the time of inspection. Based on the observed conditions on site, we recommend the replacement of all dwelling unit bathrooms.

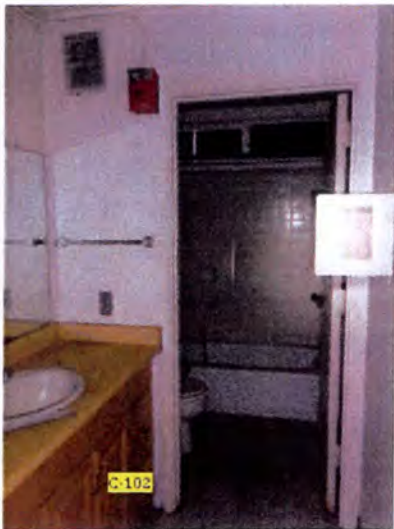
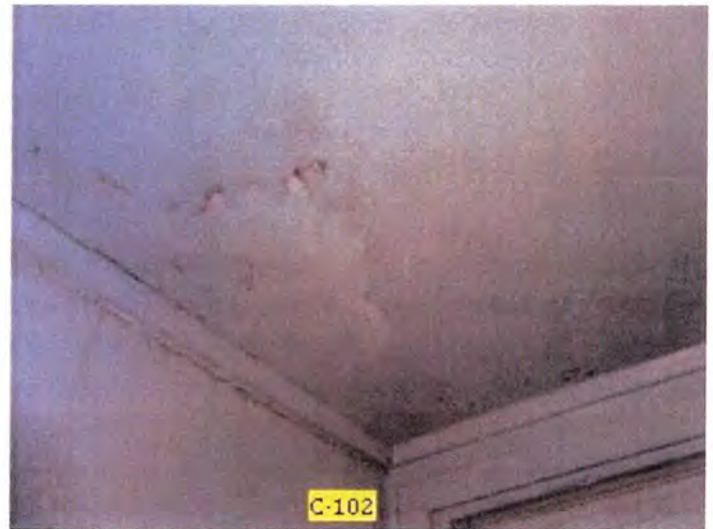
There were visible indications of moisture damage, mold growth, damaged flooring, damaged cabinets and counters, damaged mirrors, damaged toilets and damaged shower compartments observed at the time of inspection. Based on the observed conditions on site, we recommend the replacement of all dwelling unit bathrooms.

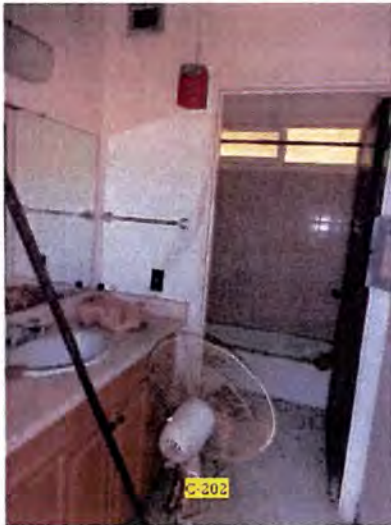
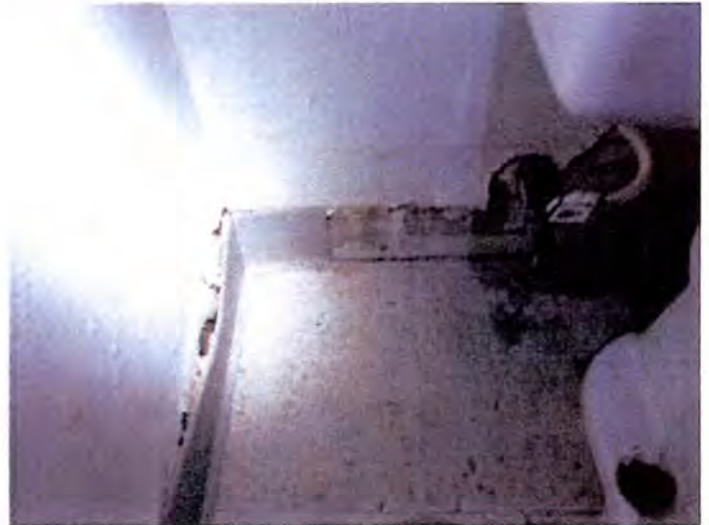
There were visible indications of moisture damage, mold growth, damaged flooring, damaged cabinets and counters, damaged mirrors, damaged toilets and damaged shower compartments observed at the time of inspection. Based on the observed conditions on site, we recommend the replacement of all dwelling unit bathrooms.

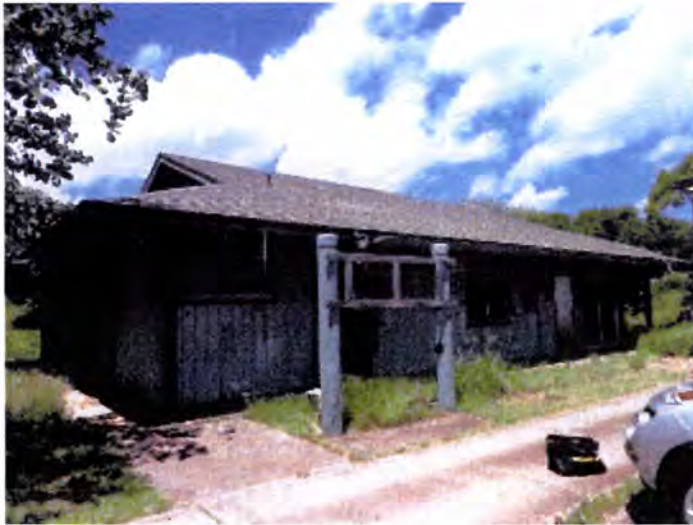
There was a hazardous bee population observed on site at the time of inspection. The single story storage building had sections of front wall removed for past been removal. The left side of the building had extensive and constant activity observed. There were been nests also observed at other exterior and interior locations through out the property.

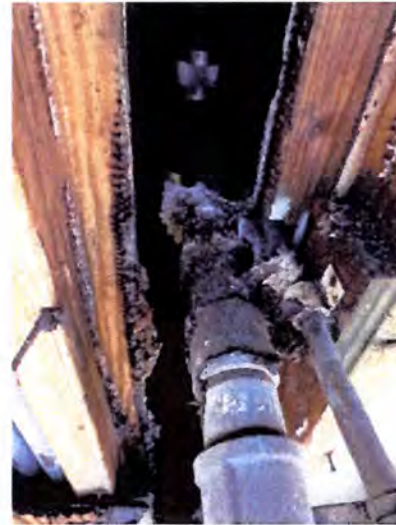
There was a hazardous bee population observed on site at the time of inspection. The single story storage building had sections of front wall removed for past been removal. The left side of the building had extensive and constant activity observed. There were been nests also observed at other exterior and interior locations through out the property.

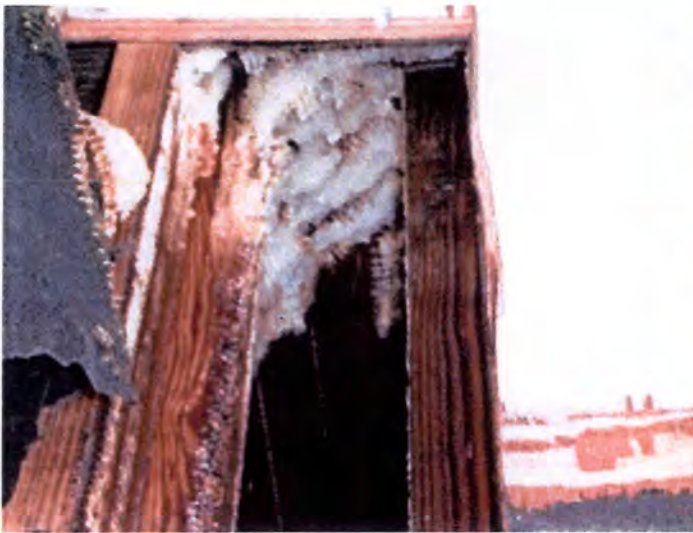
There was a hazardous bee population observed on site at the time of inspection. The single story storage building had sections of front wall removed for past been removal. The left side of the building had extensive and constant activity observed. There were been nests also observed at other exterior and interior locations through out the property.

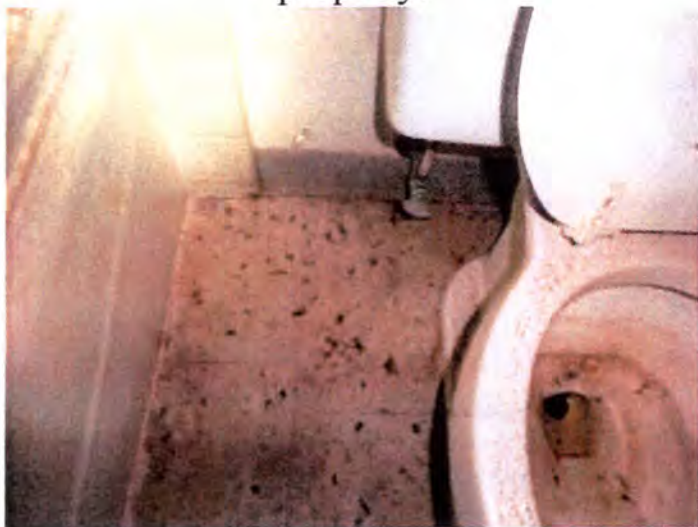
There was extensive pest (ie: cockroach) infestation observed at the interior and/or exterior areas of the building.

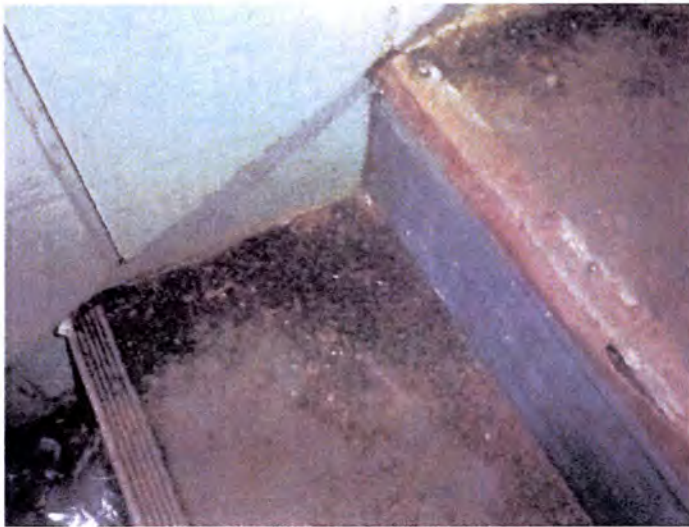
There was moderate/extensive termite/moisture damage observed at the interior and/or exterior areas of the building.

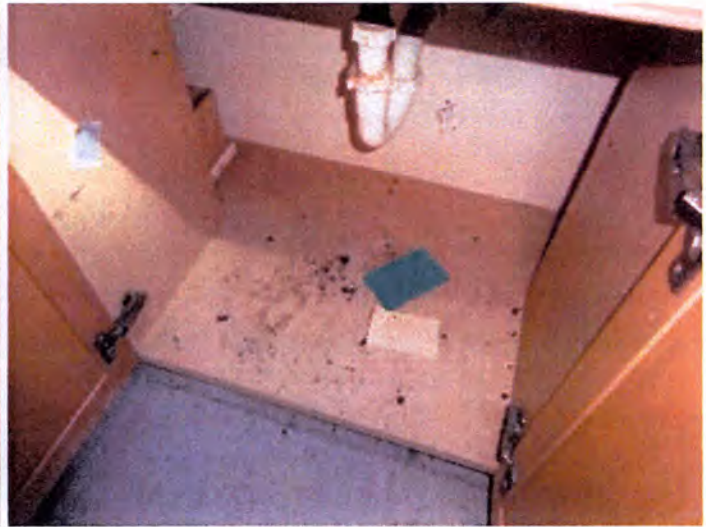
There was extensive pest (ie: cockroach) infestation observed at the interior and/or exterior areas of the building.

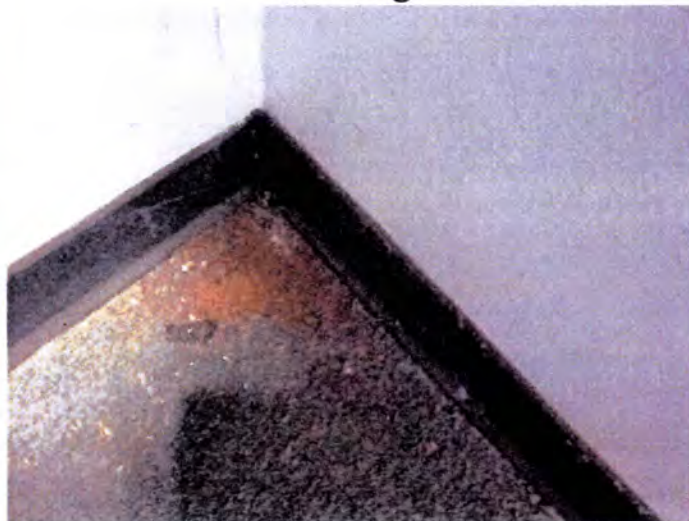
There was moderate/extensive termite/moisture damage observed at the interior and/or exterior areas of the building.

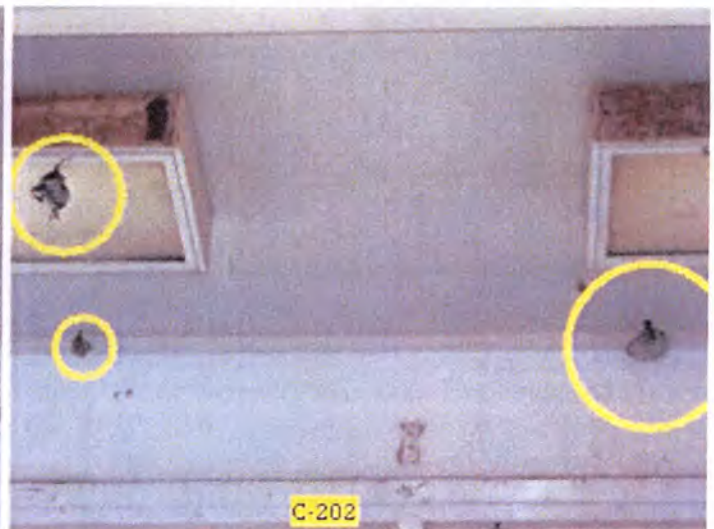
C-202

There was a hazardous bee population observed on site at the time of inspection. The single story storage building had sections of front wall removed for past been removal. The left side of the building had extensive and constant activity observed. There were been nests also observed at other exterior and interior locations through out the property.

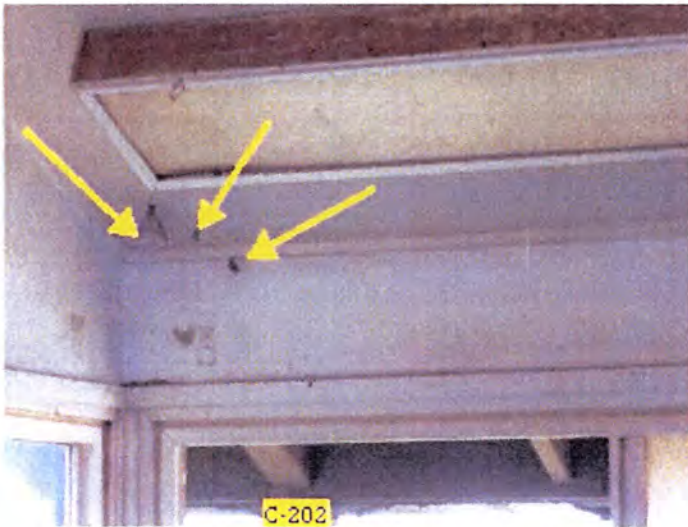
There was a hazardous bee population observed on site at the time of inspection. The single story storage building had sections of front wall removed for past been removal. The left side of the building had extensive and constant activity observed. There were been nests also observed at other exterior and interior locations through out the property.

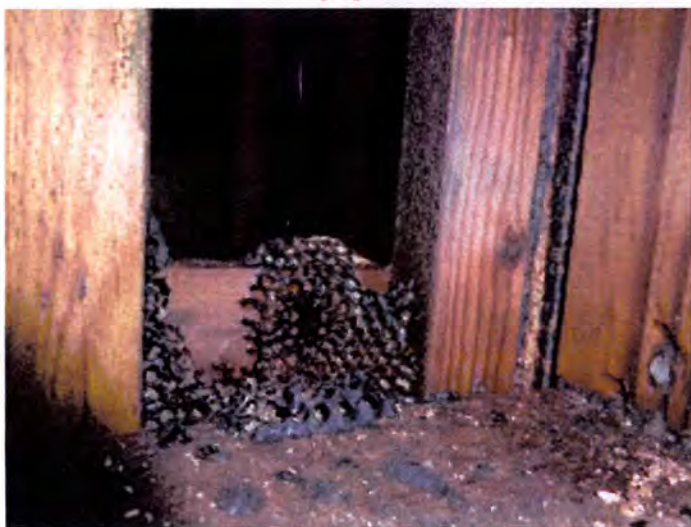
Some of the areas were inaccessible due to the presence of a robust bee population outside and inside of the buildings.

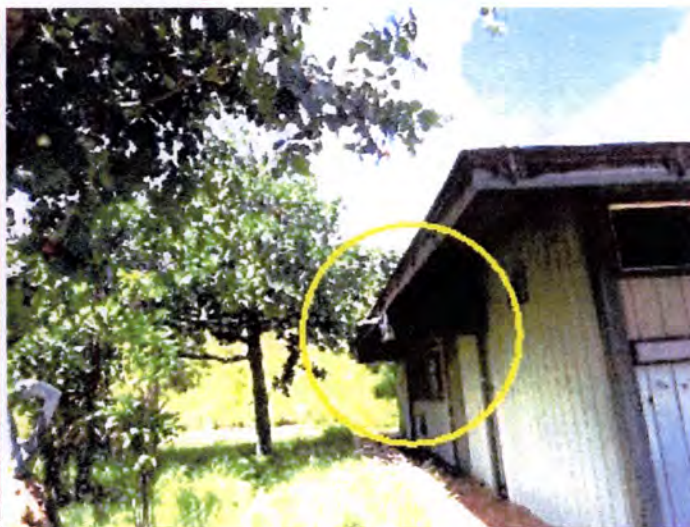
Some of the areas were inaccessible due to the presence of a robust bee population outside and inside of the buildings.

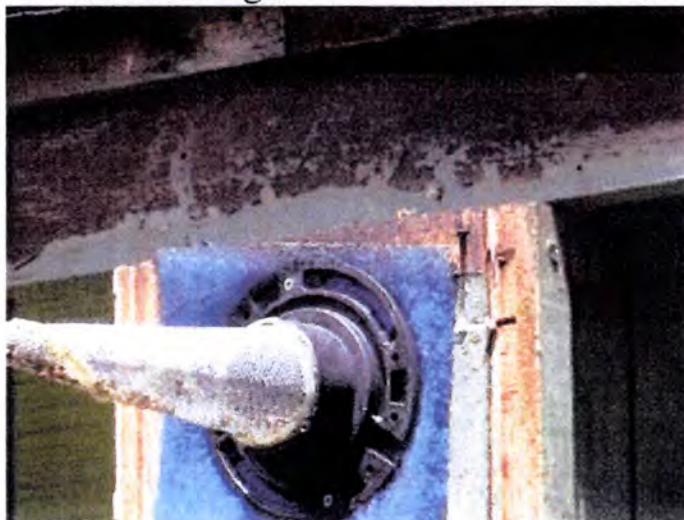
Some of the areas were inaccessible due to the presence of a robust bee population outside and inside of the buildings.
