SUBJECT: COUNTY-OWNED PARCEL ON NORTH PAPA AVENUE (KAHULUI) (HHT-14)

Property Condition Report

310 W Kaahumanu Ave, Kahului, HI 96732 Inspection prepared for: Maui County c/o Buddy Almeida Real Estate Agent: -

Date of Inspection: 3/28/2018 Time: 8:00 AM Age of Home: 1980 Size: 15000 This is a commercial property condition assessment to determine of three (3) former UH dormitories are suitable for housing. This inspection includes invasive and non-invasive inspection methods as well as sampling for asbestos and lead based paint.

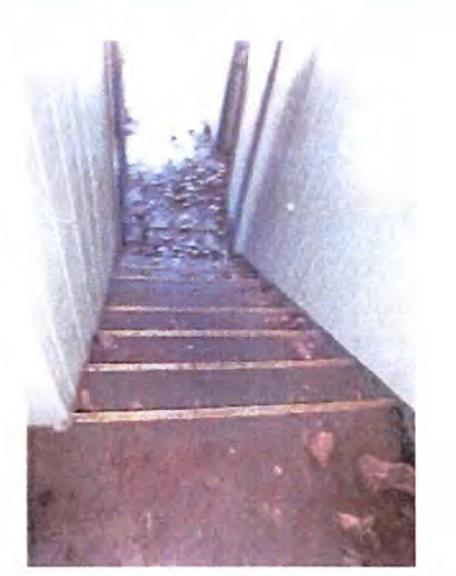
Bldg A hand rail was missing. Recommend installation as required.

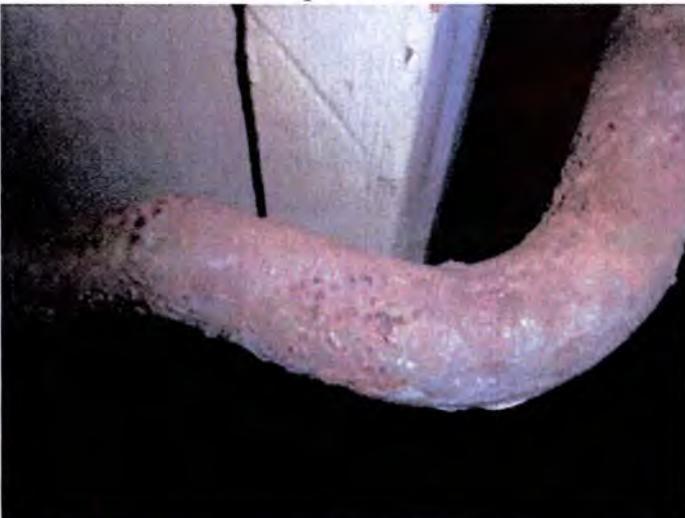
Exterior stair handrails were corroded and need to be cleaned, treated and refinished.

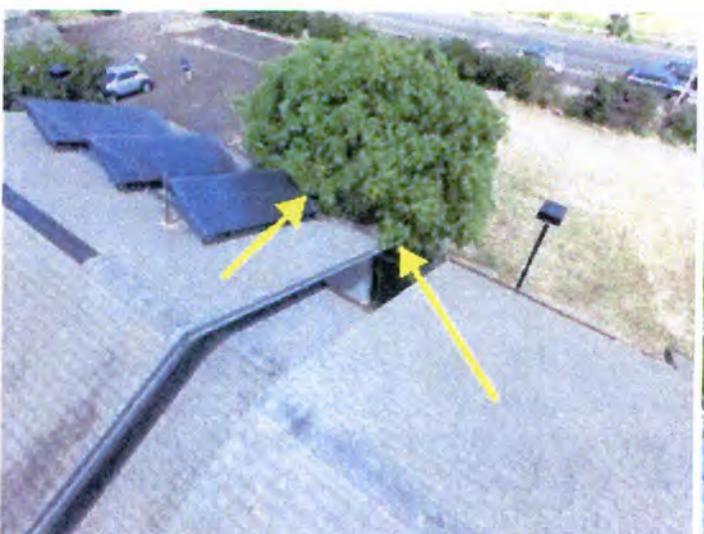
The vegetation was overgrown and causing deterioration/damage to the exterior curtain wall and fixtures.

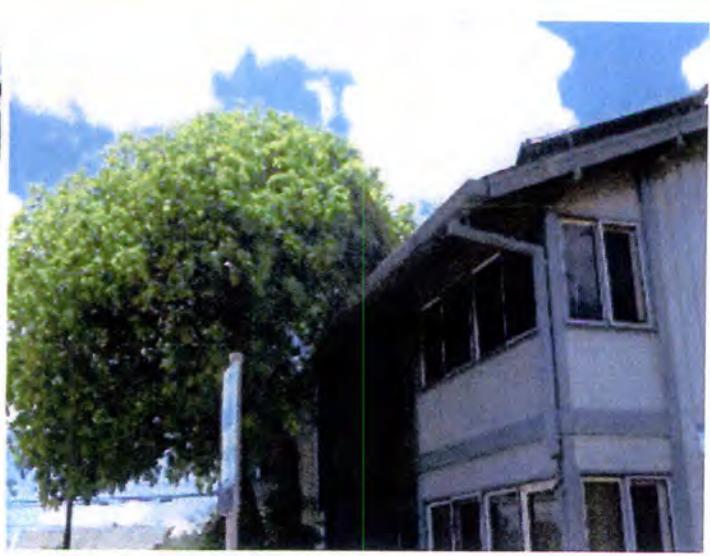
The vegetation was overgrown and causing deterioration/damage to the exterior curtain wall and fixtures.

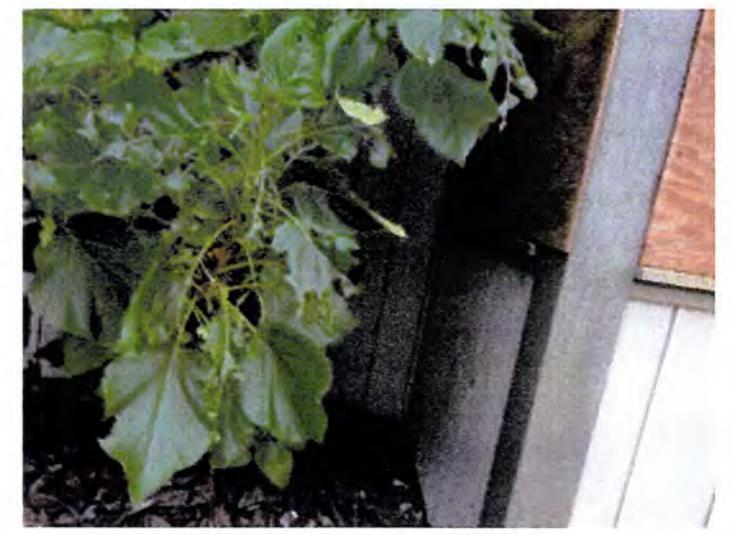
There were numerous trees contacting the Vegetation was overgrown and in need of building curtain walls and roof areas. These areas appeared to have damage/deterioration noted at the time of inspection. Recommend having a licensed landscape contractor/arborist evaluate and trim vegetation and trees as

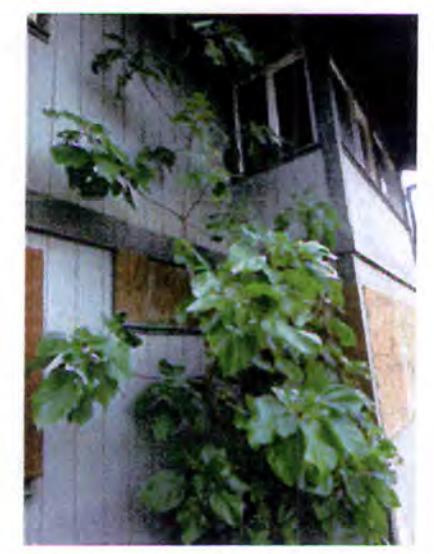
There were numerous trees contacting the building curtain walls and roof areas. These areas appeared to have damage/deterioration noted at the time of inspection. Recommend having a licensed landscape contractor/arborist evaluate and trim vegetation and trees as necessary.

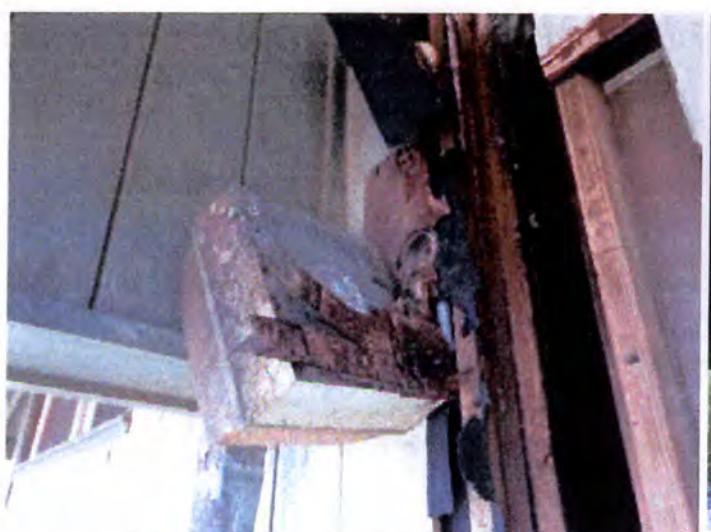
Some of the exterior lighting fixtures were damaged and need to be replaced.

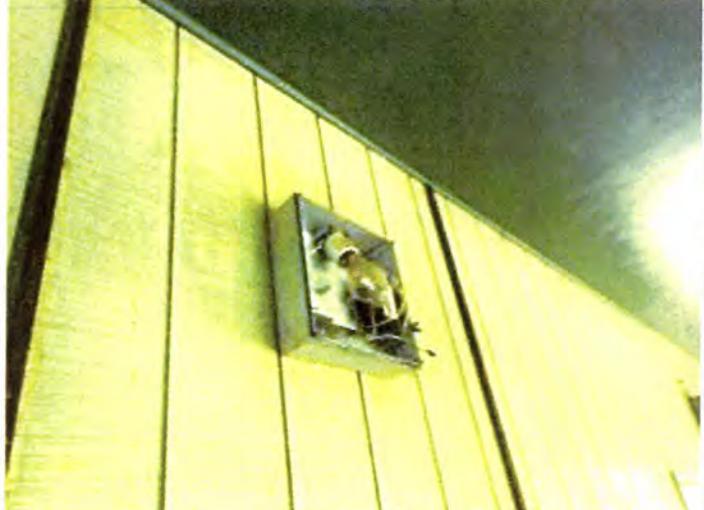
Some of the exterior lighting fixtures were damaged and need to be replaced.

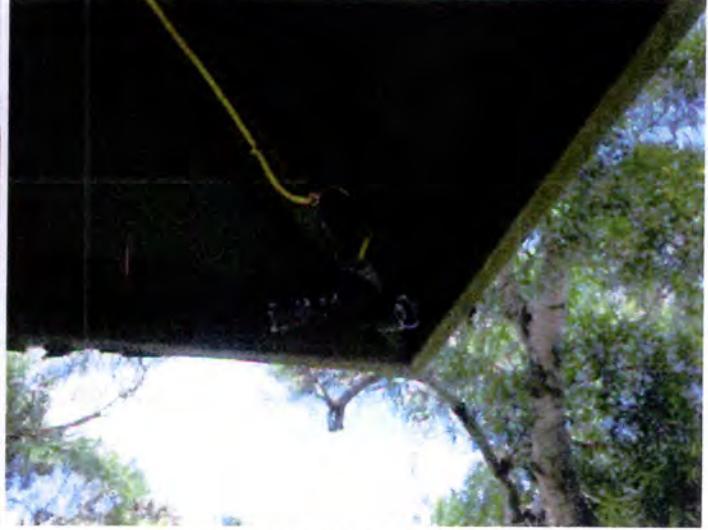
Some of the exterior lighting fixtures were damaged and need to be replaced.

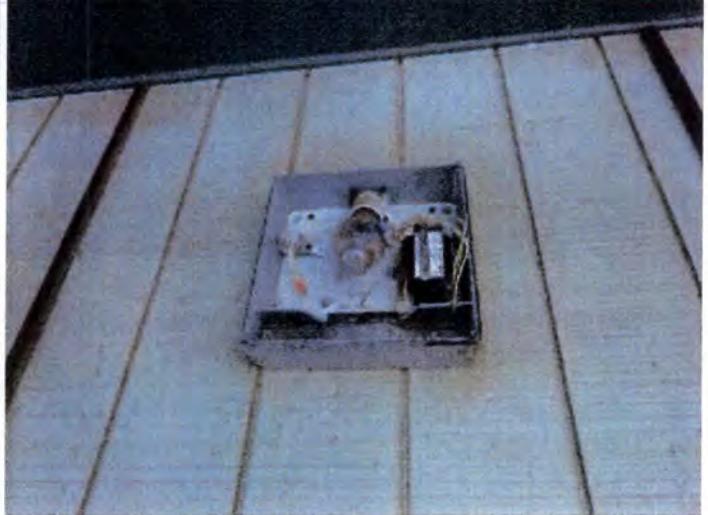
Some of the exterior lighting fixtures were damaged and need to be replaced.

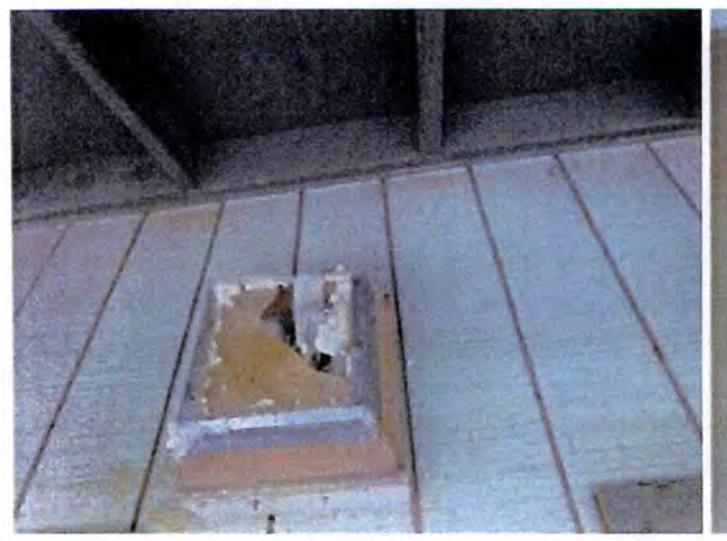
Some of the exterior lighting fixtures were damaged and need to be replaced.

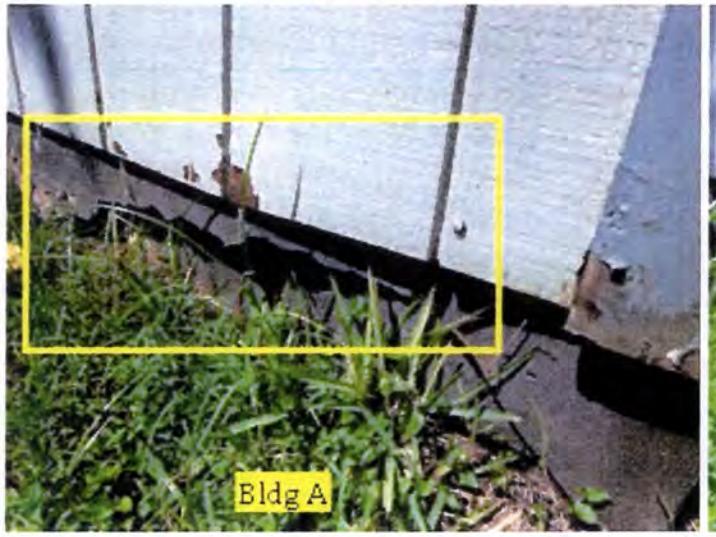
Building A and B: Visible cracks observed at the foundational areas of the observed at the foundational areas of the buildings. There were separations observed along the defect areas which represent movement between the faults.

We recommend having a licensed foundation/masonry contractor evaluate and repair the affected areas as necessary and repair the affected areas as necessary to prevent further damage.

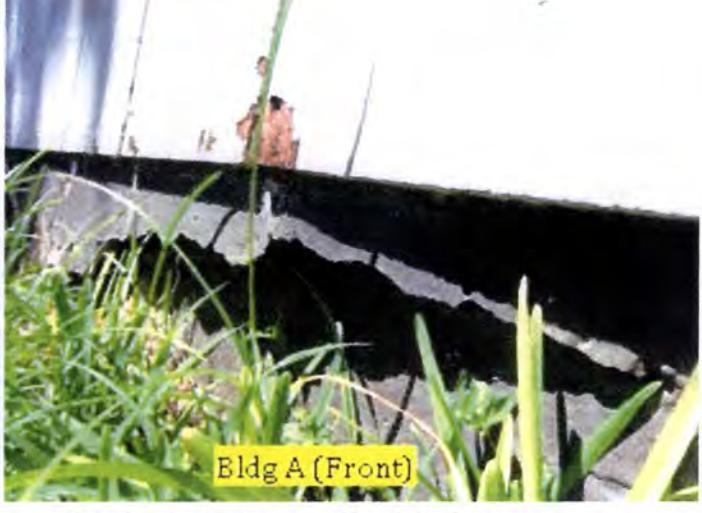
Building A and B: Visible cracks buildings. There were separations observed along the defect areas which represent movement between the faults.

We recommend having a licensed foundation/masonry contractor evaluate to prevent further damage.

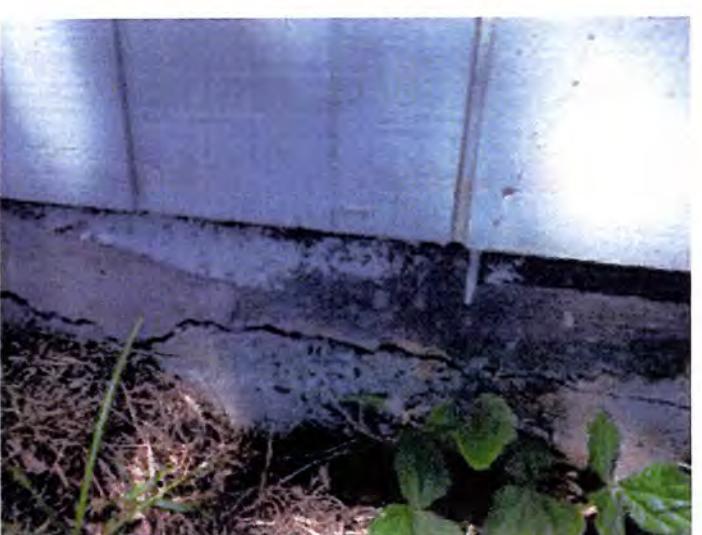
Building A and B: Visible cracks buildings. There were separations observed along the defect areas which represent movement between the faults. We recommend having a licensed foundation/masonry contractor evaluate to prevent further damage.

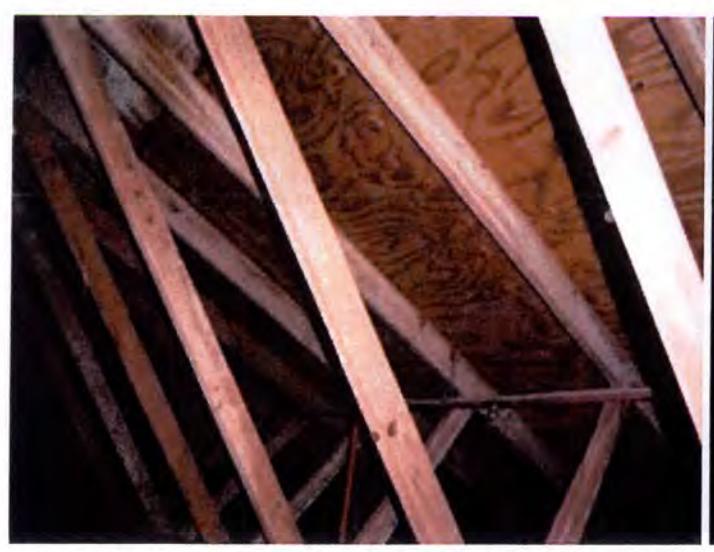
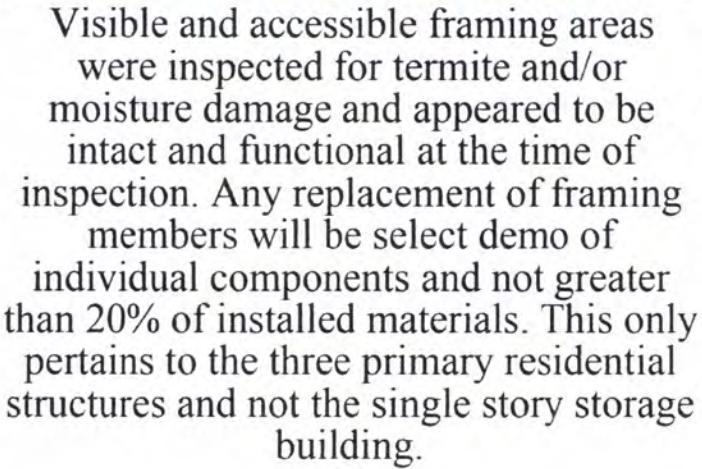
No more than two access holes were cut into the interior wall finishes of each building to determine the condition of the wall framing members. These openings were made at the areas of visible moisture/termite/mold damage. The underlying framing appeared to be intact and functional when inspected.

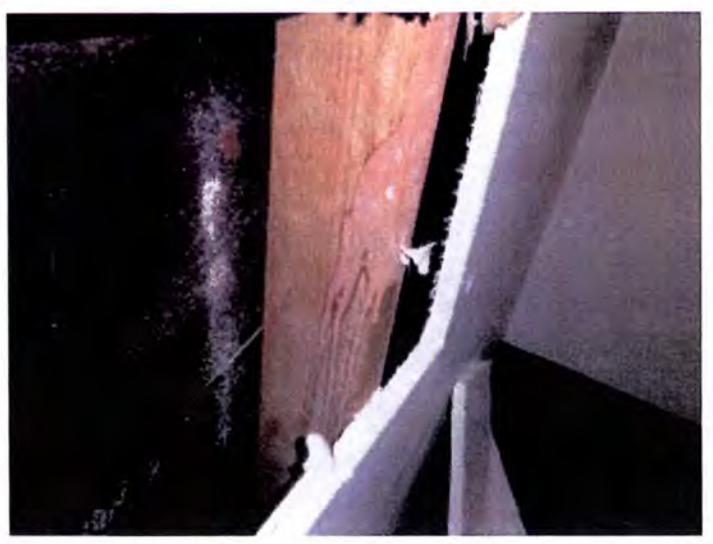
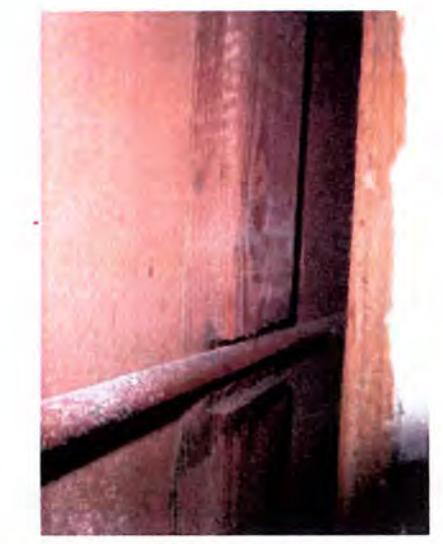
No more than two access holes were cut into the interior wall finishes of each building to determine the condition of the wall framing members. These openings were made at the areas of visible moisture/termite/mold damage. The underlying framing appeared to be intact and functional when inspected.

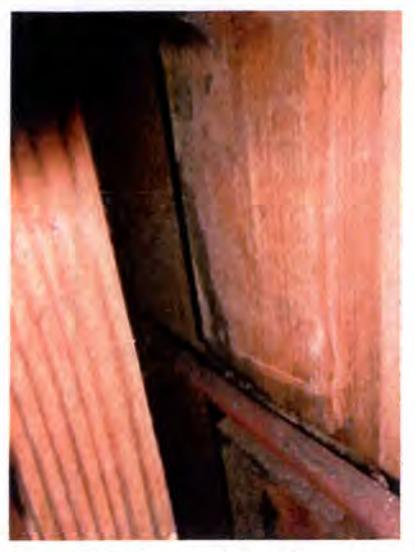
Visible and accessible framing areas were inspected for termite and/or moisture damage and appeared to be intact and functional at the time of inspection. Any replacement of framing members will be select demo of individual components and not greater than 20% of installed materials. This only pertains to the three primary residential structures and not the single story storage building.

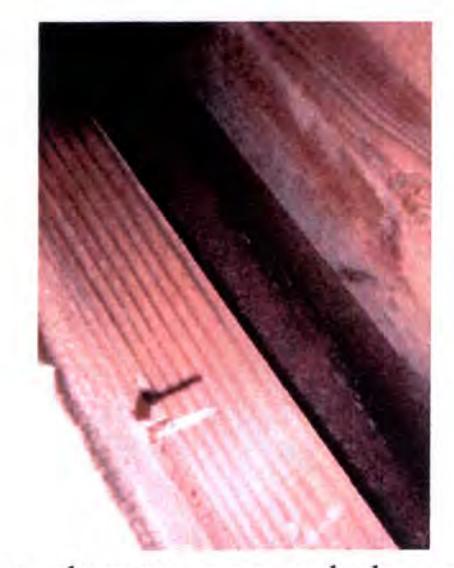
No more than two access holes were cut into the interior wall finishes of each building to determine the condition of the wall framing members. These openings were made at the areas of visible moisture/termite/mold damage. The underlying framing appeared to be intact and functional when inspected.

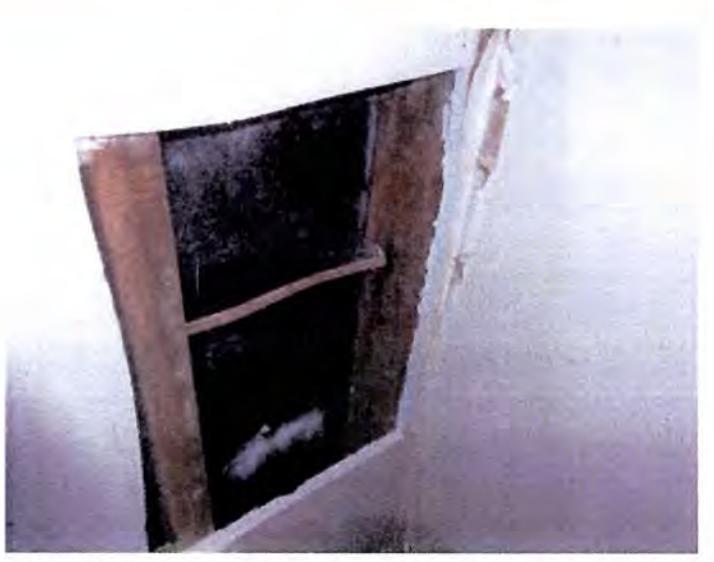
No more than two access holes were cut into the interior wall finishes of each building to determine the condition of the wall framing members. These openings were made at the areas of visible moisture/termite/mold damage. The underlying framing appeared to be intact and functional when inspected.

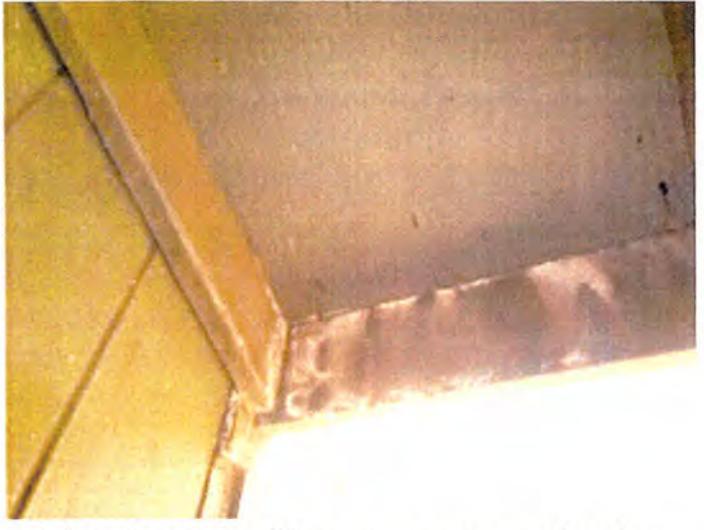
The fascia/soffit areas appeared to be rotted/water damaged/deteriorated at the licensed contractor evaluate and repair/replace as necessary.

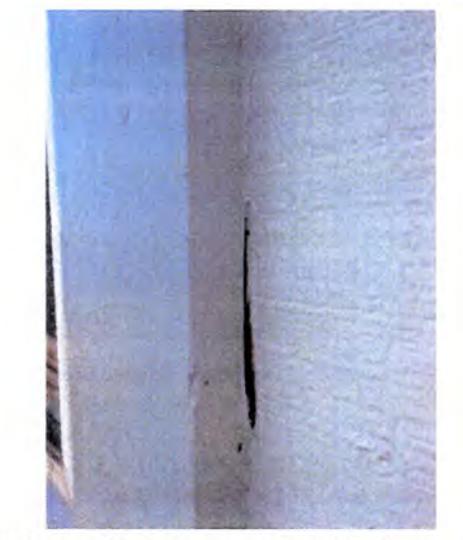
Visible indications of WDO (termite) damage noted. Recommend having a time of inspection. Recommend having a licensed pest contractor evaluate and treat as necessary. Also, recommend having a licensed contractor evaluate and repair/replace damaged material as necessary.

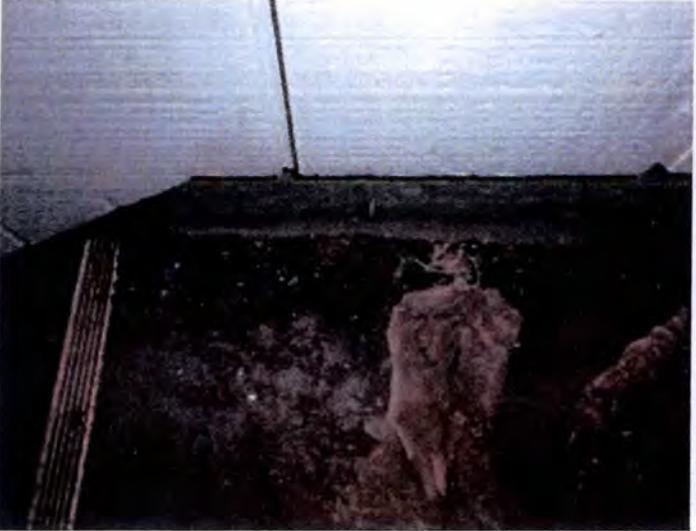
There were visible indications of WDO (Wood Destroying Organism) damage noted at the fascia and soffit areas. Recommend having a licensed contractor as necessary. Also, recommend having a evaluate and repair/replace as necessary.

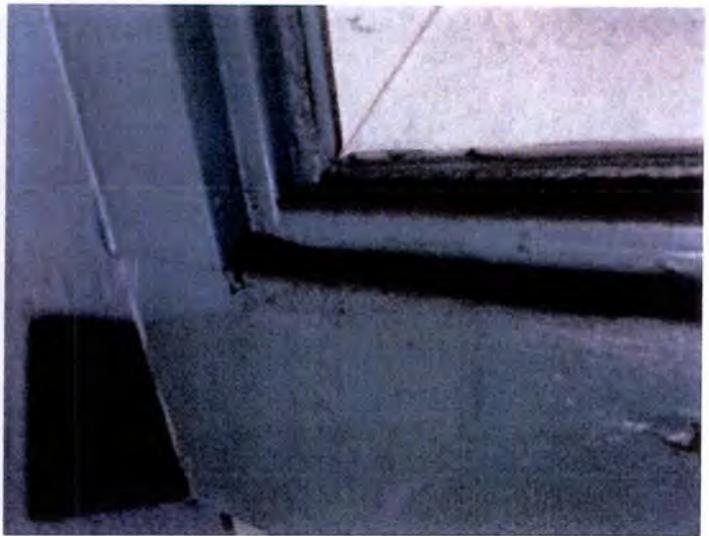
Visible indications of WDO (termite) damage noted. Recommend having a licensed pest contractor evaluate and treat licensed contractor evaluate and repair/replace damaged material as necessary.

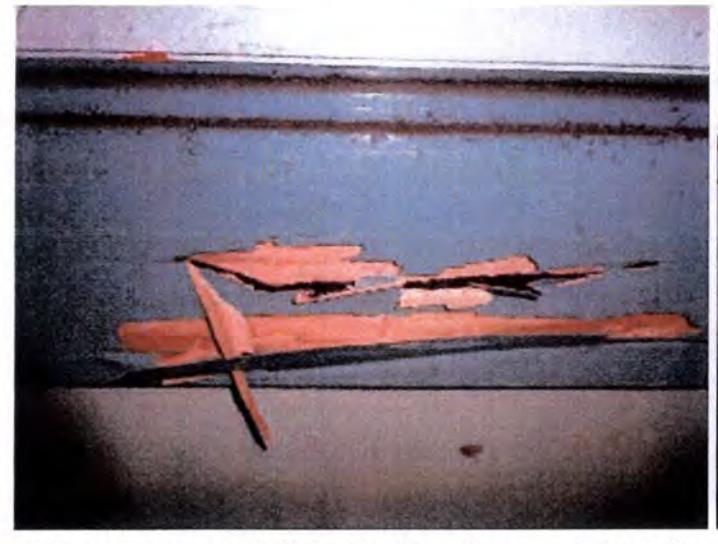
There were visible indications of WDO (Wood Destroying Organism) damage noted at the fascia and soffit areas. Recommend having a licensed contractor as necessary. Also, recommend having a evaluate and repair/replace as necessary.

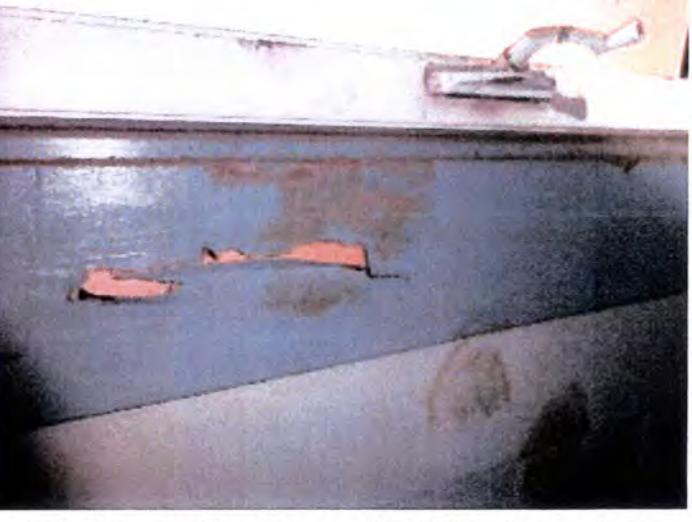
Visible indications of WDO (termite) damage noted. Recommend having a licensed pest contractor evaluate and treat licensed contractor evaluate and repair/replace damaged material as necessary.

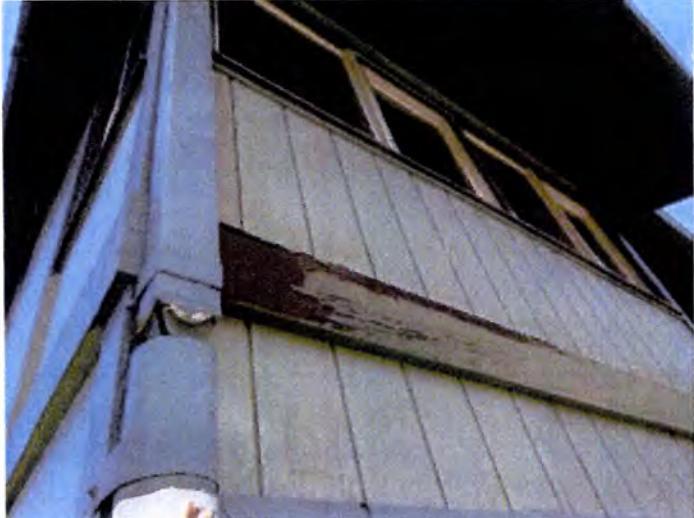
Blistering/peeling/missing paint observed at many exterior trim, fascia and soffit areas. Recommend properly preparing and refinishing exterior finishes.

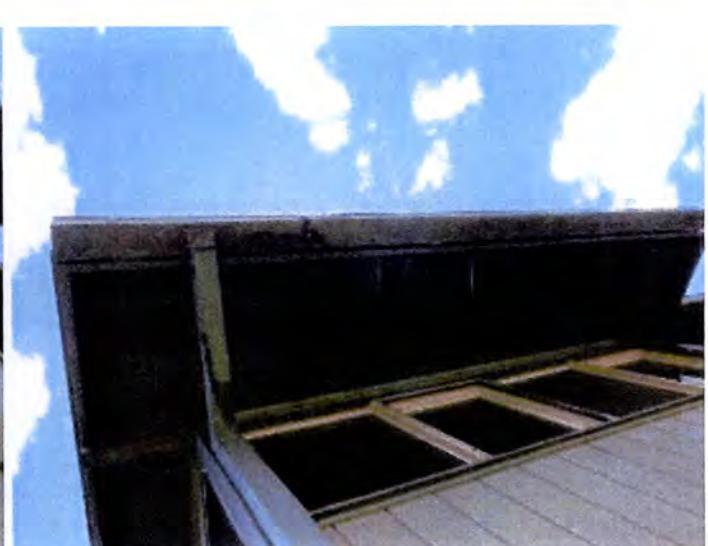
Moisture damage observed at exterior wall areas. Recommend select demolition and replacement of affected ground level exterior siding and finishes.

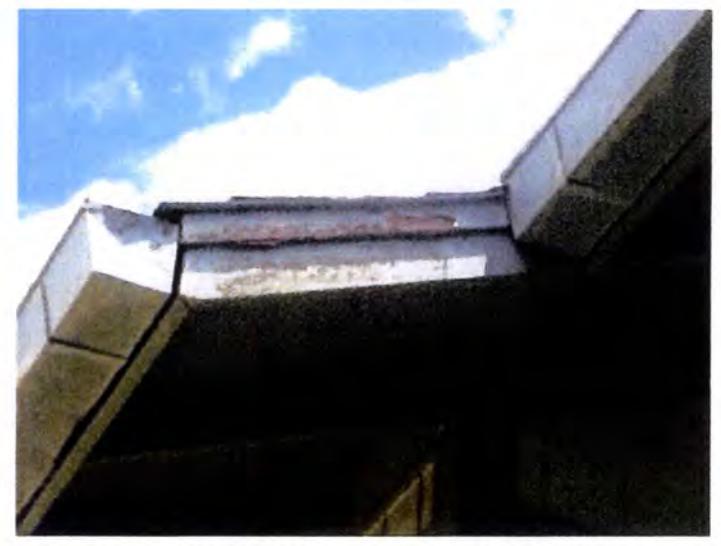
Blistering/peeling/missing paint observed at many exterior trim, fascia and soffit areas. Recommend properly preparing and refinishing exterior finishes.

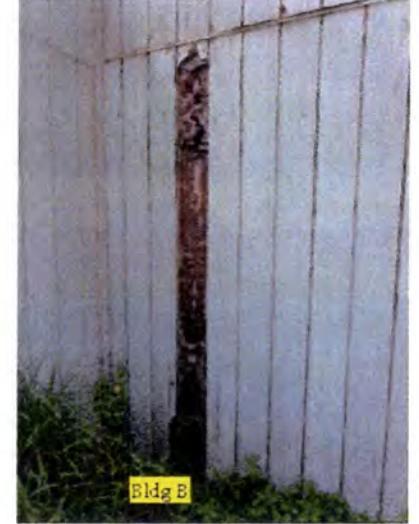
Visible indications of WDO (termite) damage noted. Recommend having a licensed pest contractor evaluate and treat as necessary. Also, recommend having a licensed contractor evaluate and repair/replace damaged material as necessary.

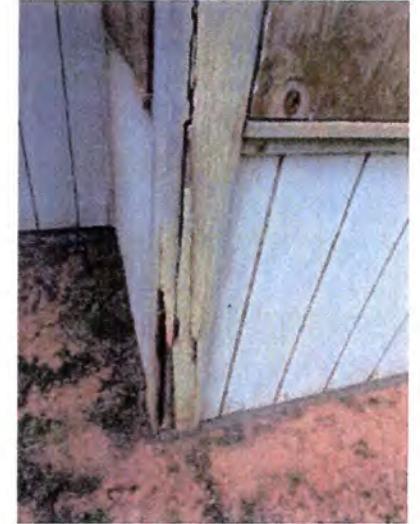
Visible indications of WDO (termite) damage noted. Recommend having a licensed pest contractor evaluate and treat as necessary. Also, recommend having a licensed contractor evaluate and repair/replace damaged material as necessary.

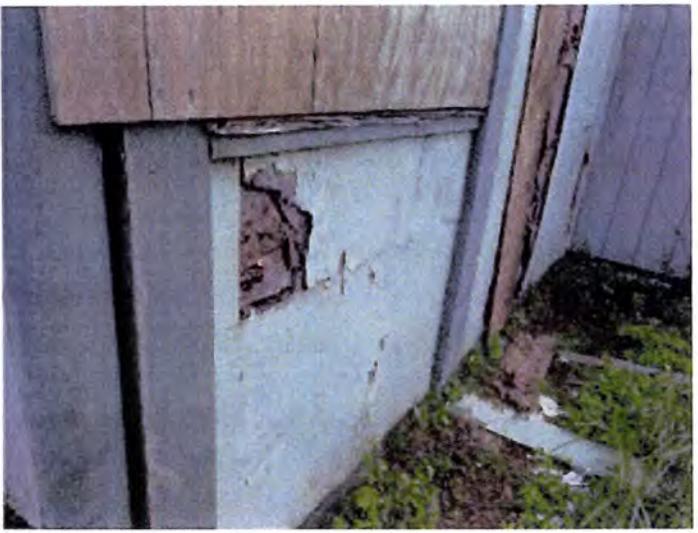
Moisture damage observed at exterior wall areas. Recommend select demolition exterior siding and finishes.

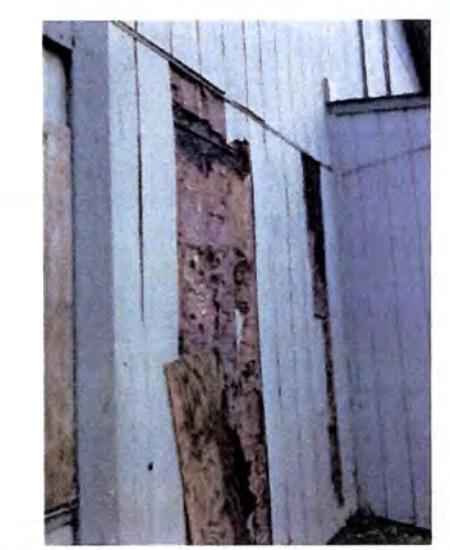
Visible indications of WDO (termite) damage noted. Recommend having a and replacement of affected ground level licensed pest contractor evaluate and treat as necessary. Also, recommend having a licensed contractor evaluate and repair/replace damaged material as necessary.

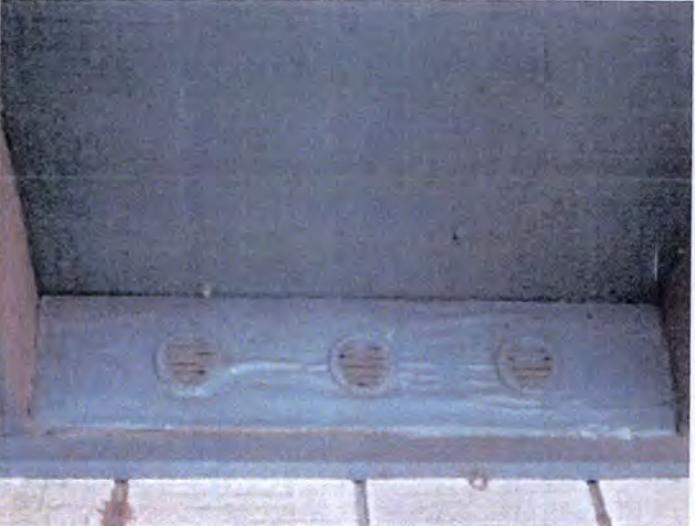
There were visible indications of WDO (Wood Destroying Organism) damage noted at the fascia and soffit areas. evaluate and repair/replace as necessary.

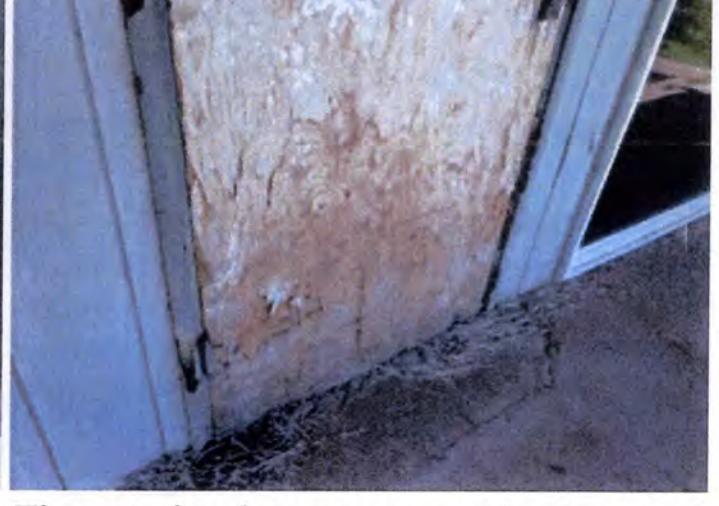
The exterior doors were termite damaged or deteriorated to the point of being inoperable. We recommend replacement Recommend having a licensed contractor of all exterior doors, framing and trim for all buildings.

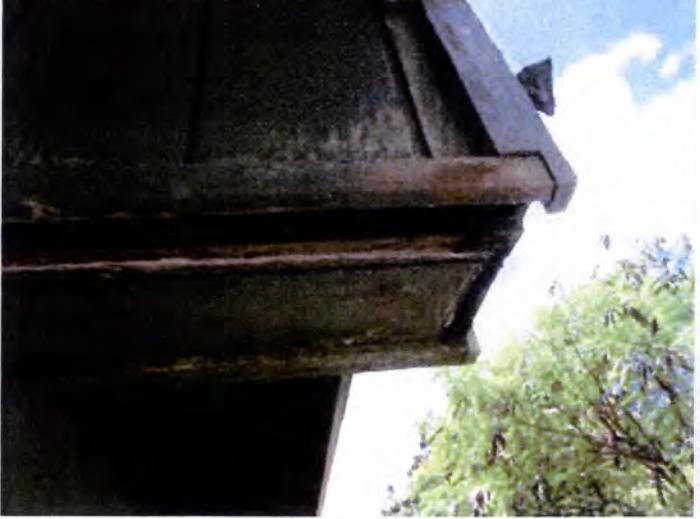
The fascia/soffit areas appeared to be rotted/water damaged/deteriorated at the licensed contractor evaluate and repair/replace as necessary.

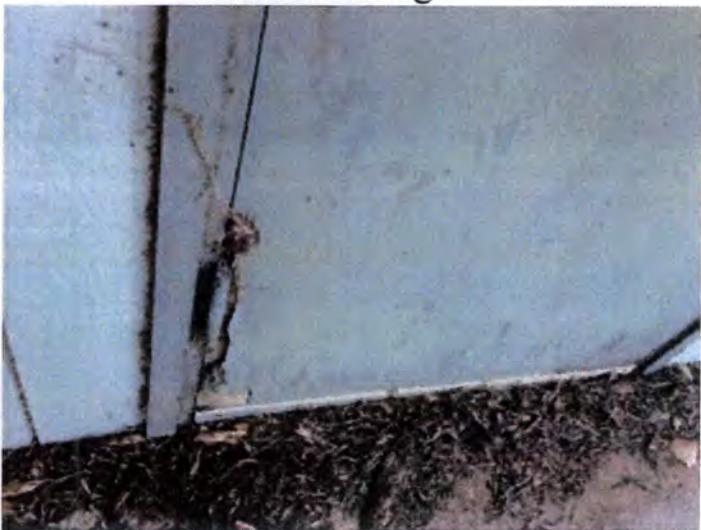
The exterior doors were termite damaged or deteriorated to the point of being time of inspection. Recommend having a inoperable. We recommend replacement of all exterior doors, framing and trim for all buildings.

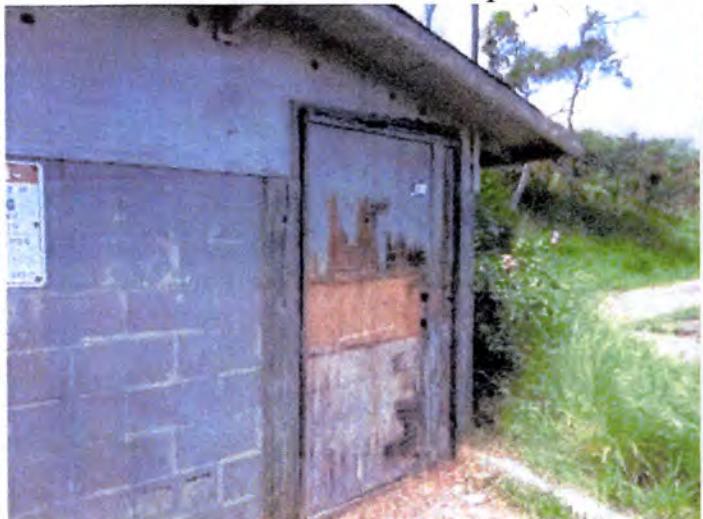
The exterior doors were termite damaged or deteriorated to the point of being inoperable. We recommend replacement of all exterior doors, framing and trim for all buildings.

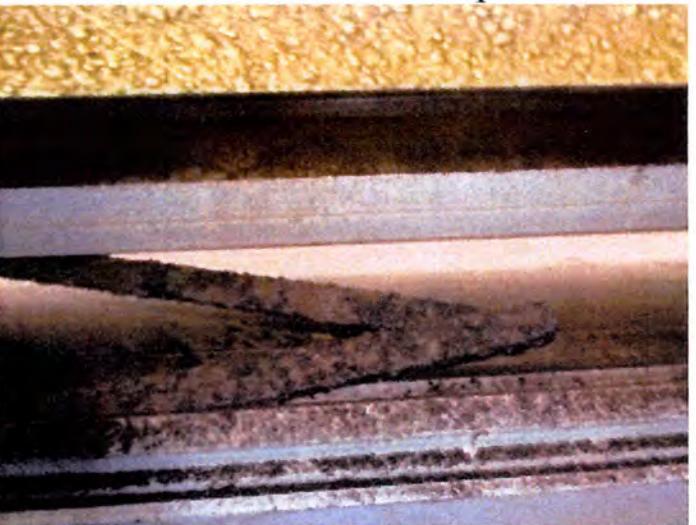
The stair way windows were heavily corroded, damaged and/or inoperable at the time of inspection. Recommend replacement.

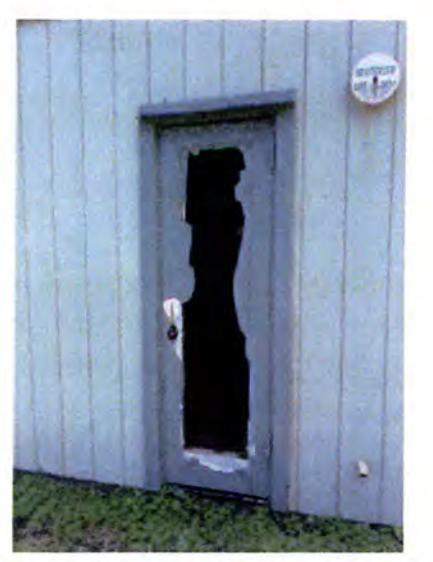
The exterior doors were termite damaged or deteriorated to the point of being inoperable. We recommend replacement of all exterior doors, framing and trim for numerous locations. We recommend the all buildings.

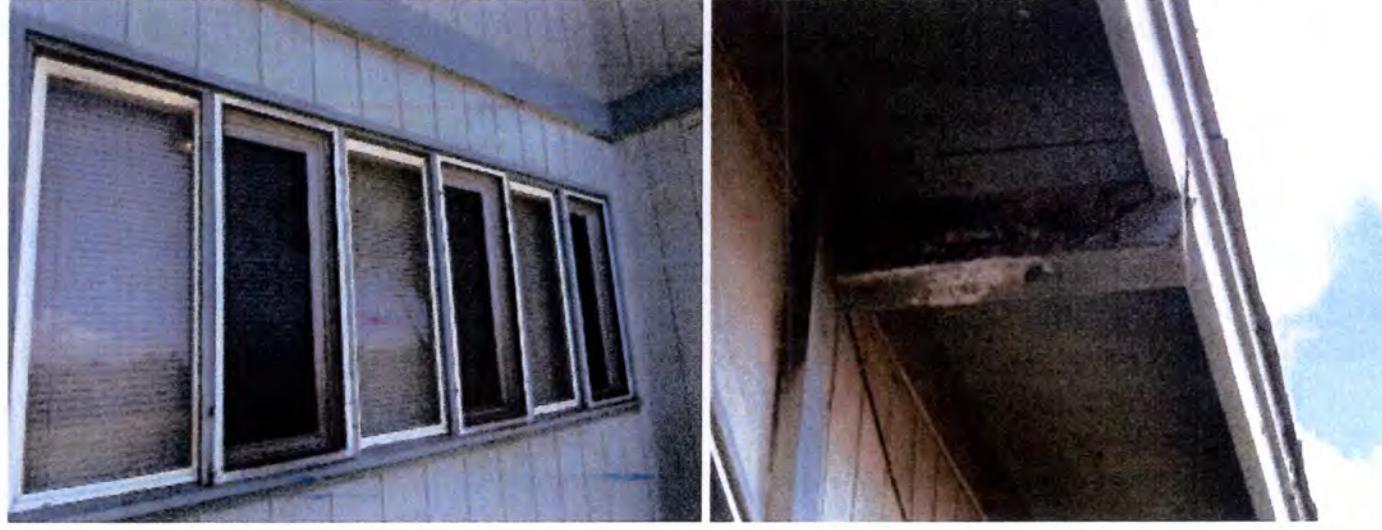
The fascia/soffit areas appeared to be rotted/water damaged/deteriorated at the time of inspection. Recommend having a licensed contractor evaluate and repair/replace as necessary.

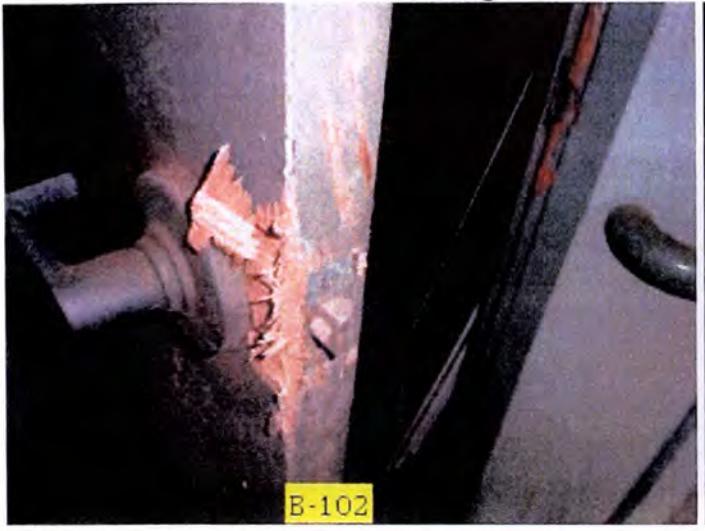
The exterior doors were termite damaged or deteriorated to the point of being inoperable. We recommend replacement of all exterior doors, framing and trim for all buildings.

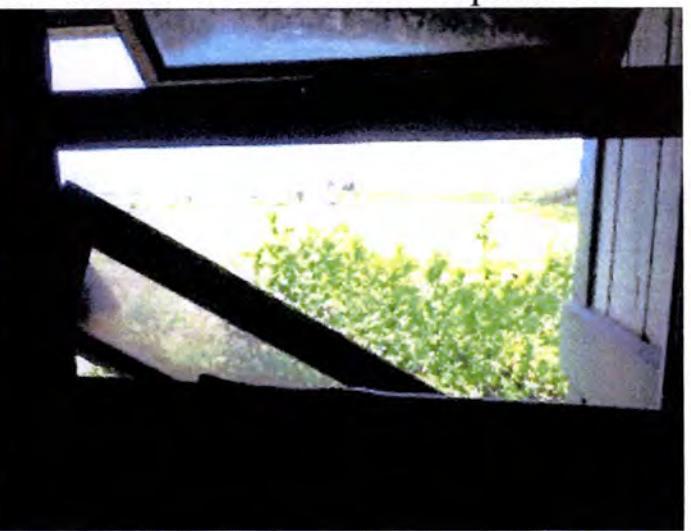
The stair way windows were heavily corroded, damaged and/or inoperable at the time of inspection. Recommend replacement.

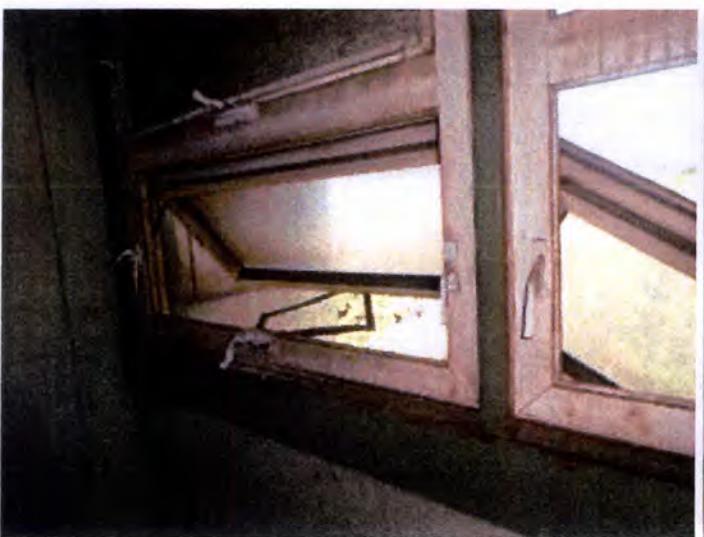
The stair way windows were heavily corroded, damaged and/or inoperable at the time of inspection. Recommend replacement.

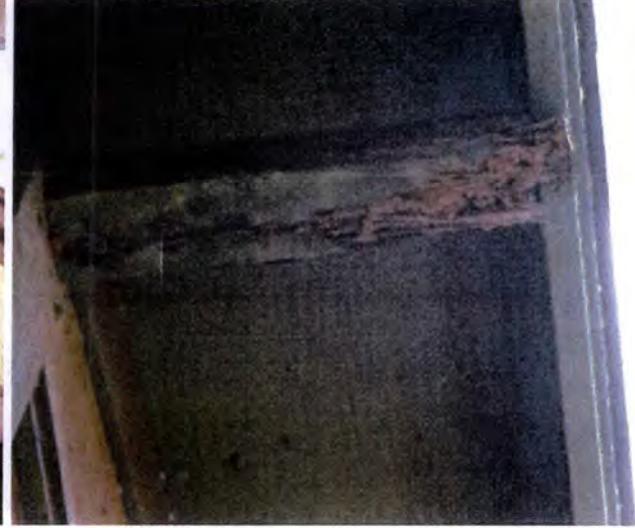
There were visible indications of WDO (Wood Destroying Organism) damage noted at the fascia and soffit areas. Recommend having a licensed contractor evaluate and repair/replace as necessary.

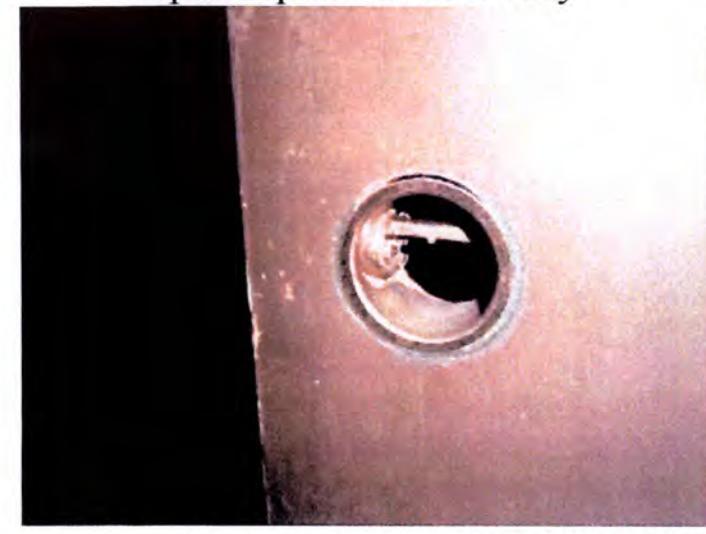
The exterior doors were termite damaged or deteriorated to the point of being inoperable. We recommend replacement of all exterior doors, framing and trim for all buildings.

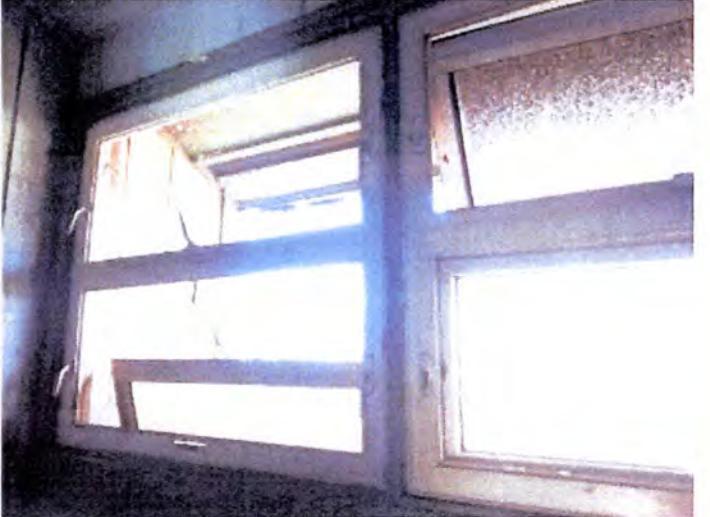
The stair way windows were heavily corroded, damaged and/or inoperable at the time of inspection. Recommend replacement.

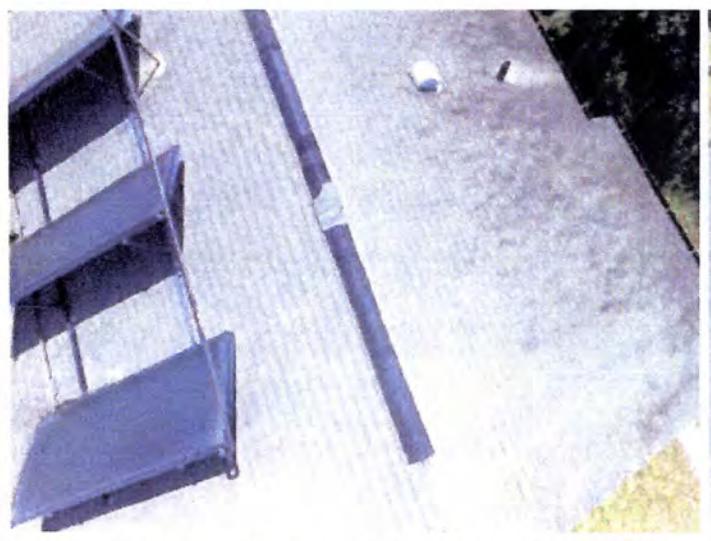
There were numerous areas of missing shingles observed at the roof ridge areas. Recommend repair in conjunction with roof replacement.

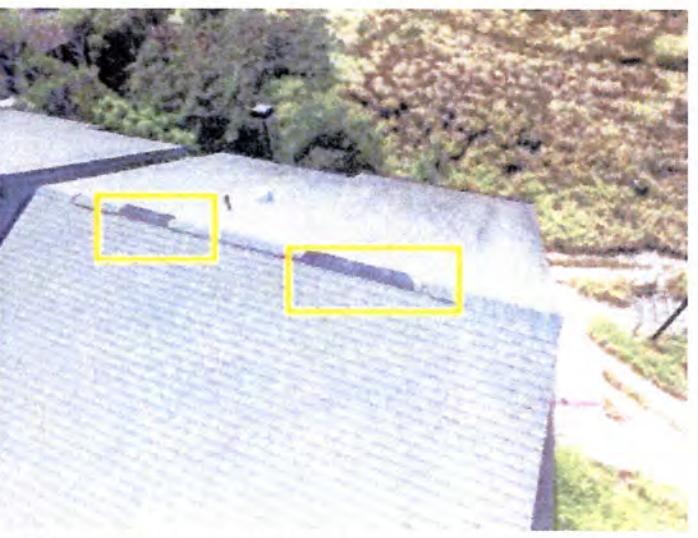
There were numerous areas of missing shingles observed at the roof ridge areas. Recommend repair in conjunction with roof replacement.

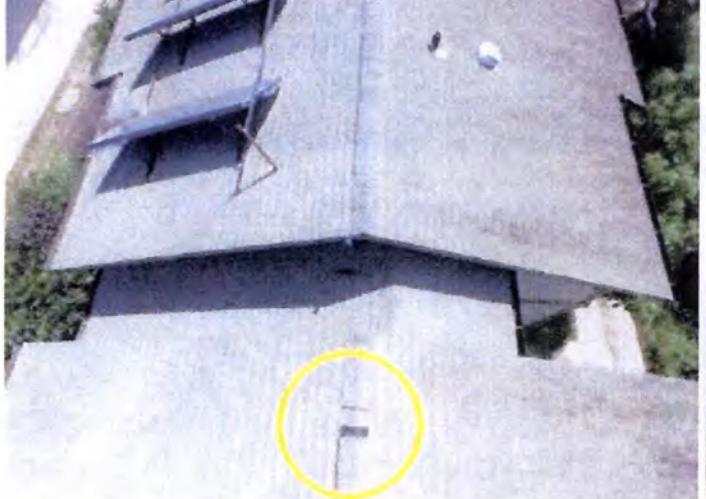
There were numerous areas of missing shingles observed at the roof ridge areas. Recommend repair in conjunction with roof replacement.

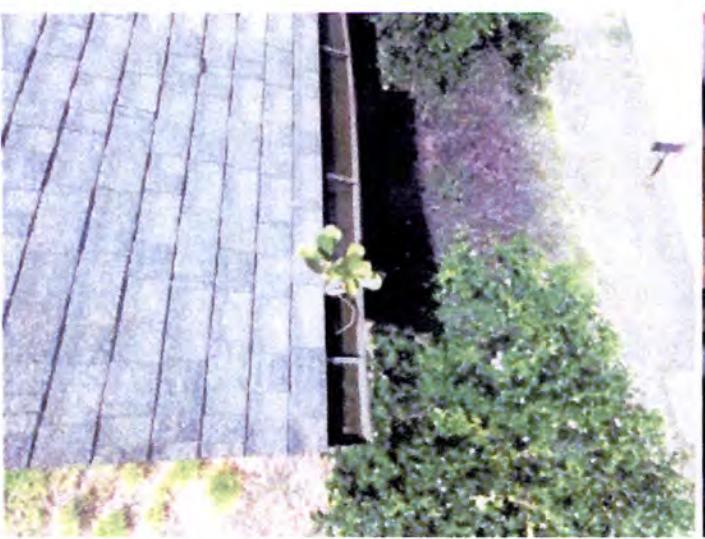
Damaged/broken/missing gutters noted. Recommend having a licensed contractor evaluate and repair/replace as necessary.

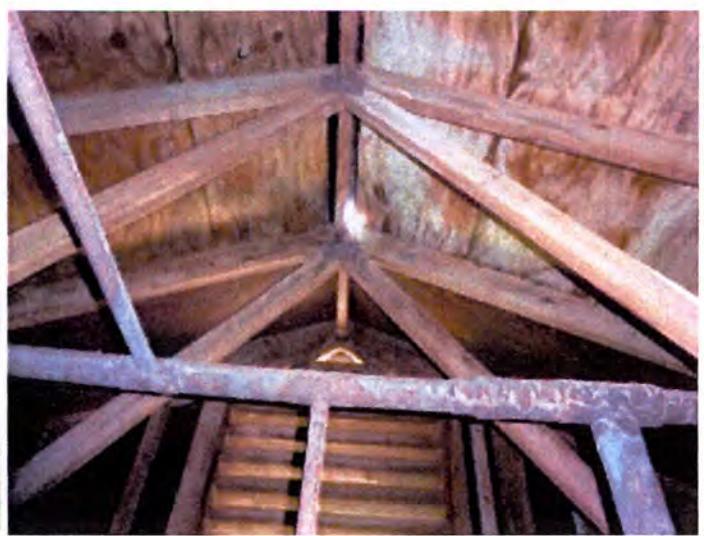
There were visible areas of moisture intrusion observed at the roof sheathing (within the attic spaces) at the time of inspection. This indicated a failed/failing roofing system. Recommend replacement of the installed sheathing and roofing finish.

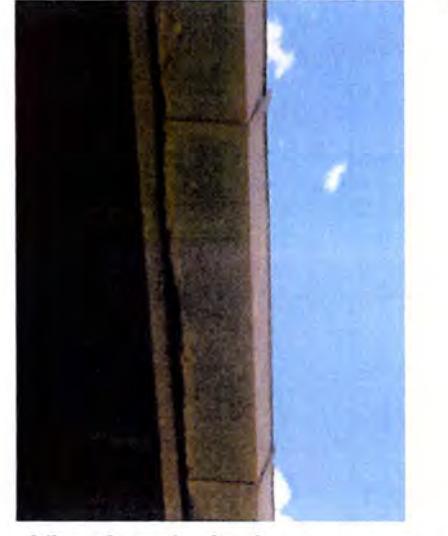
Damaged/broken/missing gutters noted. Recommend having a licensed contractor evaluate and repair/replace as necessary.

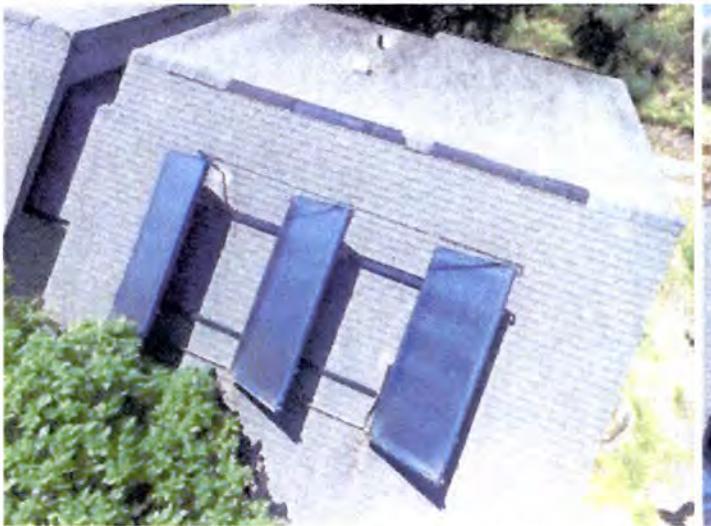
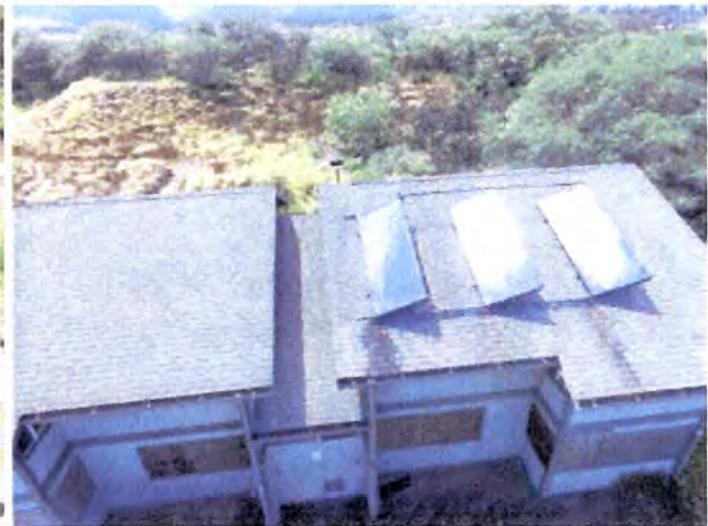
There were solar water heating panels located on the roofing areas of the buildings. There were visible indications of leaks and interior hazing at the panels which is an indication of damage to the environmental seals or panels. These should be evaluated by a licensed plumbing contractor prior to use.

There were solar water heating panels located on the roofing areas of the buildings. There were visible indications of leaks and interior hazing at the panels which is an indication of damage to the environmental seals or panels. These panels did not appear to be in service and panels did not appear to be in service and should be evaluated by a licensed plumbing contractor prior to use.
