SUBJECT: COUNTY-OWNED PARCEL ON NORTH PAPA AVENUE (KAHULUI) (HHT-14)

Property Condition Report

310 W Kaahumanu Ave, Kahului, HI 96732 Inspection prepared for: Maui County c/o Buddy Almeida Real Estate Agent: -

Date of Inspection: 3/28/2018 Time: 8:00 AM Age of Home: 1980 Size: 15000 This is a commercial property condition assessment to determine of three (3) former UH dormitories are suitable for housing. This inspection includes invasive and non-invasive inspection methods as well as sampling for asbestos and lead based paint.

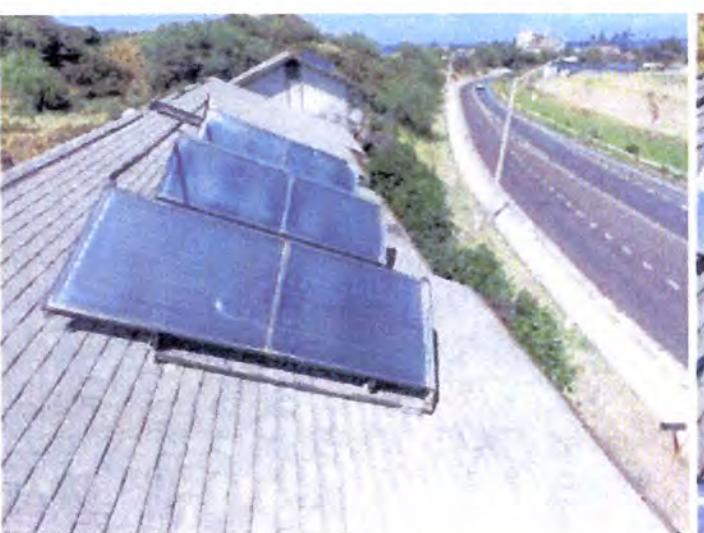
There were solar water heating panels located on the roofing areas of the buildings. There were visible indications of leaks and interior hazing at the panels which is an indication of damage to the environmental seals or panels. These should be evaluated by a licensed plumbing contractor prior to use.

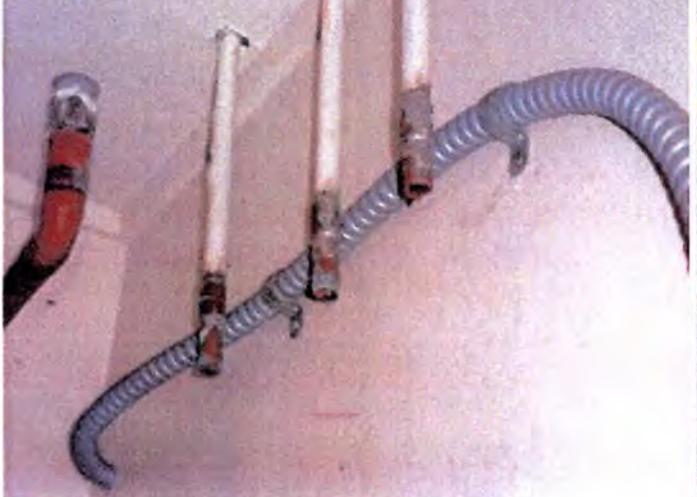
All water heating appliances were terminated with supply and service plumbing cut and electrical connections removed. Recommend having a licensed plumber evaluate and install commercial grade gas on demand hot water heating systems for each floor of each building.

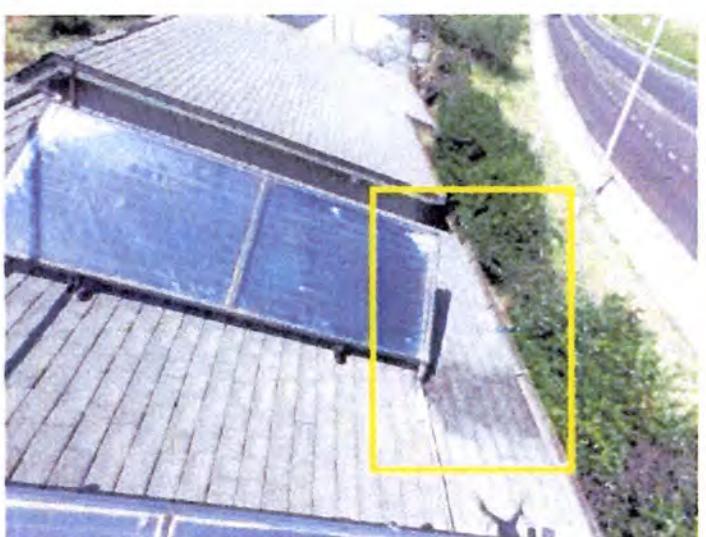
There were solar water heating panels located on the roofing areas of the buildings. There were visible indications of leaks and interior hazing at the panels which is an indication of damage to the environmental seals or panels. These panels did not appear to be in service and panels did not appear to be in service and should be evaluated by a licensed plumbing contractor prior to use.

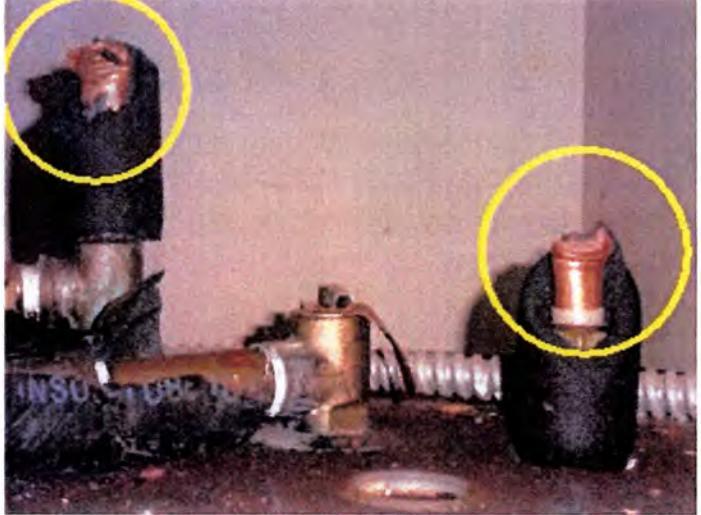
All water heating appliances were terminated with supply and service plumbing cut and electrical connections removed. Recommend having a licensed plumber evaluate and install commercial grade gas on demand hot water heating systems for each floor of each building.

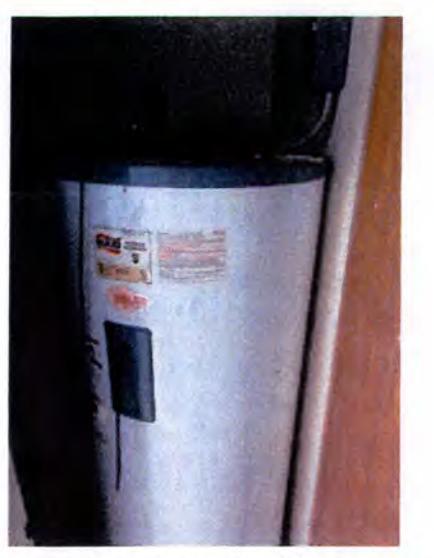
All water heating appliances were terminated with supply and service plumbing cut and electrical connections removed. Recommend having a licensed plumber evaluate and install commercial grade gas on demand hot water heating systems for each floor of each building.

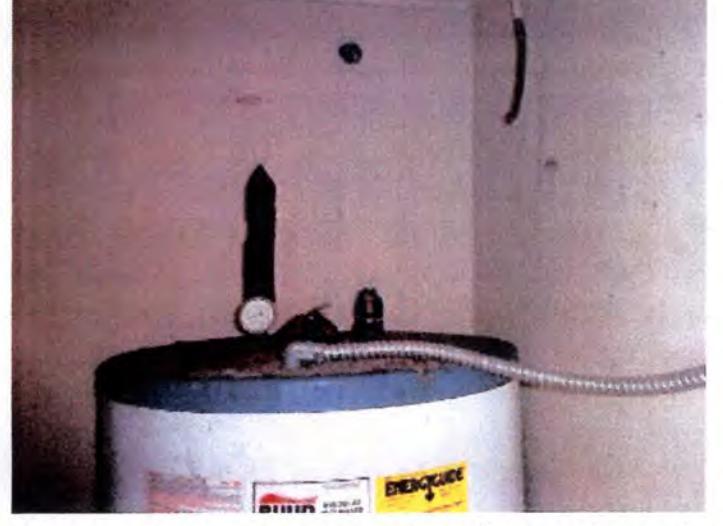
All water heating appliances were terminated with supply and service plumbing cut and electrical connections removed. Recommend having a licensed plumber evaluate and install commercial grade gas on demand hot water heating systems for each floor of each building.

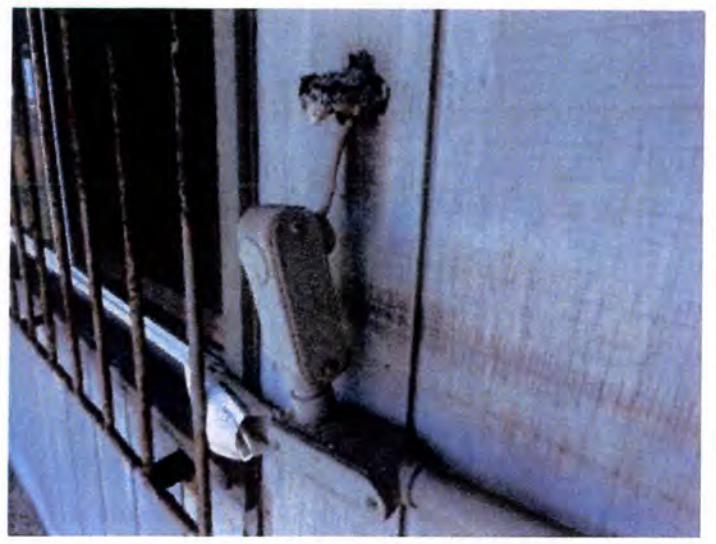
Storage bldg: Exterior conduit was damaged/detached from the bend box. Recommend repair.

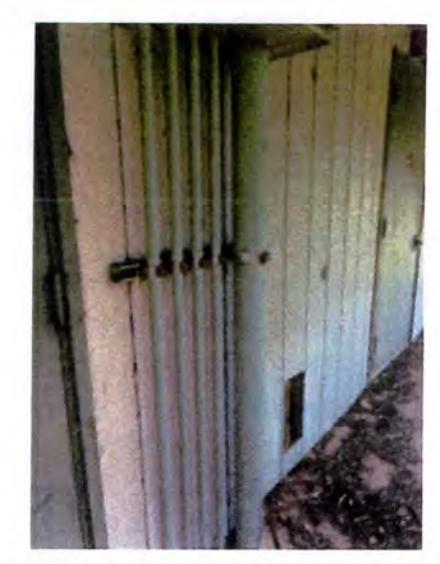
Service conductors are encased in rigid conduit

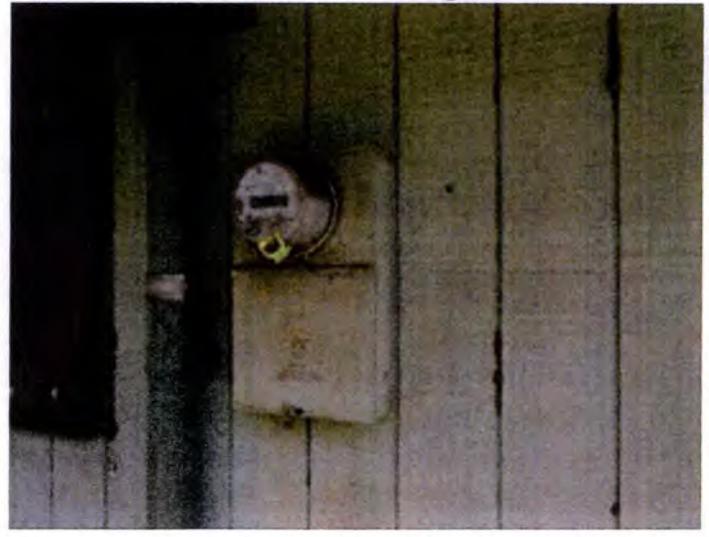
The meter enclosures were inspected for Transformers were located: rear center of installation and integrity and appeared to be intact and functioning properly at the time of inspection.

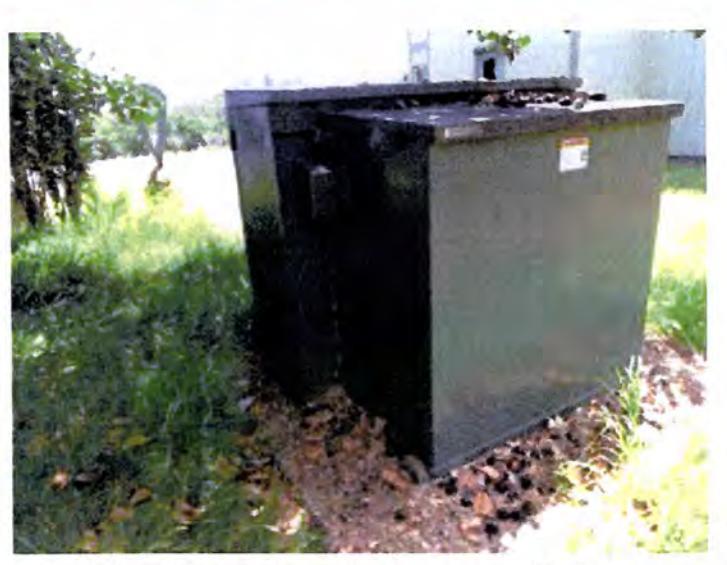
All installed transformers, switch gear and CT cabinets appeared to be installed properly with no visible signs of leaks/seepage noted at the transformers and all cabinets were intact and corrosion free at the time of inspection.

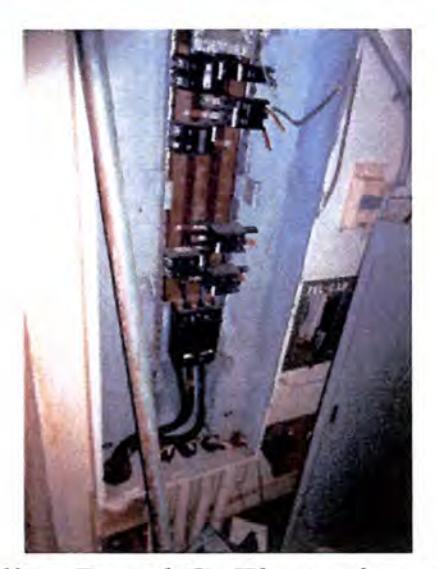
Building B and C: The main service conductors and all electrical branch wiring was cut at the main service panel entrances (located in the respective electrical rooms) when inspected. Recommend having a licensed electrical contractor evaluate and repair electrical service to each building. The installed cabinets, panels and service disconnects appeared serviceable.

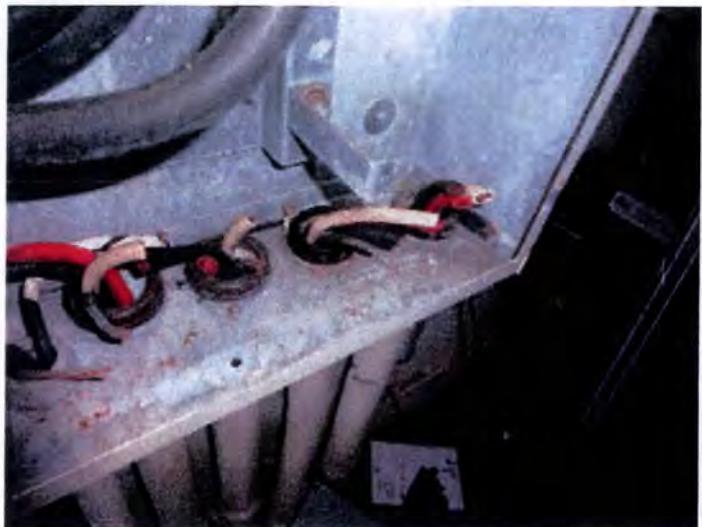
Building B and C: The main service conductors and all electrical branch wiring was cut at the main service panel entrances (located in the respective electrical rooms) when inspected. Recommend having a licensed electrical contractor evaluate and repair electrical service to each building. The installed cabinets, panels and service disconnects appeared serviceable.

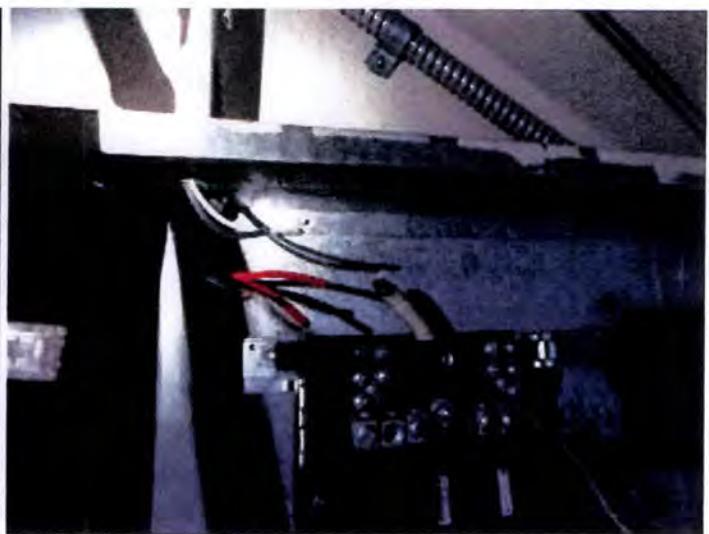
Building B and C: The main service conductors and all electrical branch wiring was cut at the main service panel entrances (located in the respective electrical rooms) when inspected. Recommend having a licensed electrical contractor evaluate and repair electrical service to each building. The installed cabinets, panels and service disconnects appeared serviceable.

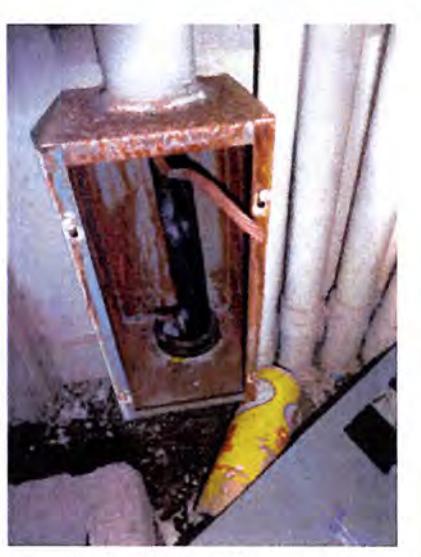
Building B and C: The main service conductors and all electrical branch wiring was cut at the main service panel entrances (located in the respective electrical rooms) when inspected. Recommend having a licensed electrical contractor evaluate and repair electrical service to each building. The installed cabinets, panels and service disconnects appeared serviceable.

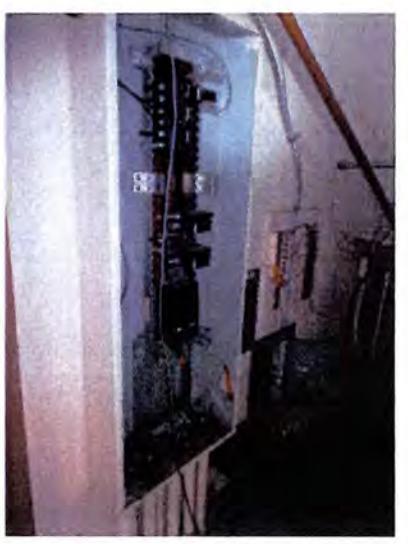
Building B and C: The main service conductors and all electrical branch wiring was cut at the main service panel entrances (located in the respective electrical rooms) when inspected. Recommend having a licensed electrical contractor evaluate and repair electrical service to each building. The installed cabinets, panels and service disconnects appeared serviceable.

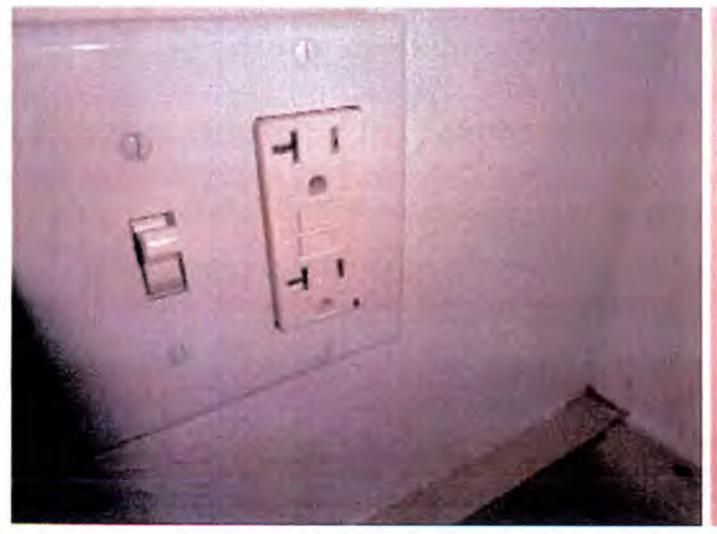
Building A's tested receptacles, switches Each dwelling unit was serviced by one and lights operated properly at the time of inspection. There were missing bulbs observed but power was present at the fixtures.

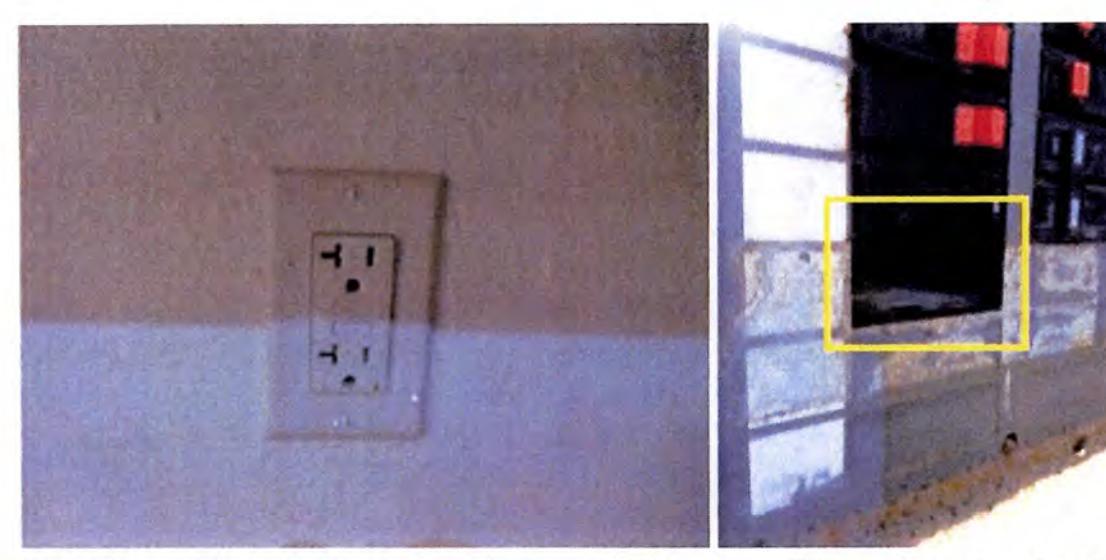
Building A's tested receptacles, switches and lights operated properly at the time of inspection. There were missing bulbs observed but power was present at the fixtures.

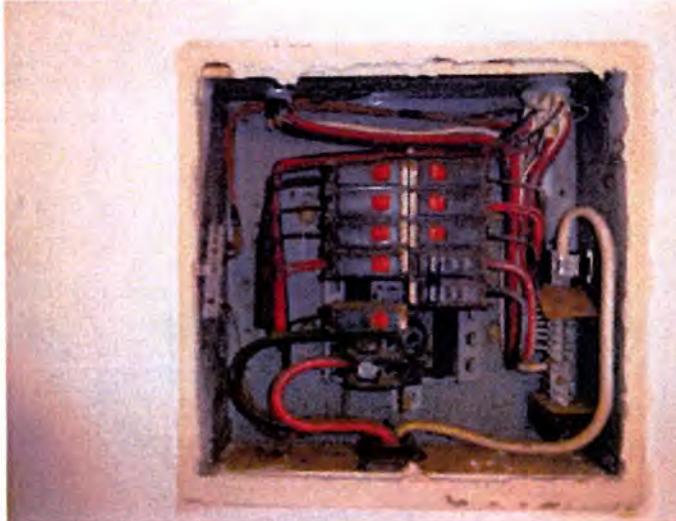
The installed circuit breakers appeared to be functioning properly and securely in place at the time of inspection.

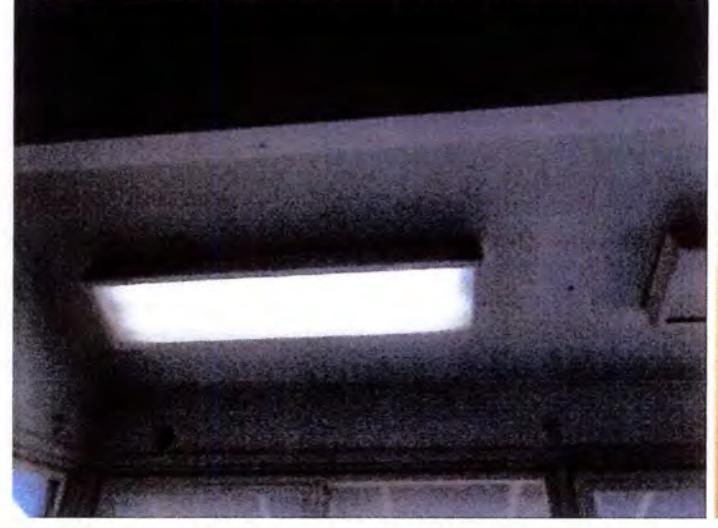
Building A's tested receptacles, switches The installed circuit breakers appeared to and lights operated properly at the time of inspection. There were missing bulbs observed but power was present at the fixtures.

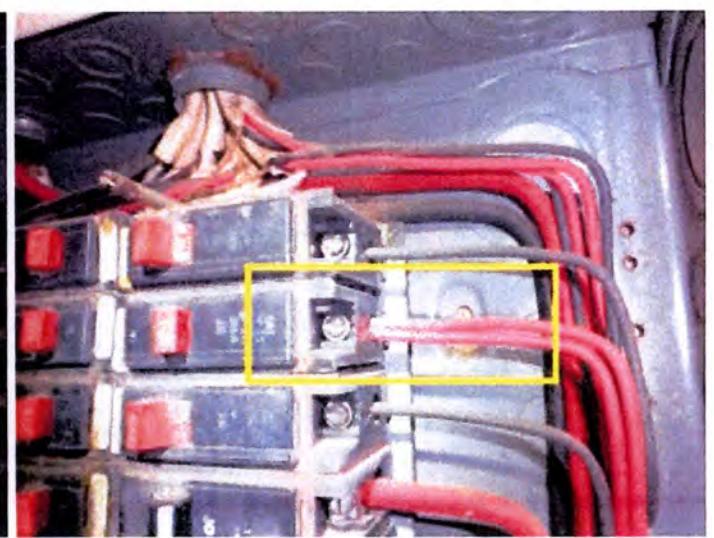
There were double tapped 1-pole circuit breakers noted at the time of inspection. This is not consistent with the We recommend having a licensed necessary.

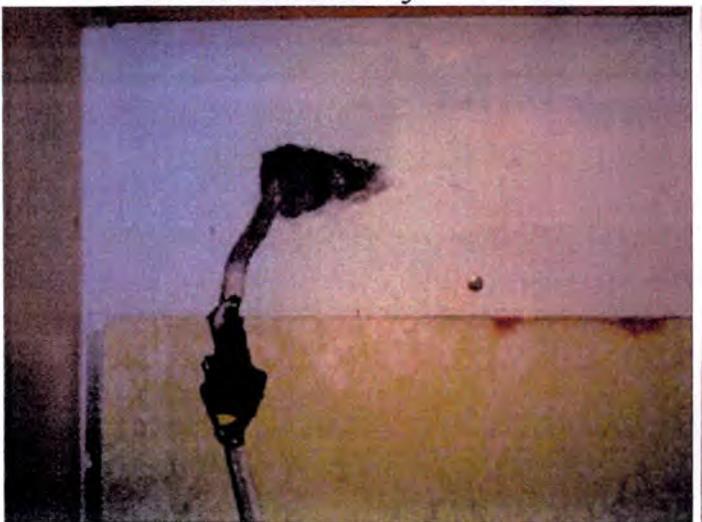
There were improperly terminated splices Each dwelling unit was serviced by one at the following locations: B-201

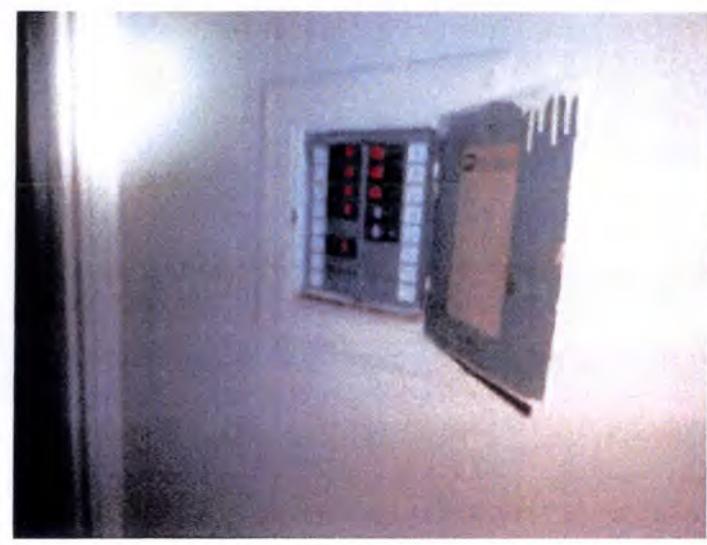
All of the branch wiring to buildings B and C was cut with circuit breakers removed. Recommend having a licensed electrical contractor repair.

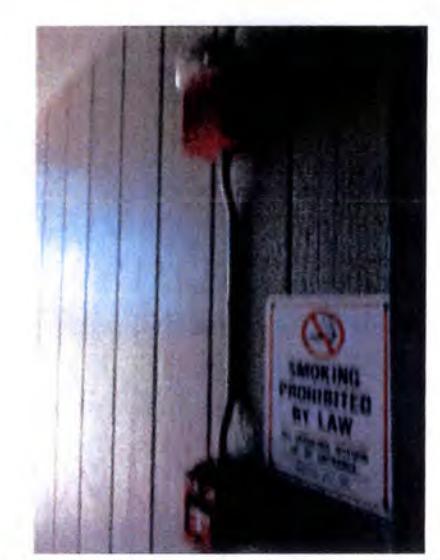
Approximately half of the installed pull stations were damaged when inspected. Recommend replacement/repair.

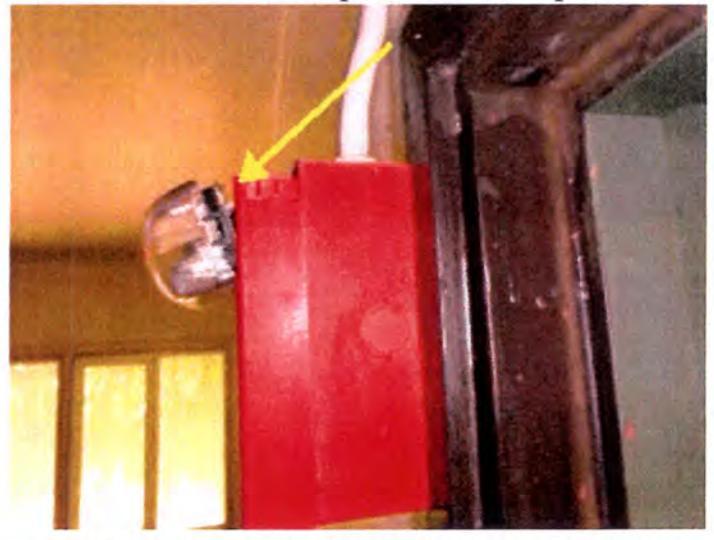
Approximately half of the installed pull stations were damaged when inspected. Recommend replacement/repair.

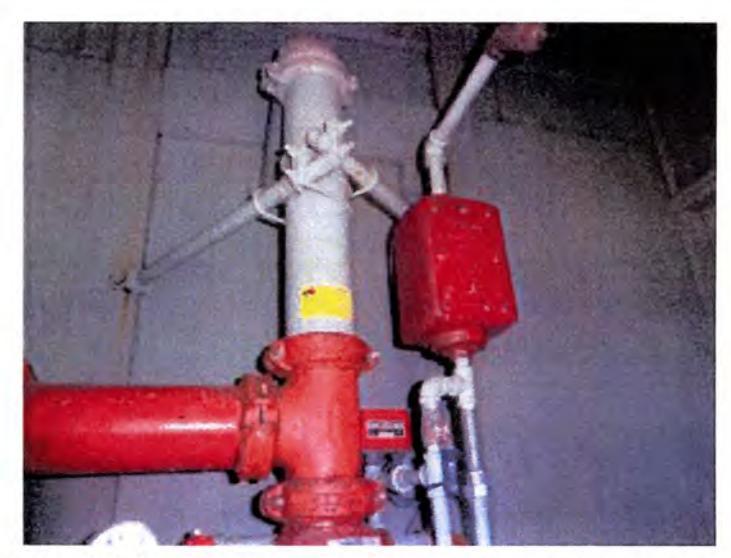
The fire suppression risers were located Sprinkler Systems: due to the system not having been properly serviced at required intervals, adequacy or performance questionable.

The installed risers and associated equipment appeared to be damaged/improperly maintained when inspected. Recommend having a licensed fire suppression contractor evaluate, service, test and inspect the entire fire suppression system.

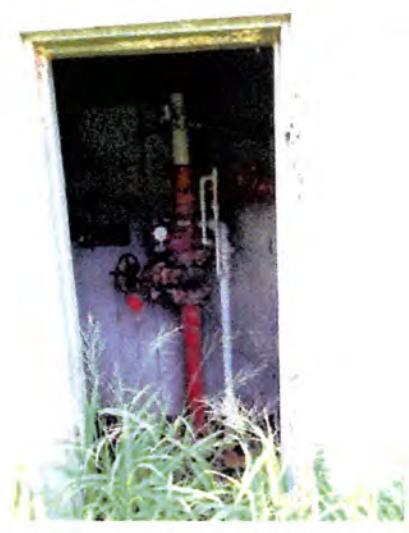
The fire suppression risers were located at the end of each building.

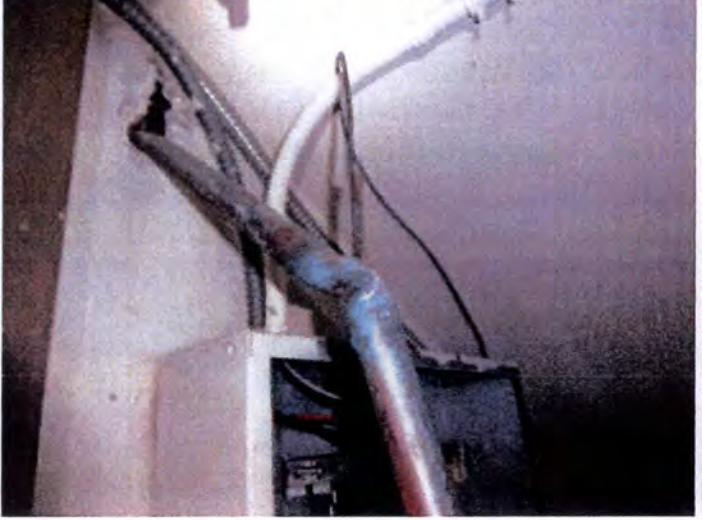
Recommend repair.

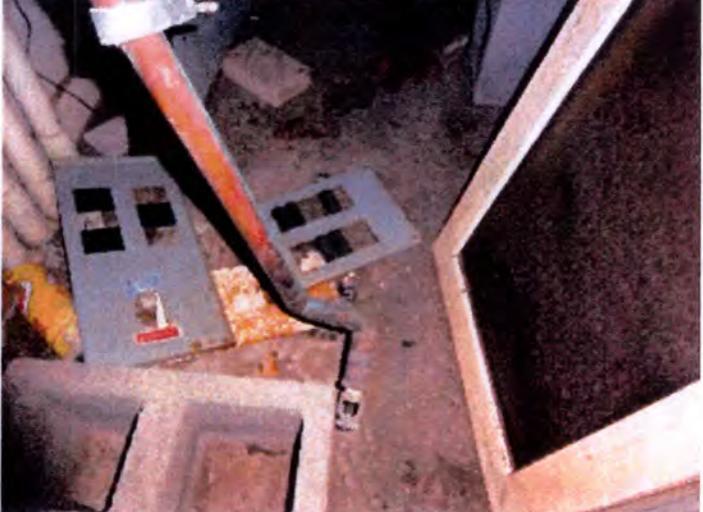
Building B: Sprinkler branch pipe was broken/bent down in the electrical room. Building B: Sprinkler branch pipe was broken/bent down in the electrical room. Recommend repair.

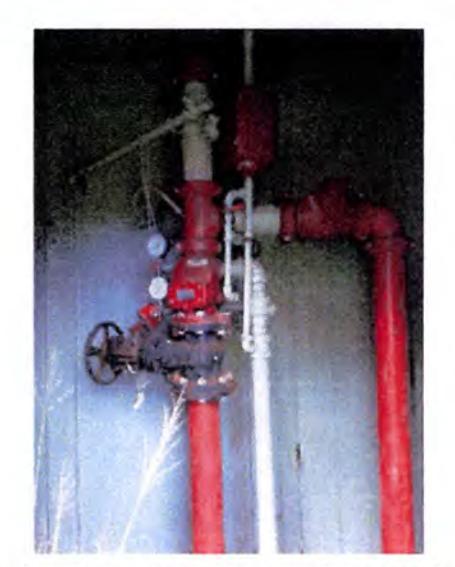
The installed risers and associated equipment appeared to be damaged/improperly maintained when inspected. Recommend having a licensed fire suppression contractor evaluate, service, test and inspect the entire fire suppression system.

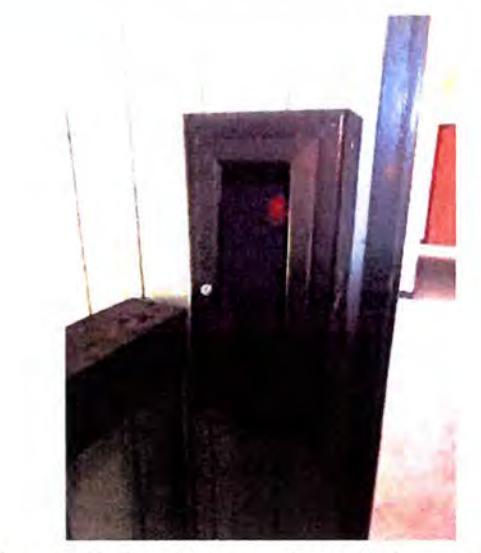
Most of the fire extinguishers were missing at required locations.

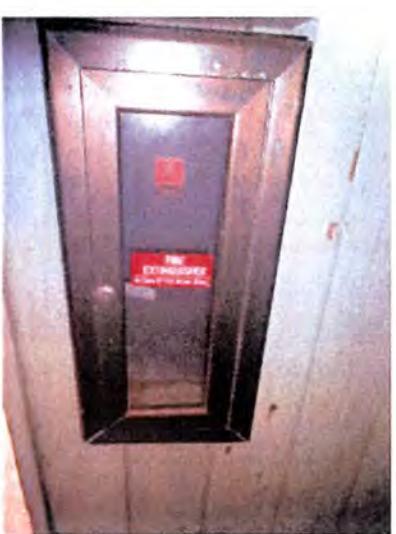
Most of the fire extinguishers were missing at required locations.

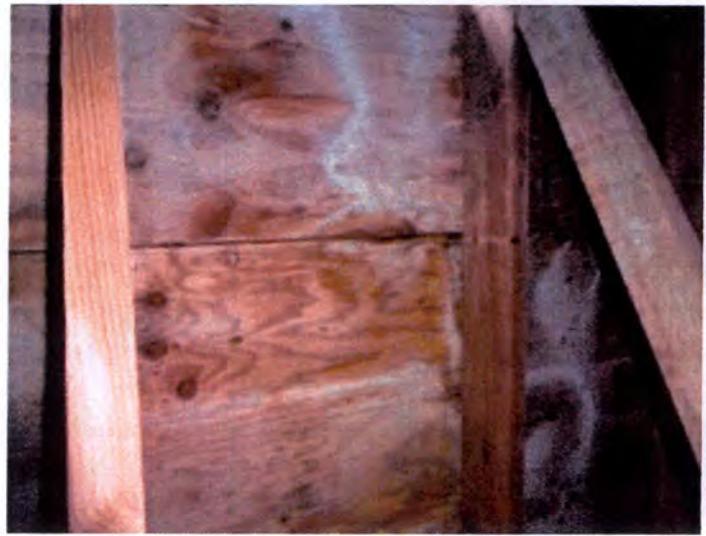
There were visible indications of mold present at all attic areas.

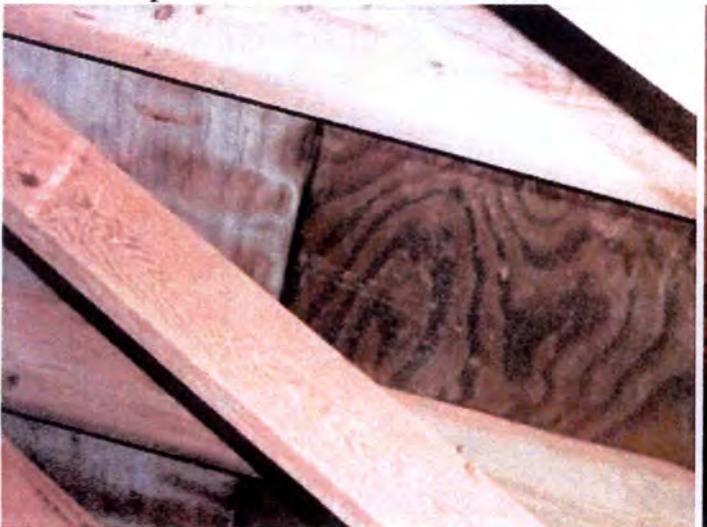
There were visible indications of mold present at all attic areas.

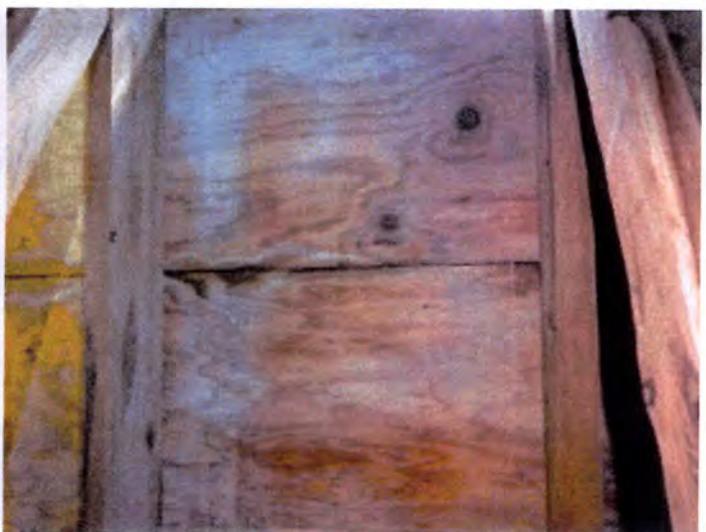
There were visible indications of mold present at all attic areas.

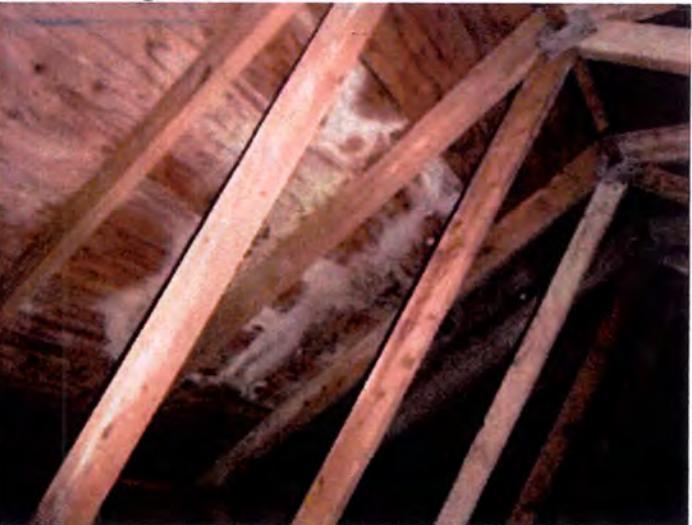
There were visible indications of mold present at all attic areas.

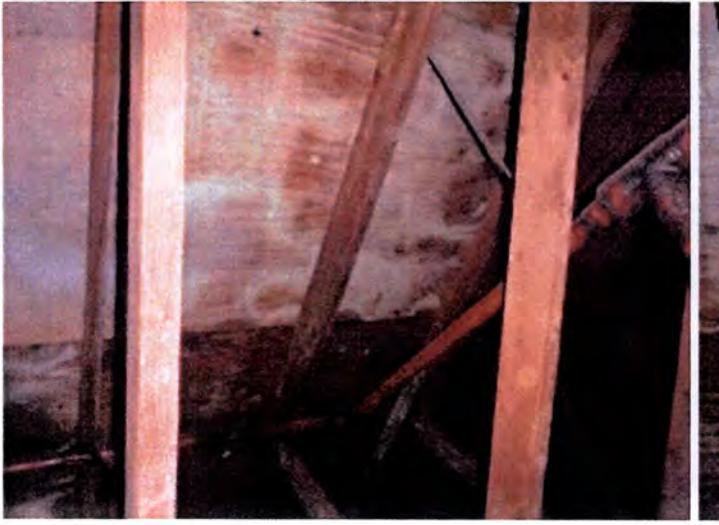
There were visible indications of mold present at all attic areas.

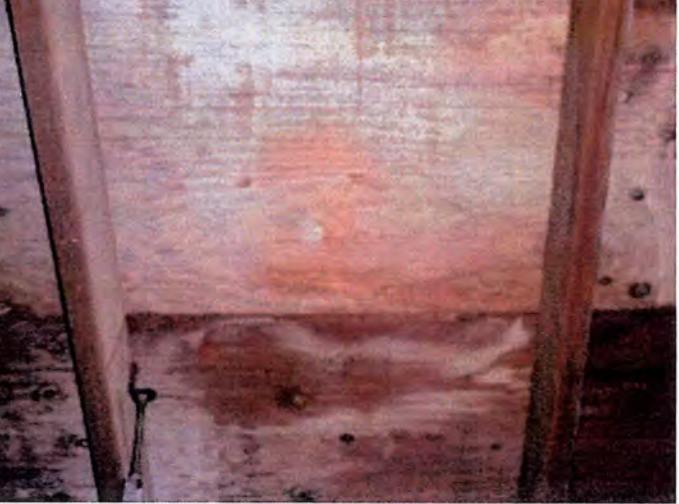
There were visible indications of mold present at all attic areas.

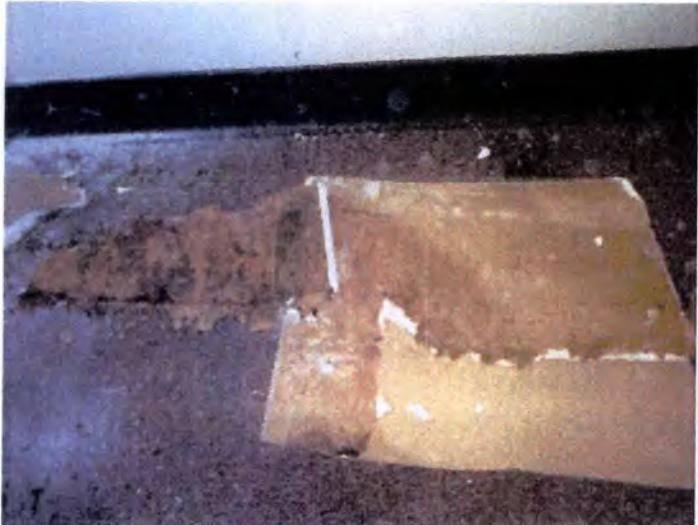
Visible indications of moisture intrusion and mold growth at building B and C interior, bedroom, bathroom and closet wall areas. Recommend removal and replacement of all interior wall finishes of B and C, after removal of all exterior vegetation.

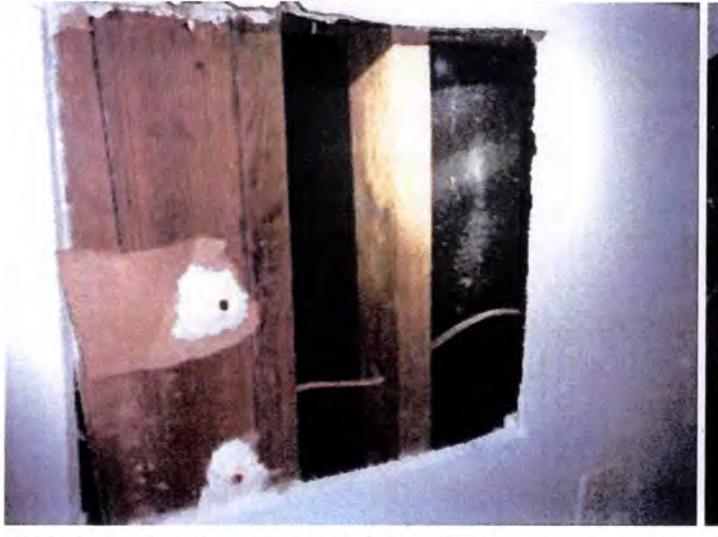
Visible indications of moisture intrusion and mold growth at building B and C interior, bedroom, bathroom and closet wall areas. Recommend removal and replacement of all interior wall finishes of B and C, after removal of all exterior vegetation.

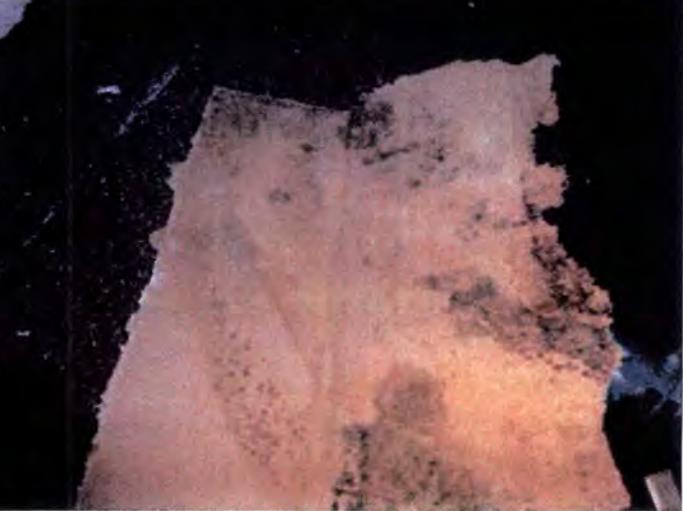
Visible indications of moisture intrusion and mold growth at building B and C interior, bedroom, bathroom and closet wall areas. Recommend removal and replacement of all interior wall finishes of B and C, after removal of all exterior vegetation.

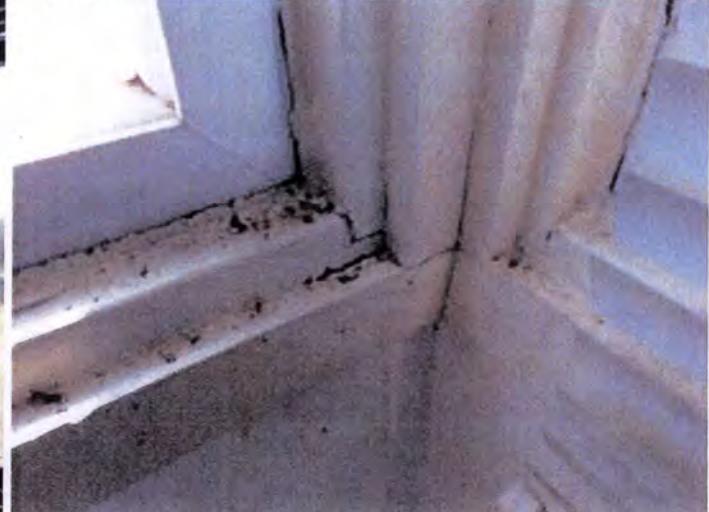
There were visible indications of moisture and termite damage observed at the interior window trim areas. Recommend replacement of all interior window trim and finishes.

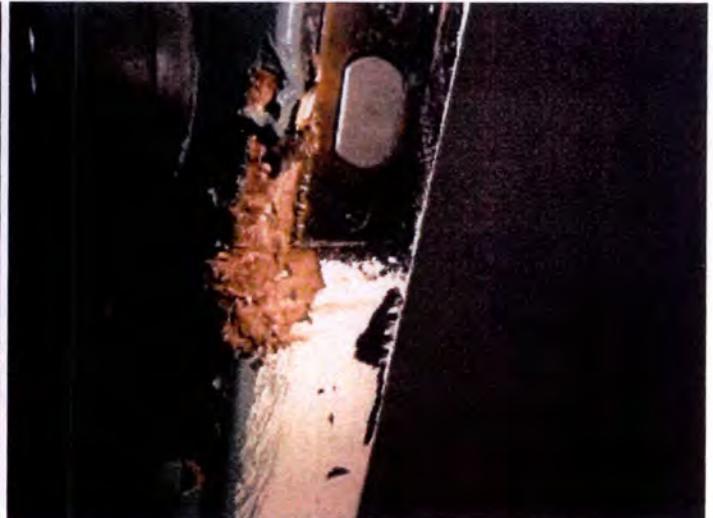
Most of the doors had varying degrees of damage observed when inspected. Based on the observed conditions, we recommend the replacement of all interior doors and trim within the dwelling units.

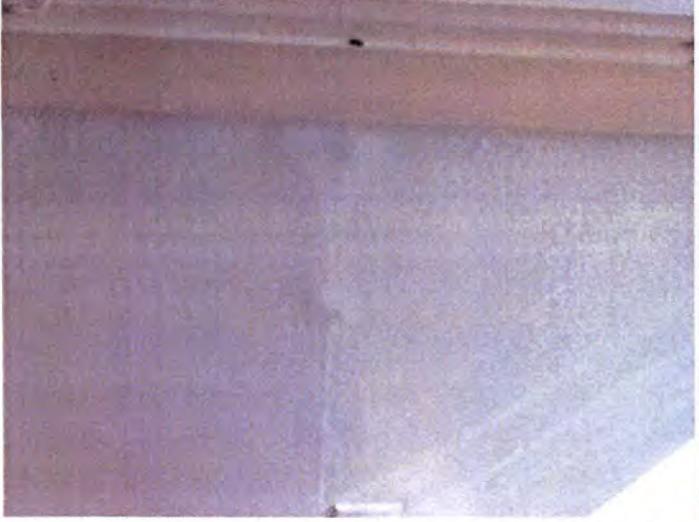
Most of the exterior facing lower interior wall finishes had moisture damage observed. Recommend removal and replacement of affected materials.

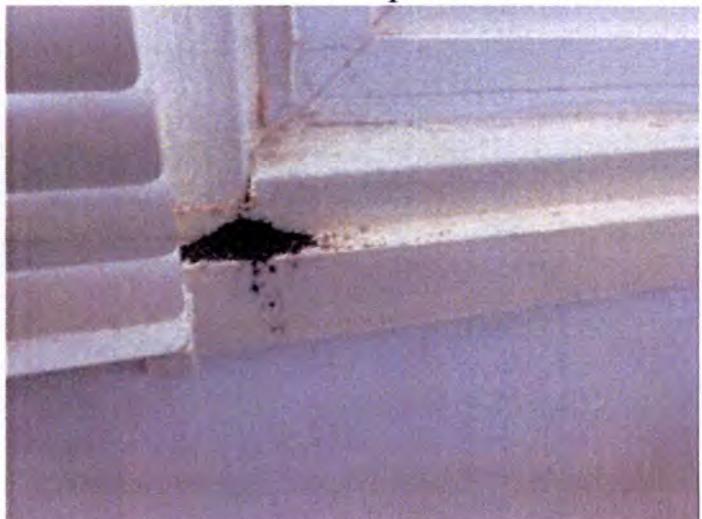
There were visible indications of moisture and termite damage observed at the interior window trim areas. Recommend replacement of all interior window trim and finishes.

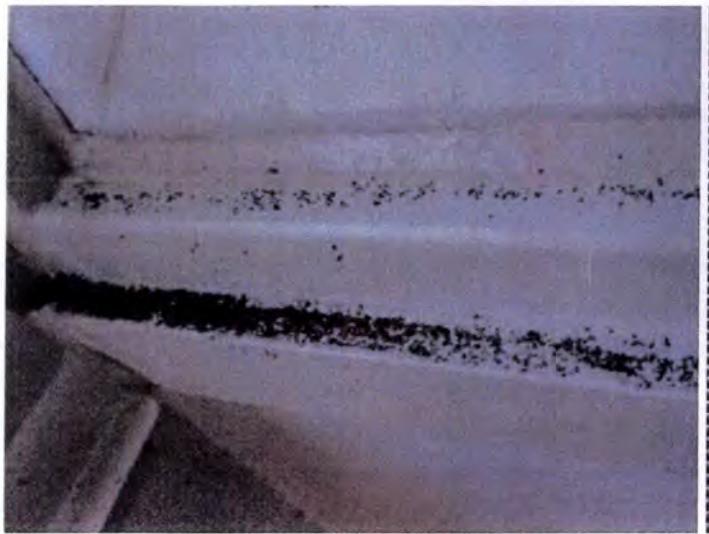
There were visible indications of moisture and termite damage observed at the interior window trim areas. Recommend replacement of all interior window trim and finishes.

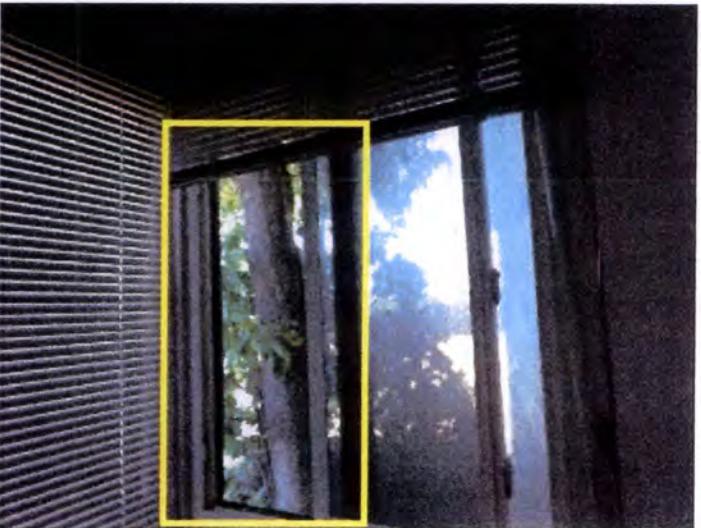
Many of the ground floor windows were broken at the time of inspection. Recommend replacement.

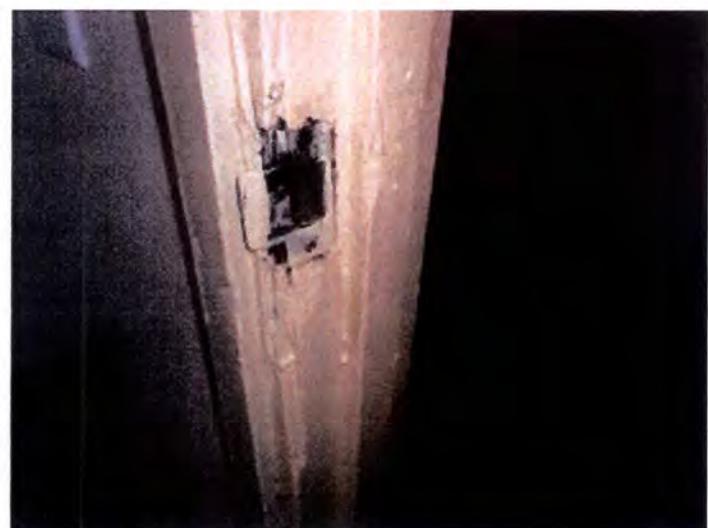
Most of the doors had varying degrees of damage observed when inspected. Based on the observed conditions, we recommend the replacement of all interior doors and trim within the dwelling units.

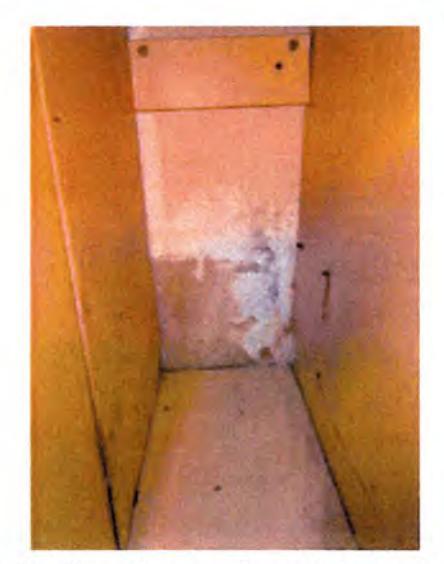
Visible indications of moisture intrusion and mold growth at building B and C interior, bedroom, bathroom and closet wall areas. Recommend removal and replacement of all interior wall finishes of B and C, after removal of all exterior vegetation.

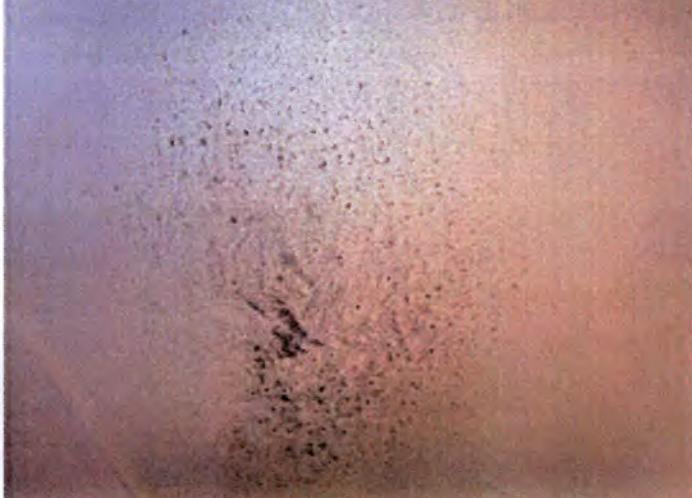
A-201

There were visible indications of water intrusion, with mold growth, noted at the ceiling areas of A-201. Recommend having a licensed contractor evaluate and repair as necessary to prevent further damage.

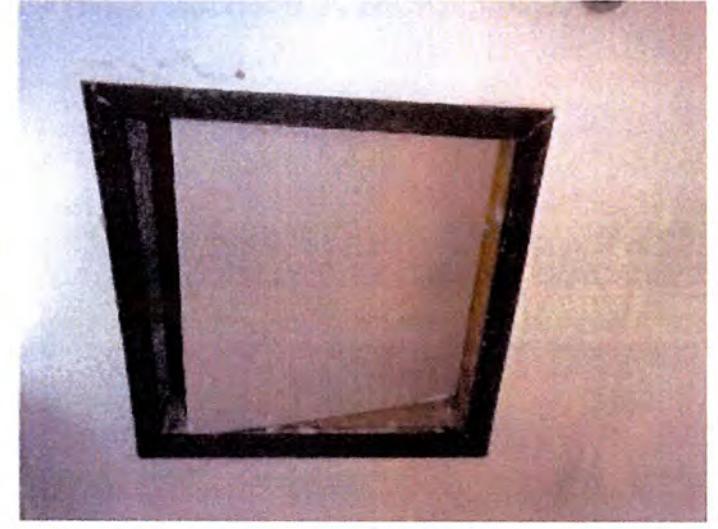
There were attic accesses located in the following locations: All second floor dwelling units.

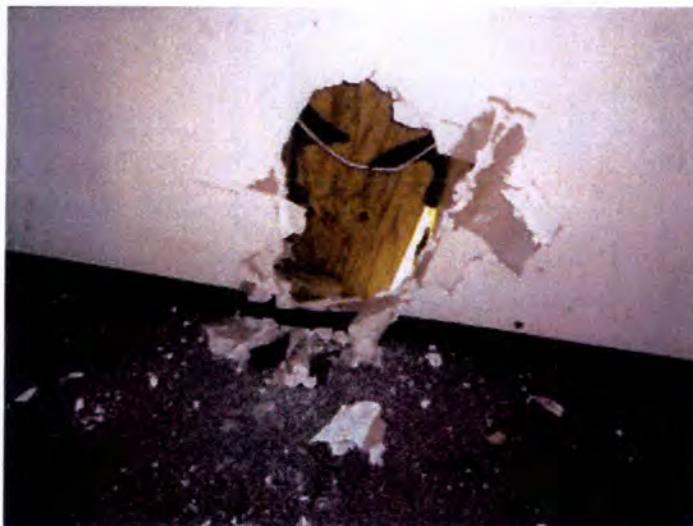
Most of the exterior facing lower interior wall finishes had moisture damage observed. Recommend removal and replacement of affected materials.

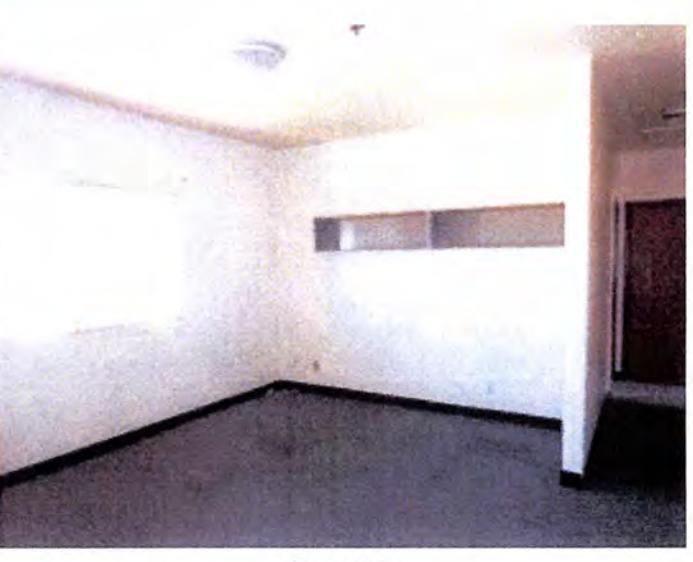
B-201

Visible indications of moisture intrusion and mold growth at building B and C interior, bedroom, bathroom and closet wall areas. Recommend removal and replacement of all interior wall finishes of B and C, after removal of all exterior vegetation.

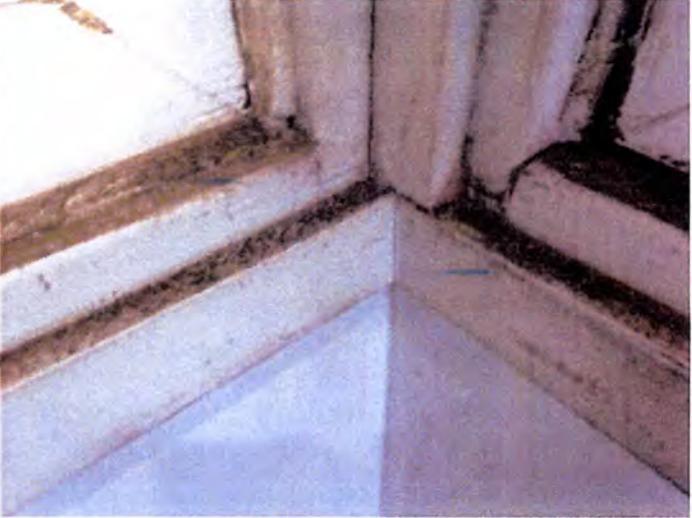
There were visible indications of moisture and termite damage observed at the interior window trim areas. Recommend replacement of all interior window trim and finishes.

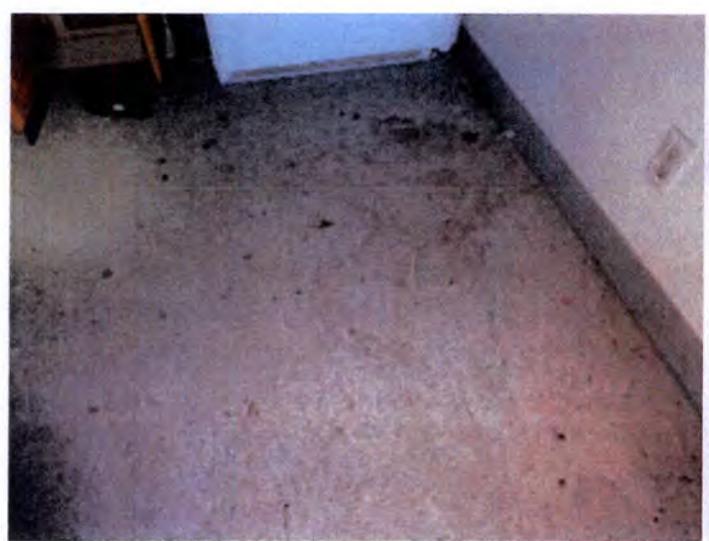
Most of the flooring in buildings B and C were damaged and should be replaced after completion of renovations.

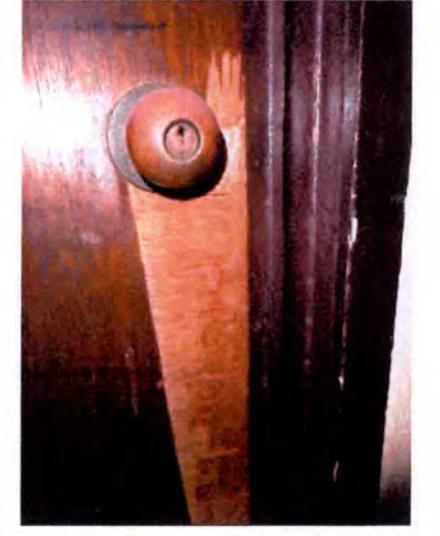
Most of the doors had varying degrees of damage observed when inspected. Based on the observed conditions, we recommend the replacement of all interior doors and trim within the dwelling units.

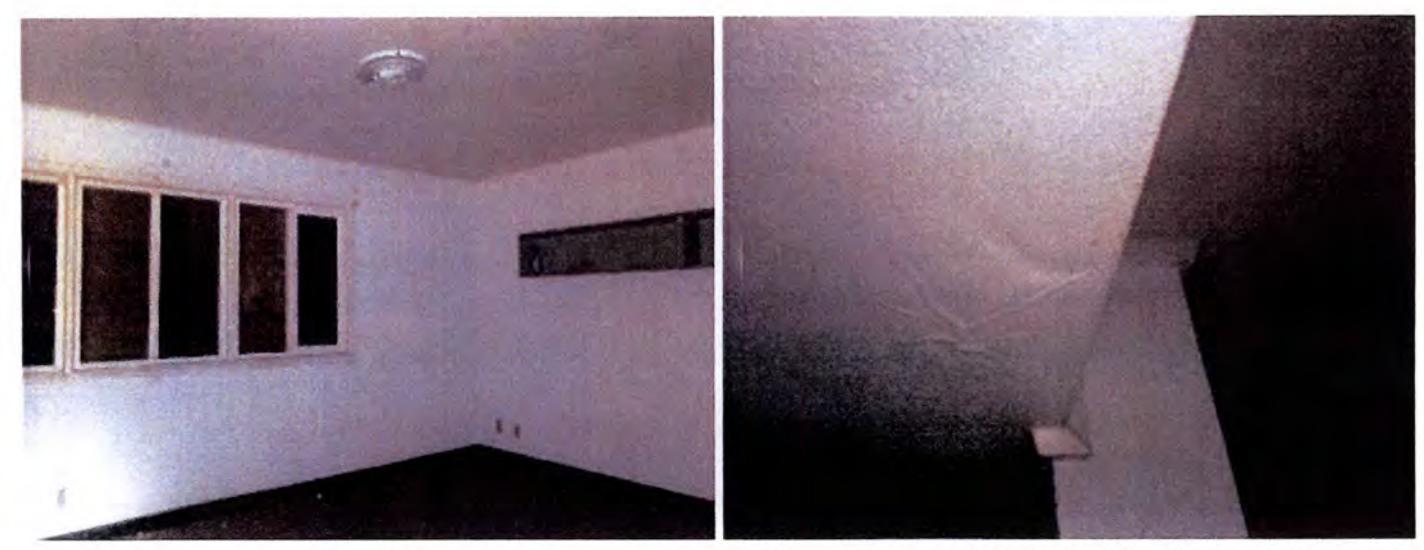
C-101

There were visible indications of water intrusion, with mold growth, noted at the ceiling areas of A-201, C-101. Recommend having a licensed contractor evaluate and repair as necessary to prevent further damage.
