SUBJECT: COUNTY-OWNED PARCEL ON NORTH PAPA AVENUE (KAHULUI) (HHT-14)

Property Condition Report

310 W Kaahumanu Ave, Kahului, HI 96732 Inspection prepared for: Maui County c/o Buddy Almeida Real Estate Agent: -

Date of Inspection: 3/28/2018 Time: 8:00 AM Age of Home: 1980 Size: 15000 This is a commercial property condition assessment to determine of three (3) former UH dormitories are suitable for housing. This inspection includes invasive and non-invasive inspection methods as well as sampling for asbestos and lead based paint.

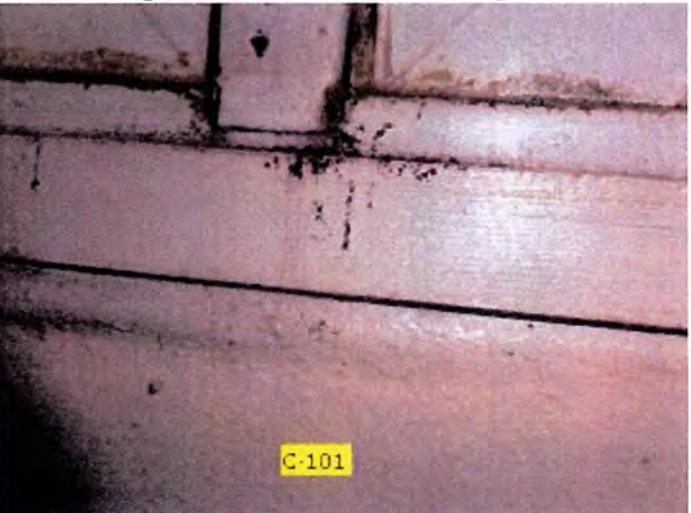
Visible indications of moisture intrusion and mold growth at building B and C interior, bedroom, bathroom and closet wall areas. Recommend removal and replacement of all interior wall finishes of B and C, after removal of all exterior vegetation.

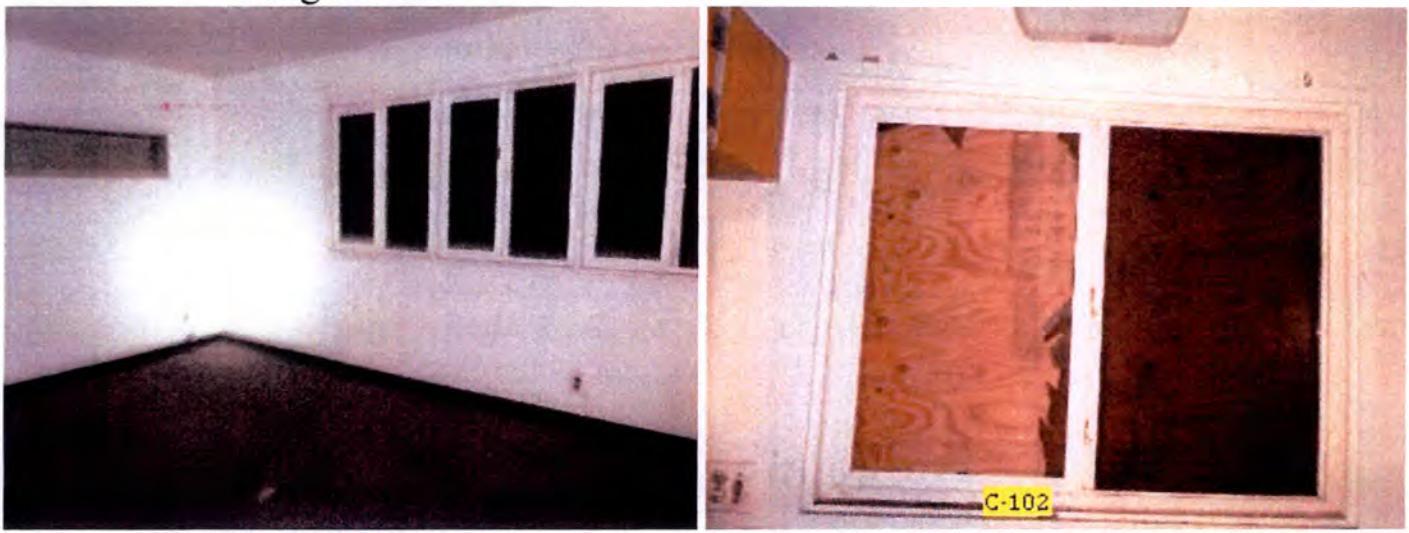
C-102

Many of the ground floor windows were broken at the time of inspection. Recommend replacement.

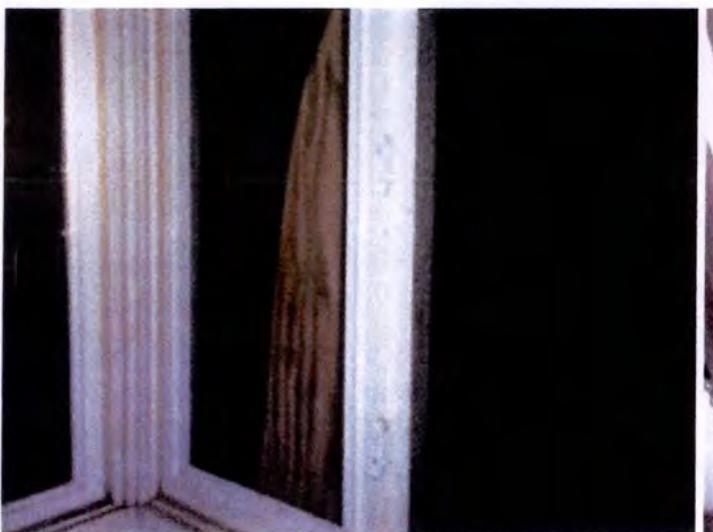
Many of the ground floor windows were broken at the time of inspection. Recommend replacement.

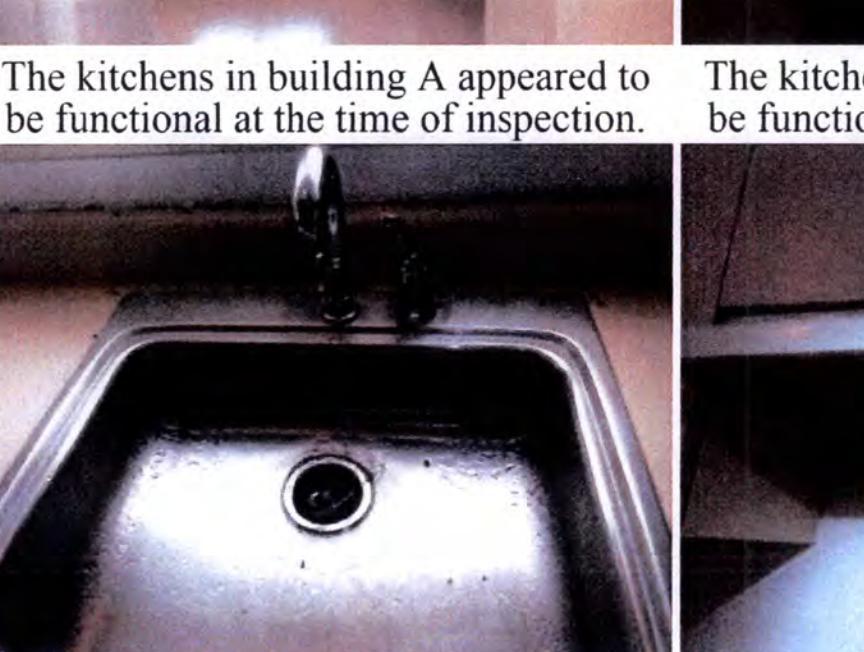
The kitchens in building A appeared to be functional at the time of inspection.

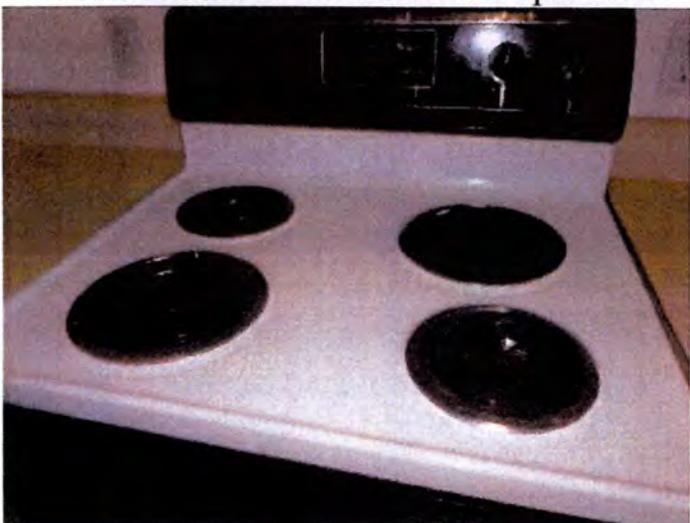
The kitchens in building A appeared to be functional at the time of inspection.

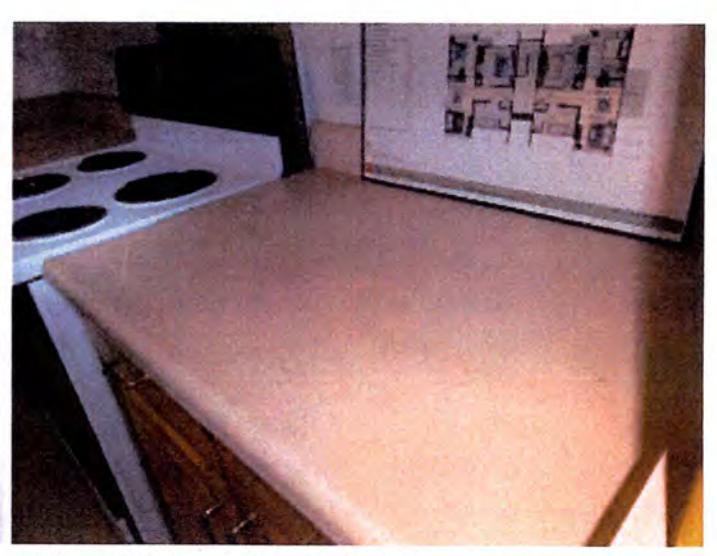
The kitchens in building A appeared to be functional at the time of inspection.

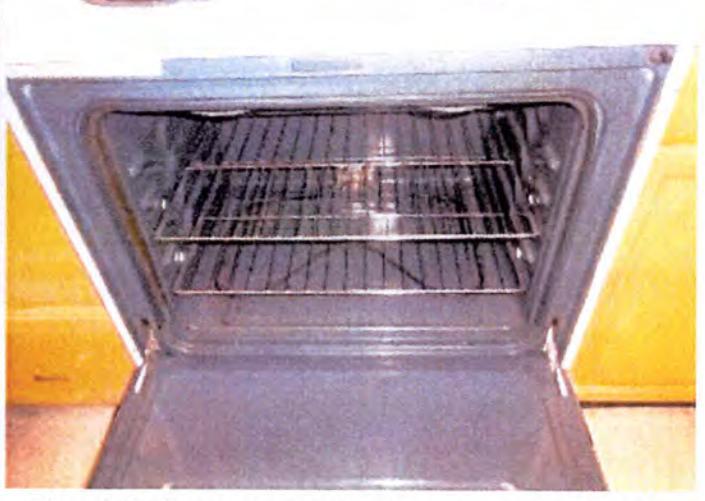
The kitchens in building A appeared to be functional at the time of inspection.

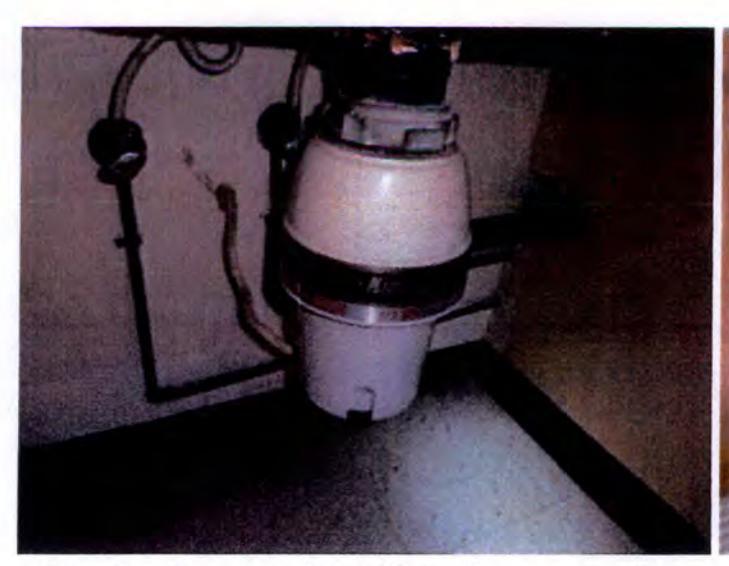
The kitchens in building A appeared to be functional at the time of inspection.

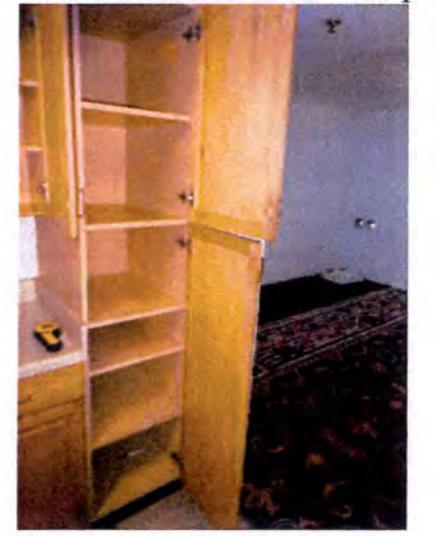
The kitchens in building A appeared to be functional at the time of inspection.

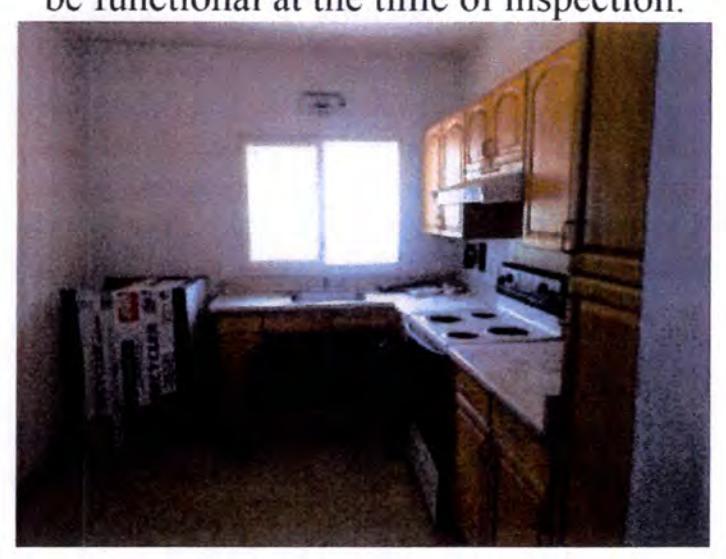
The kitchens in building A appeared to be functional at the time of inspection.

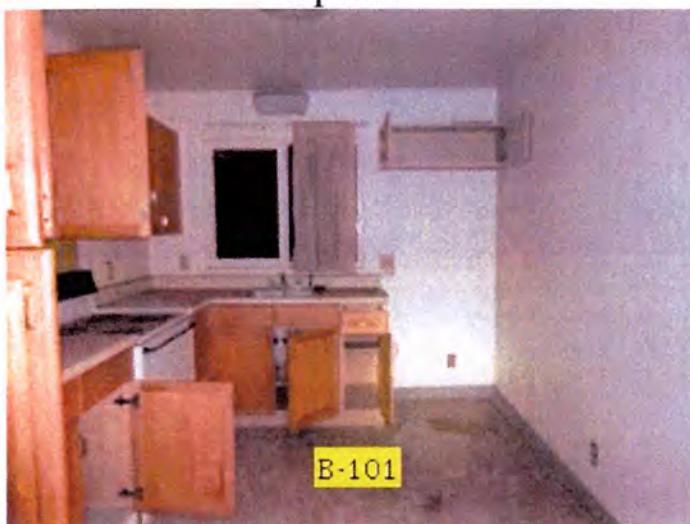
The kitchens of buildings B and C were deteriorated with moisture damage, termite damage and general damage observed at the cabinets, counters and finishes. Recommend the replacement of finishes. Recommend the replacement of all dwelling unit kitchens, fixtures and appliances.

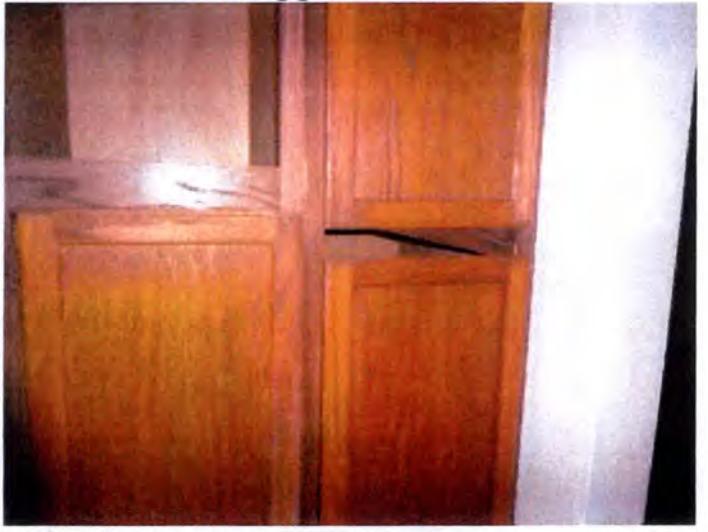
The kitchens of buildings B and C were deteriorated with moisture damage, termite damage and general damage observed at the cabinets, counters and all dwelling unit kitchens, fixtures and appliances.

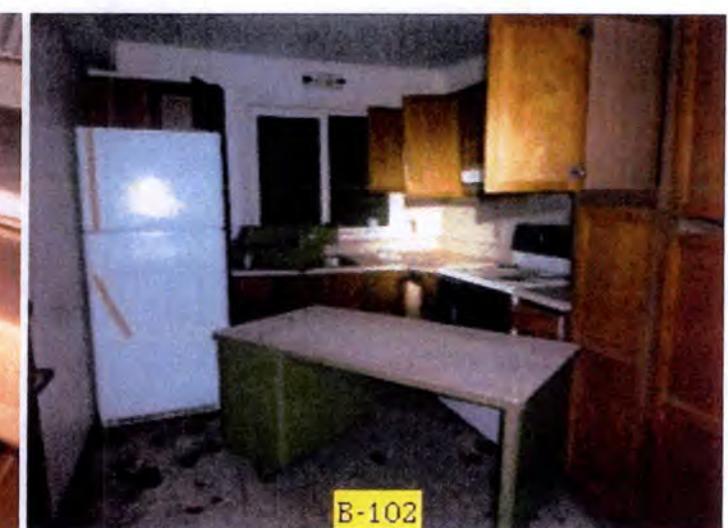
be functional condition at the time of inspection. Recommend replacement.

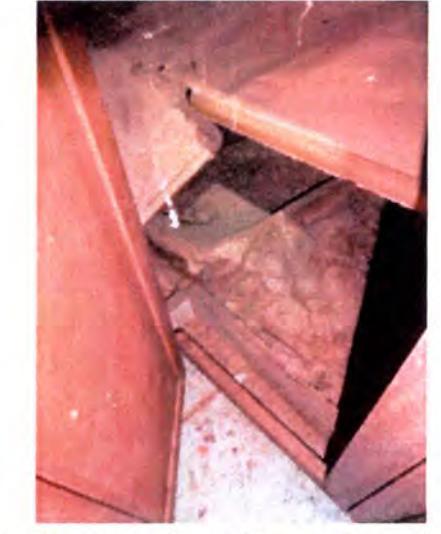
The kitchens of buildings B and C were deteriorated with moisture damage, termite damage and general damage observed at the cabinets, counters and finishes. Recommend the replacement of finishes. Recommend the replacement of all dwelling unit kitchens, fixtures and appliances.

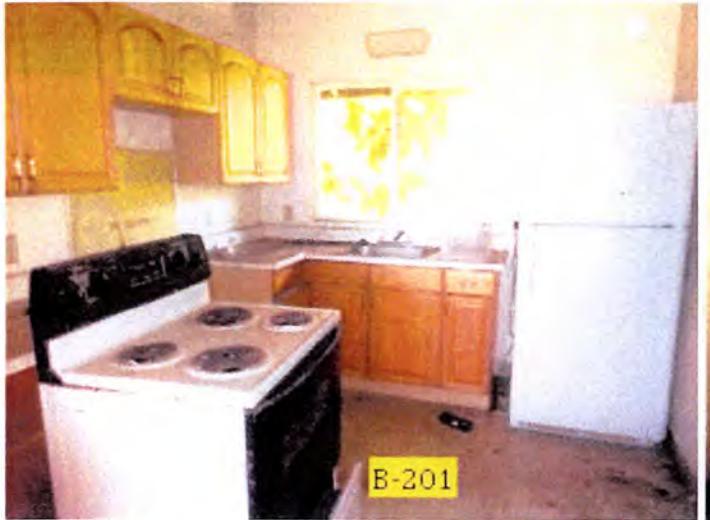
The kitchens of buildings B and C were deteriorated with moisture damage, termite damage and general damage observed at the cabinets, counters and finishes. Recommend the replacement of finishes. Recommend the replacement of all dwelling unit kitchens, fixtures and appliances.

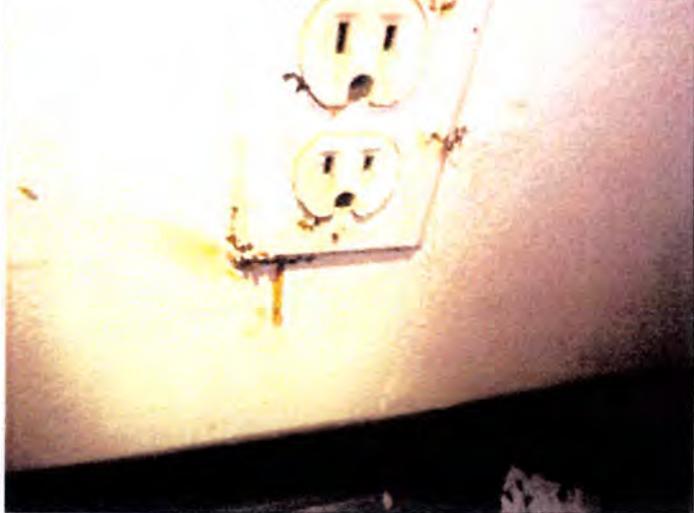
The kitchens of buildings B and C were deteriorated with moisture damage, termite damage and general damage observed at the cabinets, counters and all dwelling unit kitchens, fixtures and appliances.

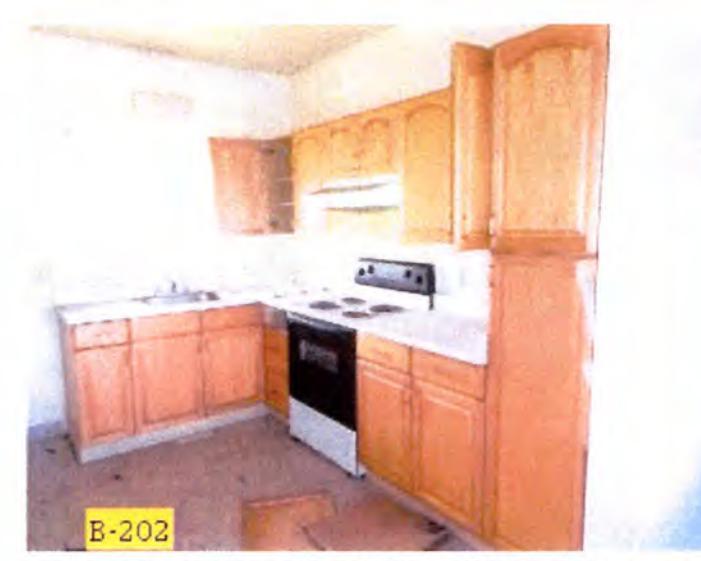
The kitchens of buildings B and C were deteriorated with moisture damage, termite damage and general damage observed at the cabinets, counters and finishes. Recommend the replacement of finishes. Recommend the replacement of all dwelling unit kitchens, fixtures and appliances.

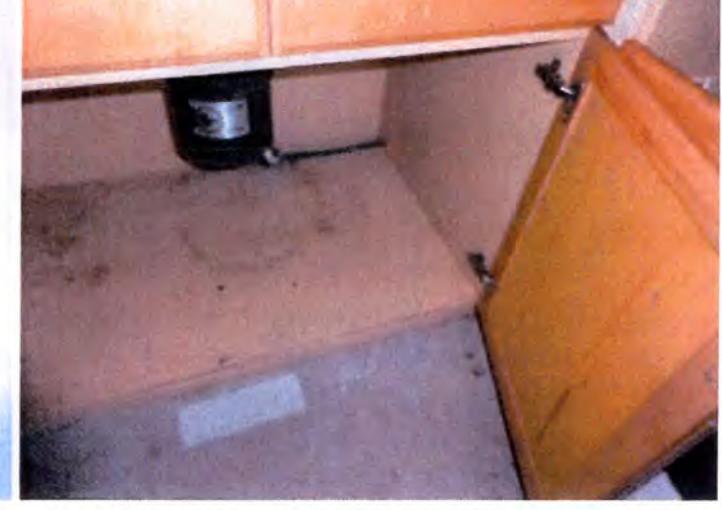
The kitchens of buildings B and C were deteriorated with moisture damage, termite damage and general damage observed at the cabinets, counters and all dwelling unit kitchens, fixtures and appliances.

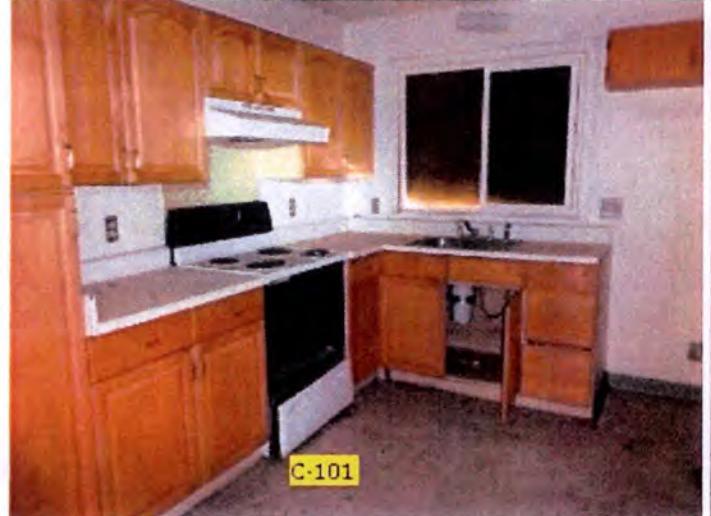
The kitchens of buildings B and C were deteriorated with moisture damage, termite damage and general damage observed at the cabinets, counters and all dwelling unit kitchens, fixtures and appliances.

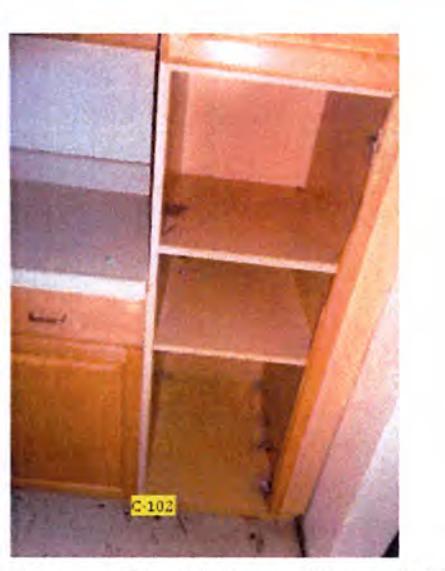
The kitchens of buildings B and C were deteriorated with moisture damage, termite damage and general damage observed at the cabinets, counters and finishes. Recommend the replacement of all dwelling unit kitchens, fixtures and appliances.

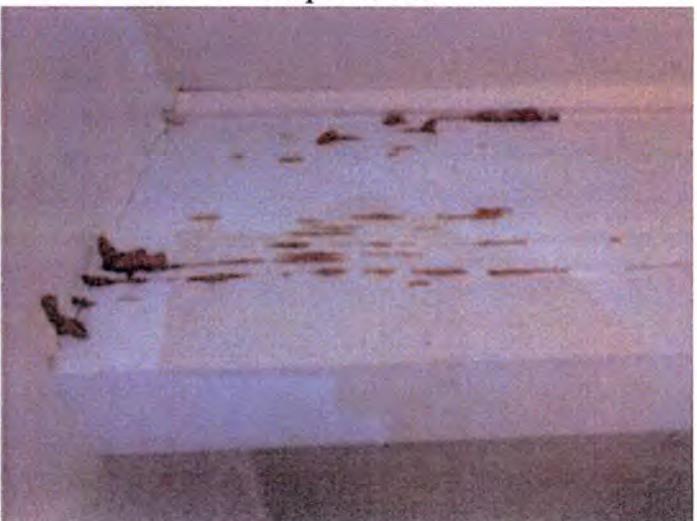
B-201: Ceiling joists were severely termite damaged and need to be repaired/replaced.

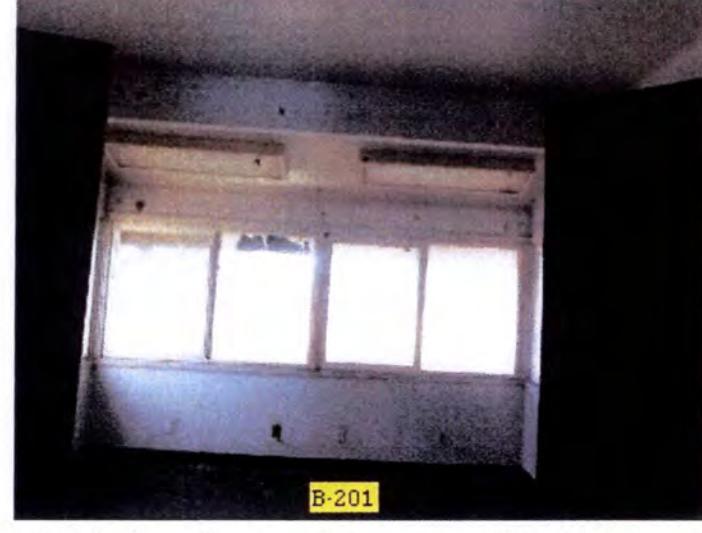
B-201: Ceiling joists were severely termite damaged and need to be repaired/replaced.

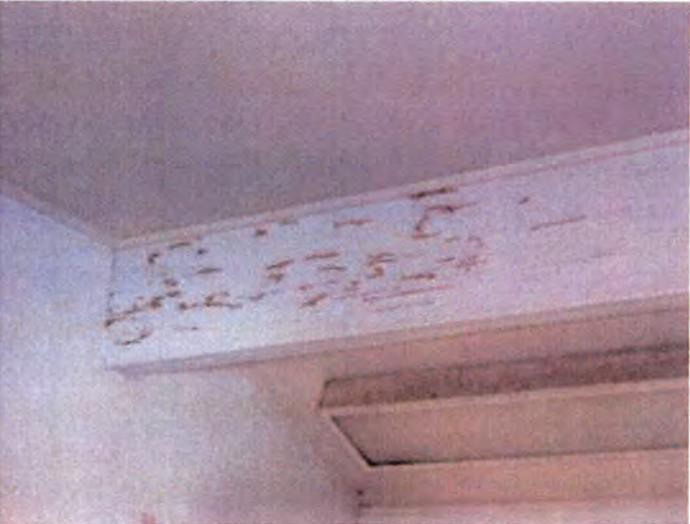
B-201: Ceiling joists were severely termite damaged and need to be repaired/replaced.

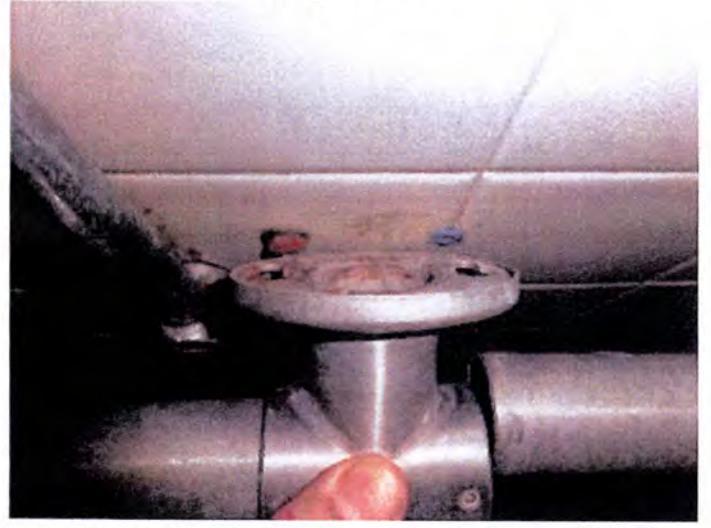
Bldg A bathroom hand rails need to be repaired.

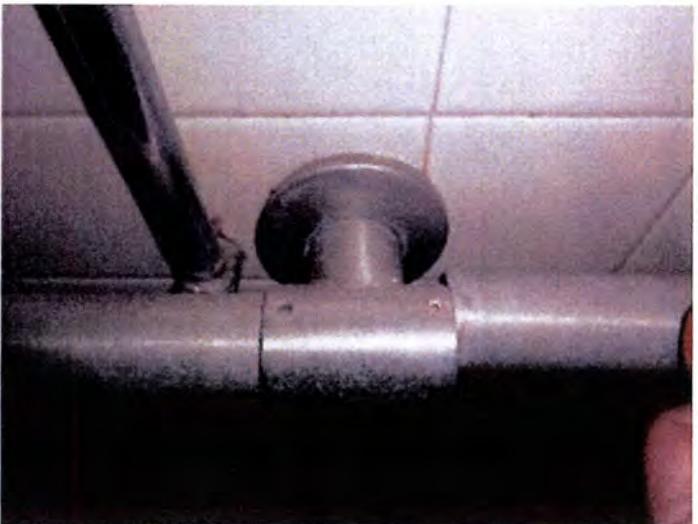
Bldg A bathroom hand rails need to be repaired.

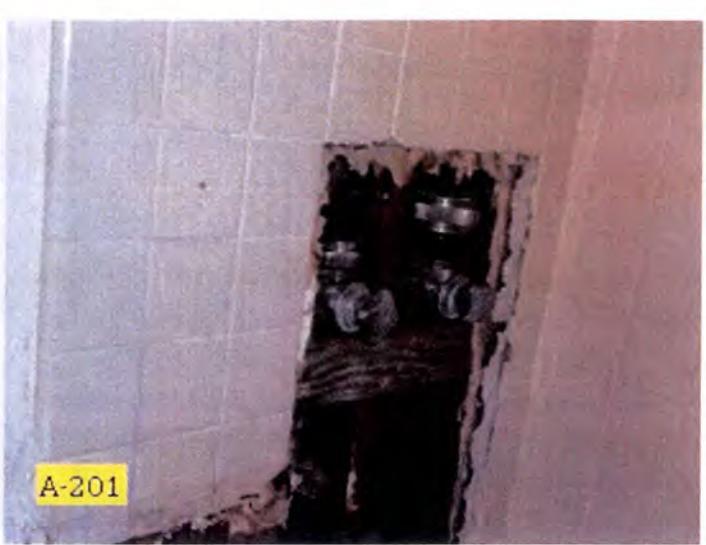
There were visible indications of moisture damage, mold growth, damaged flooring, damaged cabinets and counters, damaged mirrors, damaged toilets and damaged shower compartments observed at the time of inspection. Based on the observed conditions on site, we recommend the replacement of all dwelling unit bathrooms.

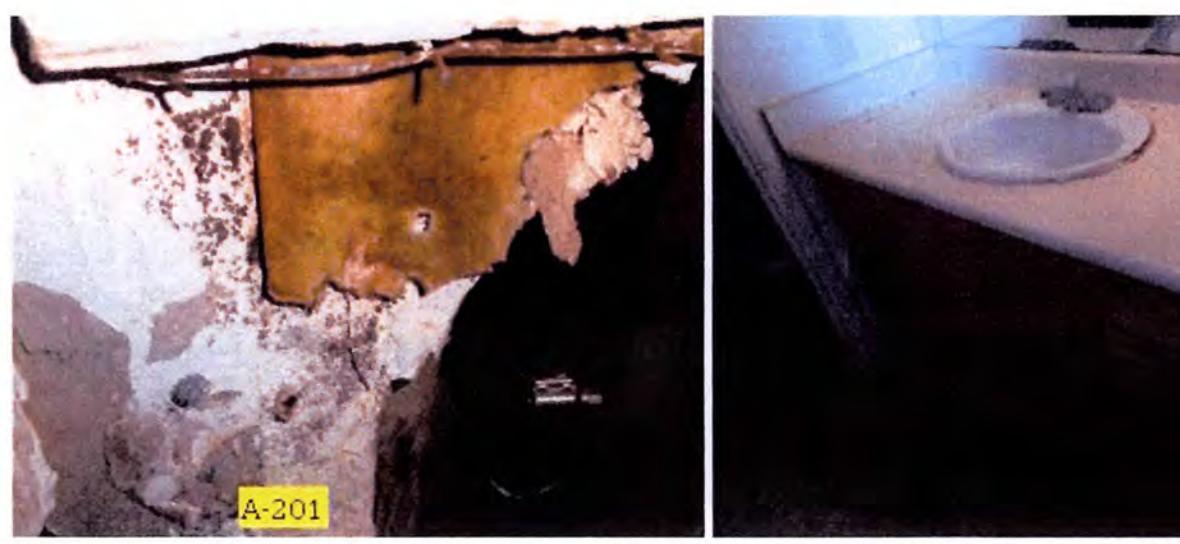
3.7: Interior Elements 3.7.6: Bathrooms

There were visible indications of moisture damage, mold growth, damaged flooring, damaged cabinets and counters, damaged mirrors, damaged toilets and damaged shower compartments observed at the time of inspection. Based on the observed conditions on site, we recommend the replacement of all dwelling unit bathrooms.

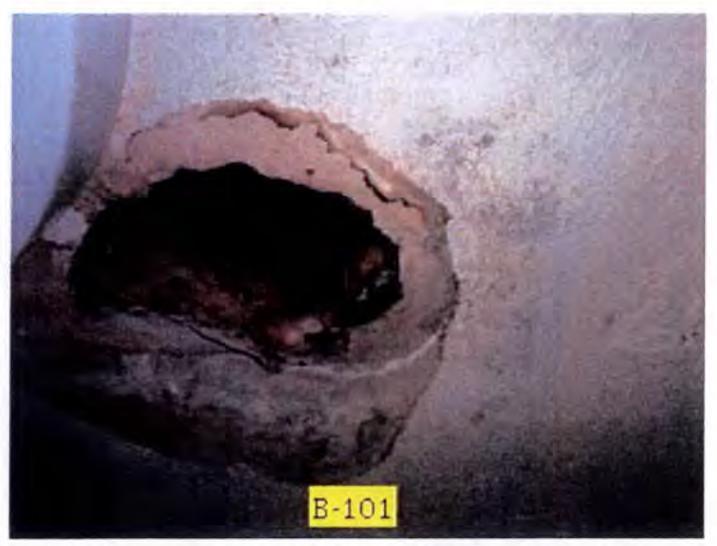
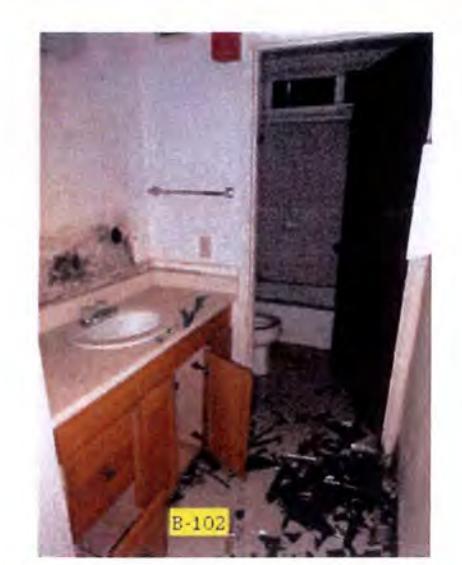
There were visible indications of moisture damage, mold growth, damaged flooring, damaged cabinets and counters, damaged mirrors, damaged toilets and damaged shower compartments observed at the time of inspection. Based on the observed conditions on site, we recommend the replacement of all dwelling unit bathrooms. There were visible indications of moisture damage, mold growth, damaged flooring, damaged cabinets and counters, damaged mirrors, damaged toilets and damaged shower compartments observed at the time of inspection. Based on the observed conditions on site, we recommend the replacement of all dwelling unit bathrooms.

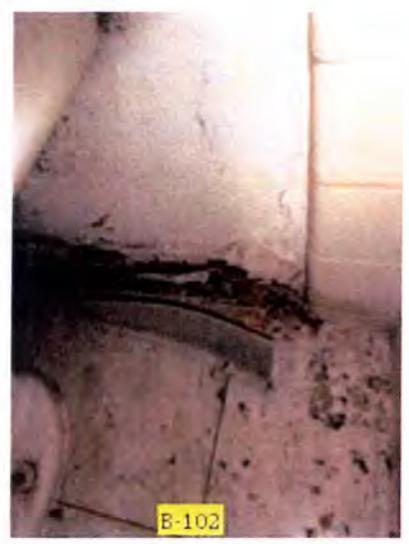
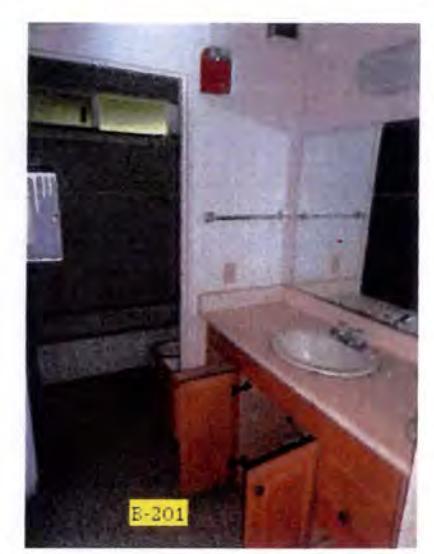
There were visible indications of moisture damage, mold growth, damaged flooring, damaged cabinets and counters, damaged mirrors, damaged toilets and damaged shower compartments observed at the time of inspection. Based on the observed conditions on site, we recommend the replacement of all dwelling unit bathrooms. There were visible indications of moisture damage, mold growth, damaged flooring, damaged cabinets and counters, damaged mirrors, damaged toilets and damaged shower compartments observed at the time of inspection. Based on the observed conditions on site, we recommend the replacement of all dwelling unit bathrooms.

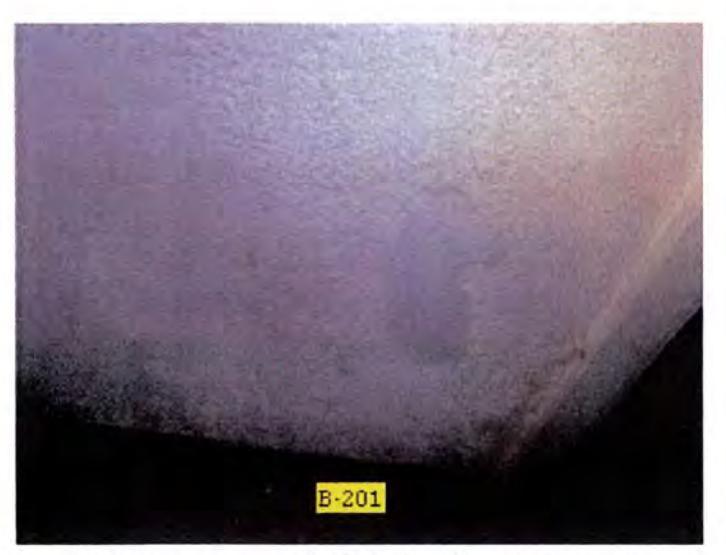
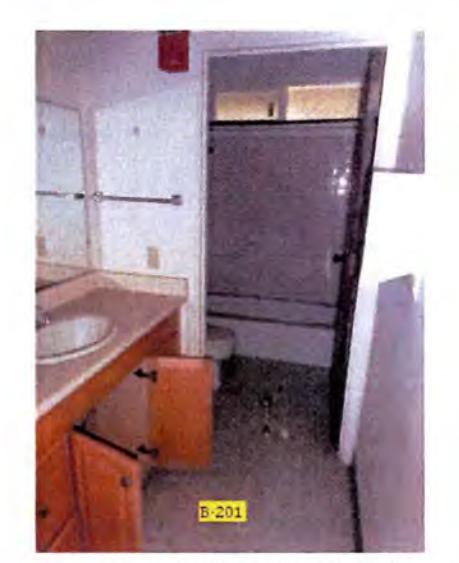
There were visible indications of moisture damage, mold growth, damaged flooring, damaged cabinets and counters, damaged mirrors, damaged toilets and damaged shower compartments observed at the time of inspection. Based on the observed conditions on site, we recommend the replacement of all dwelling unit bathrooms. There were visible indications of moisture damage, mold growth, damaged flooring, damaged cabinets and counters, damaged mirrors, damaged toilets and damaged shower compartments observed at the time of inspection. Based on the observed conditions on site, we recommend the replacement of all dwelling unit bathrooms.

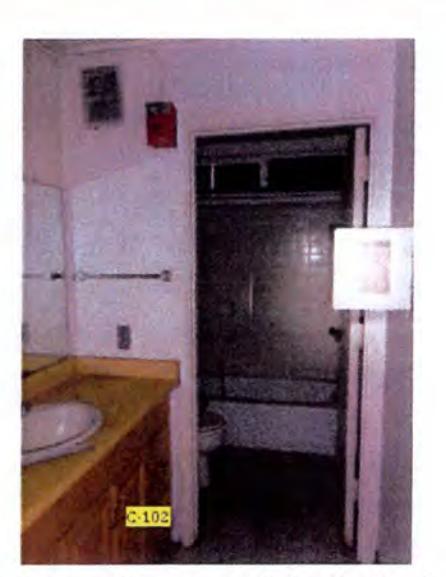
3.7: Interior Elements 3.7.6: Bathrooms

There were visible indications of moisture damage, mold growth, damaged flooring, damaged cabinets and counters, damaged mirrors, damaged toilets and damaged shower compartments observed at the time of inspection. Based on the observed conditions on site, we recommend the replacement of all dwelling unit bathrooms.

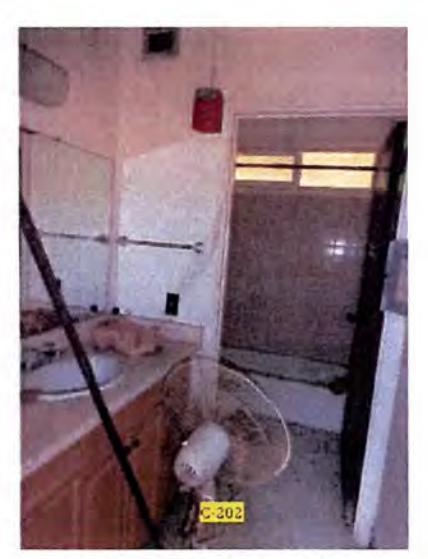
There were visible indications of damaged mirrors, damaged toilets and at the time of inspection. Based on the observed conditions on site, we recommend the replacement of all dwelling unit bathrooms.

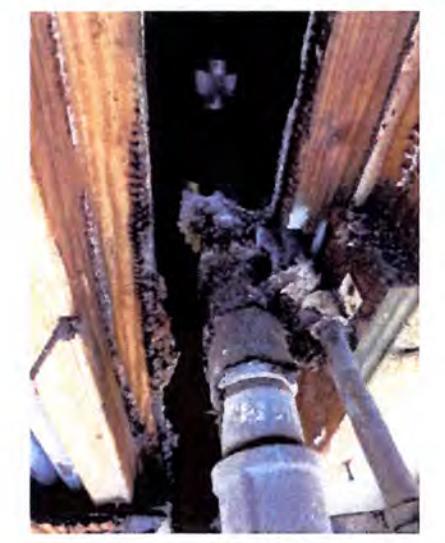
There was a hazardous bee population The single story storage building had sections of front wall removed for past been removal. The left side of the building had extensive and constant also observed at other exterior and interior locations through out the property.

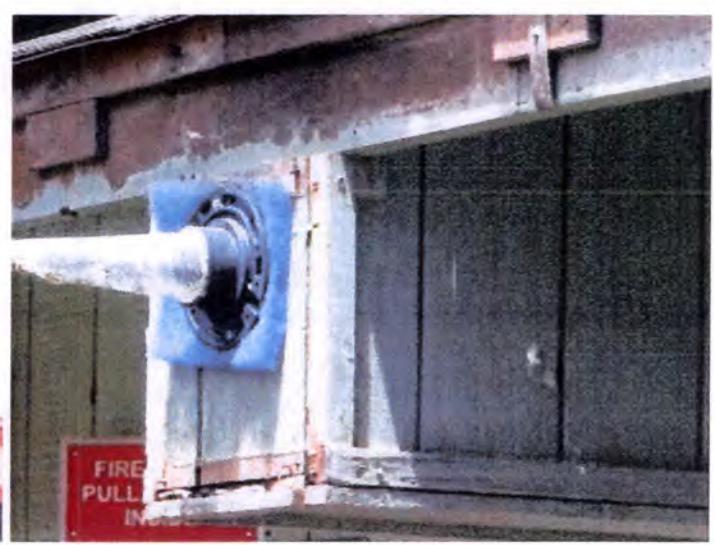
There was a hazardous bee population The single story storage building had sections of front wall removed for past been removal. The left side of the building had extensive and constant activity observed. There were been nests also observed at other exterior and interior locations through out the property.

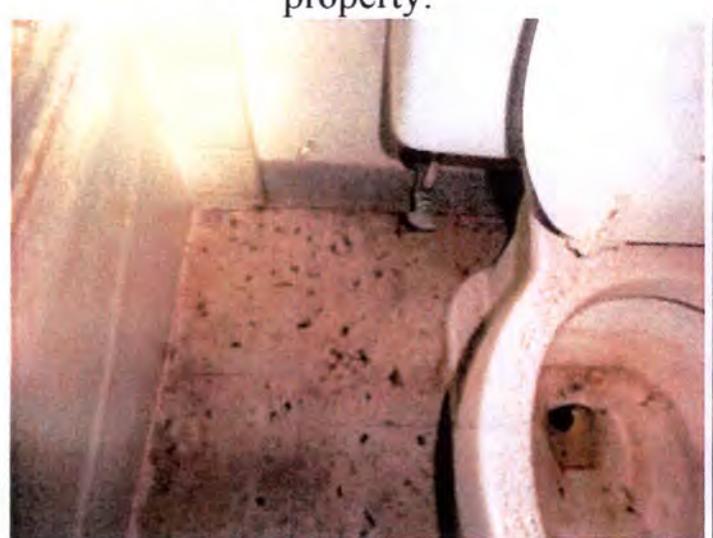
There was extensive pest (ie: cockroach) infestation observed at the interior and/or termite/moisture damage observed at the exterior areas of the building.

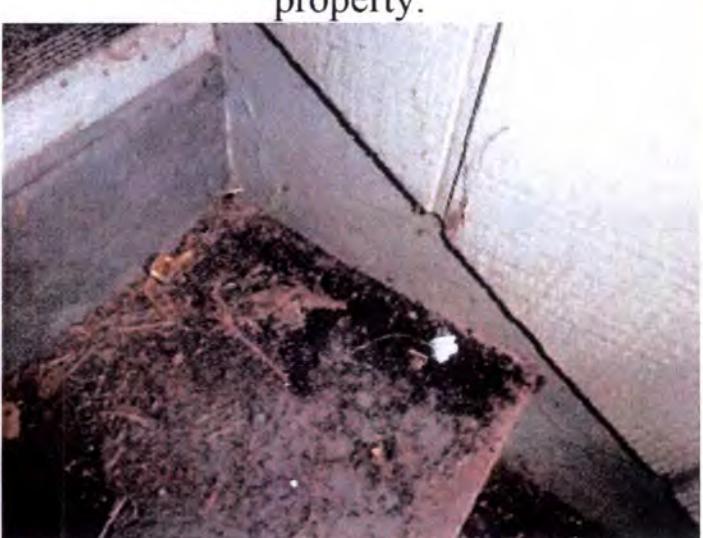
There was moderate/extensive interior and/or exterior areas of the building.

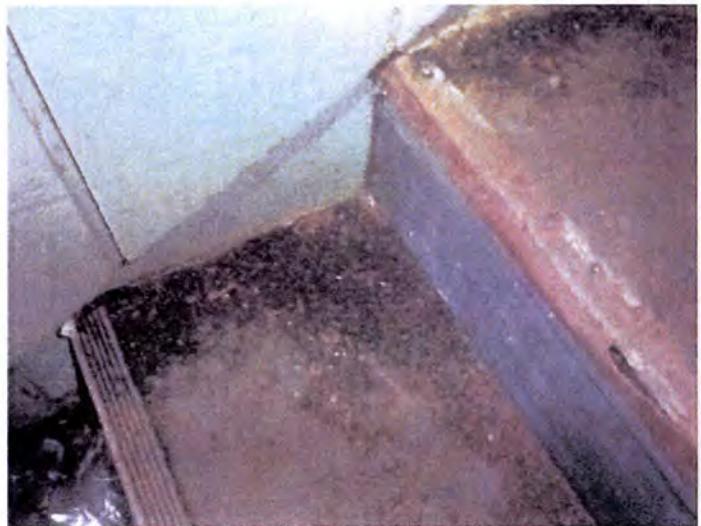
There was moderate/extensive interior and/or exterior areas of the building.

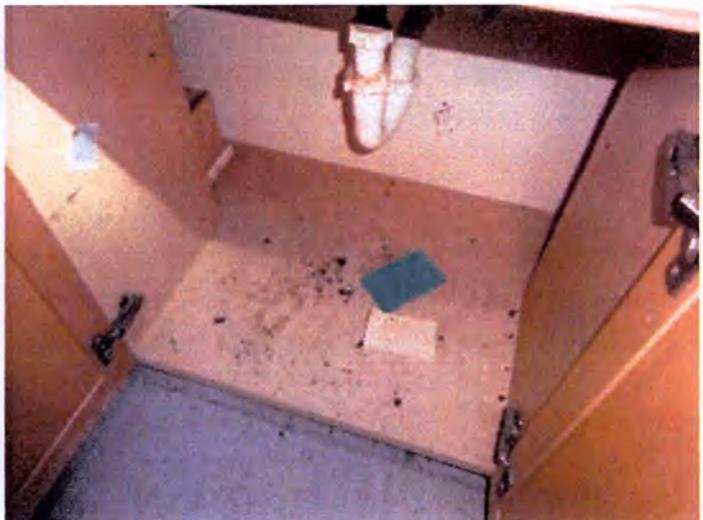
There was extensive pest (ie: cockroach) termite/moisture damage observed at the infestation observed at the interior and/or exterior areas of the building.

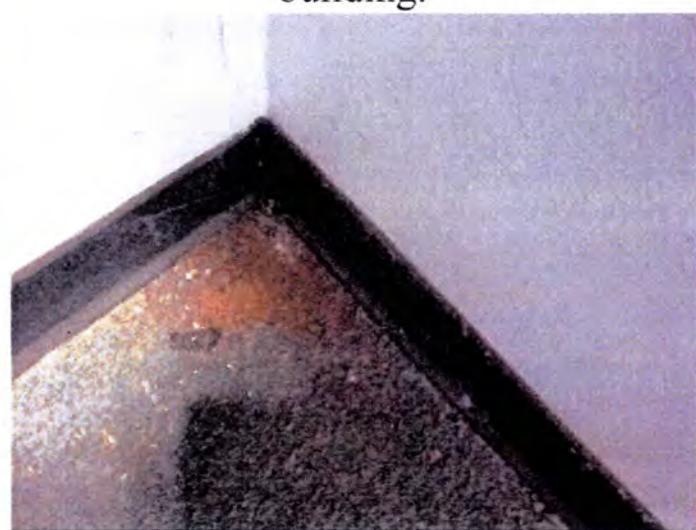
There was moderate/extensive interior and/or exterior areas of the building.

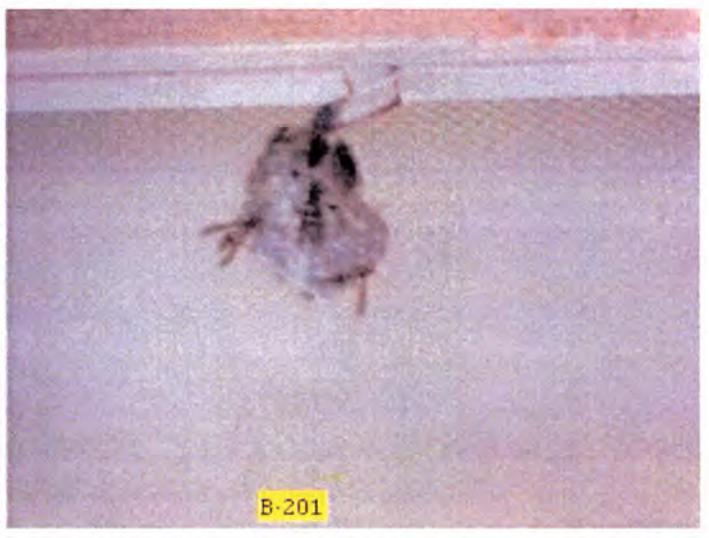
There was a hazardous bee population termite/moisture damage observed at the observed on site at the time of inspection. The single story storage building had sections of front wall removed for past been removal. The left side of the building had extensive and constant activity observed. There were been nests also observed at other exterior and interior locations through out the property.

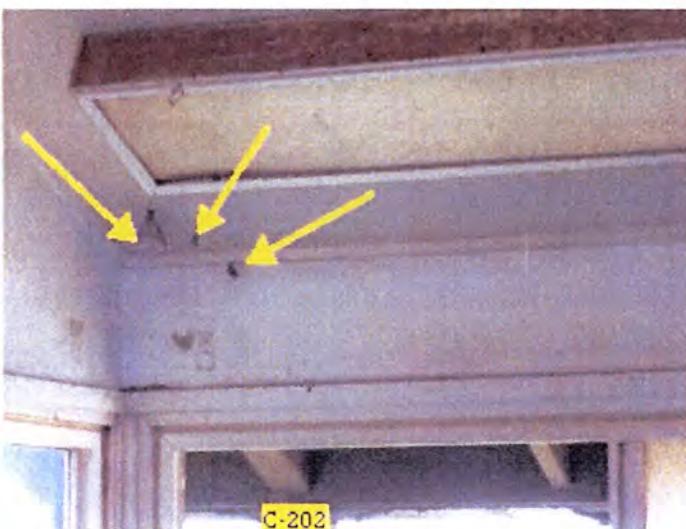
There was a hazardous bee population The single story storage building had sections of front wall removed for past been removal. The left side of the building had extensive and constant activity observed. There were been nests also observed at other exterior and interior locations through out the property.

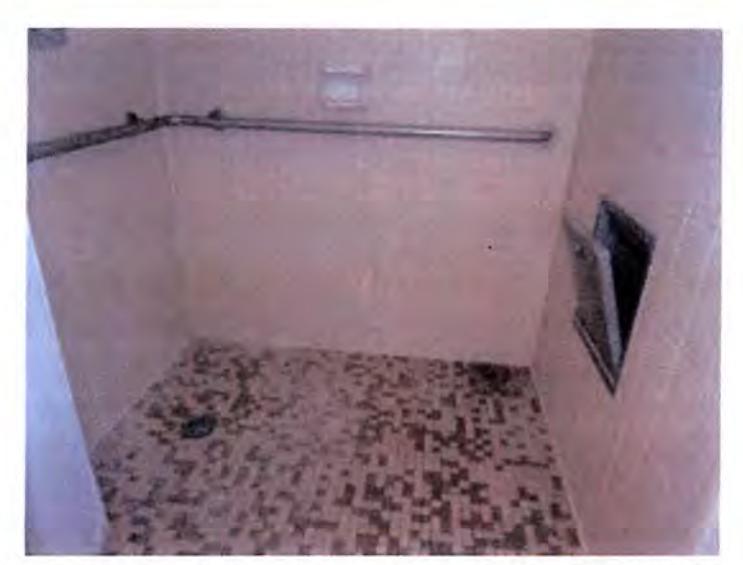
The ground floor units of building A were ADA compliant for access.
